(12) **United States Patent**  
**Donovan**

(10) **Patent No.:** **US 11,225,181 B2**  
(45) **Date of Patent:** **Jan. 18, 2022**

(54) **RESIN FUSES AND VEHICLES  
COMPRISING THE SAME**

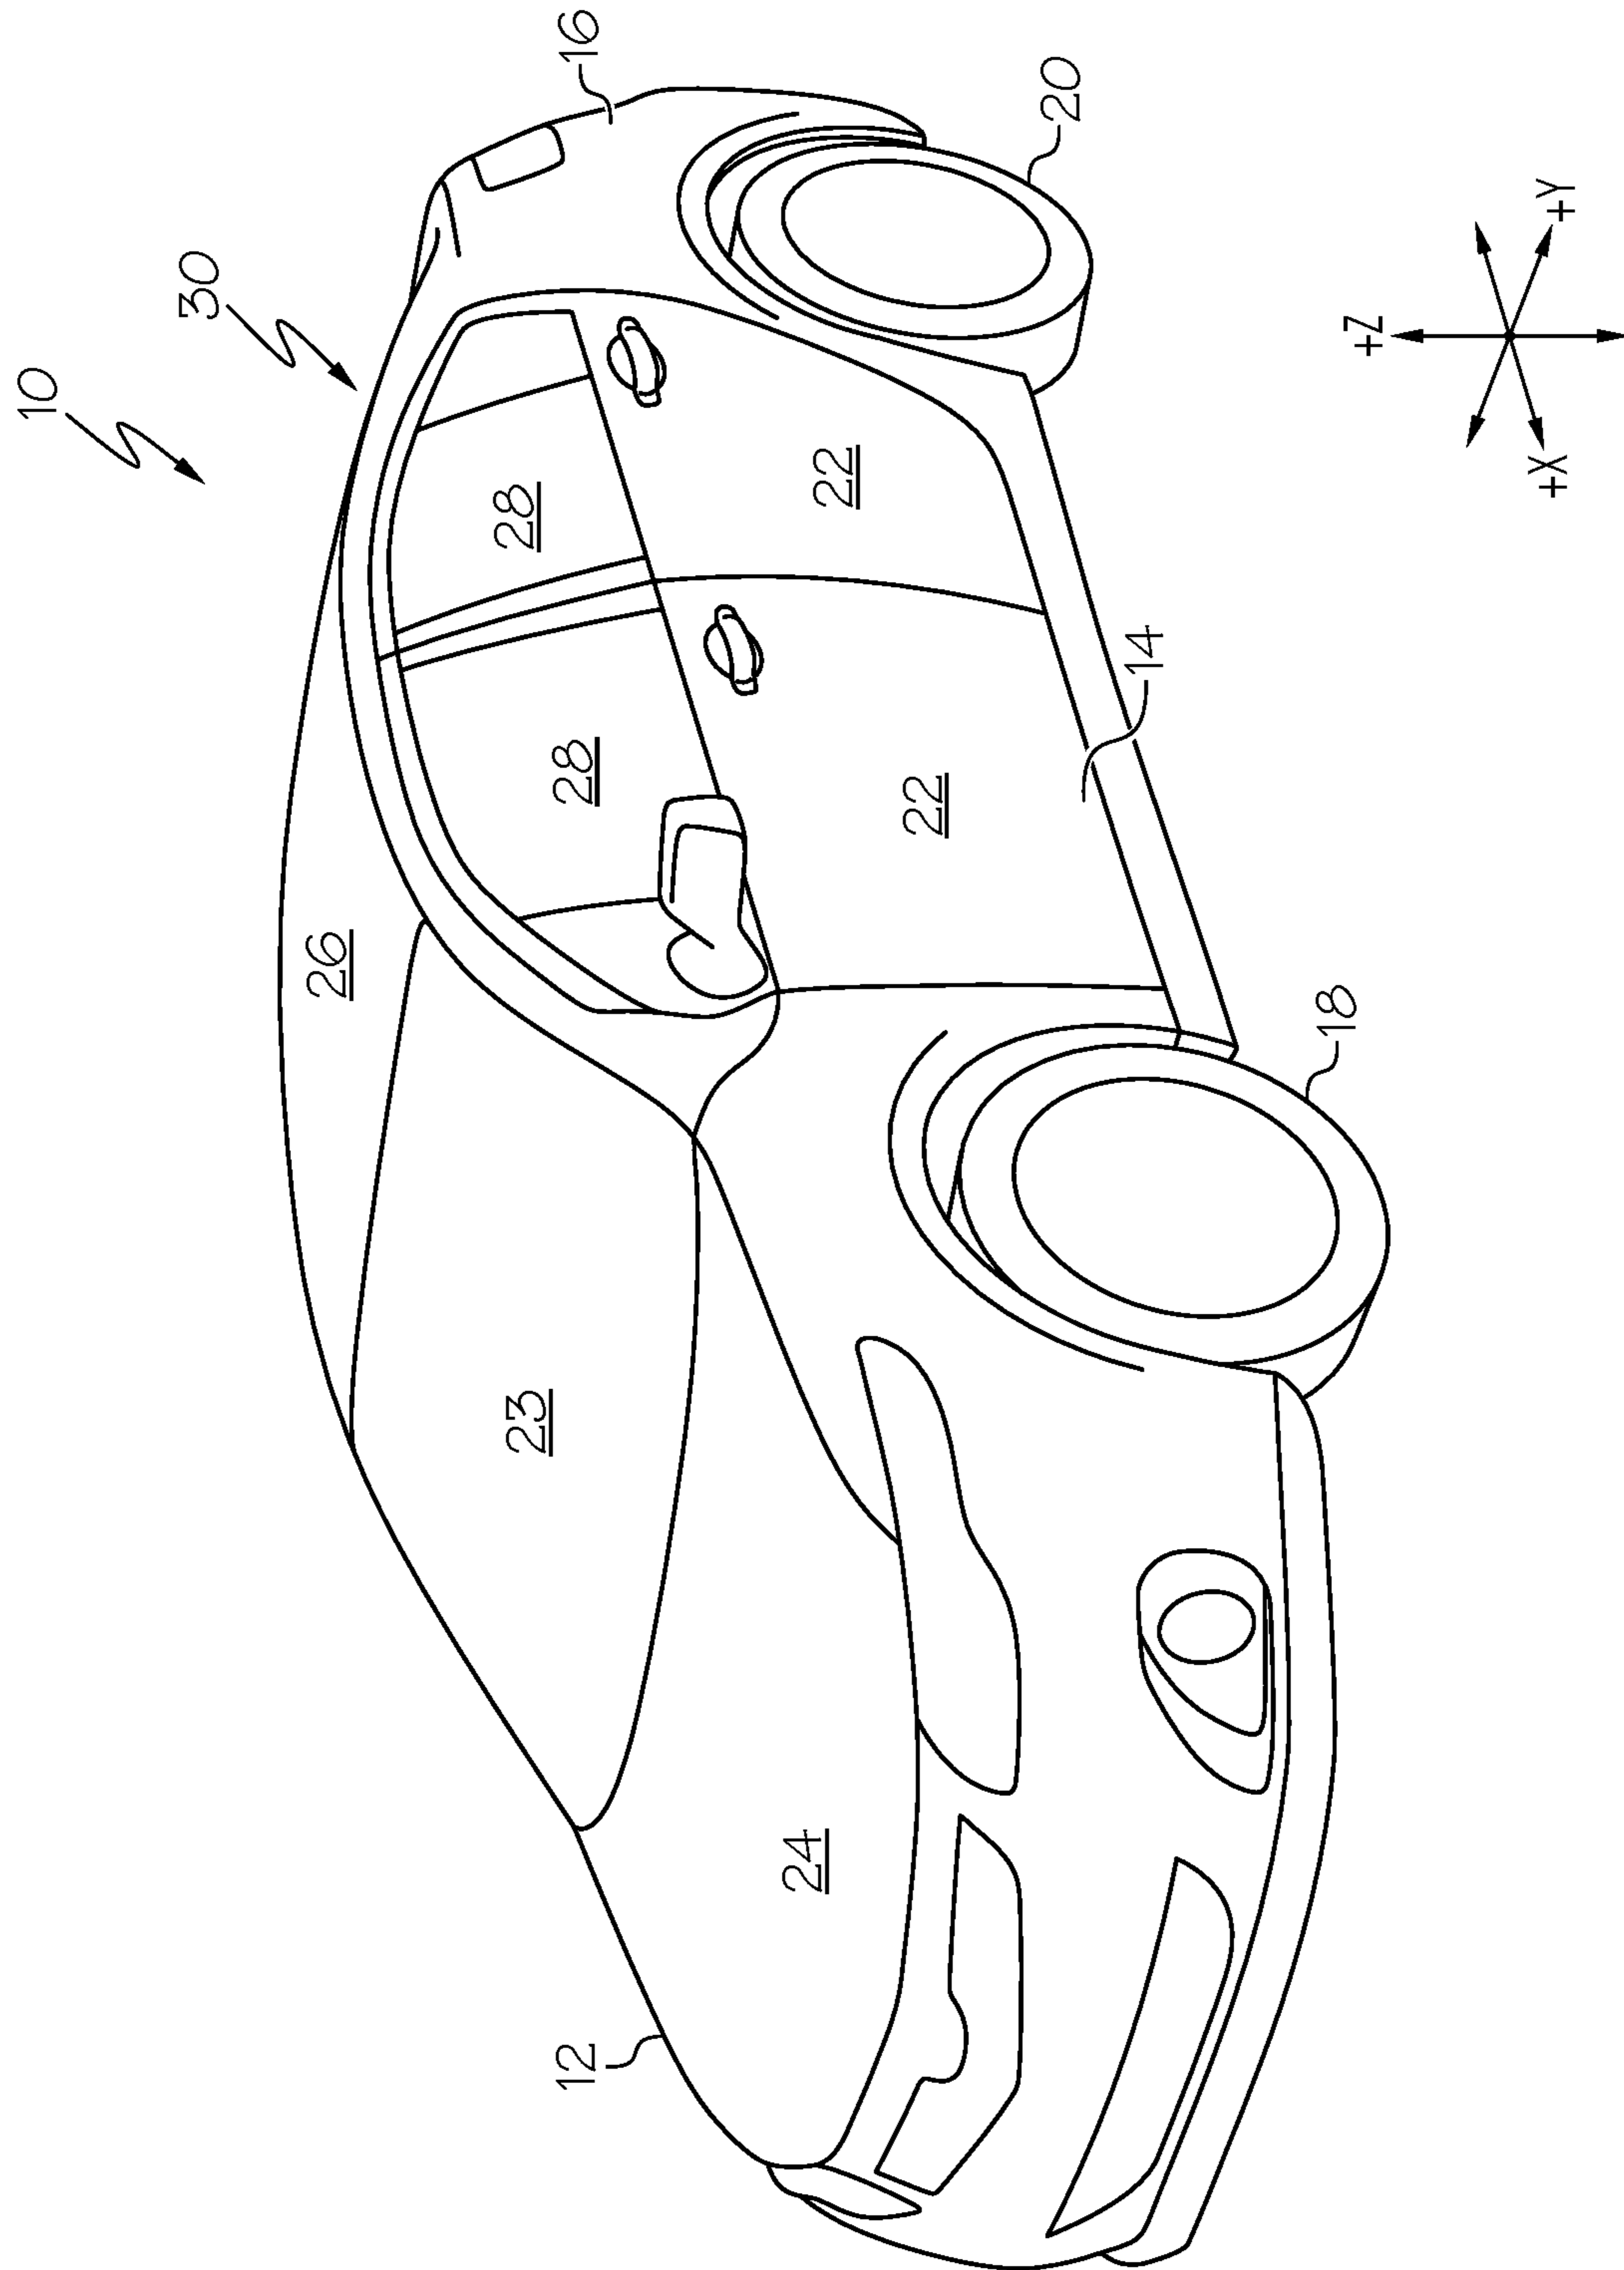
FIG. 1 depicts an illustrative vehicle that includes a vehicle seat assembly including at least one resin fuse for determining the structural integrity of the vehicle seat assembly, according to one or more embodiments shown and described herein;

Referring now to FIG. 1, selected portions of an illustrative vehicle **10** are illustrated. The vehicle **10** includes a front section **12**, a cabin **14**, and a rear section **16**. The front section **12** may include a pair of front wheels **18** and the rear section **16** may include a pair of rear wheels **20**. The front wheels **18** and the rear wheels **20** may be mechanically coupled by a vehicle drivetrain. The cabin **14** may include four doors **22**. As depicted in FIG. 1, the vehicle **10** is a sedan body style, but embodiments are not limited to this body style. It is contemplated that any vehicle body style, for example, a truck, an SUV, a van, or a coupe may include one or more vehicle seat assemblies as described herein. Moreover, although the seat assemblies are described herein with respect to an automobile, such features may be implemented in any type of vehicle, for example, a bus, boat, plane, train, wagon, or any other type of vehicle having one or more seat assemblies.

The front section **12** may include a hood **24** and the cabin **14** may include the roof **26**. A windshield **23** may slope generally from the hood **24** to the roof **26**. One or more windows **28** may be installed in each of the doors **22**. A rear windshield **30** may slope generally from the roof **26** to a trunk **32** in the rear section of the vehicle **10**.

The cabin **14** may include space for one or more passengers of the vehicle **10**. The cabin **14** may also include one or more systems for operating the vehicle, for example, pedals, shifters, gauges, etc. for controlling the vehicle **10**. The vehicle **10** may include one or more seat assemblies including seats for seating passengers of the vehicle **10** as will be described in greater detail herein.

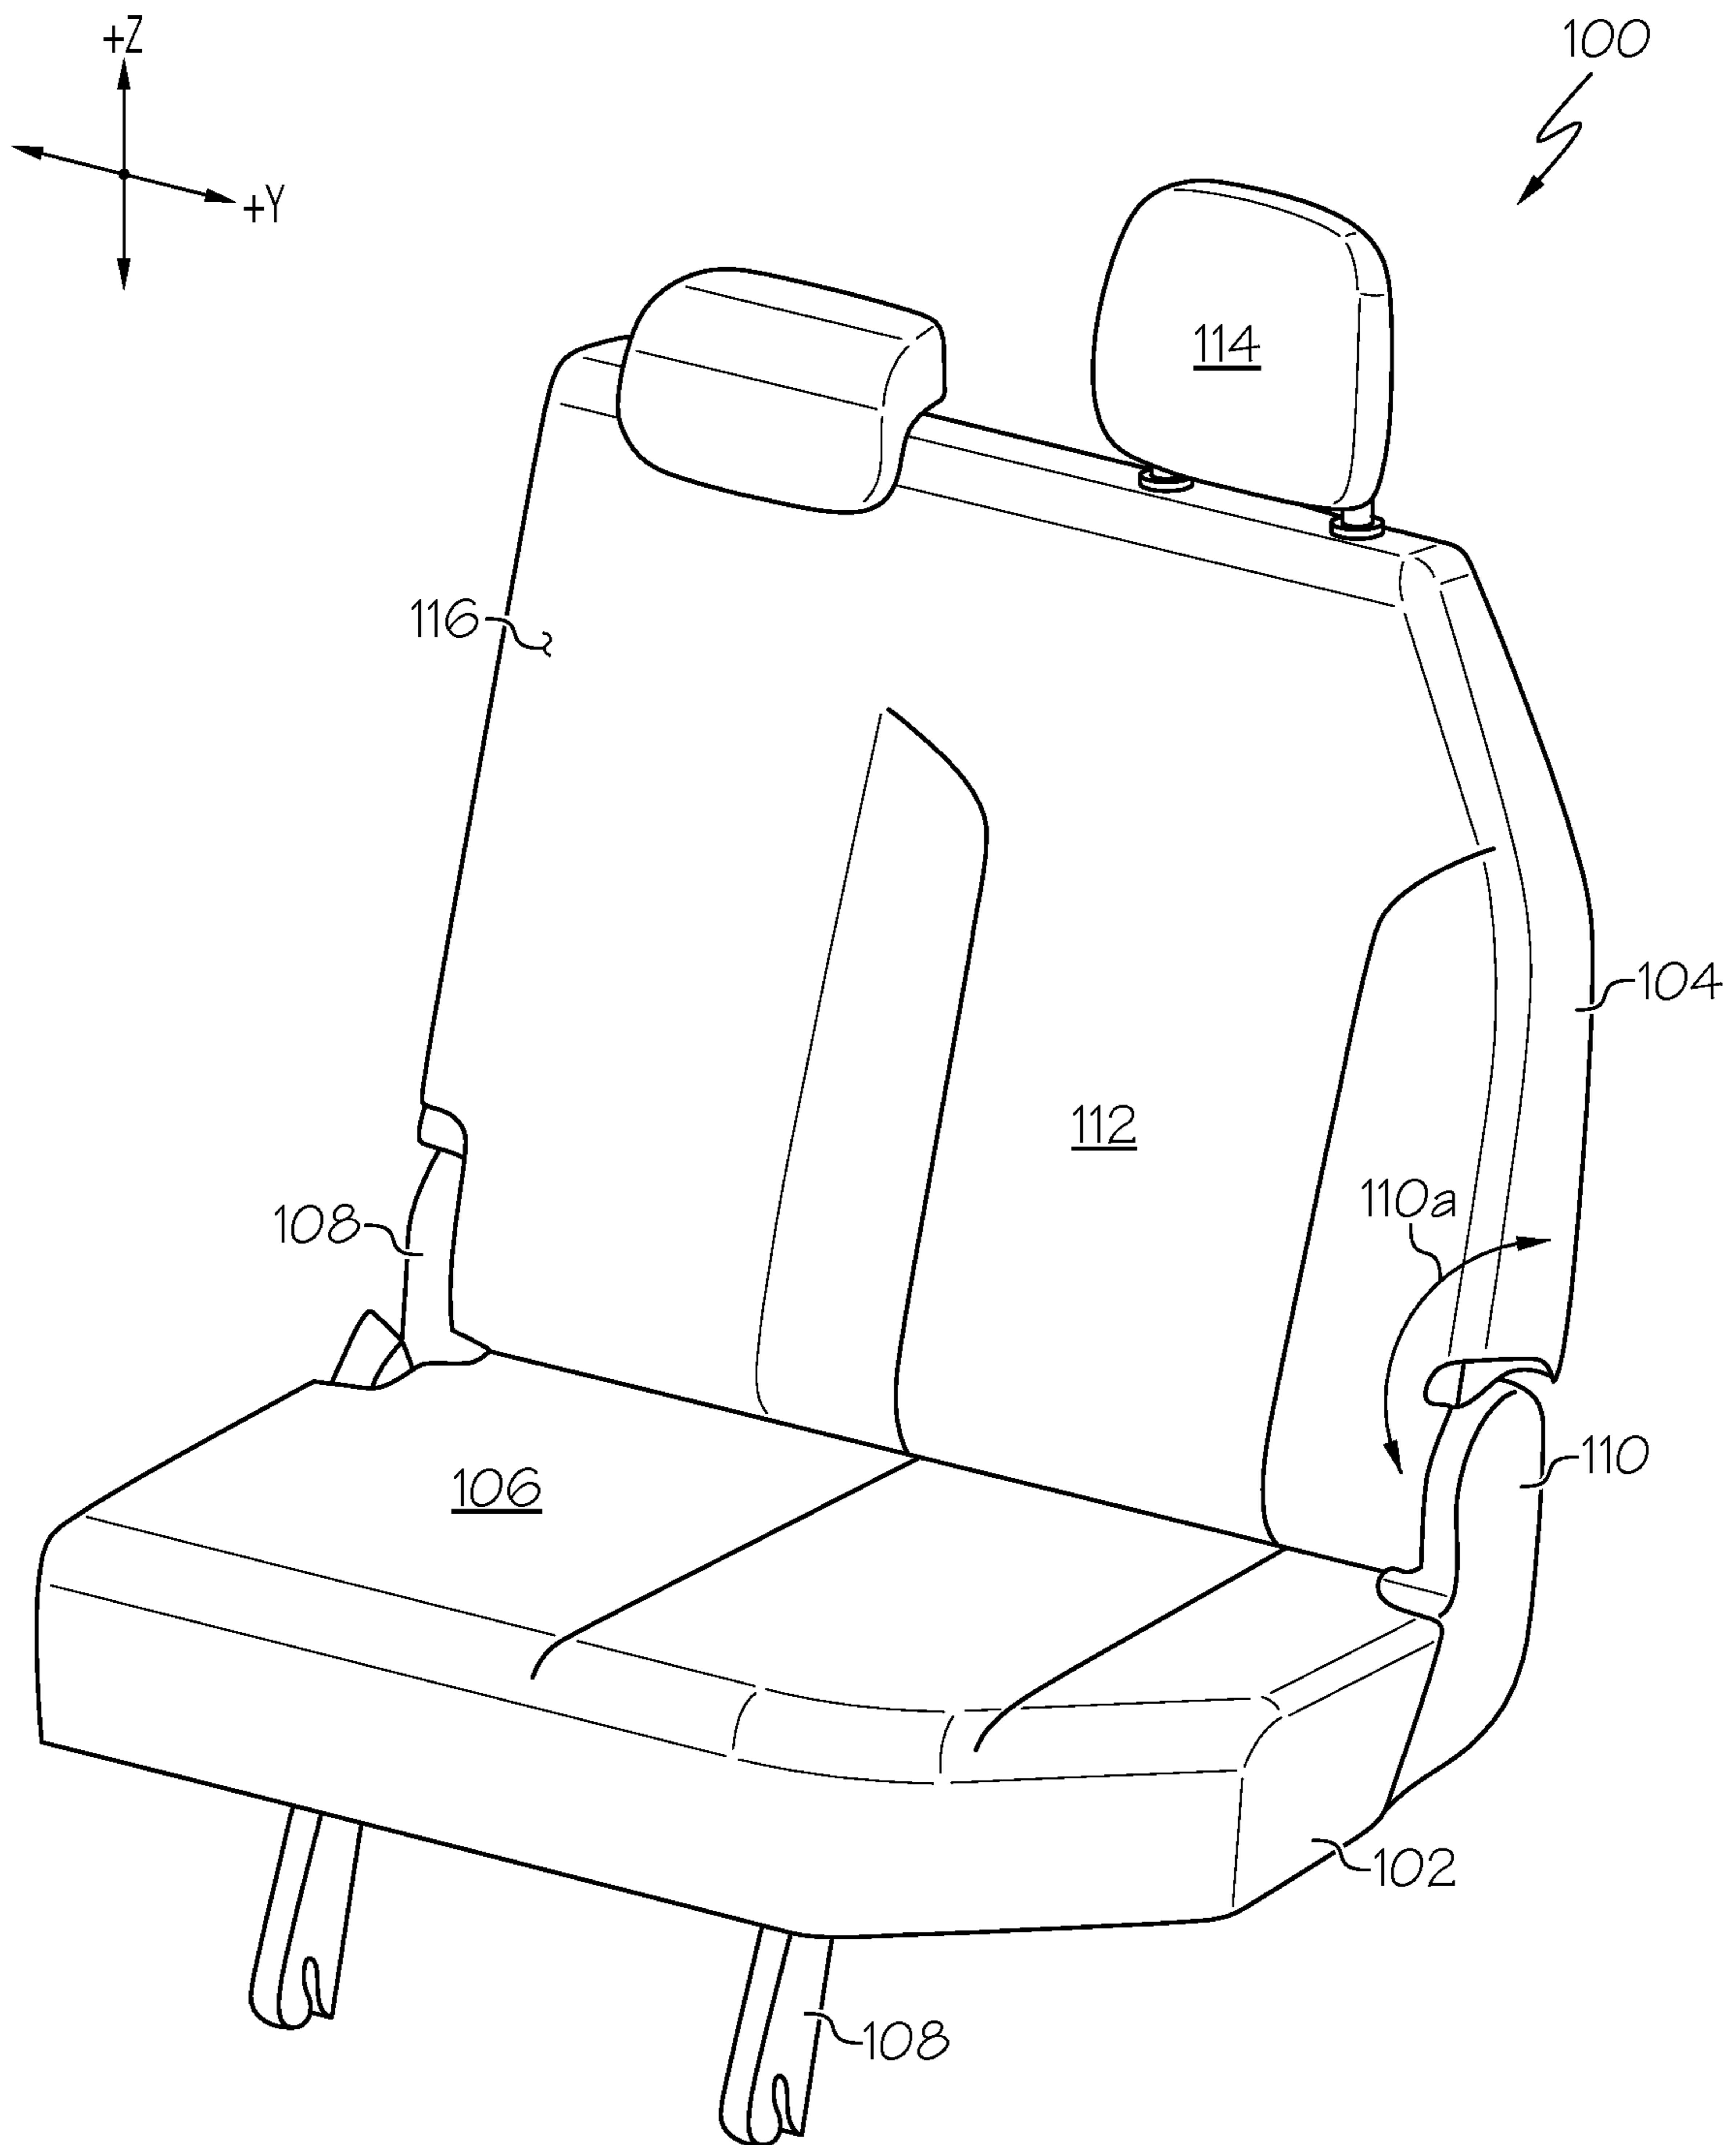
FIG. 2A depicts an illustrative vehicle seat assembly including a seat frame assembly that includes a seat cover and padding installed over a seat back and a seat base, according to one or more embodiments shown and described herein;

Referring now to FIG. 2A, an illustrative vehicle seat assembly **100** is shown. The particular example embodiment of the vehicle seat assembly **100** shown in FIG. 2A is a portion of a bench seat for the back of a vehicle having a 60/40 split rear bench seat, however, it is to be understood that the features and functions described with respect to the example embodiment shown in FIG. 2A could be implemented on other types of vehicle seats including, without limitation, bench seats and/or bucket seats. Additionally, while particular embodiments and applications of the resin fuse are described herein with respect to the vehicle seat assembly shown in FIG. 2A, it is to be understood that the features and components of the resin fuse and the application thereof, could be used with any resin component of a vehicle, and that use of resin fuses is not limited to vehicle seat assemblies, but could be applied, for example, and without limitation, in any other vehicle component formed from resin, for example, consoles, dash boards, door panels, etc.

The vehicle seat assembly **100** includes a seat base **102** and a seat back **104**. The seat base **102** may include one or more seats **106** and one or more connections **108** for mechanically coupling the vehicle seat assembly **100** to the vehicle **10**. The seat base **102** also includes a recline mechanism **110** for moveably connecting the seat base **102** with the

seat back **104**. For example, the seat back **104** may pivot or rotate about the recline mechanism **110** as indicated by double arrow **110a**.

The seat back **104** may include a back rest **112** and a head rest **114**. In some embodiments, the seat back **104** may include more than one head rest **114**. In embodiments, the seat back **104**, the seat base **102**, or both may include various vehicle seat accessories, for example, a seat belt connection, a cup holder, an armrest, a lumbar support, or other accessories.

In some embodiments, the recline mechanism **110** may allow the seat back **104** to move (i.e., rotate or pivot) relative to the seat base **102** to a variety of angular positions relative thereto. The seat back **104** may be releasably locked into place at a desired location via manual or automatic operation. The head rest **114** may be adjustable to a variety of positions in the vehicle-vertical direction (+/-Z) relative to the seat back **104** in the vehicle vertical direction and be releasably locked into place at a desired location via manual and/or automatic operation. While the vehicle seat assembly **100** is illustrated as a rear passenger seat, the vehicle seat may be provided at other occupant positions, such as one or more front and/or rear passenger seats and/or a driver seat.

The vehicle seat assembly **100** may include a seat cover **116**. The seat cover **116** may be upholstery such as leather, cloth, etc. The seat cover **116** may enclose a seat cushion made from high-density foam or some other relatively soft material, such as plastic, foam, rubber, or other soft material.

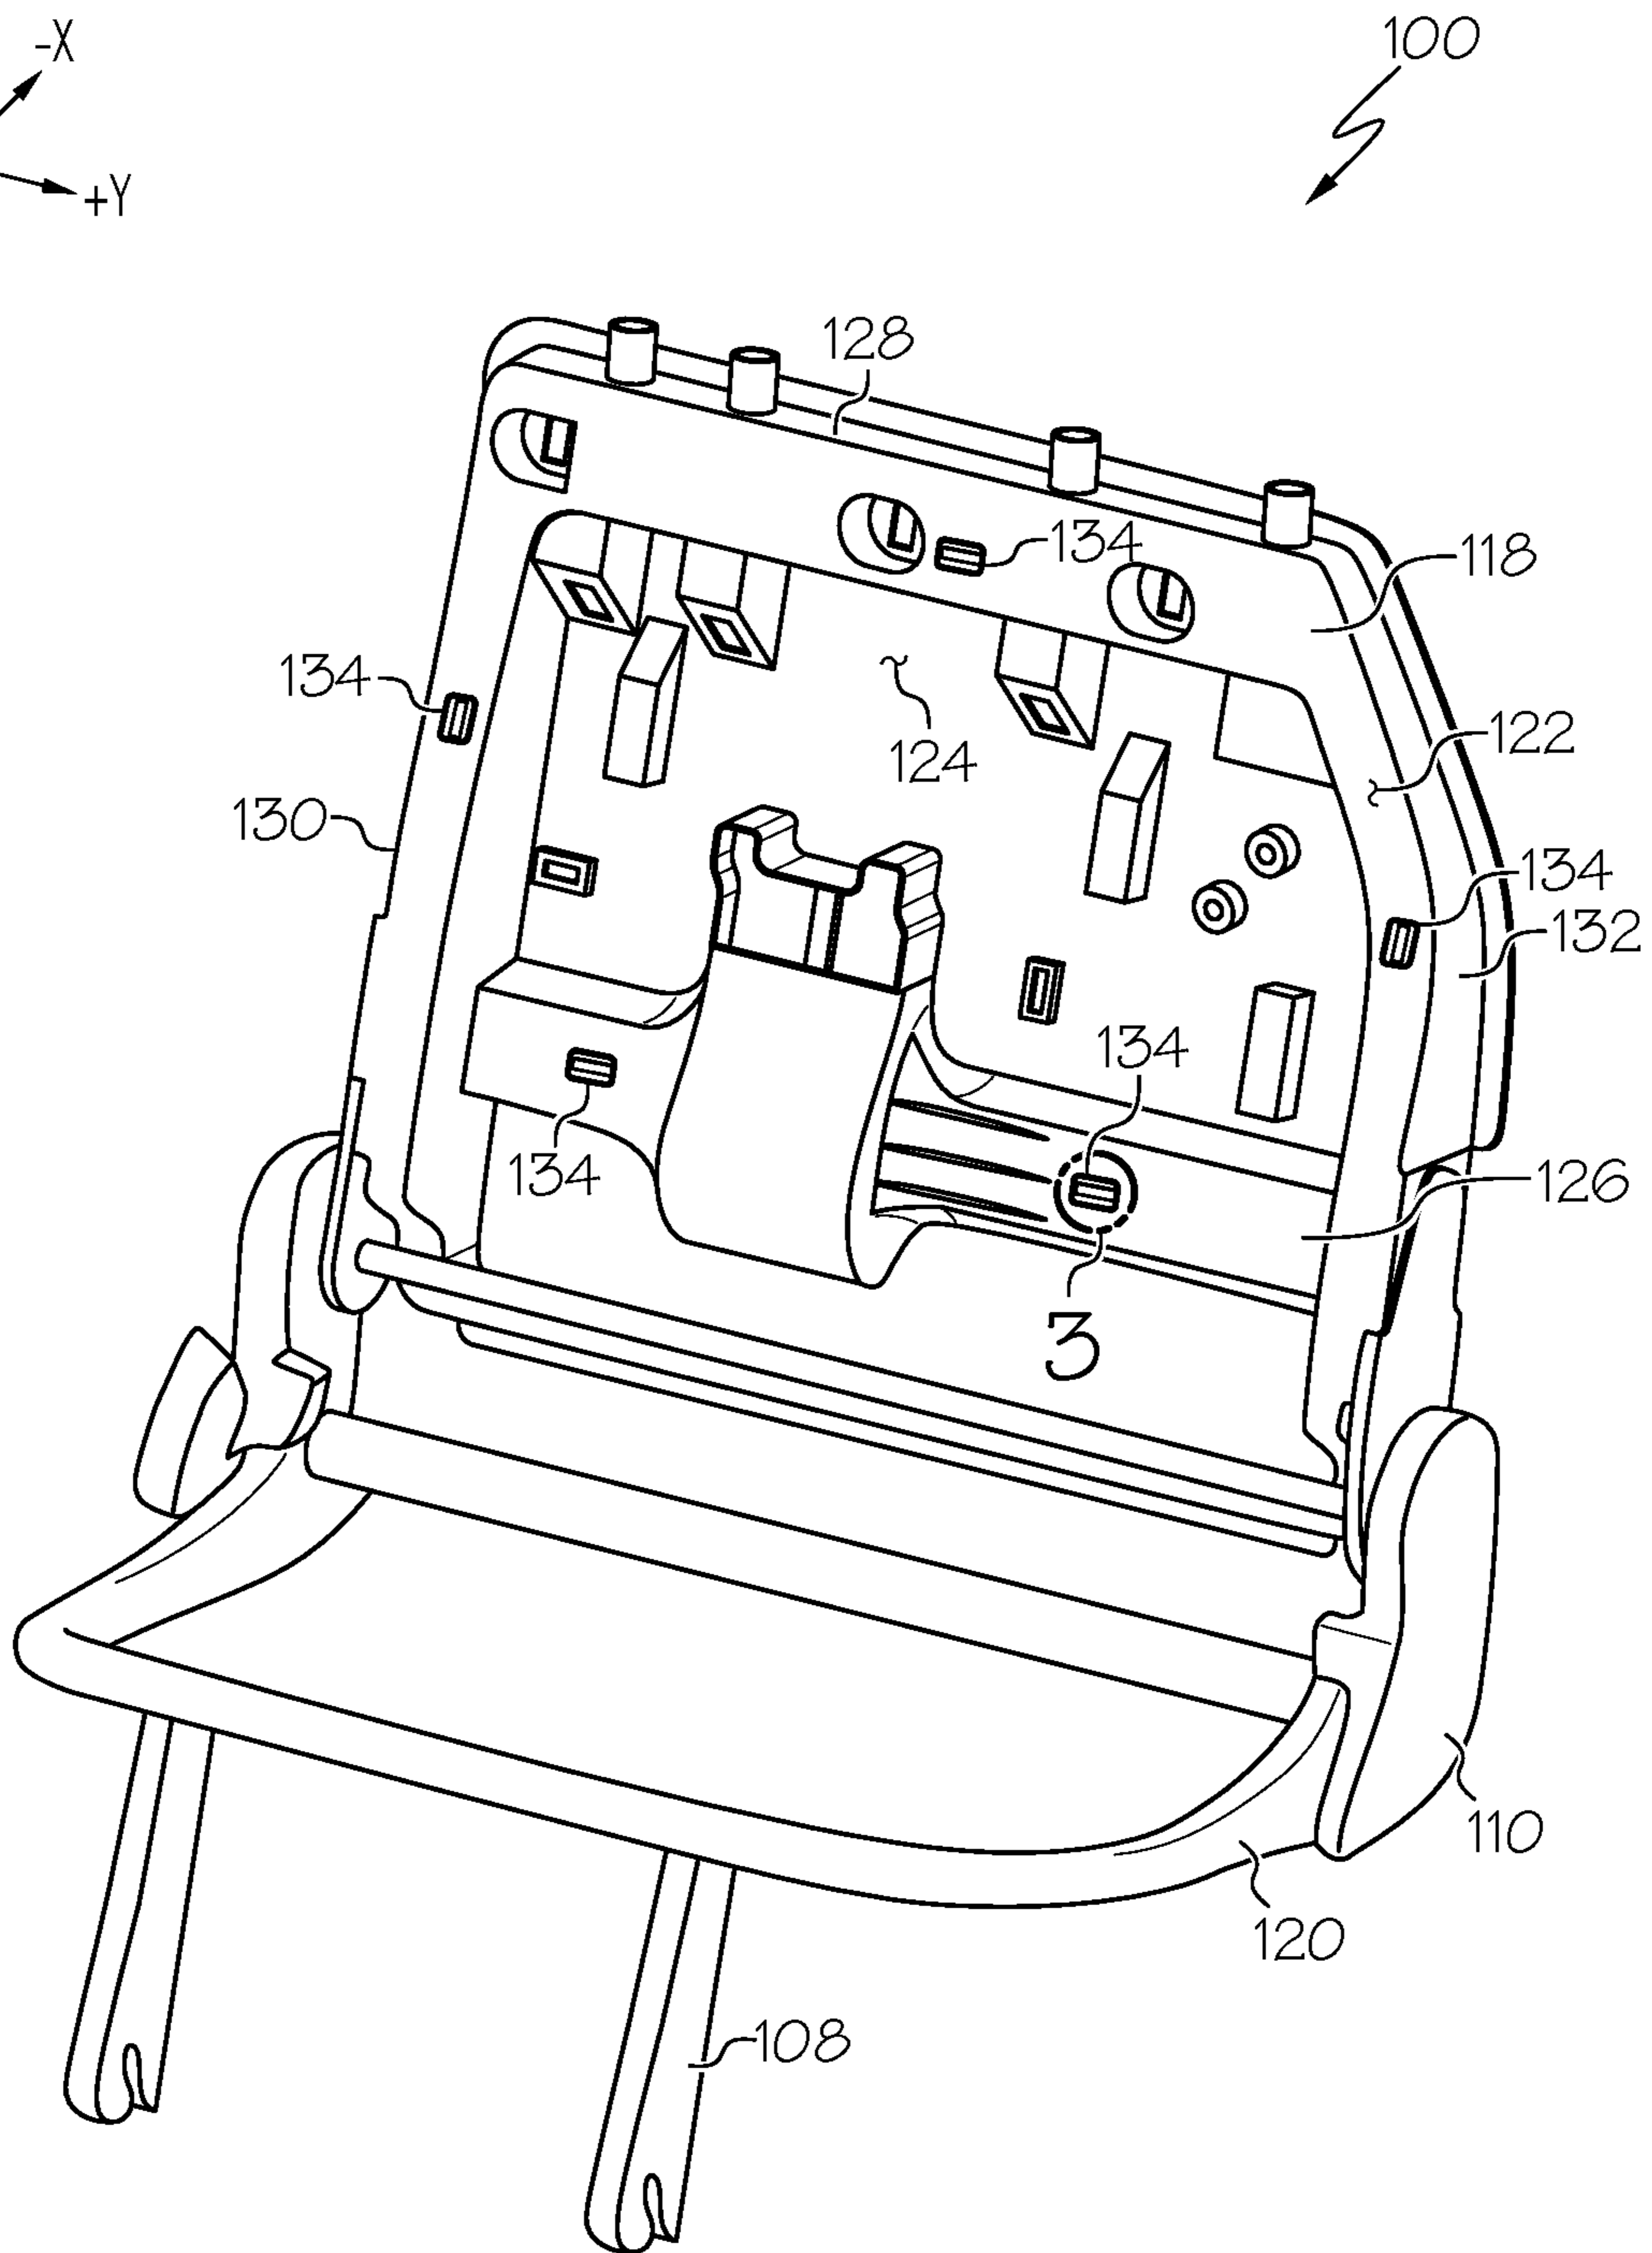
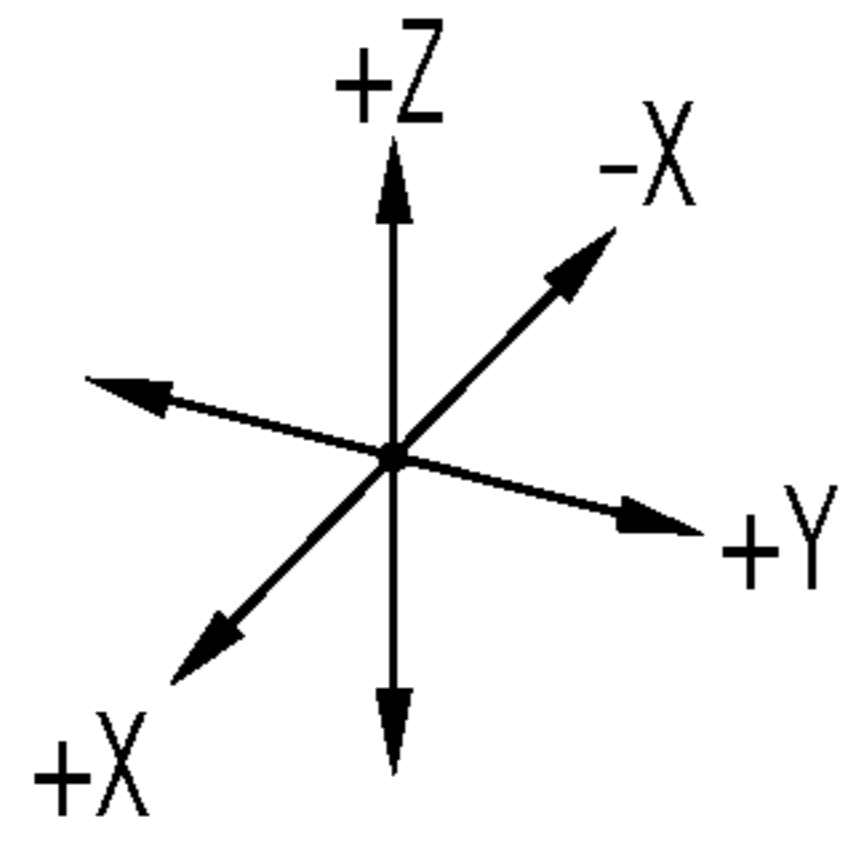
FIG. 2B depicts the vehicle seat assembly of FIG. 2A with the seat cover and the padding removed revealing at least one resin fuse for determining the structural integrity of the vehicle seat assembly, according to one or more embodiments shown and described herein;

FIG. **2B** depicts the vehicle seat assembly **100** of FIG. **2A** without upholstery or padding. FIG. **2B** shows a resin seat back **118** coupled to a base frame **120** at the recline mechanism **110**. The resin seat back **118** extends laterally in the vehicle-lateral direction (+/-Y) and upwards from the base frame **120** in a vehicle-vertical direction (+/-Z). The base frame **120** extends horizontally in the vehicle-lateral direction (+/-Y) and in the vehicle-longitudinal direction (+/-X). The base frame **120** may comprise steel, aluminum, or some other metal. In other embodiments, the base frame may comprise a resin, similar to the resin seat back **118**.

In embodiments, the resin seat back **118** may partially or completely comprise a resin. For example, the resin seat back **118** may comprise any material containing a thermoplastic or thermoset resin, for example polyester resin, polyethylene (PE), polypropylene (PP), polyurethanes, epoxy resins, or the like. The resin seat back **118** may comprise a forward panel **122**, a base panel **124**, and a cross panel **126**. The forward panel **122** may generally extend between a top **128**, a first side **130**, and a second side **132** of the resin seat back **118**. The base panel **124** may generally form a plane that extends in the vehicle-lateral (+/-Y) and vehicle-vertical (+/-Z) directions. The cross panel **126** may be generally planar and extend between opposite sides of the forward panel **122**.

Still referring to FIG. **2B**, the vehicle seat assembly **100** may include at least one resin fuse **134**. The resin fuse **134** may indicate structural loading above a tolerance level as will be described in greater detail herein. In some embodiments, the vehicle seat assembly **100** may include an arrangement of resin fuses **134** and the resin fuses **134** may be arranged in various configurations on the seat back **104**. For example, the resin fuses **134** may be arranged with one or more resin fuses **134** in a vehicle-vertical direction and/or one or more fuses in a vehicle-horizontal direction.

As depicted in the particular example embodiment shown in FIG. **2B**, there are three resin fuses **134** on the forward panel. The three resin fuses **134** on the forward panel **122** are arranged in both a vehicle-horizontal and vehicle-vertical

directions. Additionally, there are two resin fuses **134** on the cross panel **126**. Both resin fuses **134** on the cross panel **126** are shown in a vehicle-horizontal orientation. However, embodiments are not limited to this number, location, and/or arrangement of the resin fuses **134**. It is contemplated that the resin fuses may be arranged in any number, location, and/or orientation. For example, in some embodiments, one or more of the resin fuses **134** may have a diagonal orientation with respect to the vehicle-vertical and vehicle-lateral directions. Additionally, none of the resin fuses shown in the particular example embodiment depicted in FIG. **2B** are arranged in a vehicle-longitudinal direction, however, it is contemplated that one or more arrangements of resin fuses **134** in the vehicle **10** may include resin fuses **134** in a vehicle-longitudinal orientation through a thickness of one or more portions of the resin seat back **118**.

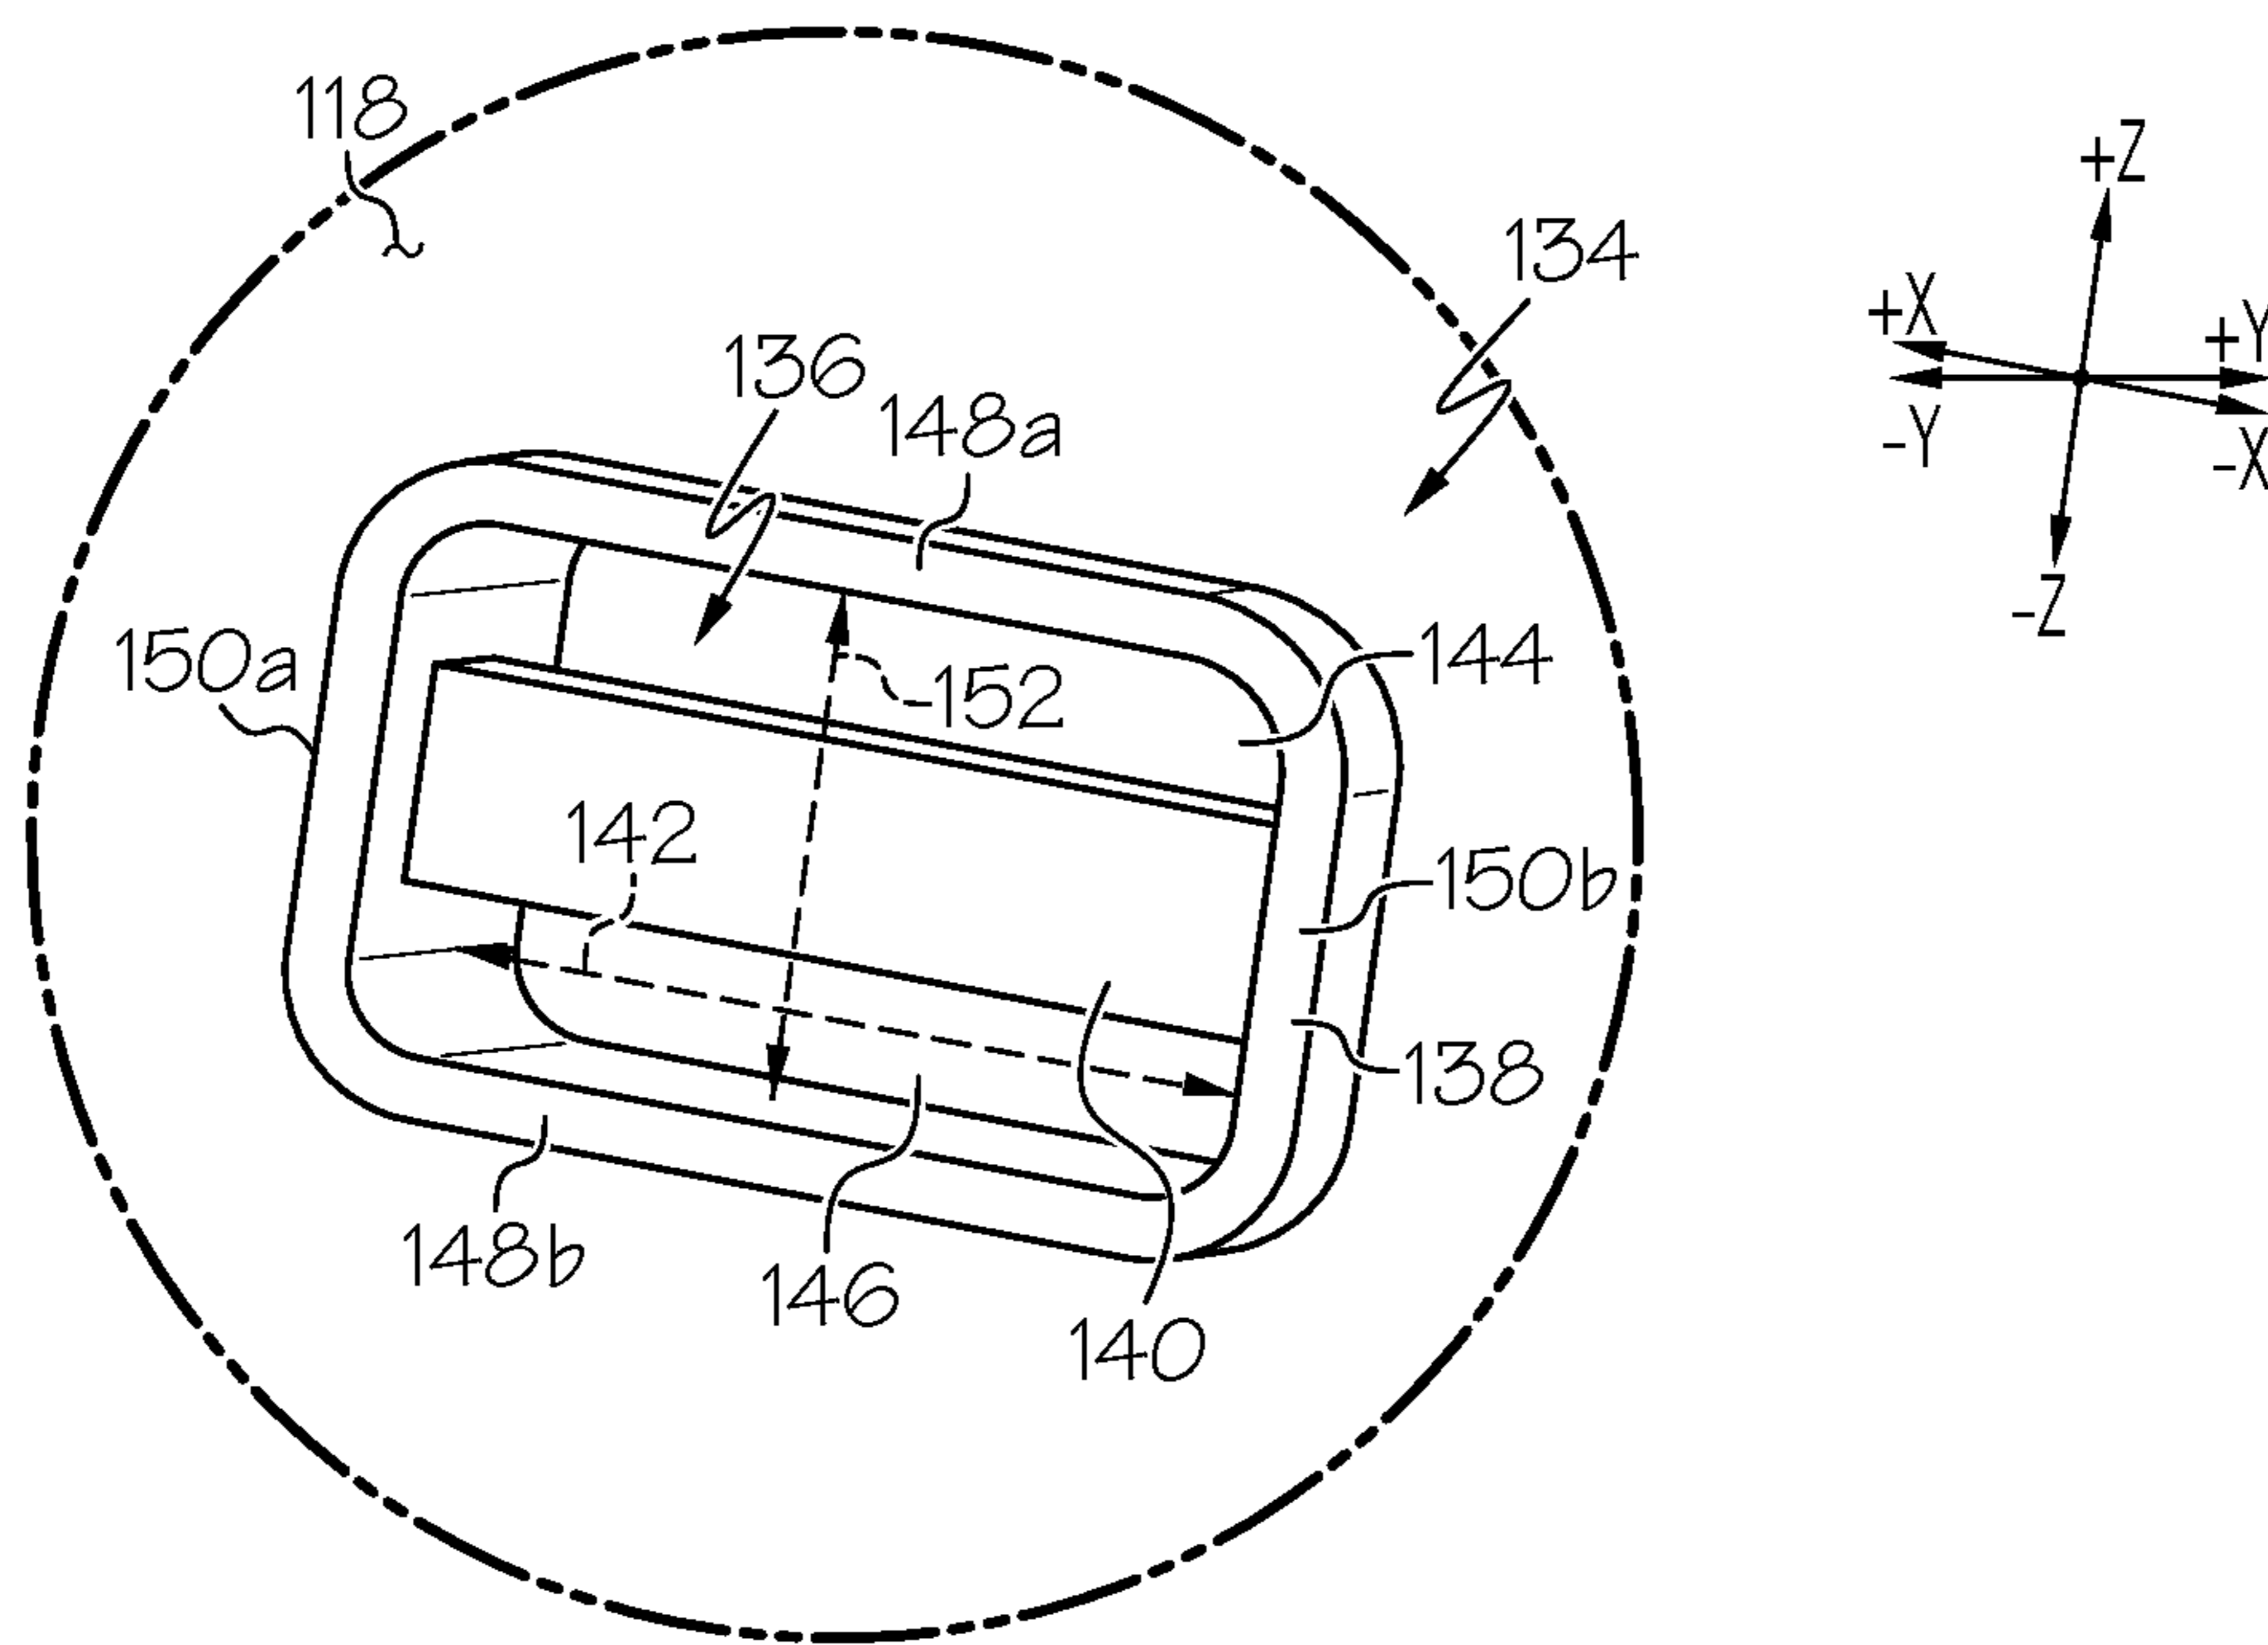
FIG. 3 depicts an illustrative resin fuse of the seat back of FIG. 2B in isolation, according to one or more embodiments shown and described herein;

Turning now to FIG. **3**, the resin fuse **134** includes an aperture **136** extending through the resin seat back **118**. The resin fuse **134** also includes a flange **138** encircling the aperture **136** and an indicator bar **140**. In some embodiments, the aperture **136** may extend through an entire thickness of the resin seat back **118**. In other embodiments, the aperture **136** may extend through only a partial thickness of the resin seat back **118**.

The flange **138** may extend generally perpendicular to the resin seat back **118** in the vehicle-longitudinal direction. In some embodiments, the flange **138** may extend forward and rearward from the resin seat back **118**. In other embodiments, one or more portions of the flange **138** may be flush with a forward or a rear surface of the resin seat back **118**. In some embodiments, such as that shown in FIG. **3**, the flange may form a generally rectangular shape with a first pair of opposing sidewalls **148a**, **148b** and a second pair of opposing sidewalls **150a**, **150b**. However, it should be understood that the flange may take on other shapes including, without limitation, circles, squares, rectangles and the like. The first pair of opposing sidewalls **148a**, **148b** may be generally perpendicular to the second pair of opposing sidewalls **150a**, **150b**. The flange **138** may extend outward from the resin seat back **118** in the vehicle-longitudinal direction (+/-X).

The aperture **136** may include a height dimension **152**. The indicator bar **140** may extend across a diameter **142** of the aperture **136**. In embodiments, the aperture **136** is open on either side of the indicator bar **140**. That is, the aperture **136** may comprise a top opening **144** above the indicator bar **140** and a bottom opening **146** below the indicator bar **140**. In some embodiments, the indicator bar **140** has a uniform width and thickness across the diameter **142** of the aperture **136**. In some other embodiments, the indicator bar **140** may optionally include one or more features that cause the indicator bar **140** to break, dislodge, snap, fracture, or otherwise form a discontinuity in the indicator bar **140**, thereby physically relating the strength of the indicator bar **140** to the loading tolerance of the resin seat back **118** for developing micro-fractures as will be described in greater detail herein.

In some embodiments, the resin fuse **134** may be integrally formed with the resin seat back **118**. In such embodiments, the resin fuse **134** including the indicator bar **140** may be formed (i.e., manufactured) at the same time or during the same process of manufacture. In such embodiments, the resin seat back **118** may be installed to the vehicle seat assembly **100** and include all of the resin fuses **134** that will be placed in the resin seat back **118** at the time of installation. In other embodiments, one or more of the resin fuses **134** may be removable elements from the resin seat

back 118 and may be uninstalled, reinstalled, replaced, etc. without removing and/or replacing the resin seat back 118. In such embodiments, one or more components of the resin fuses 134 may be configured to be removed from the resin fuse 134. For example, the indicator bar 140 may be configured to be removed from the resin fuse 134 and replaced, for example, if it is broken or if another resin fuse 134 in the seat back 104 has a broken indicator bar 140 as will be described in greater detail herein.

In other embodiments, the resin fuse 134 may be formed separately from the resin seat back 118 and installed into the aperture 136 in the resin seat back 118 during installation of the vehicle seat assembly 100.

In some embodiments, the height 152 of the aperture 136 may be constant across the diameter 142 of the aperture 136. In some embodiments, the diameter 142 of the aperture 136 may be constant along the height 152 of the aperture 136. However, it is contemplated that embodiments may include apertures 136 including one or more varying dimensions, for example, the height 152 of the aperture 136 may vary and/or the diameter 142 of the aperture 136 may vary.
