(12) **United States Patent**  
**Donovan**

(10) **Patent No.:** **US 11,225,181 B2**  
(45) **Date of Patent:** **Jan. 18, 2022**

(54) **RESIN FUSES AND VEHICLES  
COMPRISING THE SAME**

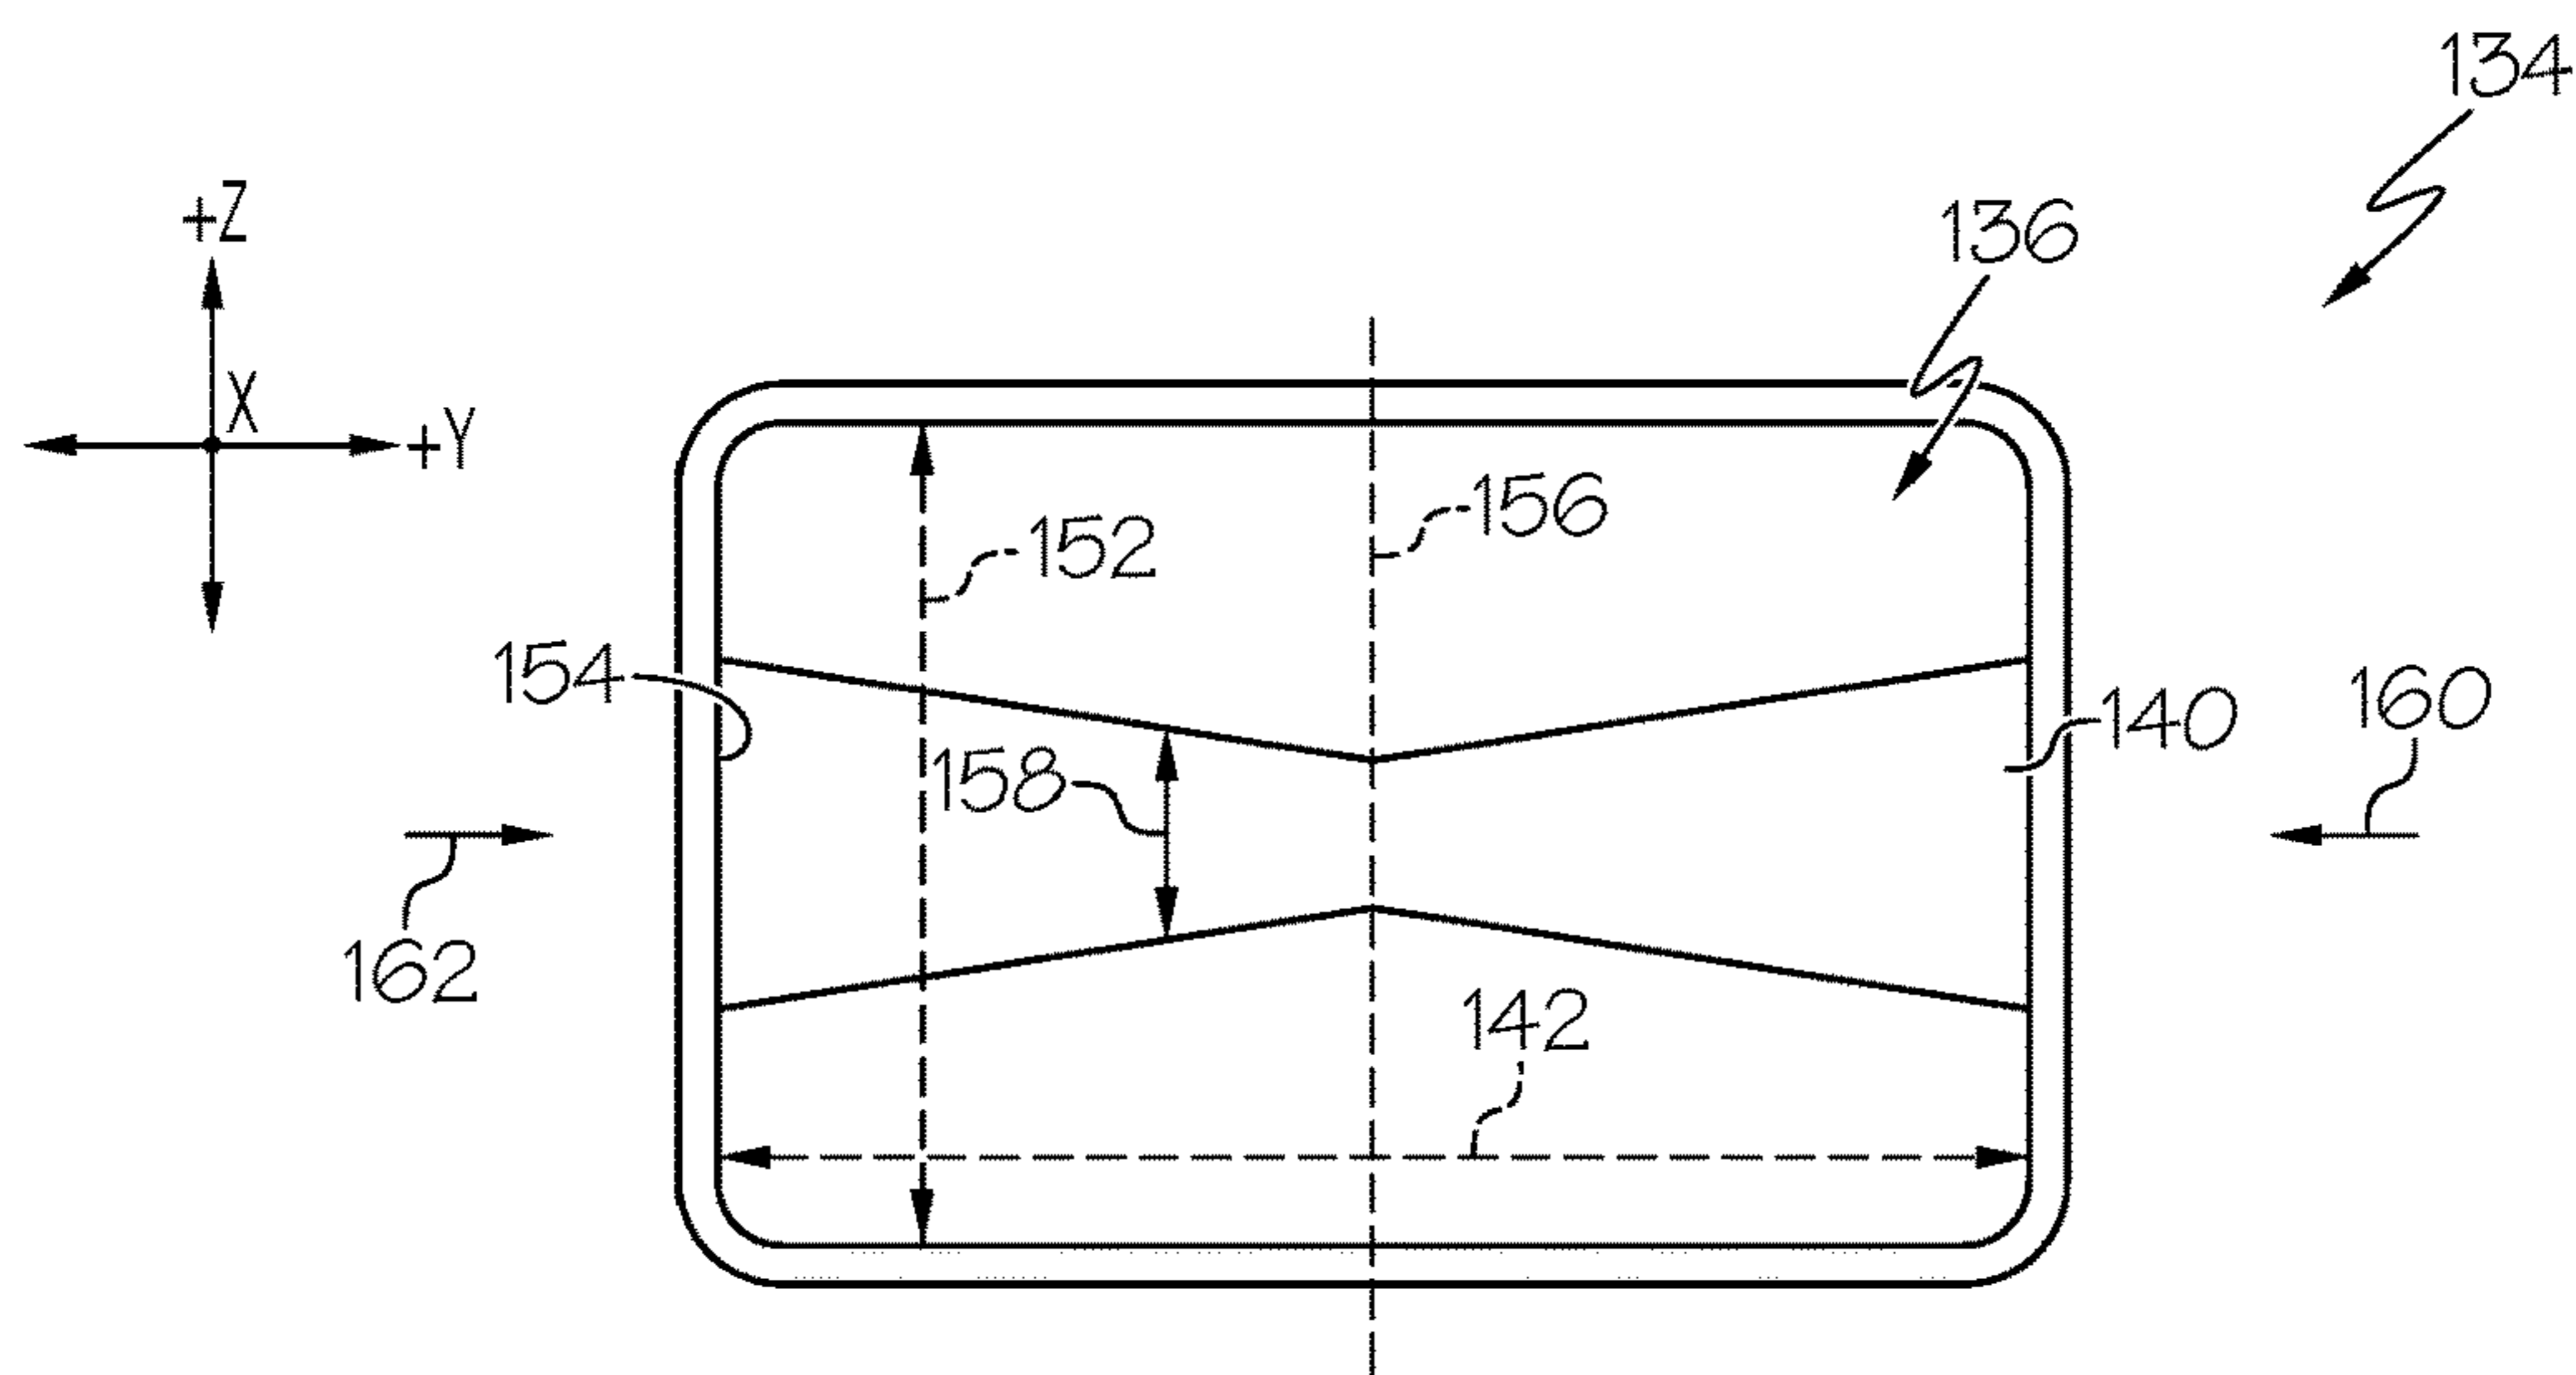
FIG. 4A depicts a front view of another embodiment of the resin fuse of FIG. 3, according to one or more embodiments shown and described herein;

FIG. 4A depicts a front (i.e., as seen in the vehicle longitudinal direction) view of an illustrative example embodiment of a resin fuse 134 for detecting a loading in a resin seatback above a tolerance loading. The resin fuse 134 of FIG. 4A includes the indicator bar 140 extending across the diameter 142 of the aperture 136. A first half (i.e., the left side as shown in the drawings) of the indicator bar 140 tapers from a proximate edge 154 of the indicator bar 140 towards a mid-line 156 of the indicator bar 140, thereby decreasing in a vertical thickness 158 along this extension. This decreasing thickness is symmetrical across the mid-line 156 of the indicator bar. Accordingly, the width of this example embodiment is thinnest at the mid-line 156.

In some embodiments, the vertical thickness 158 of the resin fuse 134 may be engineered such that a strength of the indicator bar 140 against fracture is related to, based on, or indicative of a strength of another portion of the resin seat back 118 (i.e., the indicator bar 140 is “tuned”). For example, the strength of the indicator bar 140 may be indicative of a strength of the resin seat back 118 against forming microfractures in any portion of the resin seat back 118. That is, as load is applied to the resin seat back 118, a portion or all of the load may be transferred to the resin fuse 134 and the resin fuse 134 may indicate whether that load is above or below a loading tolerance of the resin seat back 118. If the load is below a loading tolerance, there will be no damage to the indicator bar 140 of the resin fuse 134. However, if the load is above the loading tolerance, the indicator bar 140 will fracture, break, or otherwise form some discontinuity, thus indicating that the resin seat back 118 has experienced loading above the loading tolerance. In some embodiments, the strength of the indicator bar 140 to resist fracture is related to the weakest component of the vehicle seat assembly 100 and/or the resin seat back 118 such that, if there is a discontinuity in the indicator bar 140, there may be a corresponding discontinuity in the weakest portion of the vehicle seat assembly 100 or the resin seat back 118.

With particular reference to FIG. 4A, arrow 160 indicates a load applied to a vehicle, such as the vehicle 10 depicted in FIG. 1. The load applied in FIG. 4A is from a left side of the vehicle. A counter load, indicated by arrow 162, is developed due to the static internal forces in the resin seat back 118. The load and the counter load create a compressive force on the indicator bar 140 compressing the indicator bar 140 along the diameter 142 of the resin fuse 134. The

stress created by the compressive force gets progressively larger along the length of the indicator bar 140 from the proximate edge 154 toward the mid-line 156 due to the decreasing cross sectional area of the indicator bar 140 along this line. If the stress exceeds a fracture stress for the particular material making up the indicator bar 140 (e.g., PE), the indicator bar 140 will fracture. The fracture strength of the indicator bar 140 is calibrated to indicate a fracture strength of the resin seat back 118 as a whole by controlling the dimensions of the indicator bar 140.

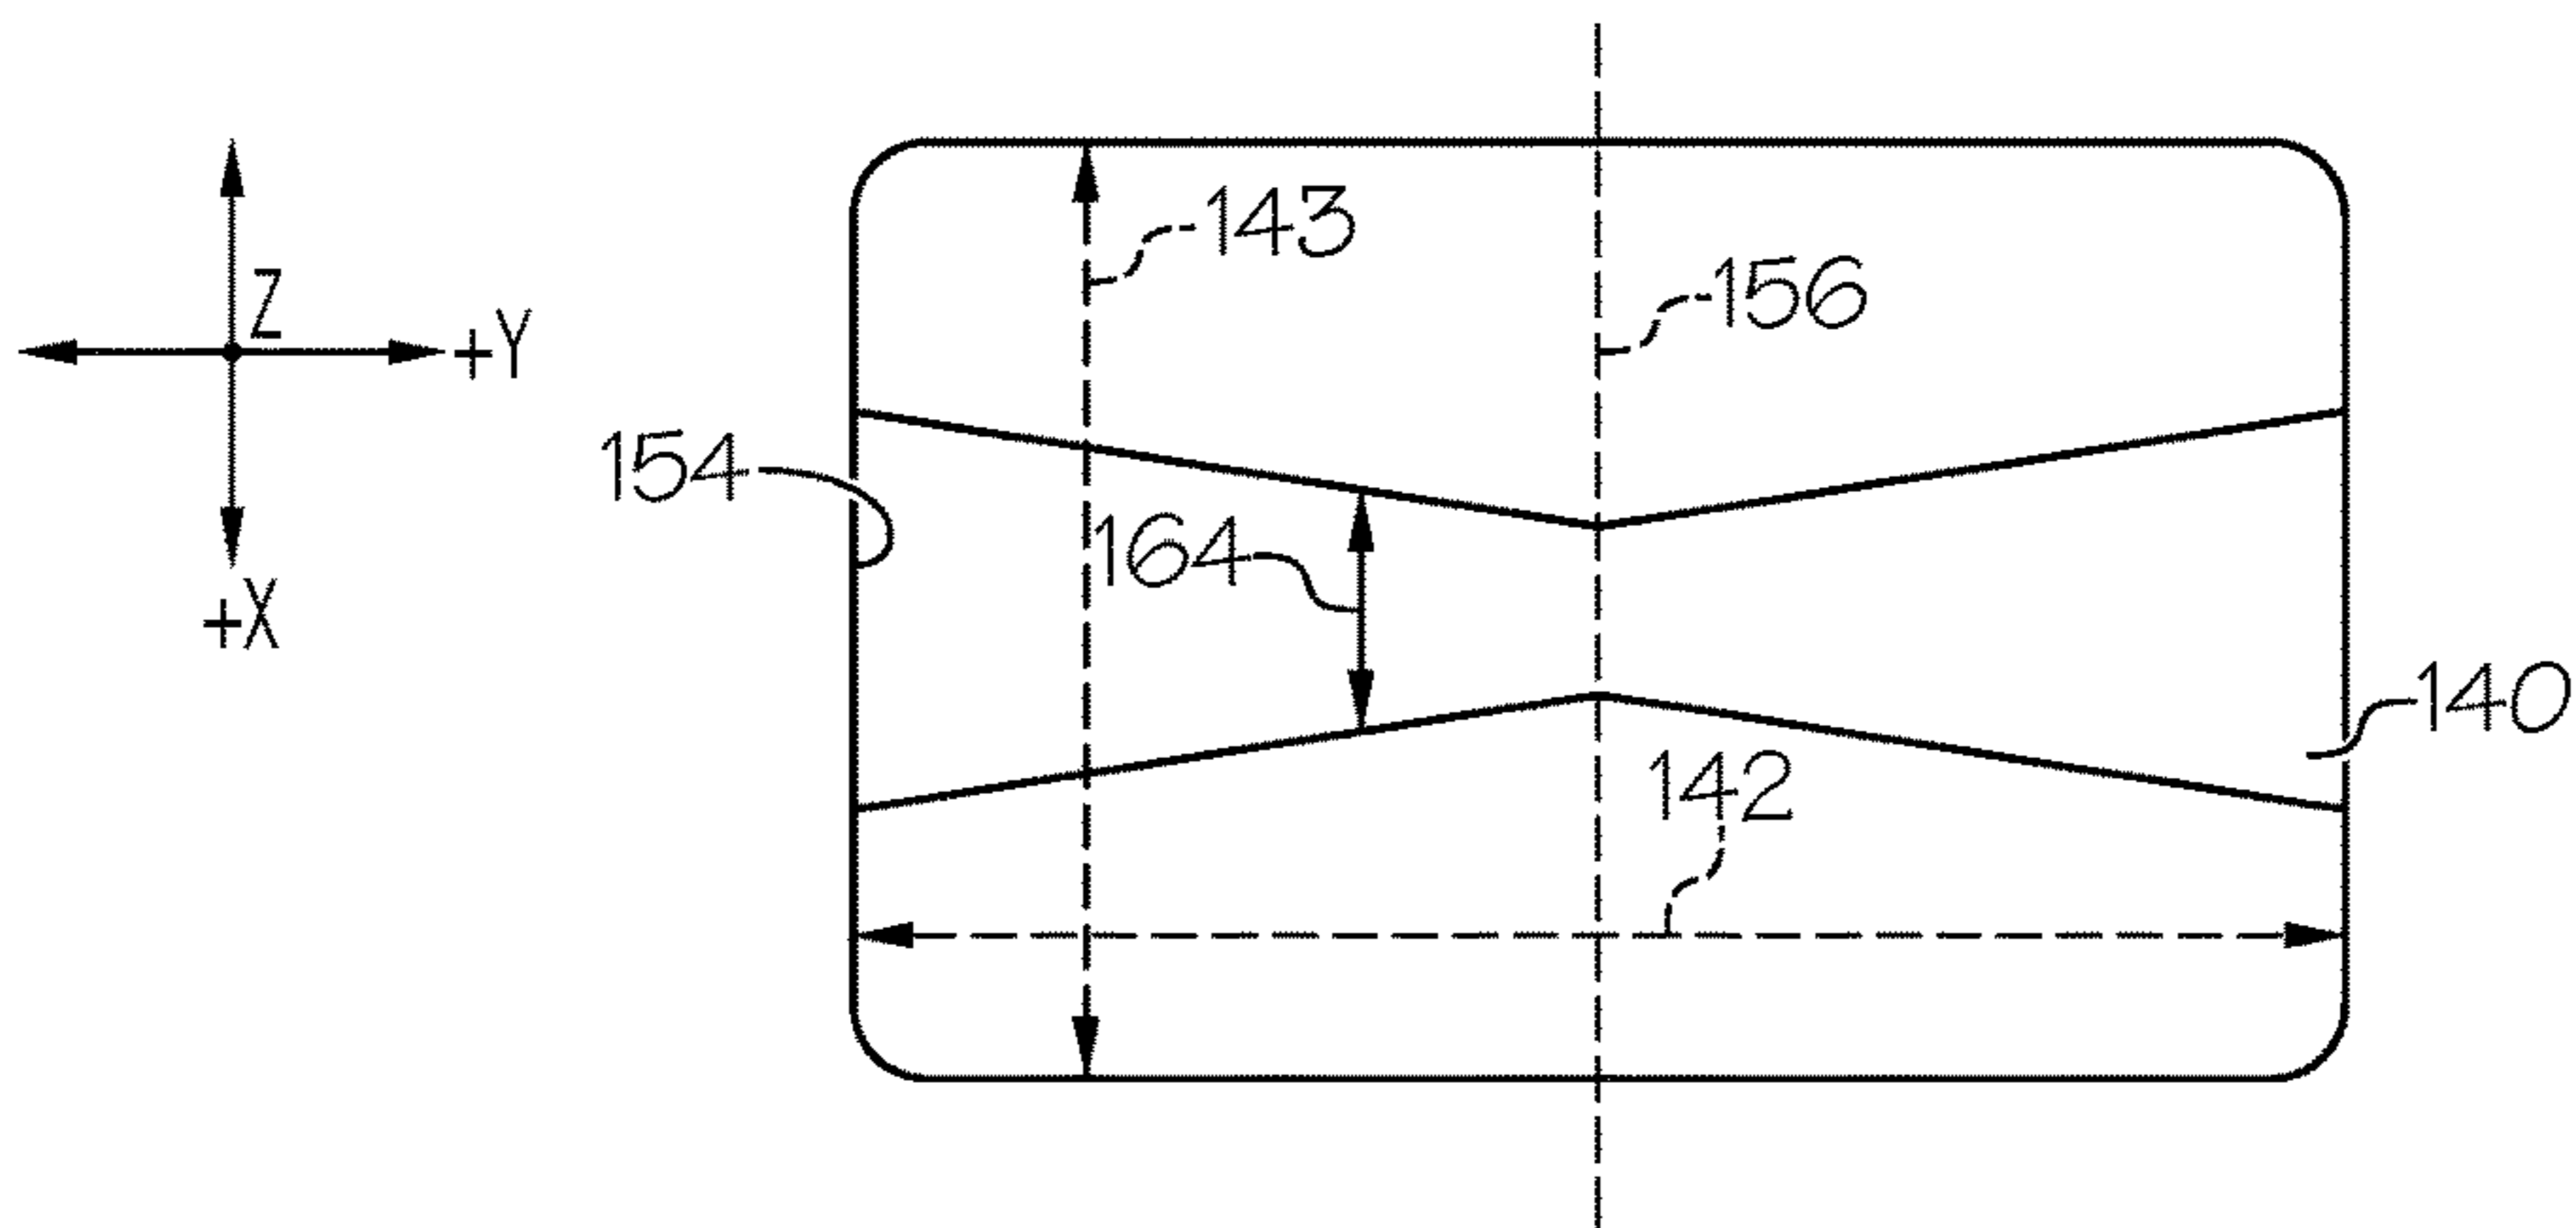
FIG. 4B depicts a top view of an embodiment of the resin fuse of FIG. 3, according to one or more embodiments shown and described herein;

FIG. 4B depicts a top view of another illustrative example embodiment of the resin fuse 134 including the indicator bar 140 for indicating loading above a tolerance loading. The indicator bar 140 of FIG. 4B extends the diameter 142 of the resin fuse 134 and a depth 143 of the resin fuse 134. A longitudinal thickness 164 decreases along the indicator bar 140 from the proximate edge 154 of the indicator bar 140 to the mid-line 156 of the indicator bar 140. More specifically, the longitudinal thickness 164 of the indicator bar 140 in the +/-X direction decreases from the left proximate edge 154 to the mid-line 156 of the indicator bar 140 along the length of the indicator bar 140 in the +Y direction. In the particular example embodiment depicted in FIG. 4B, this change in longitudinal thickness is mirrored on the opposite side of the mid-line 156 of the indicator bar 140, however, it is not necessary that the indicator bar 140 take this symmetrical shape and embodiments without a symmetrical shape are contemplated.

As with the example of the indicator bar 140 depicted in FIG. 4A, the internal stress felt by the indicator bar 140 increases as the cross sectional area of the indicator bar 140 decreases from the proximate edge 154 to the mid-line 156. Accordingly, the indicator bar 140 is more likely to fracture at the mid-line 156 given a constant stress.

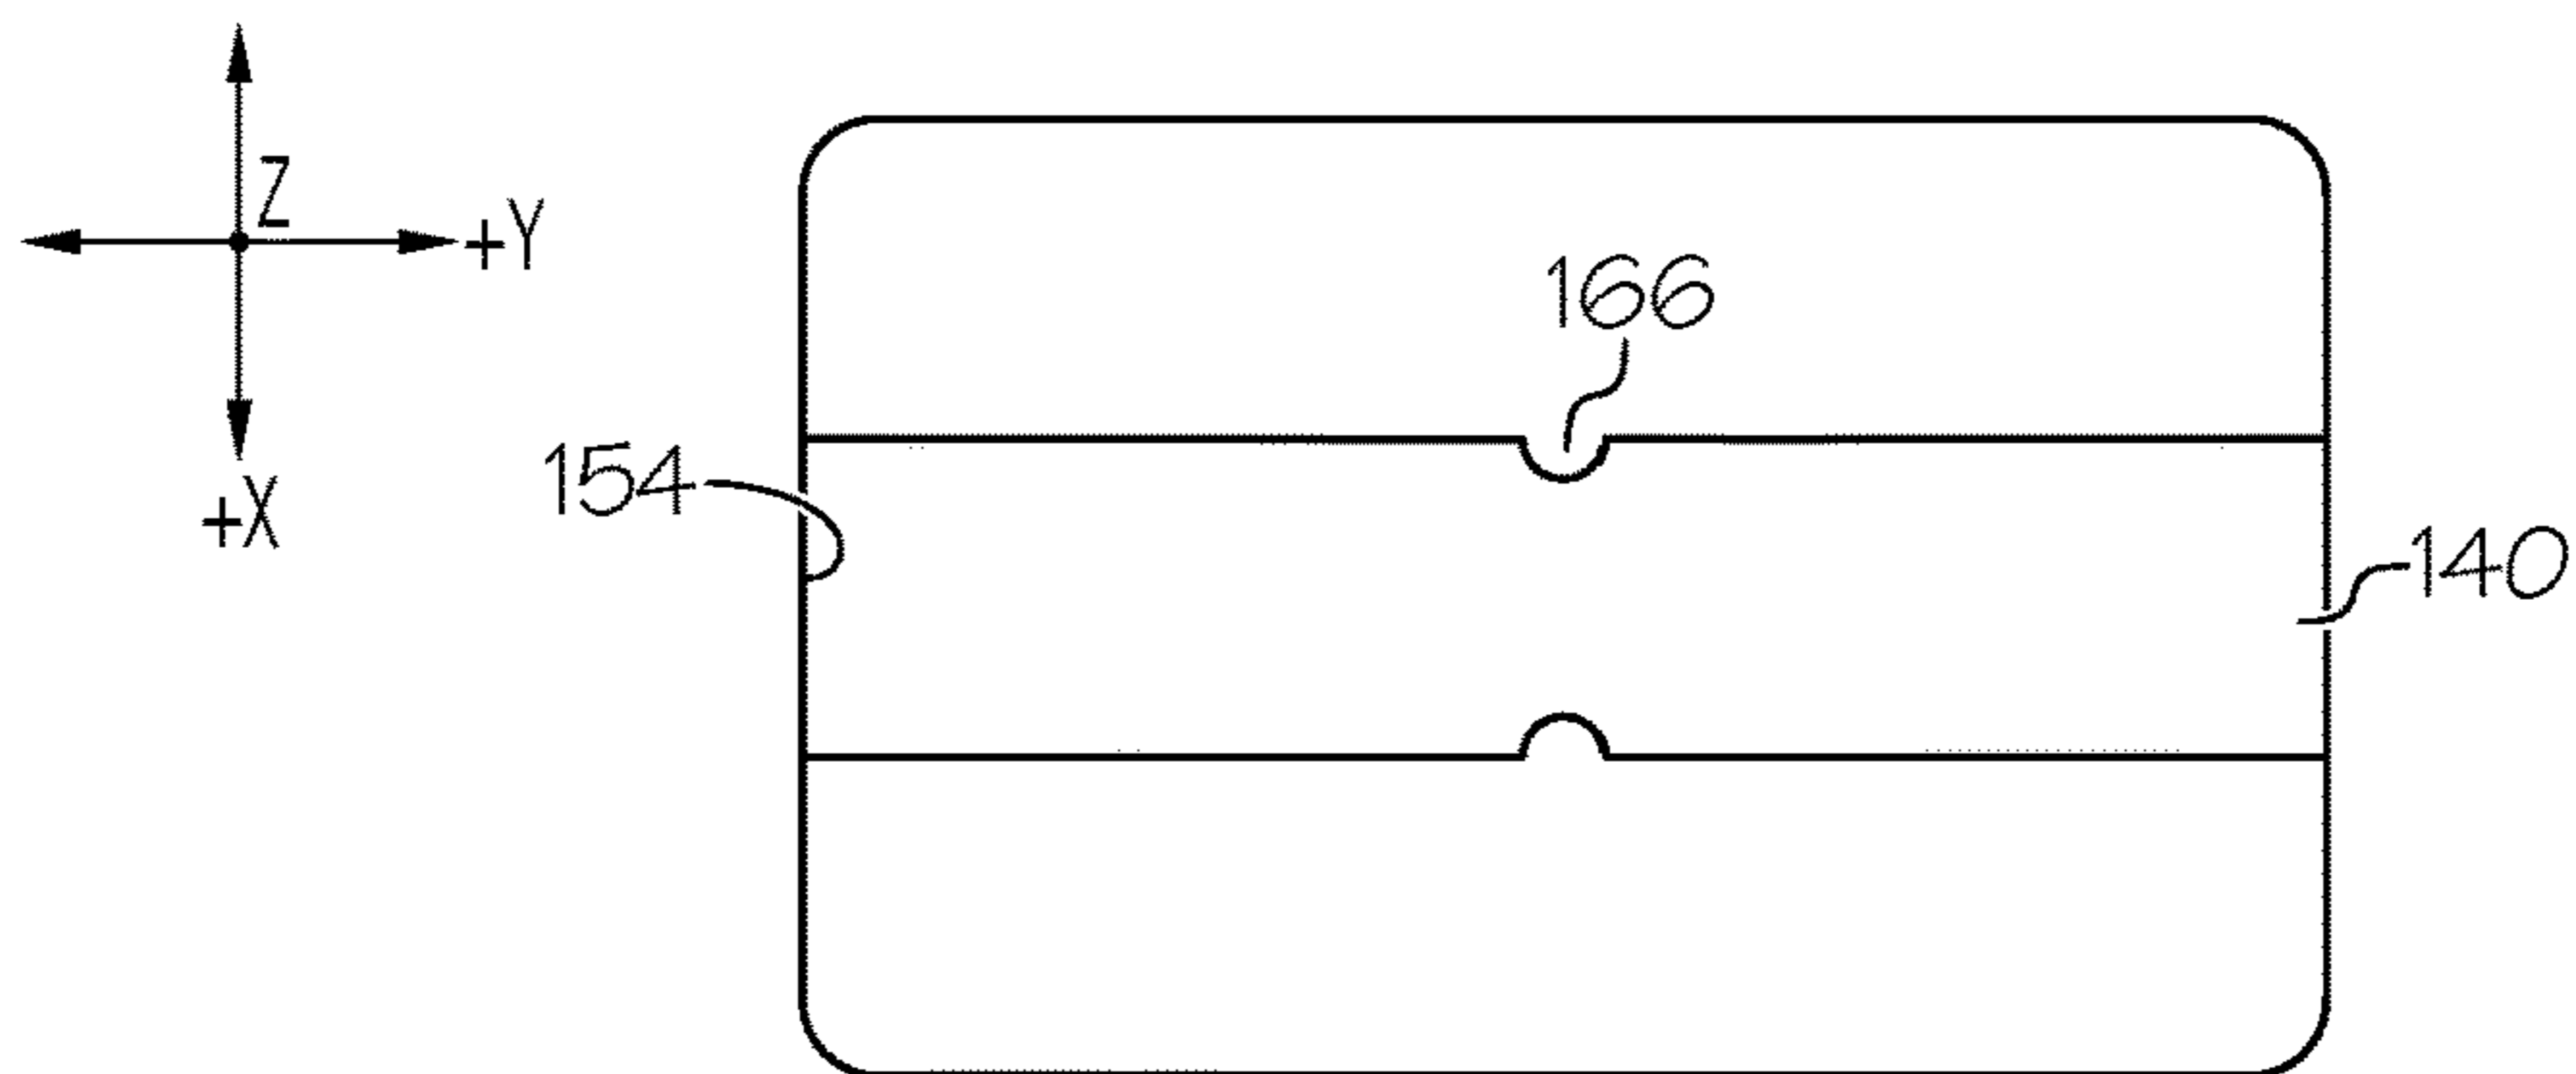
FIG. 4C depicts a top view of an embodiment of the resin fuse of FIG. 3, according to one or more embodiments shown and described herein;

FIG. 4C depicts a top view of another illustrative example embodiment of the resin fuse 134 including the indicator bar 140. The indicator bar 140 of FIG. 4c includes a strength-reduction feature 166. The strength-reduction feature 166 tunes the fracture strength of the indicator bar 140 to a predetermined value. As shown in FIG. 4C, the strength-reduction feature 166 is a semi-circular notch. The semi-circular notch reduces the cross sectional area of the indicator bar at the semi-circular notch and thus increases the stress at the location of the semi-circular notch as described

above, making it more likely that if the indicator bar **140** fails, it will fail at the semi-circular notch. The dimensions of the semi-circular notch can be engineered per the specifications of the resin seat back **118**.

While the particular embodiment shown includes a semi-circular notch, it is to be understood that any shape and size of strength-alteration feature can be used to alter the cross sectional area of the indicator bar **140**. For example, the strength-reduction feature **166** could be a v-shaped or triangular notch, a rectangular notch, a perforation, a gap, or the like. In some embodiments, the strength alteration feature may increase the cross sectional area of one or more portions of the indicator bar **140**, thereby making it less likely that the indicator bar will fail at the location of the strength-reduction feature **166**. For example, the strength-alteration feature could include a bump, a protuberance, a bulge, or the like.

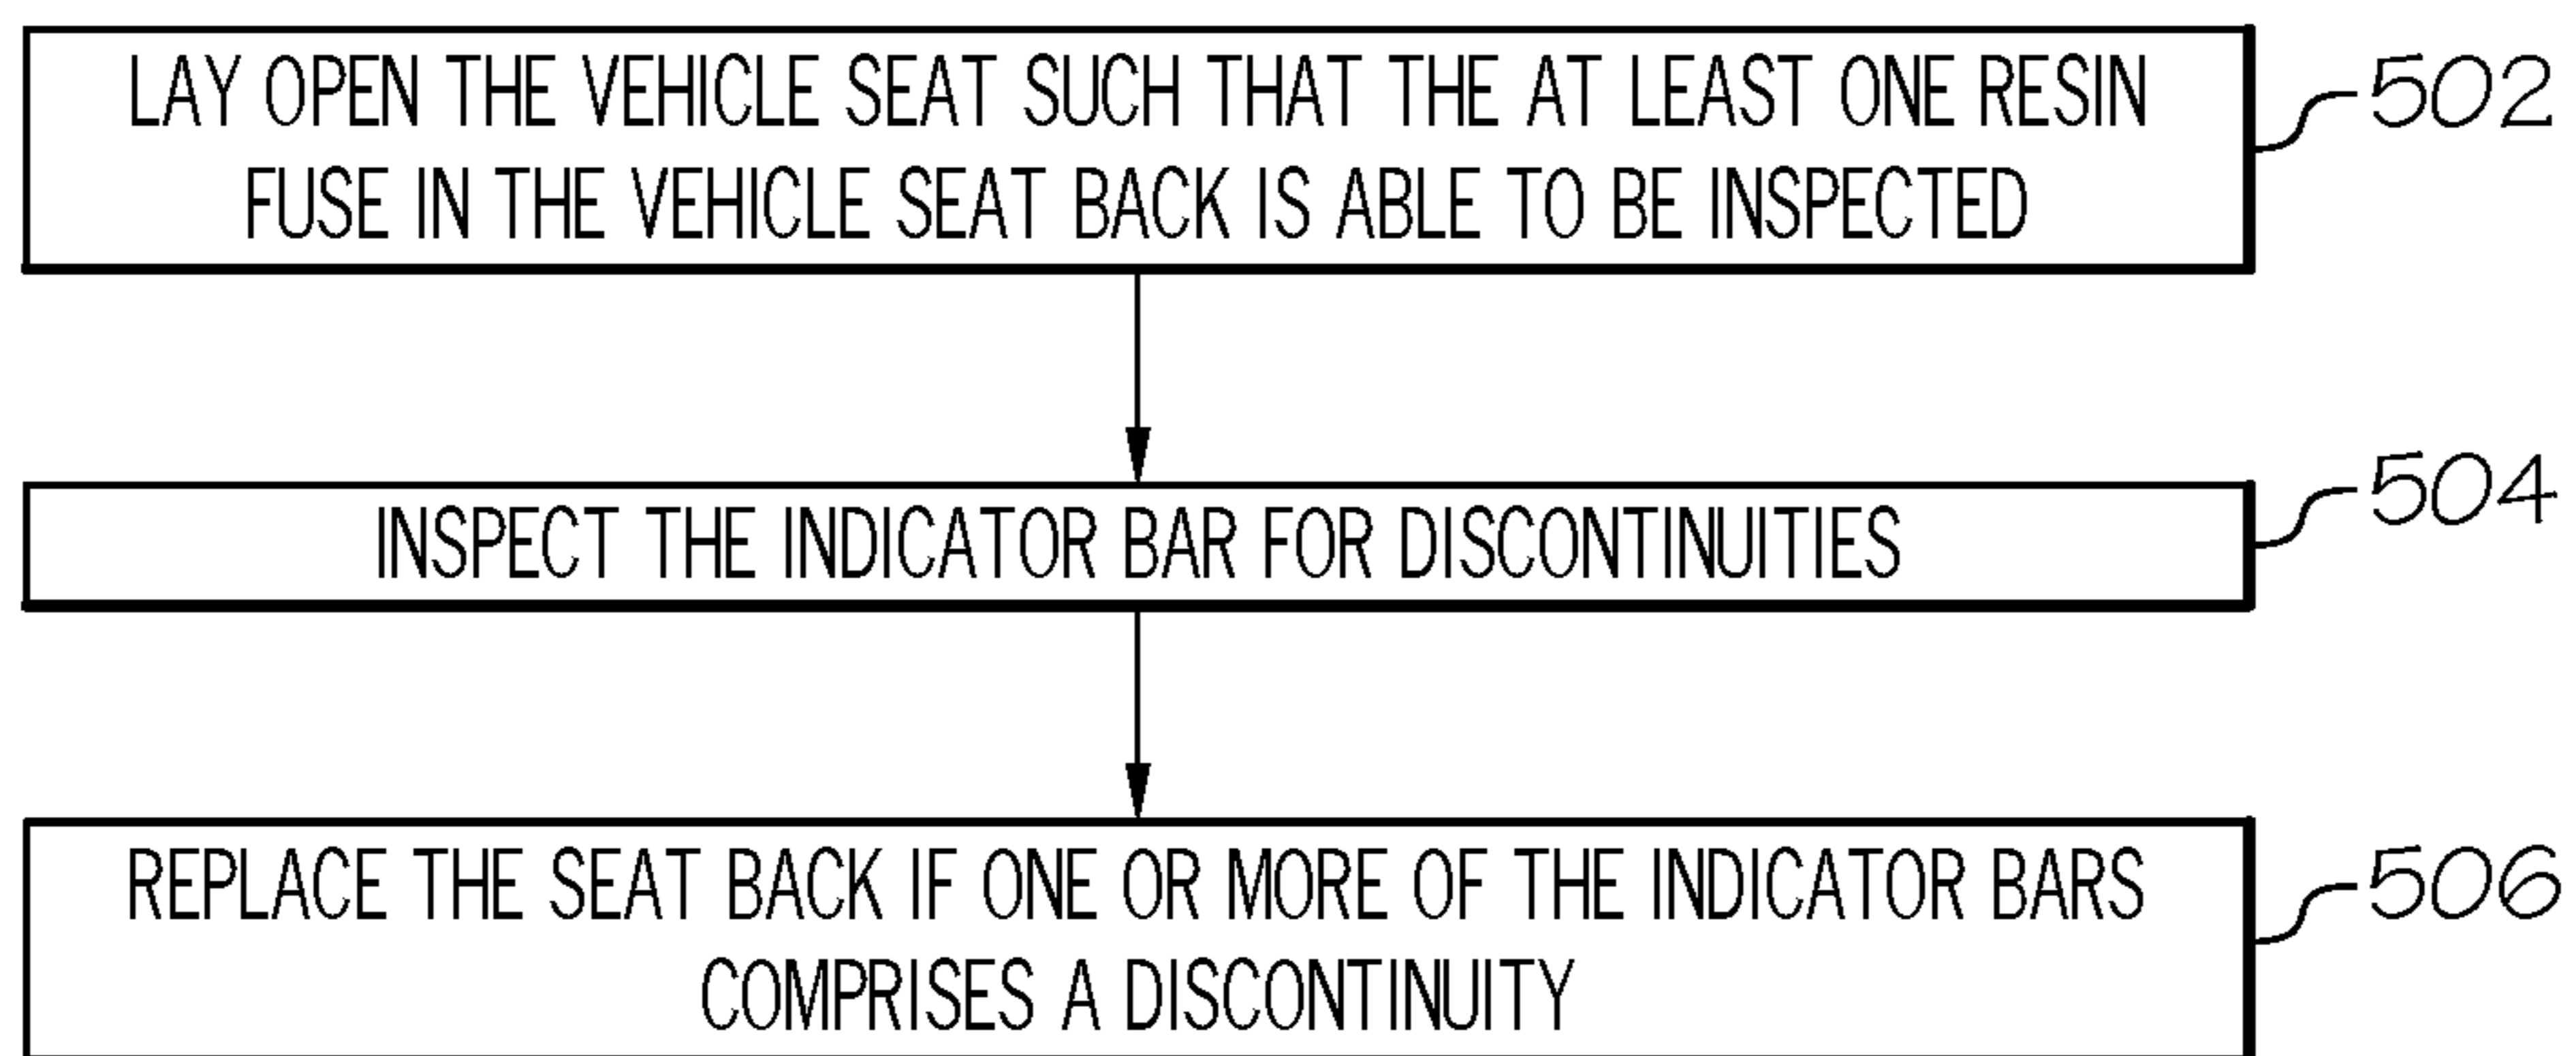
FIG. 5 depicts a method of inspecting a vehicle seat assembly to determine structural integrity of the vehicle seat assembly, according to one or more embodiments shown and described herein; and

Referring now to FIG. **5**, a method for inspecting a seat back with at least one resin fuse will be described. The method is recited with respect to inspecting a seat back and resin fuse similar to the seat back and resin fuse described above, but it is to be understood that the method could be used to inspect any type of vehicle seat having at least one resin fuse. For example, the vehicle seat could be a bucket seat with at least one resin fuse comprising an aperture extending through the seat back and a flange encircling the aperture and an indicator bar extending across a diameter of the aperture between two openings of the aperture. The method includes at least laying open the vehicle seat such that the at least one resin fuse in the vehicle seat back is able to be inspected and inspecting the indicator bar for discontinuities in the indicator bar.

With reference to the example method depicted in FIG. **5**, at step **502**, the vehicle seat is laid open such that at least one resin fuse in the vehicle seat back is able to be inspected. Laying open the vehicle seat may include any step, procedure, or process that results in the at least one resin fuse being able to be inspected. For example, without limitation, an exterior cover such as an upholstery cover, a padding, a cushion, and/or an external seat cover may be removed from the seat exposing the at least one resin fuse. In another embodiment, a device for inspecting the at least one resin fuse may be placed in the seat cover, upholstery, padding, or cushion such that the device can enable inspection of the at least one resin fuse without removing the cover, upholstery, padding, cushion, etc. For example, without limitation, a non-destructive technique may be applied to inspect the at least one resin fuse (e.g., the use of an endoscopic camera, an ultrasonic inspection, or x-ray topography).

Once the vehicle seat is laid open (e.g., the upholstery/padding is removed, and/or the inspection apparatus is in place), the at least one resin fuse may be inspected for discontinuities at step **504**. This may include inspecting the at least one resin fuse for cracks, gaps, clefts, breaches, chinks, fissures, etc. For the purpose of this specification, such cracks, gaps, etc. will be referred to as discontinuities. Inspecting the at least one resin fuse may also include inspecting the resin fuse using one or more of a camera, an X-ray topography machine, an ultrasonic transducer, etc.

Still referring to the example method depicted in FIG. **5**, the method of inspecting the vehicle seat may further include replacing the seat back if one or more of the resin fuses comprises a discontinuity at step **506**. Replacing the seat back may include replacing the entire vehicle seat assembly or one or more portions thereof. For example, replacing the seat back may include decoupling the seat back from the seat frame and replacing only the seat back. The replacement seat back may include at least one resin fuse without a discontinuity. In embodiments of vehicles having multiple seat assemblies with seatbacks having one or more resin fuses, each of the vehicle seat assemblies and/or seatbacks may be replaced if any of the seatbacks includes a resin fuse with a discontinuity. Such a method may ensure that none of the vehicle seat assemblies includes a seat back that has experienced loading above a loading tolerance.

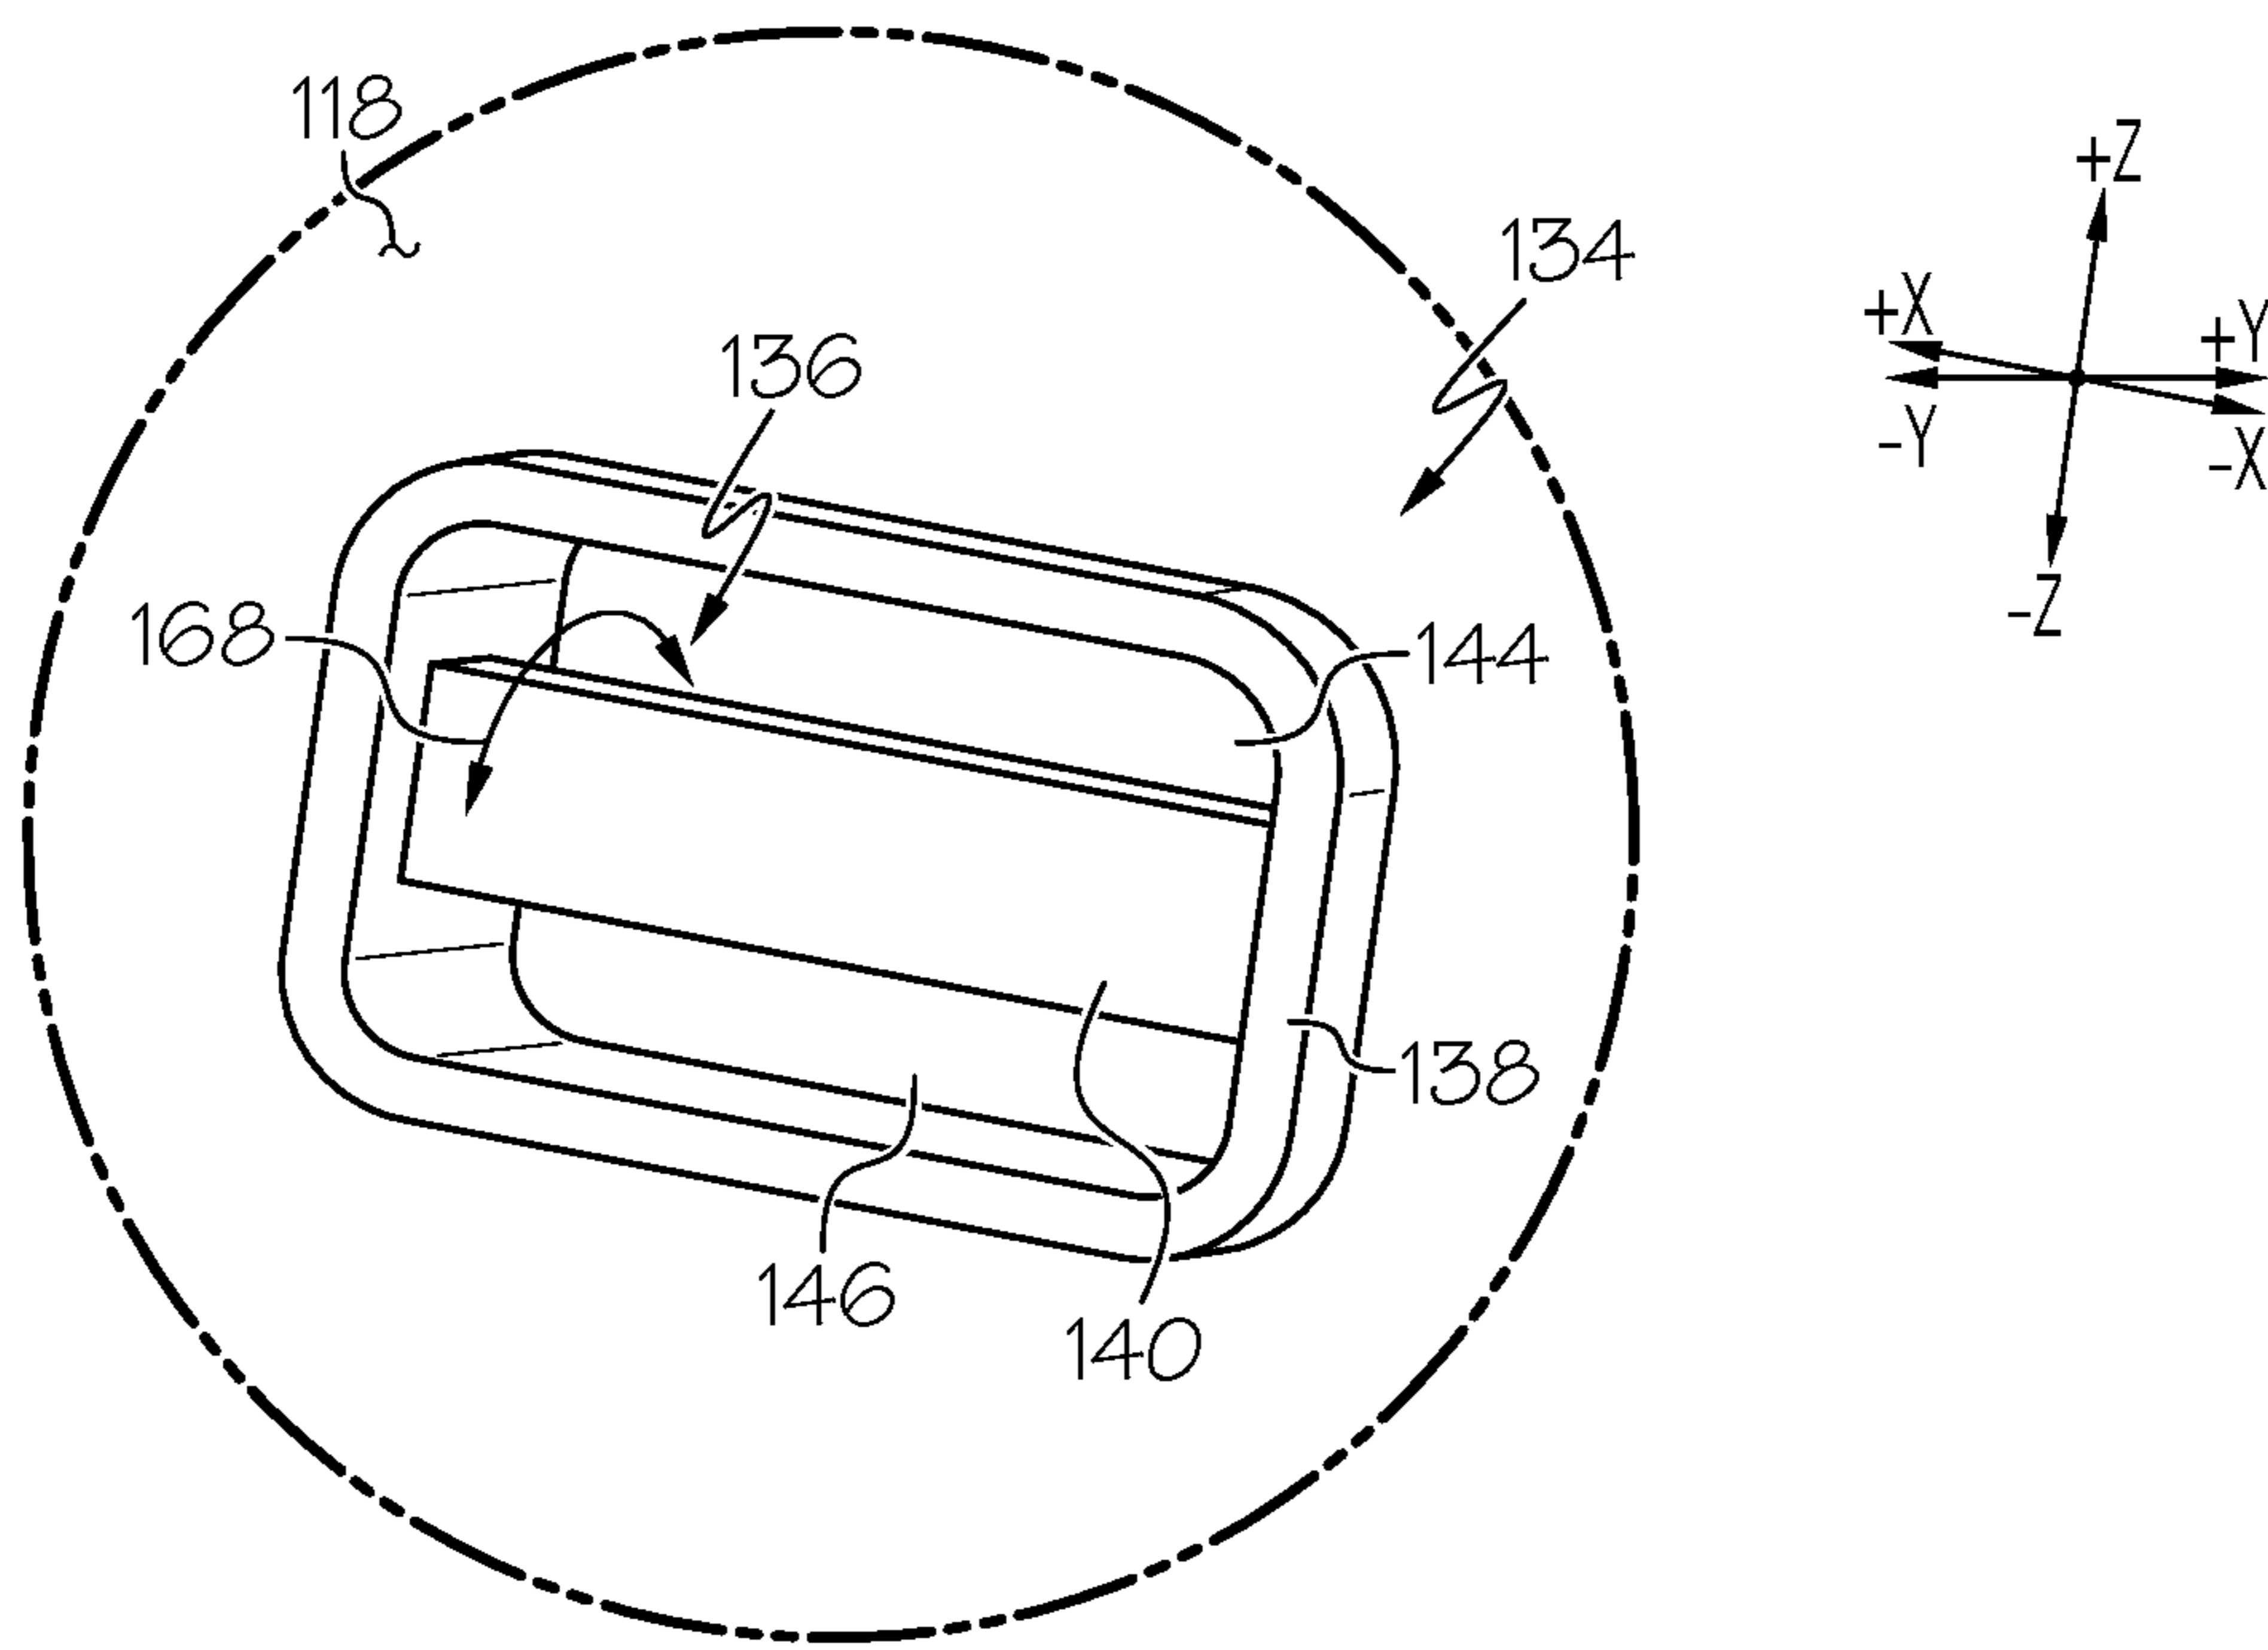
FIG. 6 depicts an illustrative resin fuse of the seat back of FIG. 2B in isolation, according to one or more embodiments shown and described herein.

Briefly referring to FIG. 6, the resin fuse 134 is shown subjected to a torsional load 168. The torsional load 168 may be developed in the resin fuse 134, for example, by applying a load to the resin seat back 118. For example, the resin seat back 118 may be bent or twisted during collision testing of the vehicle 10 of FIG. 1. The load may be transferred to the indicator bar 140 of the resin fuse 134 and may tend to twist the indicator bar 140. The torsional load 168 may result in an internal shear stress in one or more components of the resin fuse 134, for example, in the indicator bar 140. The indicator bar 140 may experience both an internal compression stress and an internal tensile stress as it twists. The torsional load capacity of the indicator bar 140 may be engineered such that if the maximum torsional load of the indicator bar 140 is exceeded (i.e., the indicator bar fractures due to the torsional load), the resin seat back 118 needs to be replaced. That is, a fracture in the indicator bar 140 may indicate loading condition in the resin seat back 118 above its design tolerance or some factor thereof. In addition to the particular design features shown in FIGS. 4A-4C, the resin fuse 134 may also include one or more features engineered to manipulate the torsional load strength of the indicator bar 140.
