(54) **METHOD AND DEVICE FOR INSPECTING THE DAMAGE TO THE SKIN OF AN AEROPLANE AFTER A LIGHTNING STRIKE**

**METHOD AND DEVICE FOR INSPECTING
THE DAMAGE TO THE SKIN OF AN
AEROPLANE AFTER A LIGHTNING STRIKE**

The present invention refers to a method and a device for aircraft damage inspection after a lightning strike by getting an optimized admissible visual damage determined by the relationship between the structural damage and the visual damage produced by a certain lightning strike energy.

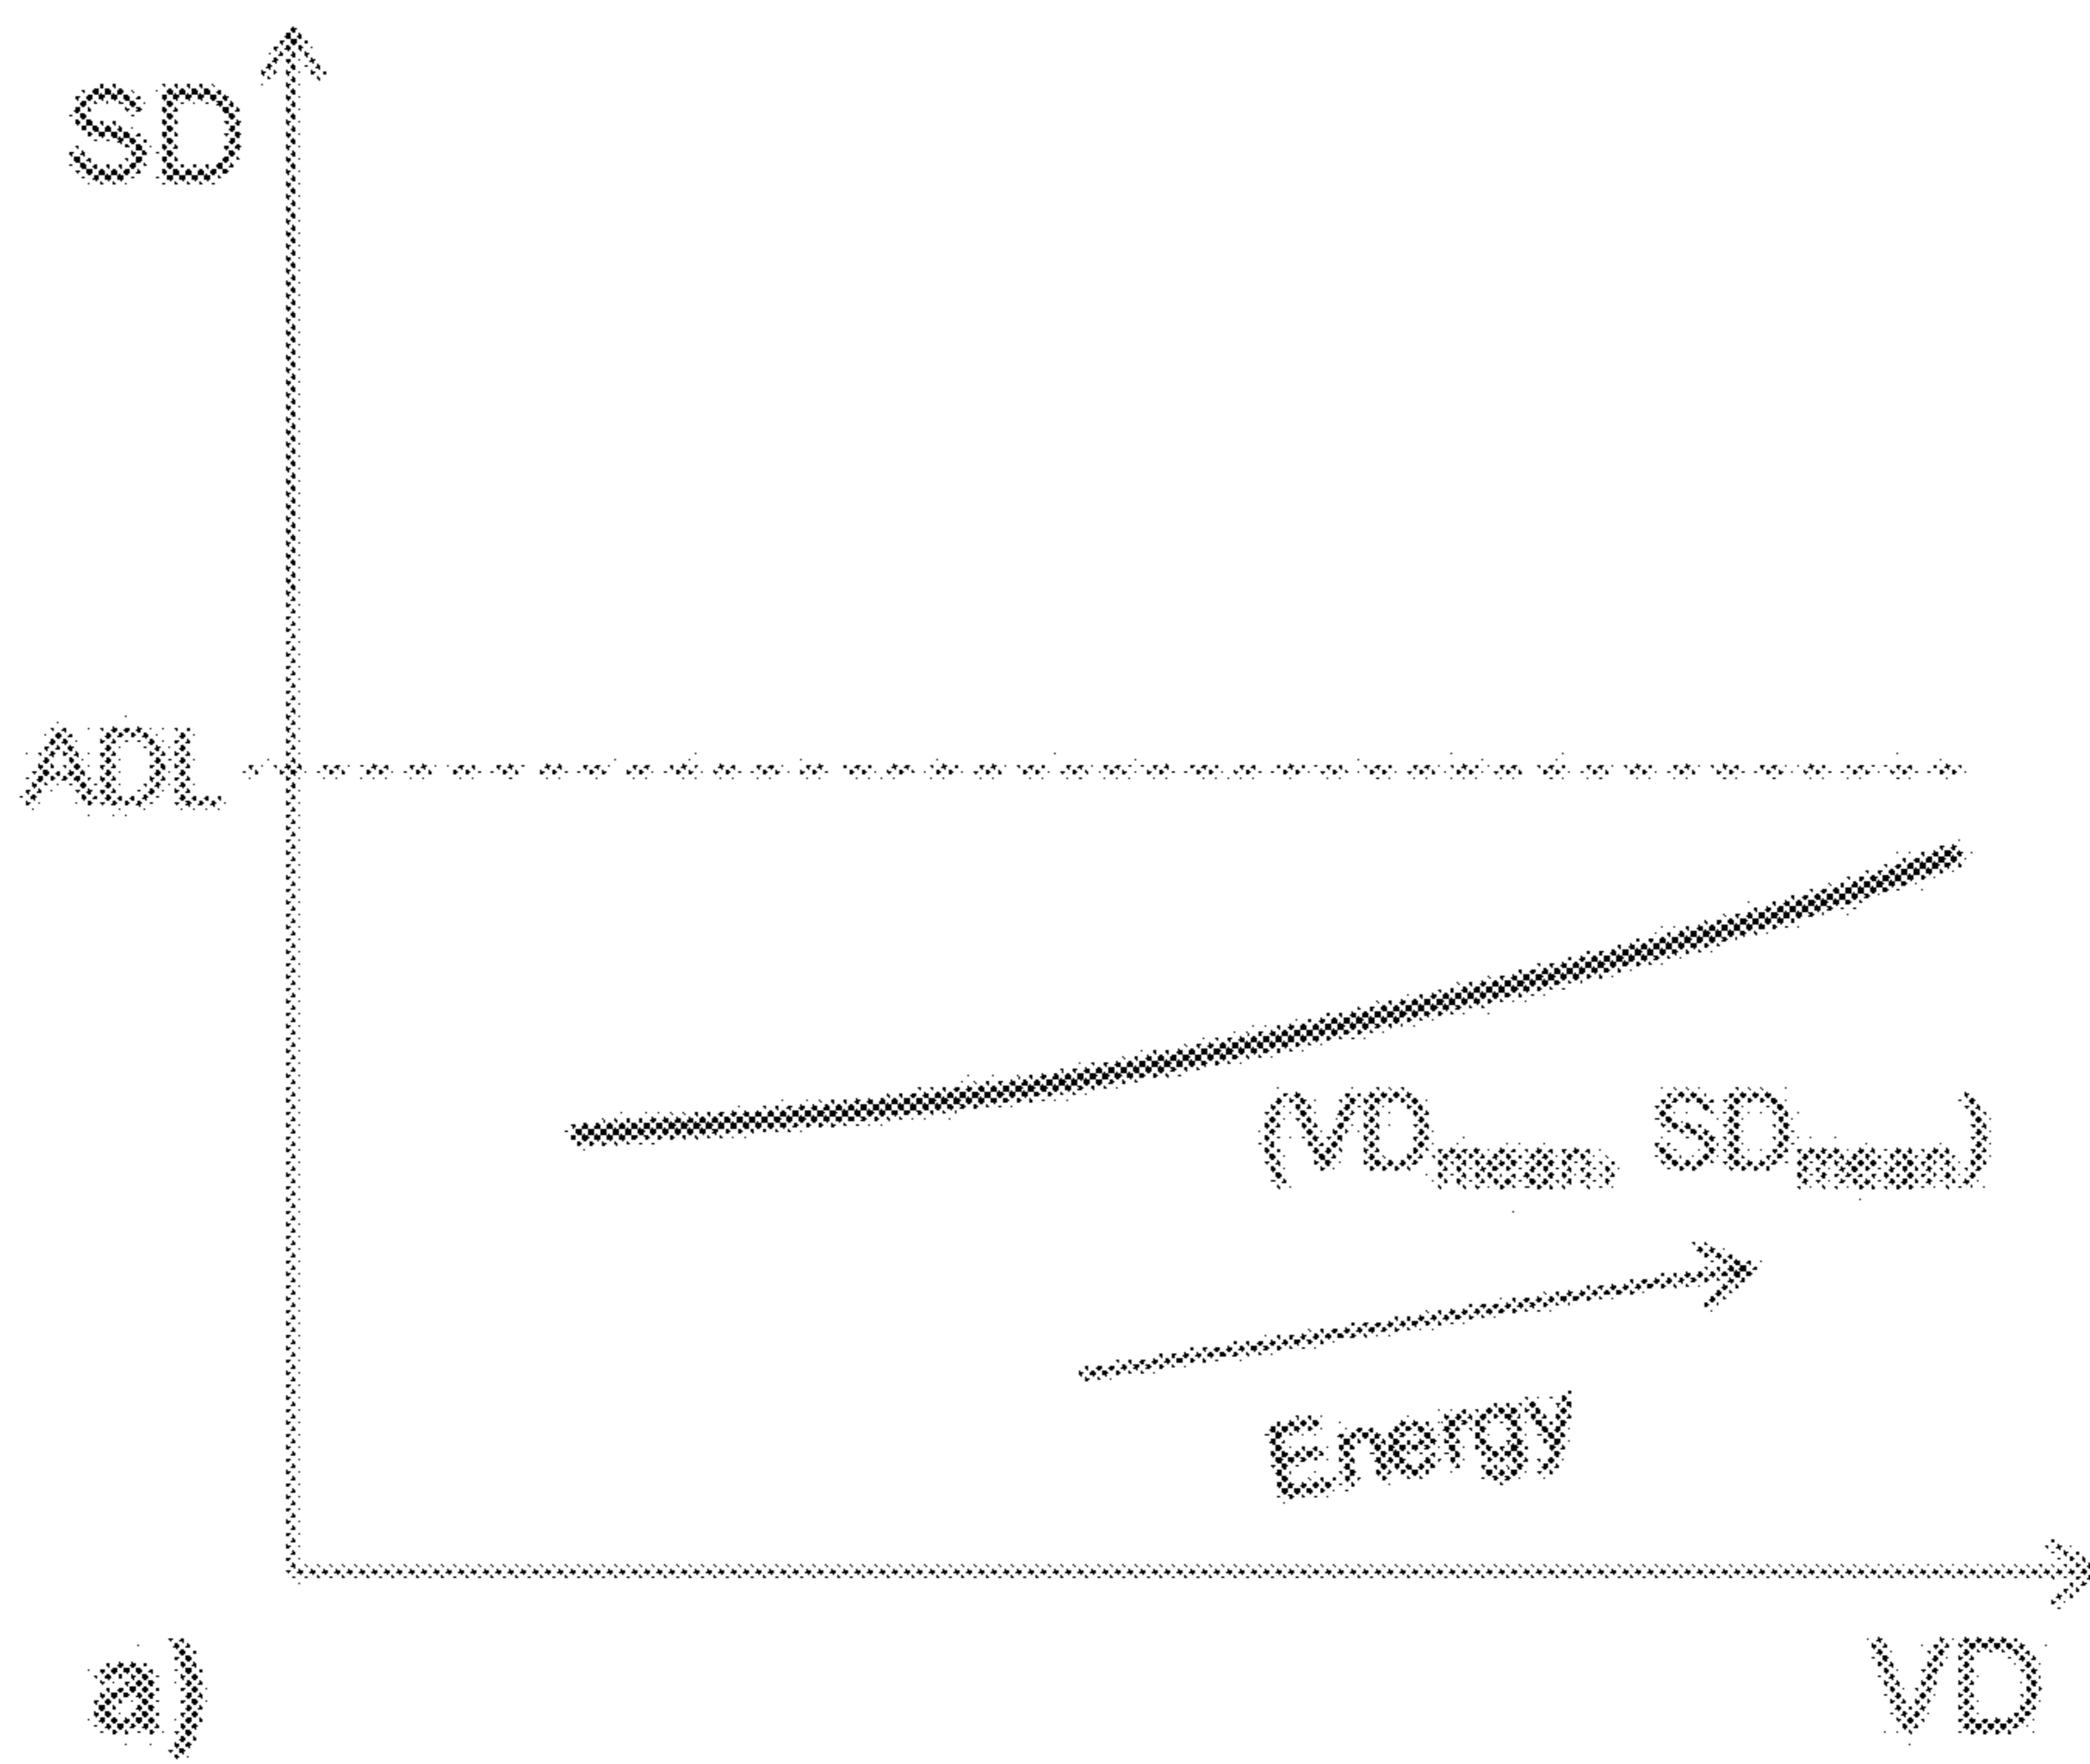
Fig. 1a

FIGS. 1a and 1b show graphics depicting the behavior of the Structural Damage (SD) and Visual Damage (VD) as the energy level of a lightning strike increases. FIG. 1a represents the case when the method called “Bounding-Box Approach” must be applied (maximum Structural Damage (SD) expected in that aircraft zone is less than the admissible Structural Damage (ADL)). FIG. 1b represents the alternative case, when the method called “Energy-Dependent Approach” must be used (maximum Structural Damage (SD) expected in that aircraft zone is greater than the admissible Structural Damage (ADL)).

As previously stated, this embodiment is valid for cases when the admissible Structural Damage (ADL) of the aircraft zone in which the mark is located is above the Structural Damage (SD) associated to the maximum lightning strike energy level or peak current expected on the aircraft section studied, see FIG. 1a.

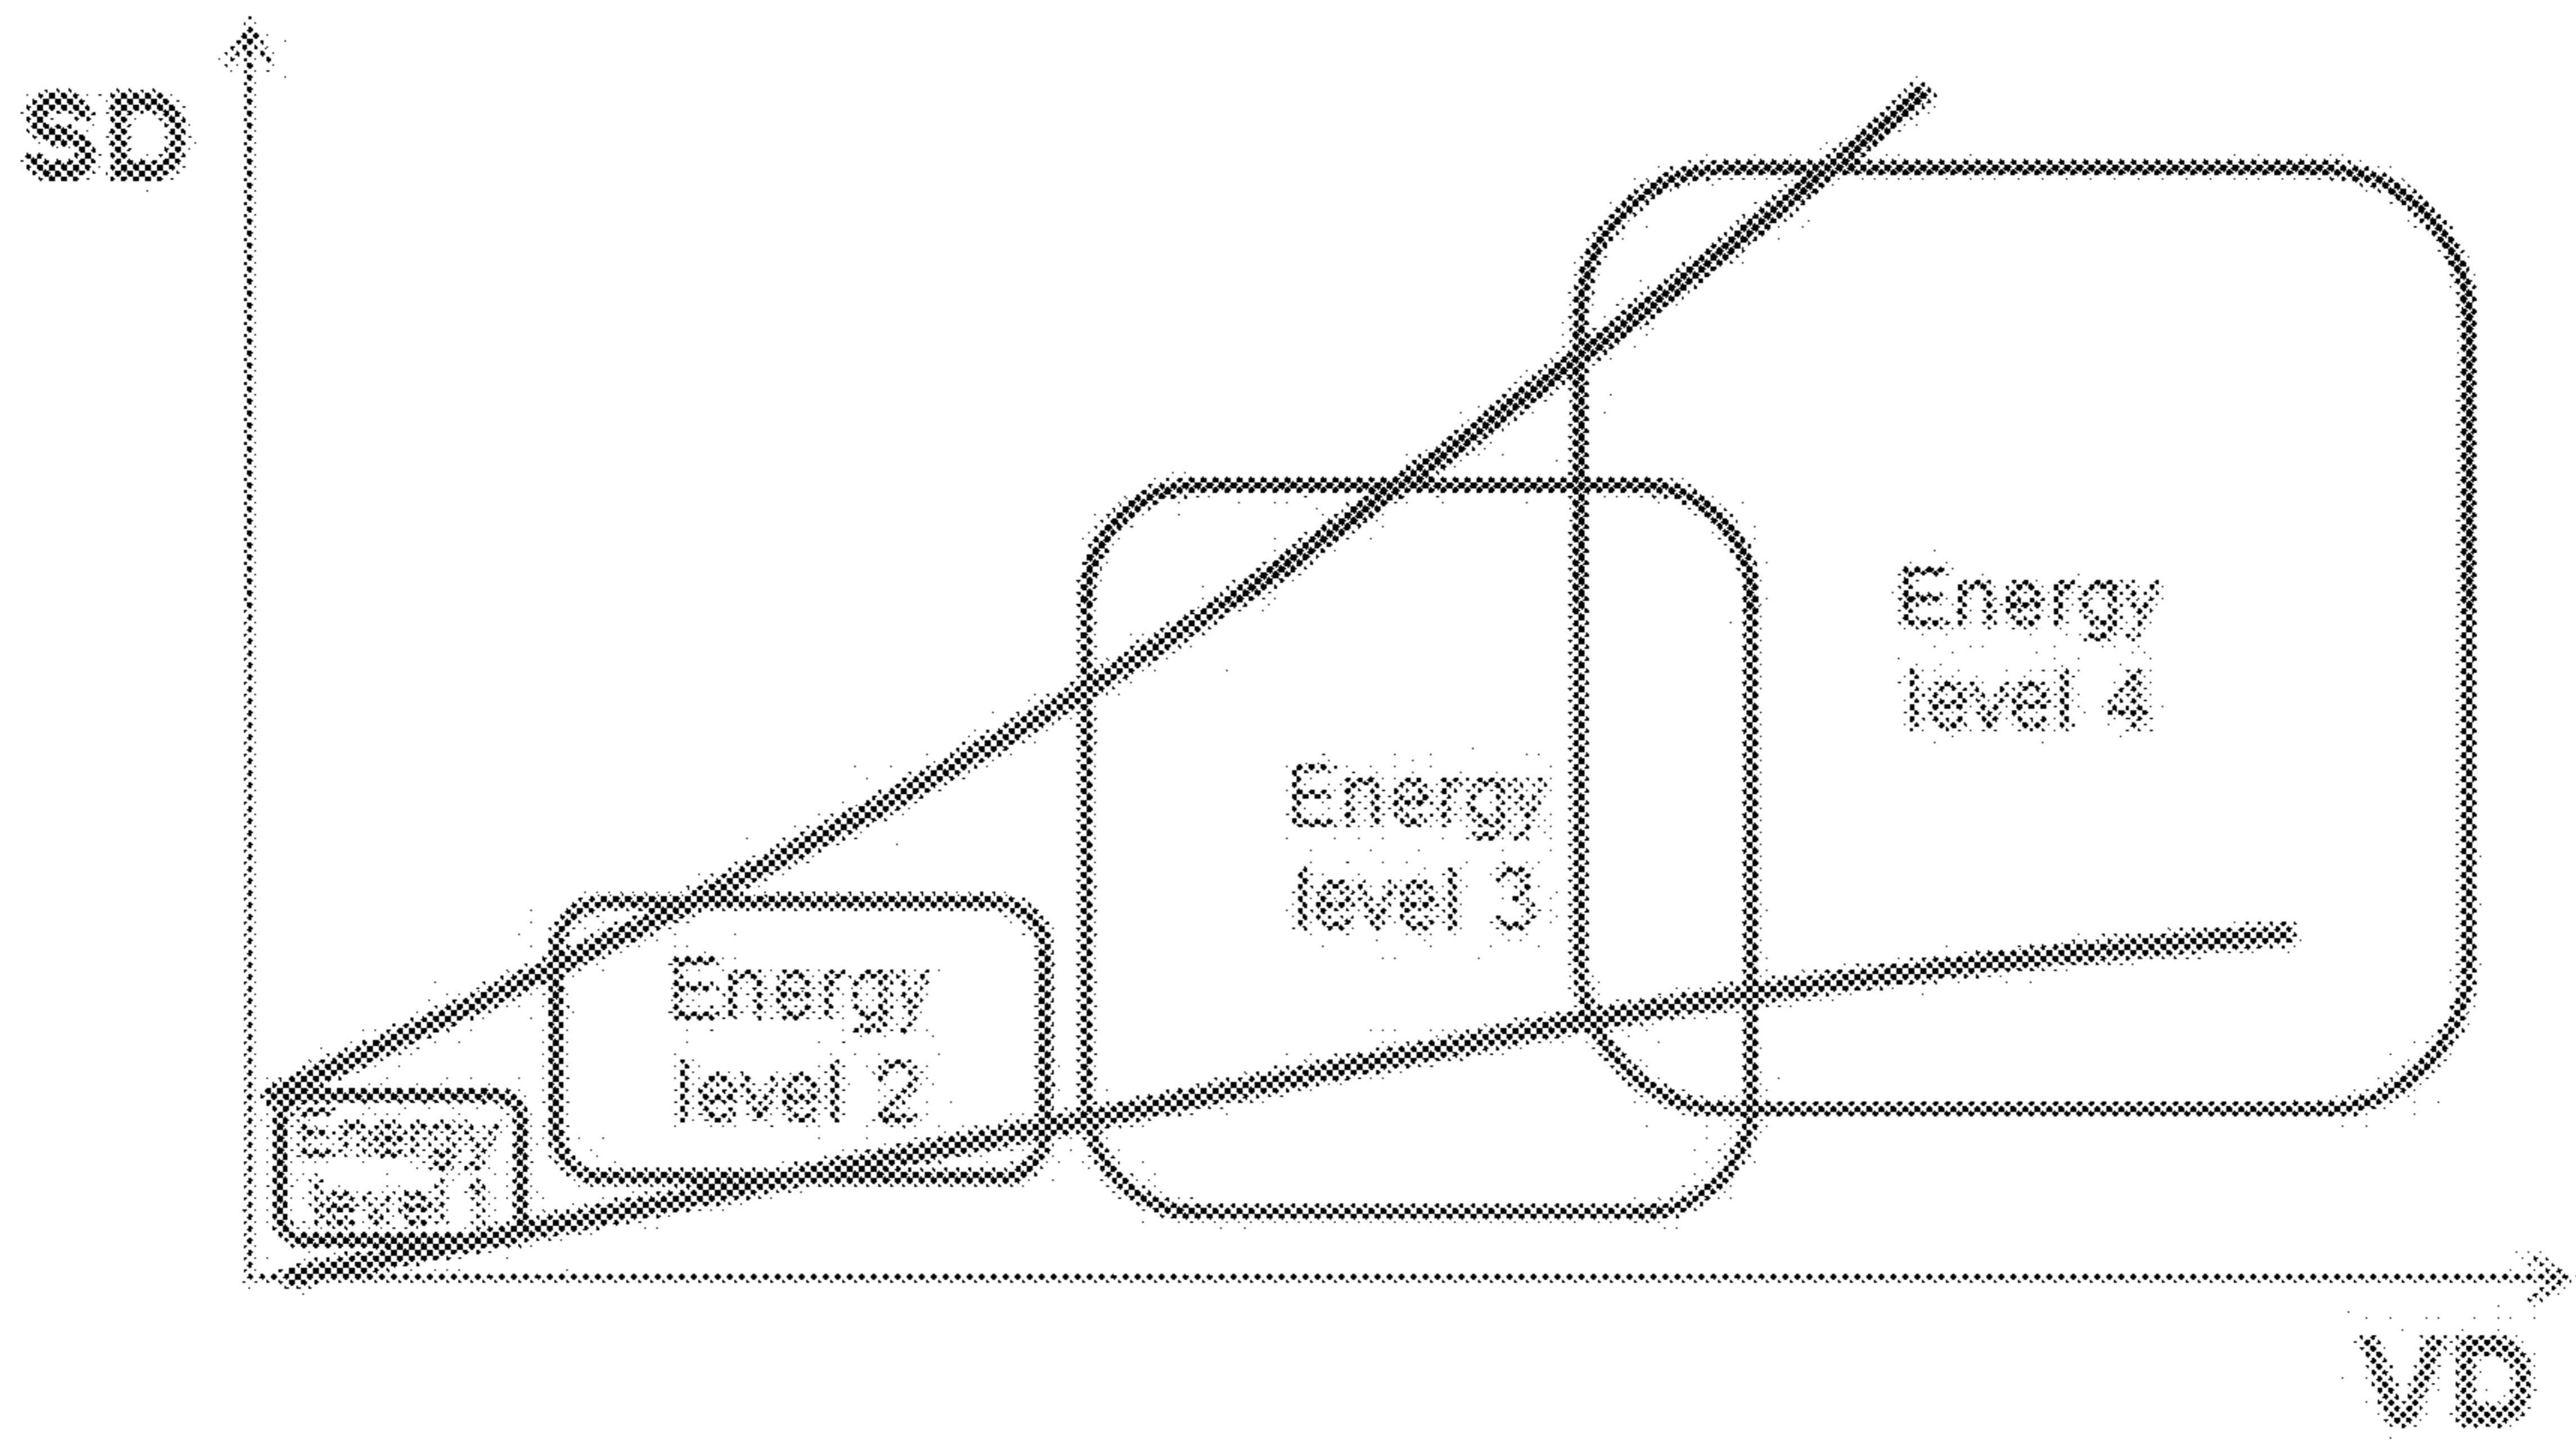
Fig. 2

FIG. 2 shows the two different approaches that can be used to find the Visual Damage-Structural Damage (VD-SD) relationship. The rectangles represent the “Bounding-Box Approach” while the other increasing lines represent the “Energy-Dependent Approach”. “Energy level 1” is the least energetic and “energy level 4” is the most energetic.

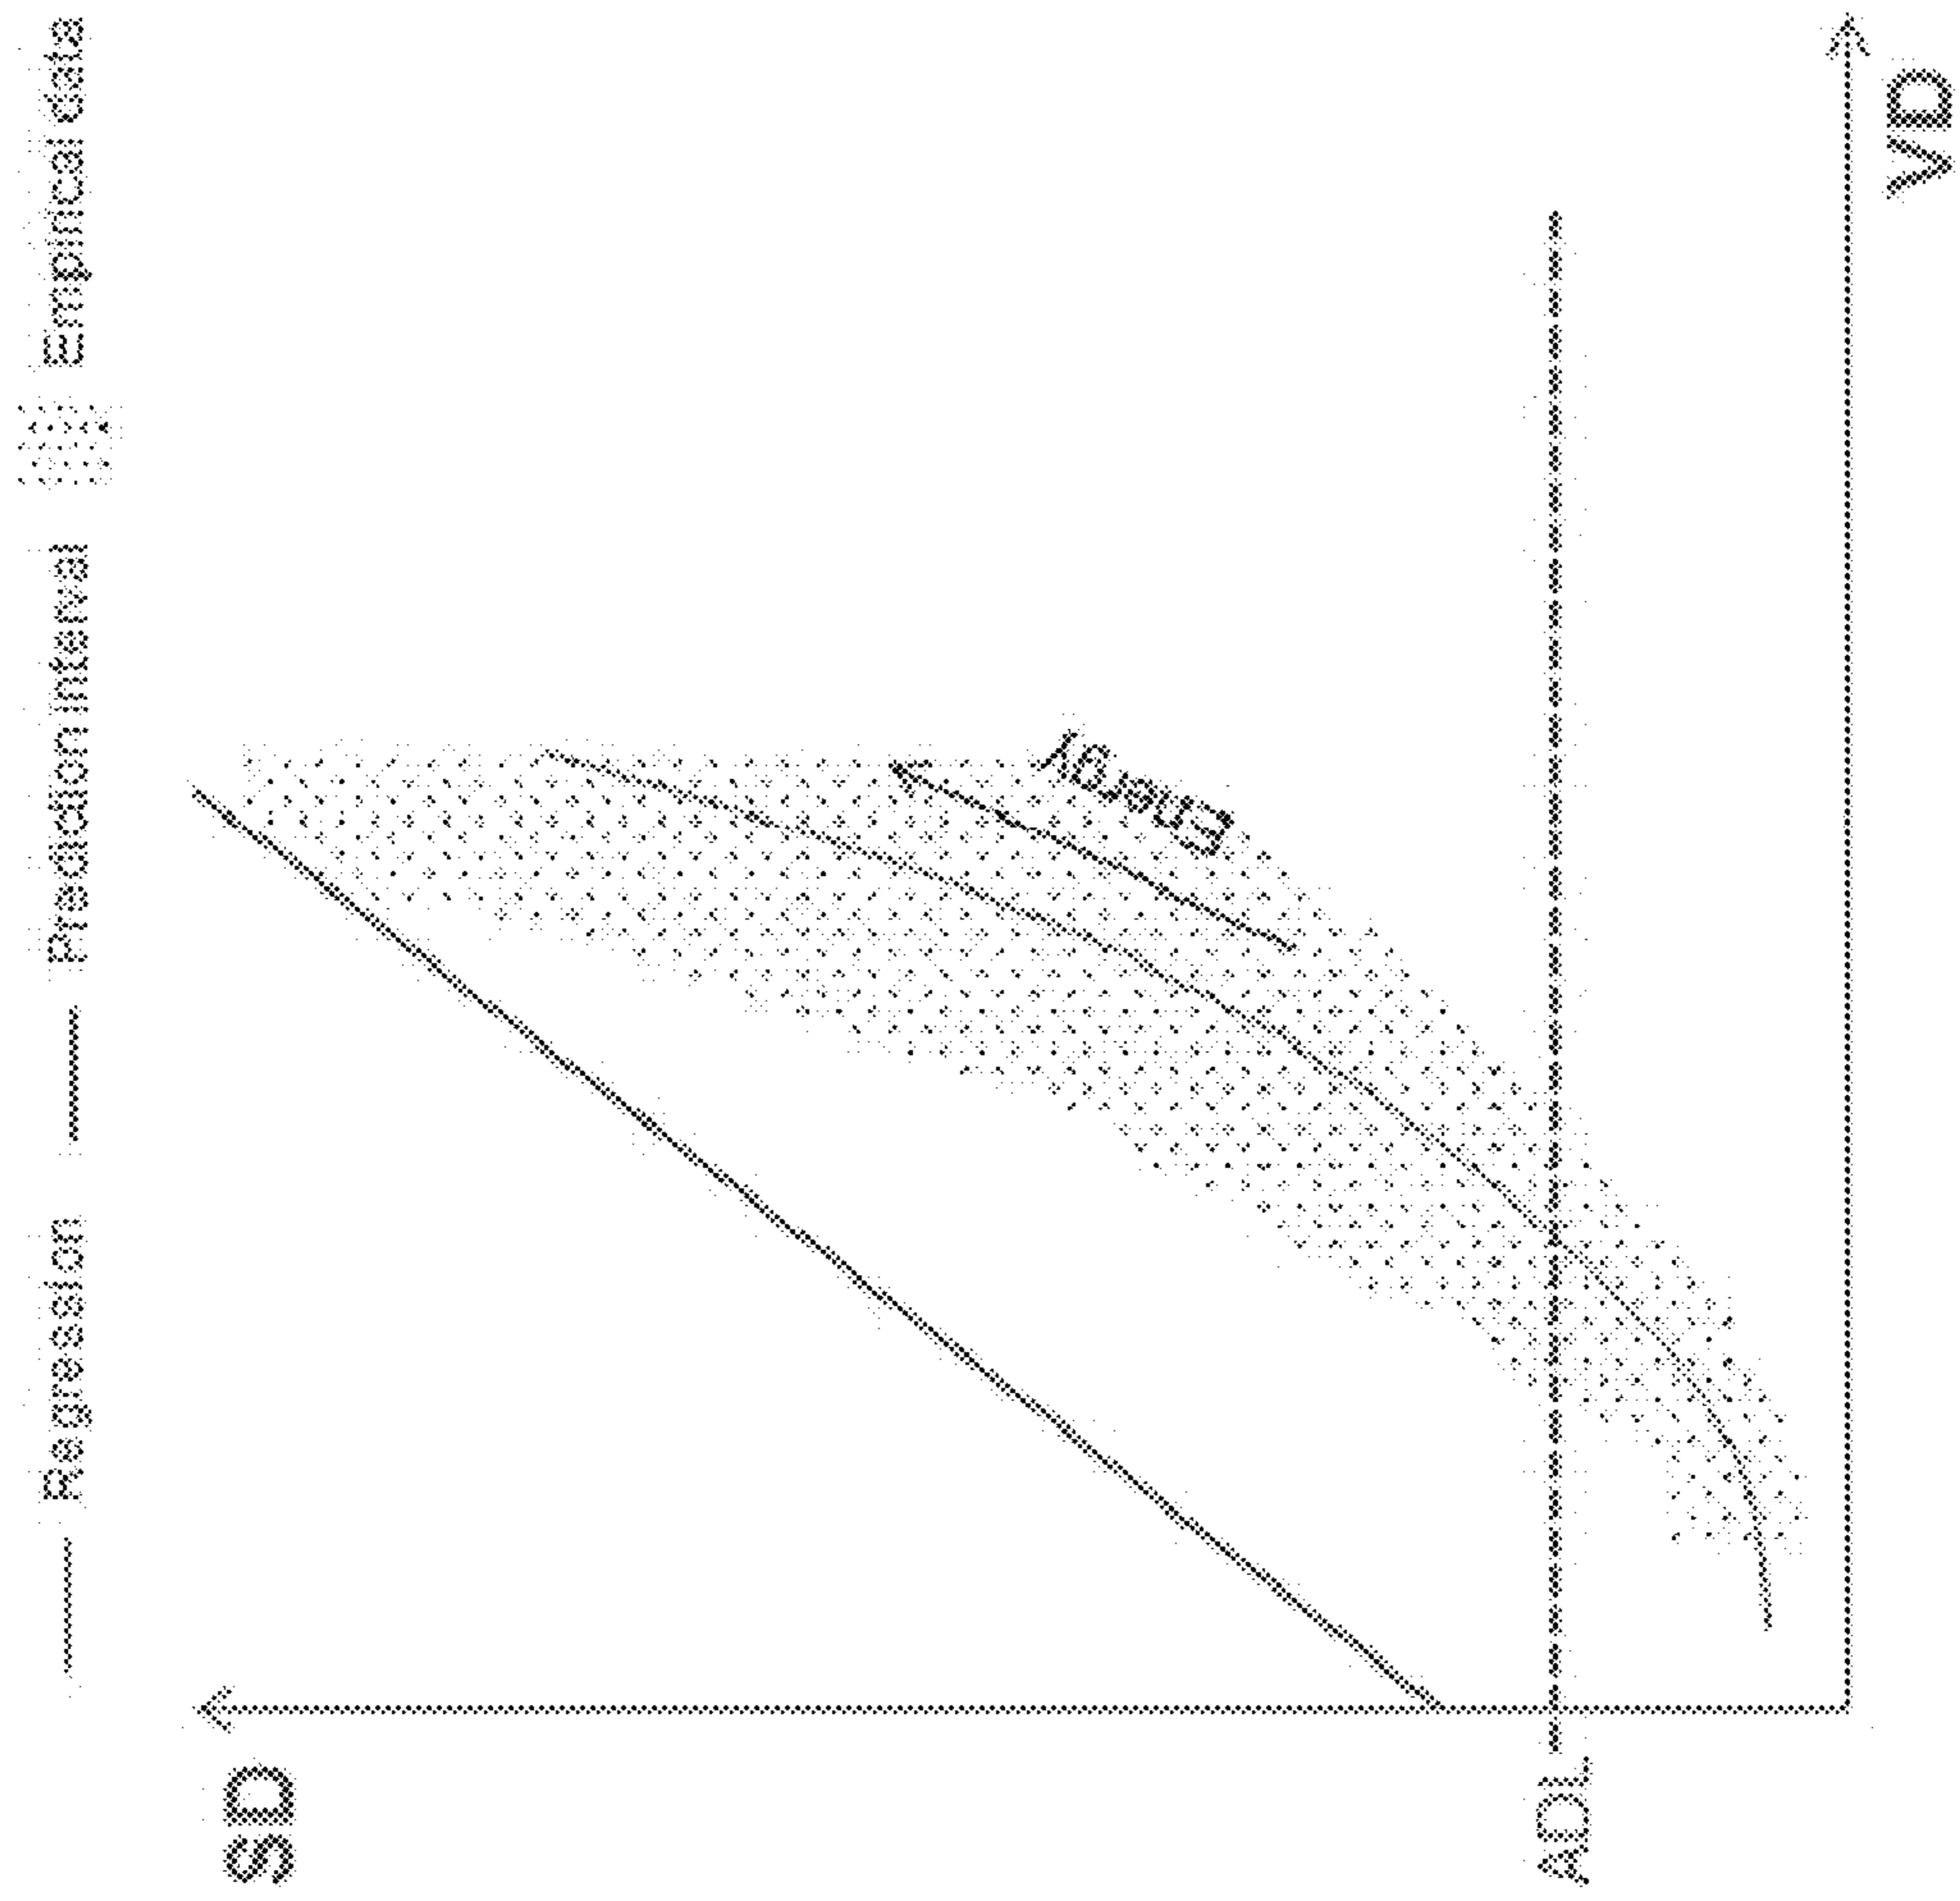
Fig. 6

FIG. 6 shows a graphic depicting the nature of the Visual Damage-Structural Damage (VD-SD) relationship and compares it to the statistical method used.

- Previous empirical data demonstrate that the Visual Damage-Structural Damage (VD-SD) relationship is clearly exponential, see FIG. 6; as the energy increases, Structural Damage (SD) increases exponentially as well as its dispersion. It would be possible to accurately define this behavior with an extensive lightning strike test campaign, but this option is not feasible as it would imply a considerable financial impact.

To overcome this issue, a mathematical model needs to be used to determine a prediction interval for the Structural Damage (SD). Unfortunately, there is no existing model able to adapt to an exponential curve with exponential increase of dispersion; standard models are driven by the Structural Damage (SD) scatter of the maximum energy level included in the calculations. As a result, extremely high values of Structural Damage (SD) are predicted for the lower energy levels, giving useless results from an applied technological perspective. This is clearly a fault of the mathematical model as empirical data show that the limit predicted by the standard models is excessively conservative, see FIG. 6.

- a. When calculating prediction intervals, due to the exponential increase of the scatter with the energy (see FIG. 6), when taking into account higher energy levels, the prediction interval is dominated by the Structural Damage-Visual Damage (SD-VD) values of the highest energy level. See FIG. 7a; when adding higher energy levels to the calculations ($e_4 \rightarrow e_4 + e_3 \rightarrow e_4 + e_3 + e_2 \rightarrow e_4 + e_3 + e_2 + e_1$; being e_i different energy levels where $e_4 < e_3 < e_2 < e_1$), the Structural Damage (SD) prediction curve (the maximum values of Structural Damage (SD) predicted for a Visual Damage (VD) range) is modified as it is strongly influenced by the higher energy level.

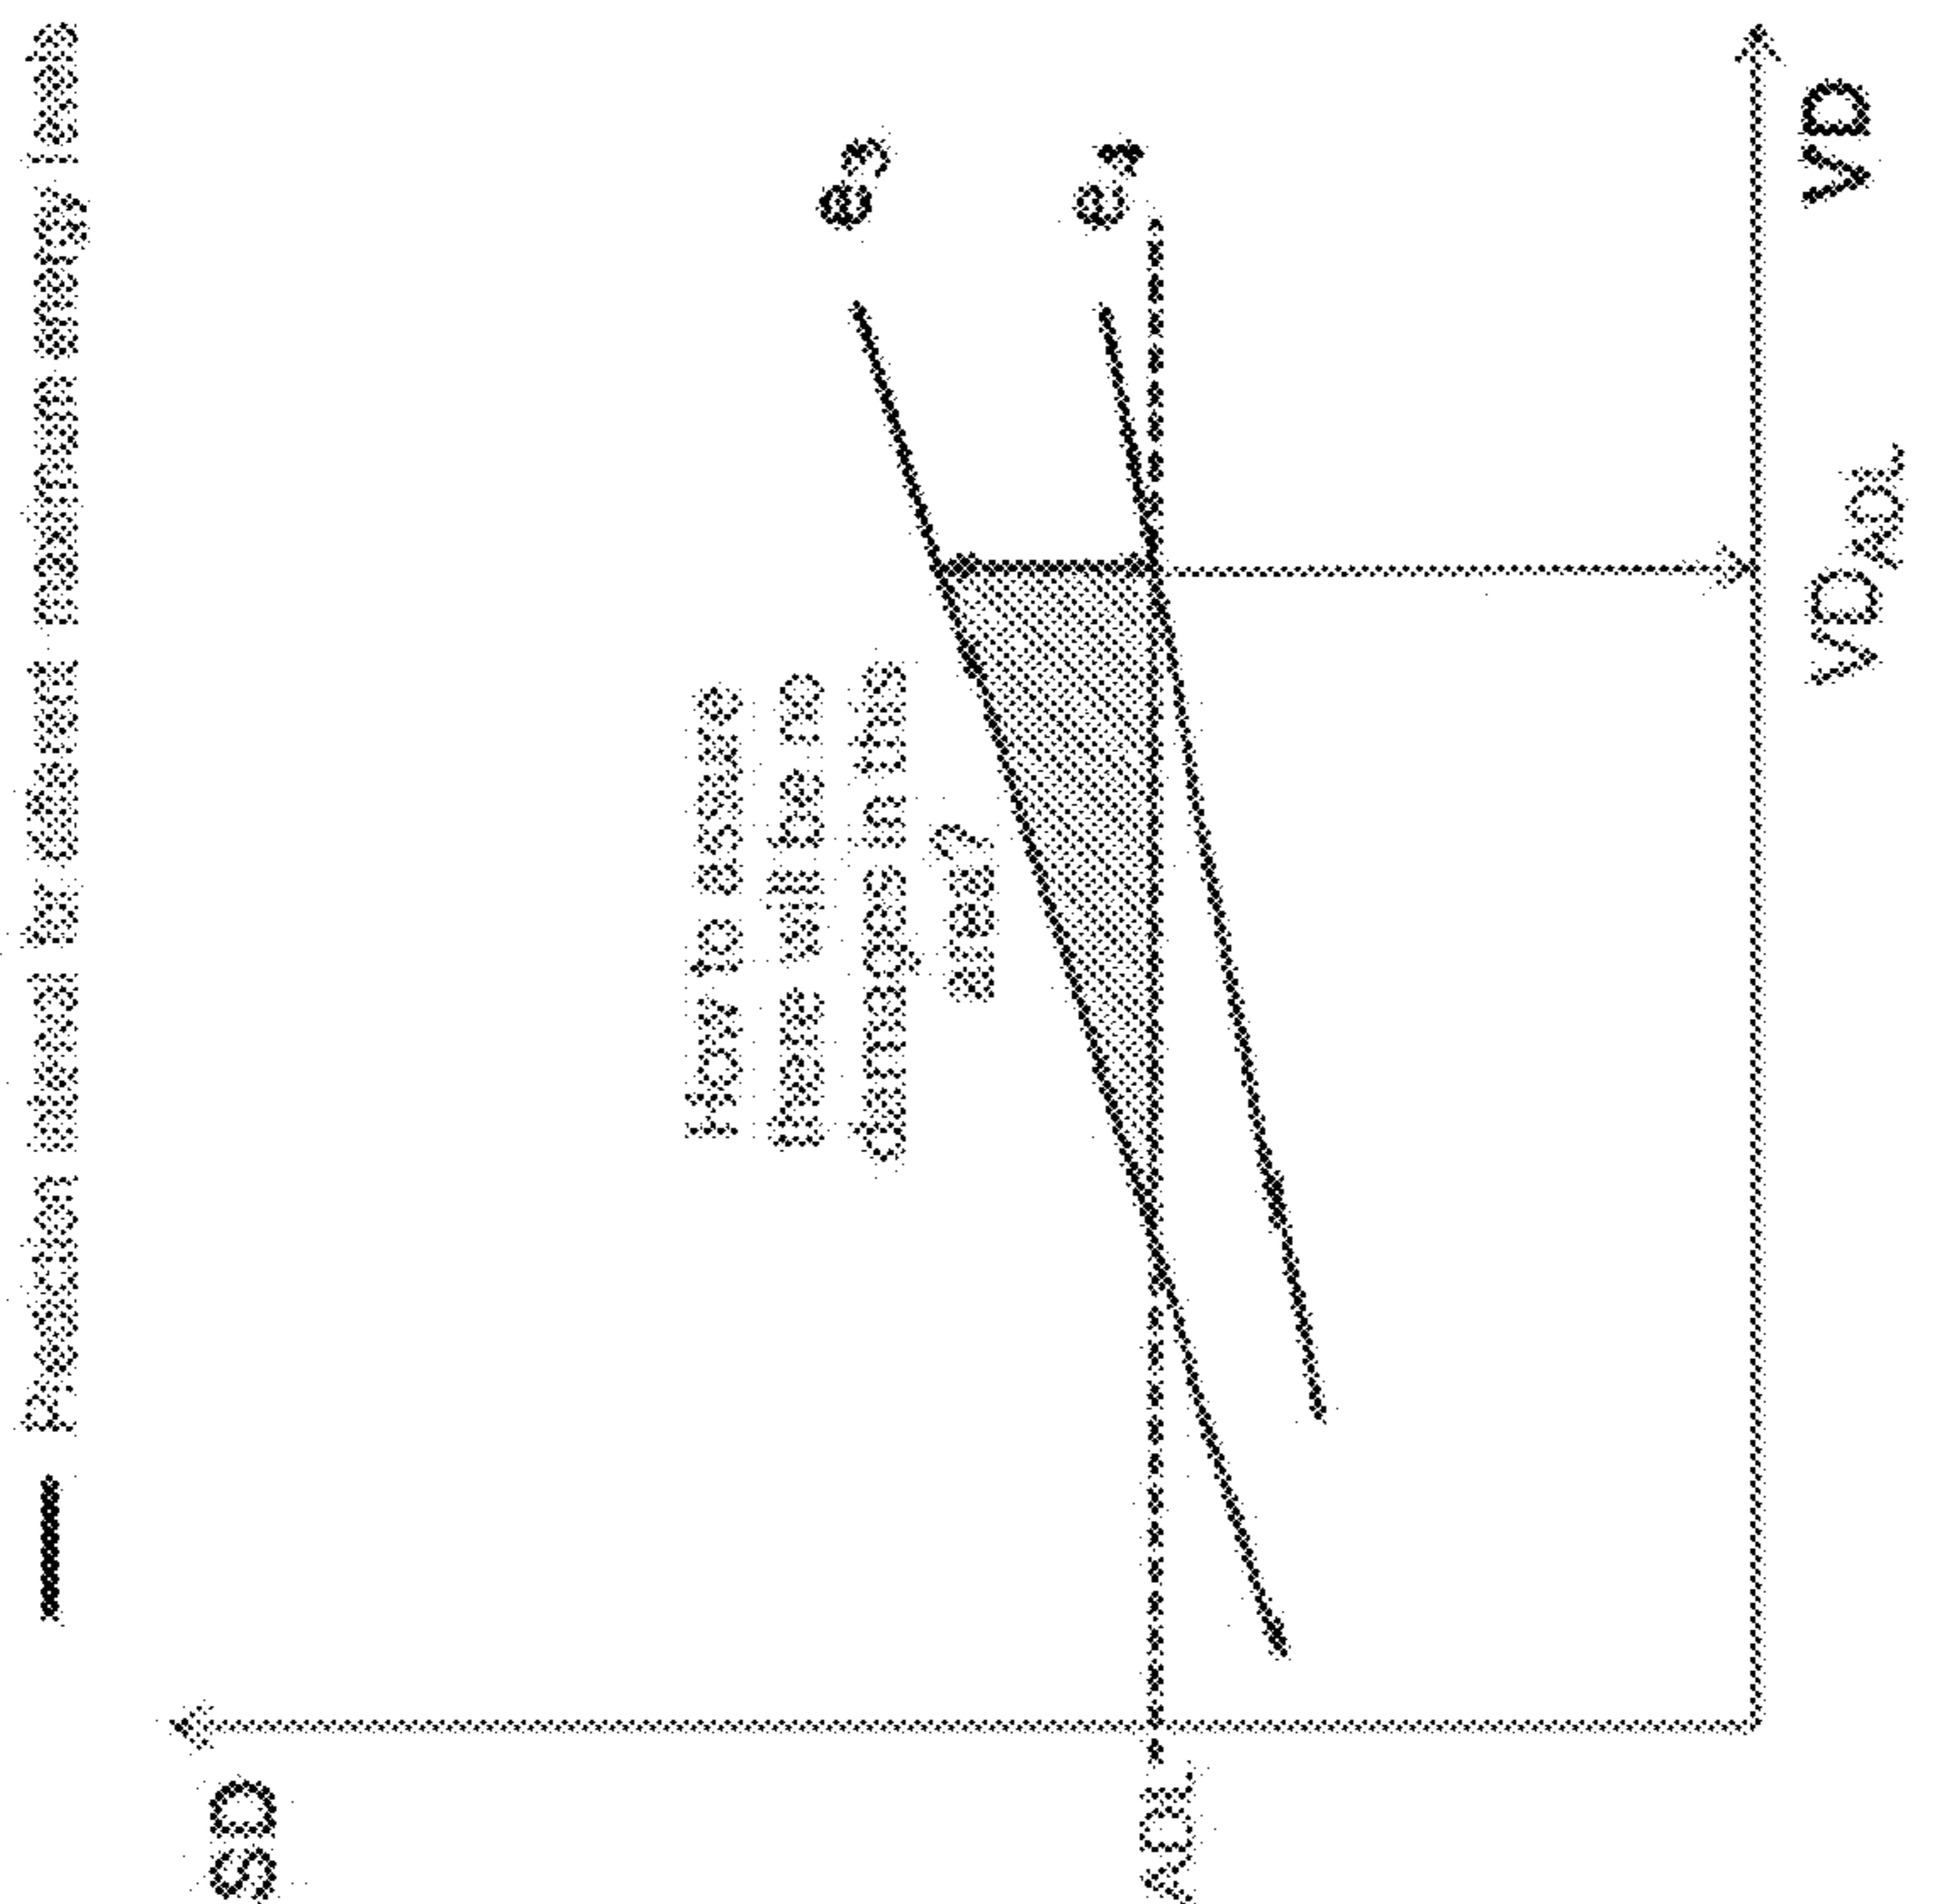
Fig. 7b

level expected on a specific zone of the aircraft in which the mark is located and e_4 the lowest one. FIG. 7b highlights the possible problem of obtaining structural damages on areas which initially may thought to be safe due to the maximum energy level chosen.

As this method allows making estimations for lower energies, it must be assured that higher energy levels will not endanger the established allowable Visual Damage (VD): Structural Damages (SD) higher than the admissible structural damage (ADL) cannot be permitted for Visual Damages (VD) lower than the admissible Visual Damage (VD_{ADL}), see FIG. 7b, as this situation could lead to a safety issue.

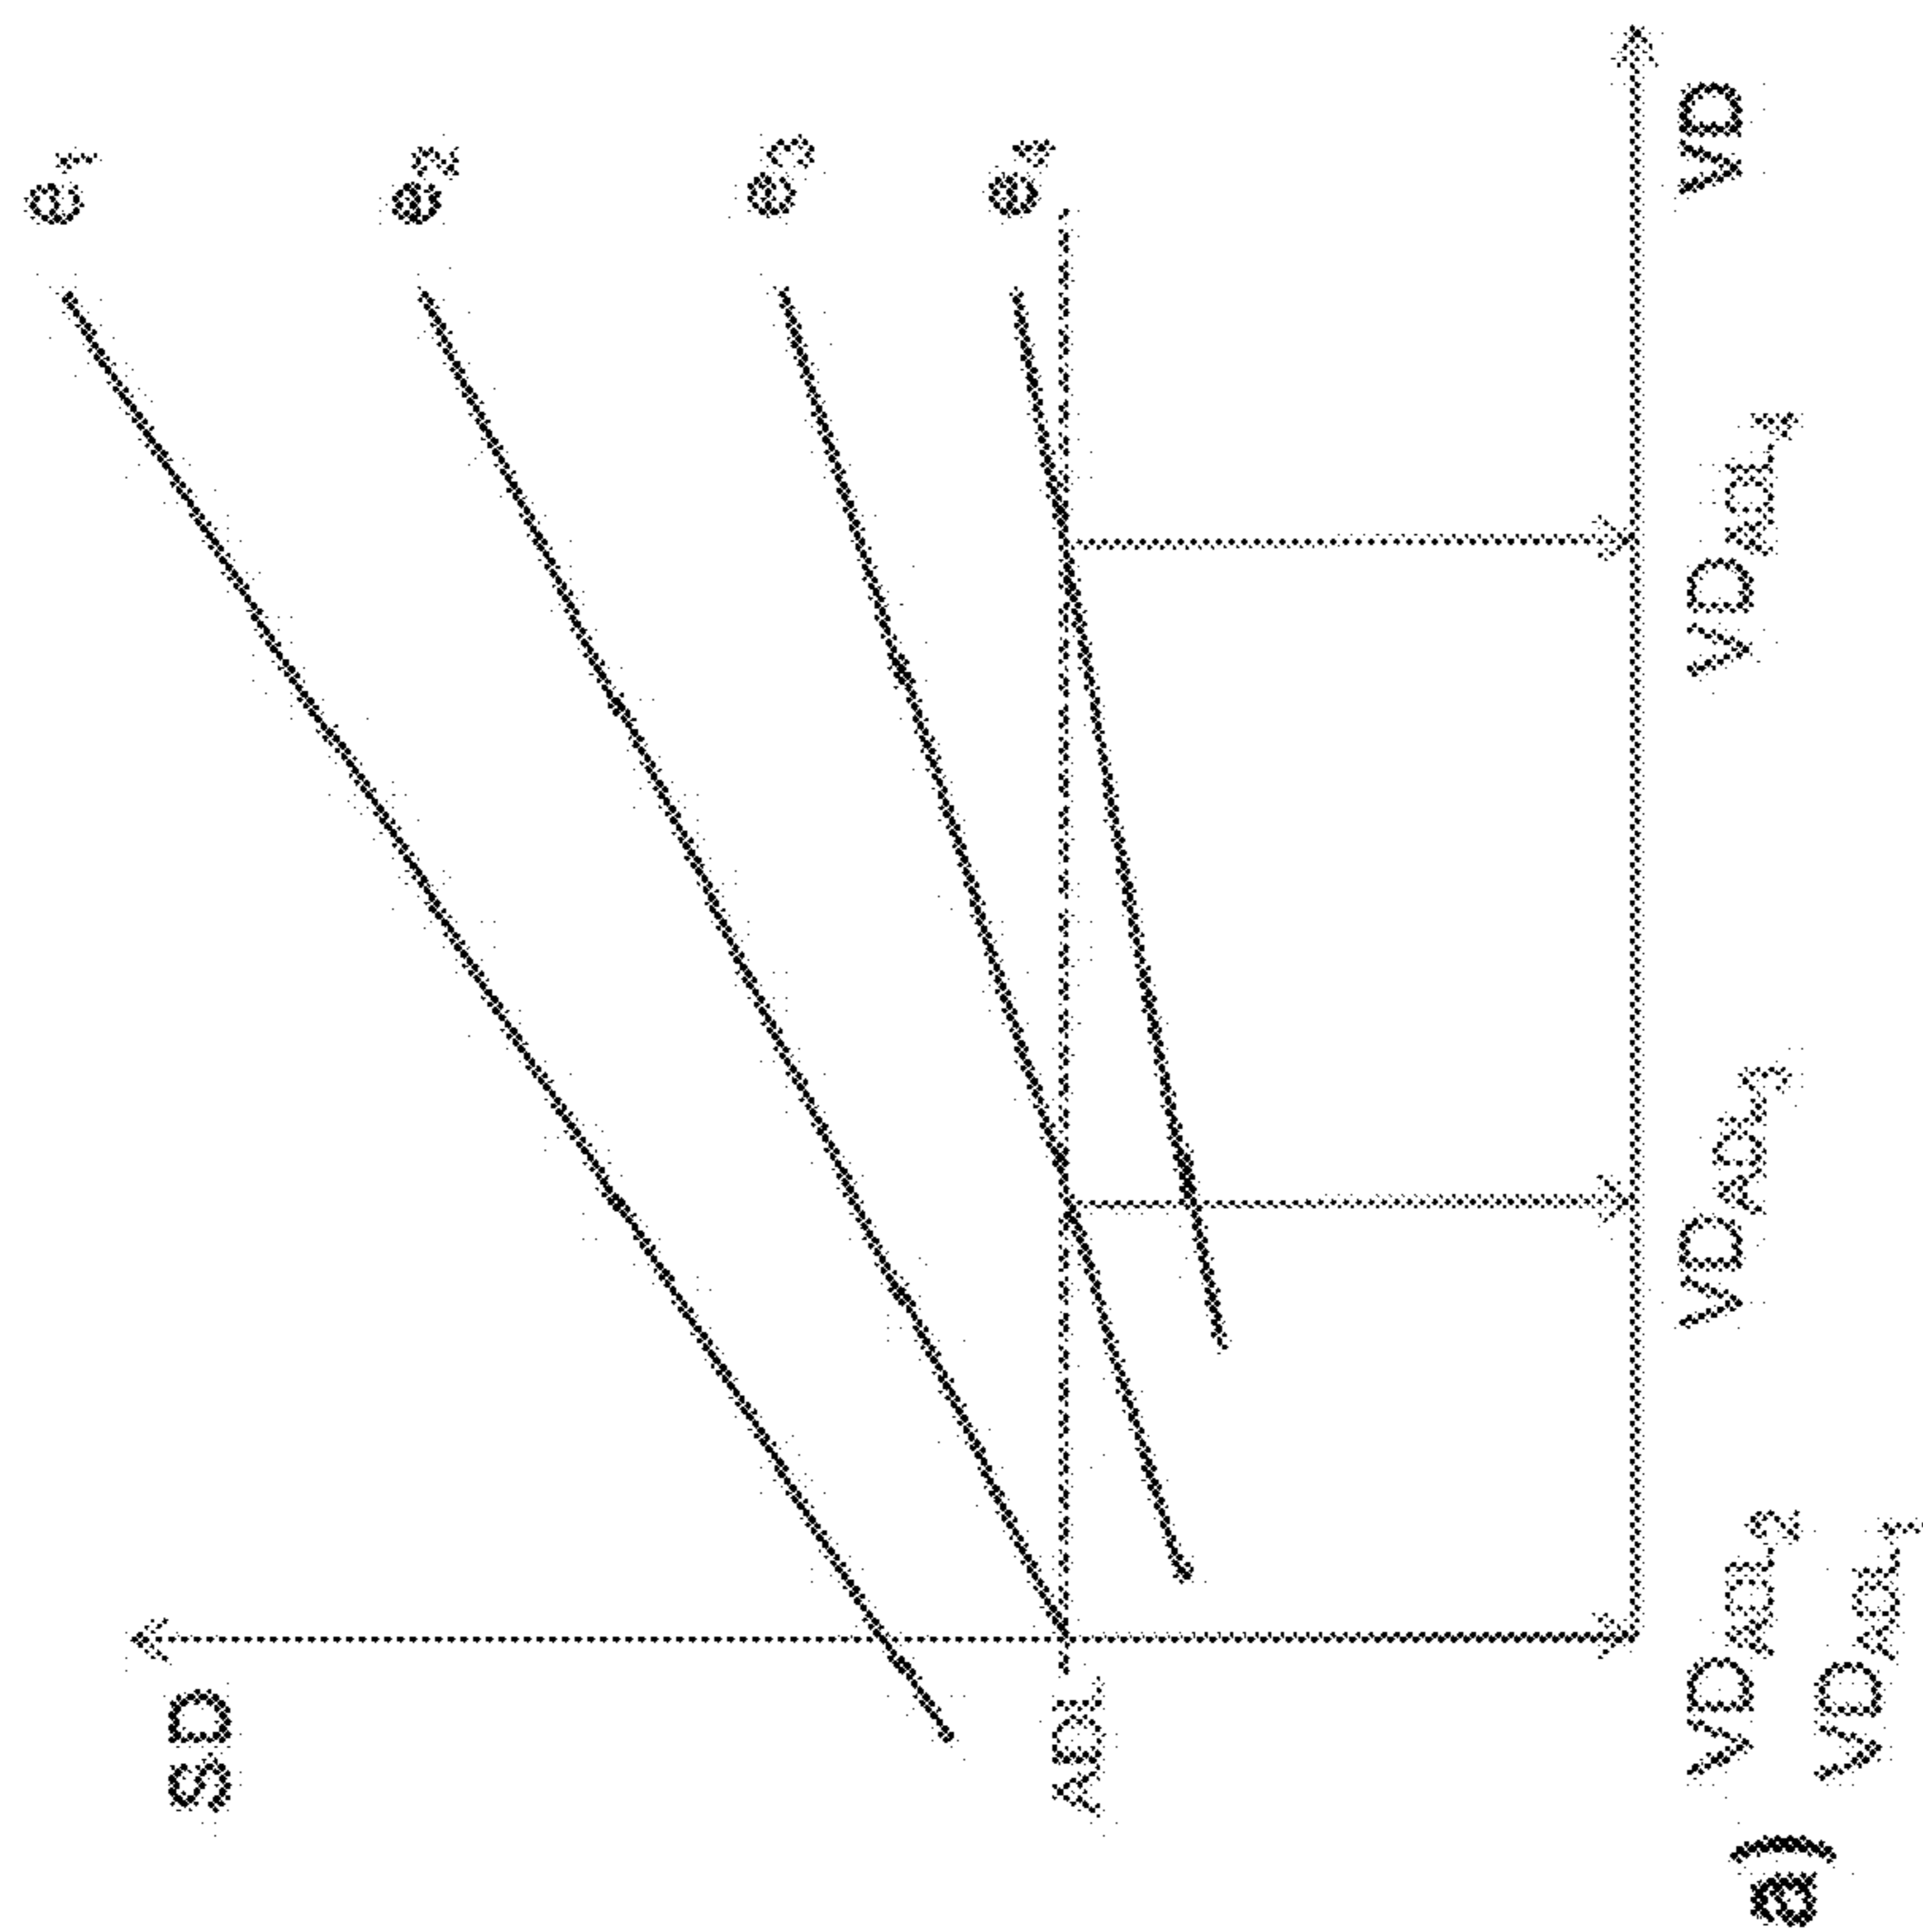
Fig. 7a

FIG. 7a shows graphics depicting the variation of Structural Damage (SD) prediction intervals with respect to the maximum energy level tested, being e_1 the highest energy

- b. See FIG. 7a. For the e_1 case, the prediction interval never intersects the admissible structural damage (ADL) line, hence, statistically, for any value of Visual Damage (VD), the Structural Damage (SD) obtained will be higher than the admissible structural damage (ADL).

- c. See FIG. 7a. For the e_3 case (only energy levels e_3 and e_a are taken into account) the prediction interval decreases as the scatter of damages associated to e_3 is lower than the one associated to e_1 . Hence, the prediction interval intersects the admissible structural damage (ADL) line, allowing to define an admissible Visual Damage (VD_{ADL3}) that assures that for lower values of Visual Damages (VD), the Structural Damage (SD) will be lower than the admissible Structural Damage (ADL).
