(54) **METHOD AND DEVICE FOR INSPECTING THE DAMAGE TO THE SKIN OF AN AEROPLANE AFTER A LIGHTNING STRIKE**

**METHOD AND DEVICE FOR INSPECTING
THE DAMAGE TO THE SKIN OF AN
AEROPLANE AFTER A LIGHTNING STRIKE**

The present invention refers to a method and a device for aircraft damage inspection after a lightning strike by getting an optimized admissible visual damage determined by the relationship between the structural damage and the visual damage produced by a certain lightning strike energy.

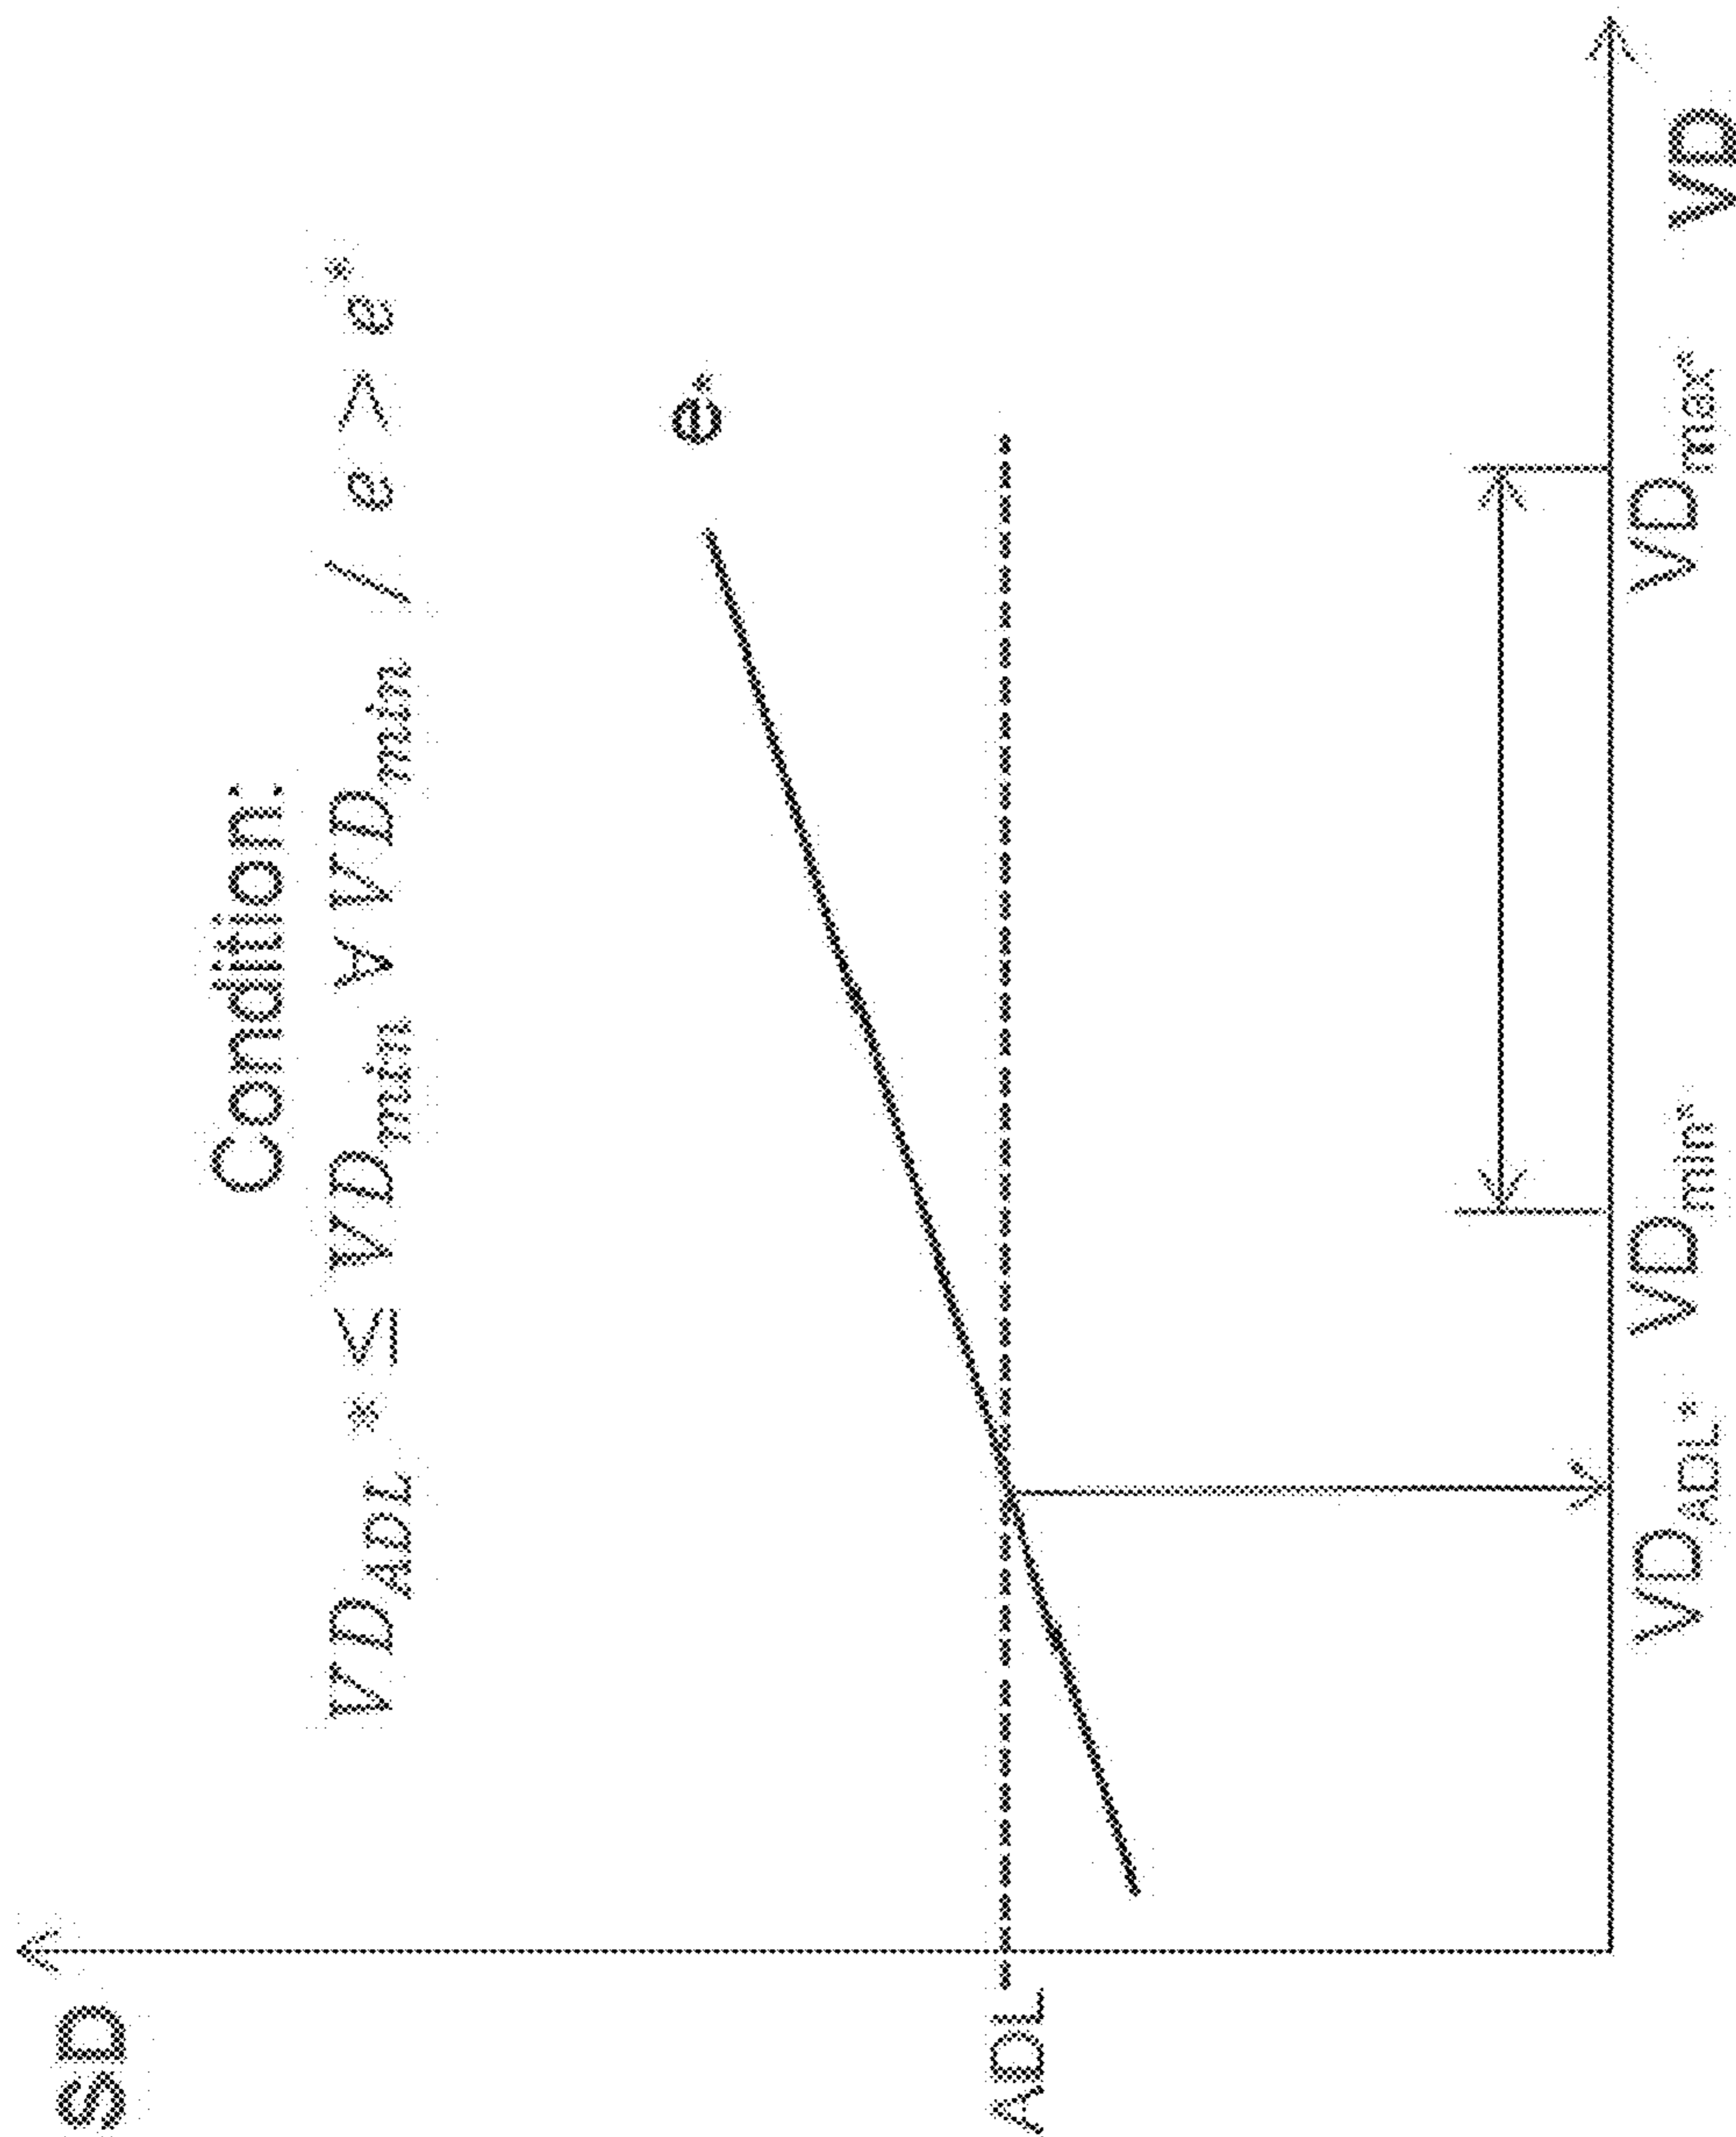
Fig. 8

FIG. 8 shows a graphic depicting the energy level for calculating the admissible Visual Damage (VD_{ADL}), and the minimum and maximum Visual Damages (VD_{min} , VD_{max}) for said energy level.

- c. Hence, each energy level has an admissible Visual Damage (VD_{ADL}) and minimum Visual Damage (VD_{min}) associated to it. See FIG. 8.
- d. The admissible Visual Damage (VD_{ADL}) corresponding to a specific energy level can be greater than the minimum Visual Damage (VD_{min}) of higher energy levels, which implies that Structural Damage (SD) higher than the admissible Structural Damage (ADL) could be found for Visual Damage (VD) lower than admissible Visual Damage (VD_{ADL}). See FIG. 7b. Contrary to admissible Visual Damage (VD_{ADL}), minimum Visual Damage (VD_{min}) does not always follow a monotonically increasing relationship with the energy (see FIG. 9), reason why this circumstance can occur.

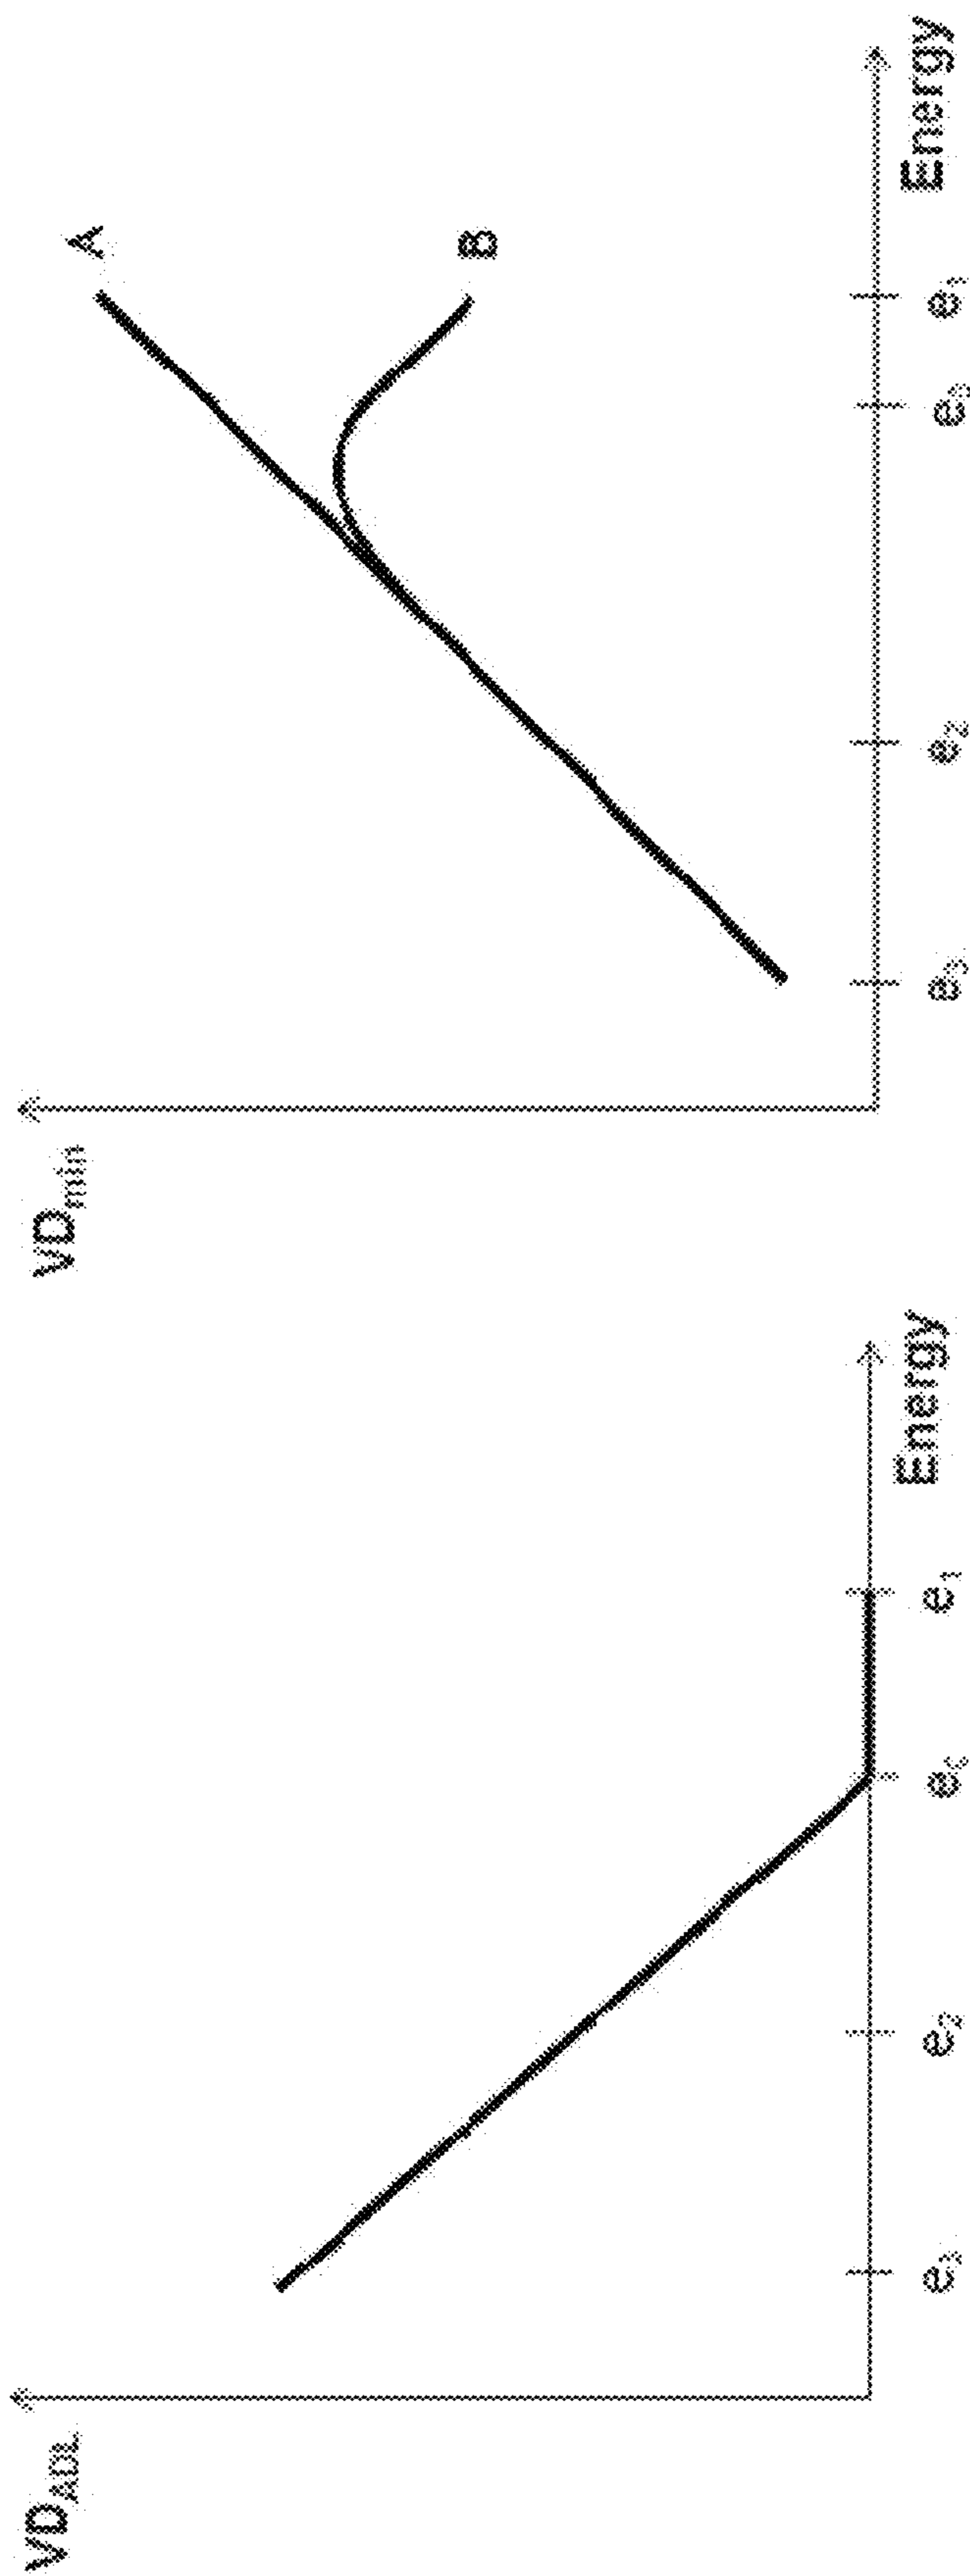
FIGS. 9a and 9b show graphics depicting the relationships admissible Visual Damage-energy (VD_{ADL} -energy) and minimum Visual Damage-energy (VD_{min} -energy), respectively. In FIG. 9b, the curve A represents the case when minimum Visual Damage (VD_{min}) is monotonically increasing with the energy, while curve B represents the case when it is not.

It is possible to set the relationship between admissible Visual Damage (VD_{ADL}) and the energy level e , as well as between the minimum Visual Damage (VD_{min}) and the energy level e , see FIG. 9. The admissible Visual Damage (VD_{ADL}) follows a monotonically decreasing function. The minimum Visual Damage (VD_{min}) follows a monotonically increasing relationship with the energy e , up to an energy level where, depending on several parameters, it may or may not continue following a monotonically increasing relationship.

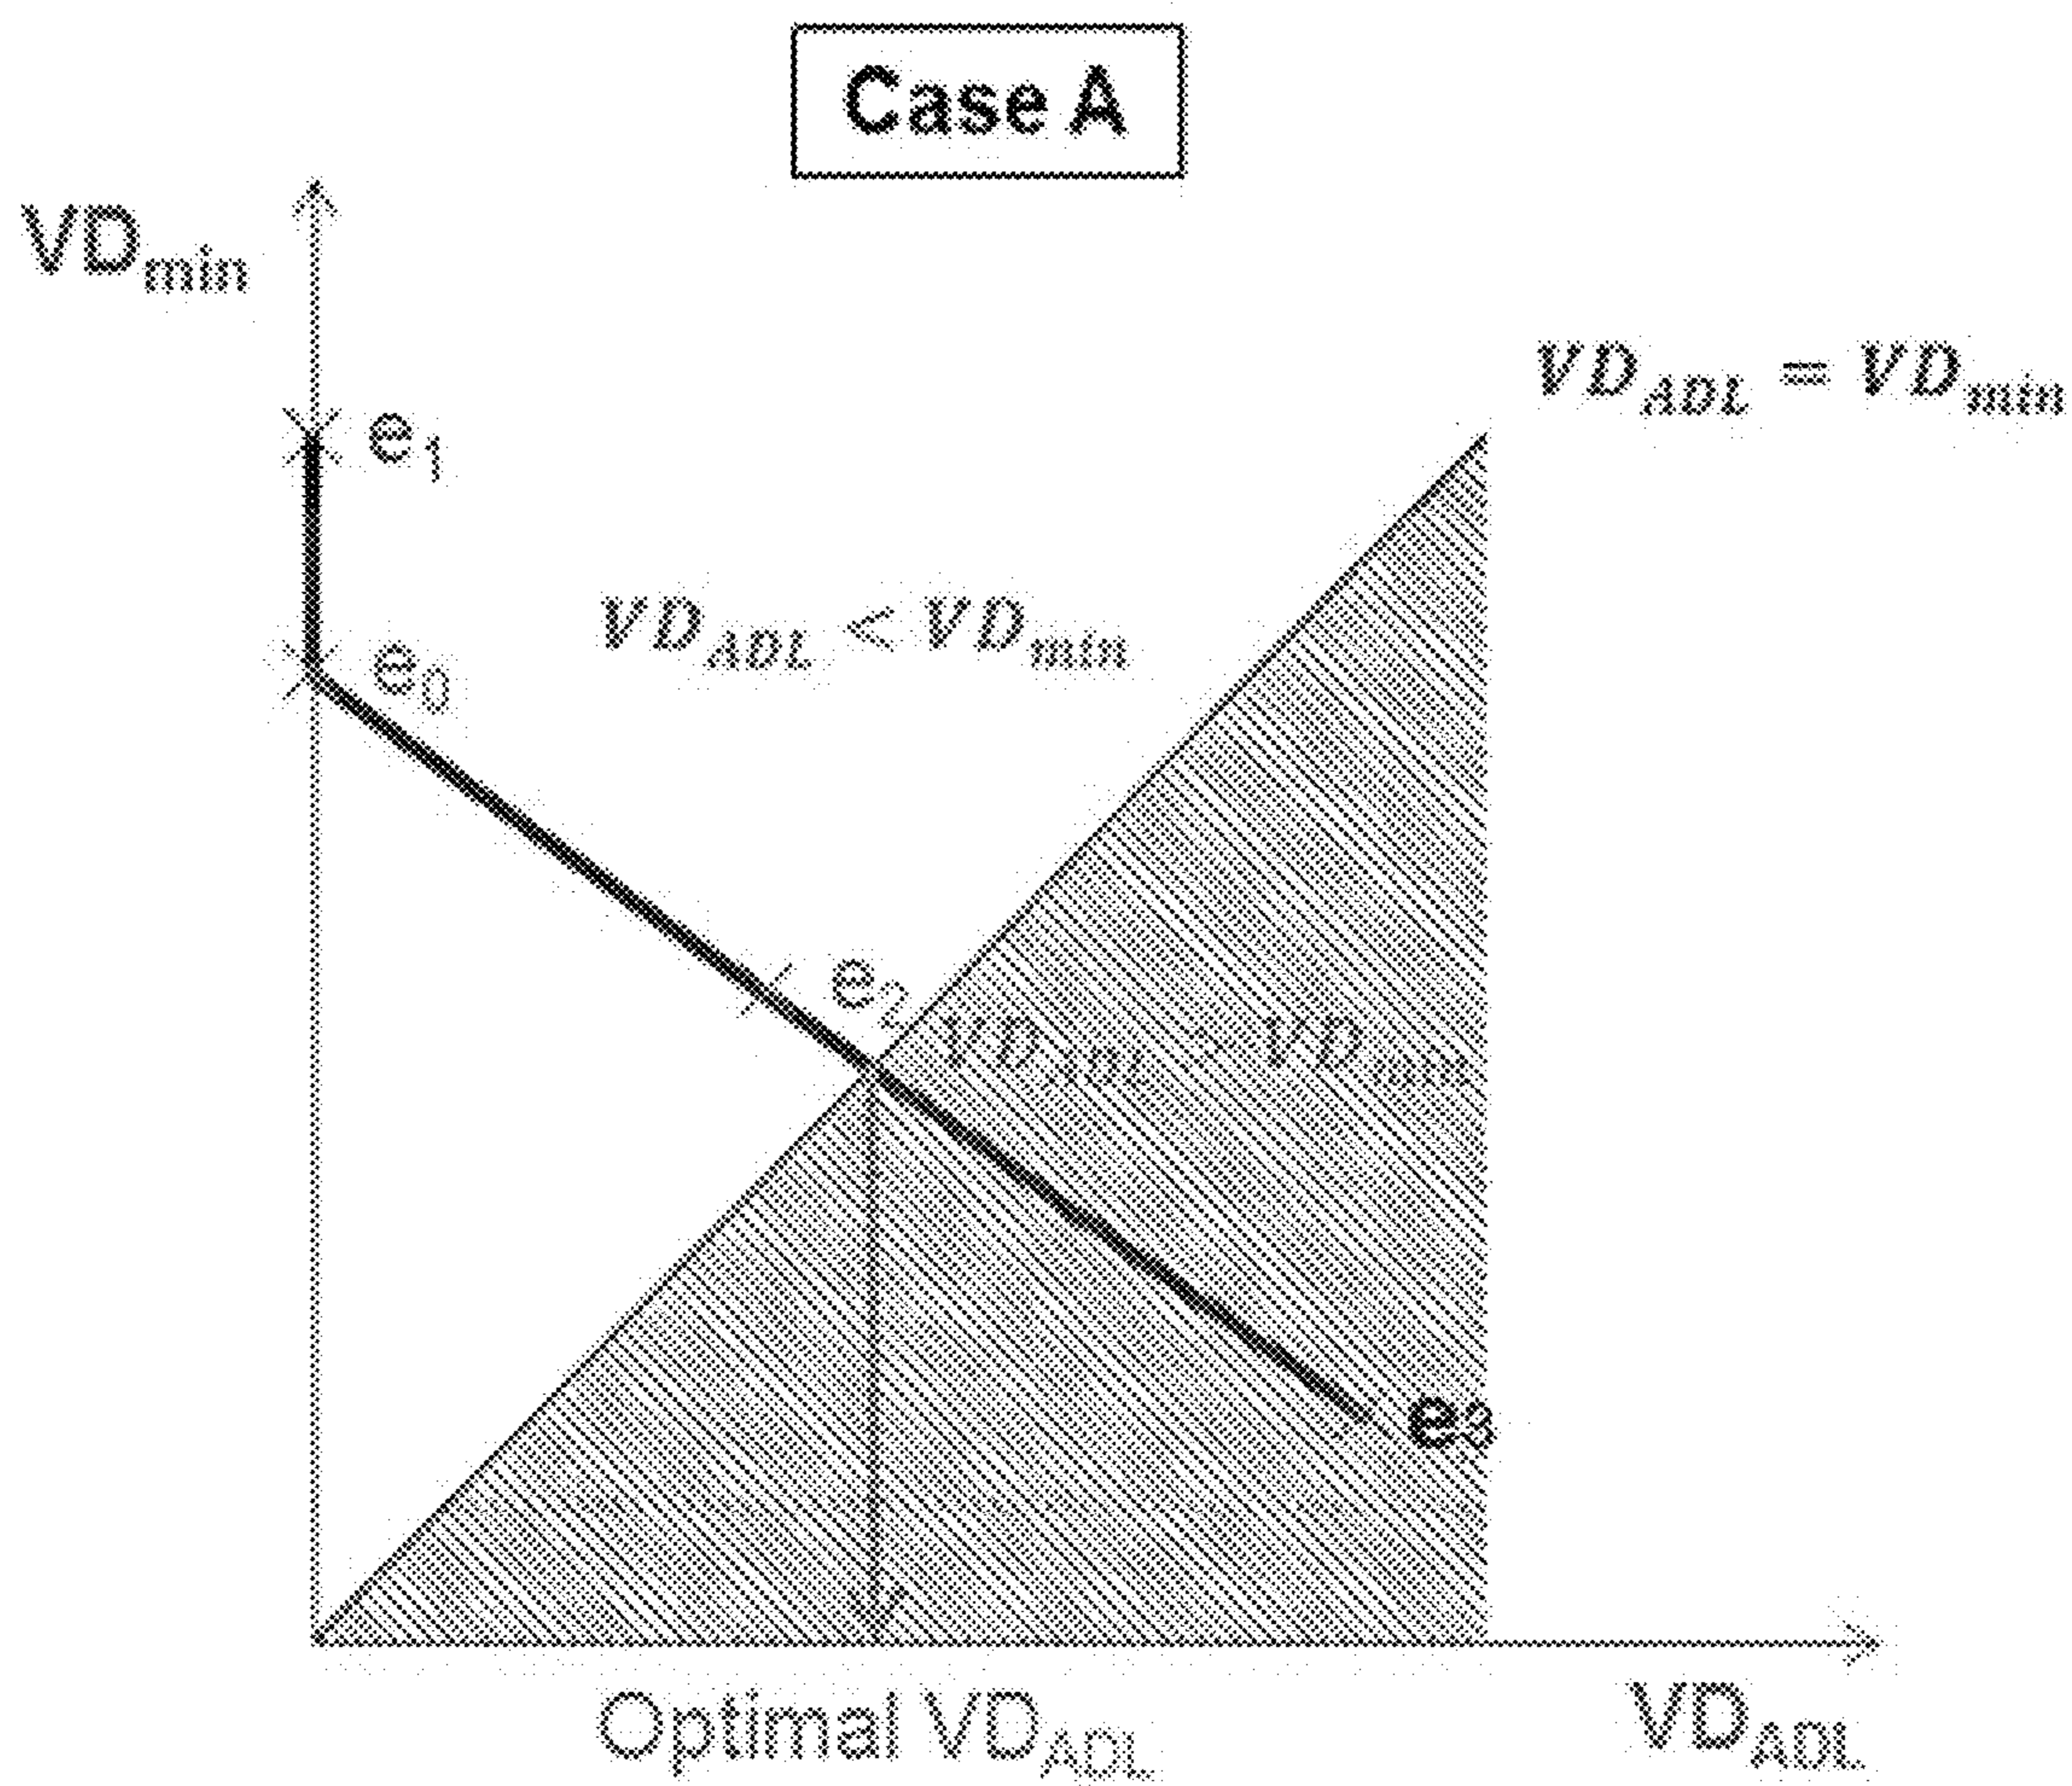
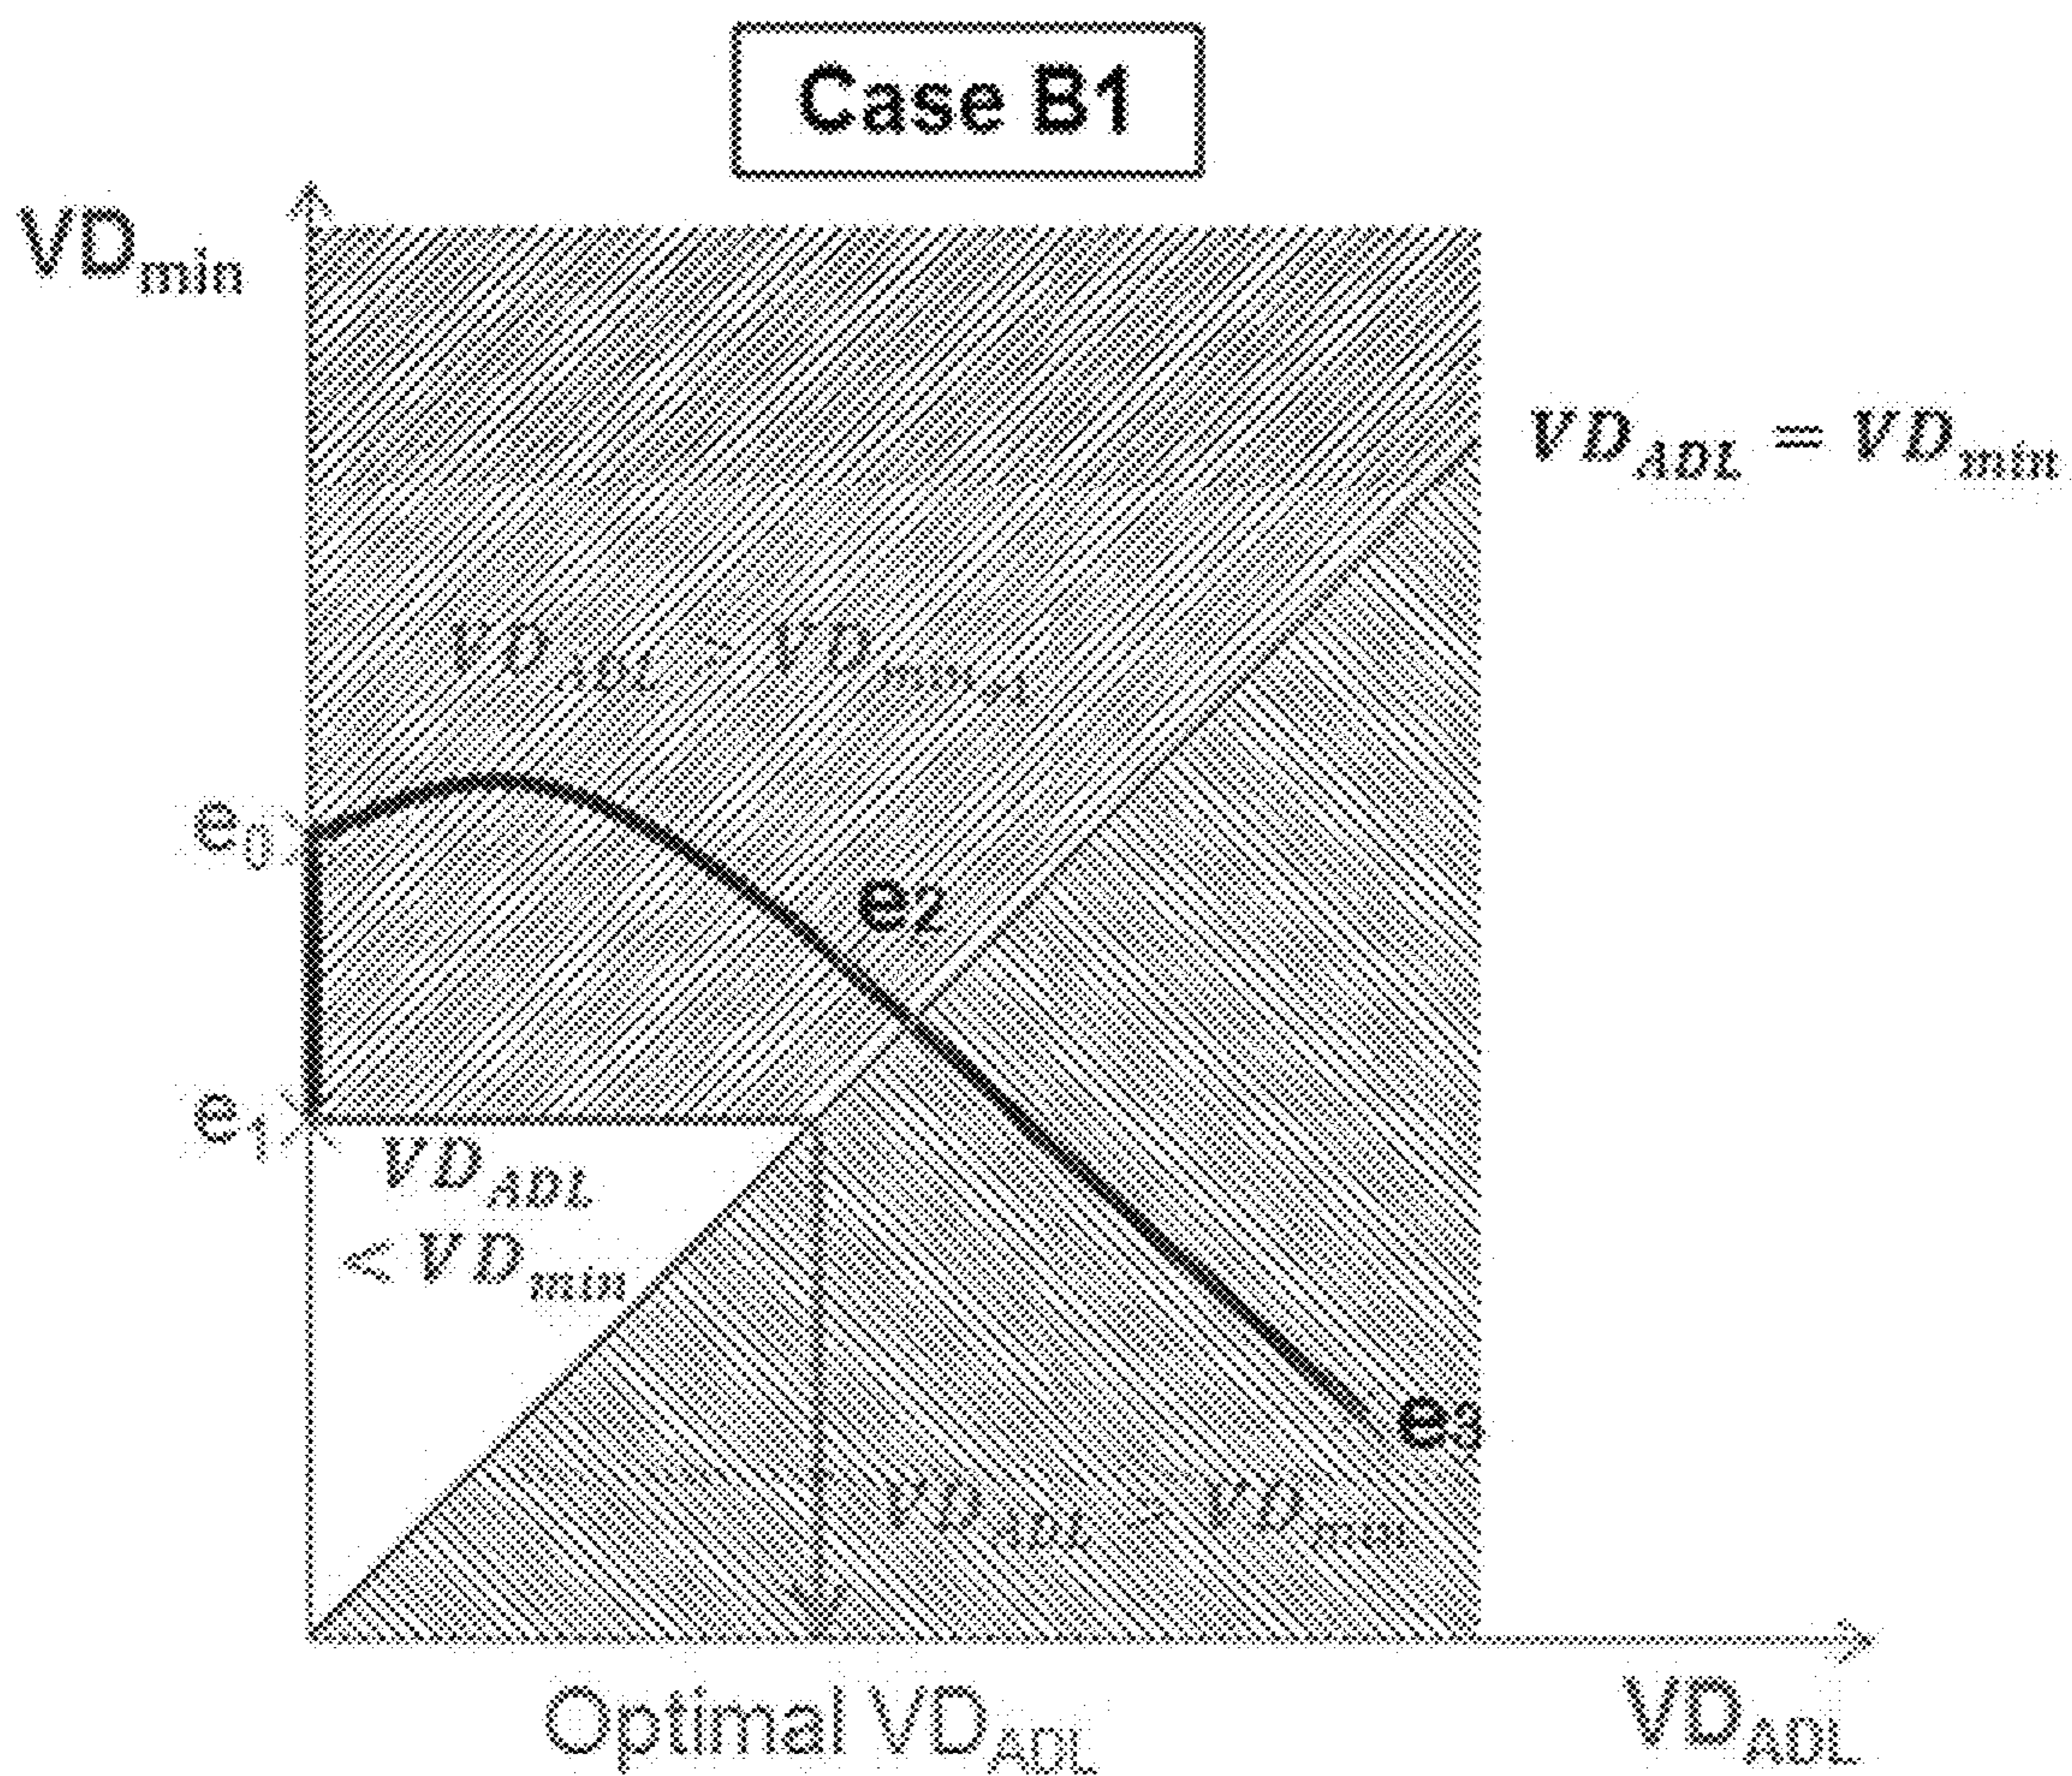
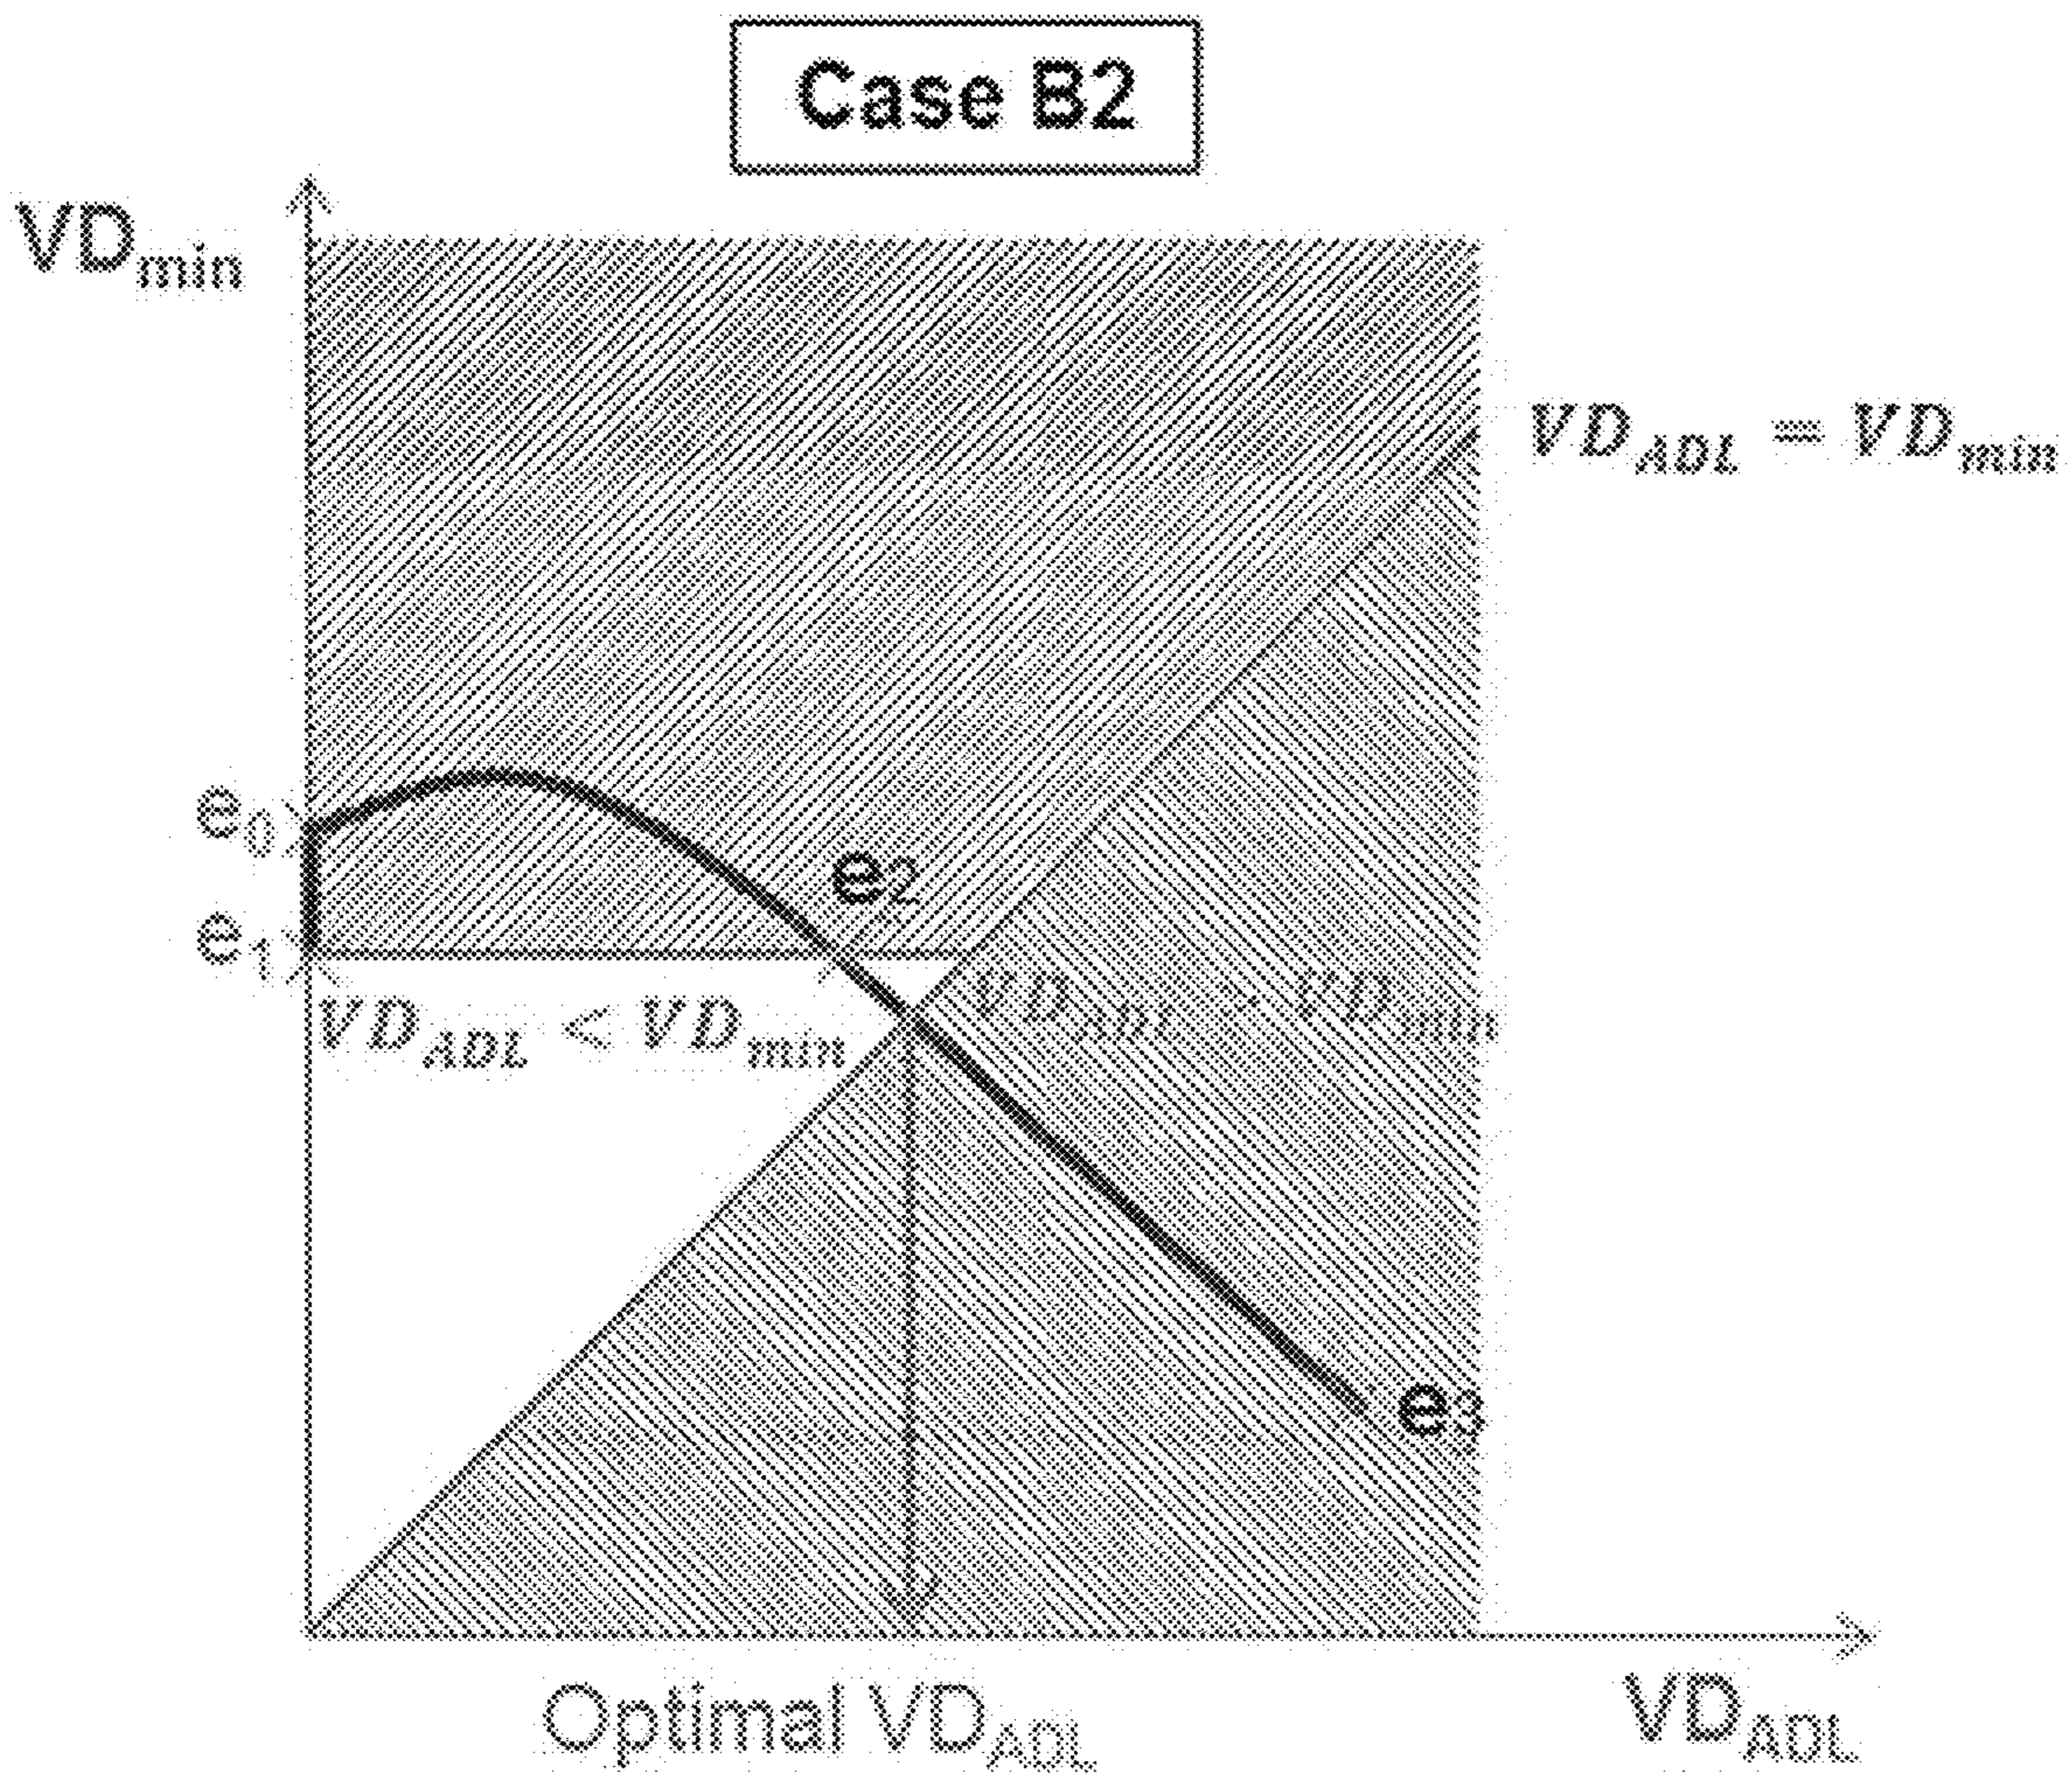
FIGS. 10A to 10C shows three graphics depicting minimum Visual Damage-admissible Visual Damage (VD_{min} - VD_{ADL}) relationship. If the minimum Visual Damage (VD_{min}) monotonically increases with the energy level, case A is applicable; if the minimum Visual Damage (VD_{min}) does not monotonically increase with the energy, case B1 and B2 are applicable.

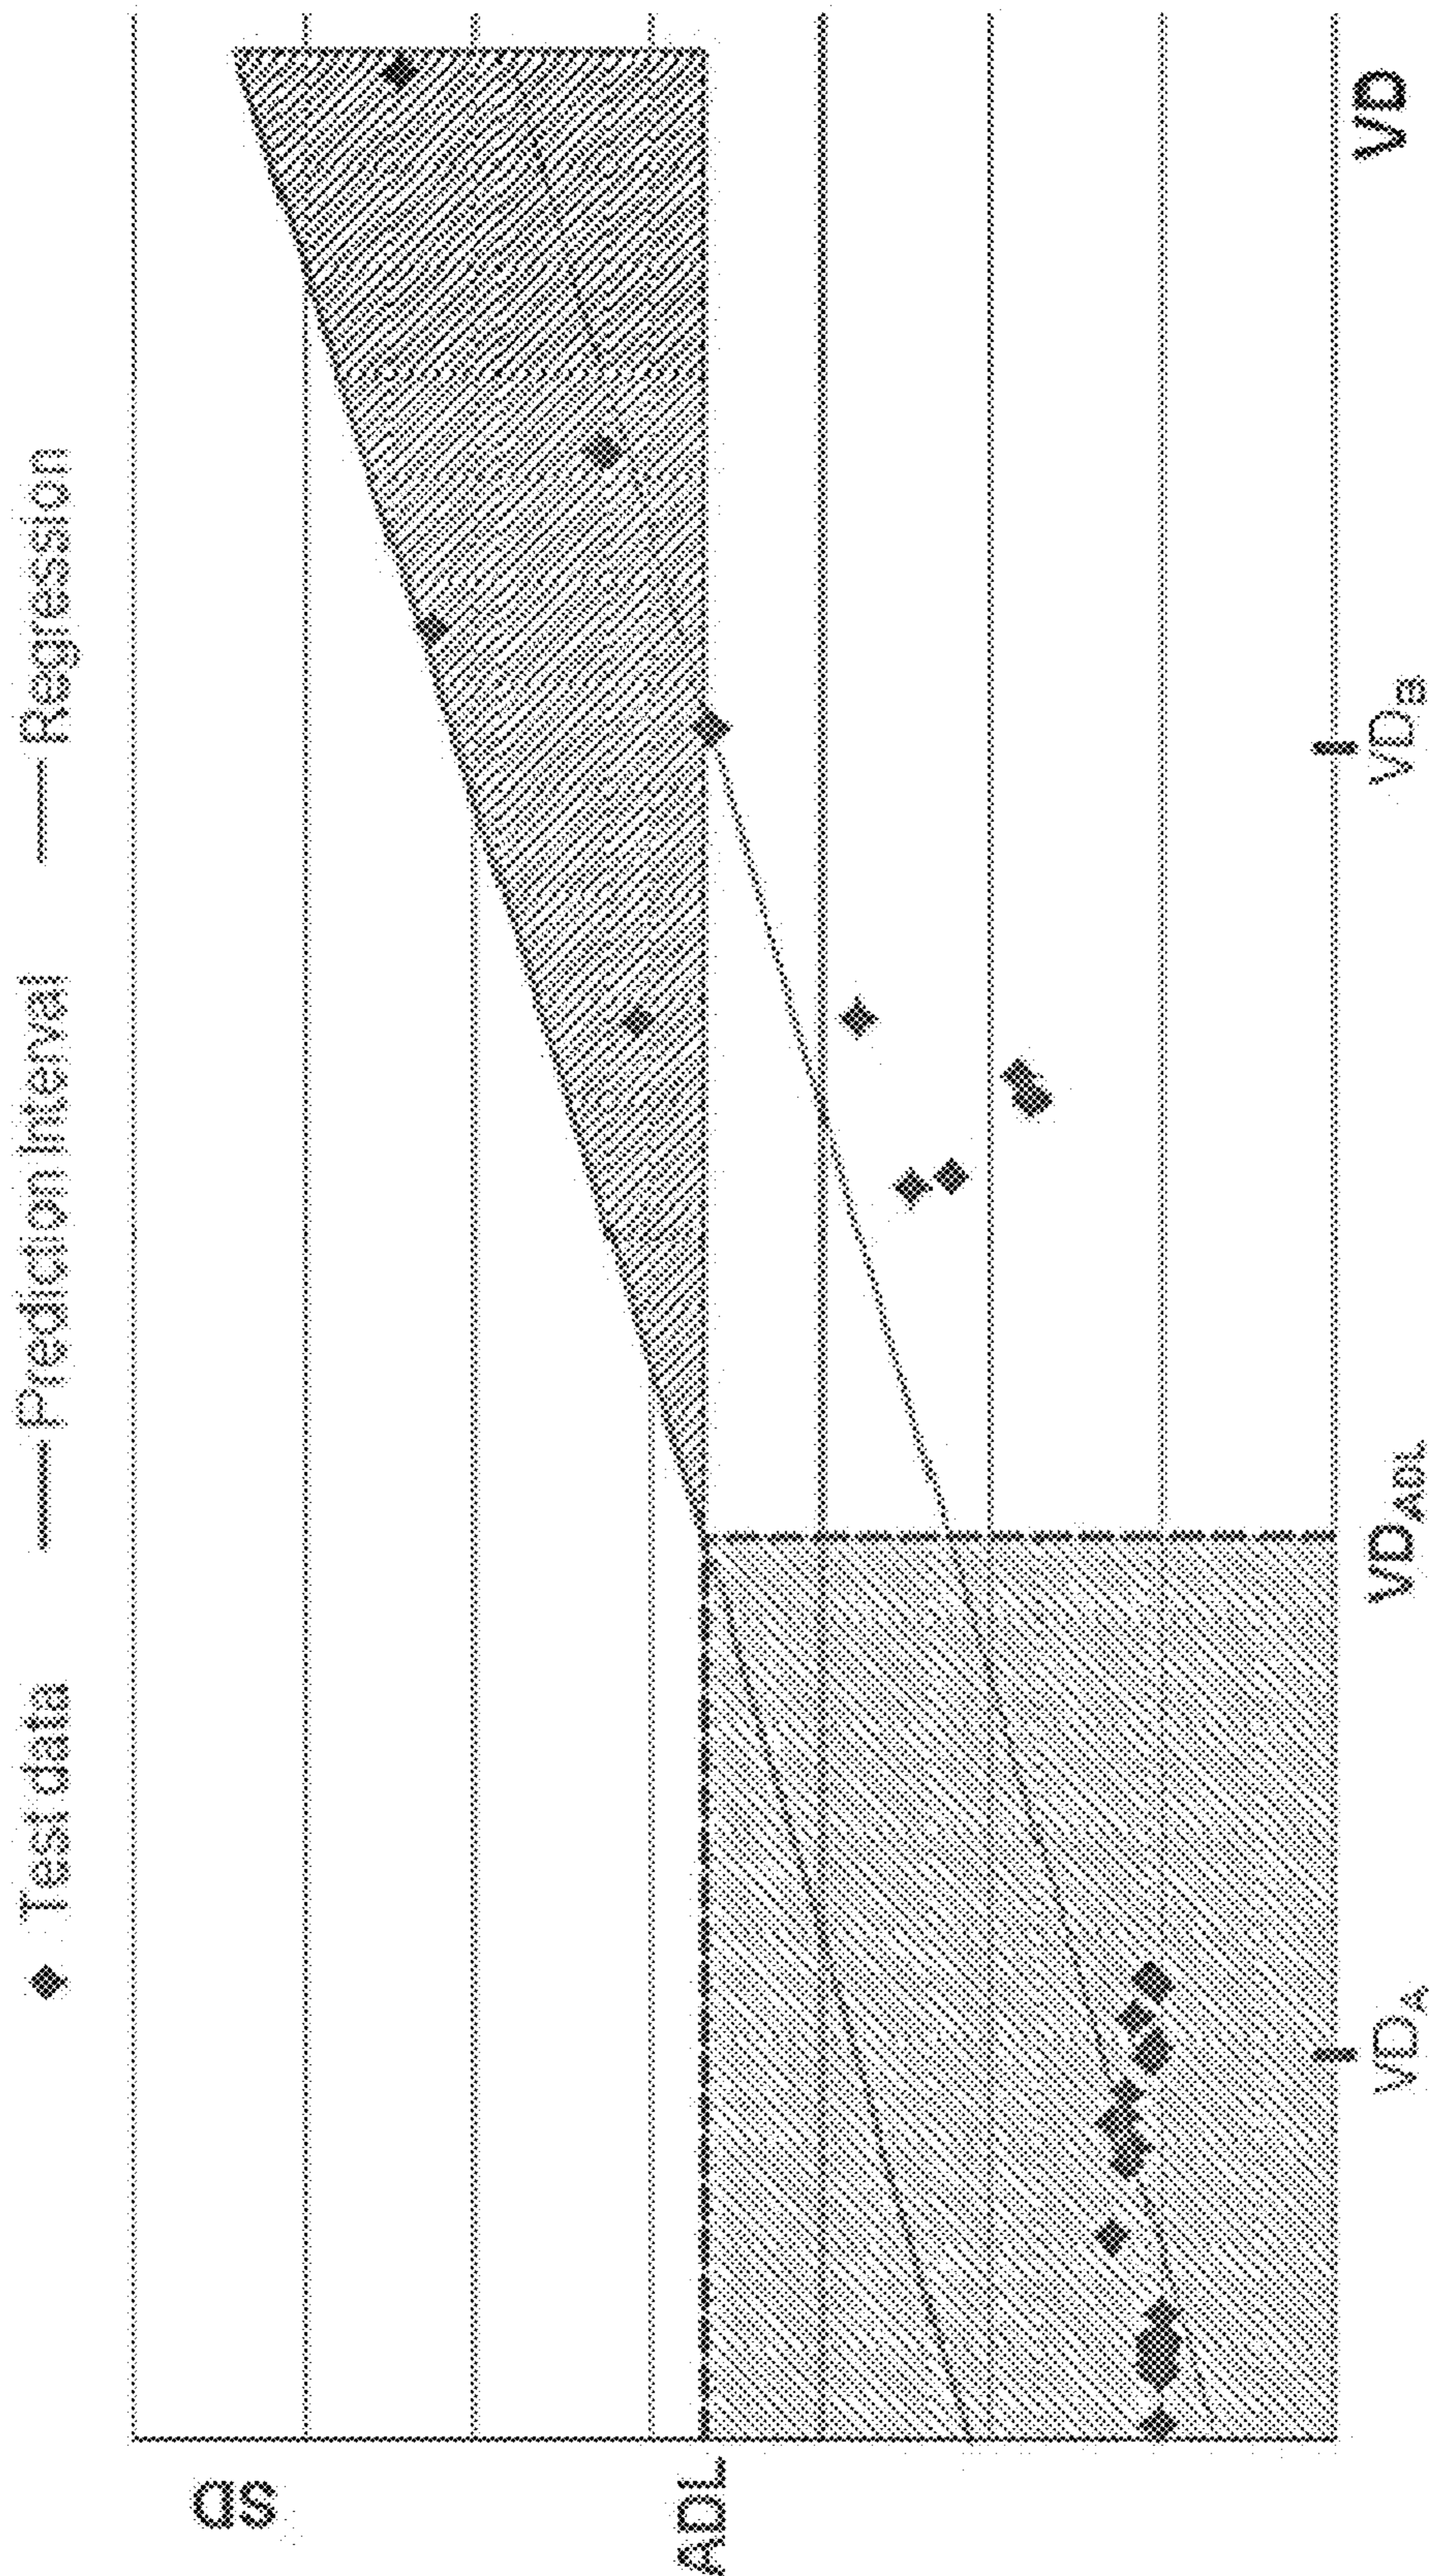
Fig. 11

FIG. 11 shows a graphic depicting the relationship Structural Damage-Visual Damage (SD-VD) found using the method called "Energy-Dependent Approach".
