(10) **Patent No.:** **US 11,320,334 B2**
(45) **Date of Patent:** **May 3, 2022**

(54) **METHOD AND ASSEMBLY FOR INSPECTING ENGINE COMPONENT**

(71) Applicant: **RAYTHEON TECHNOLOGIES CORPORATION**, Farmington, CT (US)

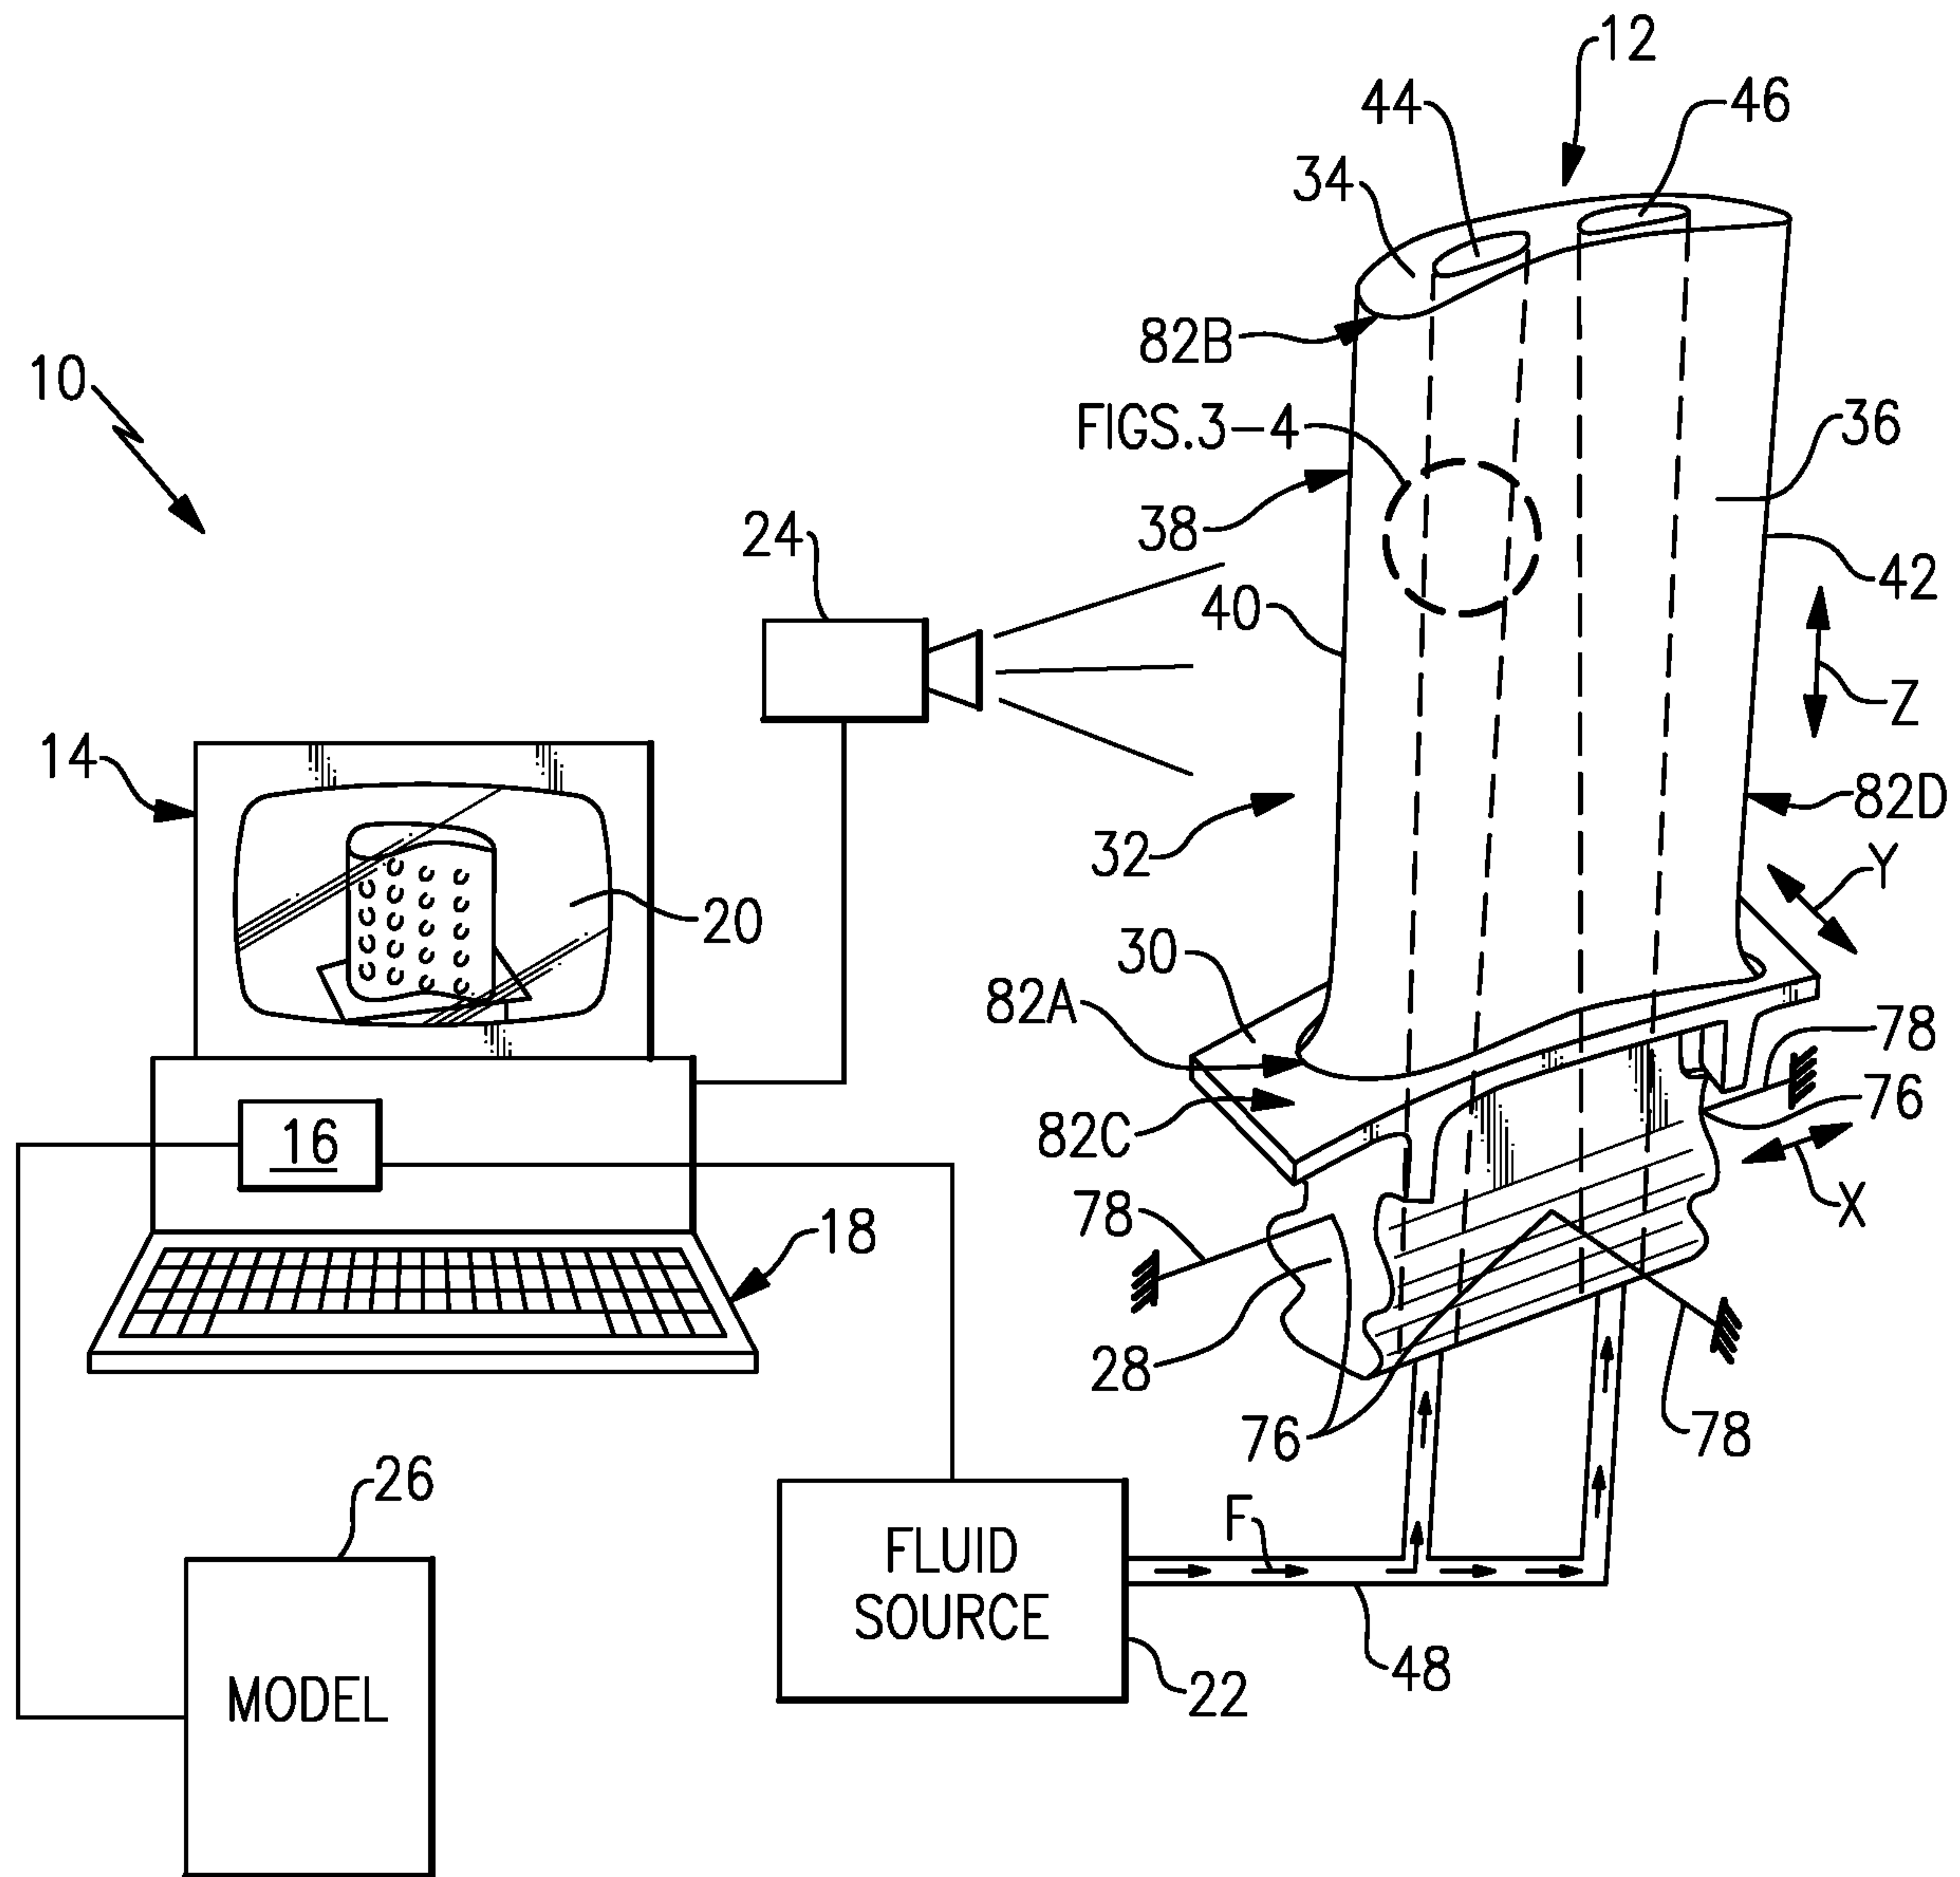
FIG. 1 schematically illustrates an example inspection assembly according to this disclosure.

FIG. 1 schematically illustrates an example inspection assembly 10 for inspecting an engine component 12. It should be understood that this disclosure is not limited to the details of the illustrated inspection assembly 10, and otherwise extends to other inspection assemblies. Further, while the engine component 12 illustrated herein as a turbine blade, it should be understood that this disclosure extends to other engine components, such as stator vanes, blade outer air seals (BOAS), combustor liners, and augmentor liners, as examples.

The inspection assembly 10 includes a computer 14 in communication with a controller 16 capable of receiving inputs, such as from the keyboard 18, and displaying an output in one example via a display, or monitor, 20. In one example, the controller 16 includes a microprocessor capable of executing instructions in accordance with the functionality described herein.

In this example, the controller 16 is in communication with a fluid source 22, which is in fluid communication with the engine component 12, as will be discussed below. The controller 16 is further in communication with a camera 24. In one example, the camera 24 is a thermal infrared (IR) camera used to determine the temperature of an object by detecting radiation and producing a still image, or alternatively a video, of that radiation. In this sense, the assembly 10 provides a flow thermography system. The controller 16 is further in communication with a model 26, which may include information such as an acceptable cooling hole location, a minimum pixel threshold for determining an acceptable hole size, etc., as will be appreciated from the below.

In the example where the engine component 12 is a rotor blade, the engine component 12 includes a root 28, a platform 30, and an airfoil section 32. The airfoil section 32 extends radially (e.g., in the radial direction Z) from the platform 30 to a blade tip 34. The airfoil section 32 includes a pressure side wall 36 and a suction side wall 38, each of which extend between a leading edge 40, and a trailing edge 42 of the airfoil section 32.

A plurality of core cooling passageways 44, 46 extend radially from the root 28 to the blade tip 34. Here, two core cooling passageways 44, 46 are illustrated. As is known in the art, these core cooling passageways 44, 46 may be in communication with a plurality of cooling holes leading from the core cooling passageways 44, 46 to an outer surface of the airfoil section 32. A plurality of cooling holes are illustrated in FIG. 3, which will be discussed in detail below. While core cooling passageways 44, 46 are illustrated, this disclosure extends to platform cooling holes that may not be in communication with a core cooling passageway.

The fluid source 22 is in communication with each of the core passageways 44, 46 by way of a conduit 48. Upon instruction from the controller 16, fluid F from the fluid source 22 is configured to be directed along the core

passageways 44, 46. As the fluid F flows along the core passageways 44, 46, a portion of that fluid F is directed out the plurality of cooling holes and flows adjacent the outer surface of the airfoil section 32.

The camera 24 is configured to generate an image of the fluid F as it exits these cooling passageways. This image may then be used to conduct a through-hole inspection, which in turn may be used to determine the location of the cooling holes.

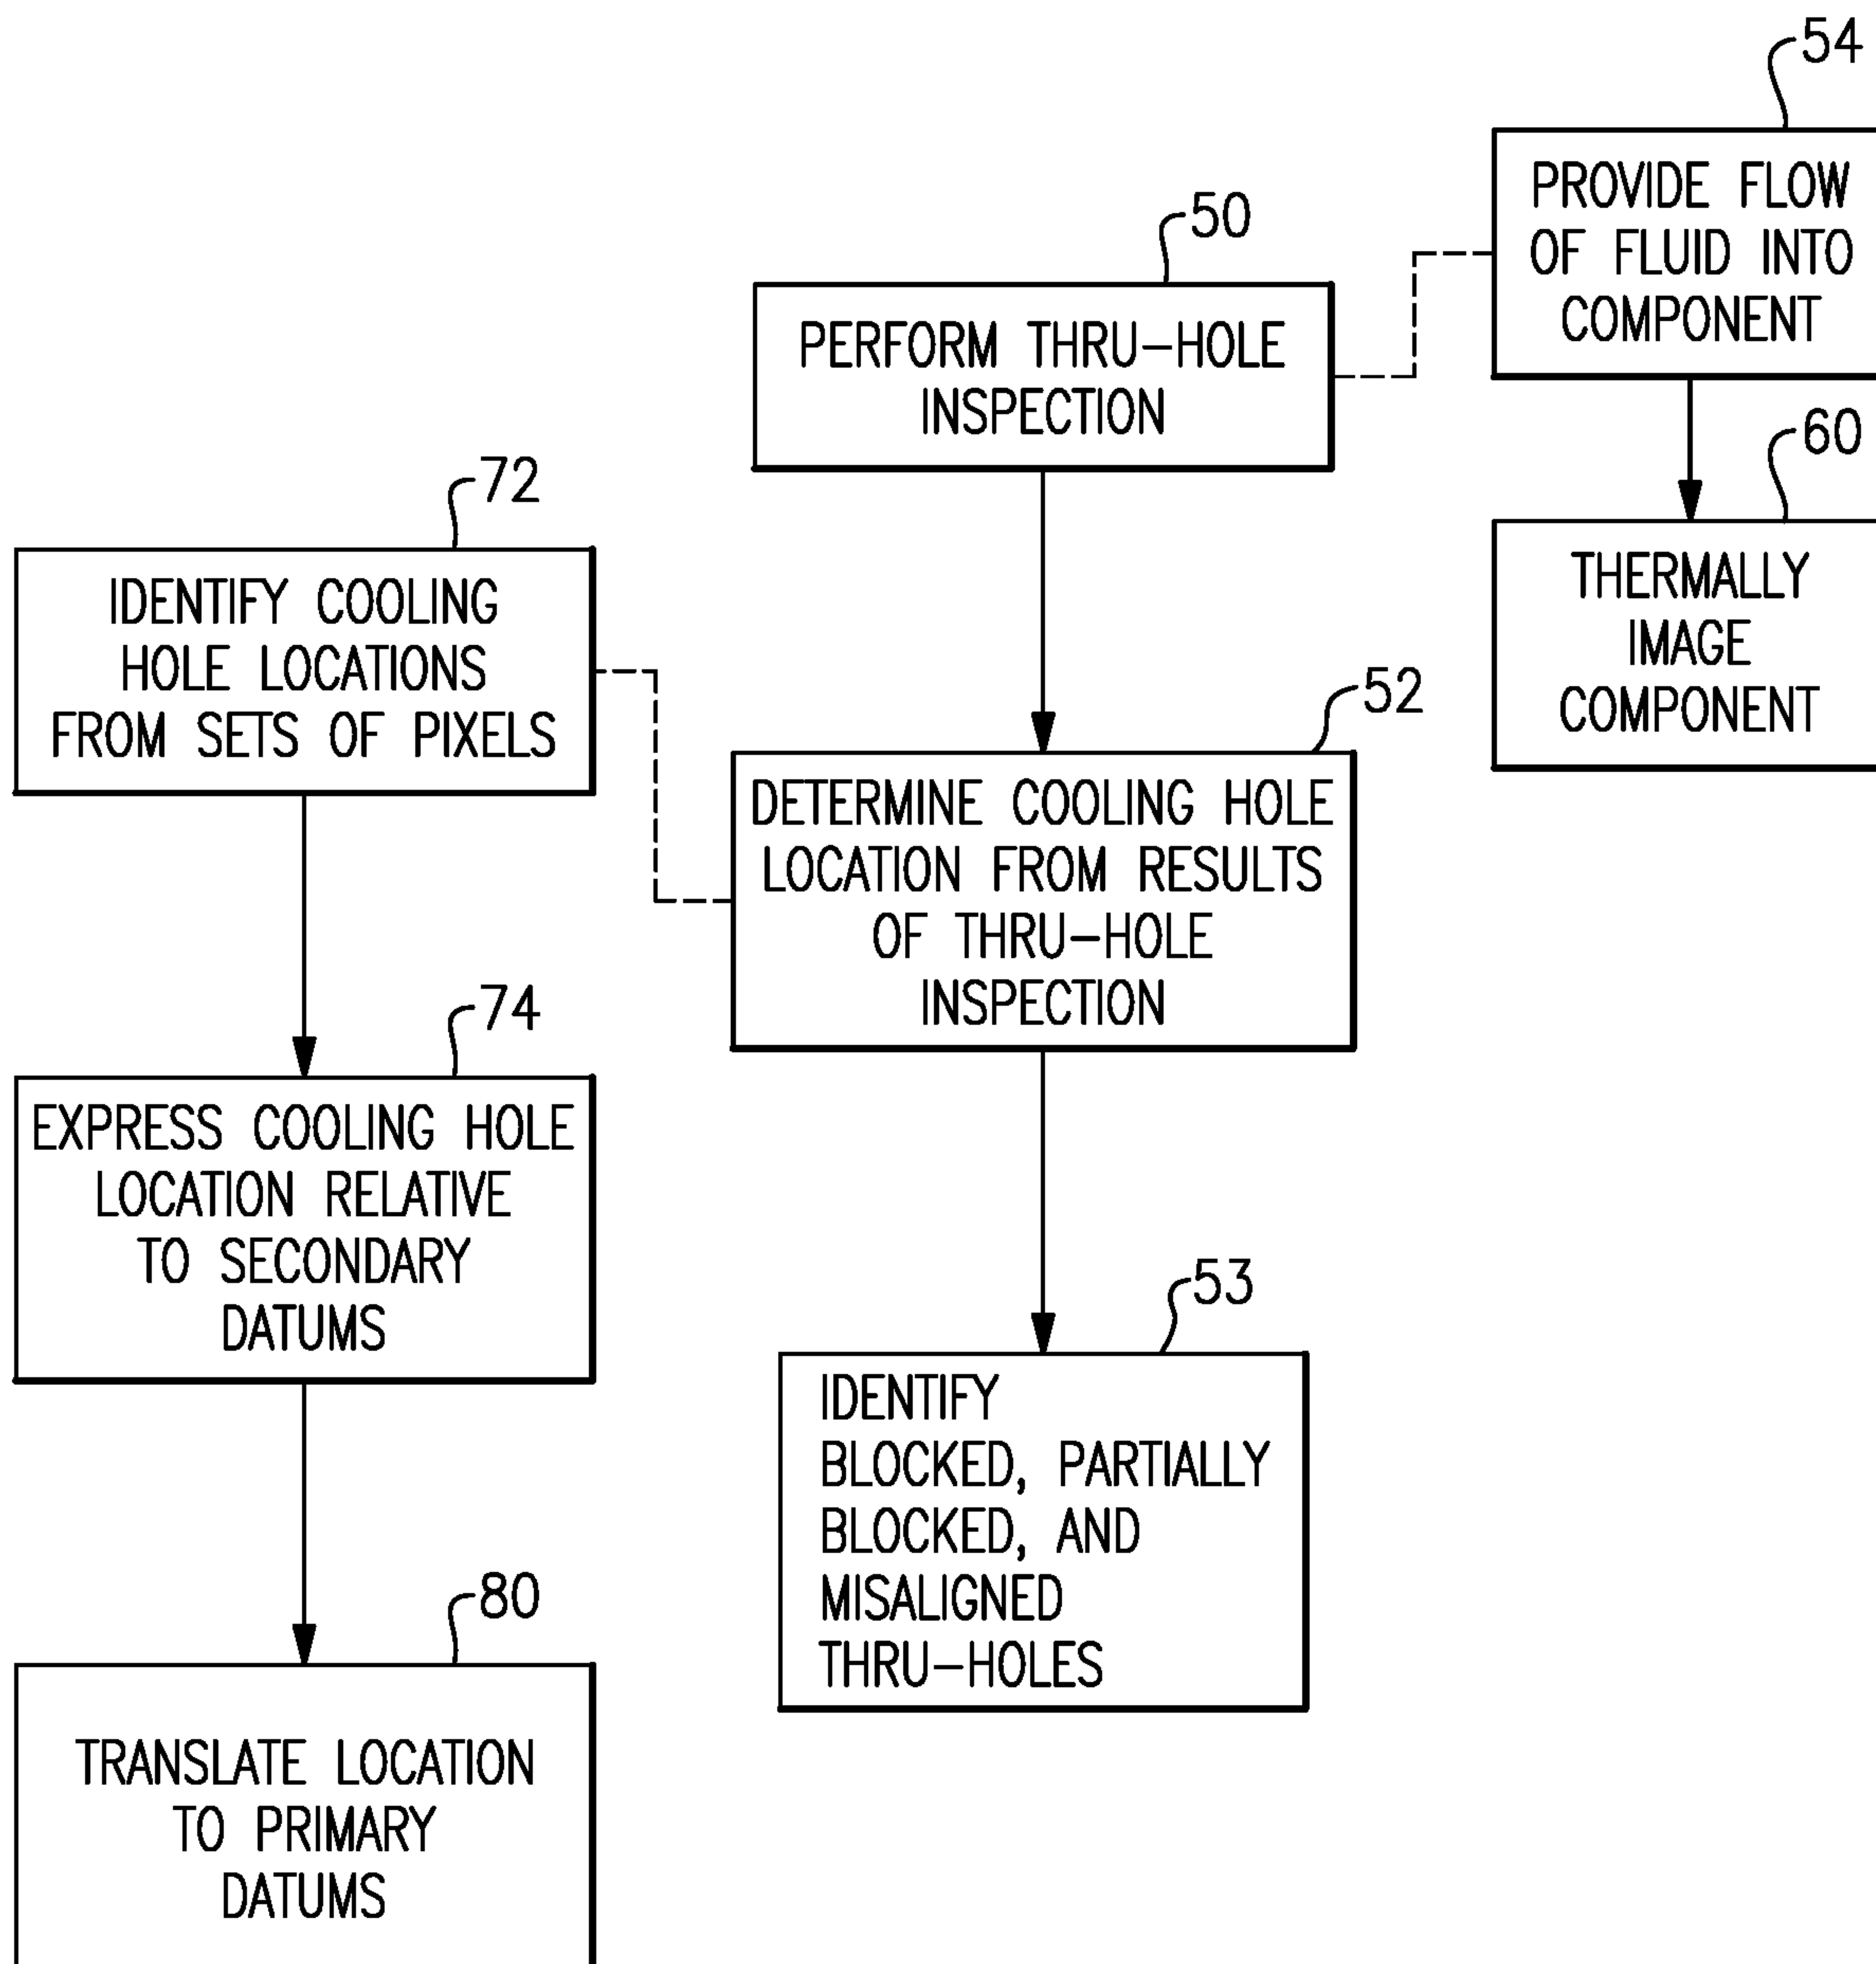
FIG.2

FIG. 2 is a flow chart illustrating an example method according to this disclosure.

A flow chart illustrating an example method according to this disclosure is provided in FIG. 2. The method according to this disclosure includes performing a through-hole inspection 50, determining a location of the plurality of holes machined in the component 12 based on the results from the through-hole inspection, at 52, and identifying blocked, partially blocked, and misaligned cooling holes, at 53.

In one example of this disclosure, a through-hole inspection, at 50, is performed using a flow thermography process. In this process, a flow of fluid F is introduced into the component 12, at 54. FIG. 3 illustrates a portion of the airfoil section 32 of the component 12. The airfoil section 32, as mentioned above, has been machined to include a plurality of cooling holes 56.

From the results of the through-hole inspection (e.g., the image illustrated in FIG. 4), the location of the cooling holes 56 can be determined, at 52. In one example, the location of the cooling holes 56 is determined first by analyzing the sets of pixels 62 from the results of the through-hole inspection, at 72. In a first example, the centroid 62C of the set of pixels 62 is reported as the determined cooling hole location. In

At any rate, at **74**, the cooling hole location is initially expressed, at **74**, relative to secondary datums **76** located on the root section **28** of the component **12**. For instance, during the through-hole inspection discussed above, the component **12** may be supported by its root section, by way a fixture **78**. The locations where the fixture **78** interfaces with the root **28** are referred to as secondary datums **76**. In examples where this disclosure is used relative to a stator vane, the secondary datums **76** would be adjacent an inner and/or outer platform.

These locations are then translated, at **80**, to be expressed in terms of primary datums. As is known in this art, primary datums are points where a component is typically supported during machining Engineering specifications, which include the acceptable cooling hole locations, are typically provided with reference to these primary datums. Example primary datums **82A-82D** are illustrated at the leading edge **40** of the airfoil section **32** adjacent the platform (**82A**), at the leading edge of the airfoil section adjacent the blade tip **34** (**82B**), at the upper surface of the platform **30** (**82C**), and at the trailing edge **42** (**82D**).

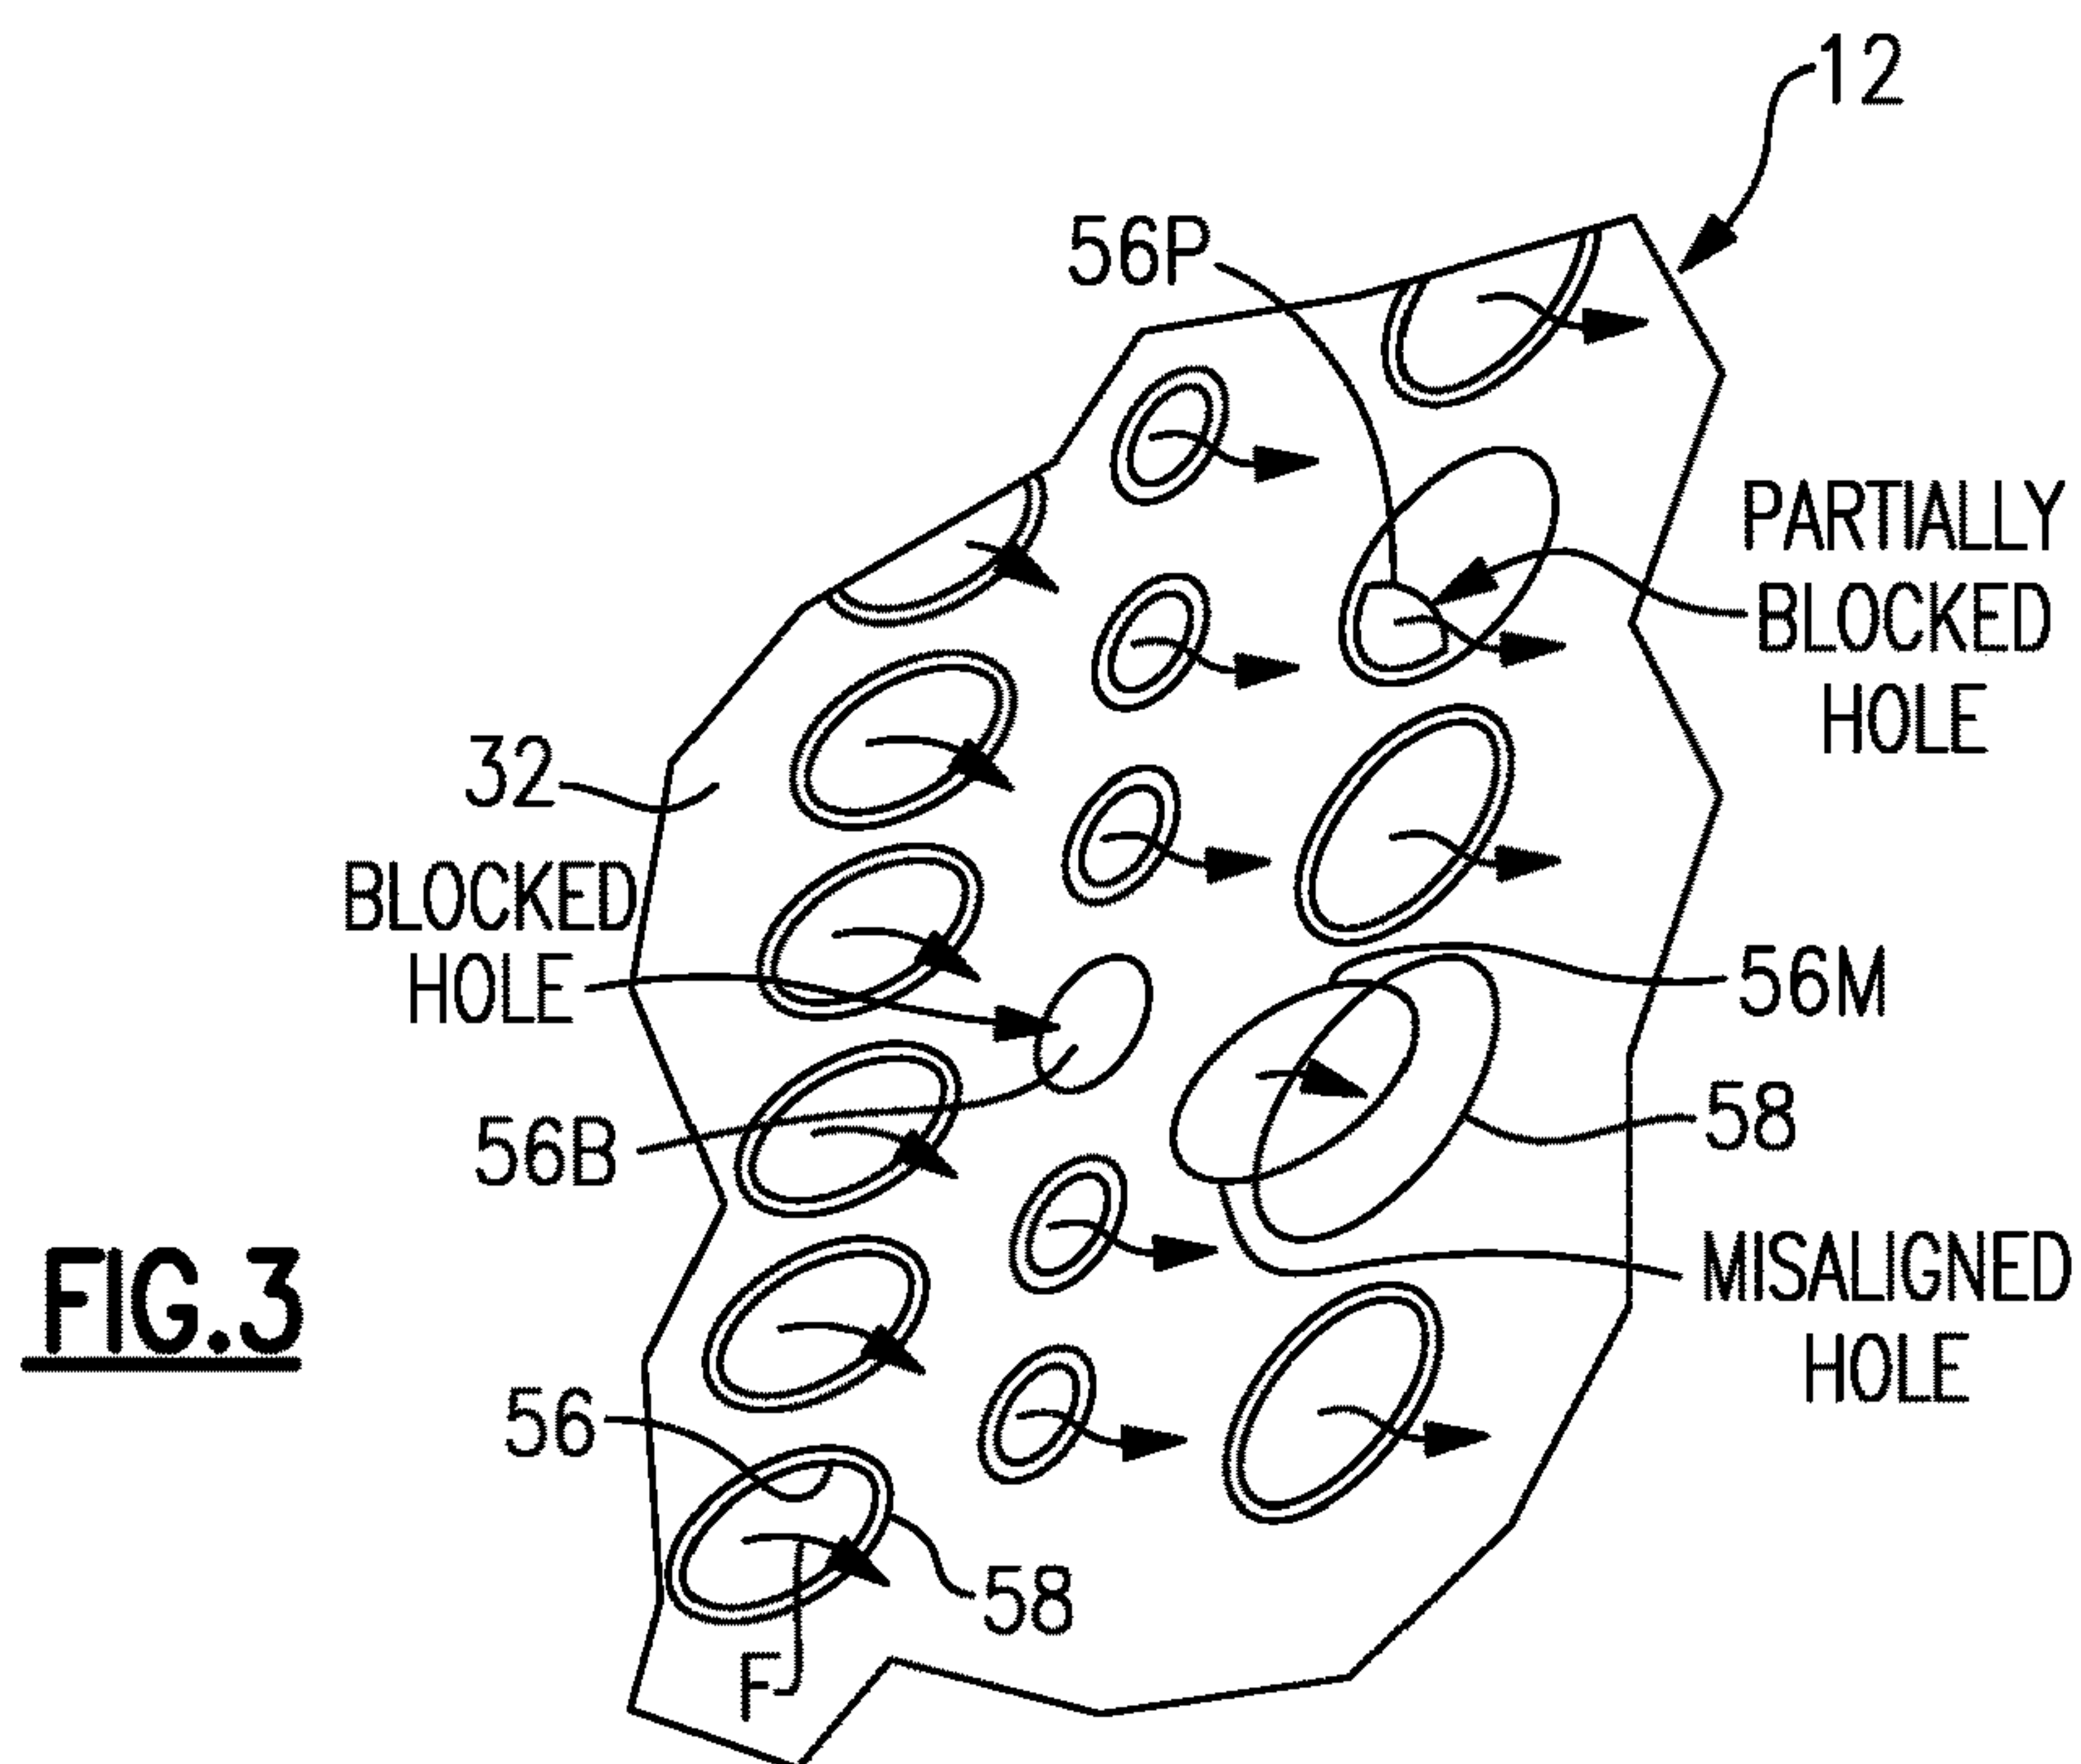
FIG. 3 illustrates a portion of the component of FIG. 1.

The cooling holes 56 are intended to communicate fluid F from one of the core passageways 44, 46 to an outer surface of the airfoil section 32. Acceptable cooling hole locations 58 are illustrated herein for purposes of explanation. The acceptable locations 58 may be provided from engineering specifications and stored in the model 26.

In some instances, the cooling holes 56 are not machined within the acceptable location 58, resulting in a misaligned hole, illustrated at 56M, wherein the misaligned hole 56M falls outside the acceptable hole location 58.

In other instances, the hole may be blocked, or not drilled at all, as illustrated at 56B. Blocked holes 56B do not communicate any fluid F from the core passageways 44, 46 to the outer surface of the airfoil section 32. Further, a hole may be partially blocked, as illustrated at 56P, in which case the flow of fluid F communicated between the core passageways 44, 46 and the outer surface of the airfoil section 32 is insufficient.

As known in the art, depending on the defects identified at **53**, corrective measures, such as further manufacturing, can be undertaken to correct the defective cooling holes (such as the **56P**, **56M**, and **56B**).

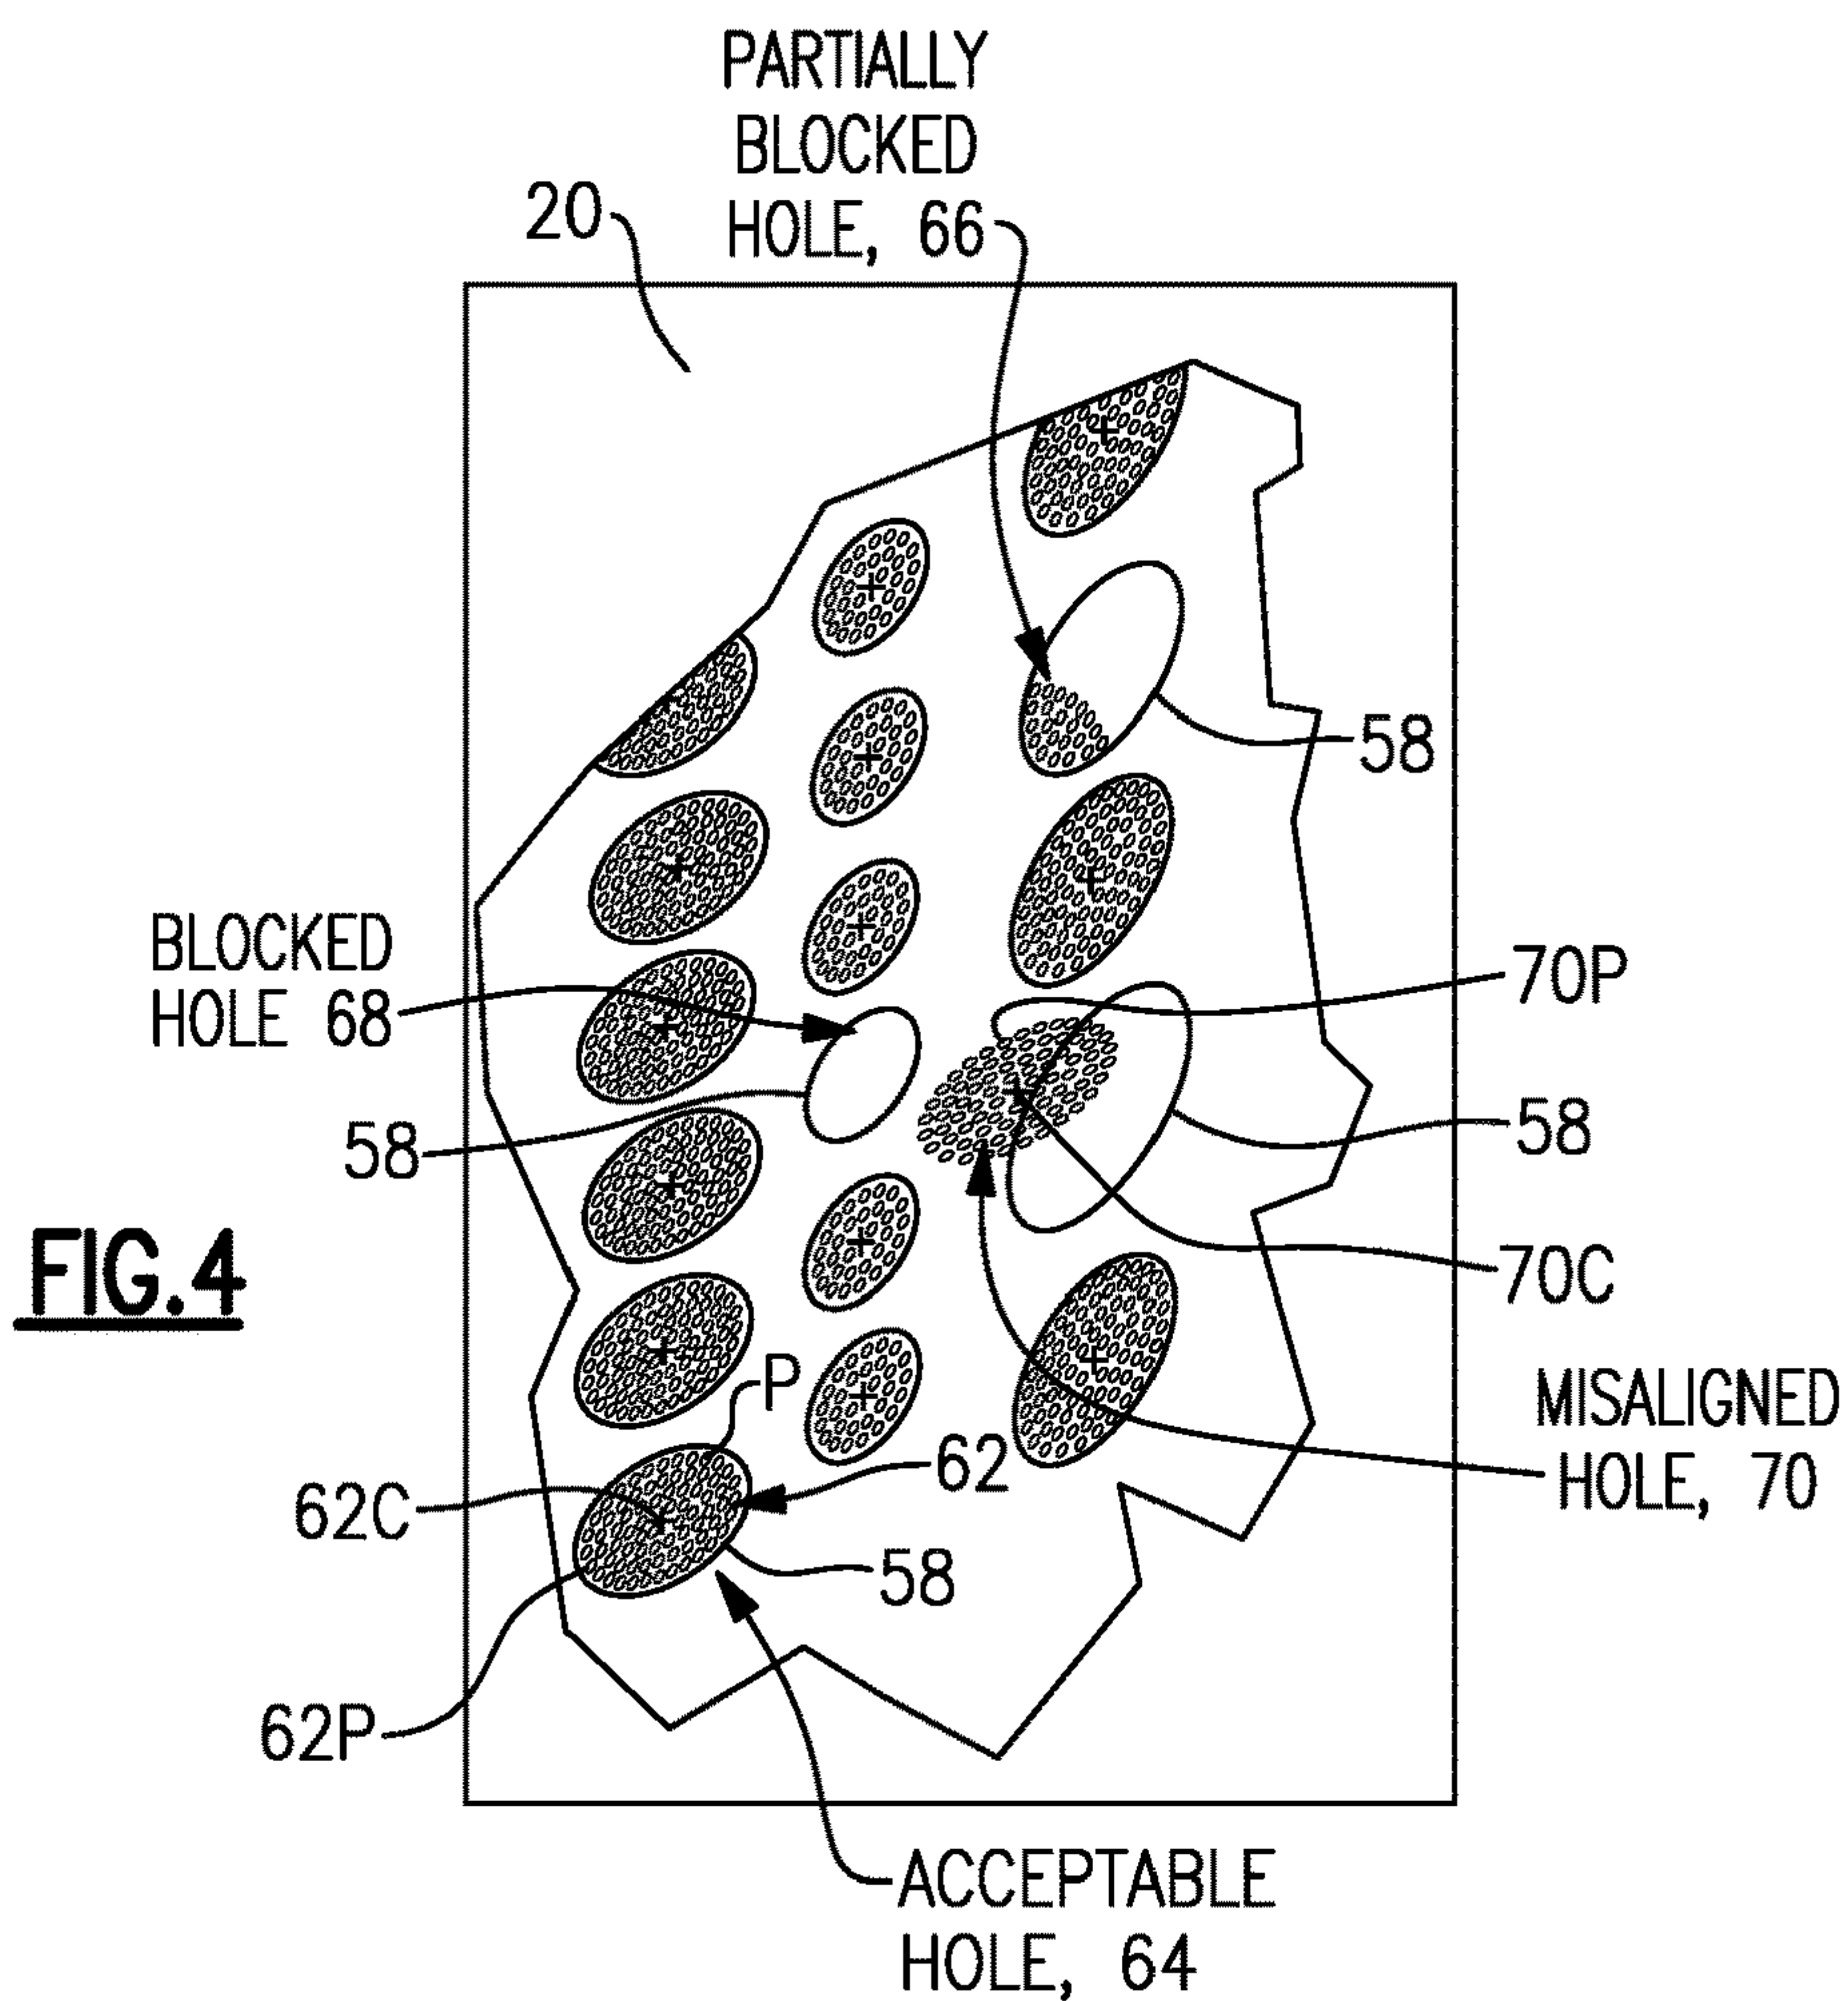
FIG. 4 illustrates an example inspection result, relative to the portion of the component illustrated in FIG. 3.

As fluid F flows through the holes 56, the camera 24 provides a thermal image of the cooling holes 56, at 60. FIG. 4 illustrates an example thermal image of the cooling holes of FIG. 3. The image, which may be displayed on the screen 20, is a plurality of sets 62 of pixels P. In one example, the pixels P are of a particular color that corresponds to the known temperature of the fluid F.

In the bottom left-hand corner of FIG. 4, a first set of pixels P indicates that the cooling hole 64 is acceptable. In this example, the pixel count within the acceptable hole location 58 is greater than or equal to a minimum threshold. The minimum threshold is a predetermined value known to correspond to a cooling hole that provides adequate cooling. The minimum threshold may be stored in the model 26. When the pixel count is below the minimum threshold, a partially blocked hole, such as the partially blocked hole 66, will be identified, at 53. Where no pixels are shown within an expected location 58, a blocked hole, such as the blocked hole 68, will be identified (again, at 53).

At **53**, the location of the cooling holes is compared with the engineering specifications to identify misaligned holes, such as the misaligned hole **56M**, which is identified as a misaligned hole, at **70** in FIG. 4, because the centroid **70C** is located outside the acceptable hole location **58**. Alternatively, if a perimeter is used to report the cooling hole locations, a misaligned hole may still be identified because at least some perimeter pixels **70P** lie outside the acceptable hole location **58**.
