(10) **Patent No.:** **US 11,440,681 B2**
(45) **Date of Patent:** **Sep. 13, 2022**

(54) **SYSTEMS AND METHODS FOR THRUST REVERSER CORROSION DAMAGE REPAIR**

(71) Applicant: **Nextant Aerospace**, Cleveland, OH (US)

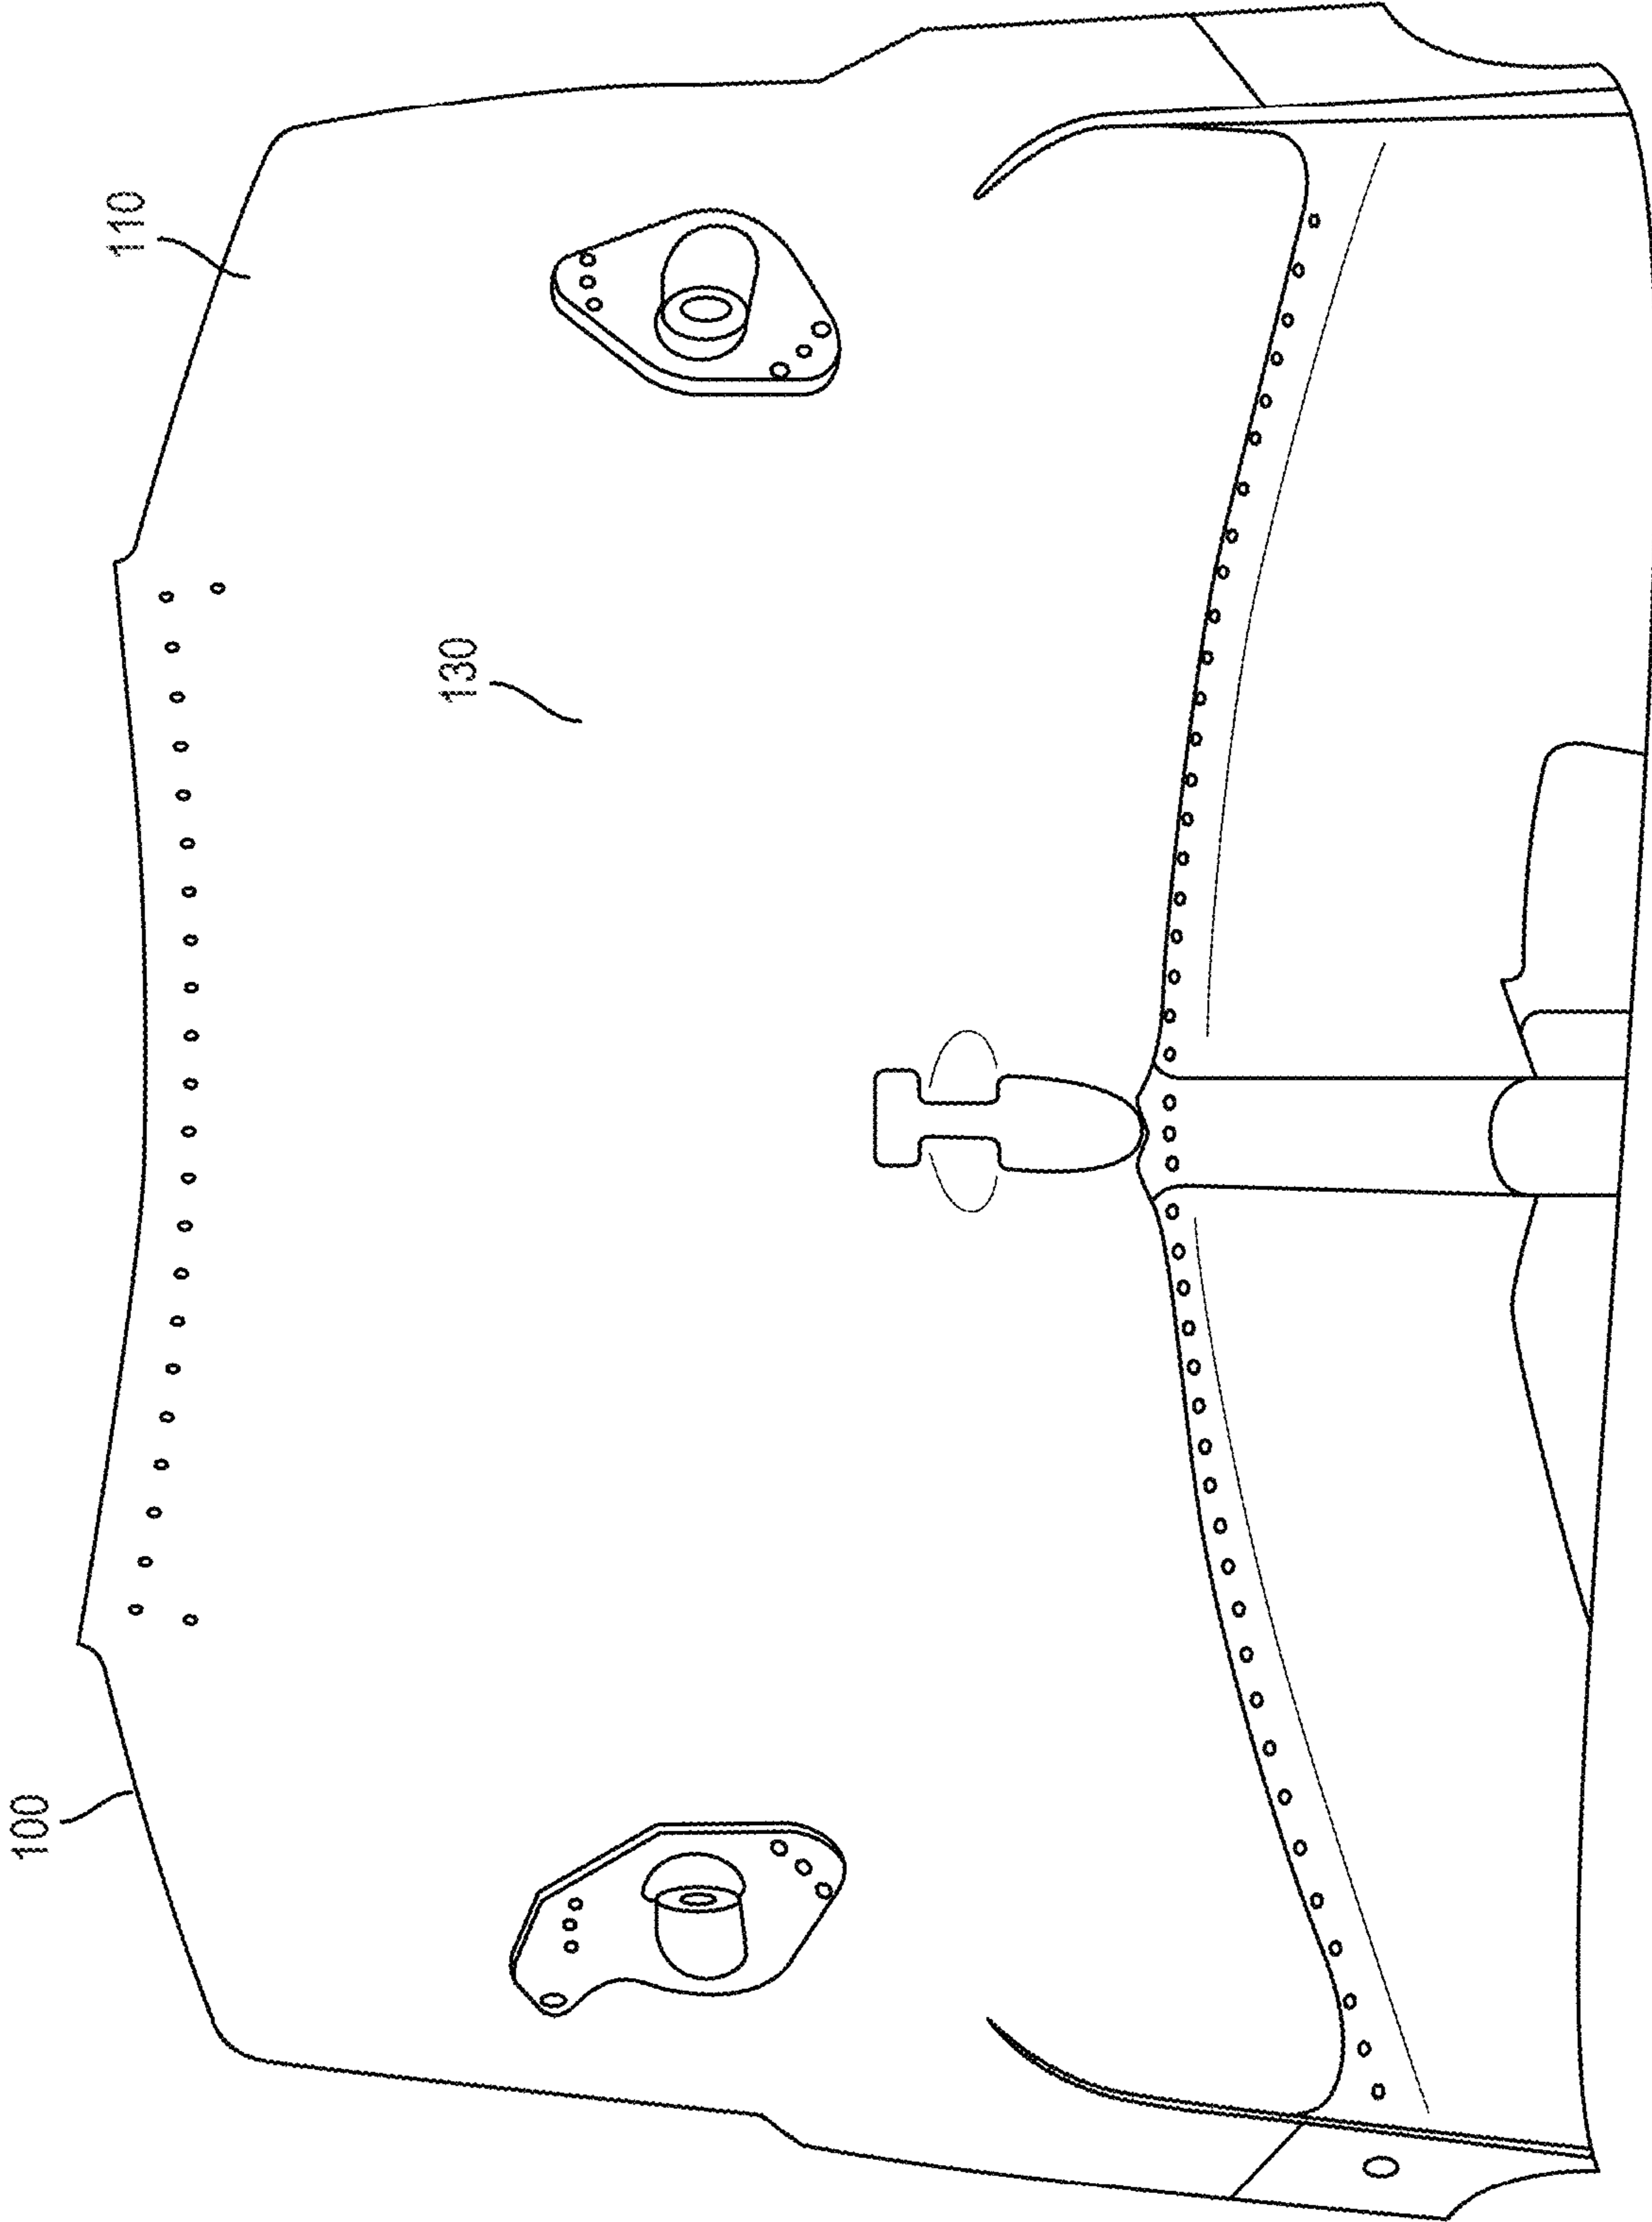
FIG. 1 is an isometric view of an exemplary part of a thrust reverser assembly, according to an embodiment of the invention.

Referring to FIGS. 1 and 2, a part 100 of a thrust reverser assembly is illustrated. For example, in some embodiments, the part 100 is one of an upper door assembly or a lower door assembly. In other embodiments, part 100 can be a machined component having corrosion damage. The part can include an inner surface 110 and an outer surface 120. The inner surface 110 and the outer surface 120 can include an outer skin 130. In order to repair corrosion damage on an area of the part 100, the part 100 is initially removed from the rest of the thrust reverser assembly. After corrosion repair has been completed, the part 100 is installed back to the thrust reverser assembly. As shown in relation to FIGS. 3A-3B, the area of the part 100 that has suffered from corrosion damage can be repaired by adding a stainless steel skin to the part 100 and sandwiching synthetic fiber material between the new skin and the part 100 to provide protection against dissimilar metal corrosion. In some embodiments, the synthetic fiber material includes Kevlar. Kevlar® is a registered trademark of DuPont de Nemours, Inc., and is DuPont's brand name for its synthetic fiber material.

As mentioned during the discussion of FIGS. 1 and 2, one or more doublers can be installed onto the ply of synthetic fiber material 310 in order to provide protection against metal corrosion. In some embodiments, the one or more doublers are stainless steel. In other embodiments, the one or more doublers include another type of steel or aluminum. For example, in some embodiments, the one or more doublers 330 are installed using rivets. In some embodiments, the one or more doublers 330 are clamped onto the part 100, locations for doubler holes are identified, and the locations for doubler holes are reamed. Once the ply of synthetic fiber material 310 has been installed, the layers of film adhesive 320 can be heat cured. For example, in some embodiments, heat curing the layers of film adhesive 320 includes ramping up a temperature of the film adhesive 320 up to 250 degrees F., dwelling at the temperature of 250 degrees F. for an hour, and ramping down the temperature of the film adhesive 320 to a room temperature.

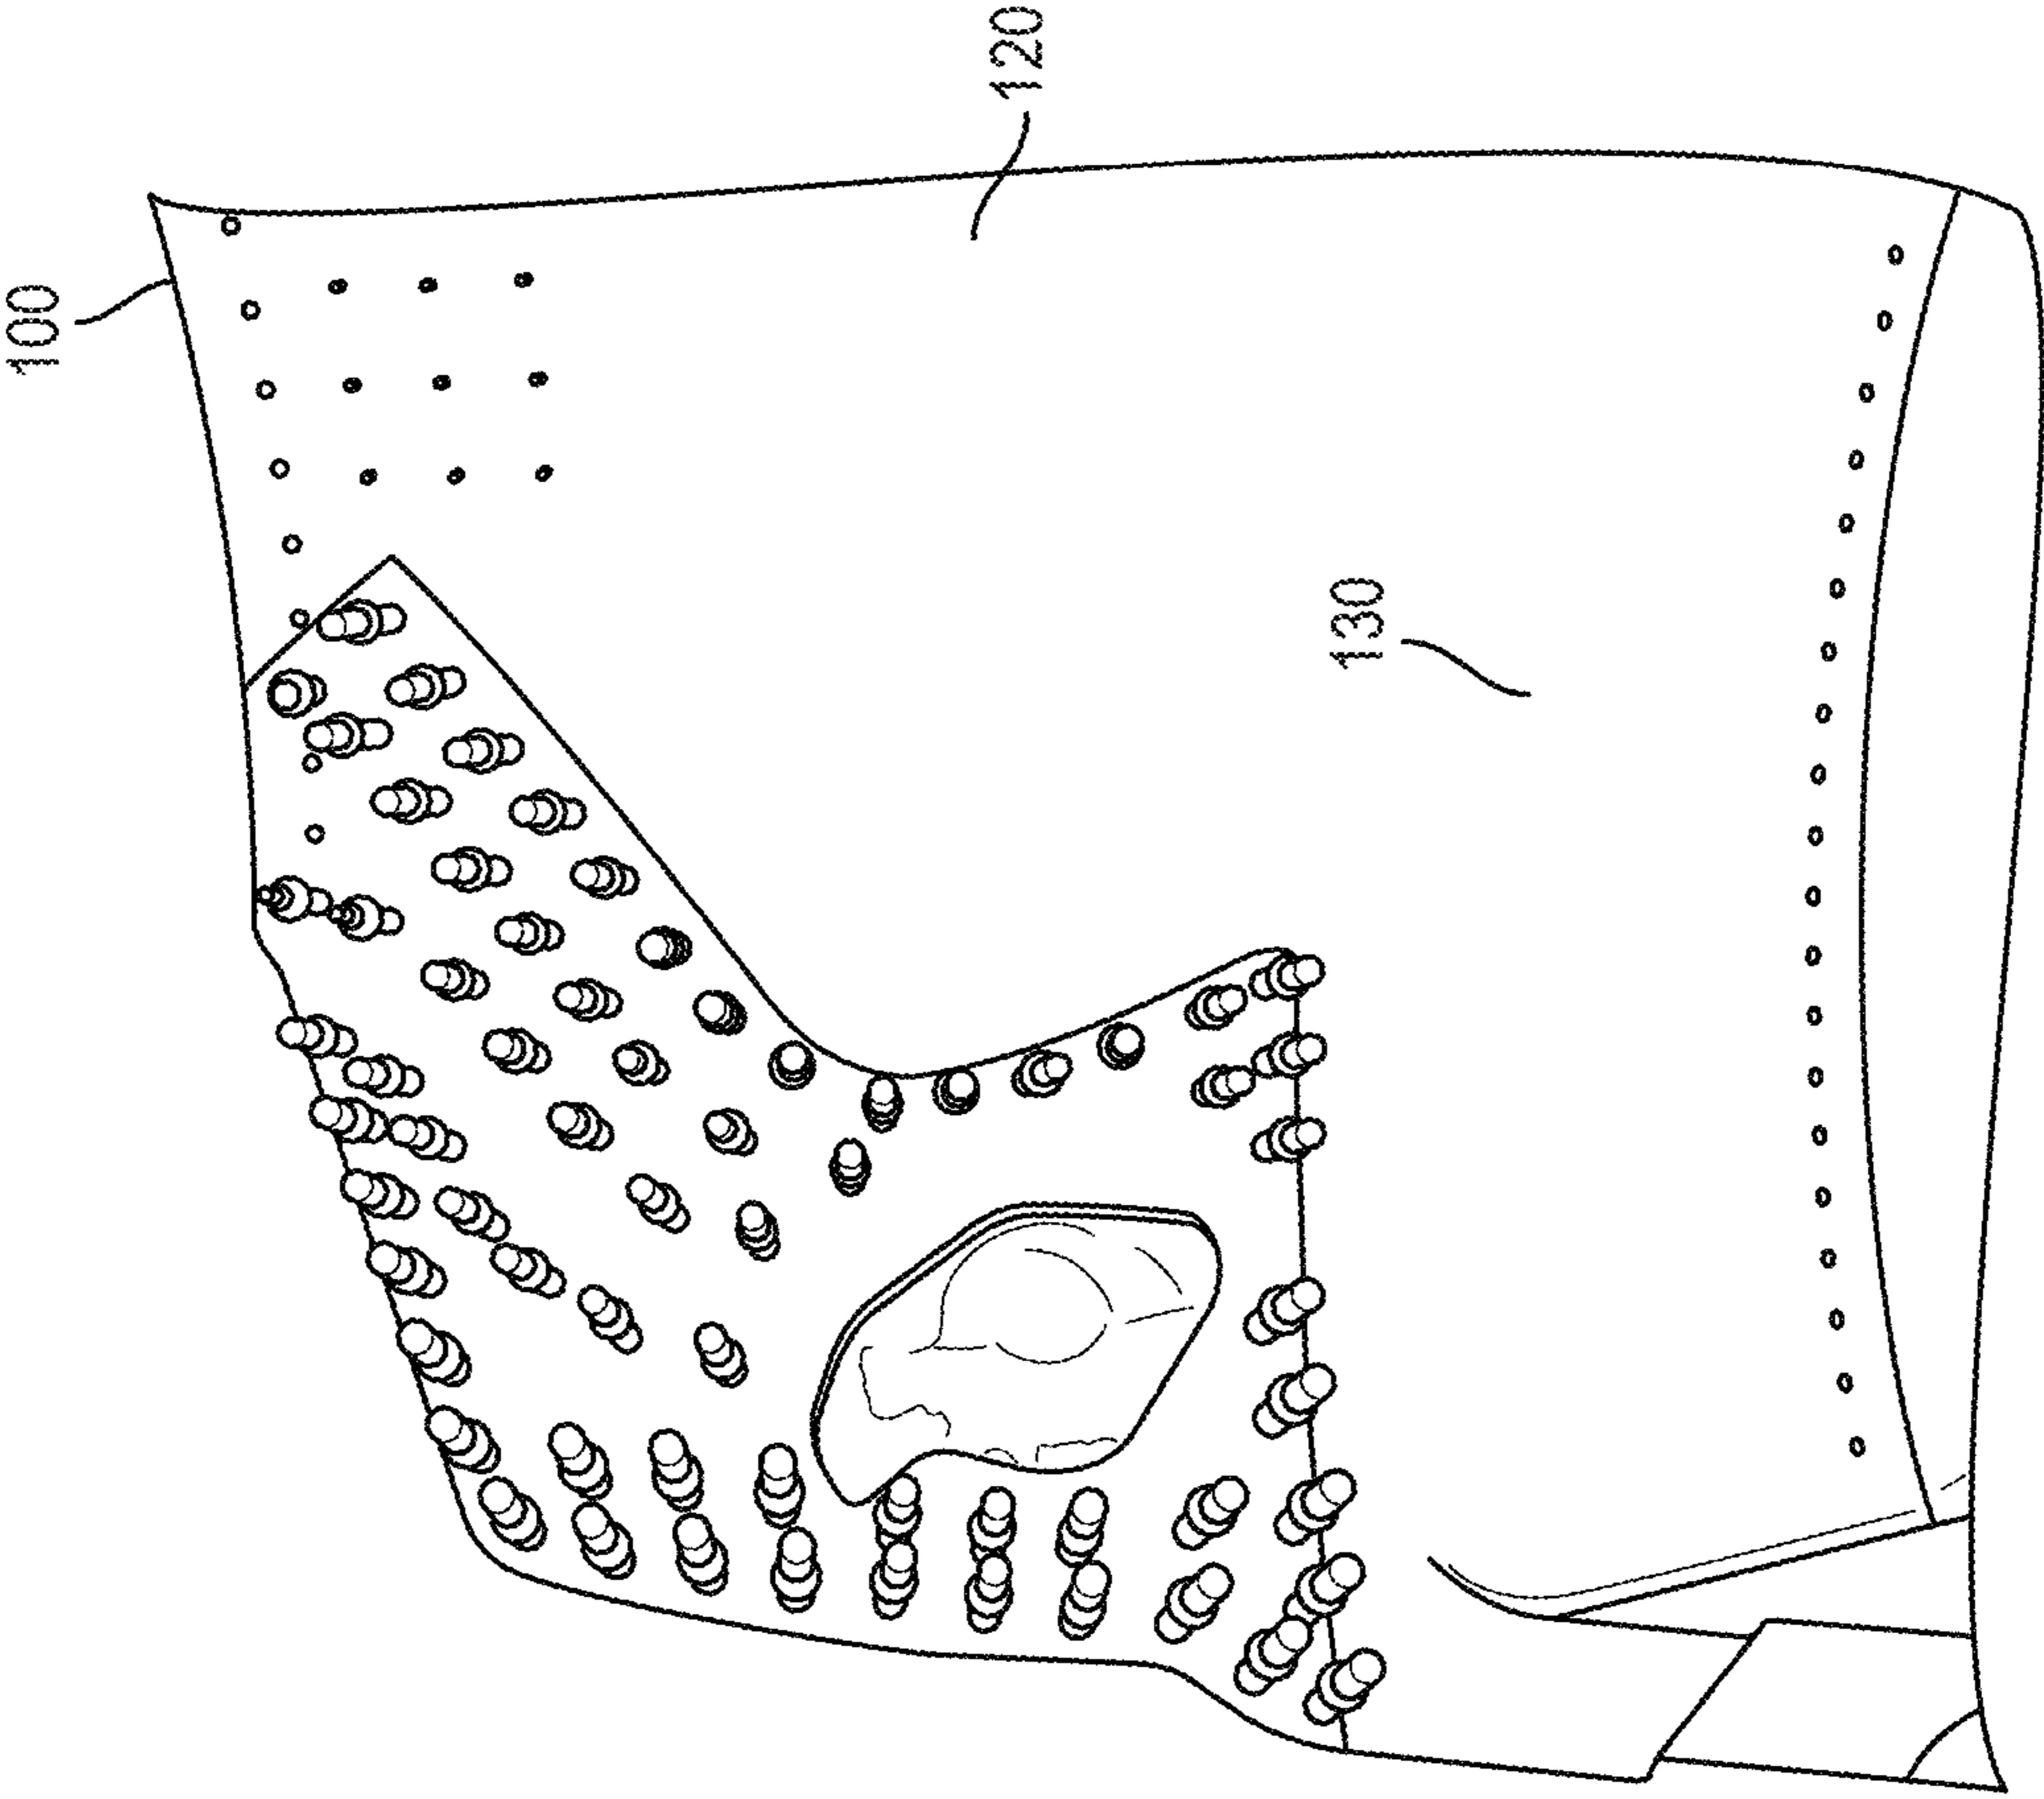
FIG. 2 is an isometric view of an exemplary part of a thrust reverser assembly, according to an embodiment of the invention.

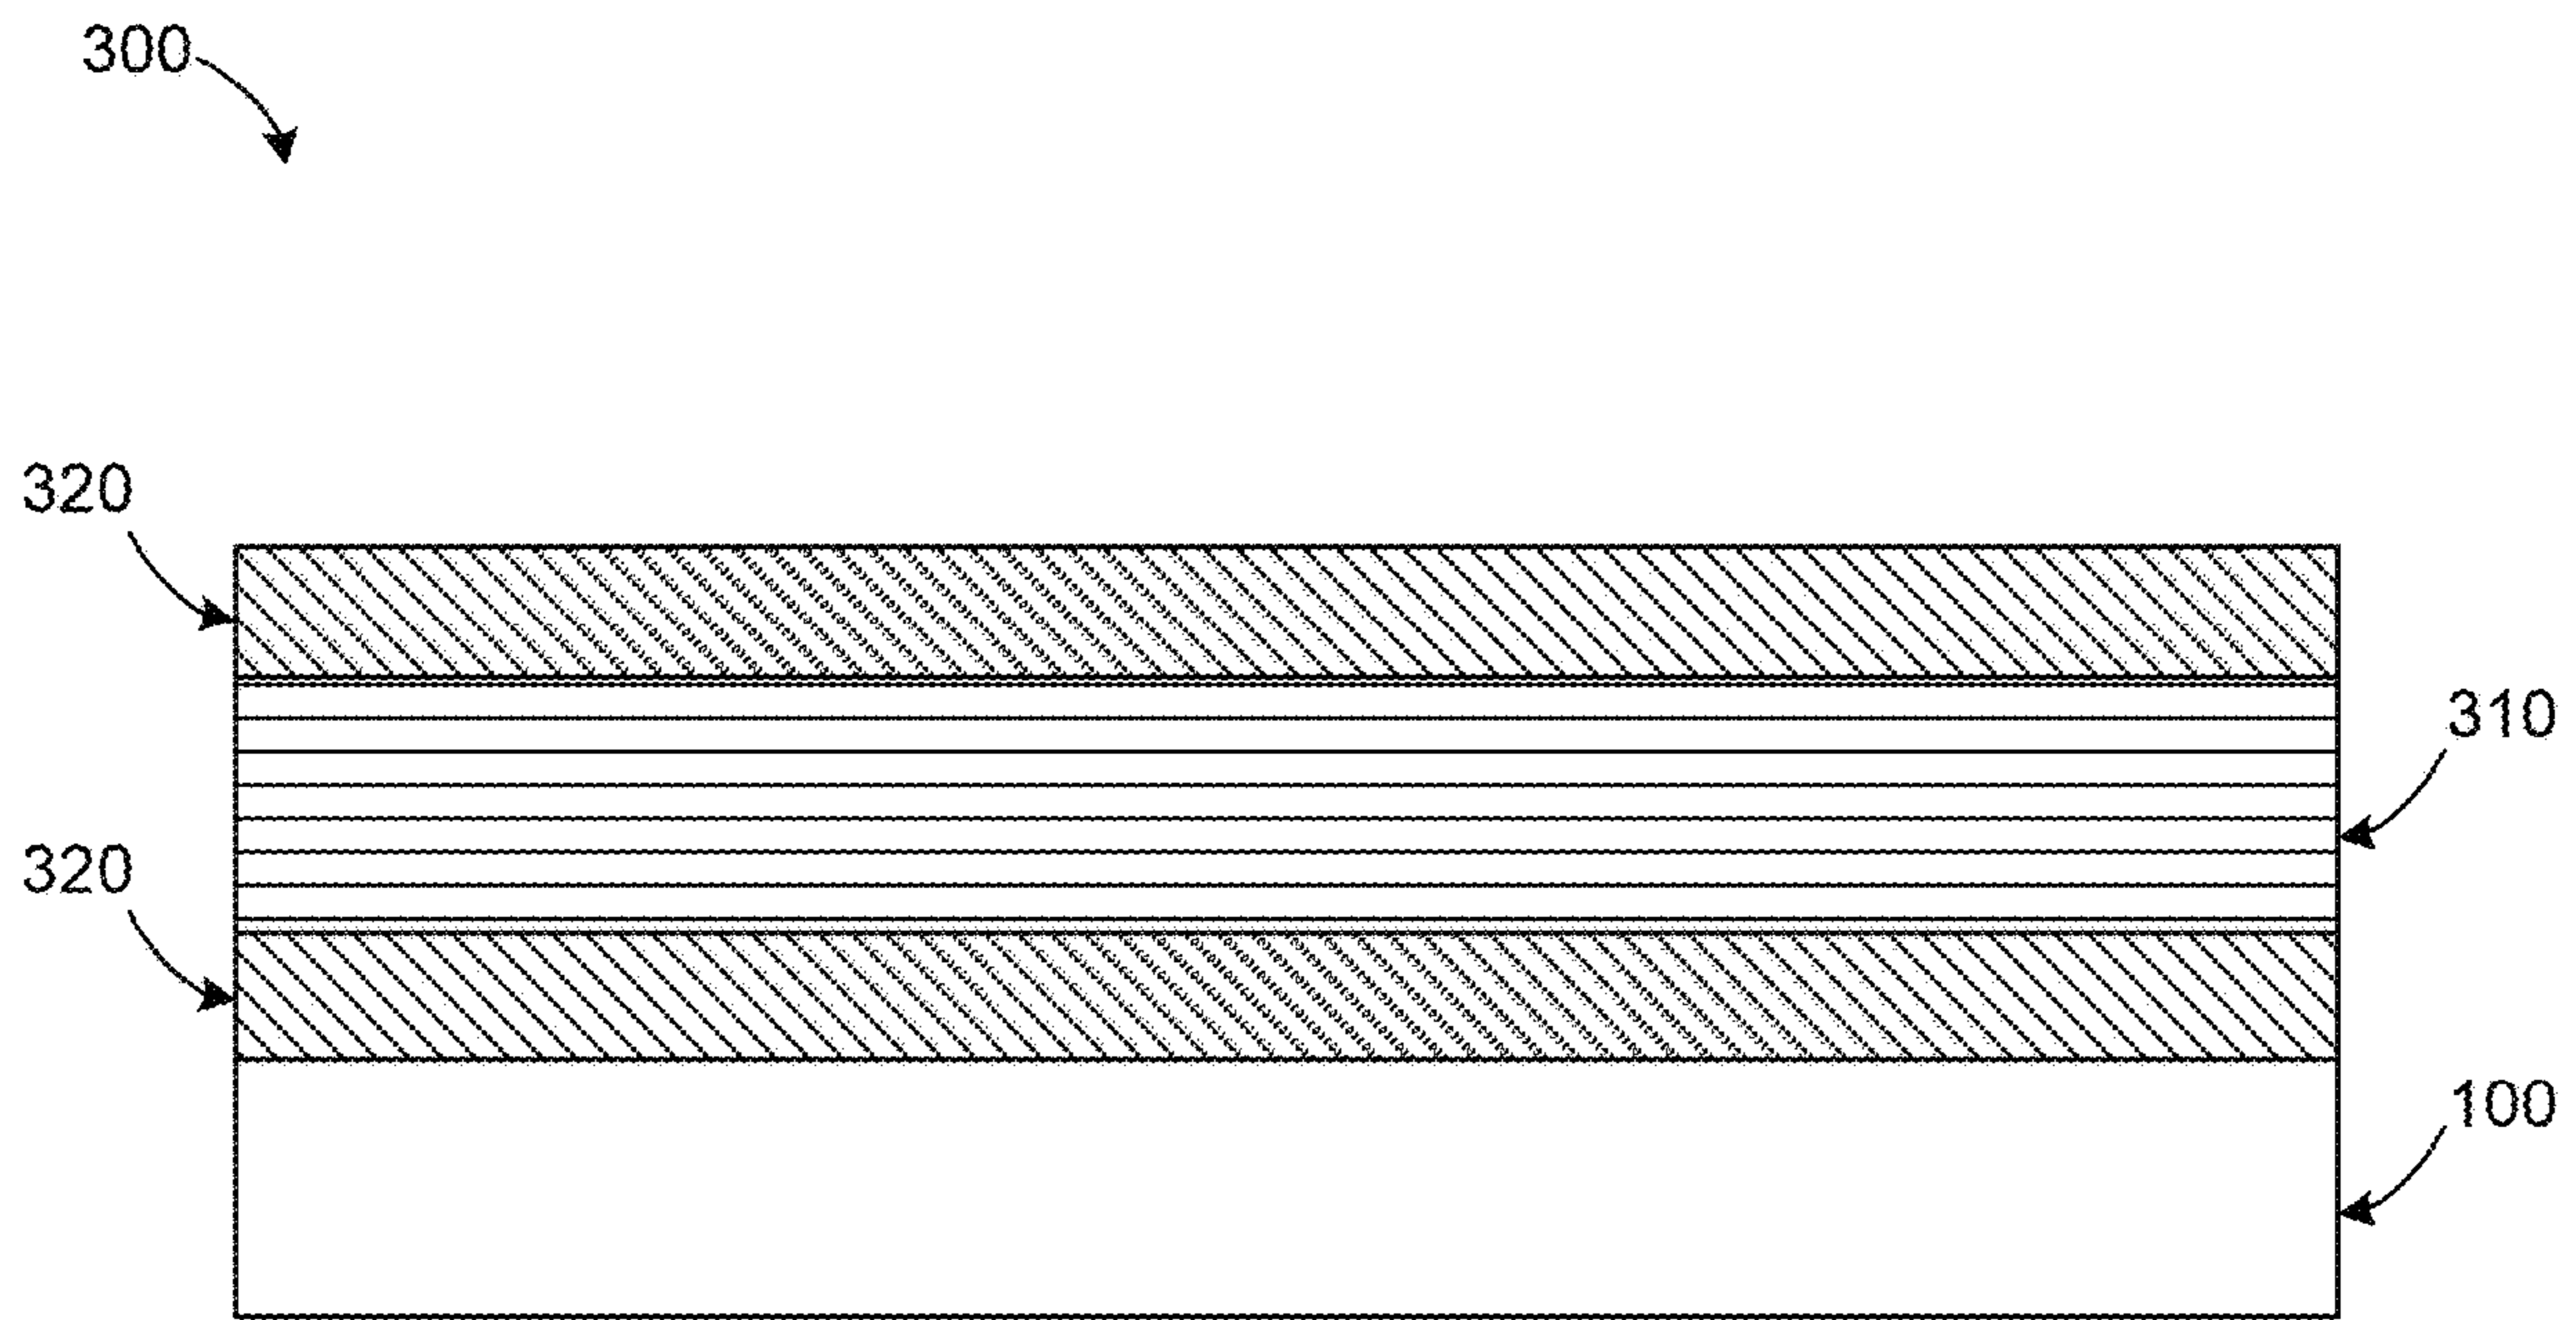
FIG. 3A is a cross-section view of an exemplary part of a thrust reverser assembly, according to an embodiment of the invention.

Before repairing the corrosion damage on the area of the part 100, the outer skin 130 is removed from the inner surface 110 and the outer surface 120. Referring to FIGS. 3A-3B, a cross-section 300 of an embodiment of part 100 after removal of the outer skin 130 is illustrated. A ply of synthetic fiber material 310 is installed onto an area of the inner surface 110 or the outer surface 120 of the part 100. The location of the installation of the ply of synthetic fiber material 310 depends on the location of the damaged area. In some embodiments, the location of the damaged area is determined during inspection of the part 100. Once installed, the ply of synthetic fiber material 310 is sandwiched between a layer of film adhesive 320 on each side of the ply of synthetic fiber material 310. In some embodiments, the synthetic fiber material includes one of a Plain Weave Kevlar or a 4-Harness Kevlar. In some embodiments, film adhesive 320 includes a 3M Scotch-Weld Structural adhesive film. AF 163 2k 0.06 is a modified epoxy structural adhesive in film form.

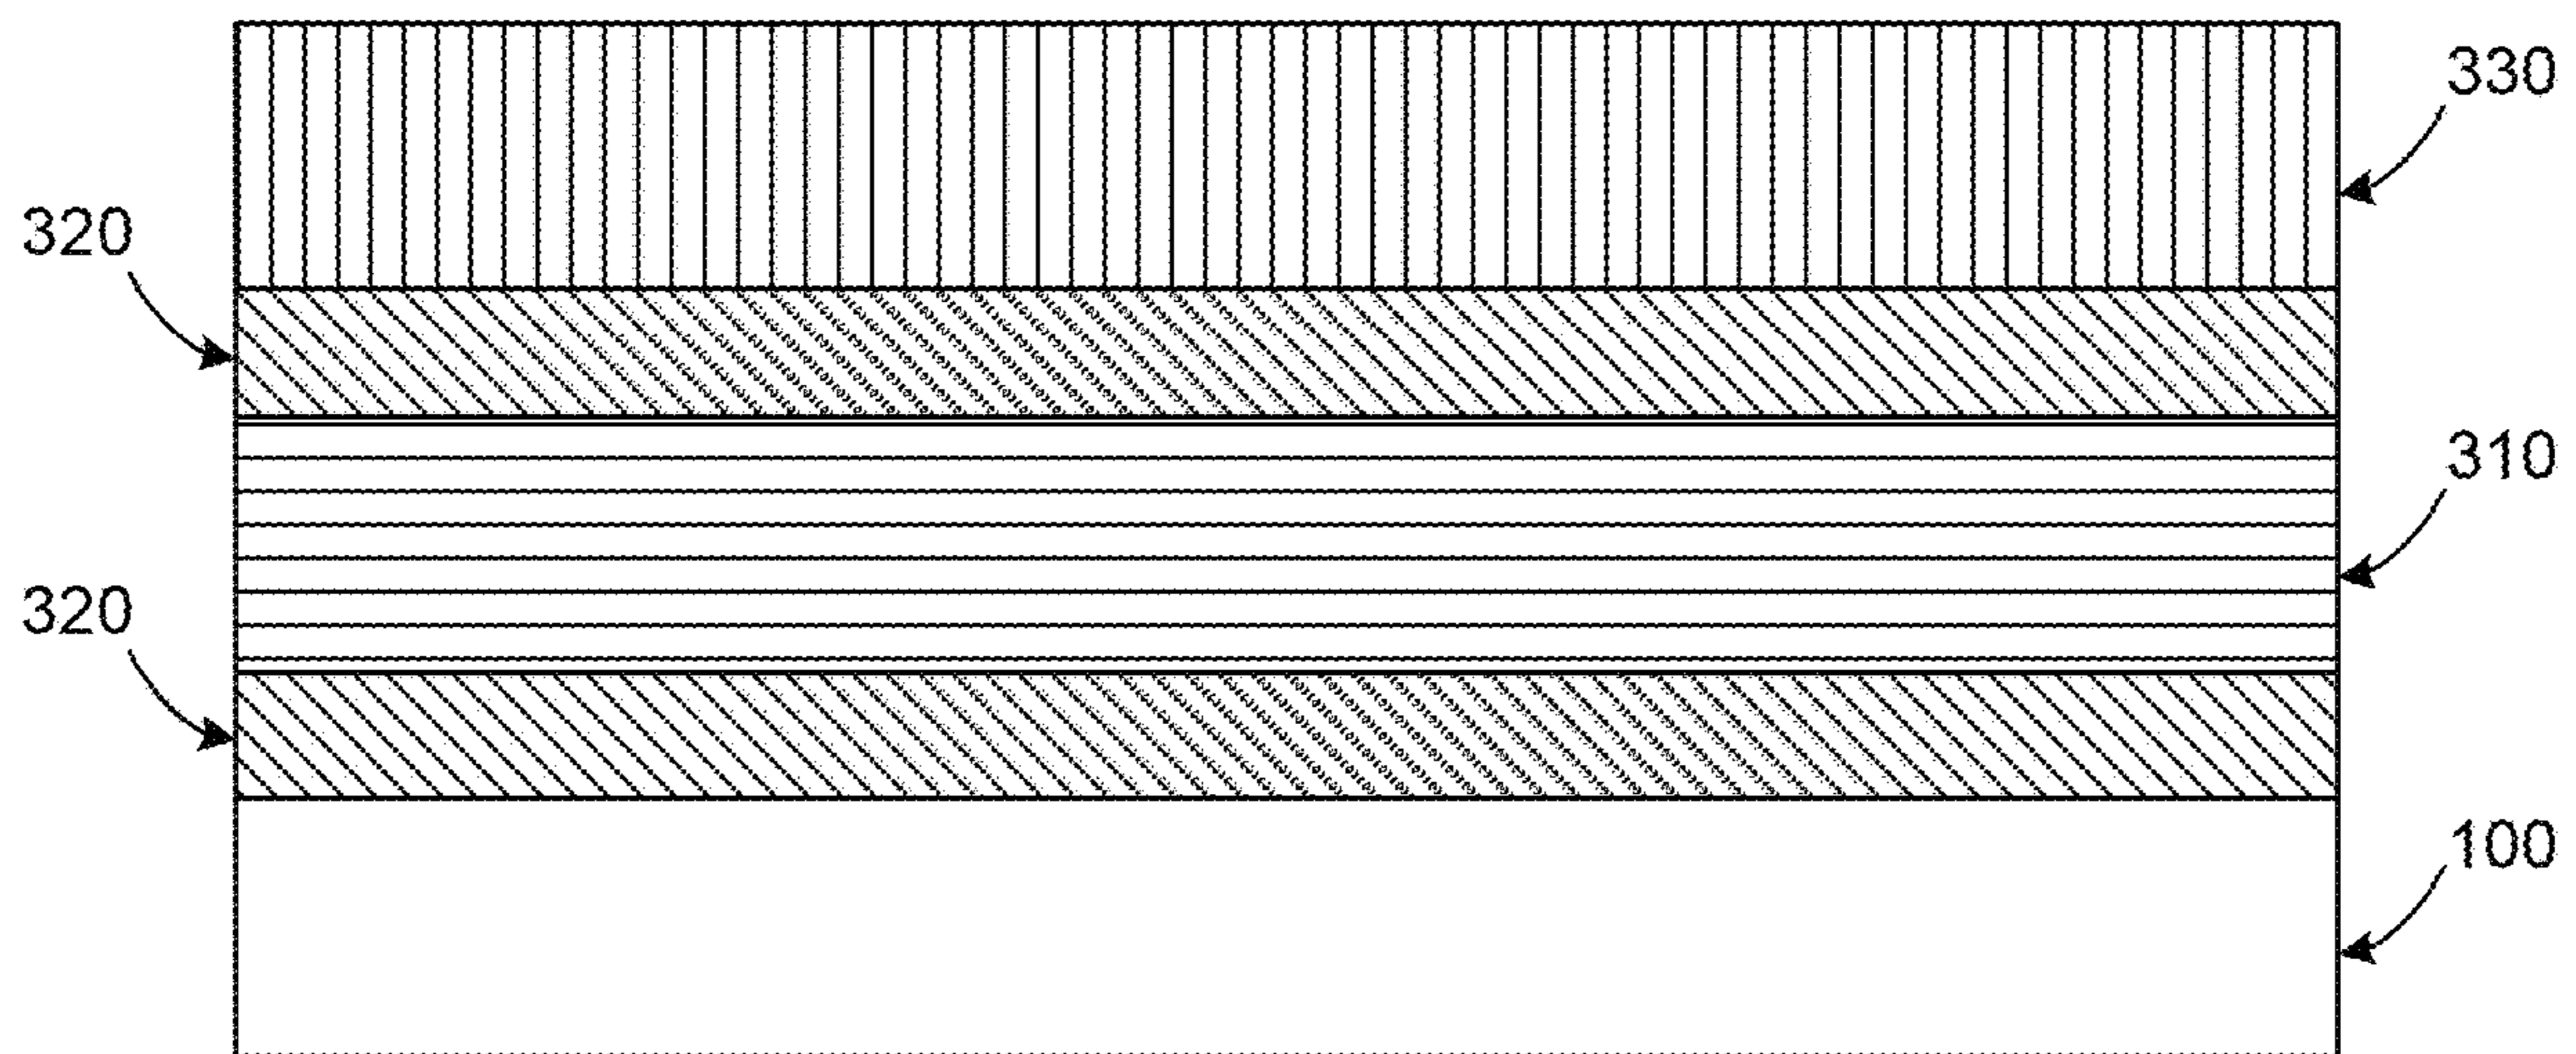
FIG. 3B is a cross-section view of an exemplary part of a thrust reverser assembly, according to an embodiment of the invention.

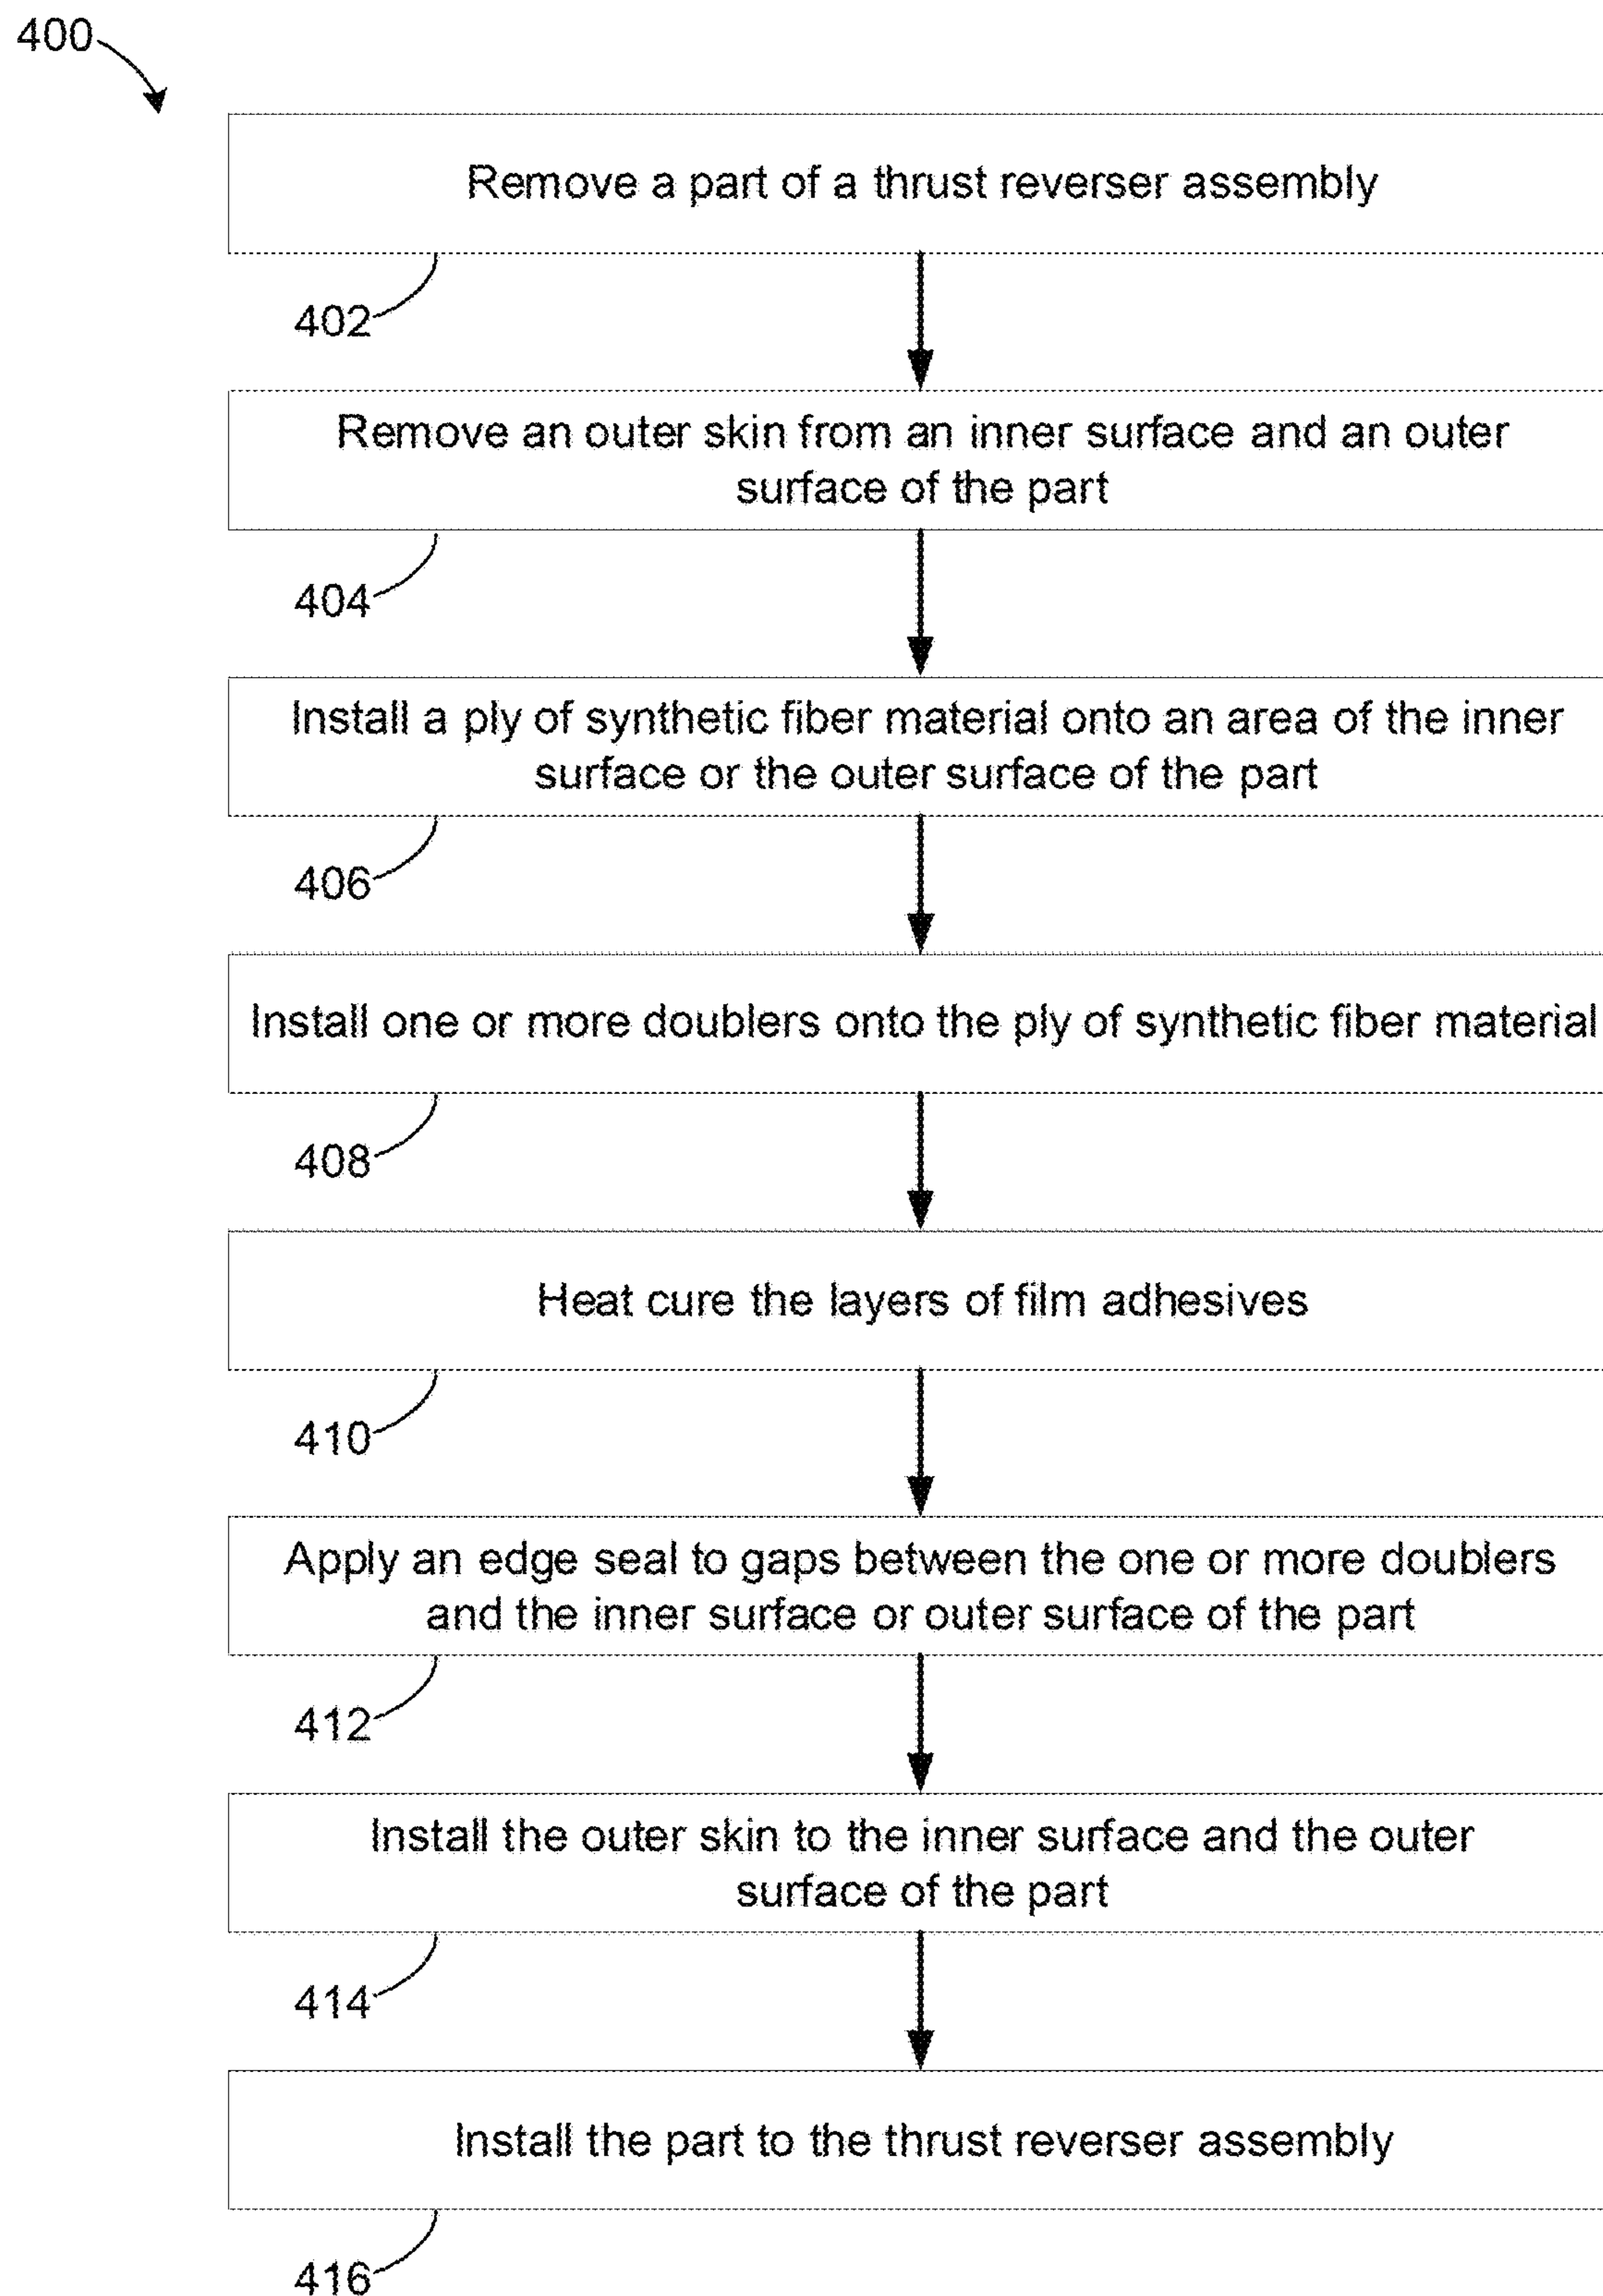
FIG. 4 is a flow diagram of method steps for repairing corrosion damage of a part of a thrust reverser assembly, according to an embodiment of the invention.

Referring to FIG. 4, a process 400 for repairing corrosion damage of a part 100 of a thrust reverser assembly is illustrated. As described in relation to FIGS. 1 and 2, the part 100 can include an inner surface 110 and an outer surface 120. The process 400 begins by removing the part 100 of the thrust reverser assembly in step 402. For example, in some embodiments, the part 100 is one of an upper door assembly or a lower door assembly. Process 400 continues by removing an outer skin 130 from the inner surface 110 and the outer surface 120 of the part 100 in step 404.

Process 400 continues by installing a ply of synthetic fiber material 310 onto an area of the inner surface 110 or the outer surface 120 of the part 100 in step 406. In some embodiments, the area includes corrosion damage. Once installed, the ply of synthetic fiber material 310 is sandwiched between a layer of film adhesive 320 on each side of the ply of synthetic fiber material 310. For example, in some embodiments, the synthetic fiber material includes one of a Plain Weave Kevlar or a 4-Harness Kevlar.

Process 400 continues by installing one or more doublers 330 onto the ply of synthetic fiber material 310 in step 408. For example, in some embodiments, the one or more doublers 330 are installed using rivets. In some embodiments, process 400 includes clamping the one or more doublers 330 onto the part 100, identifying locations for doubler holes, and reaming the locations for doubler holes.

Process 400 continues by heat curing the layers of film adhesive 320 in step 410. For example, in some embodiments, heat curing the layers of film adhesive 320 includes ramping up a temperature of the film adhesive 320 up to 250 degrees F., dwelling at the temperature of 250 degrees F. for an hour, and ramping down the temperature of the film adhesive 320 to a room temperature.

Process 400 continues by applying an edge seal to gaps between the one or more doublers 330 and the inner surface 110 or outer surface 120 of the part 100 in step 412. For example, in some embodiments, the edge seal includes a resin. In some embodiments, process 400 includes heat curing the edge seal resin. In some embodiments, process 400 includes sanding an excess of edge seal resin.

Process 400 continues by installing the outer skin 130 to the inner surface 110 and the outer surface 120 of the part 100 in step 414. Process 400 finishes by installing the part 100 to the thrust reverser assembly in step 416. In some embodiments, process 400 includes painting a topcoat to the inner surface 110 and the outer surface 120 of the part 100.
