US011447189B1

(54) **VEHICLE FRAME AND CARGO BAY LINER**

(57) **ABSTRACT**

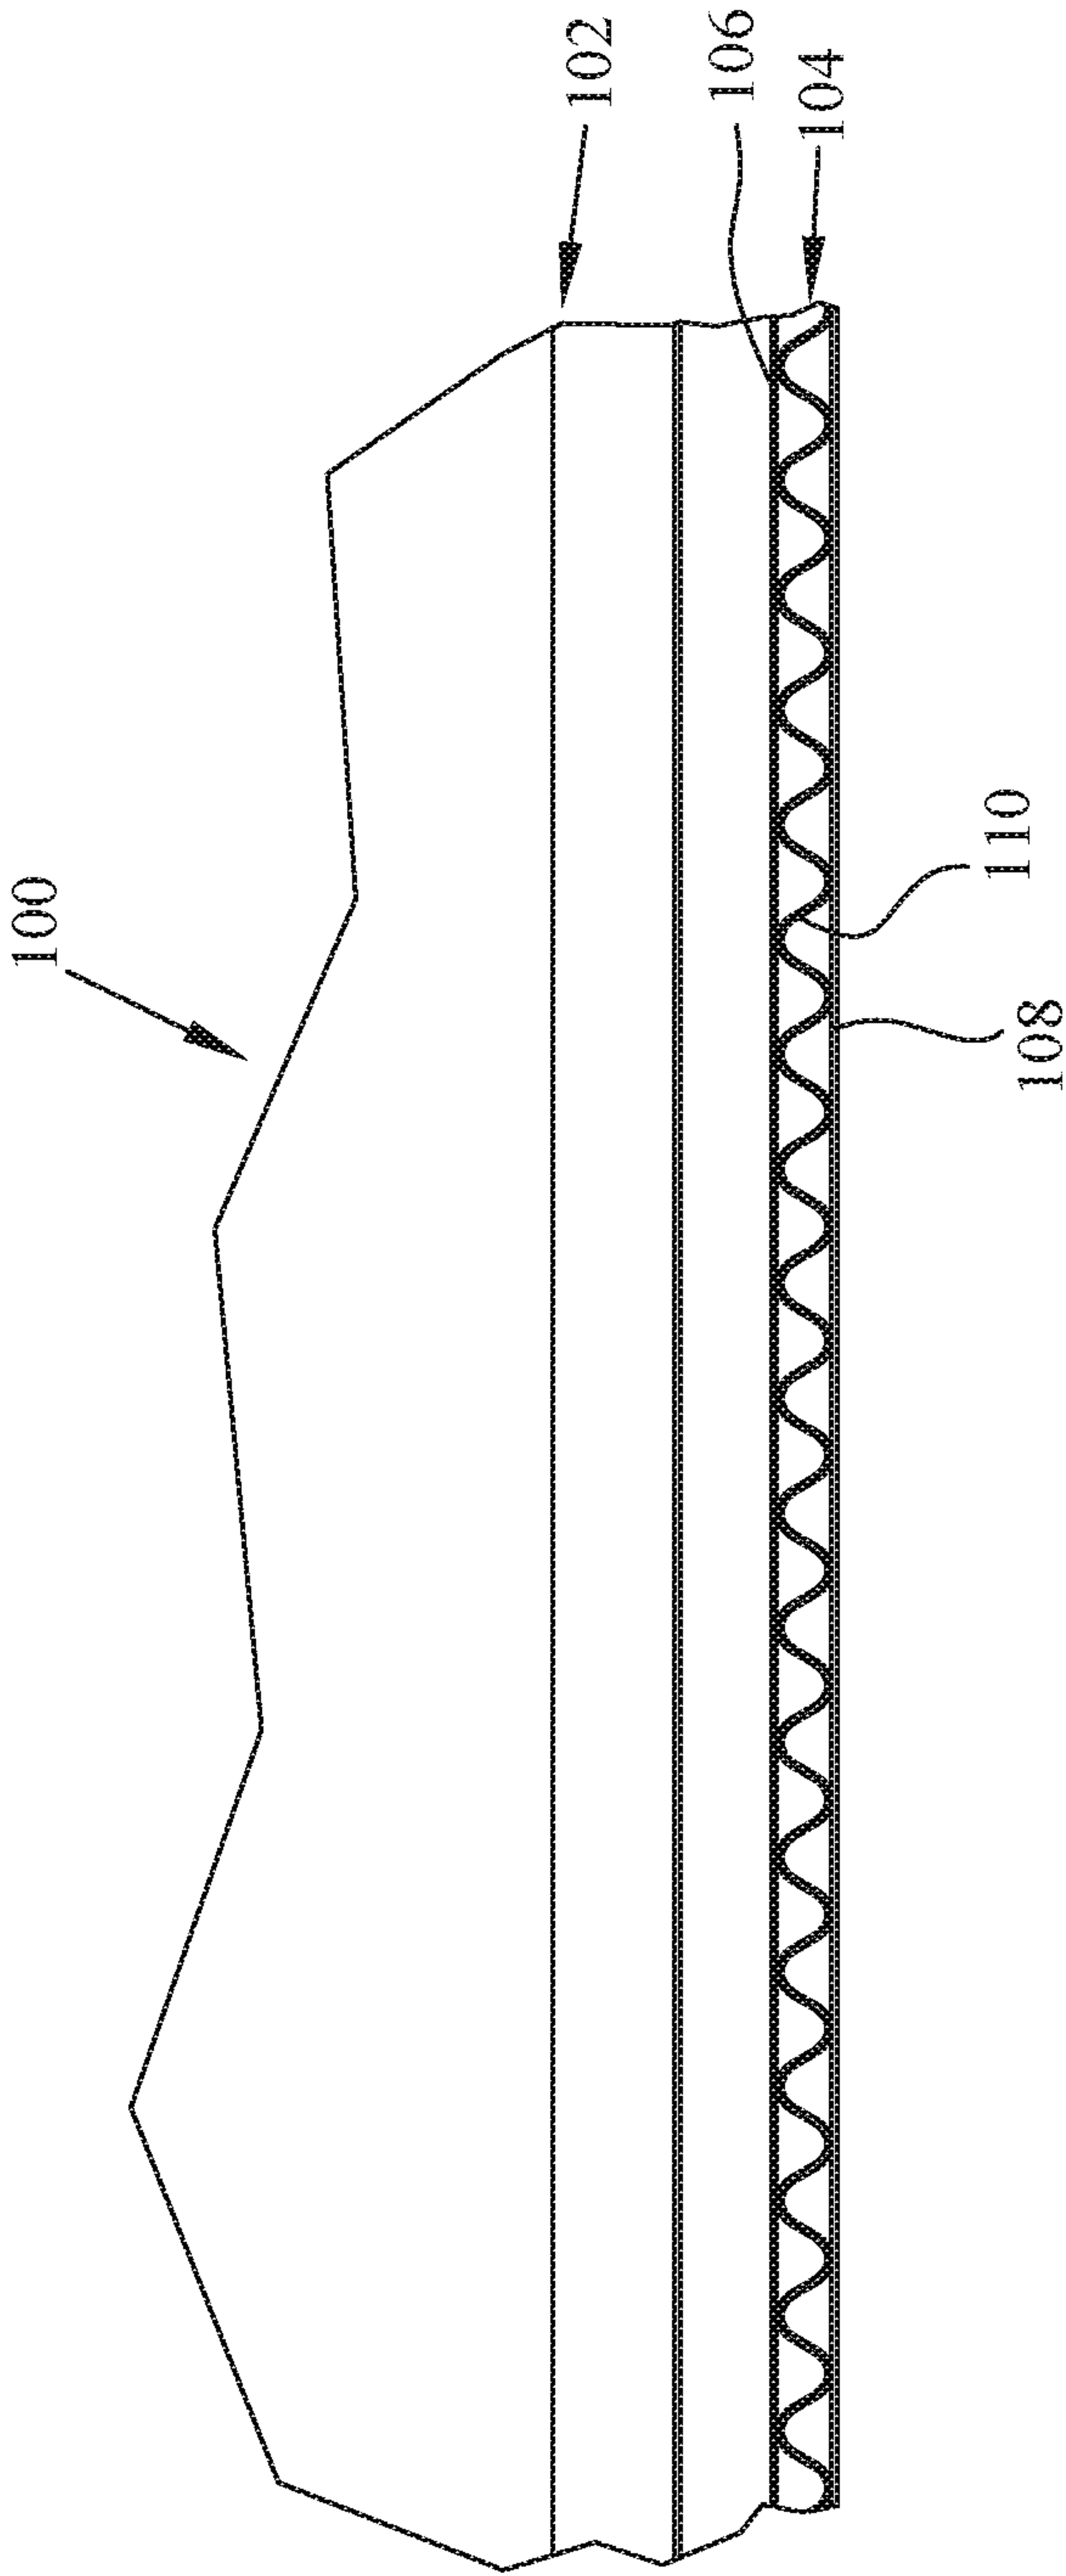
FIG. 3  
(PRIOR ART)

FIG. 3 is a side view of a prior art recreational vehicle frame liner;

Referring now to FIGS. 3 and 4, these depict prior art vehicle undercarriage frame liners in common use in the industry. A portion of a recreational vehicle is generally indicated as 100. Recreational vehicle 100 includes a frame assembly generally indicated as 102 and a corrugated liner generally indicated as 104. Corrugated liner 104 includes a top sheet 106, a bottom sheet 108, and a corrugated or sinusoidal ply 110 extending therebetween. Top sheets 106 and 108 are adhered or attached to corrugated ply 110. Typically, the corrugated material is polyethylene.

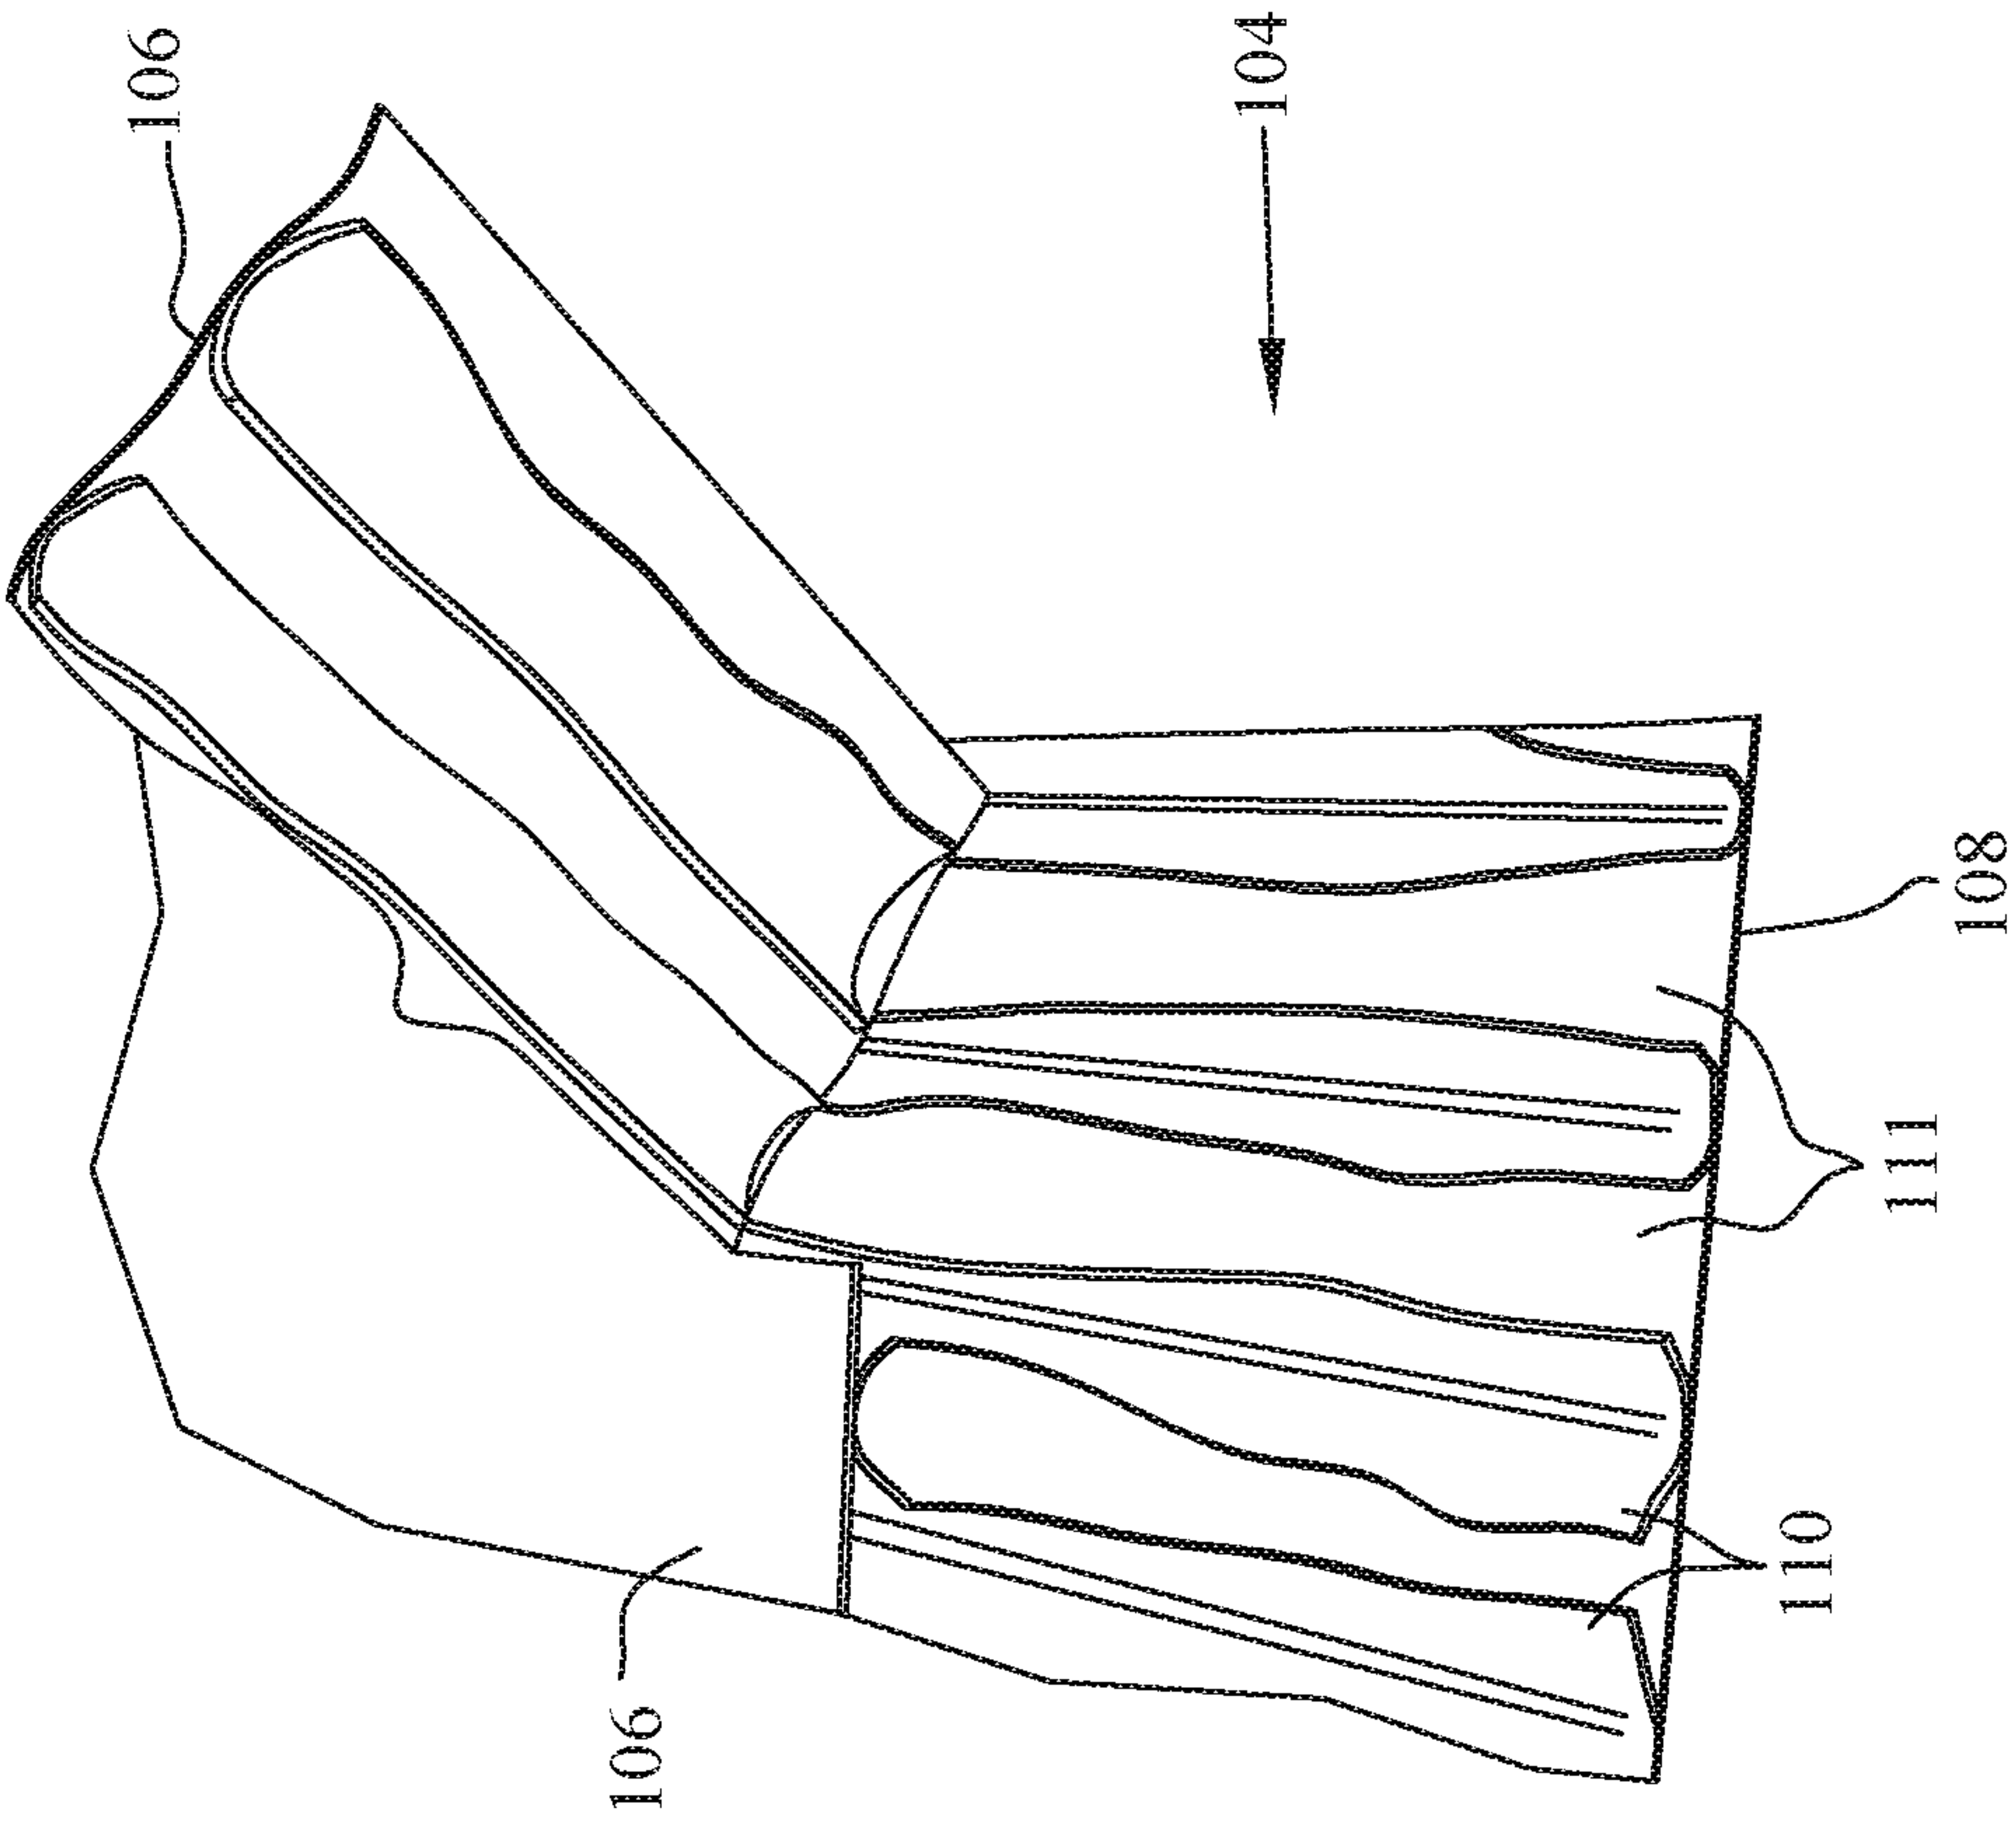
**FIG. 3A**  
**(PRIOR ART)**

FIG. 3A is an enlarged perspective view of the frame liner in FIG. 3 showing the top layer partially peeled back and channels therein.

Referring to FIG. 3A, a portion of the corrugated liner 104 is shown removed from recreational vehicle 100. In FIG. 3A, a portion of the top sheet 106 has been pulled back revealing channels 111 that extend between top sheet 106 and bottom sheet 108 and along/within the sinusoidal ply 110. As should be appreciated, a problem, with the prior art liner is that any water or moisture entering the open ends of the corrugated liner 104 easily crosses through channels 111 so that channels 111 can become filled with water. The water can leak or freezing of the water may cause ripping, tearing or pulling apart of corrugated liner 104, thereby destroying its structural integrity.

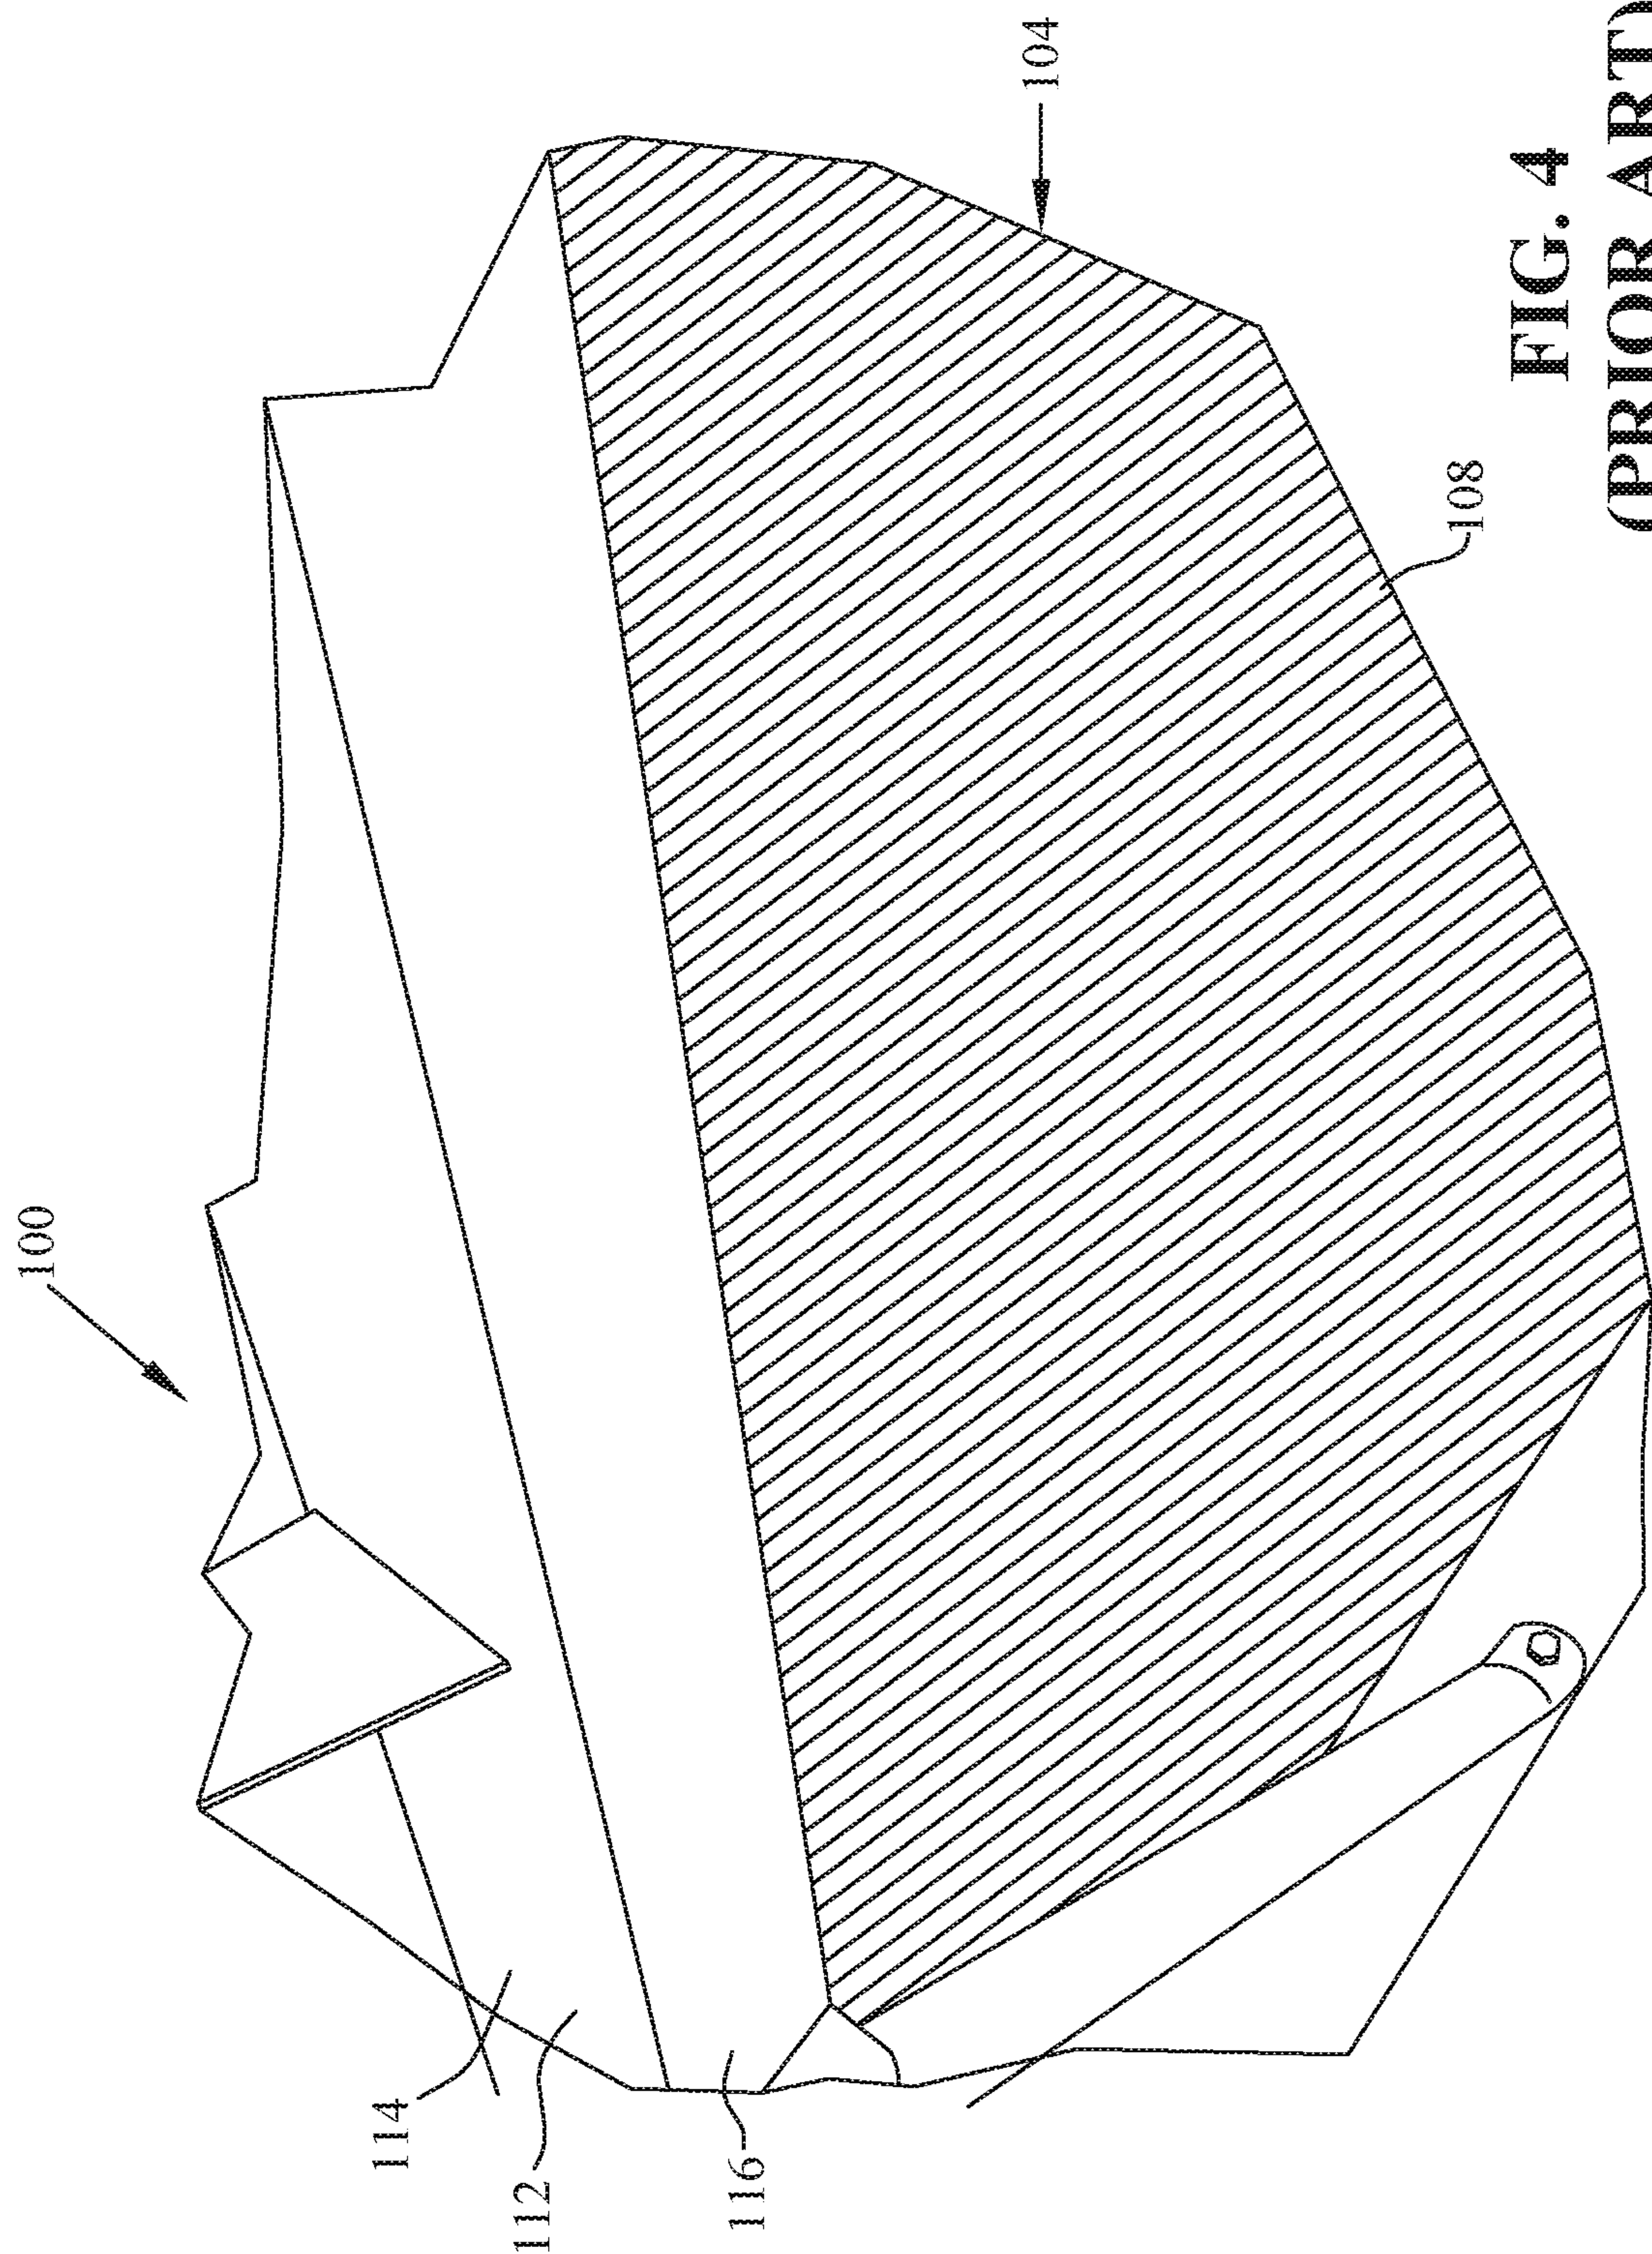
FIG. 4 is a bottom prospective view of a prior art recreational vehicle and frame liner;

Referring to FIG. 4, only the bottom sheet 108 of corrugated liner 104 is visible. Furthermore, the corrugations are not visible as recreational vehicle 100 includes a frame member 112, such as in I-beam or C-channel including a vertical web 112 and horizontal flange 116. Side edges of corrugated liner 104 are located on top of flange 112.

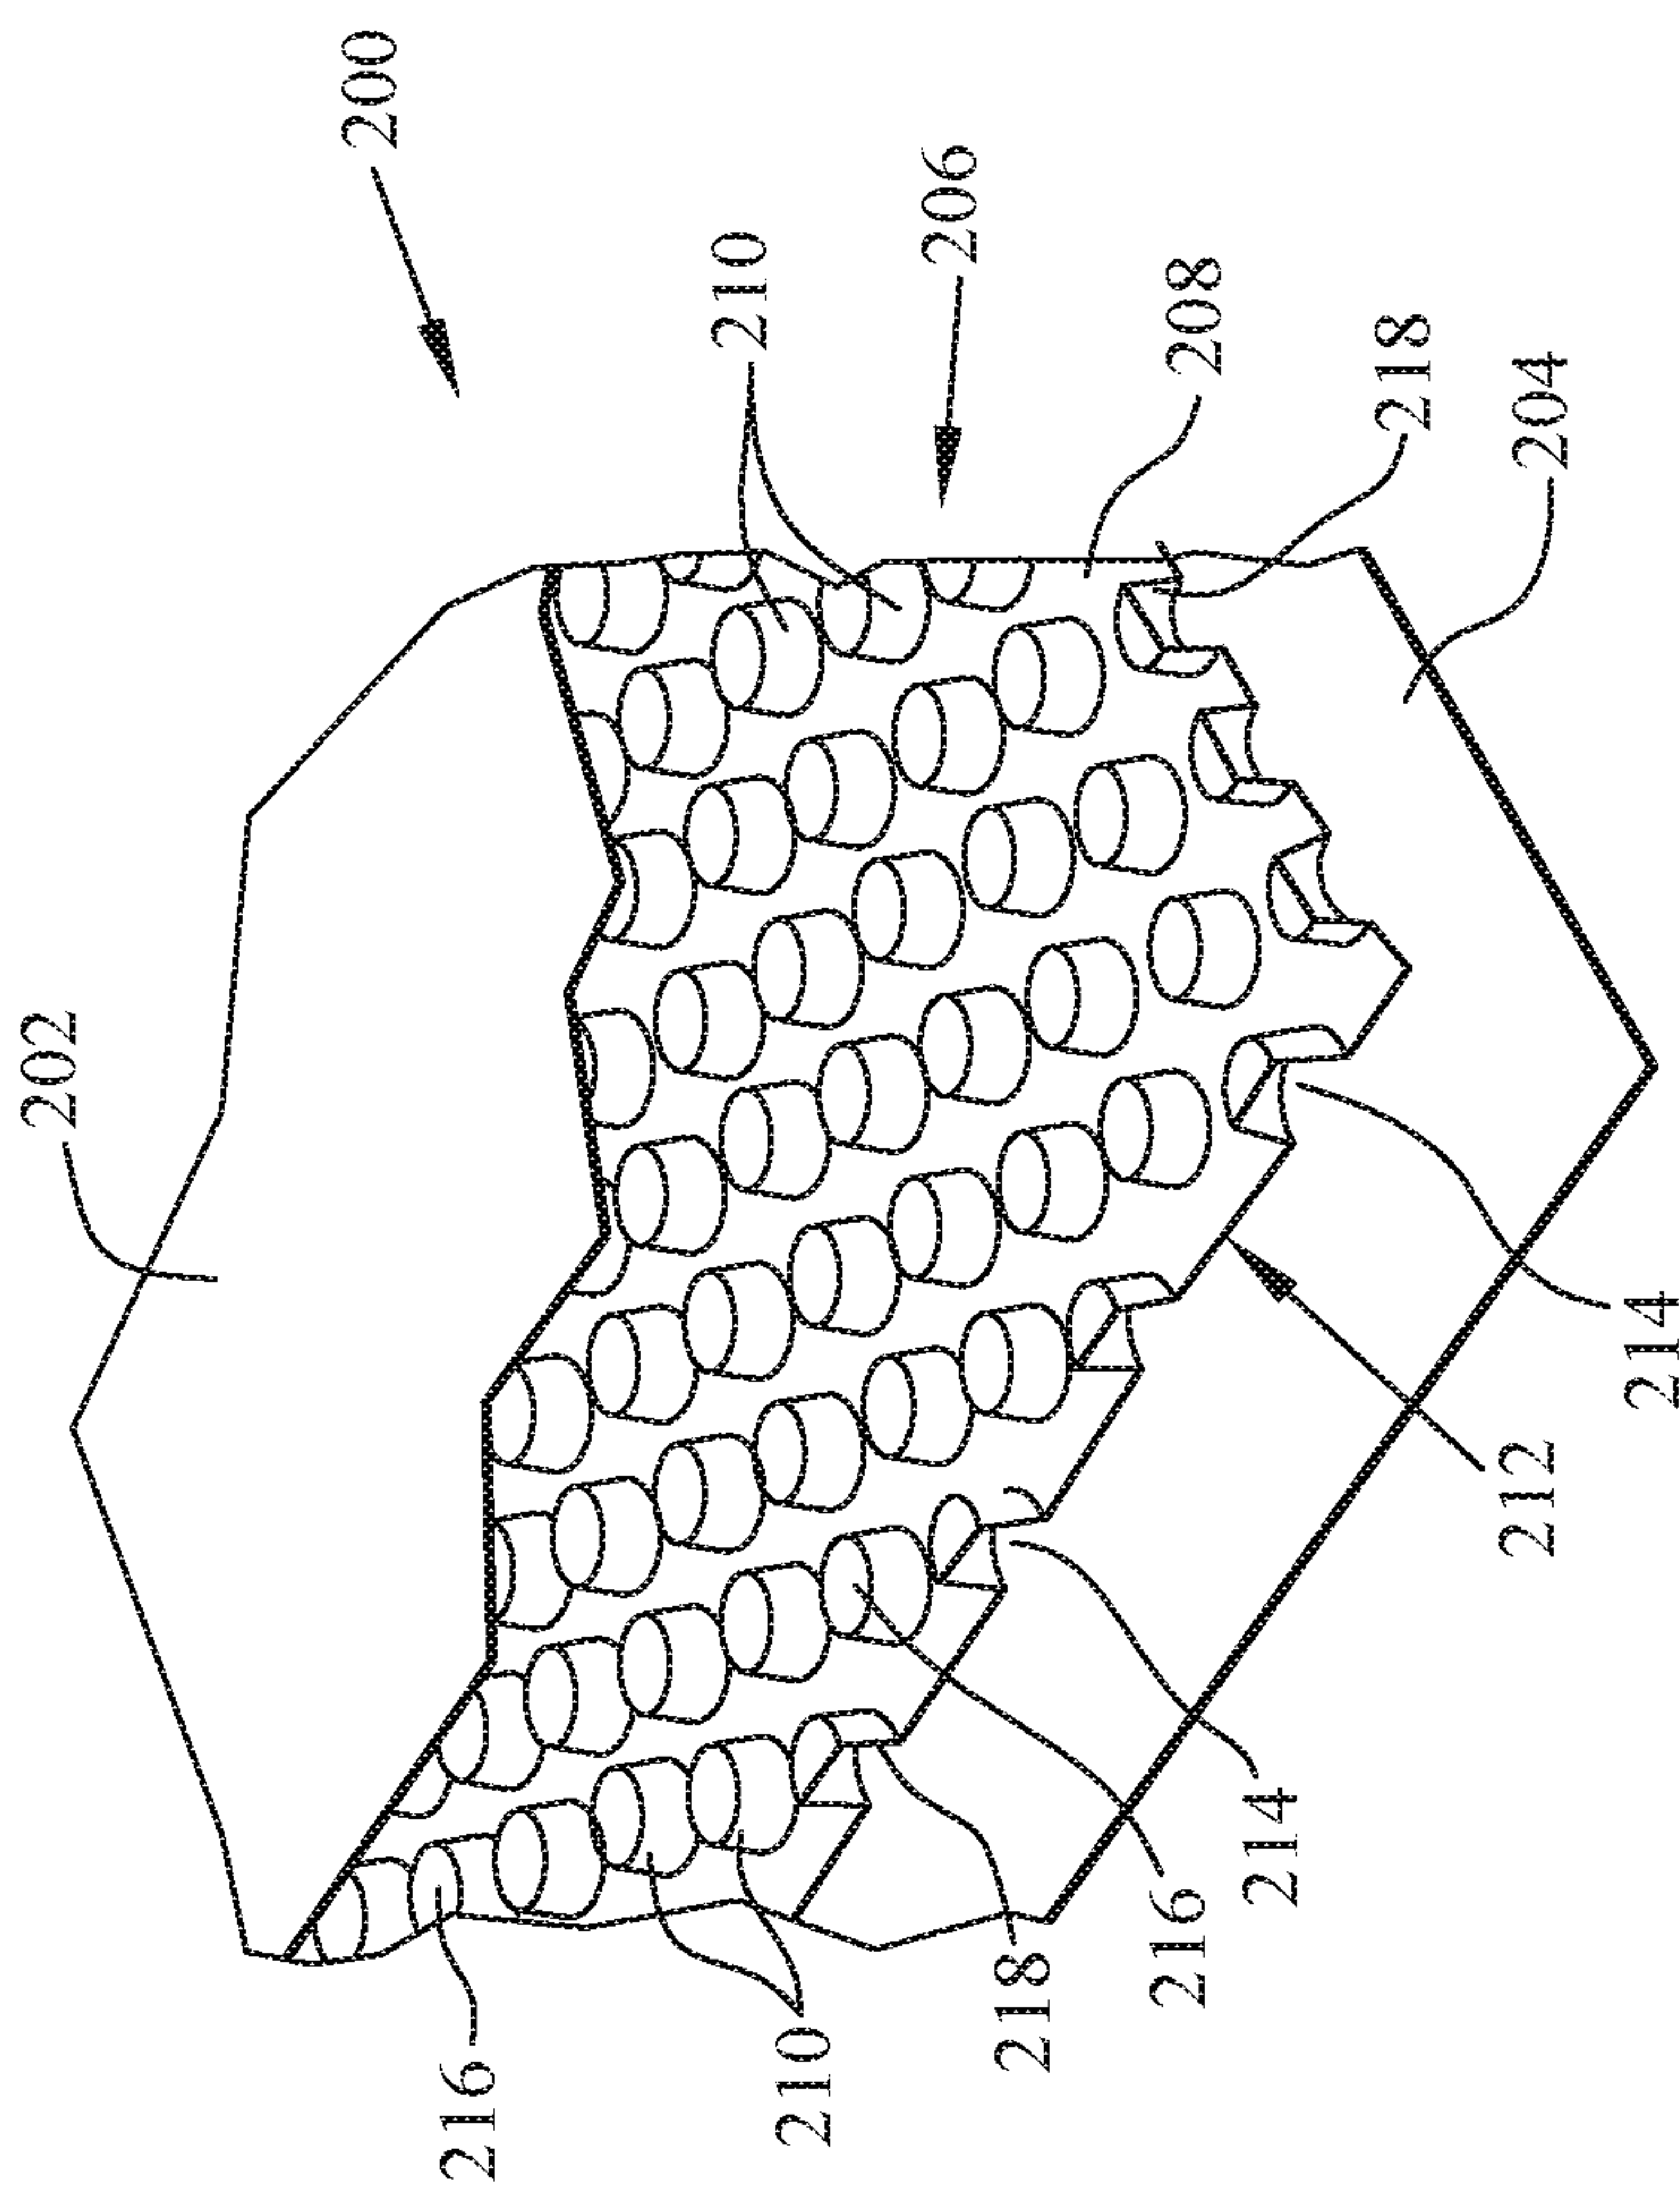
FIG. 5 is an exploded view of a sandwich material from which one embodiment of the liner for the subject invention is taken from;

Referring now to FIG. 5, an embodiment of a 3-ply panel from which the subject liner can be taken is generally indicated as 200. 3-ply panel 200 includes a top sheet 202, a bottom sheet 204, and a core generally indicated as 206. In a preferred embodiment, 3-ply panel 200 and core 206 is manufactured from polypropylene and is 100% recyclable. Core 206 may also be referred to as plastic honeycomb or plastic bubble board. 3-ply panel 200 may be provided in thicknesses of 10 mm, 5 mm or 3 mm. Applicant has found that the core 206 in a 3 mm thick 3-ply panel 200 is particularly suitable for use as a liner in accordance with the subject invention as will be discussed in further detail below. As can be seen in FIG. 5, core 206 has one face 208 having projections 210 extending upward therefrom. The opposite face 212 includes openings 214 extending downward into projections 212. Accordingly, projections 210 have a generally cylindrical configuration being hollow in the center thereof and including an end face 216 and side walls 218. Applicant has determined that one suitable 3-ply panel 200 from which core 206 may be extracted and used is IntePro® 3 mm Titan board from the IntePlast Group.

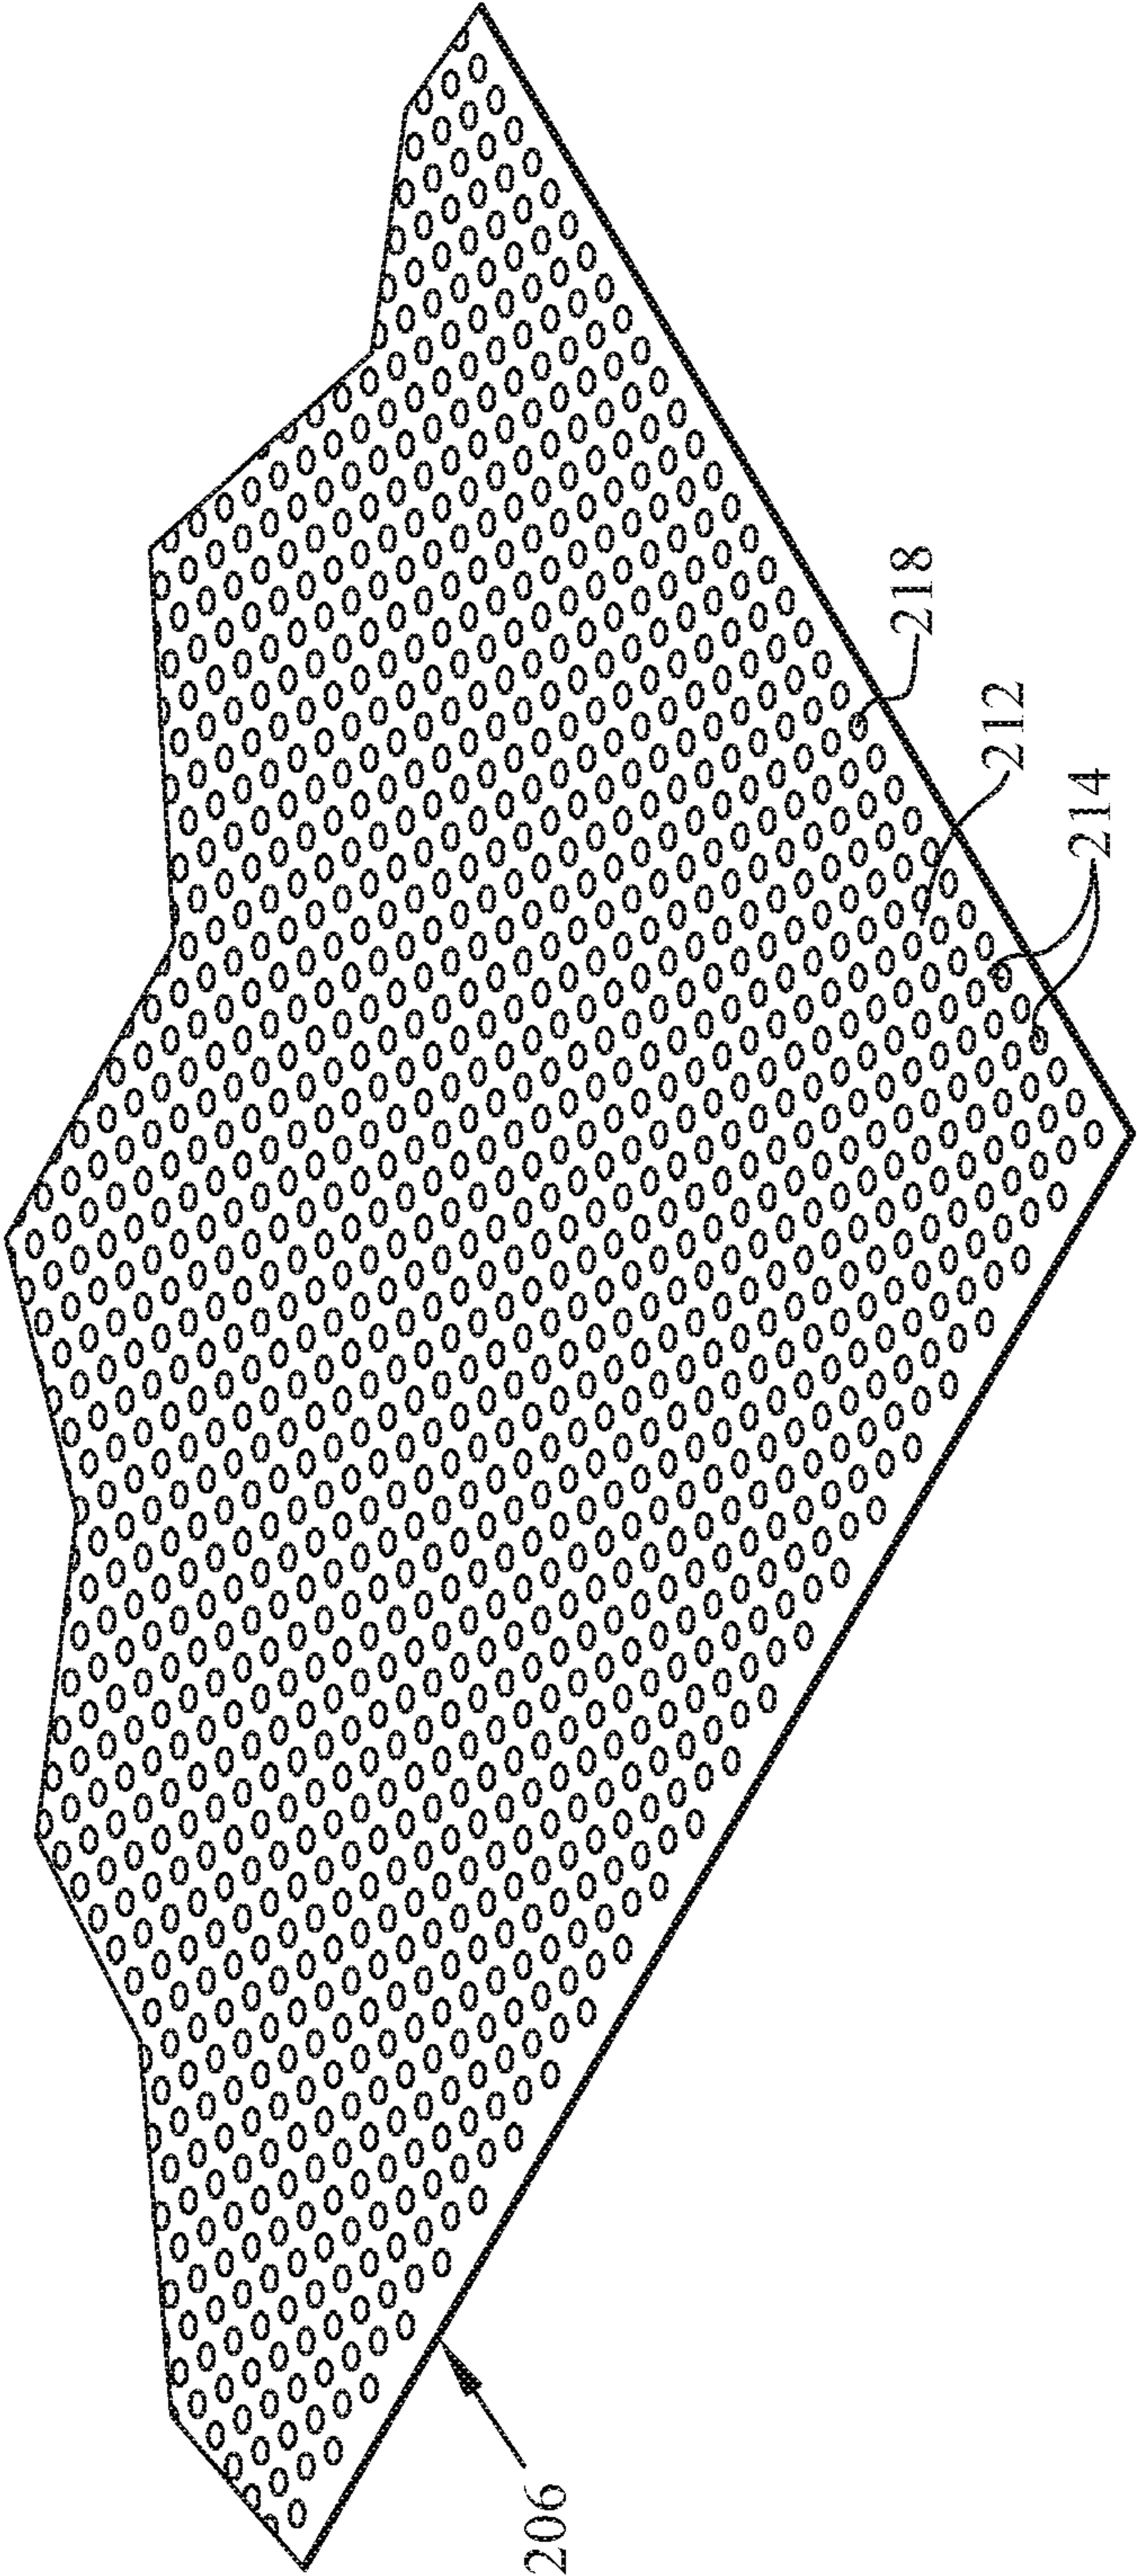
FIG. 6 is a perspective view of one embodiment of a vehicle frame liner and cargo bay liner of the subject invention, with top and bottom sheets removed, showing a face of the liner having openings therein;

Referring now to FIGS. 6-11, further details, of vehicle frame and cargo area liner/core 206 are disclosed. As can be seen, the projections and/or openings 210, 214, respectively are aligned in a lengthwise direction of core 206 but going crosswise across core 206, projections 210 and openings 214 are staggered.

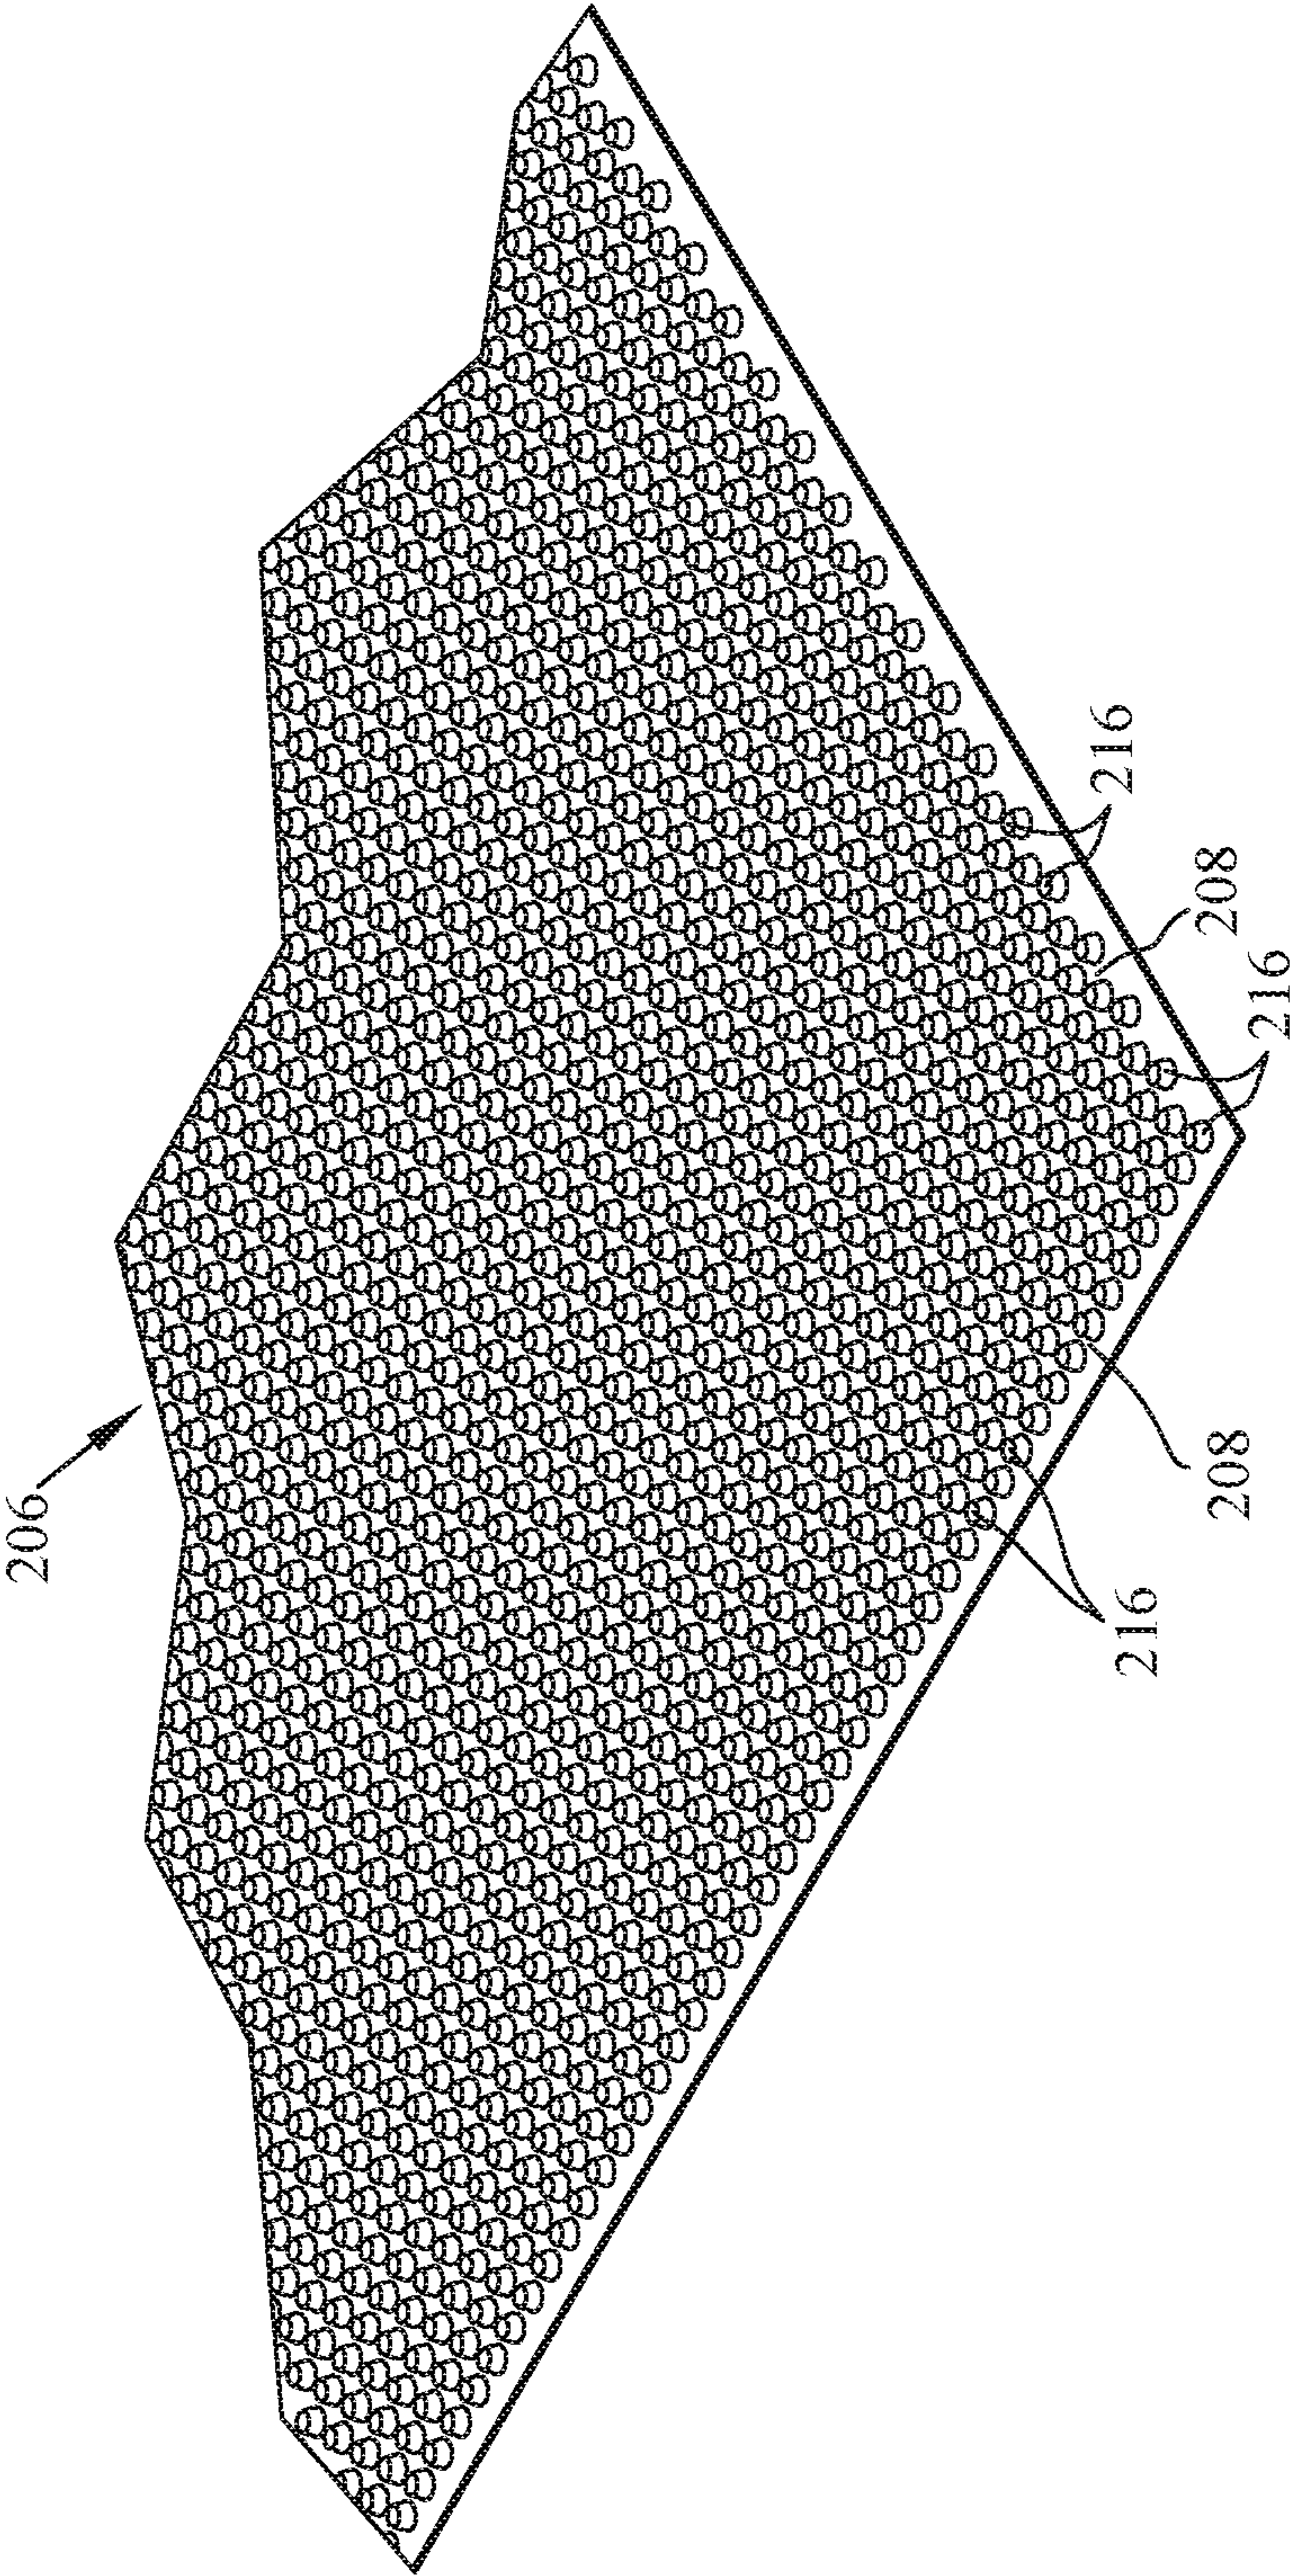
FIG. 7 is the vehicle frame and cargo bay liner of FIG. 6 showing an opposite face of the liner having projections extending therefrom;

Referring to FIG. 7, it can be appreciated that end faces 216 may have a variety of configurations including domed, flat, and/or convex.
