US011447189B1

(54) **VEHICLE FRAME AND CARGO BAY LINER**

(57) **ABSTRACT**

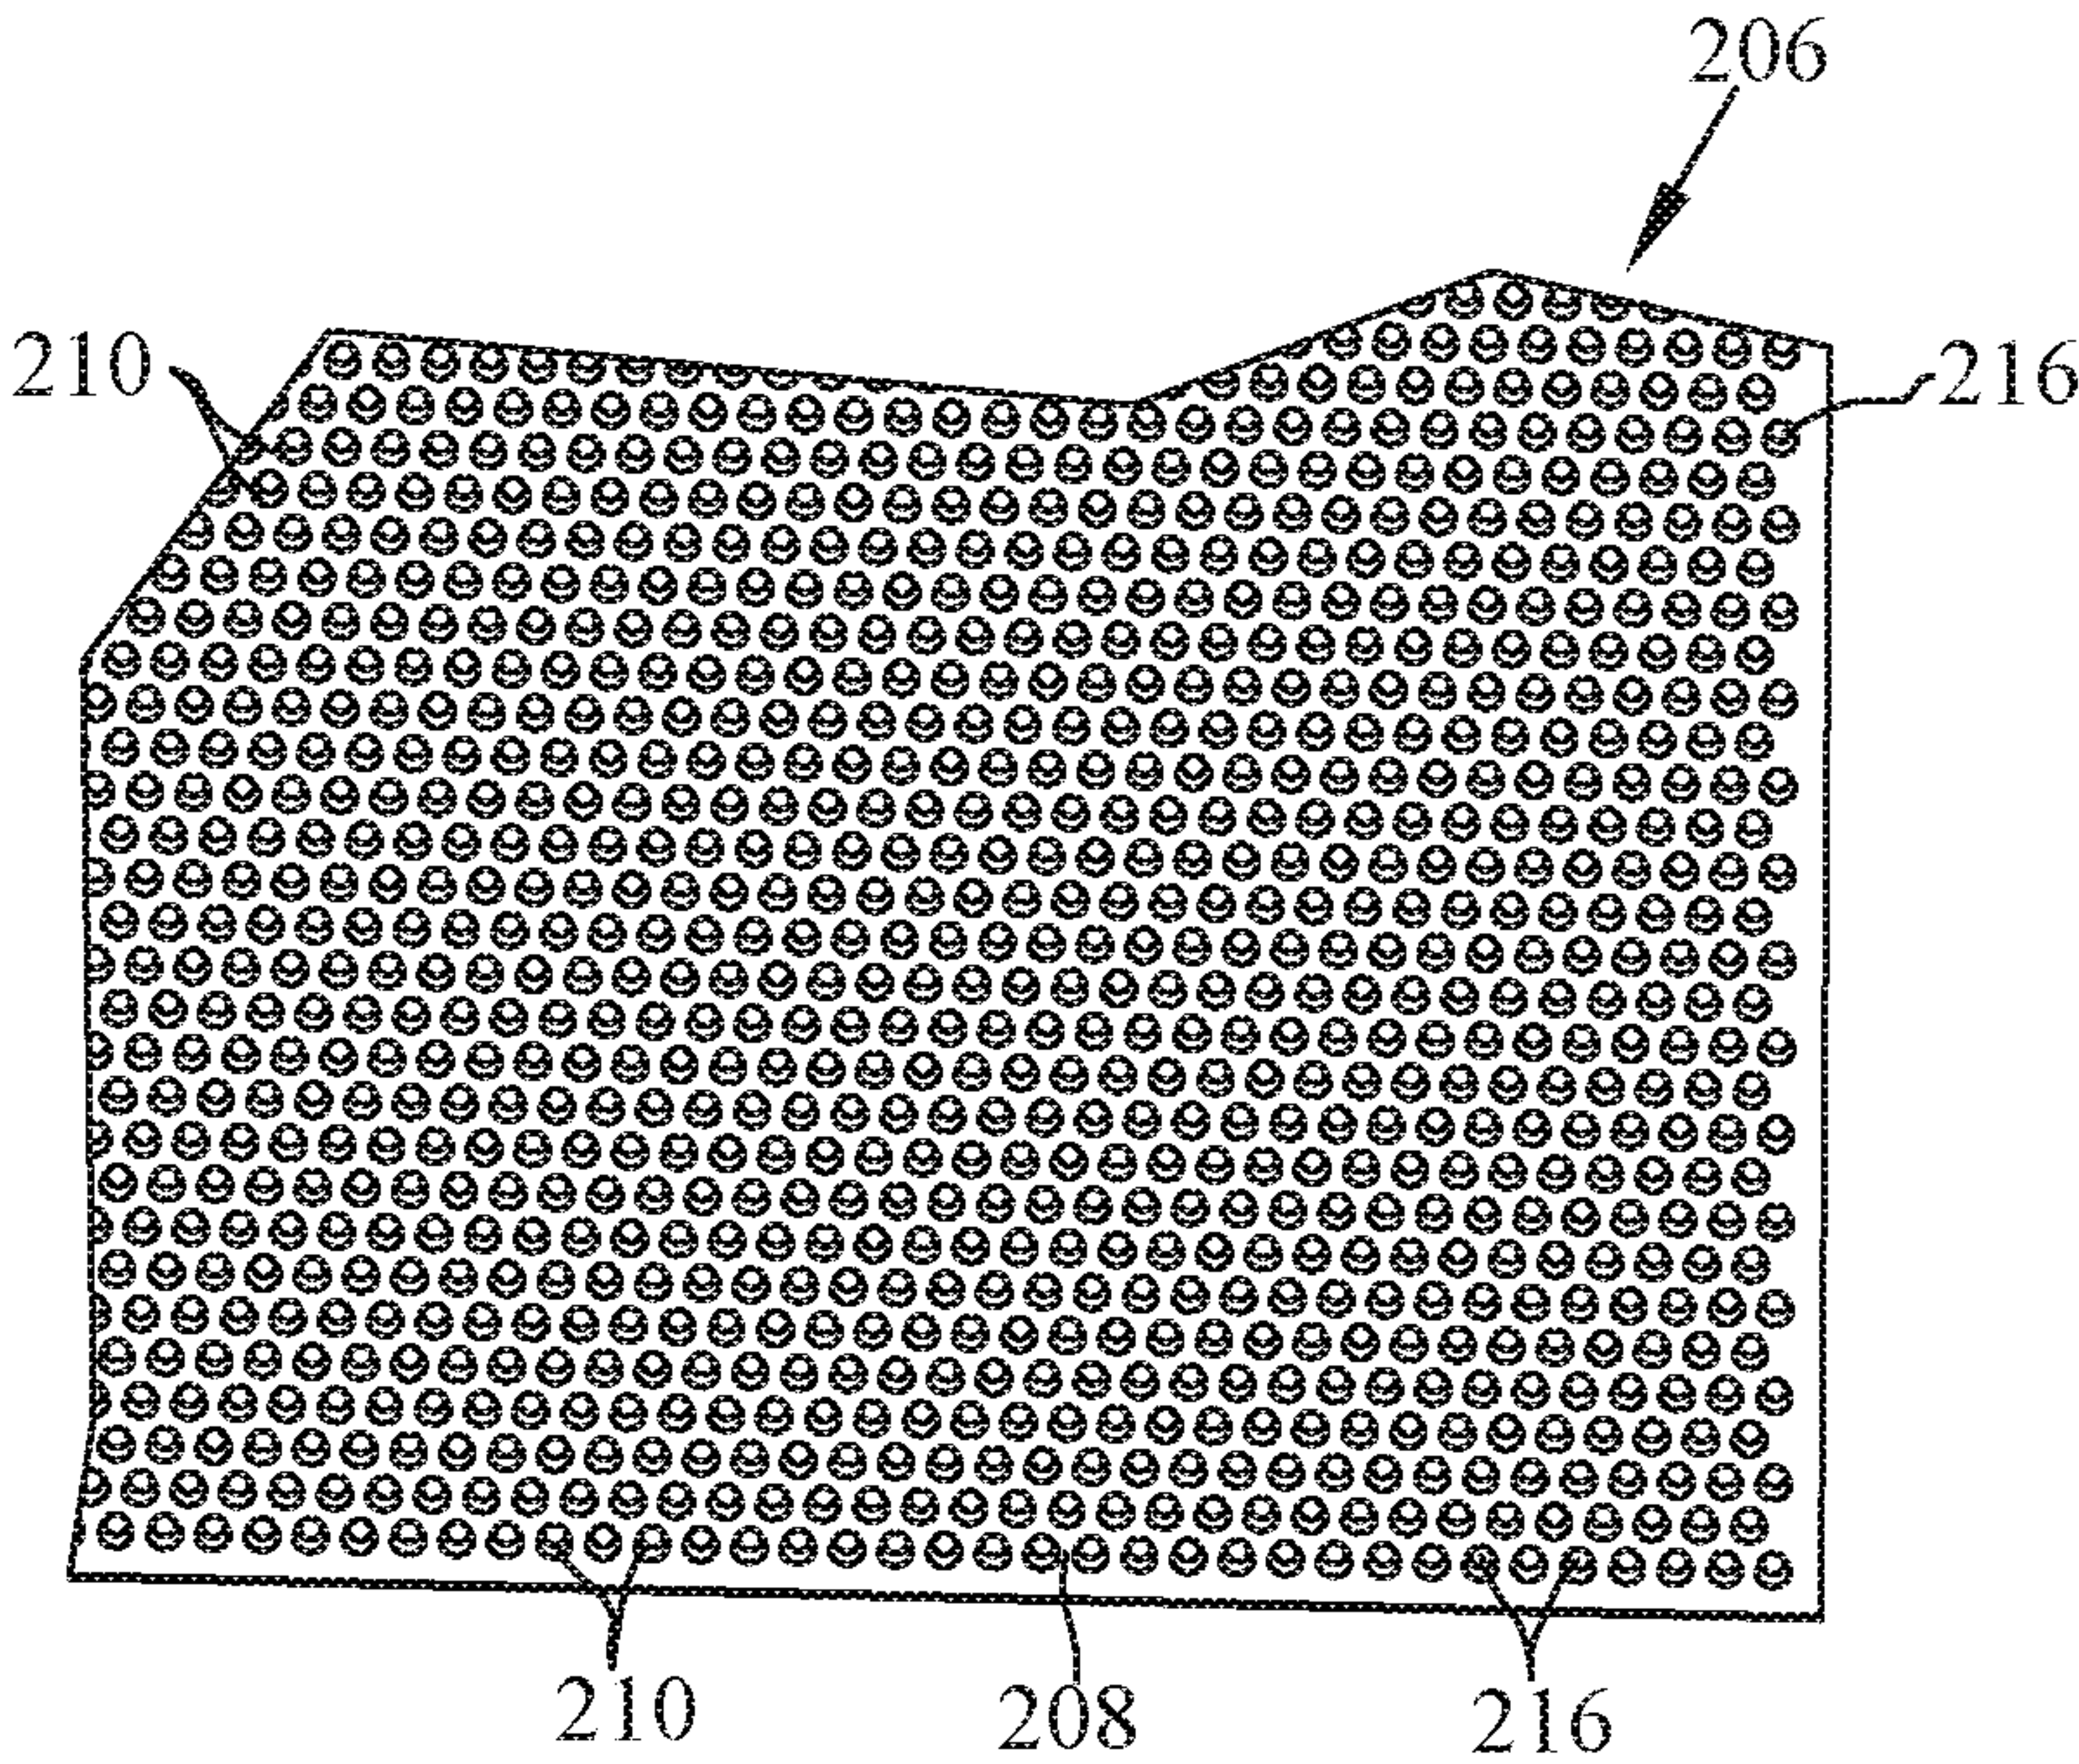
FIG. 9 is a plan view of the liner of FIG. 6 showing the face having projections extending therefrom;

Referring now to FIGS. 6-11, further details, of vehicle frame and cargo area liner/core 206 are disclosed. As can be seen, the projections and/or openings 210, 214, respectively are aligned in a lengthwise direction of core 206 but going crosswise across core 206, projections 210 and openings 214 are staggered.

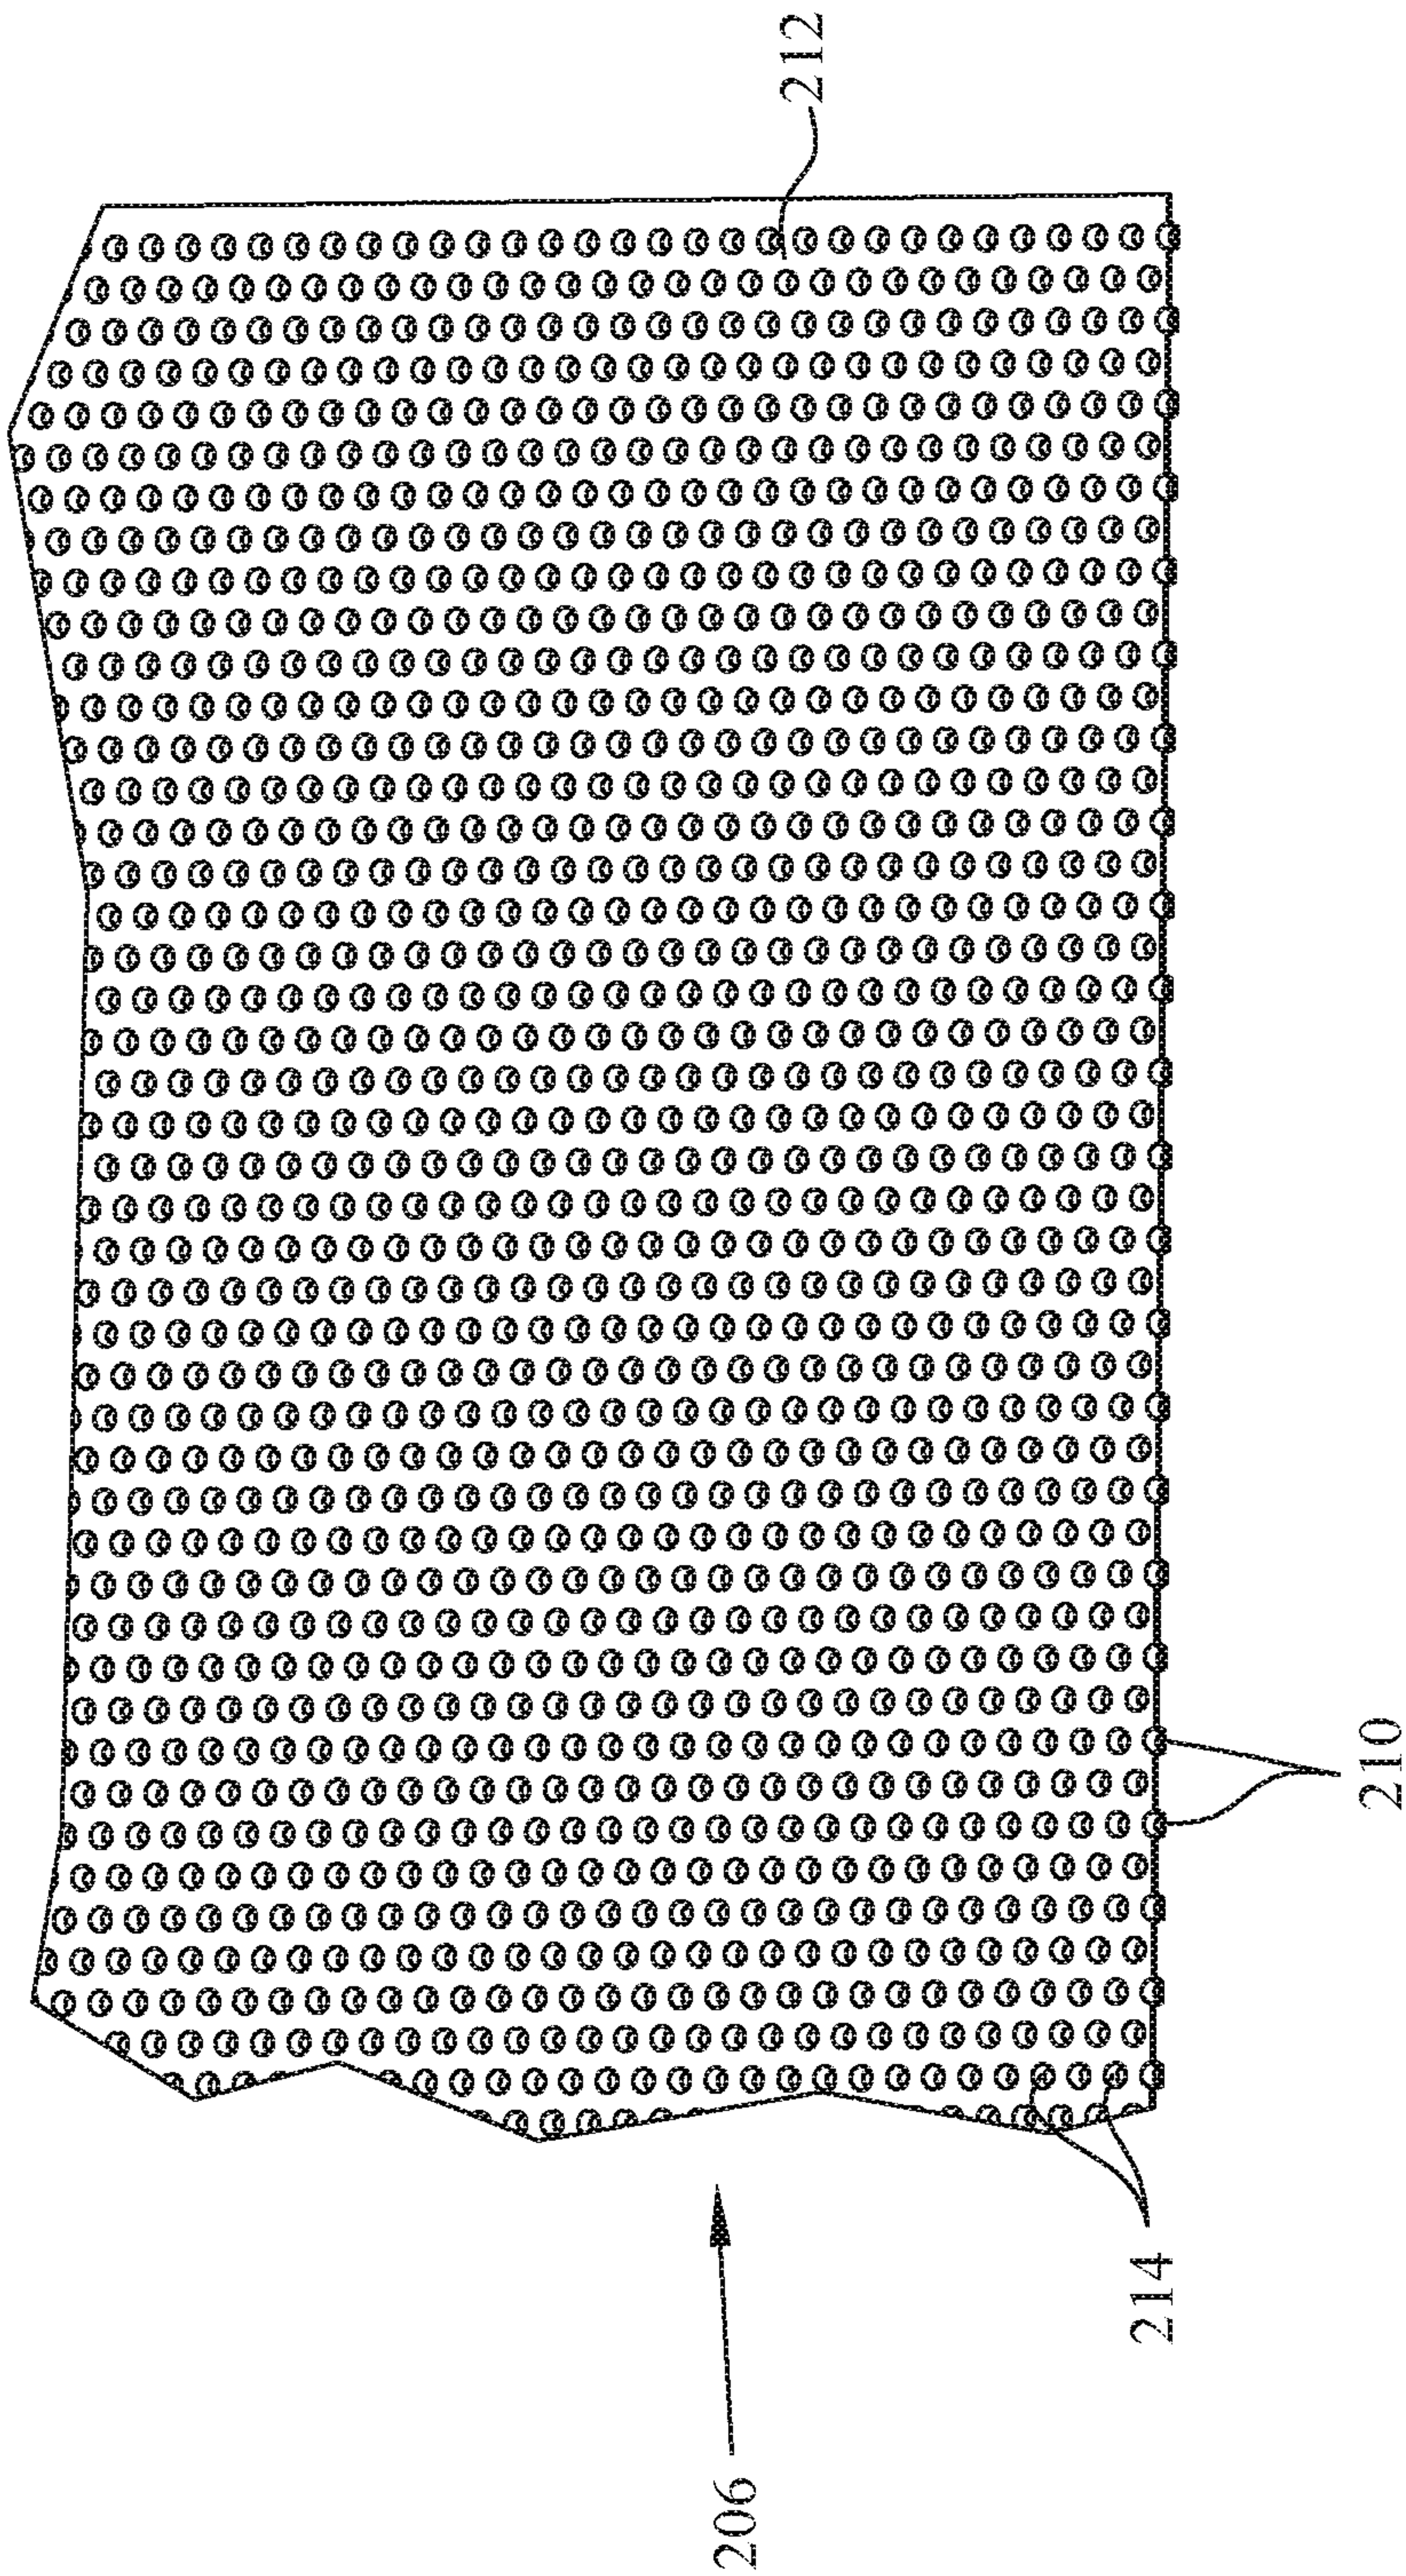
FIG. 10 is another perspective view of the vehicle and cargo bay liner of FIG. 6 with the face having openings facing upward;

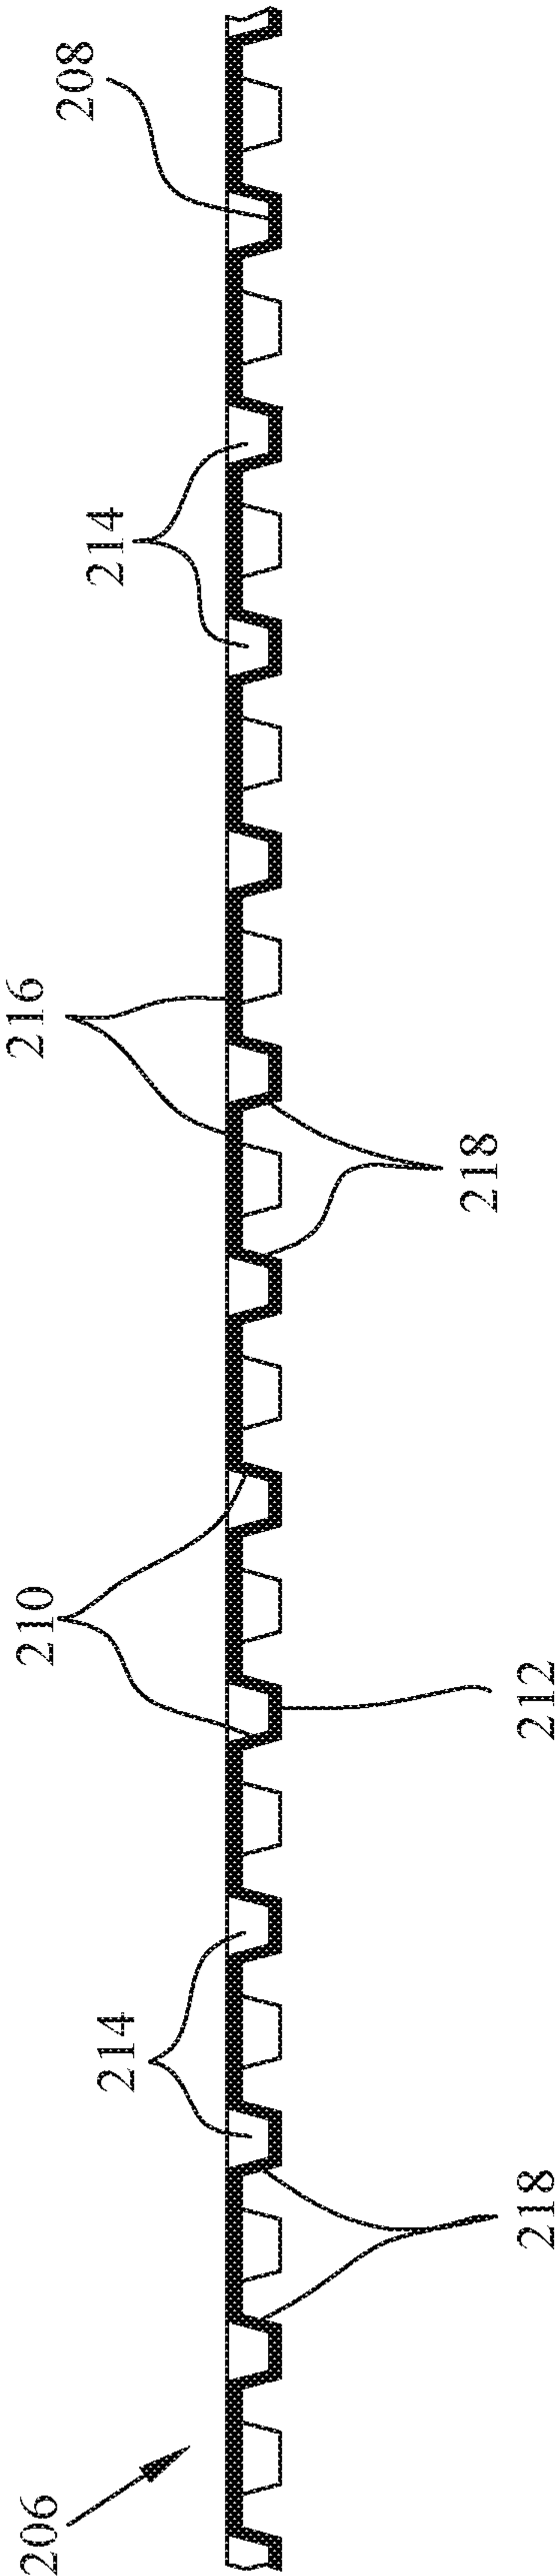
FIG. 11 is a side view of the vehicle and cargo bay liner of FIG. 6 with the projections extending upward;

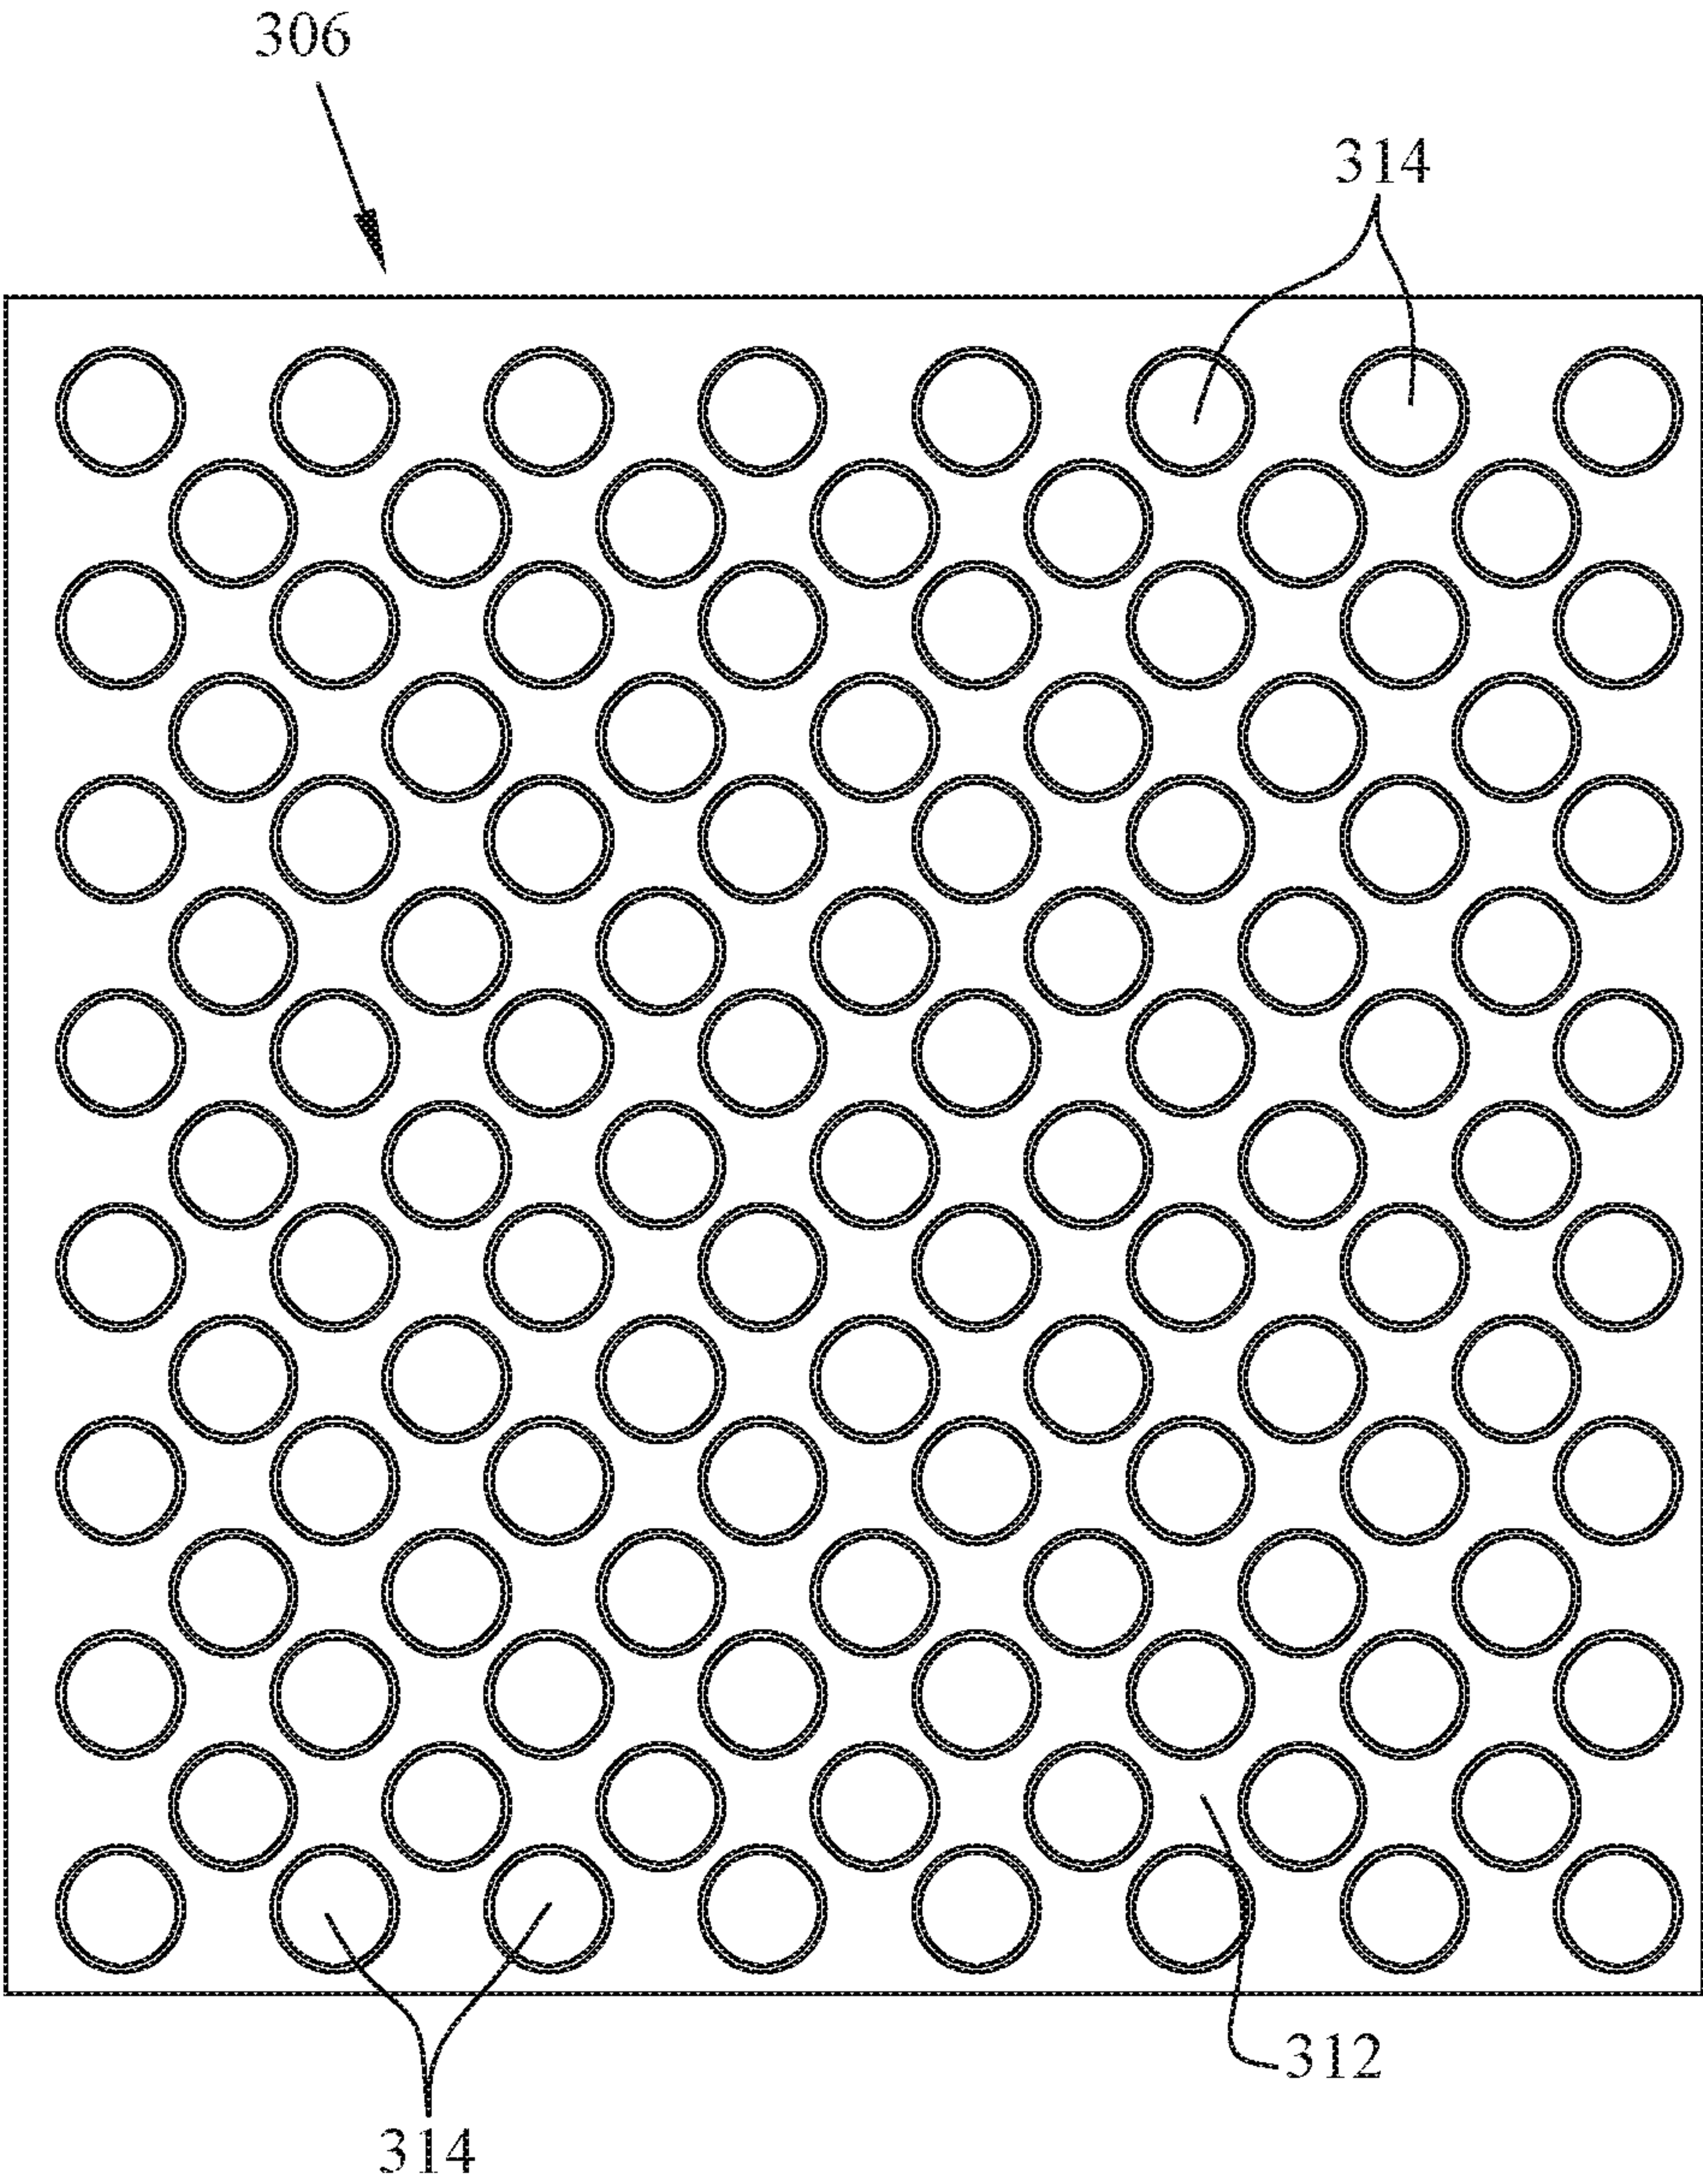
FIG. 12 is a plan view of an alternate embodiment vehicle frame and cargo bay liner showing a face having openings therein;

Now referring to FIGS. 12 and 13, an alternate vehicle frame and cargo area liner is shown generally indicated as 306. As can be seen in FIG. 13, liner 306 includes a face 308 having projections 210 thereon. As shown in FIG. 12, liner 306 has an opposite face 312 having openings 314 therein. Projections 310 include end faces 316 and sidewalls 318 as best seen in FIG. 13. Line 306 can be manufactured from single or multi-layer materials sandwiched together (twin or triple layer).

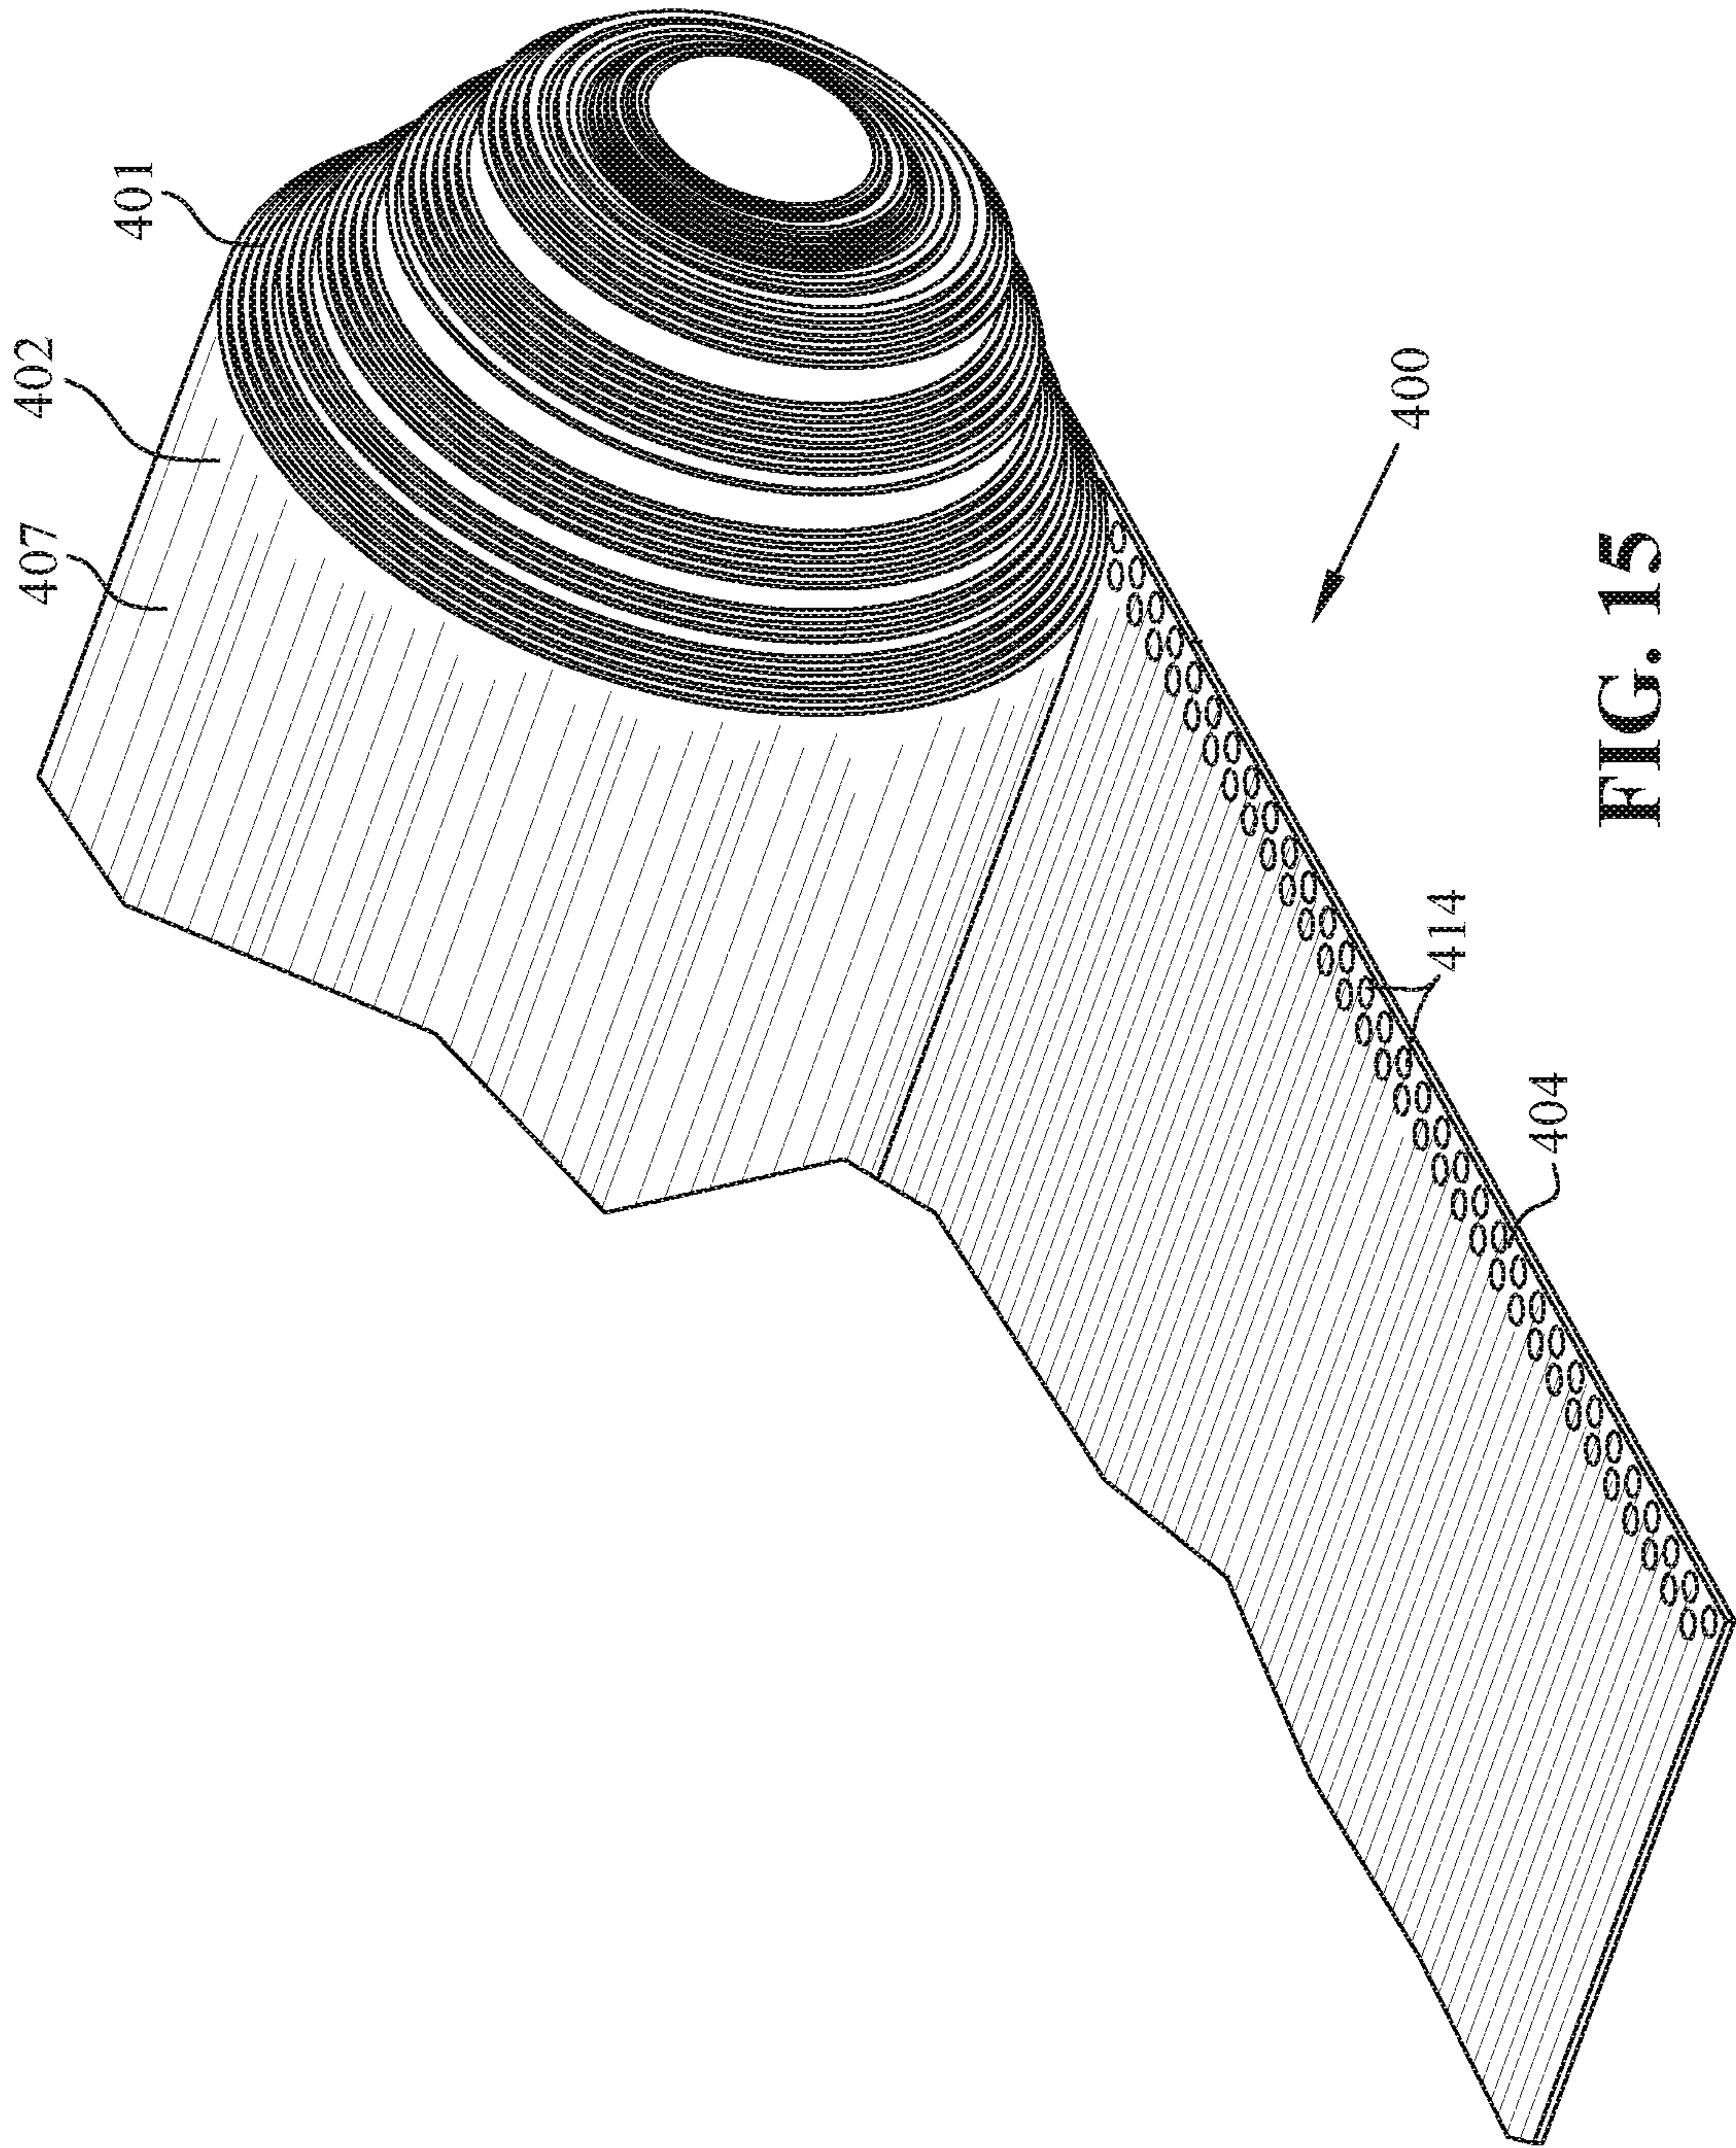
FIG. 15 is a perspective view of the vehicle frame and cargo bay liner of FIG. 14 partially rolled out showing the aluminum foil on a top side thereof;

shown in FIGS. 14 and 15, making it extremely suitable for use as a liner for vehicle frames and cargo bays. The desired length of liner can be rolled out and cut to size for assembly to the vehicle. Vehicle frame and cargo bay liner 400 is of a 3-ply configuration and includes a top ply, sheet, or layer 402 and a bottom ply, sheet, or layer 404. A core 406 (see FIGS. 19 and 22-24) separates top sheet 402 from bottom sheet 404. Additionally, vehicle frame and cargo bay liner 400 also includes a sheet of aluminum foil or metalized film 407 on one side thereof. In the embodiment shown, aluminum foil/metalized film 407 is provided on top sheet 402;

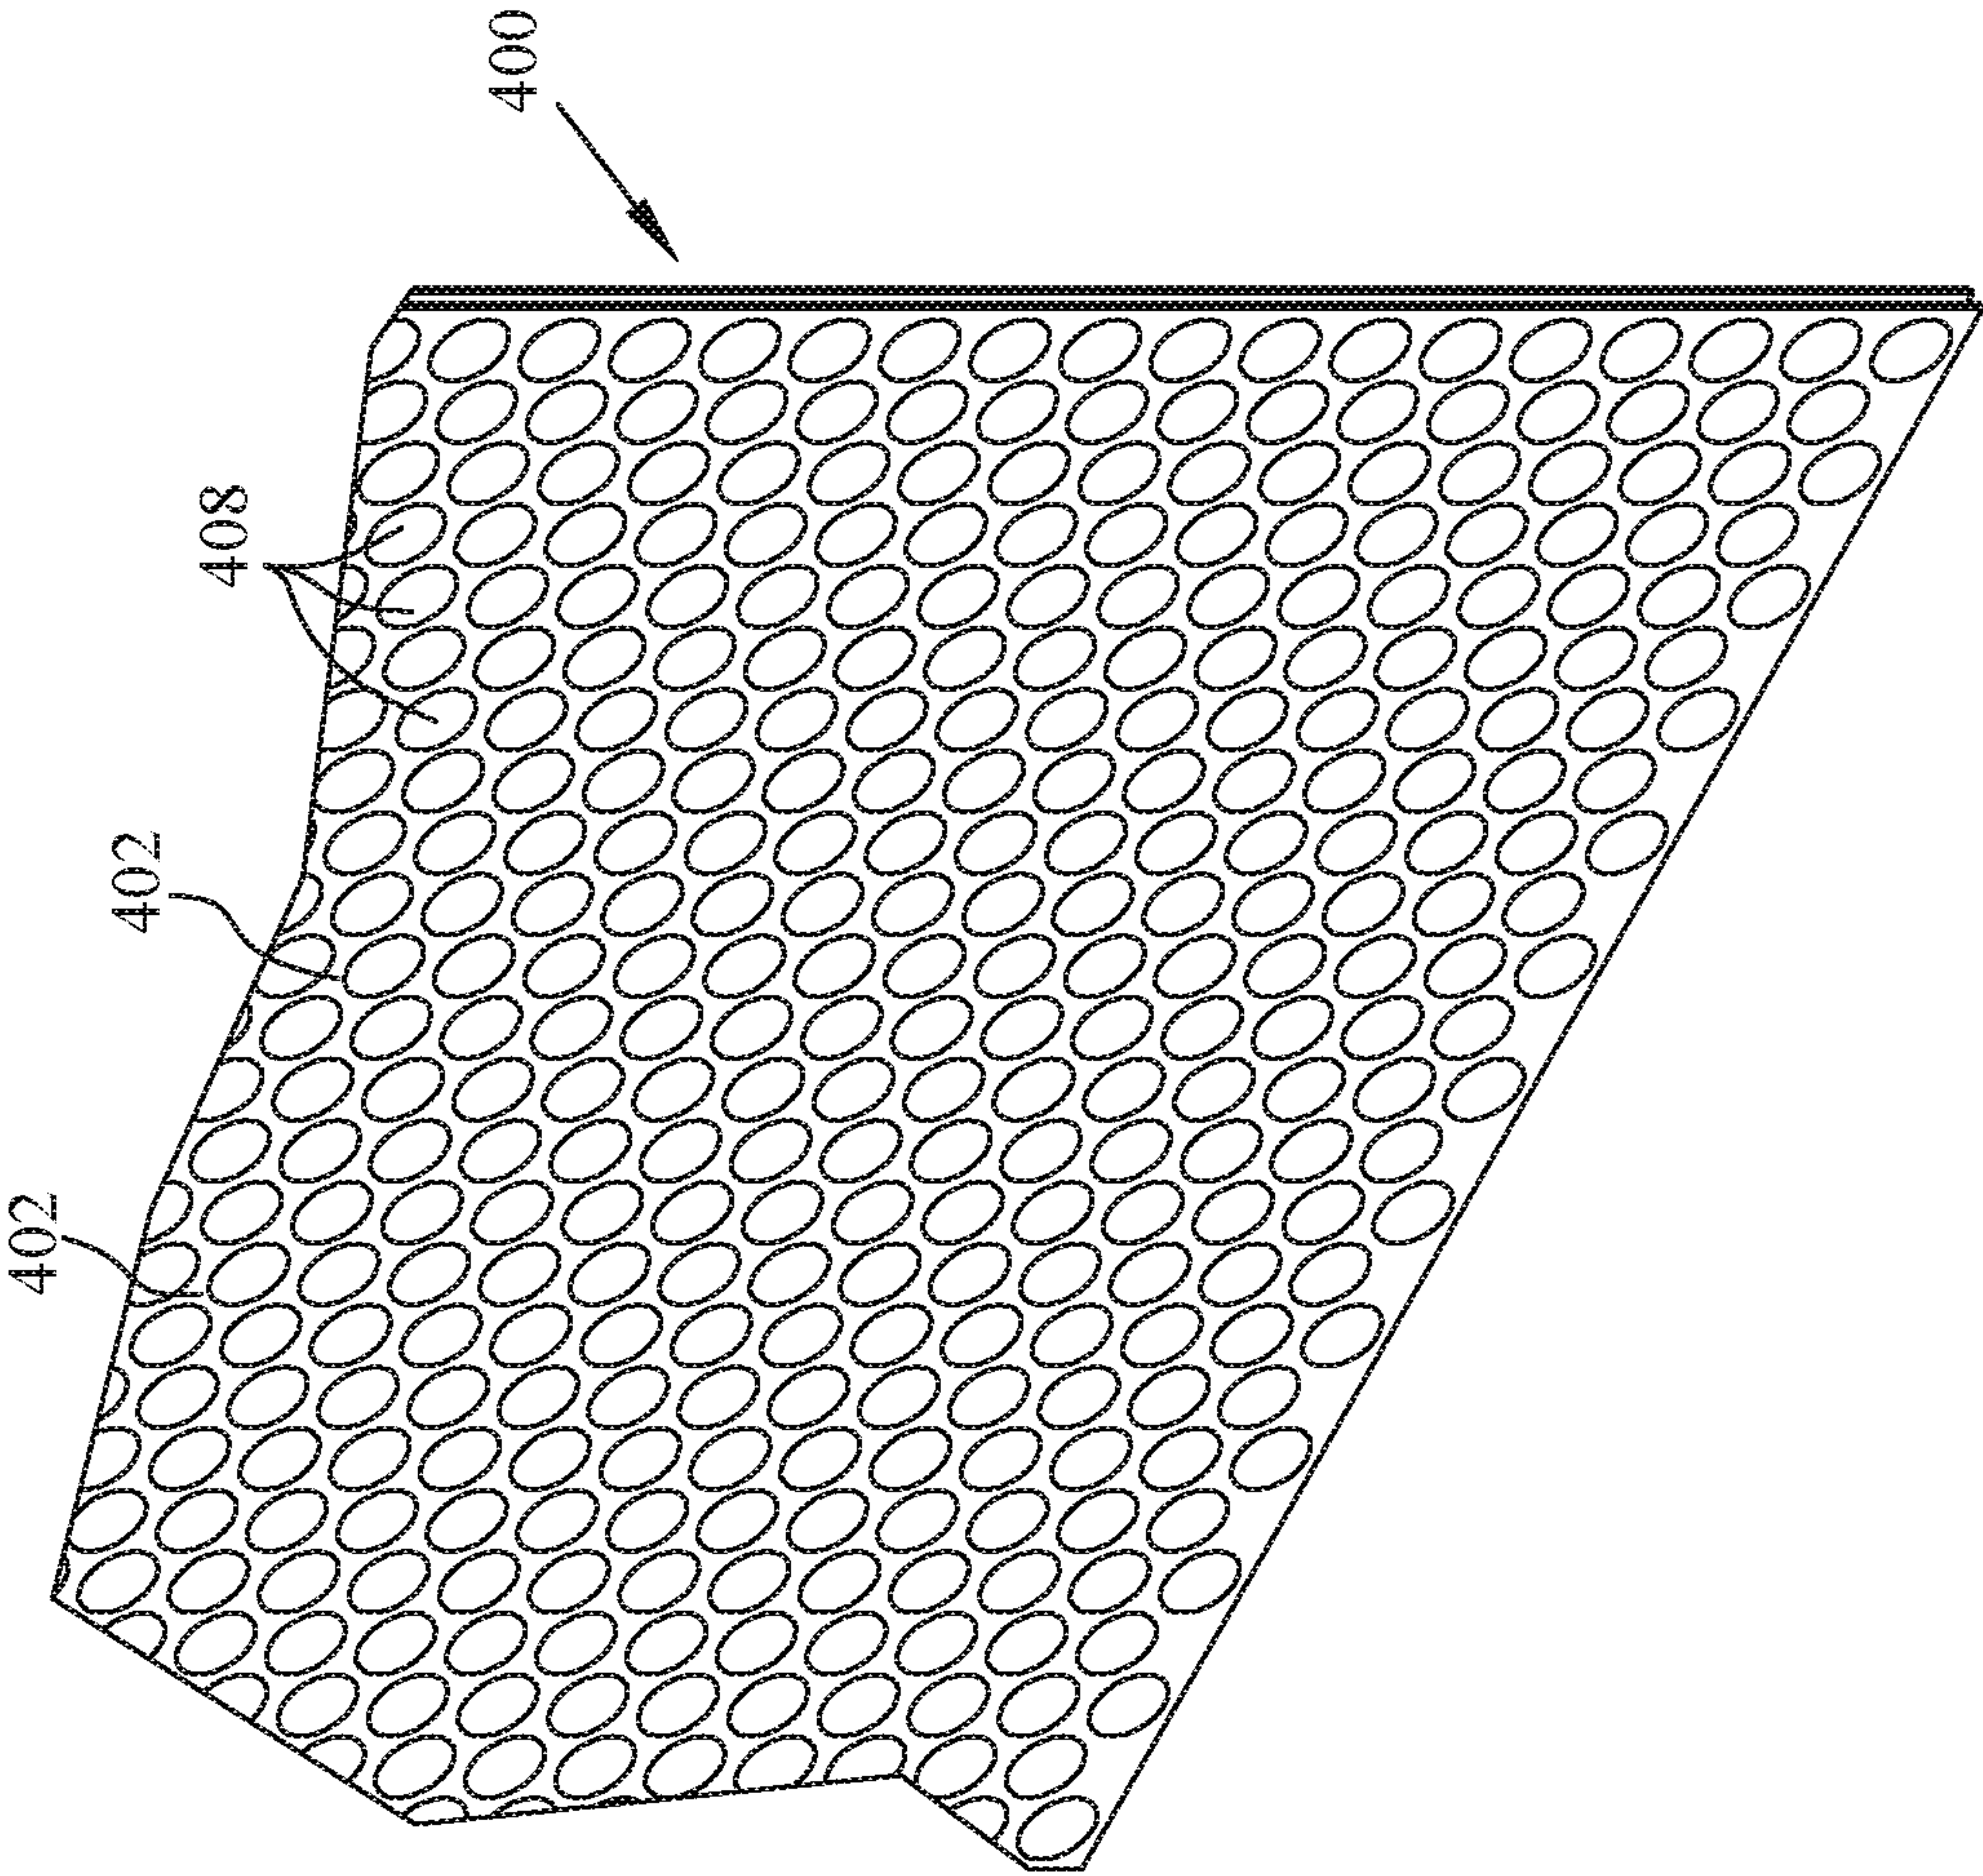
FIG. 16 is a plan view of the vehicle frame and cargo bay liner of FIG. 14 showing the top side with aluminum foil thereon;
