US011447189B1

(54) **VEHICLE FRAME AND CARGO BAY LINER**

(57) **ABSTRACT**

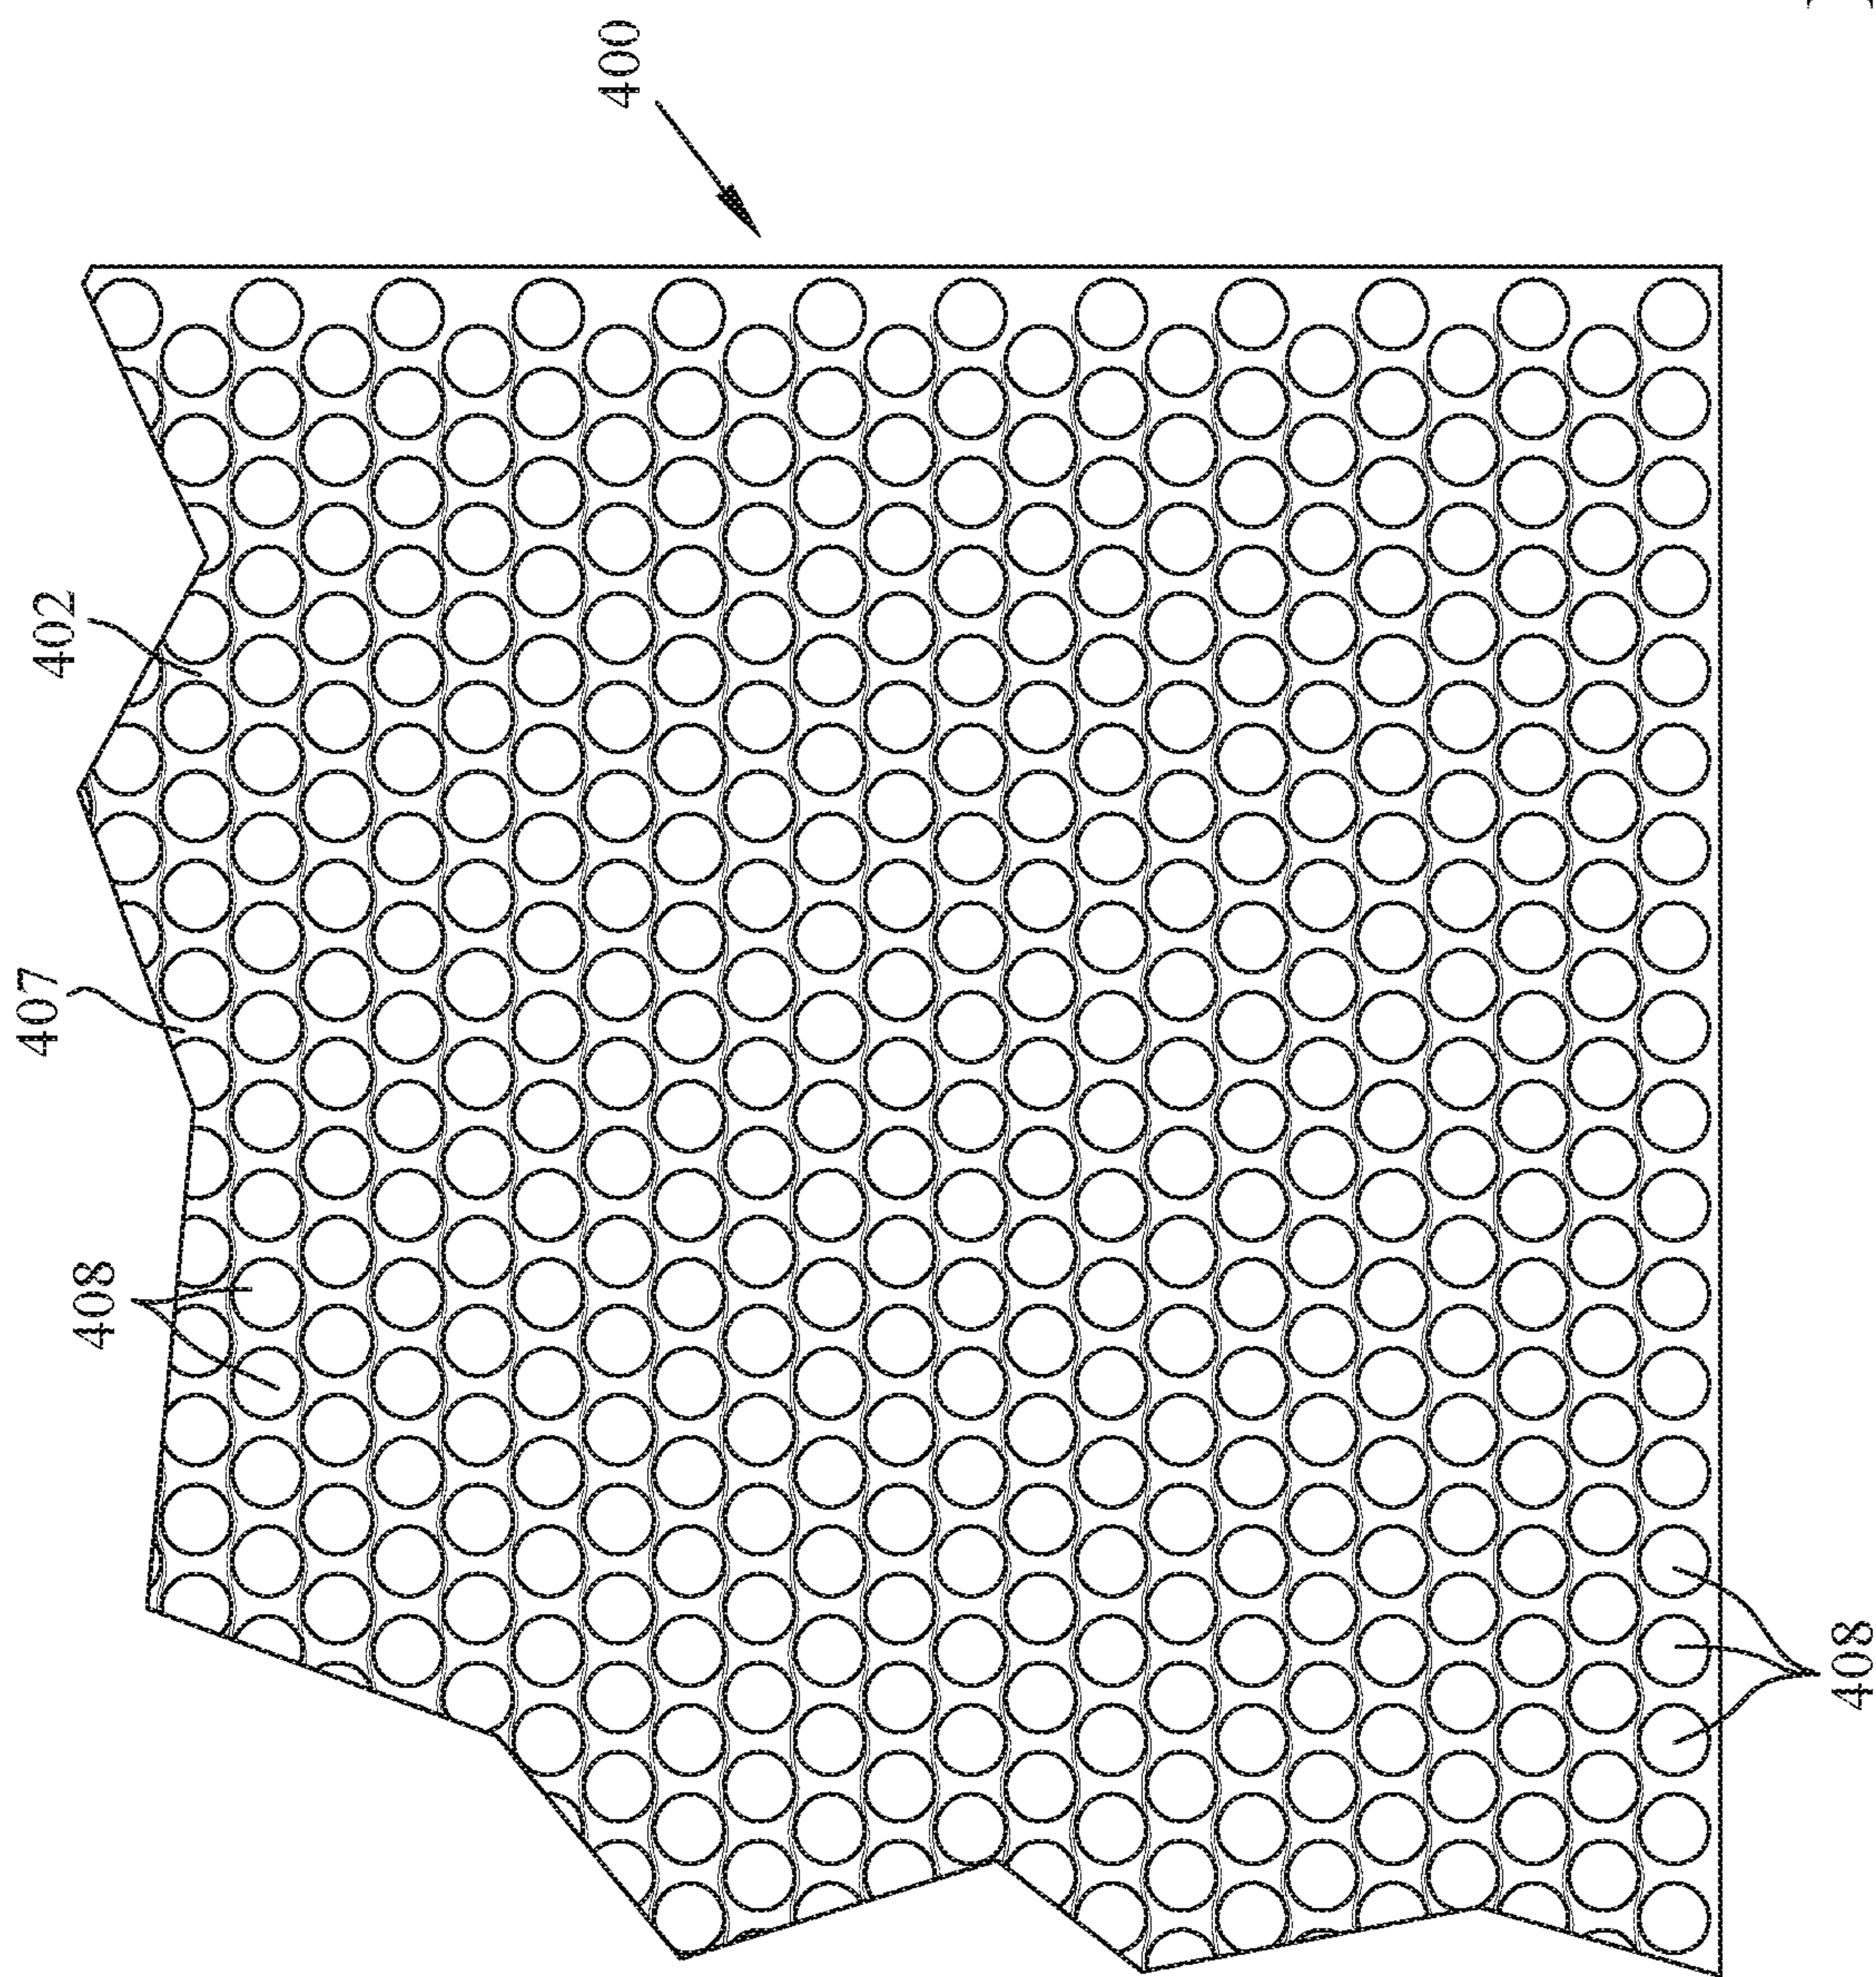
FIG. 17 is an enlarged plan view of the vehicle frame and cargo bay liner of FIG. 14 of the top side having aluminum foil thereon;

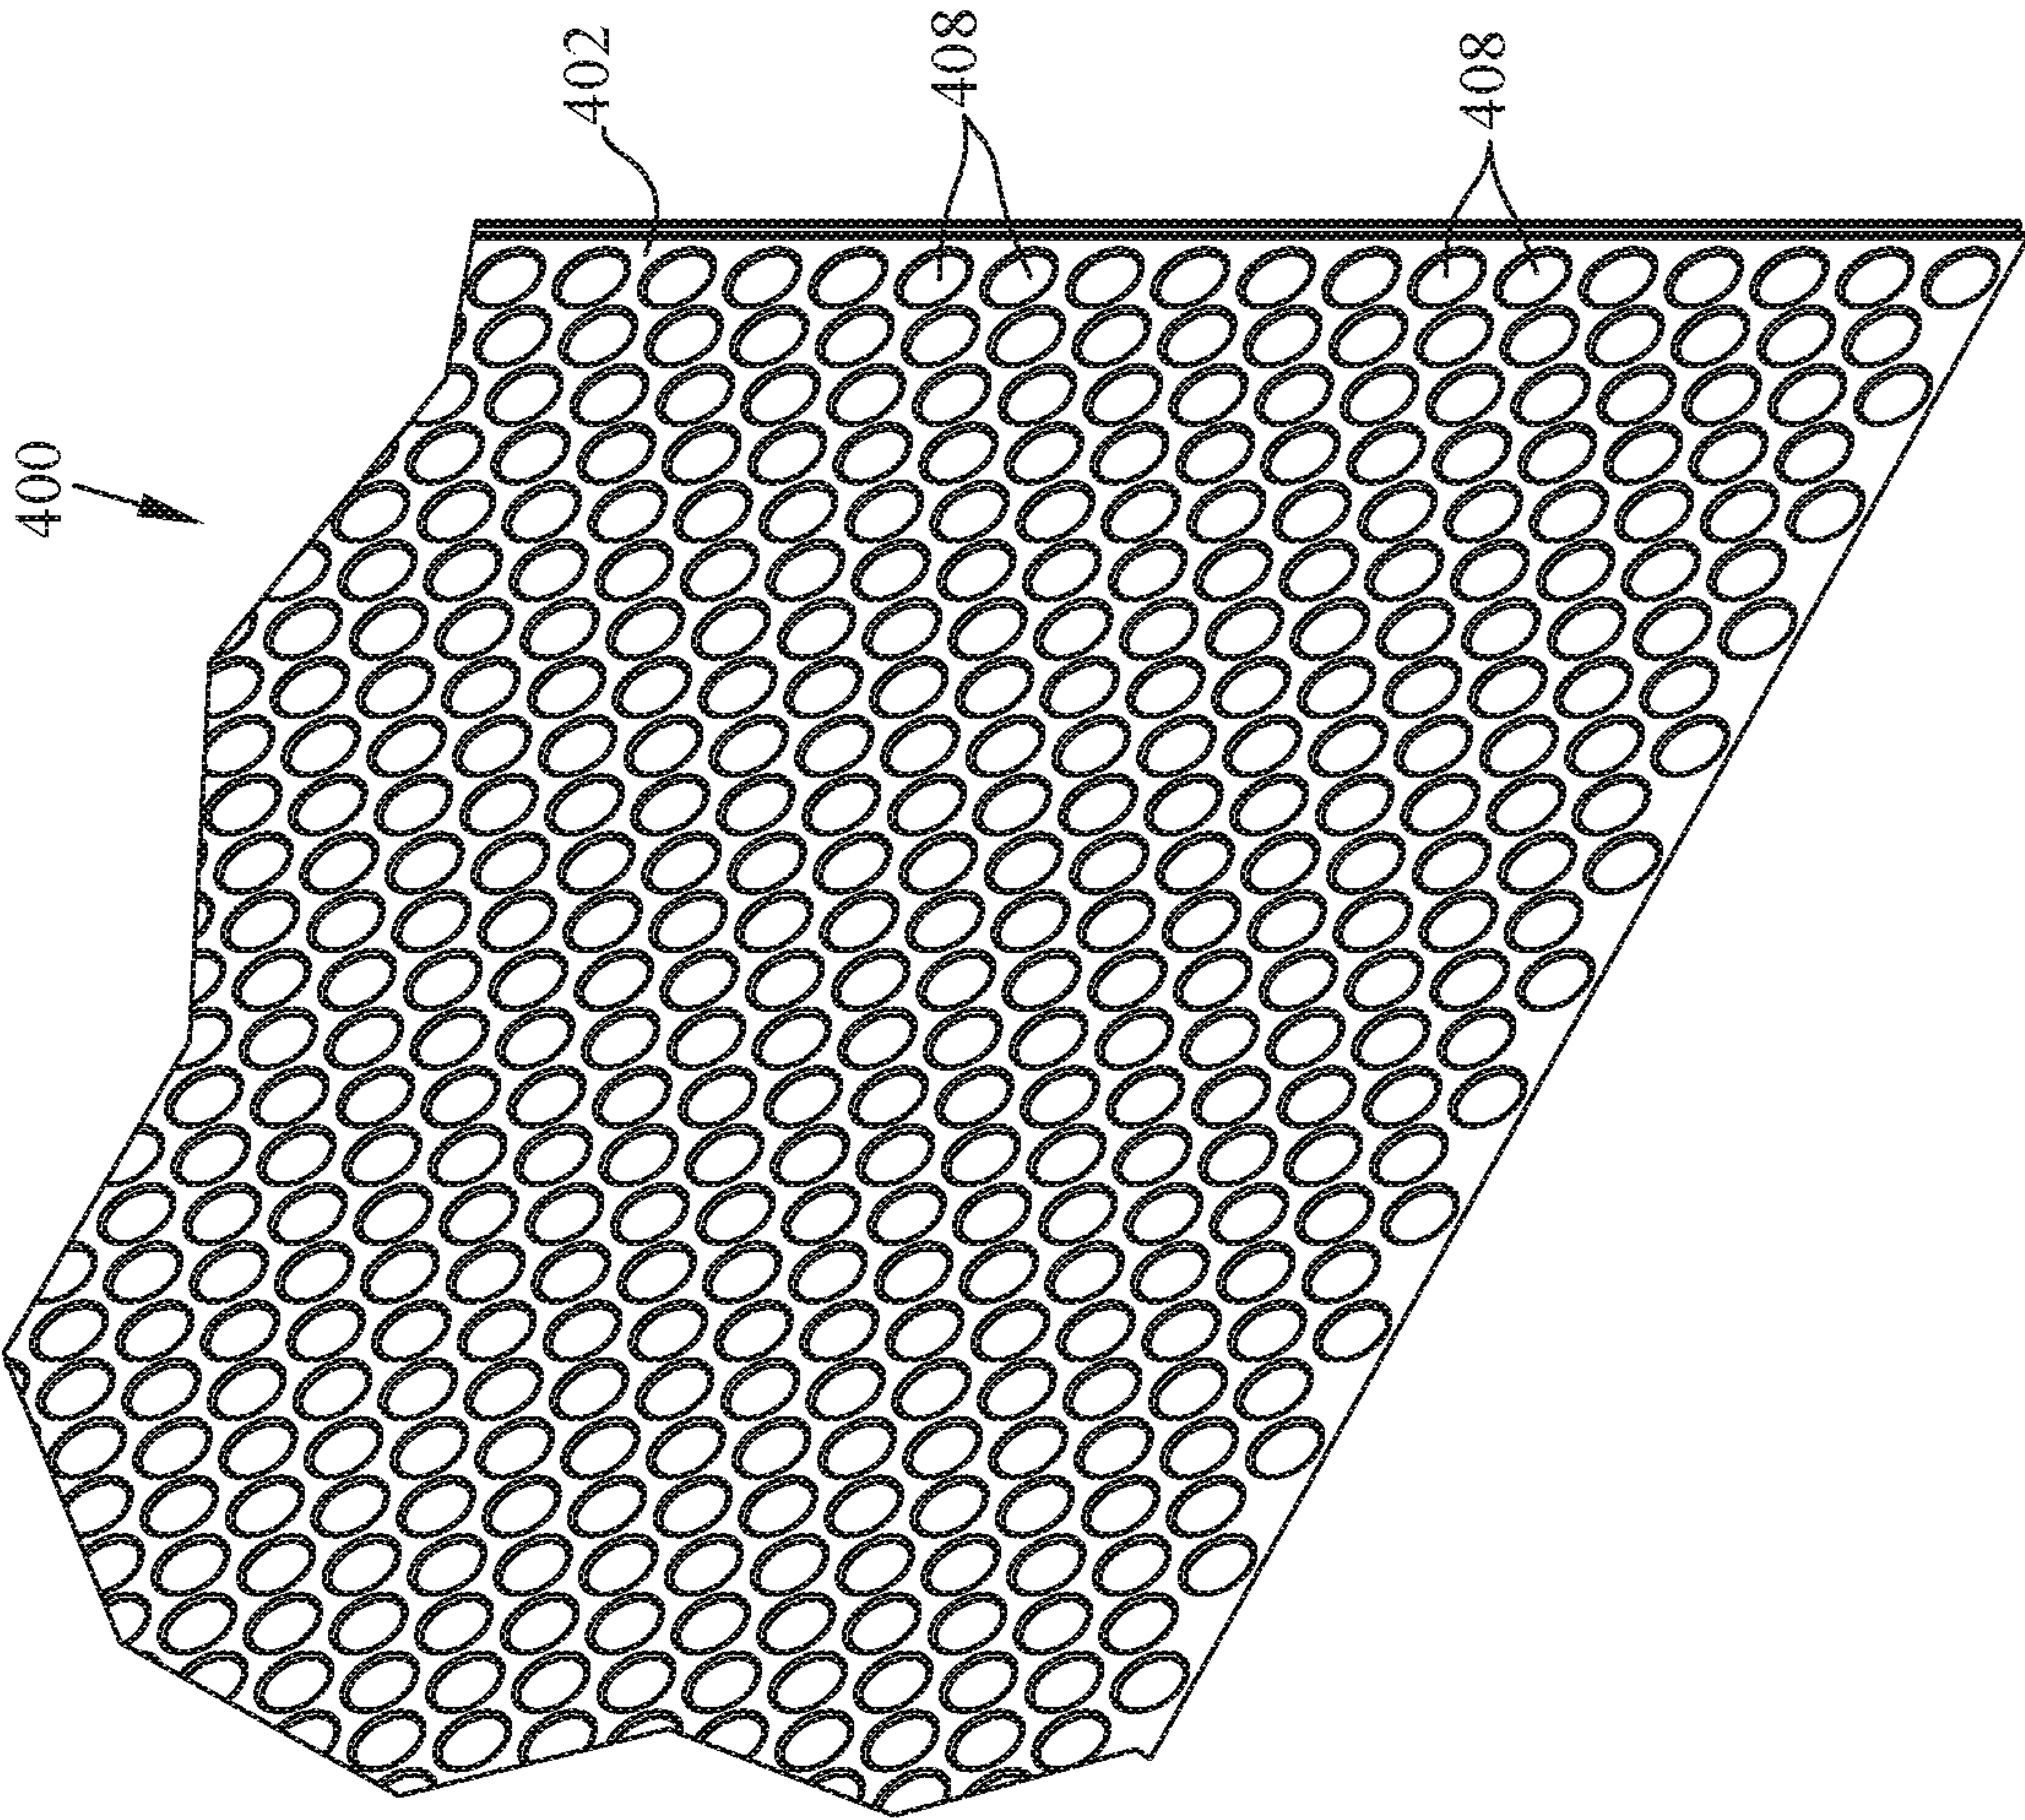
FIG. 18 is a top plan perspective view of the vehicle frame and cargo bay liner of FIG. 14 having the aluminum removed from the top side thereof;

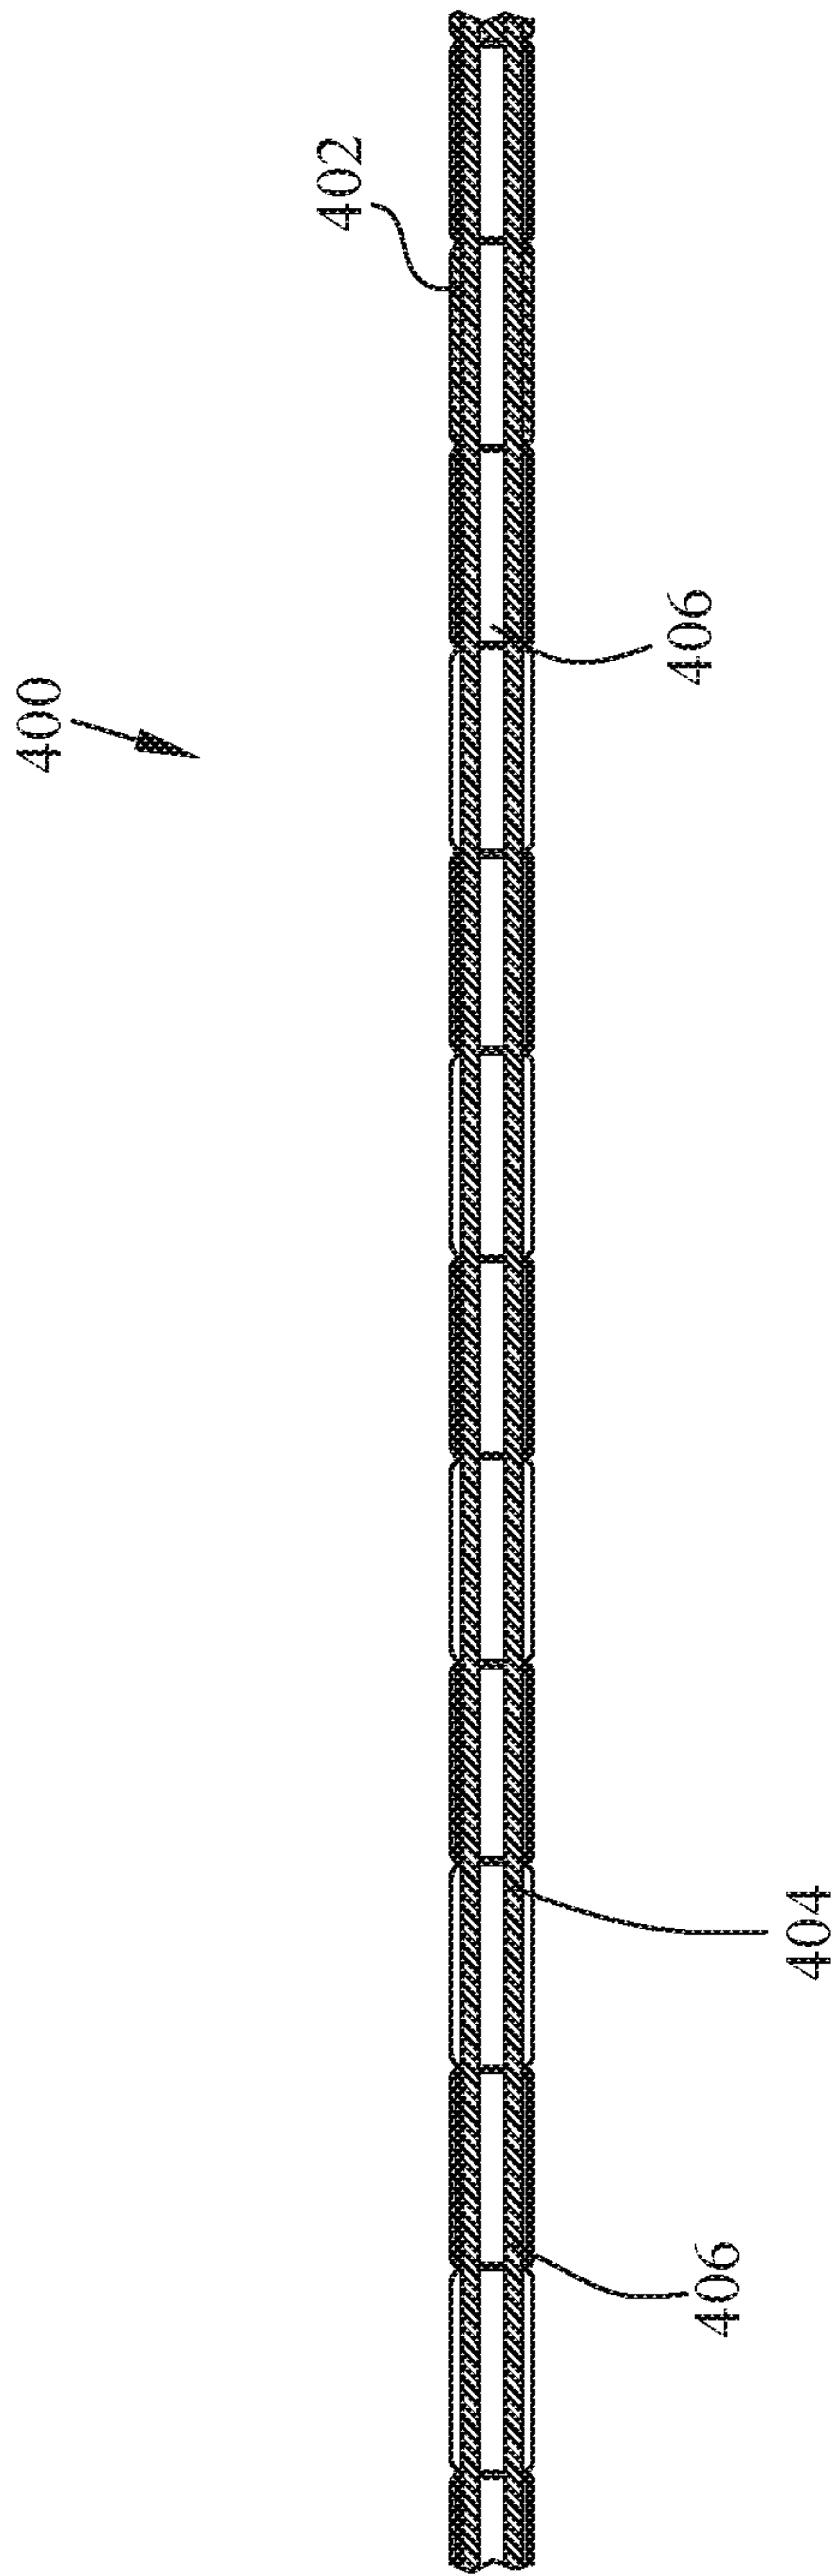
FIG. 19 is a side perspective view of the vehicle frame and cargo bay liner of FIG. 14 with the aluminum foil removed;

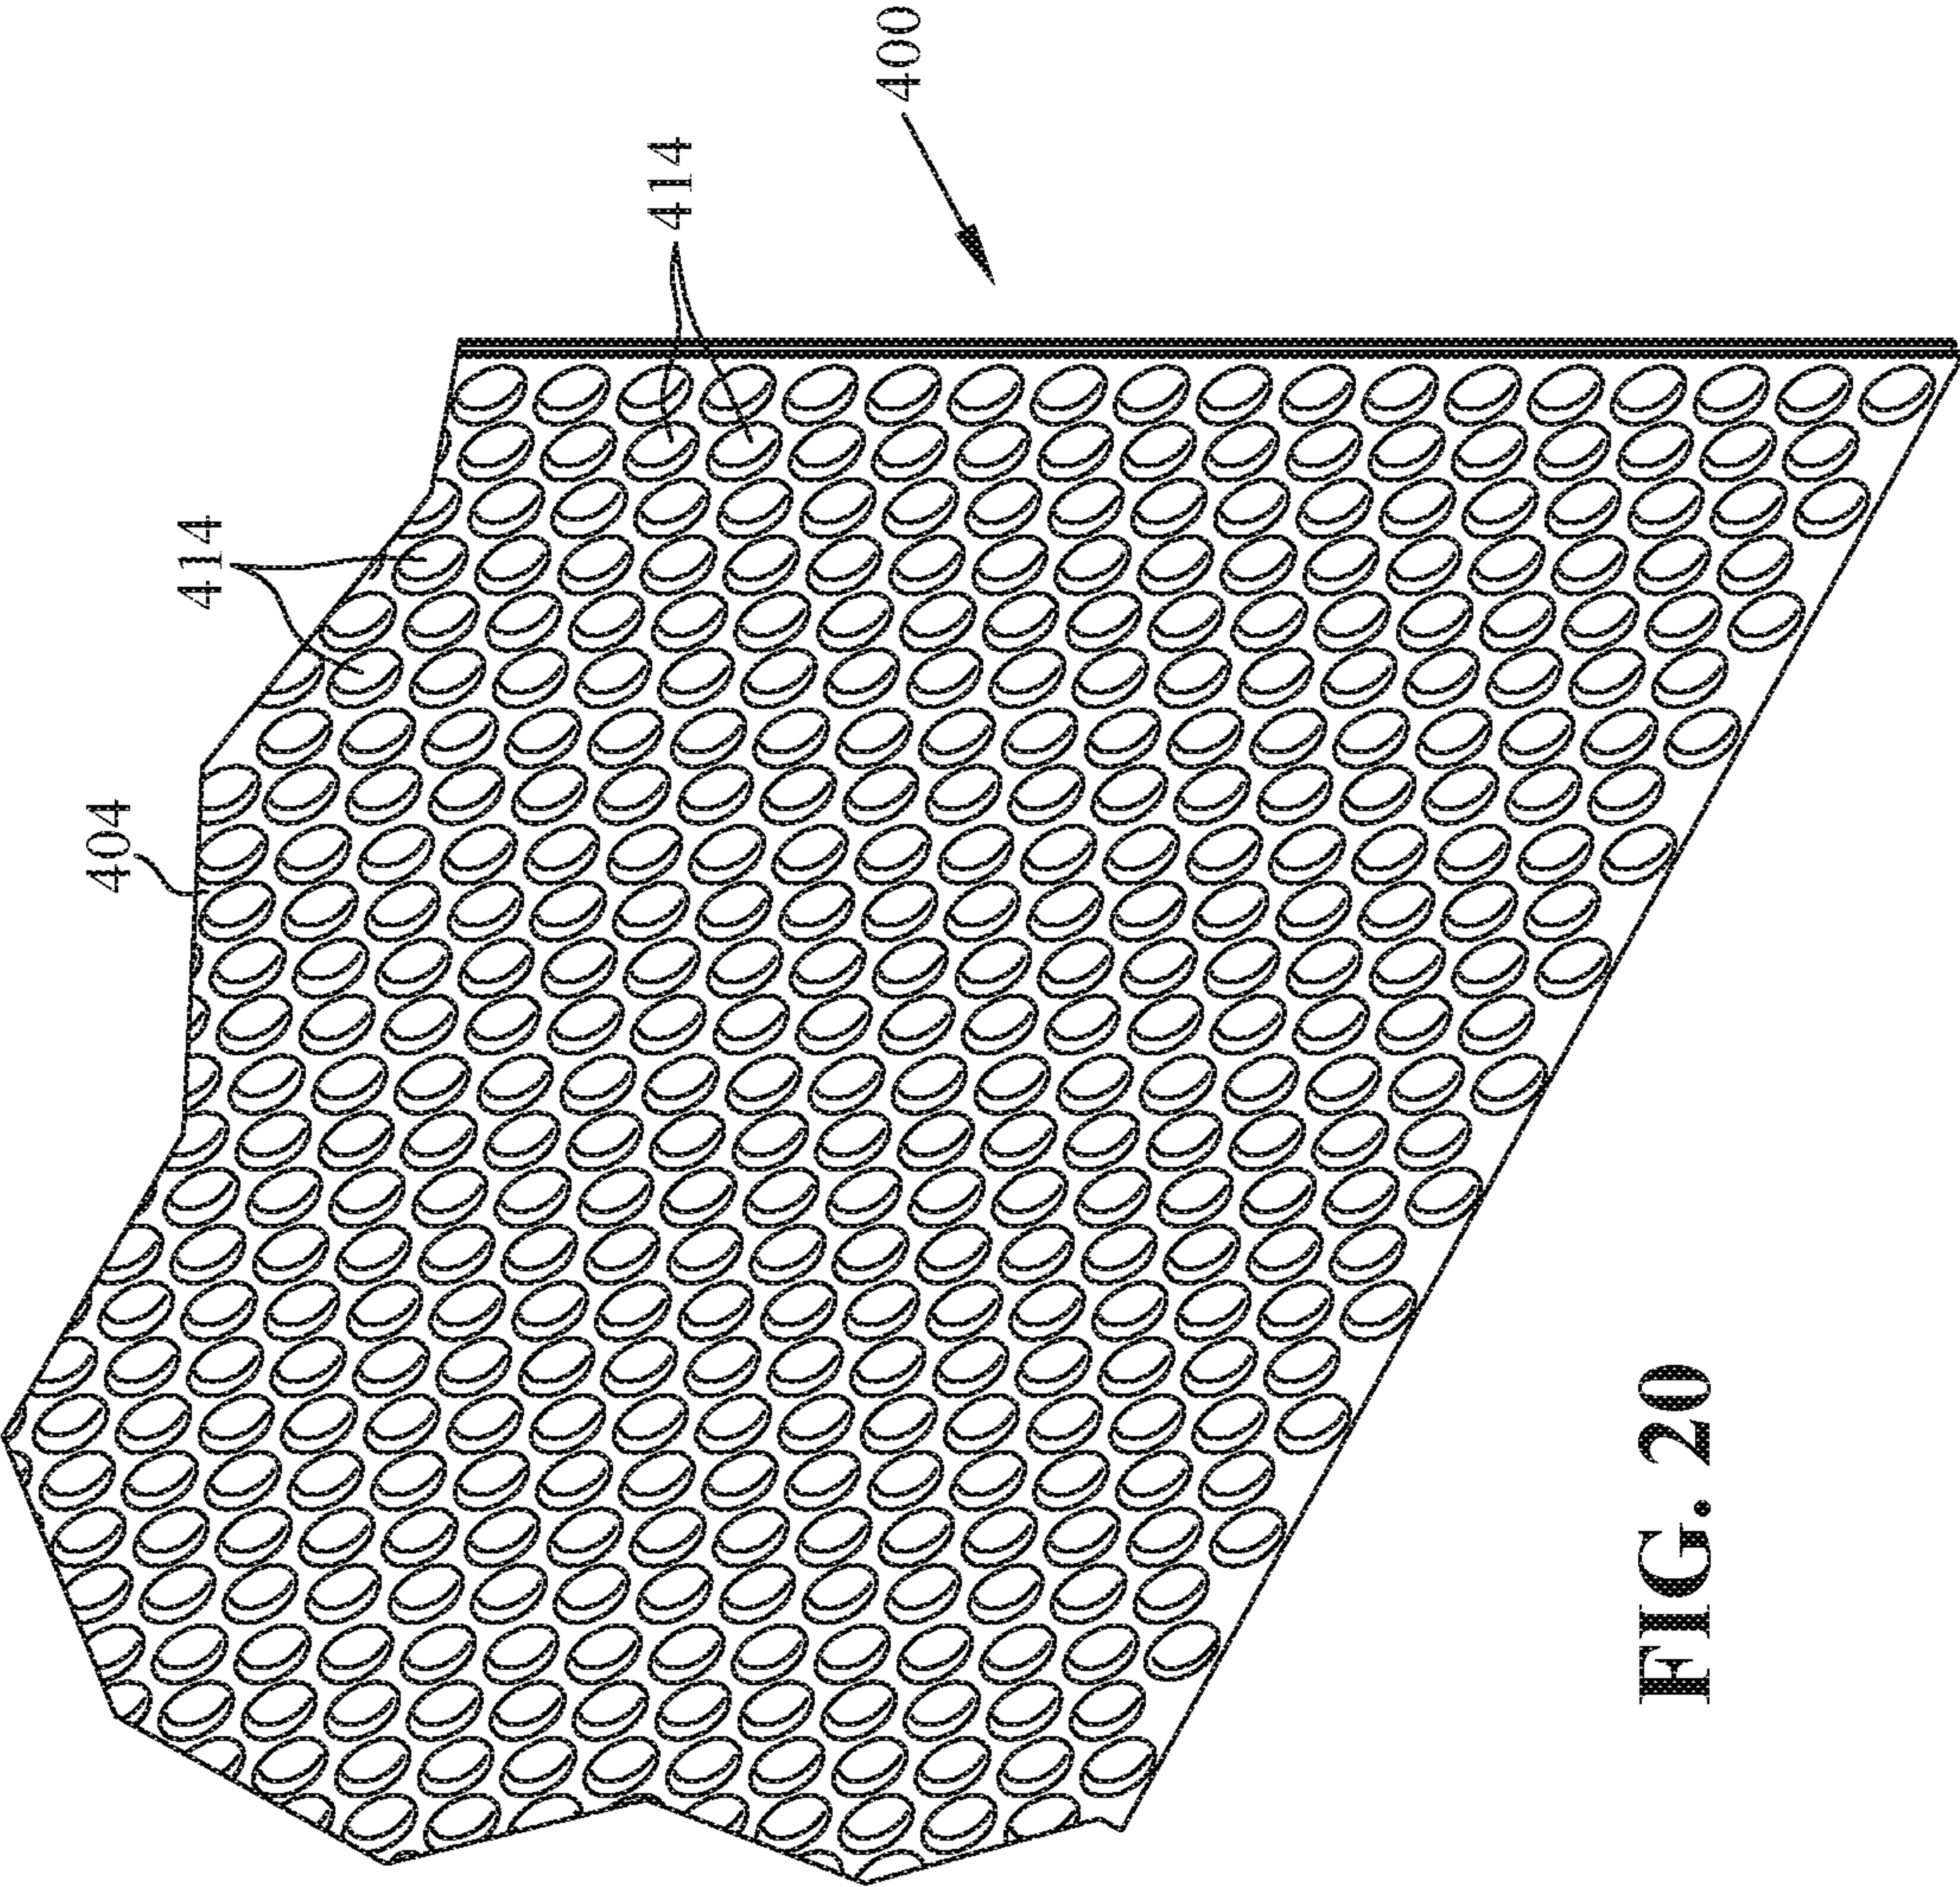
FIG. 20 is a plan perspective view of the bottom side of the vehicle frame and cargo bay liner of FIG. 14;

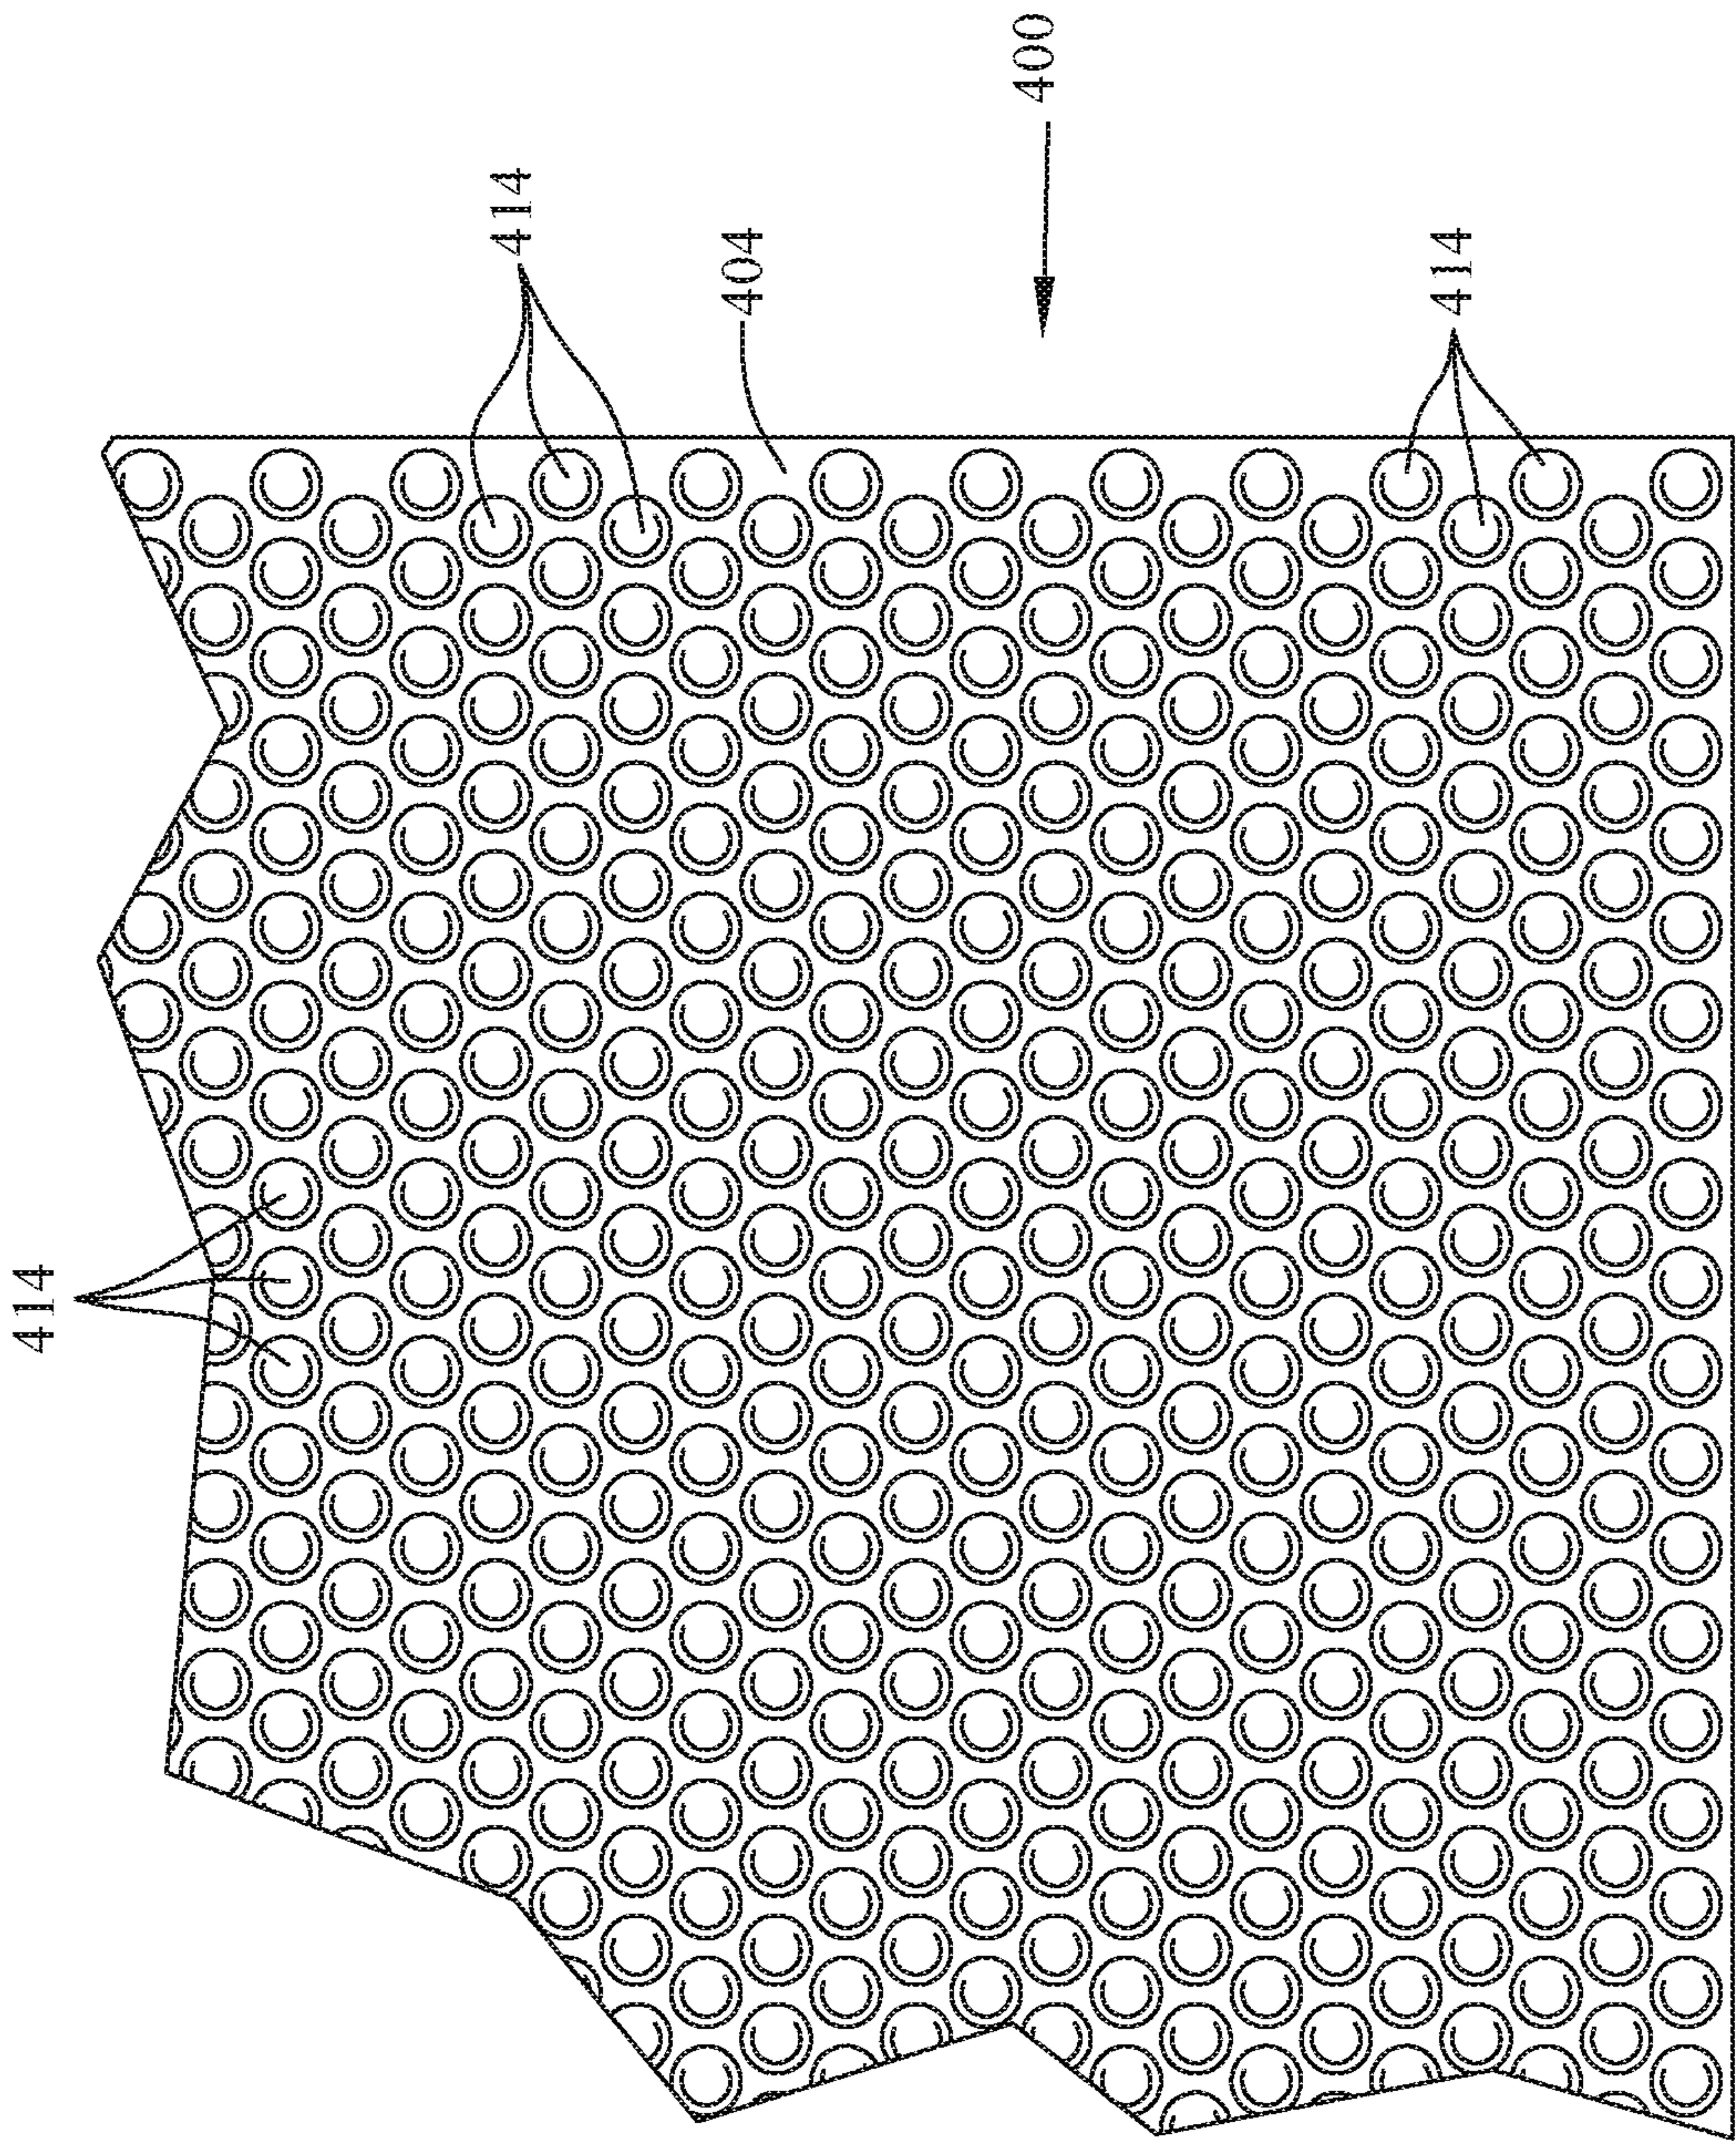
FIG. 21 is an enlarged bottom plan perspective view of the vehicle frame and cargo bay liner of FIG. 14;

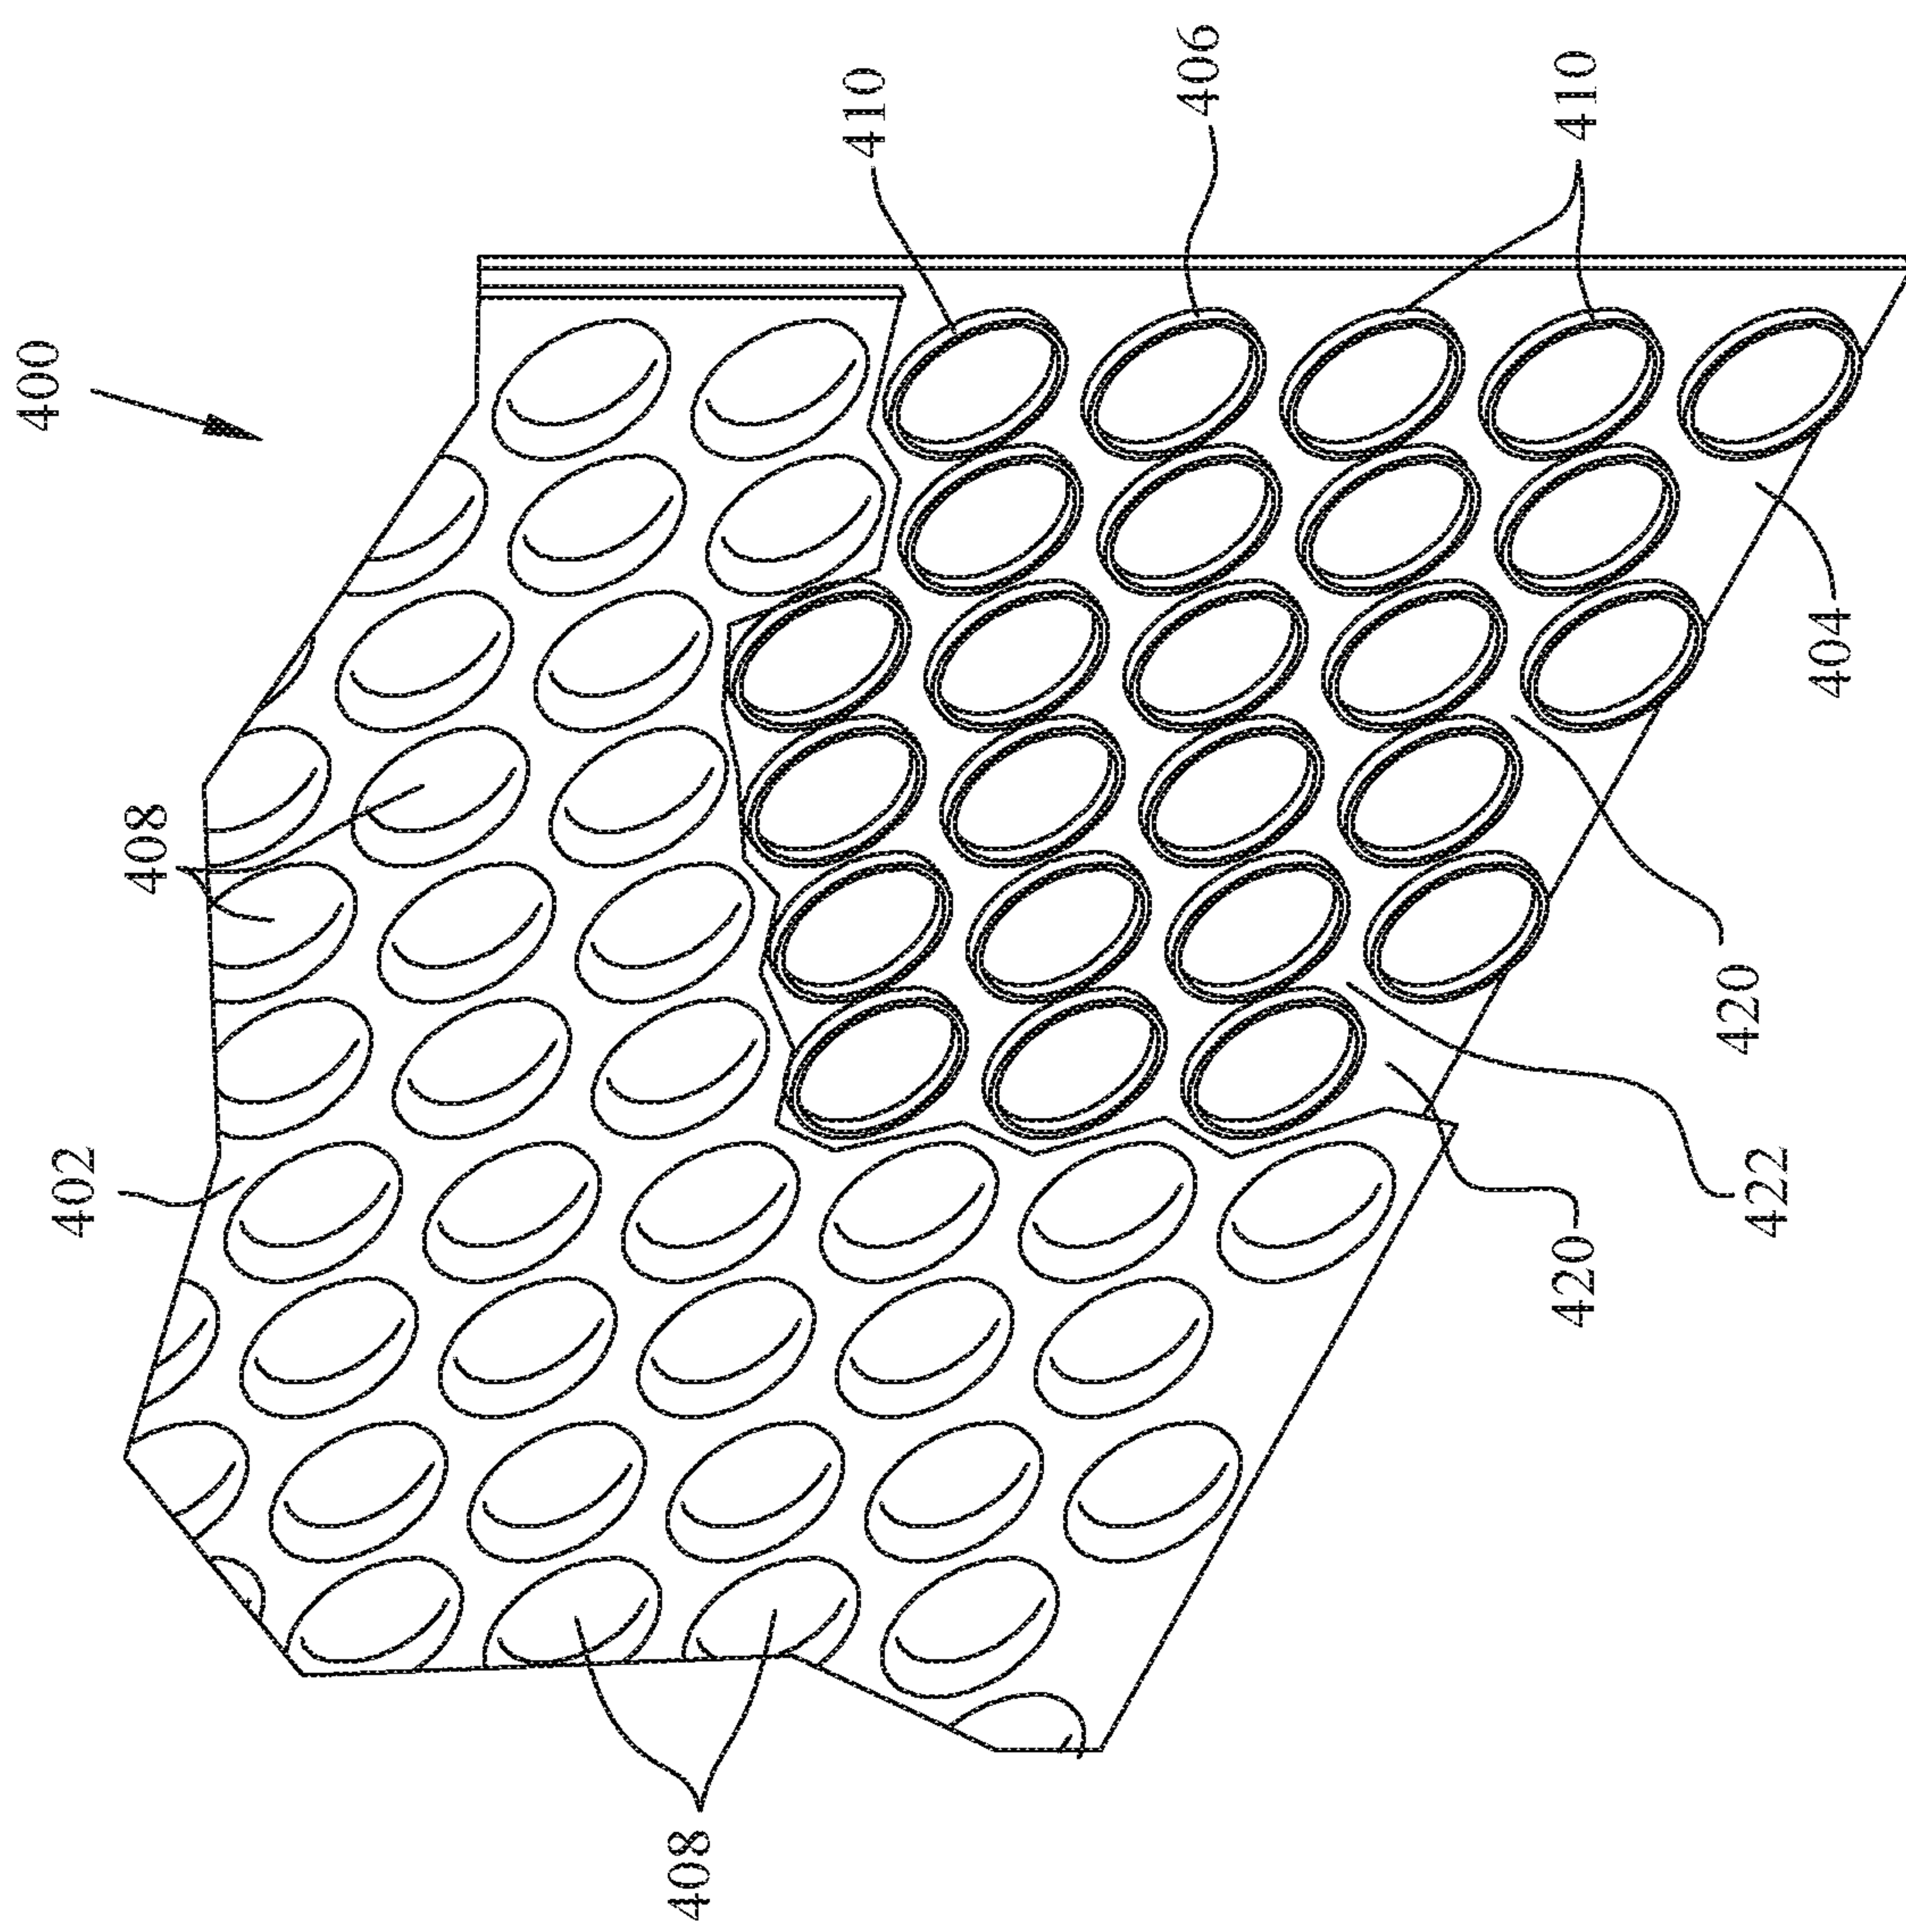
FIG. 22 is a perspective view of a portion of the vehicle frame and cargo bay liner of FIG. 14 showing part of the top layer removed;

As can be seen in FIGS. 22 and 23, cylindrical projections 410 form an obstruction to passage through core 406 such that any water entering the ends thereof is obstructed and impeded or hindered from propagating across liner 400 as compared to channels 111 in corrugated liner 104, which readily allow transport of liquids. Additionally, as where vehicle frame and cargo bay liner 400 is cut, it will intersect a plurality of cylindrical projections 410 in the liner. As each cylinder is closed off, any water entering into an end of the liner where a projection has been cut will be prevented from further propagating by encountering the wall of the projection. Only a small area or channel 422 between cylindrical projections would allow any water or moisture to enter into core 406 of liner 400, but that will not readily propagate to the offset projections internal to core 406 that will impede or hinder any advancement of the moisture.
