US011447189B1

(54) **VEHICLE FRAME AND CARGO BAY LINER**

(57) **ABSTRACT**

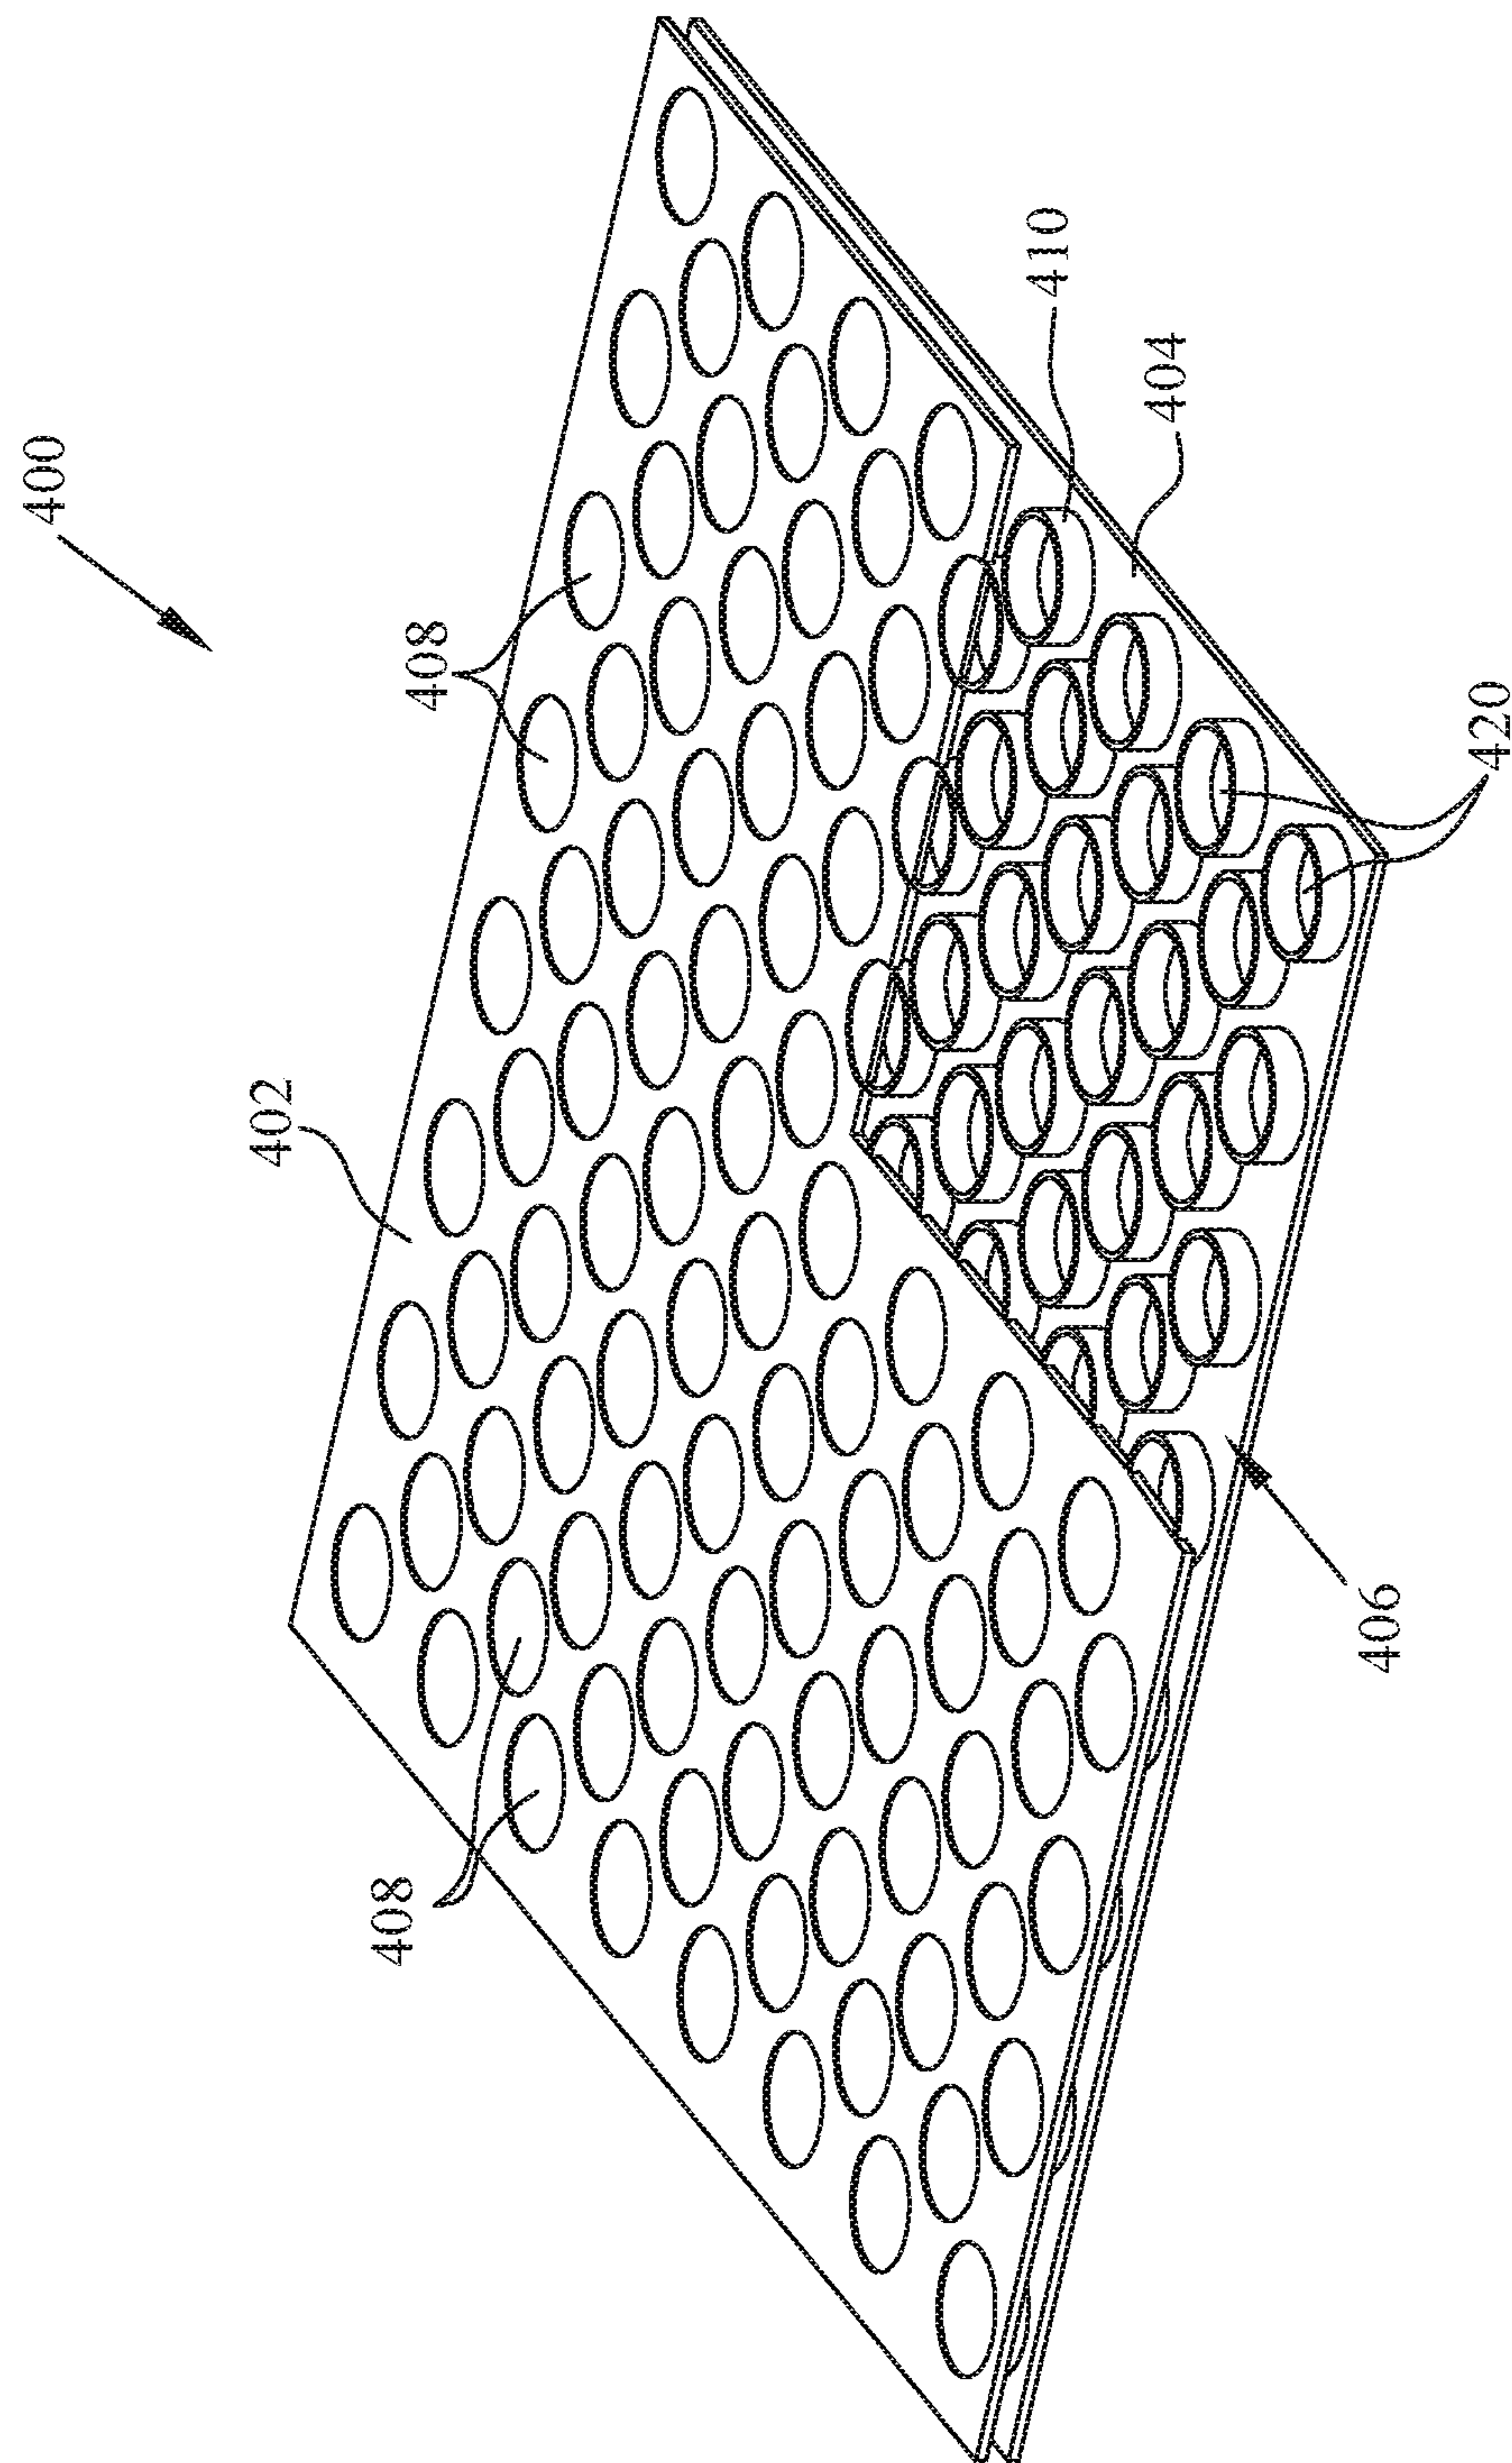
FIG. 23 is another perspective view of a portion of the vehicle frame and cargo bay liner of FIG. 14 with part of the top layer removed;

As can be seen in FIGS. 22 and 23, cylindrical projections 410 form an obstruction to passage through core 406 such that any water entering the ends thereof is obstructed and impeded or hindered from propagating across liner 400 as compared to channels 111 in corrugated liner 104, which readily allow transport of liquids. Additionally, as where vehicle frame and cargo bay liner 400 is cut, it will intersect a plurality of cylindrical projections 410 in the liner. As each cylinder is closed off, any water entering into an end of the liner where a projection has been cut will be prevented from further propagating by encountering the wall of the projection. Only a small area or channel 422 between cylindrical projections would allow any water or moisture to enter into core 406 of liner 400, but that will not readily propagate to the offset projections internal to core 406 that will impede or hinder any advancement of the moisture.

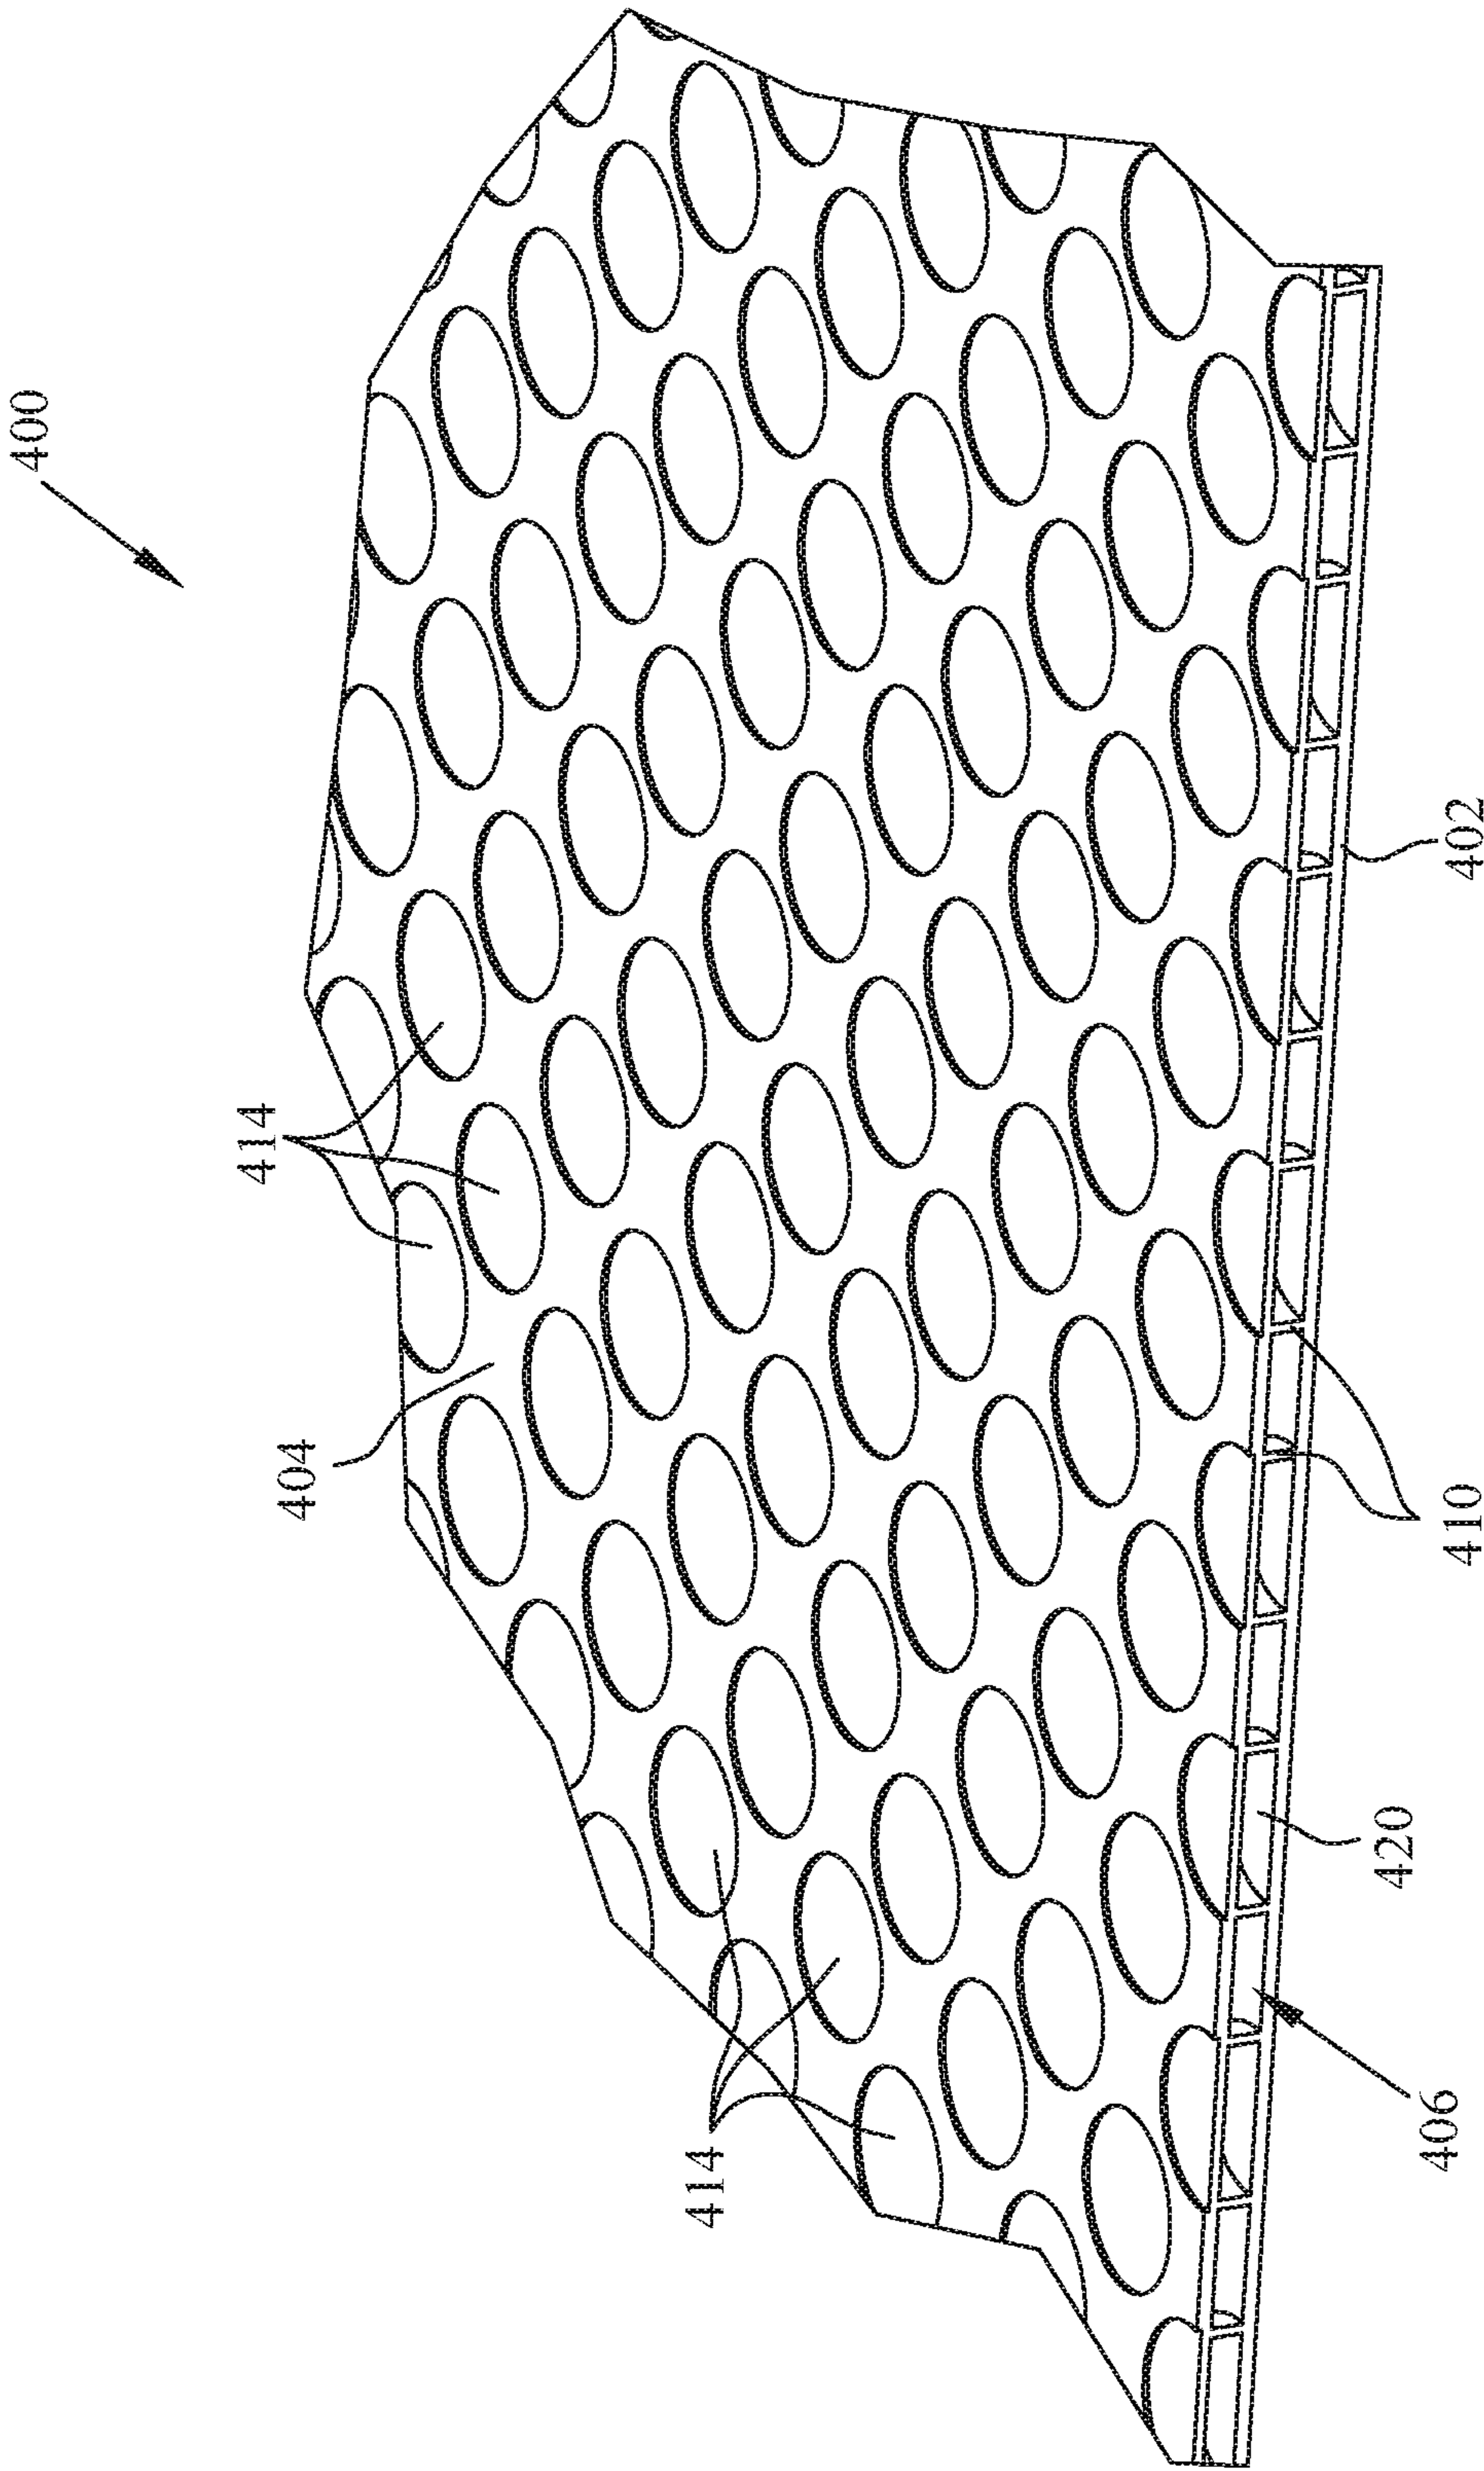
FIG. 24 is a perspective view of the bottom side of a portion of the vehicle frame and cargo bay liner of FIG. 14;

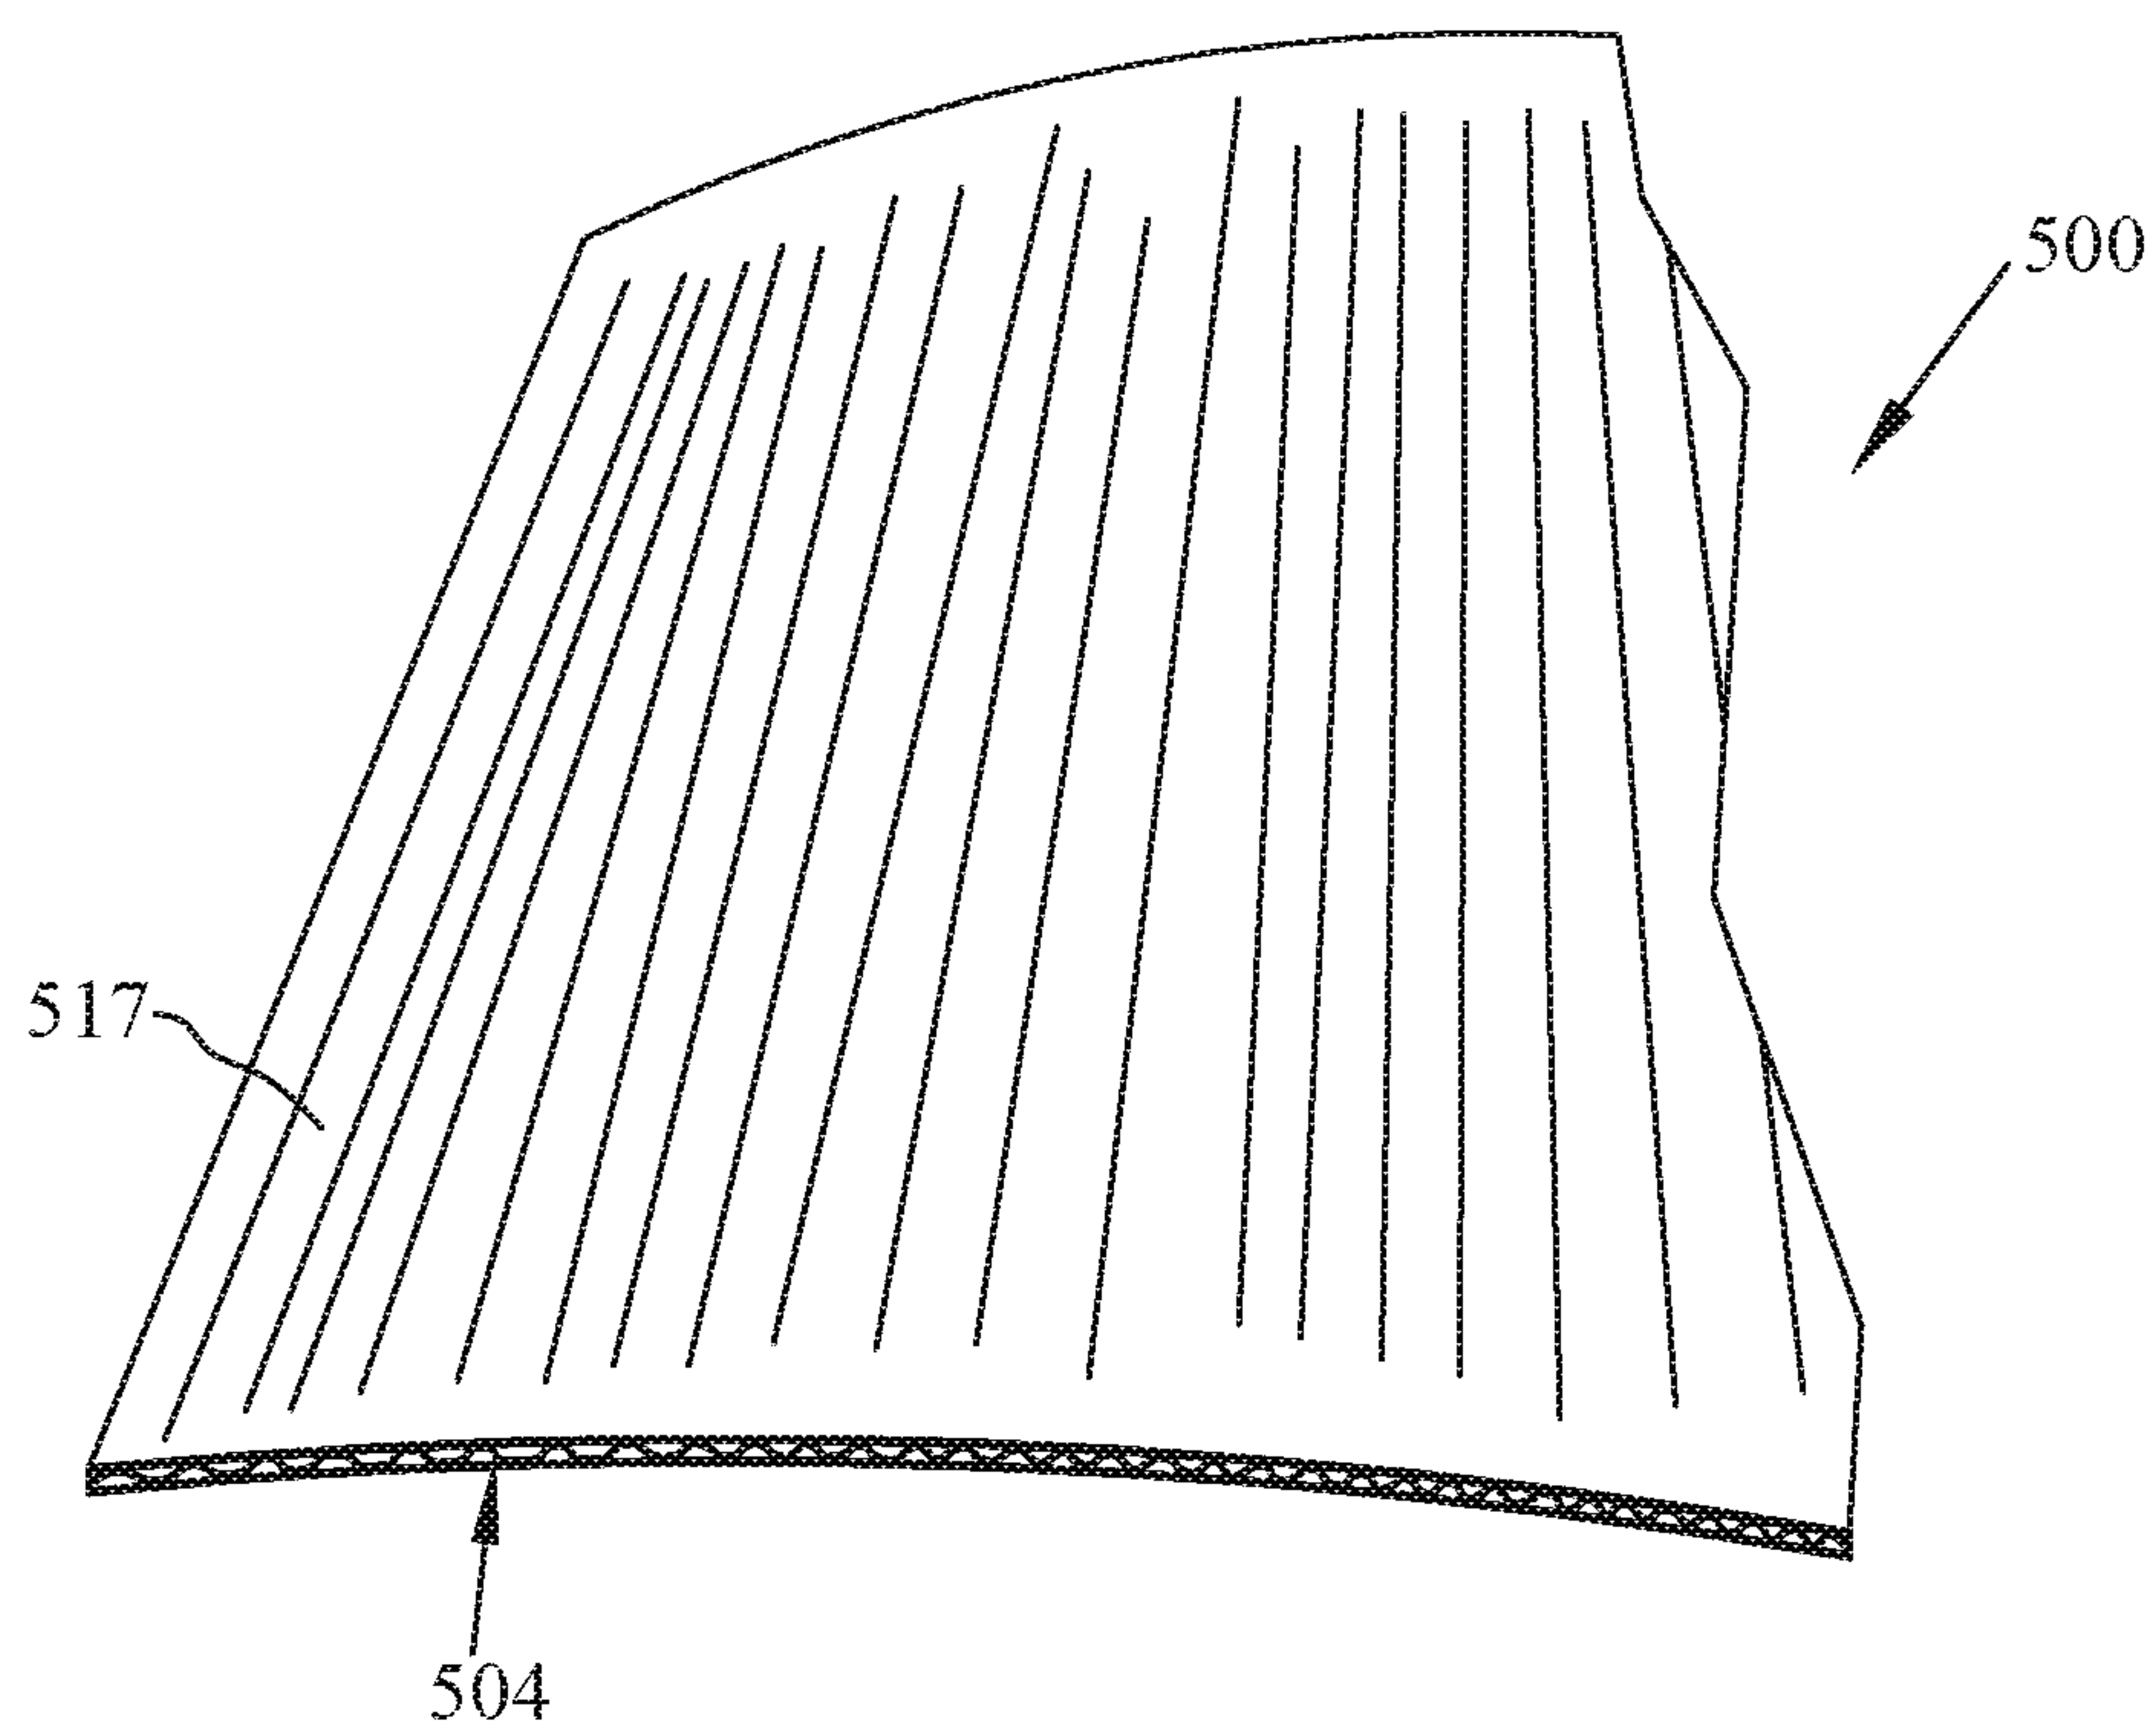
FIG. 25 is a perspective view of an additional alternate embodiment vehicle frame and cargo bay liner shown laid out and having an aluminum foil on one side thereof;

Now referring to FIGS. 25-27, other alternate embodiment vehicle frame and cargo area liner is shown generally indicated as 500. Liner 500 includes a corrugated liner, generally indicated as 504. Corrugated liner 504 includes a top sheet 506, a bottom sheet 508, and a corrugated or sinusoidal ply 510 extending therebetween, as best shown in FIGS. 26 and 27. Top sheet 506 and bottom sheet 508 each have a generally planar configuration, not including any rolling memory that may be embedded therein and are adhered or thermally attached to corrugated ply 510. It should be appreciated that the corrugated ply is defined to include either a sinusoidal configuration as shown in FIGS. 26 and 27 or alternately a plurality of member perpendicular to top sheet 506 and bottom sheet 508 such as is shown in the material utilized in FIGS. 7 and 8 of U.S. Pat. No. 10,000,930 B2 to Lowe et al., which is incorporated in its entirety herein by reference. In one embodiment, corrugated liner 504 is polyethylene. Of course, other materials, and in particular, polymers such as polypropylene may be used for corrugated liner 504. As best shown in FIG. 26, when the corrugated liner 504 is rolled, the outer sheet will become stretched and the inner sheet may fold as shown with top sheet 506, and bottom sheet 508 in FIG. 26, respectively.

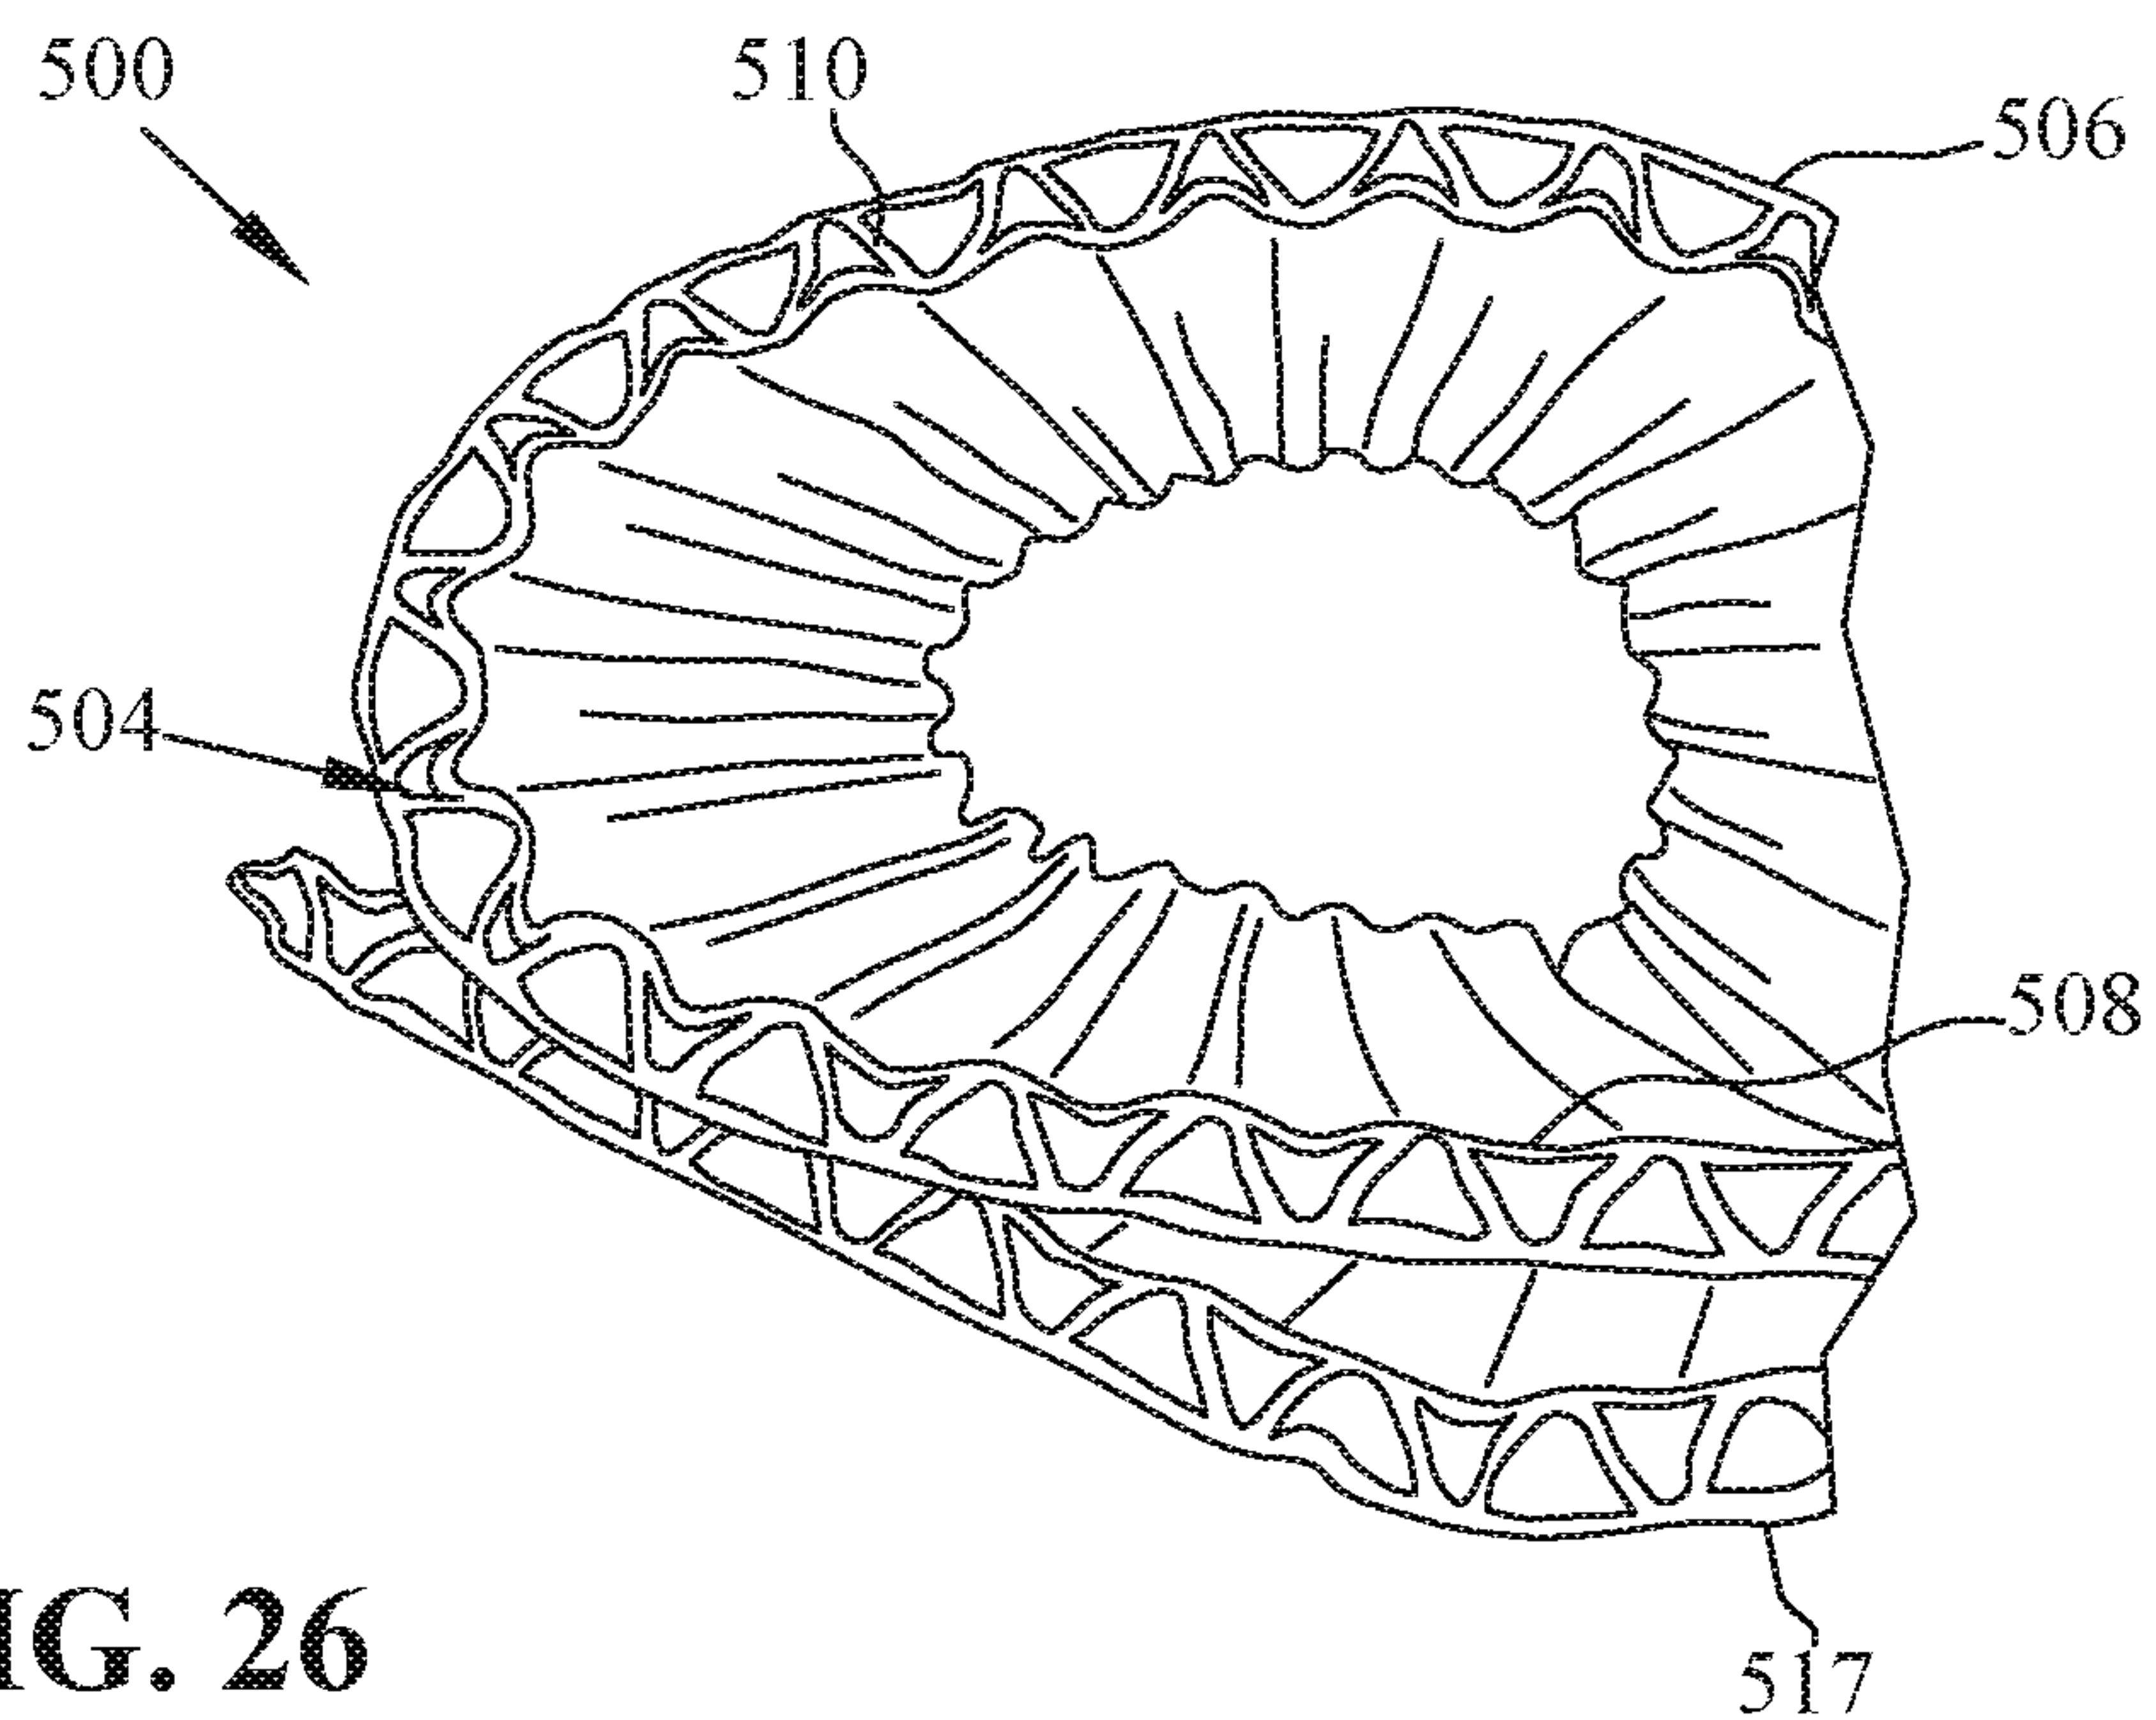
FIG. 26 is an end view of the vehicle frame and cargo bay liner of FIG. 25 shown rolled up wherein corrugations of the liner are readily visible;

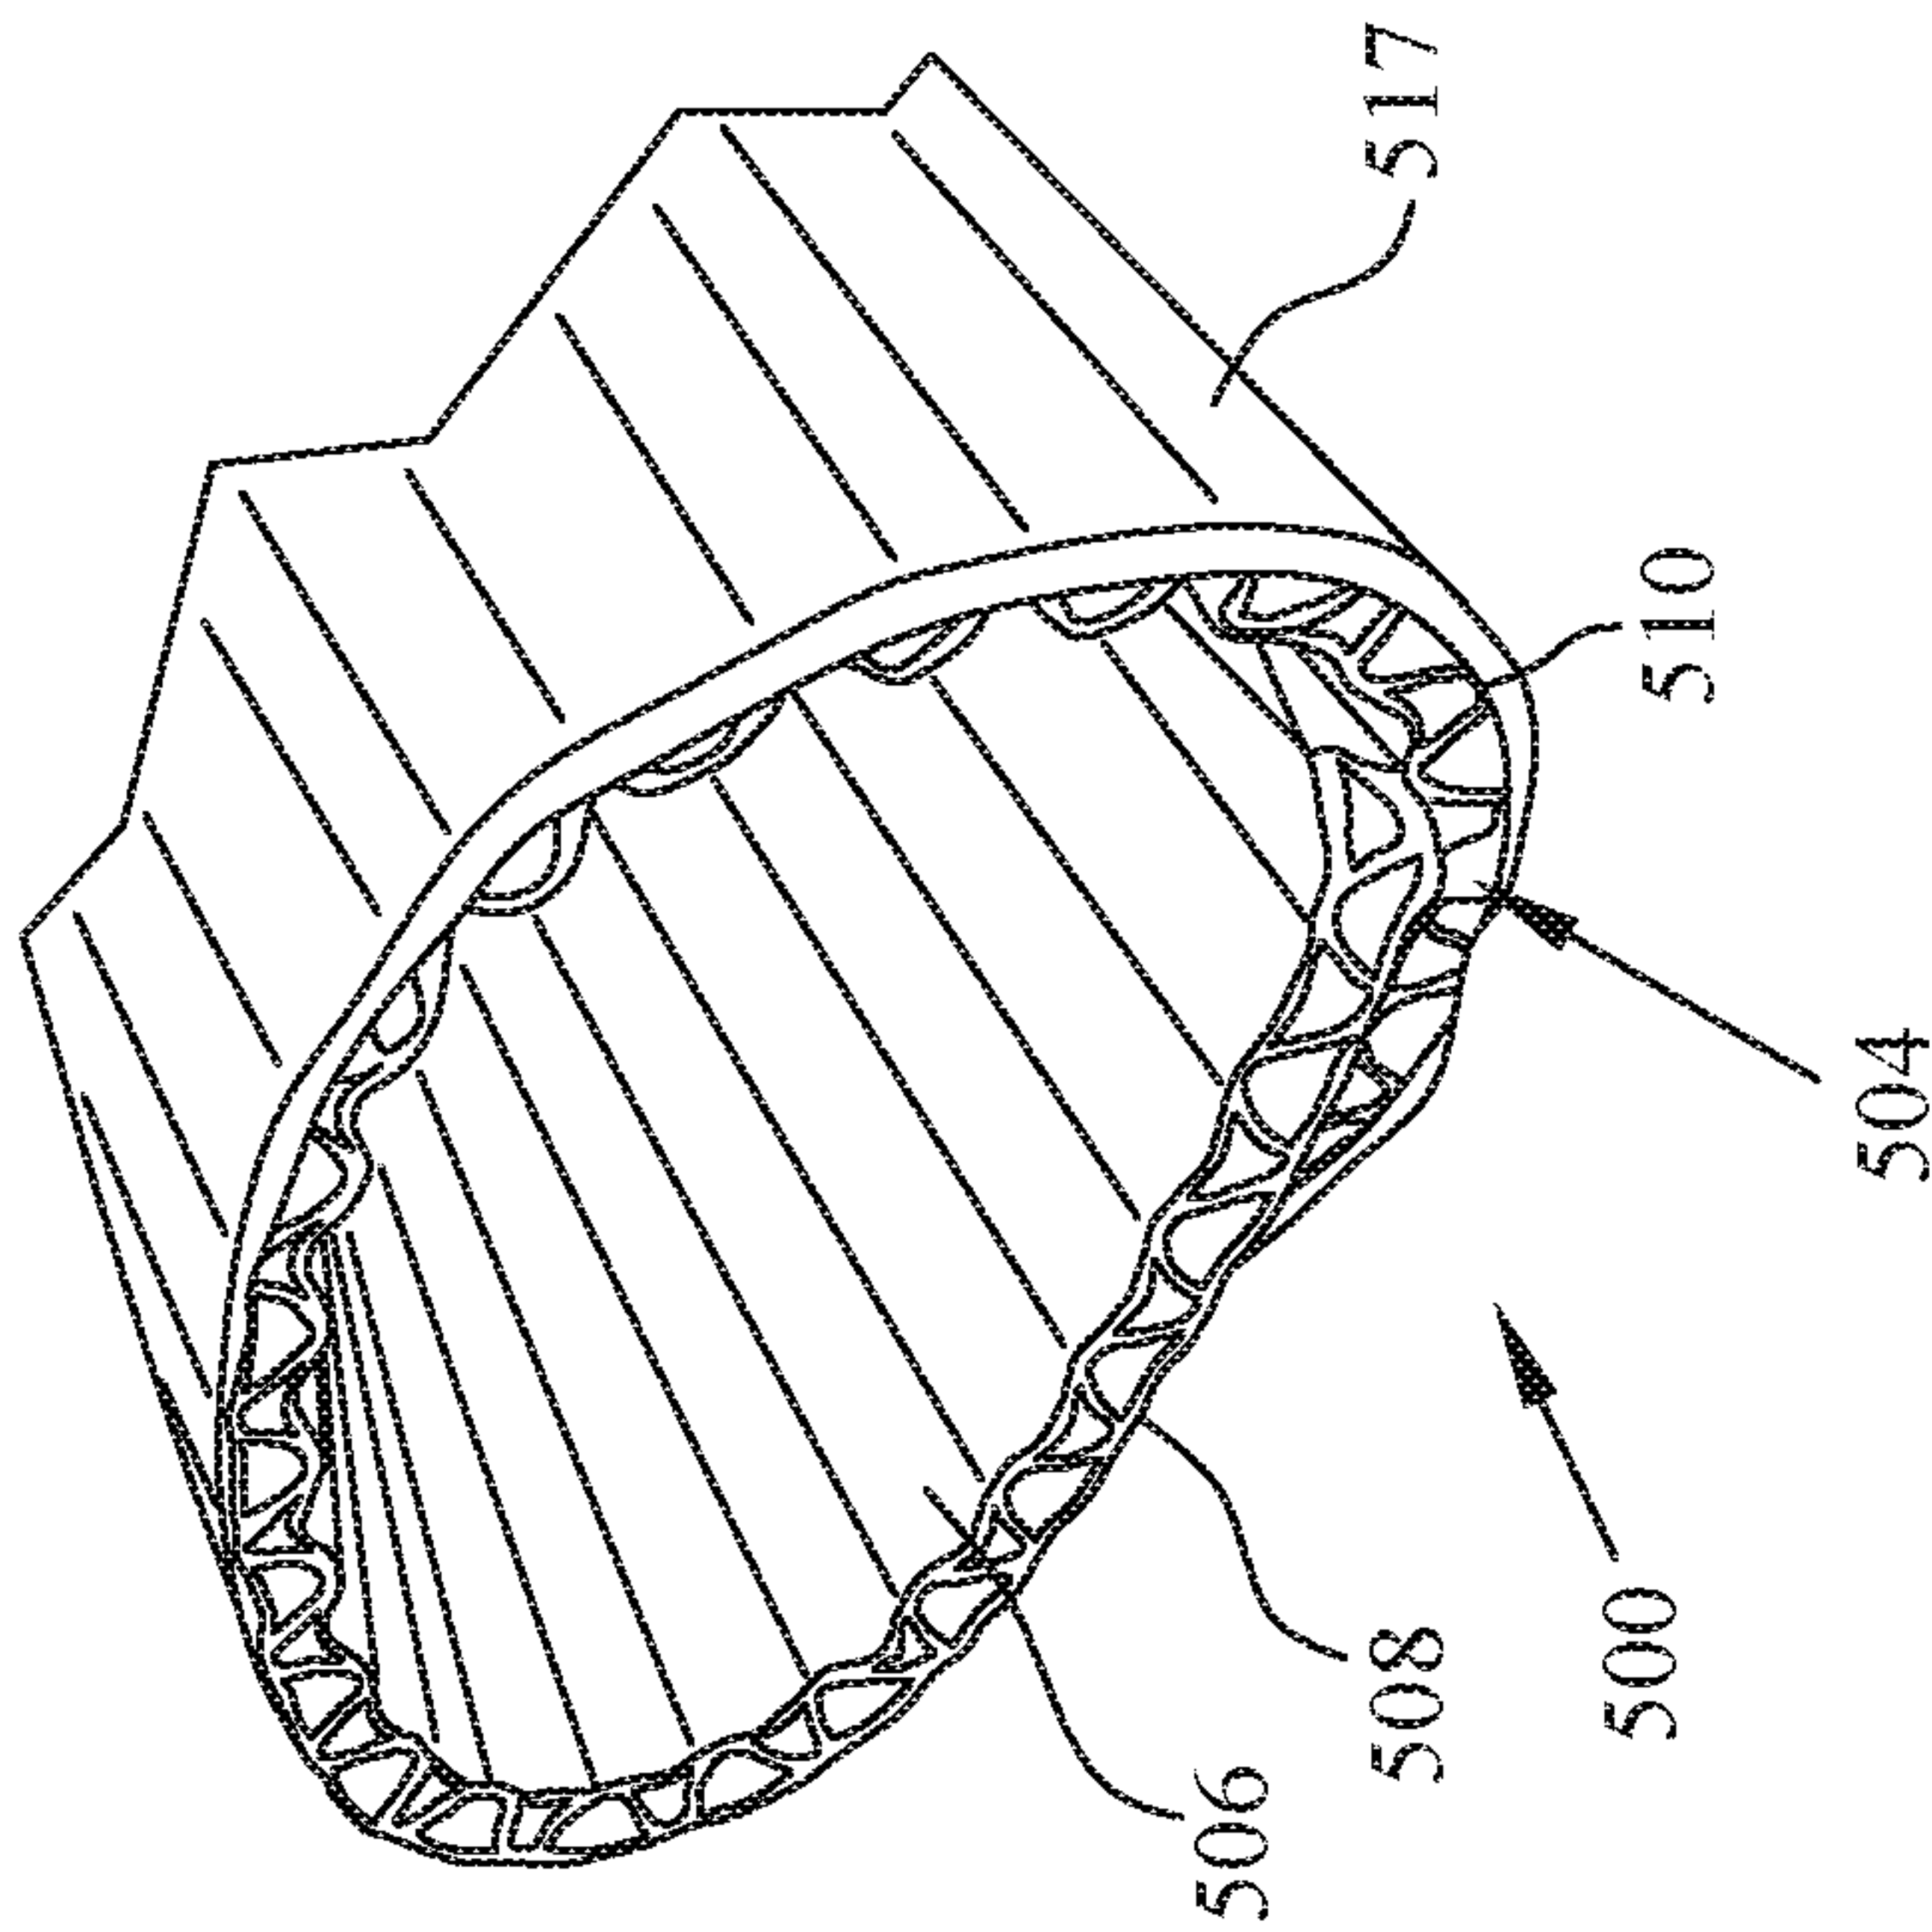
FIG. 27 is a perspective view of the vehicle frame and cargo bay liner of FIG. 25 rolled up with the aluminum foil on the outside thereof;

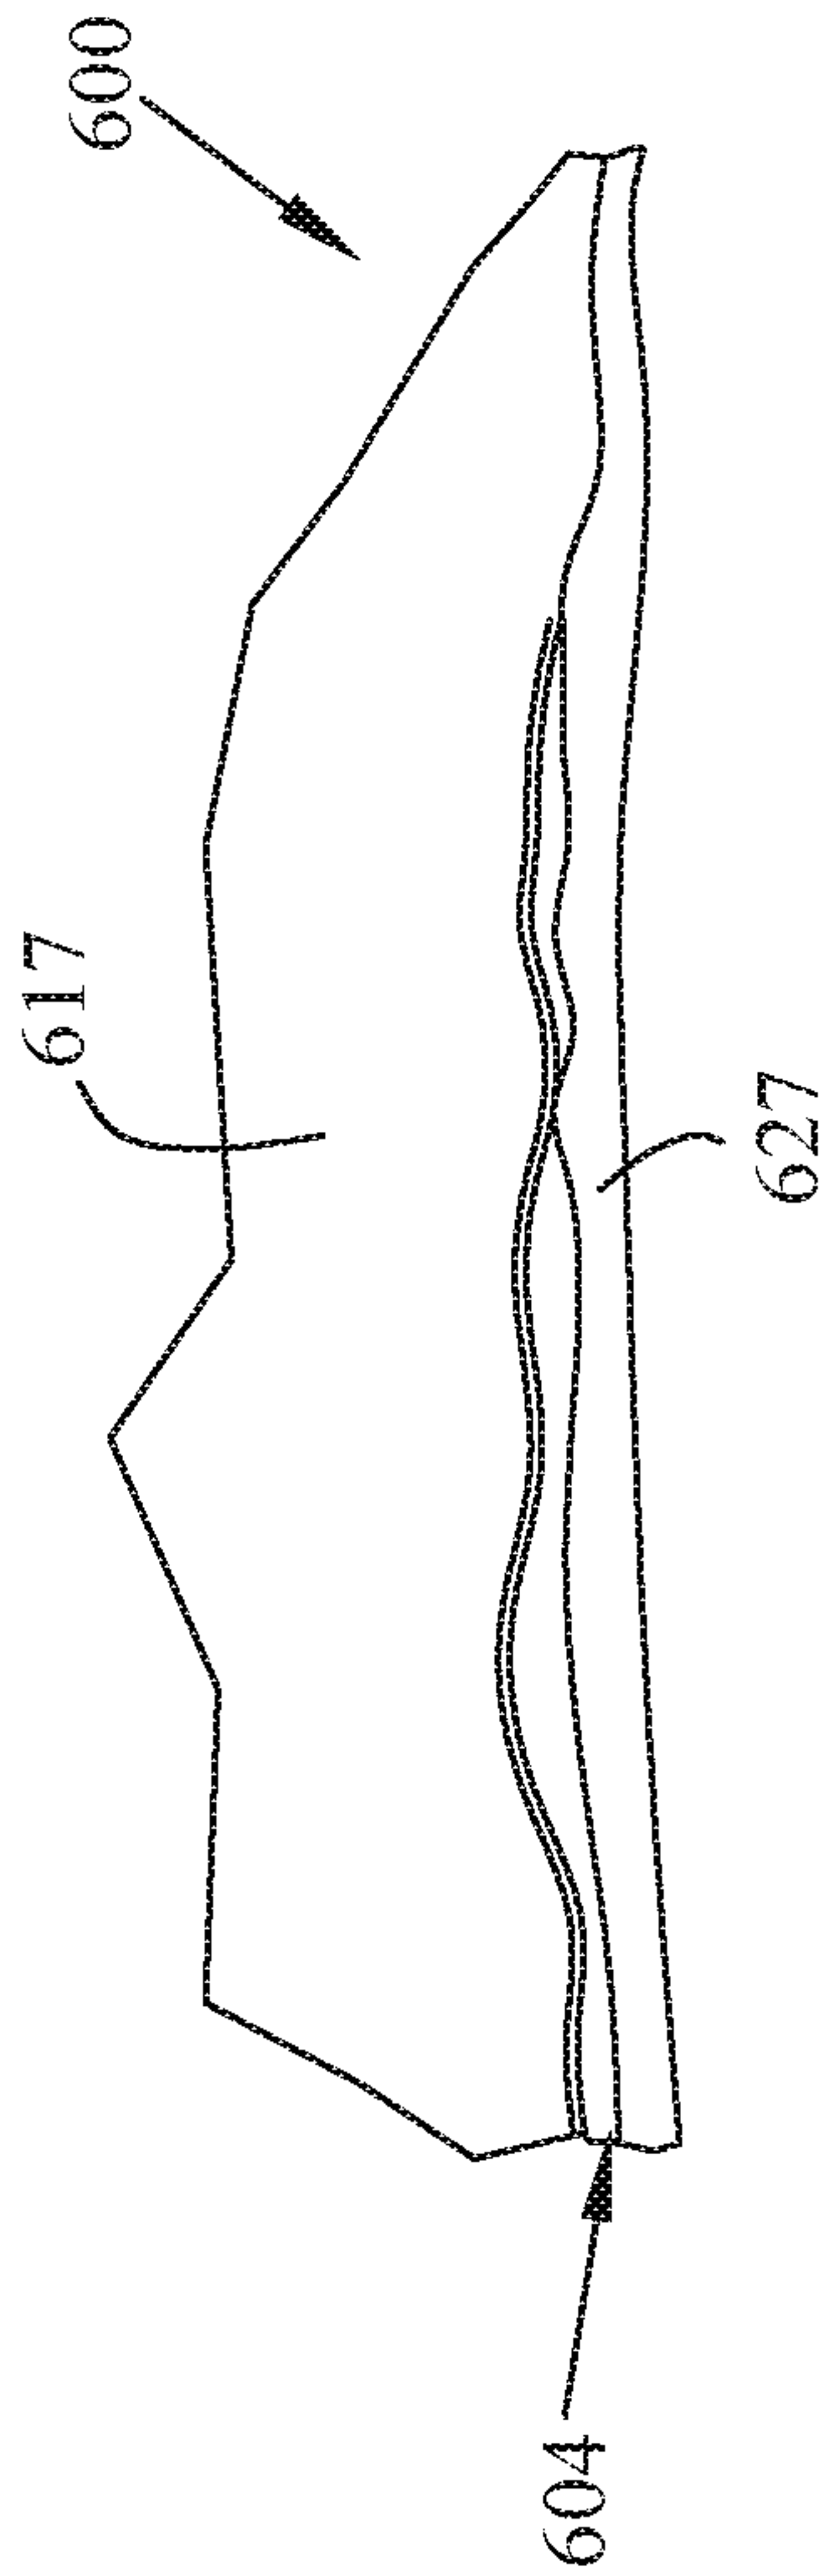
FIG. 28 is an end perspective view of another alternate embodiment vehicle frame and cargo bay liner shown laid out and having aluminum foil on both sides thereof;

Now referring to FIGS. 28-30, an additional embodiment of a 3-ply panel vehicle frame and cargo area liner is

generally indicated as **600**. As with vehicle frame and cargo area liners **500**, vehicle frame and cargo area liner **600** includes a corrugated liner, generally indicated as **604**. Corrugated liner **604** includes a top sheet **606**, a bottom sheet **608**, and a corrugated or sinusoidal ply **610** extending therebetween. Top sheet **606** and bottom sheet **608** are adhered or thermally attached to corrugated ply **610** and may be made from materials similar to corrugated liner **500**, such as but not limited to polyurethane or polyethylene. Alternatively, liner **600** may be an extruded manufactured design, as is well known in the art, including a top ply, a bottom ply and transverse supports, extending between the top and bottom plies, which can include square or rectangular passageways between the plies. Likewise, the extruded liner may be manufactured from materials such as, but not limited to polyurethane or polyethylene.
