US011447189B1

(54) **VEHICLE FRAME AND CARGO BAY LINER**

(57) **ABSTRACT**

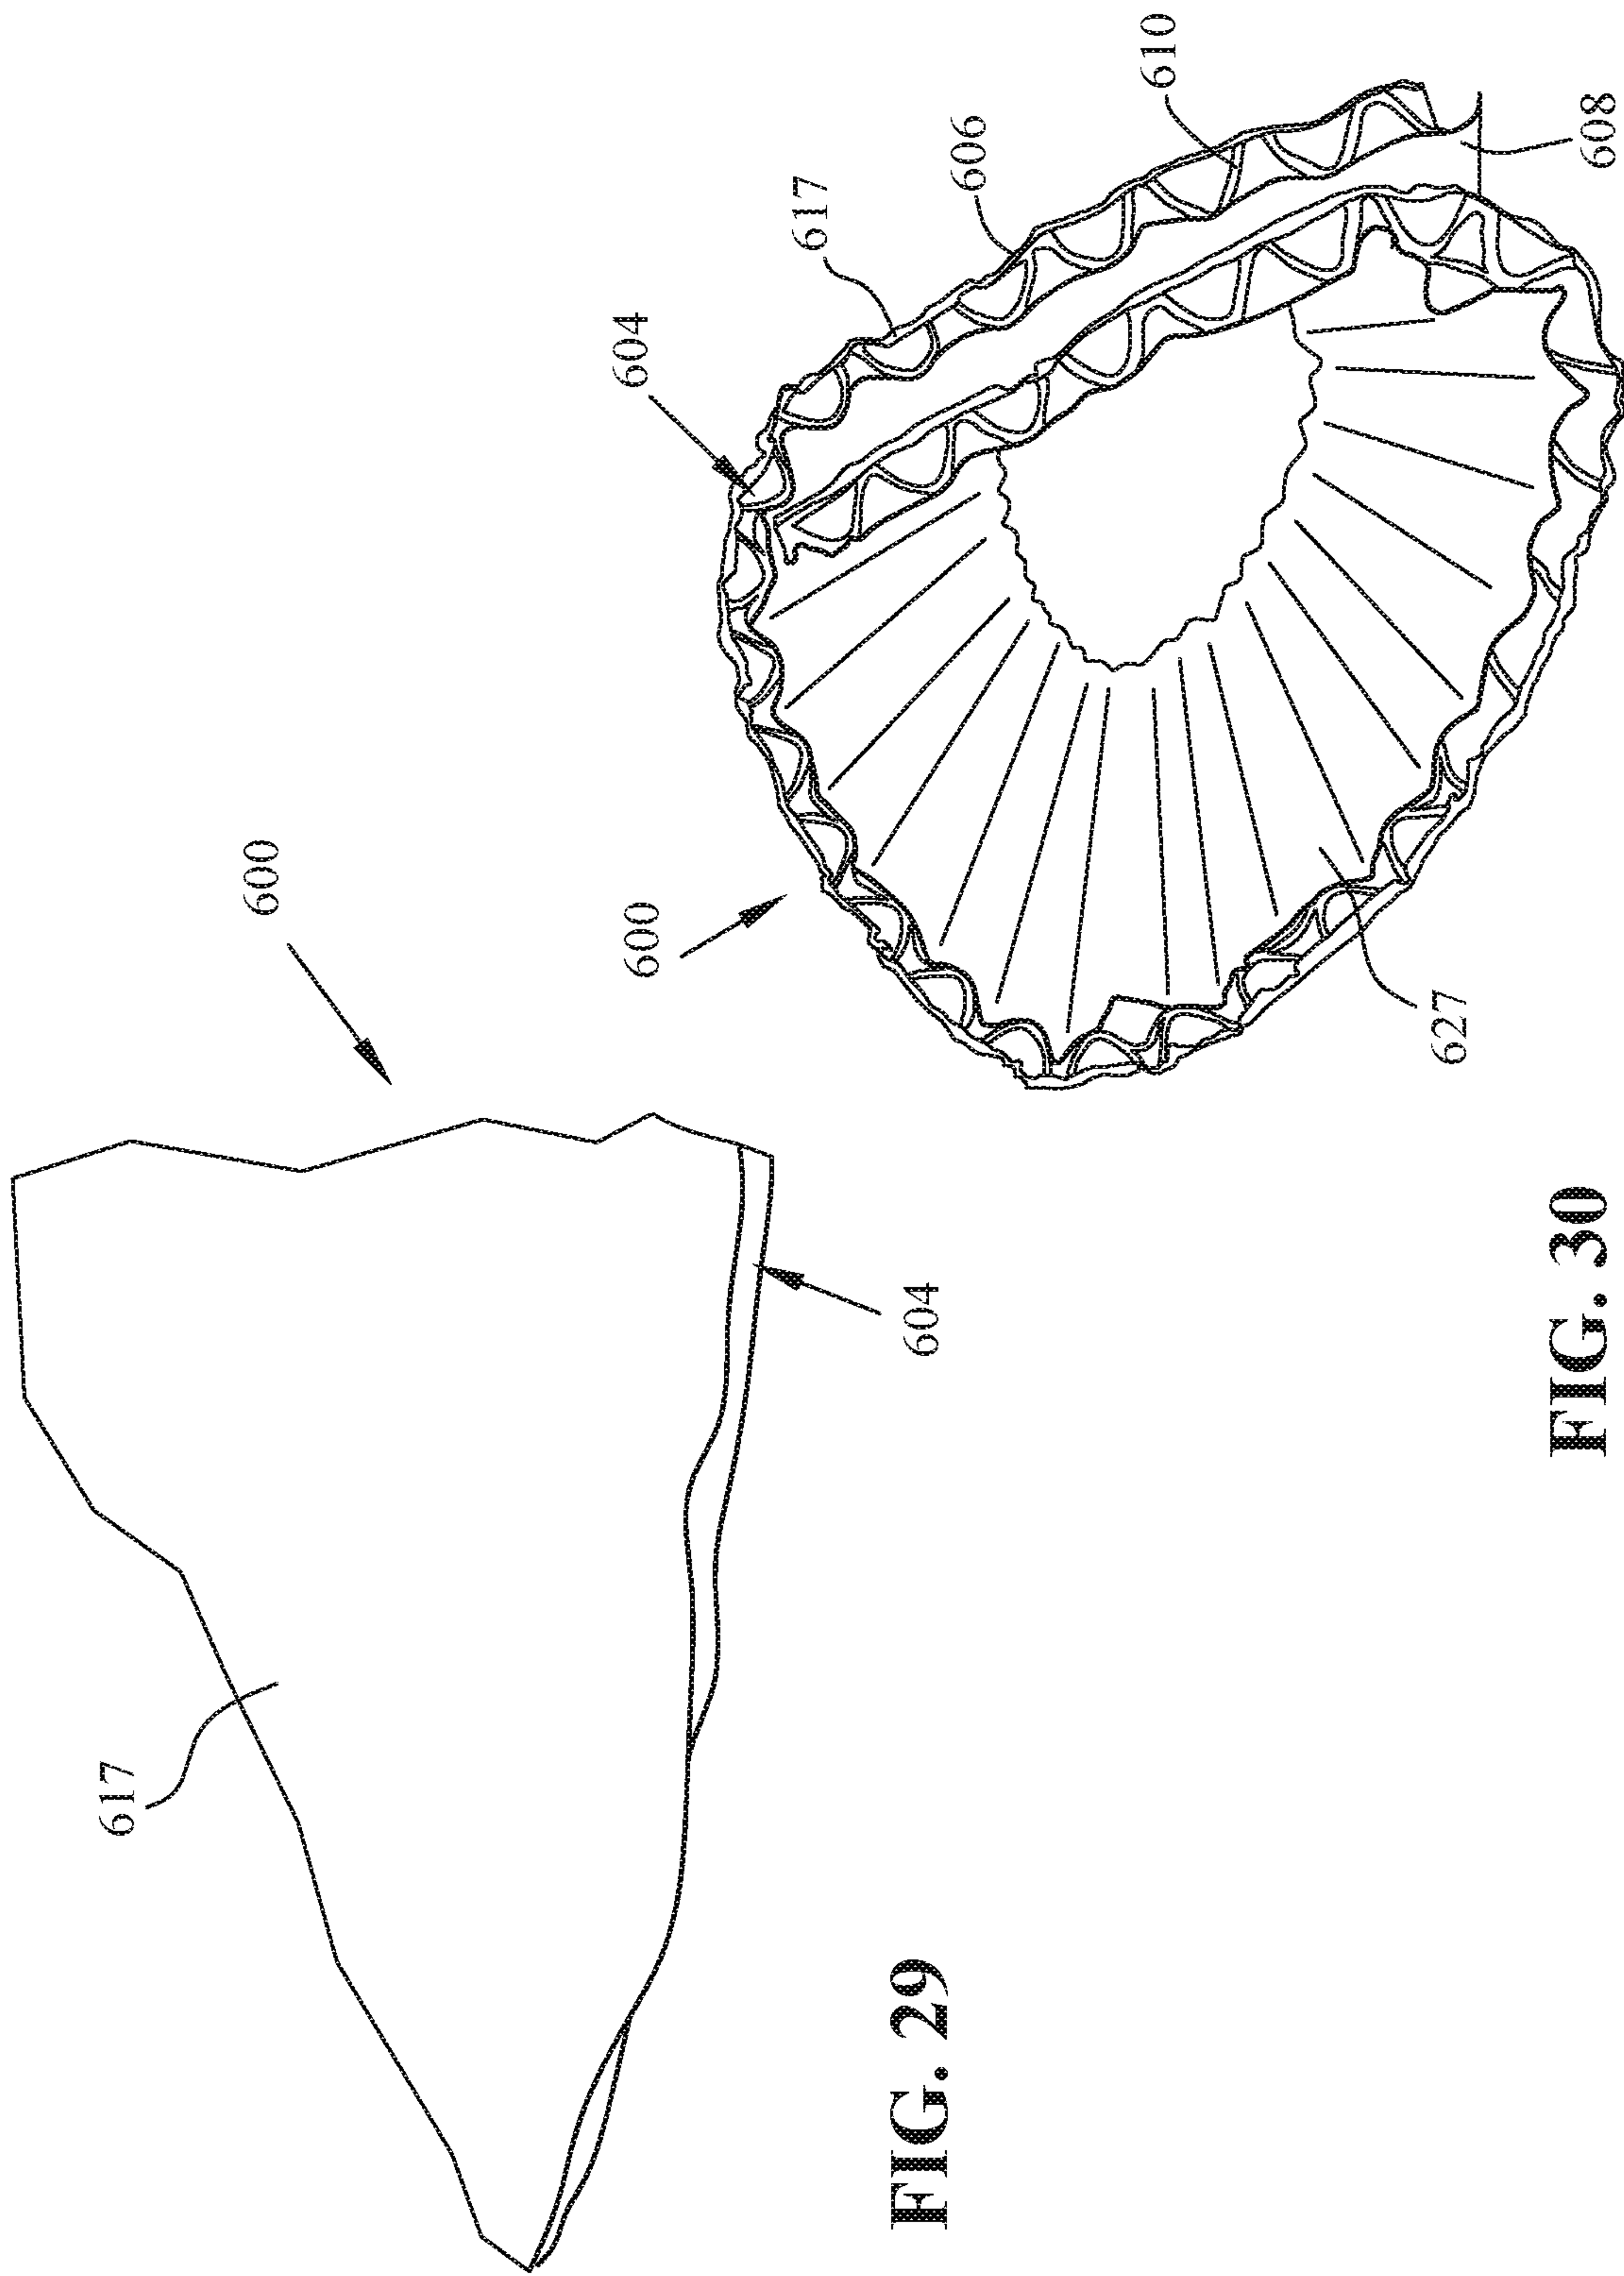
FIG. 29 is a perspective view of the vehicle frame and cargo bay liner of FIG. 28;

As with vehicle and frame and cargo area liner **500**, liner **600** also includes an aluminum foil or sheet **617** adhered to top ply or sheet **606**. Additionally, however, vehicle frame and cargo area liner **600** also includes a second aluminum foil or sheet **627** adhered to bottom sheet or ply **608** of corrugated liner **604**.

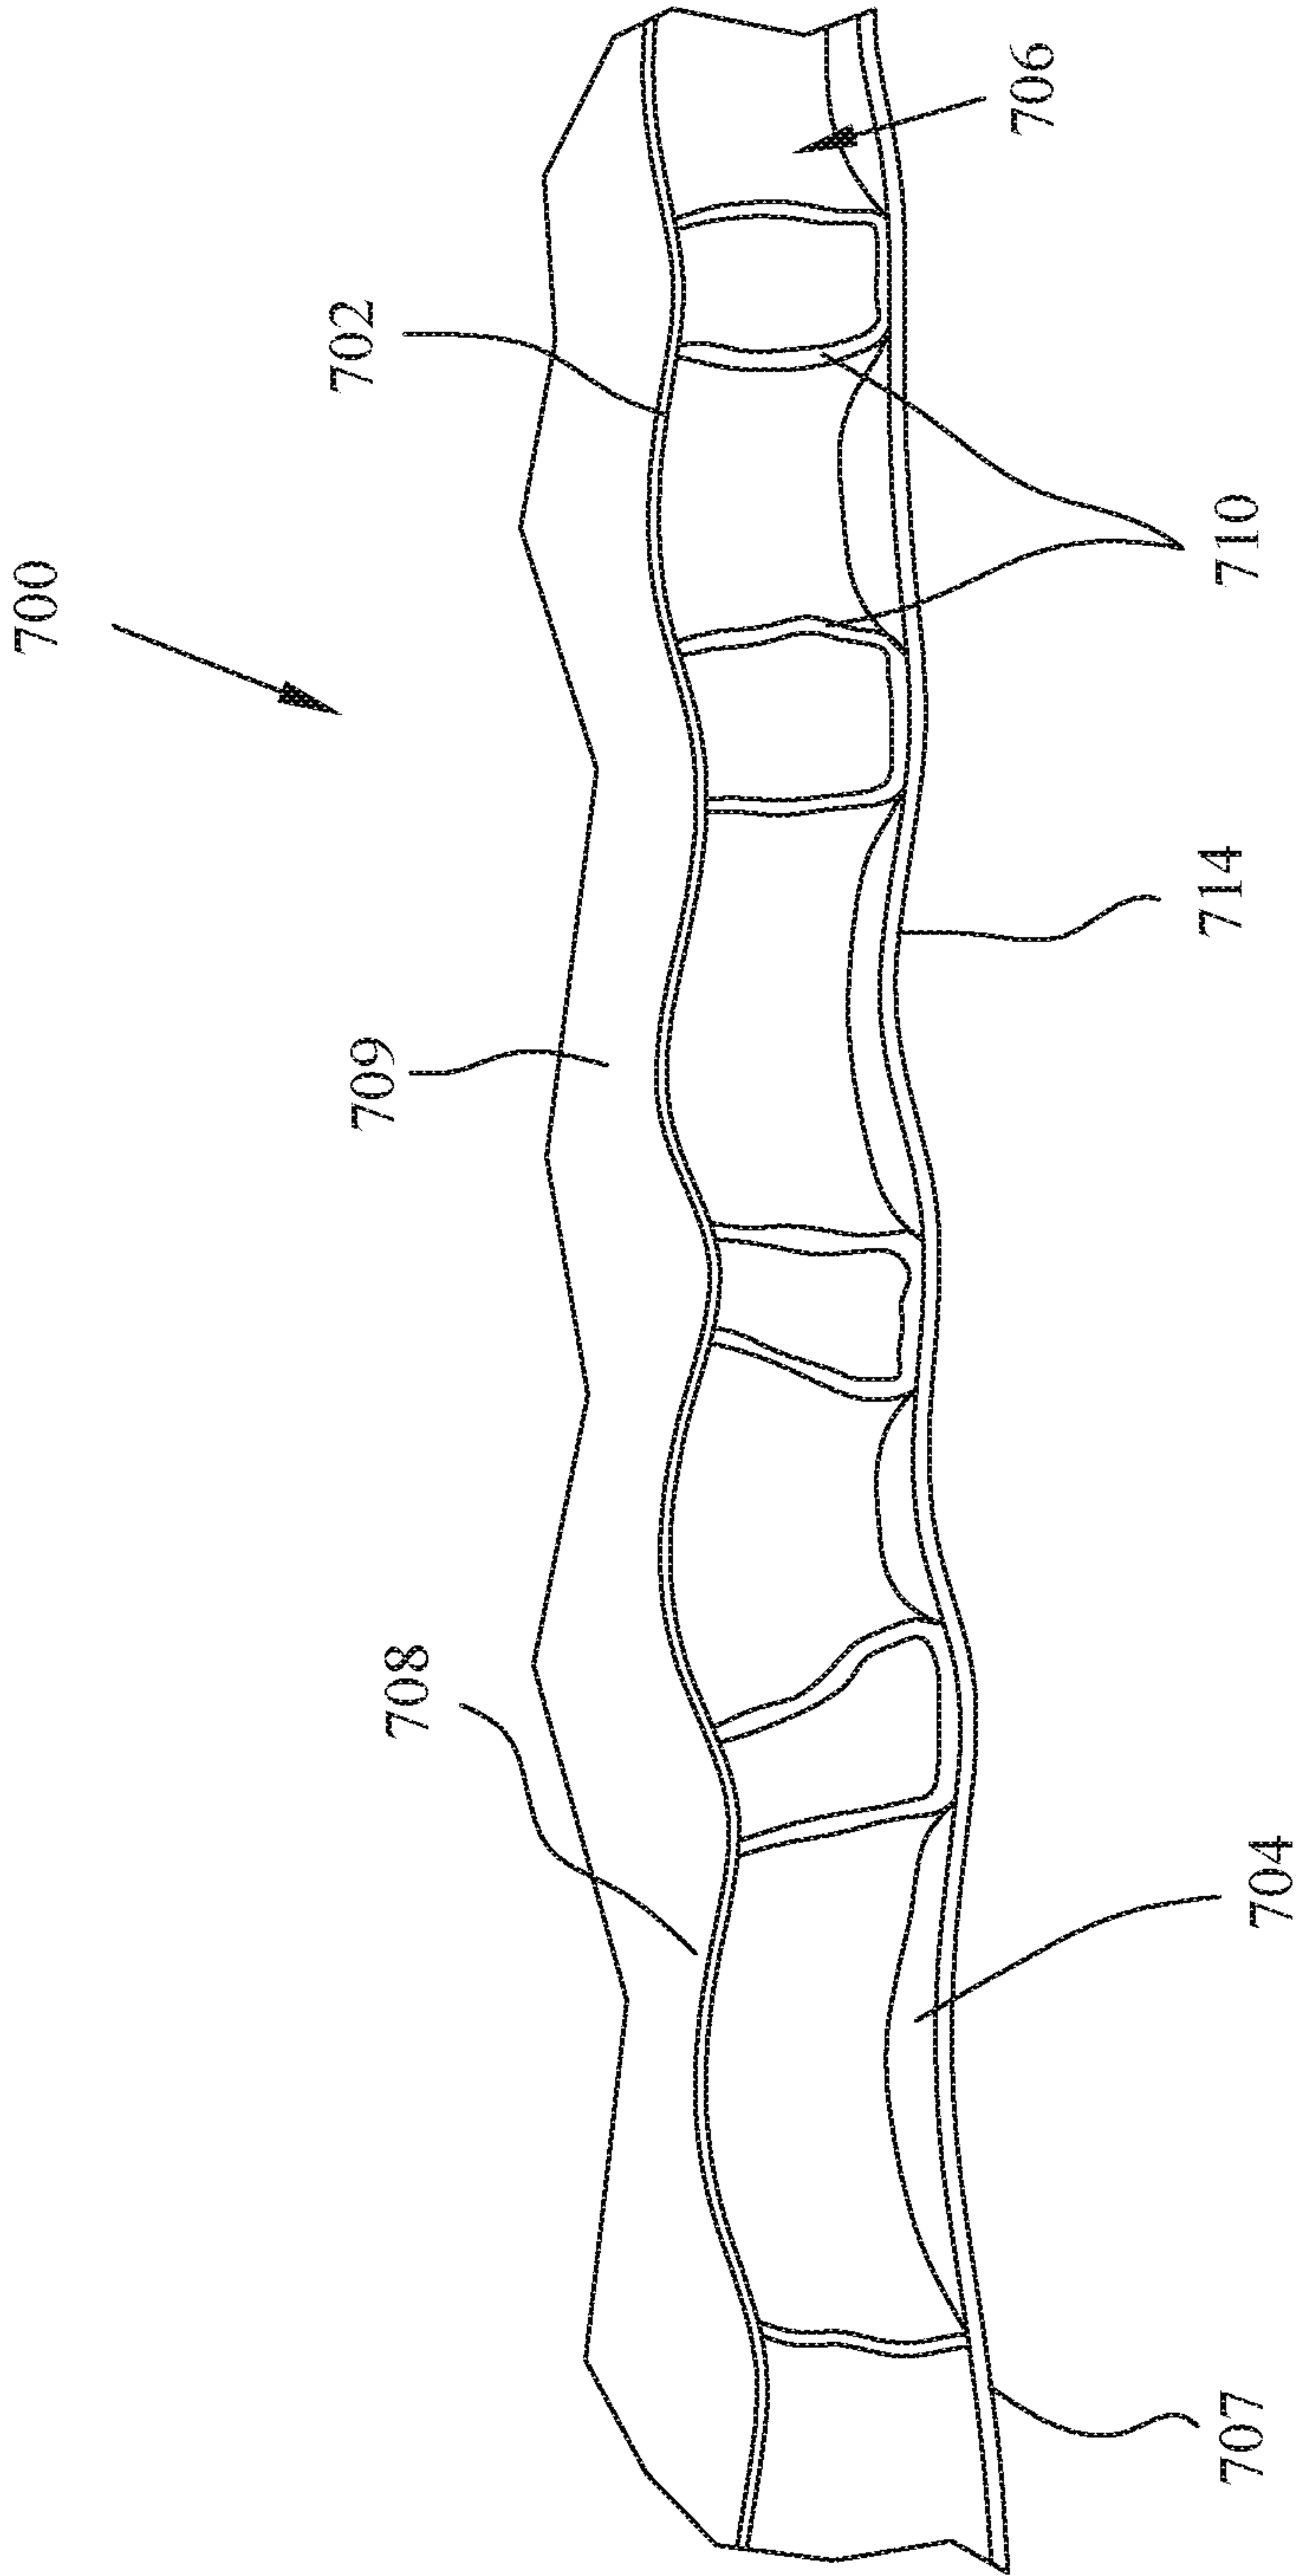
FIG. 31 is a side perspective view of yet another alternate embodiment vehicle frame and cargo bay liner having an aluminum foil on one side and a woven material on the opposite side

Now referring to FIGS. **31-34**, another alternate vehicle frame and cargo area liner is shown generally indicated as **700**. Liner **700** can be provided in a coiled form as liner **400**, making it extremely suitable for use as a liner for vehicle frames and cargo bays. The desired length of liner can be rolled out and cut to size for assembly to the vehicle. Vehicle frame and cargo bay liner **700** is of a 3-ply configuration and includes a top ply, sheet, or layer **702** and a bottom ply, sheet, or layer **704**. A core **706** (see FIG. **31**) separates top sheet **702** from bottom sheet **704**. Additionally, vehicle frame and cargo bay liner **700** also includes a sheet of aluminum foil or metalized film **707** on one side thereof. In the embodiment shown, aluminum foil/metalized film **707** is provided on bottom sheet **404**; however, it should be appreciated that aluminum foil/metalized film could also be provided on the top sheet **702** (see embodiment **700A** discussed below). Aluminum foil/film **707** may be adhered to bottom sheet **704** using an adhesive or other suitable means. Vehicle frame and cargo bay liner **700** also includes a woven or nonwoven layer of material **709** adhered to top layer **702**, opposite the side with aluminum foil **707** or metalized film. In one embodiment, material **709** is a woven sheet of polypropylene fabric.

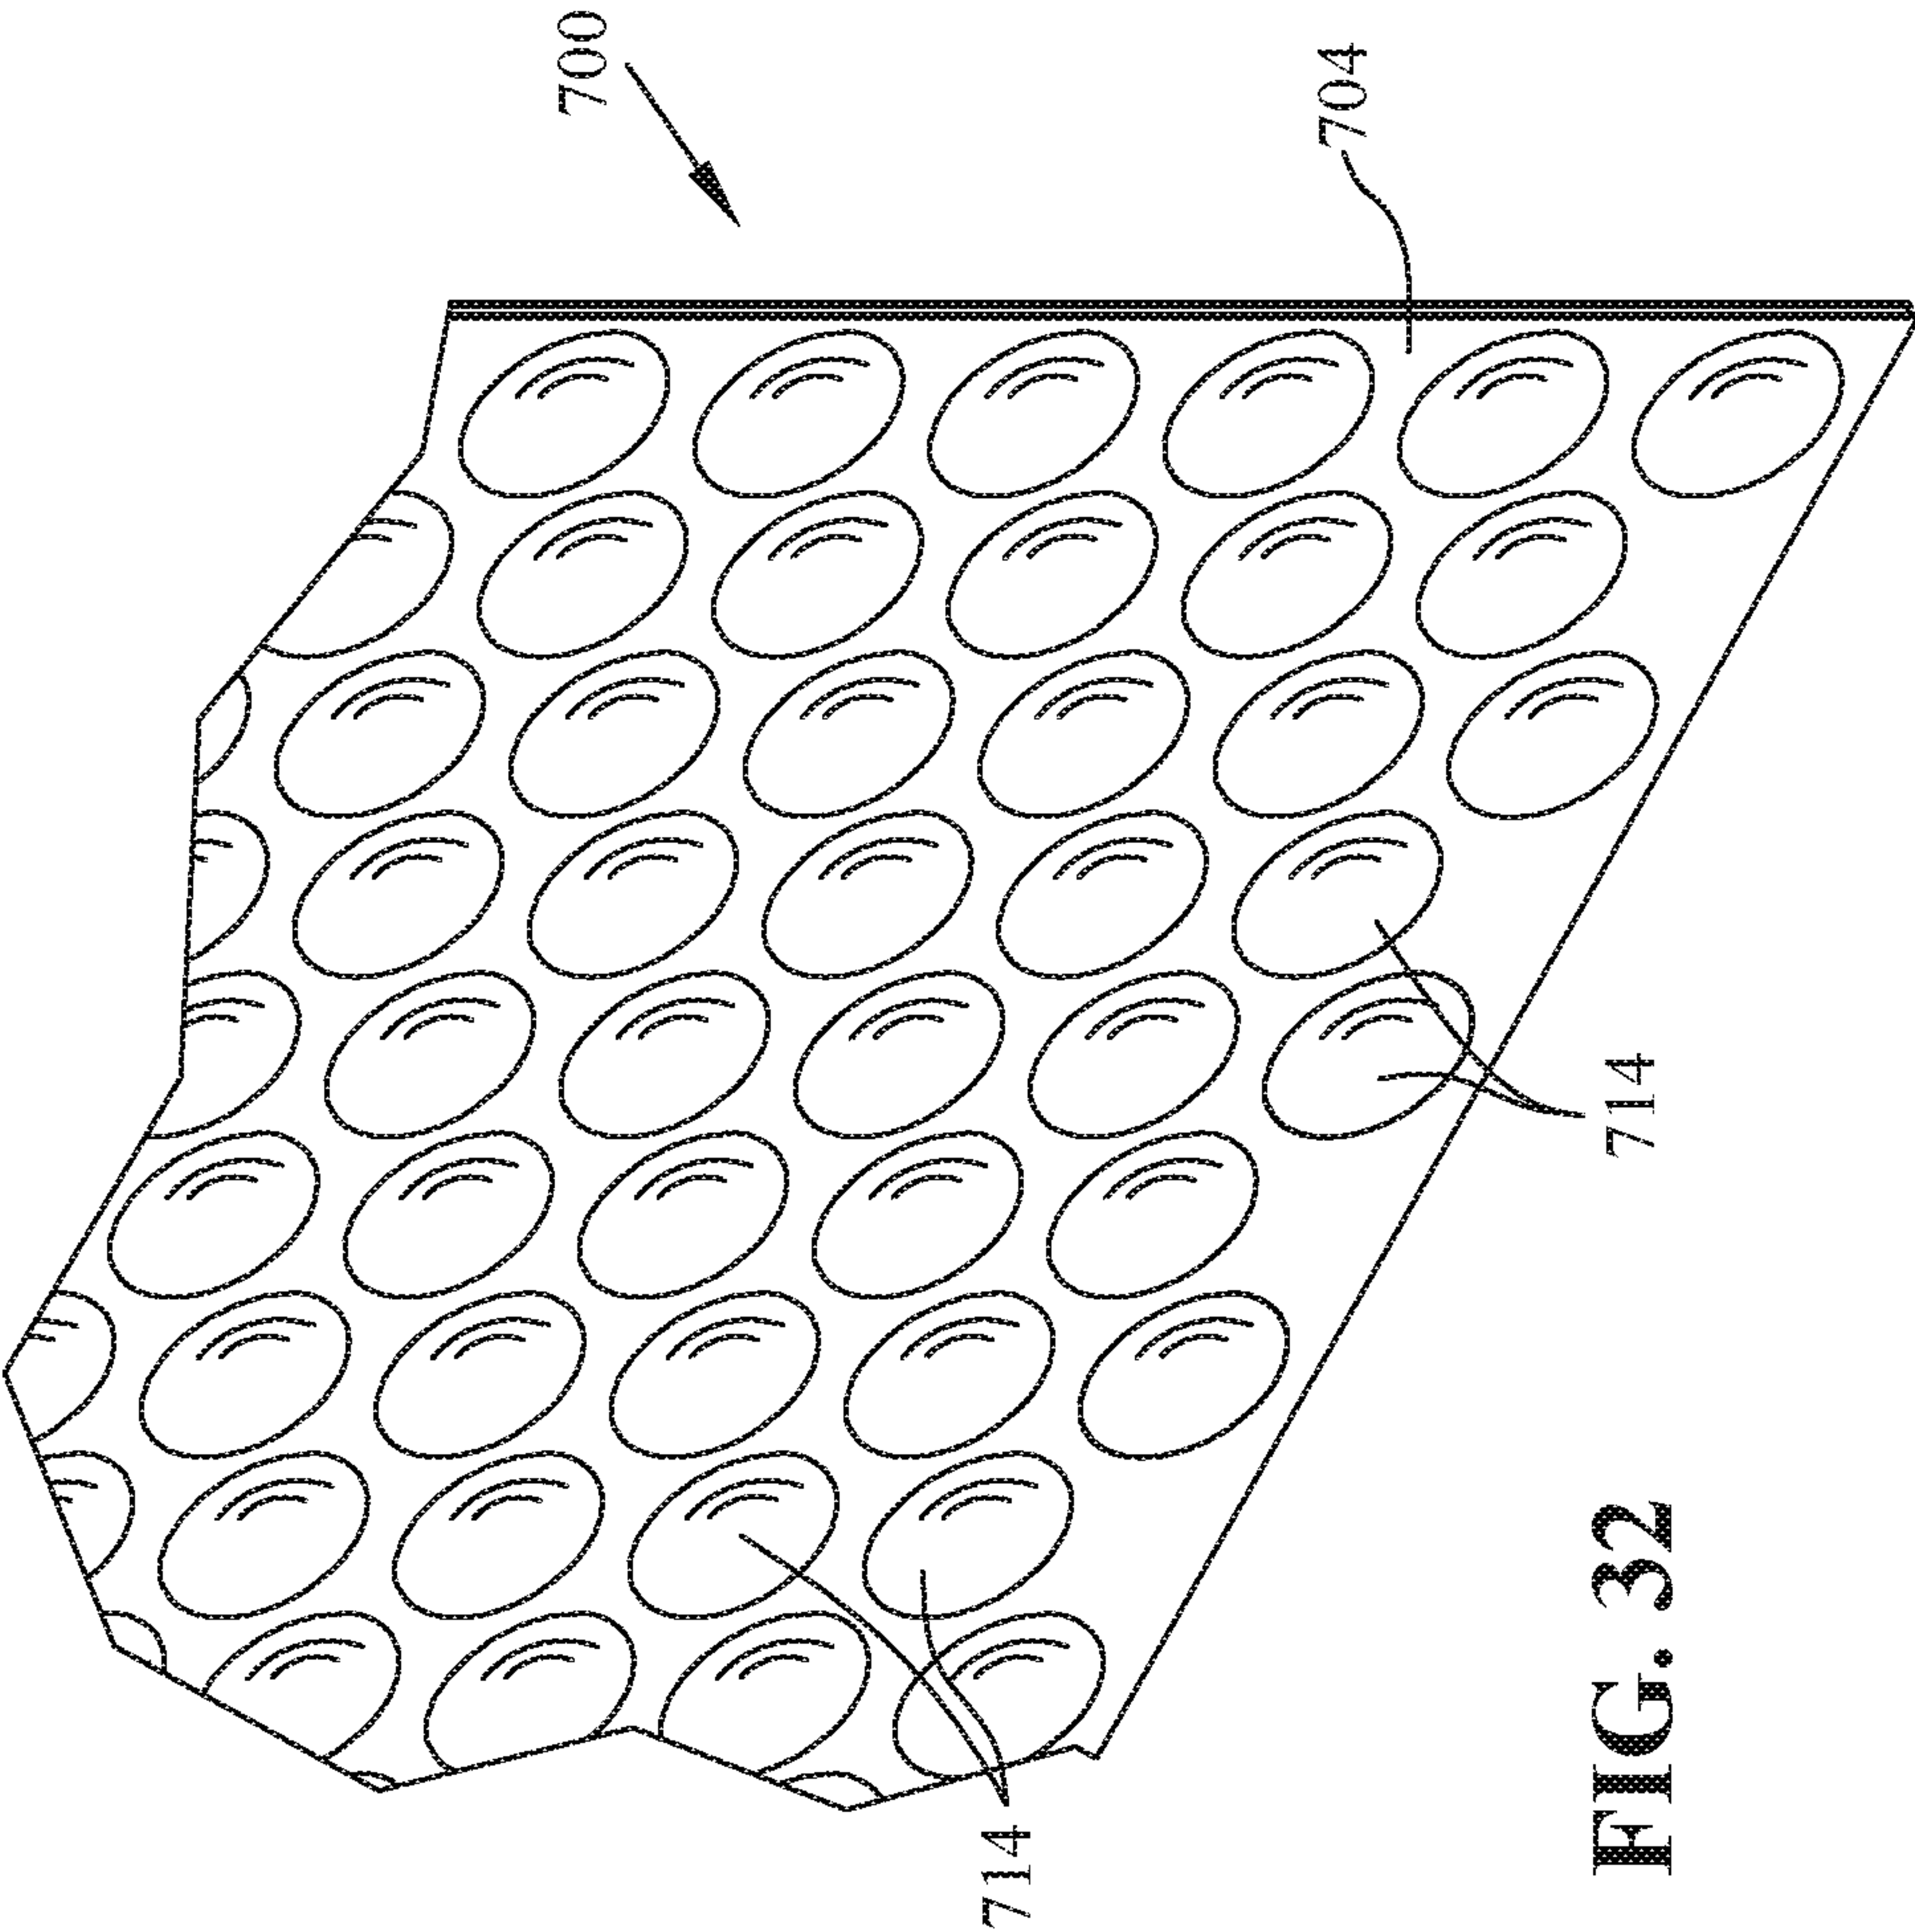
FIG. 32 is a plan view of the vehicle frame and cargo bay liner of FIG. 31 with the aluminum foil and woven material removed show a layer of the liner having dimples thereon.

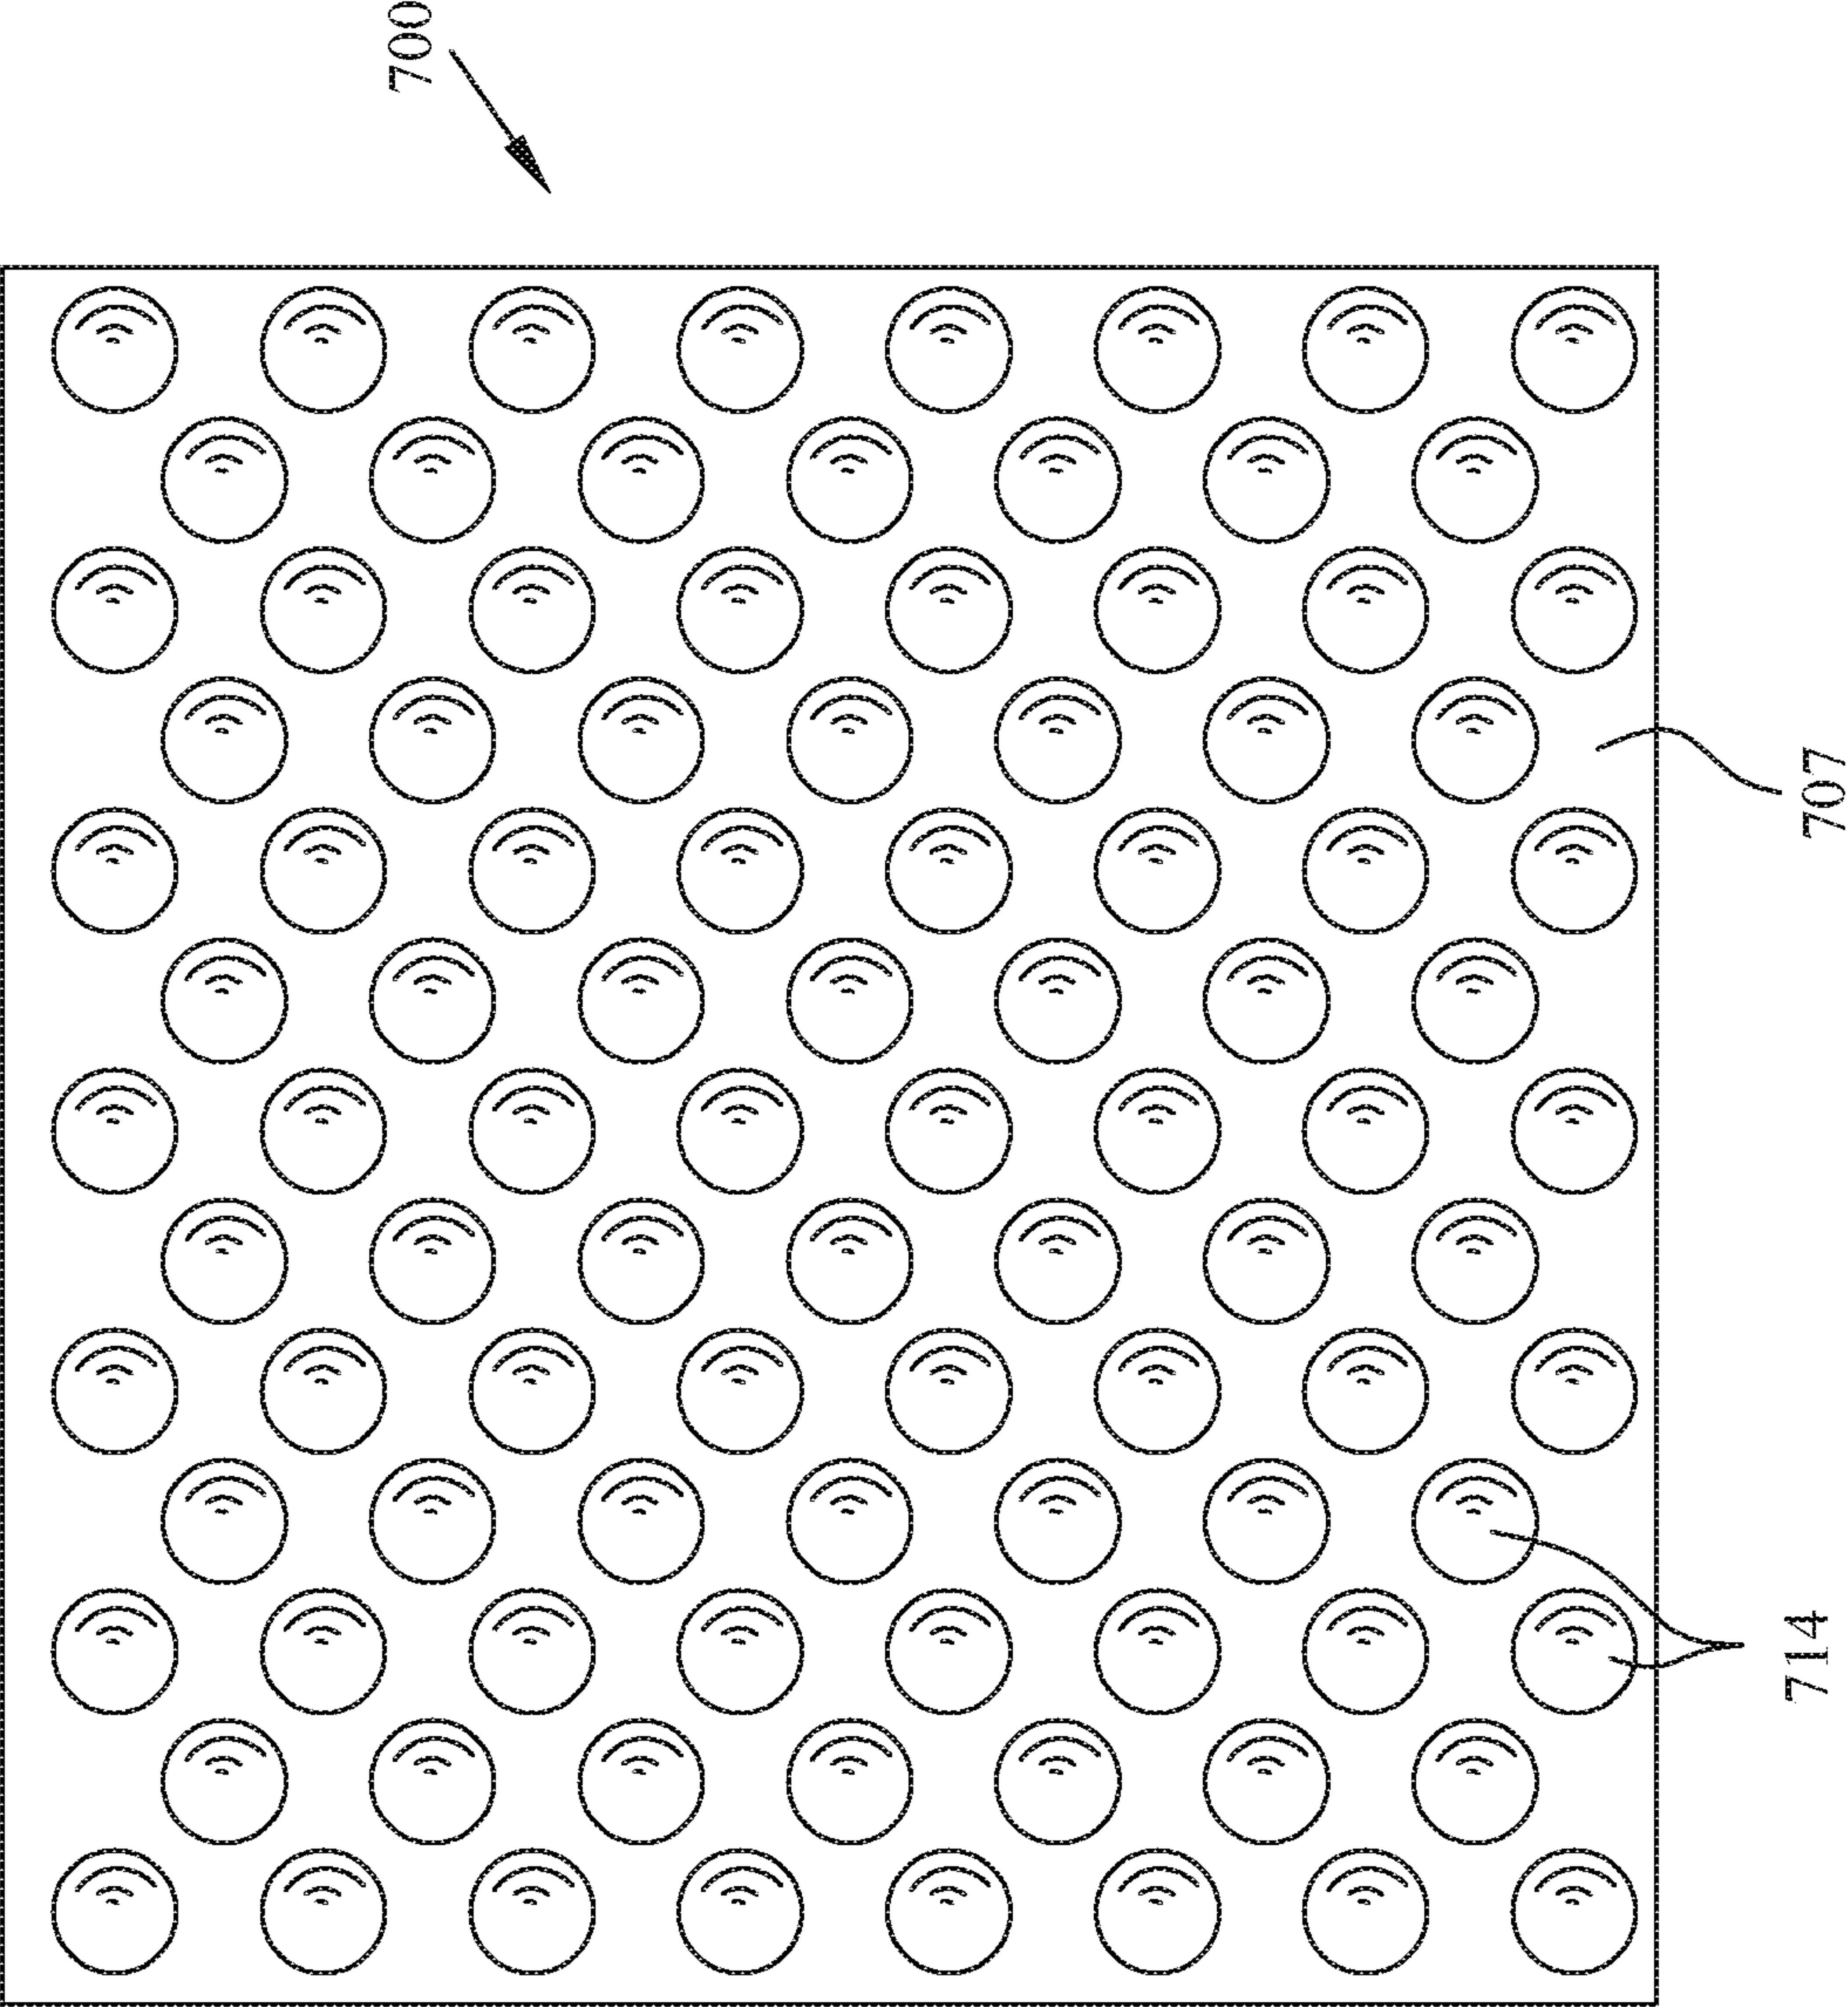
FIG. 33 is a perspective plan view of the vehicle frame and cargo bay liner of FIG. 31 showing the side with dimples and aluminum foil thereon;

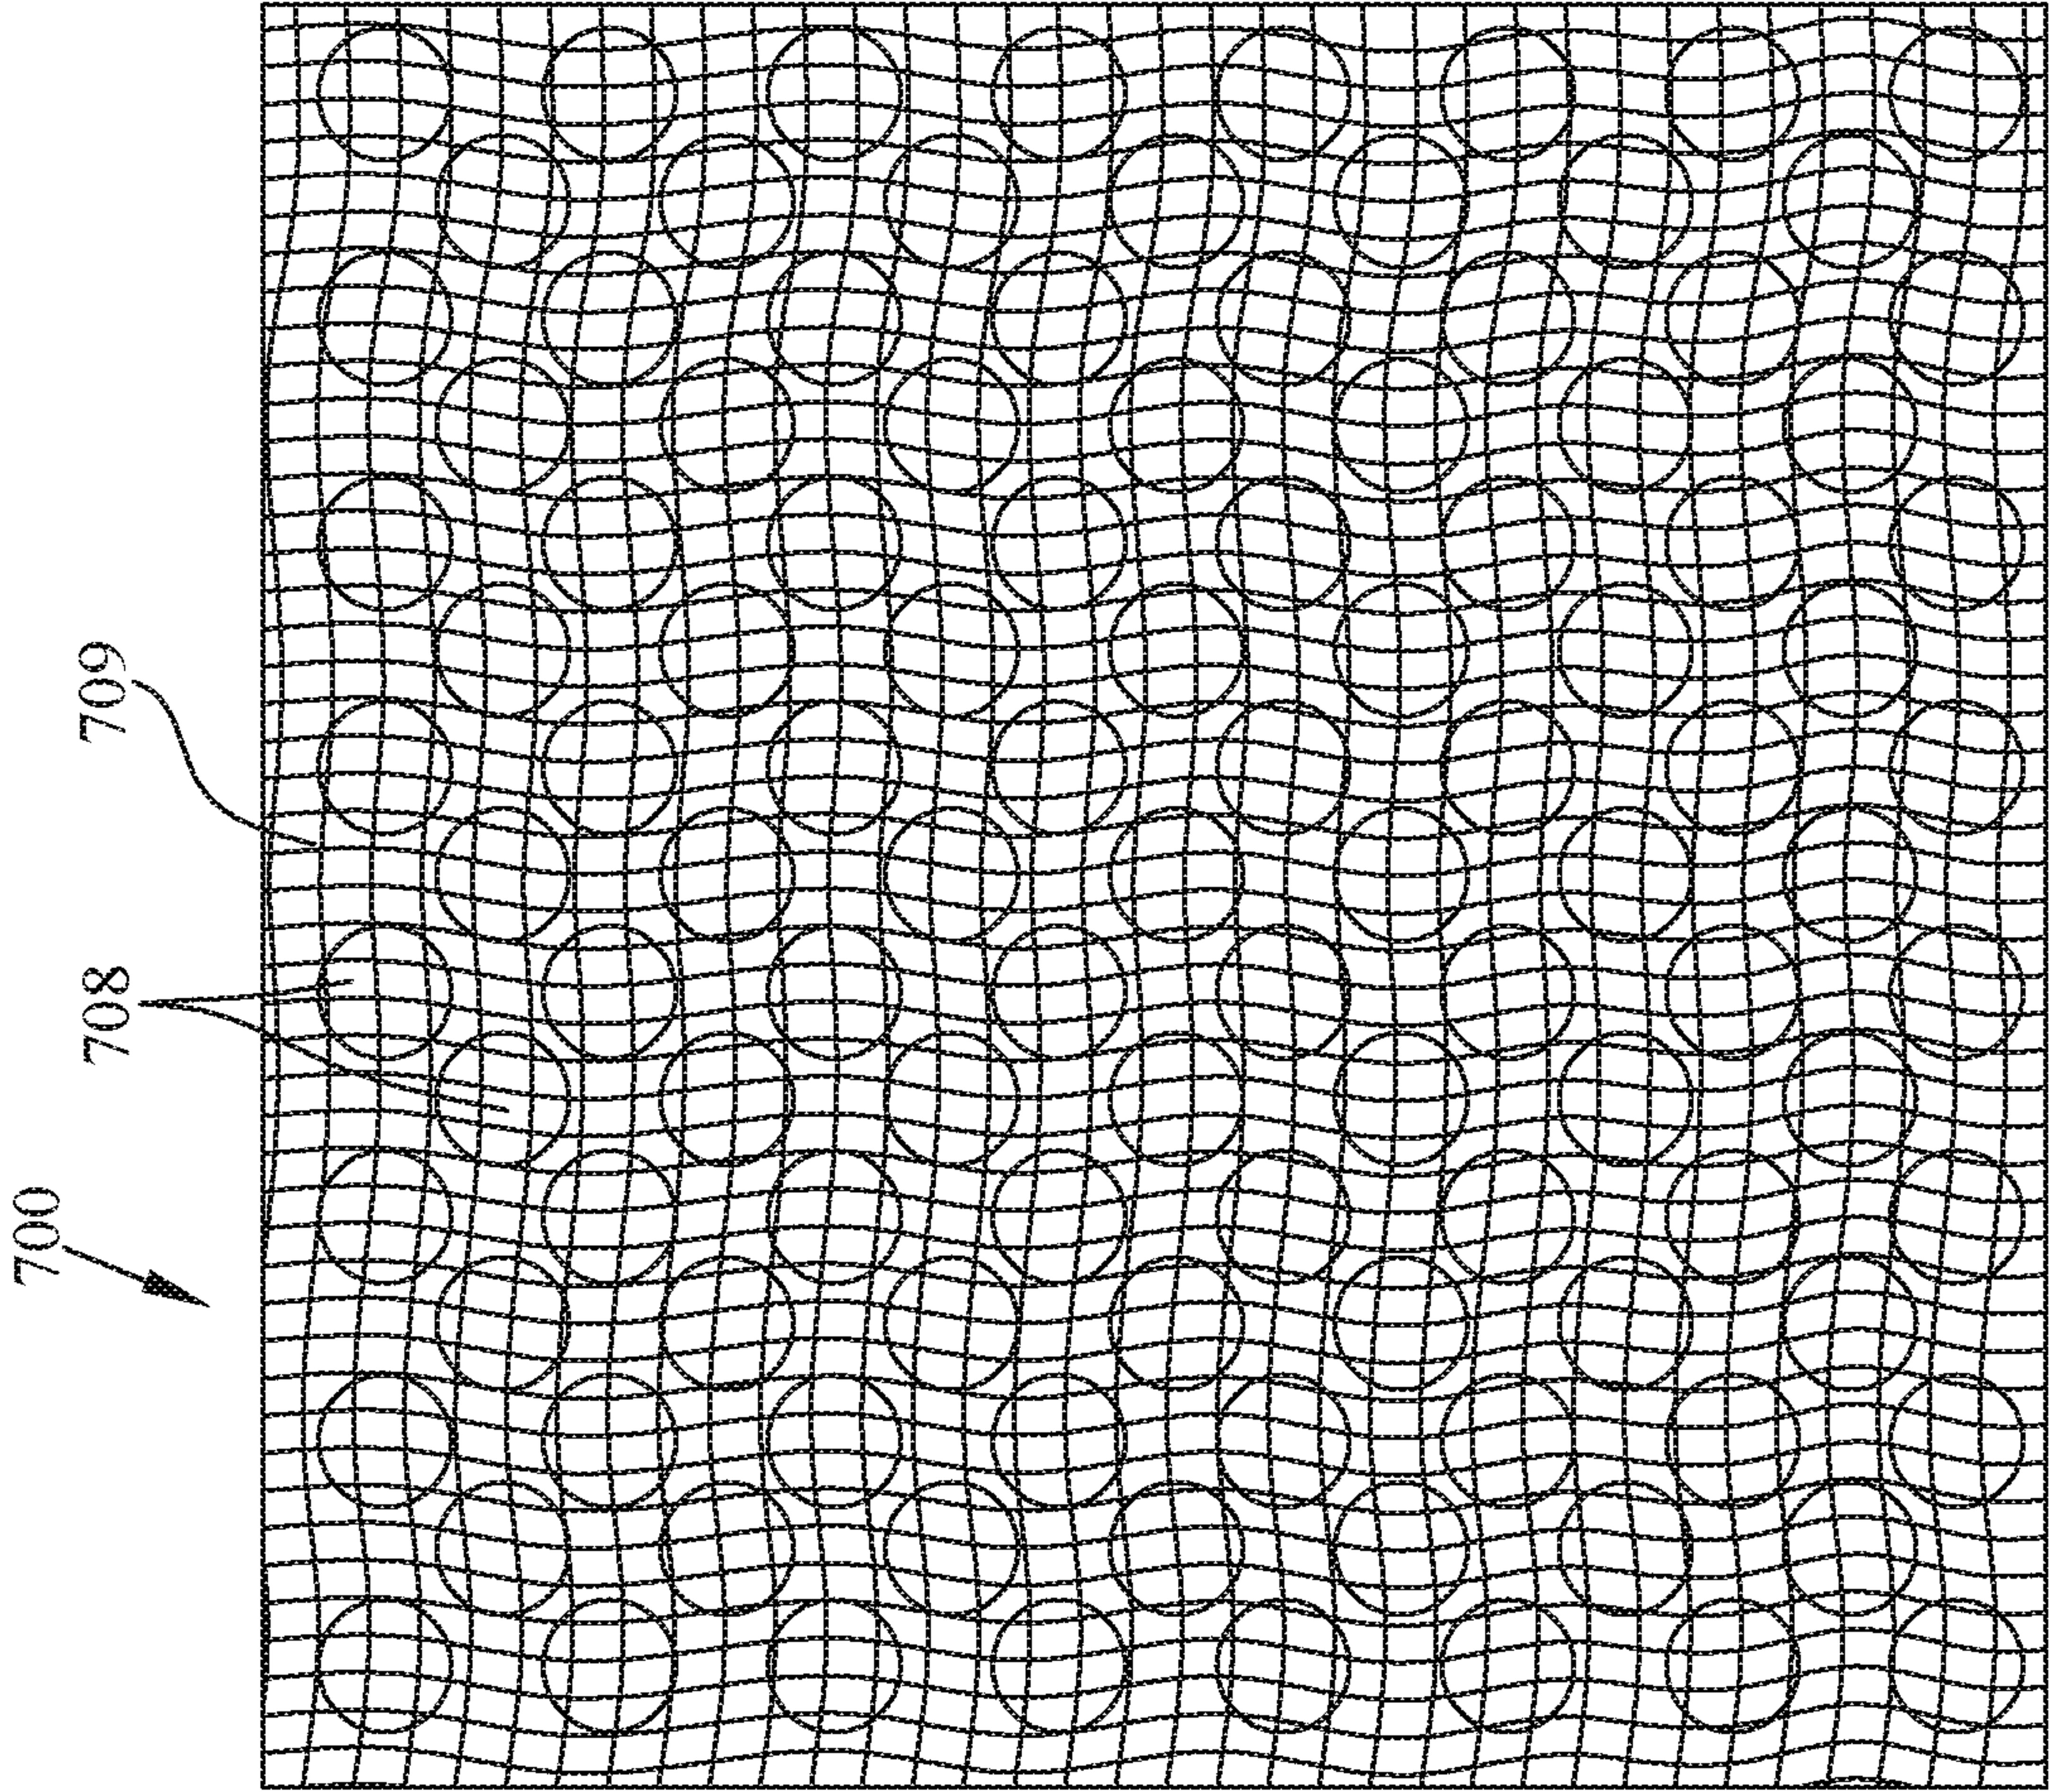
FIG. 34 is a perspective plan view of the vehicle frame and cargo bay liner of FIG. 31 showing a side with convexities and a woven material thereon;

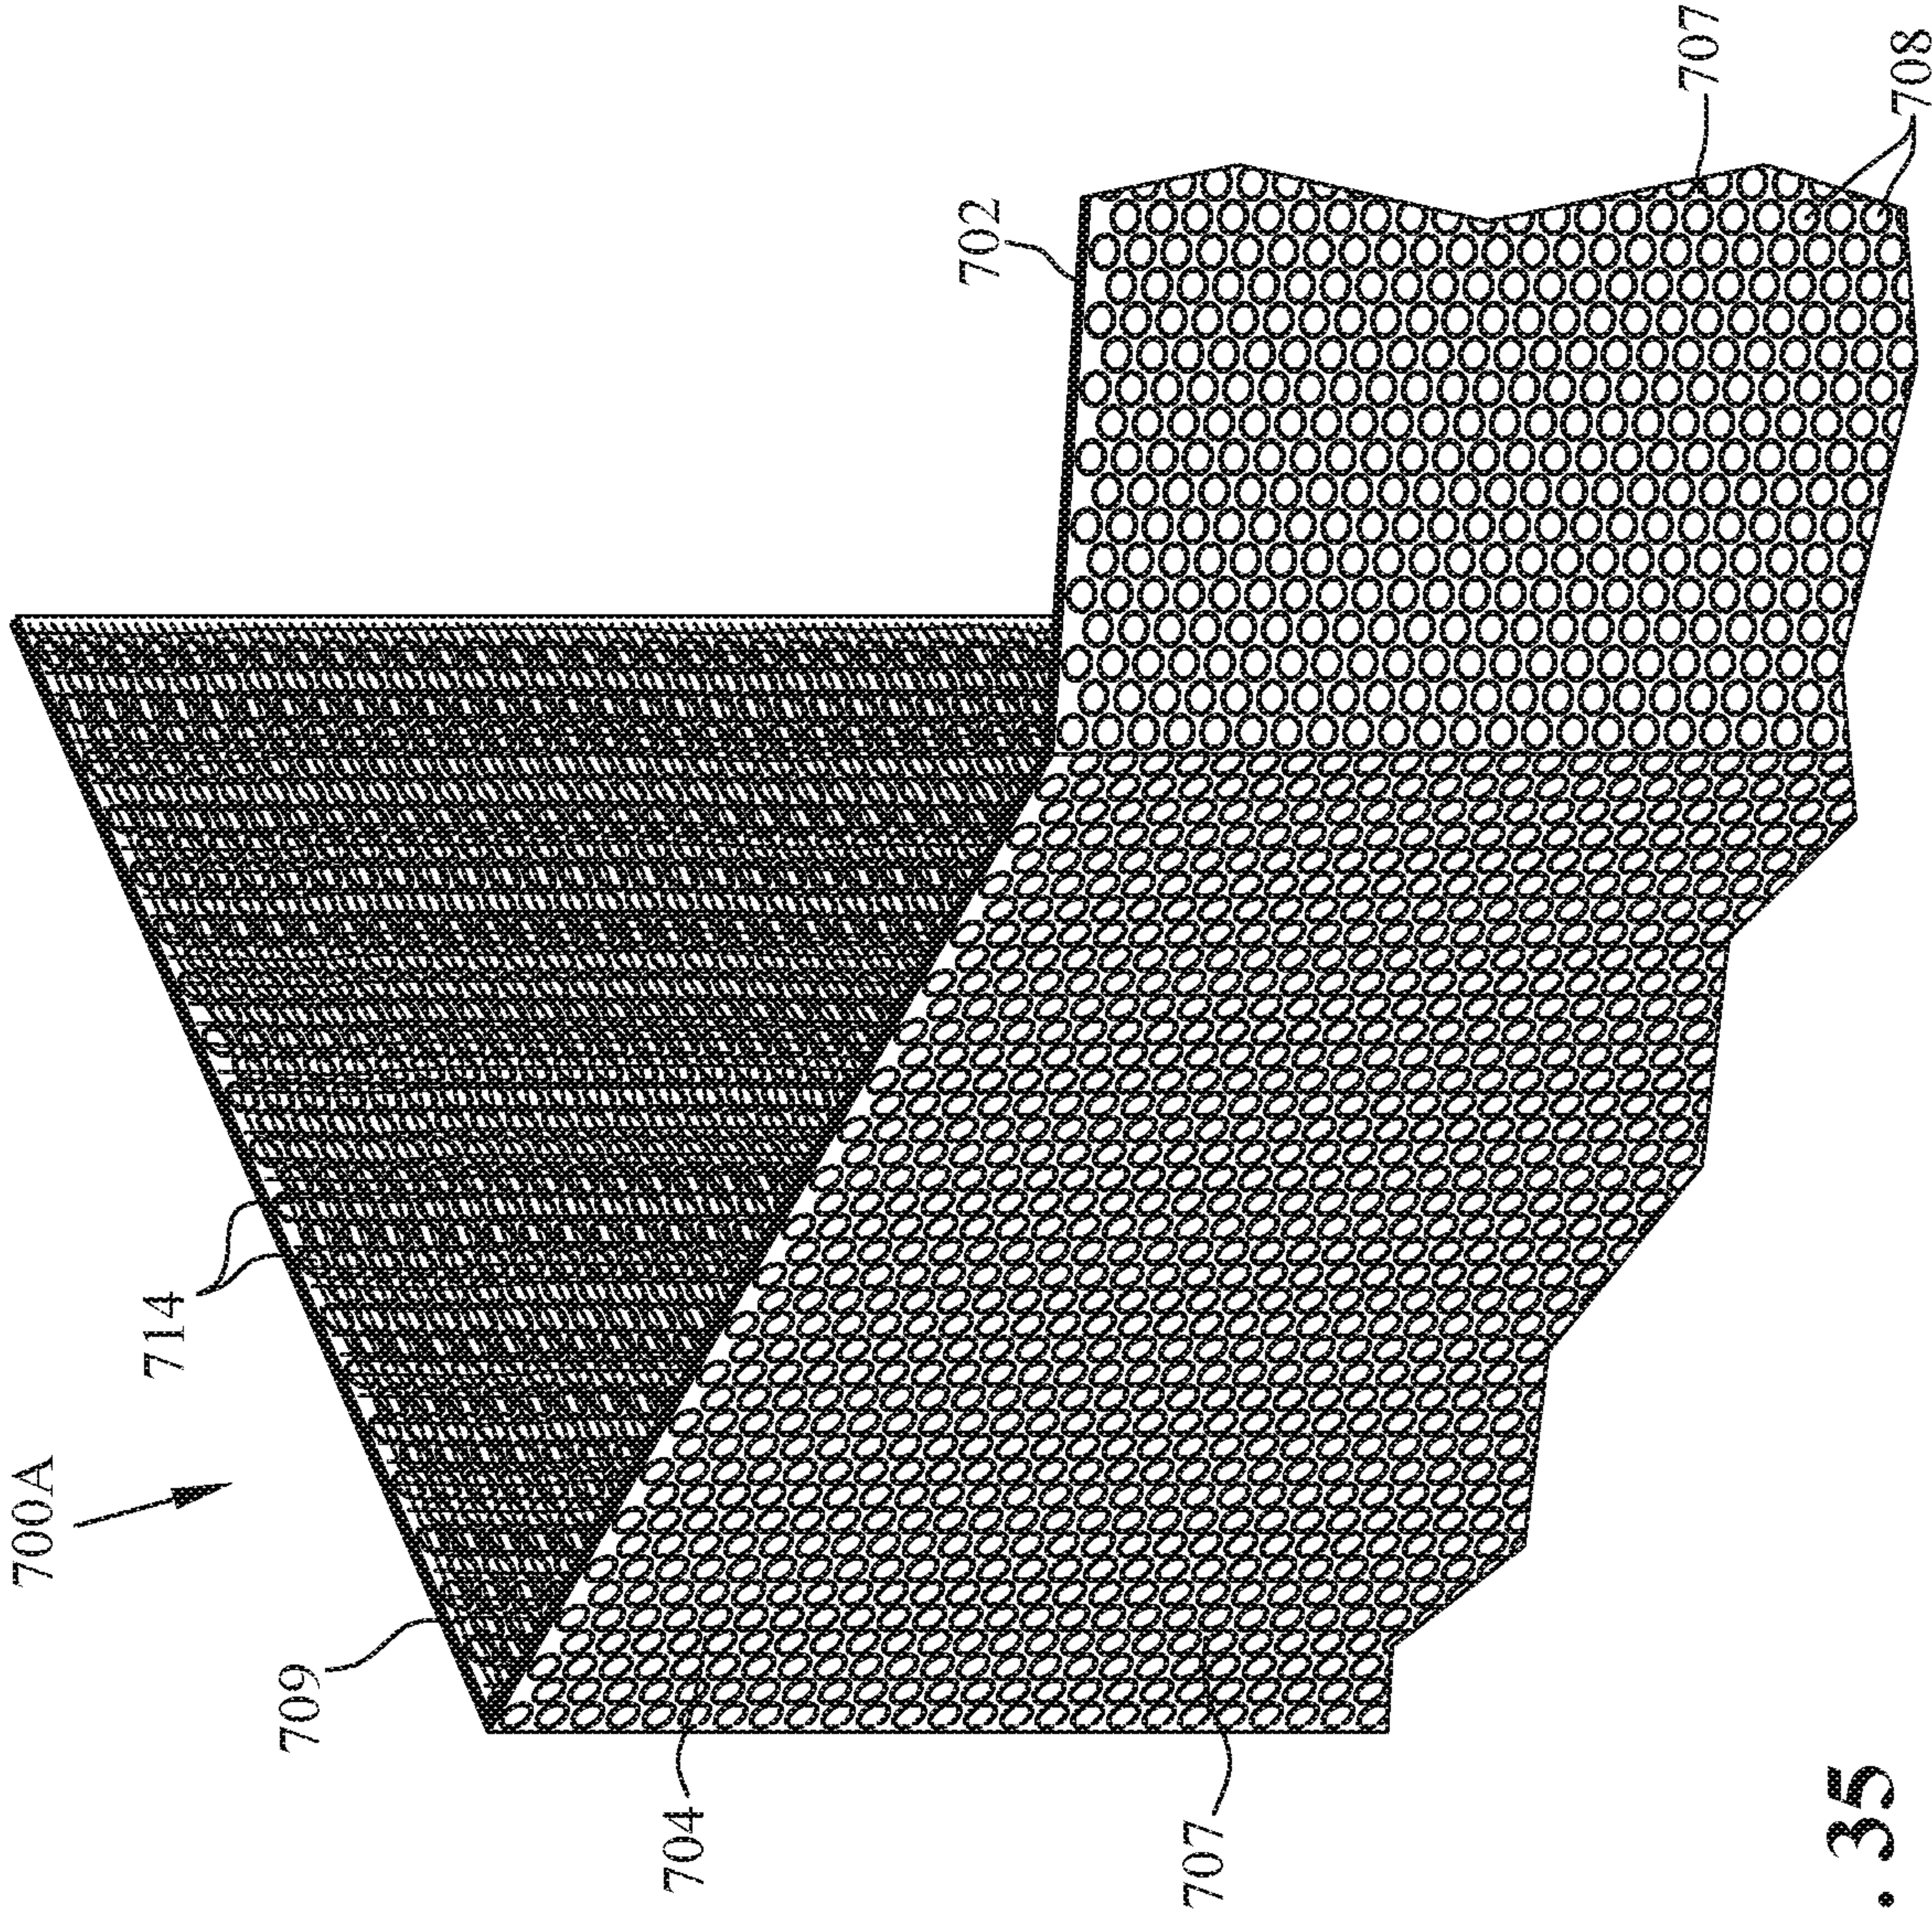
FIG. 35 is a perspective of a similar alternate embodiment view of a vehicle frame and cargo bay liner like FIG. 31, but with the aluminum foil on the side with convexities and a woven material on the opposite side with dimples;
