US011447189B1

(54) **VEHICLE FRAME AND CARGO BAY LINER**

(57) **ABSTRACT**

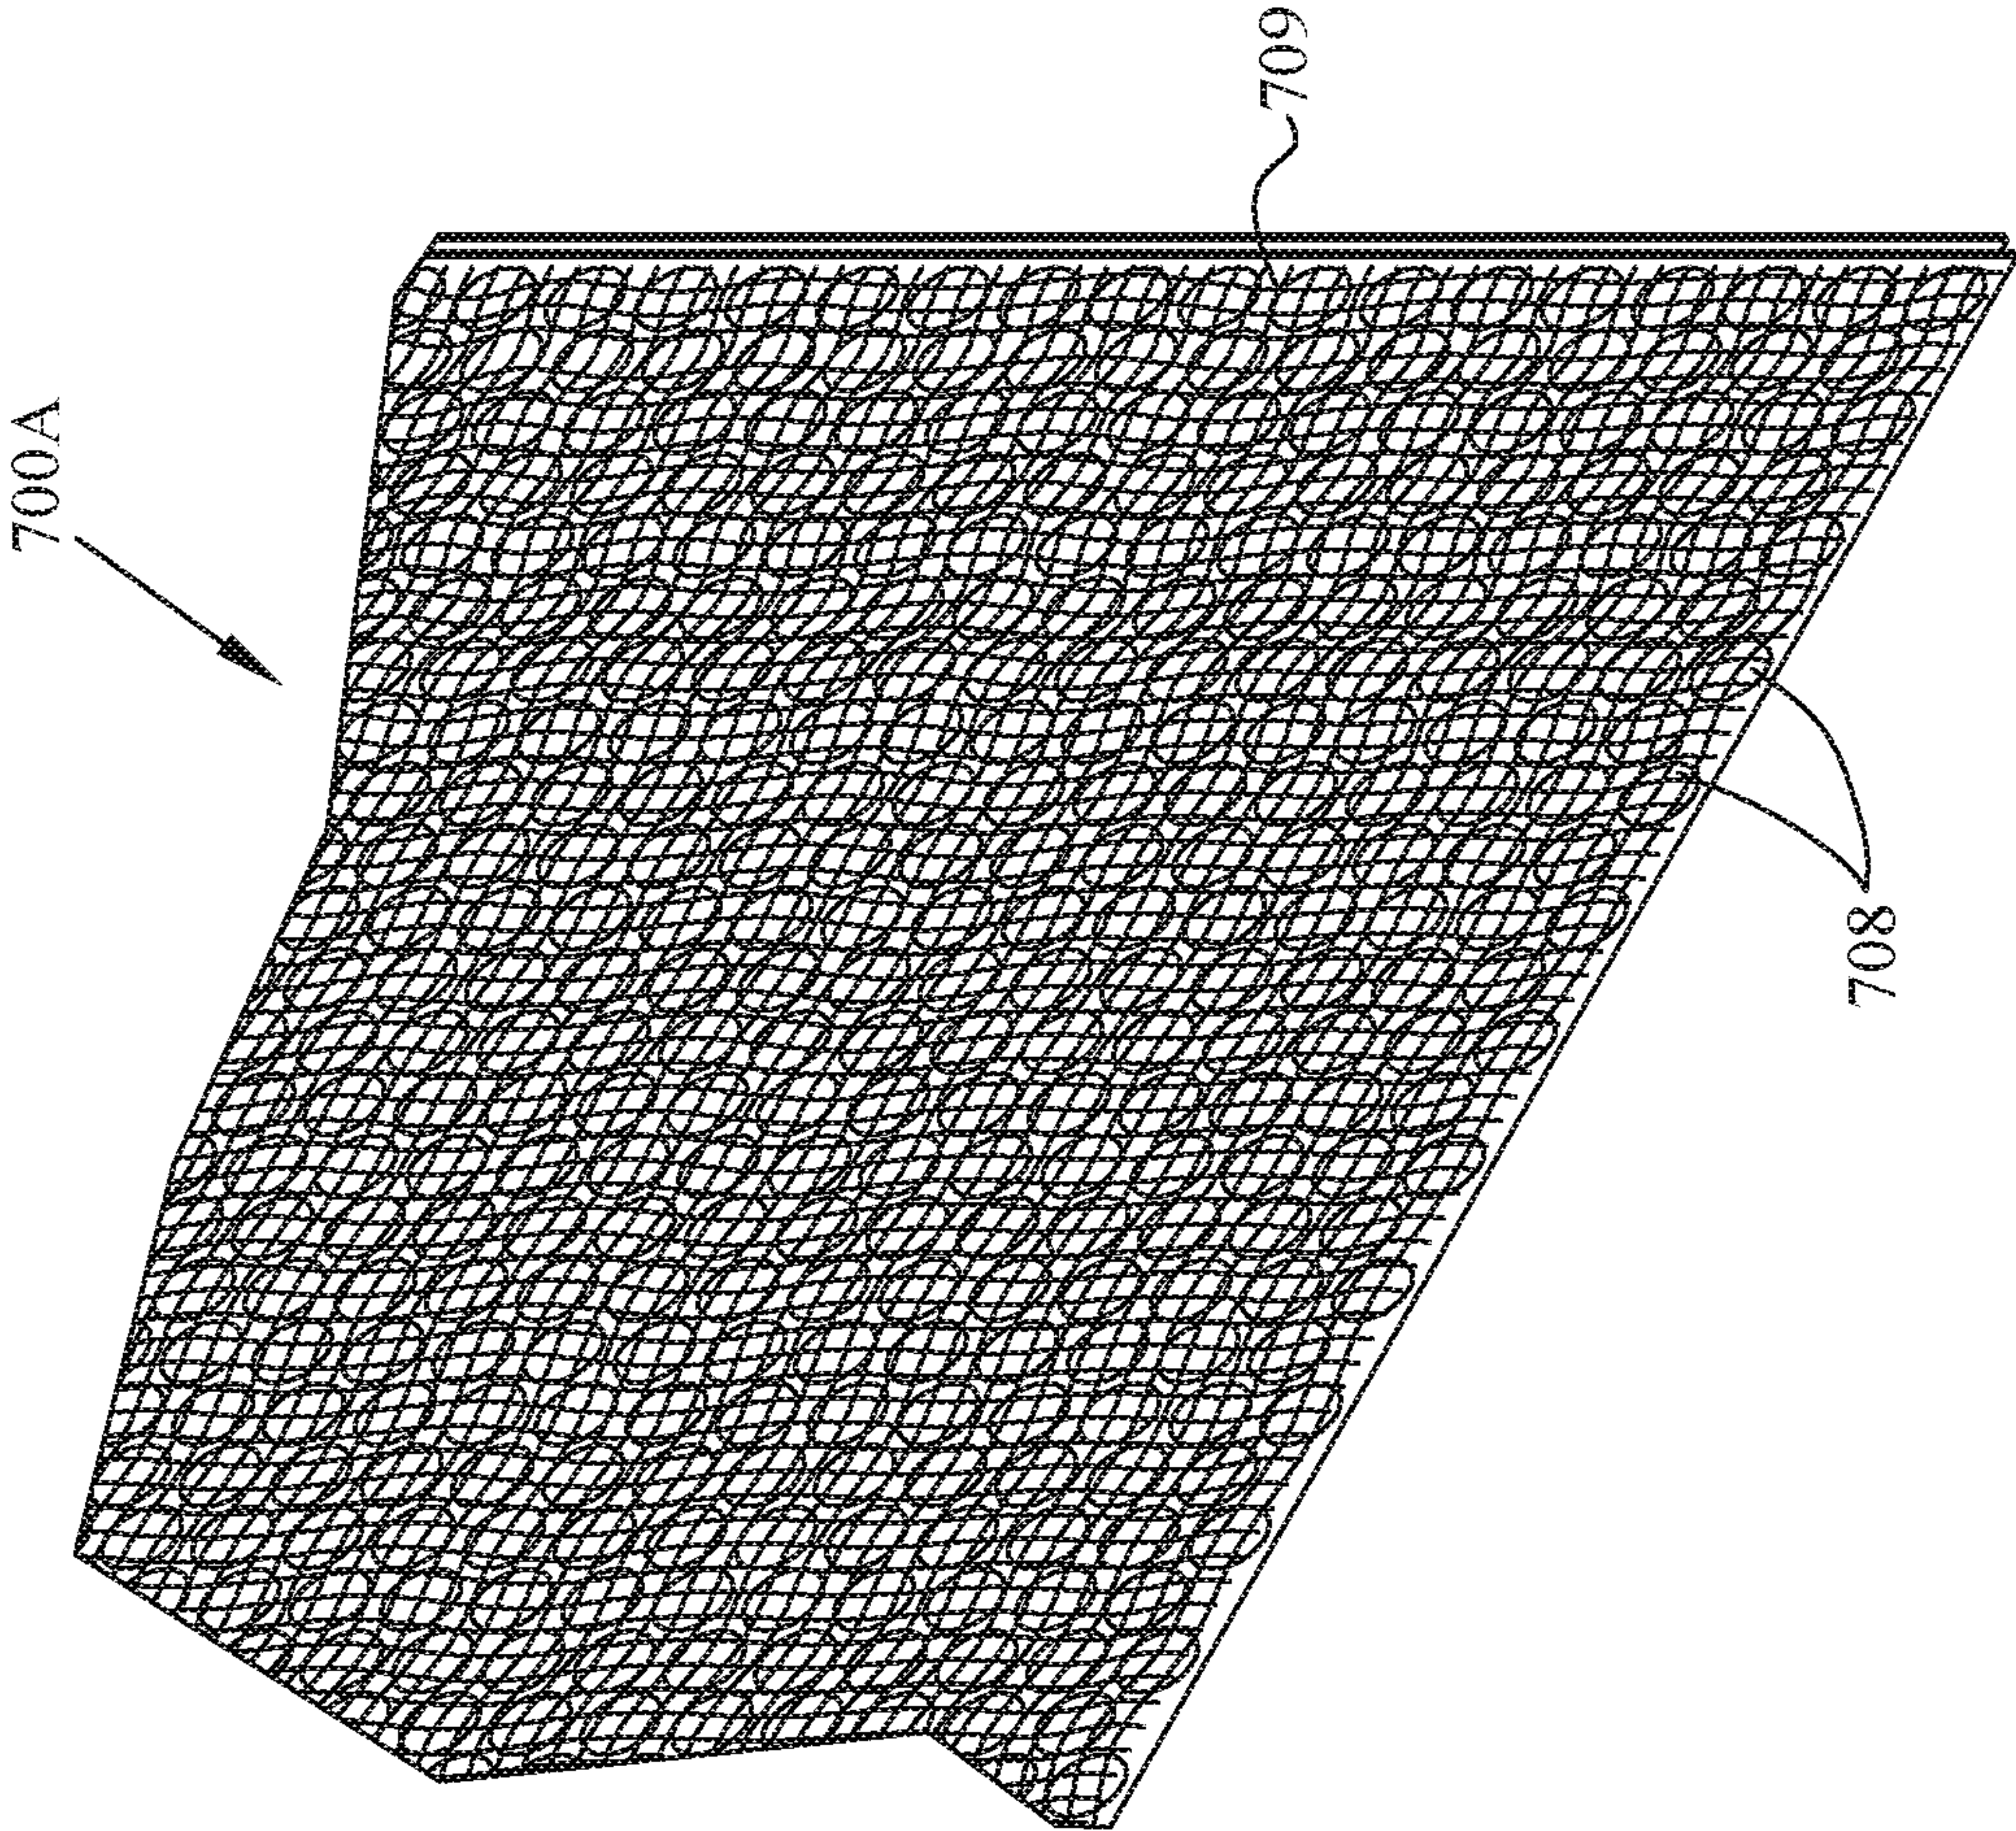
FIG. 36 is a plan perspective plan view of the vehicle frame and cargo bay liner of FIG. 35 showing the dimpled side having the woven material thereon;

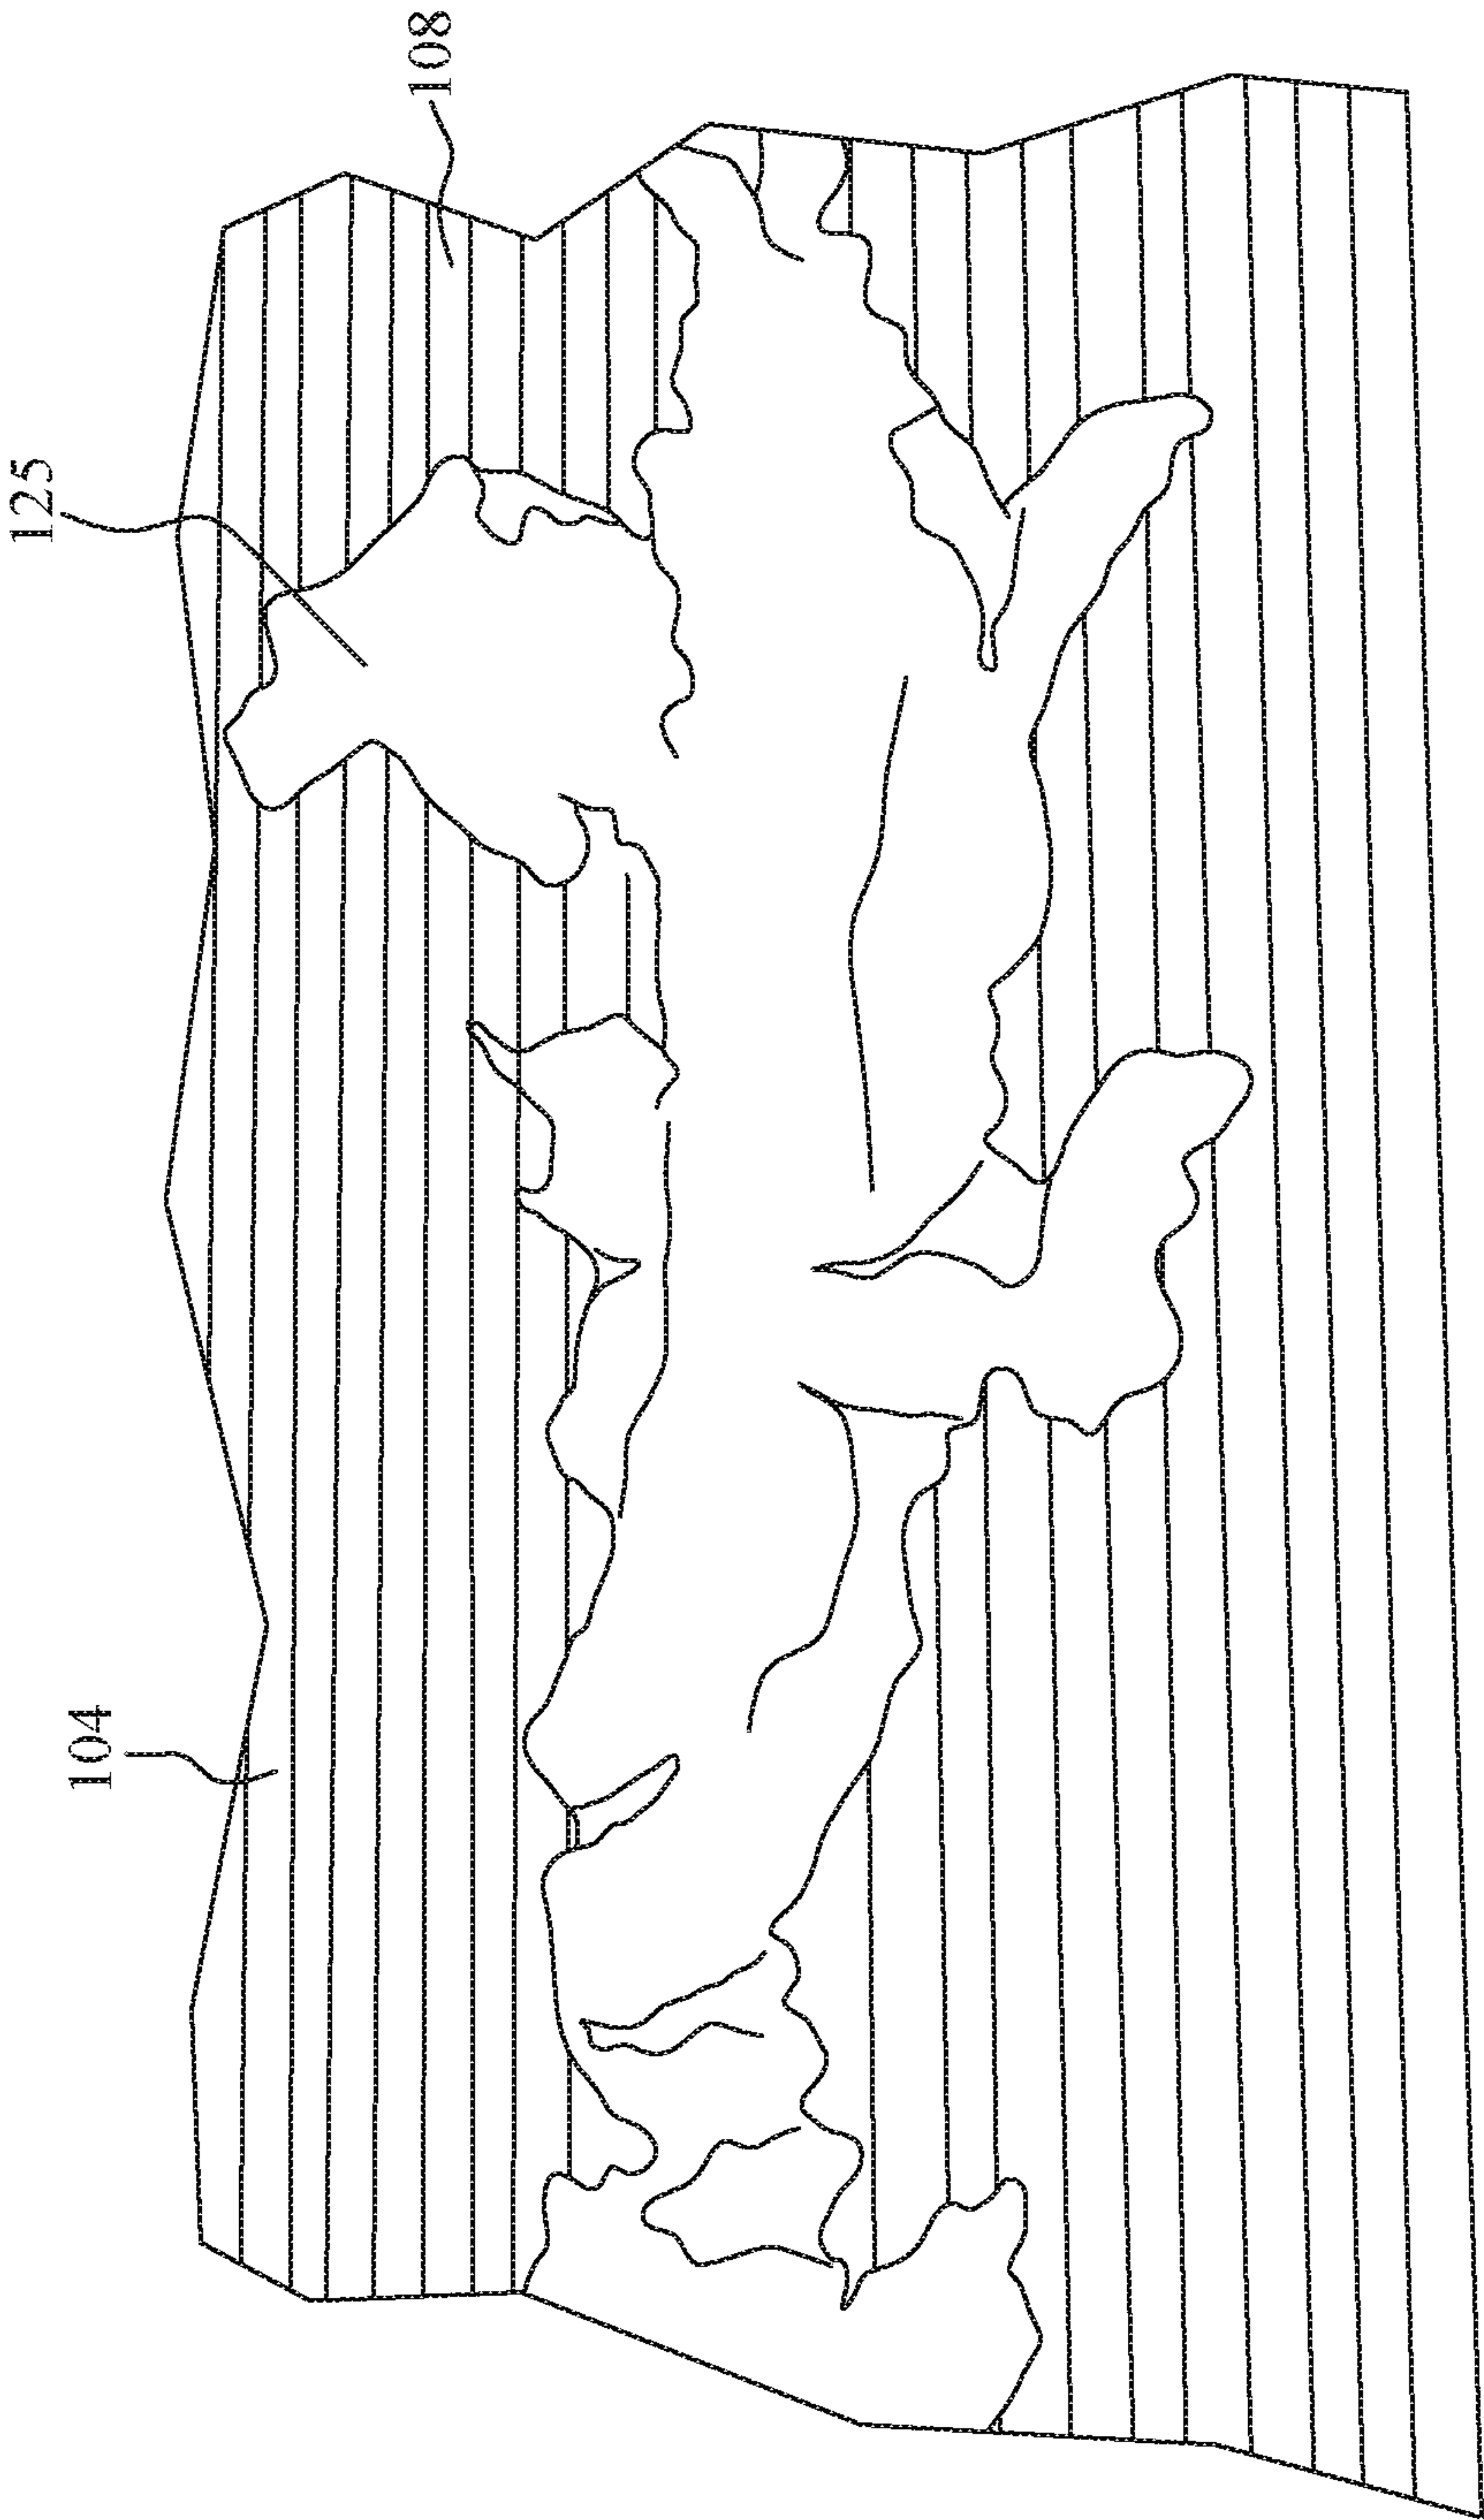
FIG. 38 is a plan perspective view showing a foam sealing material adhered to the bottom of a prior art liner;

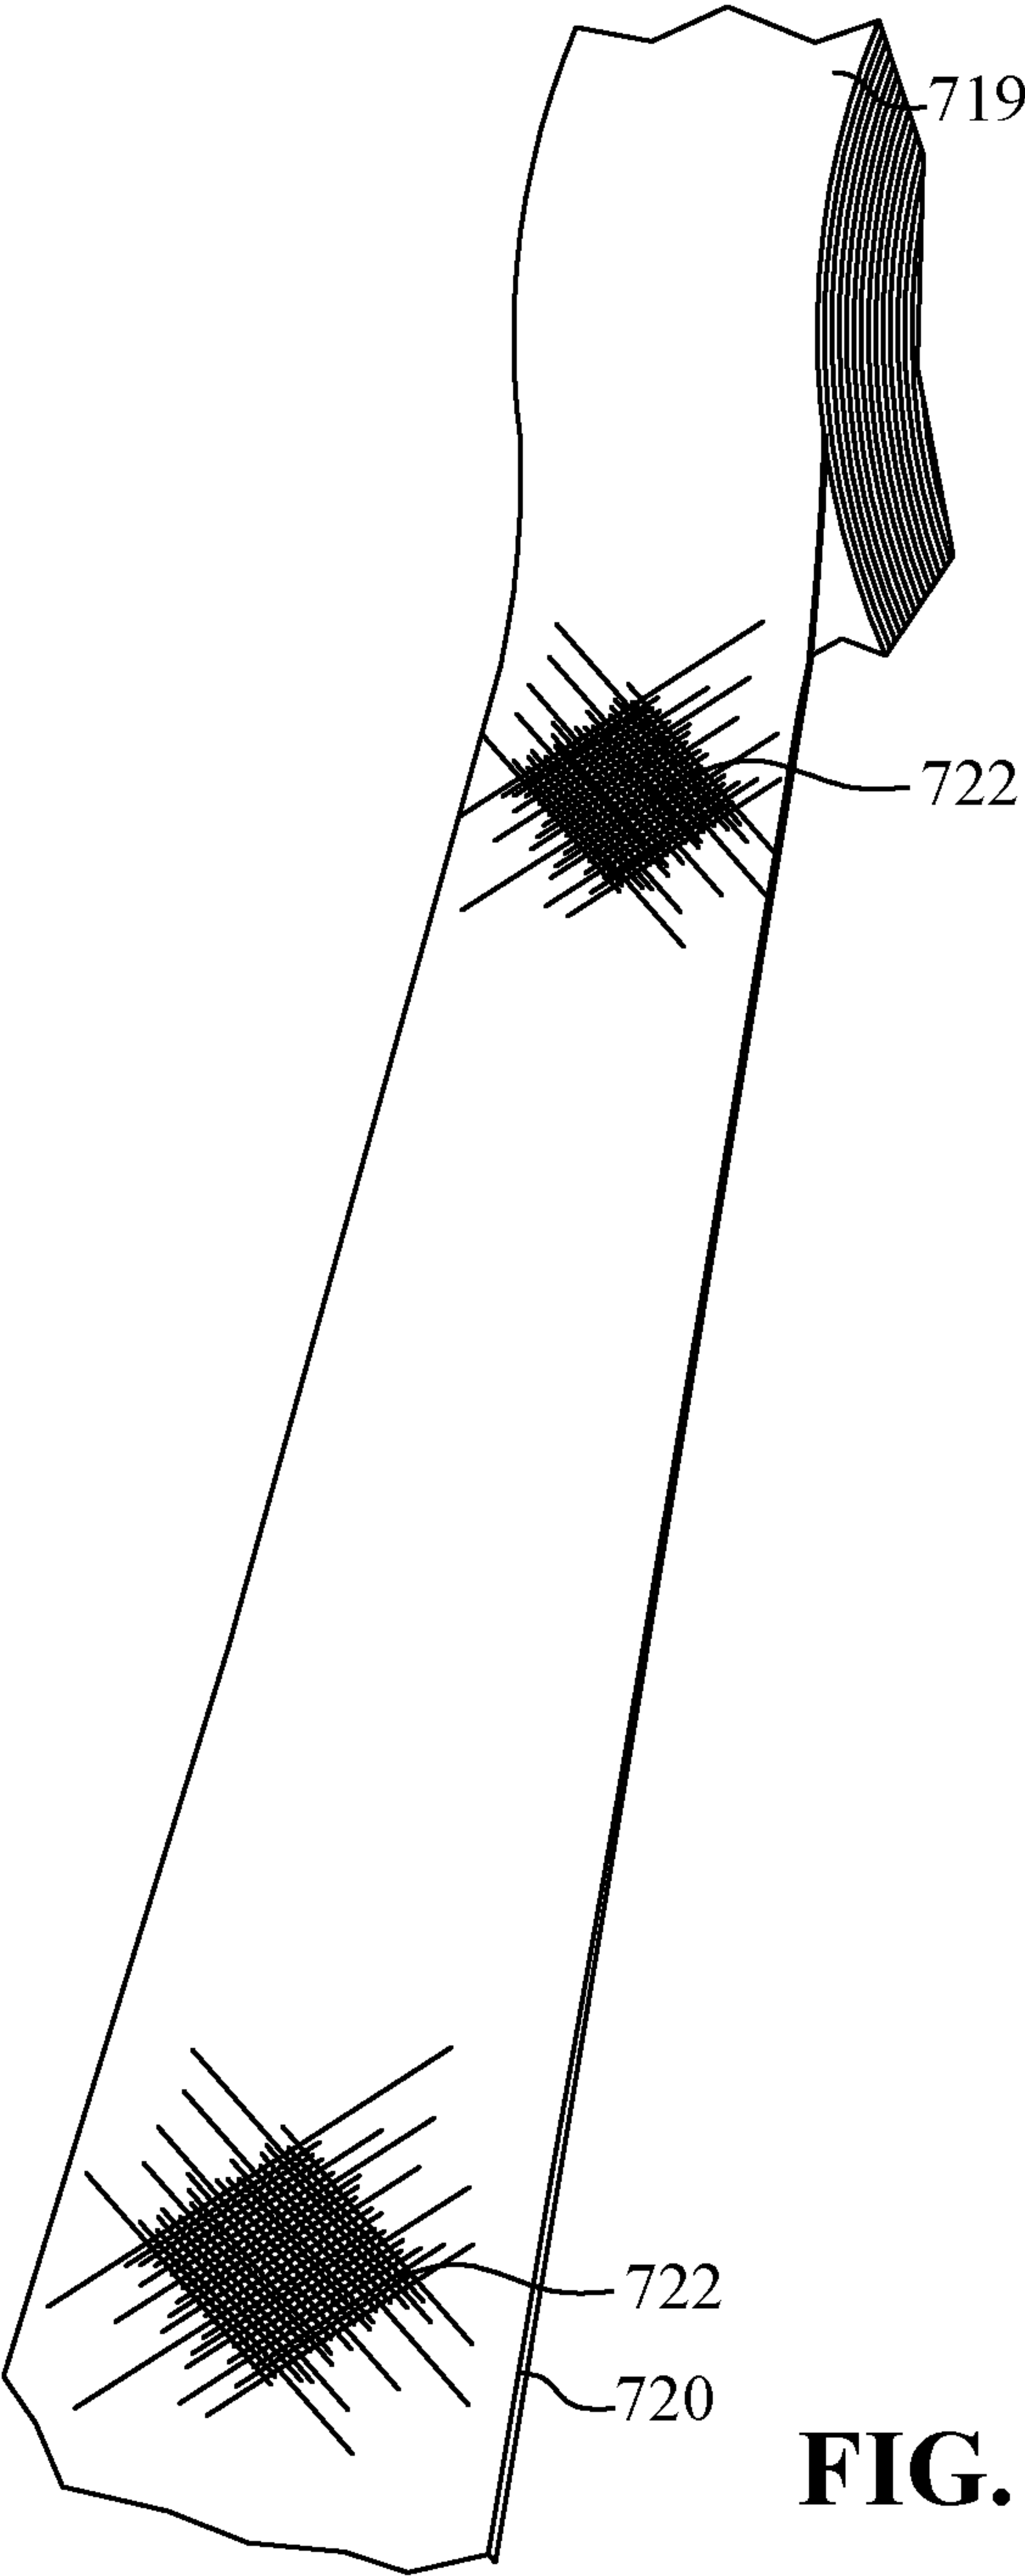
**FIG. 39**

FIG. 39 is a perspective view of a role of repair tape for use in repairing the woven material;

In one embodiment, the repair system includes a role of woven or nonwoven fabric tape shown indicated as 719. In the embodiment shown, the fabric tape includes a woven fabric shown as 722. Also, in the embodiment shown, the tape can be supplied with a contact adhesive attached to one side thereof for attachment to the liner, foil, film or fabric that it is repairing or reinforcing. A protective layer of material 720 (see FIG. 39) to which the adhesive will readily release from may be used to facilitate providing the repair tape in a rolled form or otherwise facilitate removing thereof for easy repair or reinforcement of the recreational vehicle. As shown in FIGS. 42 and 43, repair tape 719 is attached to woven fabric layer 709, on the exterior thereof, creating an additional layer to the liner 700 as is best shown in FIG. 43. It should be appreciated that repair and reinforcing tape 719 could be placed or attached over itself to create additional reinforcing layers, and/or on the other side of the liner over the sheet of aluminum foil or metalized file 707. As many additional layers as is desired can be placed on either or both sides. It should also be appreciated that the repair tape could be an aluminum foil, or metalized film or other polymer or material, but the woven fabric tape has shown to be particularly suitable.

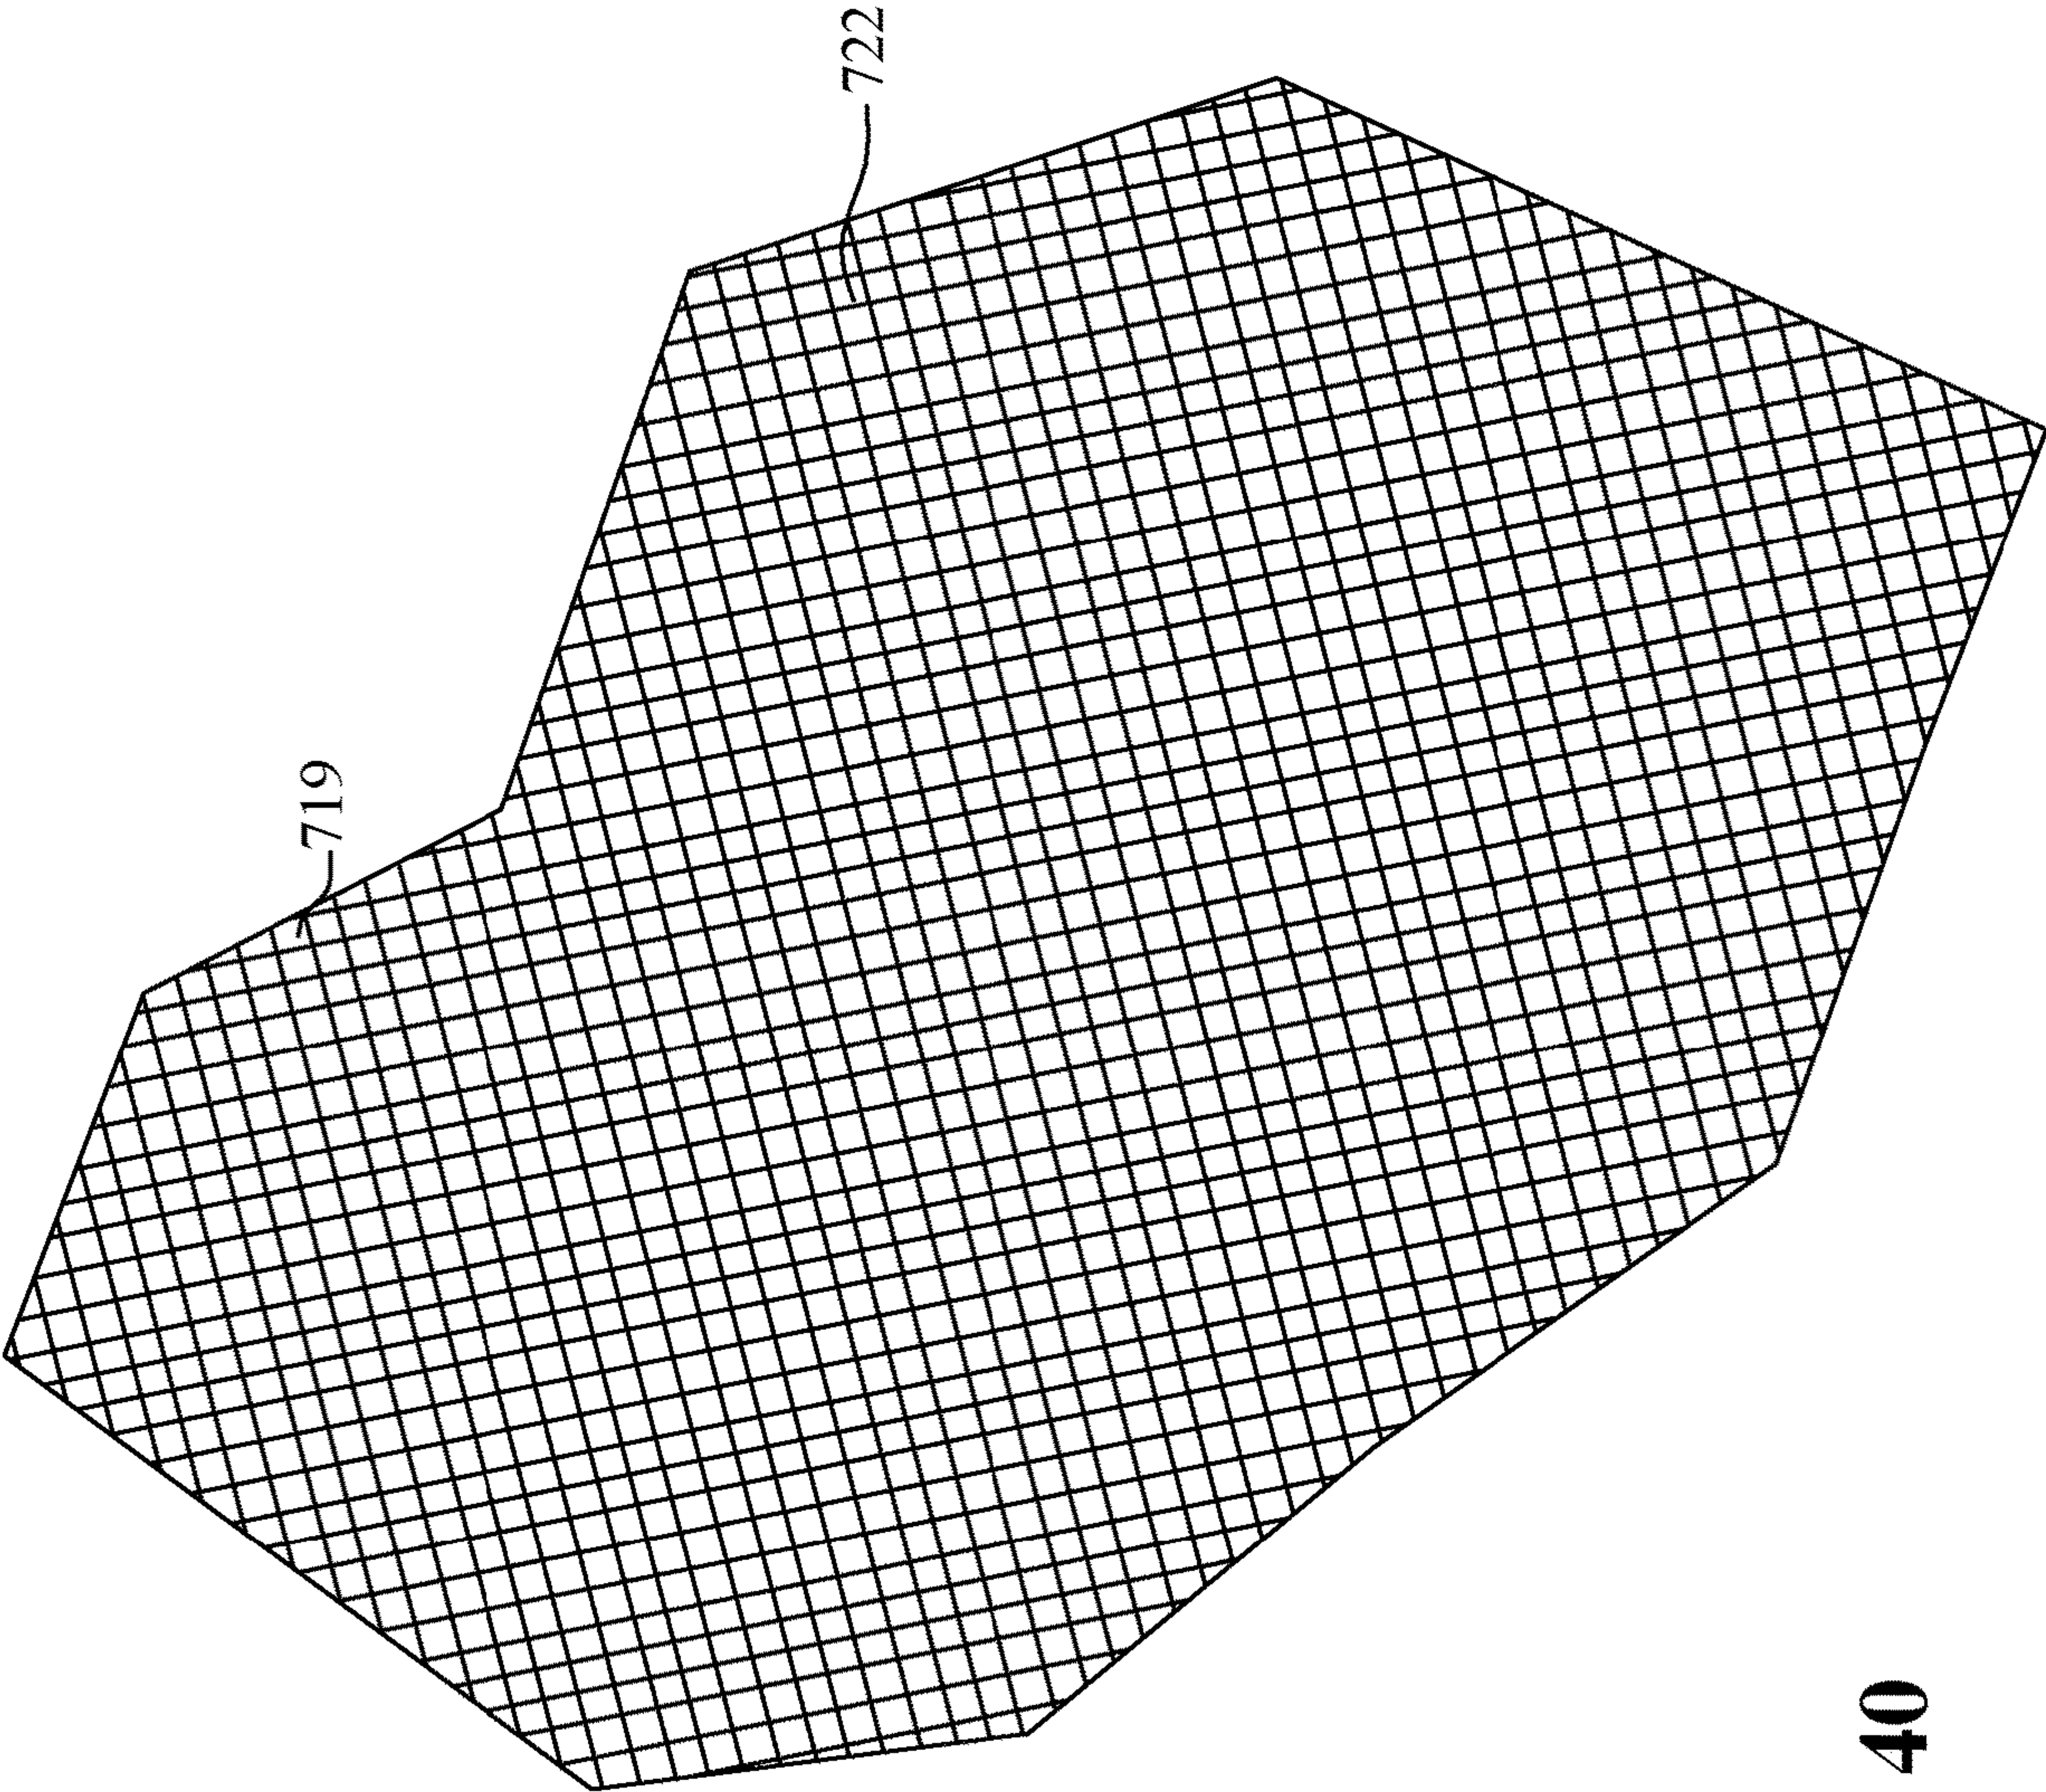
FIG. 40 is an enlarged plan view of the woven material repair tape;

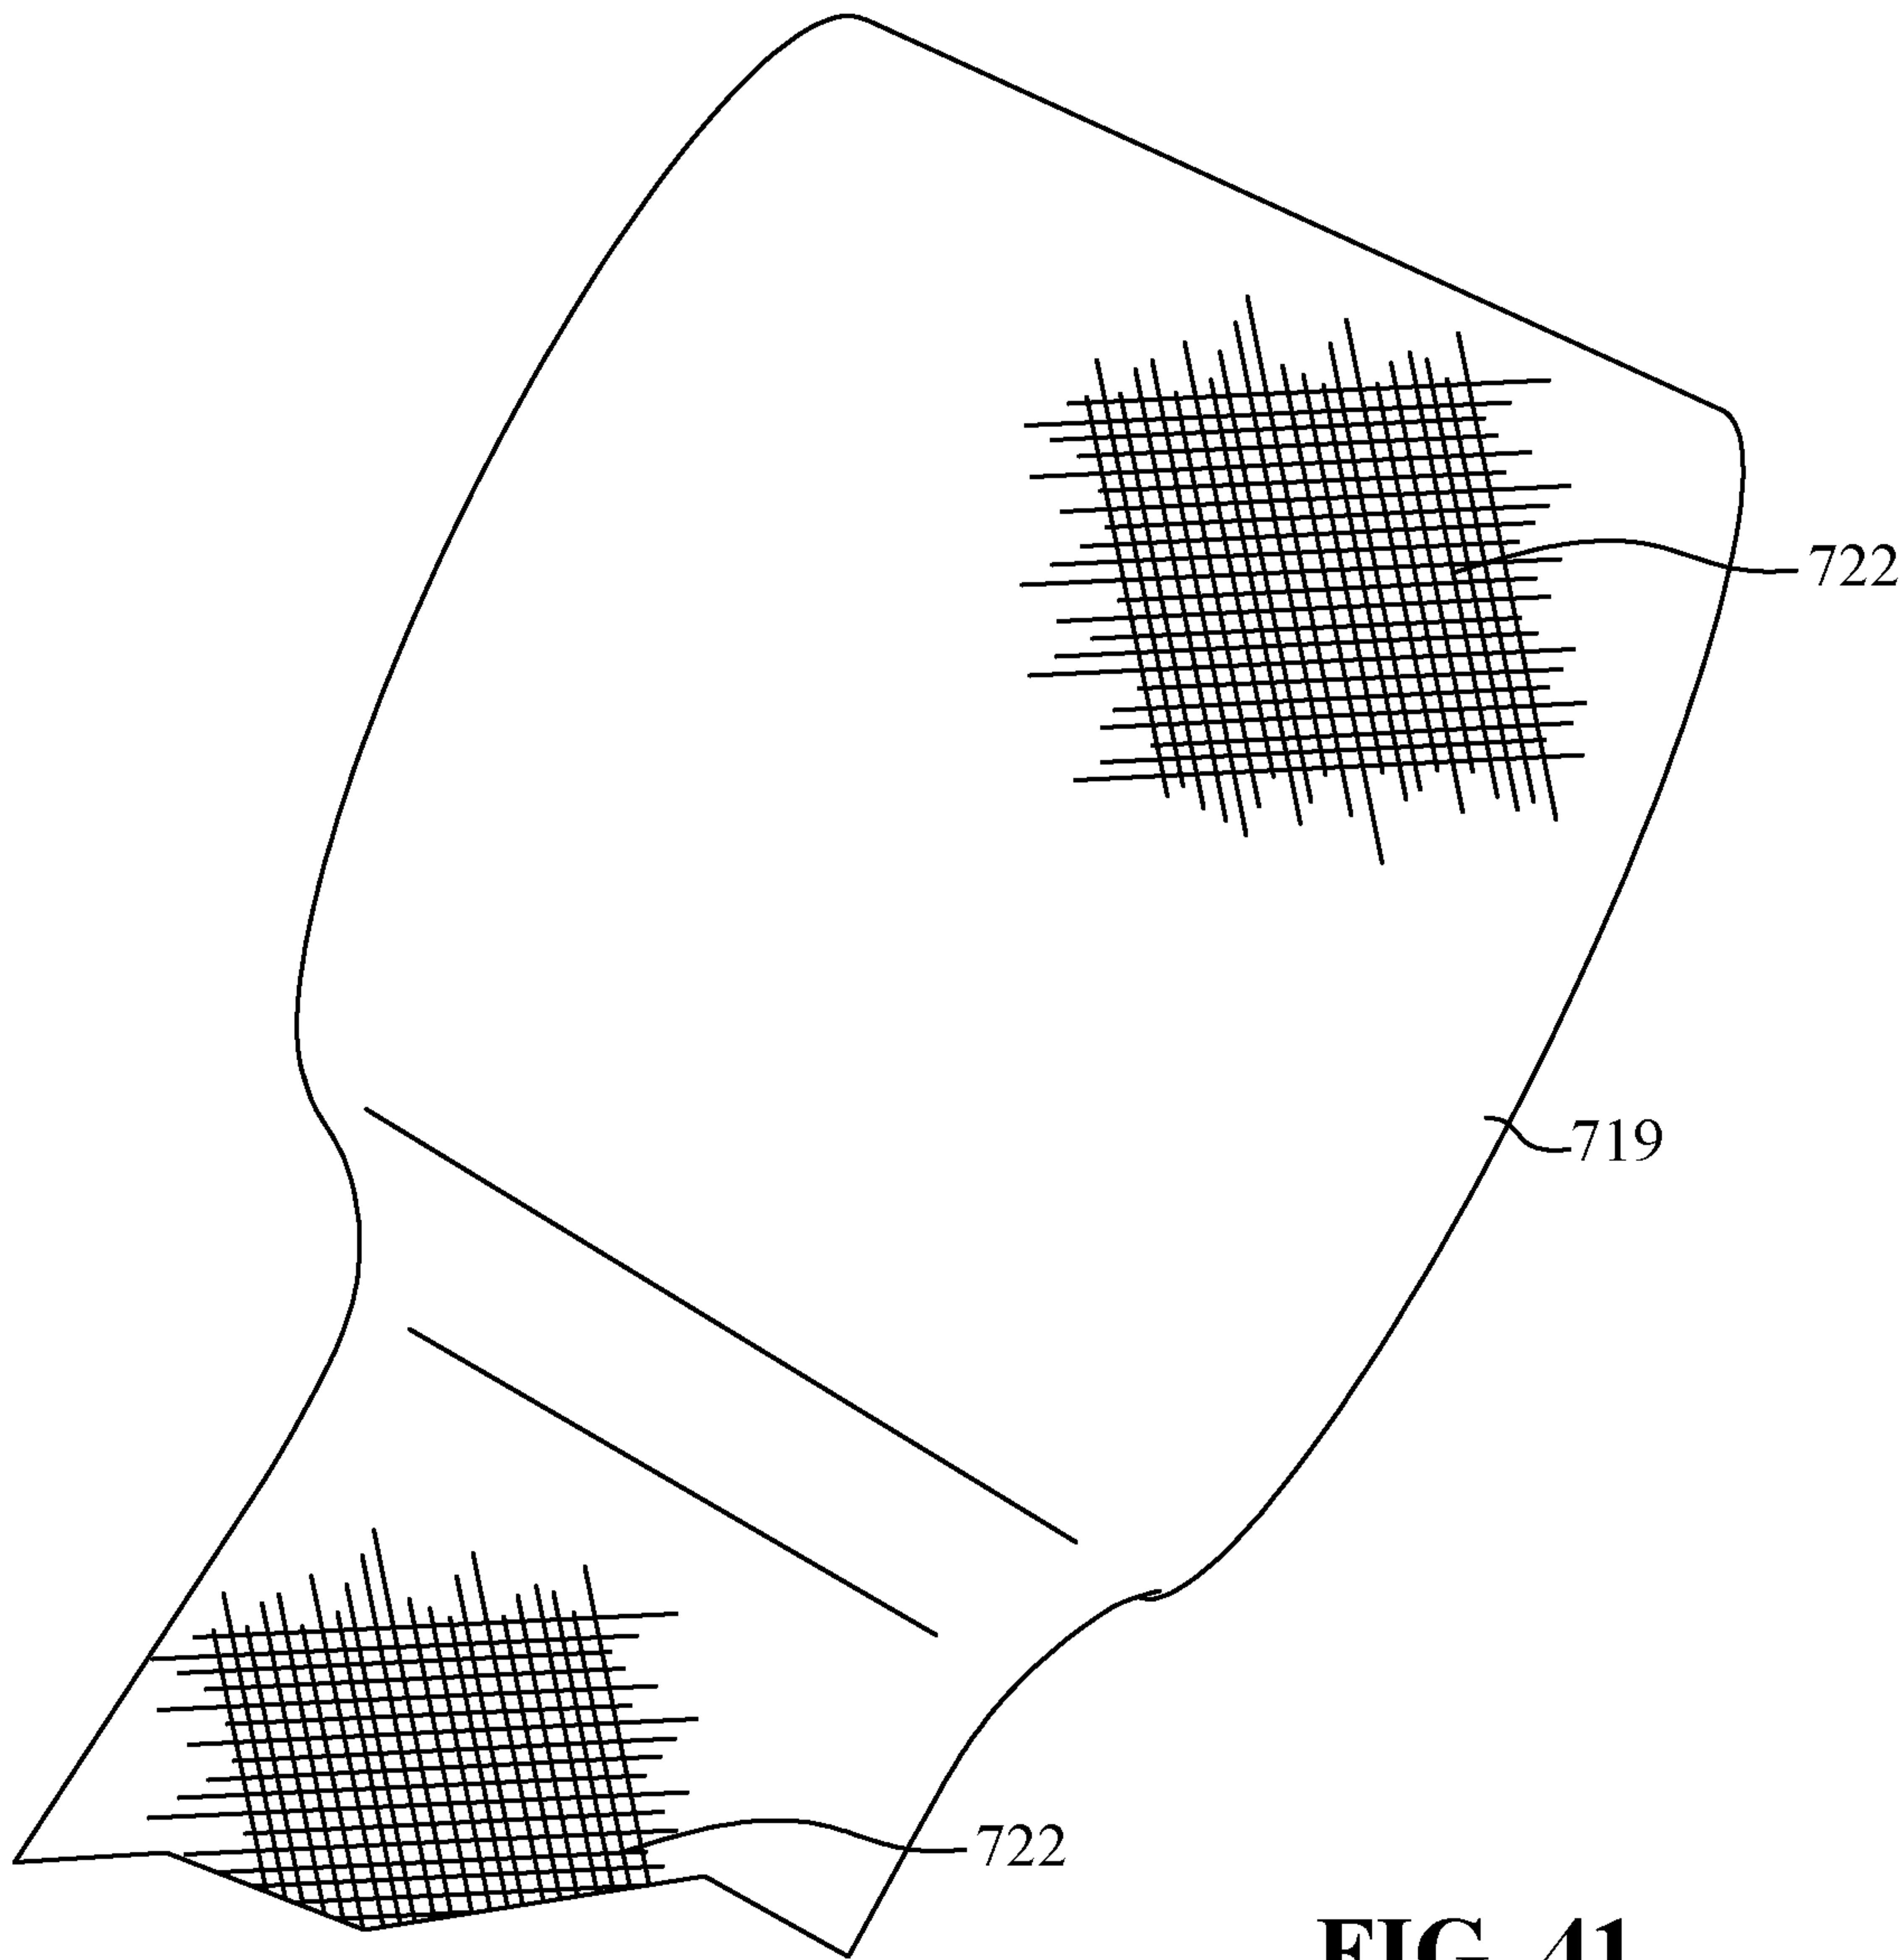
FIG. 41 is another plan view of the role of woven material repair tape;

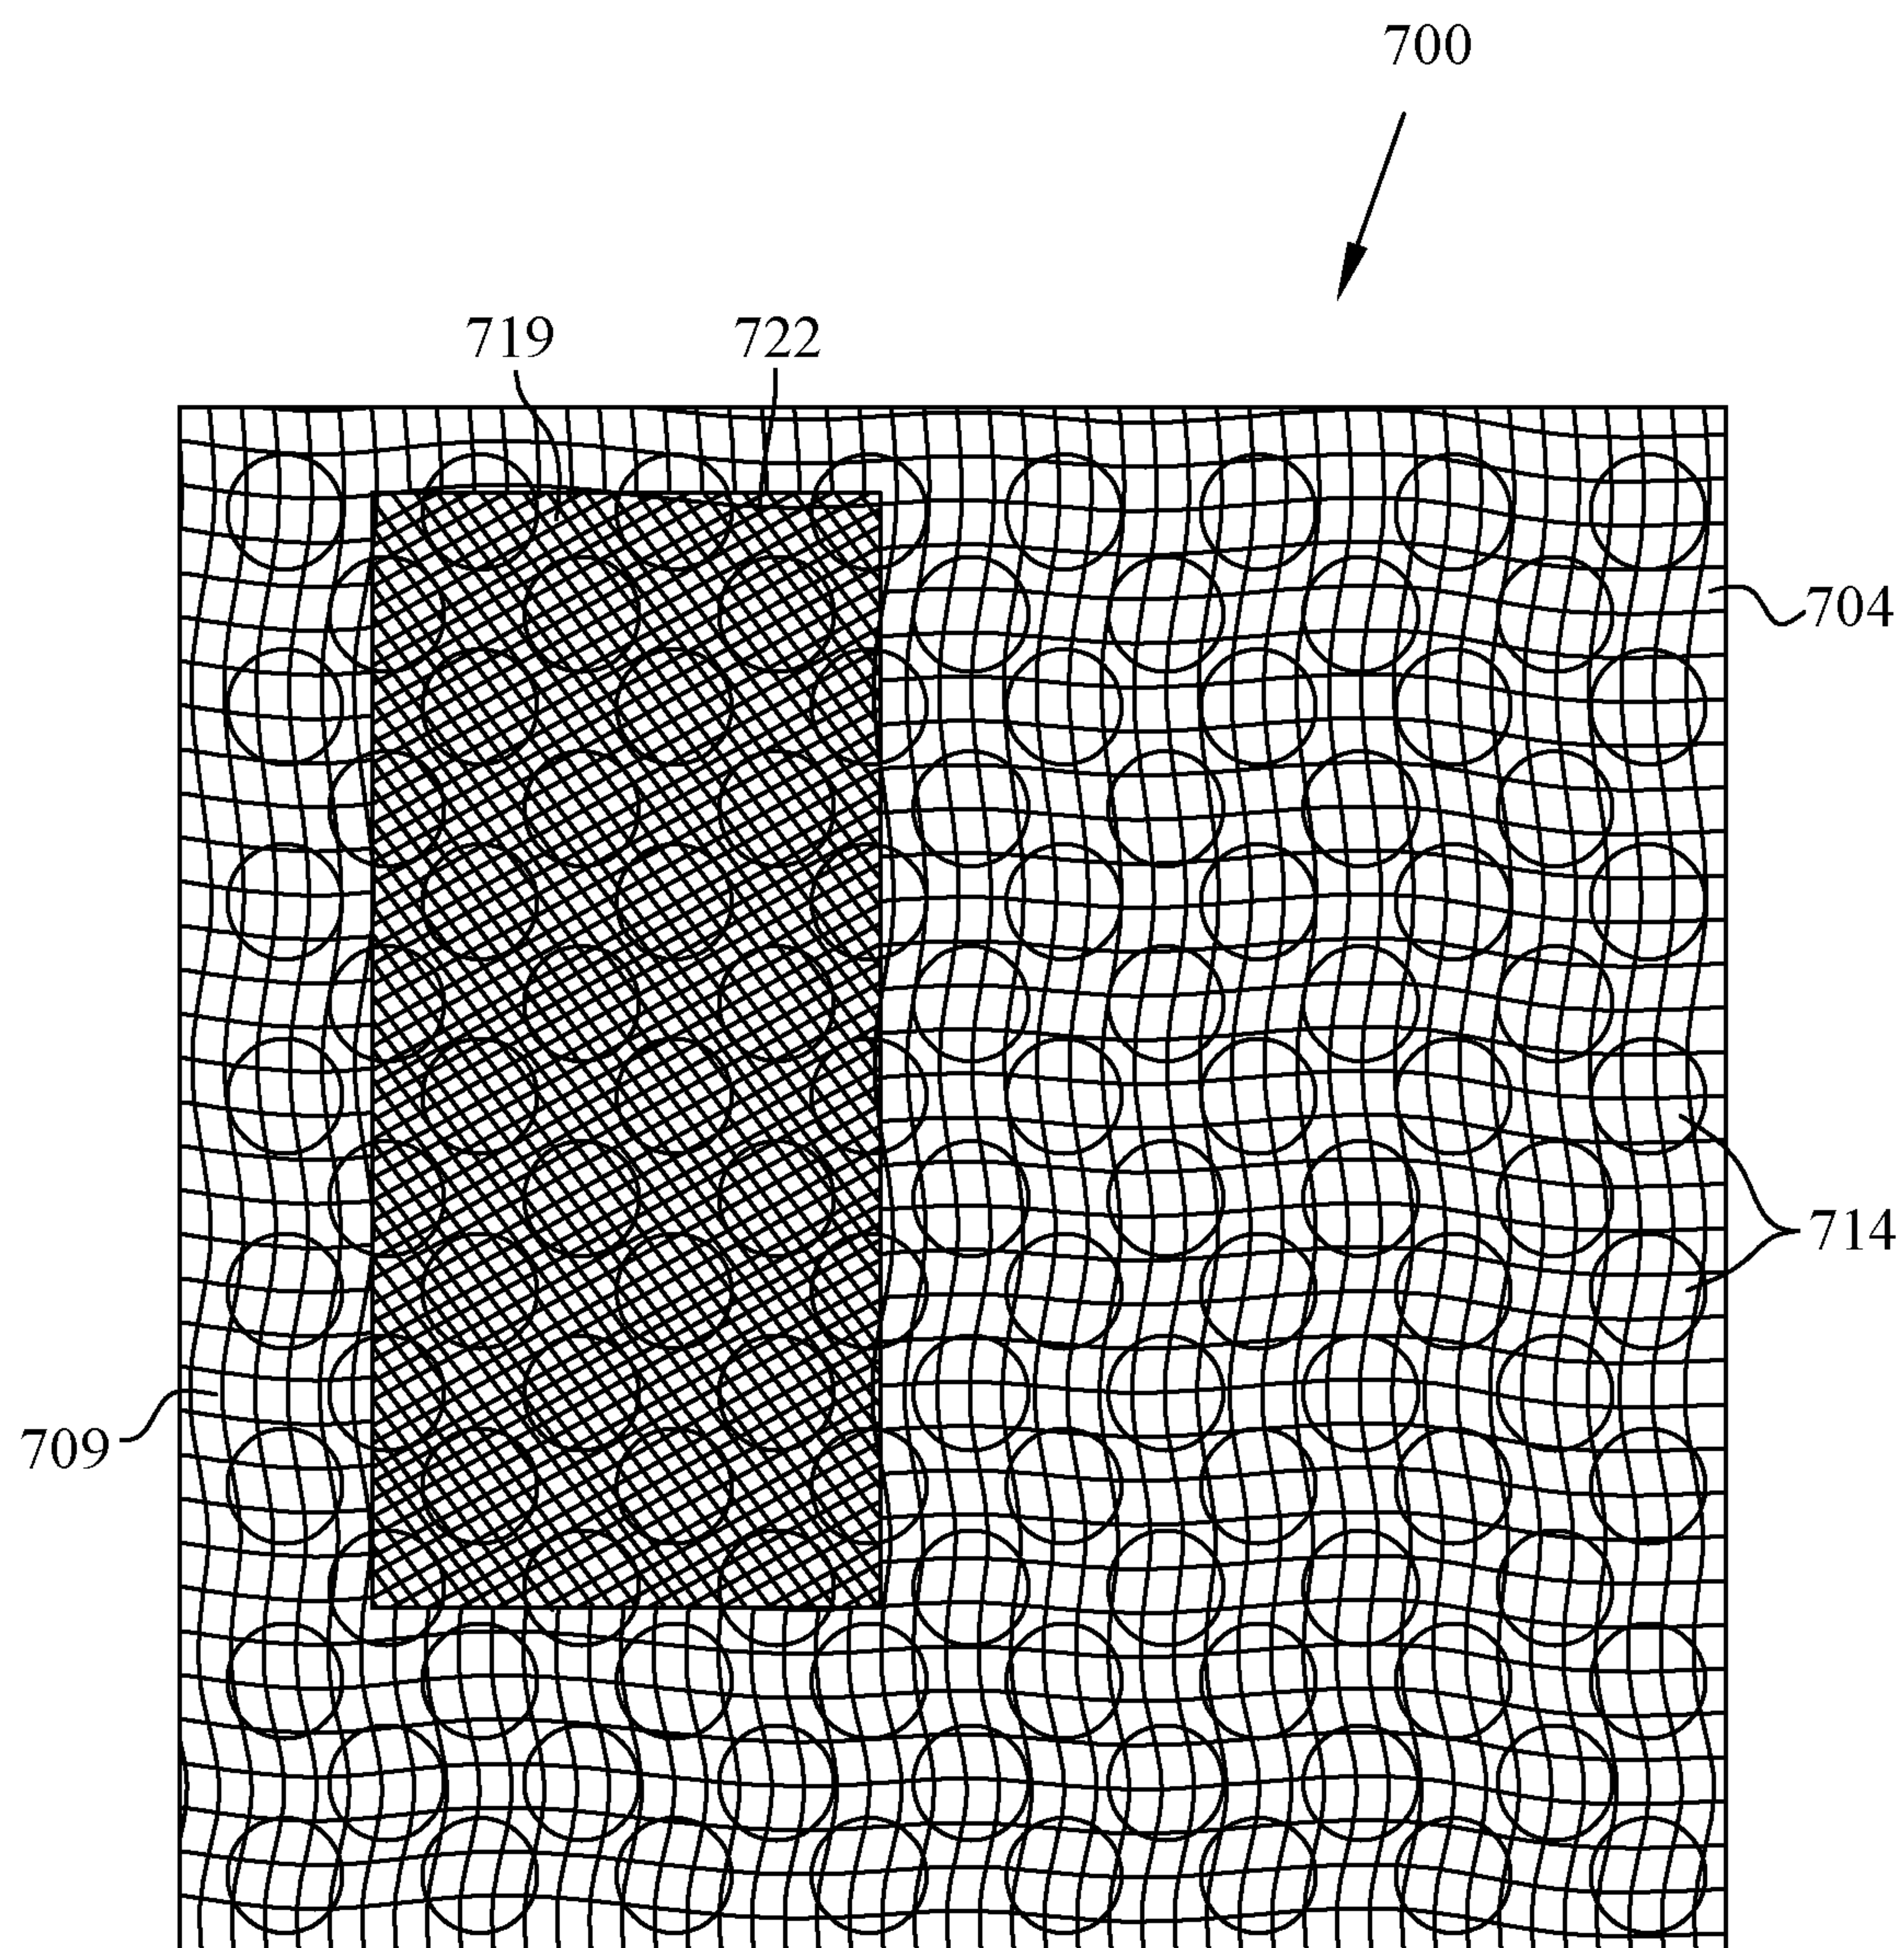
**FIG. 42**

FIG. 42 is a plan view of a liner having a sheet of material with a woven fabric attached thereon and a piece of repair tape attached to the woven material; and
