US011447189B1

(54) **VEHICLE FRAME AND CARGO BAY LINER**

(57) **ABSTRACT**

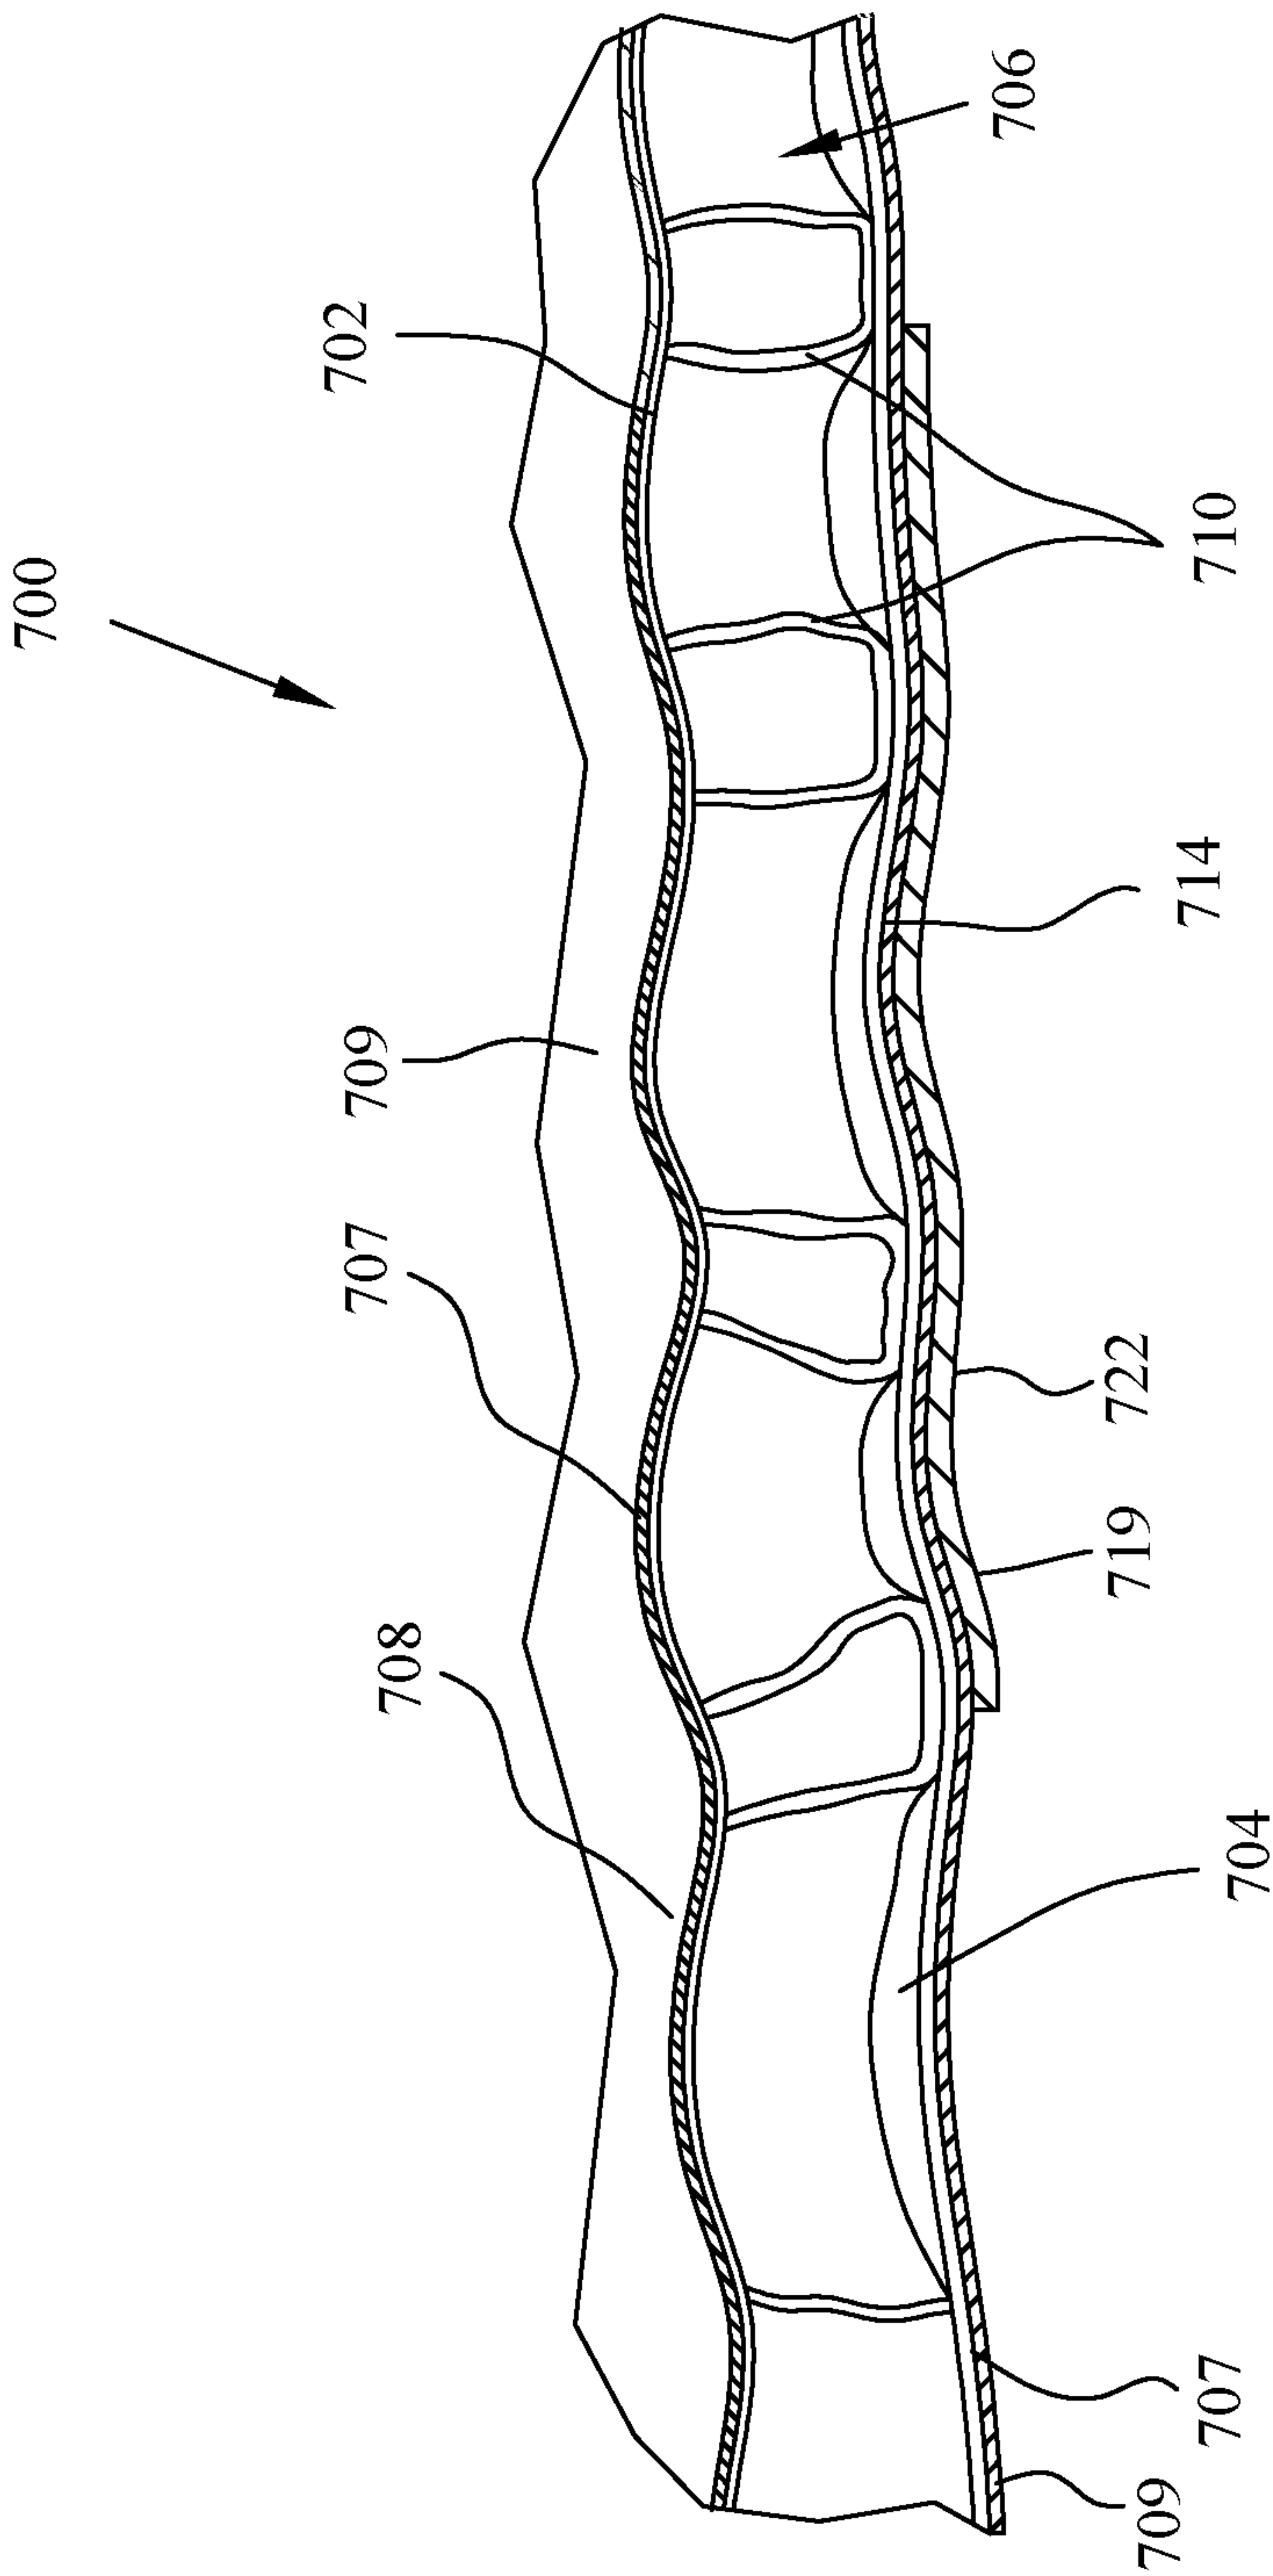
FIG. 43 is a cross sectional view of the liner of FIG. 42 taken through the piece of repair tape.
