US011447189B1

(54) **VEHICLE FRAME AND CARGO BAY LINER**

A vehicle and liner assembly is provided that includes a
recreational vehicle having a housing, a front end, a rear end,
a top, a bottom, and a pair of sidewalls. A frame assembly
is provided wherein, the housing is mounted on and sup-
ported by the frame assembly. The liner is attached to the
frame assembly and covers at least a substantial portion of the
bottom of the housing. The liner has a first face having
projections extending therefrom and a second face having
openings therein. The openings coincide with and extend
into corresponding projections on the first face.

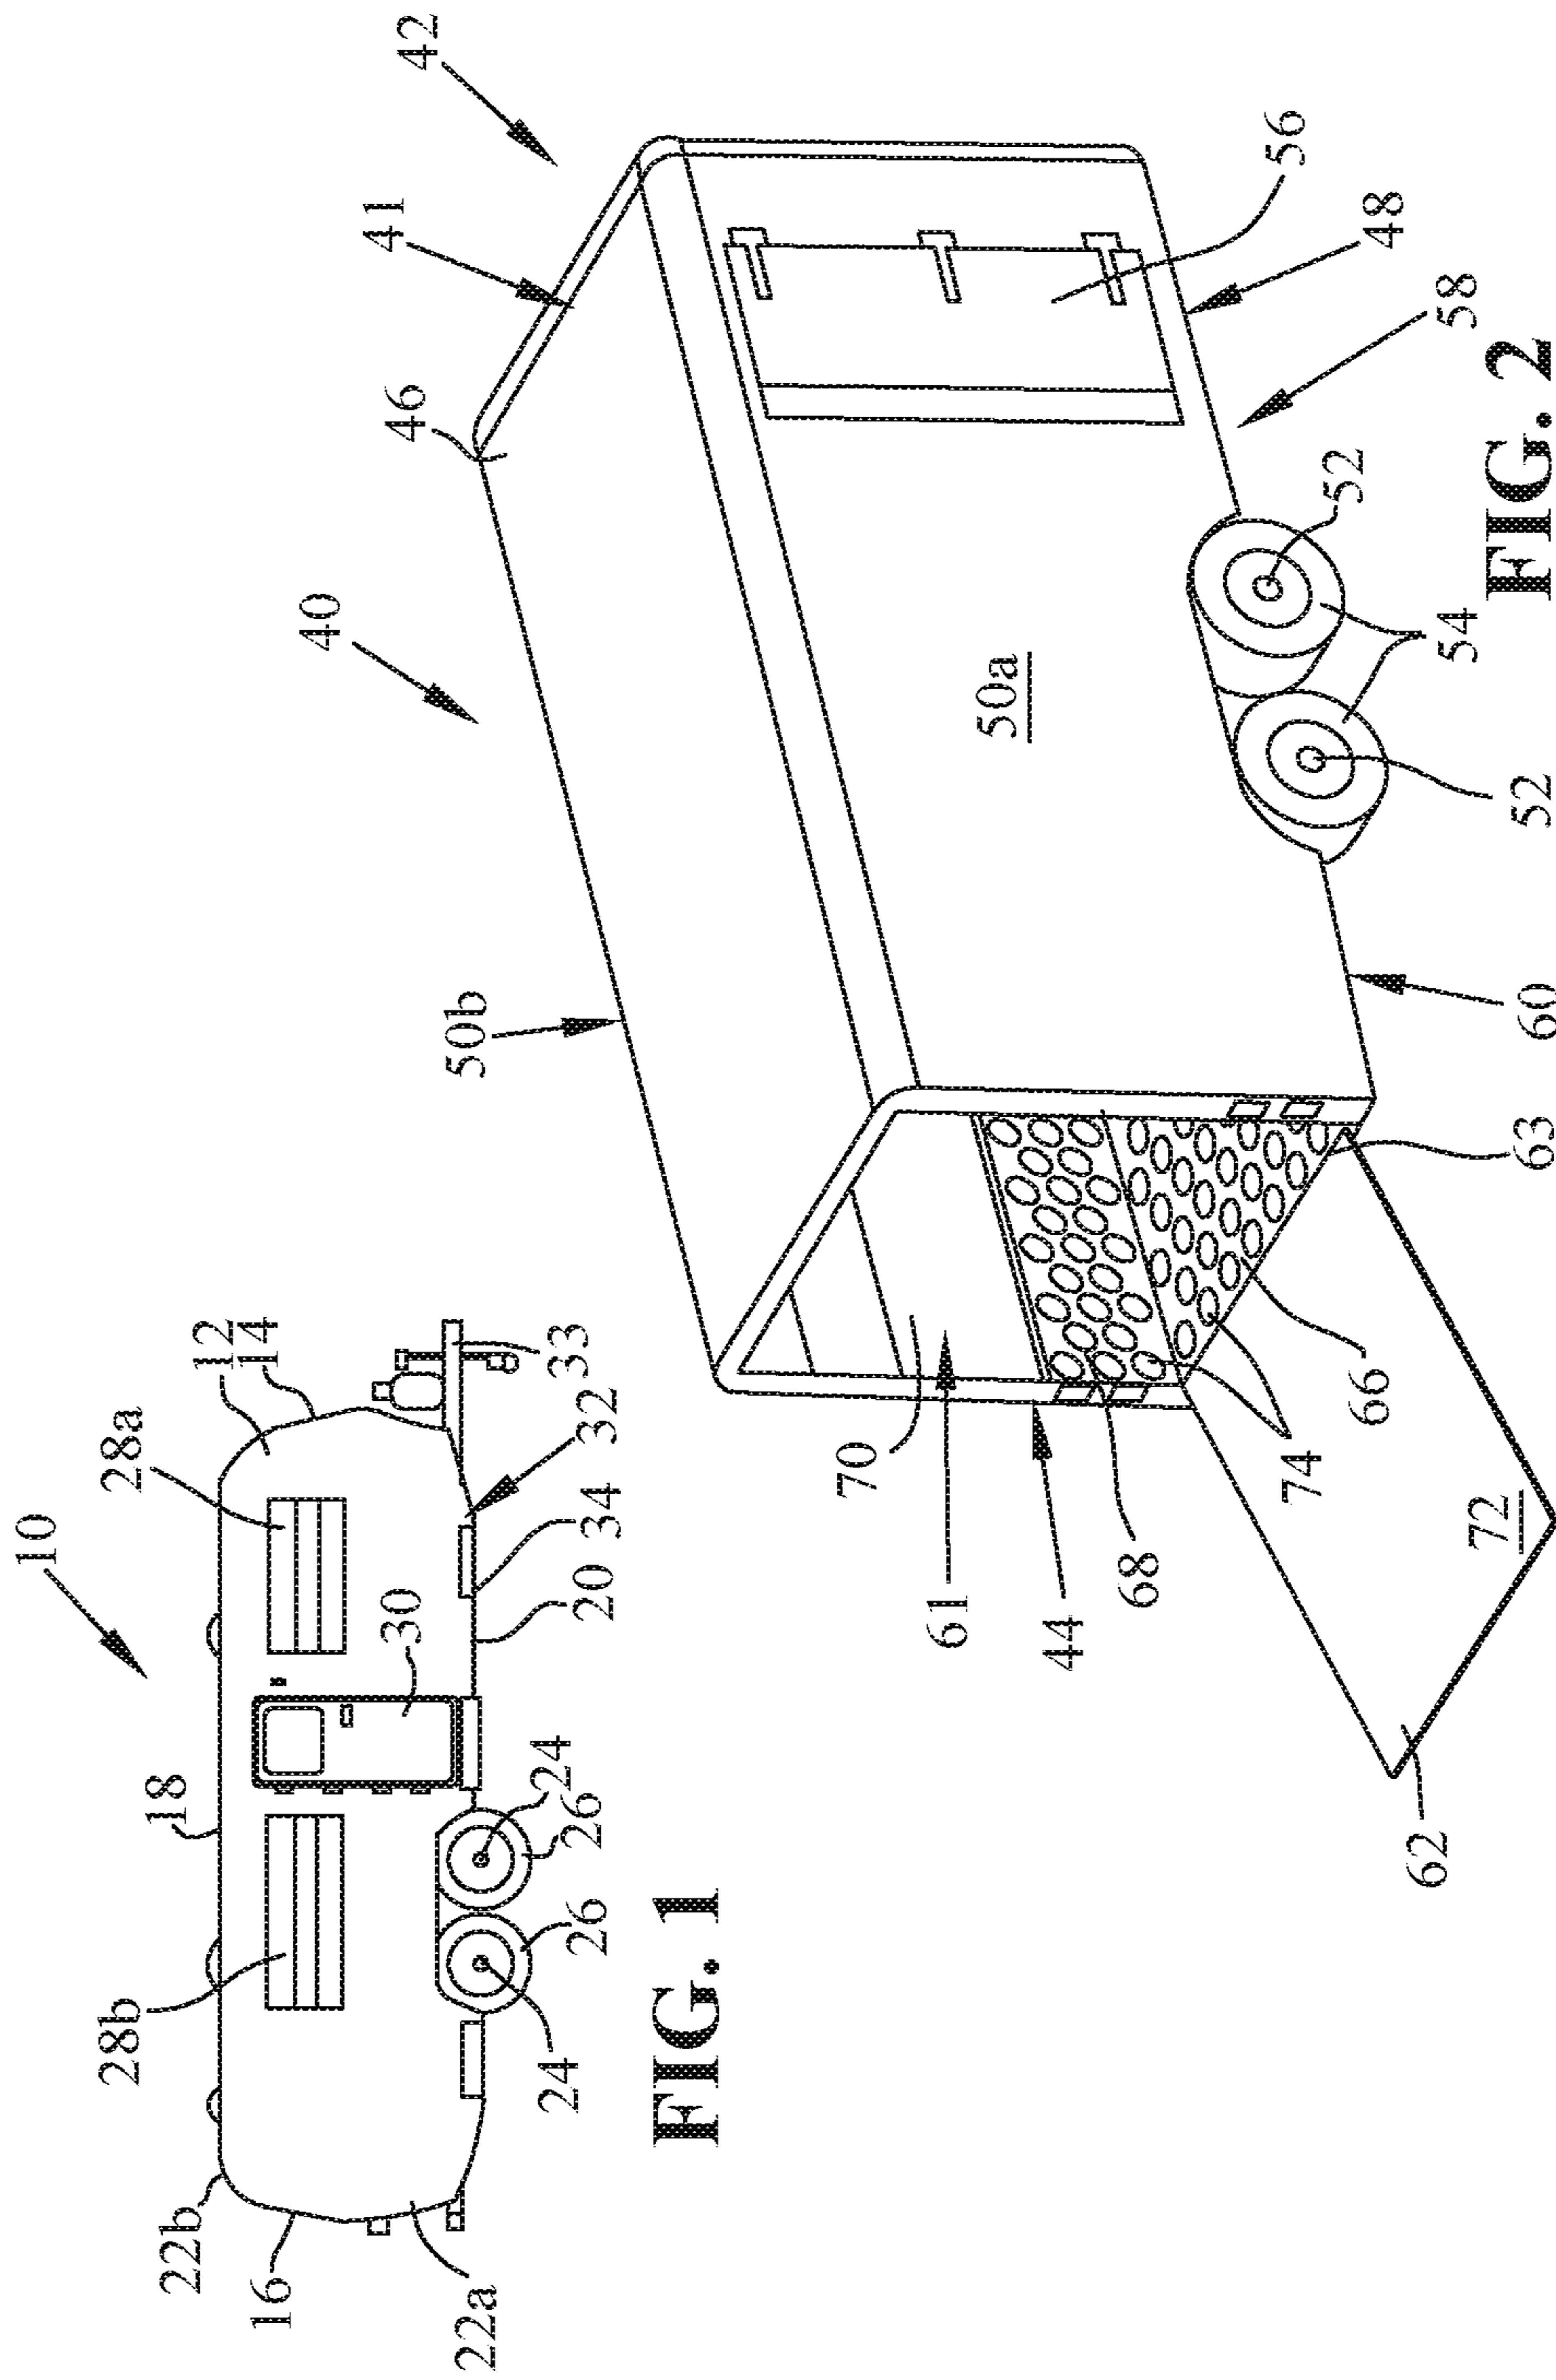
FIG. 2 is a perspective view of a cargo trailer and cargo bay liner in accordance with the subject invention;

Now referring to FIG. 2, a trailer of a type normally considered a cargo trailer or toy hauler is shown generally indicated as 40. A toy hauler is generally considered to be a vehicle that has at least a portion or all of the trailer designed as a cargo area or bay to contain and transport another type of vehicle, such as but not limited to motorcycles, ATV's, snowmobiles, or specialty vehicles. Similar to recreational vehicle 10, carbon trailer 40 is defined by a housing, generally indicated as 41. Housing 41 includes a front end 42, a rear end 44, a top 46, a bottom 48, and a pair of generally parallel sides 50a, 50b. Cargo trailer 40 further includes a pair of axels 52 having wheels 54 mounted thereon. Cargo trailer 40 also includes a door 56. Housing 41 is mounted upon and supported by a frame assembly, generally indicated as 58 that extends into a hitch 59. These are all known and common in the cargo trailer and toy hauler industry. Cargo trailer 40 includes a liner 60 in accordance with the subject invention that is mounted and attached at the bottom of frame assembly 58 to protect the undercarriage of cargo trailer 40 similar to recreational vehicle 10.

Cargo trailer 40 also includes a cargo or bay area, generally indicated as 61 which is accessed through a door 62 which swings downward at rear end 44 on a bottom hinge 64. A floor liner 66 in accordance with the subject invention is mounted on top of the floor of cargo area 61 and a similar liner 68 is mounted on walls 70 of cargo area 61. In the embodiment shown, wall liner 68 is mounted partially up wall 70; however, it should be appreciated that the liner could be mounted to extend completely up wall 70. The liner may also be mounted partially or completely on a front wall of cargo area 61 as well on an inside surface 72 of rear door 62. Although not shown to scale, in embodiments shown in FIG. 2, liners 66 and 68 include projections 74 extending from the liner into the cargo area.

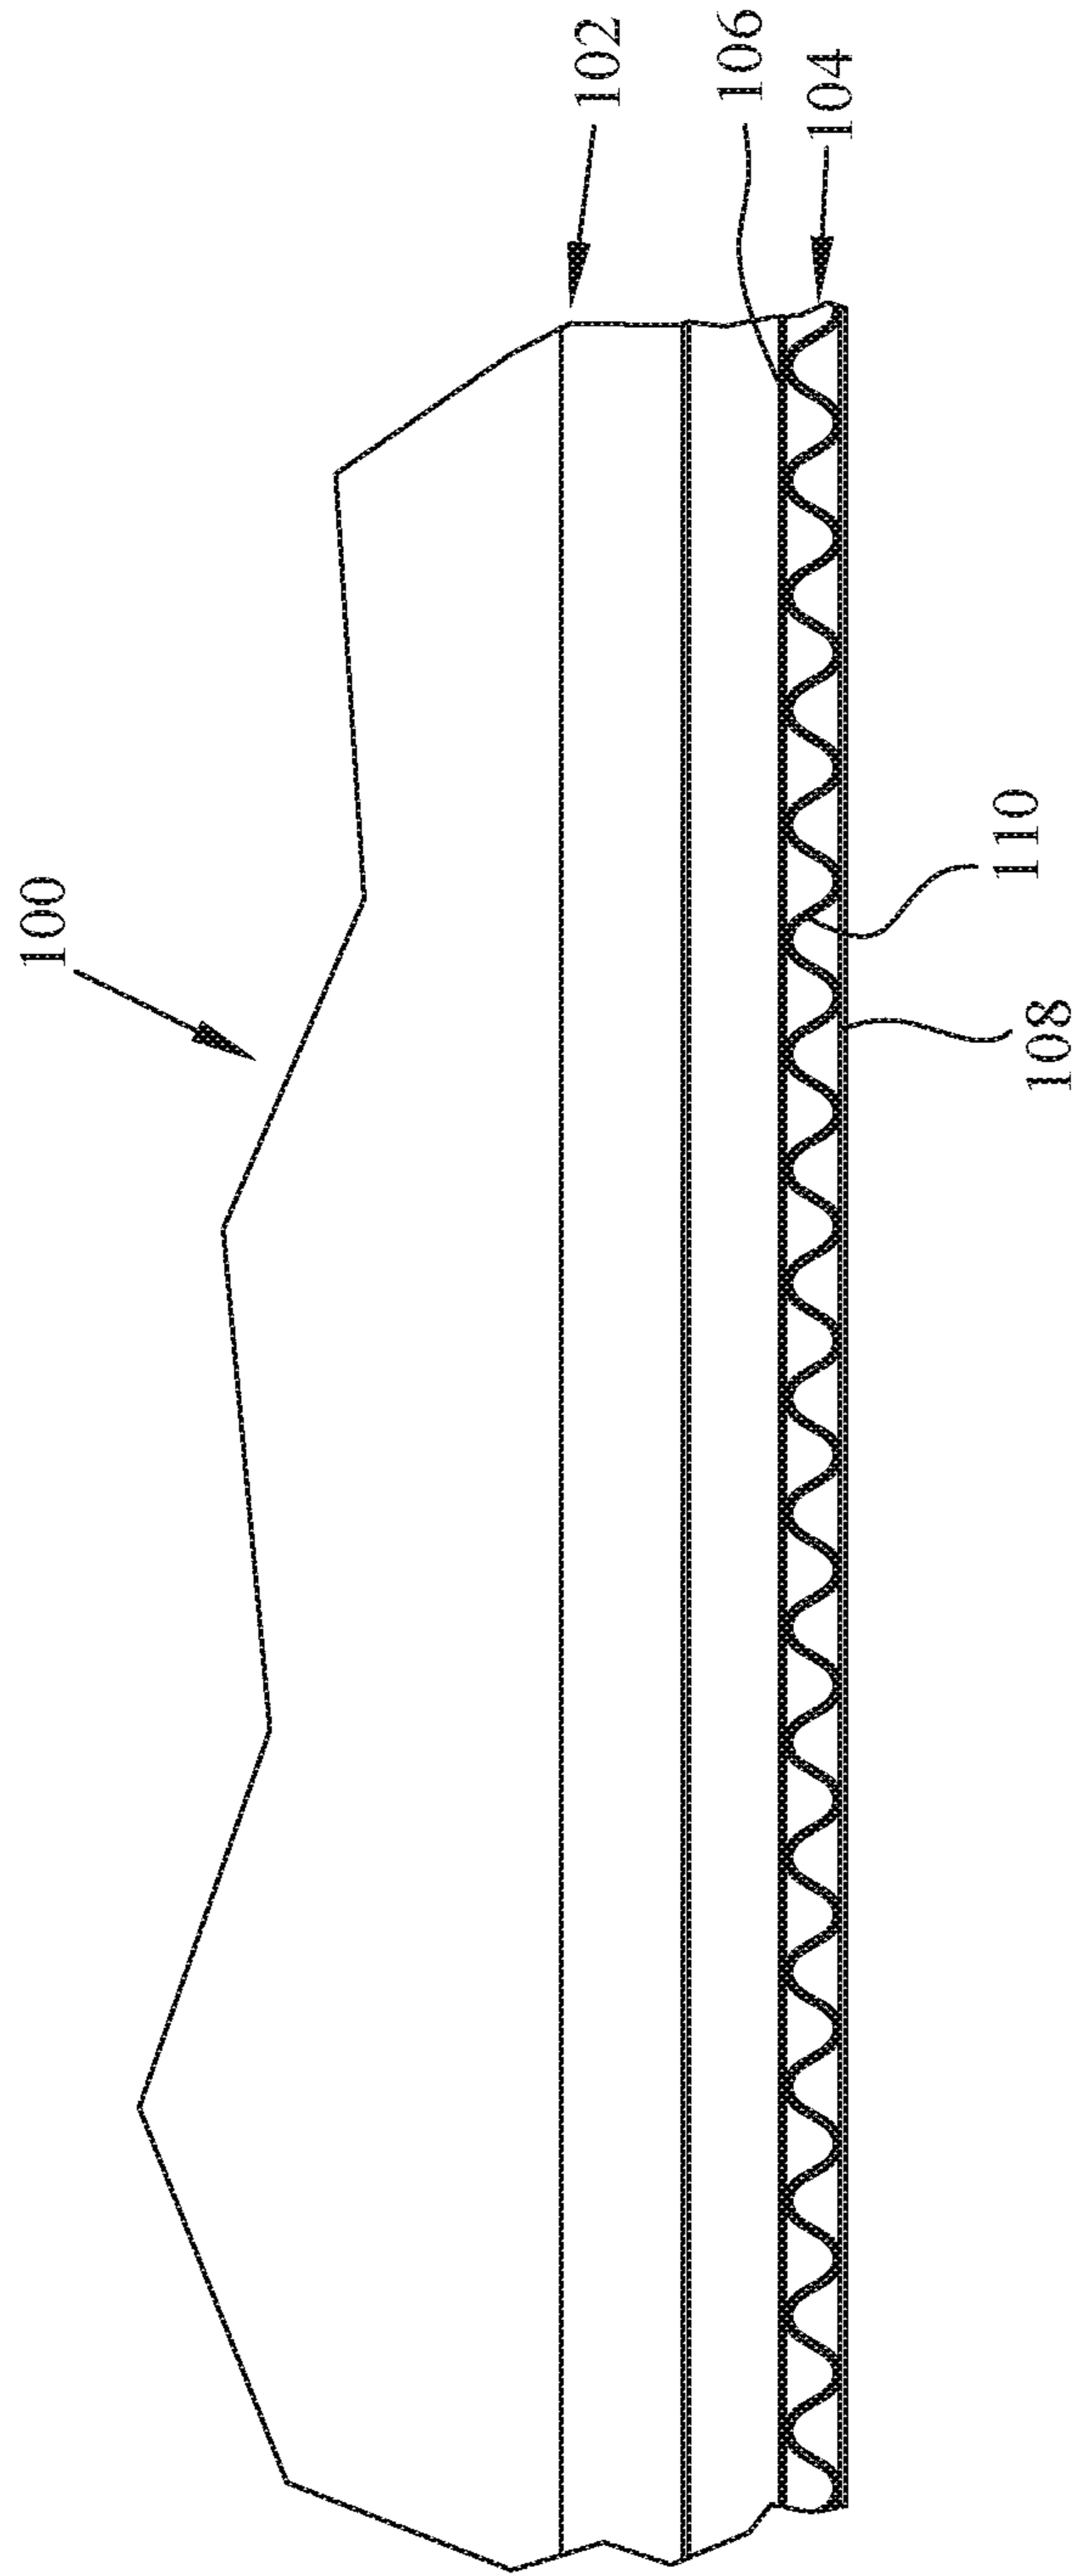
FIG. 3
(PRIOR ART)

FIG. 3 is a side view of a prior art recreational vehicle frame liner;

Referring now to FIGS. 3 and 4, these depict prior art vehicle undercarriage frame liners in common use in the industry. A portion of a recreational vehicle is generally indicated as 100. Recreational vehicle 100 includes a frame assembly generally indicated as 102 and a corrugated liner generally indicated as 104. Corrugated liner 104 includes a top sheet 106, a bottom sheet 108, and a corrugated or sinusoidal ply 110 extending therebetween. Top sheets 106 and 108 are adhered or attached to corrugated ply 110. Typically, the corrugated material is polyethylene.

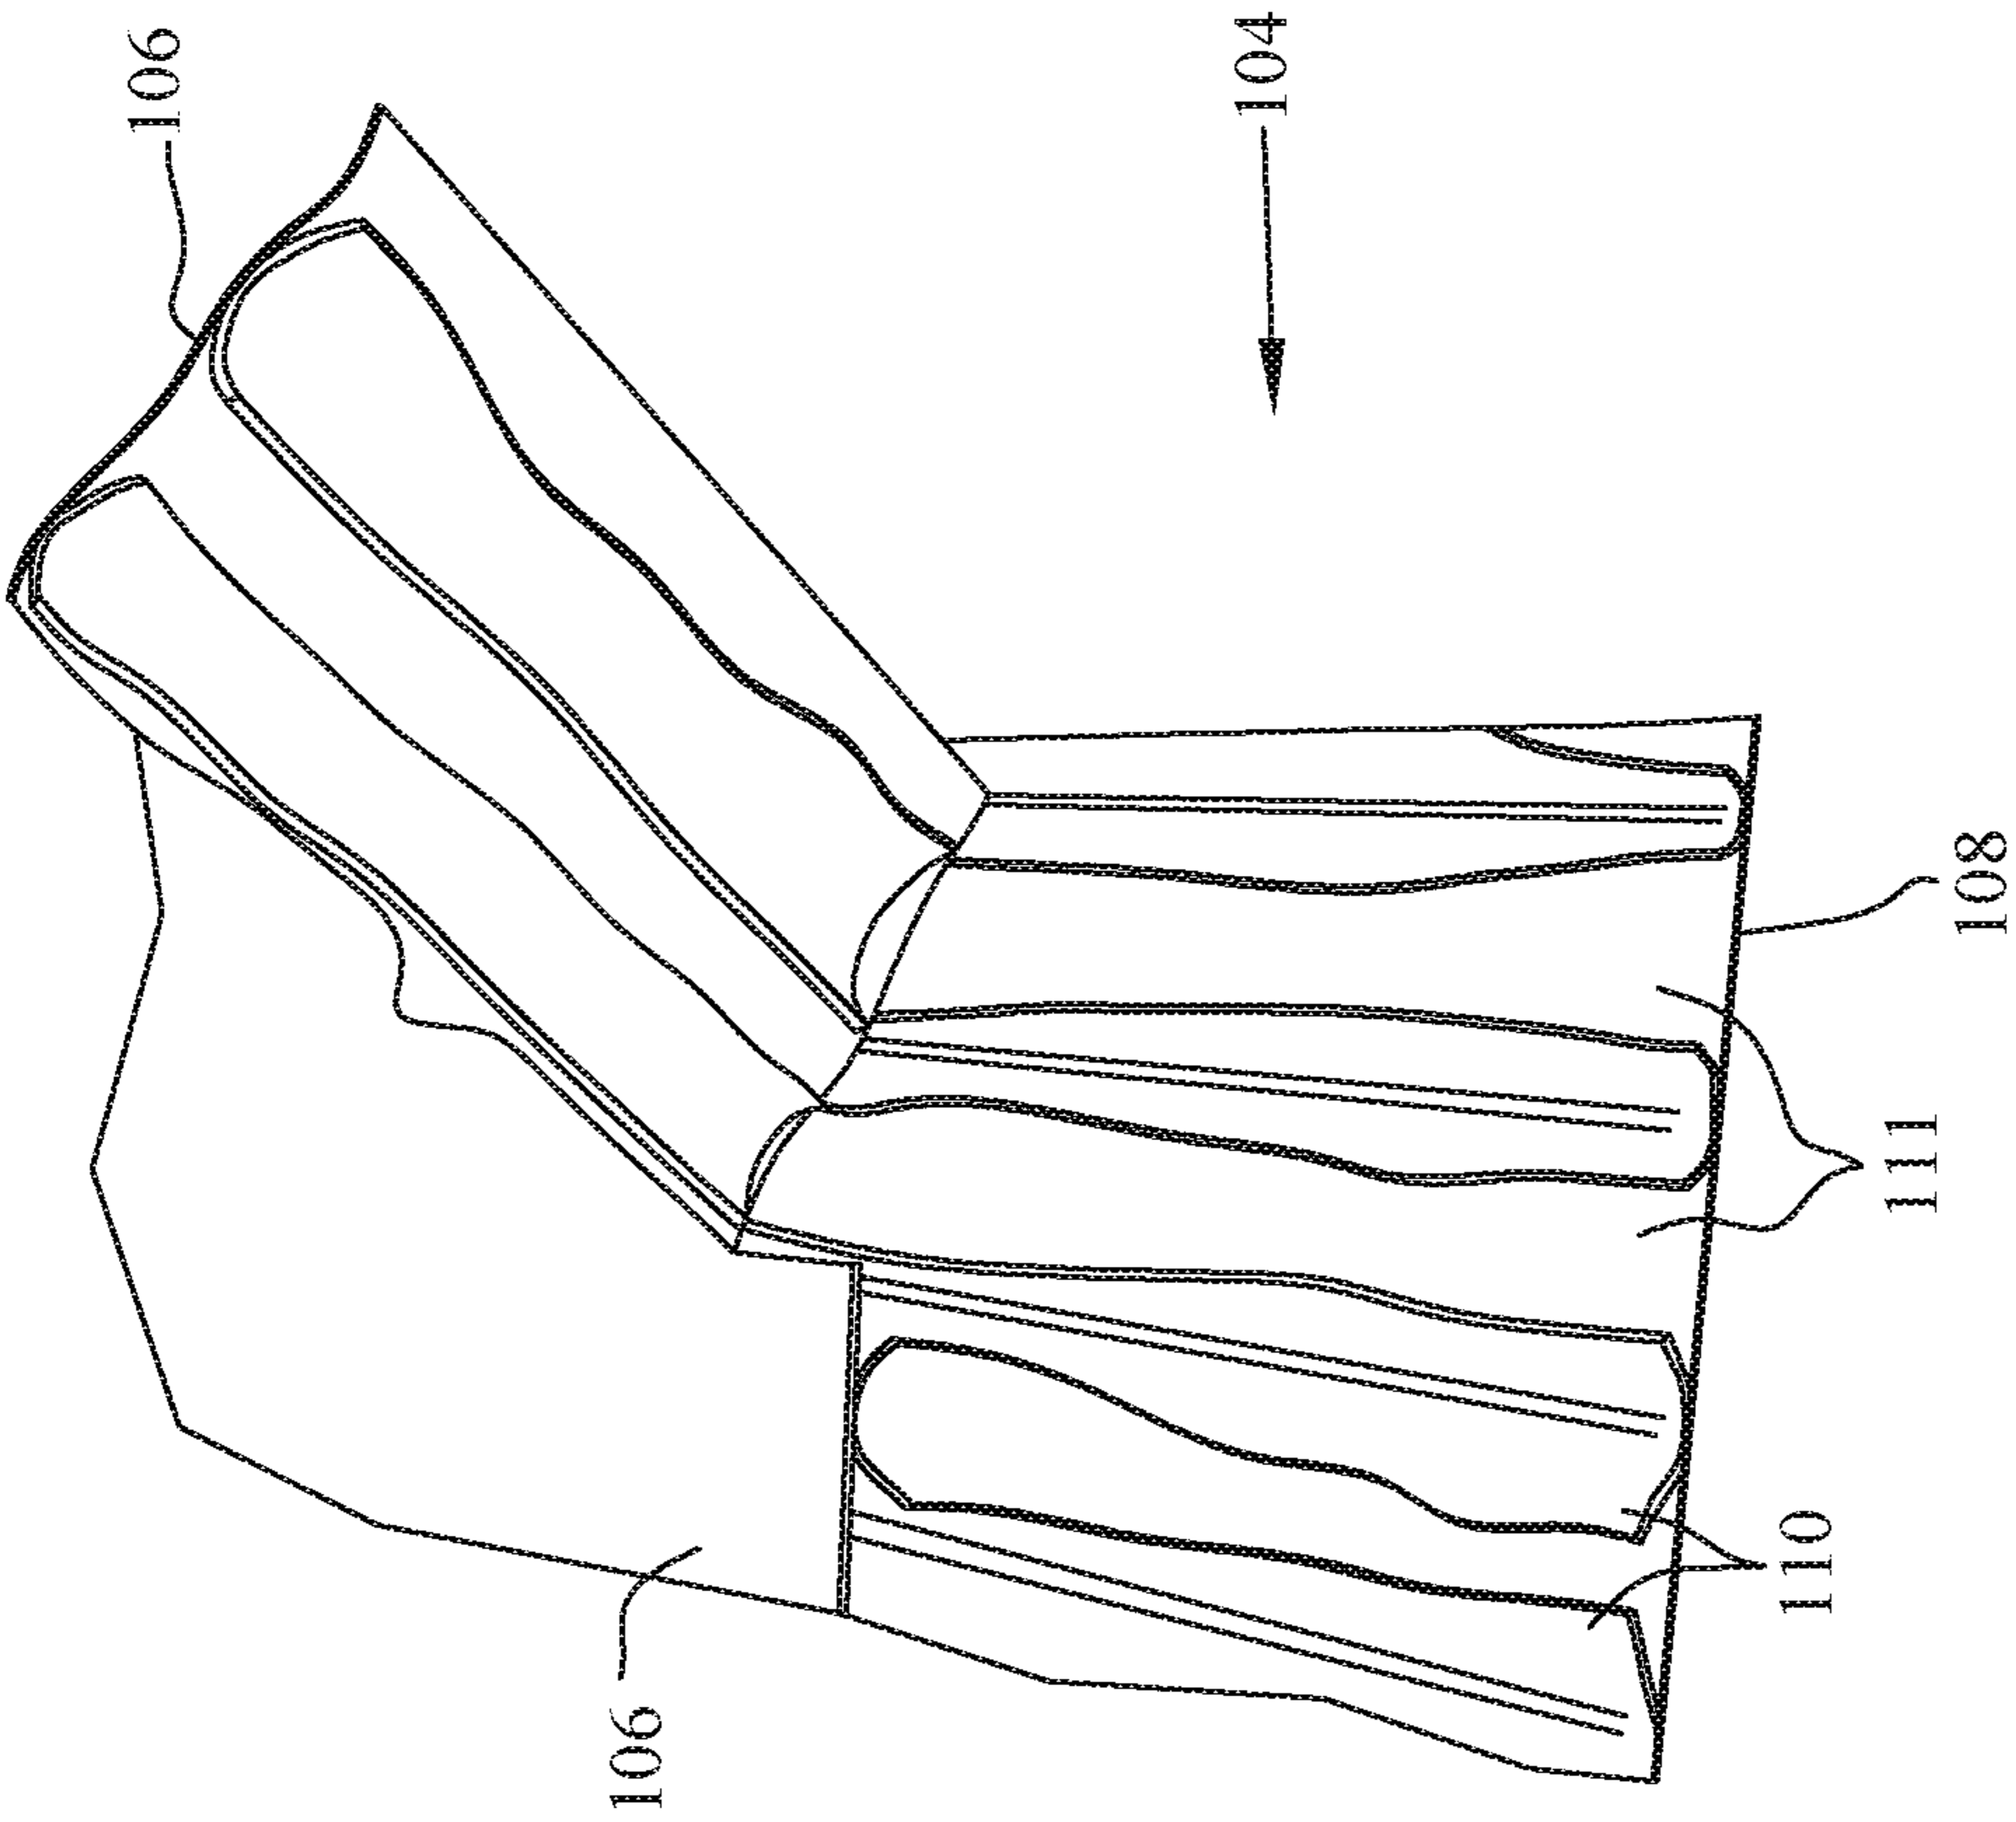
FIG. 3A
(PRIOR ART)

FIG. 3A is an enlarged perspective view of the frame liner in FIG. 3 showing the top layer partially peeled back and channels therein.

Referring to FIG. 3A, a portion of the corrugated liner 104 is shown removed from recreational vehicle 100. In FIG. 3A, a portion of the top sheet 106 has been pulled back revealing channels 111 that extend between top sheet 106 and bottom sheet 108 and along/within the sinusoidal ply 110. As should be appreciated, a problem, with the prior art liner is that any water or moisture entering the open ends of the corrugated liner 104 easily crosses through channels 111 so that channels 111 can become filled with water. The water can leak or freezing of the water may cause ripping, tearing or pulling apart of corrugated liner 104, thereby destroying its structural integrity.

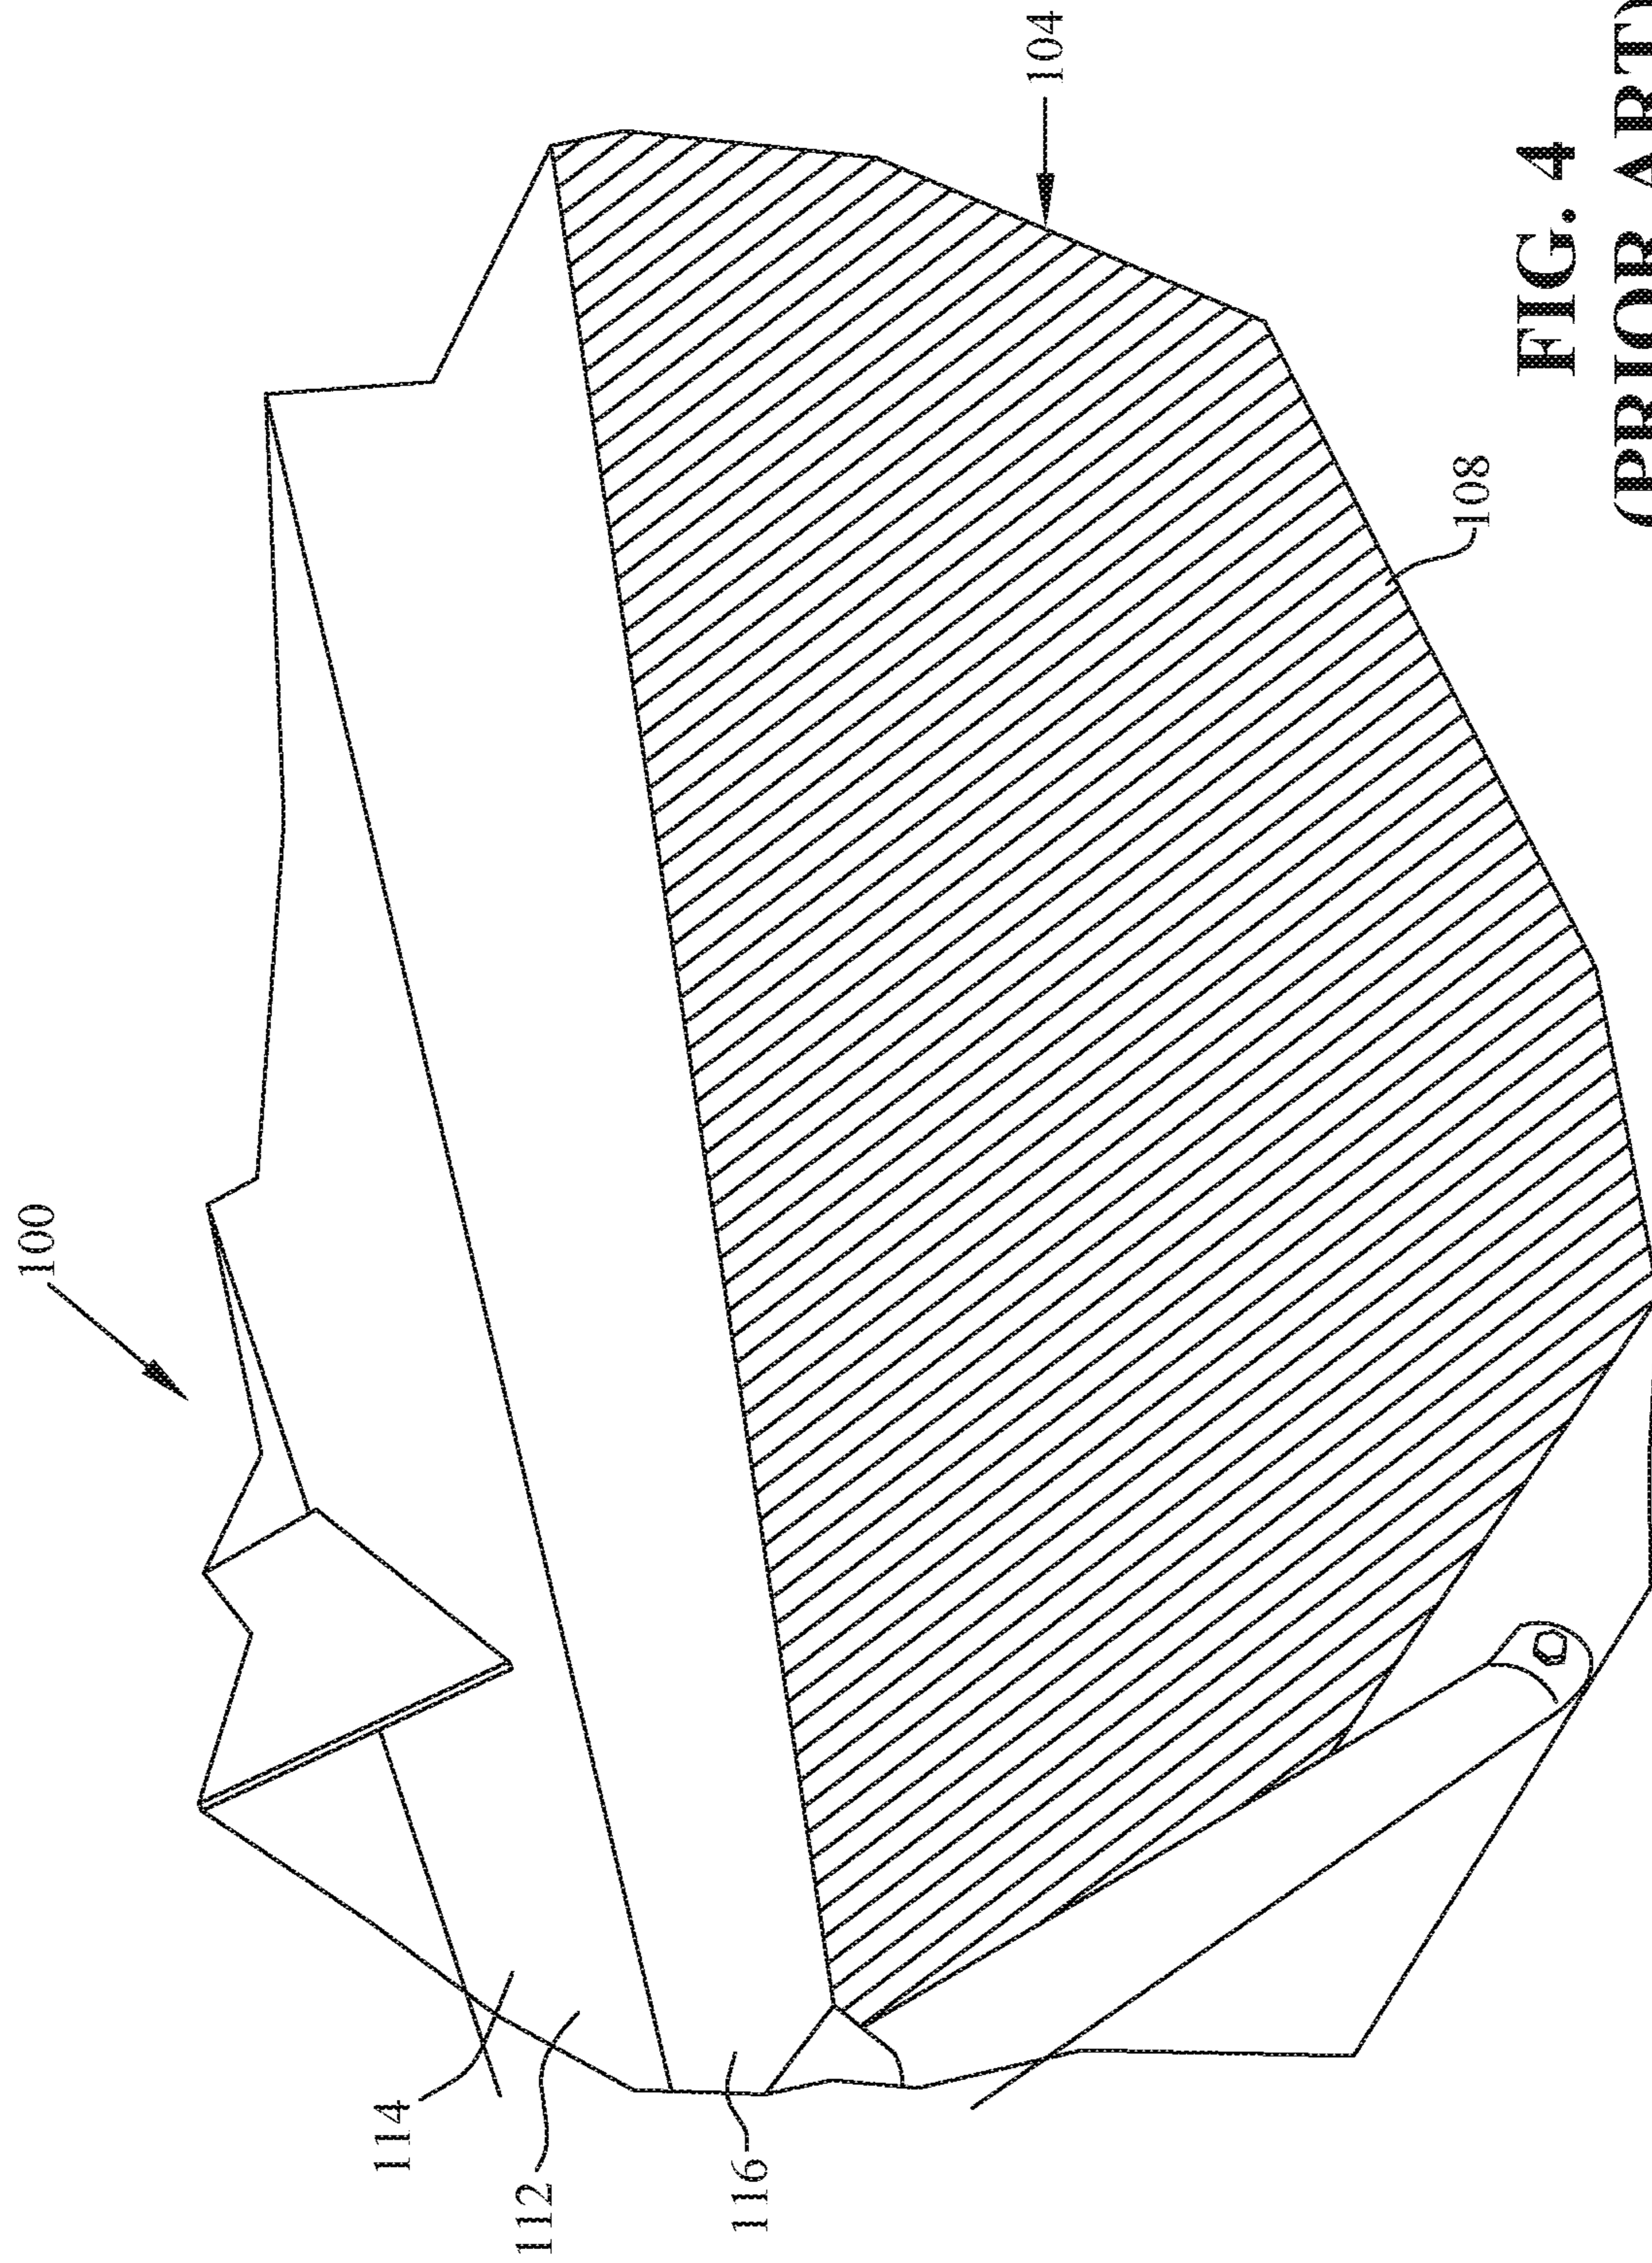
FIG. 4
(PRIOR ART)

FIG. 4 is a bottom prospective view of a prior art recreational vehicle and frame liner;

Referring to FIG. 4, only the bottom sheet 108 of corrugated liner 104 is visible. Furthermore, the corrugations are not visible as recreational vehicle 100 includes a frame member 112, such as in I-beam or C-channel including a vertical web 112 and horizontal flange 116. Side edges of corrugated liner 104 are located on top of flange 112.

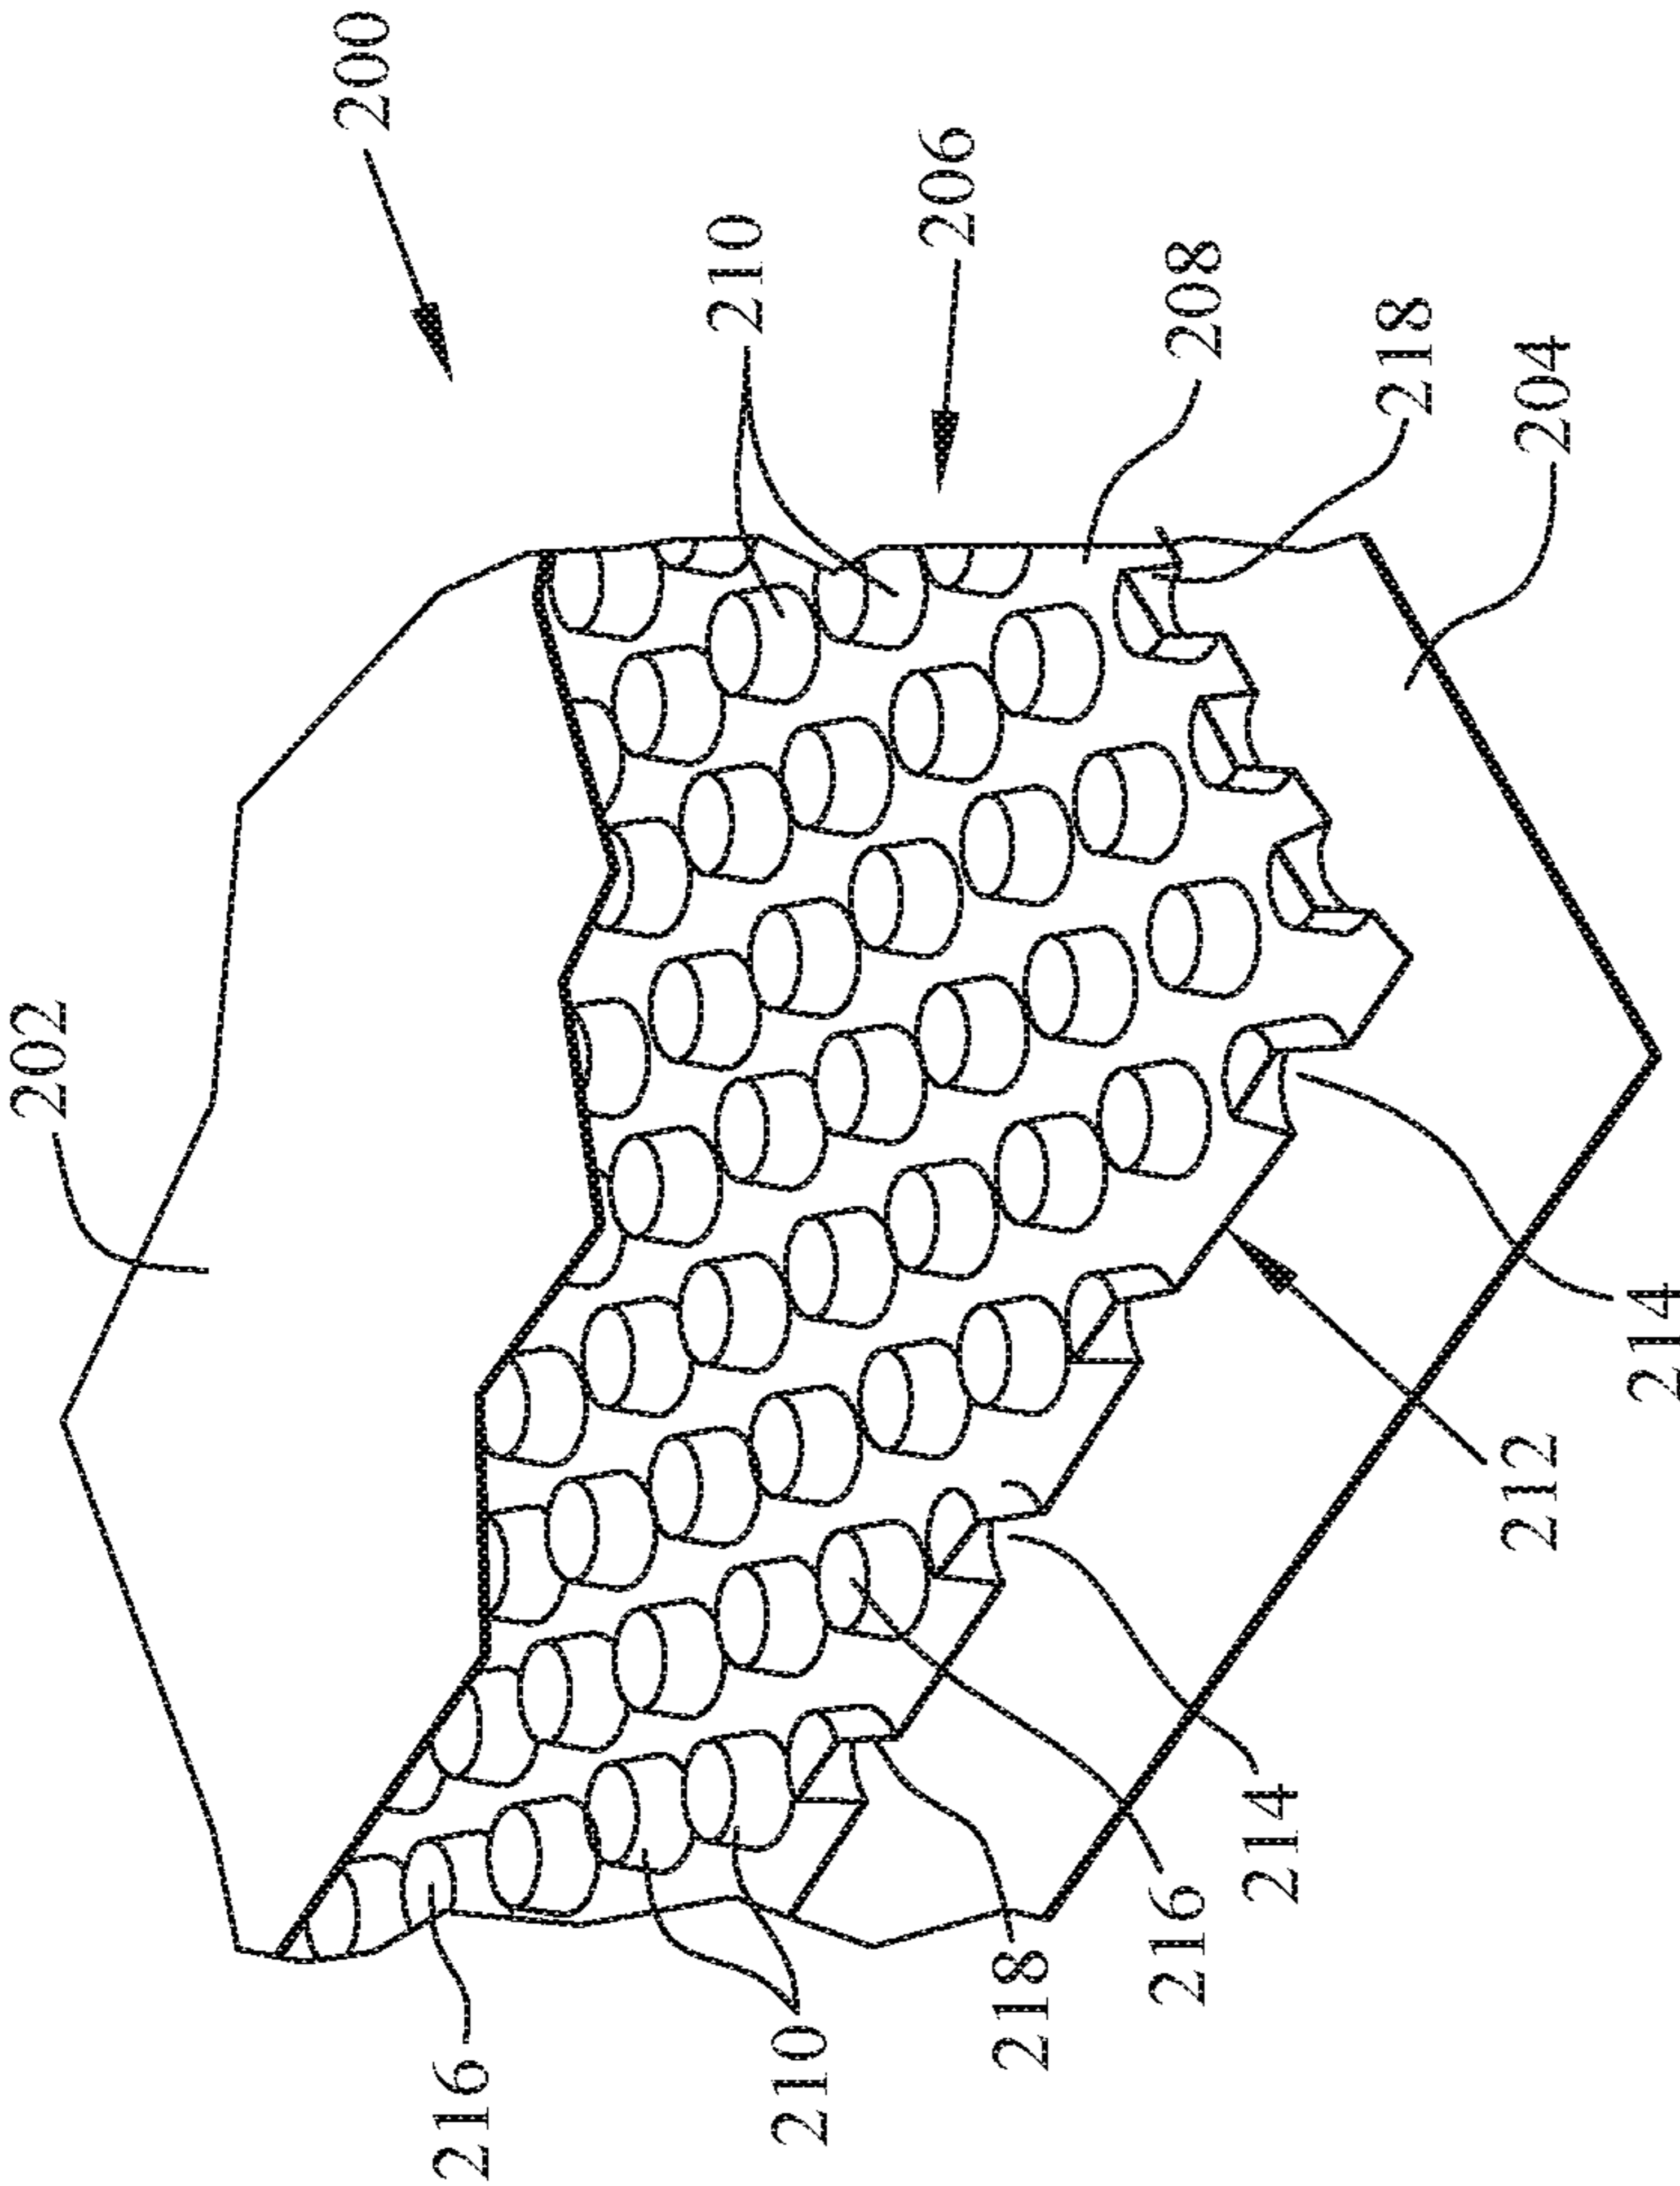
FIG. 5 is an exploded view of a sandwich material from which one embodiment of the liner for the subject invention is taken from;

Referring now to FIG. 5, an embodiment of a 3-ply panel from which the subject liner can be taken is generally indicated as 200. 3-ply panel 200 includes a top sheet 202, a bottom sheet 204, and a core generally indicated as 206. In a preferred embodiment, 3-ply panel 200 and core 206 is manufactured from polypropylene and is 100% recyclable. Core 206 may also be referred to as plastic honeycomb or plastic bubble board. 3-ply panel 200 may be provided in thicknesses of 10 mm, 5 mm or 3 mm. Applicant has found that the core 206 in a 3 mm thick 3-ply panel 200 is particularly suitable for use as a liner in accordance with the subject invention as will be discussed in further detail below. As can be seen in FIG. 5, core 206 has one face 208 having projections 210 extending upward therefrom. The opposite face 212 includes openings 214 extending downward into projections 212. Accordingly, projections 210 have a generally cylindrical configuration being hollow in the center thereof and including an end face 216 and side walls 218. Applicant has determined that one suitable 3-ply panel 200 from which core 206 may be extracted and used is IntePro® 3 mm Titan board from the IntePlast Group.

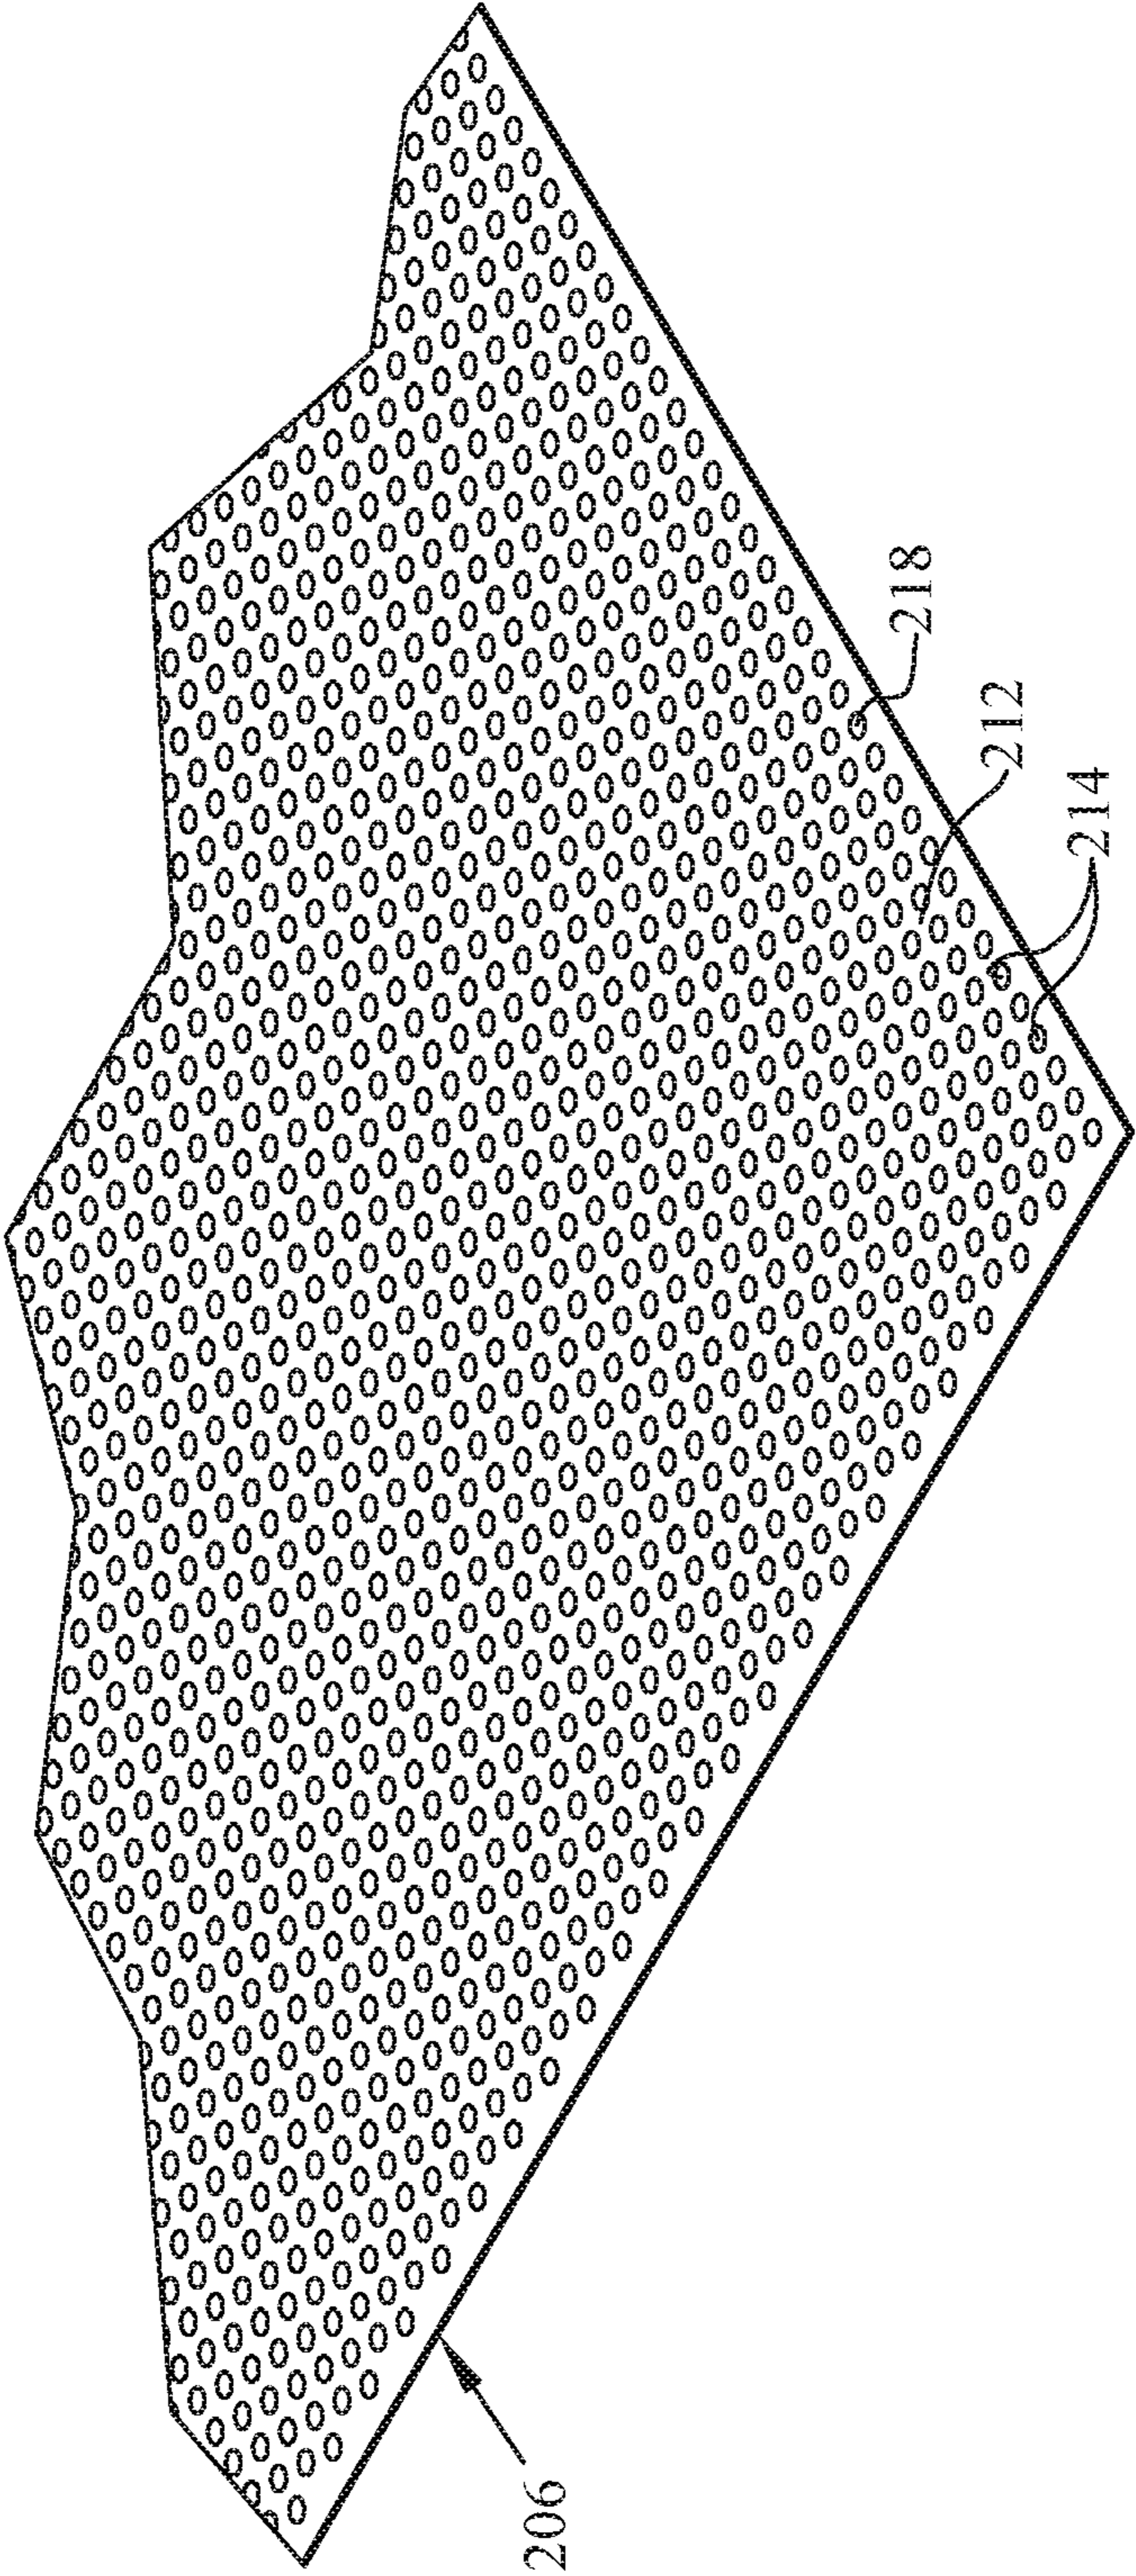
FIG. 6 is a perspective view of one embodiment of a vehicle frame liner and cargo bay liner of the subject invention, with top and bottom sheets removed, showing a face of the liner having openings therein;

Referring now to FIGS. 6-11, further details, of vehicle frame and cargo area liner/core 206 are disclosed. As can be seen, the projections and/or openings 210, 214, respectively are aligned in a lengthwise direction of core 206 but going crosswise across core 206, projections 210 and openings 214 are staggered.
