US011447189B1

(54) **VEHICLE FRAME AND CARGO BAY LINER**

A vehicle and liner assembly is provided that includes a
recreational vehicle having a housing, a front end, a rear end,
a top, a bottom, and a pair of sidewalls. A frame assembly
is provided wherein, the housing is mounted on and sup-
ported by the frame assembly. The liner is attached to the
frame assembly and covers at least a substantial portion of the
bottom of the housing. The liner has a first face having
projections extending therefrom and a second face having
openings therein. The openings coincide with and extend
into corresponding projections on the first face.

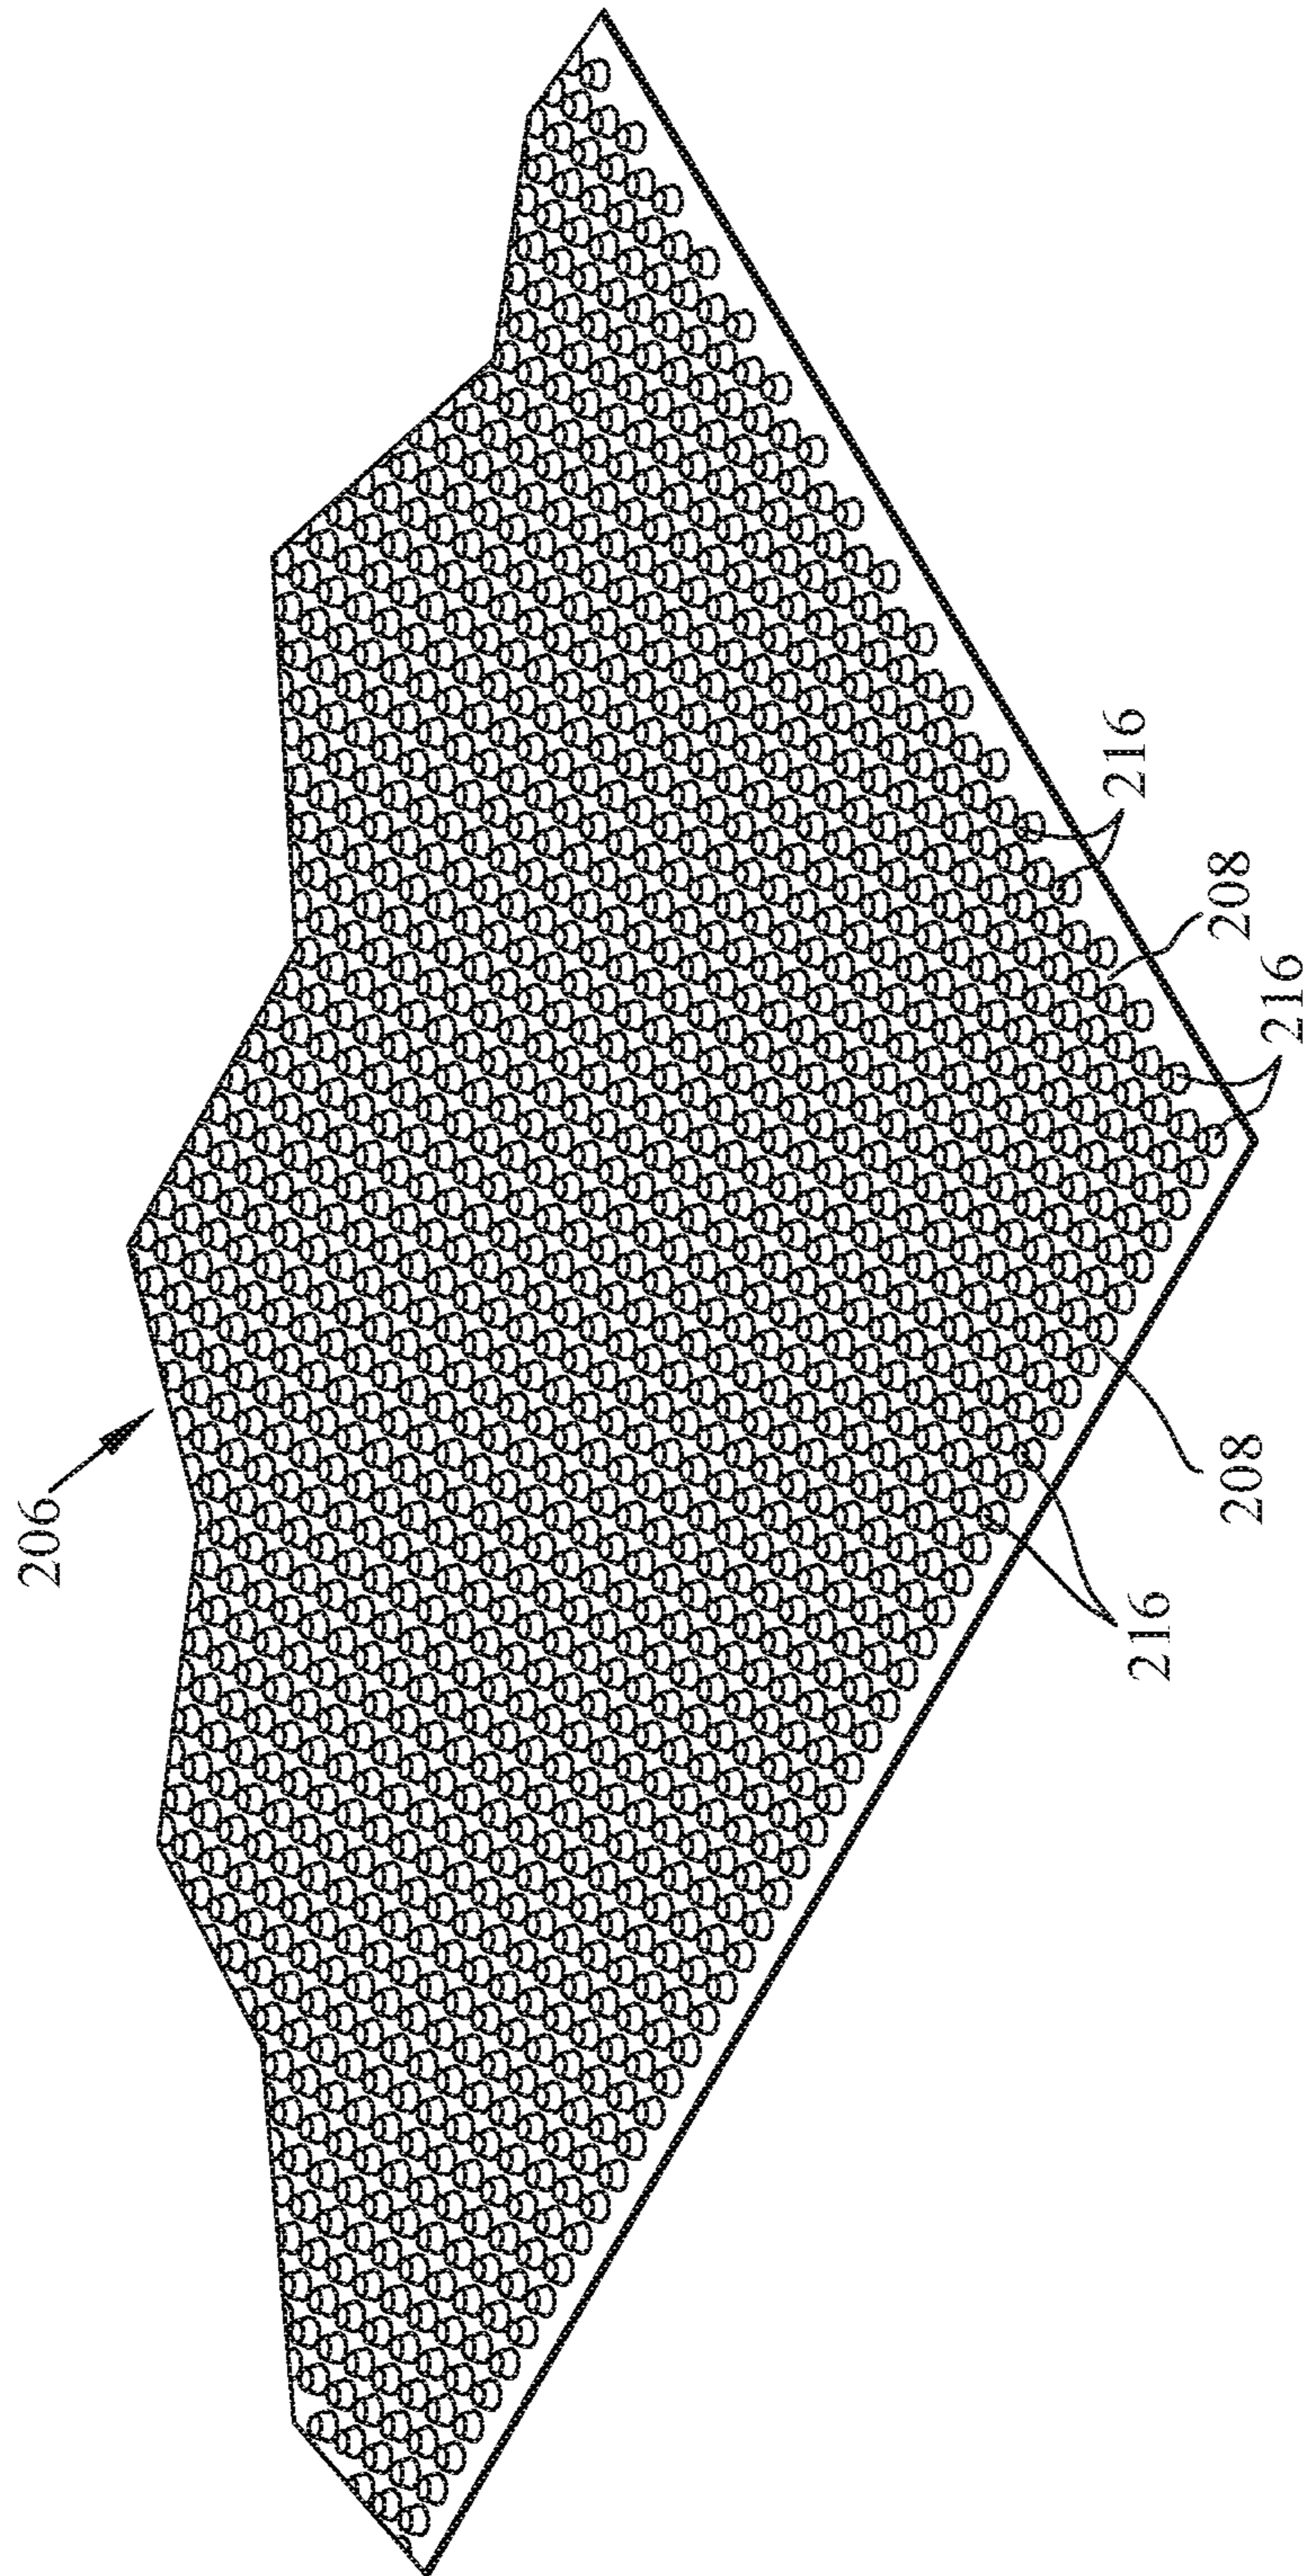
FIG. 7 is the vehicle frame and cargo bay liner of FIG. 6 showing an opposite face of the liner having projections extending therefrom;

Referring to FIG. 7, it can be appreciated that end faces 216 may have a variety of configurations including domed, flat, and/or convex.

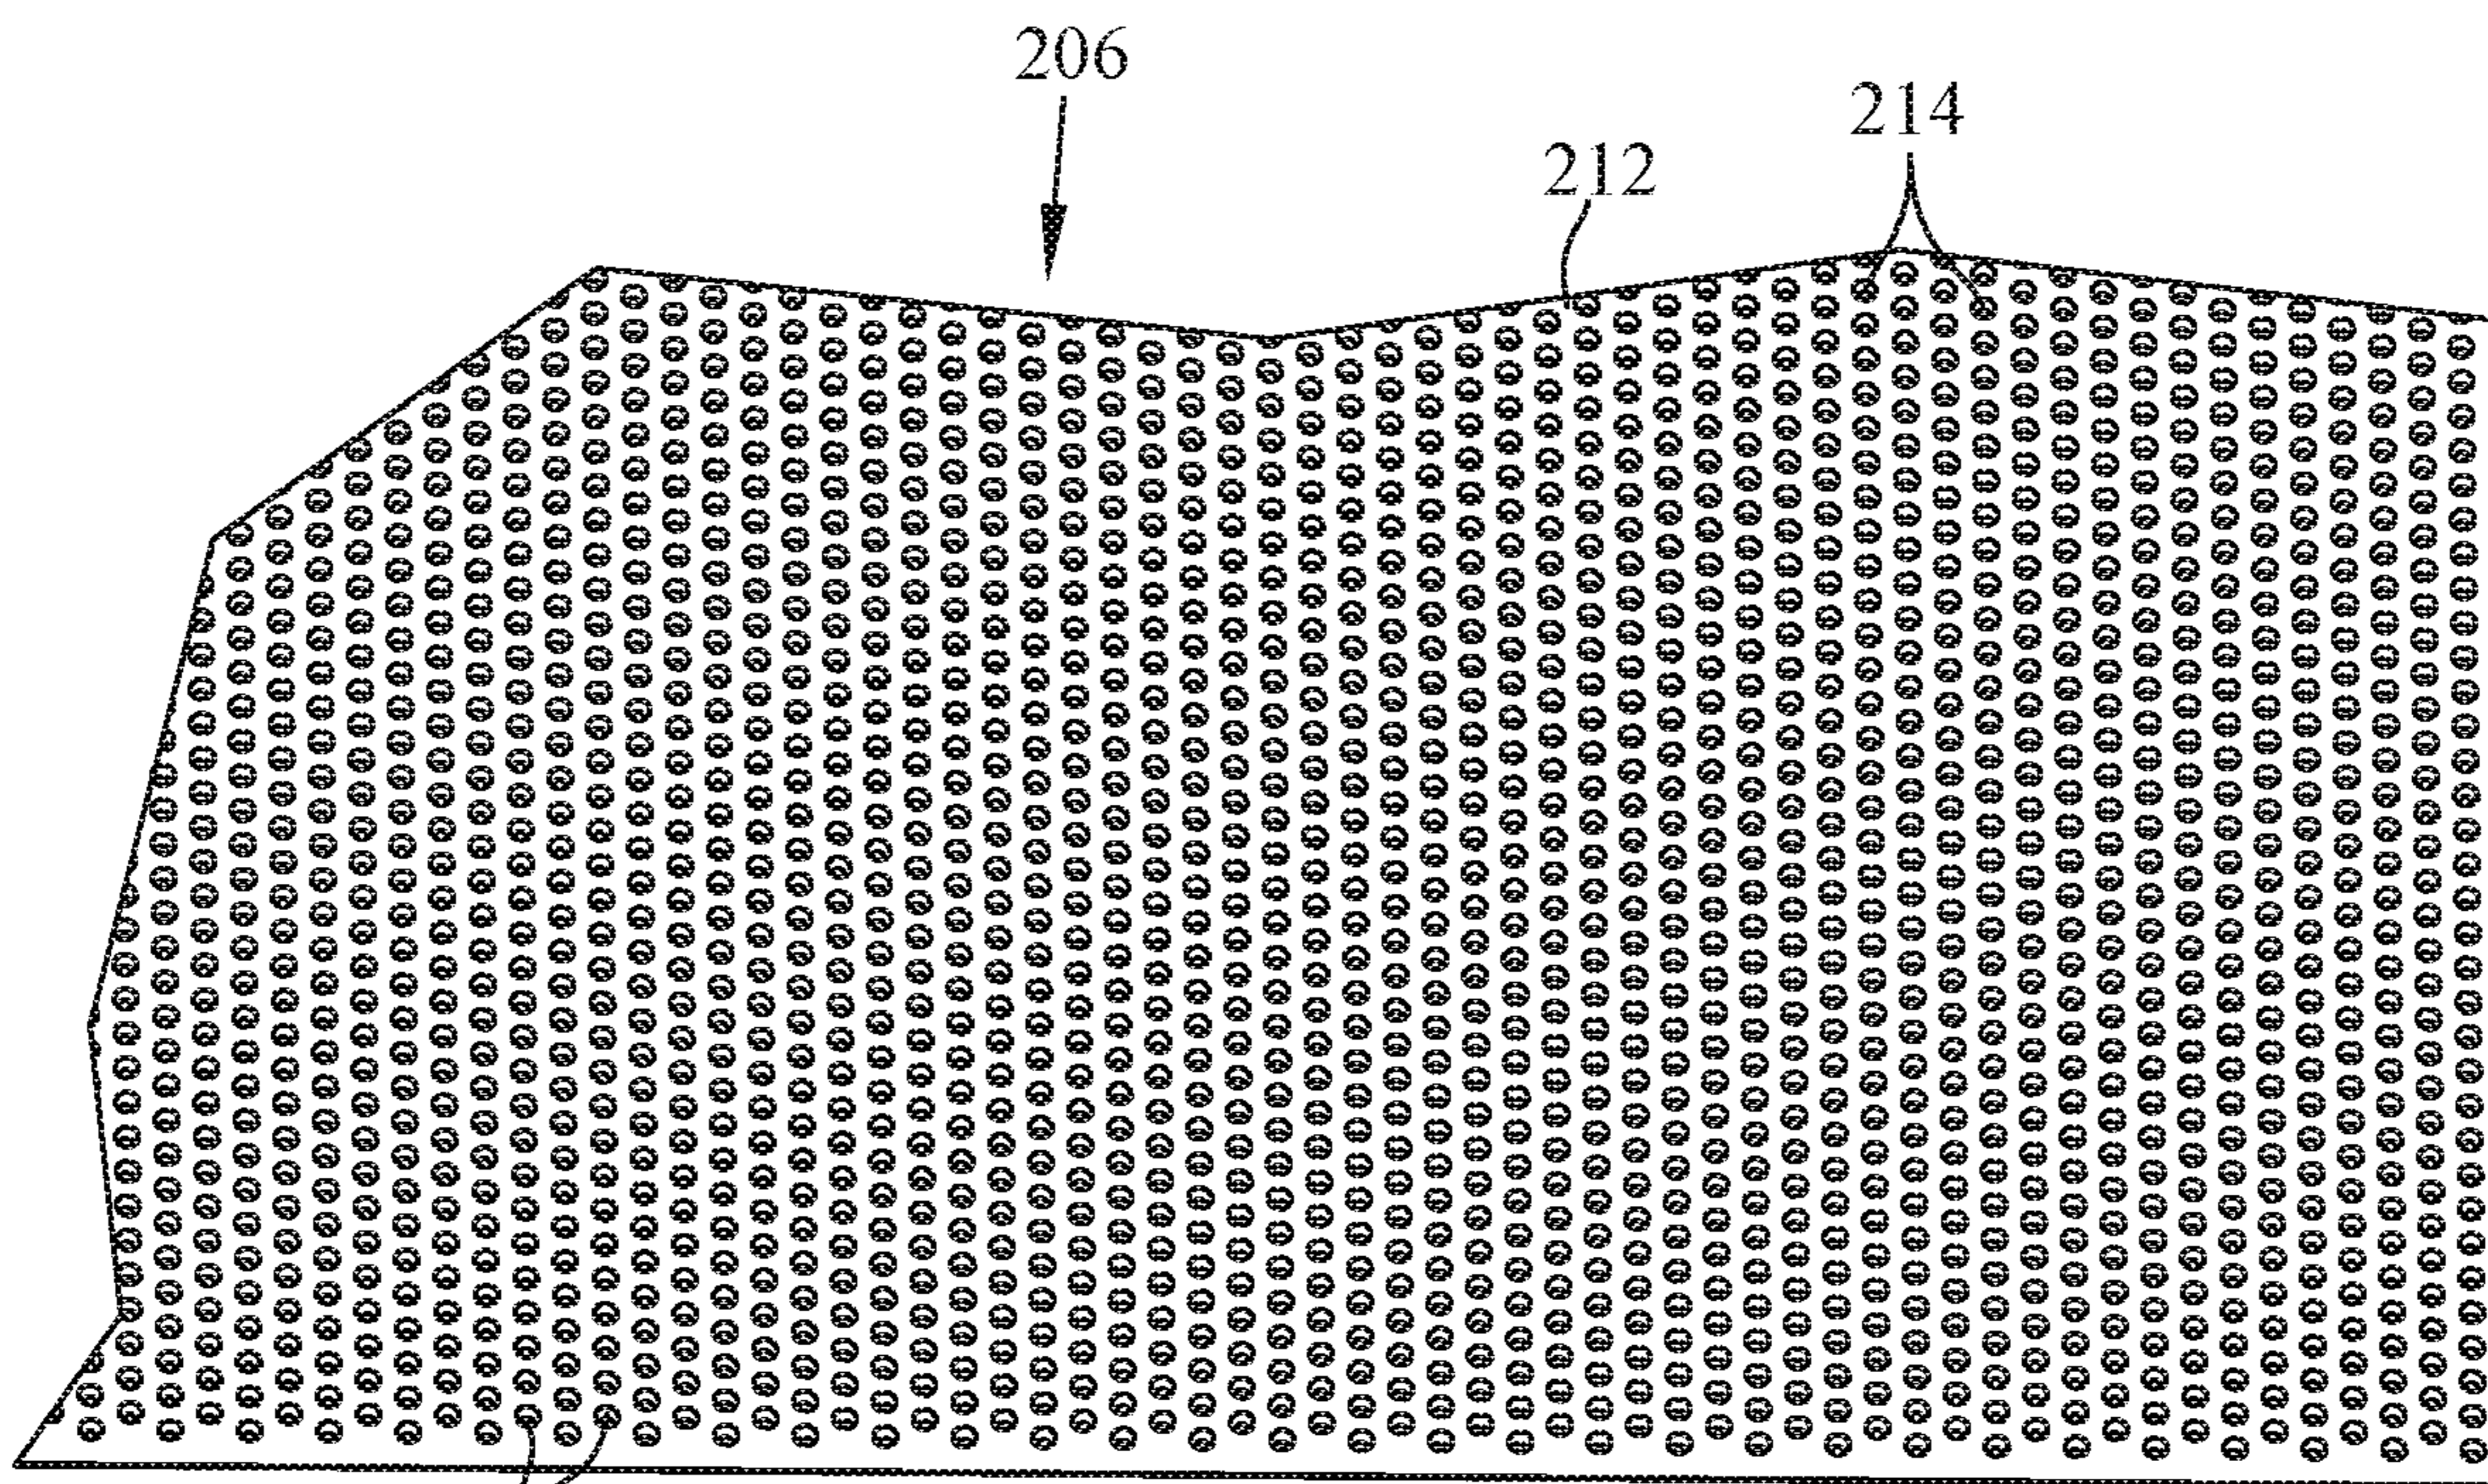
FIG. 8 is a plan view of the liner of FIG. 6 showing the face having openings;

Referring now to FIGS. 6-11, further details, of vehicle frame and cargo area liner/core 206 are disclosed. As can be seen, the projections and/or openings 210, 214, respectively are aligned in a lengthwise direction of core 206 but going crosswise across core 206, projections 210 and openings 214 are staggered.

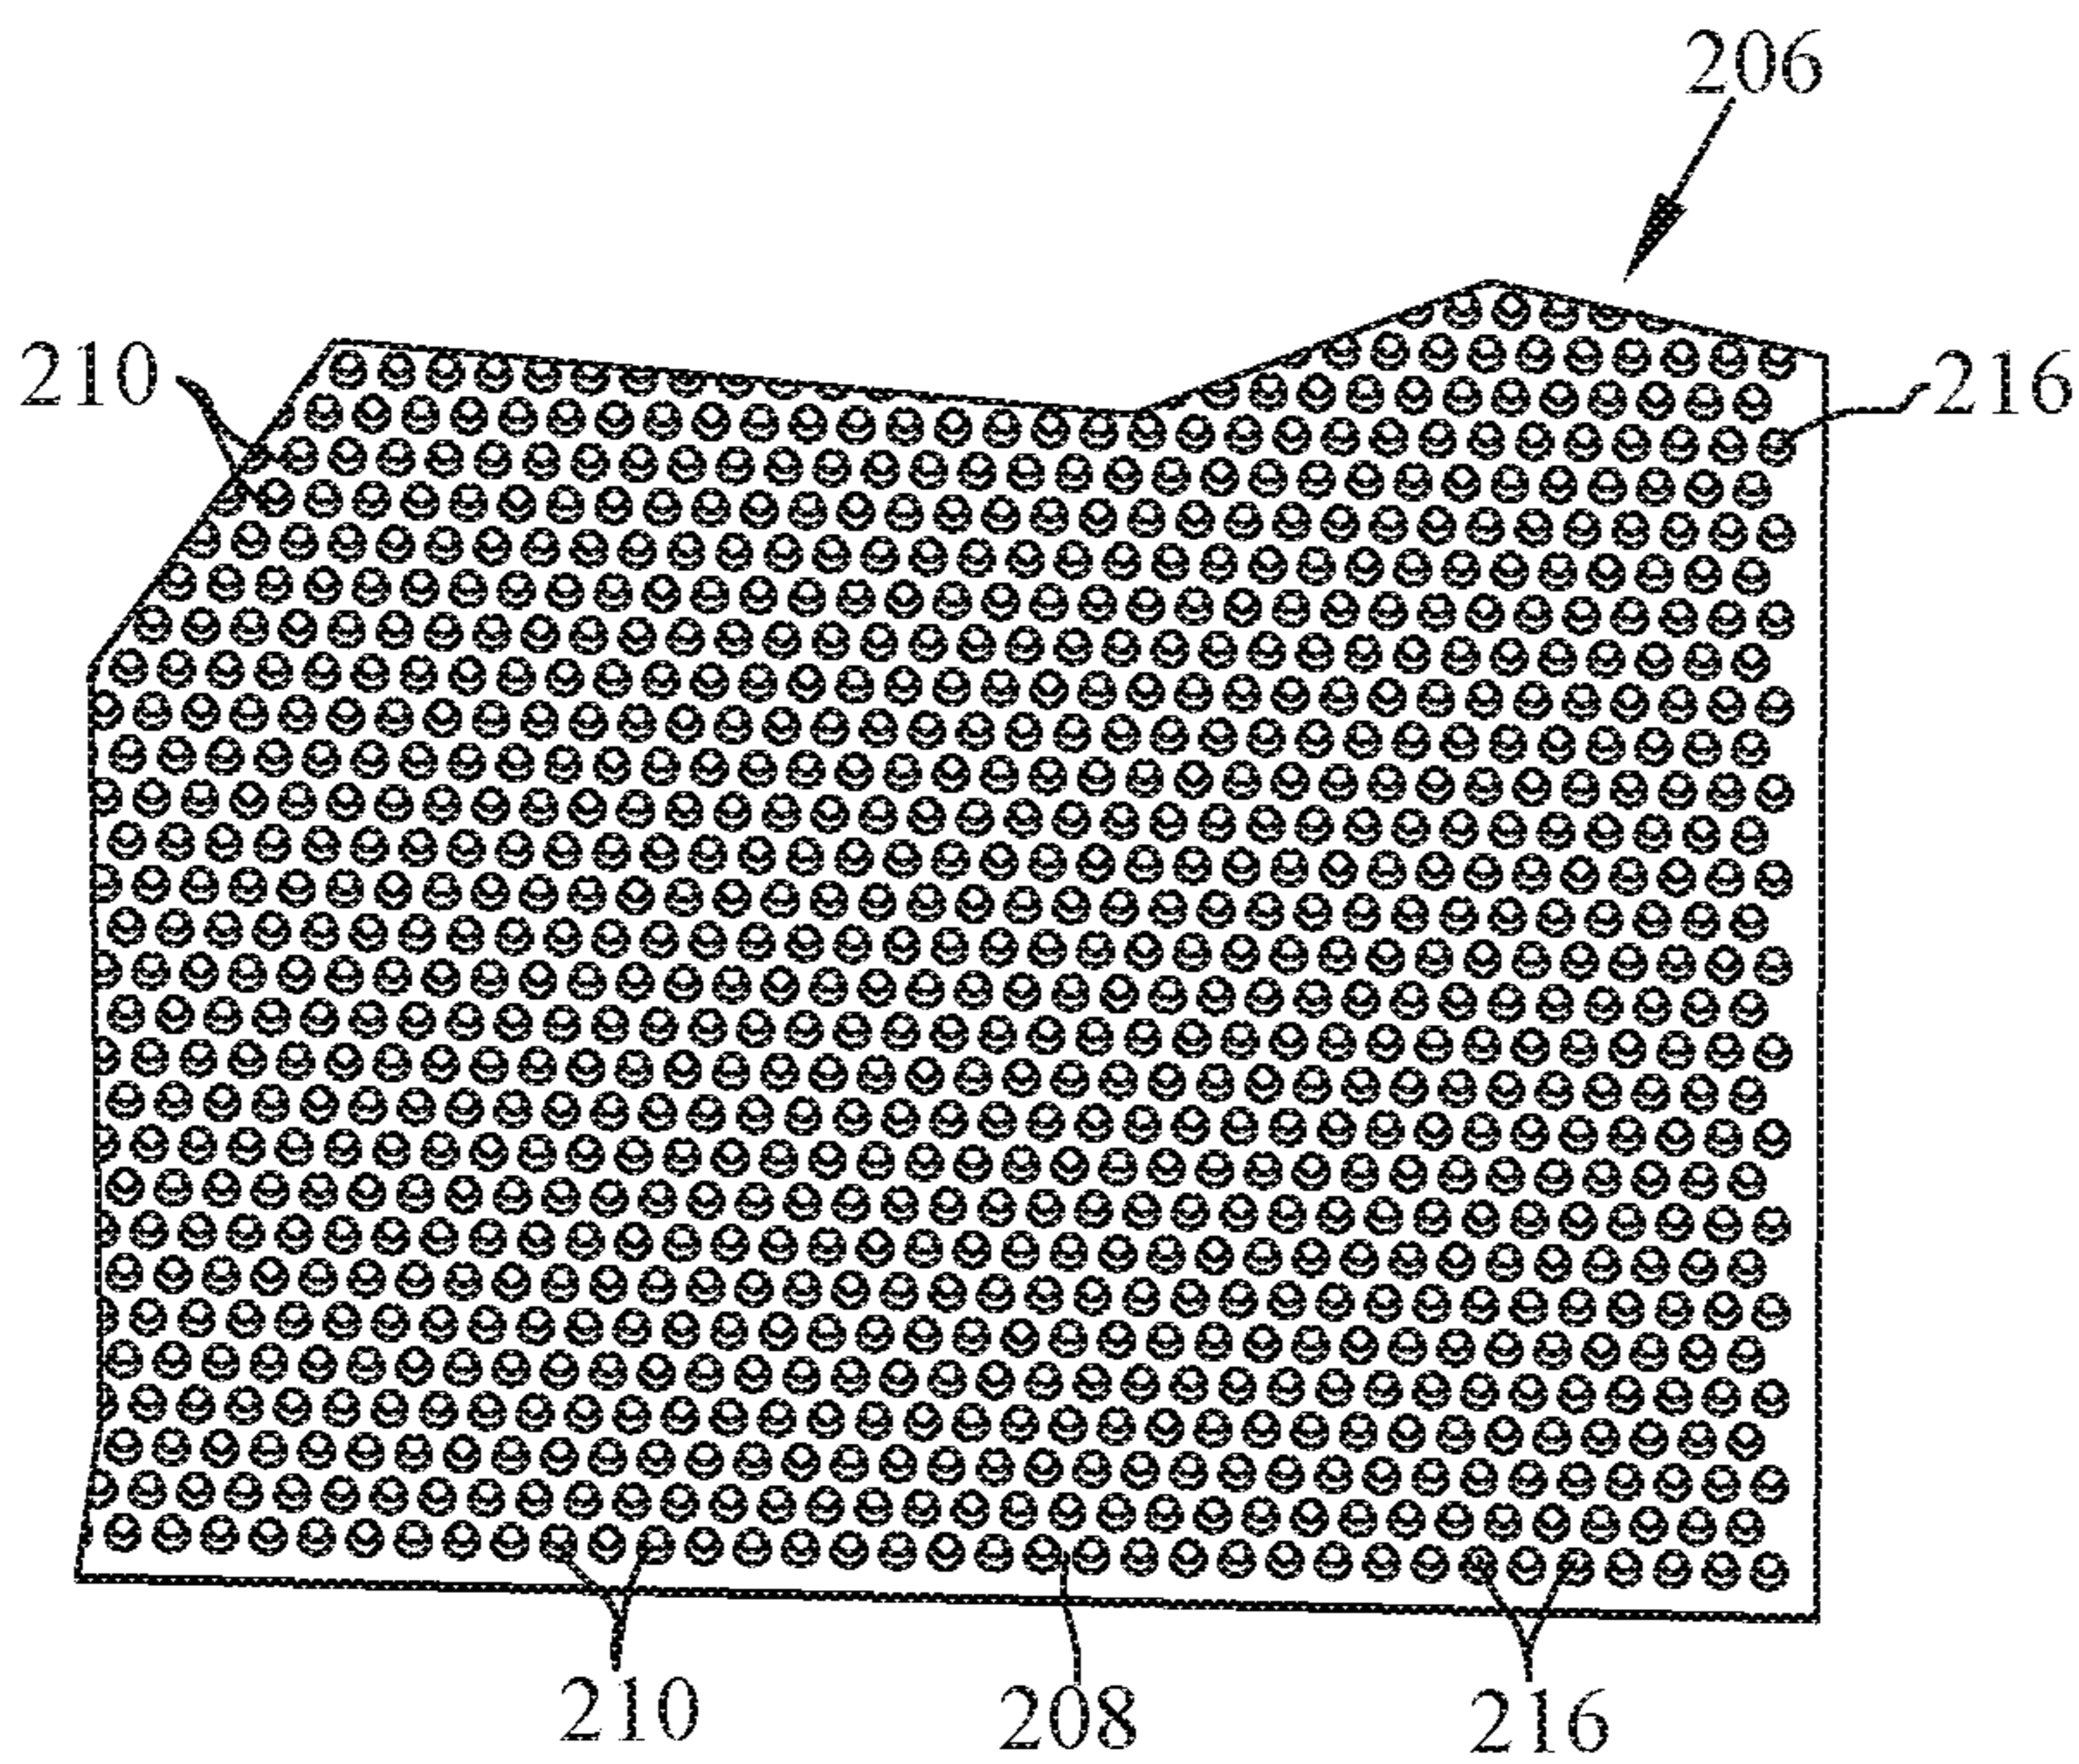
FIG. 9 is a plan view of the liner of FIG. 6 showing the face having projections extending therefrom;

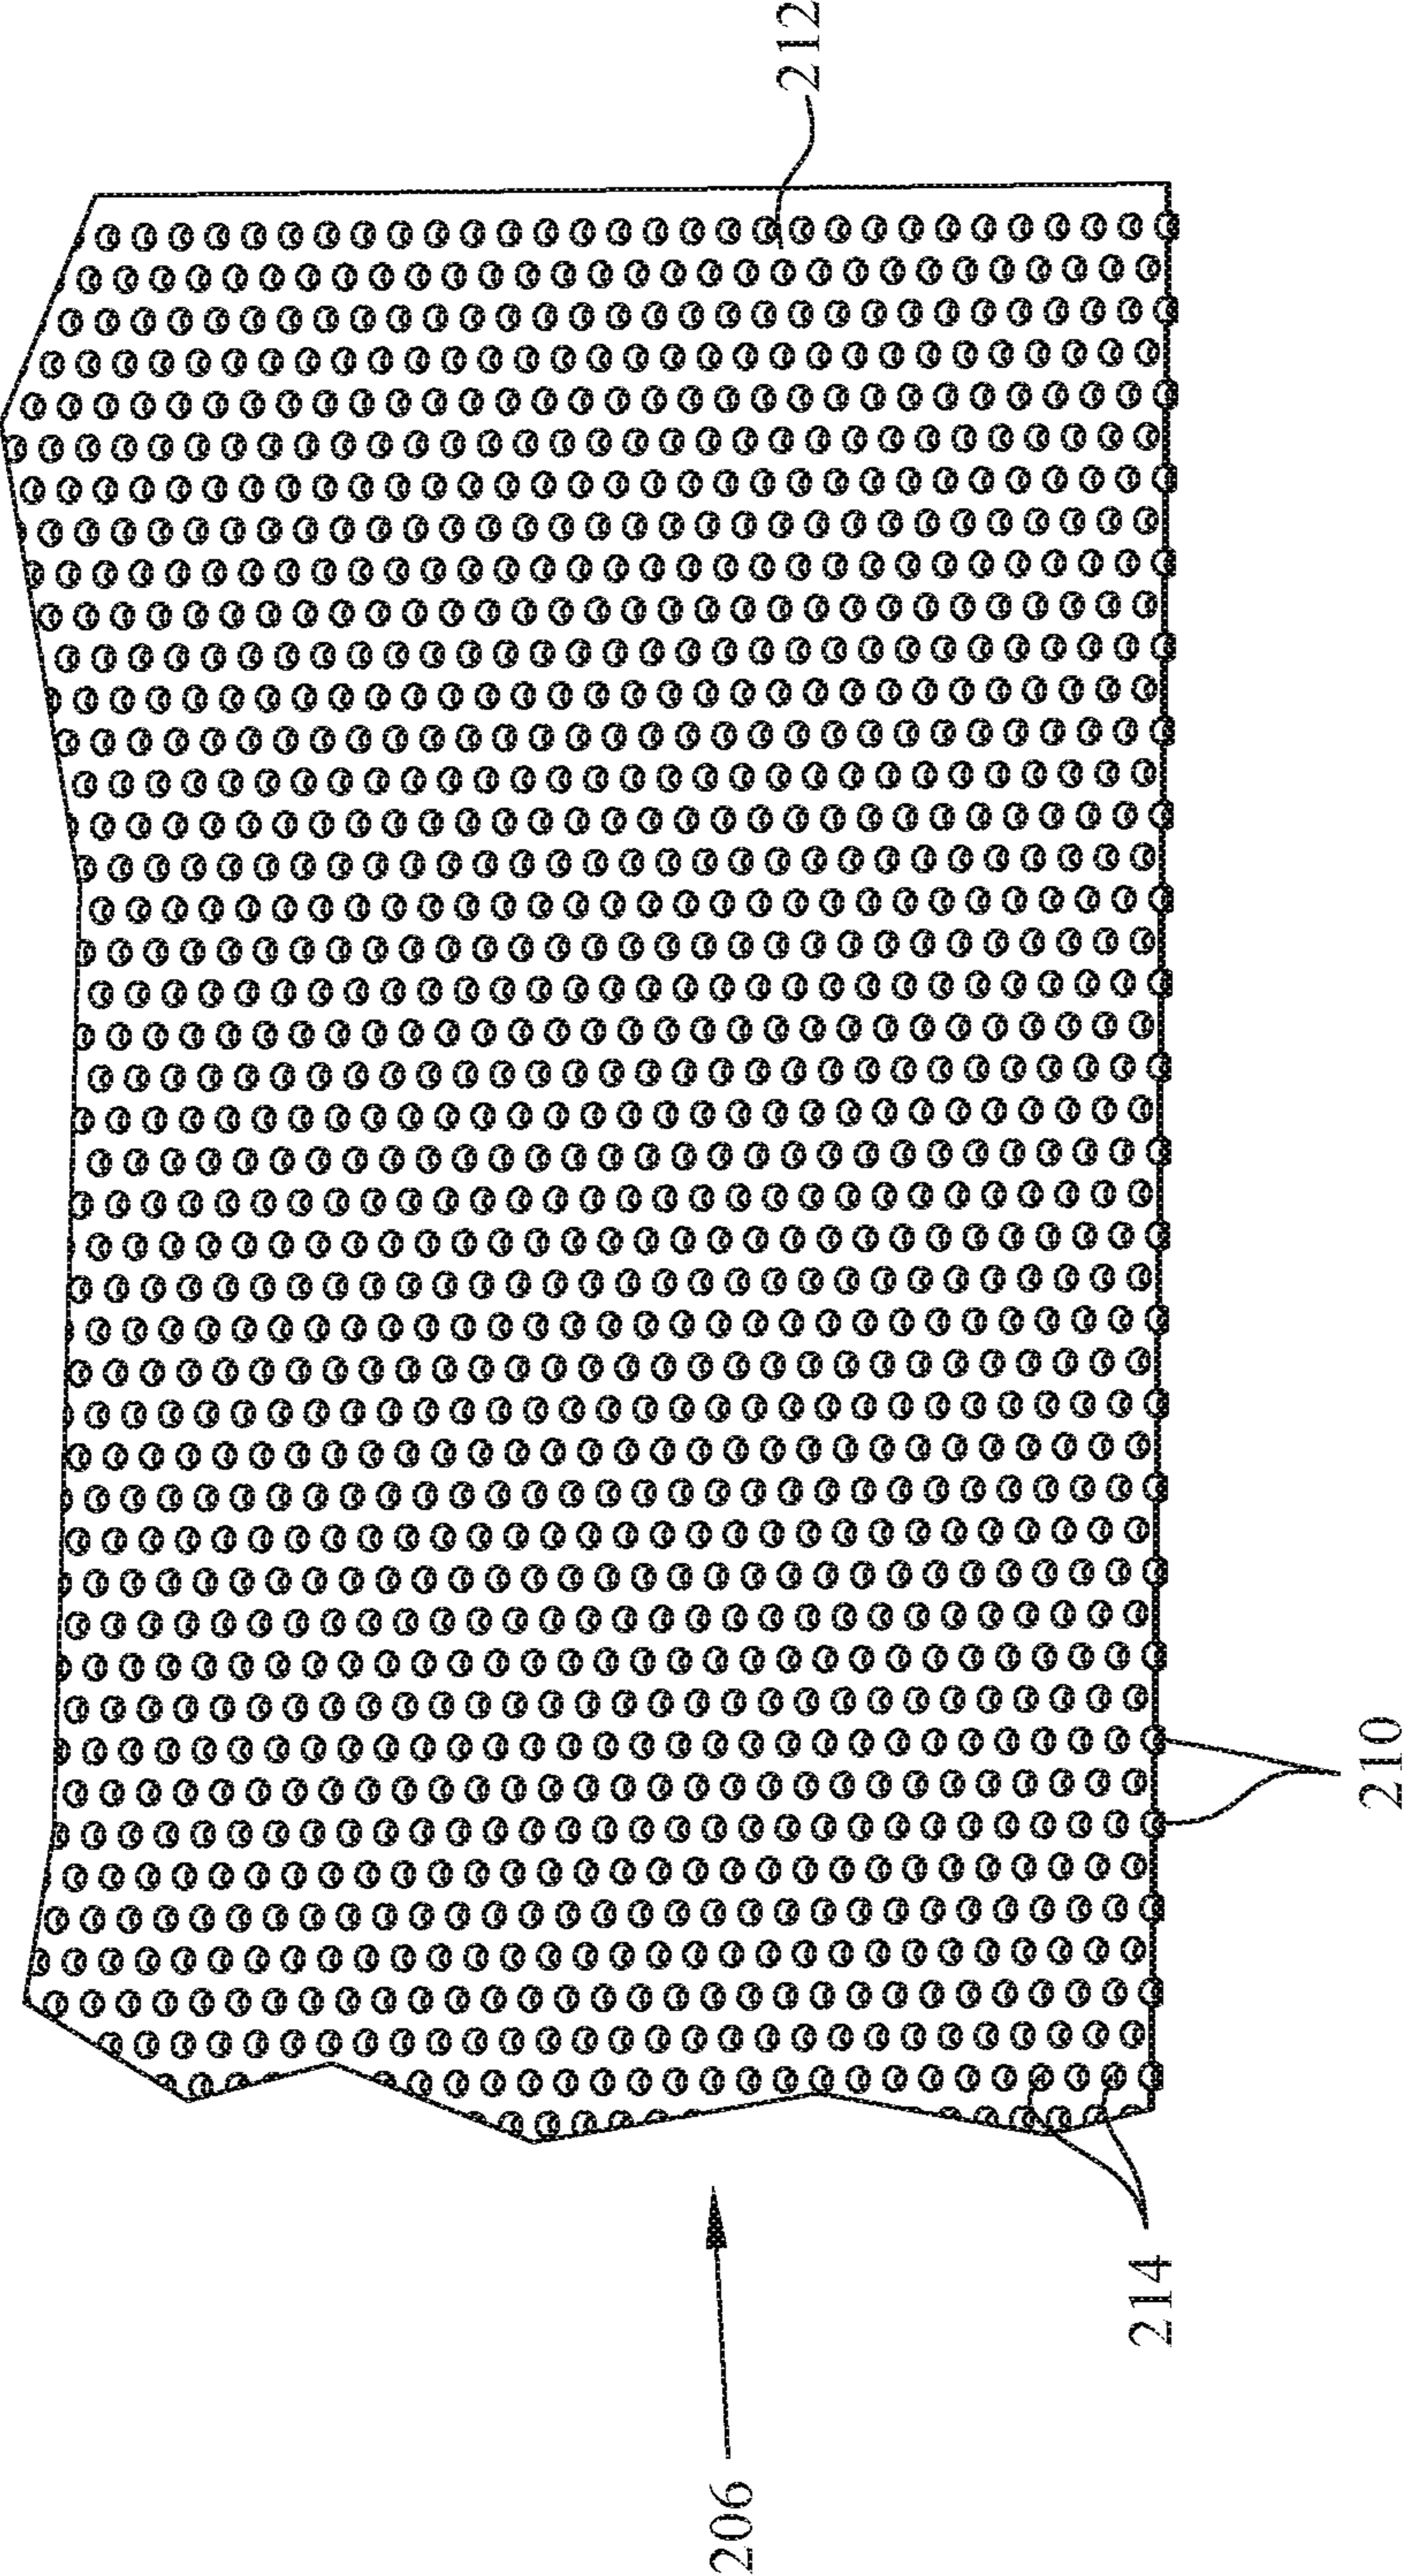
FIG. 10 is another perspective view of the vehicle and cargo bay liner of FIG. 6 with the face having openings facing upward;

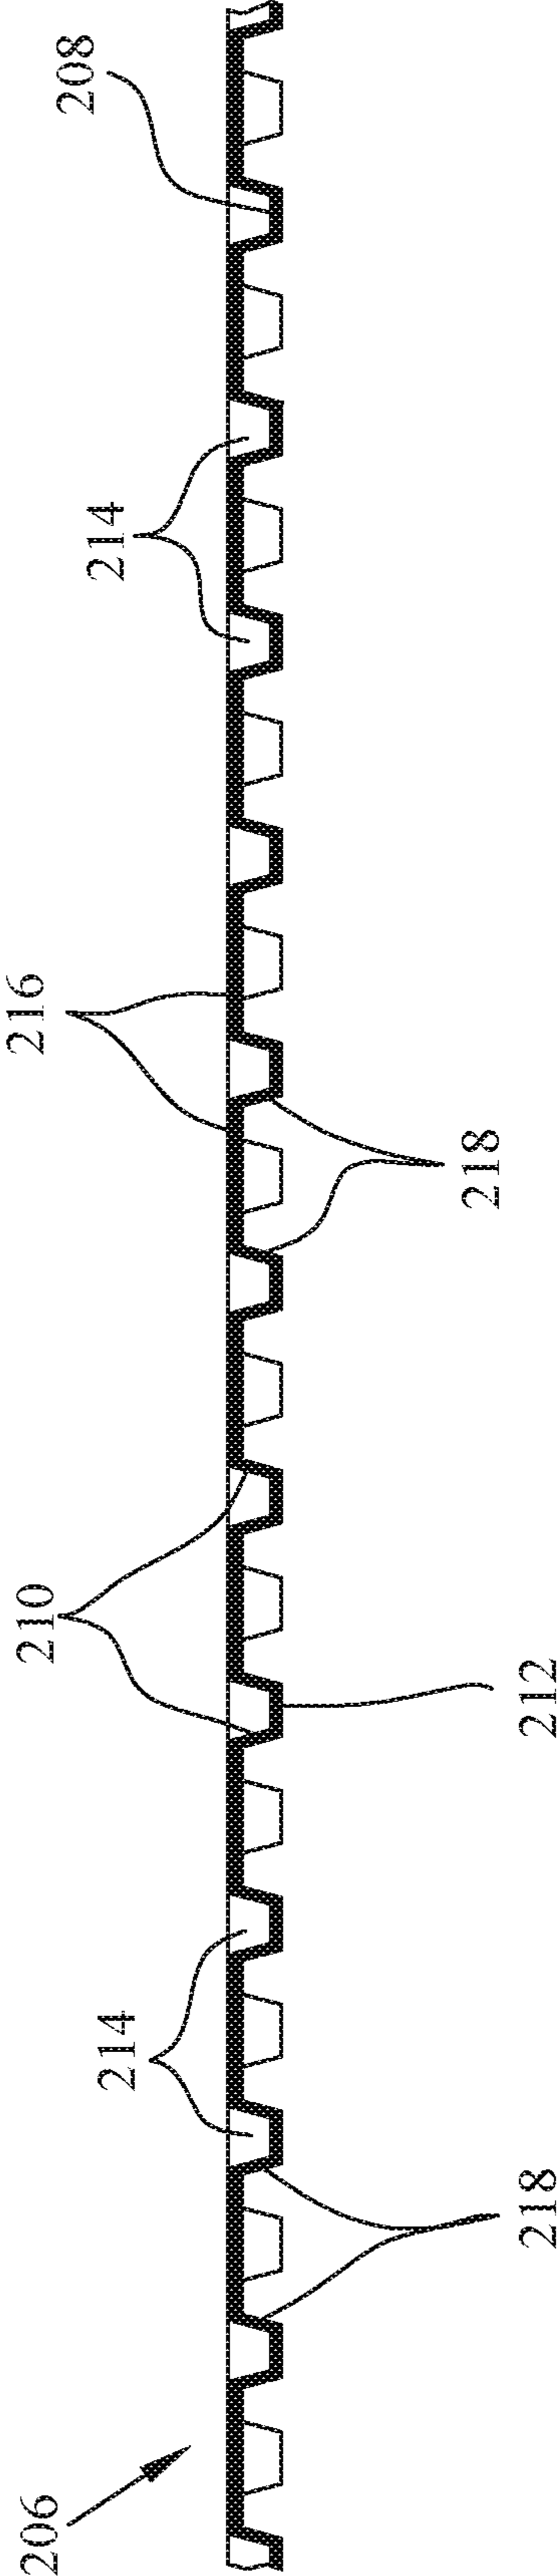
FIG. 11 is a side view of the vehicle and cargo bay liner of FIG. 6 with the projections extending upward;

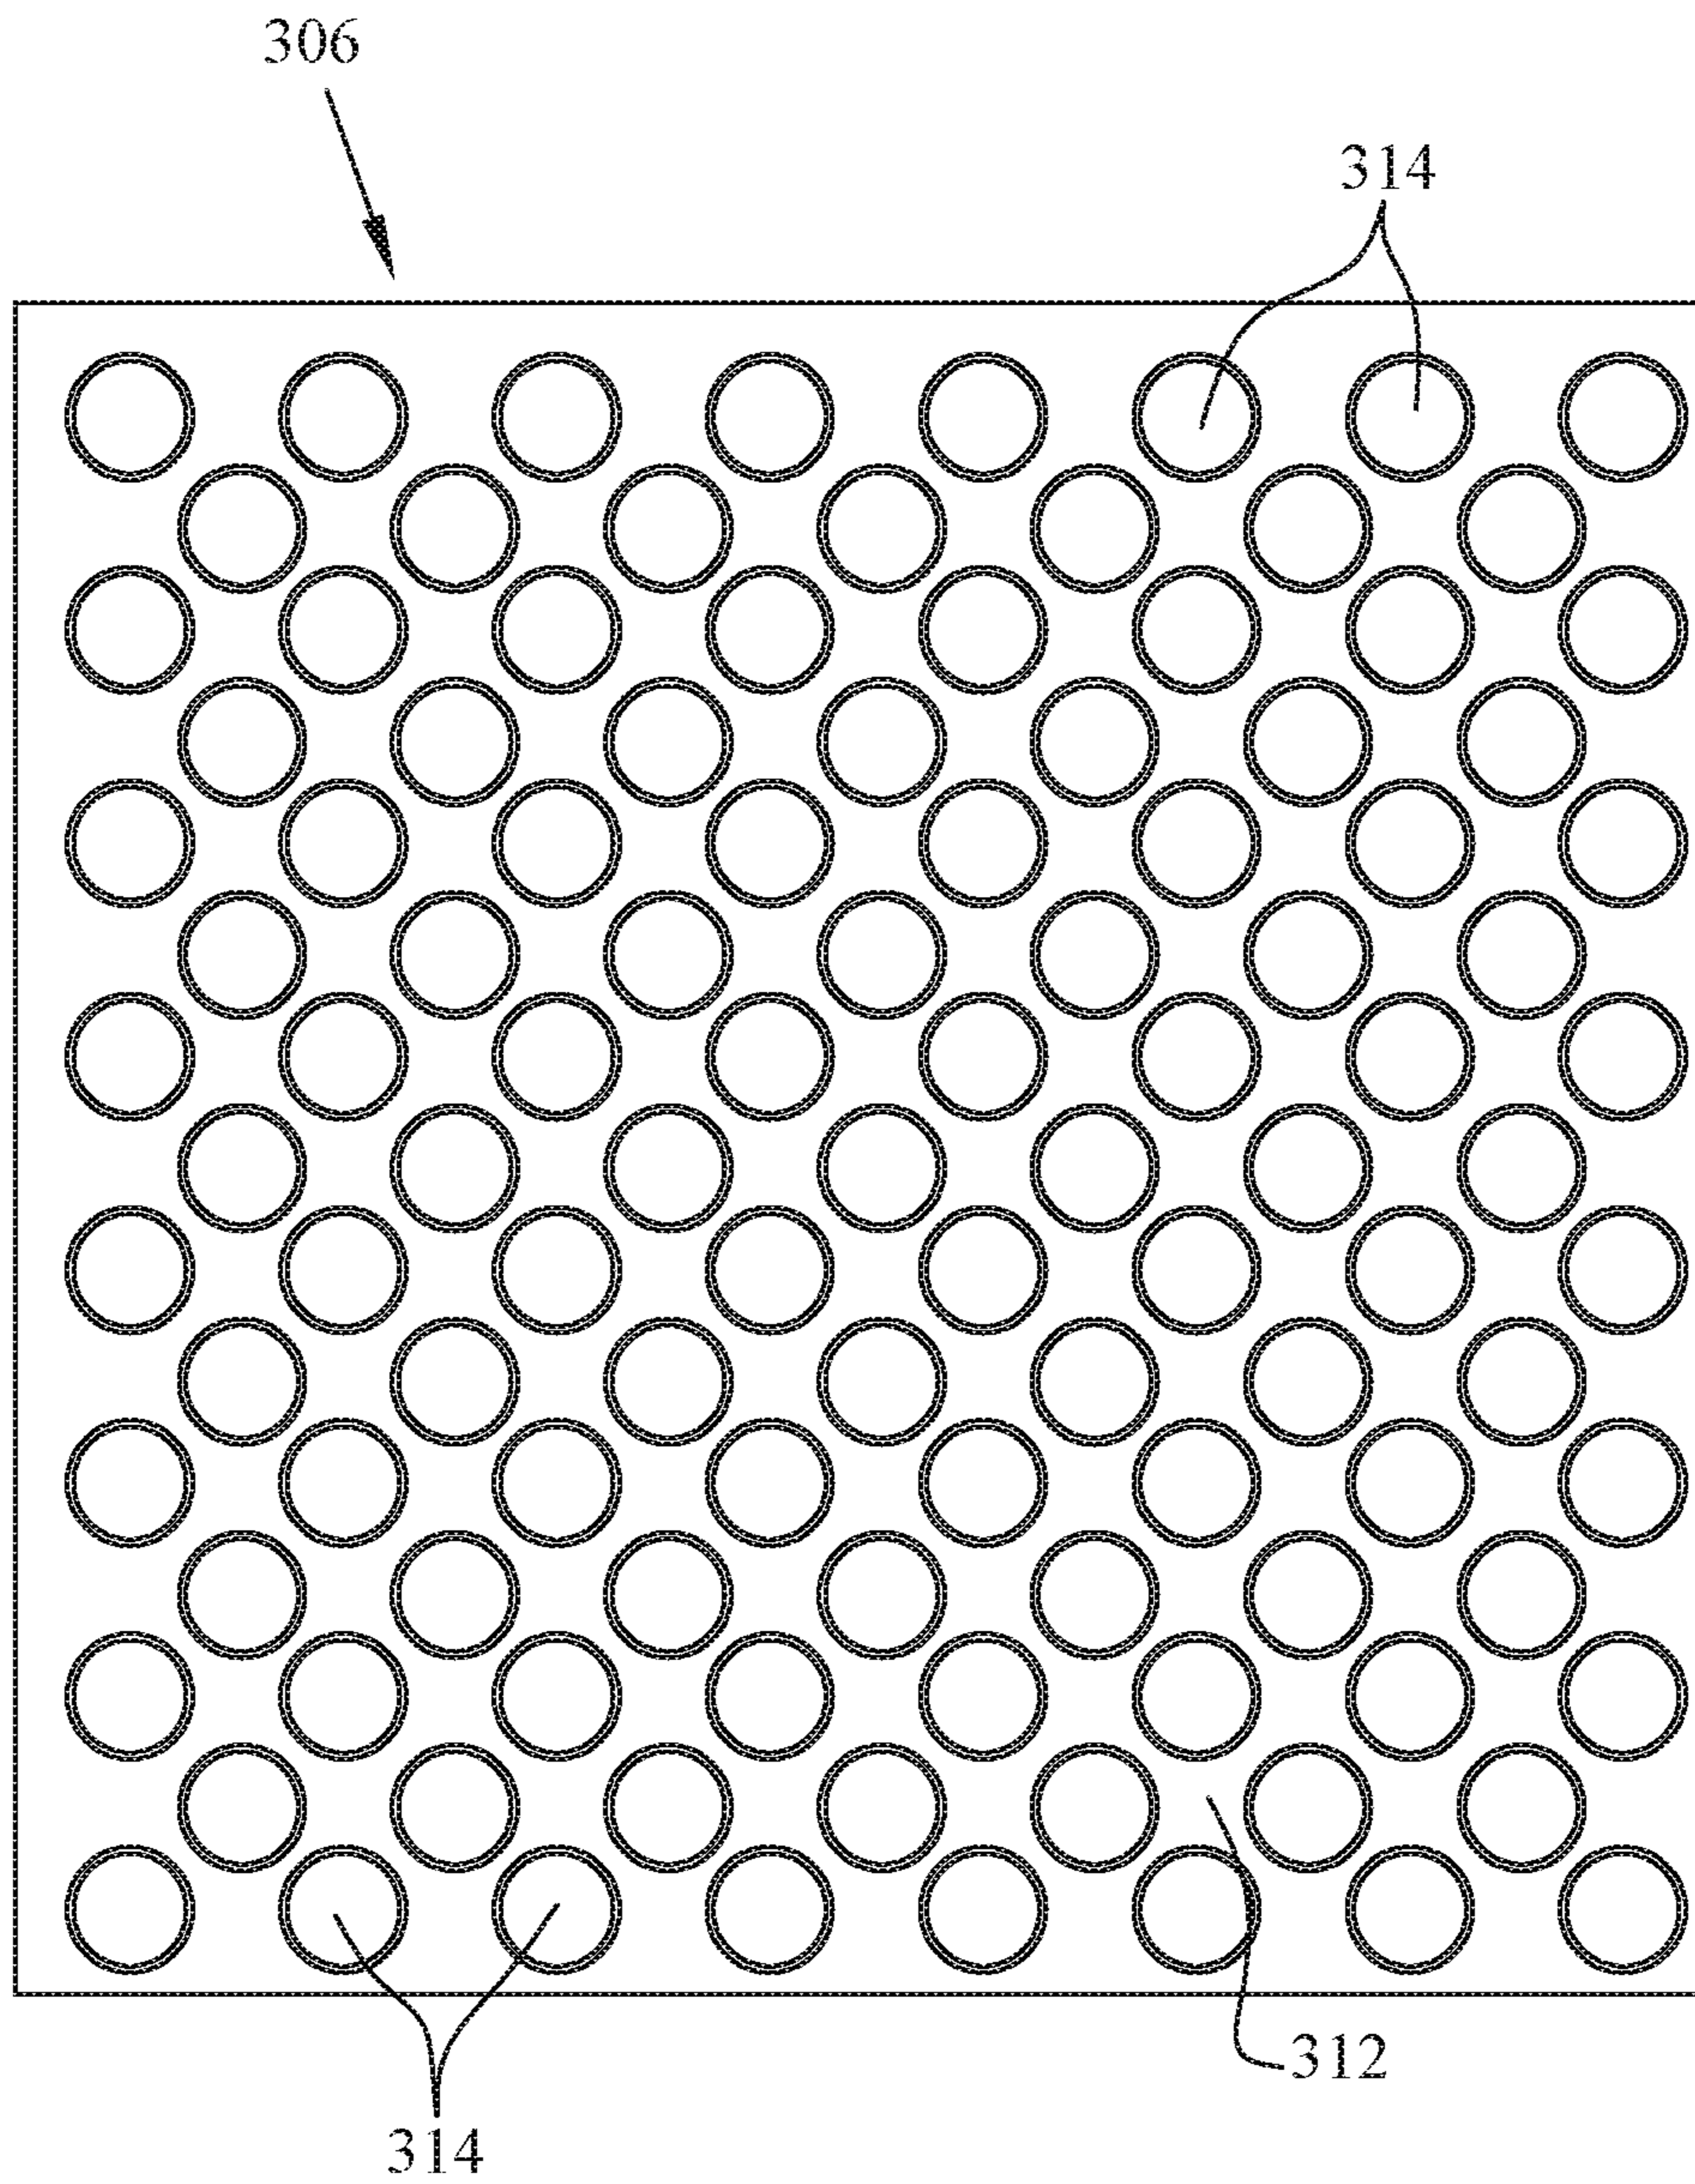
FIG. 12 is a plan view of an alternate embodiment vehicle frame and cargo bay liner showing a face having openings therein;

Now referring to FIGS. 12 and 13, an alternate vehicle frame and cargo area liner is shown generally indicated as 306. As can be seen in FIG. 13, liner 306 includes a face 308 having projections 210 thereon. As shown in FIG. 12, liner 306 has an opposite face 312 having openings 314 therein. Projections 310 include end faces 316 and sidewalls 318 as best seen in FIG. 13. Line 306 can be manufactured from single or multi-layer materials sandwiched together (twin or triple layer).
