US011447189B1

(54) **VEHICLE FRAME AND CARGO BAY LINER**

A vehicle and liner assembly is provided that includes a
recreational vehicle having a housing, a front end, a rear end,
a top, a bottom, and a pair of sidewalls. A frame assembly
is provided wherein, the housing is mounted on and sup-
ported by the frame assembly. The liner is attached to the
frame assembly and covers at least a substantial portion of the
bottom of the housing. The liner has a first face having
projections extending therefrom and a second face having
openings therein. The openings coincide with and extend
into corresponding projections on the first face.

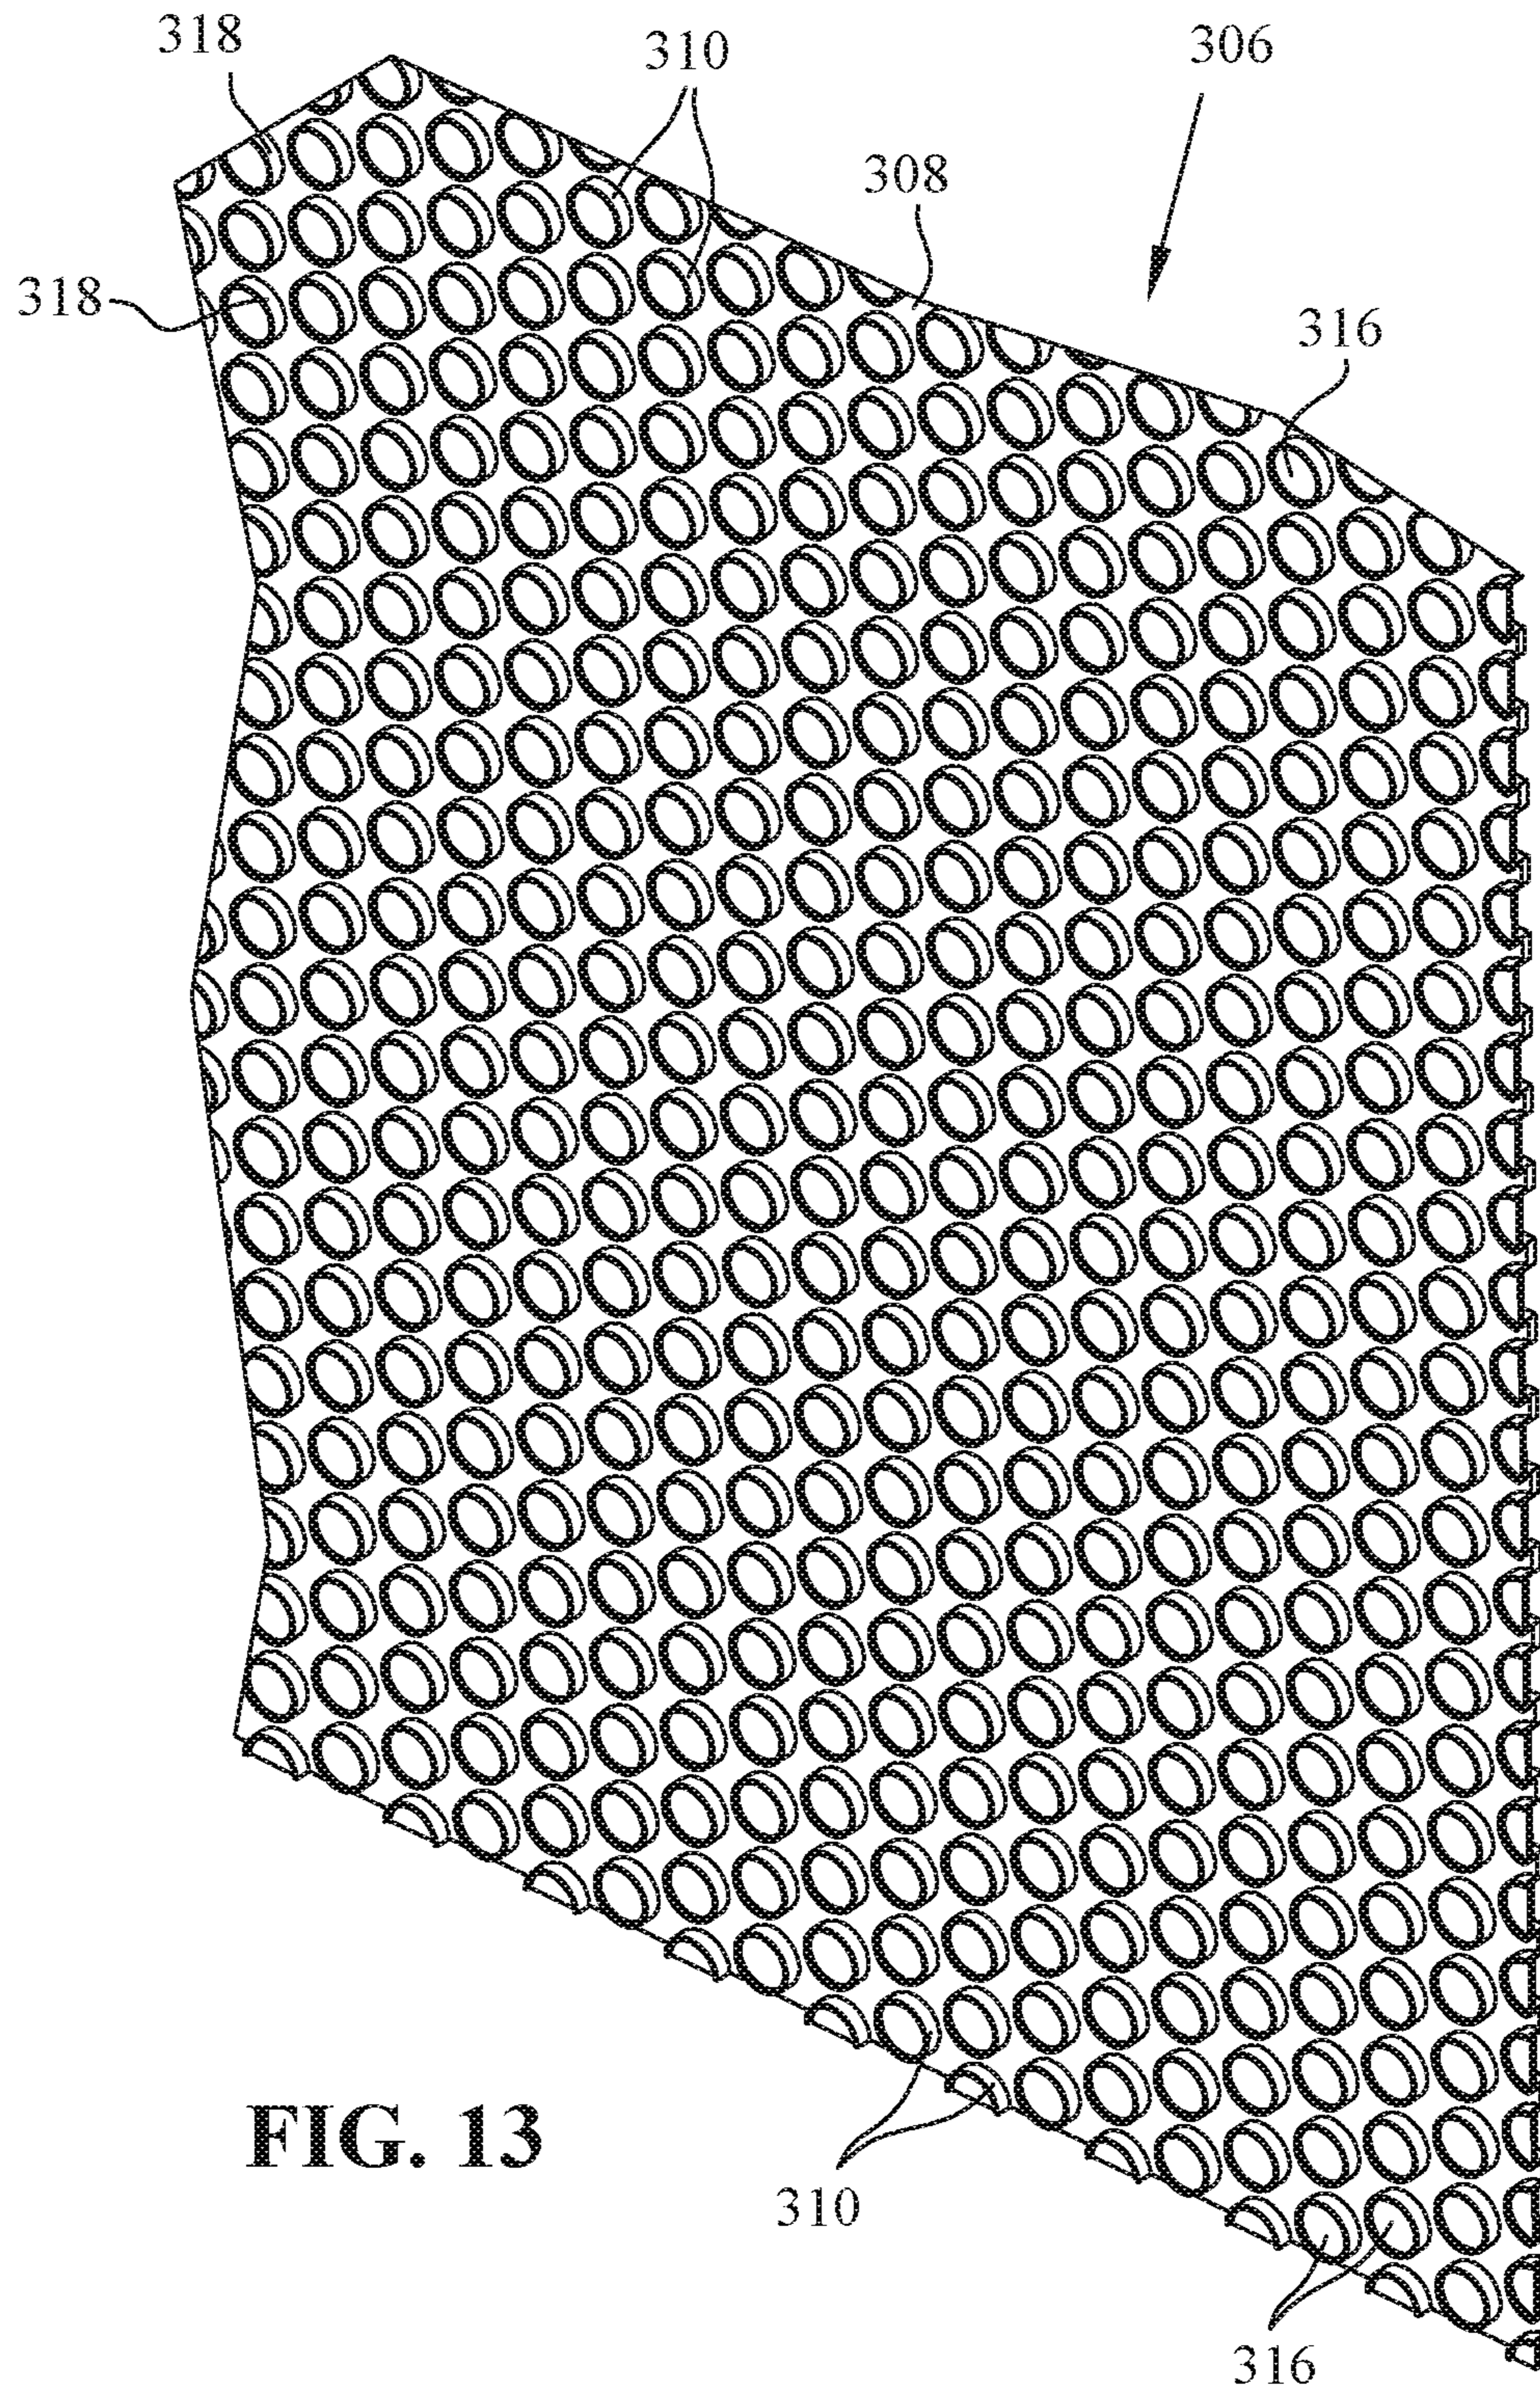
FIG. 13 is a plan perspective view of the alternate embodiment vehicle frame and cargo bay liner of FIG. 12 showing a face having projections extending therefrom;

Now referring to FIGS. 12 and 13, an alternate vehicle frame and cargo area liner is shown generally indicated as 306. As can be seen in FIG. 13, liner 306 includes a face 308 having projections 210 thereon. As shown in FIG. 12, liner 306 has an opposite face 312 having openings 314 therein. Projections 310 include end faces 316 and sidewalls 318 as best seen in FIG. 13. Line 306 can be manufactured from single or multi-layer materials sandwiched together (twin or triple layer).

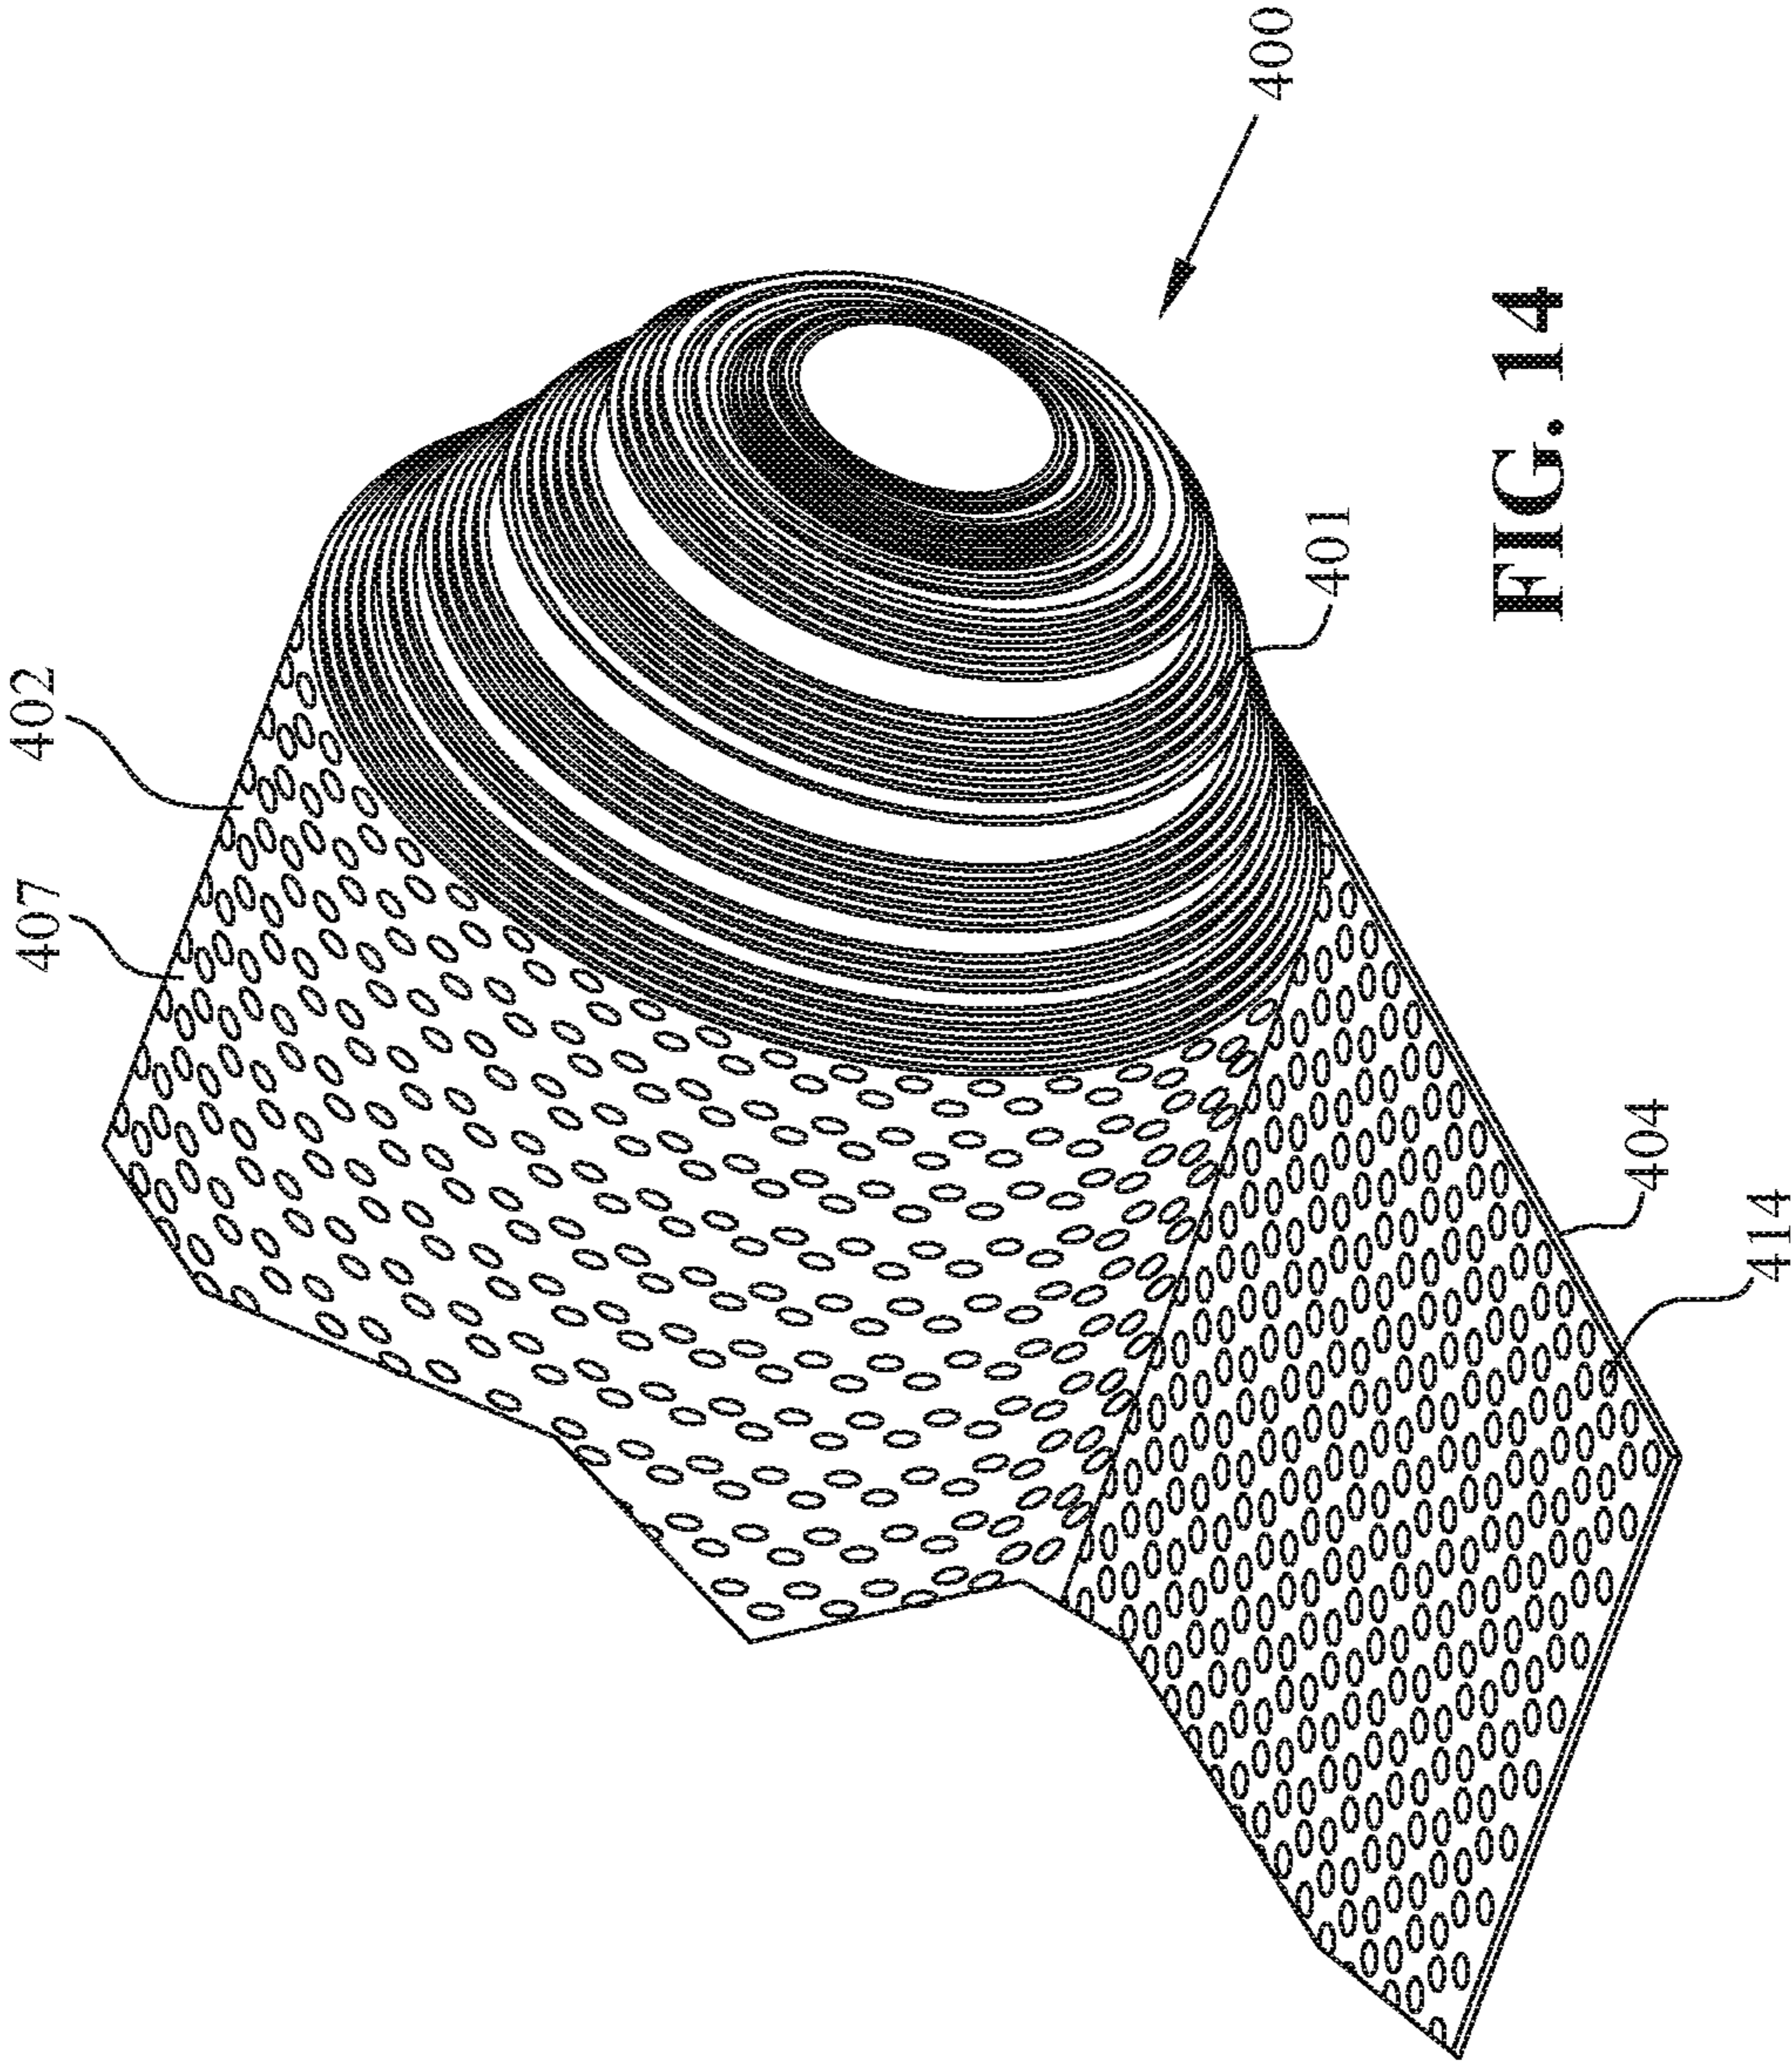
FIG. 14 is a perspective view of another alternate embodiment vehicle frame and cargo bay liner shown rolled in a coil and having aluminum foil on one side thereof;

Now referring to FIGS. 14-24, another alternate vehicle frame and cargo area liner is shown generally indicated as 400. Liner 400 can be provided in a coiled form 401 as

shown in FIGS. 14 and 15, making it extremely suitable for use as a liner for vehicle frames and cargo bays. The desired length of liner can be rolled out and cut to size for assembly to the vehicle. Vehicle frame and cargo bay liner **400** is of a 3-ply configuration and includes a top ply, sheet, or layer **402** and a bottom ply, sheet, or layer **404**. A core **406** (see FIGS. 19 and 22-24) separates top sheet **402** from bottom sheet **404**. Additionally, vehicle frame and cargo bay liner **400** also includes a sheet of aluminum foil or metalized film **407** on one side thereof. In the embodiment shown, aluminum foil/metalized film **407** is provided on top sheet **402**;

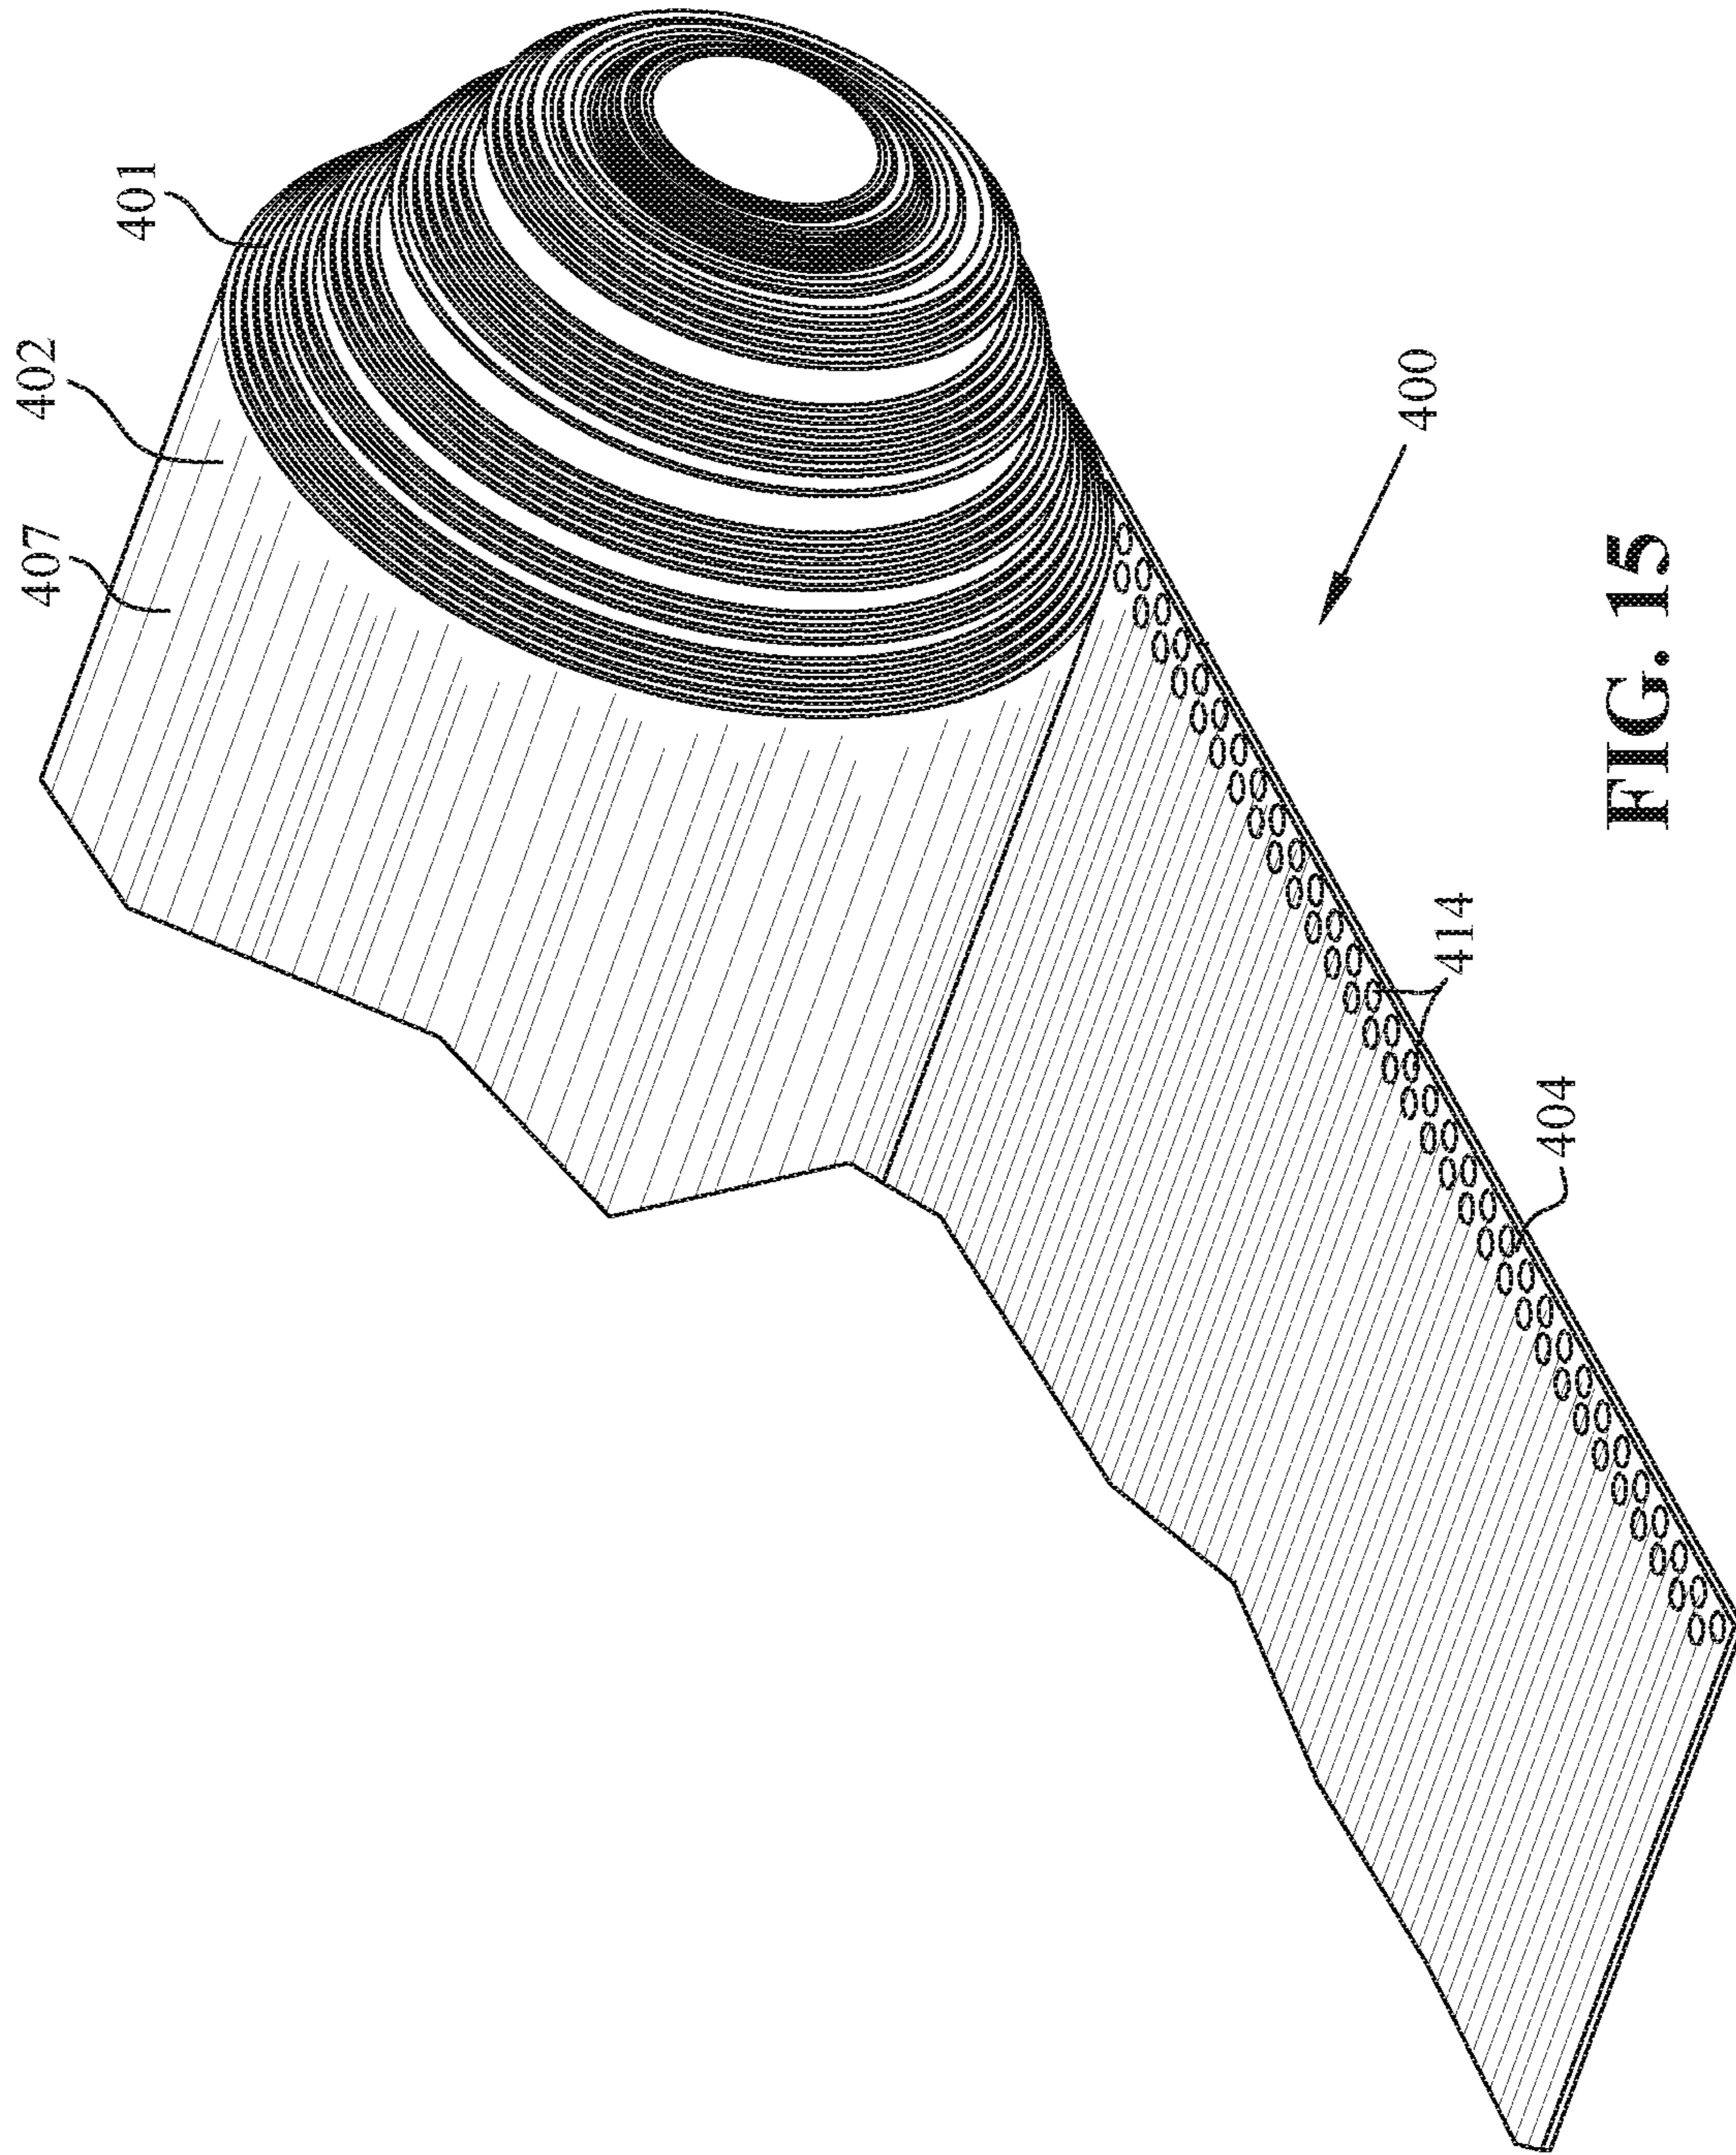
FIG. 15 is a perspective view of the vehicle frame and cargo bay liner of FIG. 14 partially rolled out showing the aluminum foil on a top side thereof;

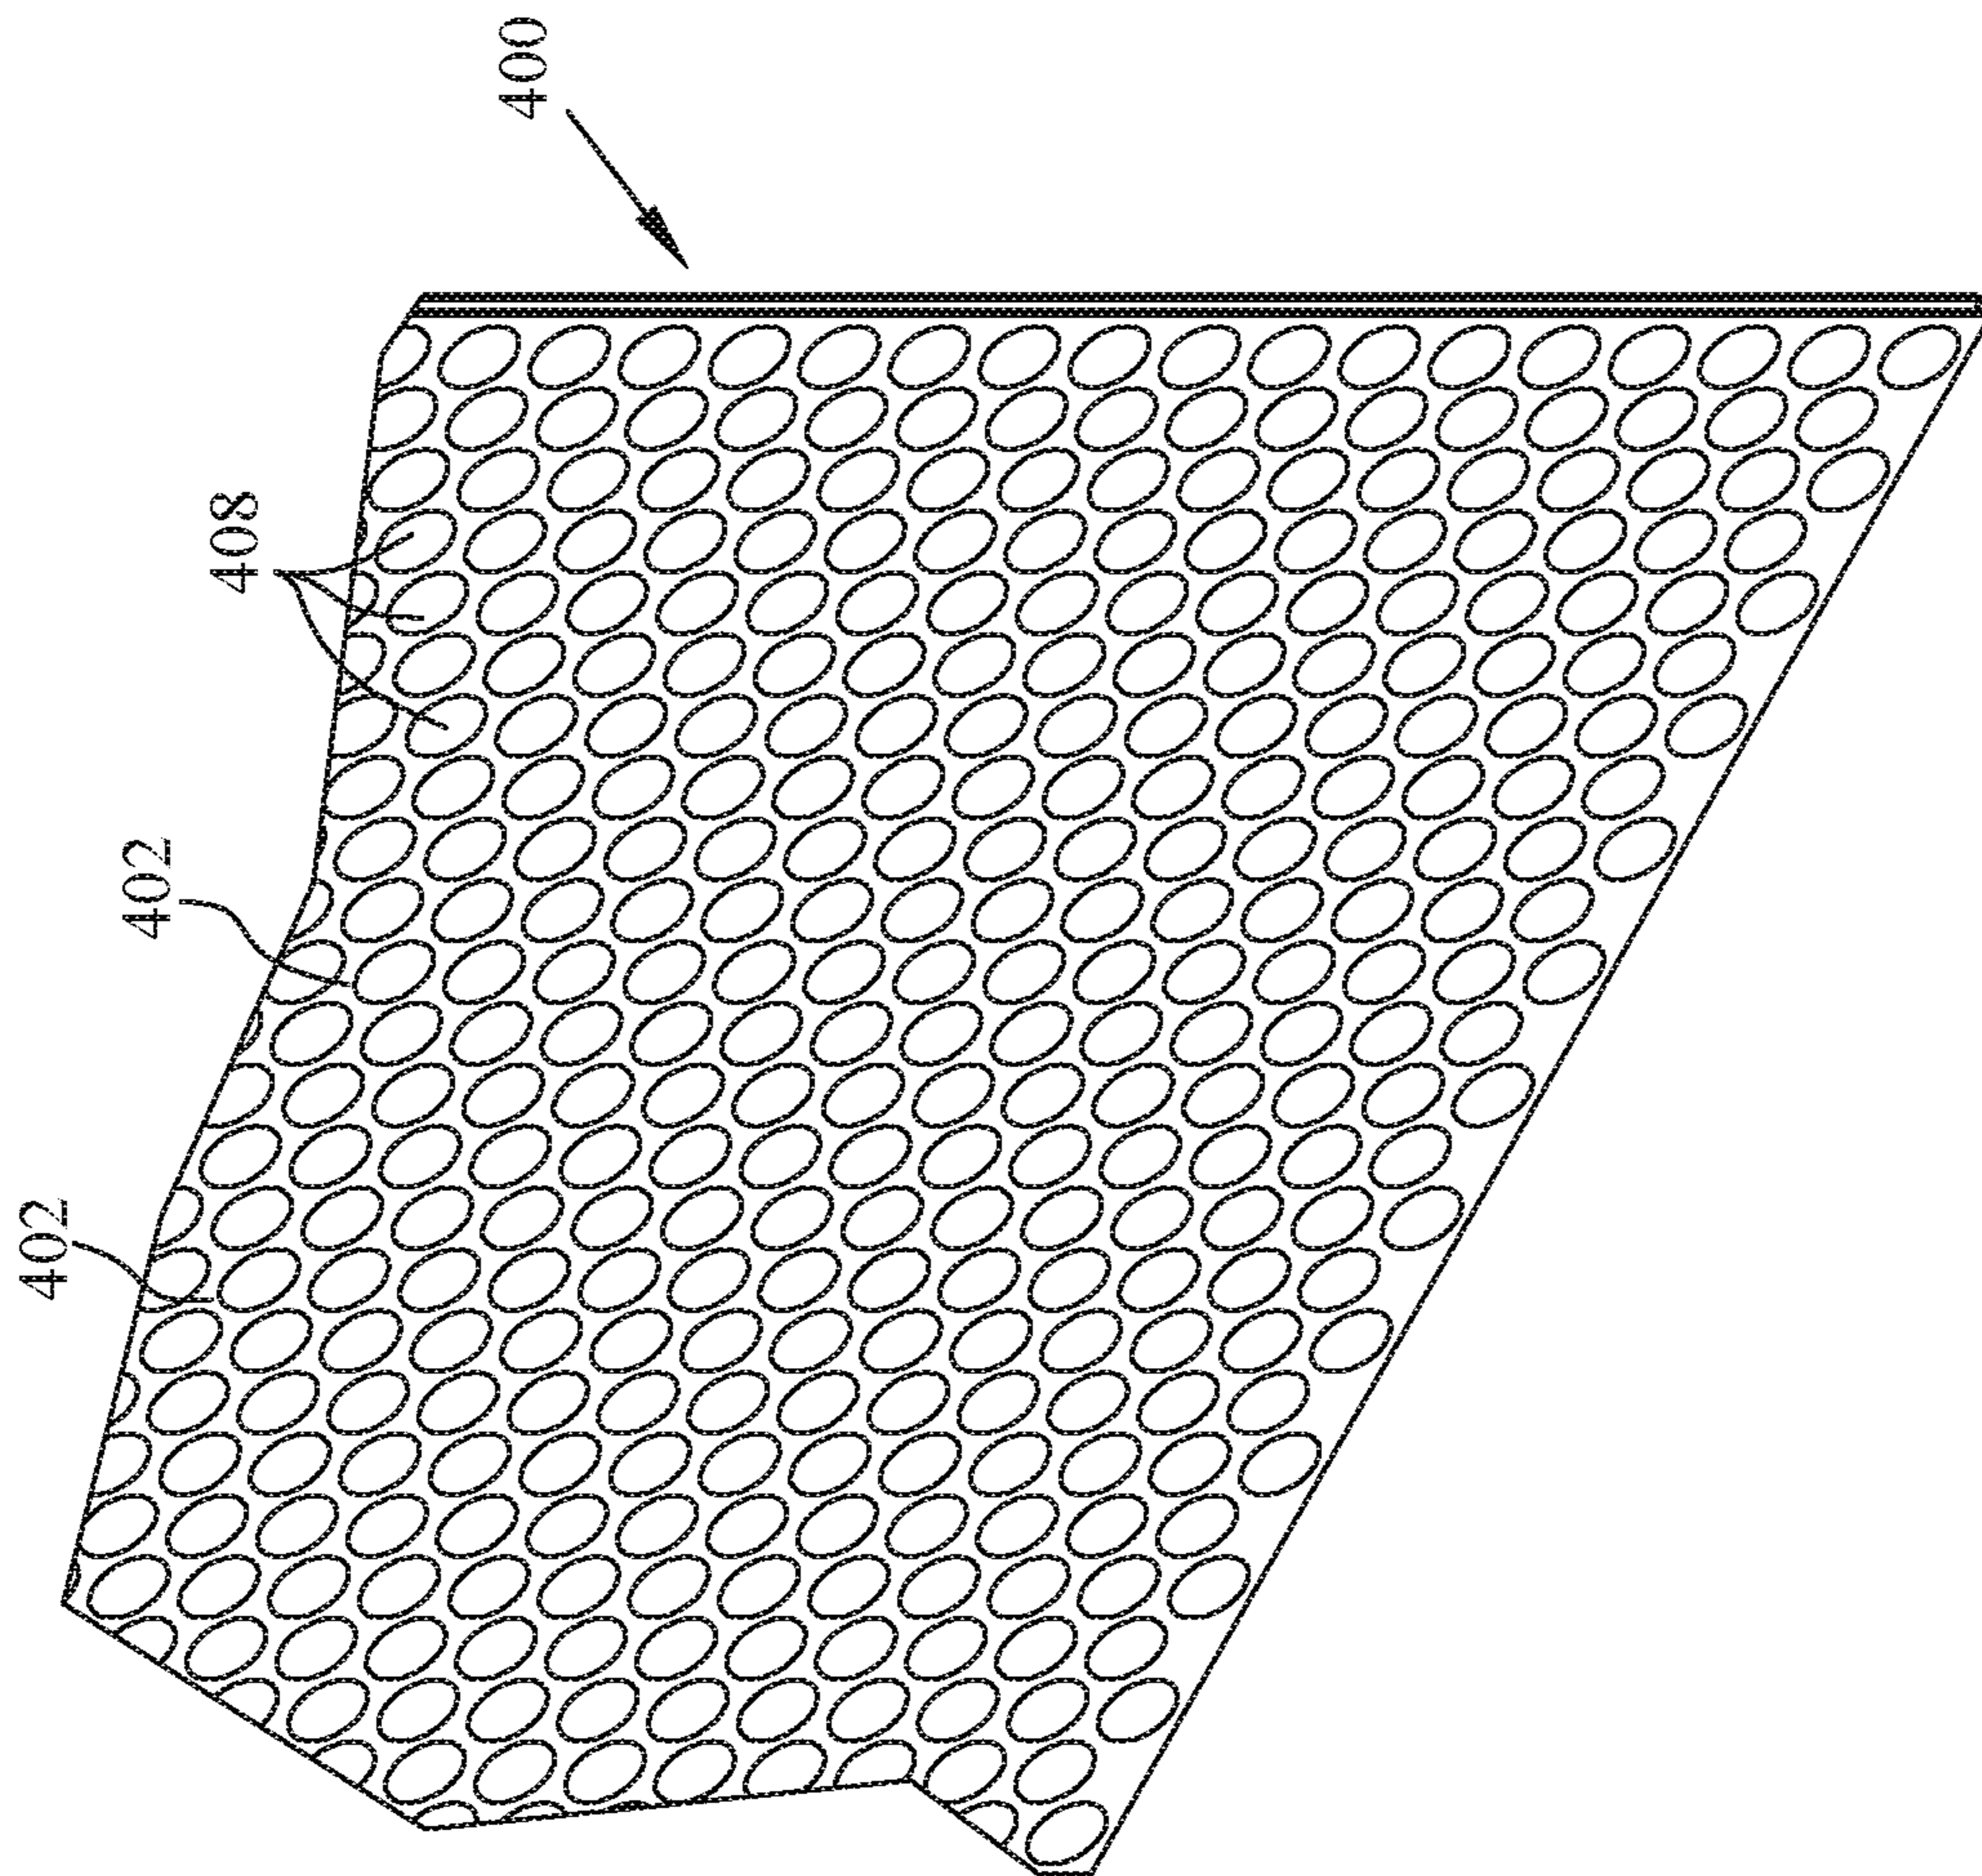
FIG. 16 is a plan view of the vehicle frame and cargo bay liner of FIG. 14 showing the top side with aluminum foil thereon;

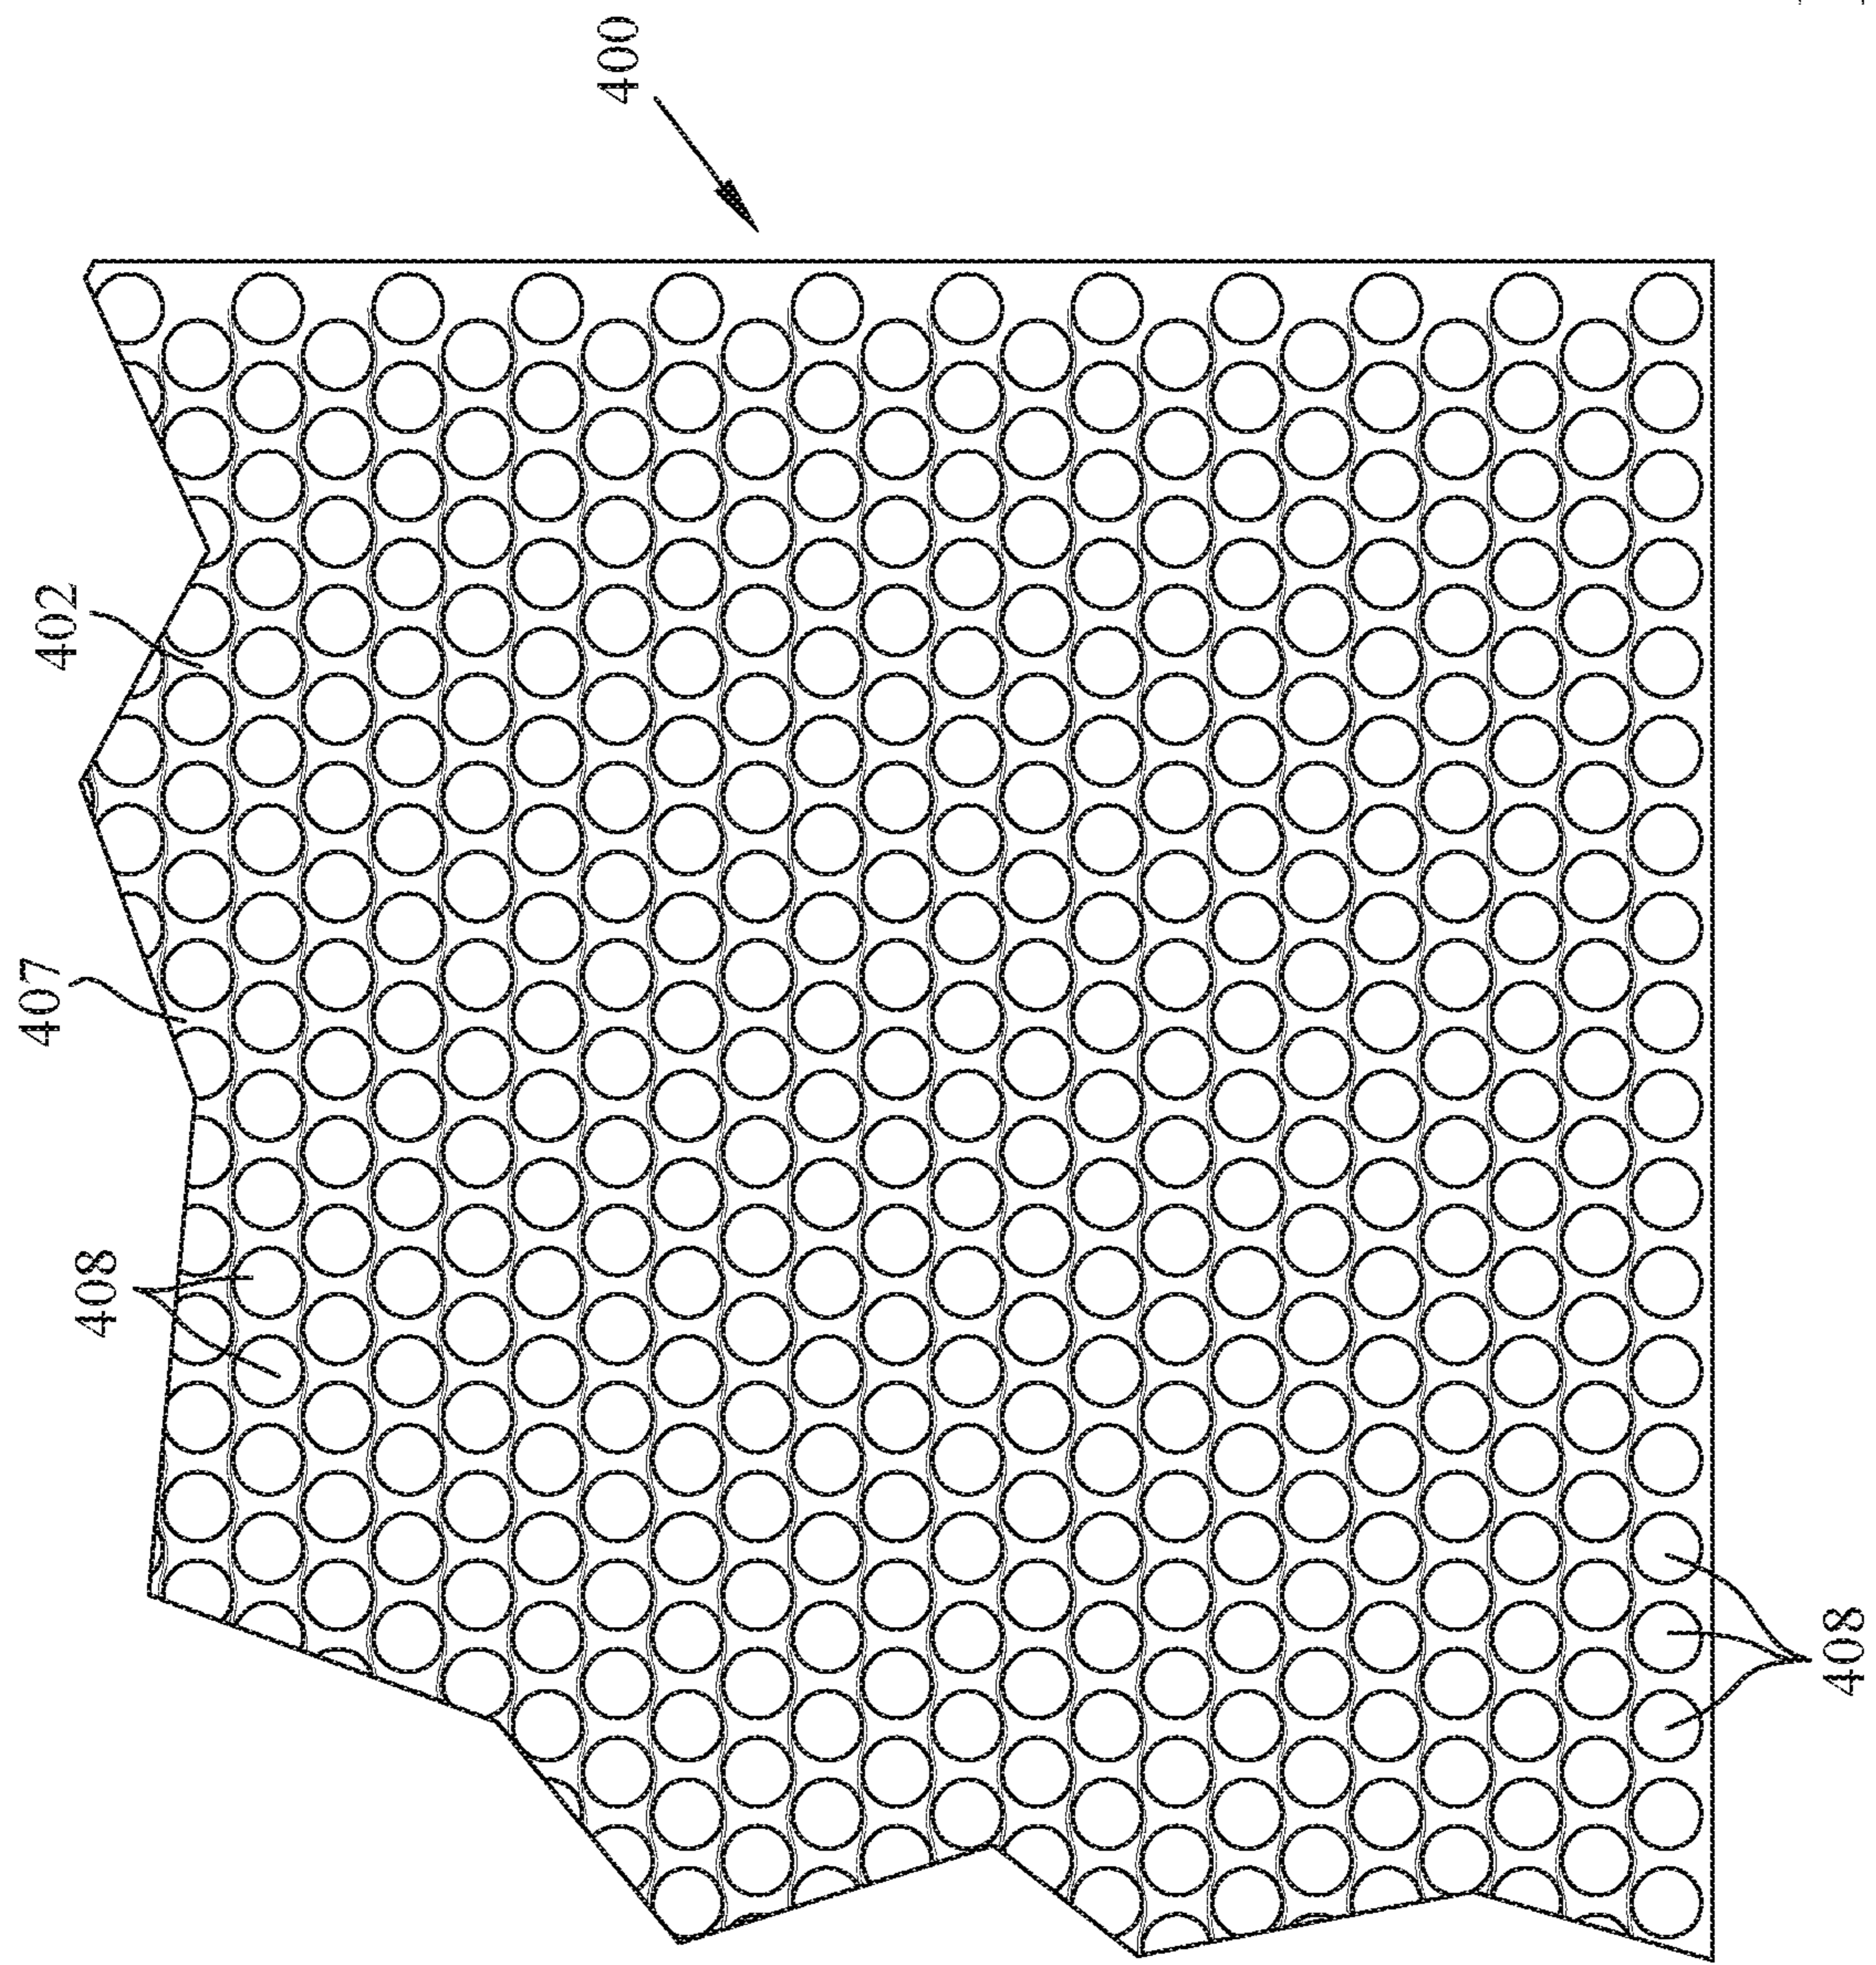
FIG. 17 is an enlarged plan view of the vehicle frame and cargo bay liner of FIG. 14 of the top side having aluminum foil thereon;

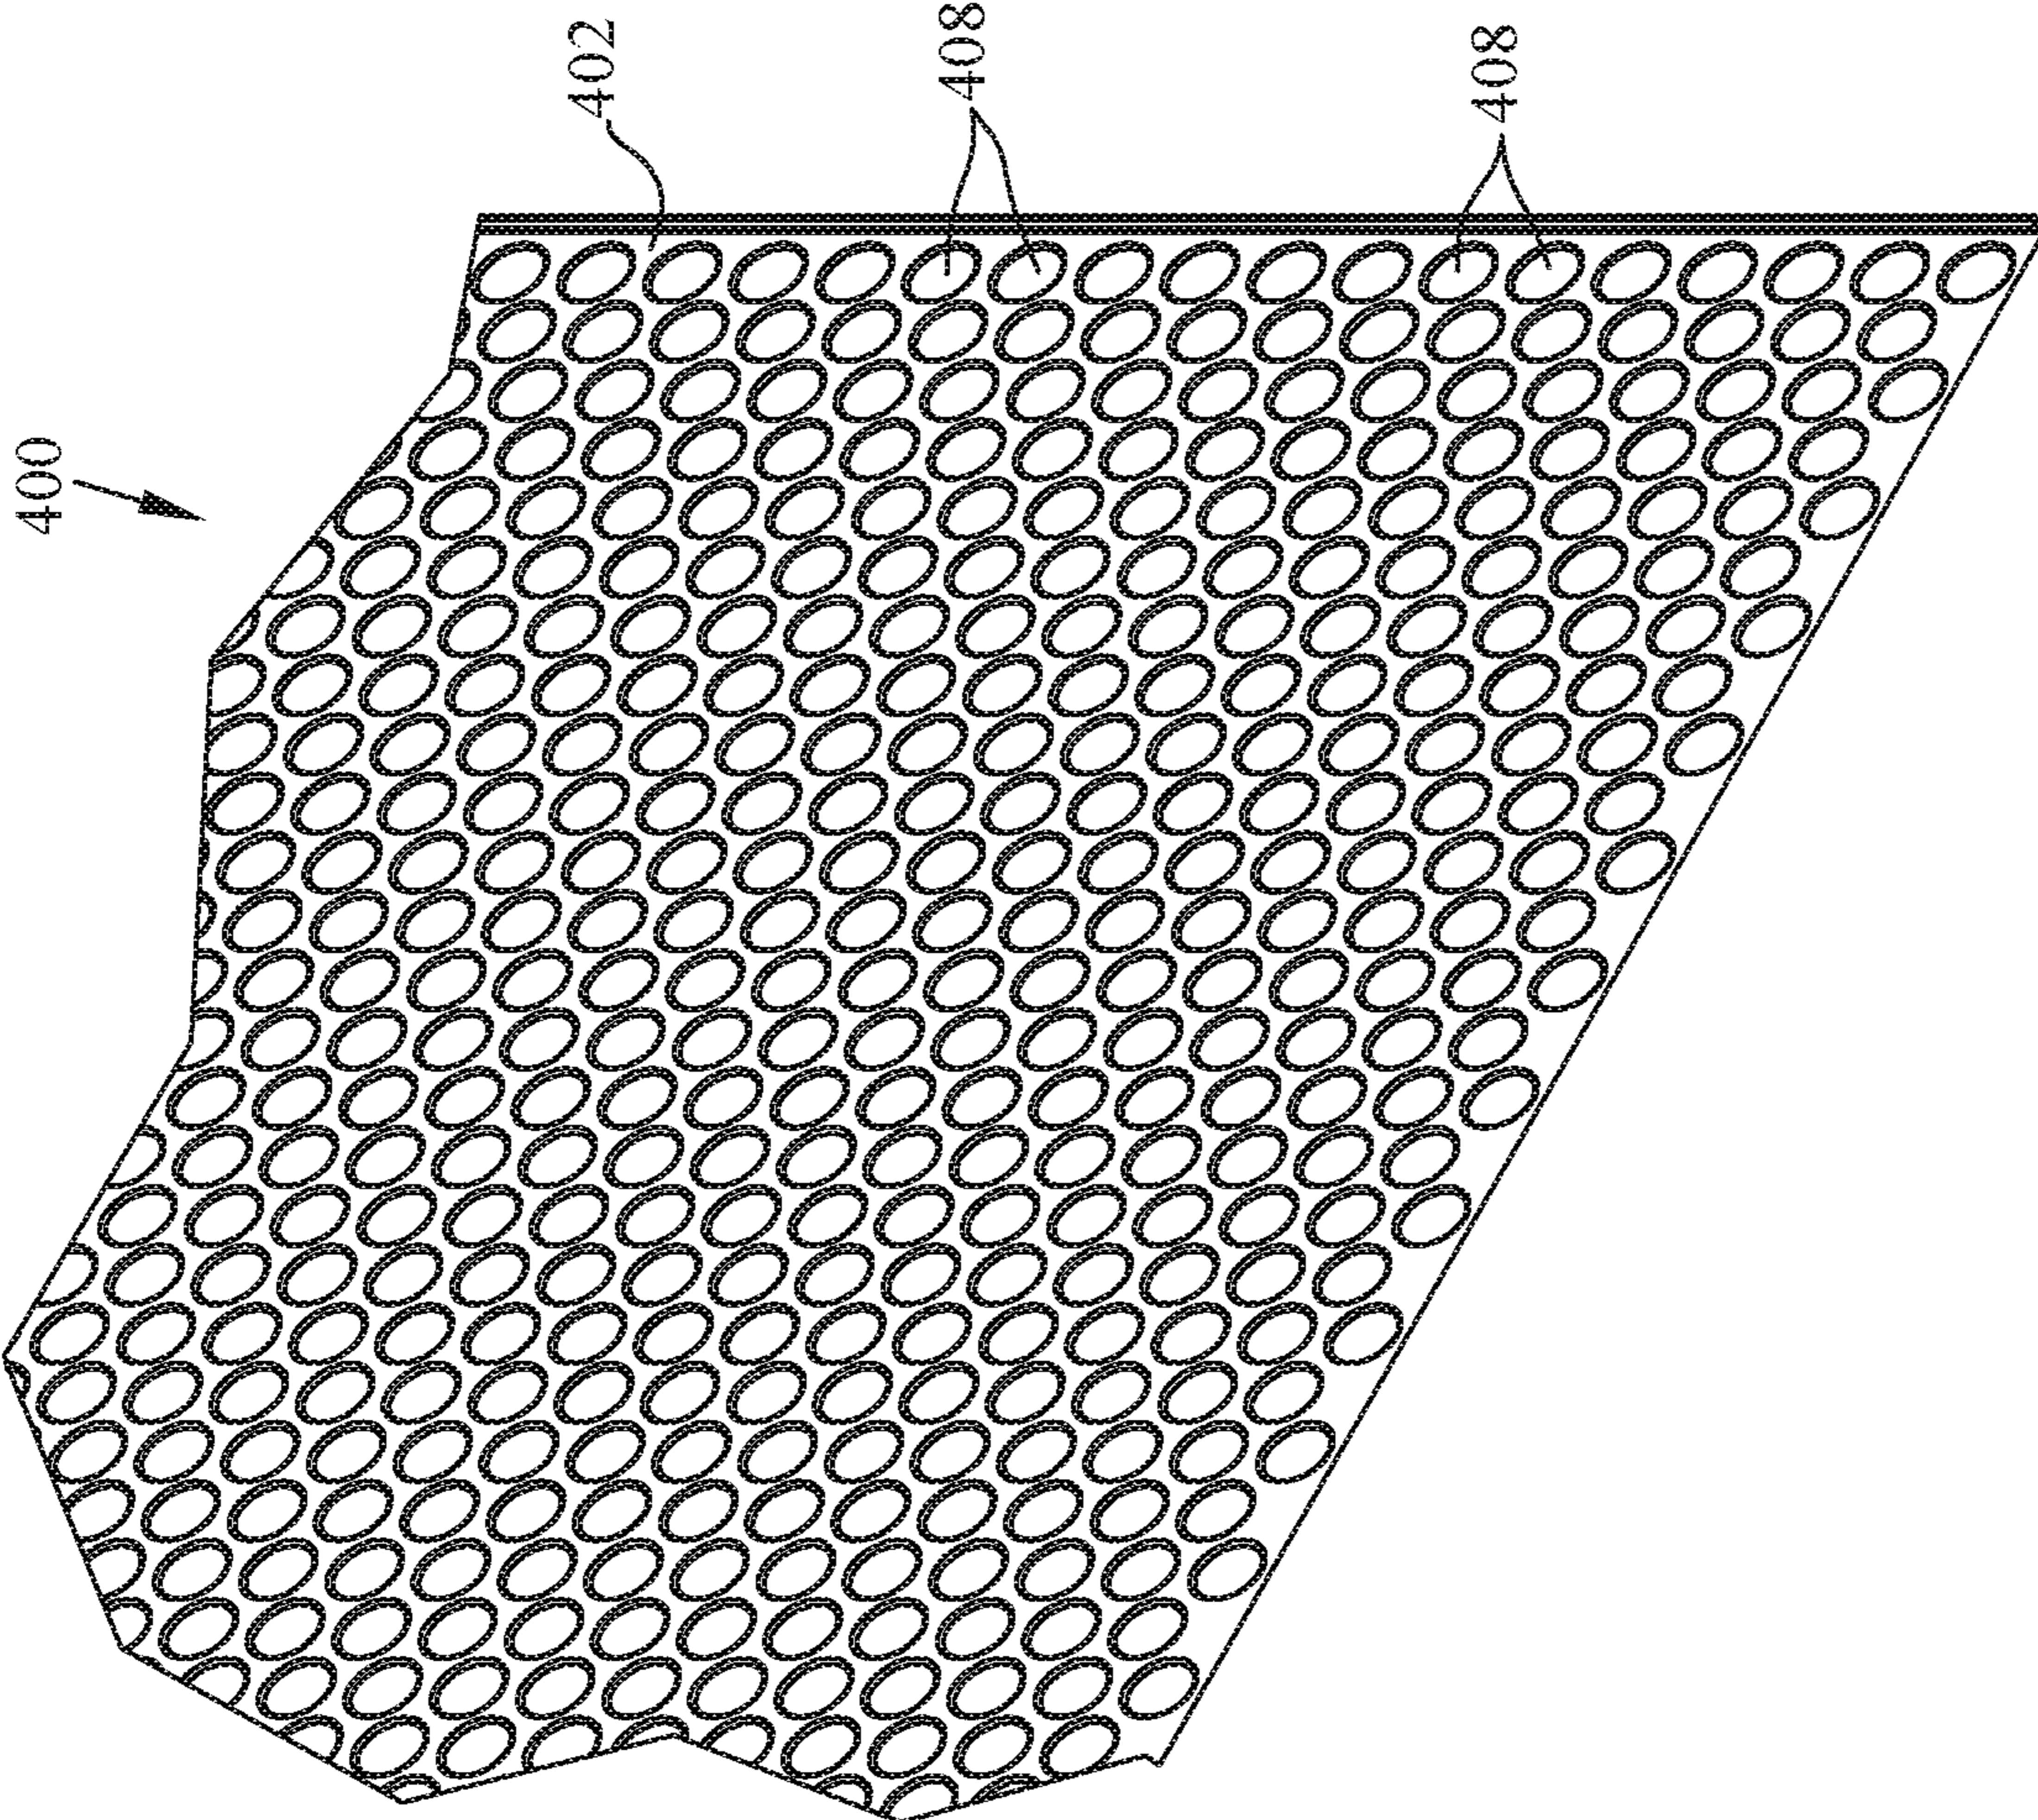
FIG. 18 is a top plan perspective view of the vehicle frame and cargo bay liner of FIG. 14 having the aluminum removed from the top side thereof;
