US011447189B1

(54) **VEHICLE FRAME AND CARGO BAY LINER**

A vehicle and liner assembly is provided that includes a
recreational vehicle having a housing, a front end, a rear end,
a top, a bottom, and a pair of sidewalls. A frame assembly
is provided wherein, the housing is mounted on and sup-
ported by the frame assembly. The liner is attached to the
frame assembly and covers at least a substantial portion of the
bottom of the housing. The liner has a first face having
projections extending therefrom and a second face having
openings therein. The openings coincide with and extend
into corresponding projections on the first face.

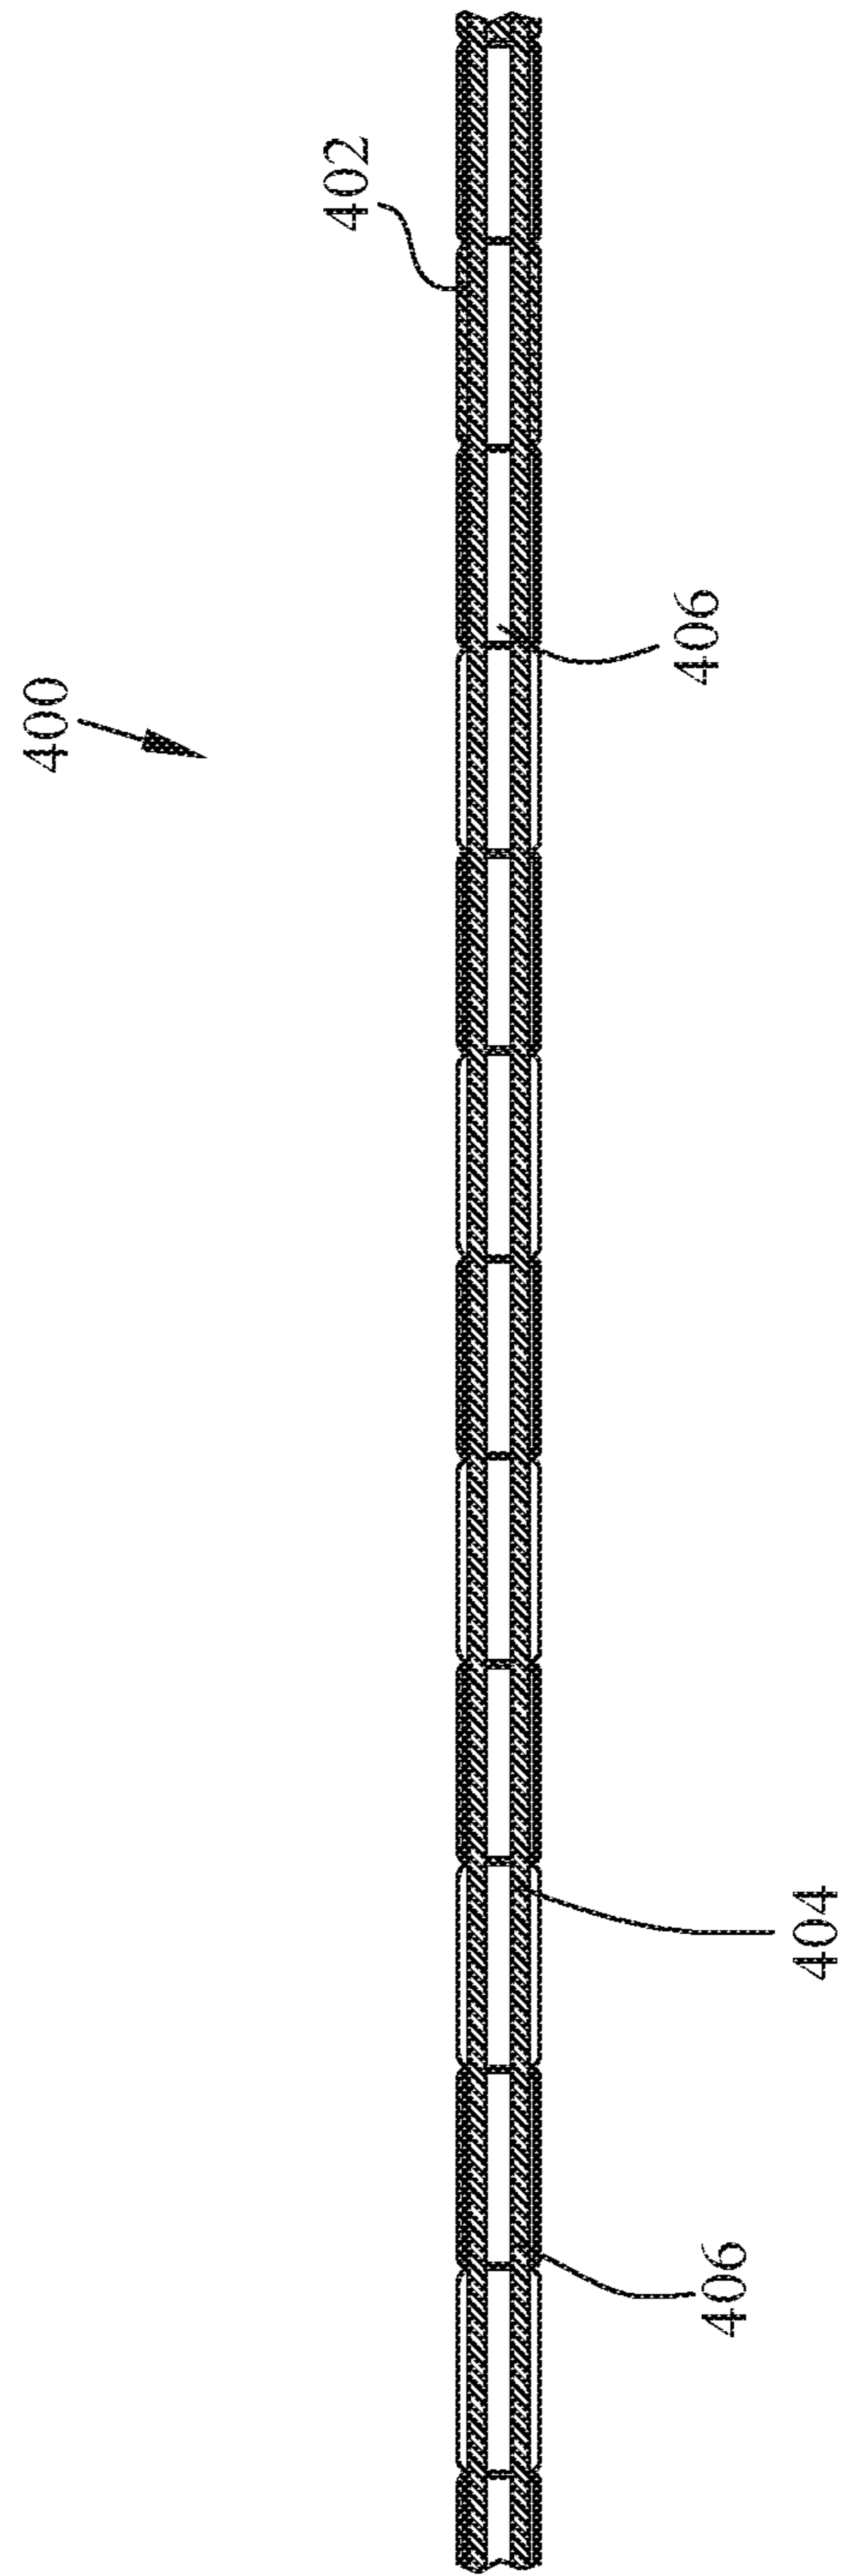
FIG. 19 is a side perspective view of the vehicle frame and cargo bay liner of FIG. 14 with the aluminum foil removed;

Now referring to FIGS. 14-24, another alternate vehicle frame and cargo area liner is shown generally indicated as 400. Liner 400 can be provided in a coiled form 401 as

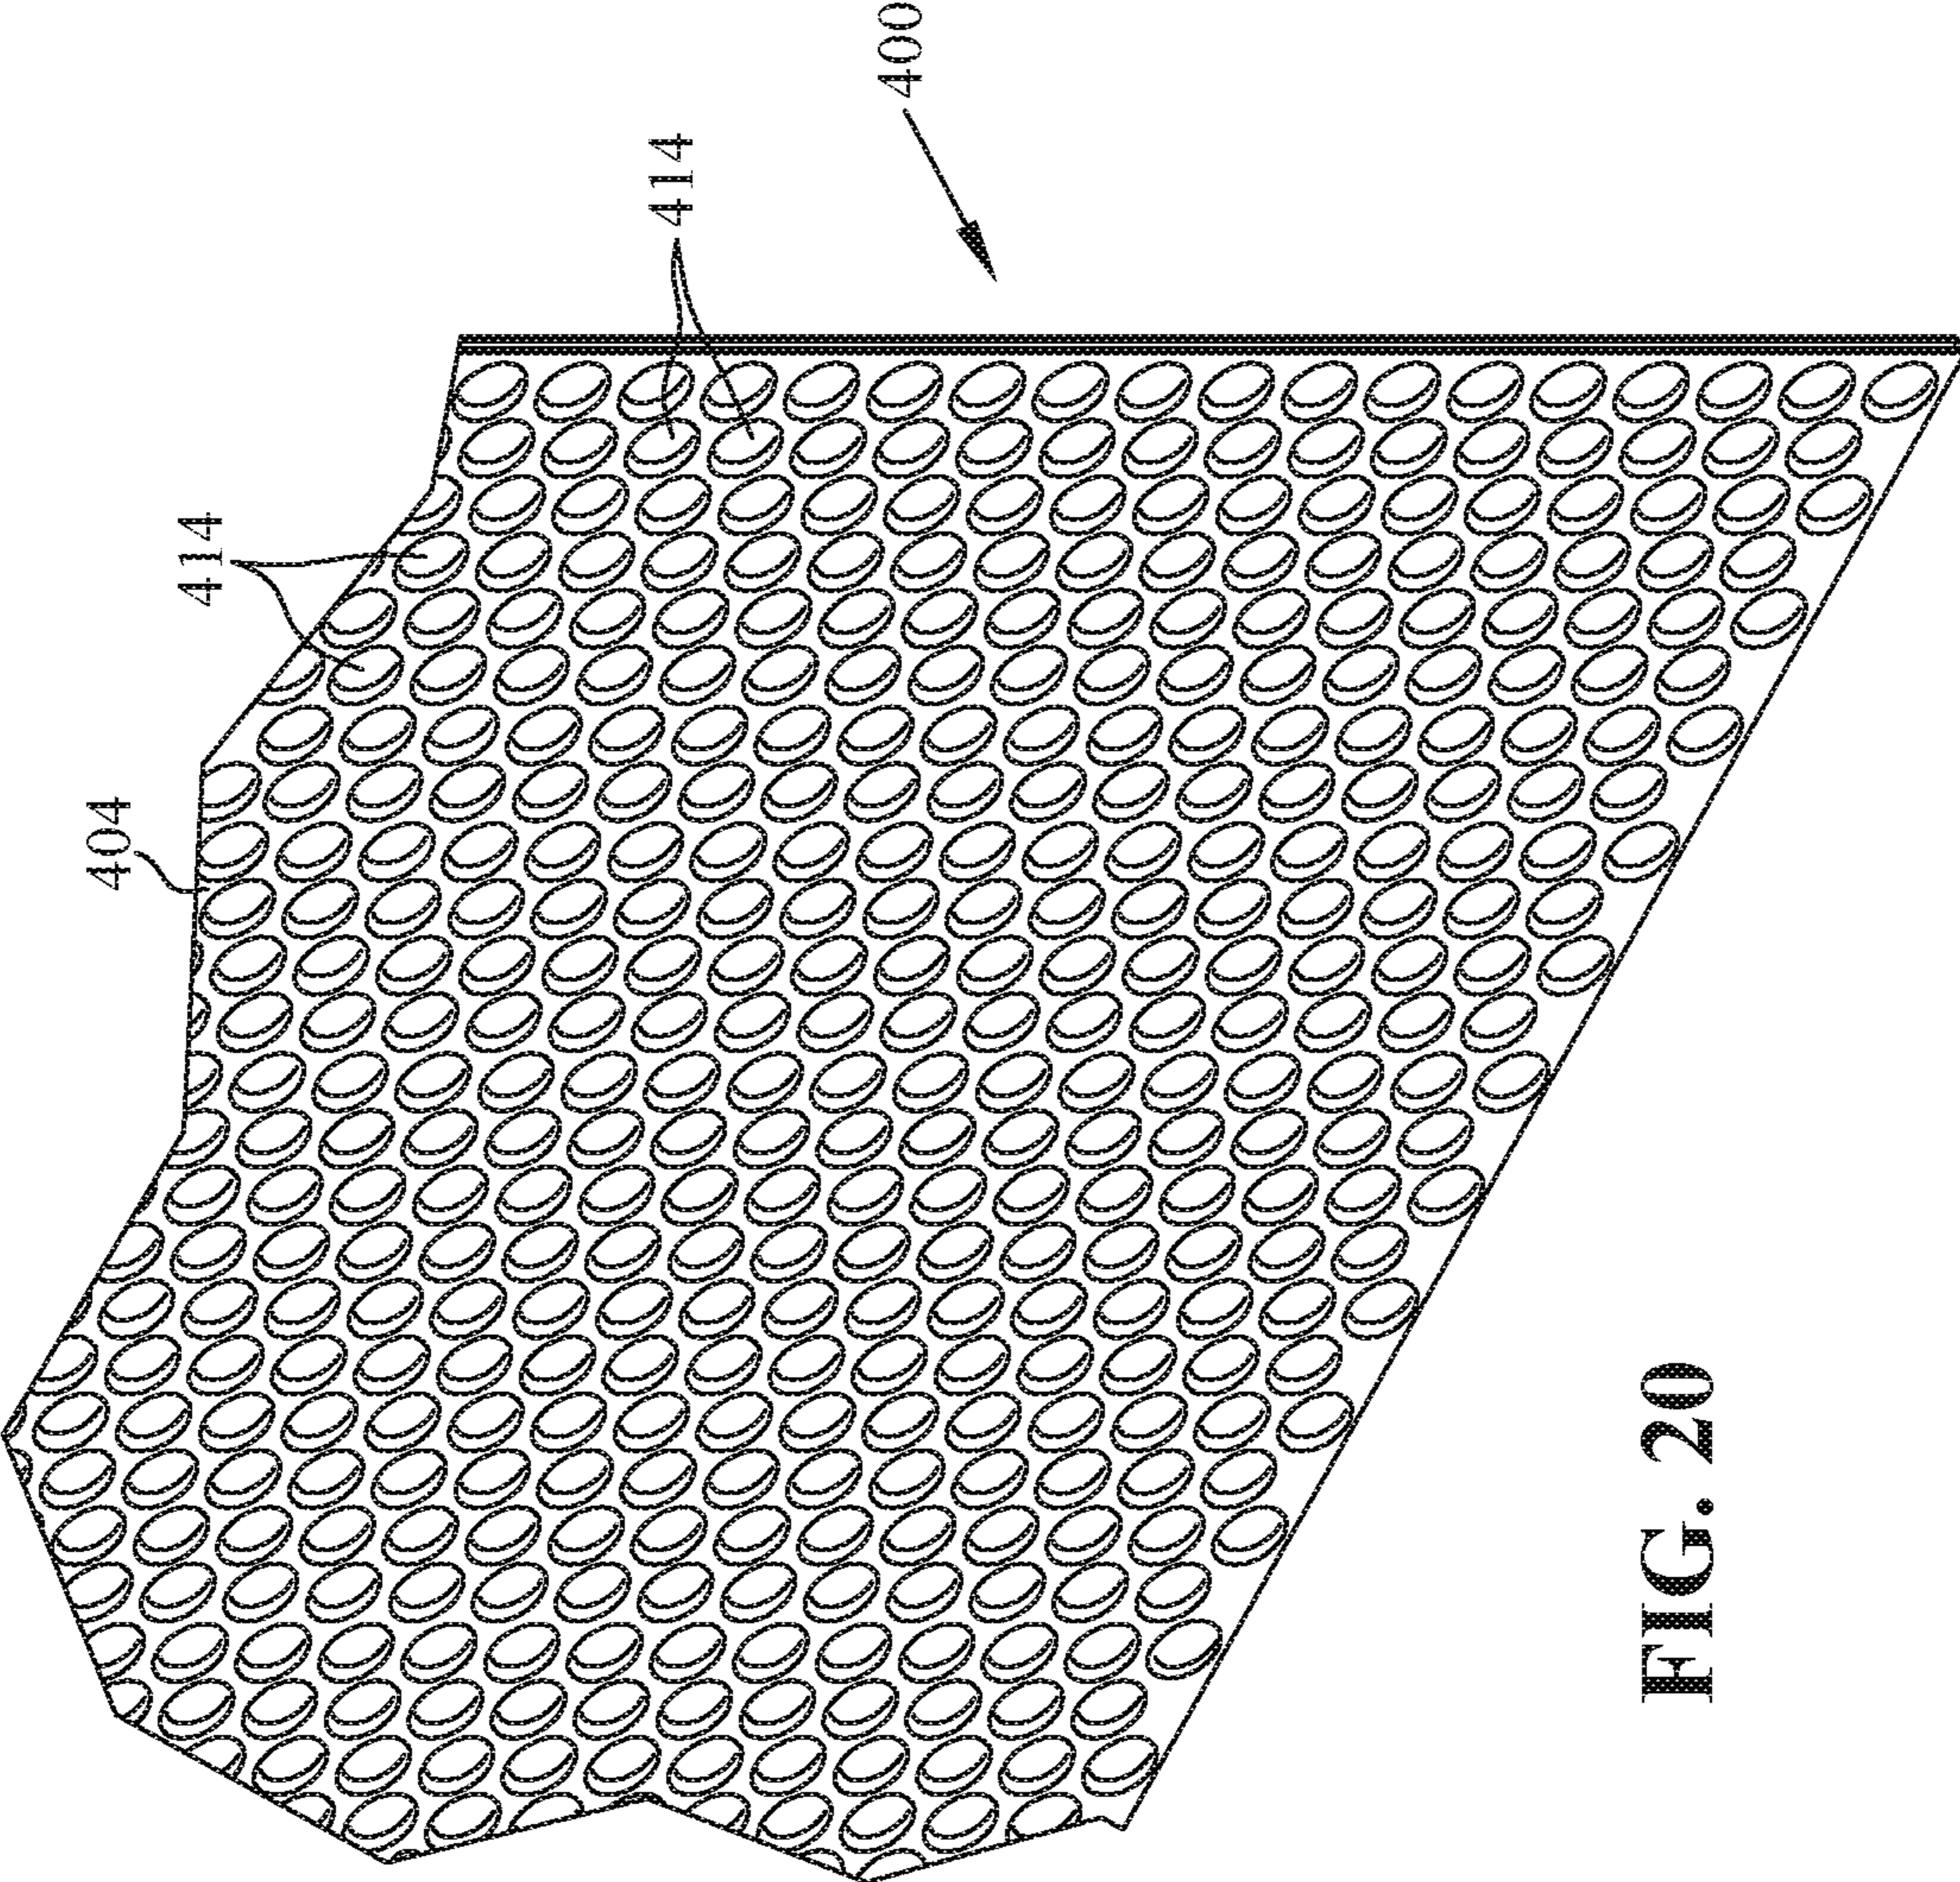
FIG. 20 is a plan perspective view of the bottom side of the vehicle frame and cargo bay liner of FIG. 14;

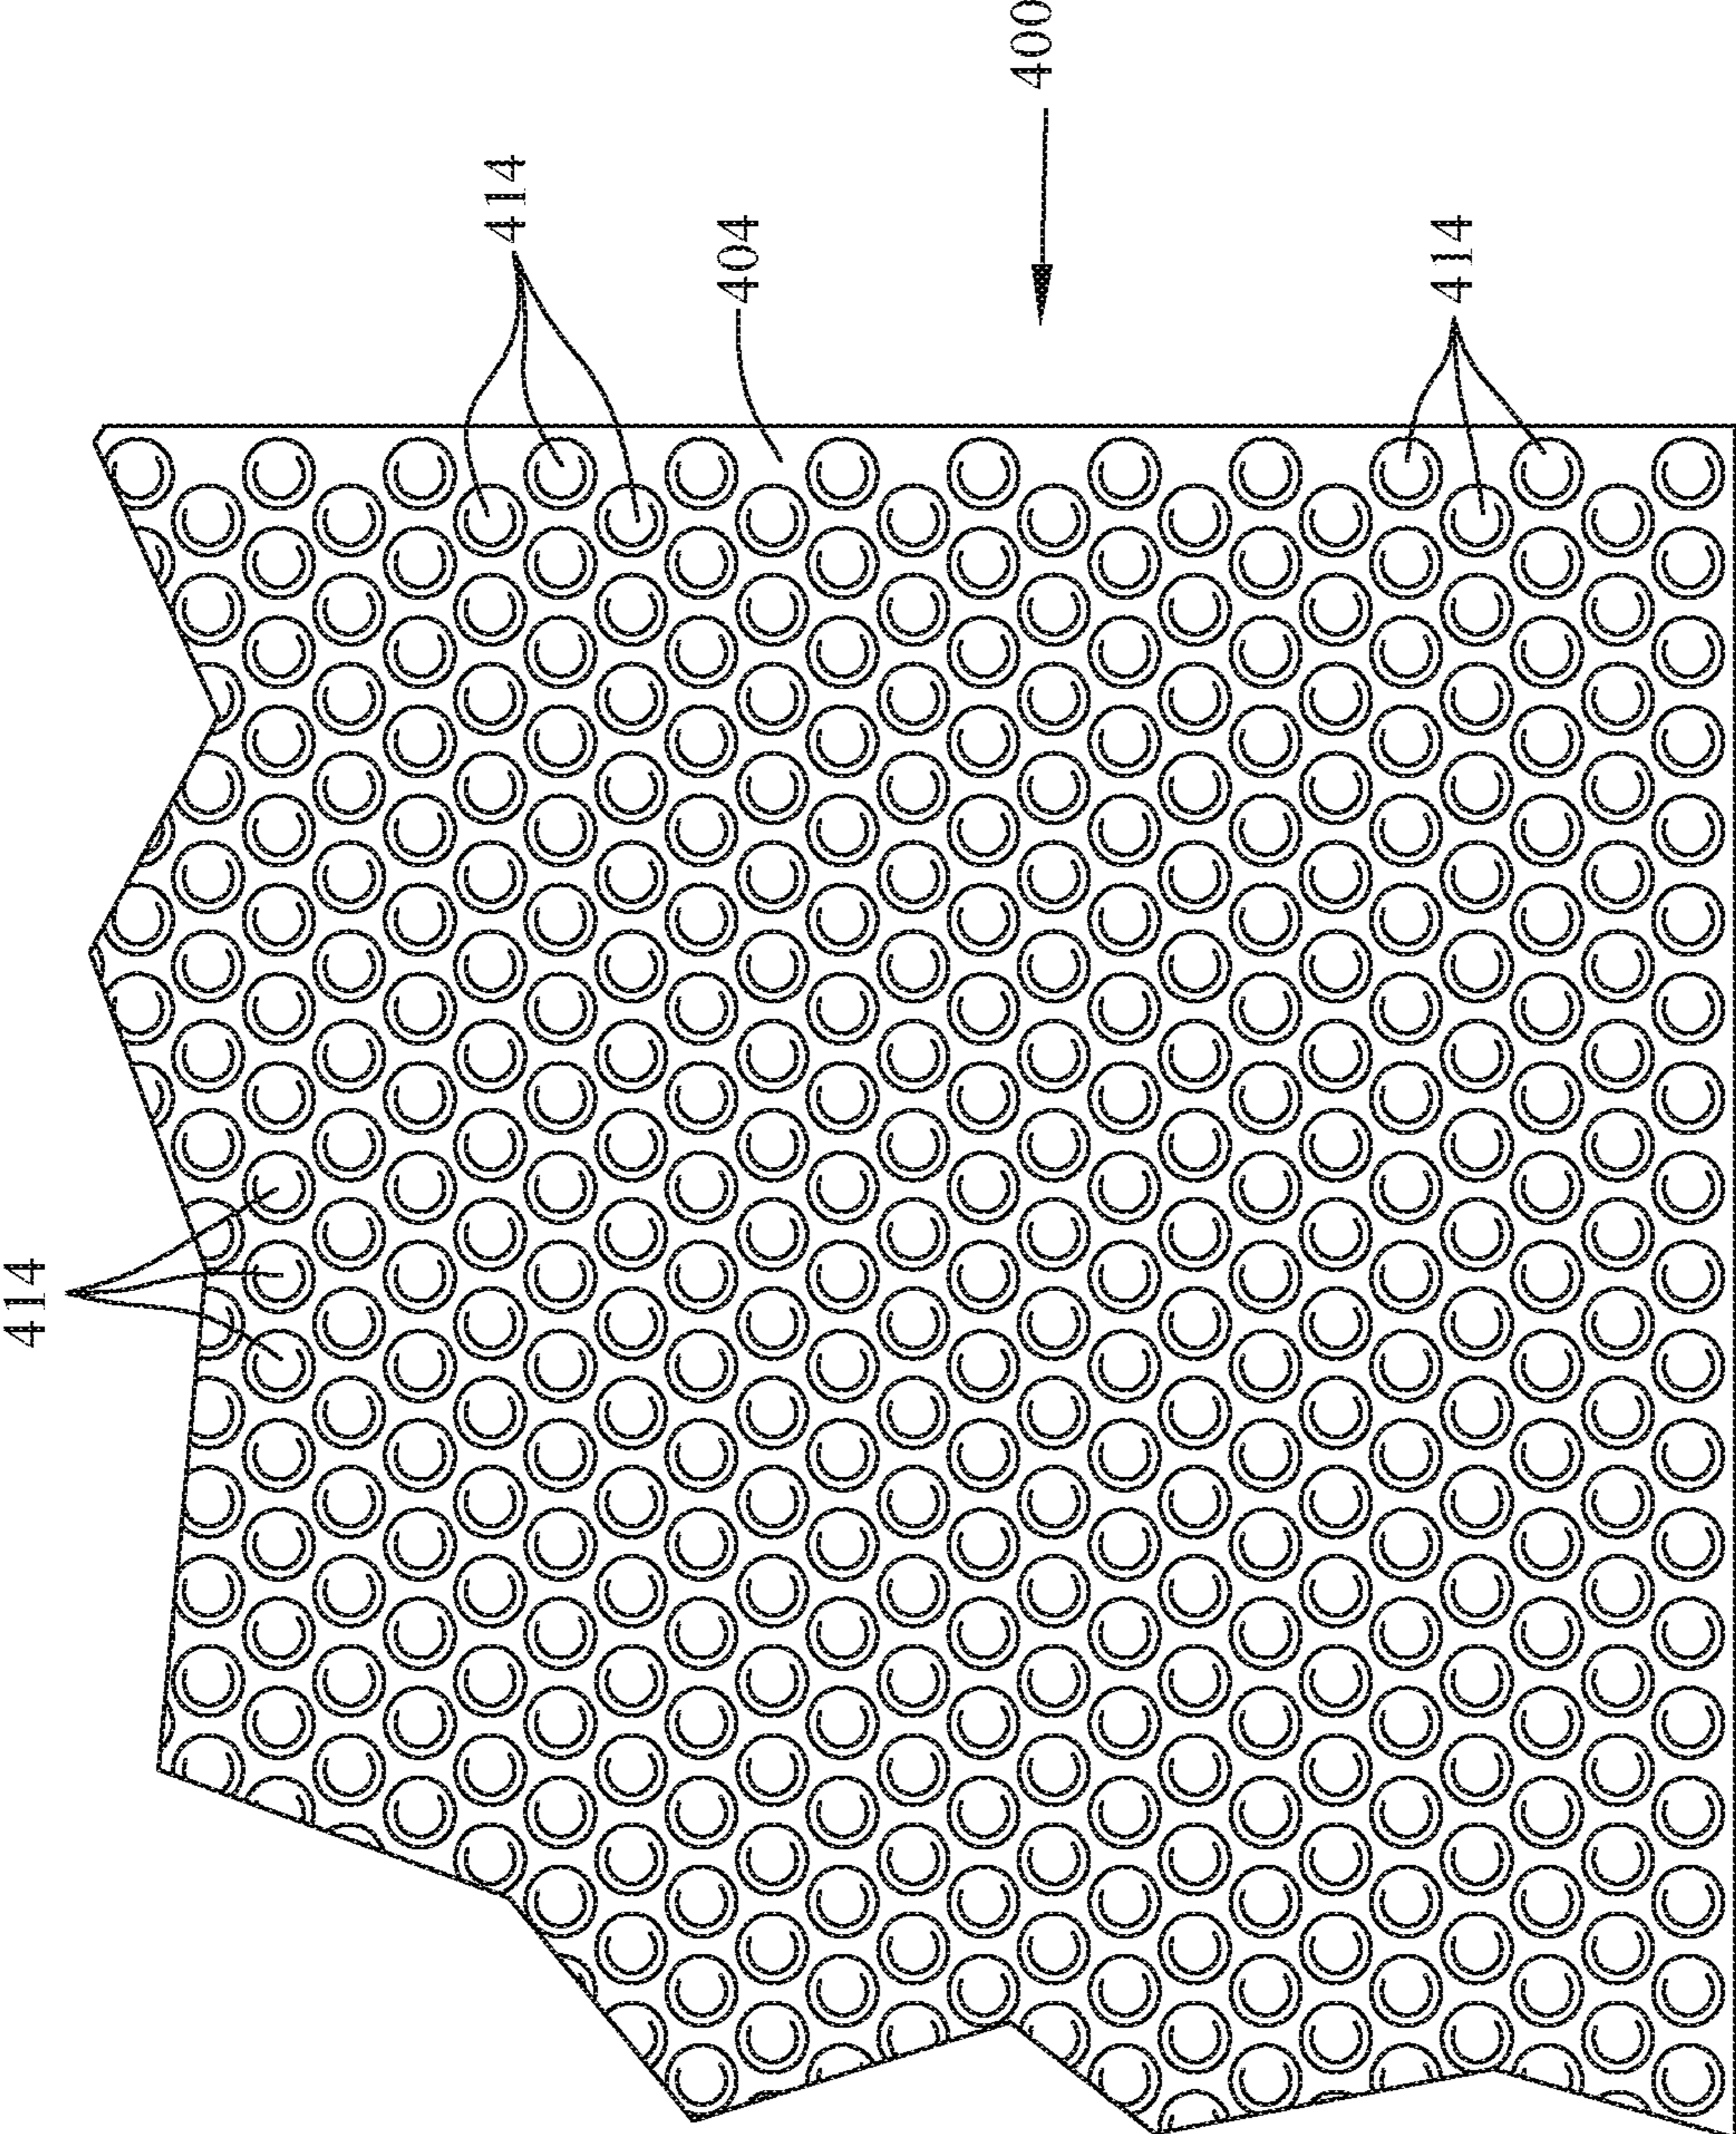
FIG. 21 is an enlarged bottom plan perspective view of the vehicle frame and cargo bay liner of FIG. 14;

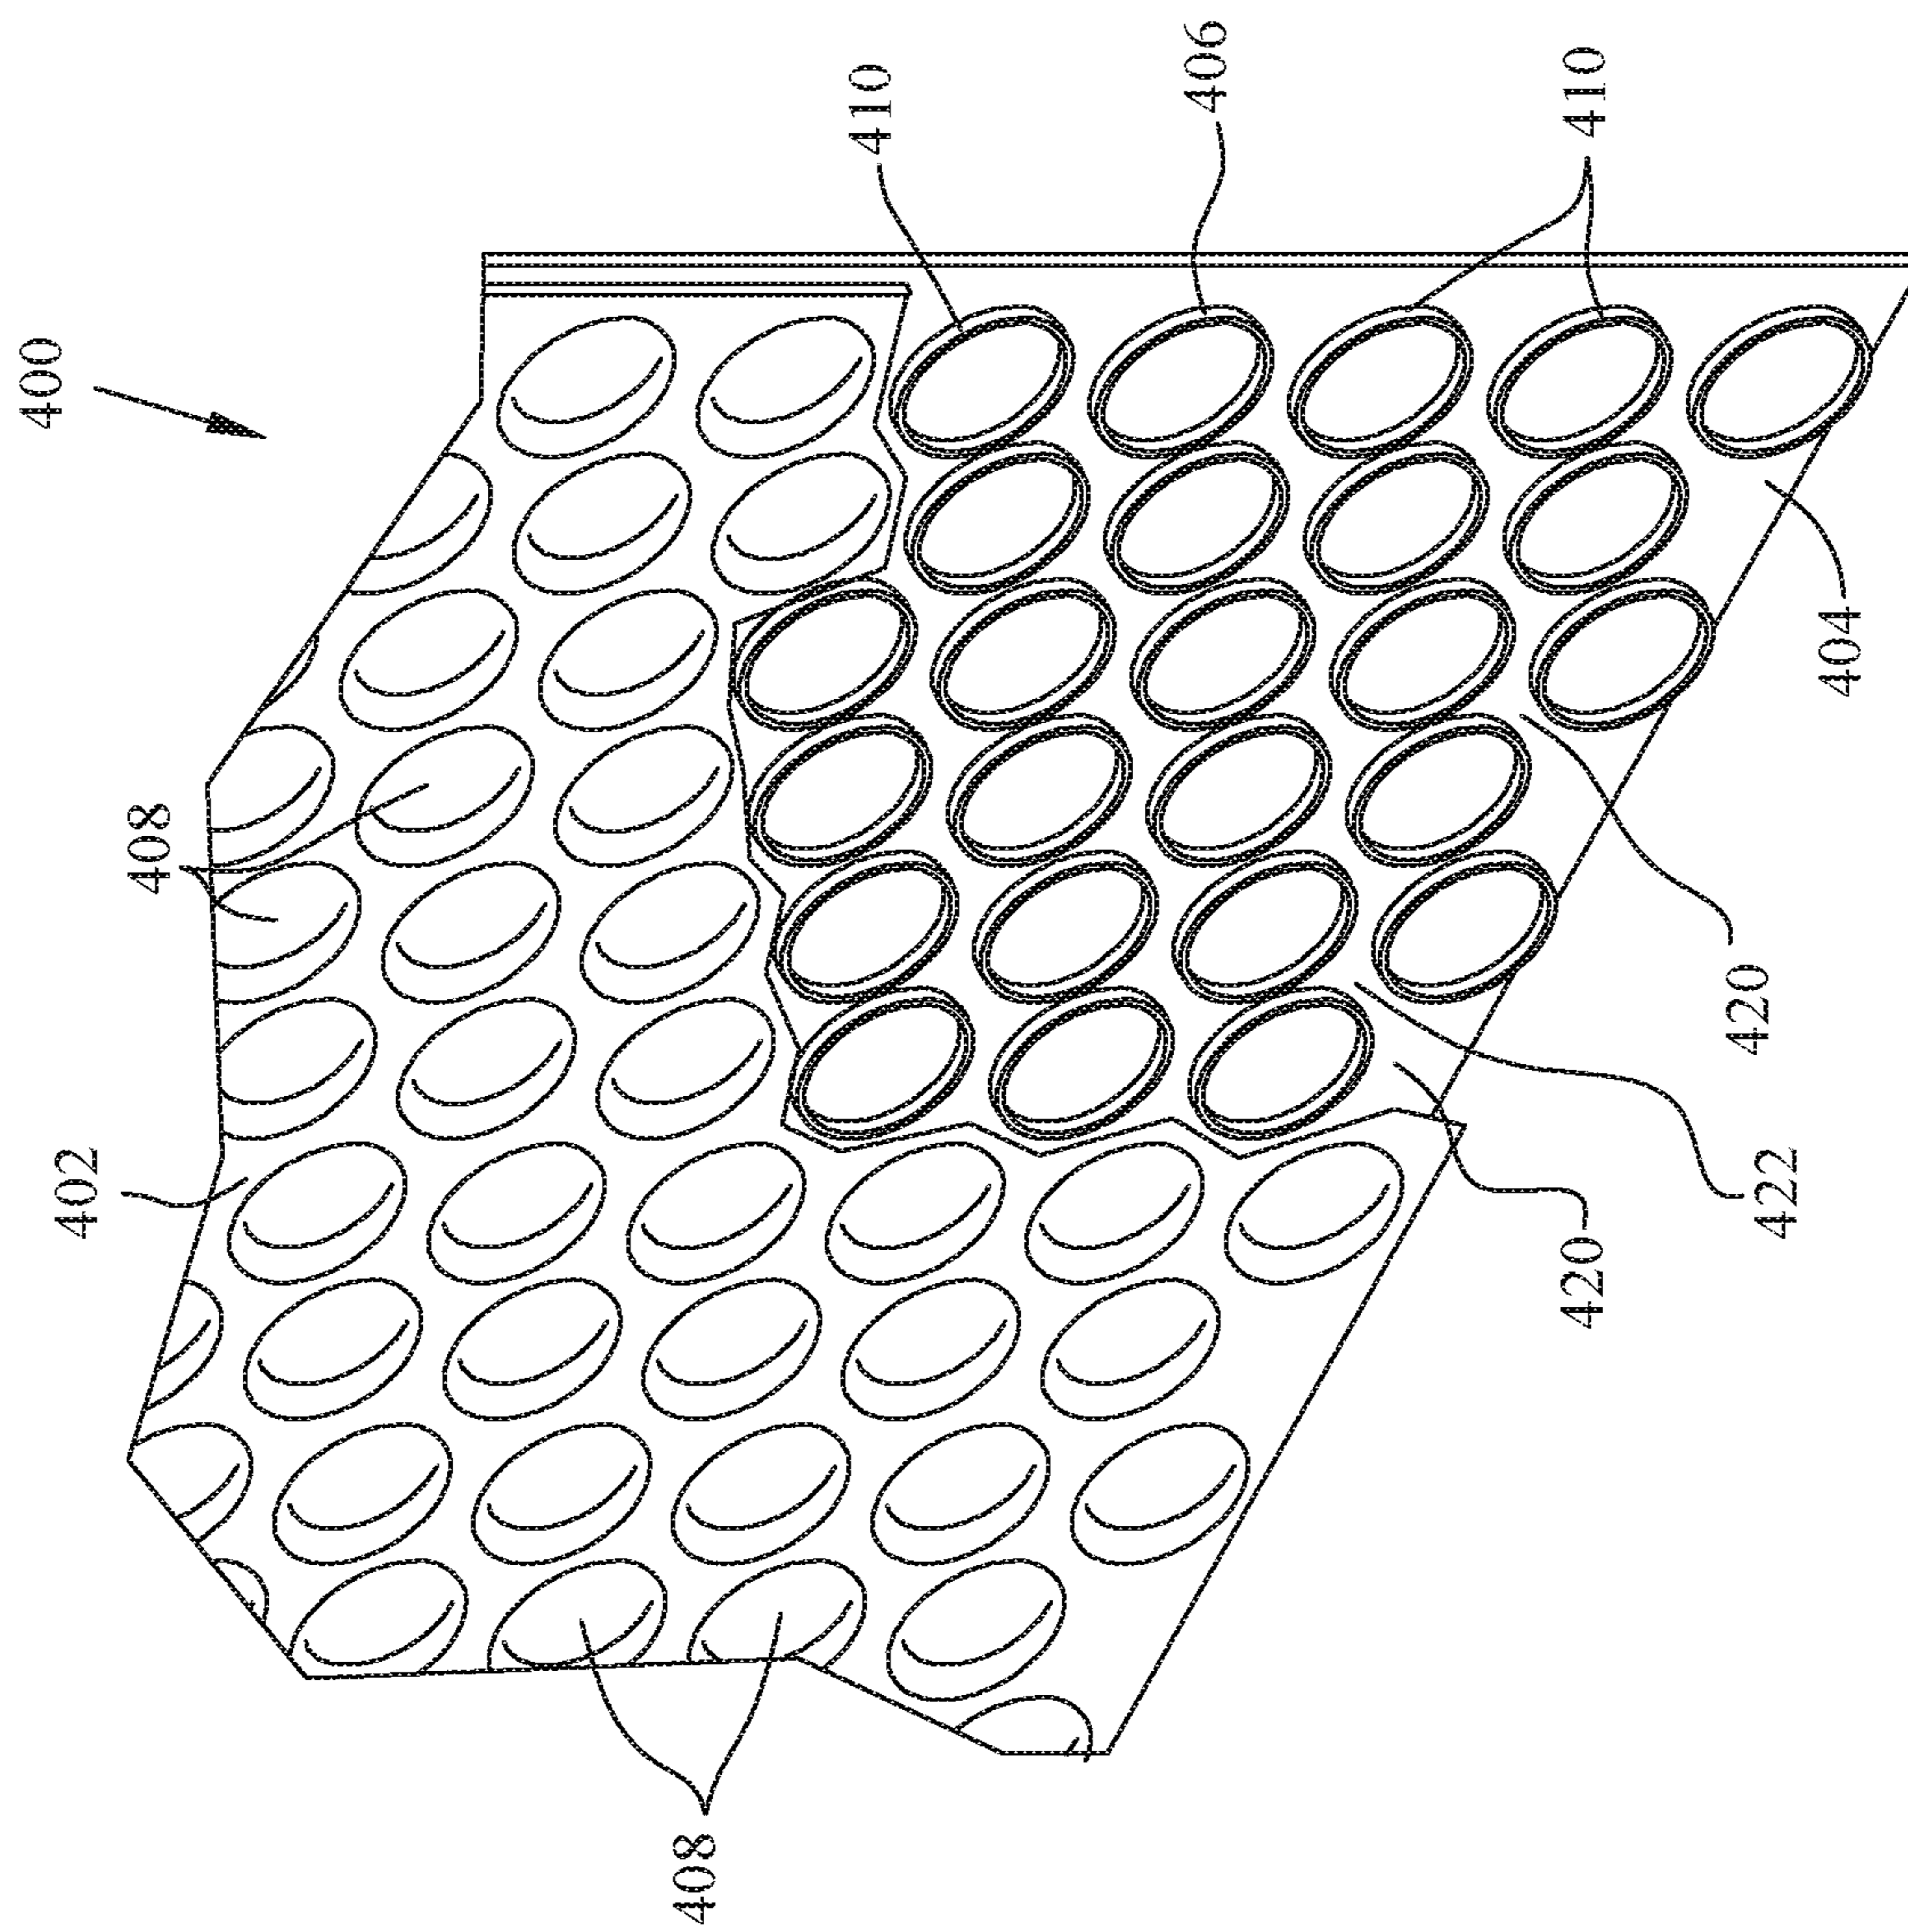
FIG. 22 is a perspective view of a portion of the vehicle frame and cargo bay liner of FIG. 14 showing part of the top layer removed;

As can be seen in FIGS. 22 and 23, cylindrical projections **410** form an obstruction to passage through core **406** such that any water entering the ends thereof is obstructed and impeded or hindered from propagating across liner **400** as compared to channels **111** in corrugated liner **104**, which readily allow transport of liquids. Additionally, as where vehicle frame and cargo bay liner **400** is cut, it will intersect a plurality of cylindrical projections **410** in the liner. As each cylinder is closed off, any water entering into an end of the liner where a projection has been cut will be prevented from further propagating by encountering the wall of the projection. Only a small area or channel **422** between cylindrical projections would allow any water or moisture to enter into core **406** of liner **400**, but that will not readily propagate to the offset projections internal to core **406** that will impede or hinder any advancement of the moisture.

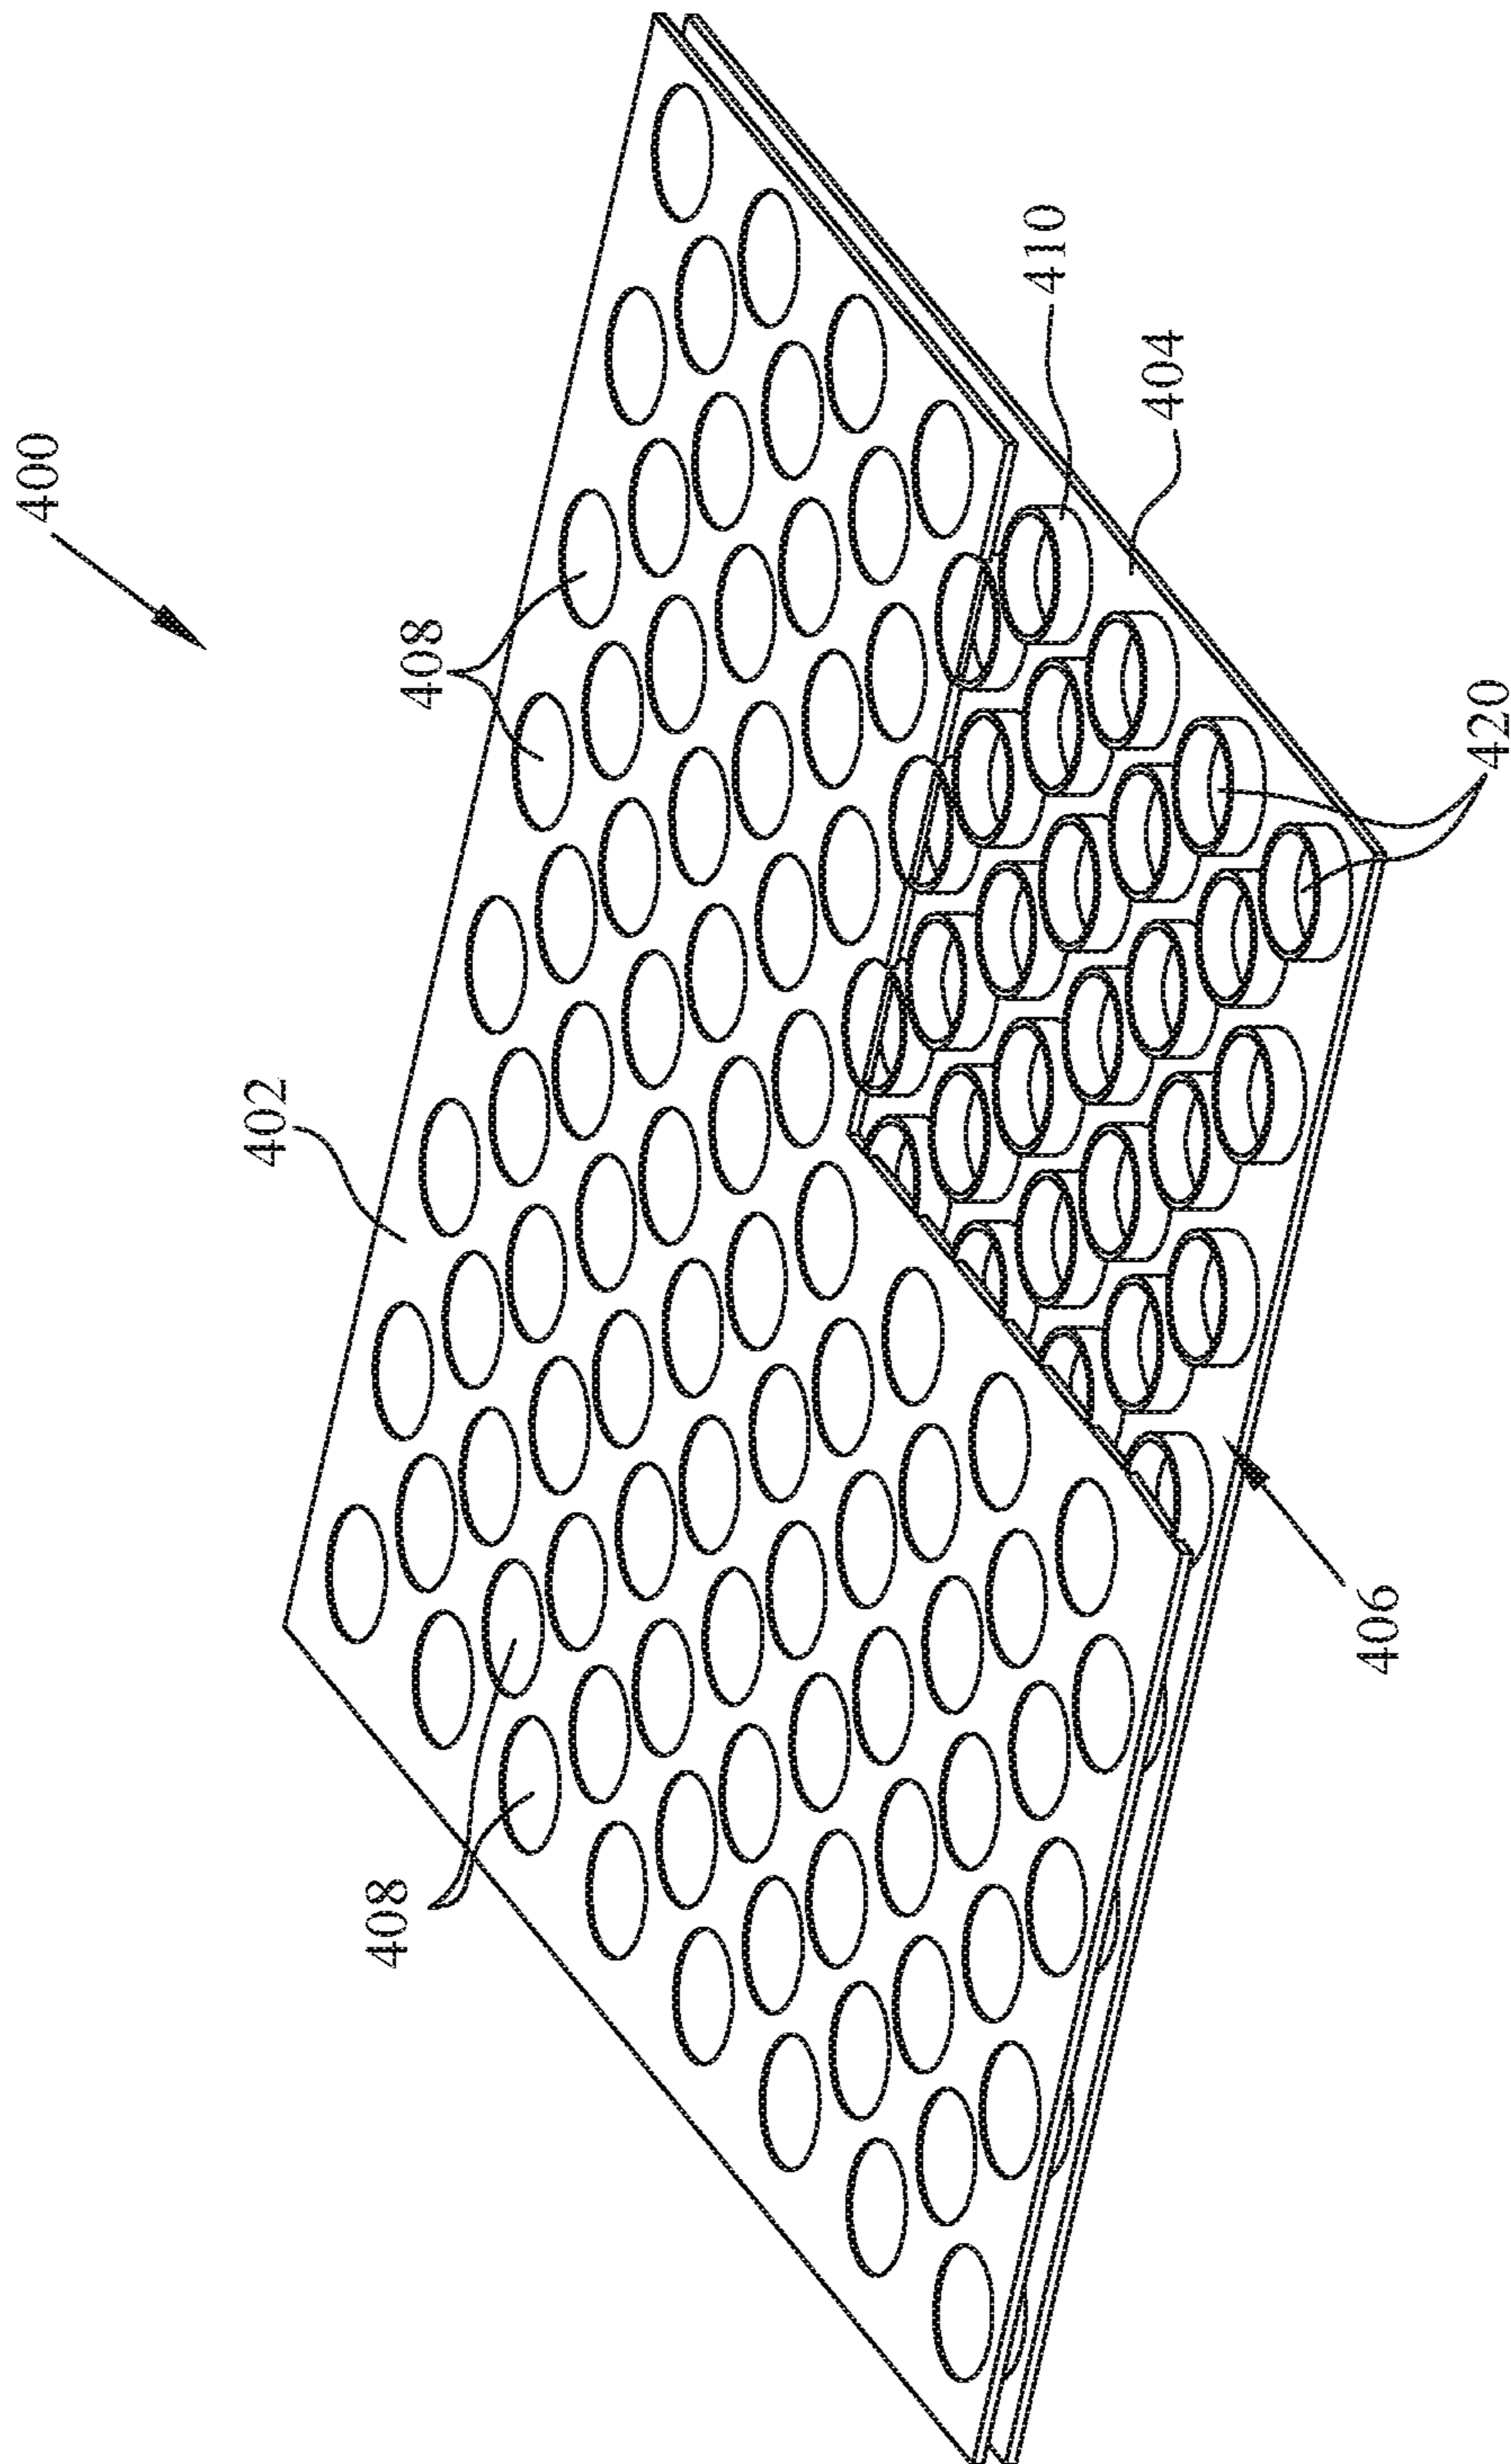
FIG. 23 is another perspective view of a portion of the vehicle frame and cargo bay liner of FIG. 14 with part of the top layer removed;

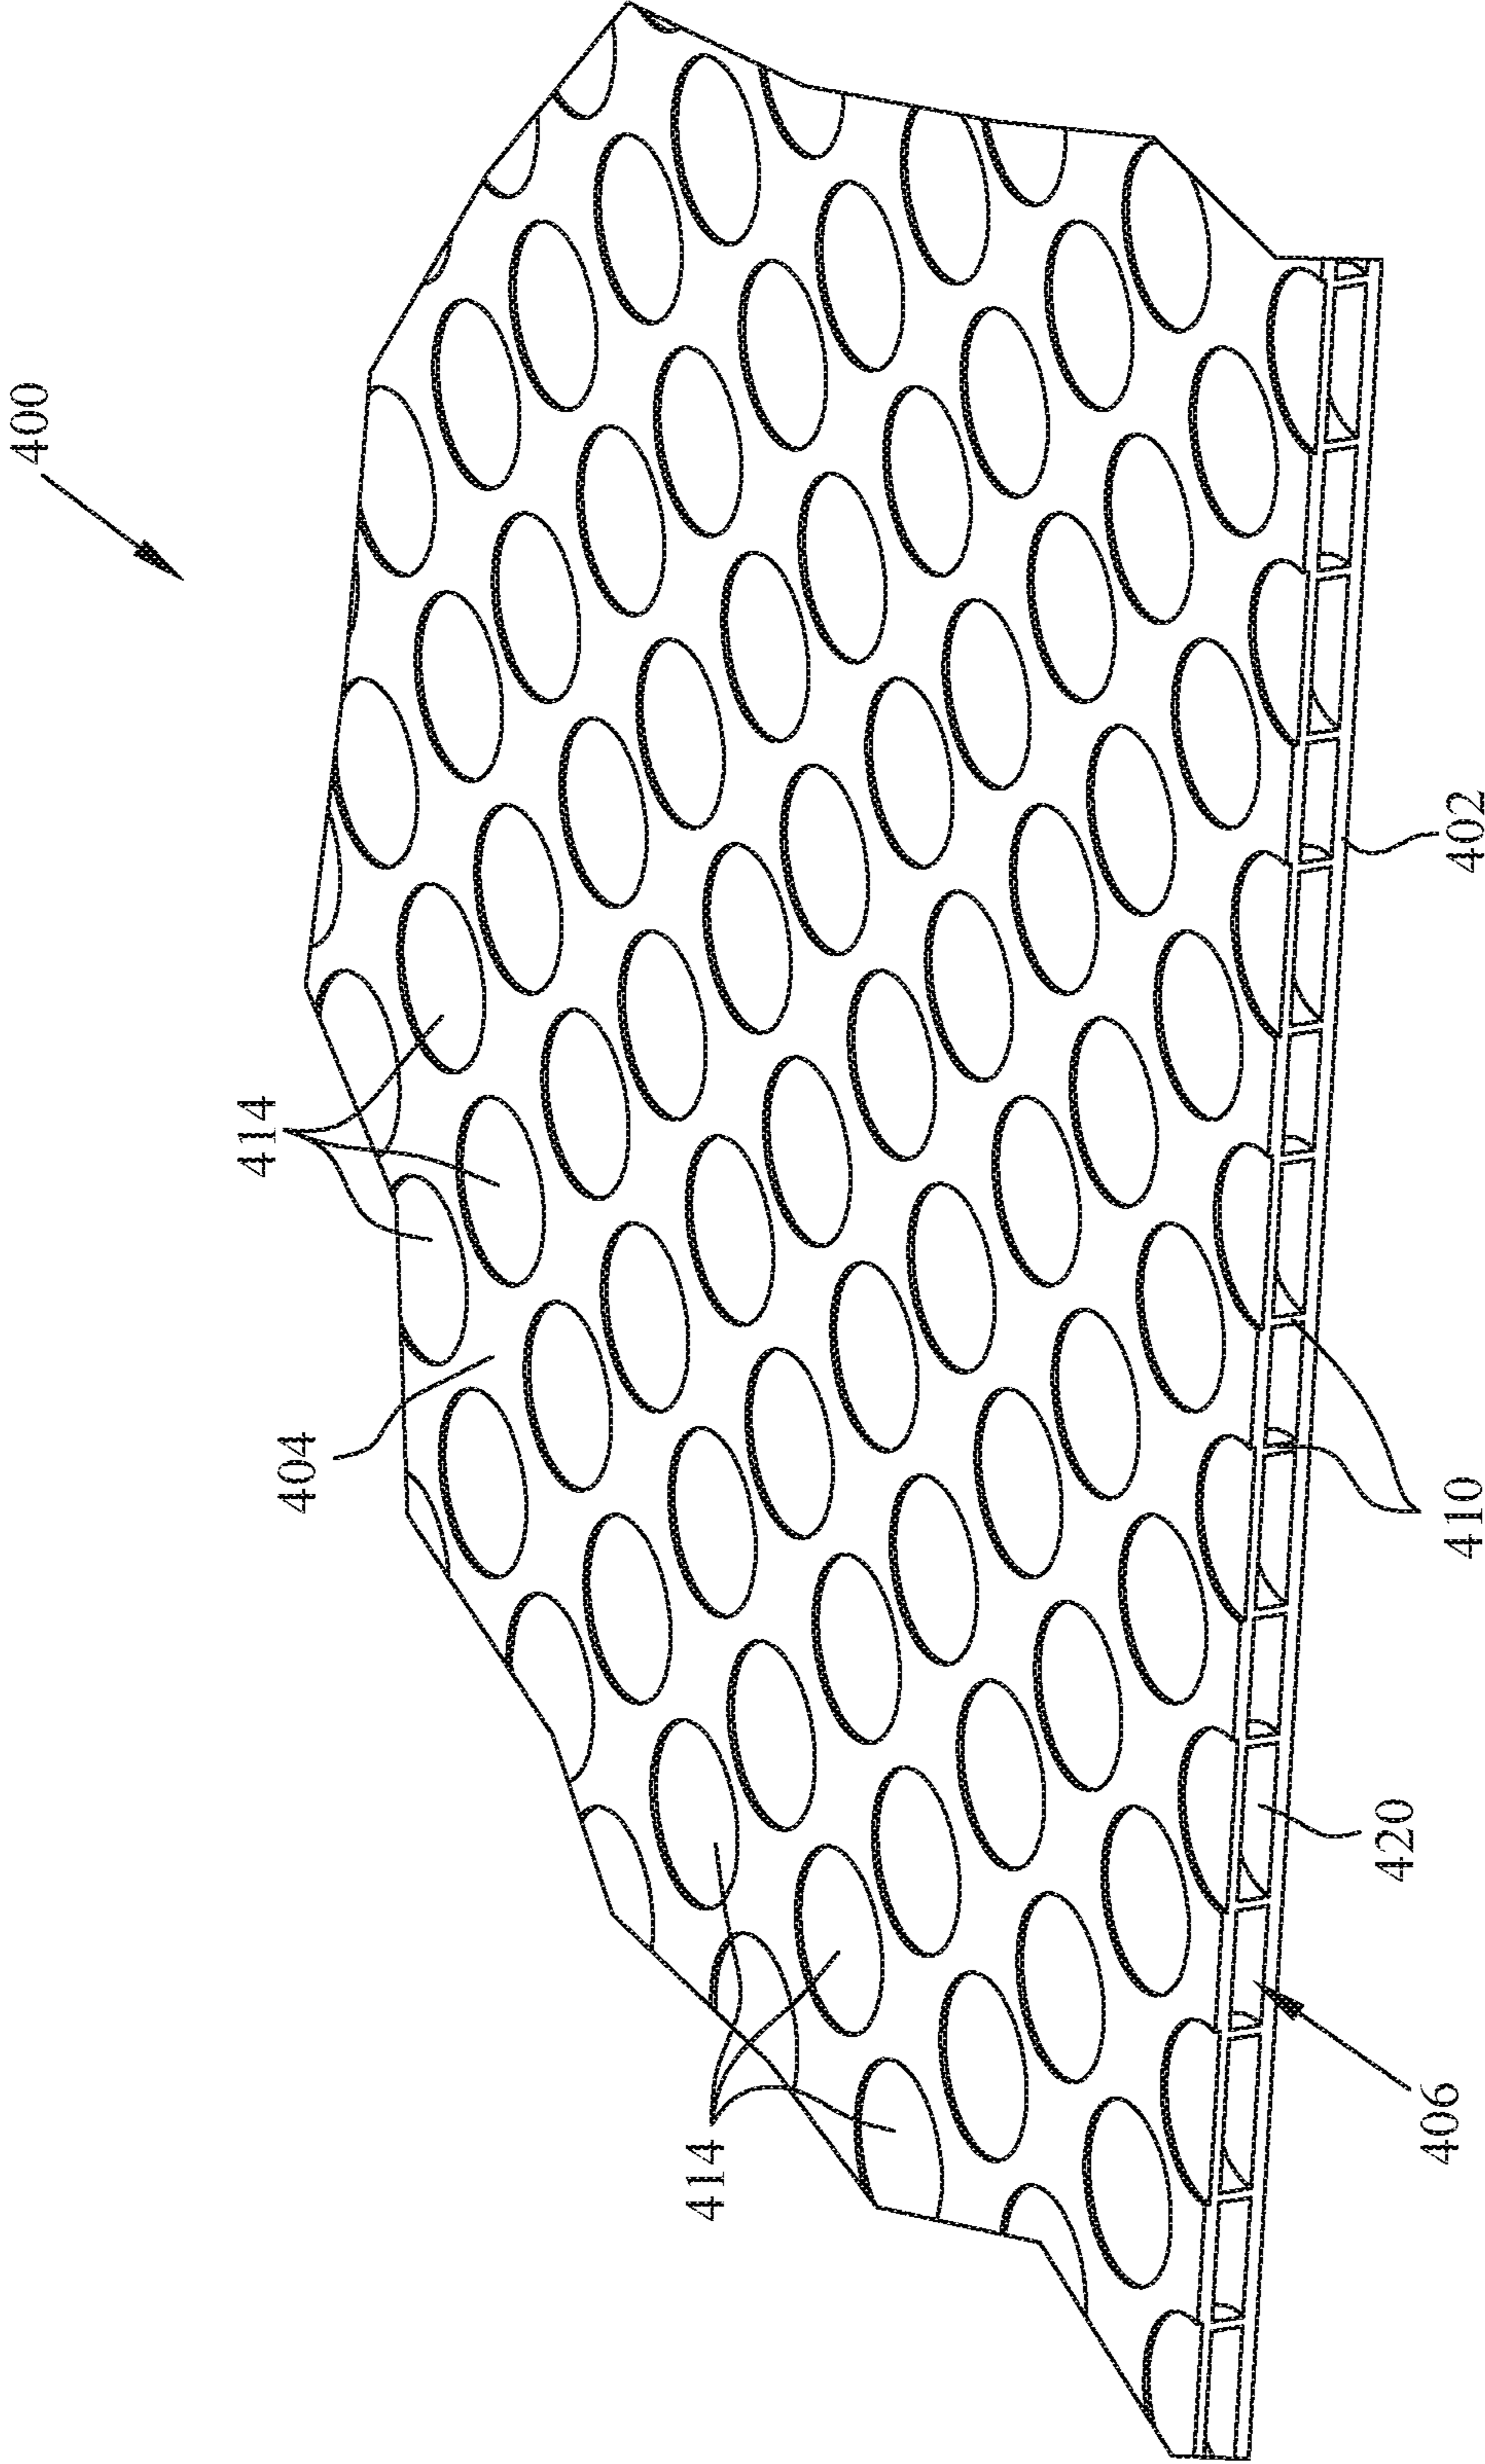
FIG. 24 is a perspective view of the bottom side of a portion of the vehicle frame and cargo bay liner of FIG. 14;
