US011447189B1

(54) **VEHICLE FRAME AND CARGO BAY LINER**

A vehicle and liner assembly is provided that includes a
recreational vehicle having a housing, a front end, a rear end,
a top, a bottom, and a pair of sidewalls. A frame assembly
is provided wherein, the housing is mounted on and sup-
ported by the frame assembly. The liner is attached to the
frame assembly and covers at least a substantial portion of the
bottom of the housing. The liner has a first face having
projections extending therefrom and a second face having
openings therein. The openings coincide with and extend
into corresponding projections on the first face.

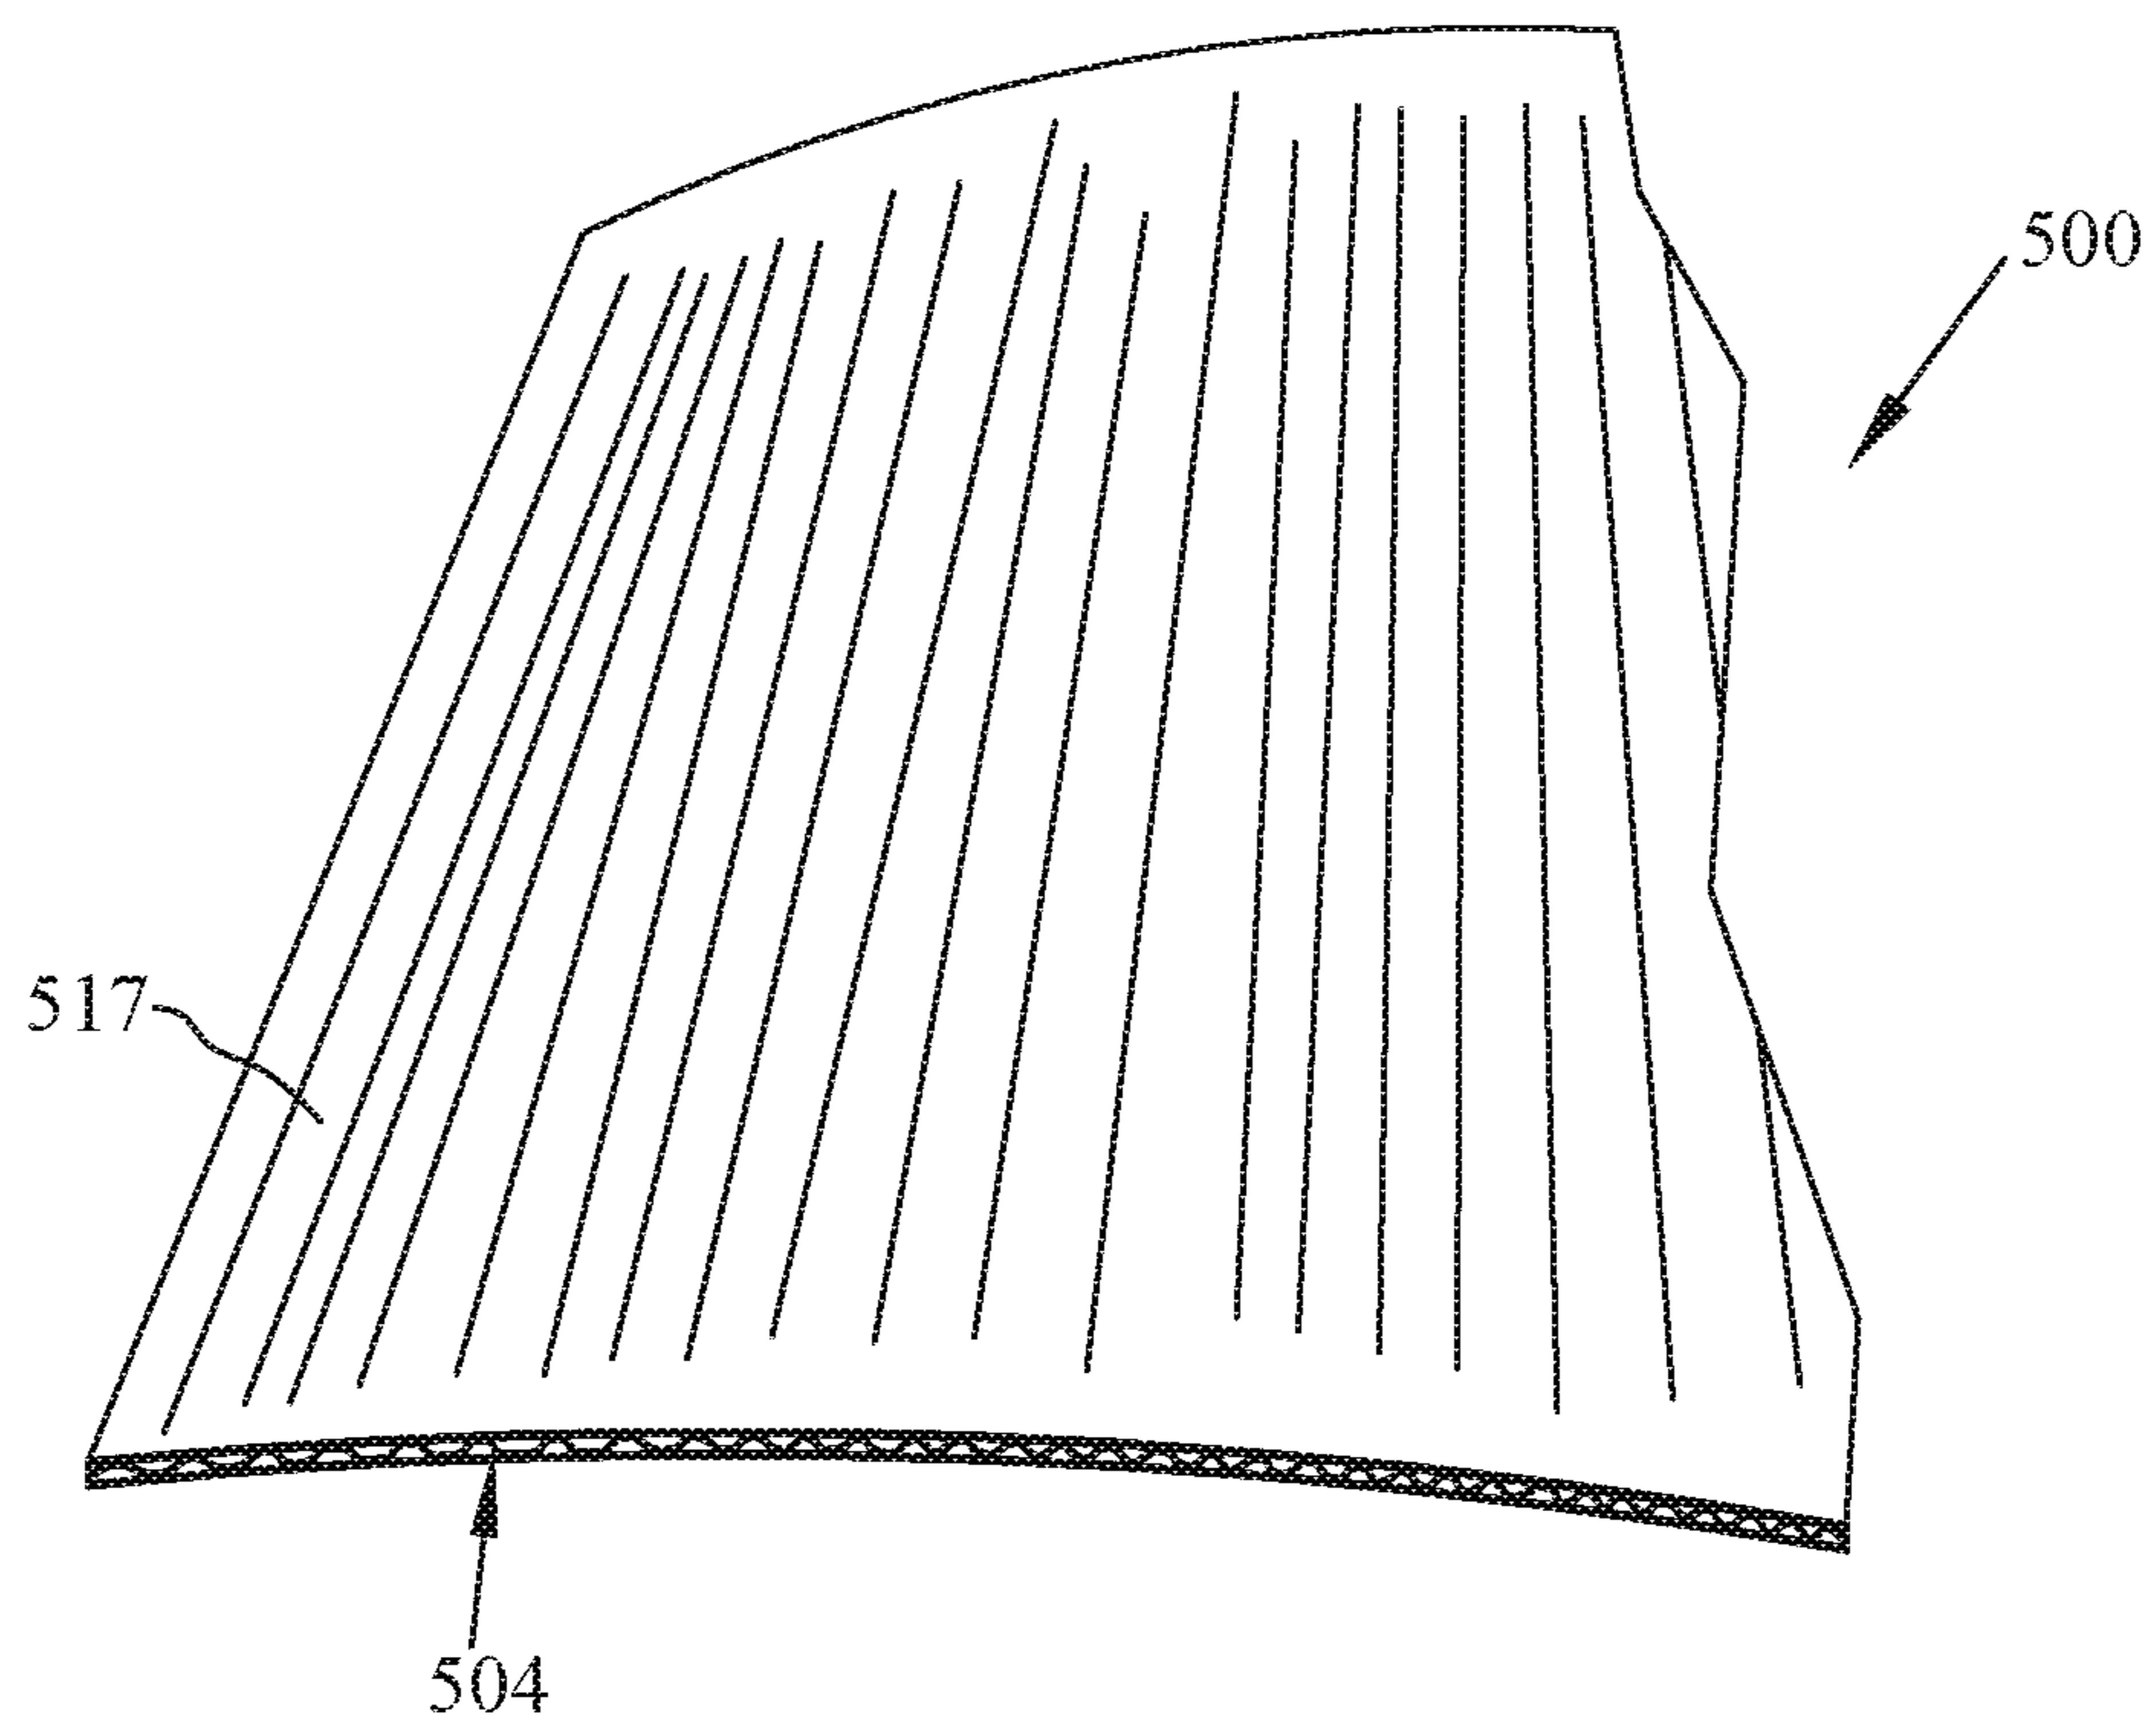
FIG. 25 is a perspective view of an additional alternate embodiment vehicle frame and cargo bay liner shown laid out and having an aluminum foil on one side thereof;

Now referring to FIGS. 25-27, other alternate embodiment vehicle frame and cargo area liner is shown generally indicated as **500**. Liner **500** includes a corrugated liner, generally indicated as **504**. Corrugated liner **504** includes a top sheet **506**, a bottom sheet **508**, and a corrugated or sinusoidal ply **510** extending therebetween, as best shown in FIGS. 26 and 27. Top sheet **506** and bottom sheet **508** each have a generally planar configuration, not including any rolling memory that may be embedded therein and are adhered or thermally attached to corrugated ply **510**. It should be appreciated that the corrugated ply is defined to include either a sinusoidal configuration as shown in FIGS. 26 and 27 or alternately a plurality of member perpendicular to top sheet **506** and bottom sheet **508** such as is shown in the material utilized in FIGS. 7 and 8 of U.S. Pat. No. 10,000,930 B2 to Lowe et al., which is incorporated in its entirety herein by reference. In one embodiment, corrugated liner **504** is polyethylene. Of course, other materials, and in particular, polymers such as polypropylene may be used for corrugated liner **504**. As best shown in FIG. 26, when the corrugated liner **504** is rolled, the outer sheet will become stretched and the inner sheet may fold as shown with top sheet **506**, and bottom sheet **508** in FIG. 26, respectively.

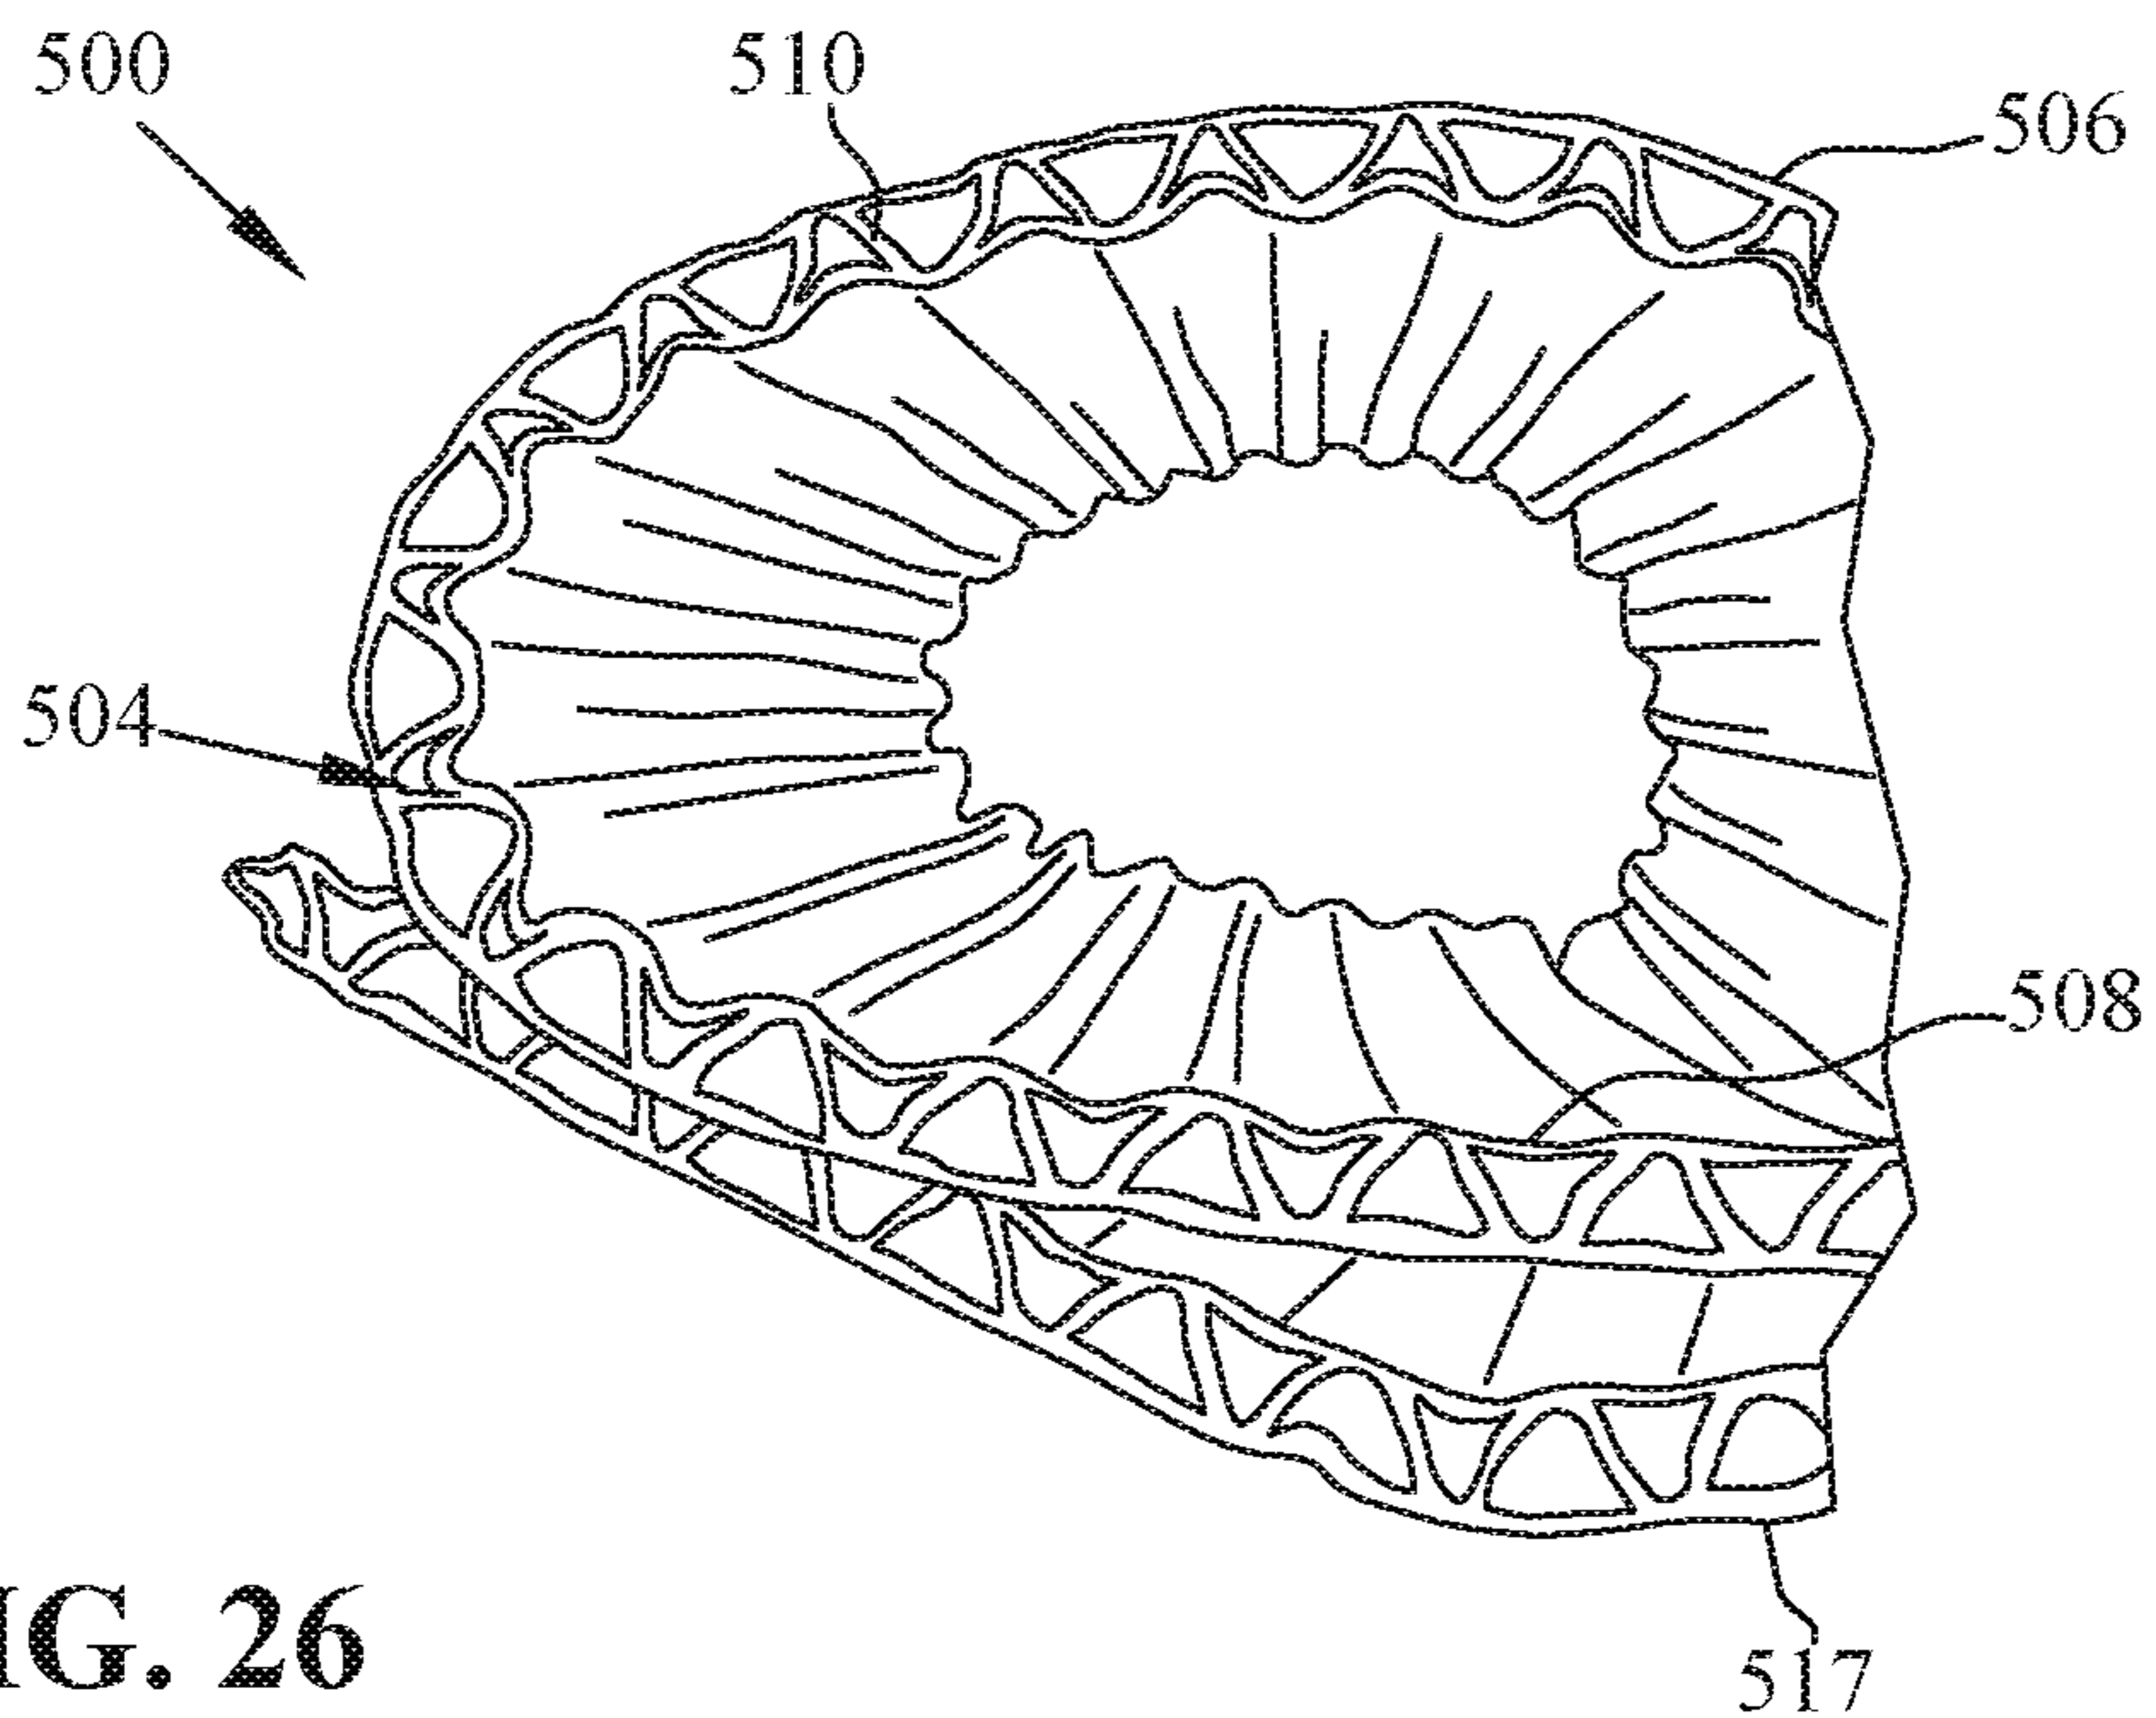
FIG. 26 is an end view of the vehicle frame and cargo bay liner of FIG. 25 shown rolled up wherein corrugations of the liner are readily visible;

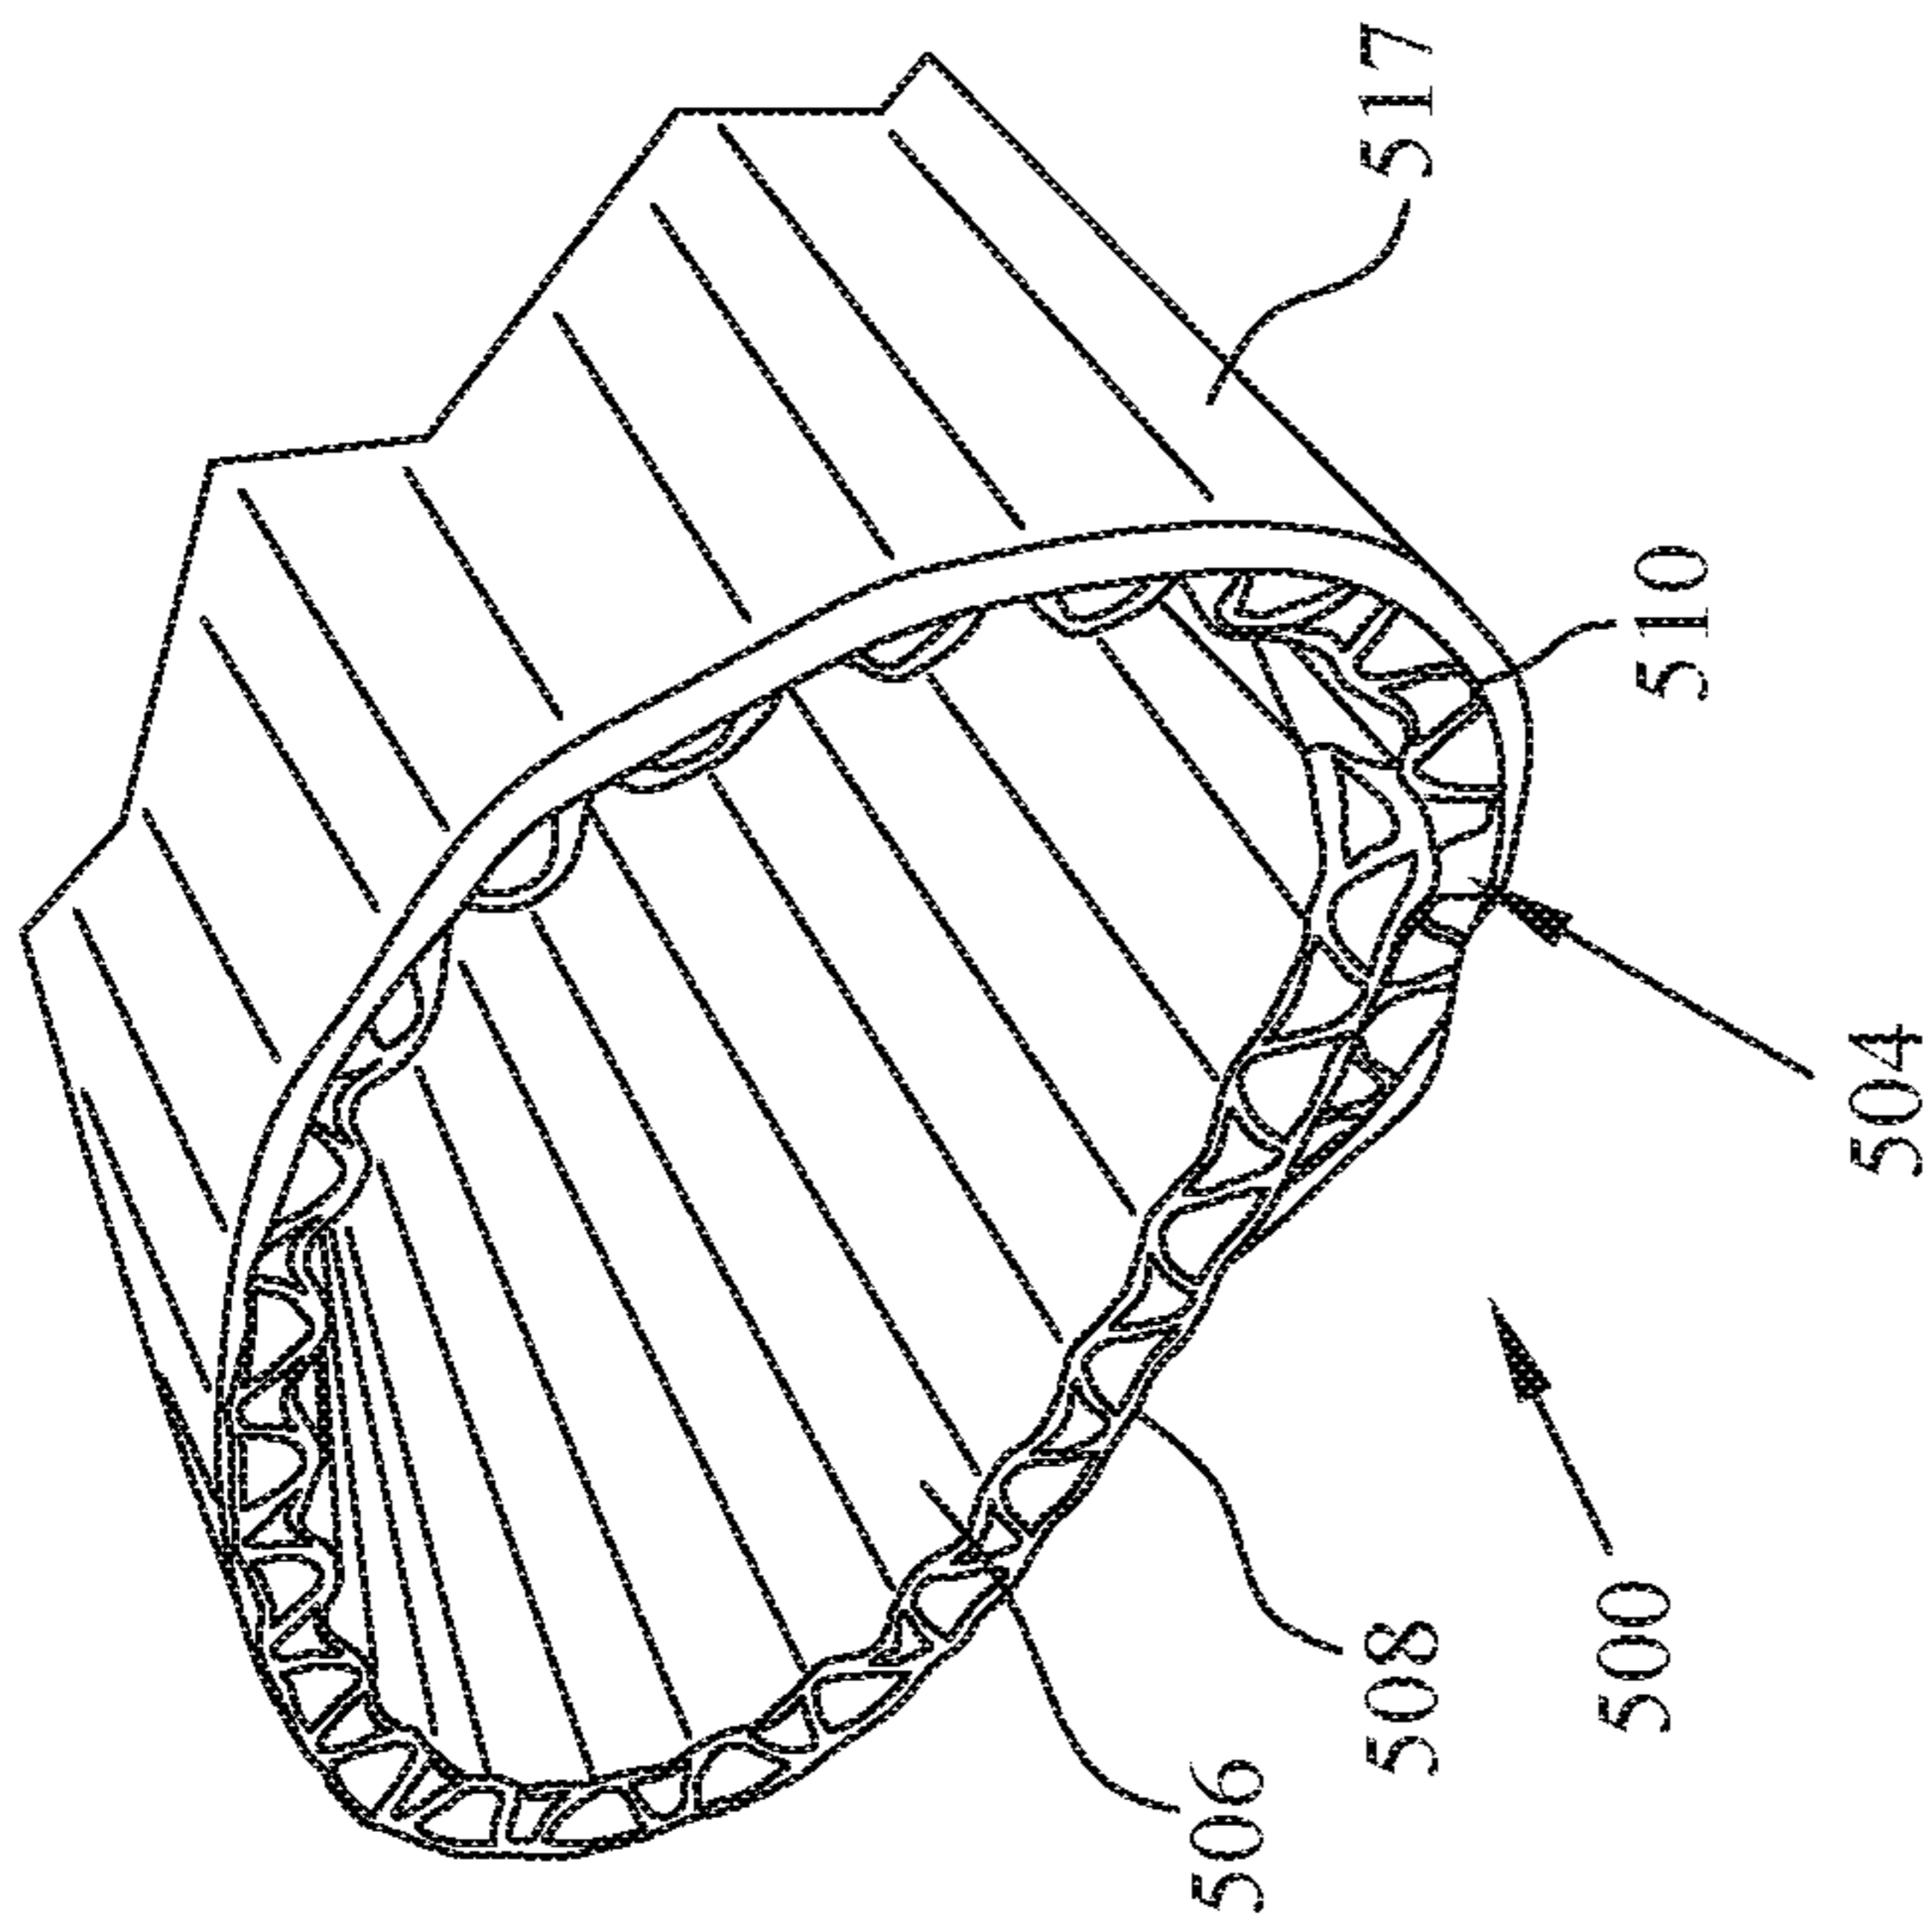
FIG. 27 is a perspective view of the vehicle frame and cargo bay liner of FIG. 25 rolled up with the aluminum foil on the outside thereof;

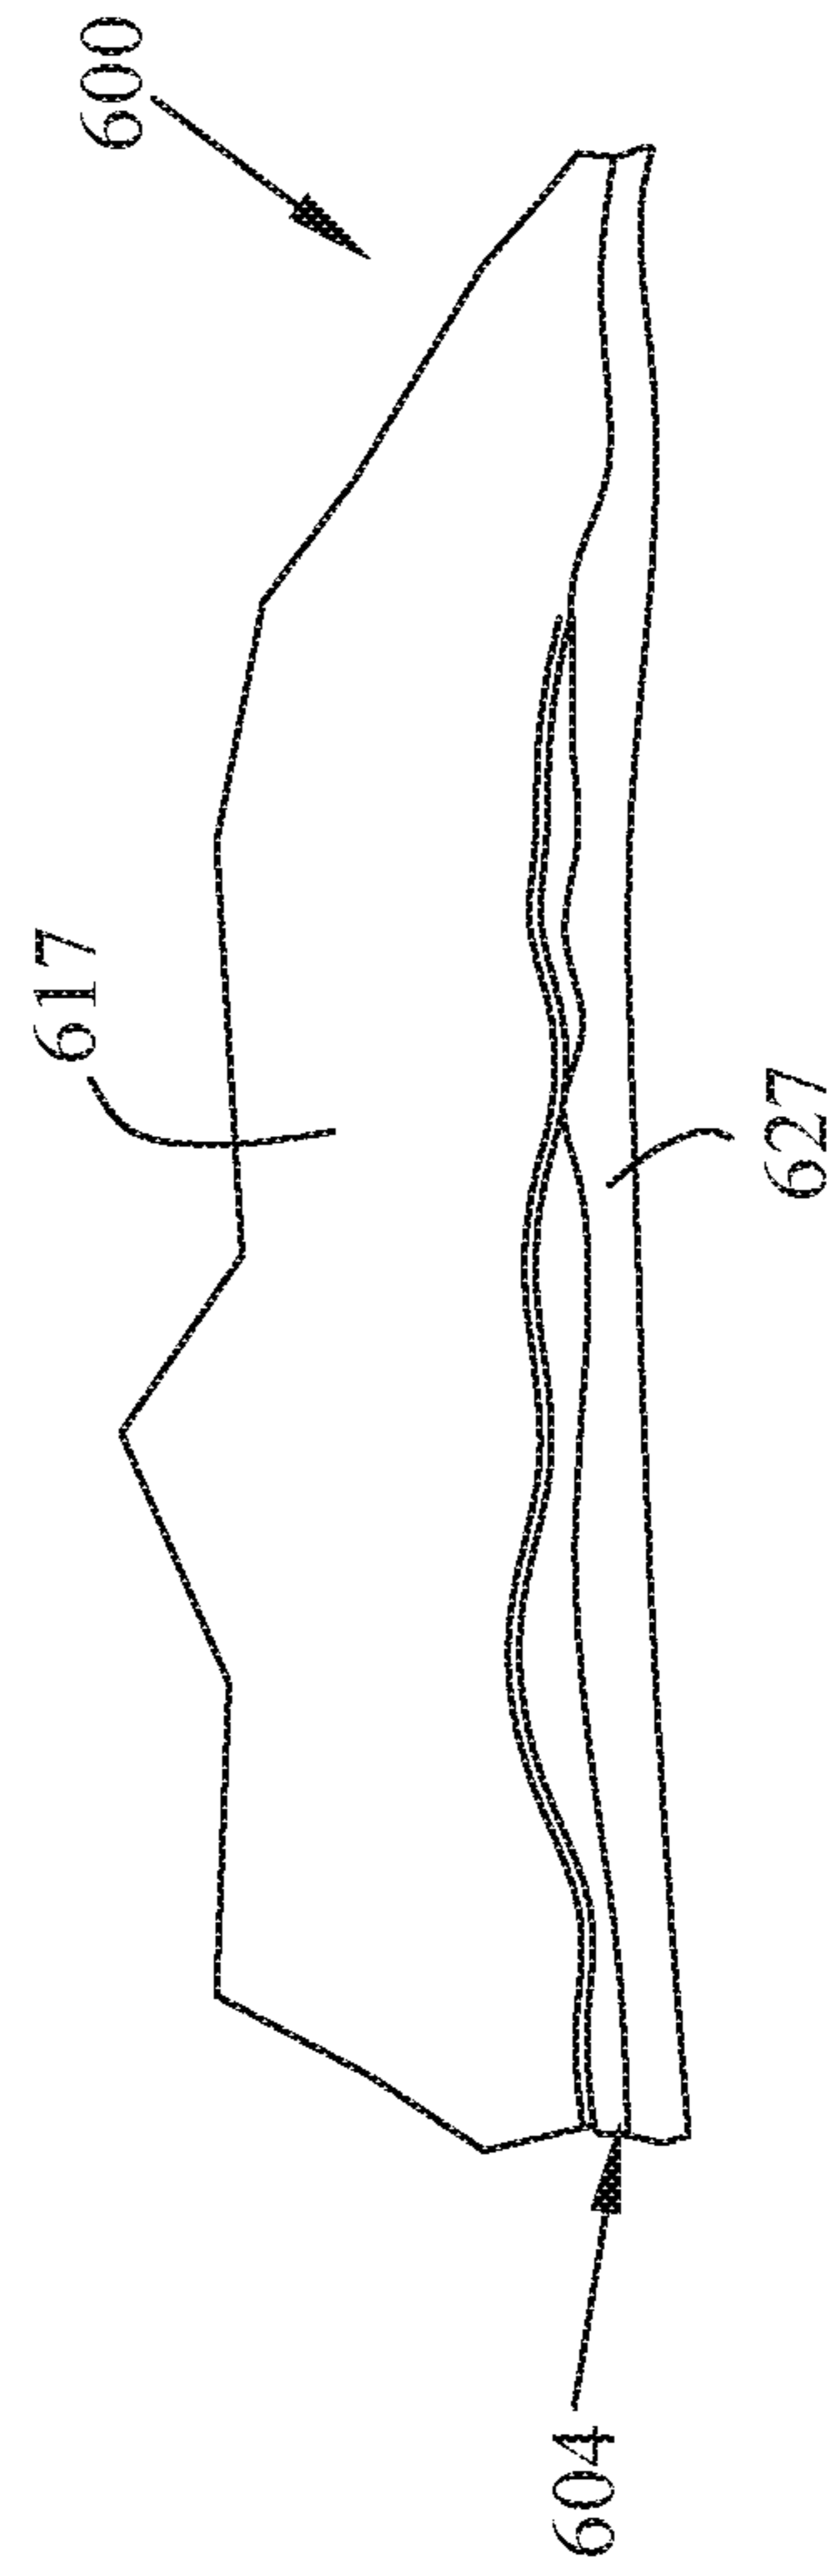
FIG. 28 is an end perspective view of another alternate embodiment vehicle frame and cargo bay liner shown laid out and having aluminum foil on both sides thereof;

Now referring to FIGS. 28-30, an additional embodiment of a 3-ply panel vehicle frame and cargo area liner is

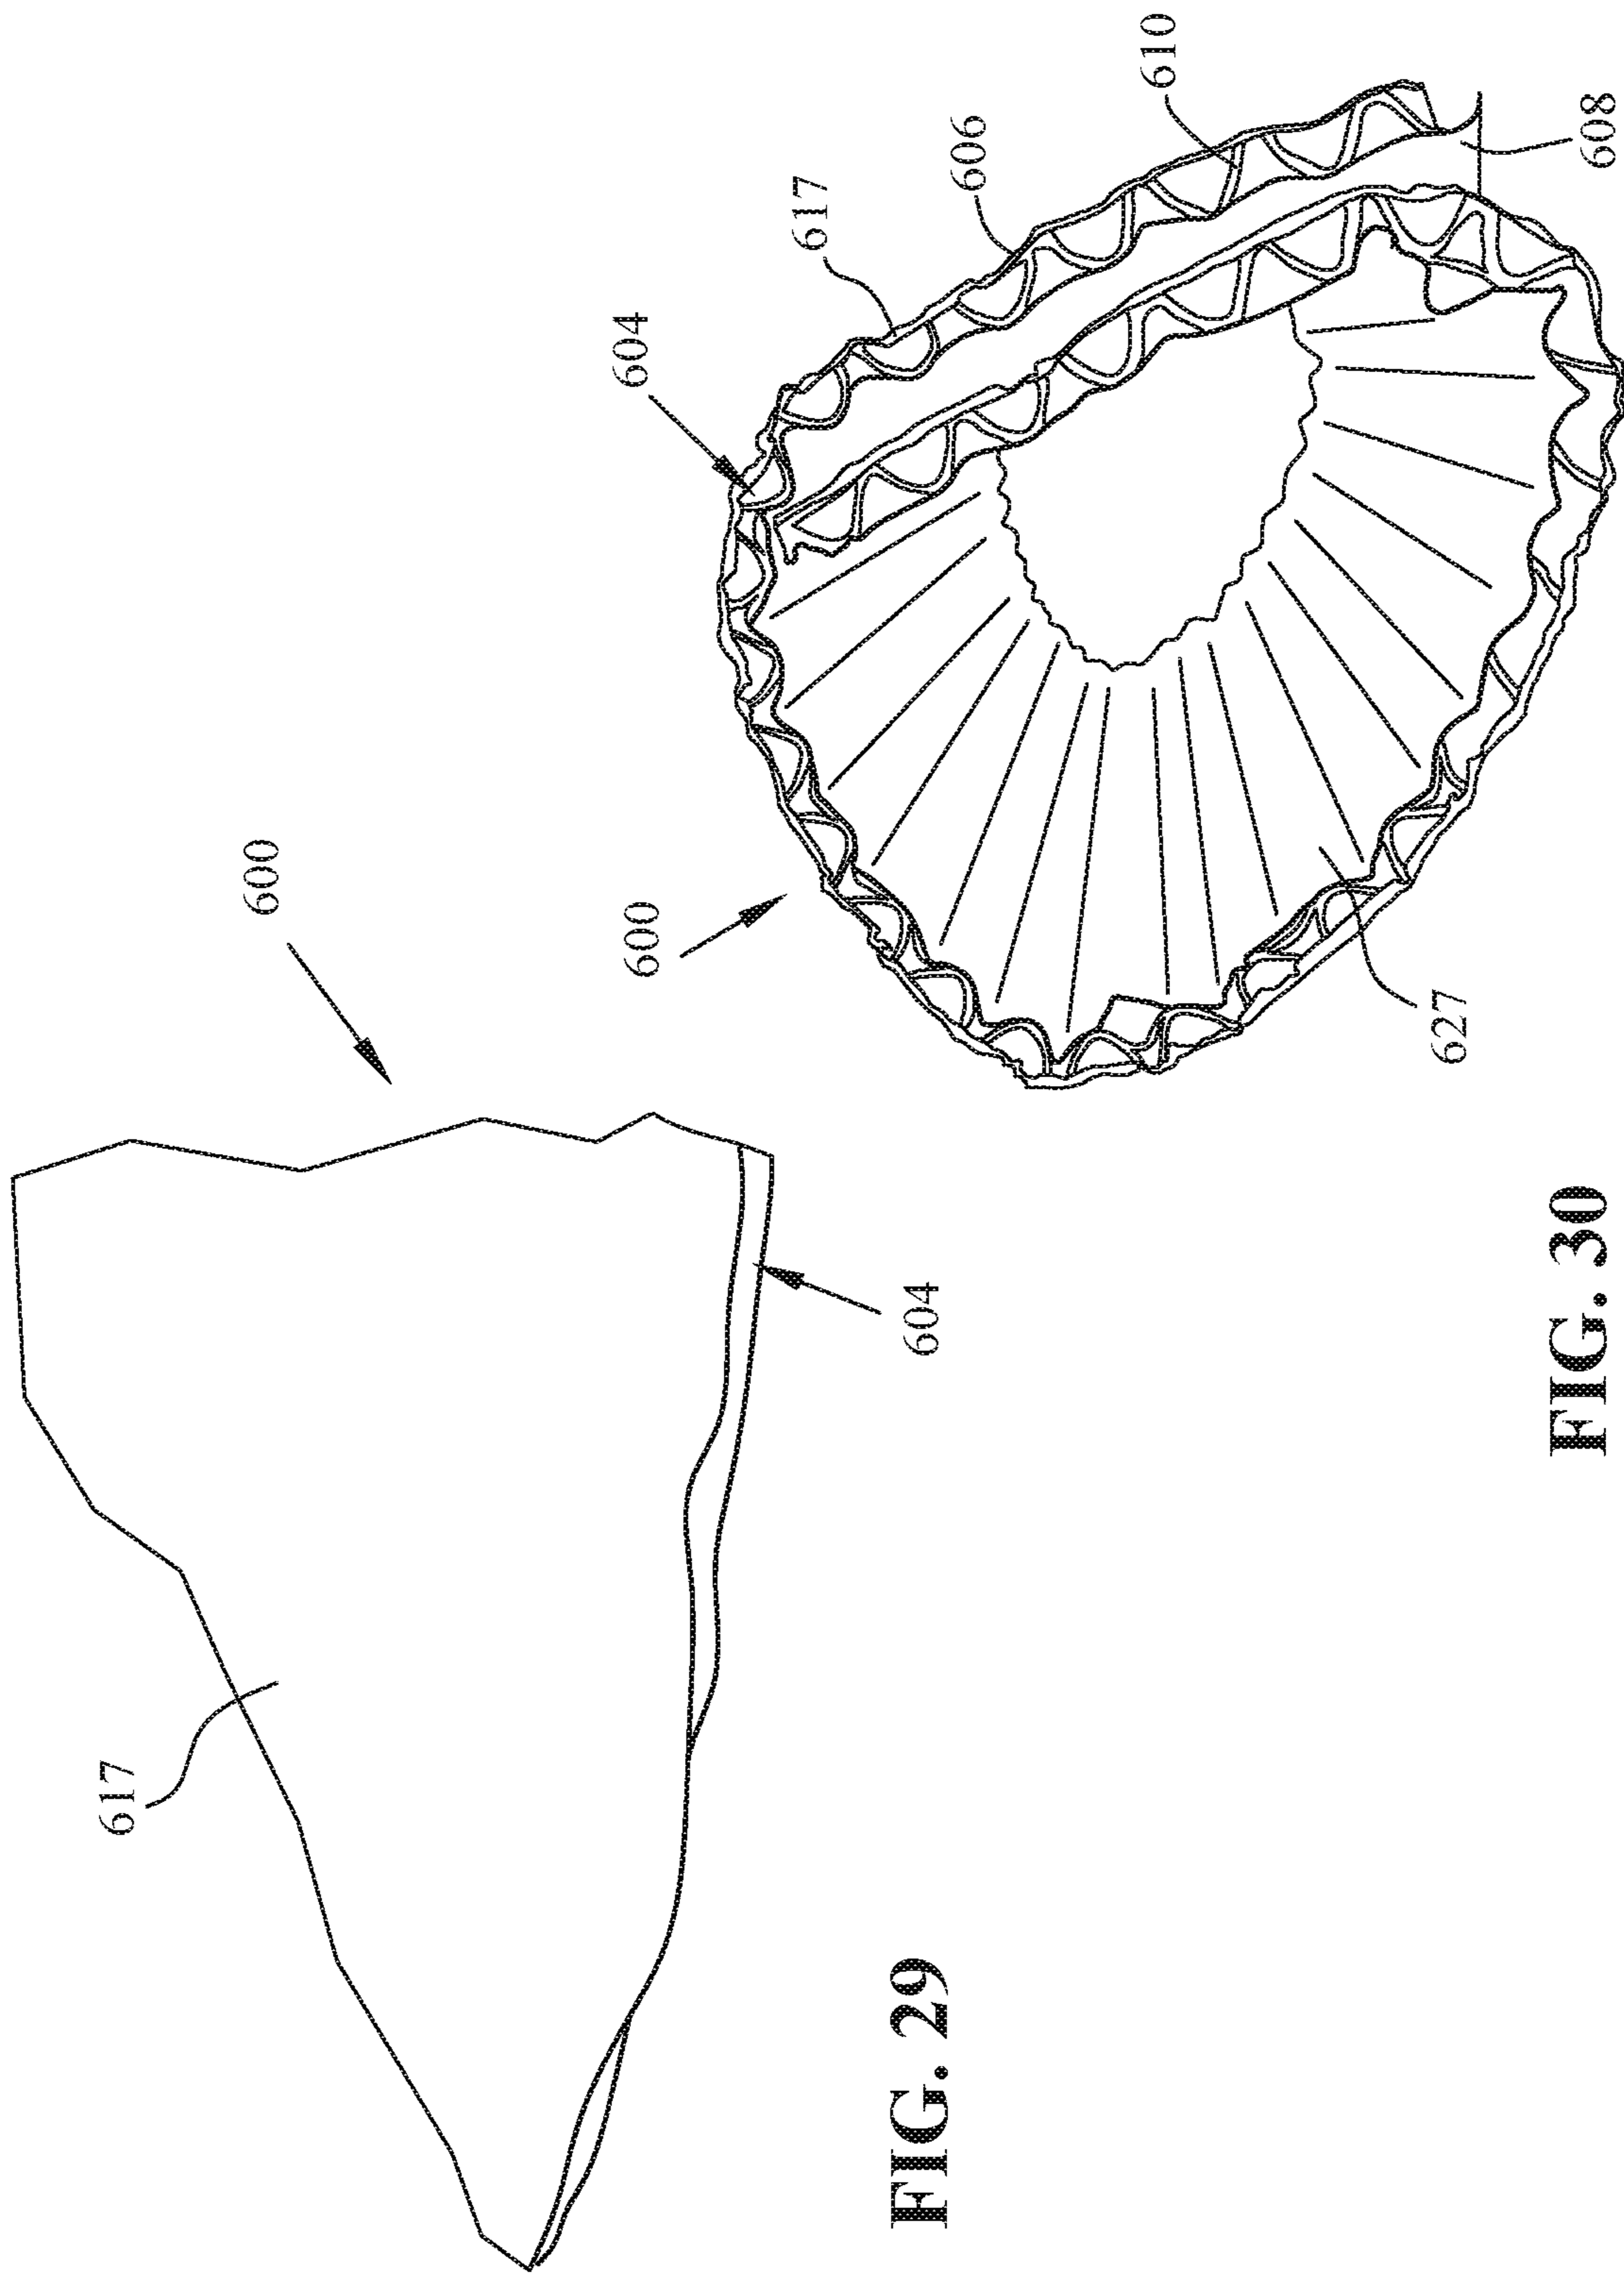
FIG. 29 is a perspective view of the vehicle frame and cargo bay liner of FIG. 28;

FIG. 30 is an end view of the vehicle frame and cargo bay liner of FIG. 28 rolled up and showing the aluminum foil on both sides thereof;

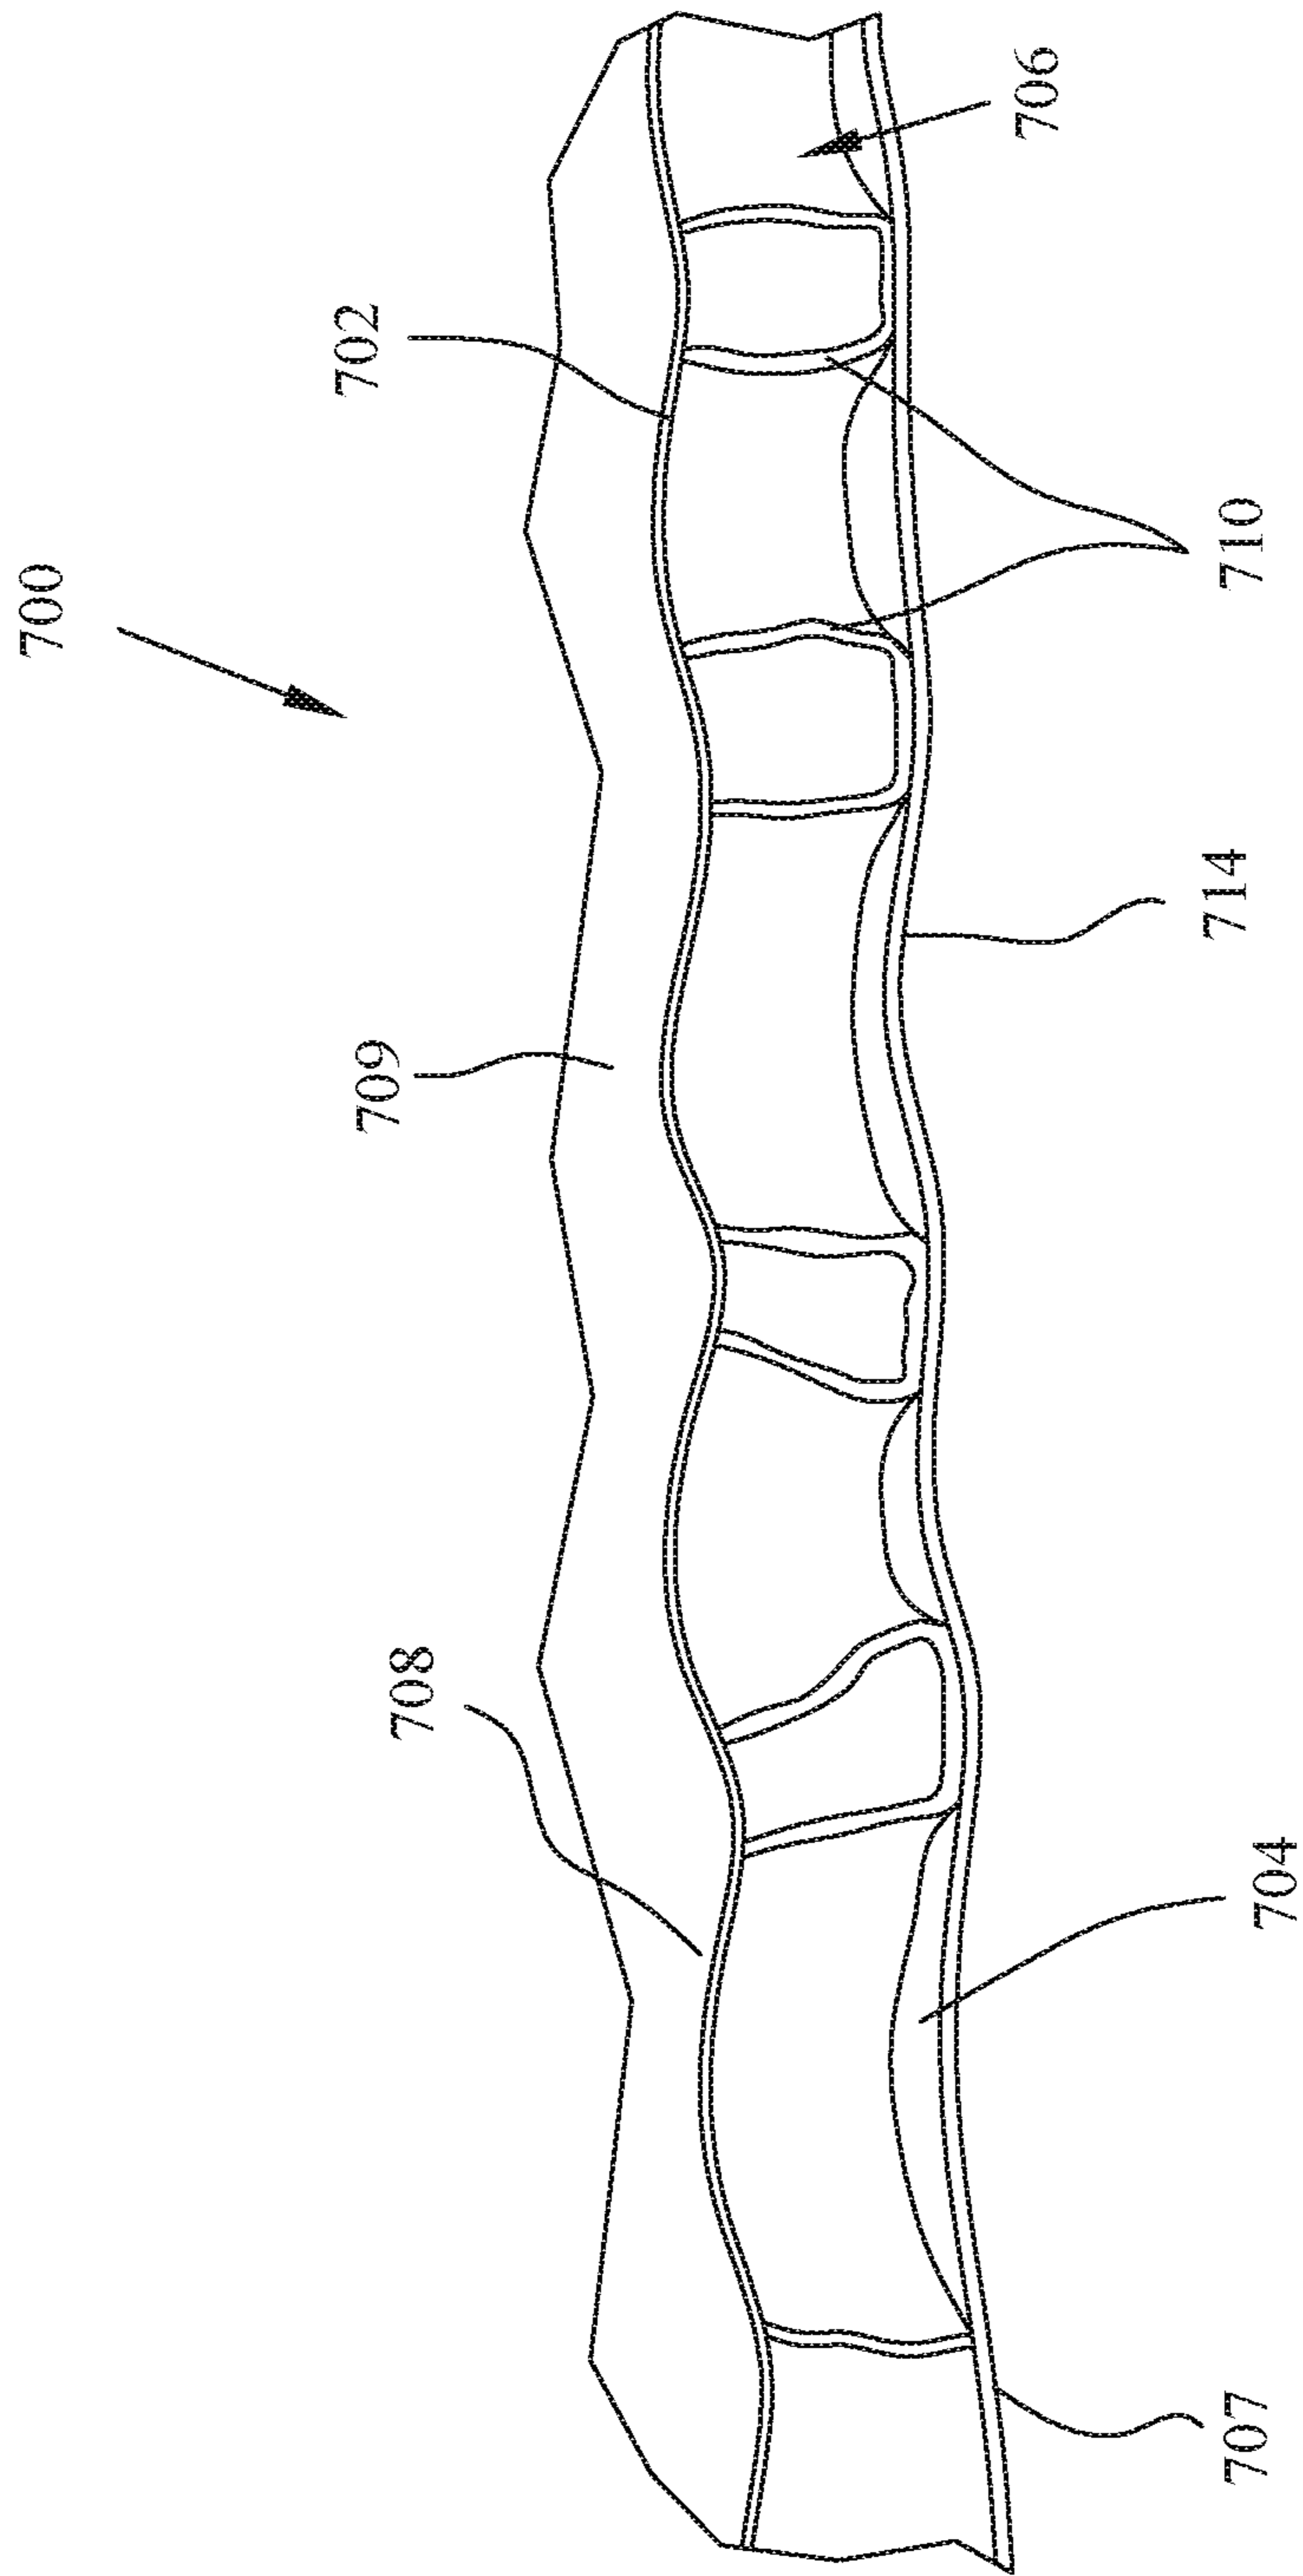
FIG. 31 is a side perspective view of yet another alternate embodiment vehicle frame and cargo bay liner having an aluminum foil on one side and a woven material on the opposite side

Now referring to FIGS. **31-34**, another alternate vehicle frame and cargo area liner is shown generally indicated as **700**. Liner **700** can be provided in a coiled form as liner **400**, making it extremely suitable for use as a liner for vehicle frames and cargo bays. The desired length of liner can be rolled out and cut to size for assembly to the vehicle. Vehicle frame and cargo bay liner **700** is of a 3-ply configuration and includes a top ply, sheet, or layer **702** and a bottom ply, sheet, or layer **704**. A core **706** (see FIG. **31**) separates top sheet **702** from bottom sheet **704**. Additionally, vehicle frame and cargo bay liner **700** also includes a sheet of aluminum foil or metalized film **707** on one side thereof. In the embodiment shown, aluminum foil/metalized film **707** is provided on bottom sheet **404**; however, it should be appreciated that aluminum foil/metalized film could also be provided on the top sheet **702** (see embodiment **700A** discussed below). Aluminum foil/film **707** may be adhered to bottom sheet **704** using an adhesive or other suitable means. Vehicle frame and cargo bay liner **700** also includes a woven or nonwoven layer of material **709** adhered to top layer **702**, opposite the side with aluminum foil **707** or metalized film. In one embodiment, material **709** is a woven sheet of polypropylene fabric.

In the embodiment of the 3 ply vehicle frame and cargo bay liner **700** of FIGS. **31-34**, the aluminum foil **707** is shown adhered to the side of liner **700** with dimples **714** and woven material **709** is shown adhered to the side with convexities **708**; however, in FIGS. **35-37** an alternate embodiment vehicle frame and cargo bay liner, shown generally indicated as **700a**, has the woven or nonwoven sheet of material **709** adhered to the side of the liner having dimples **714** and the aluminum foil **707** adhered to the side of the liner having convexities **708**. Also, the vehicle frame and cargo bay liner may be manufactured with only a layer of woven or nonwoven sheet of fabric material and no aluminum foil or alternately with aluminum foil and no woven or nonwoven fabric. Alternatively, it may be provided with either aluminum foil on both sides or with woven or nonwoven fabric on both sides.
