US011447189B1

(54) **VEHICLE FRAME AND CARGO BAY LINER**

A vehicle and liner assembly is provided that includes a
recreational vehicle having a housing, a front end, a rear end,
a top, a bottom, and a pair of sidewalls. A frame assembly
is provided wherein, the housing is mounted on and sup-
ported by the frame assembly. The liner is attached to the
frame assembly and covers at least a substantial portion of the
bottom of the housing. The liner has a first face having
projections extending therefrom and a second face having
openings therein. The openings coincide with and extend
into corresponding projections on the first face.

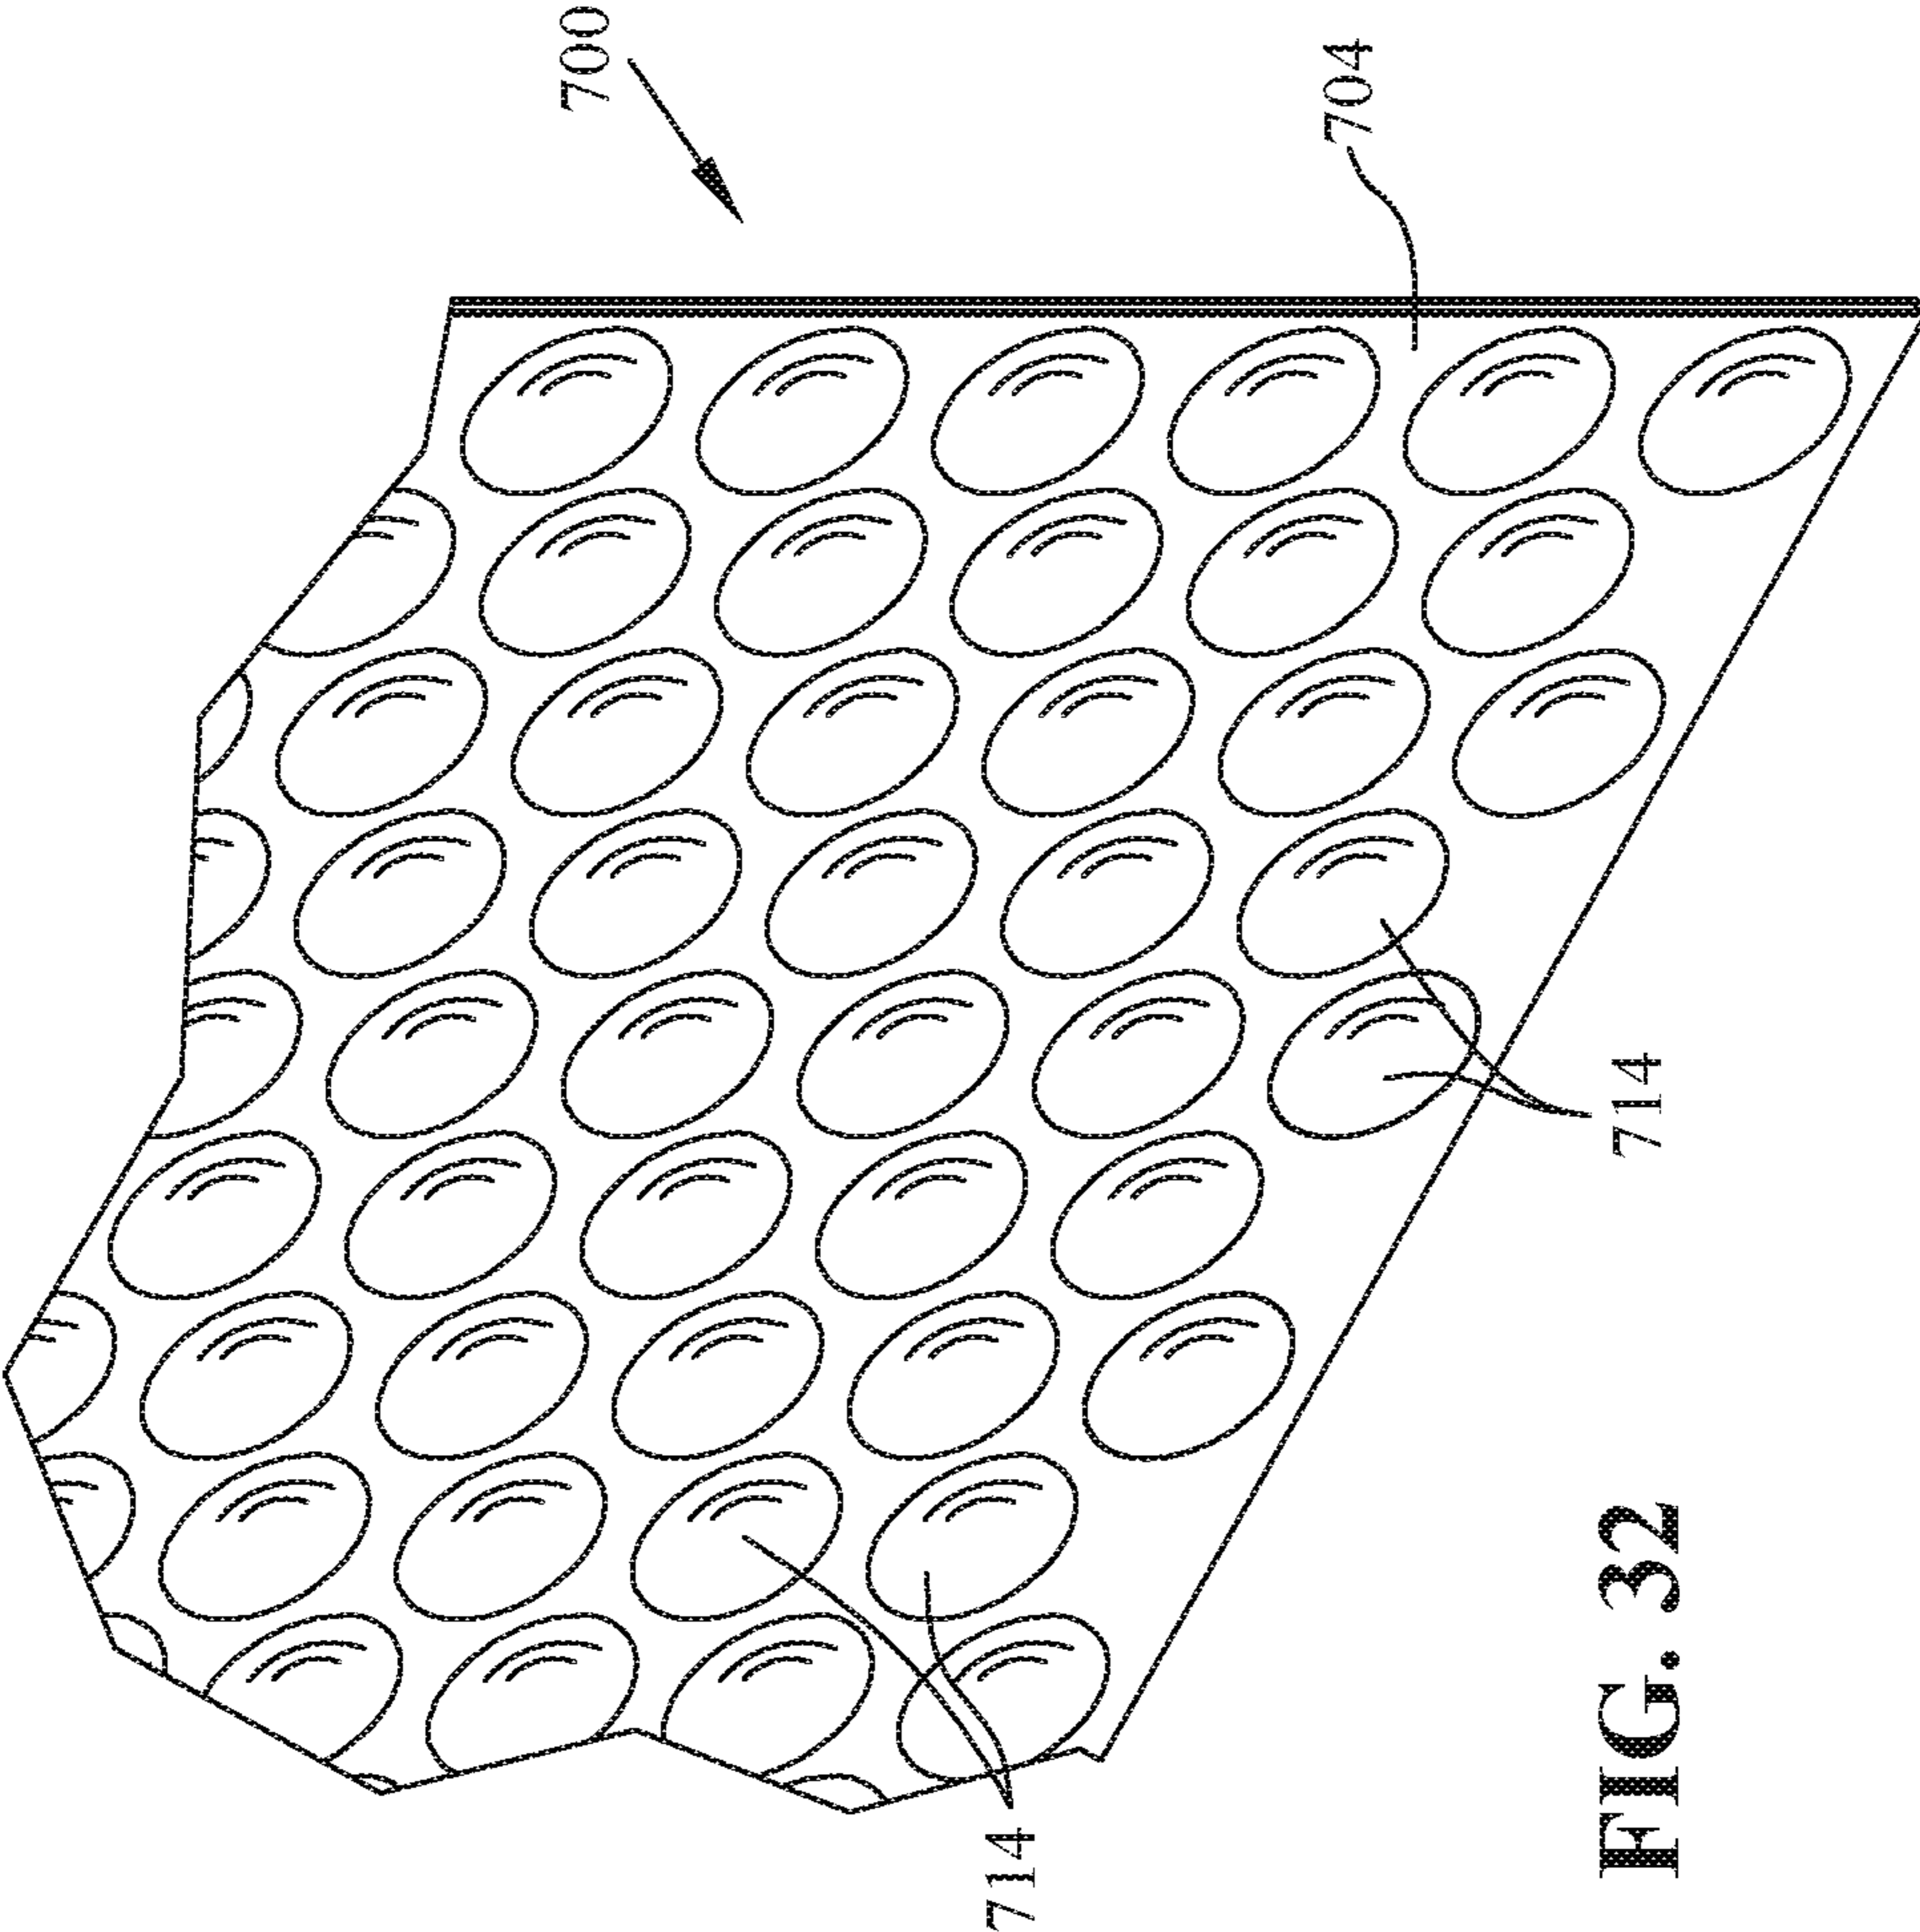
FIG. 32 is a plan view of the vehicle frame and cargo bay liner of FIG. 31 with the aluminum foil and woven material removed show a layer of the liner having dimples thereon.

Now referring to FIGS. **31-34**, another alternate vehicle frame and cargo area liner is shown generally indicated as **700**. Liner **700** can be provided in a coiled form as liner **400**, making it extremely suitable for use as a liner for vehicle frames and cargo bays. The desired length of liner can be rolled out and cut to size for assembly to the vehicle. Vehicle frame and cargo bay liner **700** is of a 3-ply configuration and includes a top ply, sheet, or layer **702** and a bottom ply, sheet, or layer **704**. A core **706** (see FIG. **31**) separates top sheet **702** from bottom sheet **704**. Additionally, vehicle frame and cargo bay liner **700** also includes a sheet of aluminum foil or metalized film **707** on one side thereof. In the embodiment shown, aluminum foil/metalized film **707** is provided on bottom sheet **404**; however, it should be appreciated that aluminum foil/metalized film could also be provided on the top sheet **702** (see embodiment **700A** discussed below). Aluminum foil/film **707** may be adhered to bottom sheet **704** using an adhesive or other suitable means. Vehicle frame and cargo bay liner **700** also includes a woven or nonwoven layer of material **709** adhered to top layer **702**, opposite the side with aluminum foil **707** or metalized film. In one embodiment, material **709** is a woven sheet of polypropylene fabric.

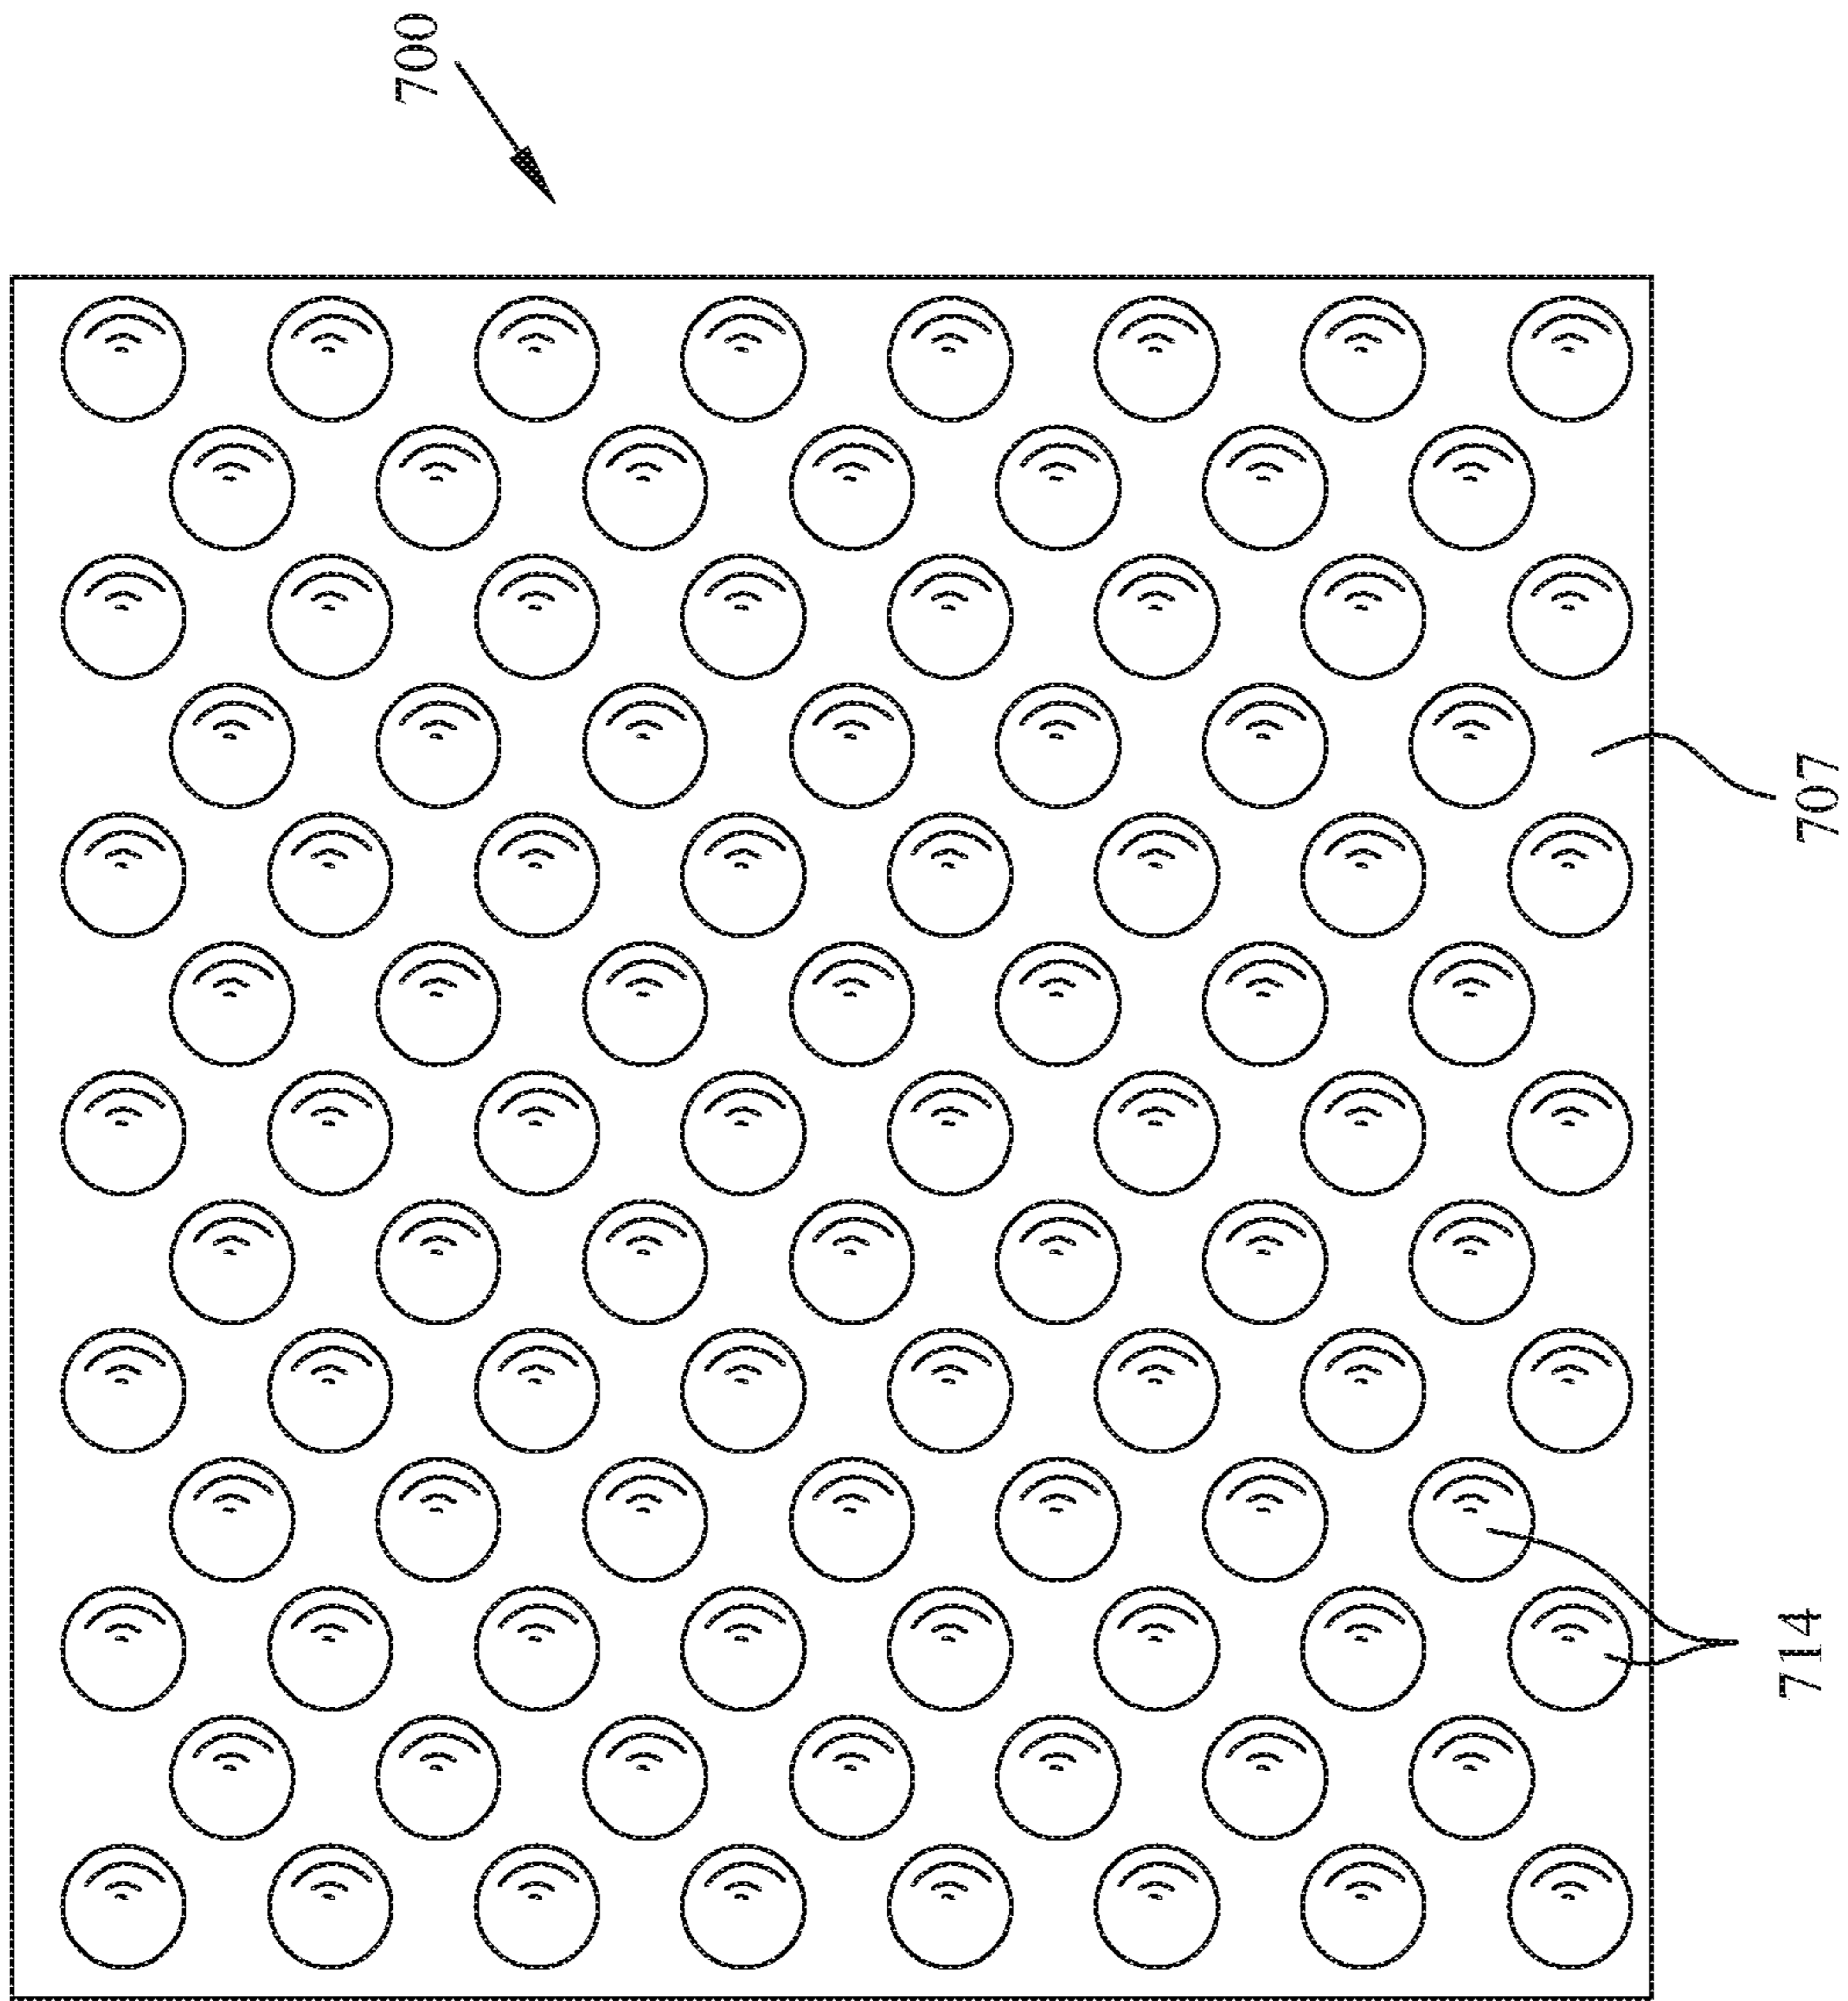
FIG. 33 is a perspective plan view of the vehicle frame and cargo bay liner of FIG. 31 showing the side with dimples and aluminum foil thereon;

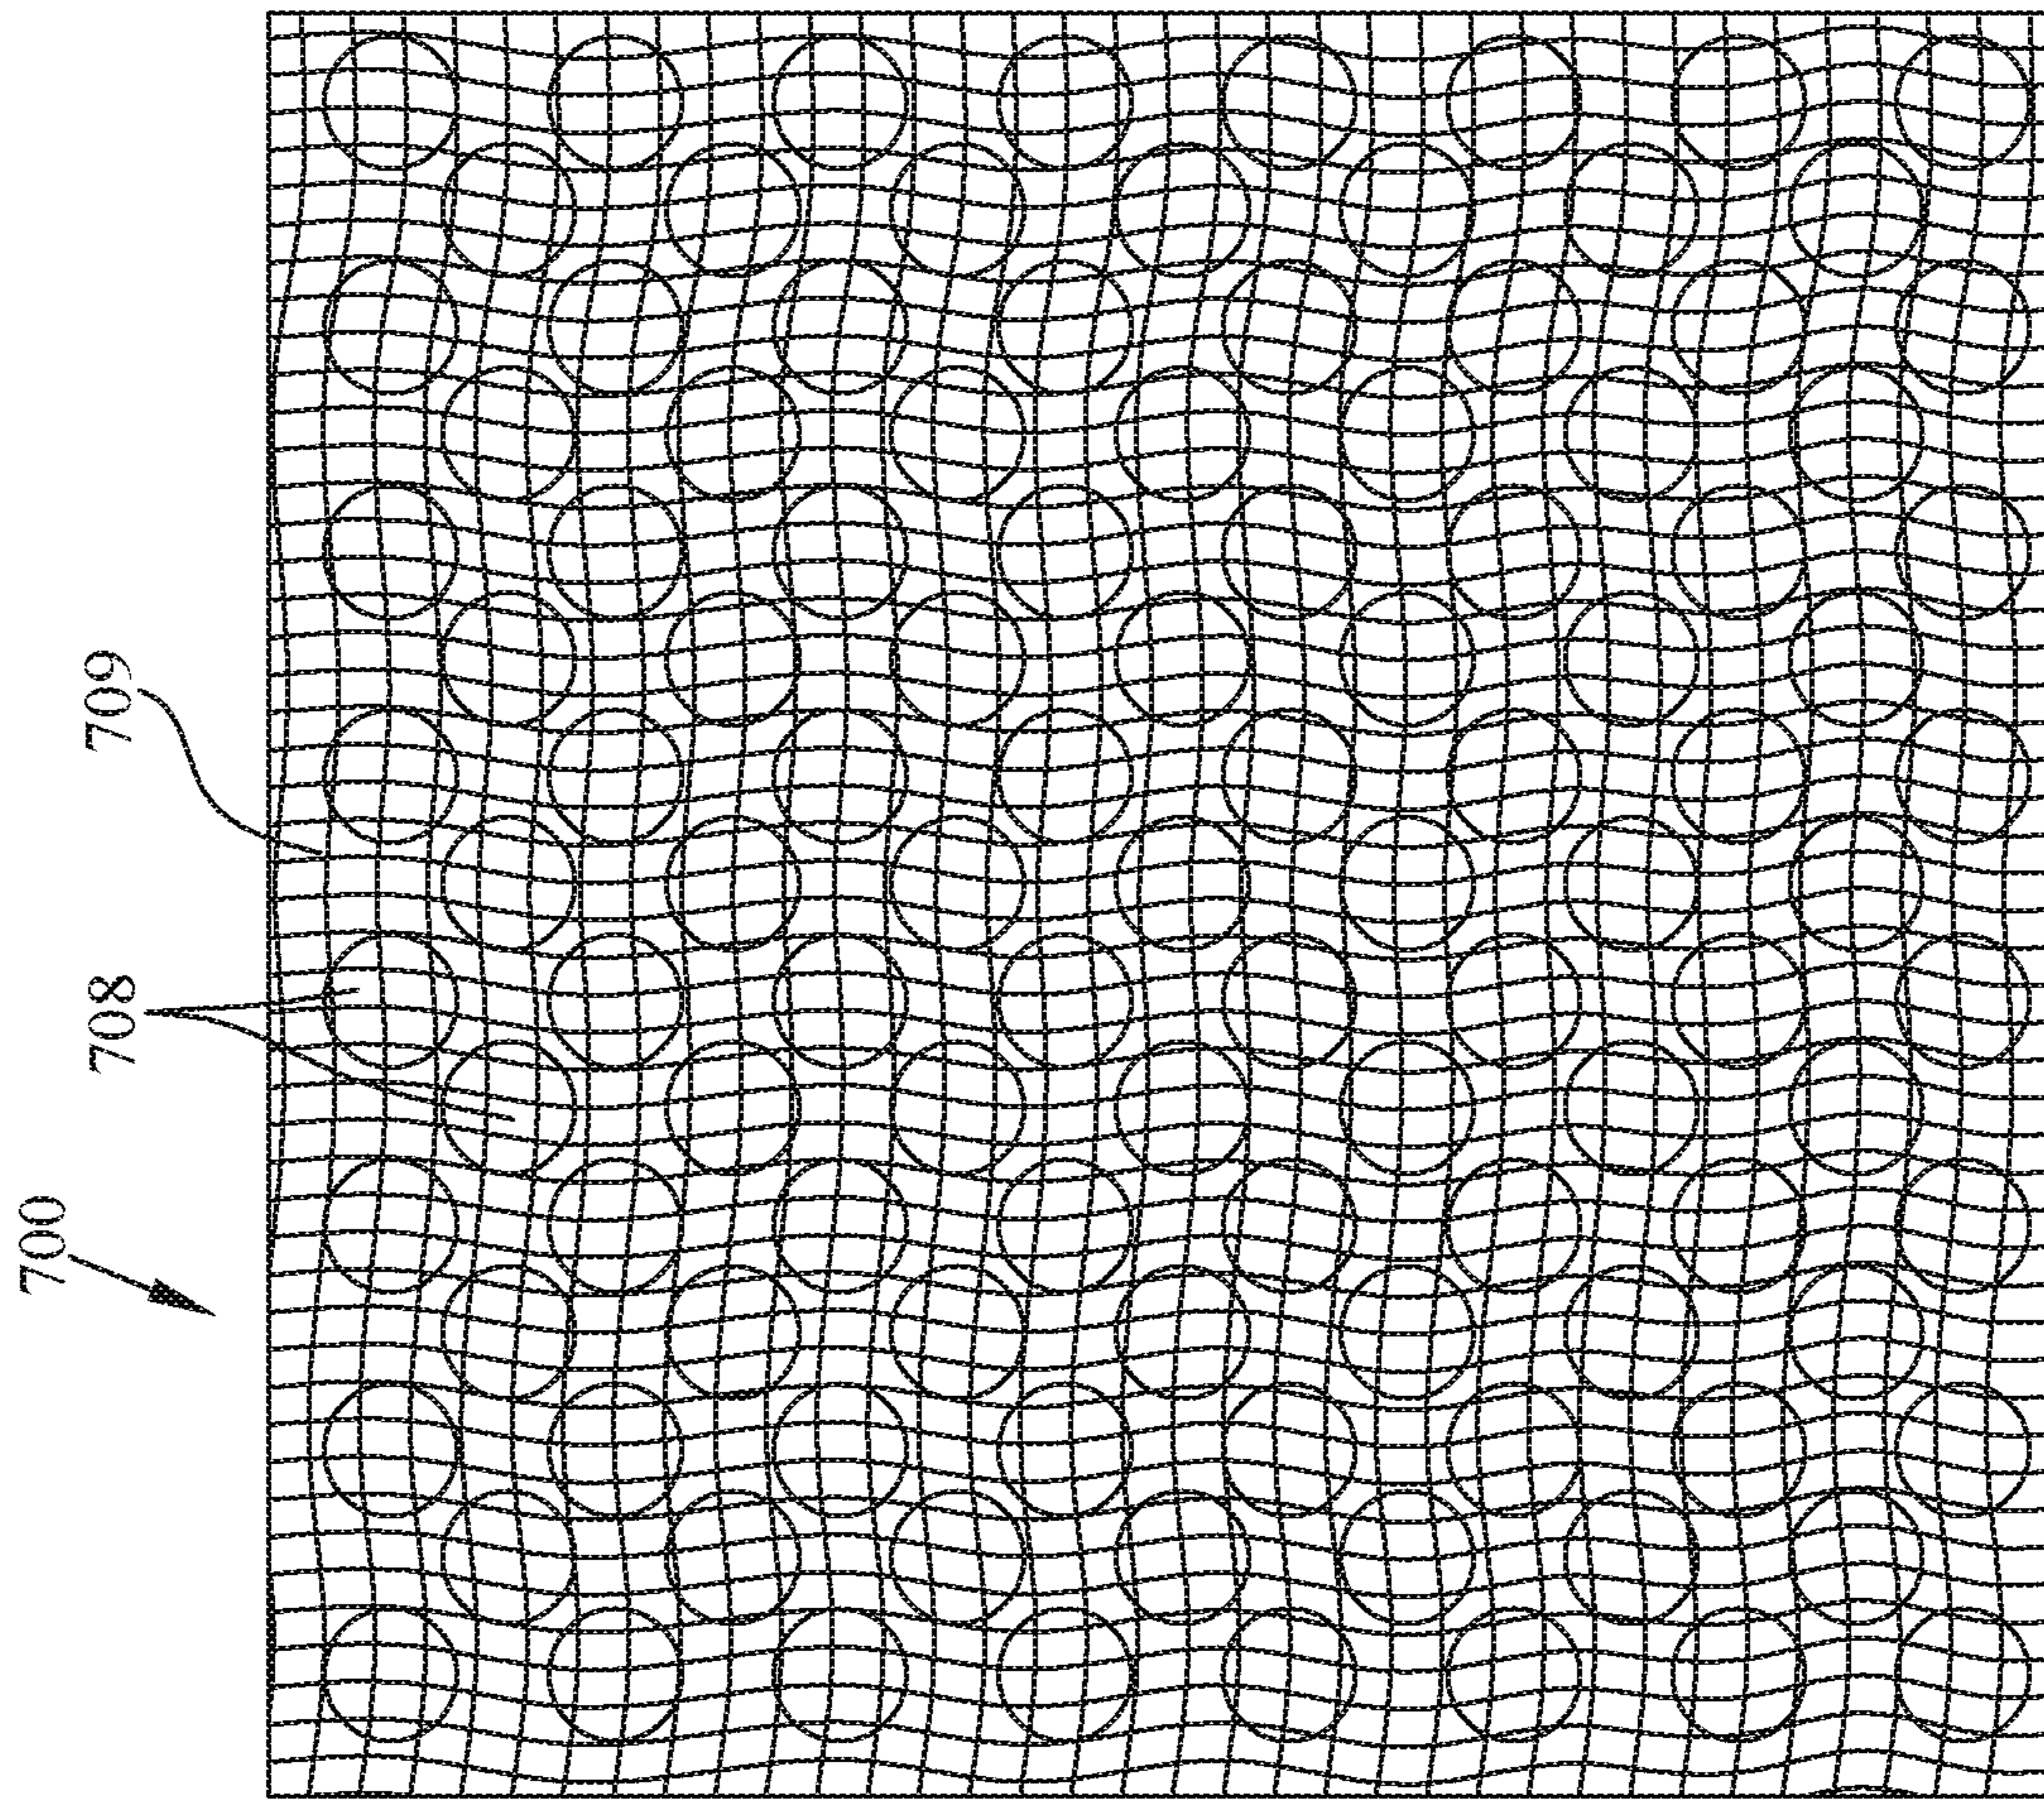
FIG. 34 is a perspective plan view of the vehicle frame and cargo bay liner of FIG. 31 showing a side with convexities and a woven material thereon;

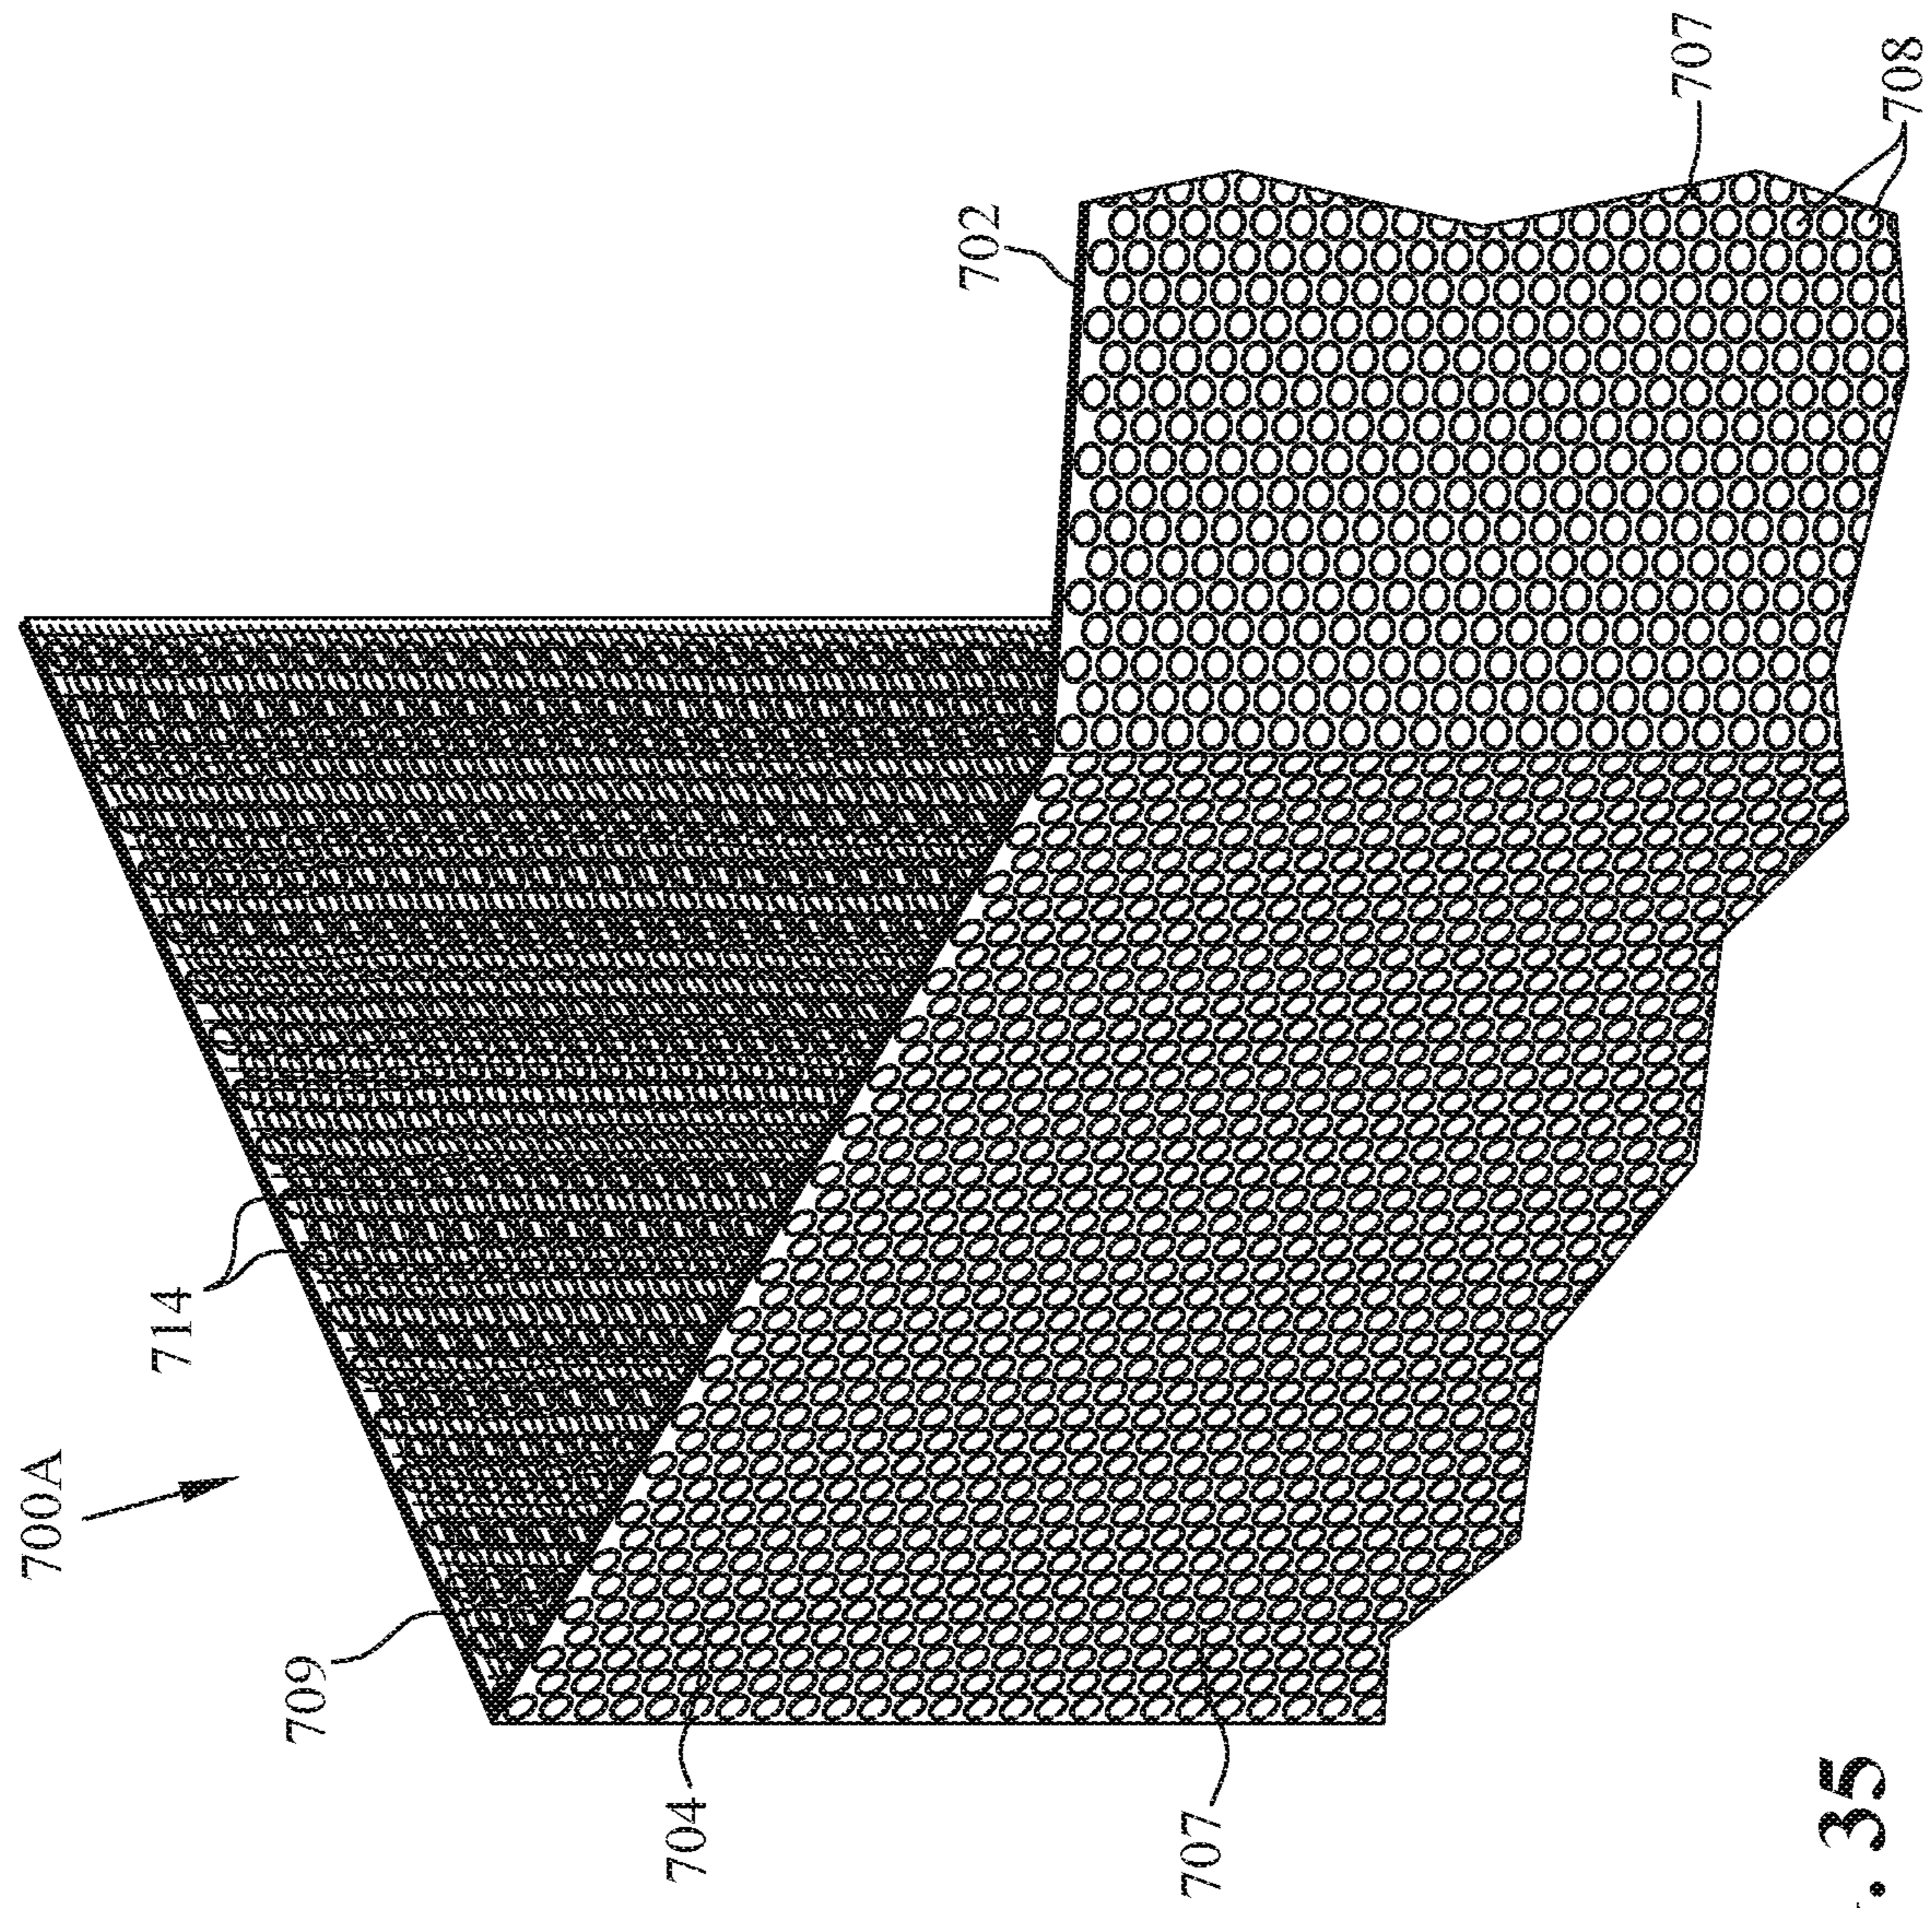
FIG. 35 is a perspective of a similar alternate embodiment view of a vehicle frame and cargo bay liner like FIG. 31, but with the aluminum foil on the side with convexities and a woven material on the opposite side with dimples;

In the embodiment of the 3 ply vehicle frame and cargo bay liner **700** of FIGS. **31-34**, the aluminum foil **707** is shown adhered to the side of liner **700** with dimples **714** and woven material **709** is shown adhered to the side with convexities **708**; however, in FIGS. **35-37** an alternate embodiment vehicle frame and cargo bay liner, shown generally indicated as **700a**, has the woven or nonwoven sheet of material **709** adhered to the side of the liner having dimples **714** and the aluminum foil **707** adhered to the side of the liner having convexities **708**. Also, the vehicle frame and cargo bay liner may be manufactured with only a layer of woven or nonwoven sheet of fabric material and no aluminum foil or alternately with aluminum foil and no woven or nonwoven fabric. Alternatively, it may be provided with either aluminum foil on both sides or with woven or nonwoven fabric on both sides.

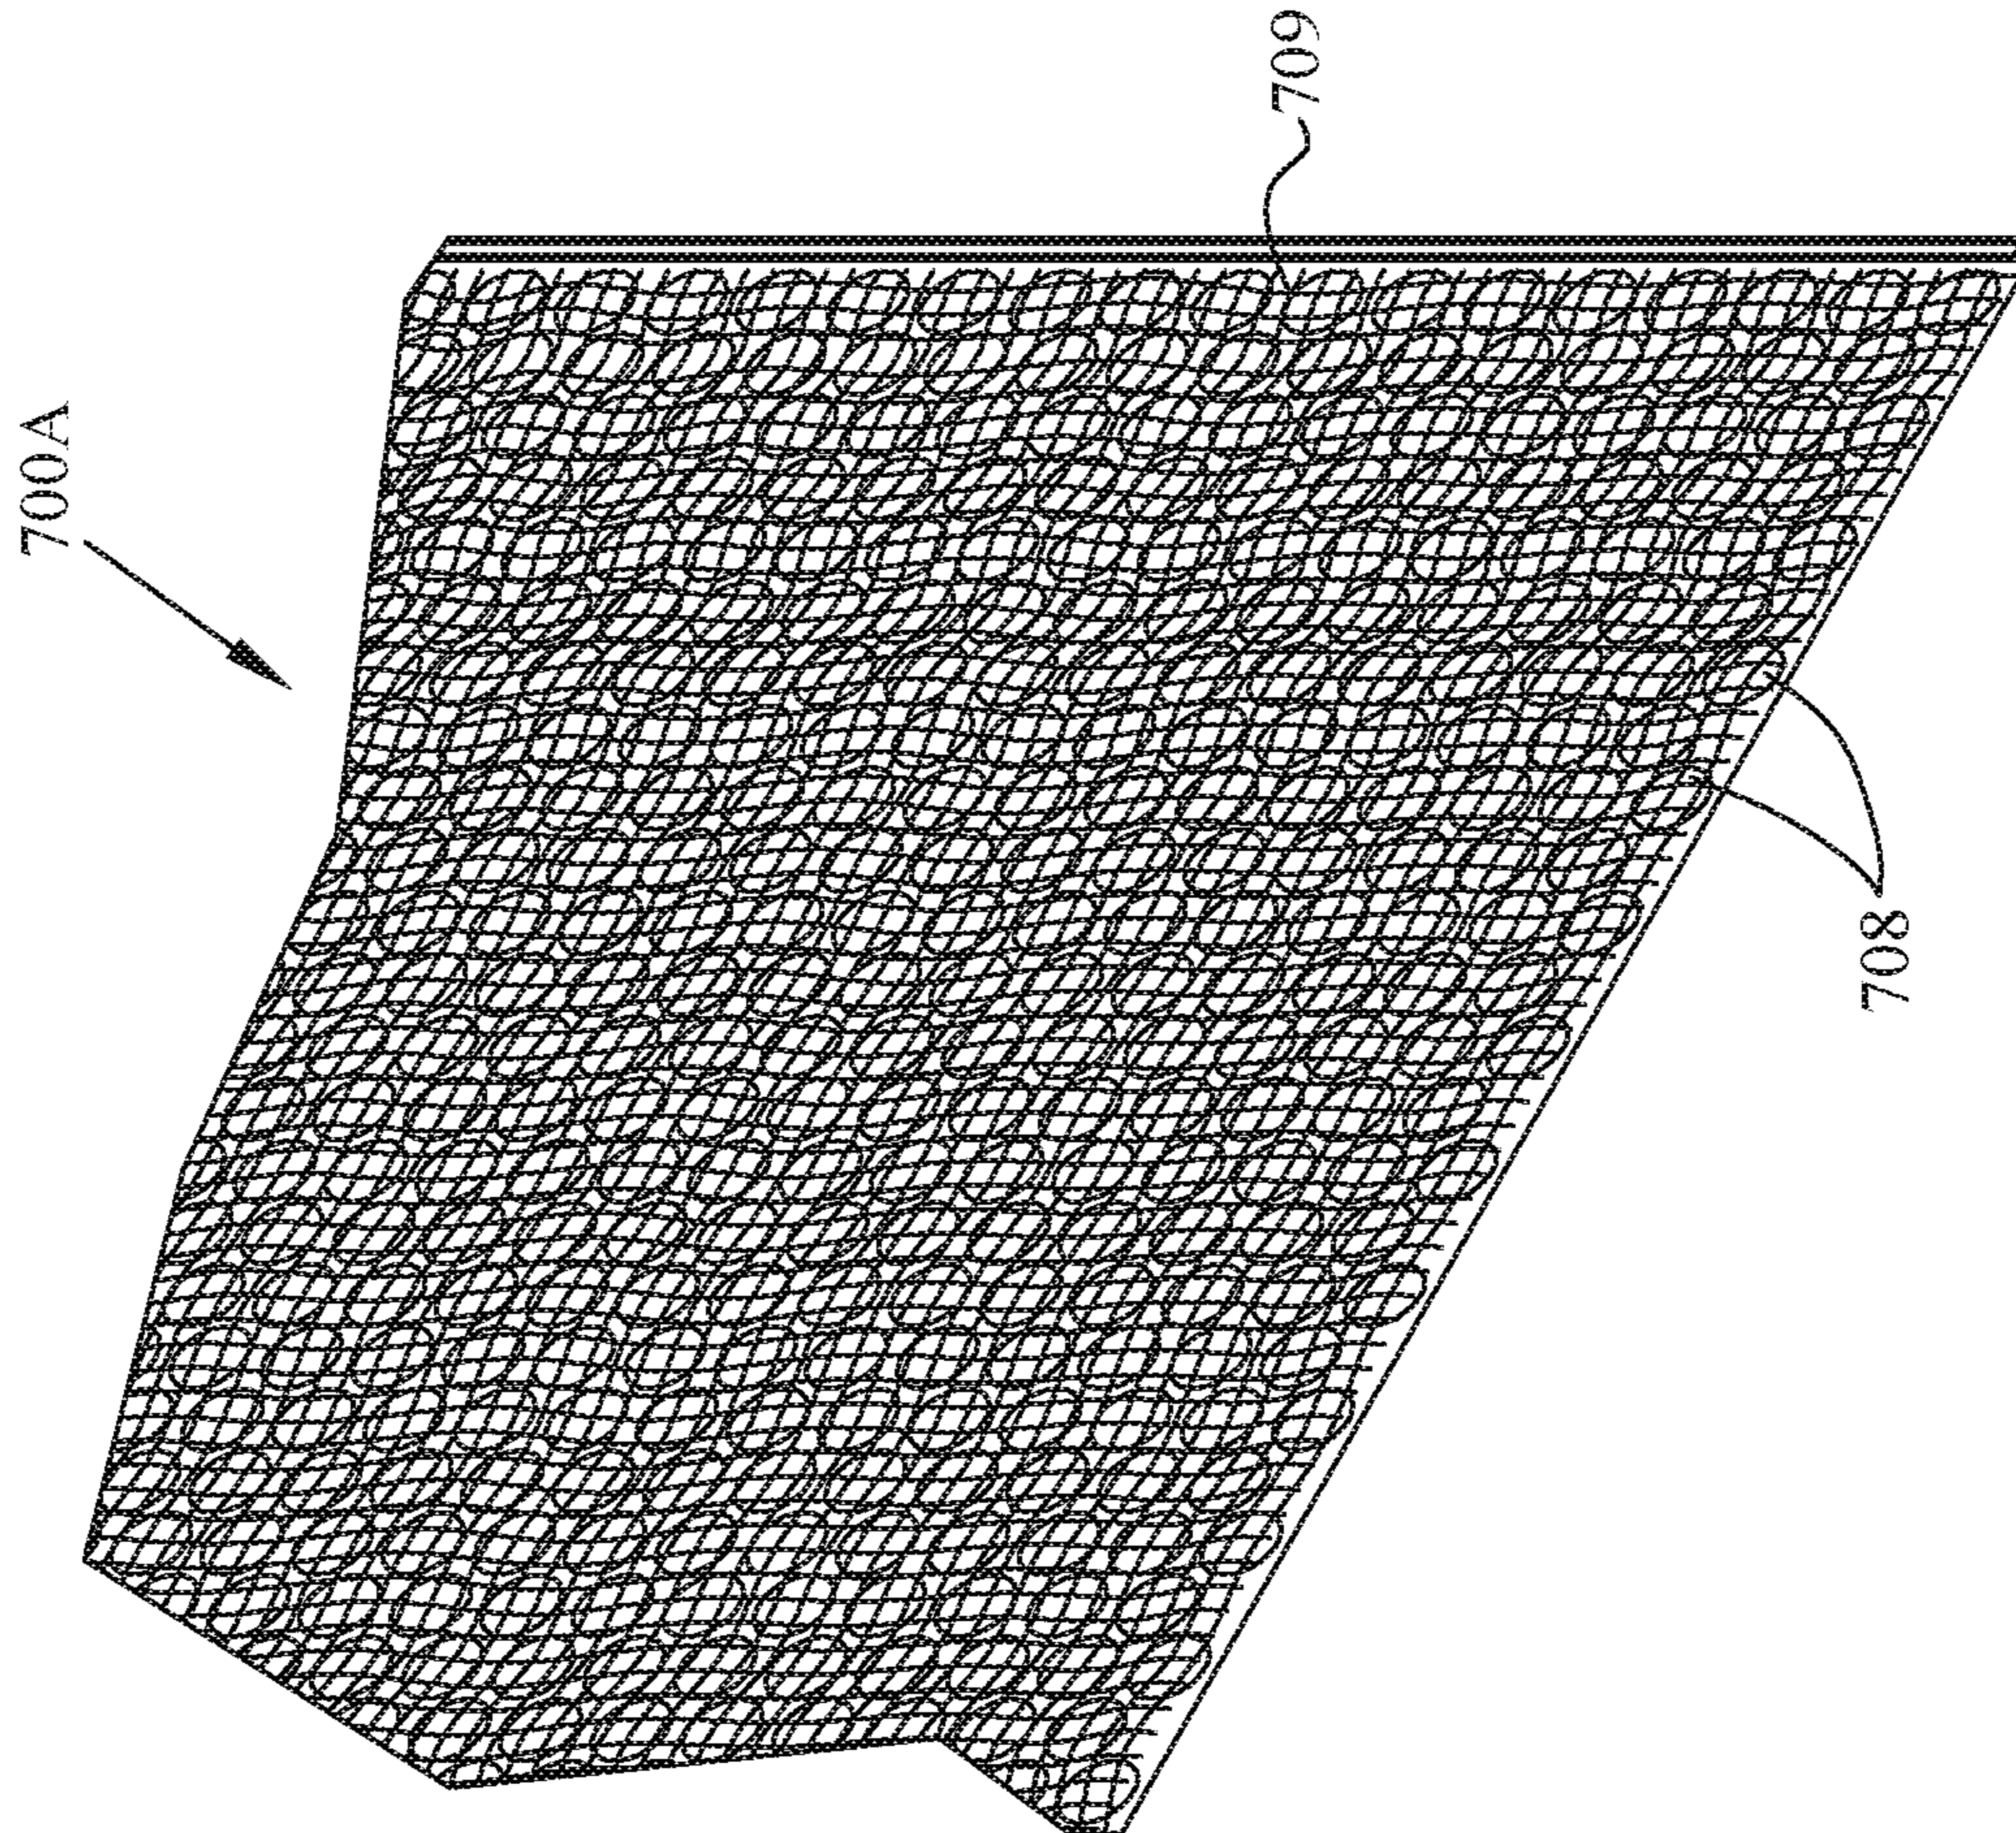
FIG. 36 is a plan perspective plan view of the vehicle frame and cargo bay liner of FIG. 35 showing the dimpled side having the woven material thereon;
