US011447189B1

(54) **VEHICLE FRAME AND CARGO BAY LINER**

A vehicle and liner assembly is provided that includes a
recreational vehicle having a housing, a front end, a rear end,
a top, a bottom, and a pair of sidewalls. A frame assembly
is provided wherein, the housing is mounted on and sup-
ported by the frame assembly. The liner is attached to the
frame assembly and covers at least a substantial portion of the
bottom of the housing. The liner has a first face having
projections extending therefrom and a second face having
openings therein. The openings coincide with and extend
into corresponding projections on the first face.

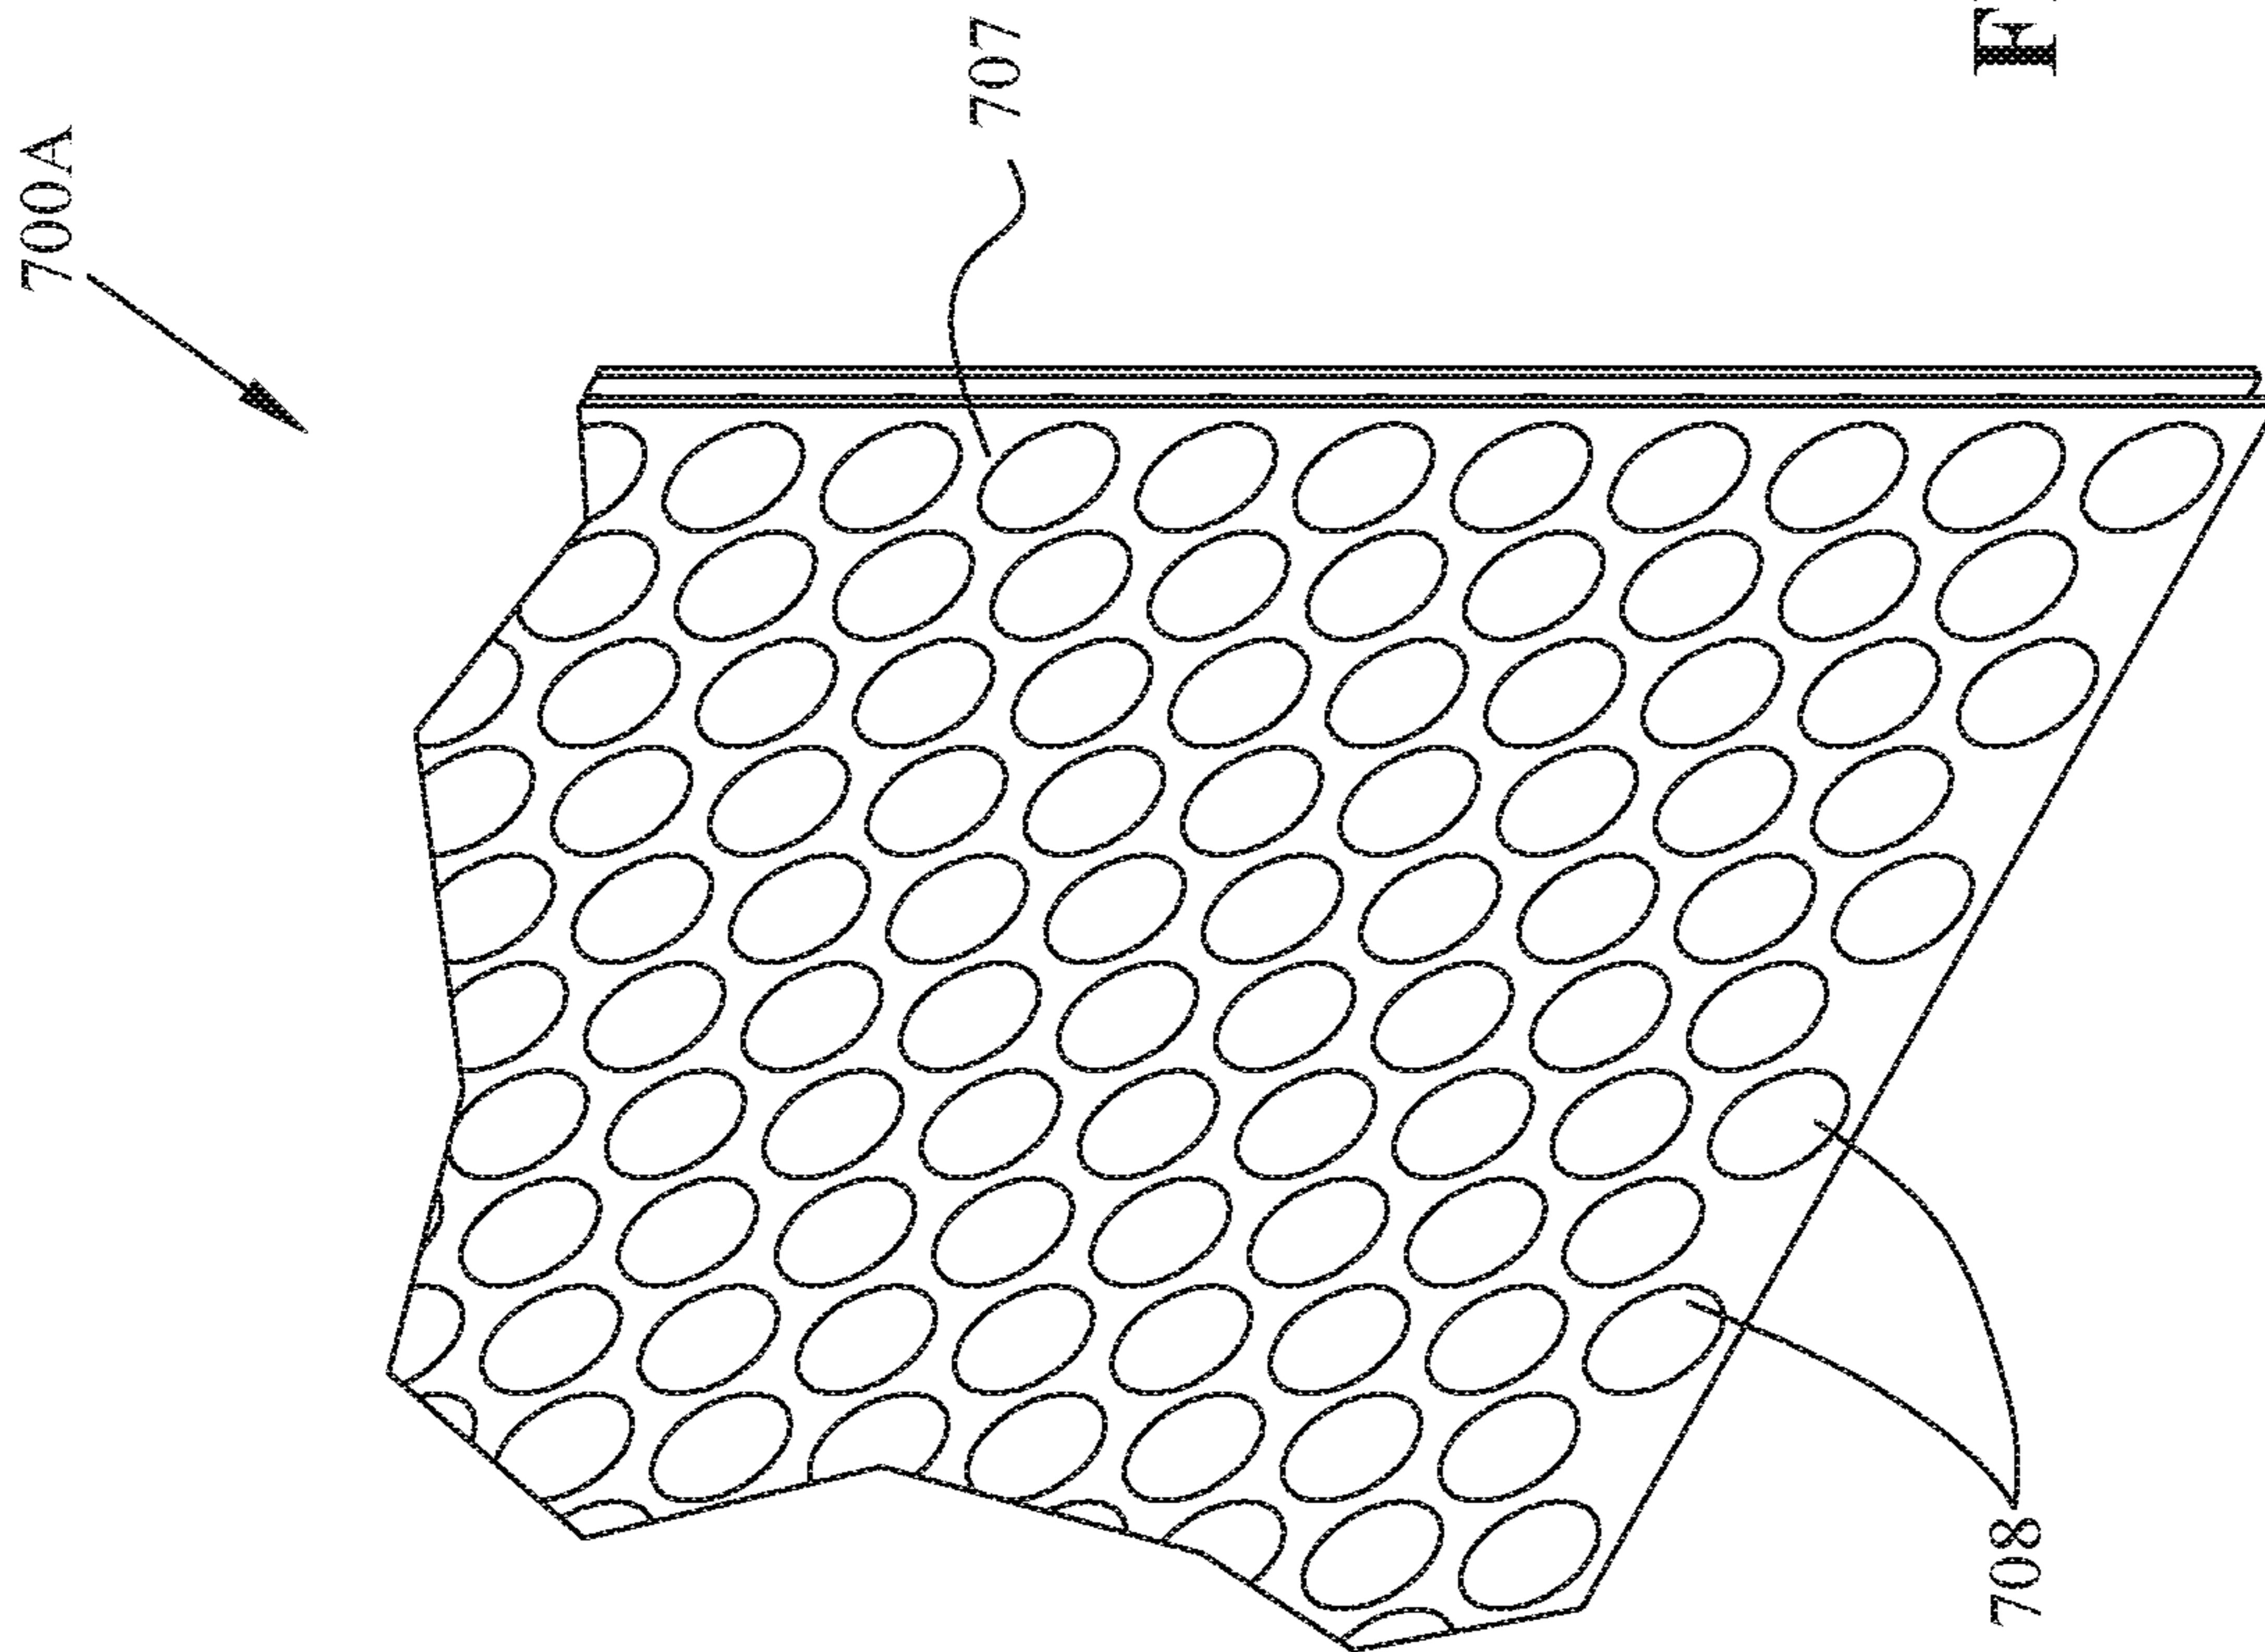
FIG. 37 is a plan perspective plan view of the vehicle frame and cargo bay liner of FIG. 35 showing the convex side having the aluminum foil thereon side;

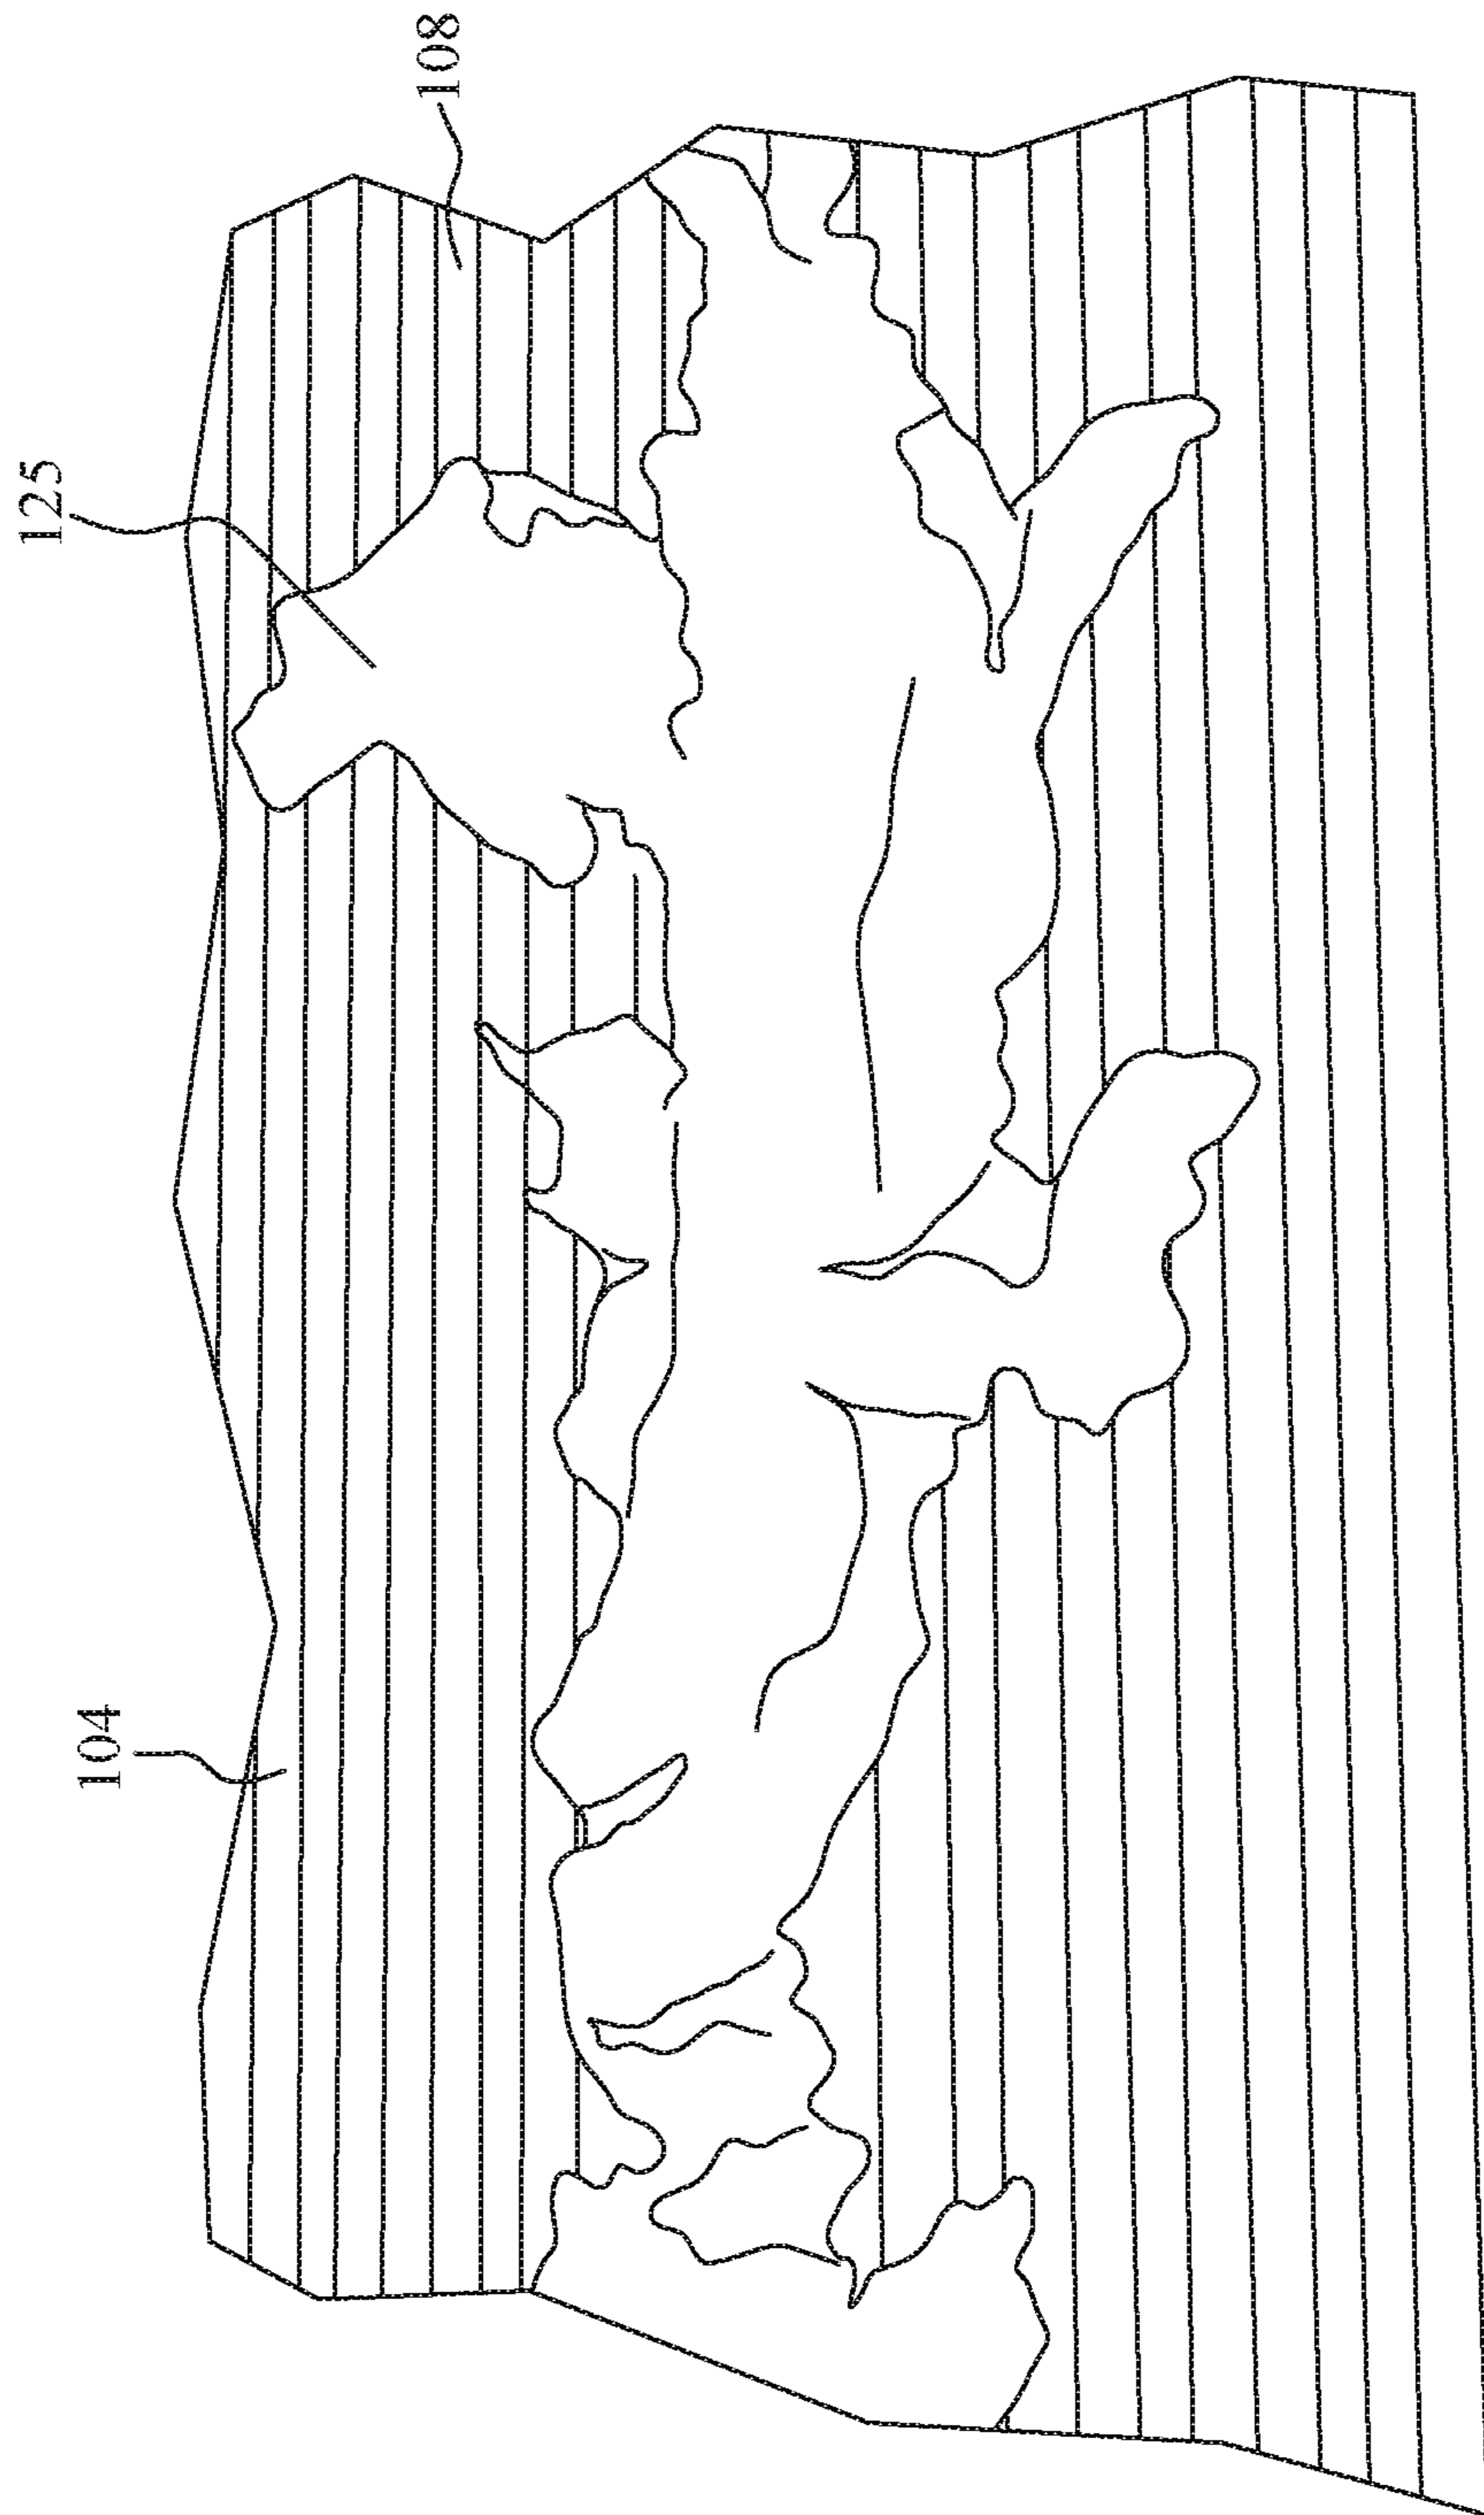
FIG. 38 is a plan perspective view showing a foam sealing material adhered to the bottom of a prior art liner;

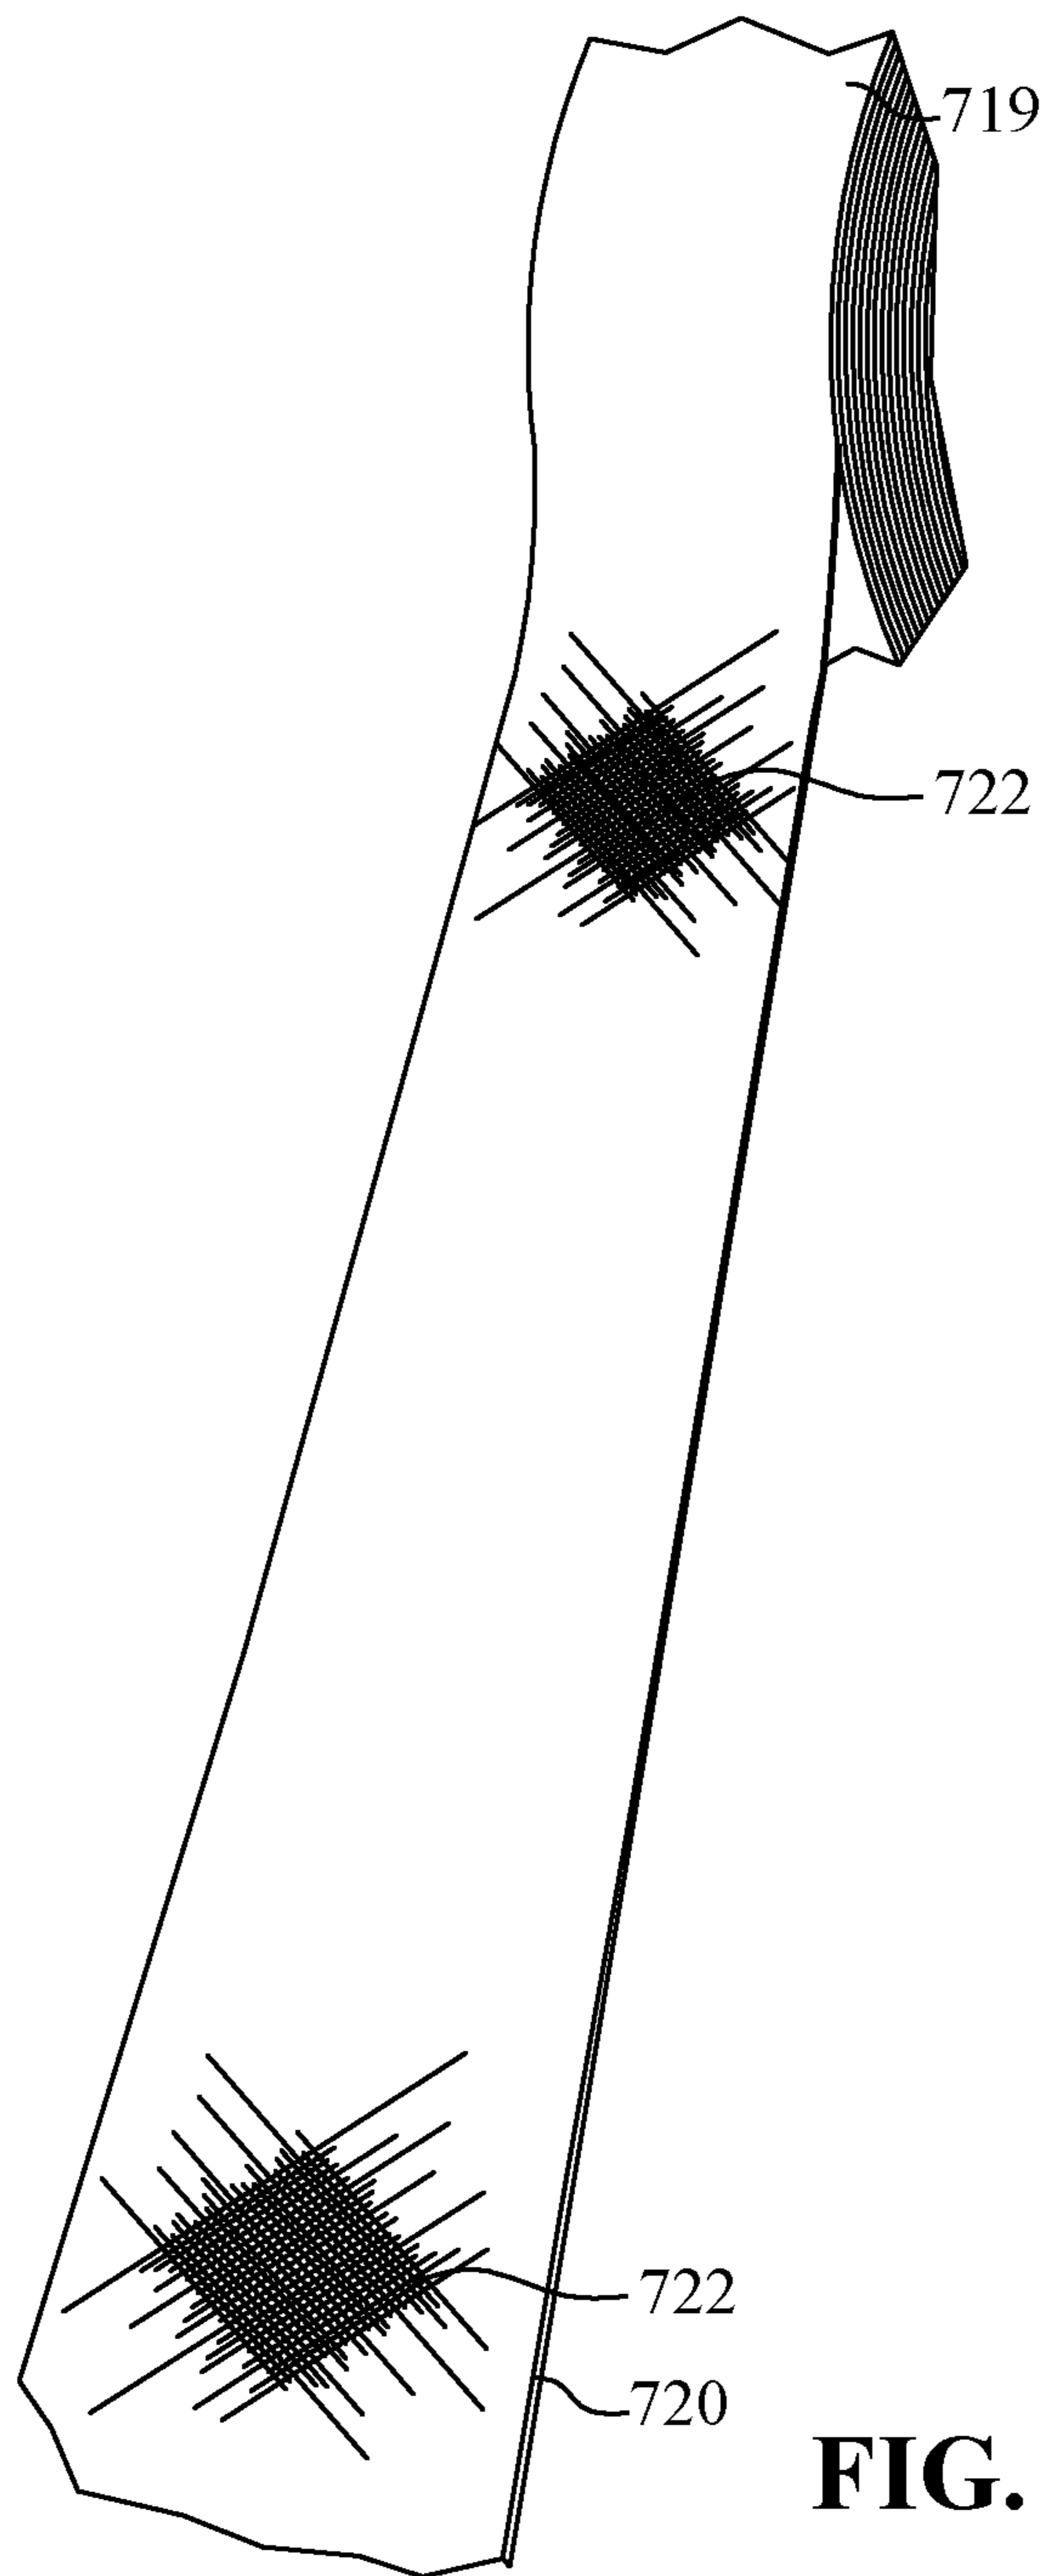
FIG. 39 is a perspective view of a role of repair tape for use in repairing the woven material;

Now referring now to FIGS. **39-42**, a unique repair and reinforcing system is provided for any of the liners provide herein and may be used to repair rips, tears or holes in the

In one embodiment, the repair system includes a role of woven or nonwoven fabric tape shown indicated as 719. In the embodiment shown, the fabric tape includes a woven fabric shown as 722. Also, in the embodiment shown, the tape can be supplied with a contact adhesive attached to one side thereof for attachment to the liner, foil, film or fabric that it is repairing or reinforcing. A protective layer of material 720 (see FIG. 39) to which the adhesive will readily release from may be used to facilitate providing the repair tape in a rolled form or otherwise facilitate removing thereof for easy repair or reinforcement of the recreational vehicle. As shown in FIGS. 42 and 43, repair tape 719 is attached to woven fabric layer 709, on the exterior thereof, creating an additional layer to the liner 700 as is best shown in FIG. 43. It should be appreciated that repair and reinforcing tape 719 could be placed or attached over itself to create additional reinforcing layers, and/or on the other side of the liner over the sheet of aluminum foil or metalized file 707. As many additional layers as is desired can be placed on either or both sides. It should also be appreciated that the repair tape could be an aluminum foil, or metalized film or other polymer or material, but the woven fabric tape has shown to be particularly suitable.

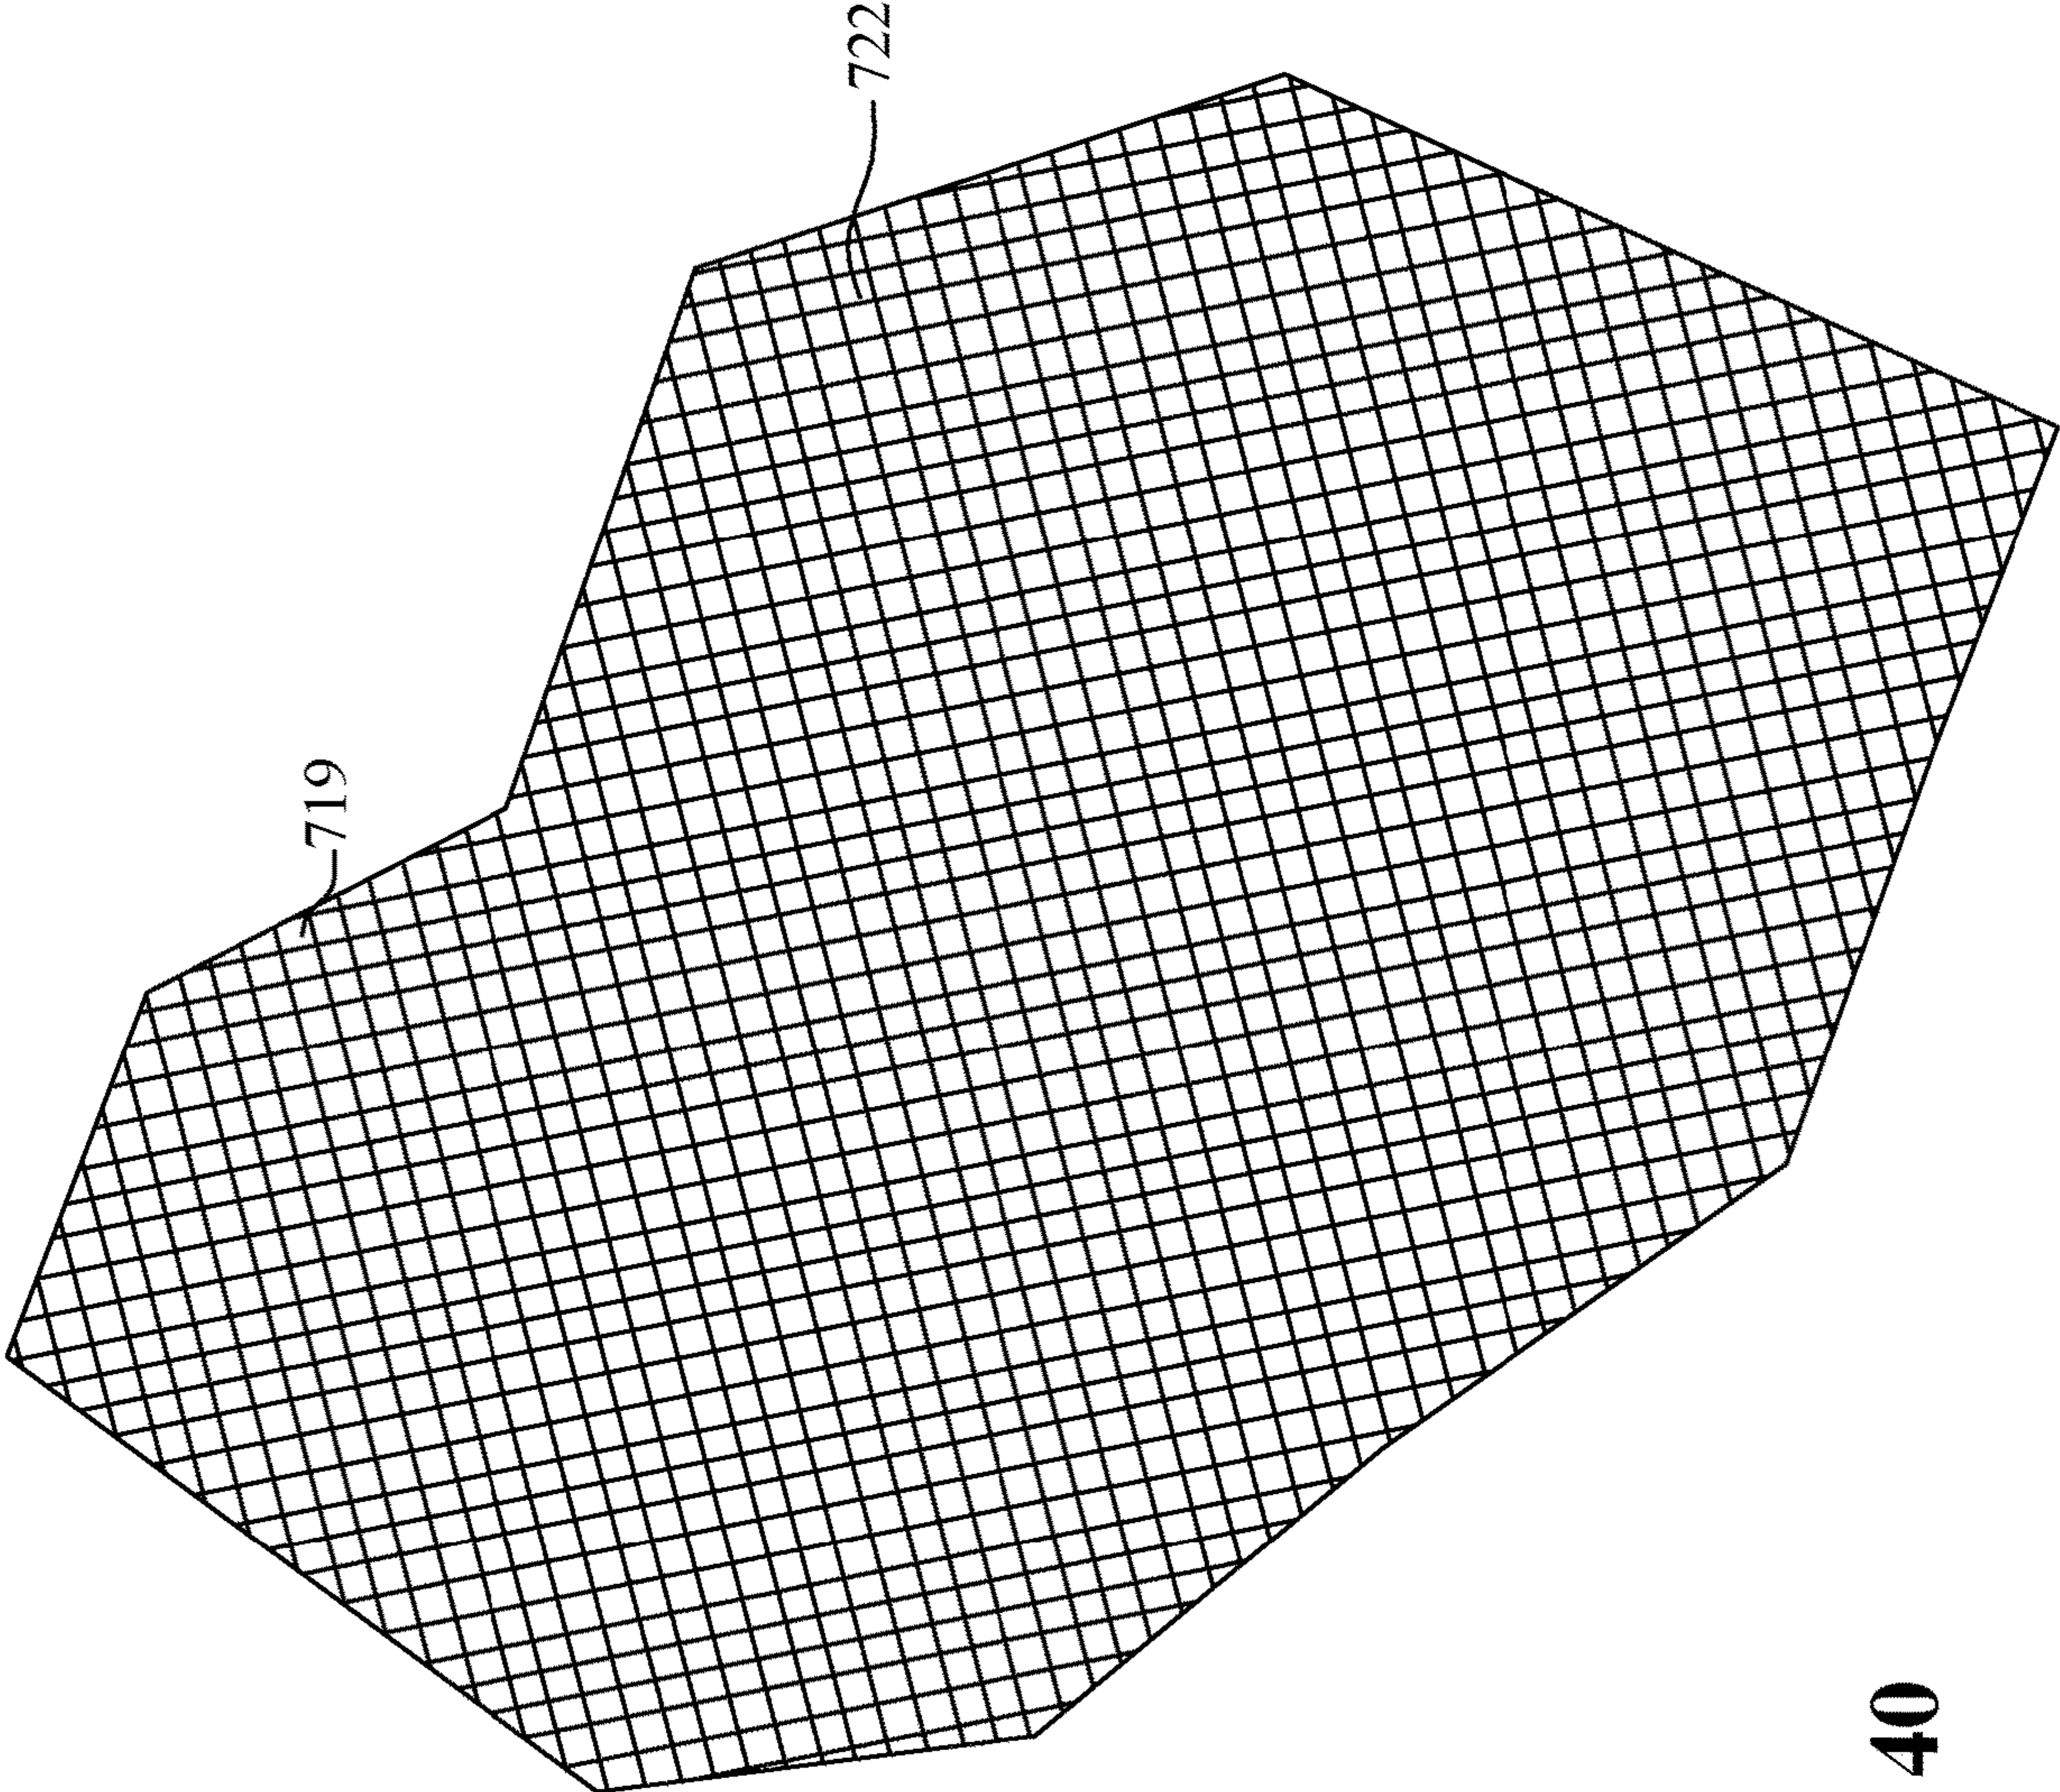
FIG. 40 is an enlarged plan view of the woven material repair tape;

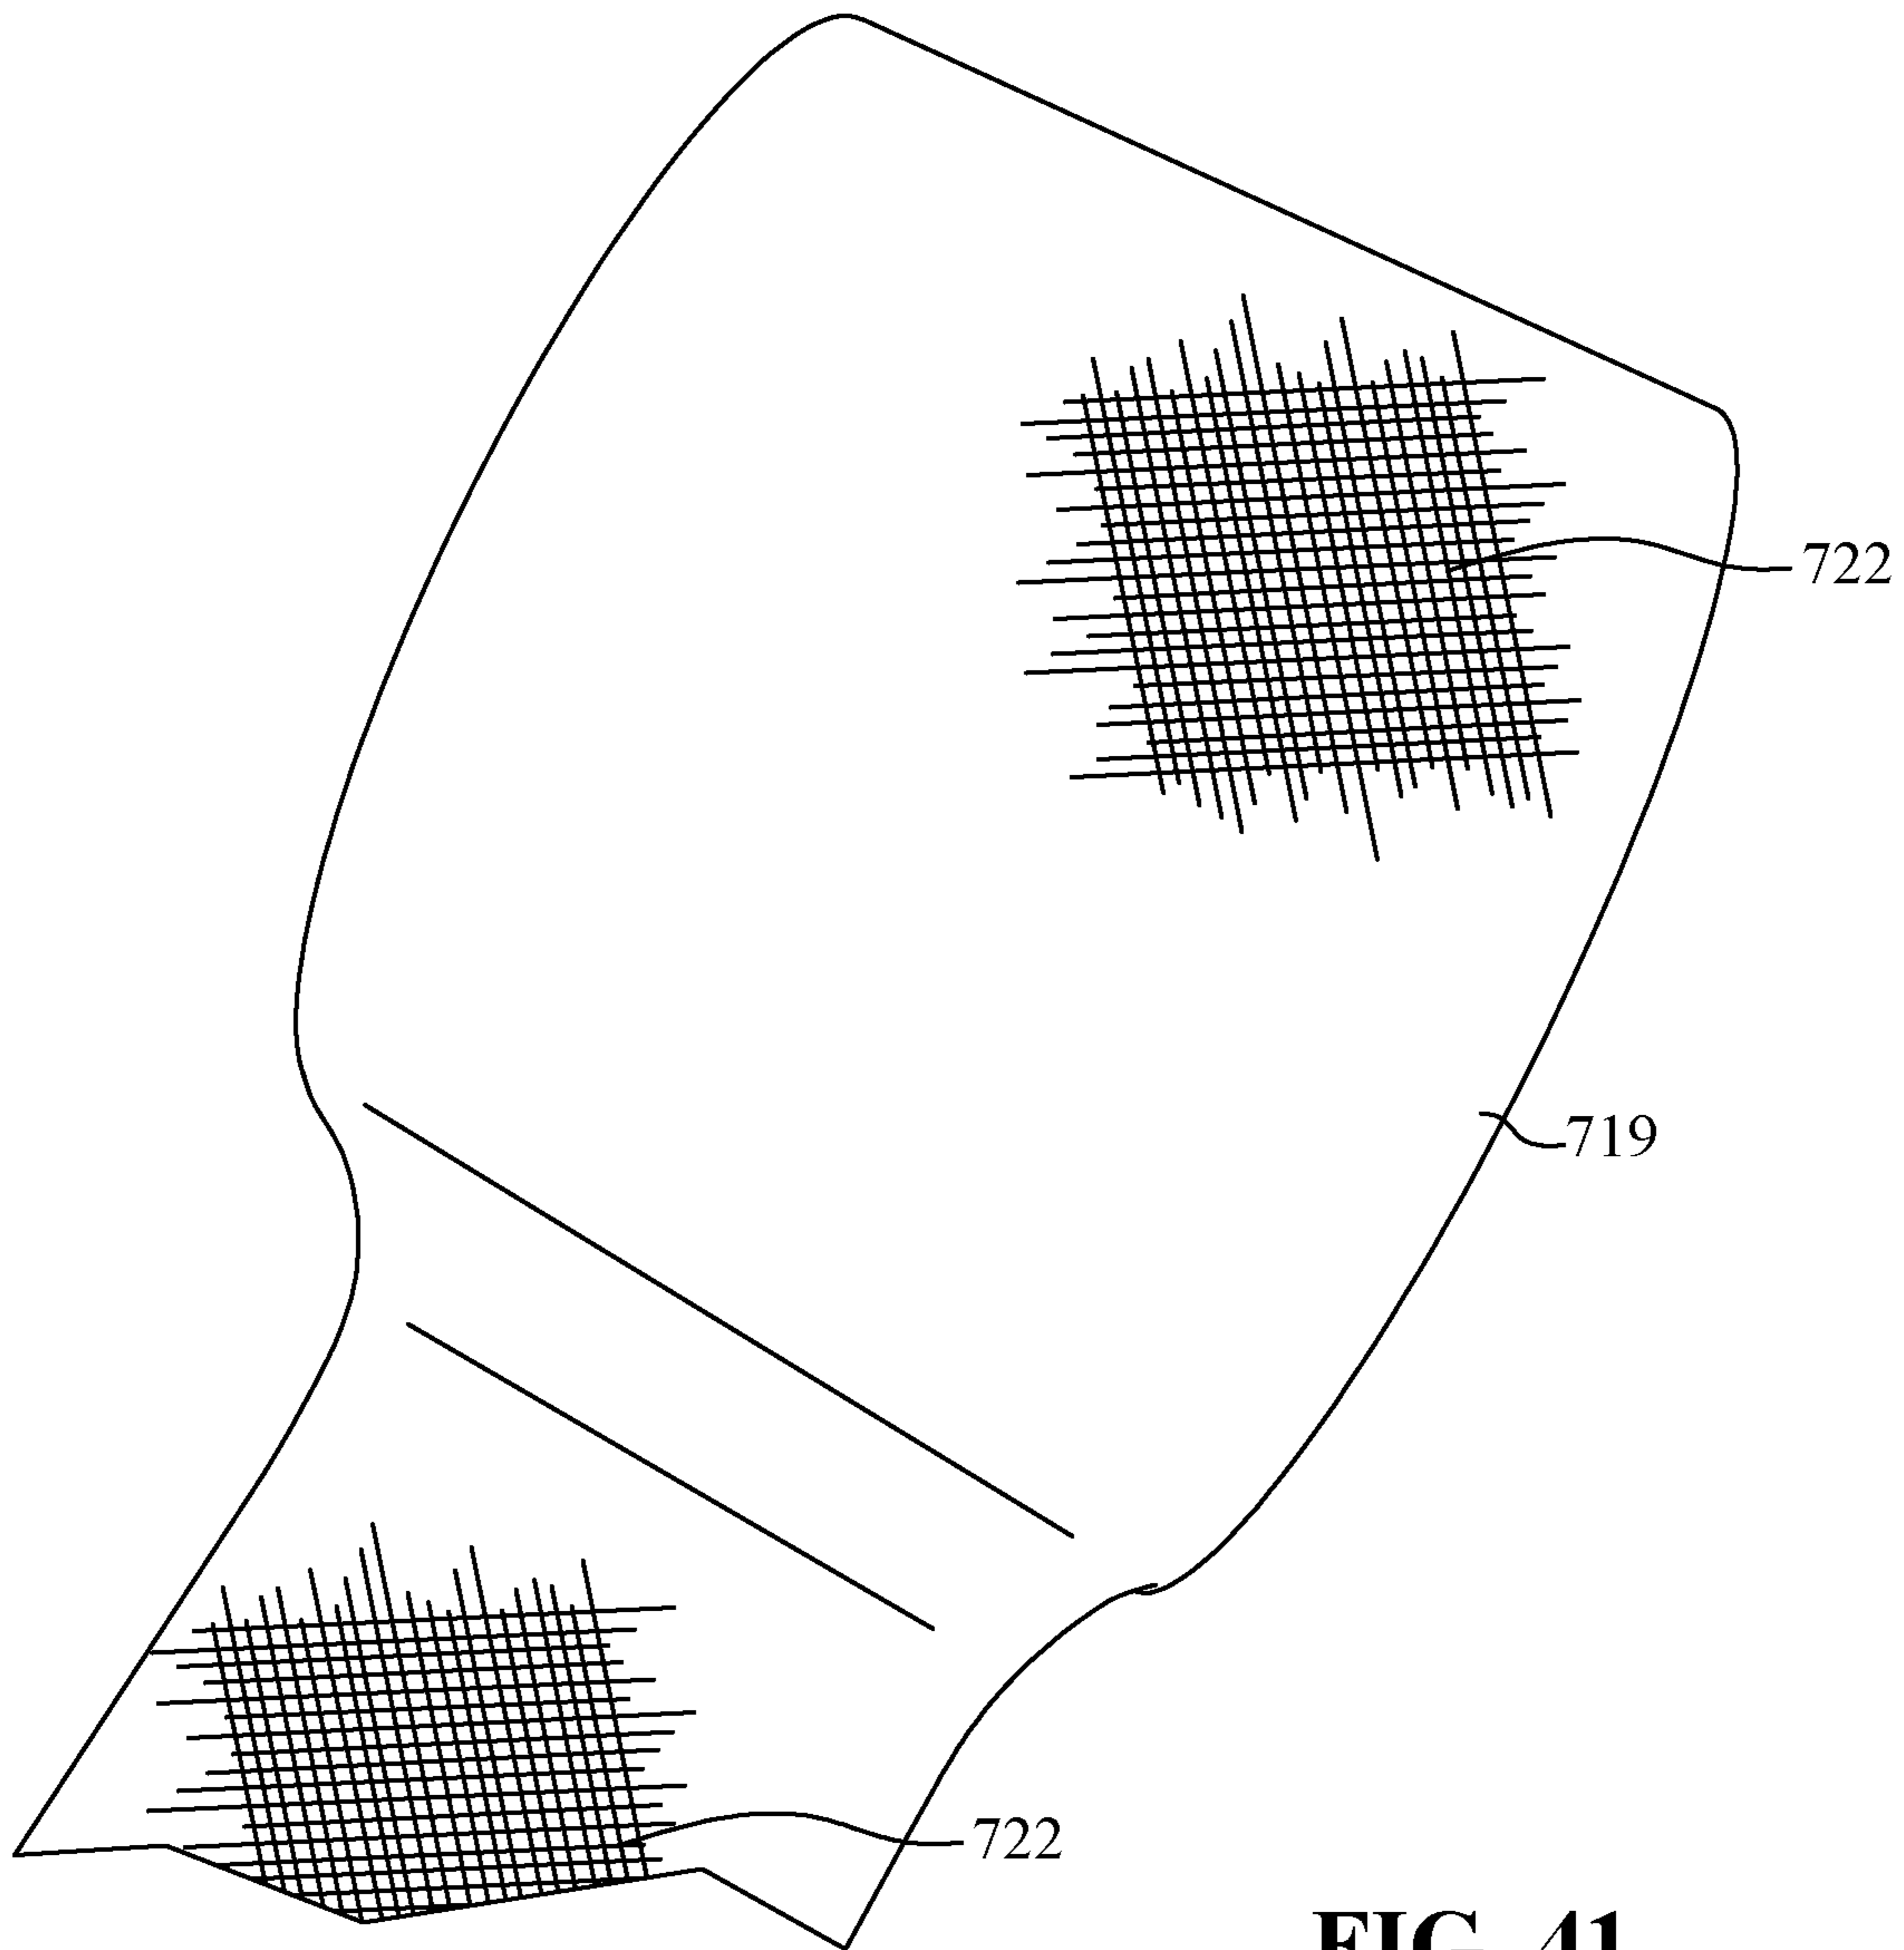
FIG. 41 is another plan view of the role of woven material repair tape;

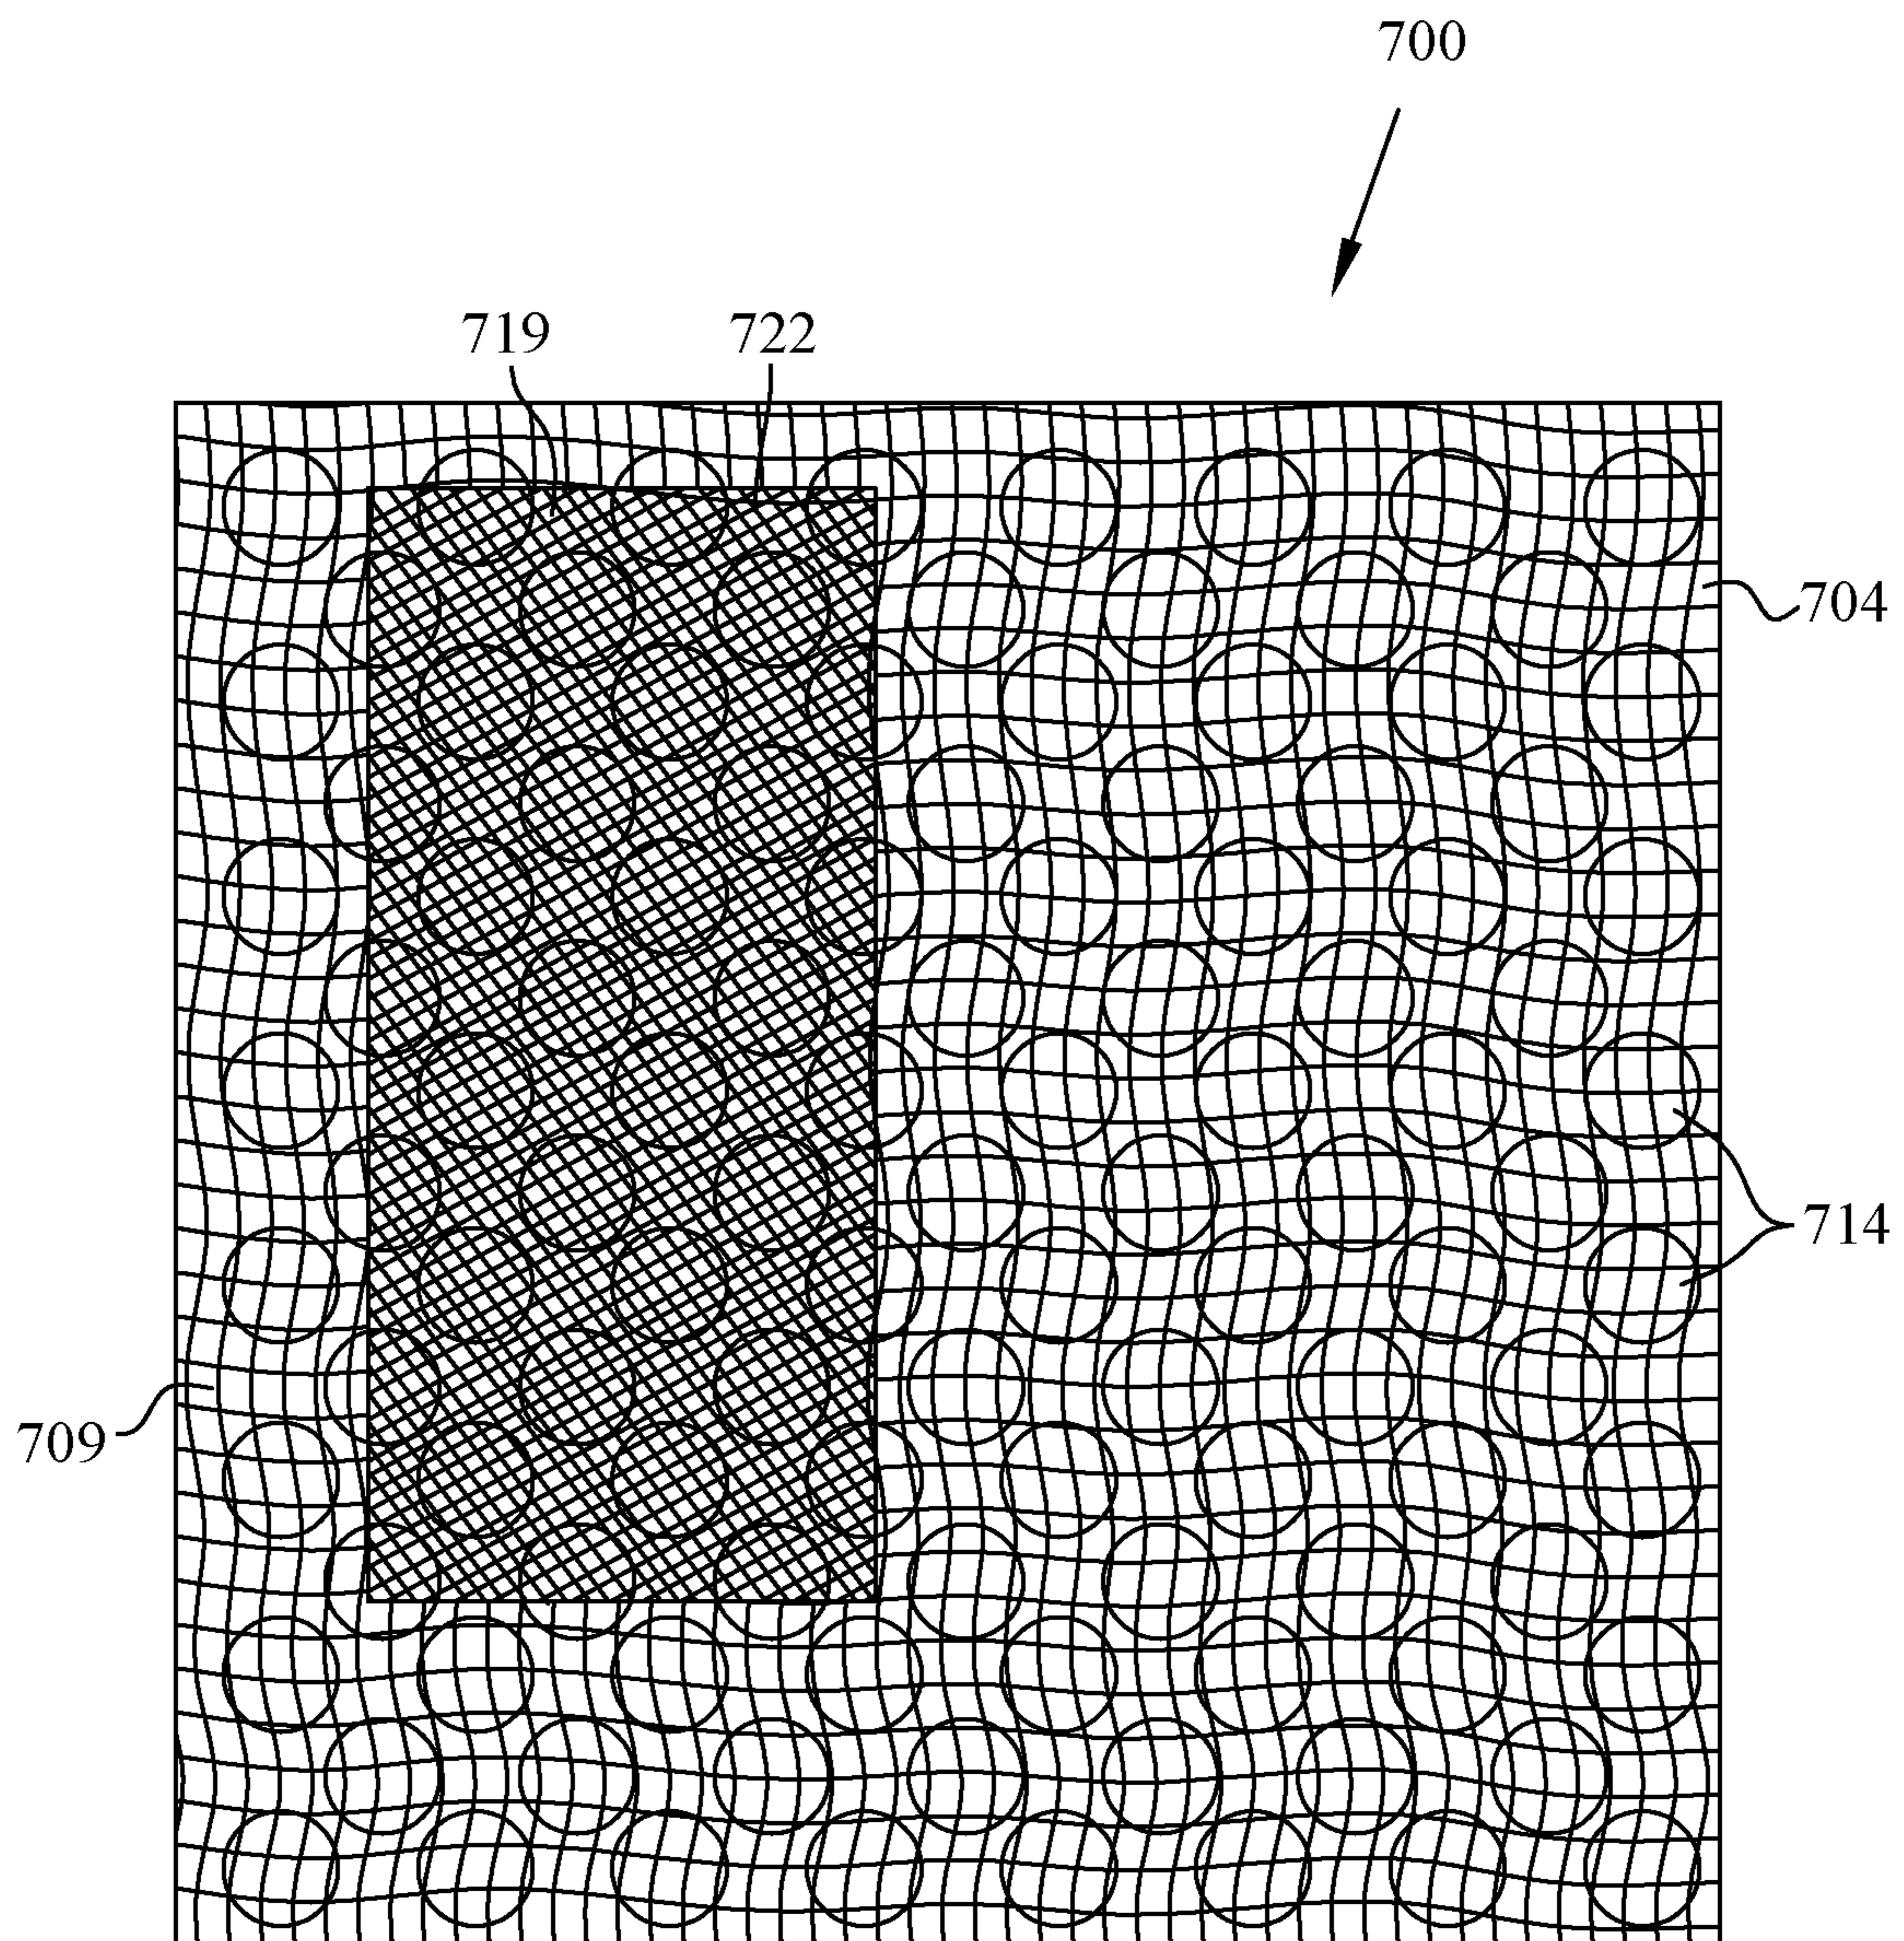
FIG. 42 is a plan view of a liner having a sheet of material with a woven fabric attached thereon and a piece of repair tape attached to the woven material; and
