US011447189B1

(54) **VEHICLE FRAME AND CARGO BAY LINER**

A vehicle and liner assembly is provided that includes a
recreational vehicle having a housing, a front end, a rear end,
a top, a bottom, and a pair of sidewalls. A frame assembly
is provided wherein, the housing is mounted on and sup-
ported by the frame assembly. The liner is attached to the
frame assembly and covers at least a substantial portion of the
bottom of the housing. The liner has a first face having
projections extending therefrom and a second face having
openings therein. The openings coincide with and extend
into corresponding projections on the first face.

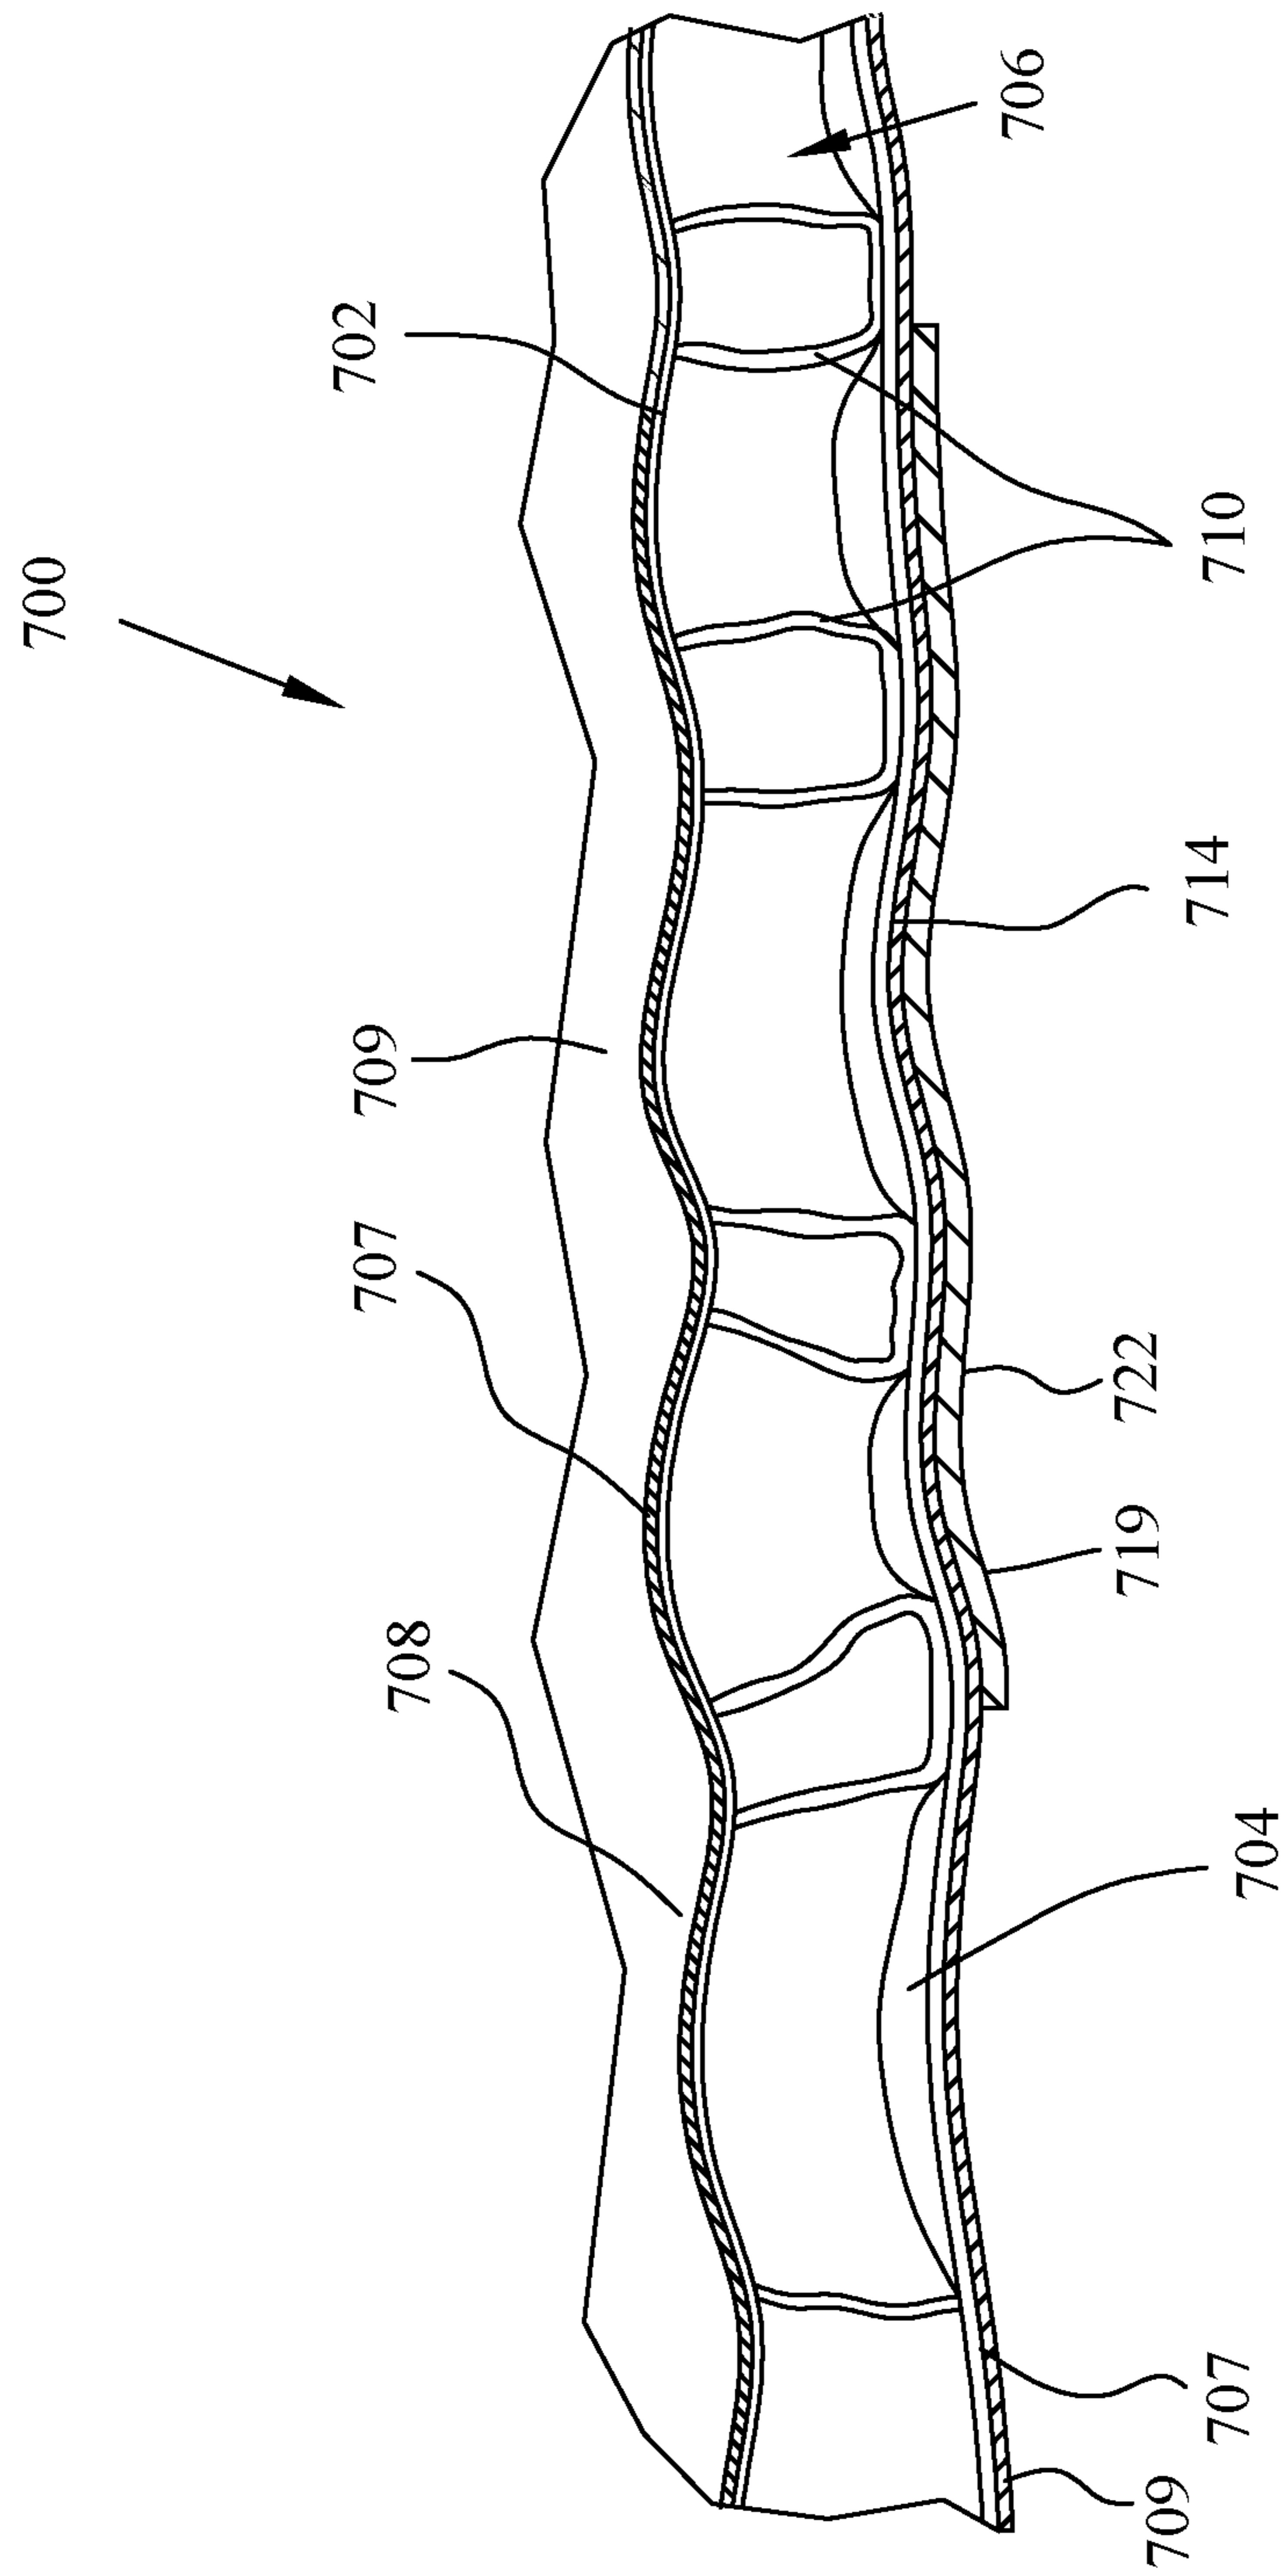
FIG. 43 is a cross sectional view of the liner of FIG. 42 taken through the piece of repair tape.
