US011447189B1

(54) **VEHICLE FRAME AND CARGO BAY LINER**

(71) Applicant: **PennPlastics, LLC**, Mishawaka, IN
(US)

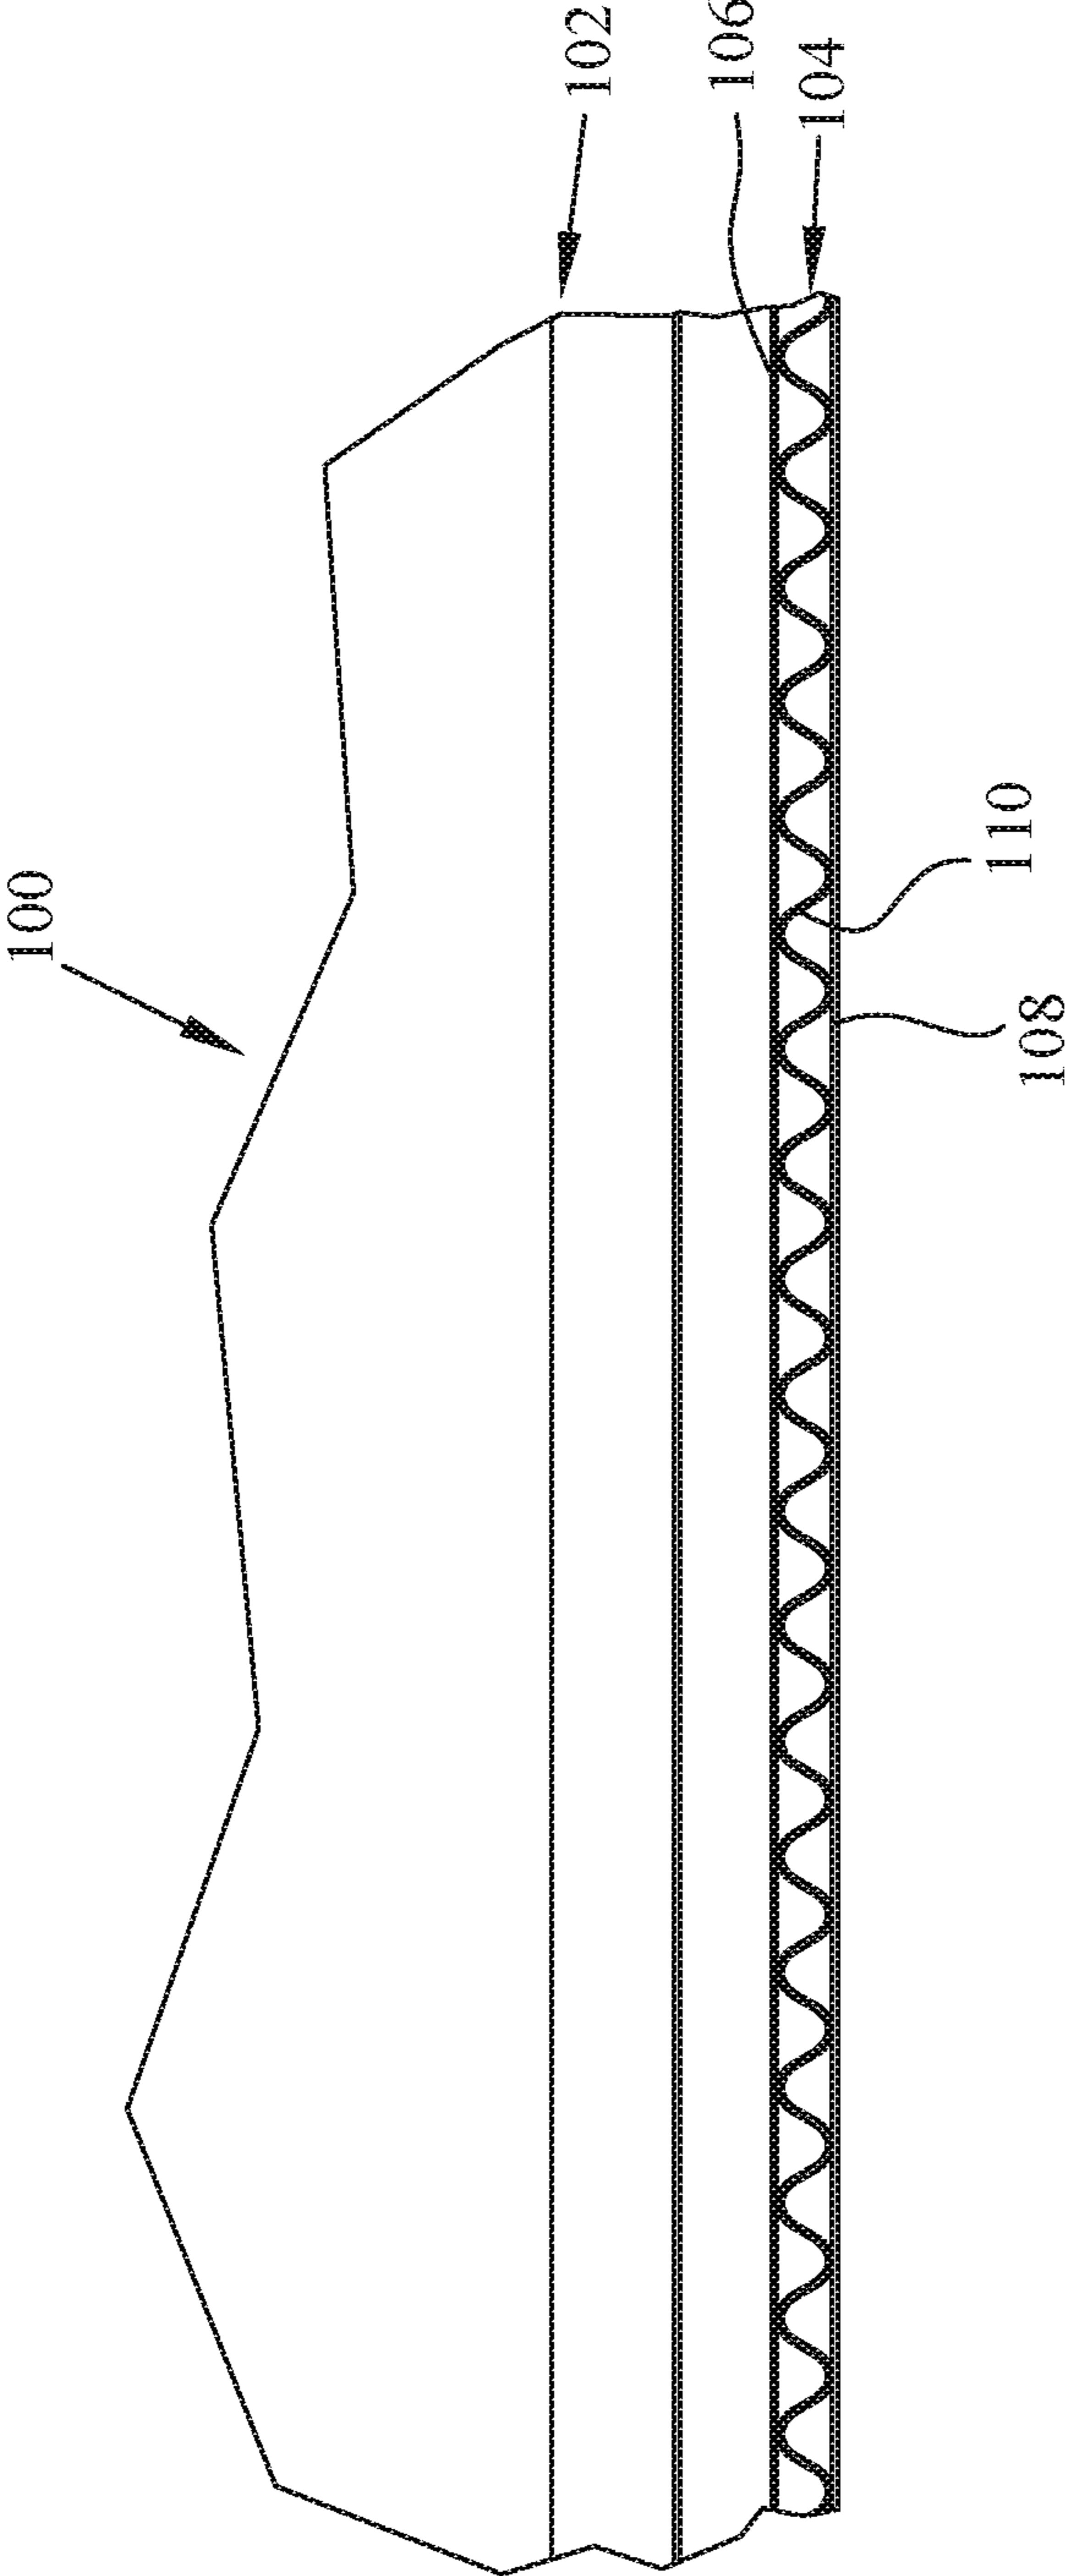
FIG. 3
(PRIOR ART)

FIG. 3 is a side view of a prior art recreational vehicle frame liner;

Referring now to FIGS. 3 and 4, these depict prior art vehicle undercarriage frame liners in common use in the industry. A portion of a recreational vehicle is generally indicated as 100. Recreational vehicle 100 includes a frame assembly generally indicated as 102 and a corrugated liner generally indicated as 104. Corrugated liner 104 includes a top sheet 106, a bottom sheet 108, and a corrugated or sinusoidal ply 110 extending therebetween. Top sheets 106 and 108 are adhered or attached to corrugated ply 110. Typically, the corrugated material is polyethylene.

In the recreational vehicle (RV) industry, it is common place to apply a liner beneath the frame to protect the underbody of the vehicle and any parts, plumbing, and/or electrical items that may be beneath the floor of the vehicle. Such a liner can also be referred to as a belly liner. Currently known in-use liners are shown in prior art FIGS. 3 and 4. Typically, the liner material is a corrugated plastic (polyethylene) material. The liner material consists of a top sheet, a bottom sheet, and a spacer extending there between. The spacer has a corrugated or sinusoidal configuration to which the top and bottom sheets are mounted (see Prior Art FIG. 3).

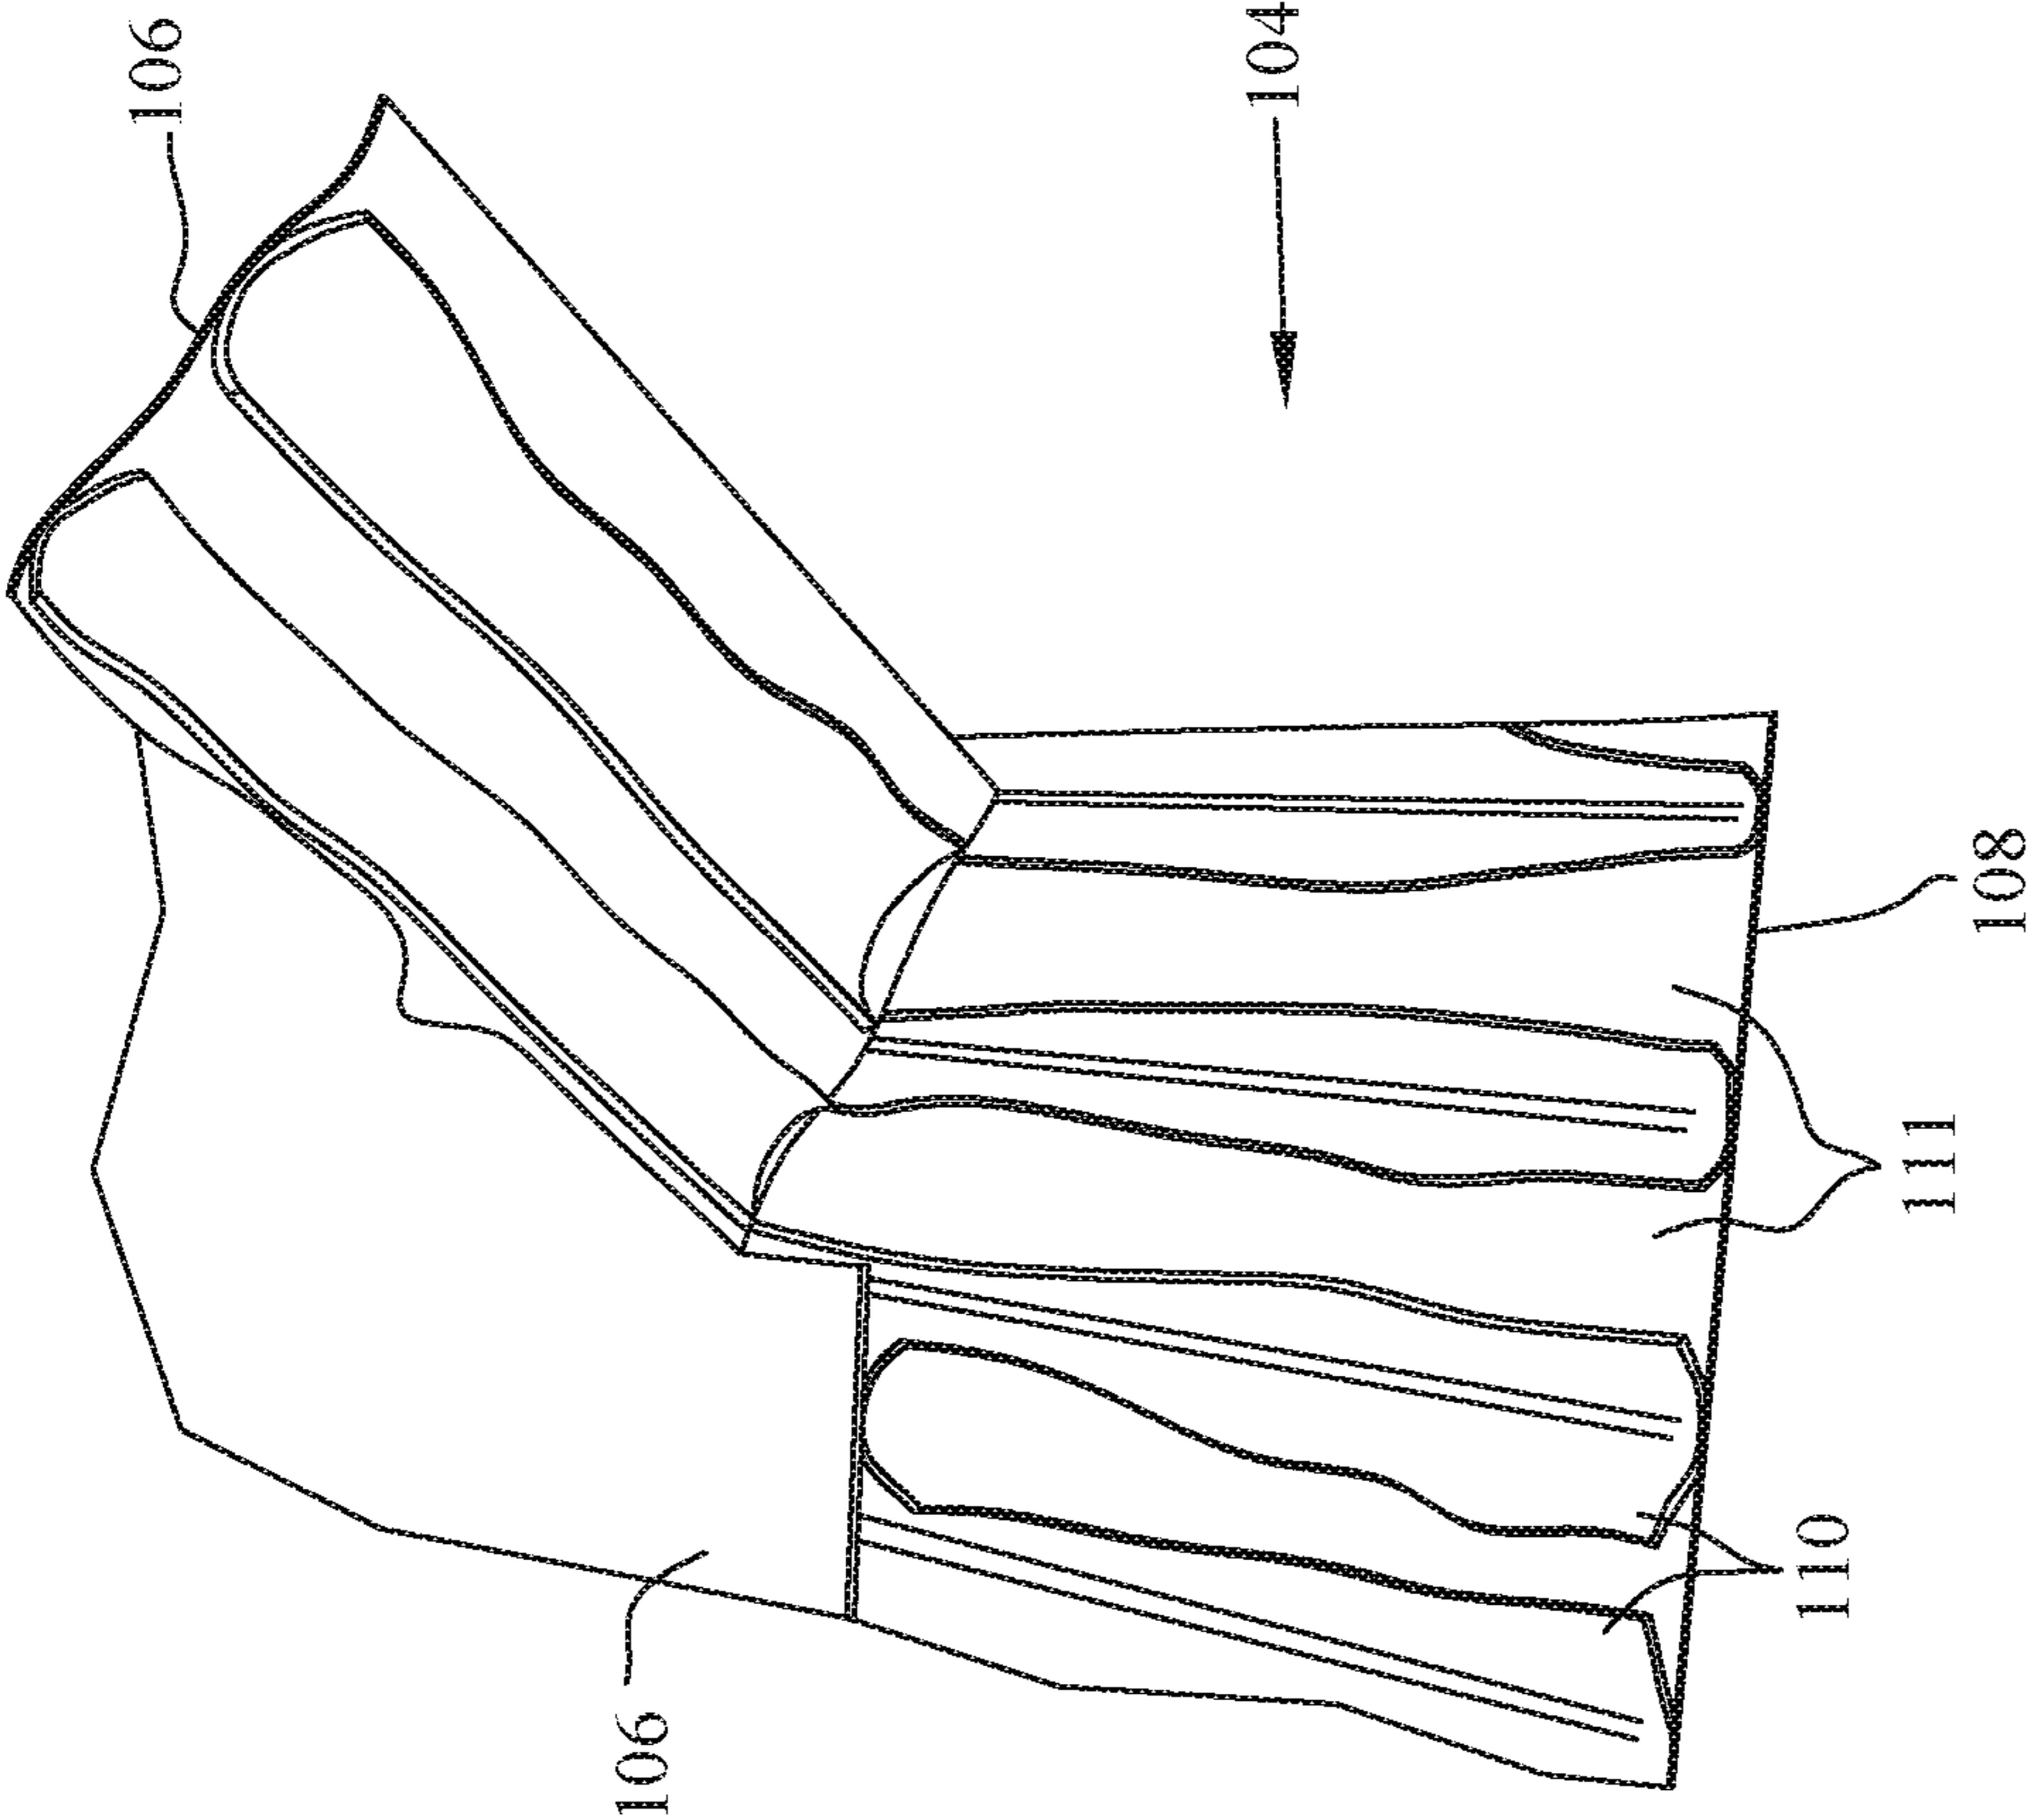
FIG. 3A
(PRIOR ART)

FIG. 3A is an enlarged perspective view of the frame liner in FIG. 3 showing the top layer partially peeled back and channels therein.

Referring to FIG. 3A, a portion of the corrugated liner 104 is shown removed from recreational vehicle 100. In FIG. 3A, a portion of the top sheet 106 has been pulled back revealing channels 111 that extend between top sheet 106 and bottom sheet 108 and along/within the sinusoidal ply 110. As should be appreciated, a problem, with the prior art liner is that any water or moisture entering the open ends of the corrugated liner 104 easily crosses through channels 111 so that channels 111 can become filled with water. The water can leak or freezing of the water may cause ripping, tearing or pulling apart of corrugated liner 104, thereby destroying its structural integrity.

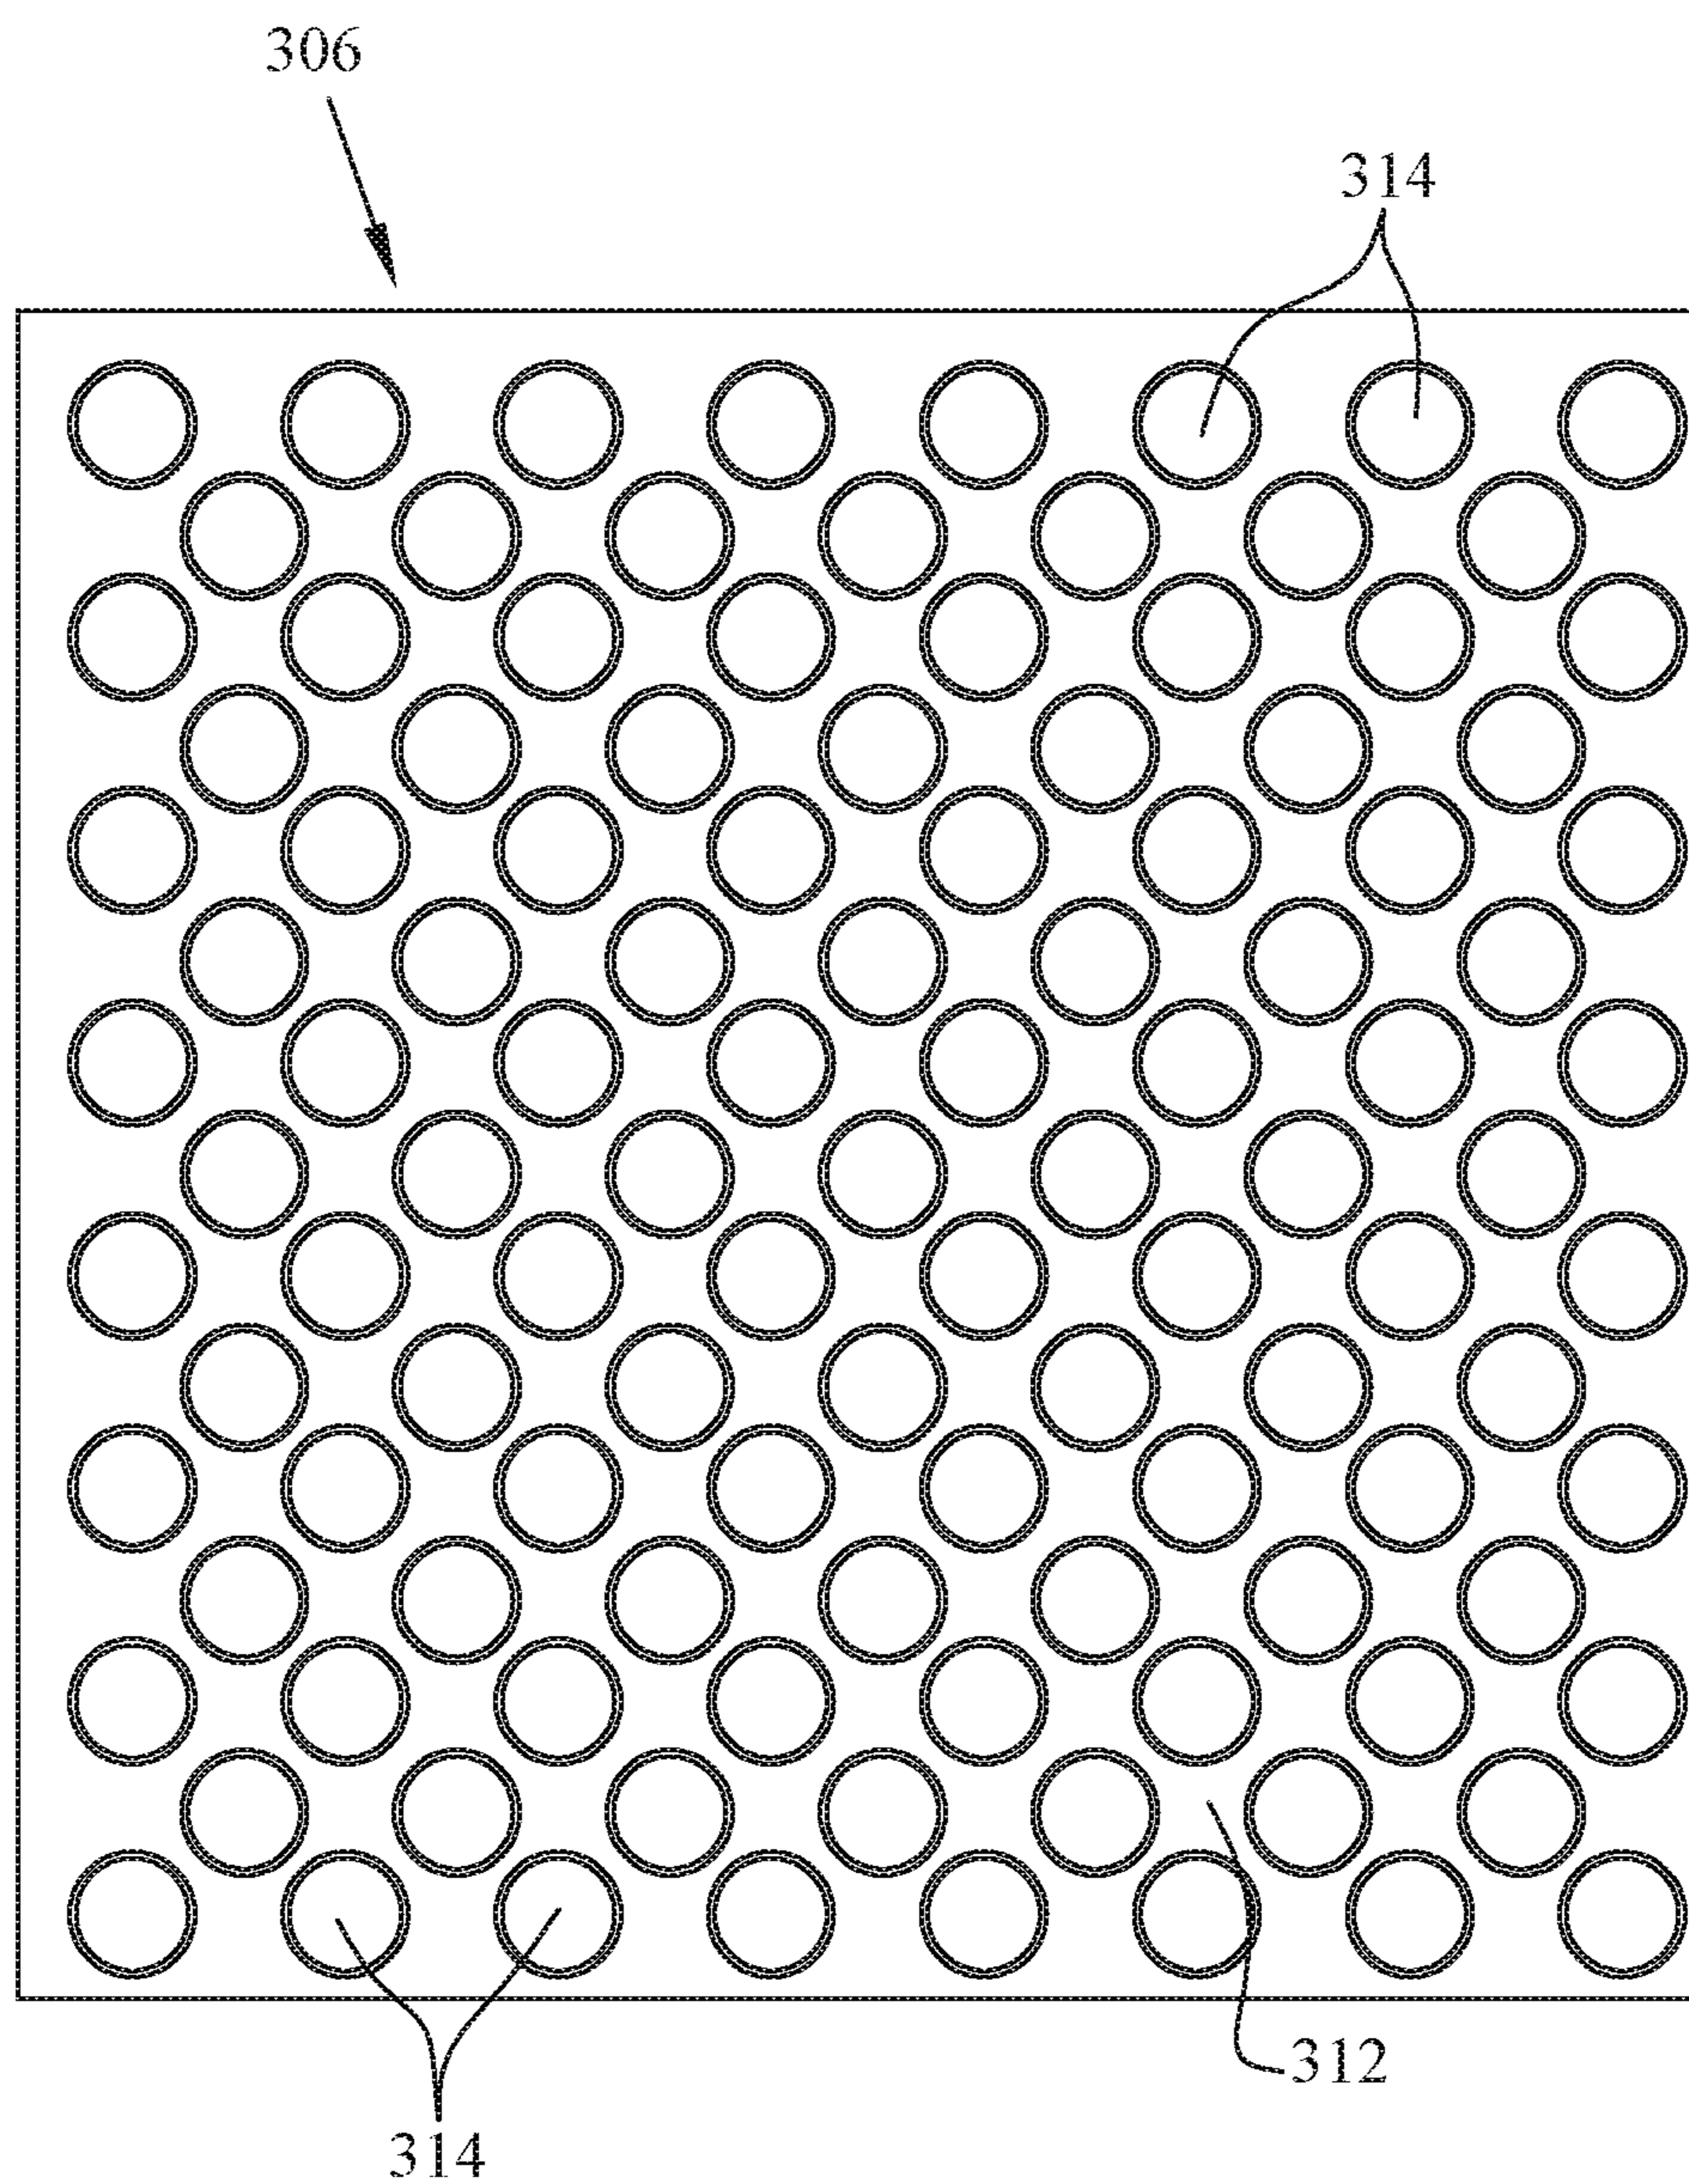
FIG. 12 is a plan view of an alternate embodiment vehicle frame and cargo bay liner showing a face having openings therein;

Now referring to FIGS. 12 and 13, an alternate vehicle frame and cargo area liner is shown generally indicated as 306. As can be seen in FIG. 13, liner 306 includes a face 308 having projections 210 thereon. As shown in FIG. 12, liner 306 has an opposite face 312 having openings 314 therein. Projections 310 include end faces 316 and sidewalls 318 as best seen in FIG. 13. Line 306 can be manufactured from single or multi-layer materials sandwiched together (twin or triple layer).

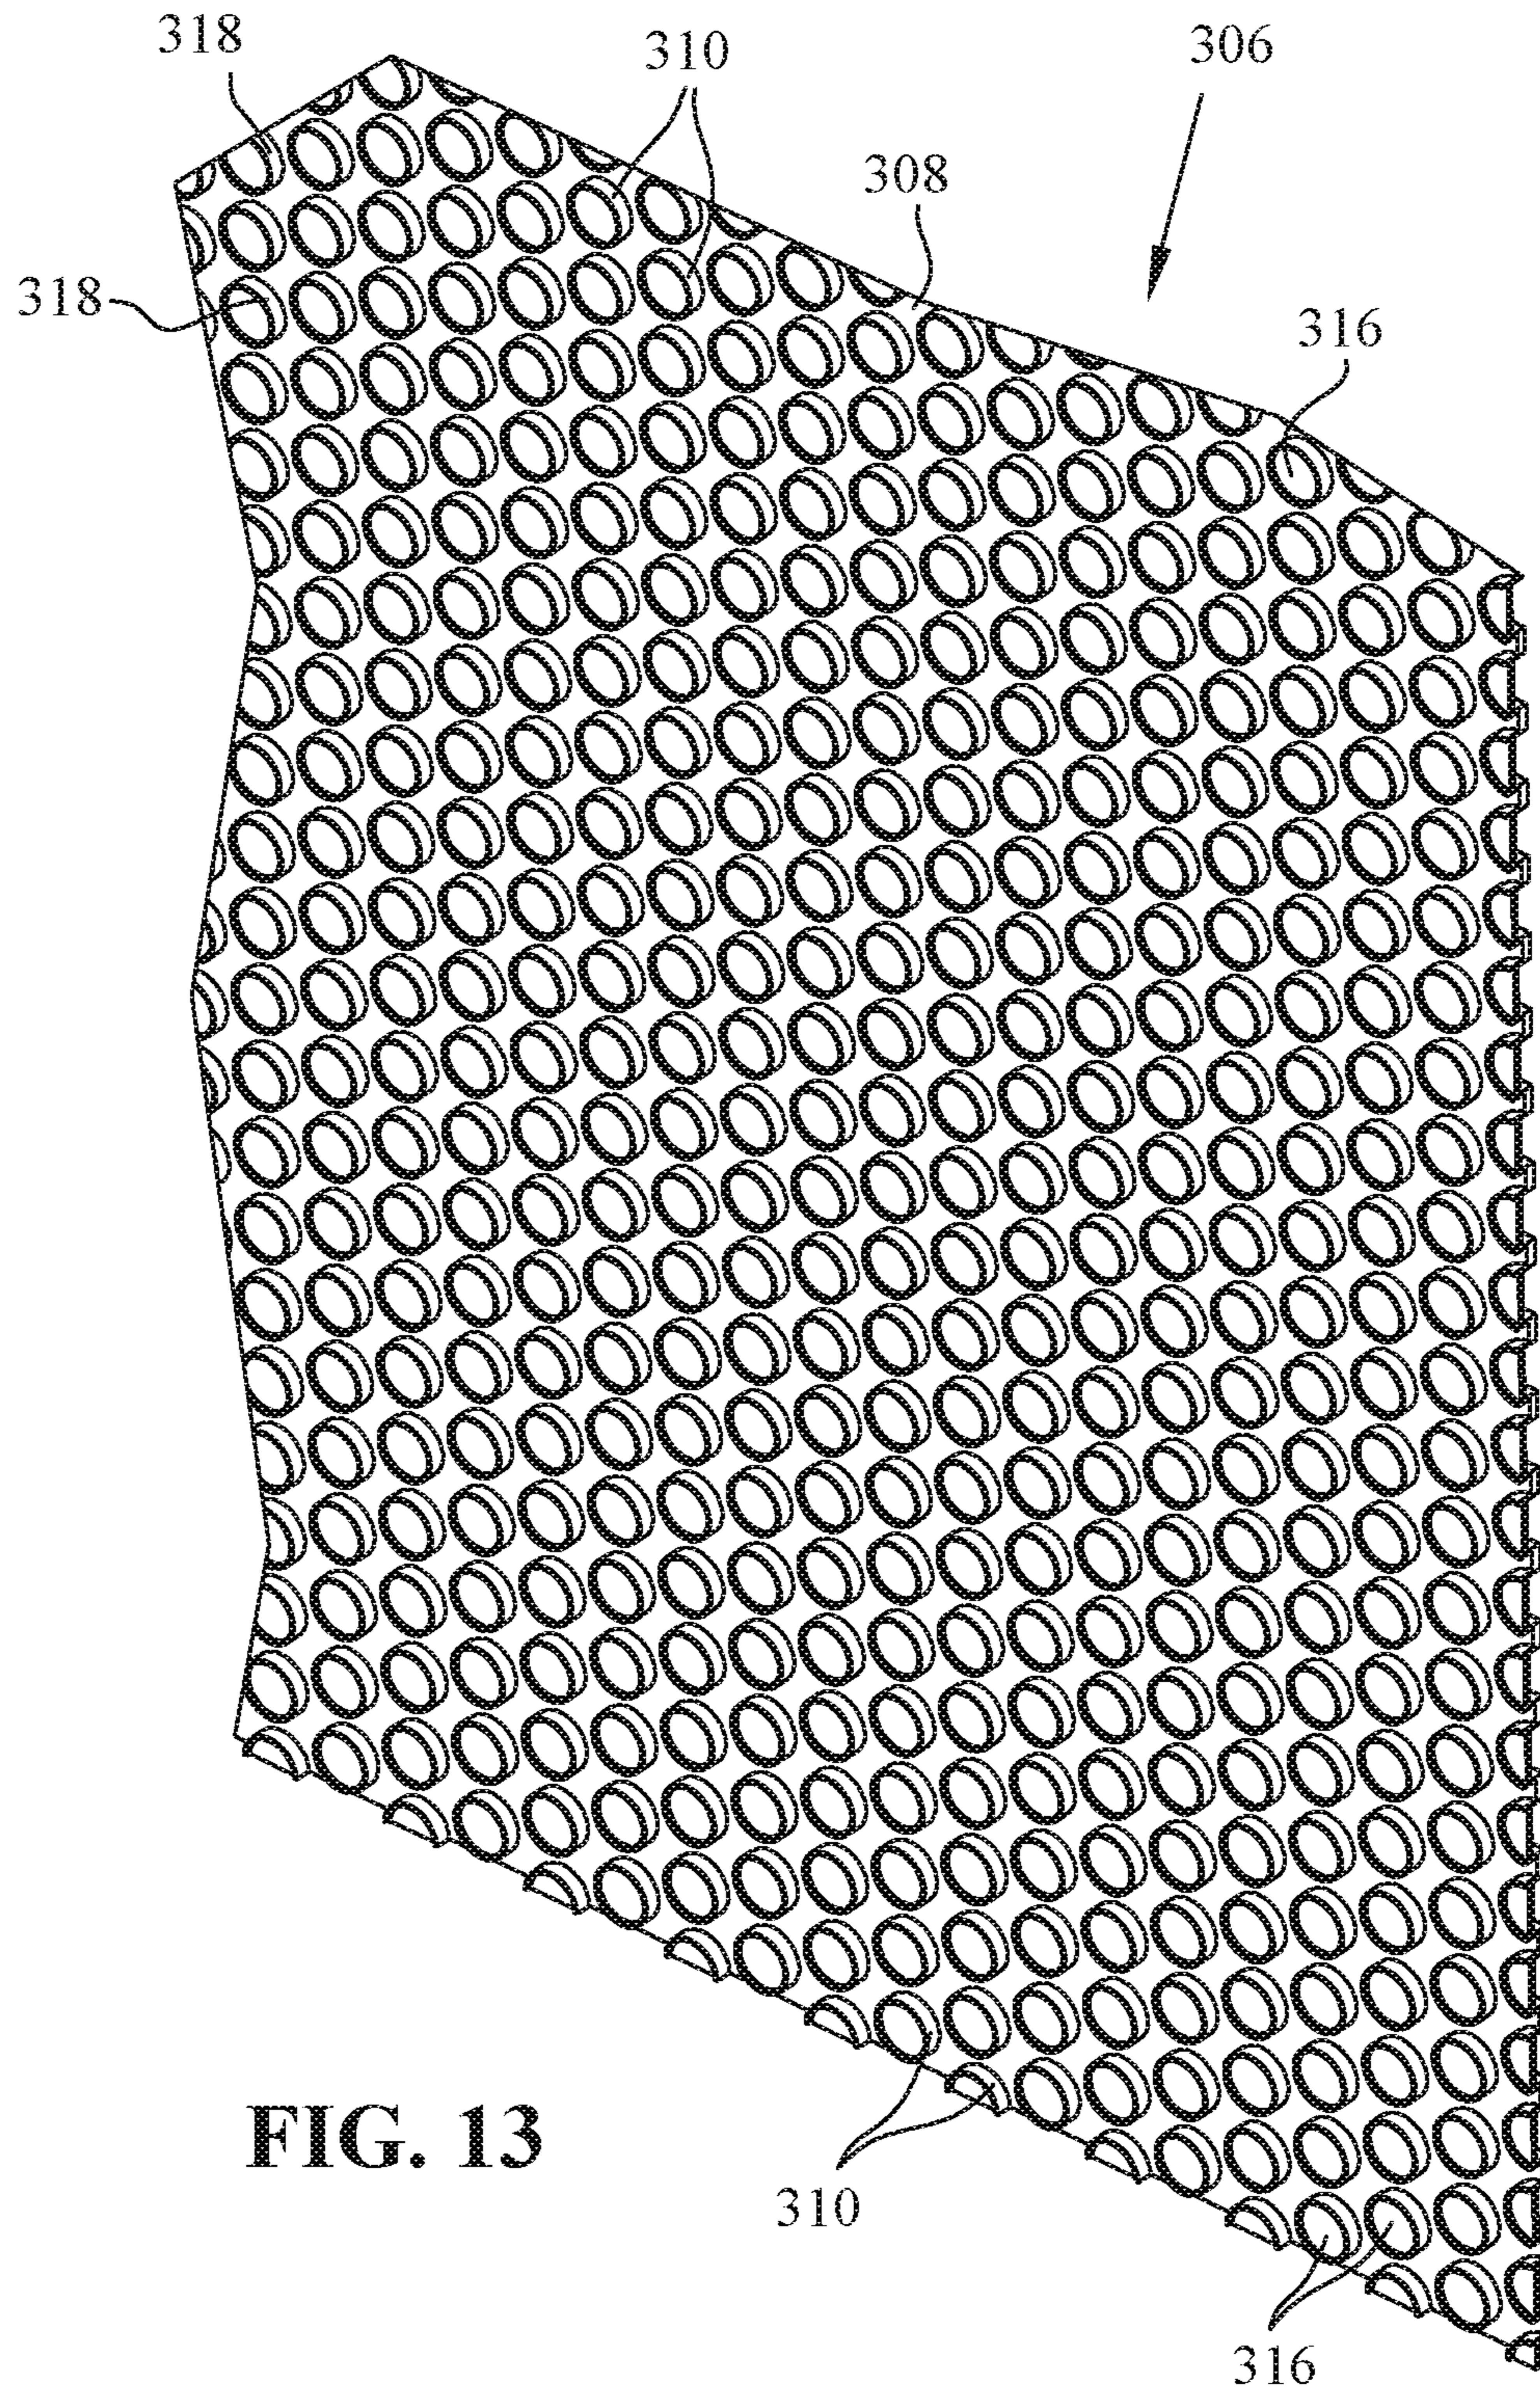
FIG. 13 is a plan perspective view of the alternate embodiment vehicle frame and cargo bay liner of FIG. 12 showing a face having projections extending therefrom;

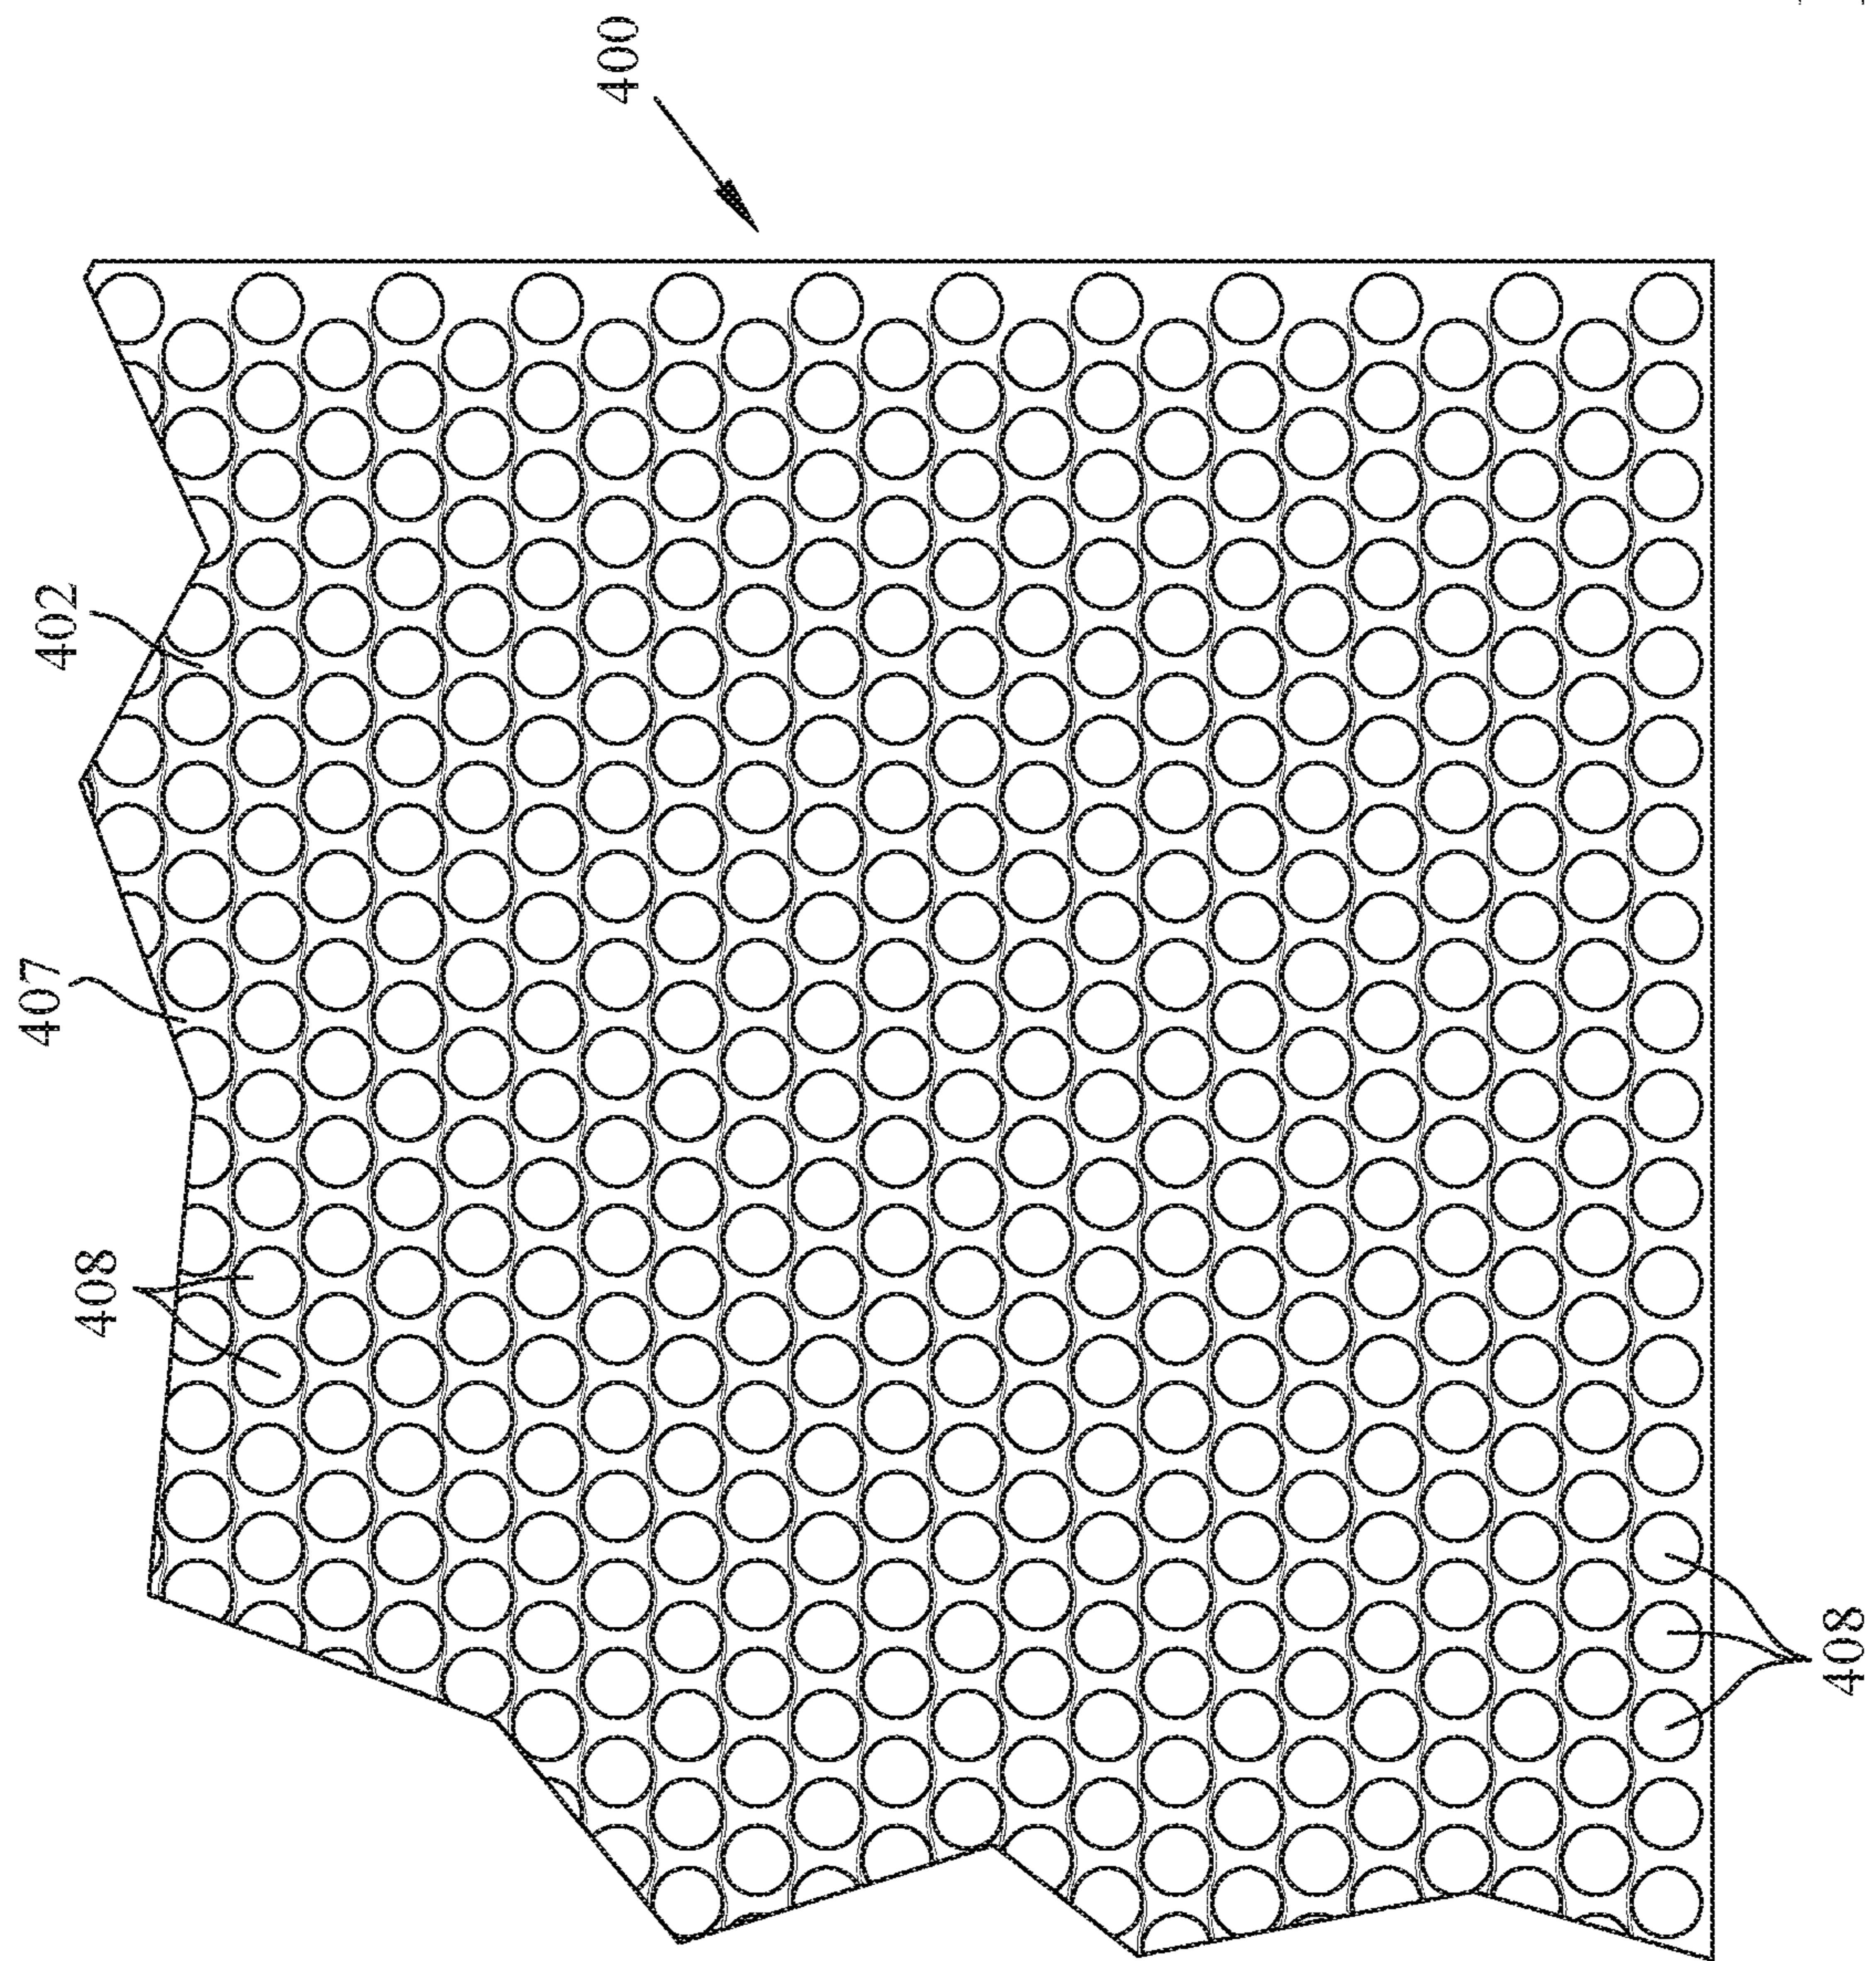
FIG. 17 is an enlarged plan view of the vehicle frame and cargo bay liner of FIG. 14 of the top side having aluminum foil thereon;

Now referring to FIGS. 14-24, another alternate vehicle frame and cargo area liner is shown generally indicated as 400. Liner 400 can be provided in a coiled form 401 as

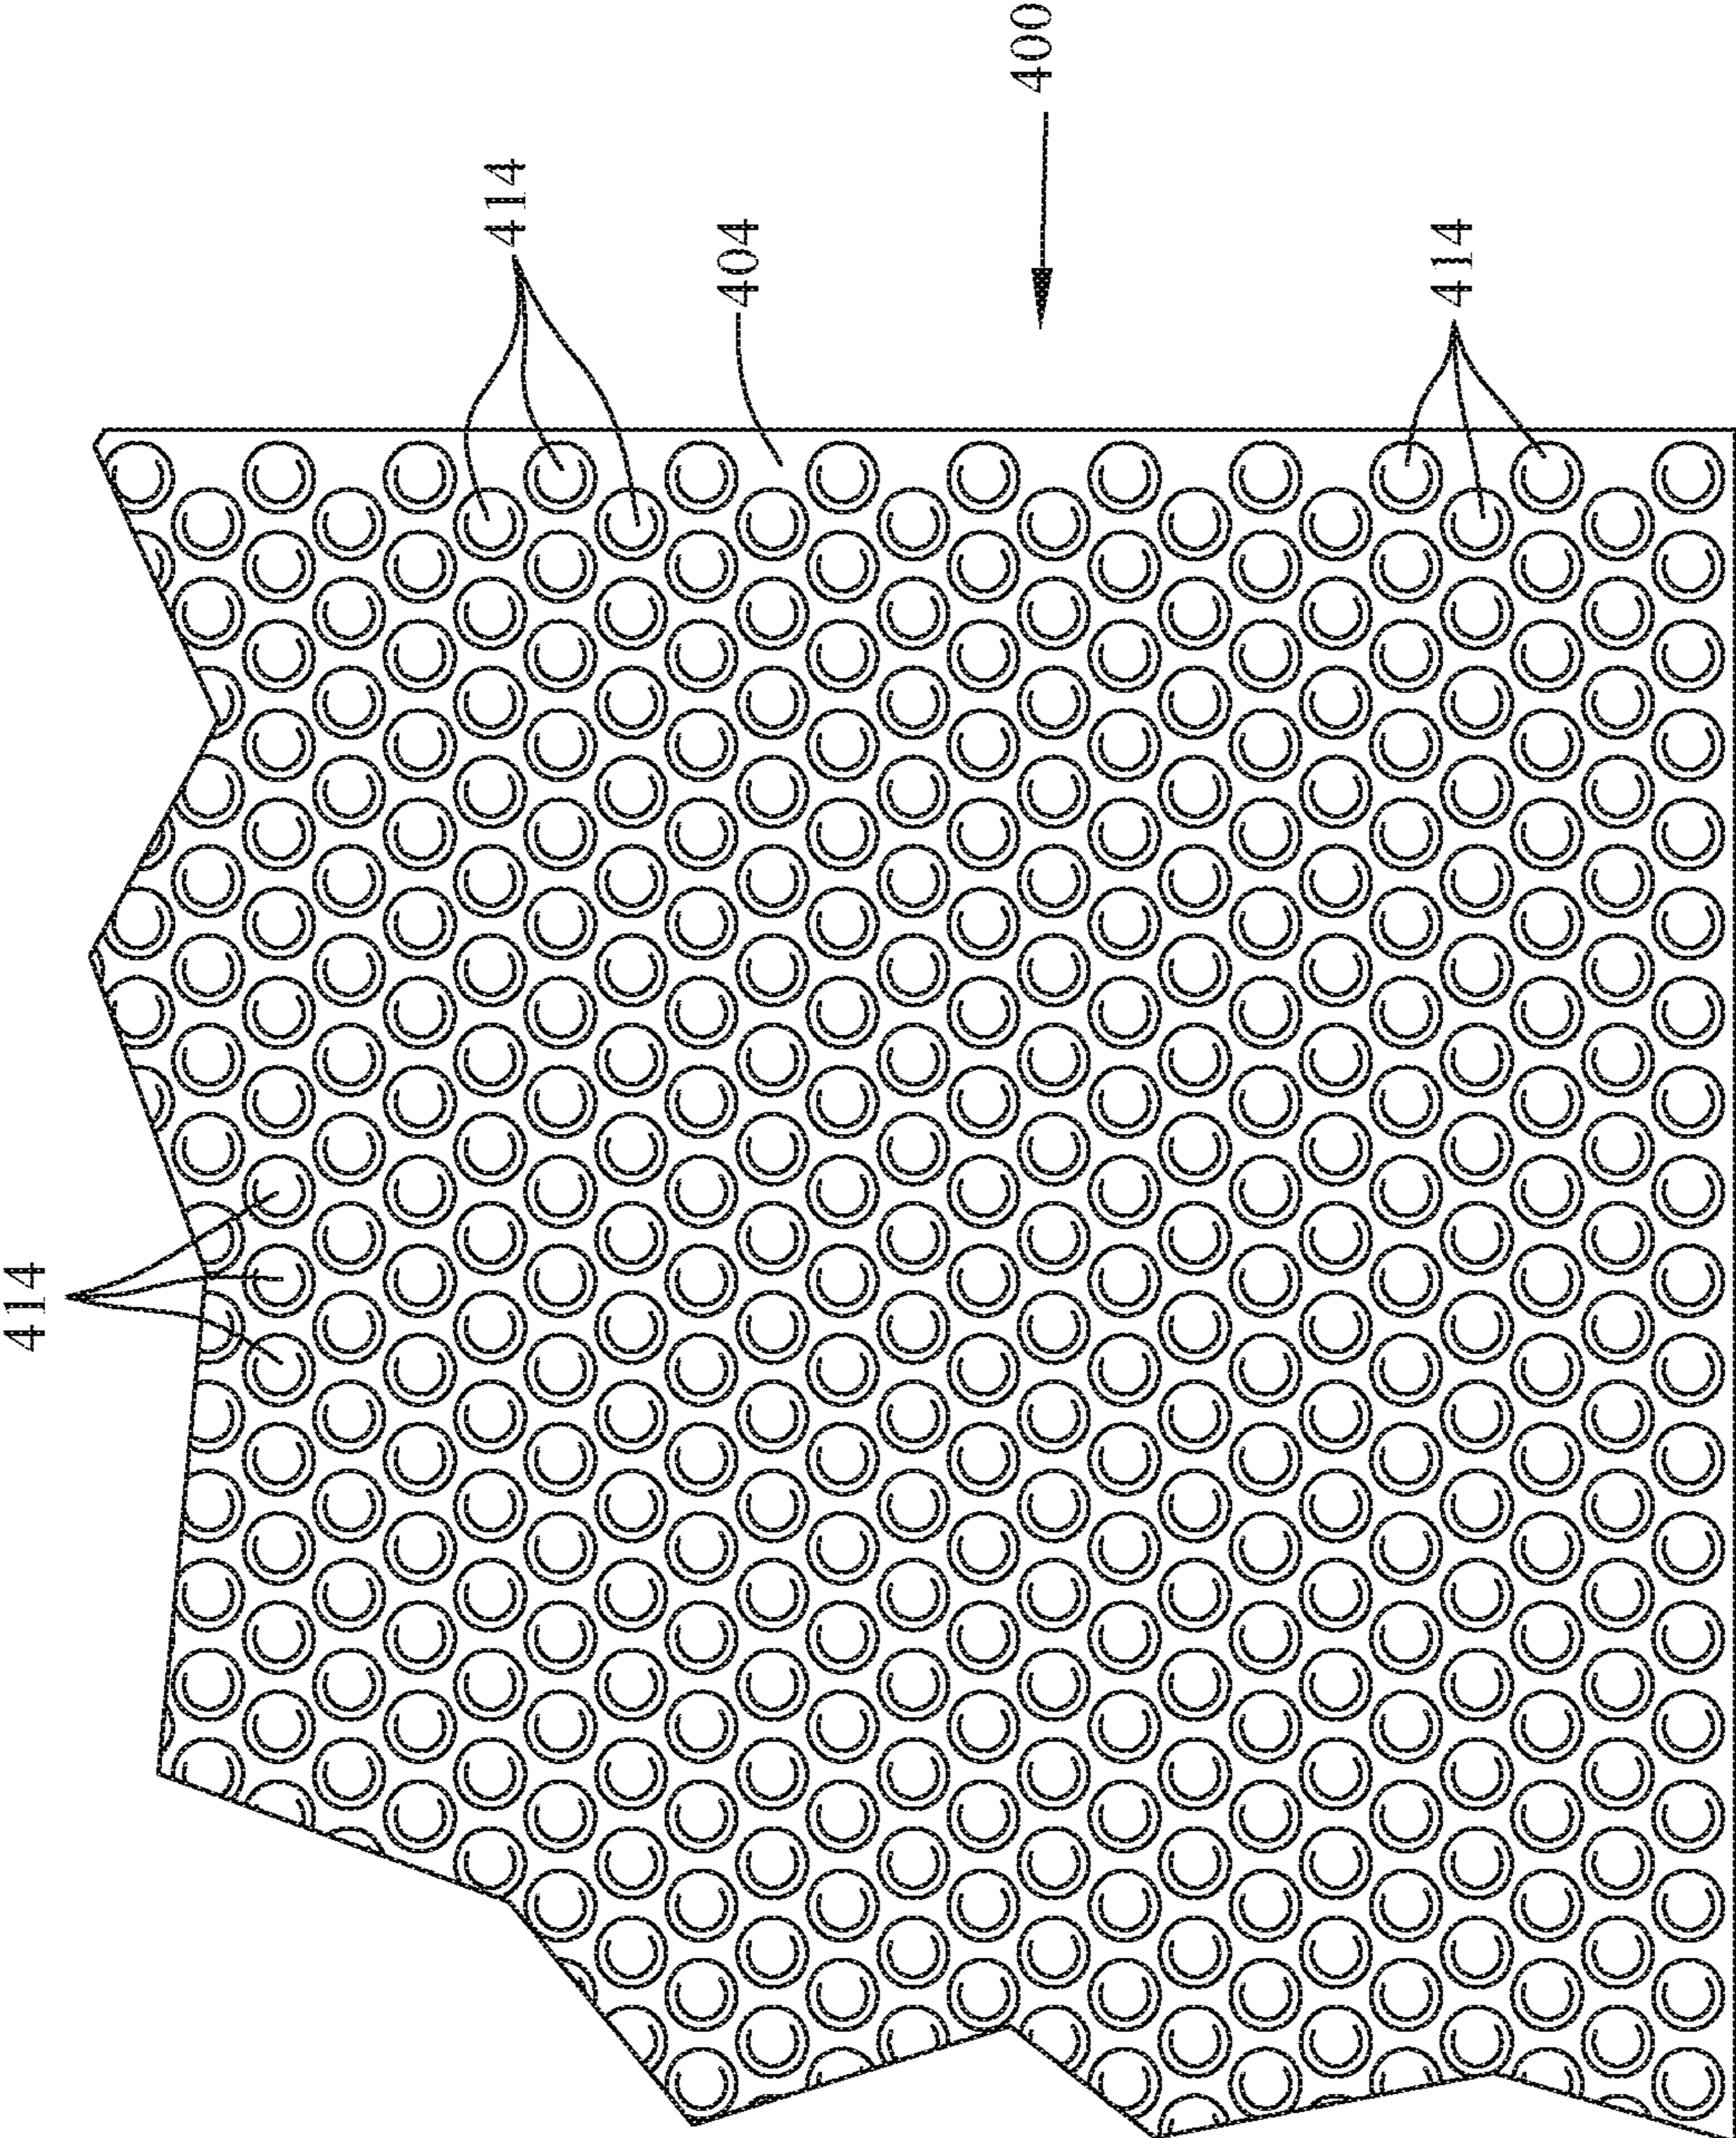
FIG. 21 is an enlarged bottom plan perspective view of the vehicle frame and cargo bay liner of FIG. 14;
