US011447189B1

(54) **VEHICLE FRAME AND CARGO BAY LINER**

(71) Applicant: **PennPlastics, LLC**, Mishawaka, IN
(US)

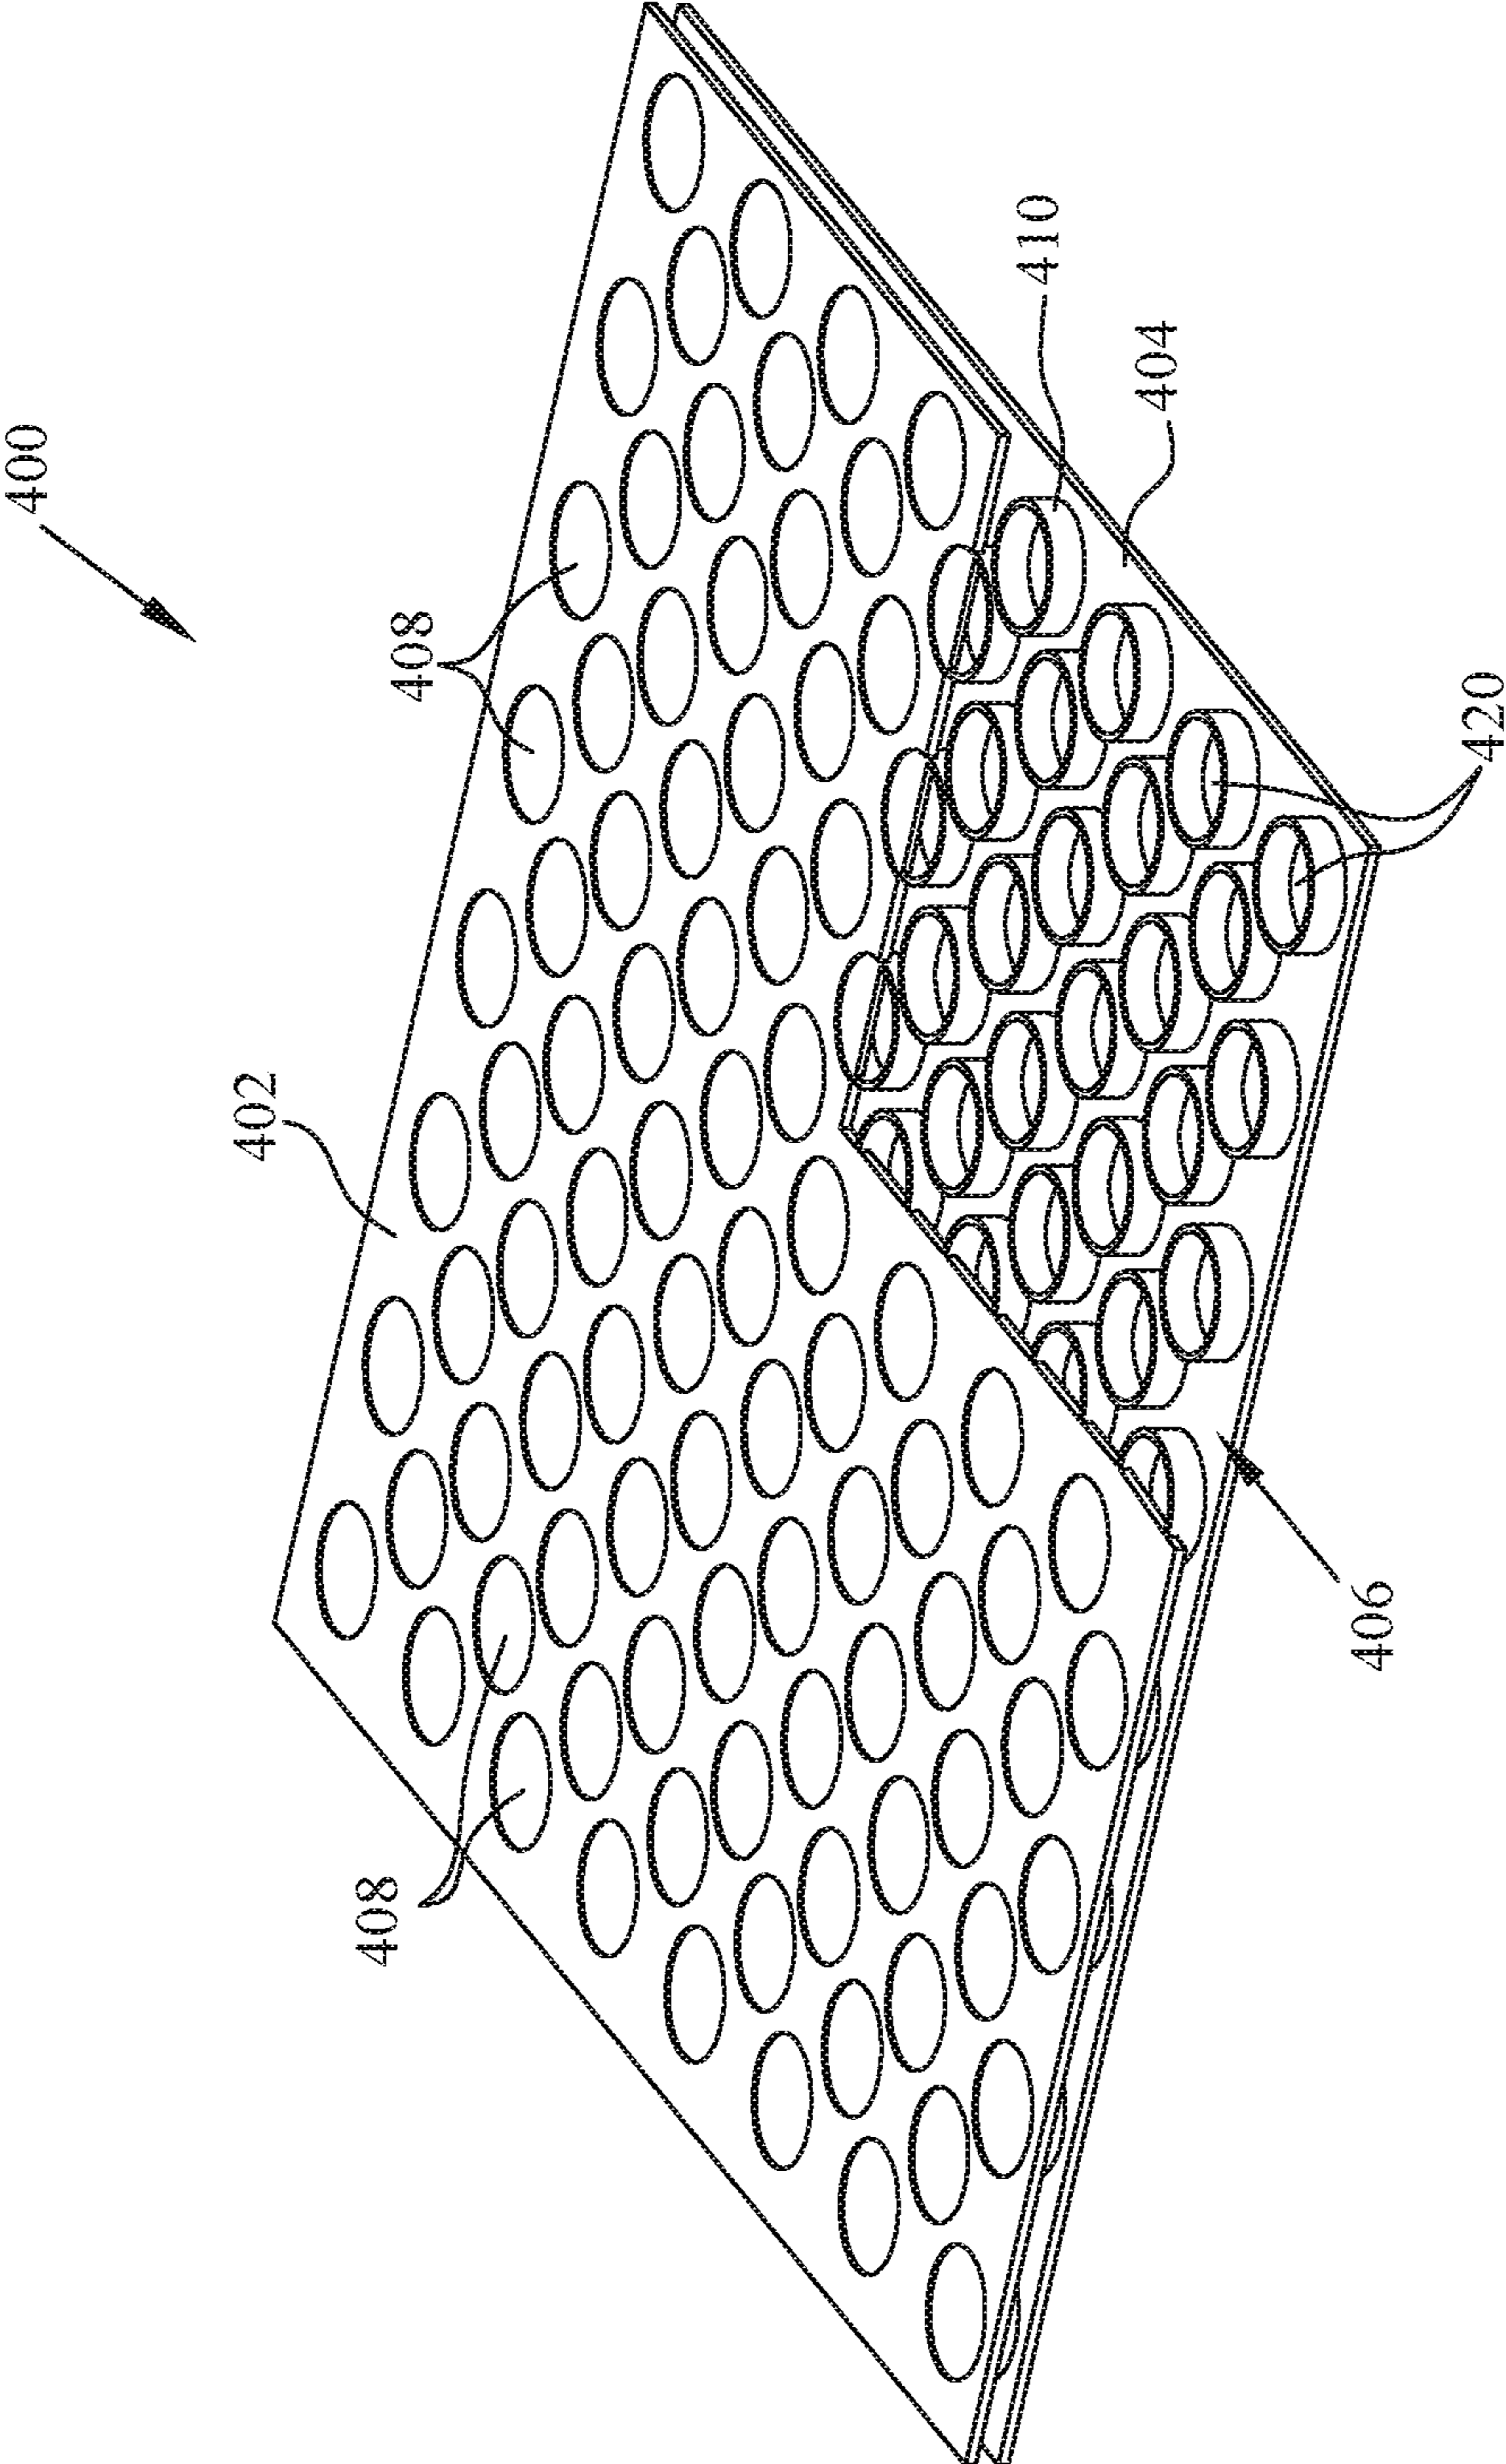
FIG. 23 is another perspective view of a portion of the vehicle frame and cargo bay liner of FIG. 14 with part of the top layer removed;

As can be seen in FIGS. 22 and 23, cylindrical projections **410** form an obstruction to passage through core **406** such that any water entering the ends thereof is obstructed and impeded or hindered from propagating across liner **400** as compared to channels **111** in corrugated liner **104**, which readily allow transport of liquids. Additionally, as where vehicle frame and cargo bay liner **400** is cut, it will intersect a plurality of cylindrical projections **410** in the liner. As each cylinder is closed off, any water entering into an end of the liner where a projection has been cut will be prevented from further propagating by encountering the wall of the projection. Only a small area or channel **422** between cylindrical projections would allow any water or moisture to enter into core **406** of liner **400**, but that will not readily propagate to the offset projections internal to core **406** that will impede or hinder any advancement of the moisture.

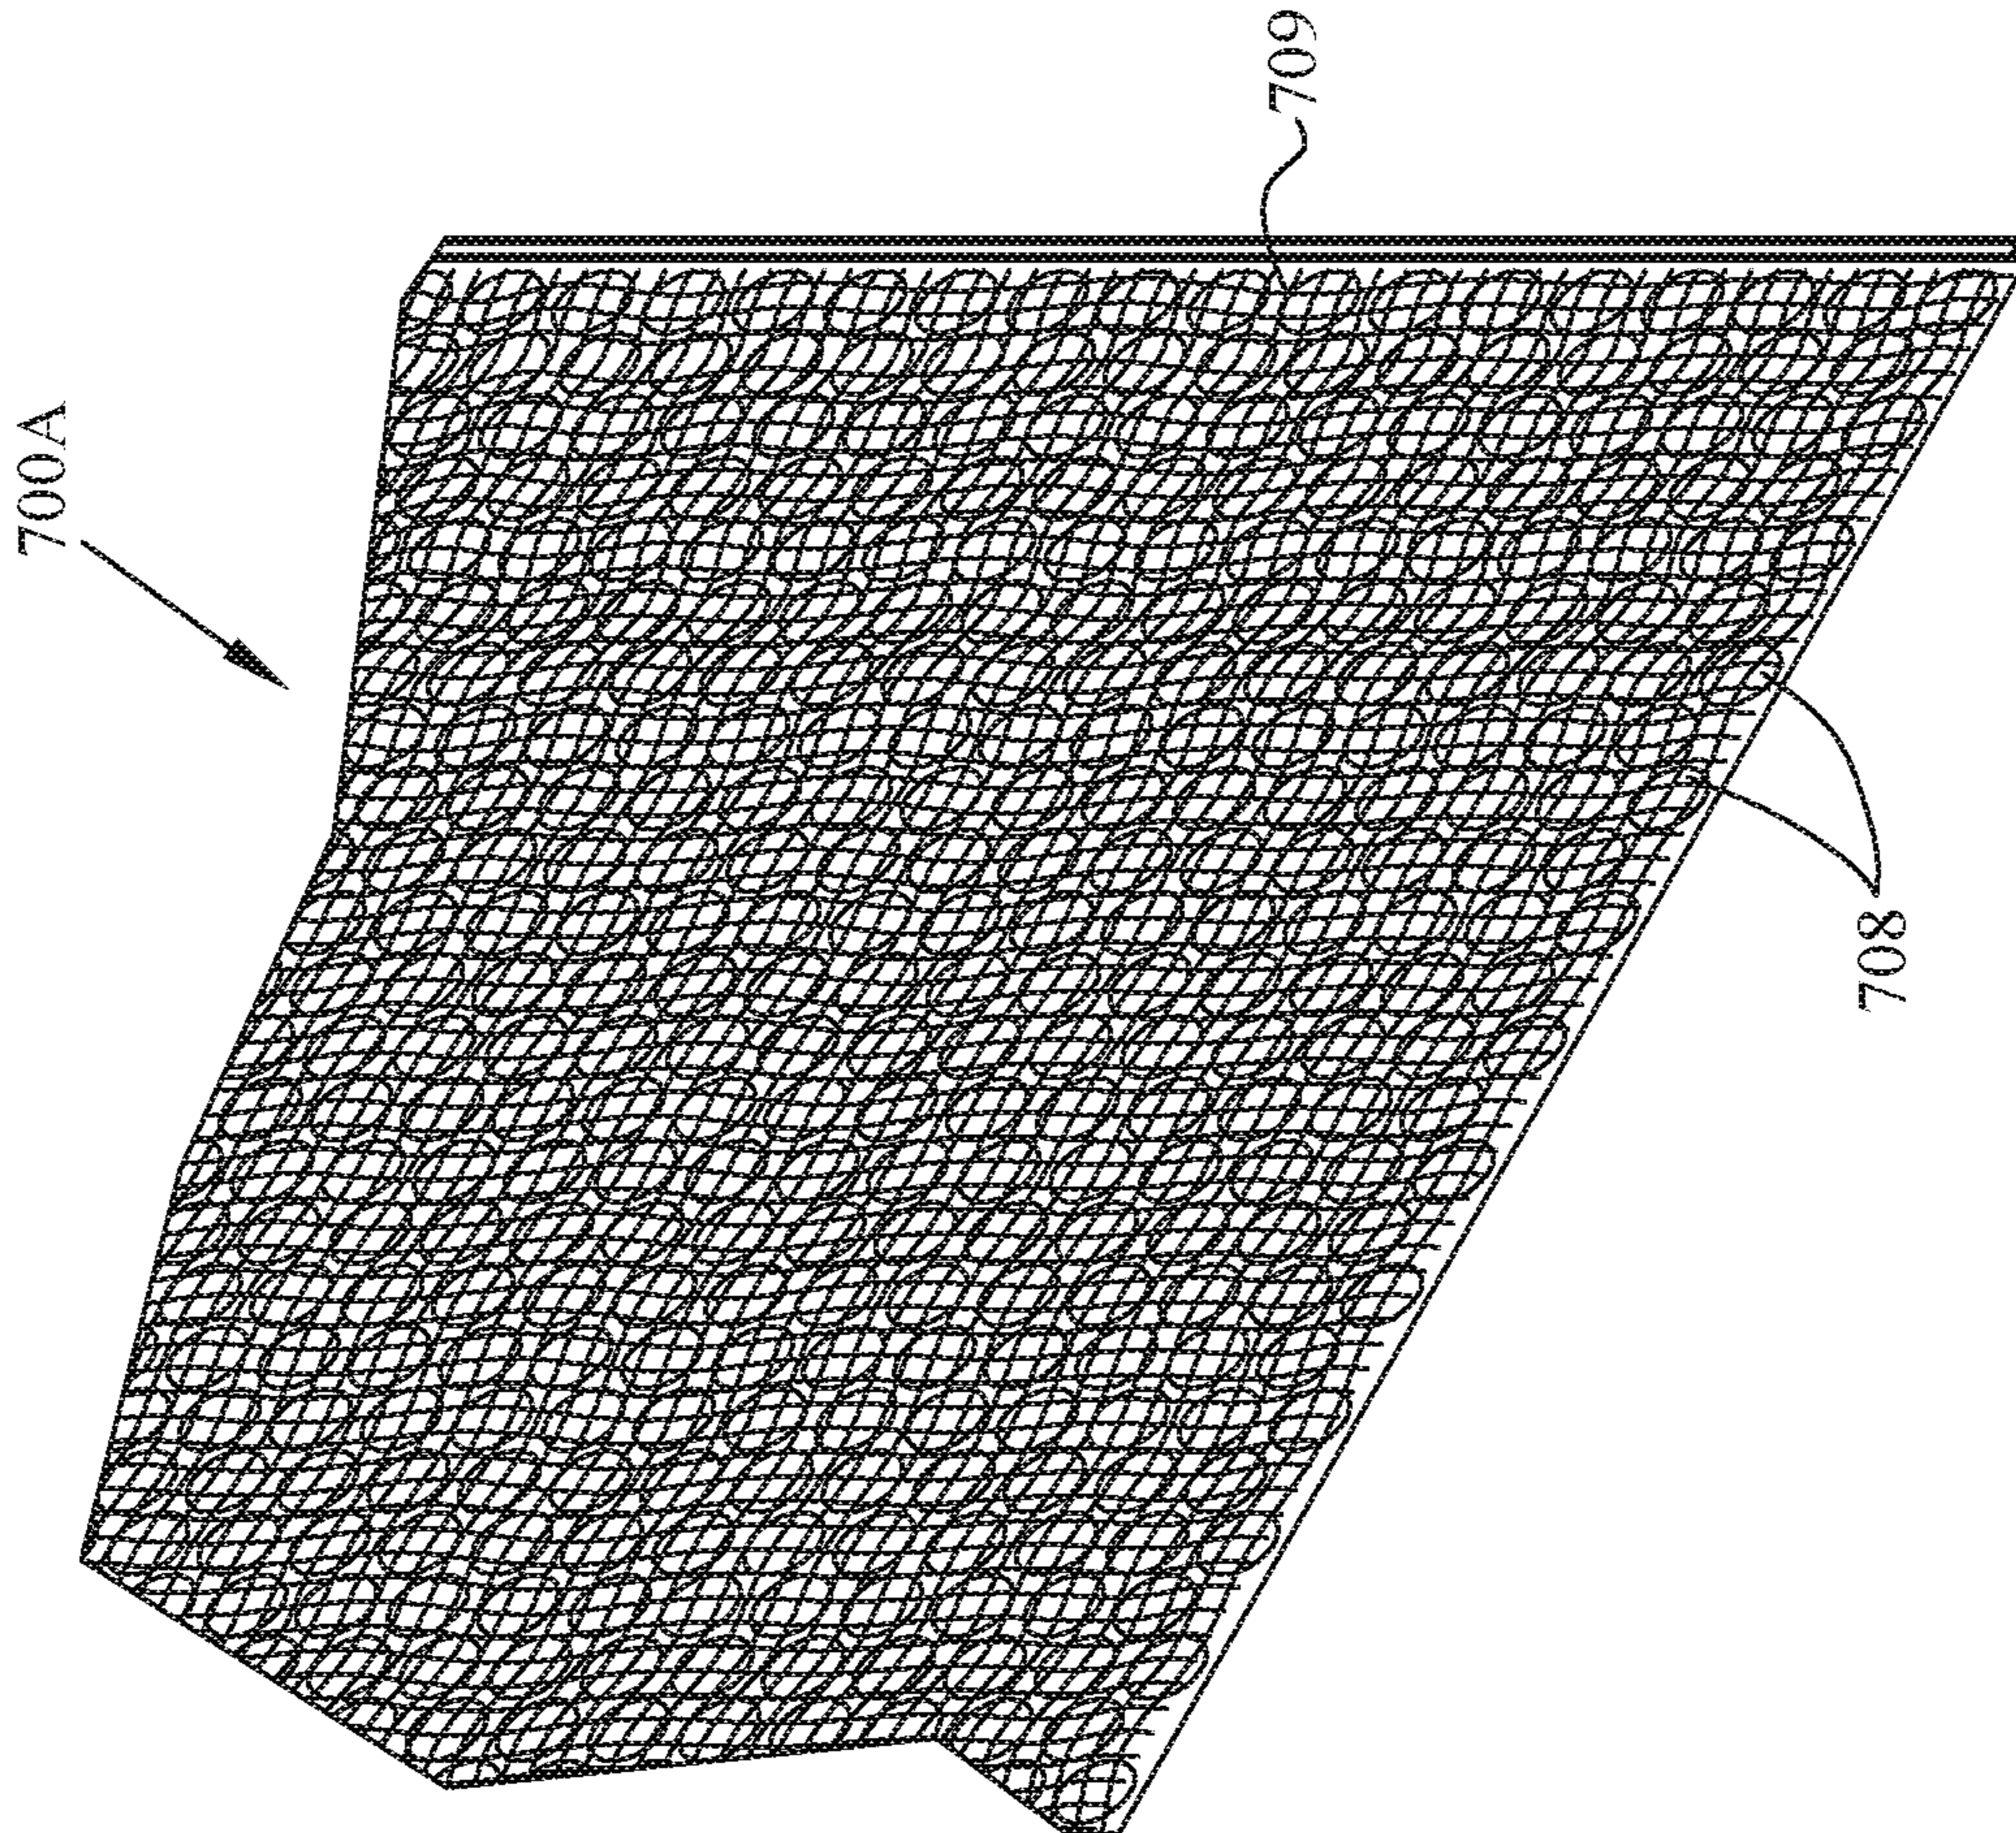
FIG. 36 is a plan perspective plan view of the vehicle frame and cargo bay liner of FIG. 35 showing the dimpled side having the woven material thereon;

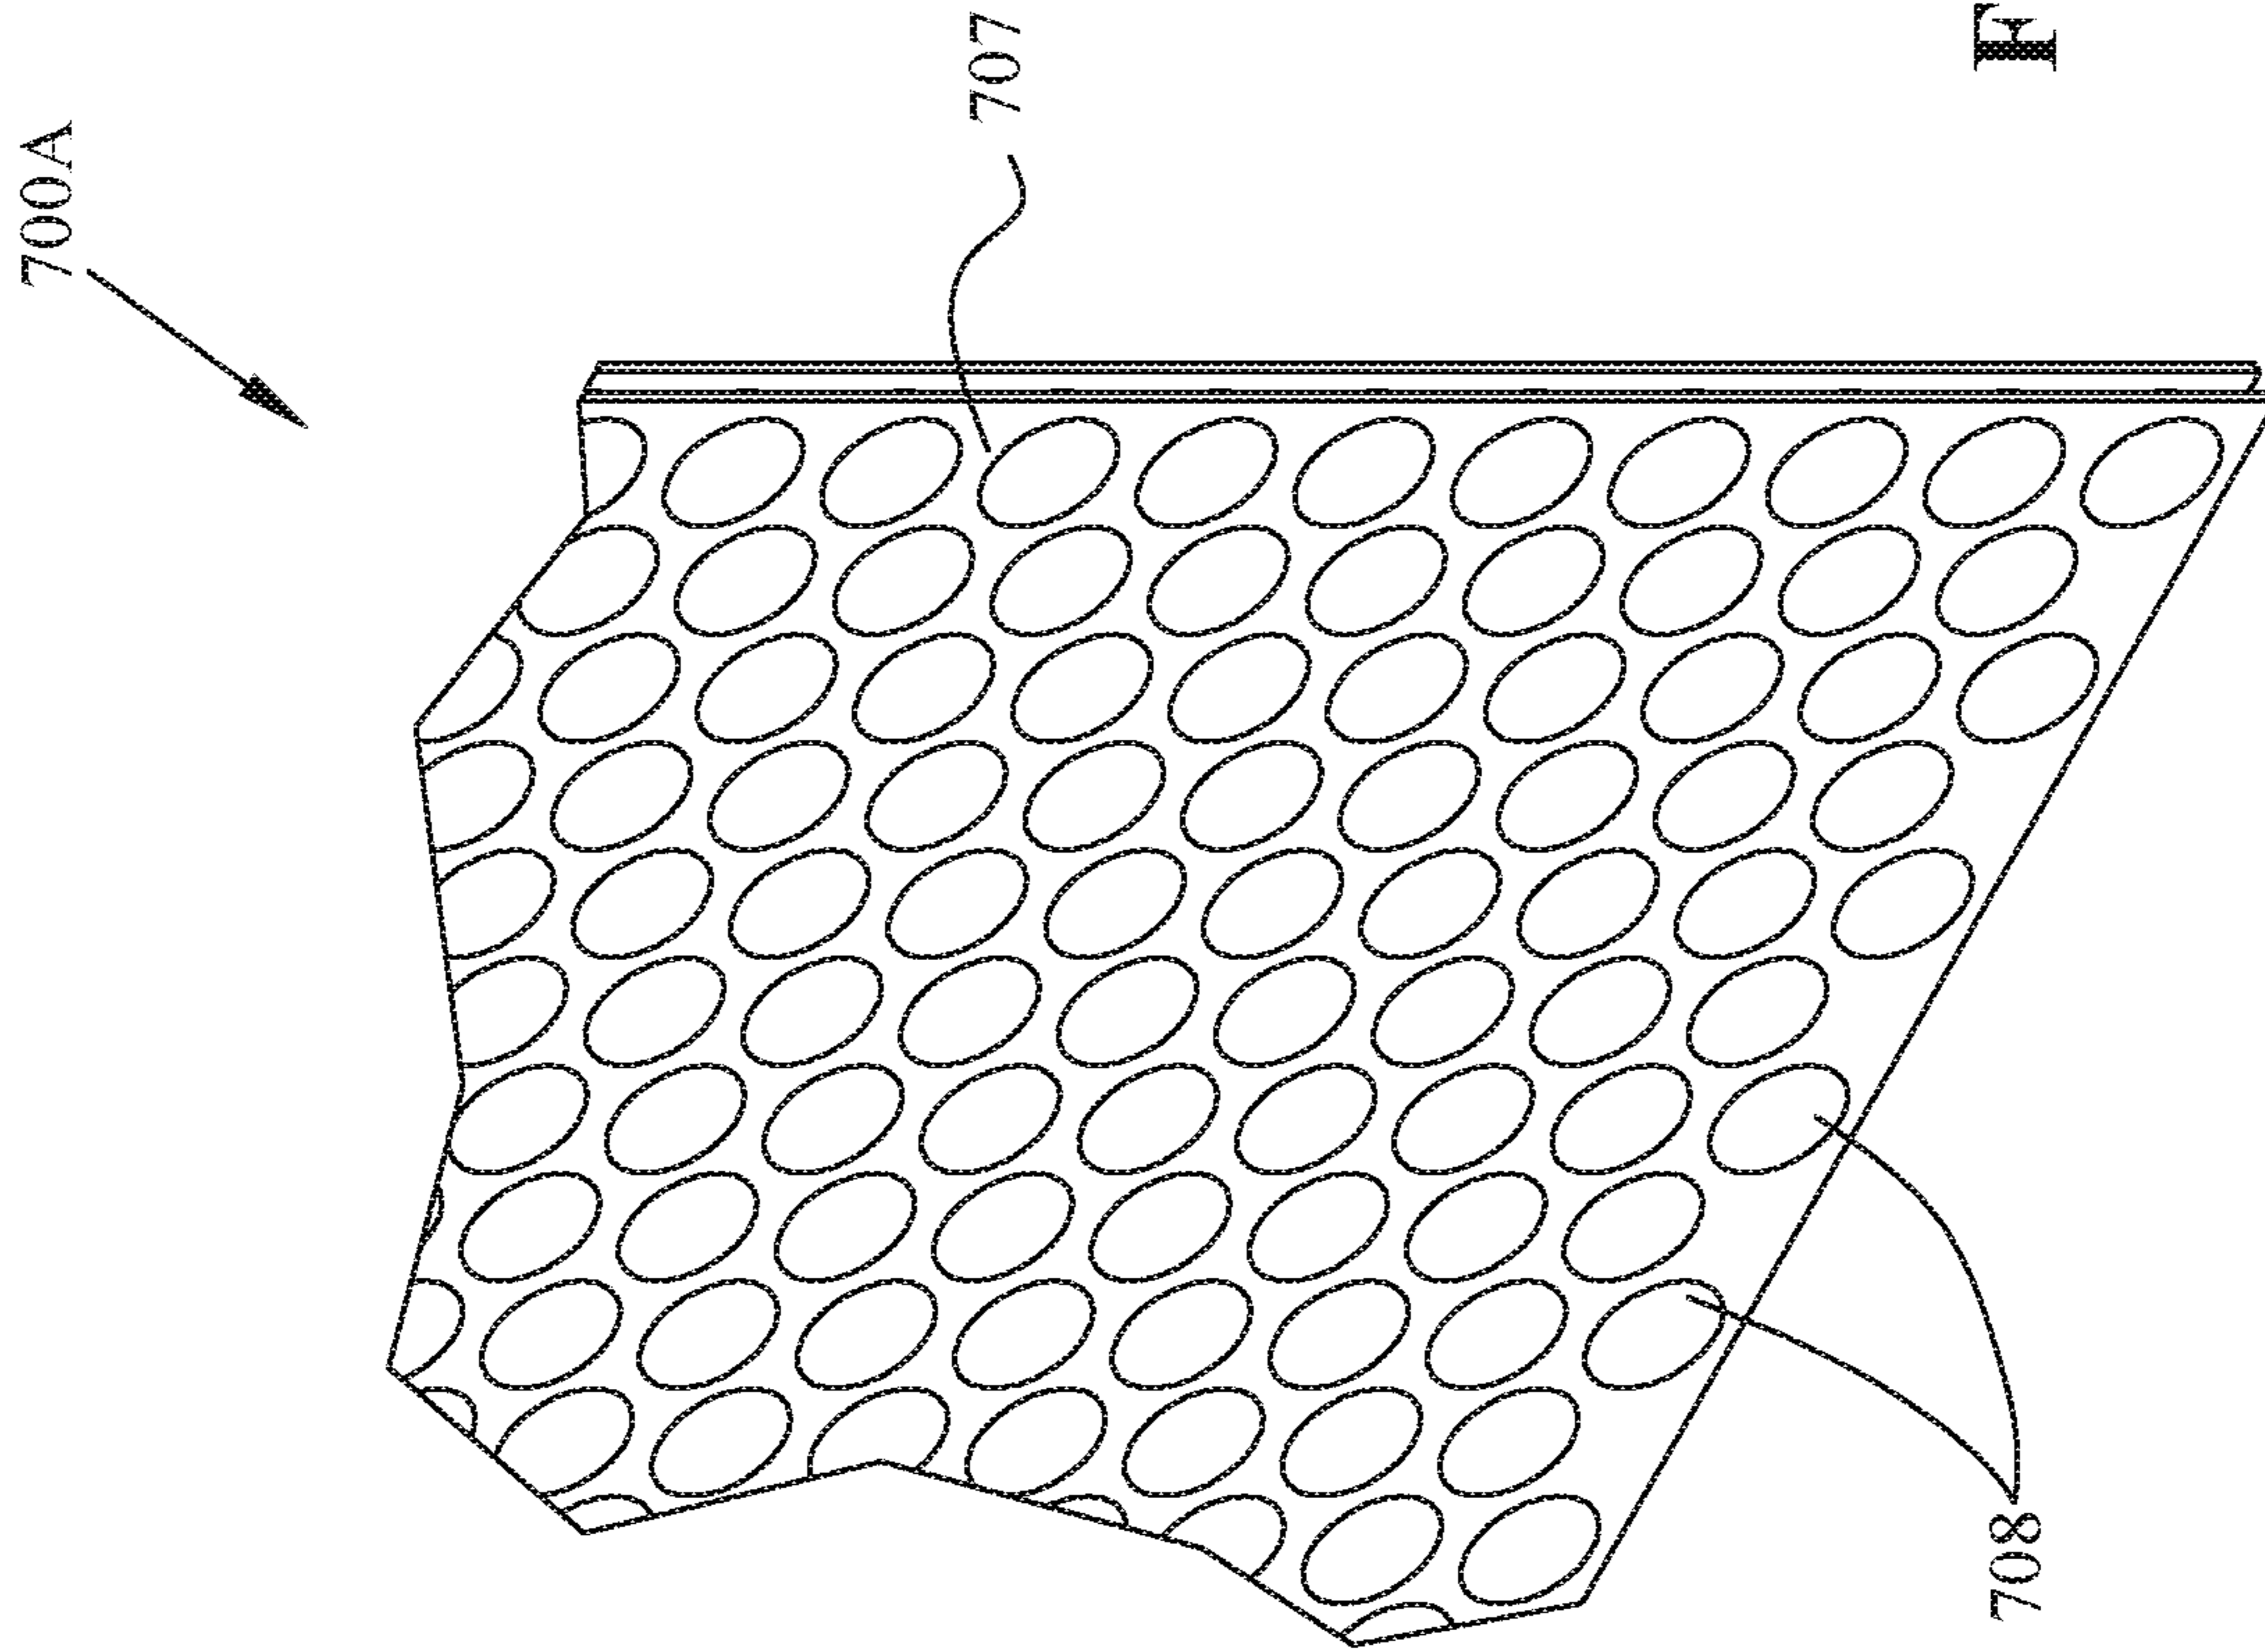
FIG. 37 is a plan perspective plan view of the vehicle frame and cargo bay liner of FIG. 35 showing the convex side having the aluminum foil thereon side;

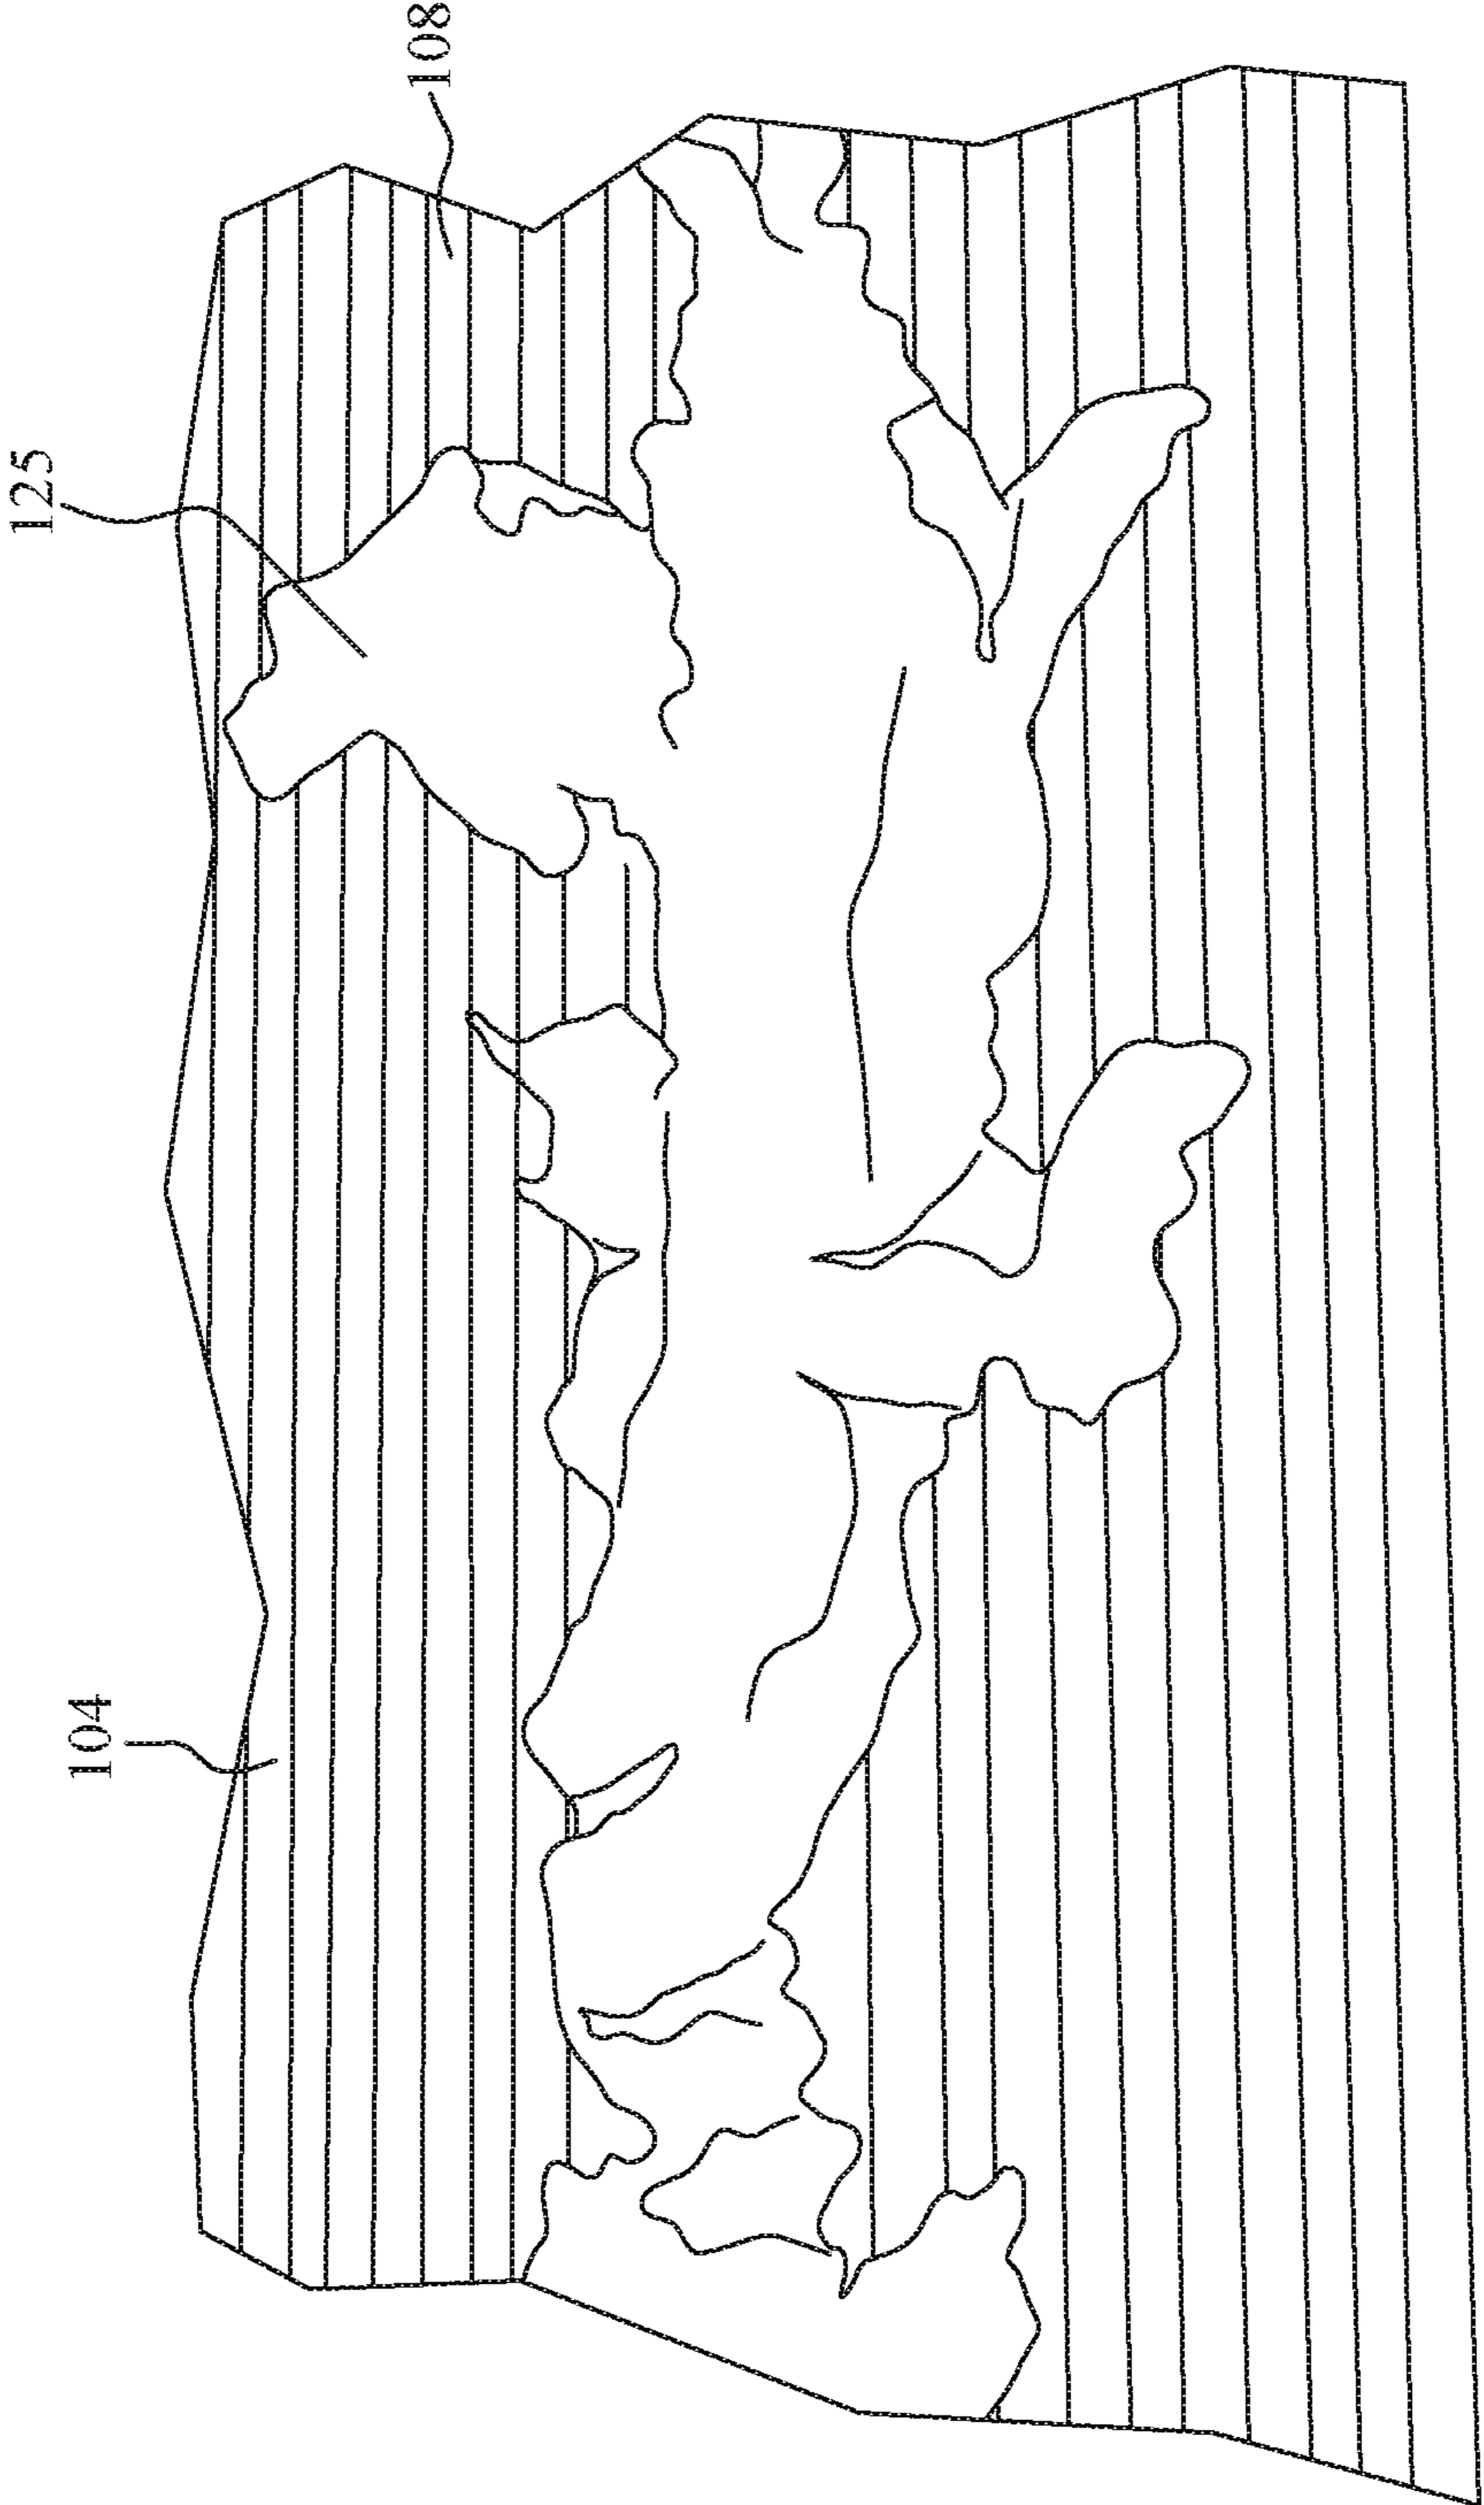
FIG. 38 is a plan perspective view showing a foam sealing material adhered to the bottom of a prior art liner;

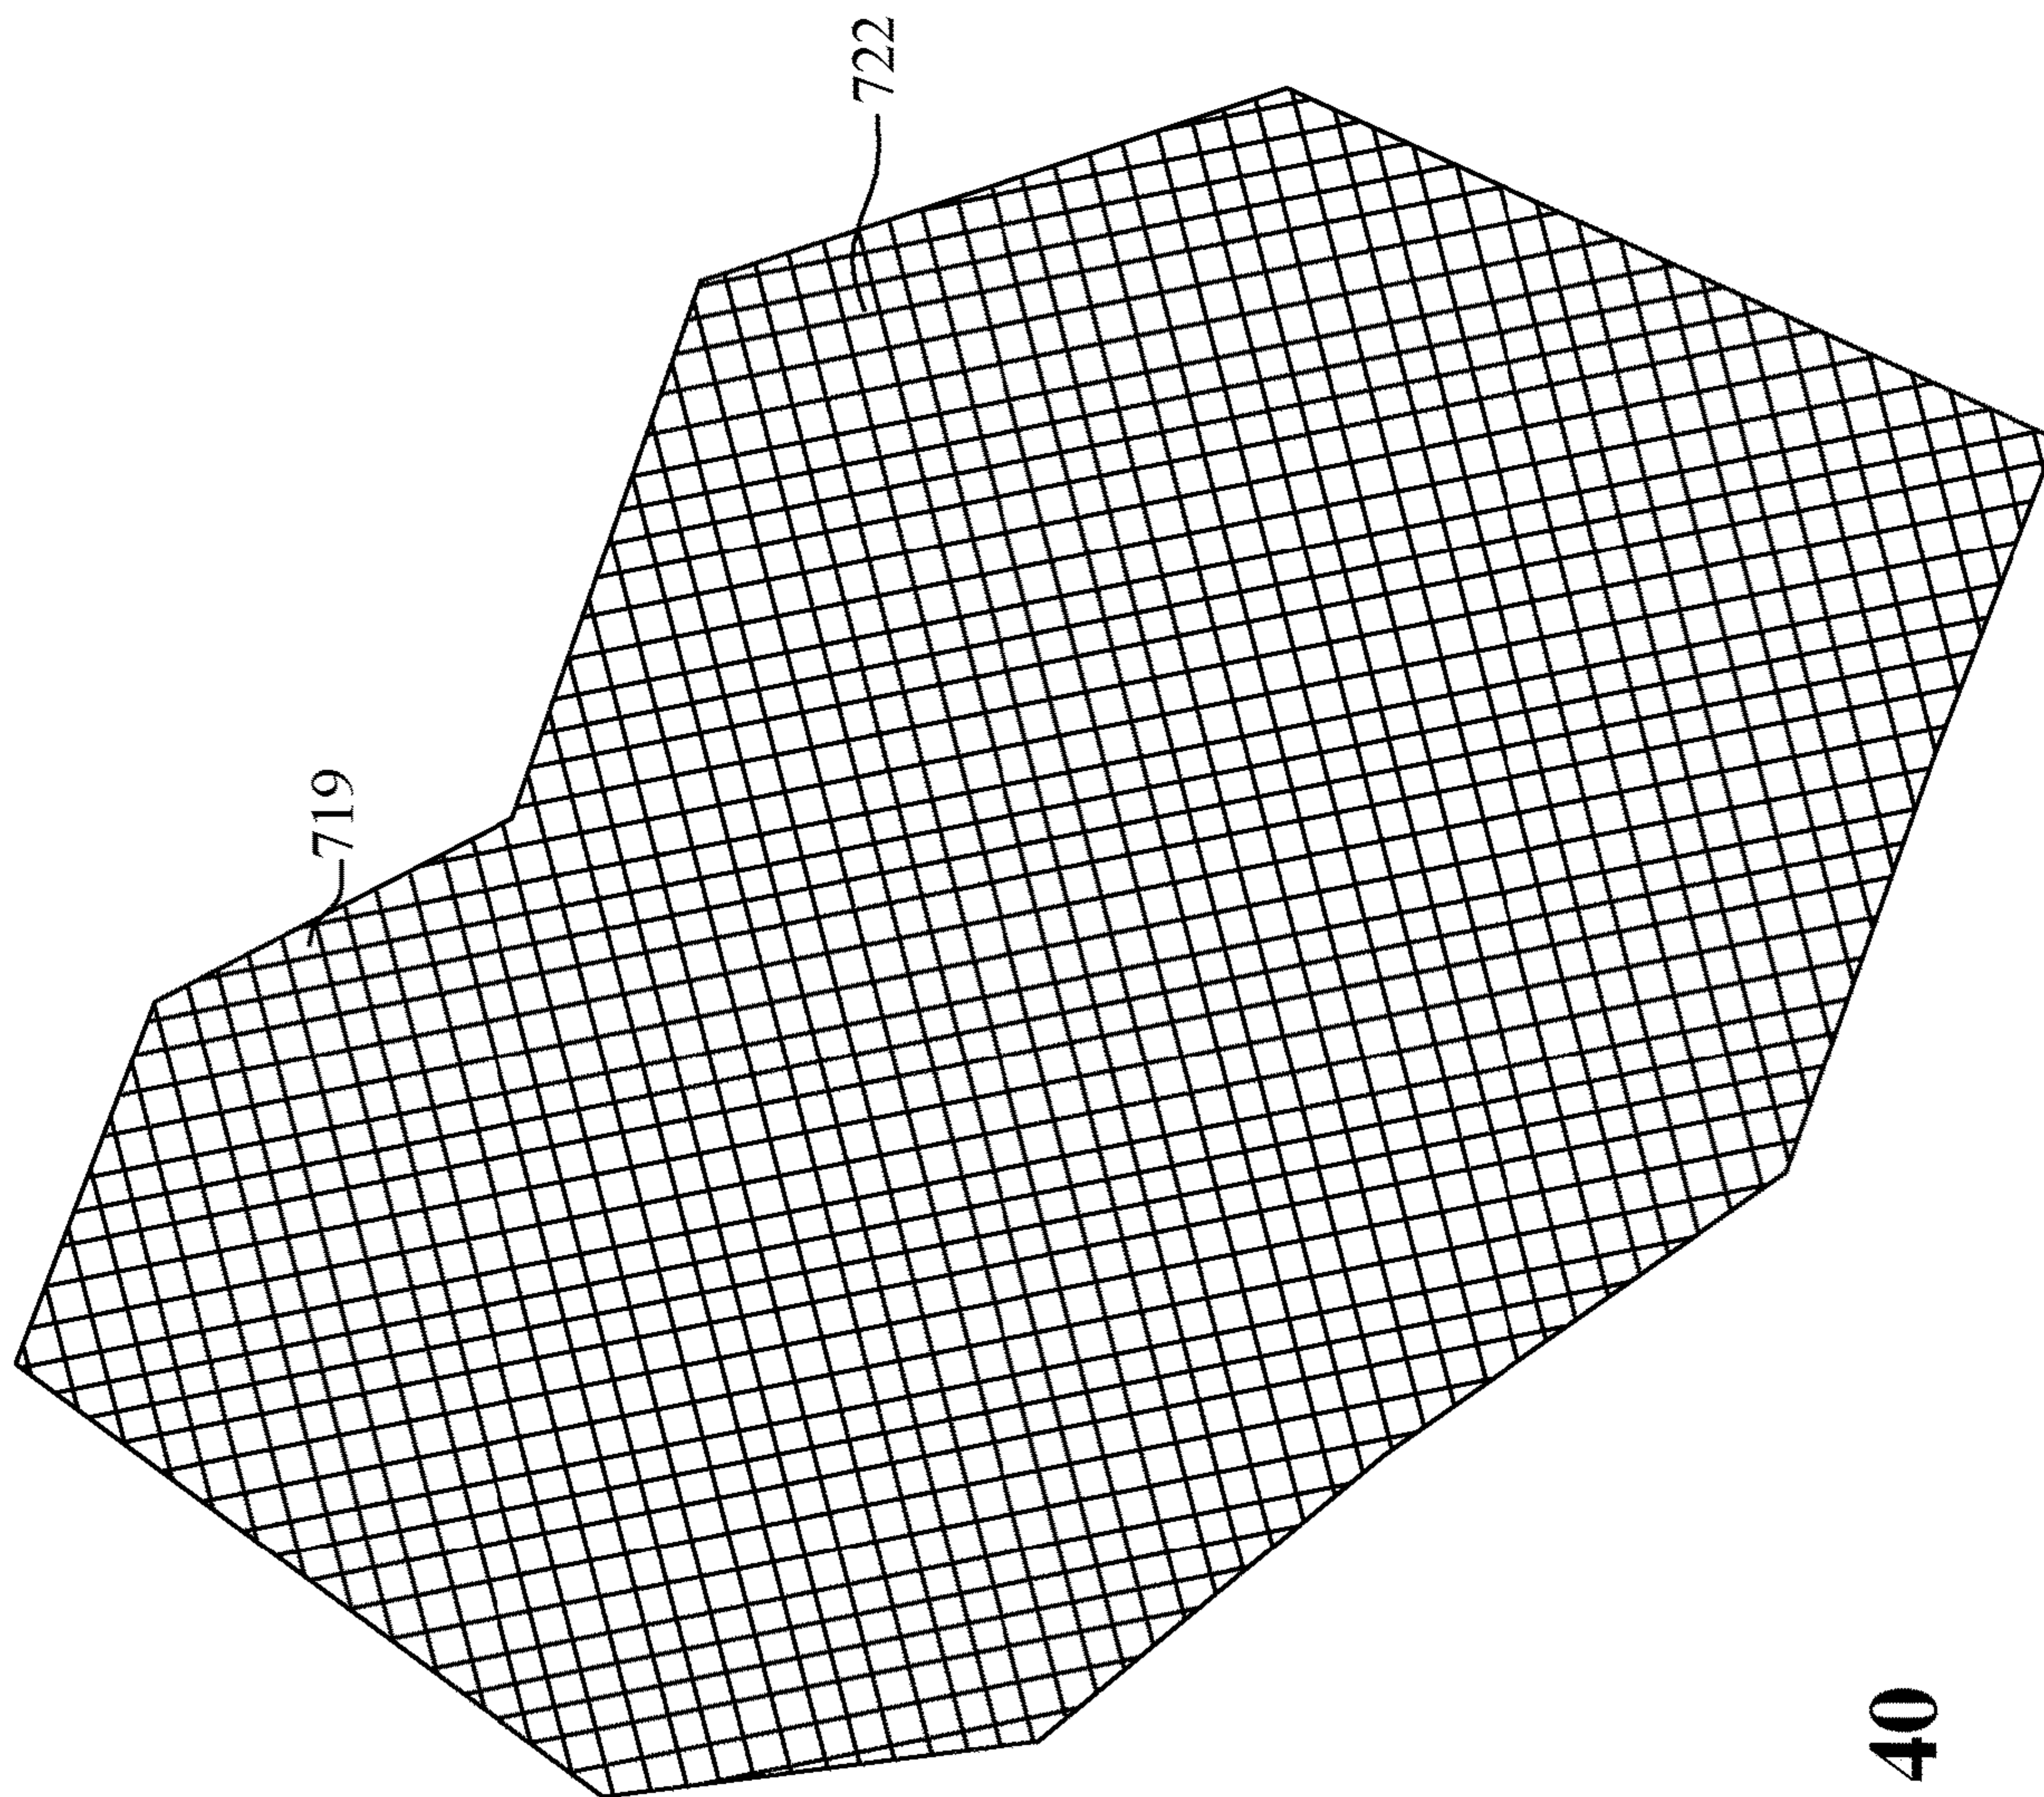
FIG. 40 is an enlarged plan view of the woven material repair tape;

Now referring now to FIGS. **39-42**, a unique repair and reinforcing system is provided for any of the liners provide herein and may be used to repair rips, tears or holes in the

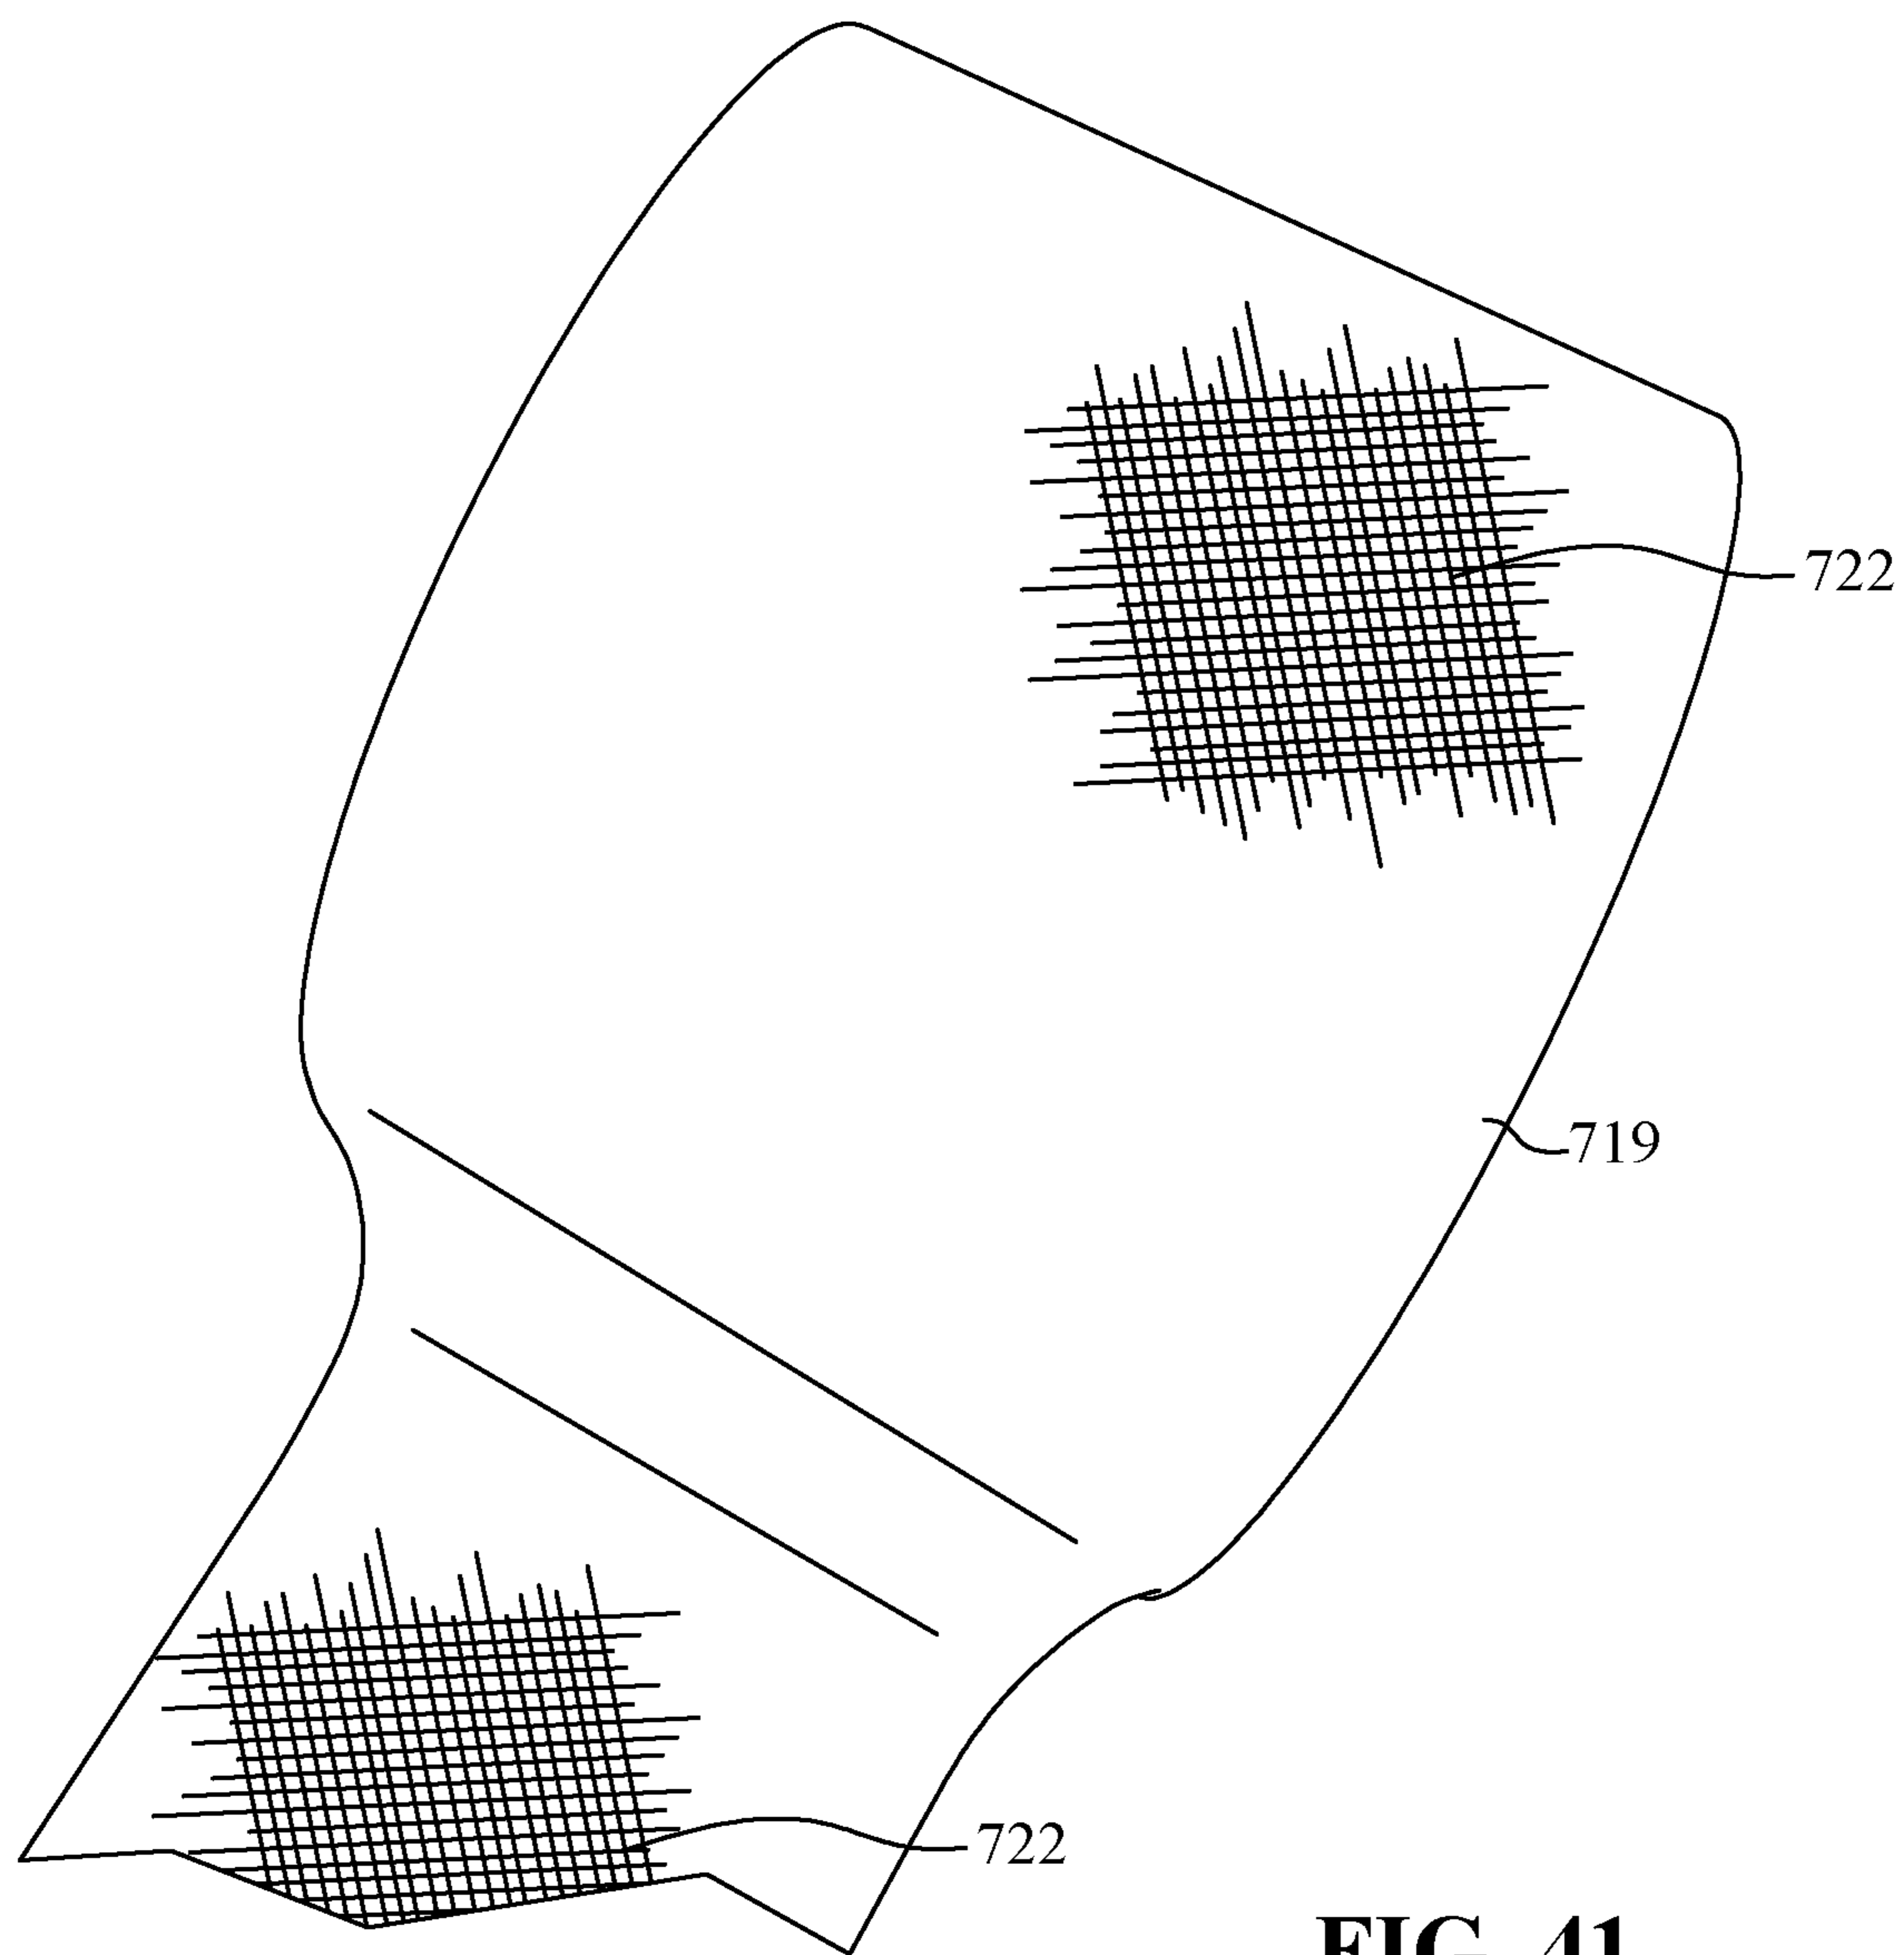
FIG. 41 is another plan view of the role of woven material repair tape;
