US011447189B1

(54) **VEHICLE FRAME AND CARGO BAY LINER**

A vehicle and liner assembly is provided that includes a  
recreational vehicle having a housing, a front end, a rear end,  
a top, a bottom, and a pair of sidewalls. A frame assembly  
is provided wherein, the housing is mounted on and sup-  
ported by the frame assembly. The liner is attached to the  
frame assembly and covers at least a substantial portion of the  
bottom of the housing. The liner has a first face having  
projections extending therefrom and a second face having  
openings therein. The openings coincide with and extend  
into corresponding projections on the first face.

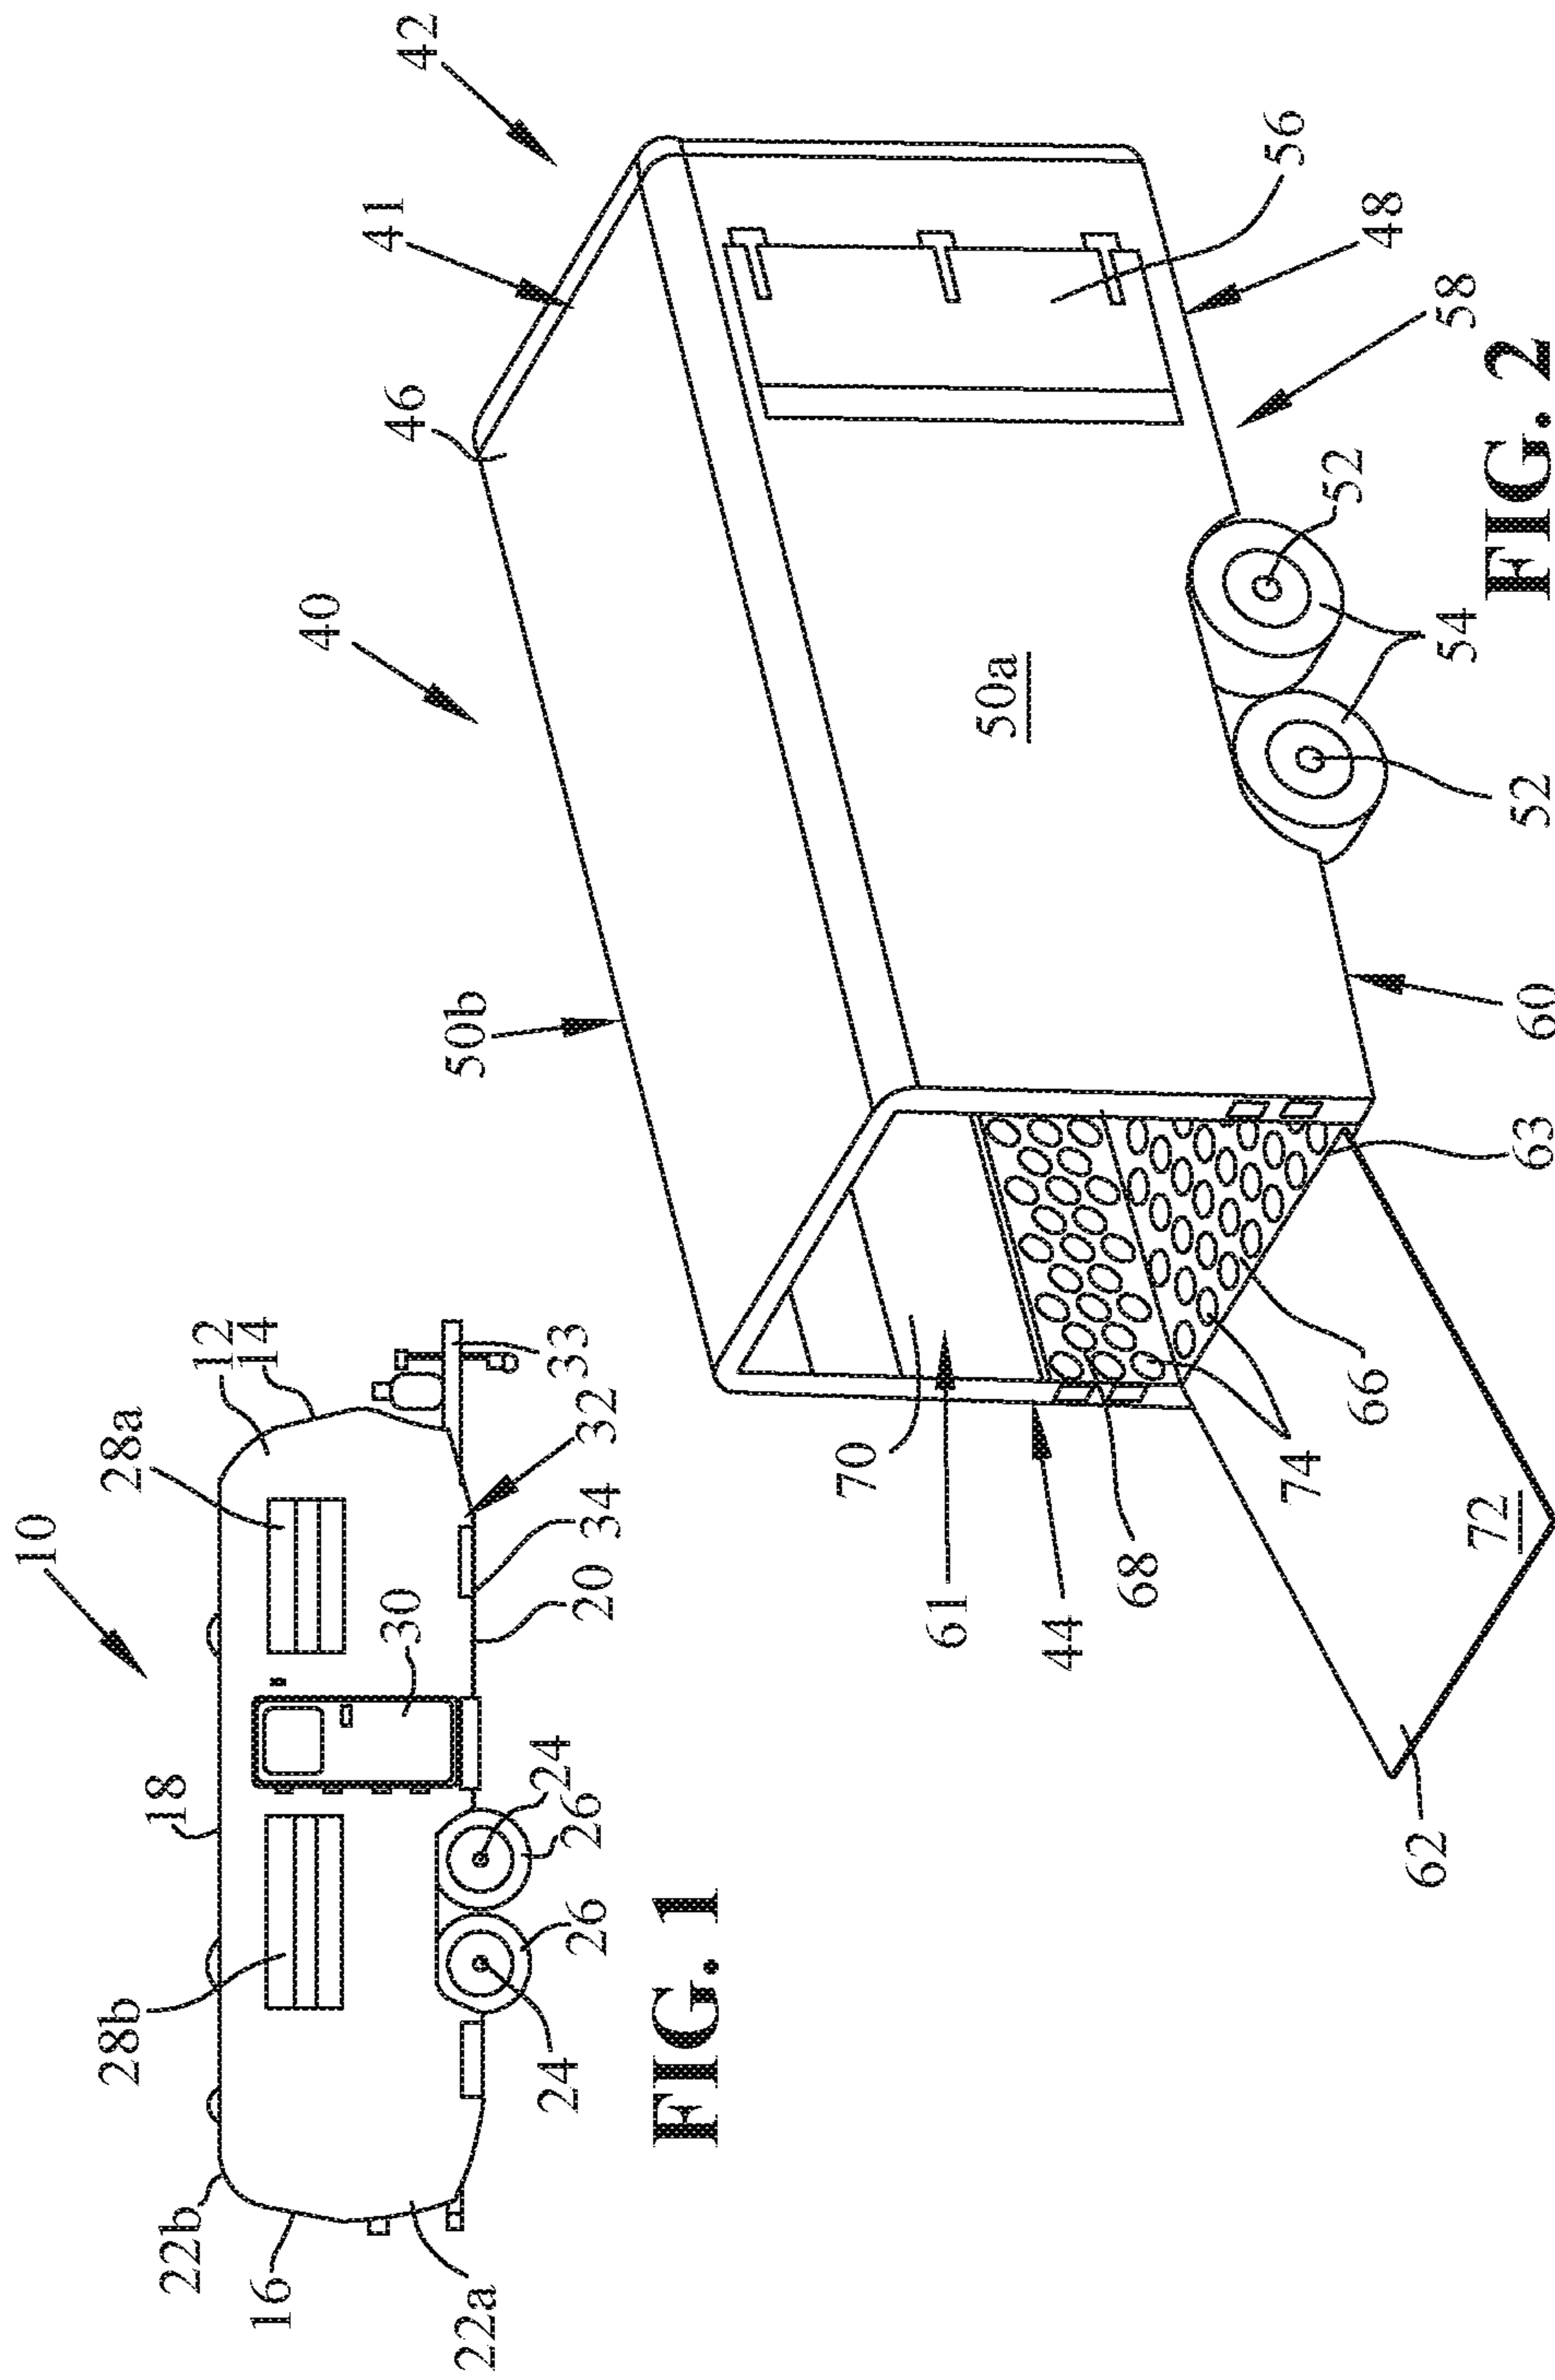
FIG. 1 is a side view of a recreational vehicle and frame liner in accordance with the subject invention;

FIG. 2 is a perspective view of a cargo trailer and cargo bay liner in accordance with the subject invention;

Referring now to FIG. 1, a recreational vehicle is shown generally indicated as 10. In the embodiment shown, recreational vehicle 10 is a type commonly called a travel trailer. Travel trailer 10 is generally defined by a housing 12 including a front end 14, a rear end 16, a top 18, a bottom 20, and a pair of generally parallel sides 22a, 22b. Recreational 10 further includes a pair of axels 24 having wheels 26 mounted thereon. Recreational vehicle 10 also includes windows 28a, 28b and a door 30. Housing 14 is mounted upon and supported by a frame assembly, generally indicated as 32, extending into a hitch 33. These are all known and common in the recreational vehicle industry. A liner 34

in accordance with the subject invention is mounted and attached at the bottom of frame assembly 32 to protect the undercarriage of recreational vehicle 10 as described above in the background section.

Now referring to FIG. 2, a trailer of a type normally considered a cargo trailer or toy hauler is shown generally indicated as 40. A toy hauler is generally considered to be a vehicle that has at least a portion or all of the trailer designed as a cargo area or bay to contain and transport another type of vehicle, such as but not limited to motorcycles, ATV's, snowmobiles, or specialty vehicles. Similar to recreational vehicle 10, carbon trailer 40 is defined by a housing, generally indicated as 41. Housing 41 includes a front end 42, a rear end 44, a top 46, a bottom 48, and a pair of generally parallel sides 50a, 50b. Cargo trailer 40 further includes a pair of axels 52 having wheels 54 mounted thereon. Cargo trailer 40 also includes a door 56. Housing 41 is mounted upon and supported by a frame assembly, generally indicated as 58 that extends into a hitch 59. These are all known and common in the cargo trailer and toy hauler industry. Cargo trailer 40 includes a liner 60 in accordance with the subject invention that is mounted and attached at the bottom of frame assembly 58 to protect the undercarriage of cargo trailer 40 similar to recreational vehicle 10.

Cargo trailer 40 also includes a cargo or bay area, generally indicated as 61 which is accessed through a door 62 which swings downward at rear end 44 on a bottom hinge 64. A floor liner 66 in accordance with the subject invention is mounted on top of the floor of cargo area 61 and a similar liner 68 is mounted on walls 70 of cargo area 61. In the embodiment shown, wall liner 68 is mounted partially up wall 70; however, it should be appreciated that the liner could be mounted to extend completely up wall 70. The liner may also be mounted partially or completely on a front wall of cargo area 61 as well on an inside surface 72 of rear door 62. Although not shown to scale, in embodiments shown in FIG. 2, liners 66 and 68 include projections 74 extending from the liner into the cargo area.

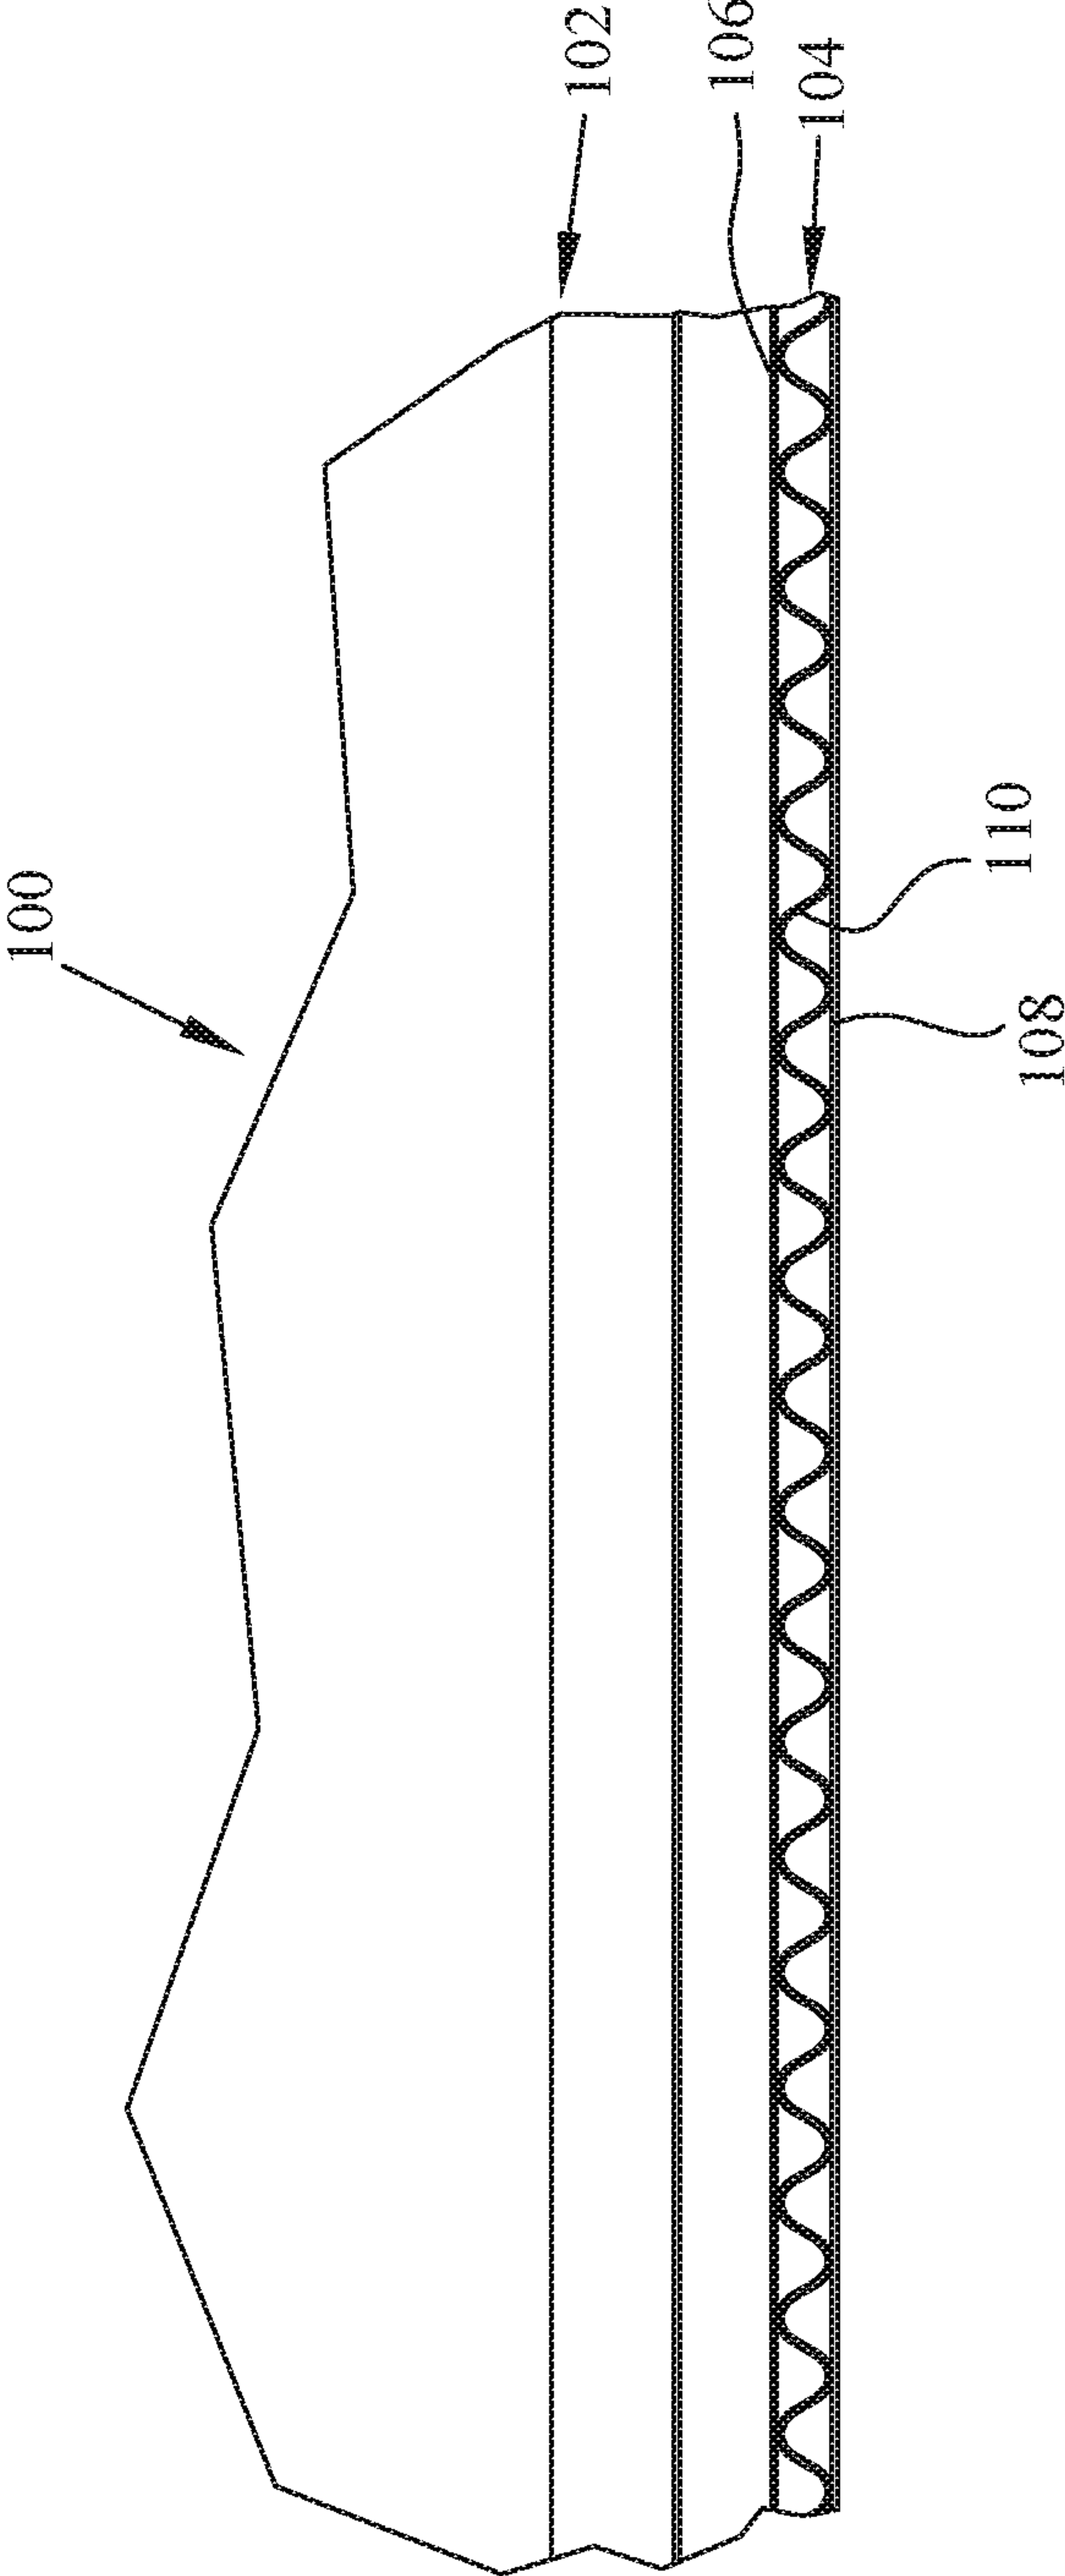
**FIG. 3**  
**(PRIOR ART)**

FIG. 3 is a side view of a prior art recreational vehicle frame liner;

Referring now to FIGS. 3 and 4, these depict prior art vehicle undercarriage frame liners in common use in the industry. A portion of a recreational vehicle is generally indicated as 100. Recreational vehicle 100 includes a frame assembly generally indicated as 102 and a corrugated liner generally indicated as 104. Corrugated liner 104 includes a top sheet 106, a bottom sheet 108, and a corrugated or sinusoidal ply 110 extending therebetween. Top sheets 106 and 108 are adhered or attached to corrugated ply 110. Typically, the corrugated material is polyethylene.

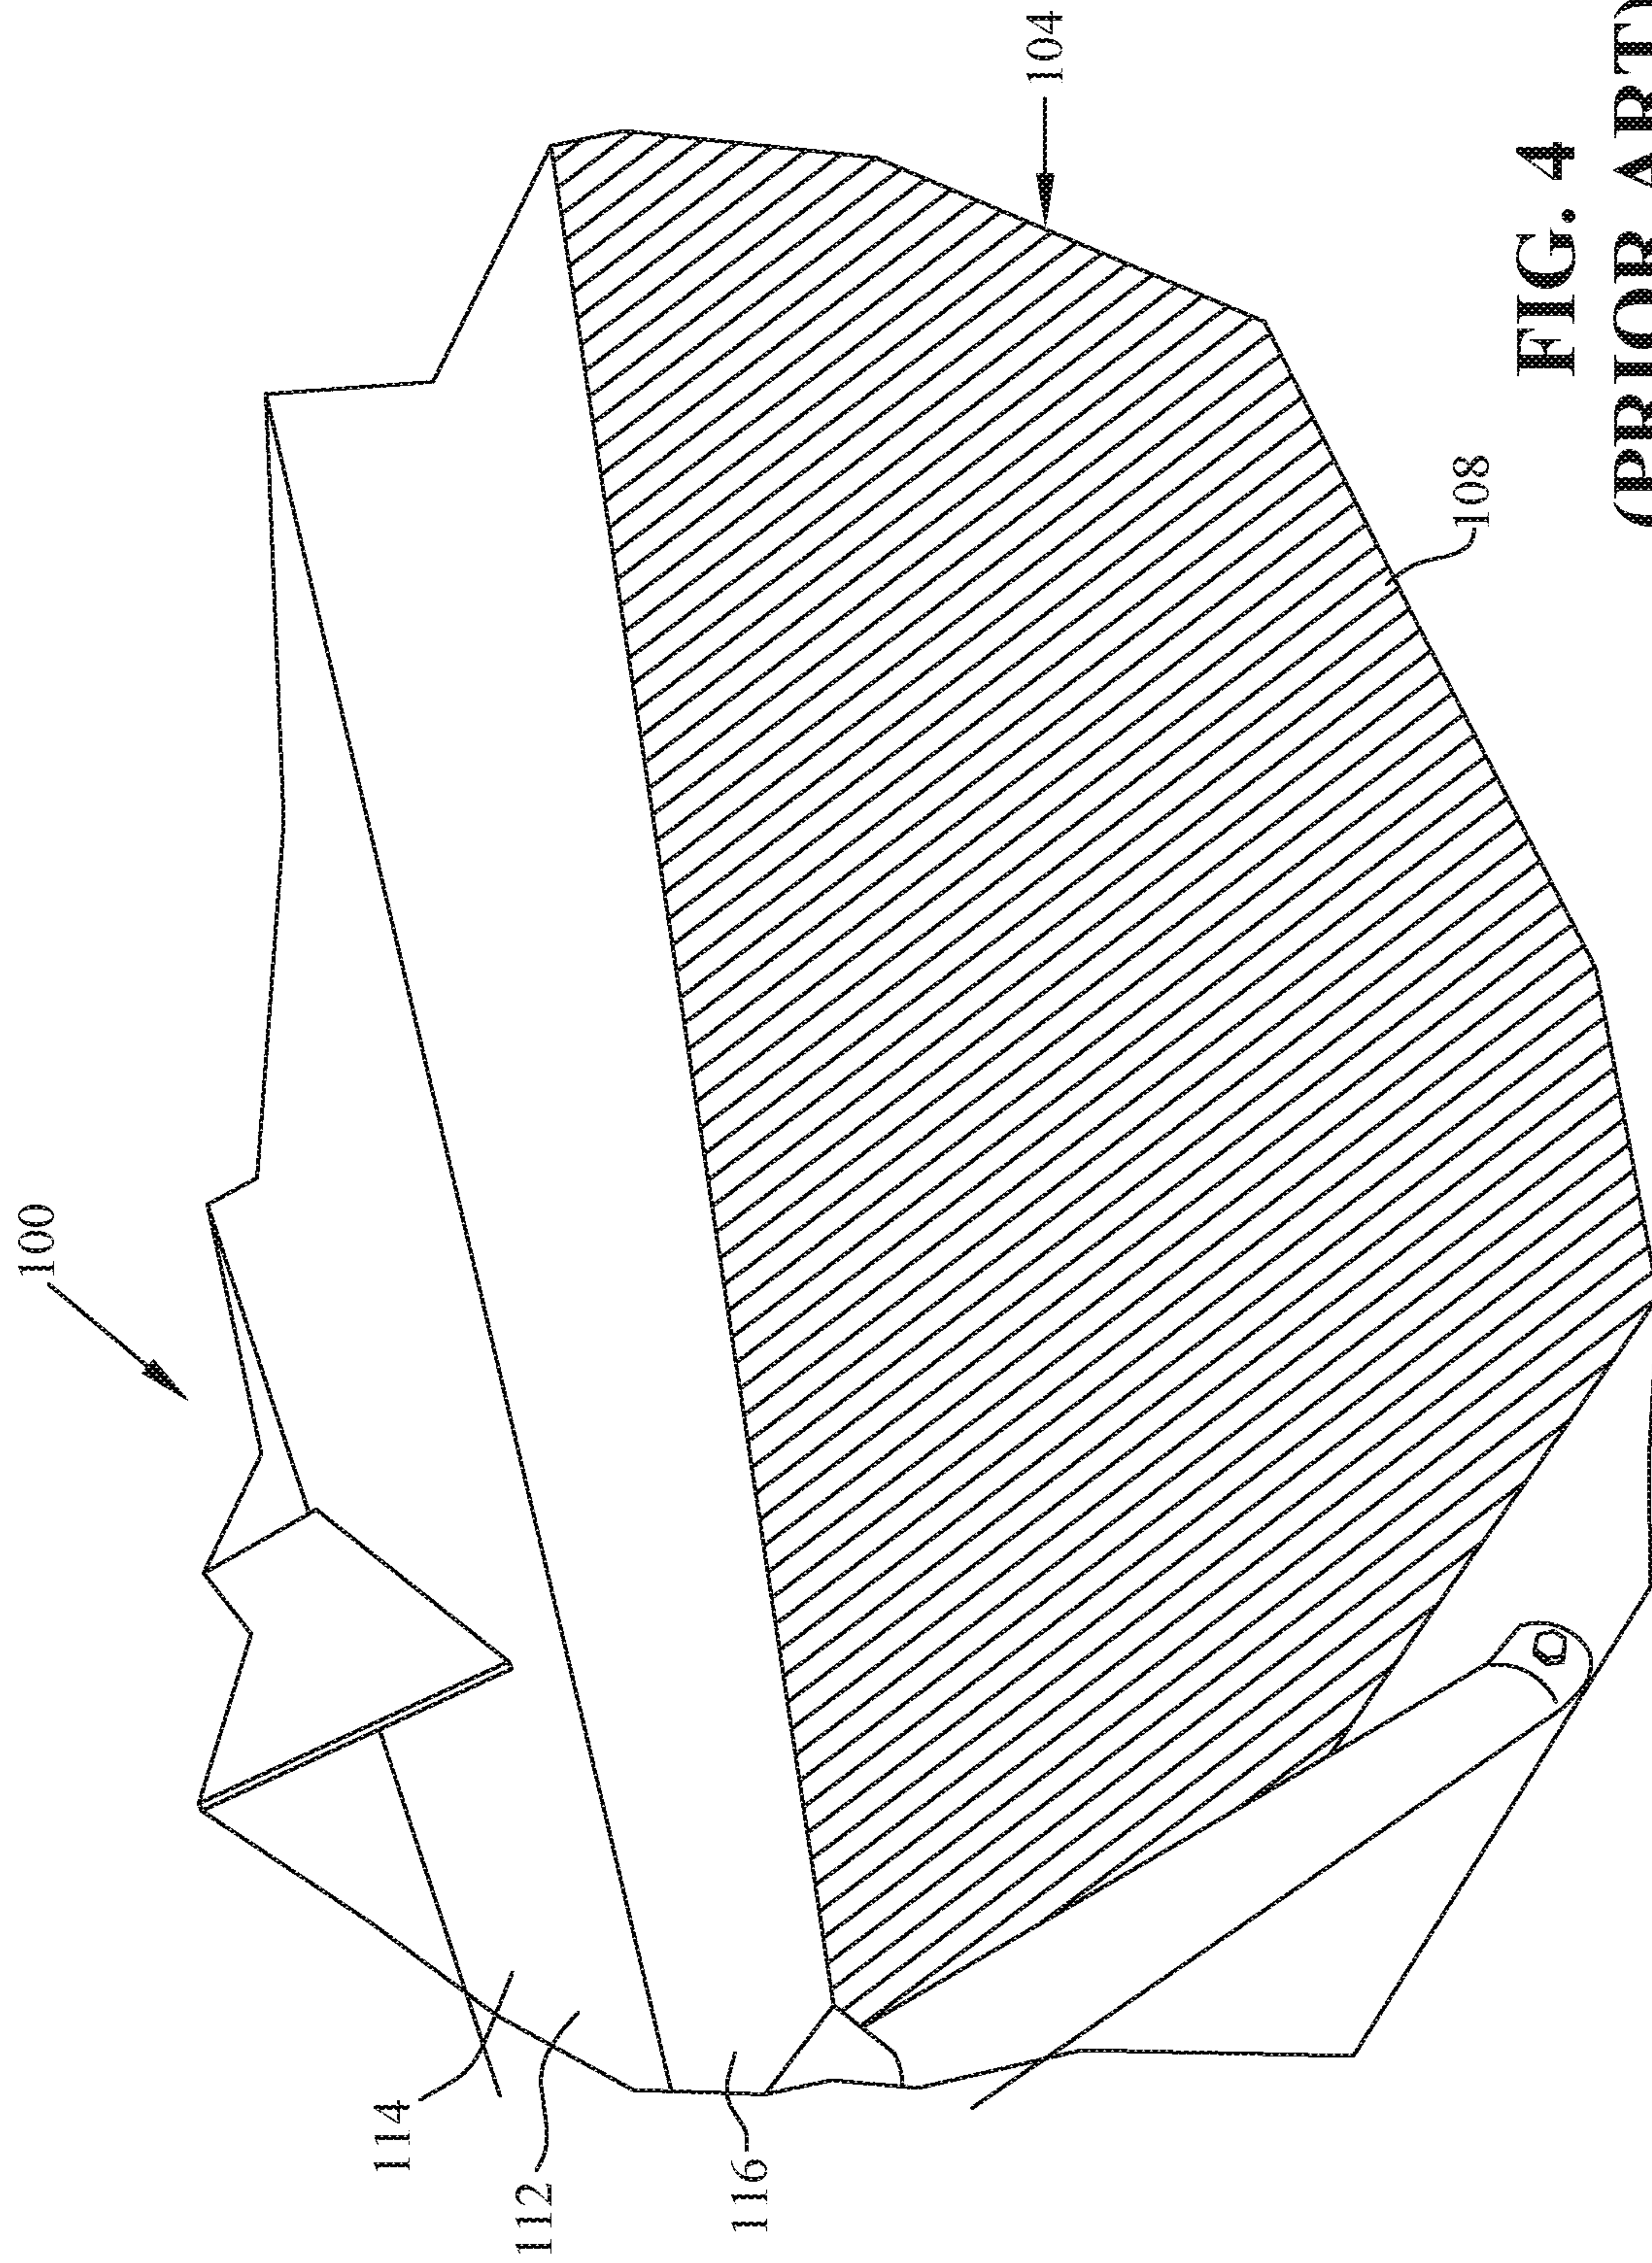
**FIG. 4**  
**(PRIOR ART)**

FIG. 4 is a bottom prospective view of a prior art recreational vehicle and frame liner;

Referring to FIG. 4, only the bottom sheet 108 of corrugated liner 104 is visible. Furthermore, the corrugations are not visible as recreational vehicle 100 includes a frame member 112, such as in I-beam or C-channel including a vertical web 112 and horizontal flange 116. Side edges of corrugated liner 104 are located on top of flange 112.

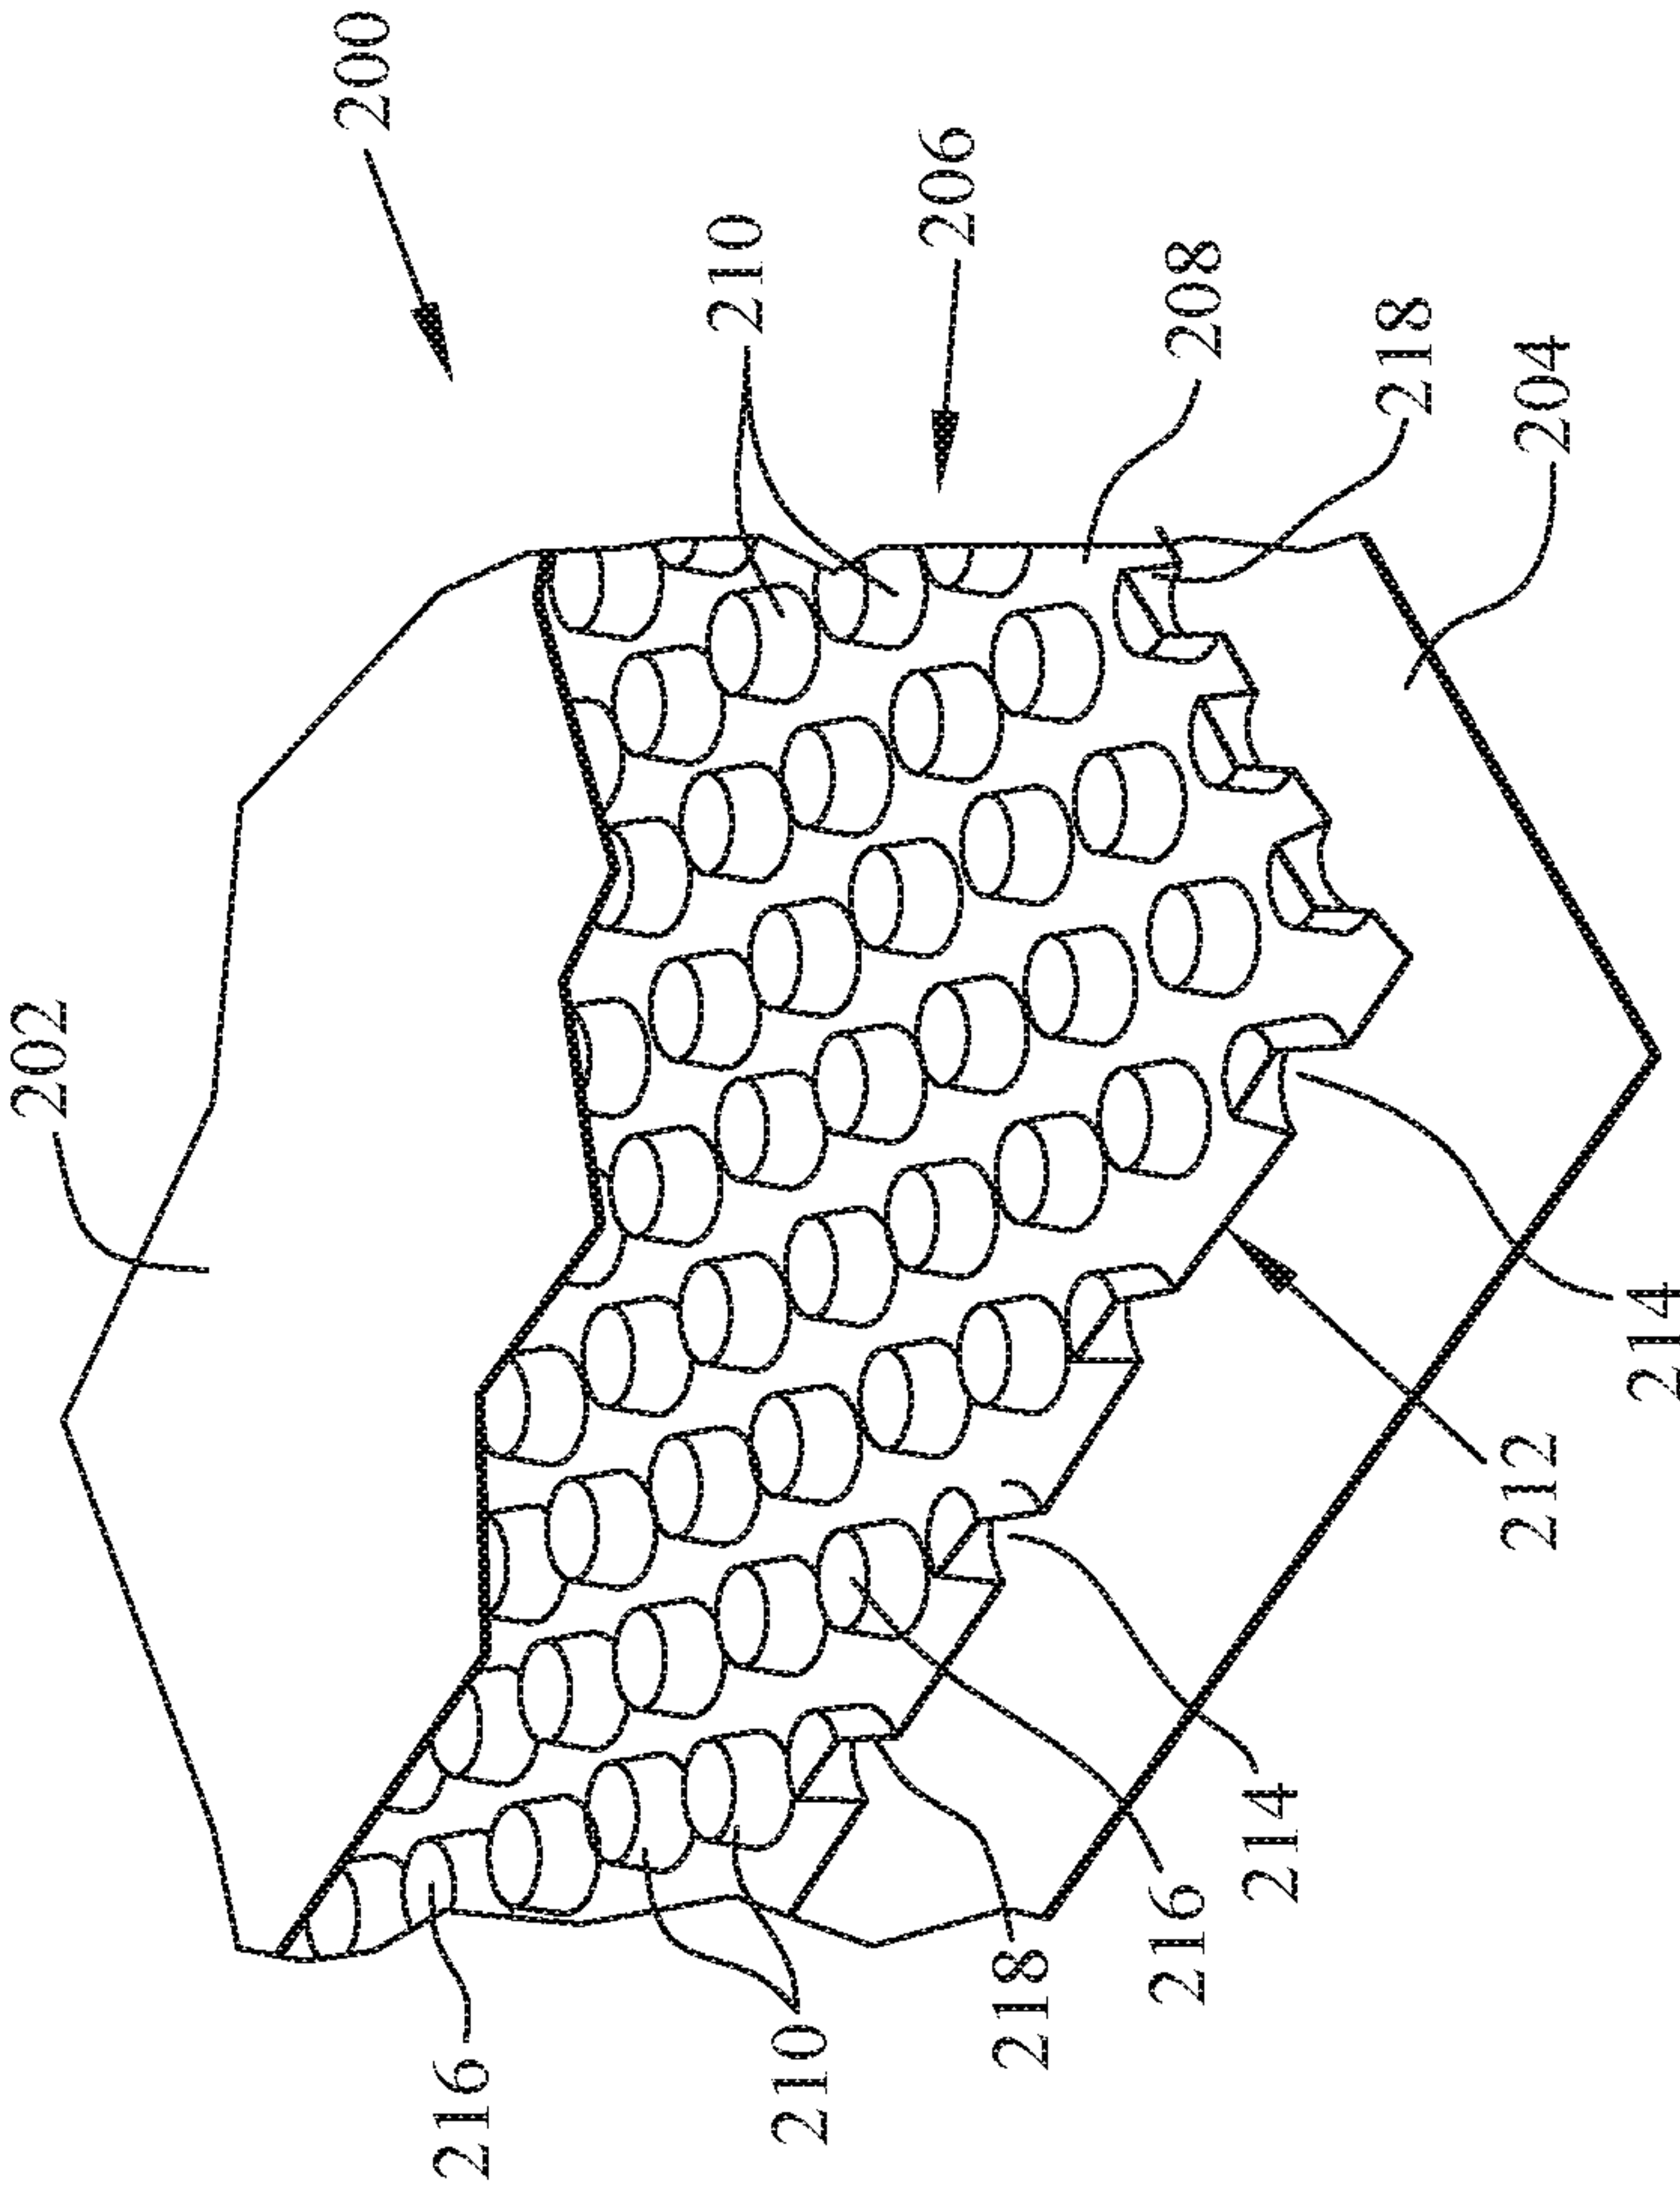
FIG. 5 is an exploded view of a sandwich material from which one embodiment of the liner for the subject invention is taken from;

Referring now to FIG. 5, an embodiment of a 3-ply panel from which the subject liner can be taken is generally indicated as 200. 3-ply panel 200 includes a top sheet 202, a bottom sheet 204, and a core generally indicated as 206. In a preferred embodiment, 3-ply panel 200 and core 206 is manufactured from polypropylene and is 100% recyclable. Core 206 may also be referred to as plastic honeycomb or plastic bubble board. 3-ply panel 200 may be provided in thicknesses of 10 mm, 5 mm or 3 mm. Applicant has found that the core 206 in a 3 mm thick 3-ply panel 200 is particularly suitable for use as a liner in accordance with the subject invention as will be discussed in further detail below. As can be seen in FIG. 5, core 206 has one face 208 having projections 210 extending upward therefrom. The opposite face 212 includes openings 214 extending downward into projections 212. Accordingly, projections 210 have a generally cylindrical configuration being hollow in the center thereof and including an end face 216 and side walls 218. Applicant has determined that one suitable 3-ply panel 200 from which core 206 may be extracted and used is IntePro® 3 mm Titan board from the IntePlast Group.

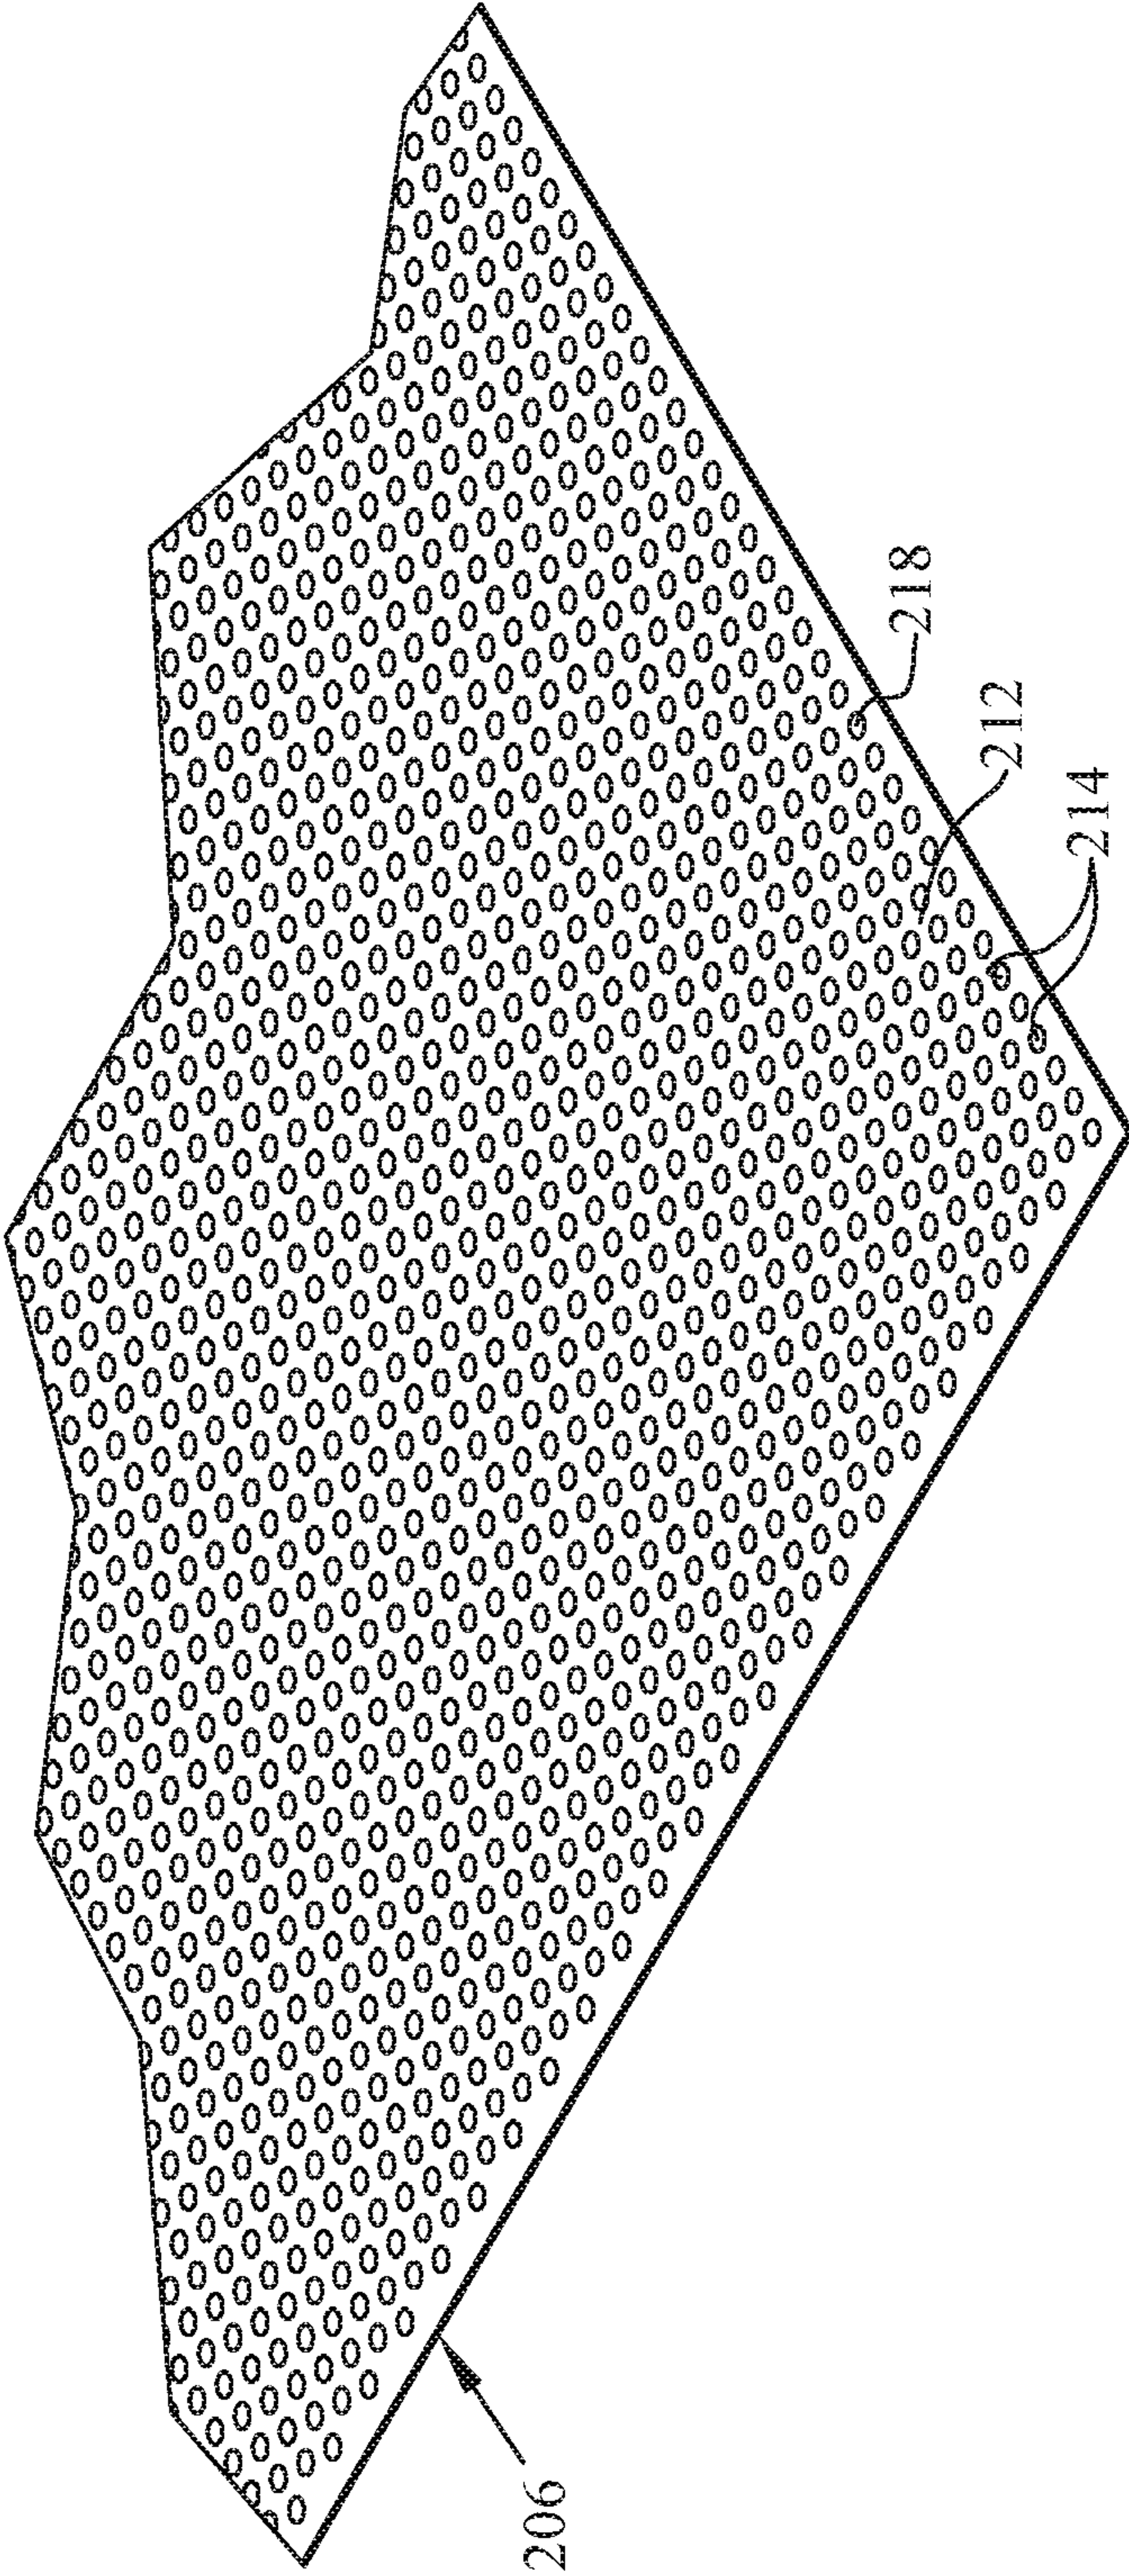
FIG. 6 is a perspective view of one embodiment of a vehicle frame liner and cargo bay liner of the subject invention, with top and bottom sheets removed, showing a face of the liner having openings therein;

Referring now to FIGS. 6-11, further details, of vehicle frame and cargo area liner/core 206 are disclosed. As can be seen, the projections and/or openings 210, 214, respectively are aligned in a lengthwise direction of core 206 but going crosswise across core 206, projections 210 and openings 214 are staggered.

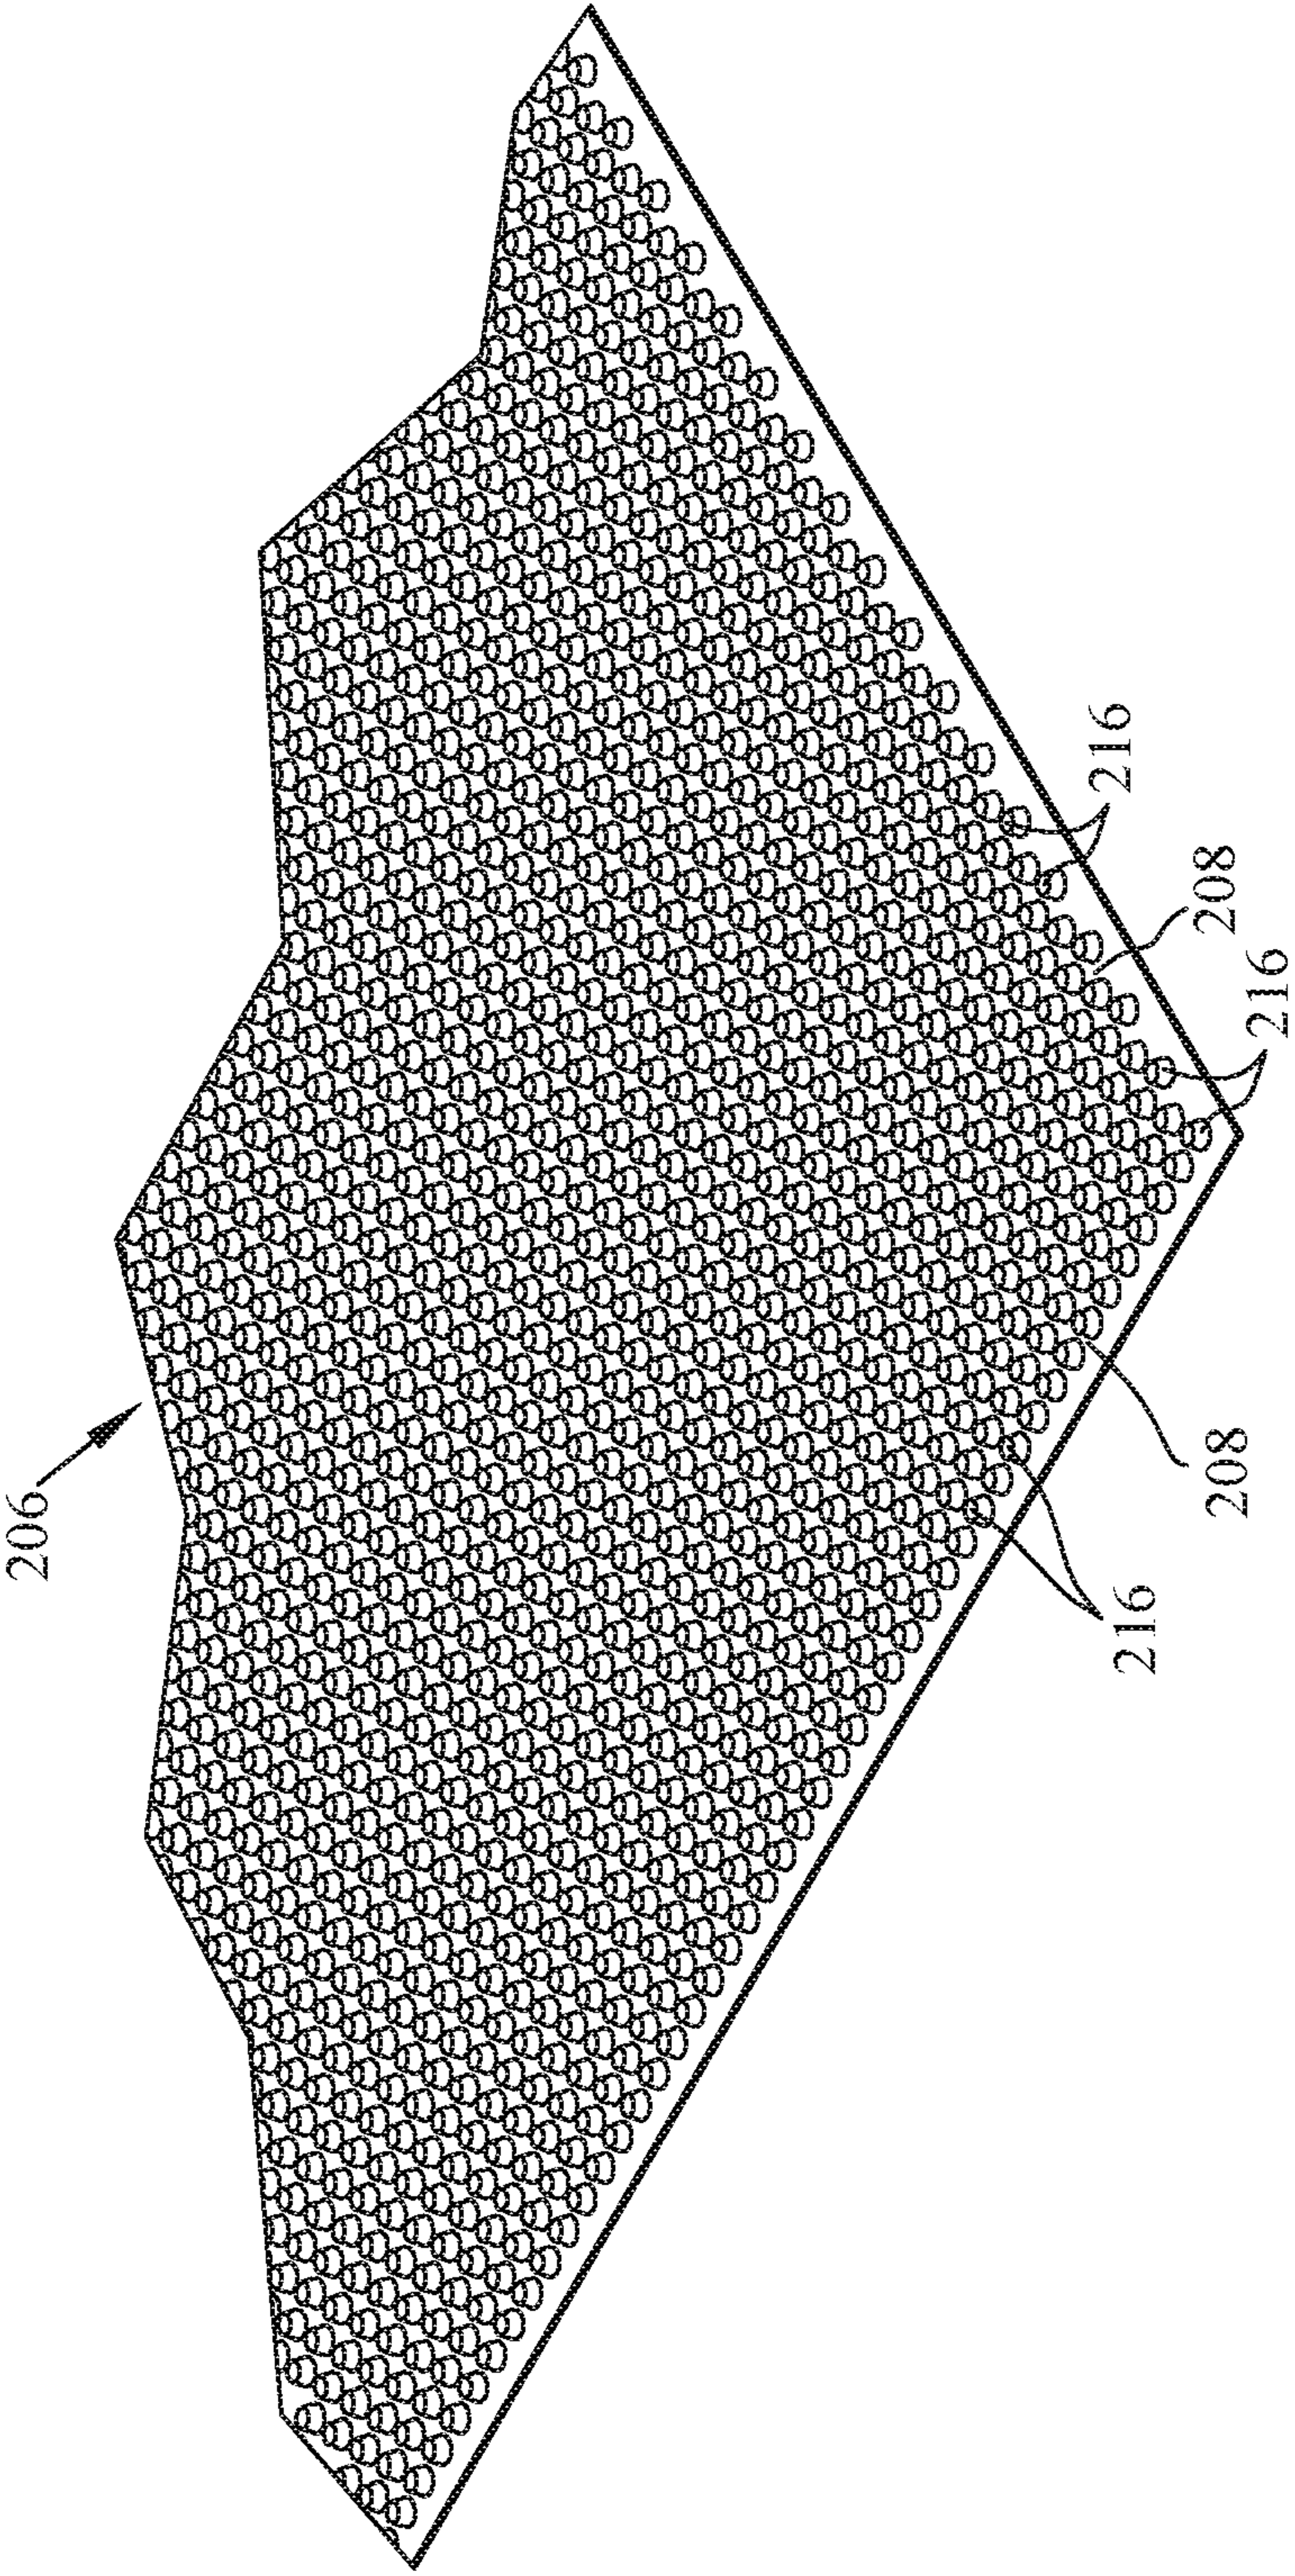
FIG. 7 is the vehicle frame and cargo bay liner of FIG. 6 showing an opposite face of the liner having projections extending therefrom;

Referring to FIG. 7, it can be appreciated that end faces 216 may have a variety of configurations including domed, flat, and/or convex.
