US011447189B1

(54) **VEHICLE FRAME AND CARGO BAY LINER**

A vehicle and liner assembly is provided that includes a  
recreational vehicle having a housing, a front end, a rear end,  
a top, a bottom, and a pair of sidewalls. A frame assembly  
is provided wherein, the housing is mounted on and sup-  
ported by the frame assembly. The liner is attached to the  
frame assembly and covers at least a substantial portion of the  
bottom of the housing. The liner has a first face having  
projections extending therefrom and a second face having  
openings therein. The openings coincide with and extend  
into corresponding projections on the first face.

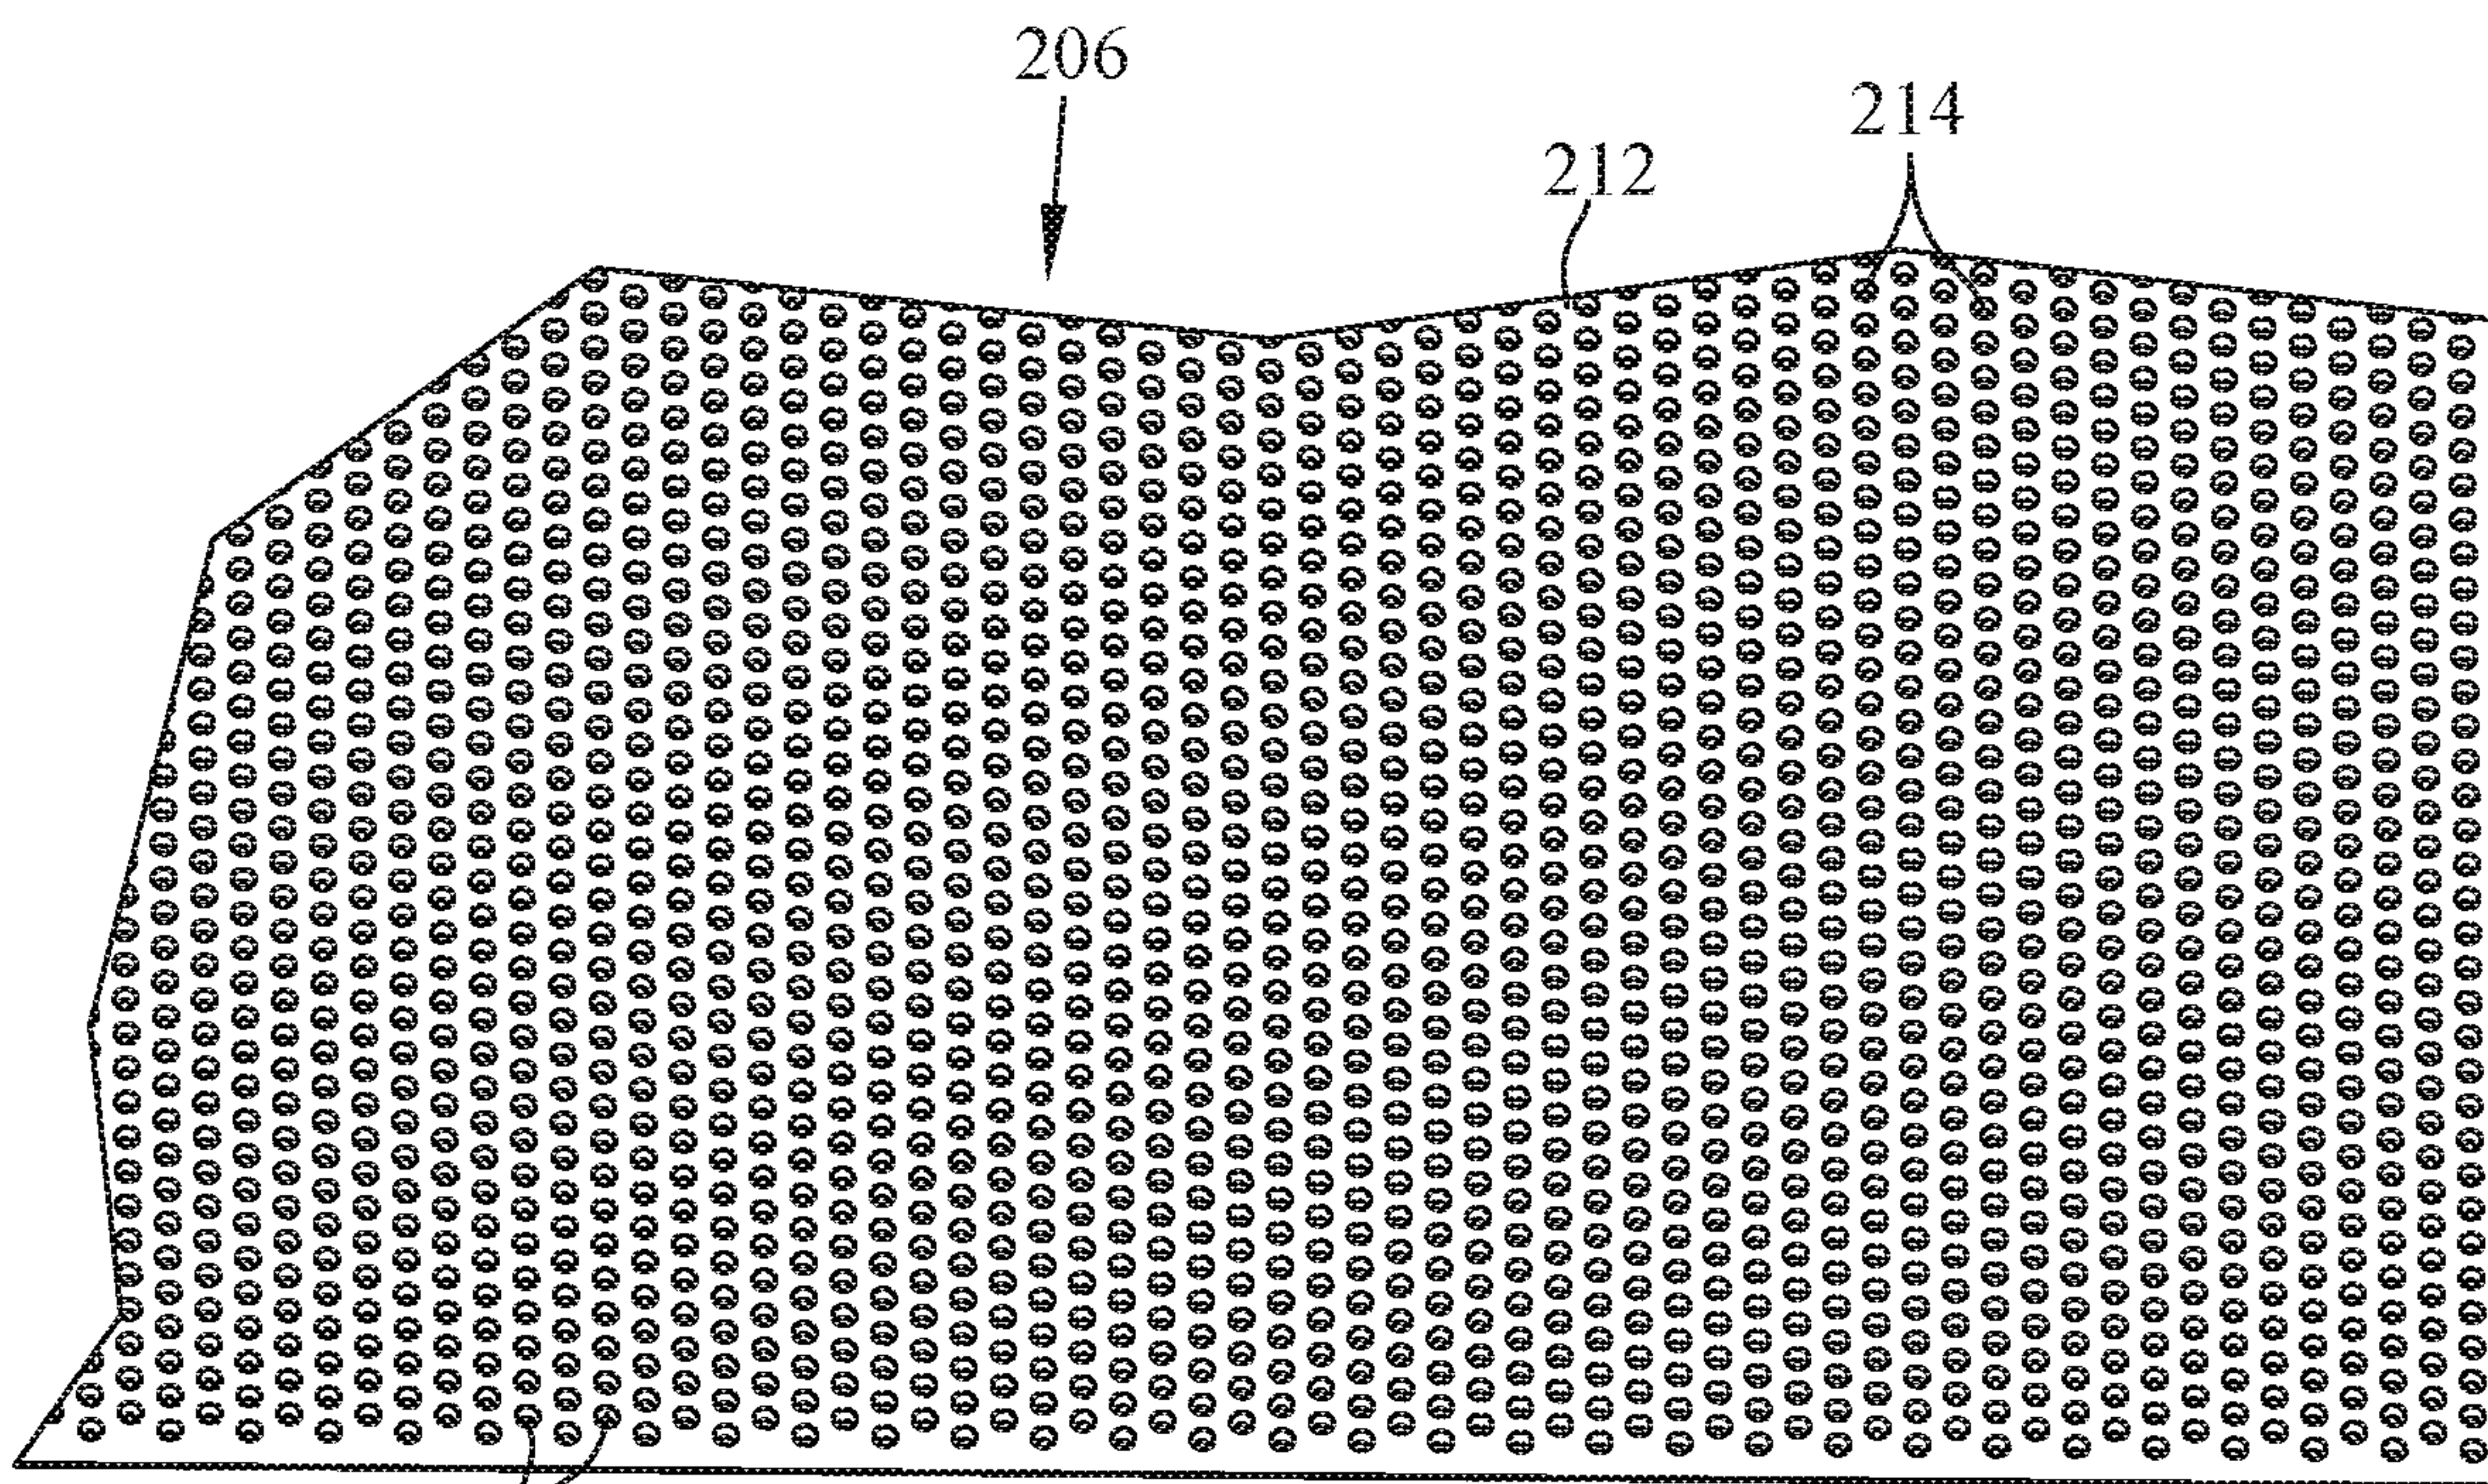
FIG. 8 is a plan view of the liner of FIG. 6 showing the face having openings;

Referring now to FIGS. 6-11, further details, of vehicle frame and cargo area liner/core 206 are disclosed. As can be seen, the projections and/or openings 210, 214, respectively are aligned in a lengthwise direction of core 206 but going crosswise across core 206, projections 210 and openings 214 are staggered.

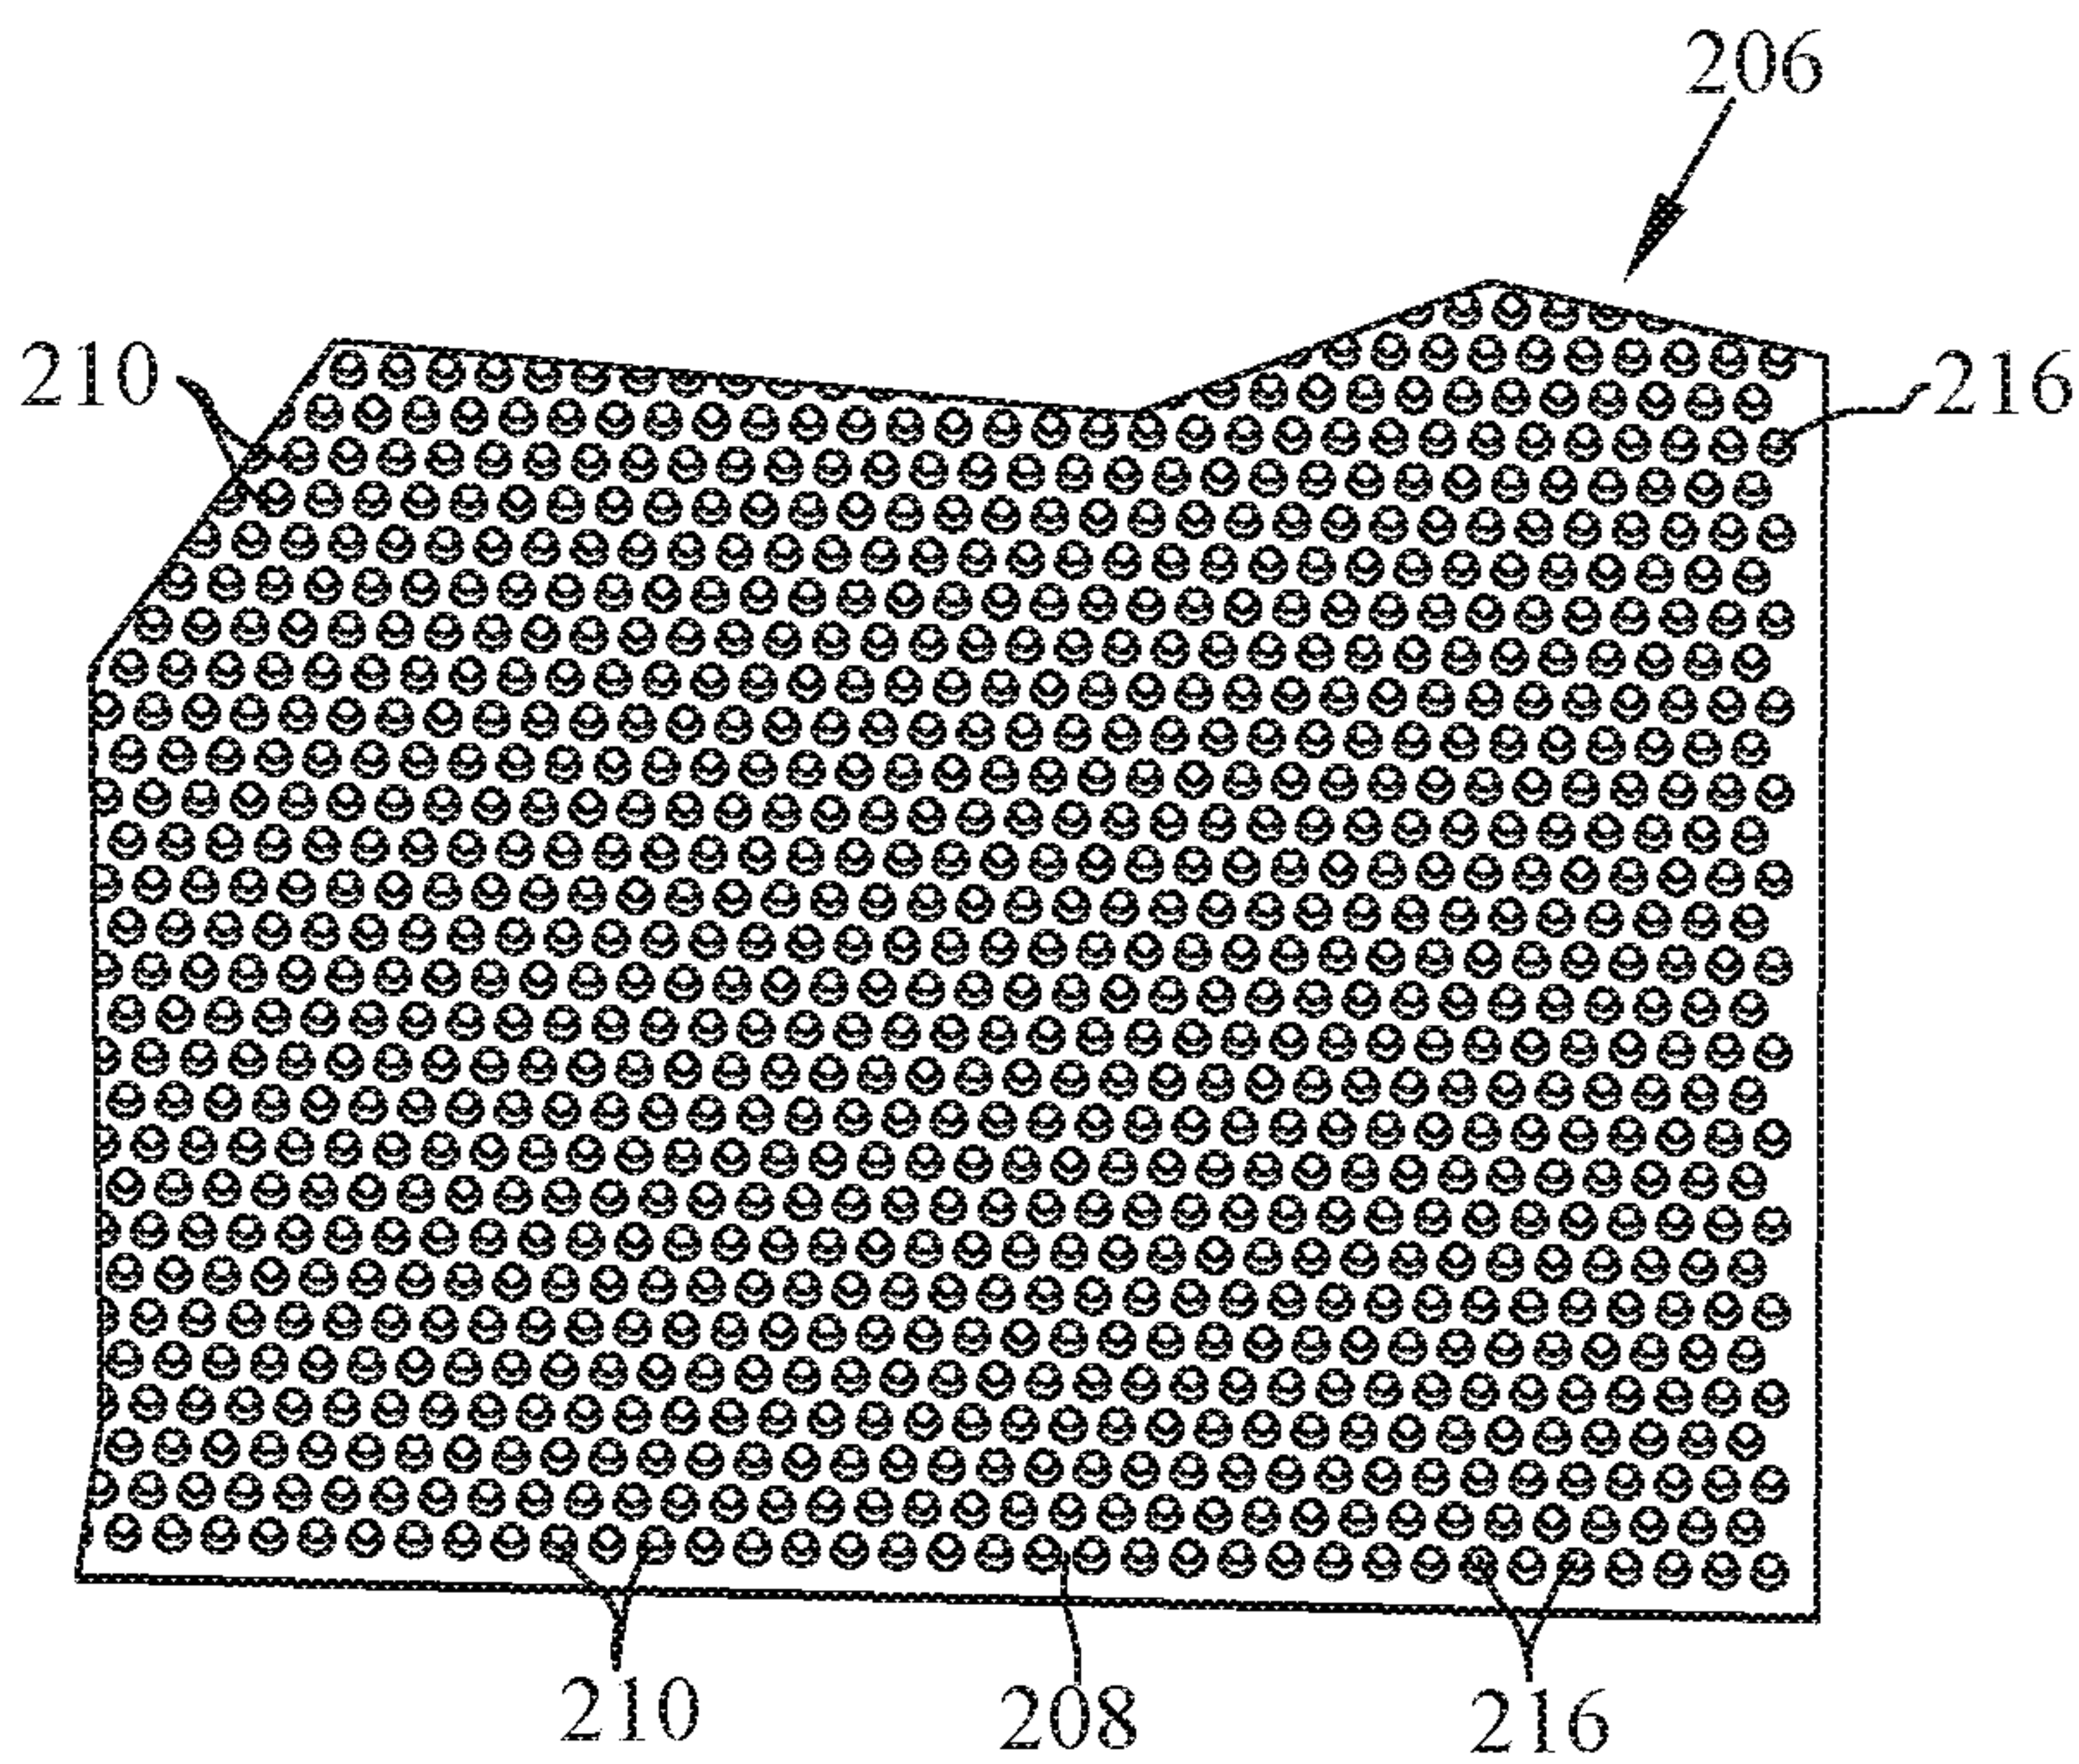
FIG. 9 is a plan view of the liner of FIG. 6 showing the face having projections extending therefrom;

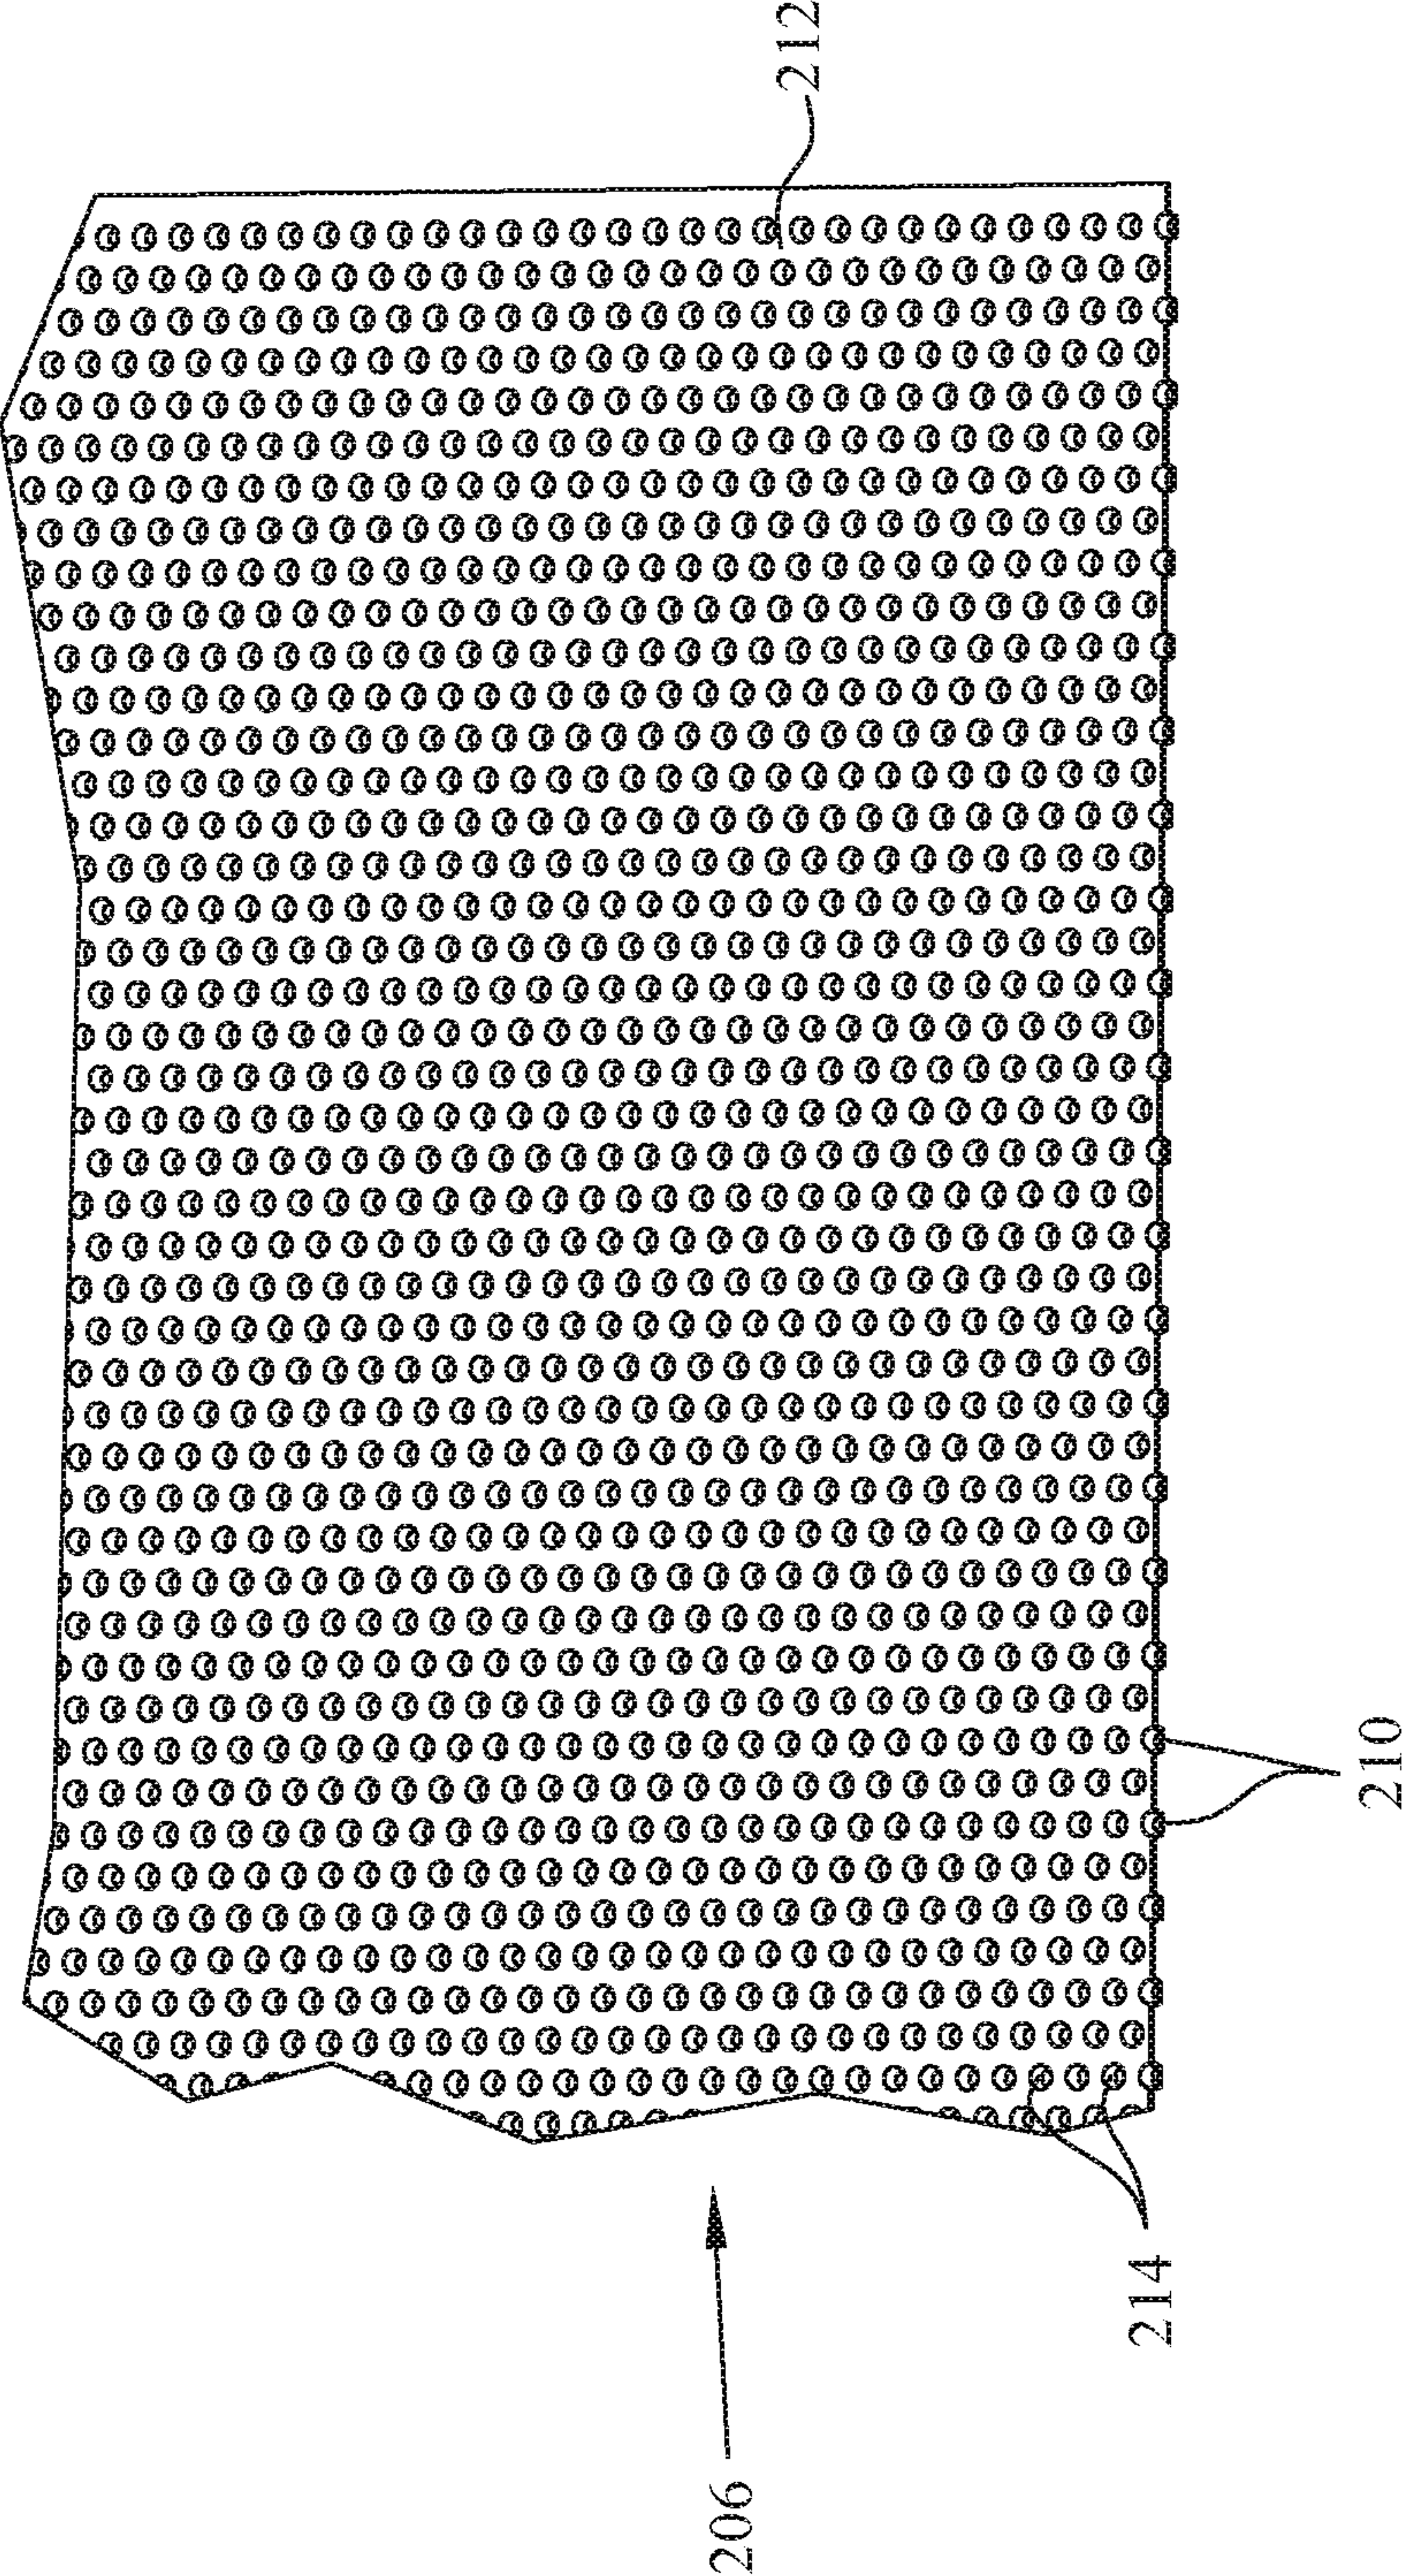
FIG. 10 is another perspective view of the vehicle and cargo bay liner of FIG. 6 with the face having openings facing upward;

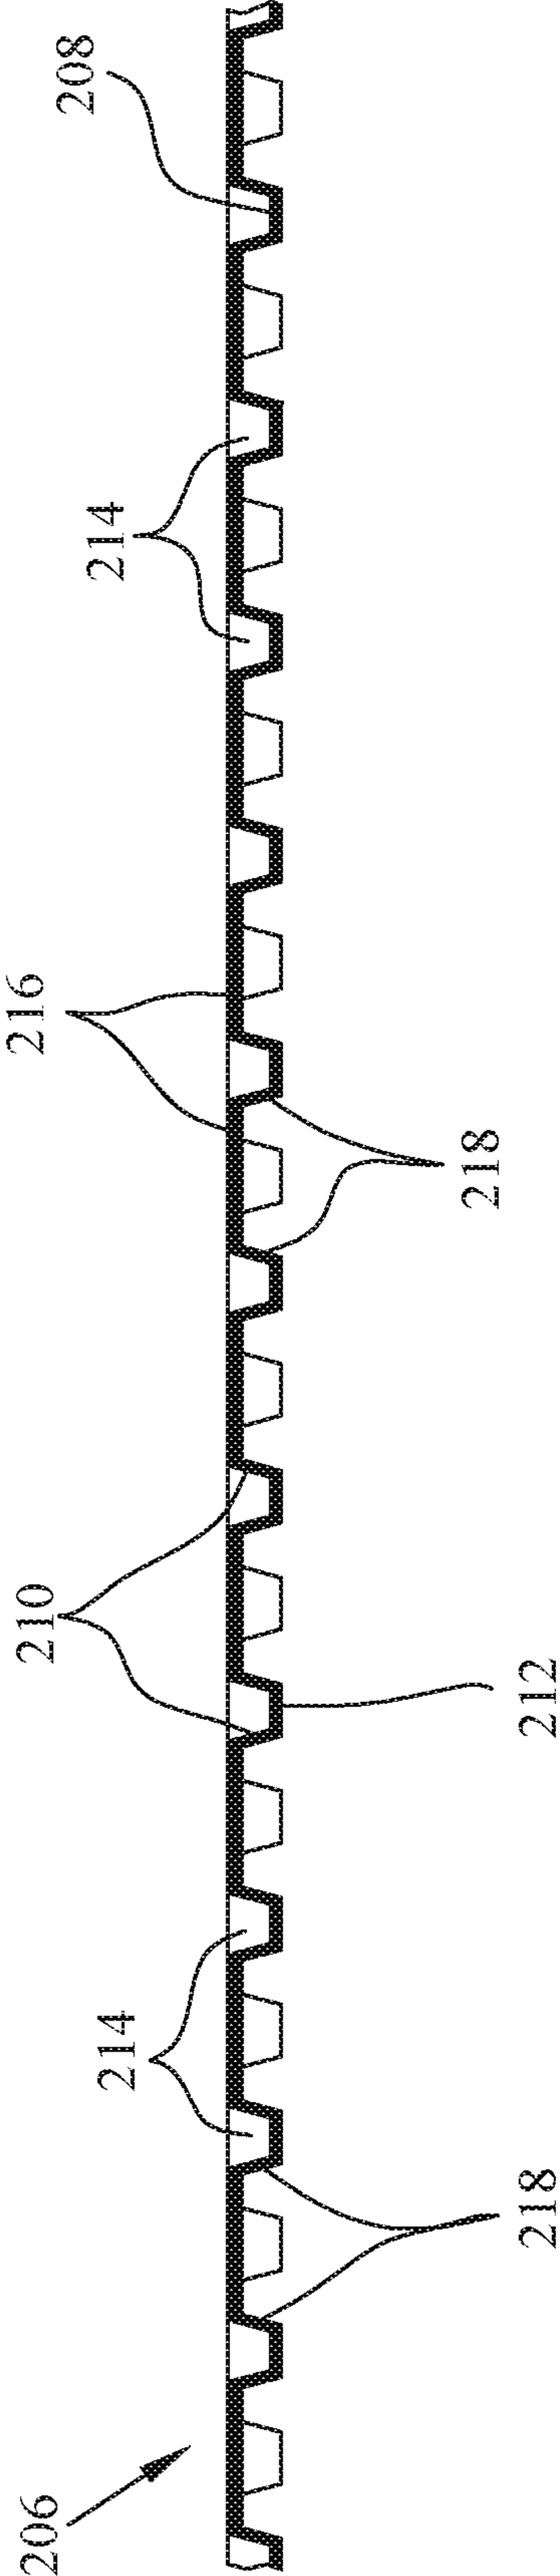
FIG. 11 is a side view of the vehicle and cargo bay liner of FIG. 6 with the projections extending upward;

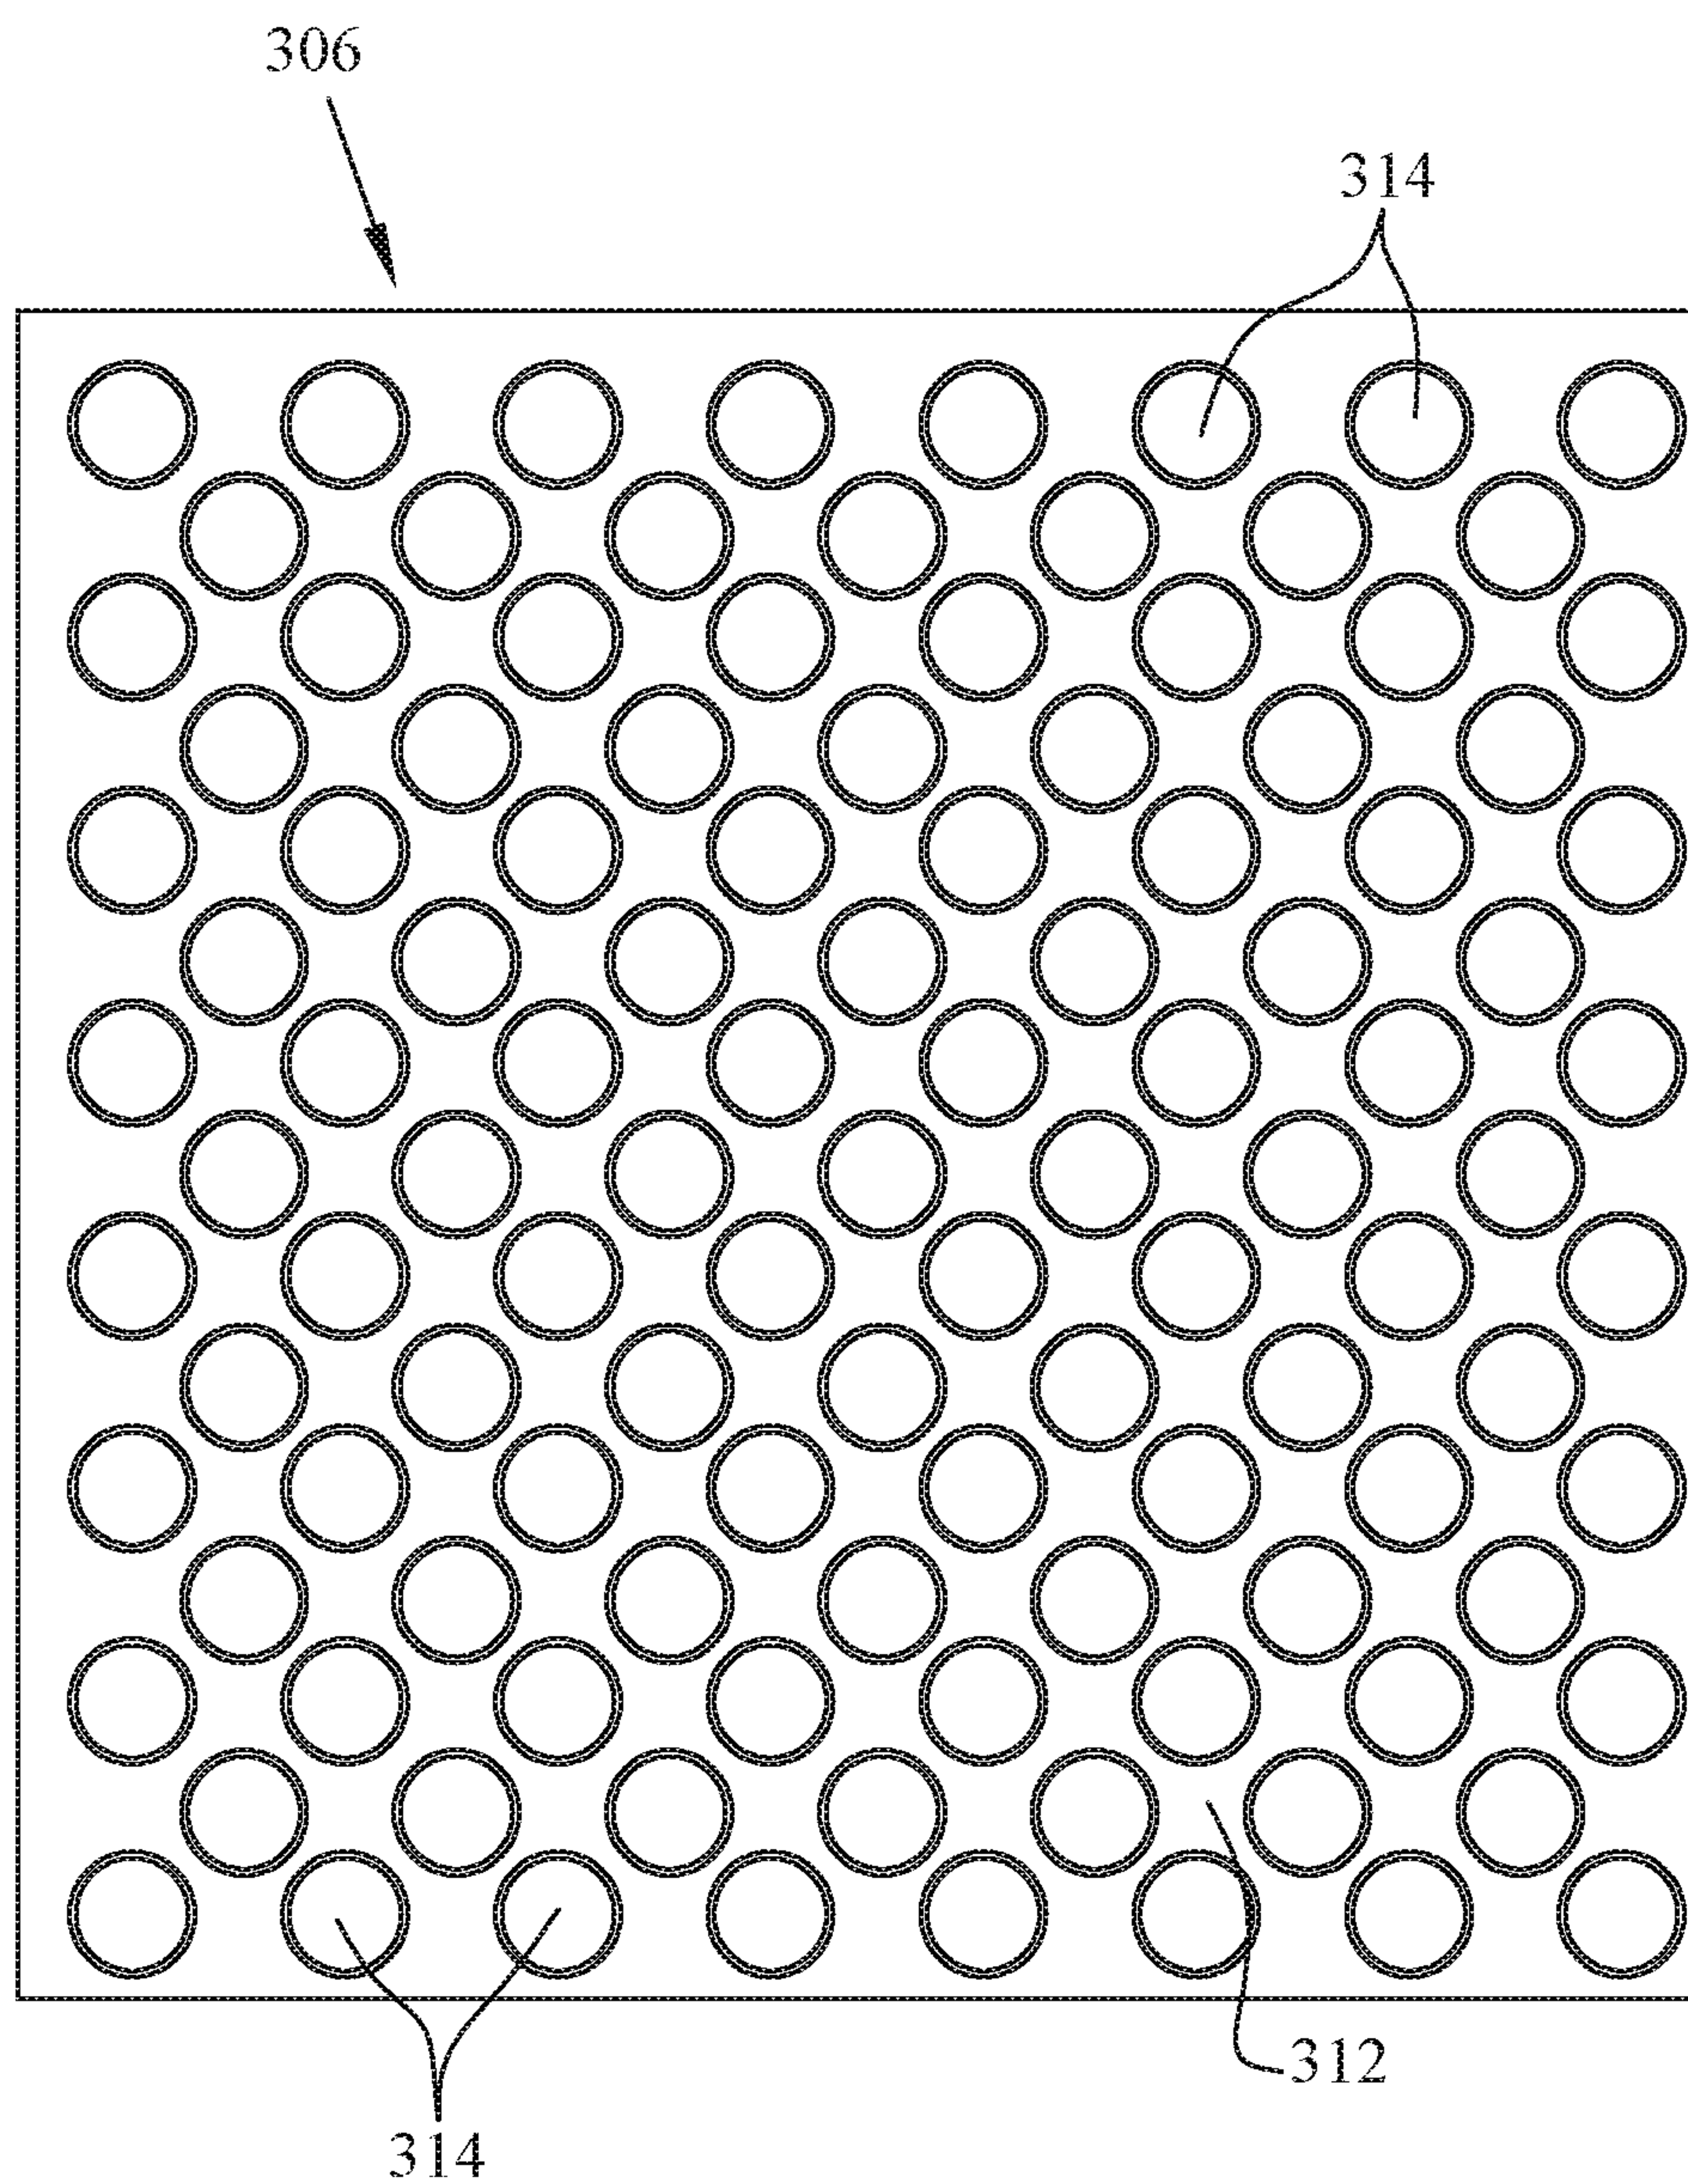
**FIG. 12**

FIG. 12 is a plan view of an alternate embodiment vehicle frame and cargo bay liner showing a face having openings therein;

Now referring to FIGS. 12 and 13, an alternate vehicle frame and cargo area liner is shown generally indicated as 306. As can be seen in FIG. 13, liner 306 includes a face 308 having projections 210 thereon. As shown in FIG. 12, liner 306 has an opposite face 312 having openings 314 therein. Projections 310 include end faces 316 and sidewalls 318 as best seen in FIG. 13. Line 306 can be manufactured from single or multi-layer materials sandwiched together (twin or triple layer).

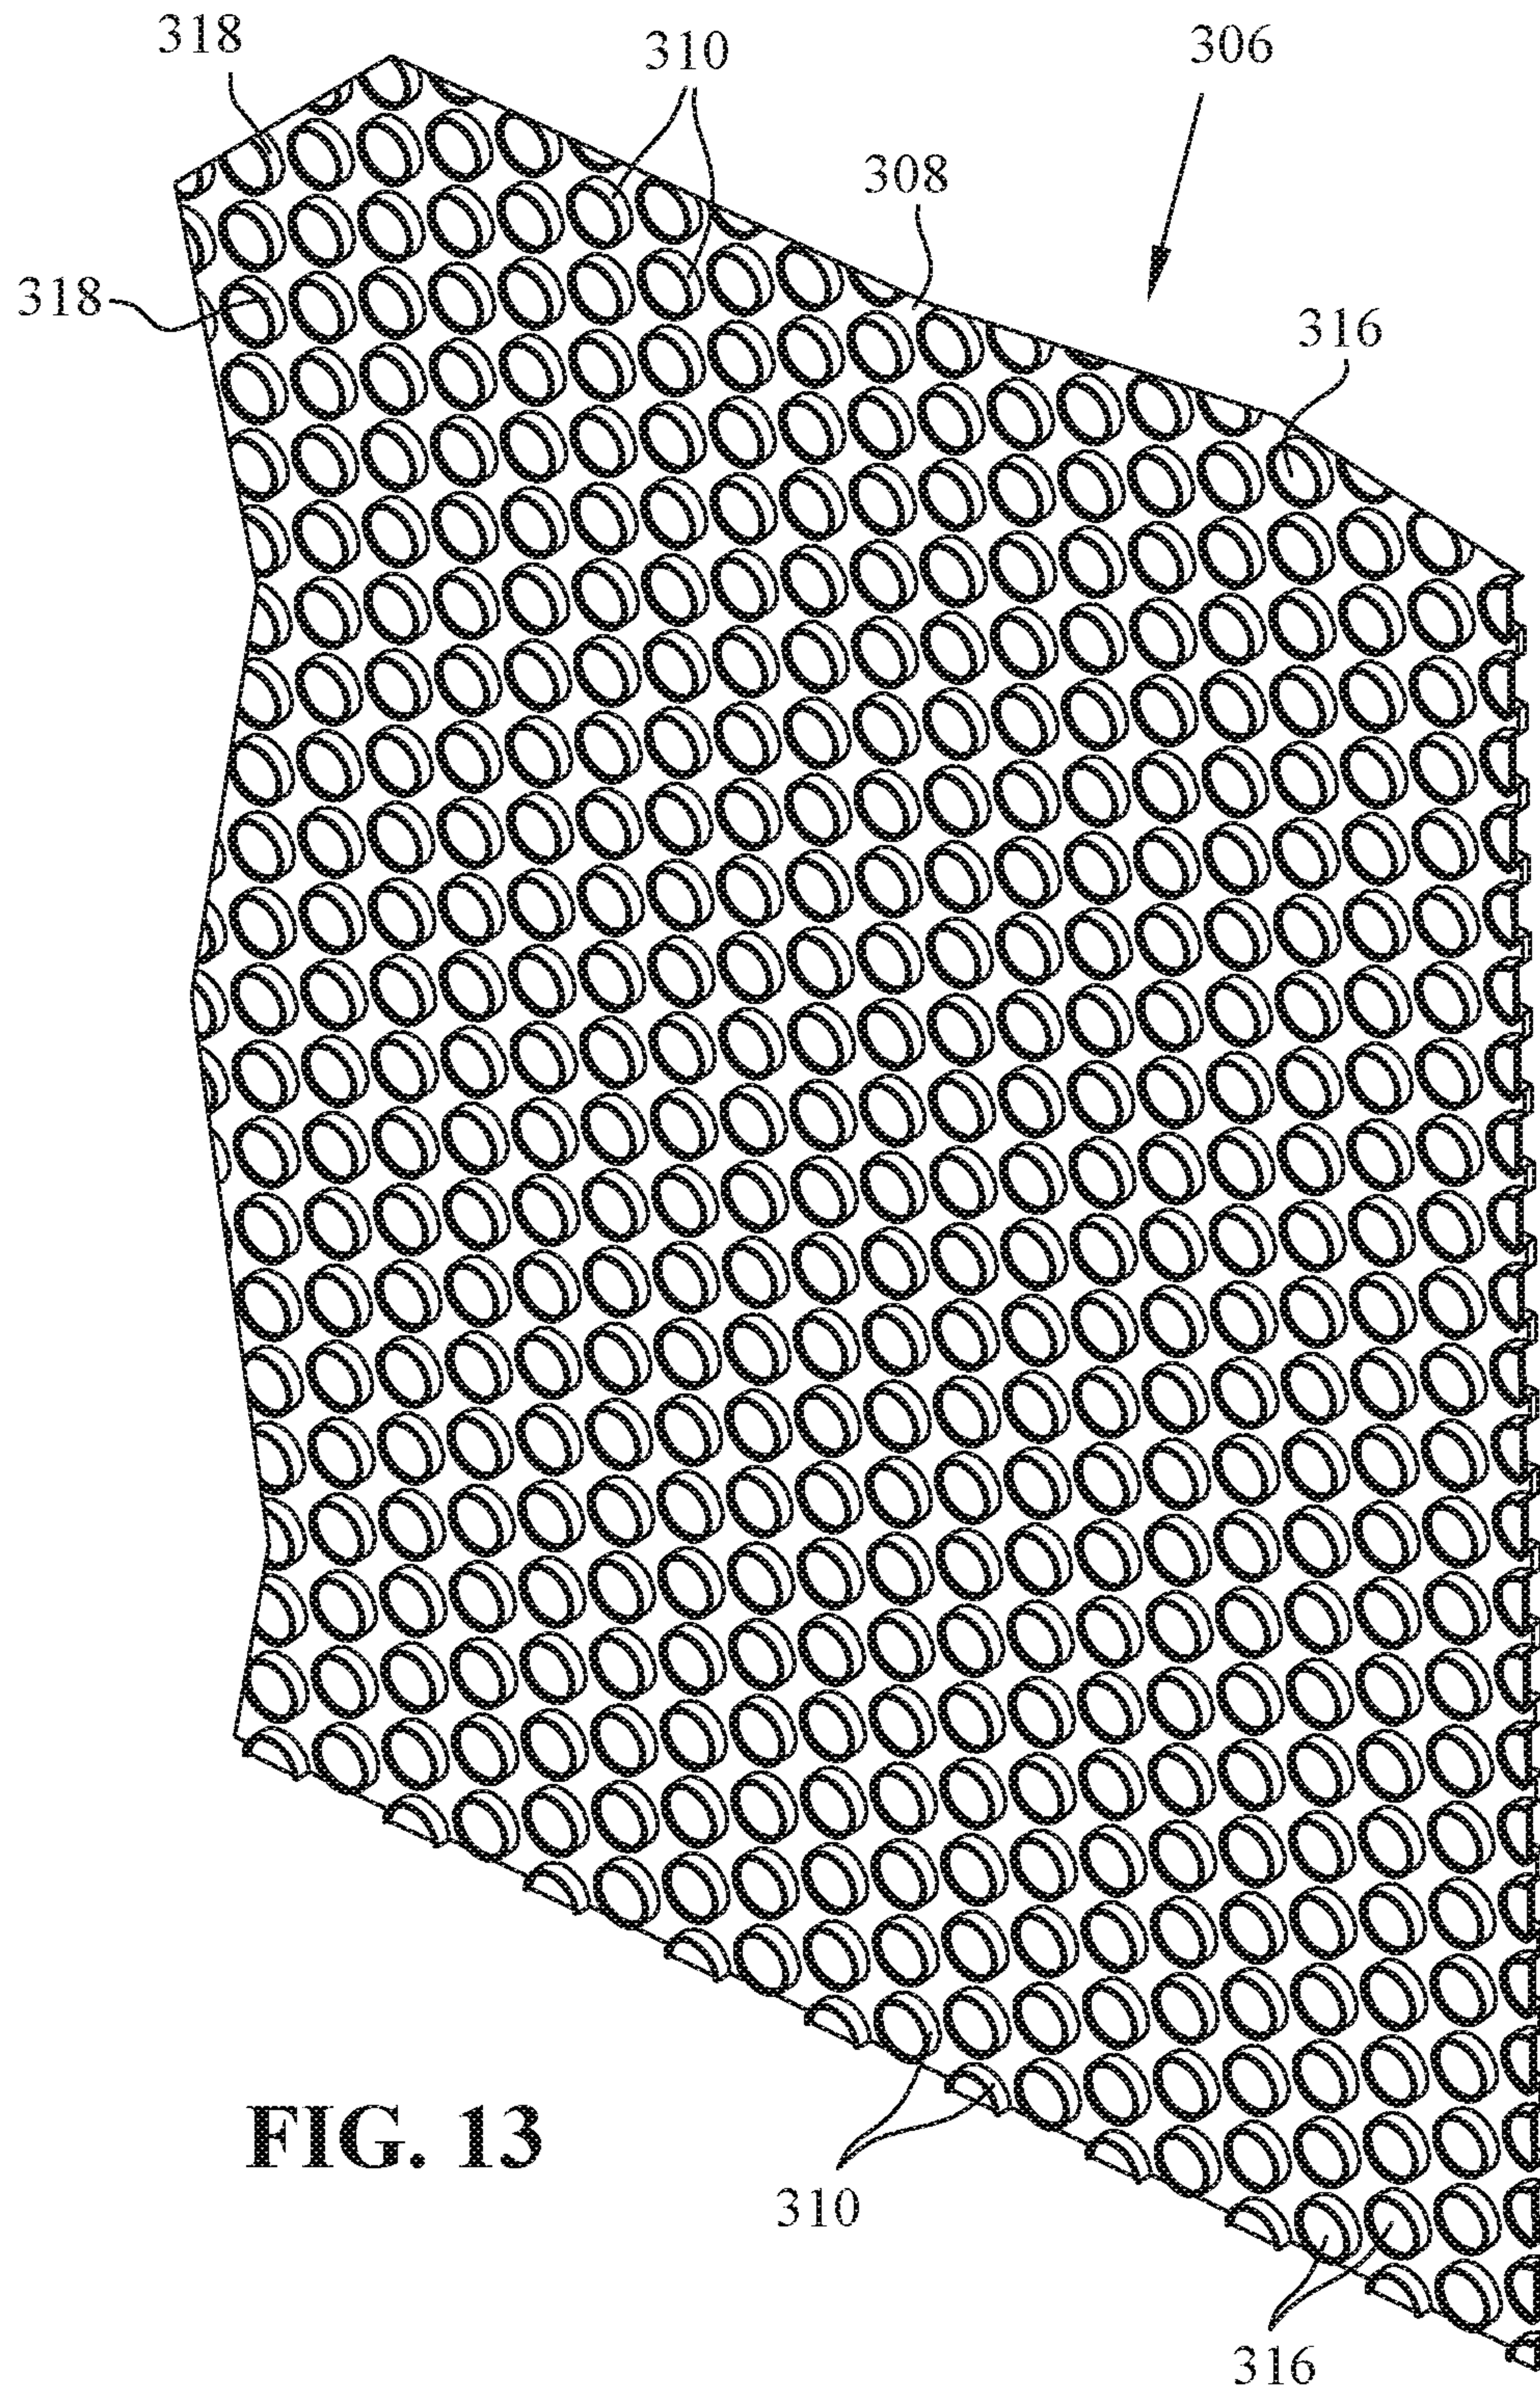
**FIG. 13**

FIG. 13 is a plan perspective view of the alternate embodiment vehicle frame and cargo bay liner of FIG. 12 showing a face having projections extending therefrom;
