US011447189B1

(54) **VEHICLE FRAME AND CARGO BAY LINER**

A vehicle and liner assembly is provided that includes a  
recreational vehicle having a housing, a front end, a rear end,  
a top, a bottom, and a pair of sidewalls. A frame assembly  
is provided wherein, the housing is mounted on and sup-  
ported by the frame assembly. The liner is attached to the  
frame assembly and covers at least a substantial portion of the  
bottom of the housing. The liner has a first face having  
projections extending therefrom and a second face having  
openings therein. The openings coincide with and extend  
into corresponding projections on the first face.

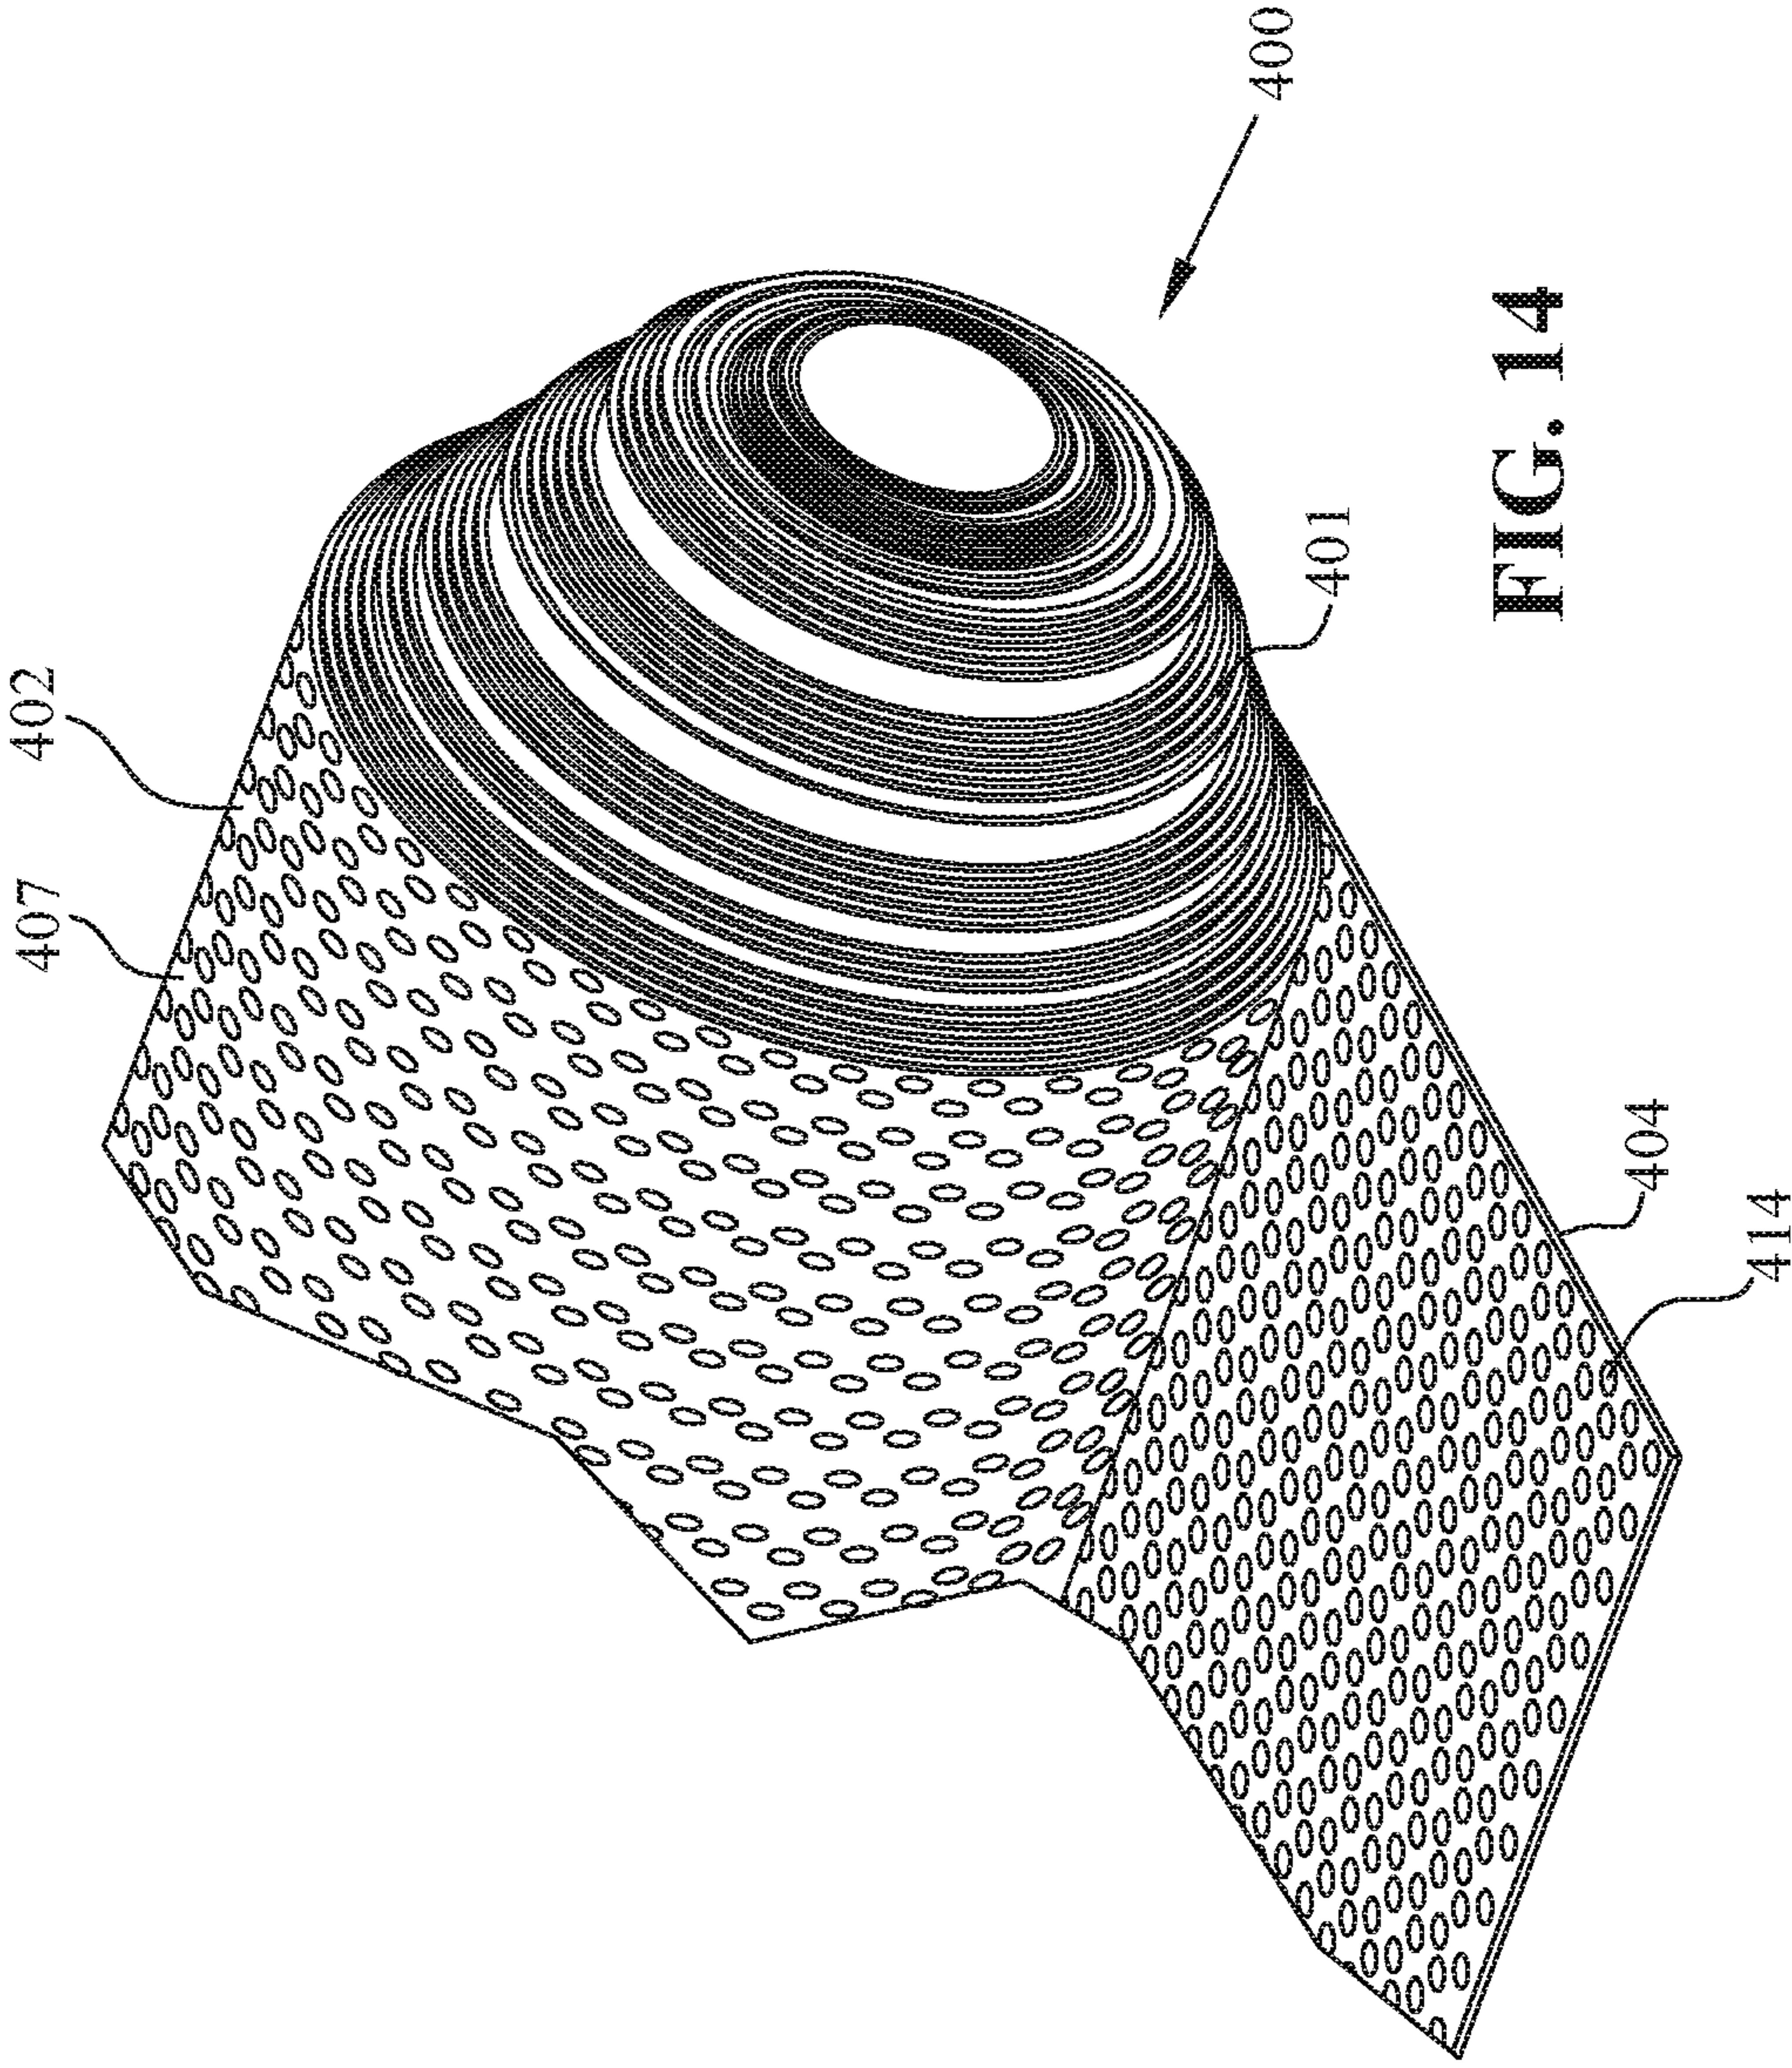
FIG. 14 is a perspective view of another alternate embodiment vehicle frame and cargo bay liner shown rolled in a coil and having aluminum foil on one side thereof;

Now referring to FIGS. 14-24, another alternate vehicle frame and cargo area liner is shown generally indicated as 400. Liner 400 can be provided in a coiled form 401 as

shown in FIGS. 14 and 15, making it extremely suitable for use as a liner for vehicle frames and cargo bays. The desired length of liner can be rolled out and cut to size for assembly to the vehicle. Vehicle frame and cargo bay liner **400** is of a 3-ply configuration and includes a top ply, sheet, or layer **402** and a bottom ply, sheet, or layer **404**. A core **406** (see FIGS. 19 and 22-24) separates top sheet **402** from bottom sheet **404**. Additionally, vehicle frame and cargo bay liner **400** also includes a sheet of aluminum foil or metalized film **407** on one side thereof. In the embodiment shown, aluminum foil/metalized film **407** is provided on top sheet **402**;

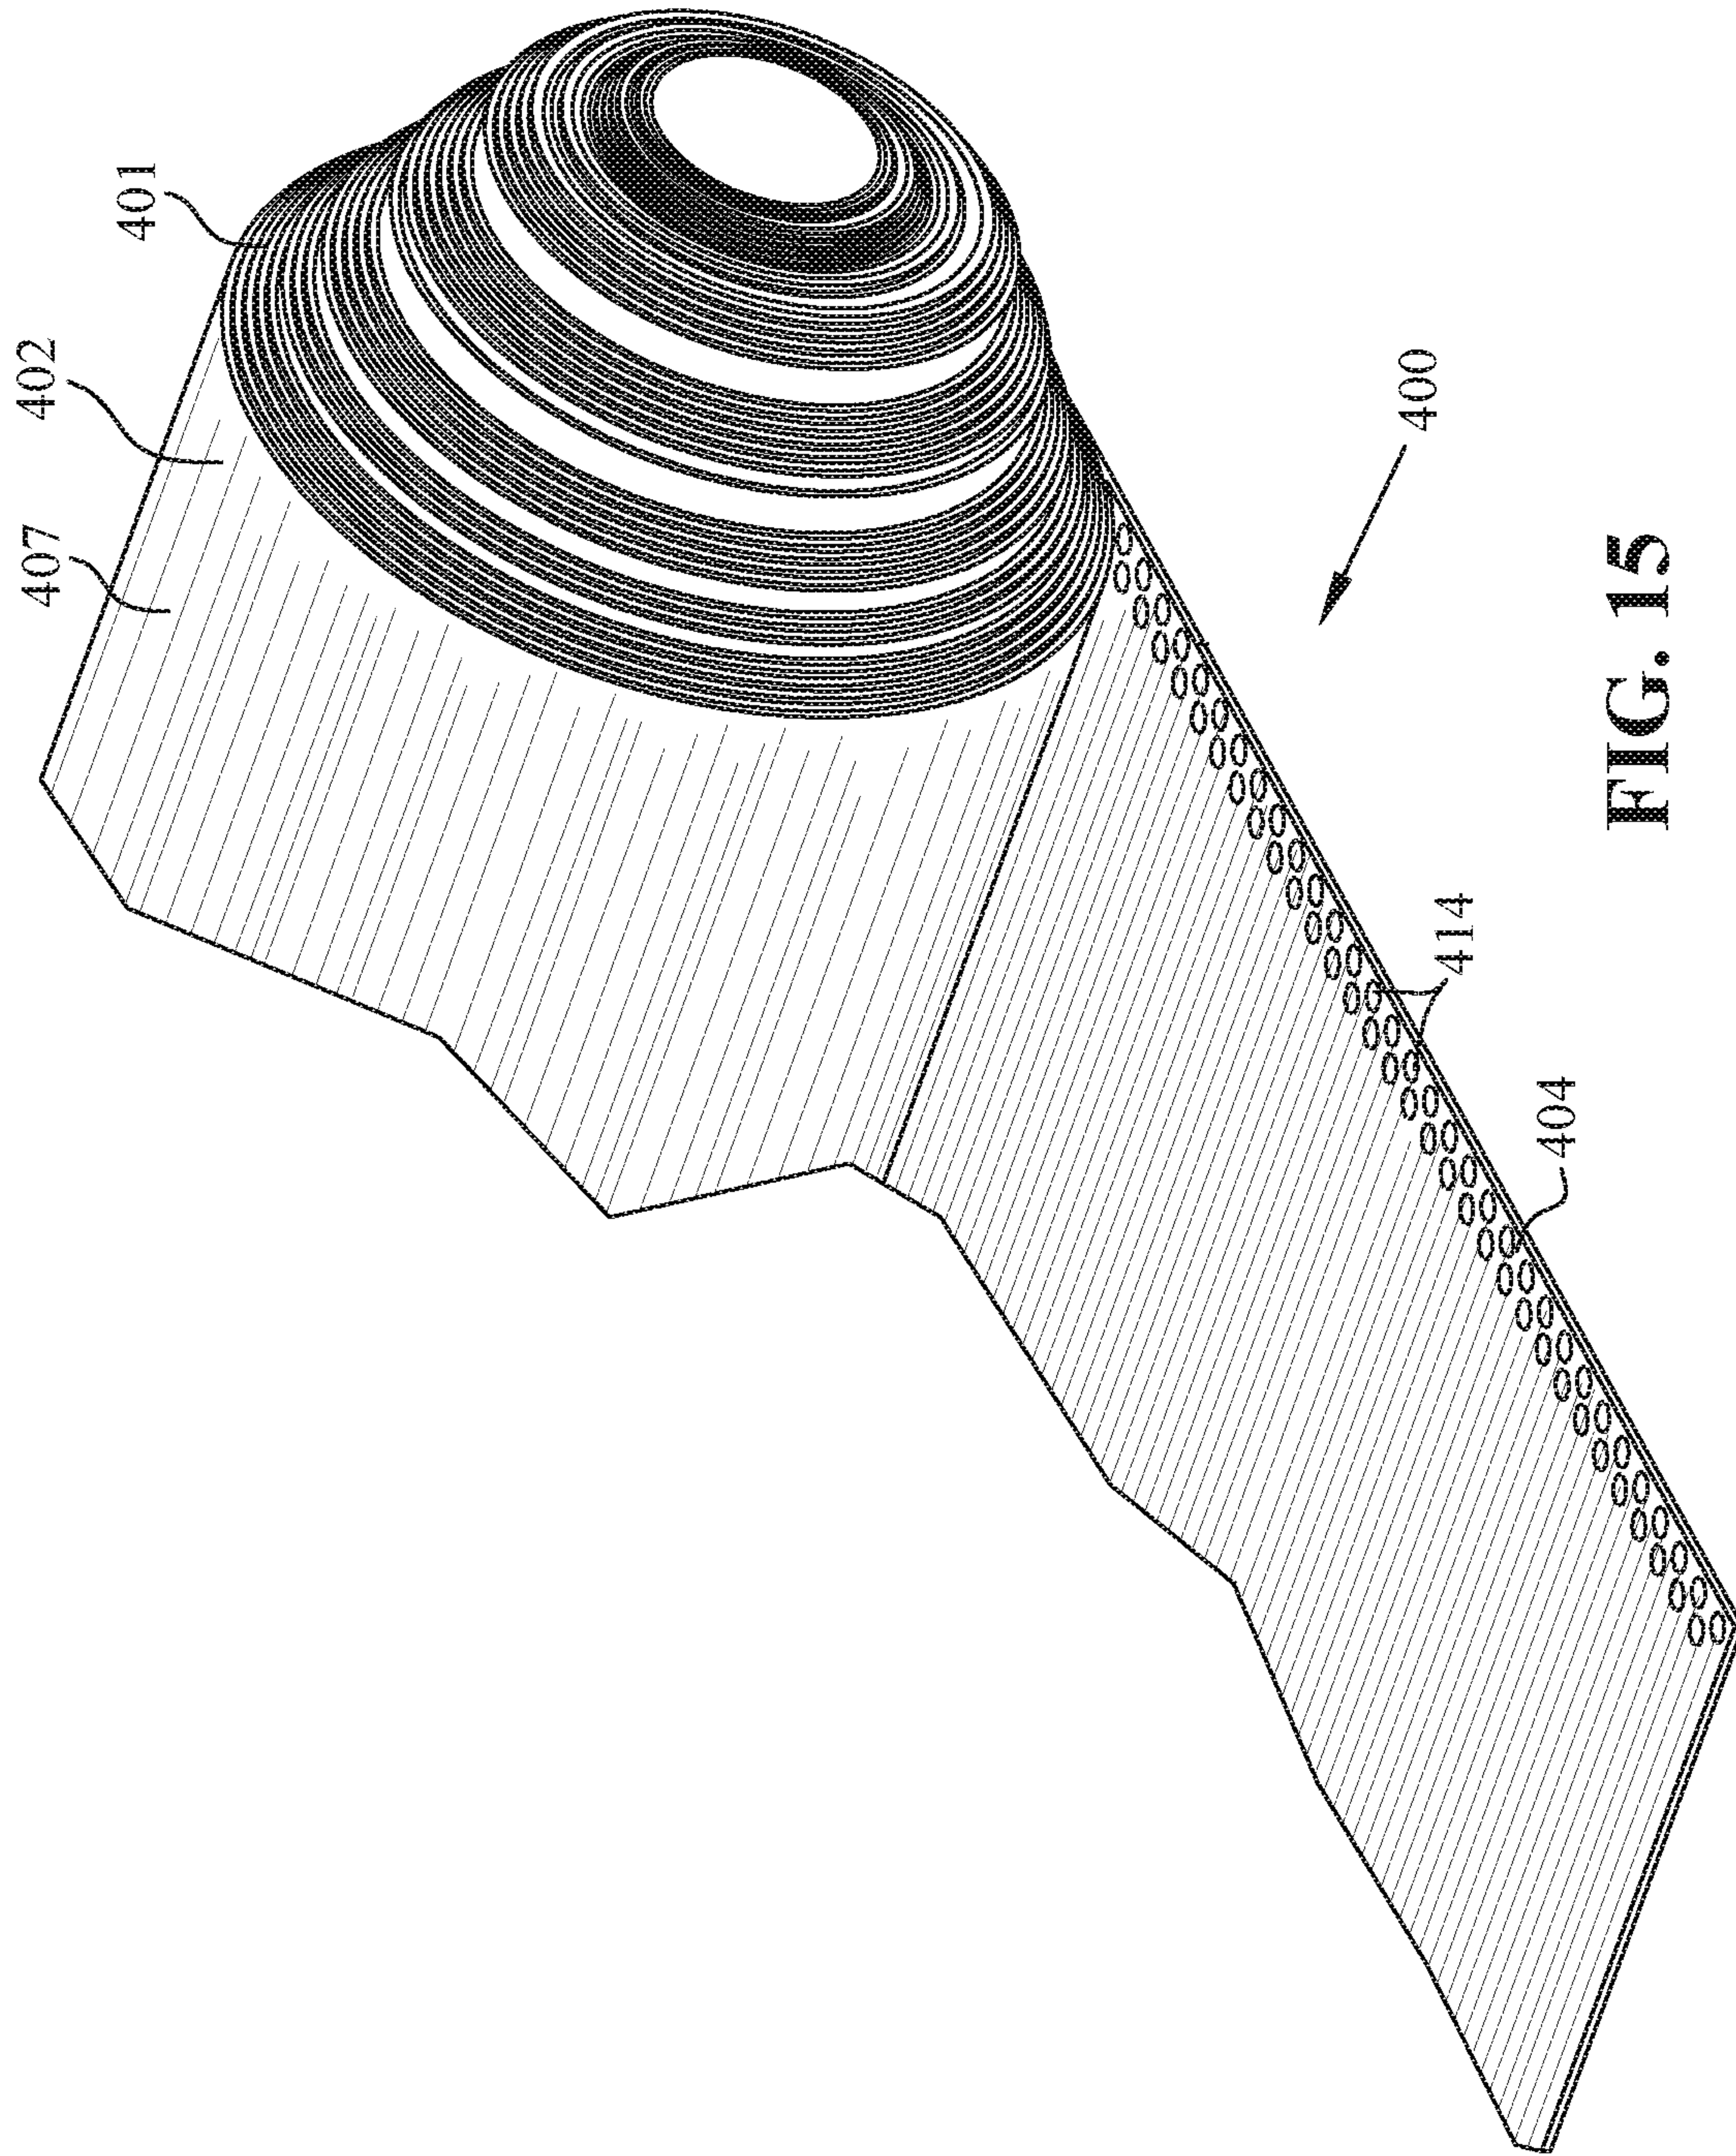
FIG. 15 is a perspective view of the vehicle frame and cargo bay liner of FIG. 14 partially rolled out showing the aluminum foil on a top side thereof;

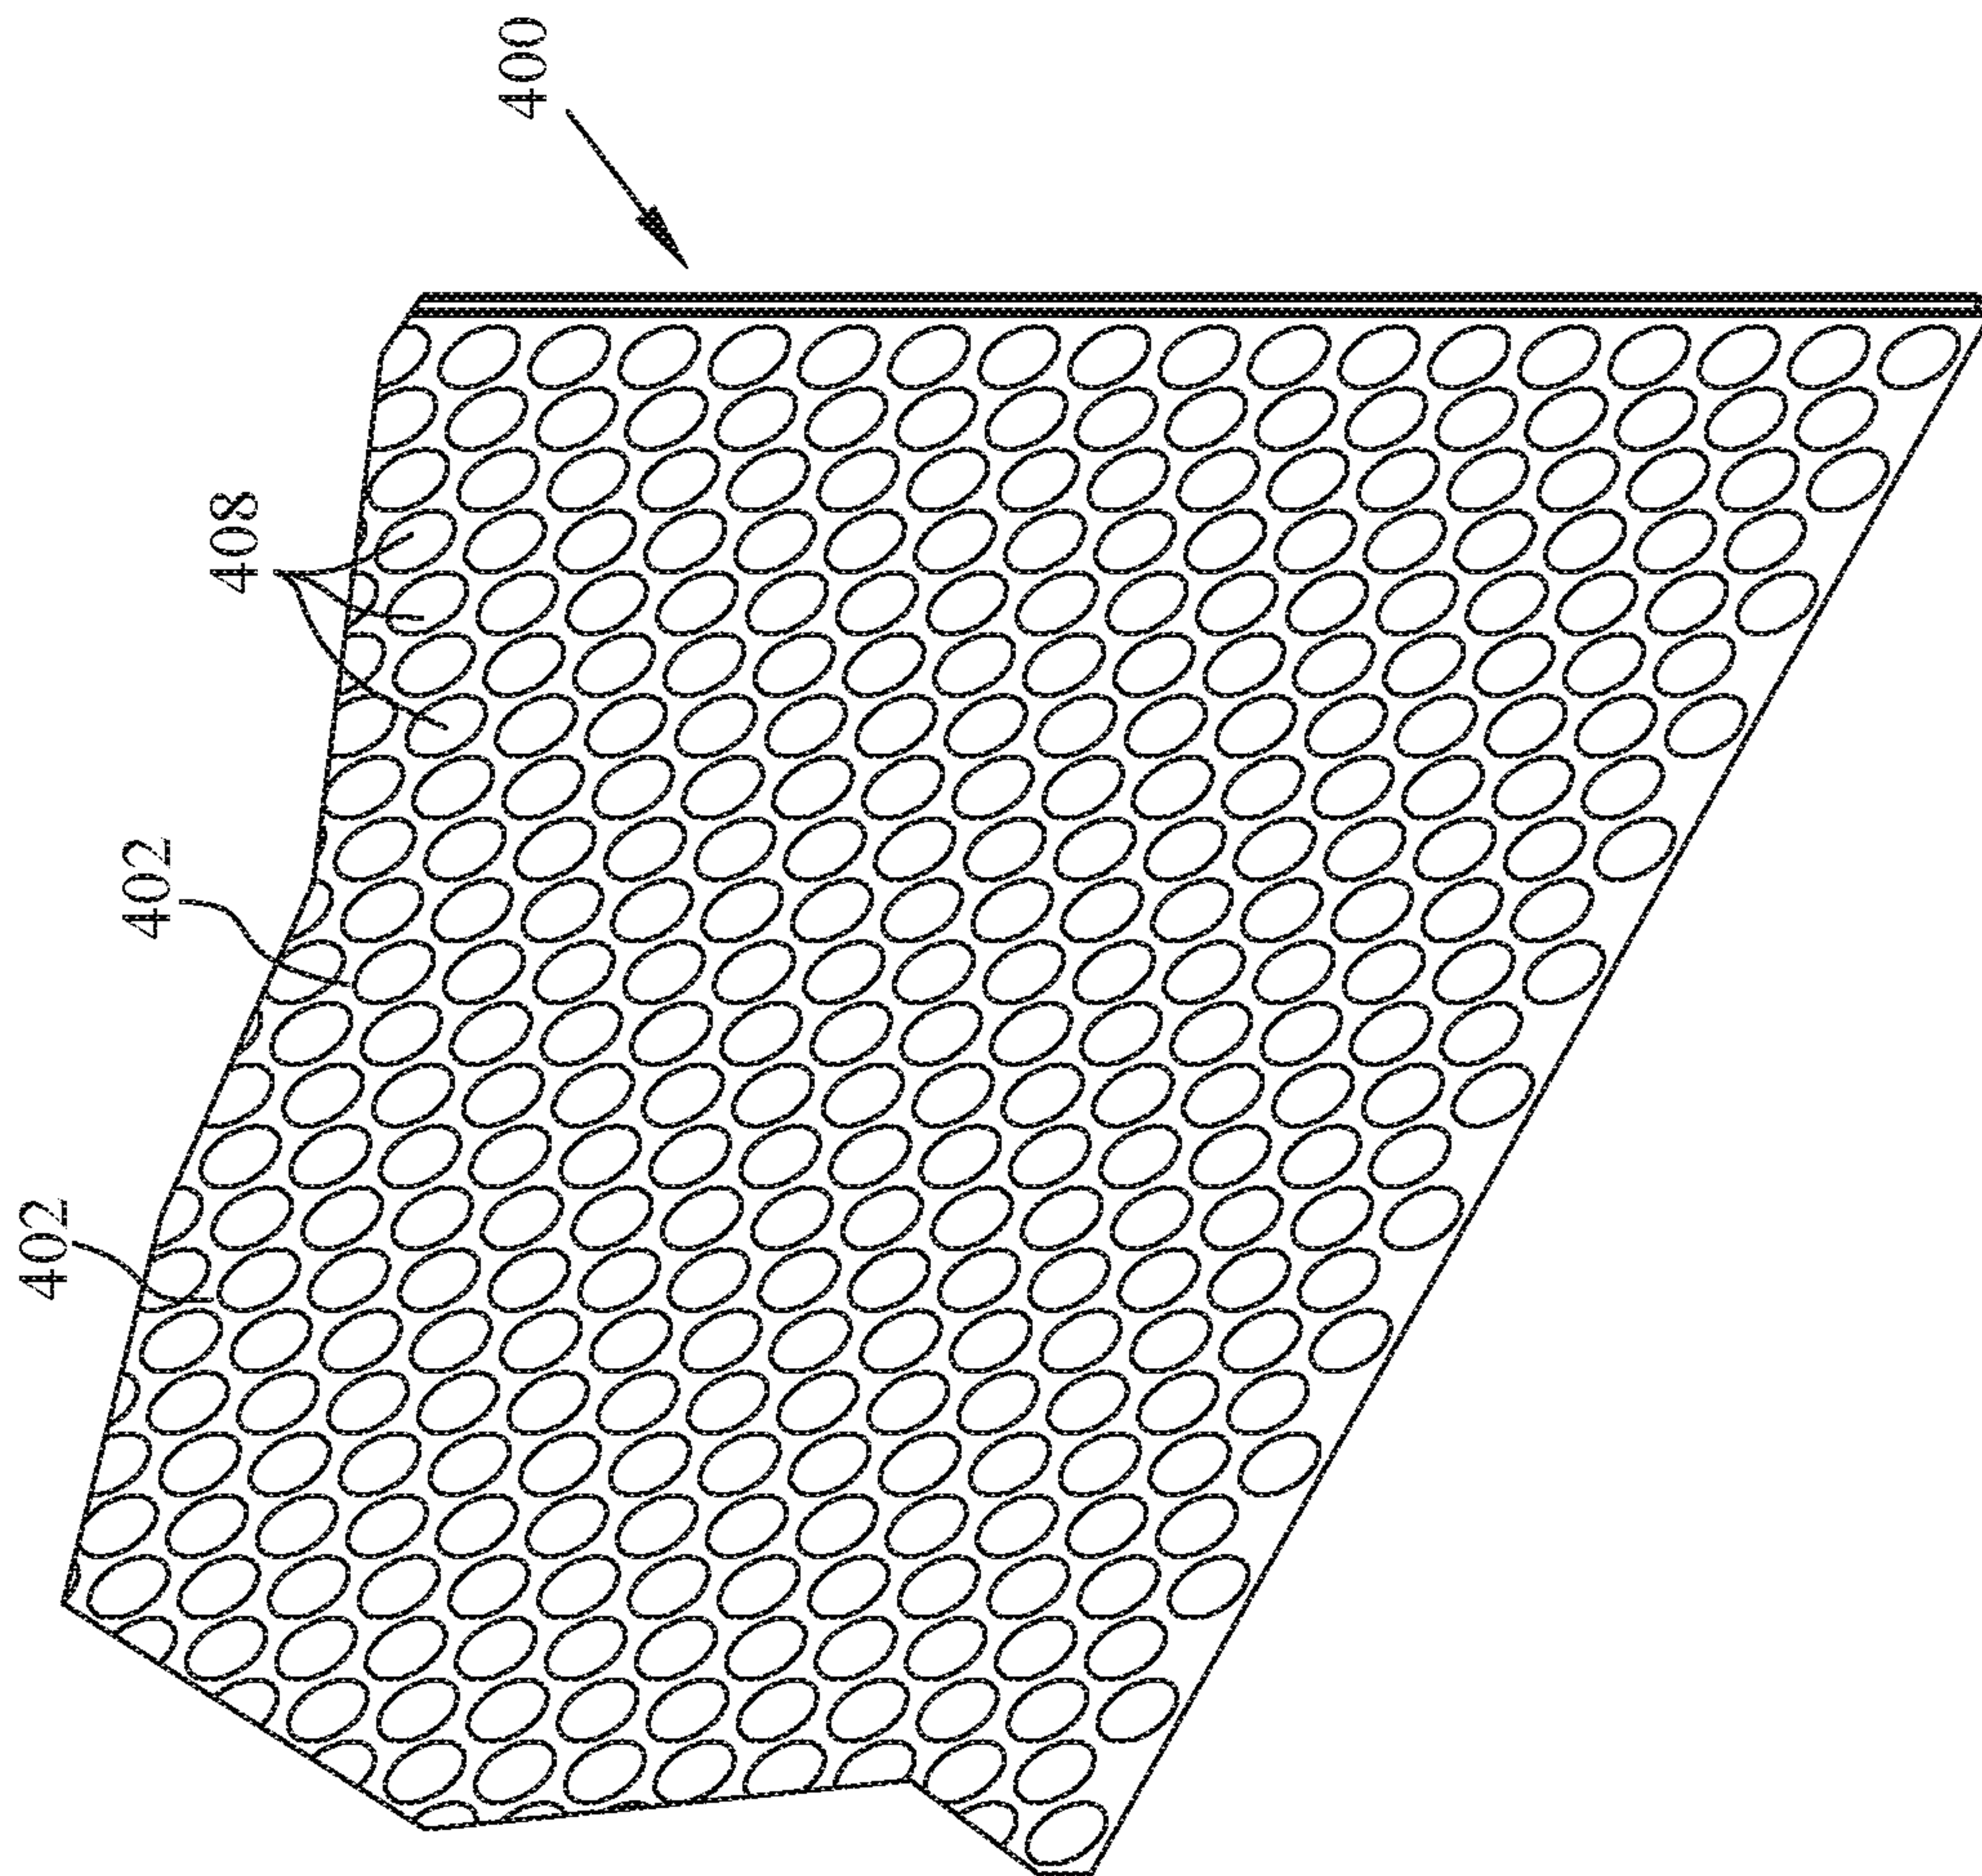
FIG. 16 is a plan view of the vehicle frame and cargo bay liner of FIG. 14 showing the top side with aluminum foil thereon;

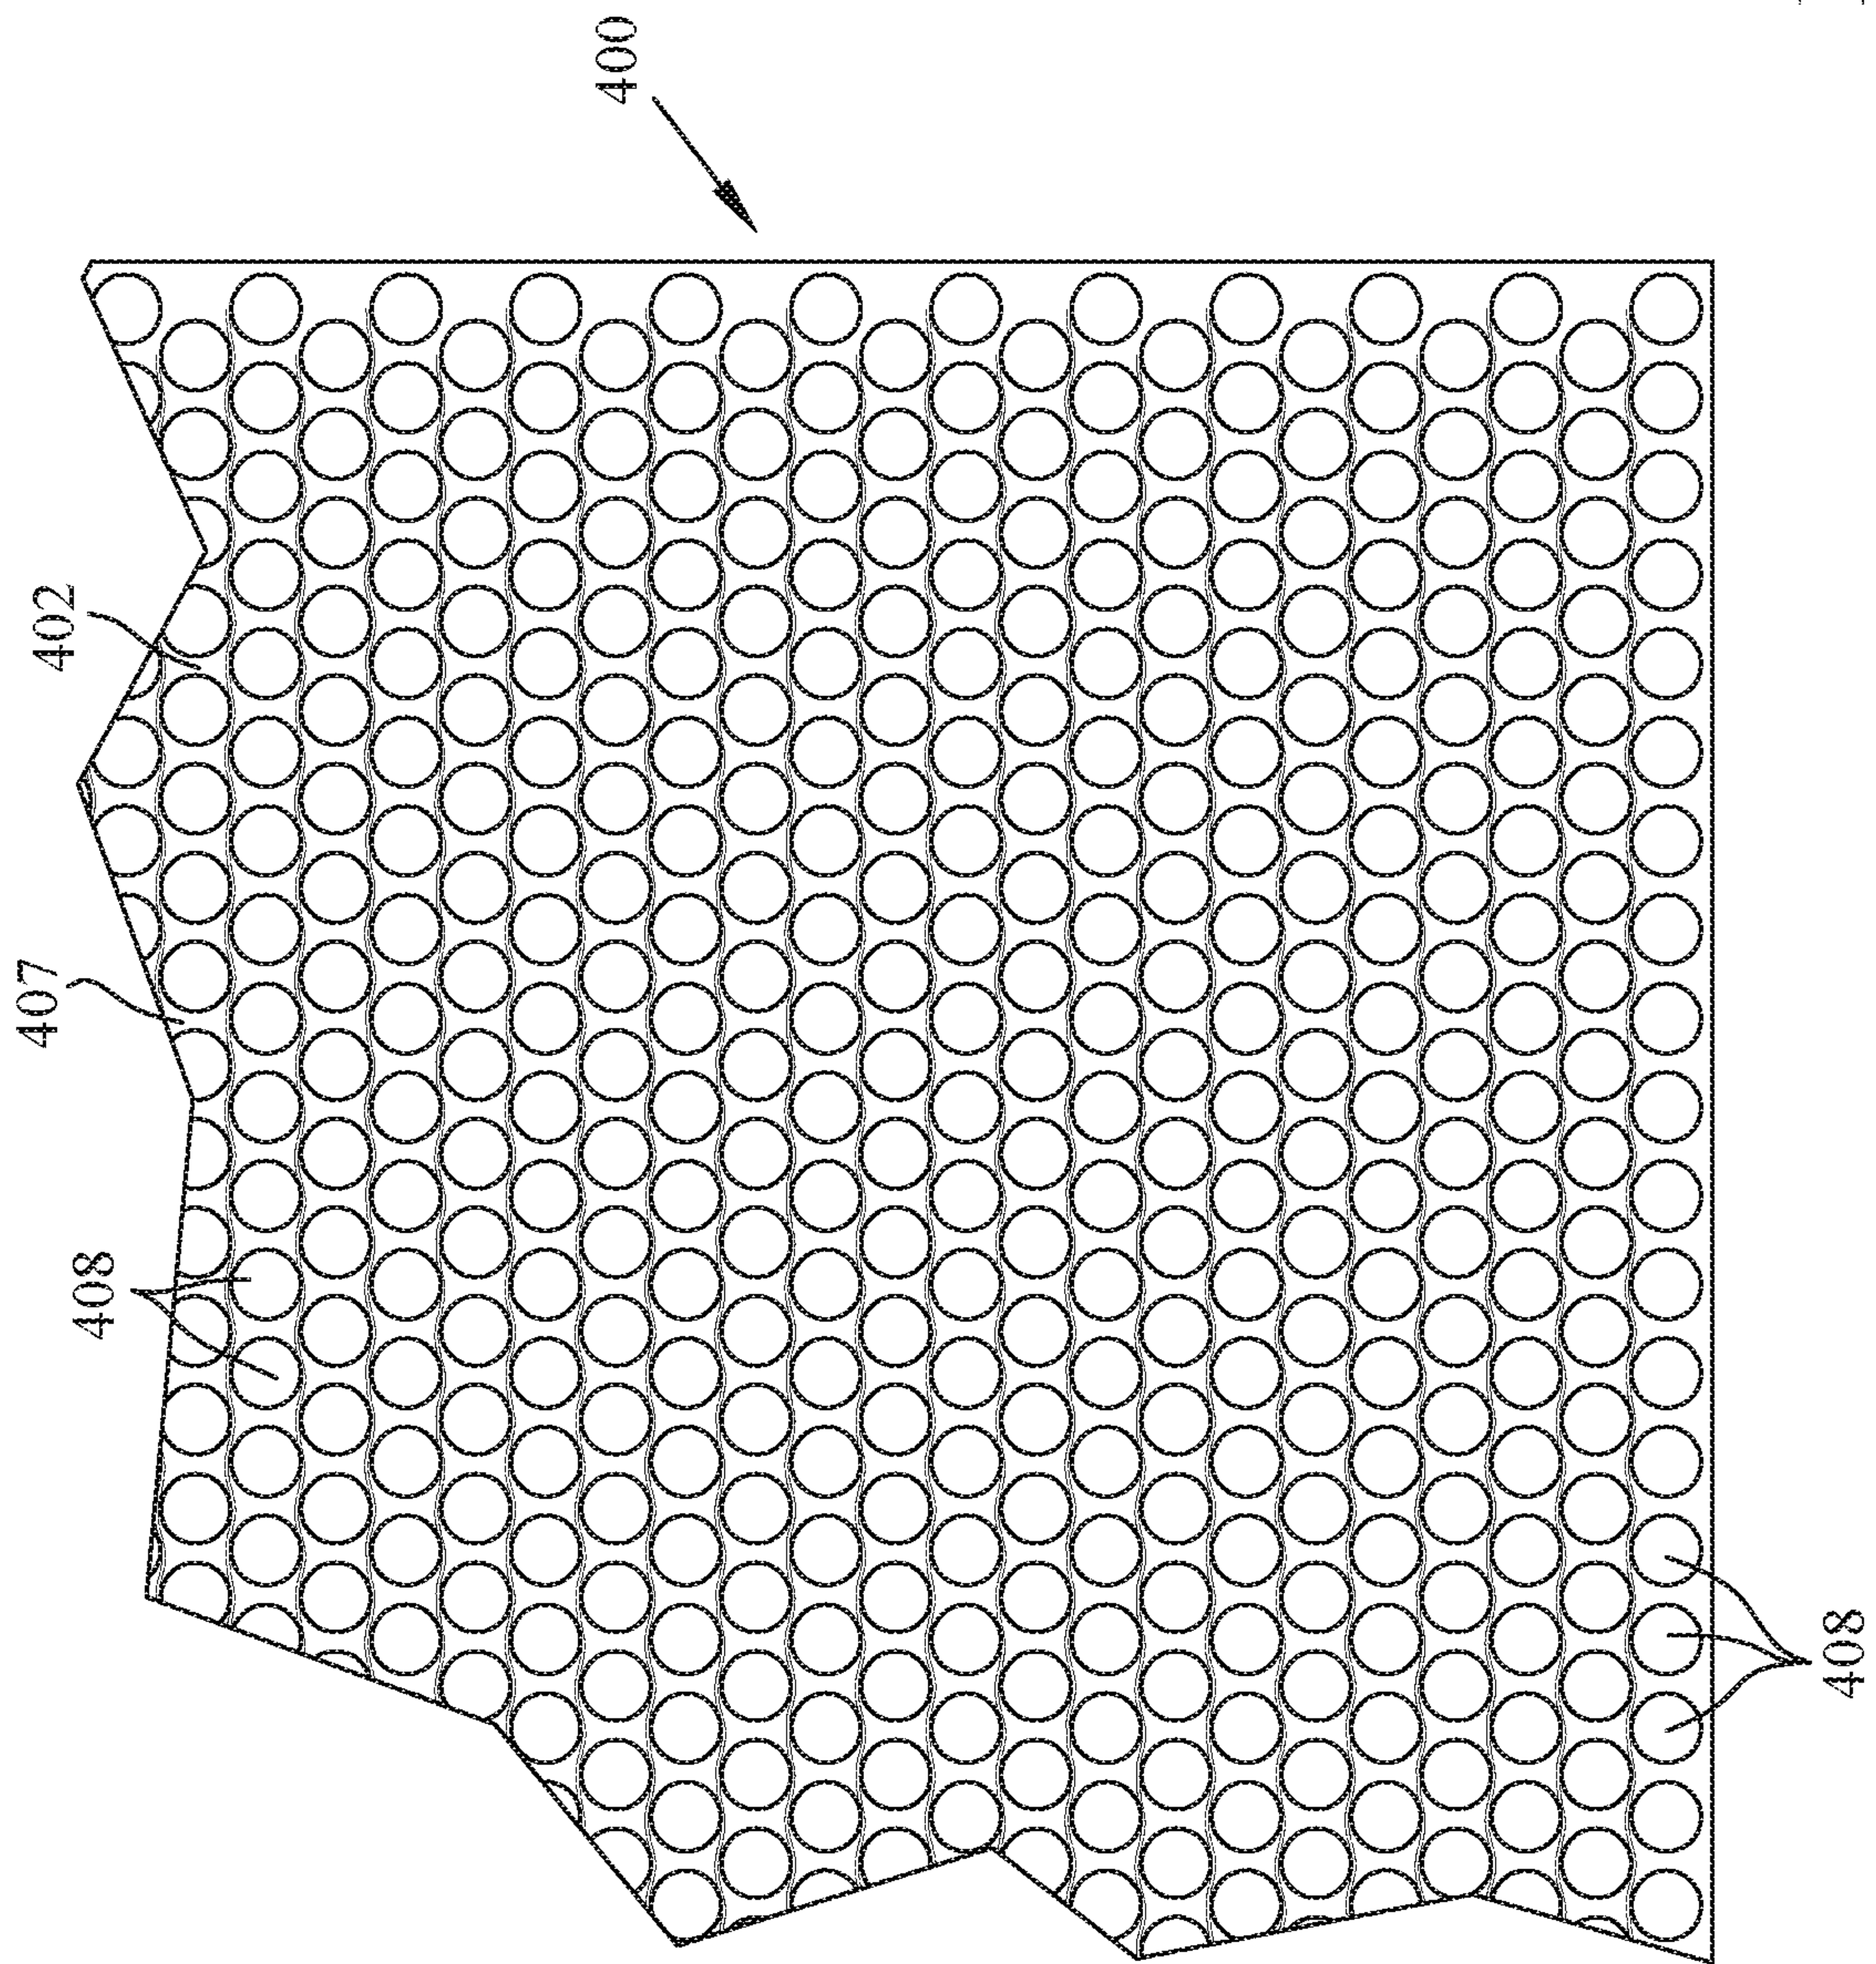
FIG. 17 is an enlarged plan view of the vehicle frame and cargo bay liner of FIG. 14 of the top side having aluminum foil thereon;

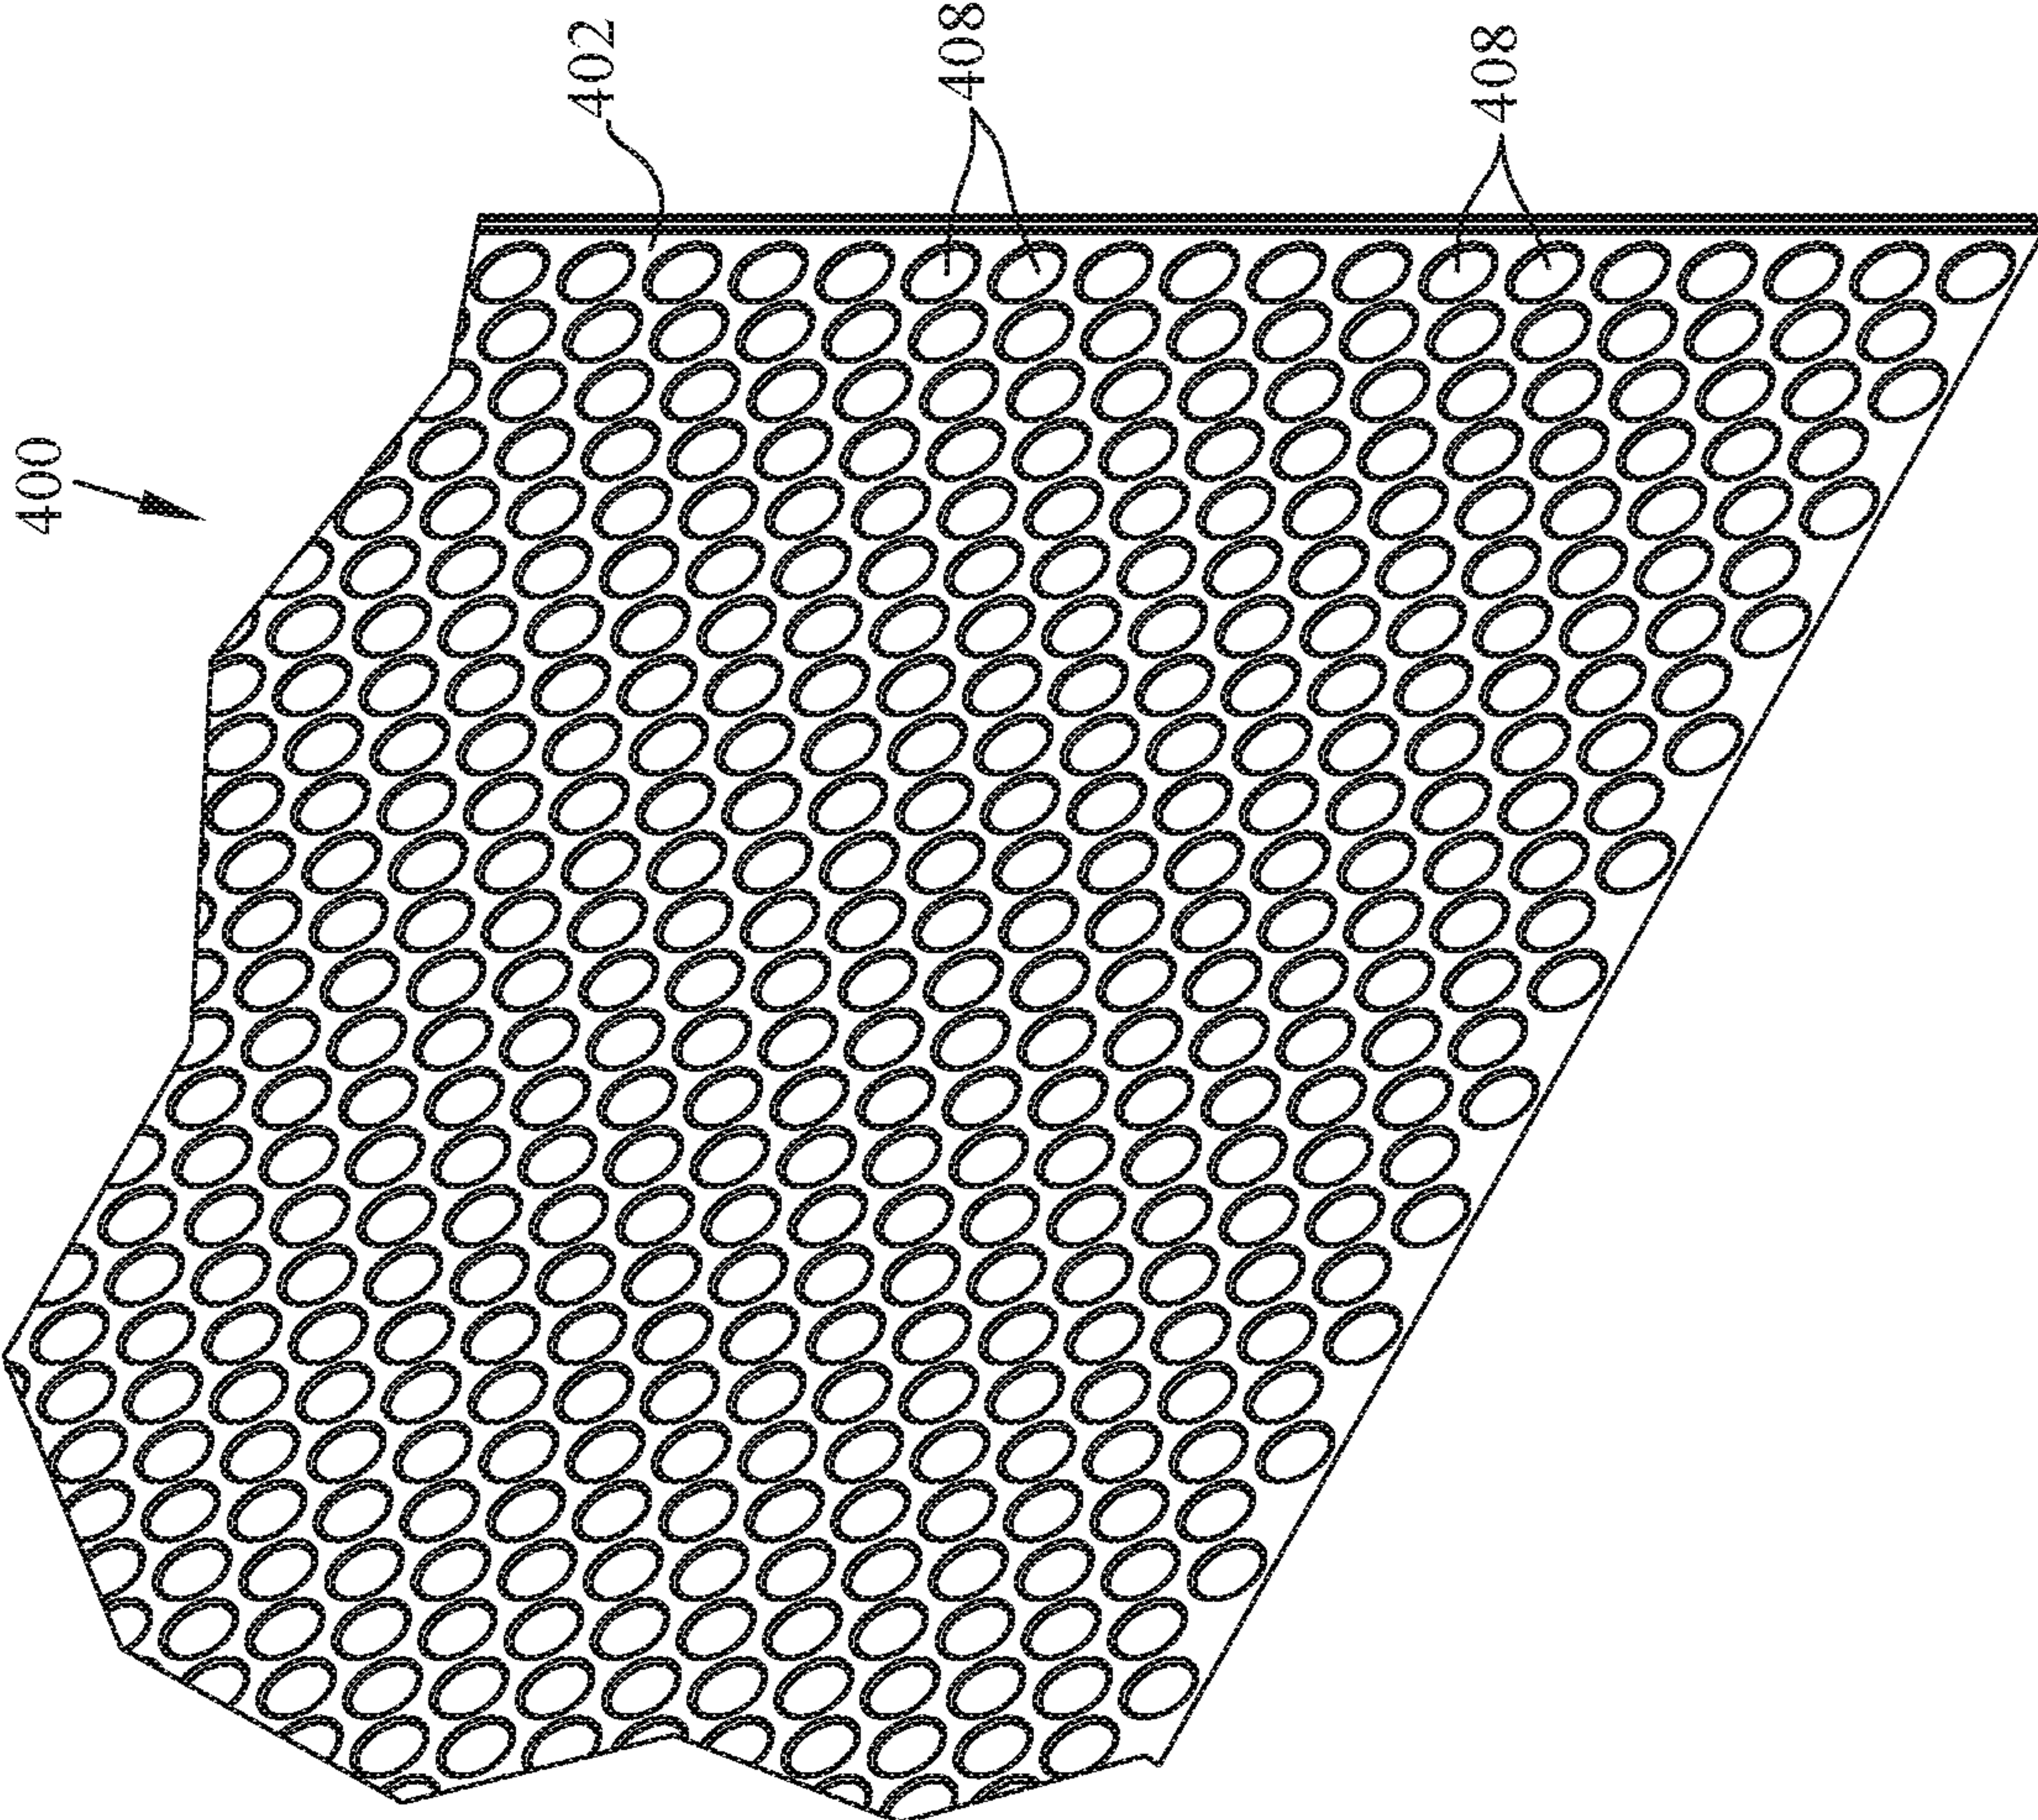
FIG. 18 is a top plan perspective view of the vehicle frame and cargo bay liner of FIG. 14 having the aluminum removed from the top side thereof;

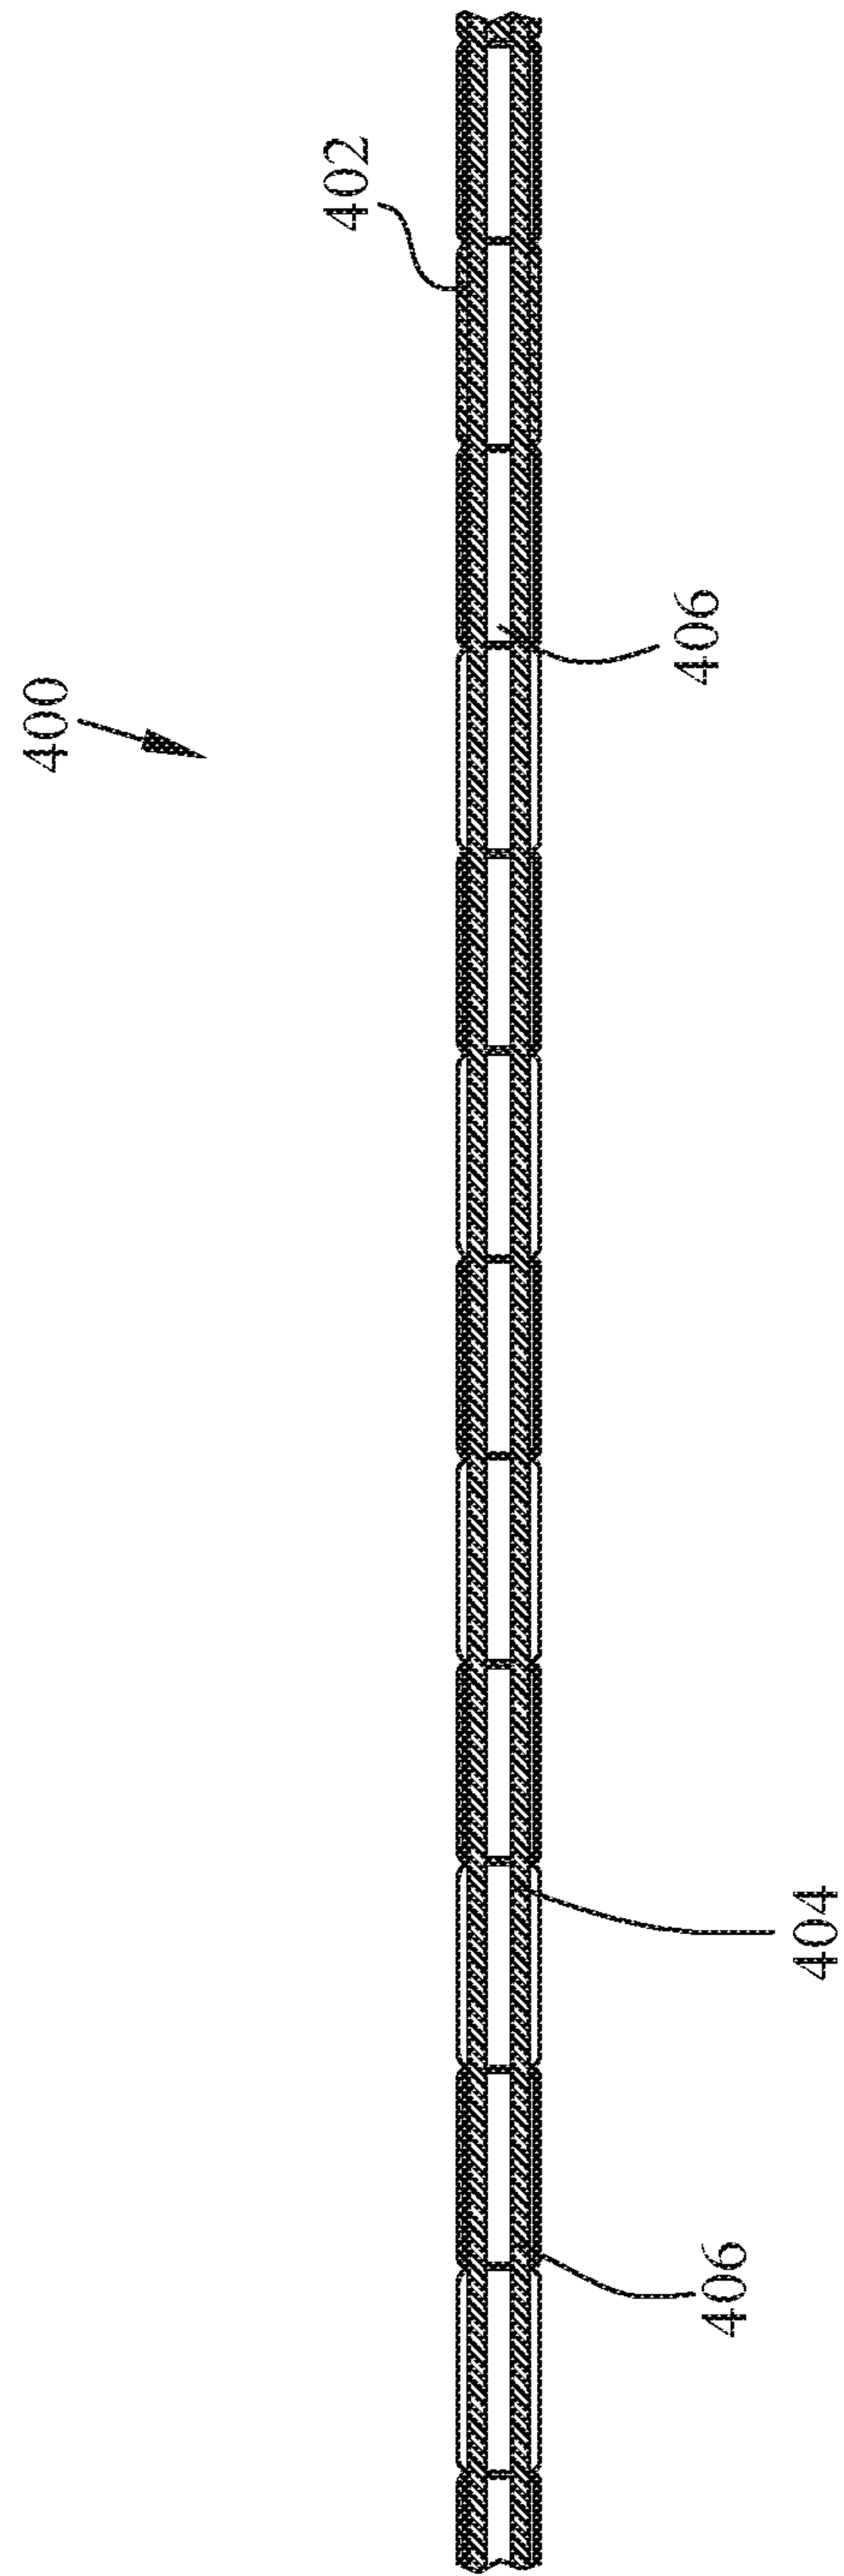
FIG. 19 is a side perspective view of the vehicle frame and cargo bay liner of FIG. 14 with the aluminum foil removed;
