US011447189B1

(54) **VEHICLE FRAME AND CARGO BAY LINER**

A vehicle and liner assembly is provided that includes a  
recreational vehicle having a housing, a front end, a rear end,  
a top, a bottom, and a pair of sidewalls. A frame assembly  
is provided wherein, the housing is mounted on and sup-  
ported by the frame assembly. The liner is attached to the  
frame assembly and covers at least a substantial portion of the  
bottom of the housing. The liner has a first face having  
projections extending therefrom and a second face having  
openings therein. The openings coincide with and extend  
into corresponding projections on the first face.

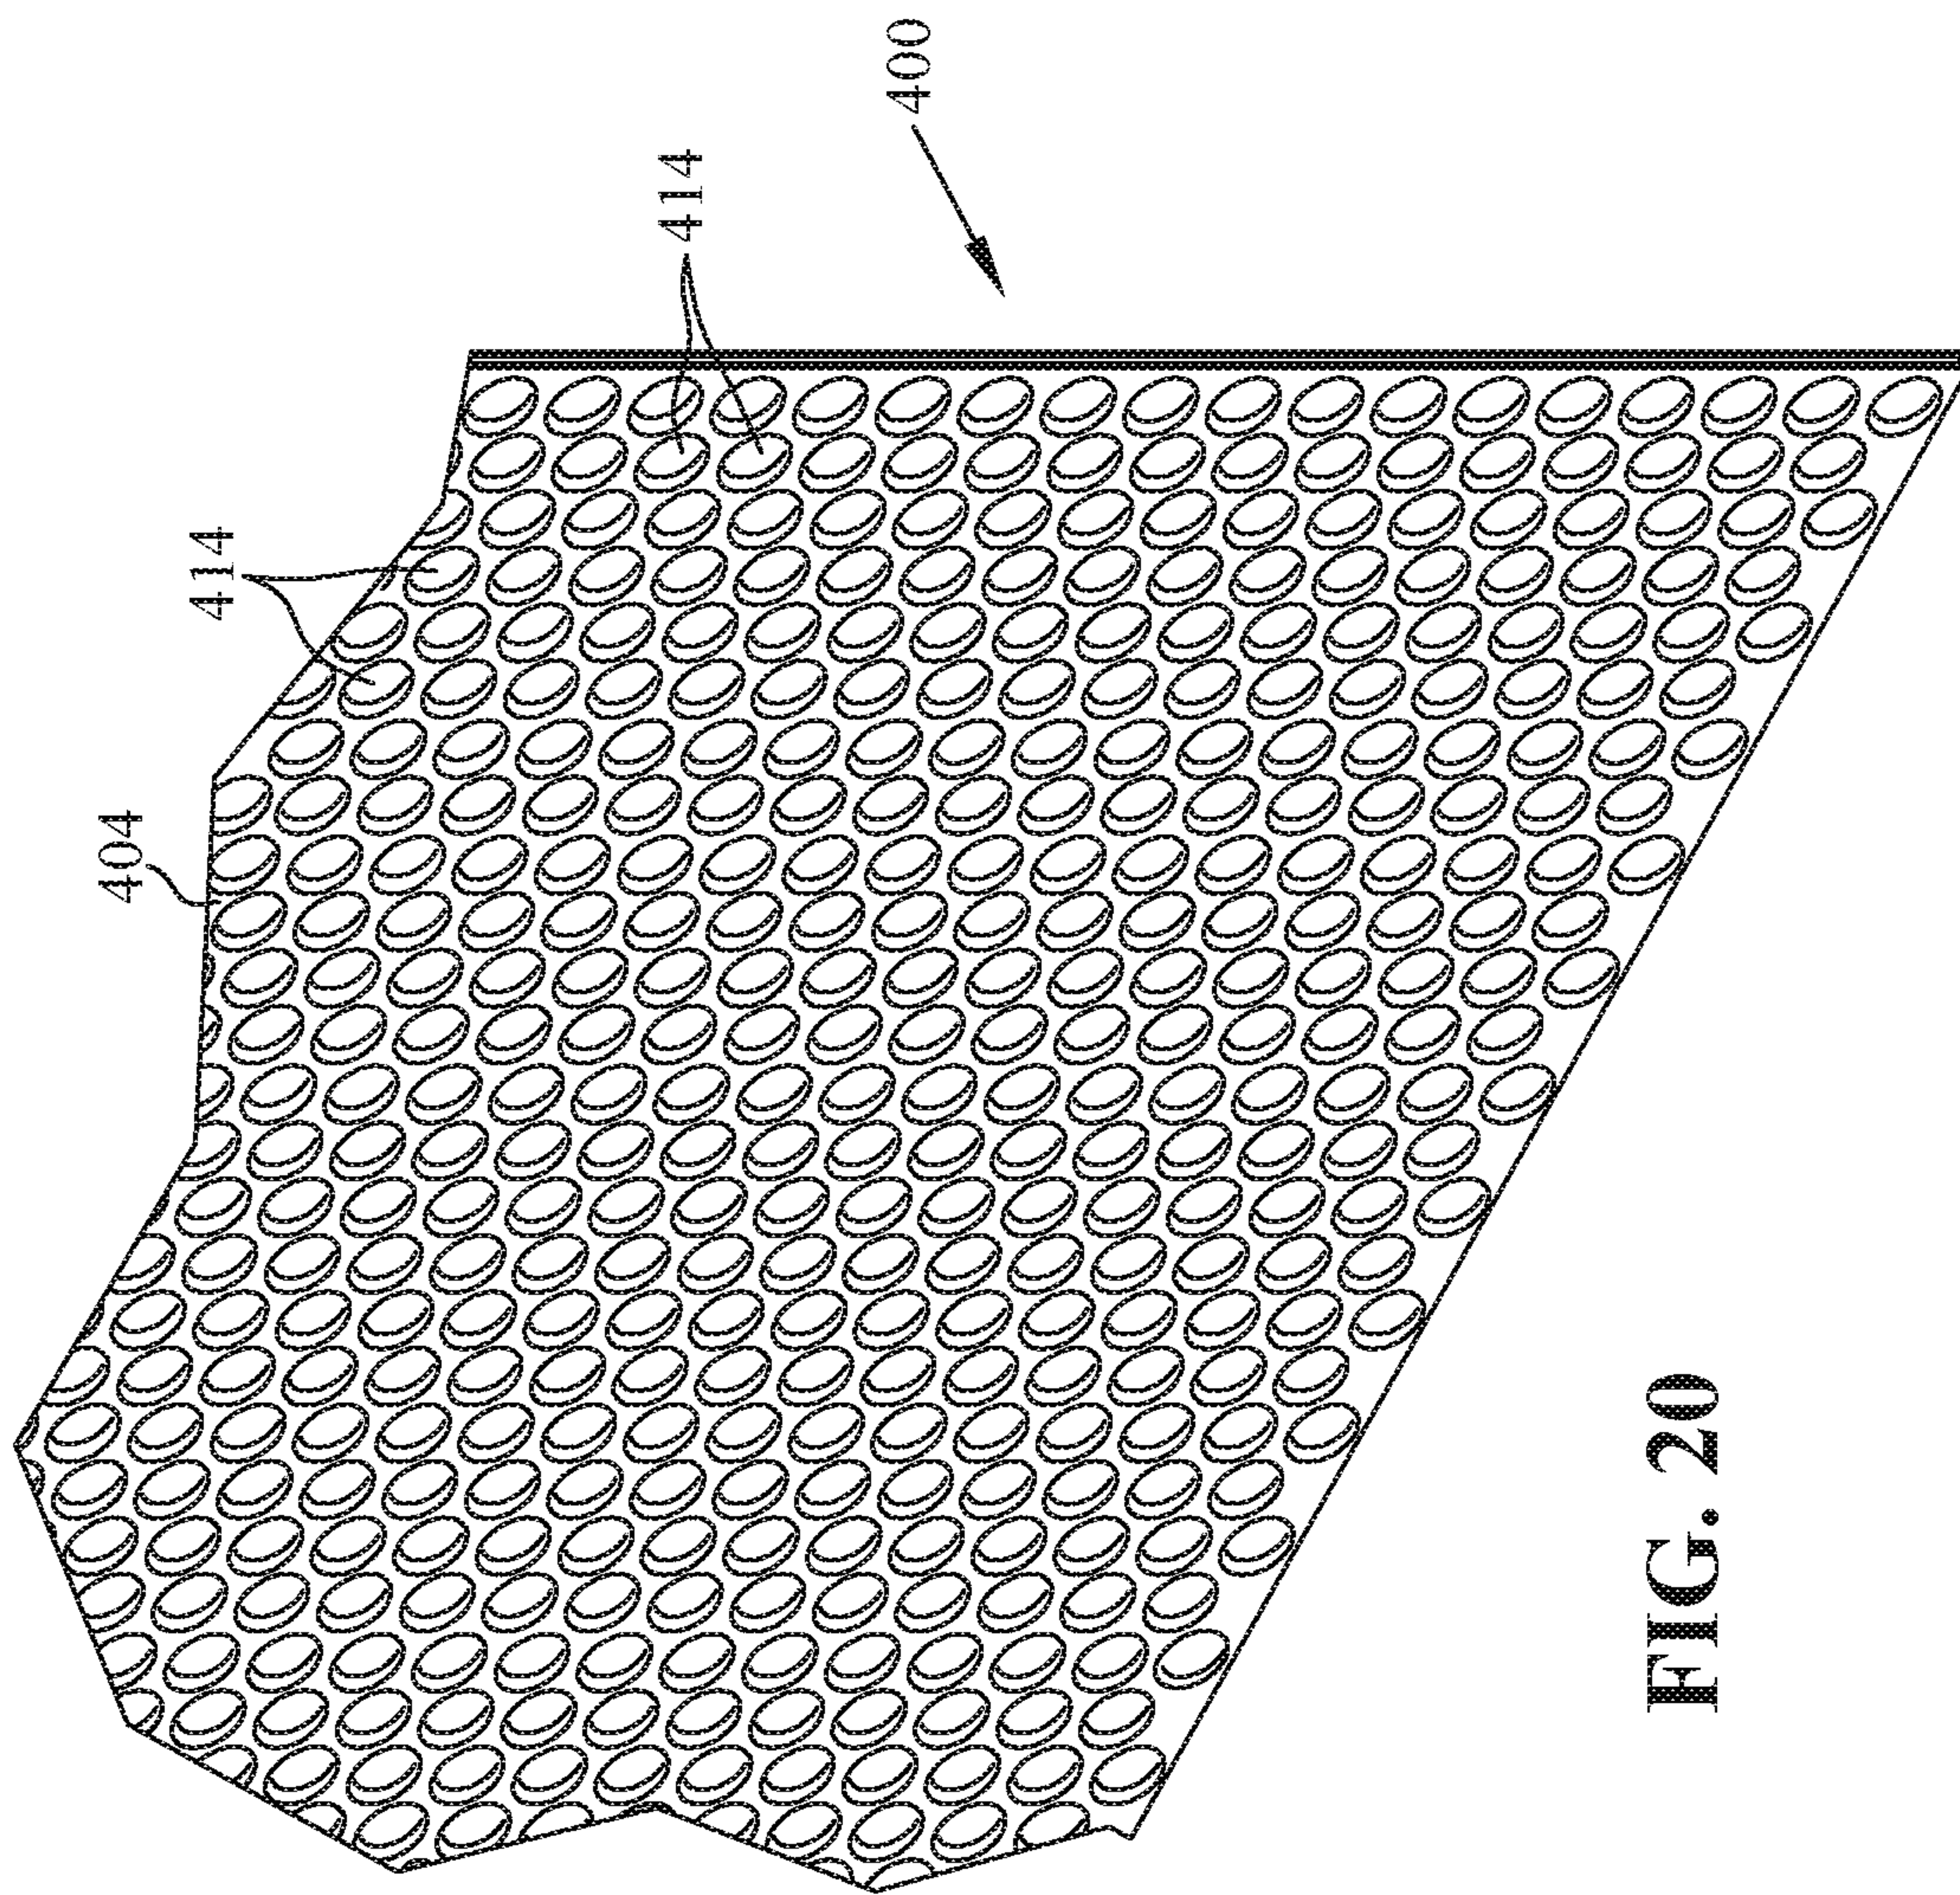
FIG. 20 is a plan perspective view of the bottom side of the vehicle frame and cargo bay liner of FIG. 14;

Now referring to FIGS. 14-24, another alternate vehicle frame and cargo area liner is shown generally indicated as 400. Liner 400 can be provided in a coiled form 401 as

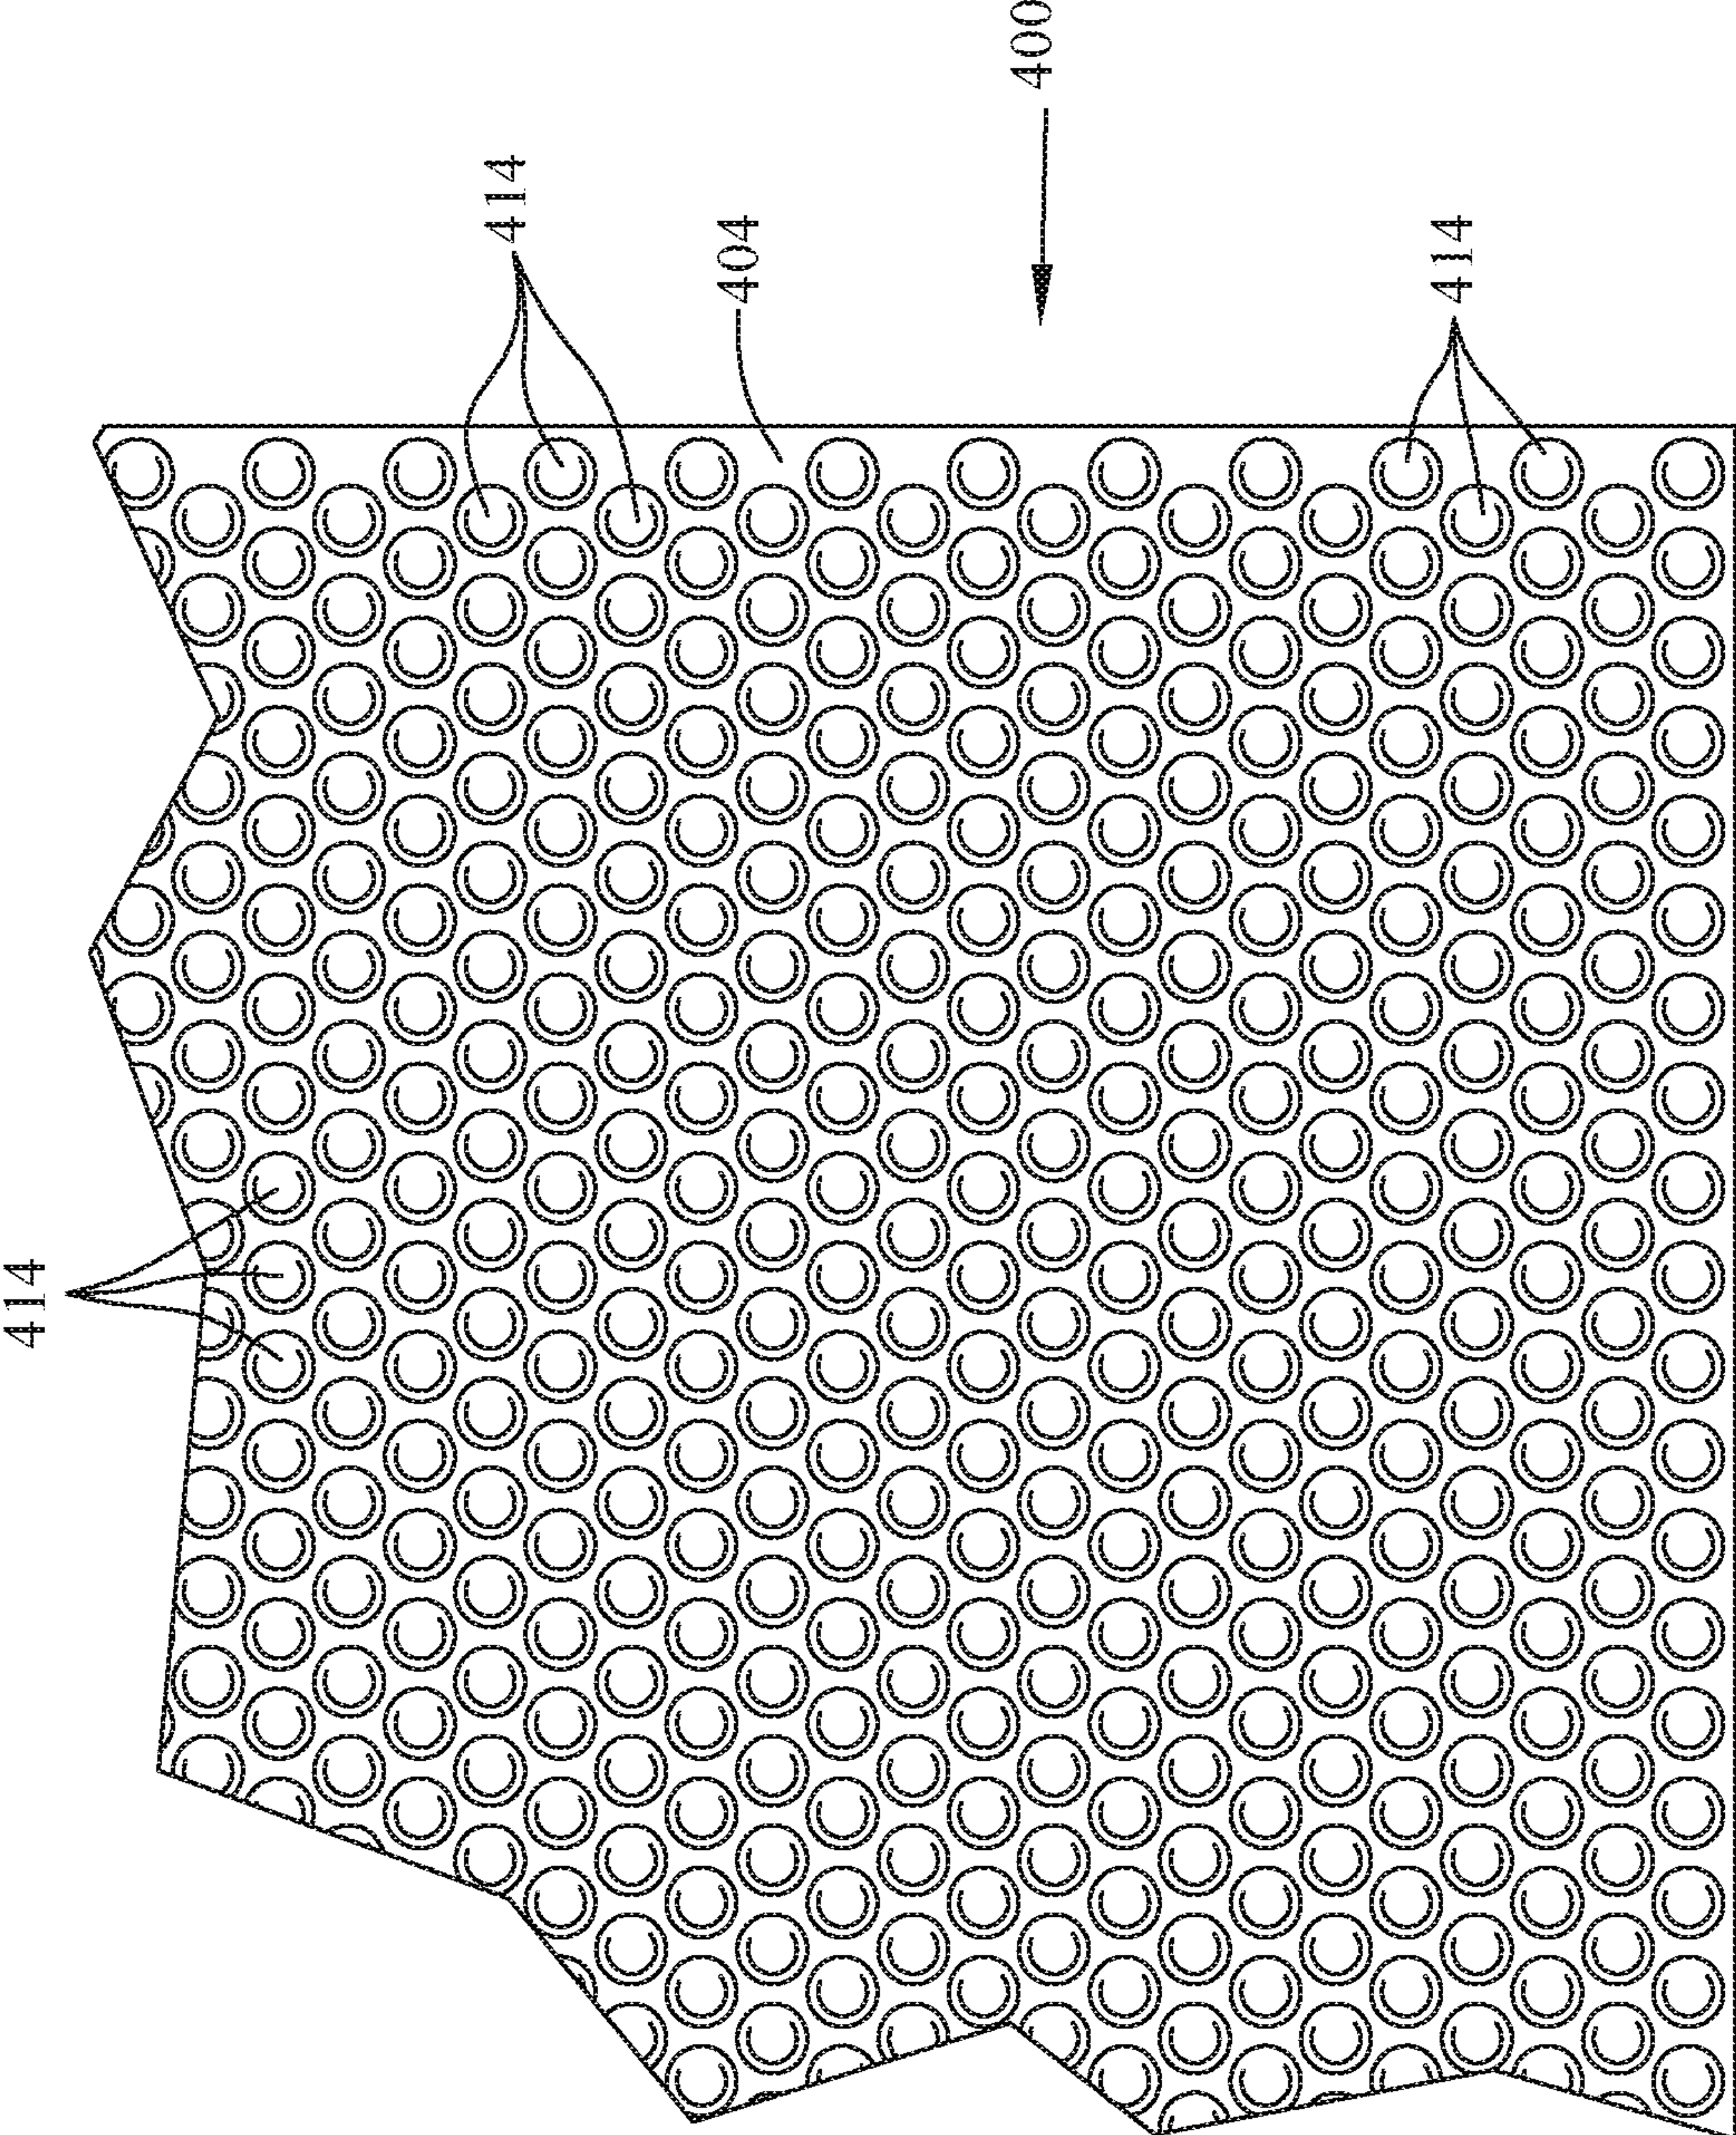
FIG. 21 is an enlarged bottom plan perspective view of the vehicle frame and cargo bay liner of FIG. 14;

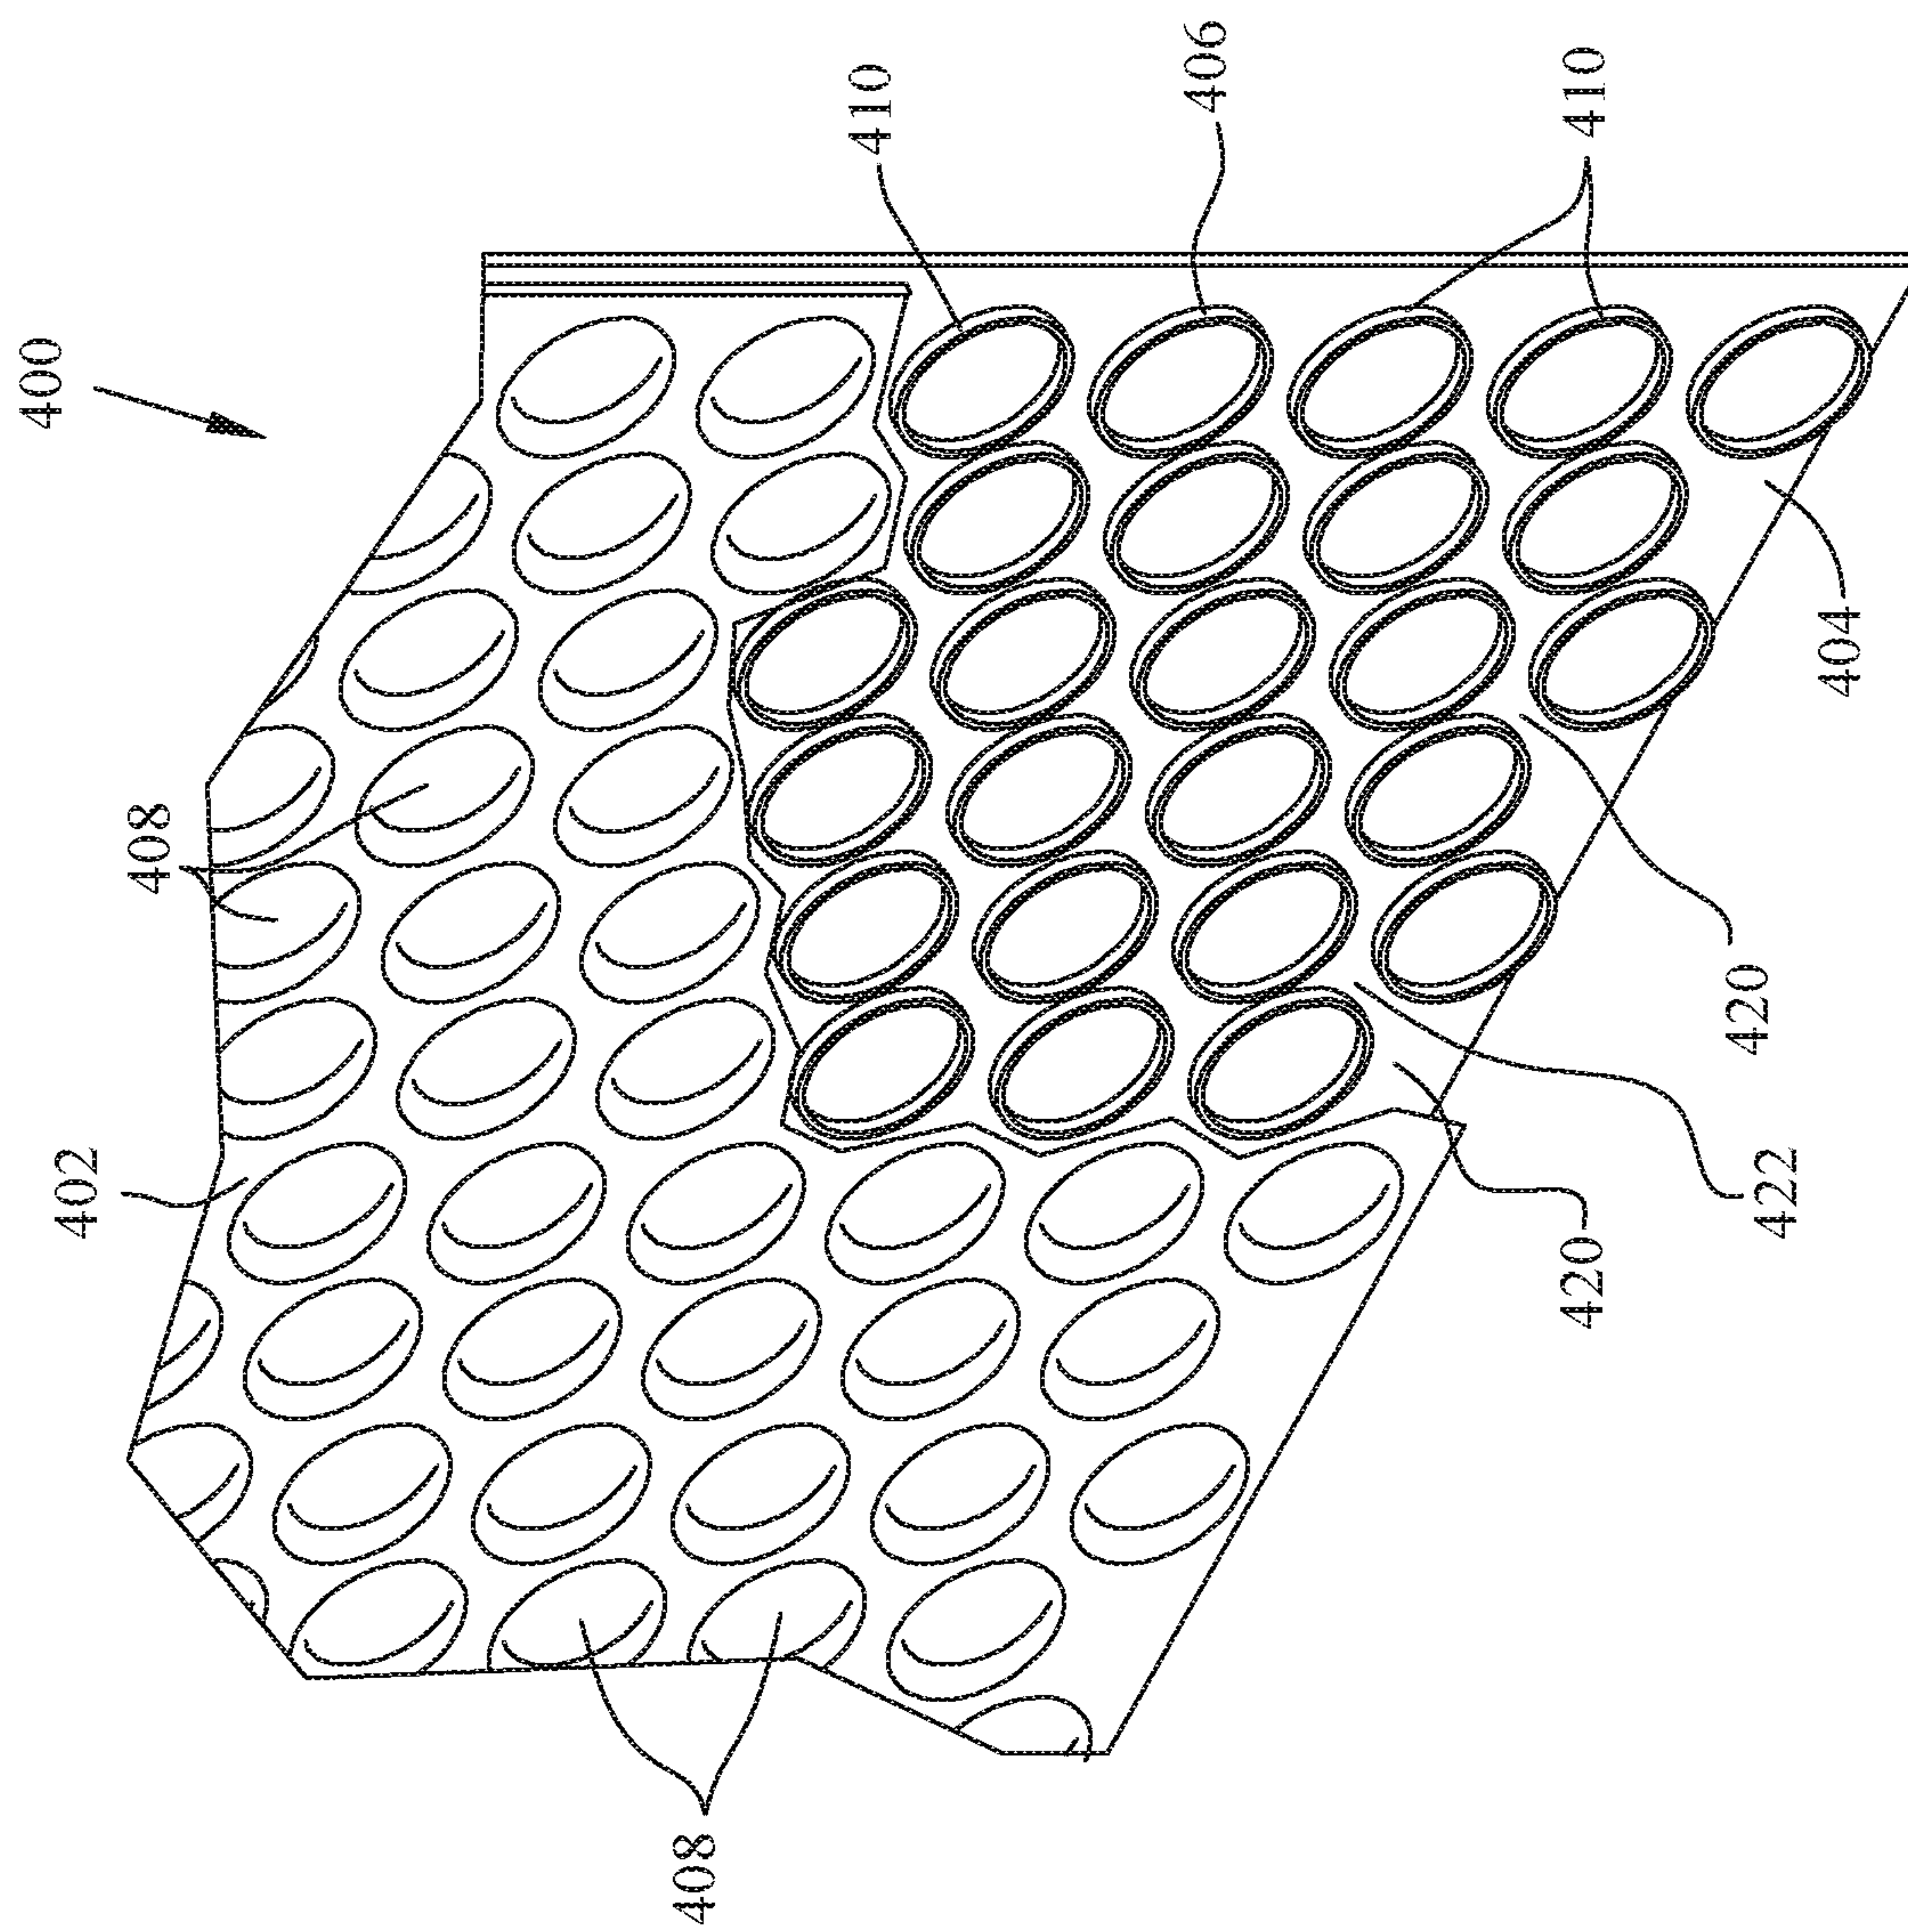
FIG. 22 is a perspective view of a portion of the vehicle frame and cargo bay liner of FIG. 14 showing part of the top layer removed;

As can be seen in FIGS. 22 and 23, cylindrical projections **410** form an obstruction to passage through core **406** such that any water entering the ends thereof is obstructed and impeded or hindered from propagating across liner **400** as compared to channels **111** in corrugated liner **104**, which readily allow transport of liquids. Additionally, as where vehicle frame and cargo bay liner **400** is cut, it will intersect a plurality of cylindrical projections **410** in the liner. As each cylinder is closed off, any water entering into an end of the liner where a projection has been cut will be prevented from further propagating by encountering the wall of the projection. Only a small area or channel **422** between cylindrical projections would allow any water or moisture to enter into core **406** of liner **400**, but that will not readily propagate to the offset projections internal to core **406** that will impede or hinder any advancement of the moisture.

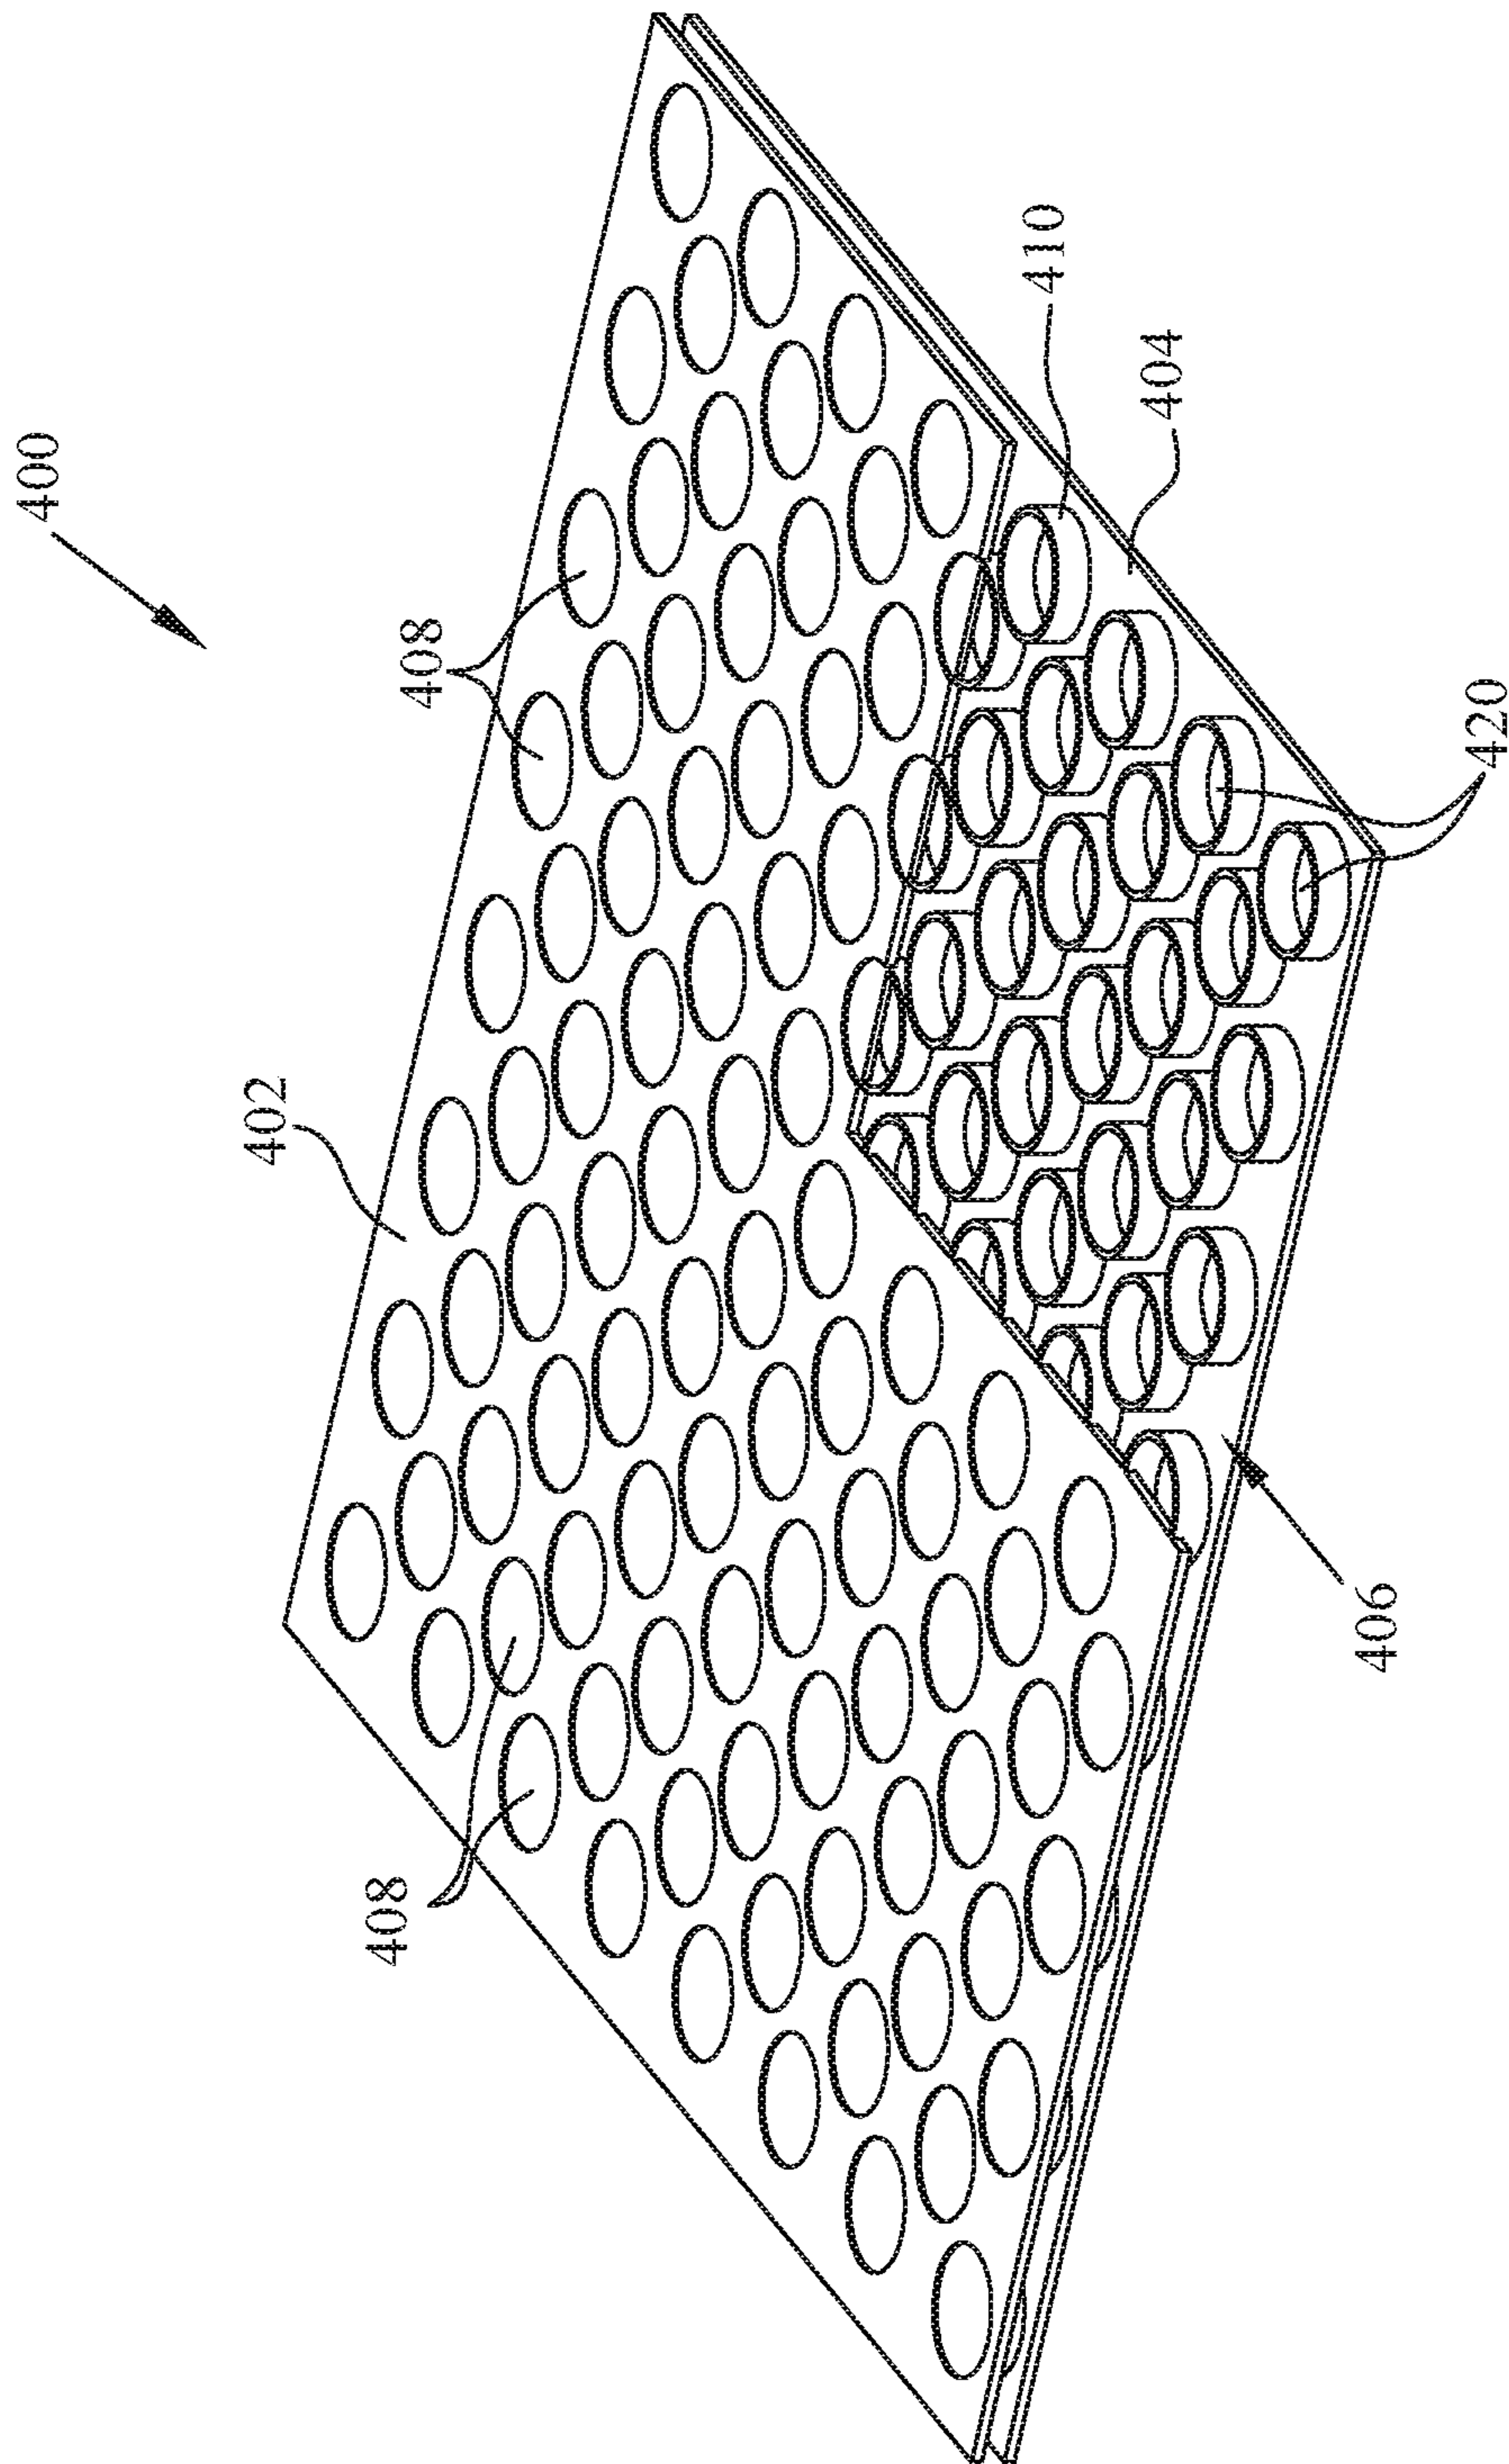
FIG. 23 is another perspective view of a portion of the vehicle frame and cargo bay liner of FIG. 14 with part of the top layer removed;

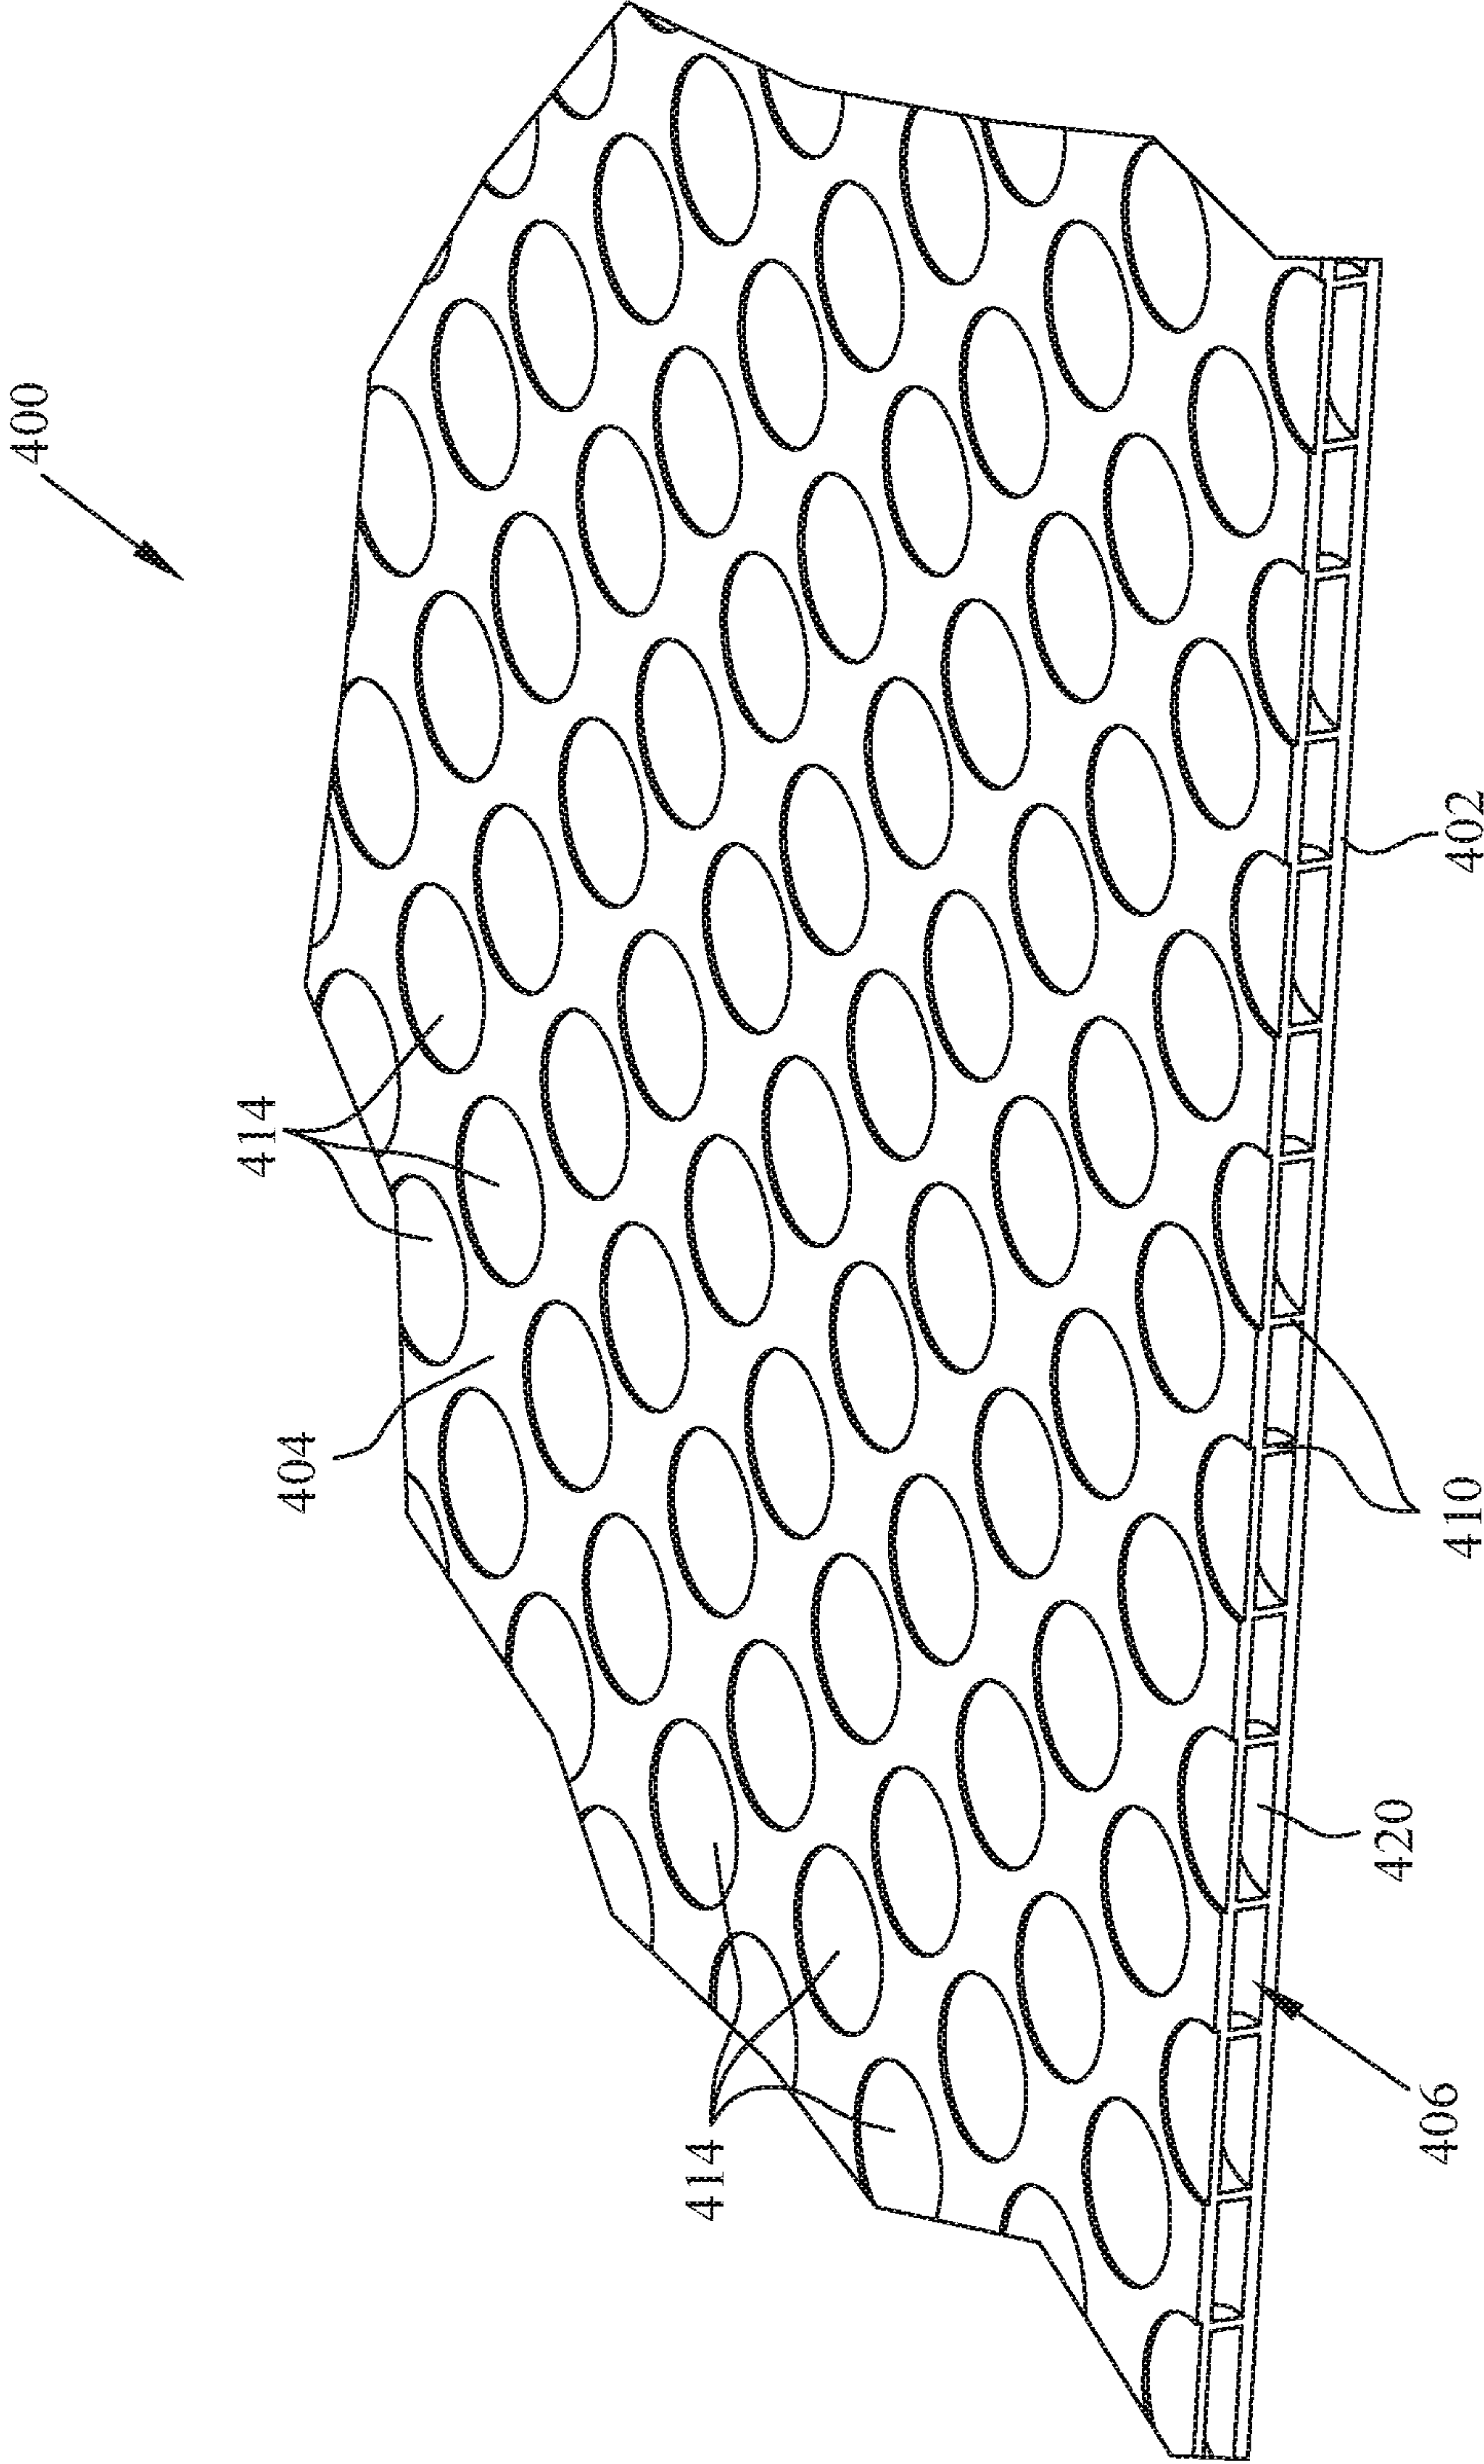
FIG. 24 is a perspective view of the bottom side of a portion of the vehicle frame and cargo bay liner of FIG. 14;
