US011447189B1

(54) **VEHICLE FRAME AND CARGO BAY LINER**

A vehicle and liner assembly is provided that includes a  
recreational vehicle having a housing, a front end, a rear end,  
a top, a bottom, and a pair of sidewalls. A frame assembly  
is provided wherein, the housing is mounted on and sup-  
ported by the frame assembly. The liner is attached to the  
frame assembly and covers at least a substantial portion of the  
bottom of the housing. The liner has a first face having  
projections extending therefrom and a second face having  
openings therein. The openings coincide with and extend  
into corresponding projections on the first face.

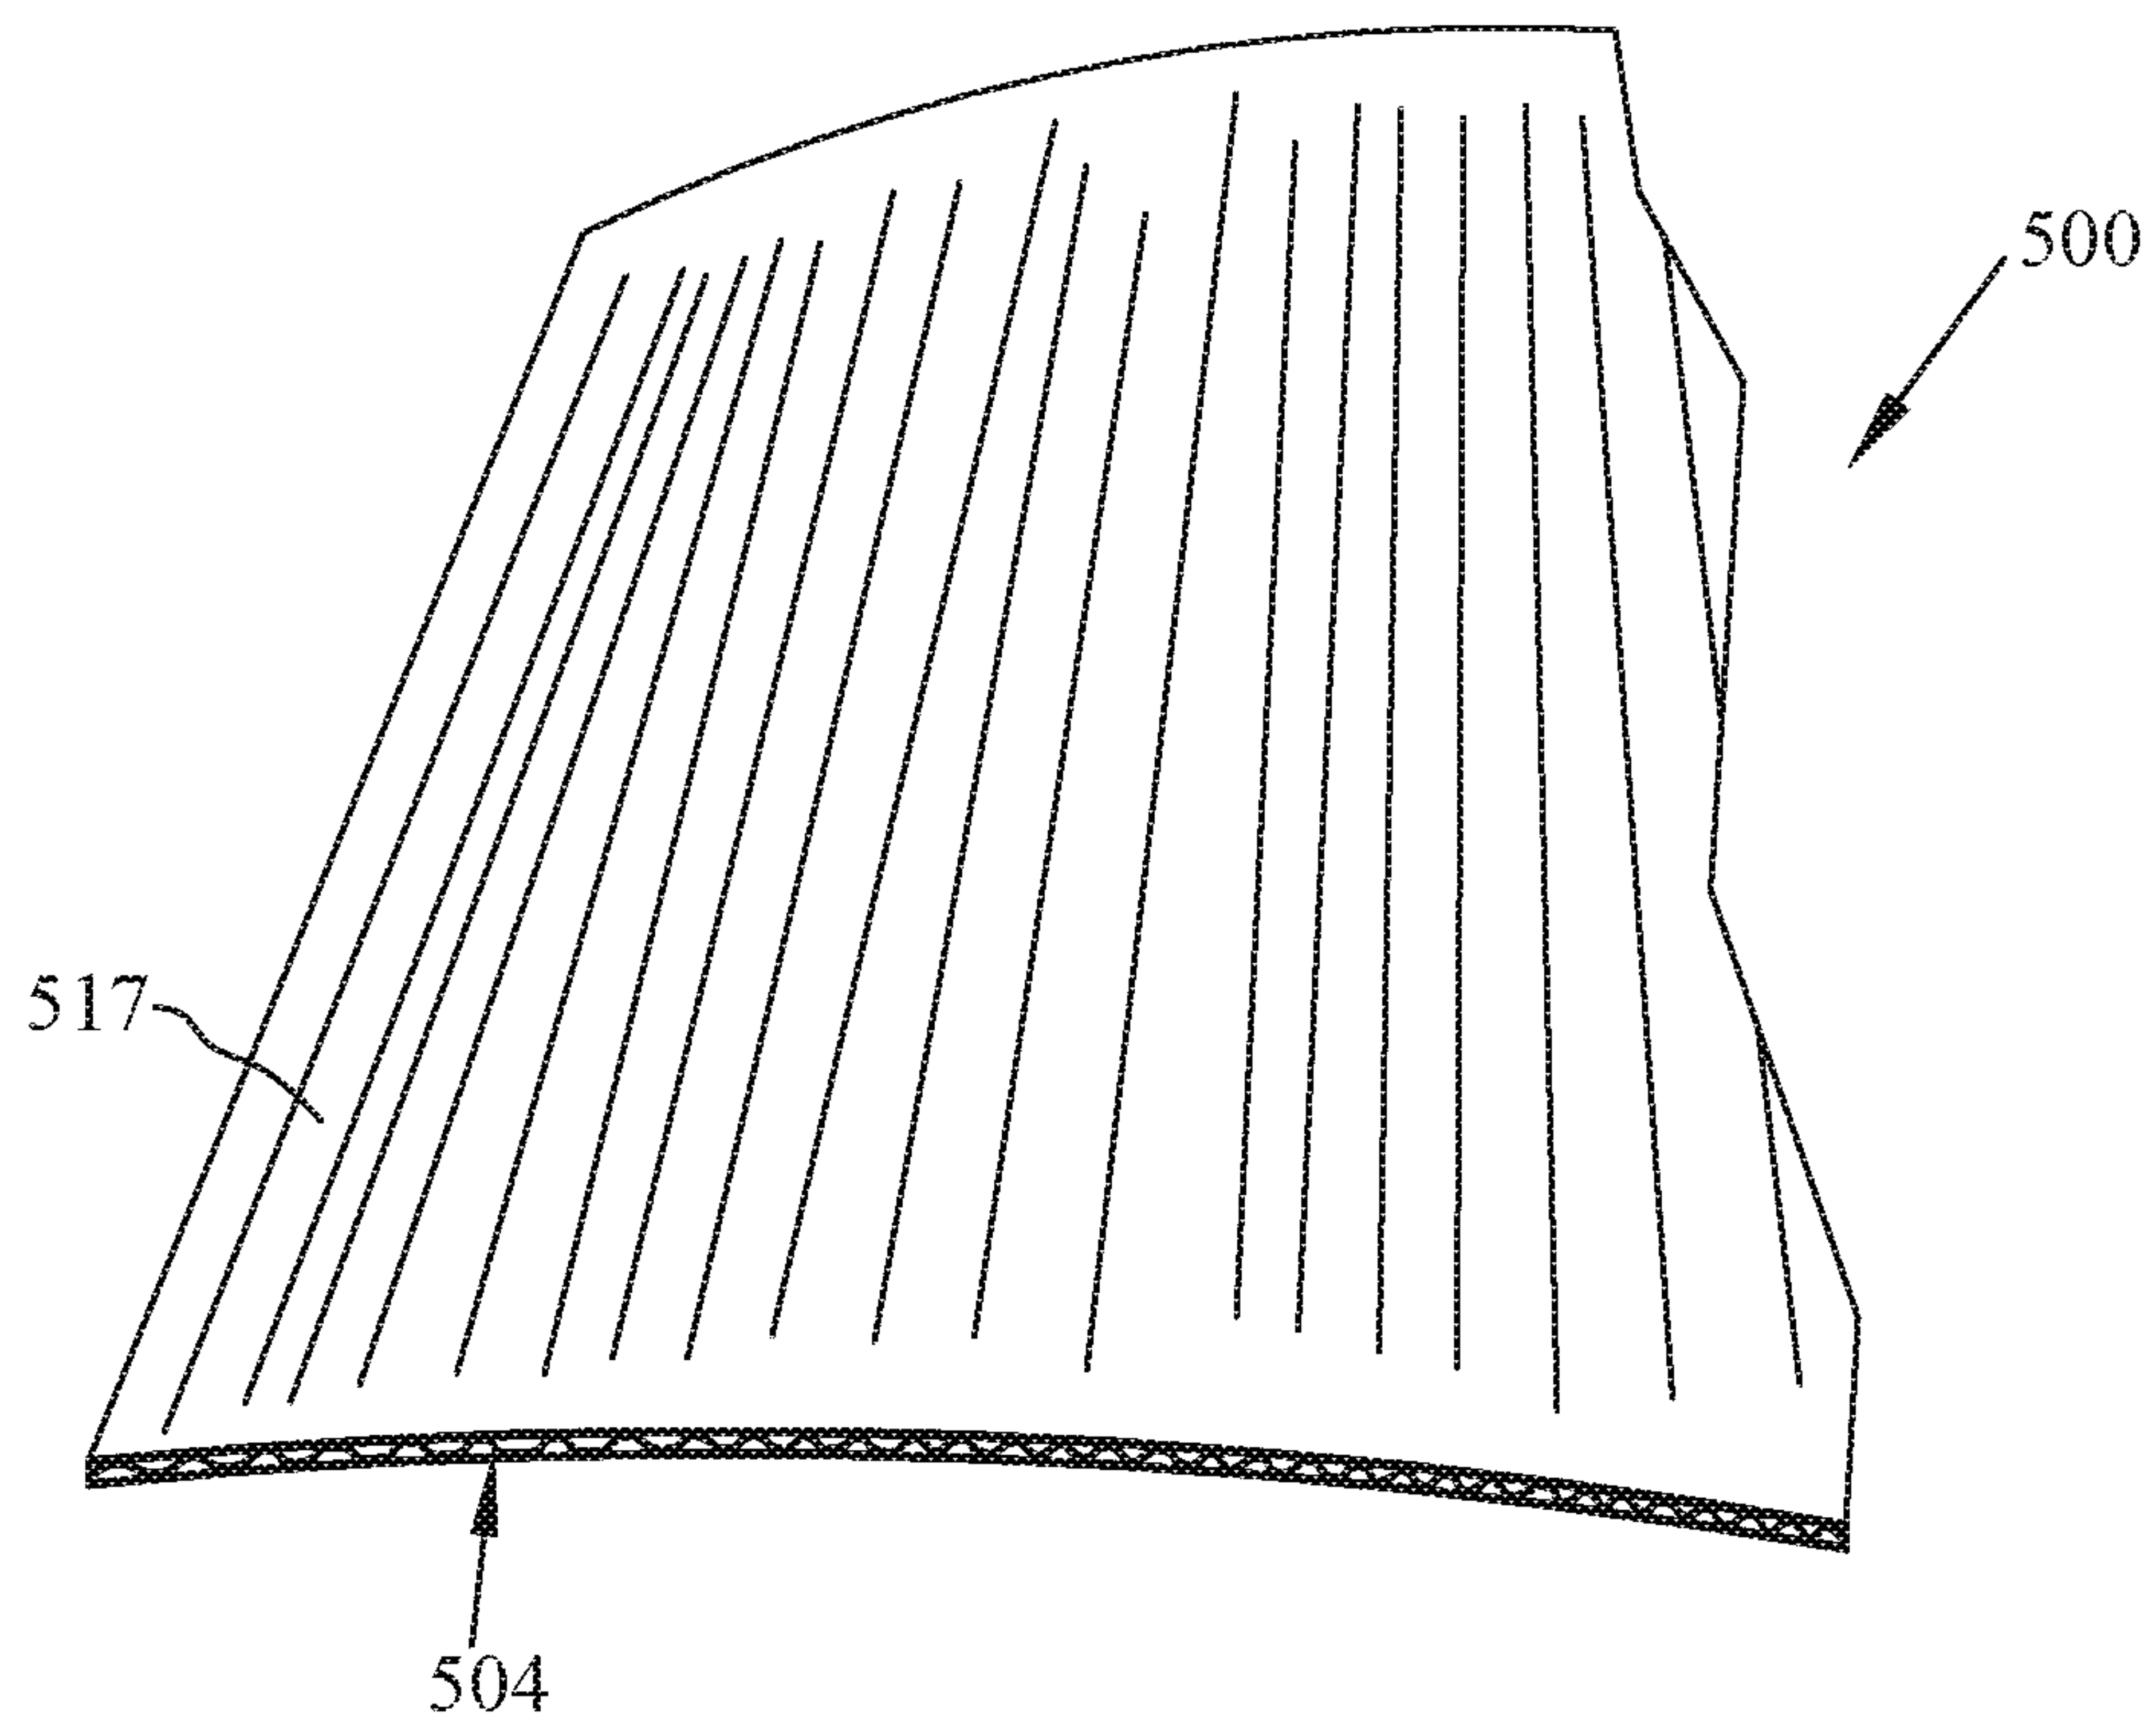
**FIG. 25**

FIG. 25 is a perspective view of an additional alternate embodiment vehicle frame and cargo bay liner shown laid out and having an aluminum foil on one side thereof;

Now referring to FIGS. 25-27, other alternate embodiment vehicle frame and cargo area liner is shown generally indicated as **500**. Liner **500** includes a corrugated liner, generally indicated as **504**. Corrugated liner **504** includes a top sheet **506**, a bottom sheet **508**, and a corrugated or sinusoidal ply **510** extending therebetween, as best shown in FIGS. 26 and 27. Top sheet **506** and bottom sheet **508** each have a generally planar configuration, not including any rolling memory that may be embedded therein and are adhered or thermally attached to corrugated ply **510**. It should be appreciated that the corrugated ply is defined to include either a sinusoidal configuration as shown in FIGS. 26 and 27 or alternately a plurality of member perpendicular to top sheet **506** and bottom sheet **508** such as is shown in the material utilized in FIGS. 7 and 8 of U.S. Pat. No. 10,000,930 B2 to Lowe et al., which is incorporated in its entirety herein by reference. In one embodiment, corrugated liner **504** is polyethylene. Of course, other materials, and in particular, polymers such as polypropylene may be used for corrugated liner **504**. As best shown in FIG. 26, when the corrugated liner **504** is rolled, the outer sheet will become stretched and the inner sheet may fold as shown with top sheet **506**, and bottom sheet **508** in FIG. 26, respectively.

Additionally, vehicle frame and cargo area liner **500** also includes an aluminum foil or sheet or metalized film **517** adhered to top sheet **506** of corrugated liner **504**. Aluminum foil or sheet or metalized film **517** is preferably mounted so that it is between corrugated liner **504** and housing or living quarters **14** of the recreational vehicle **10**, in order to provide additional protection and insulation to the living quarters. However, aluminum foil or sheet or metalized film **517** may also be mounted downwardly on the vehicle frame so that it is facing the road surface. It should be appreciated that aluminum foil or sheet or metalized film **517** may be adhered to bottom sheet **508** rather than top sheet **506**. Vehicle frame and cargo area liner **500** may be mounted to a vehicle frame **32** utilizing means discussed above or other known means.

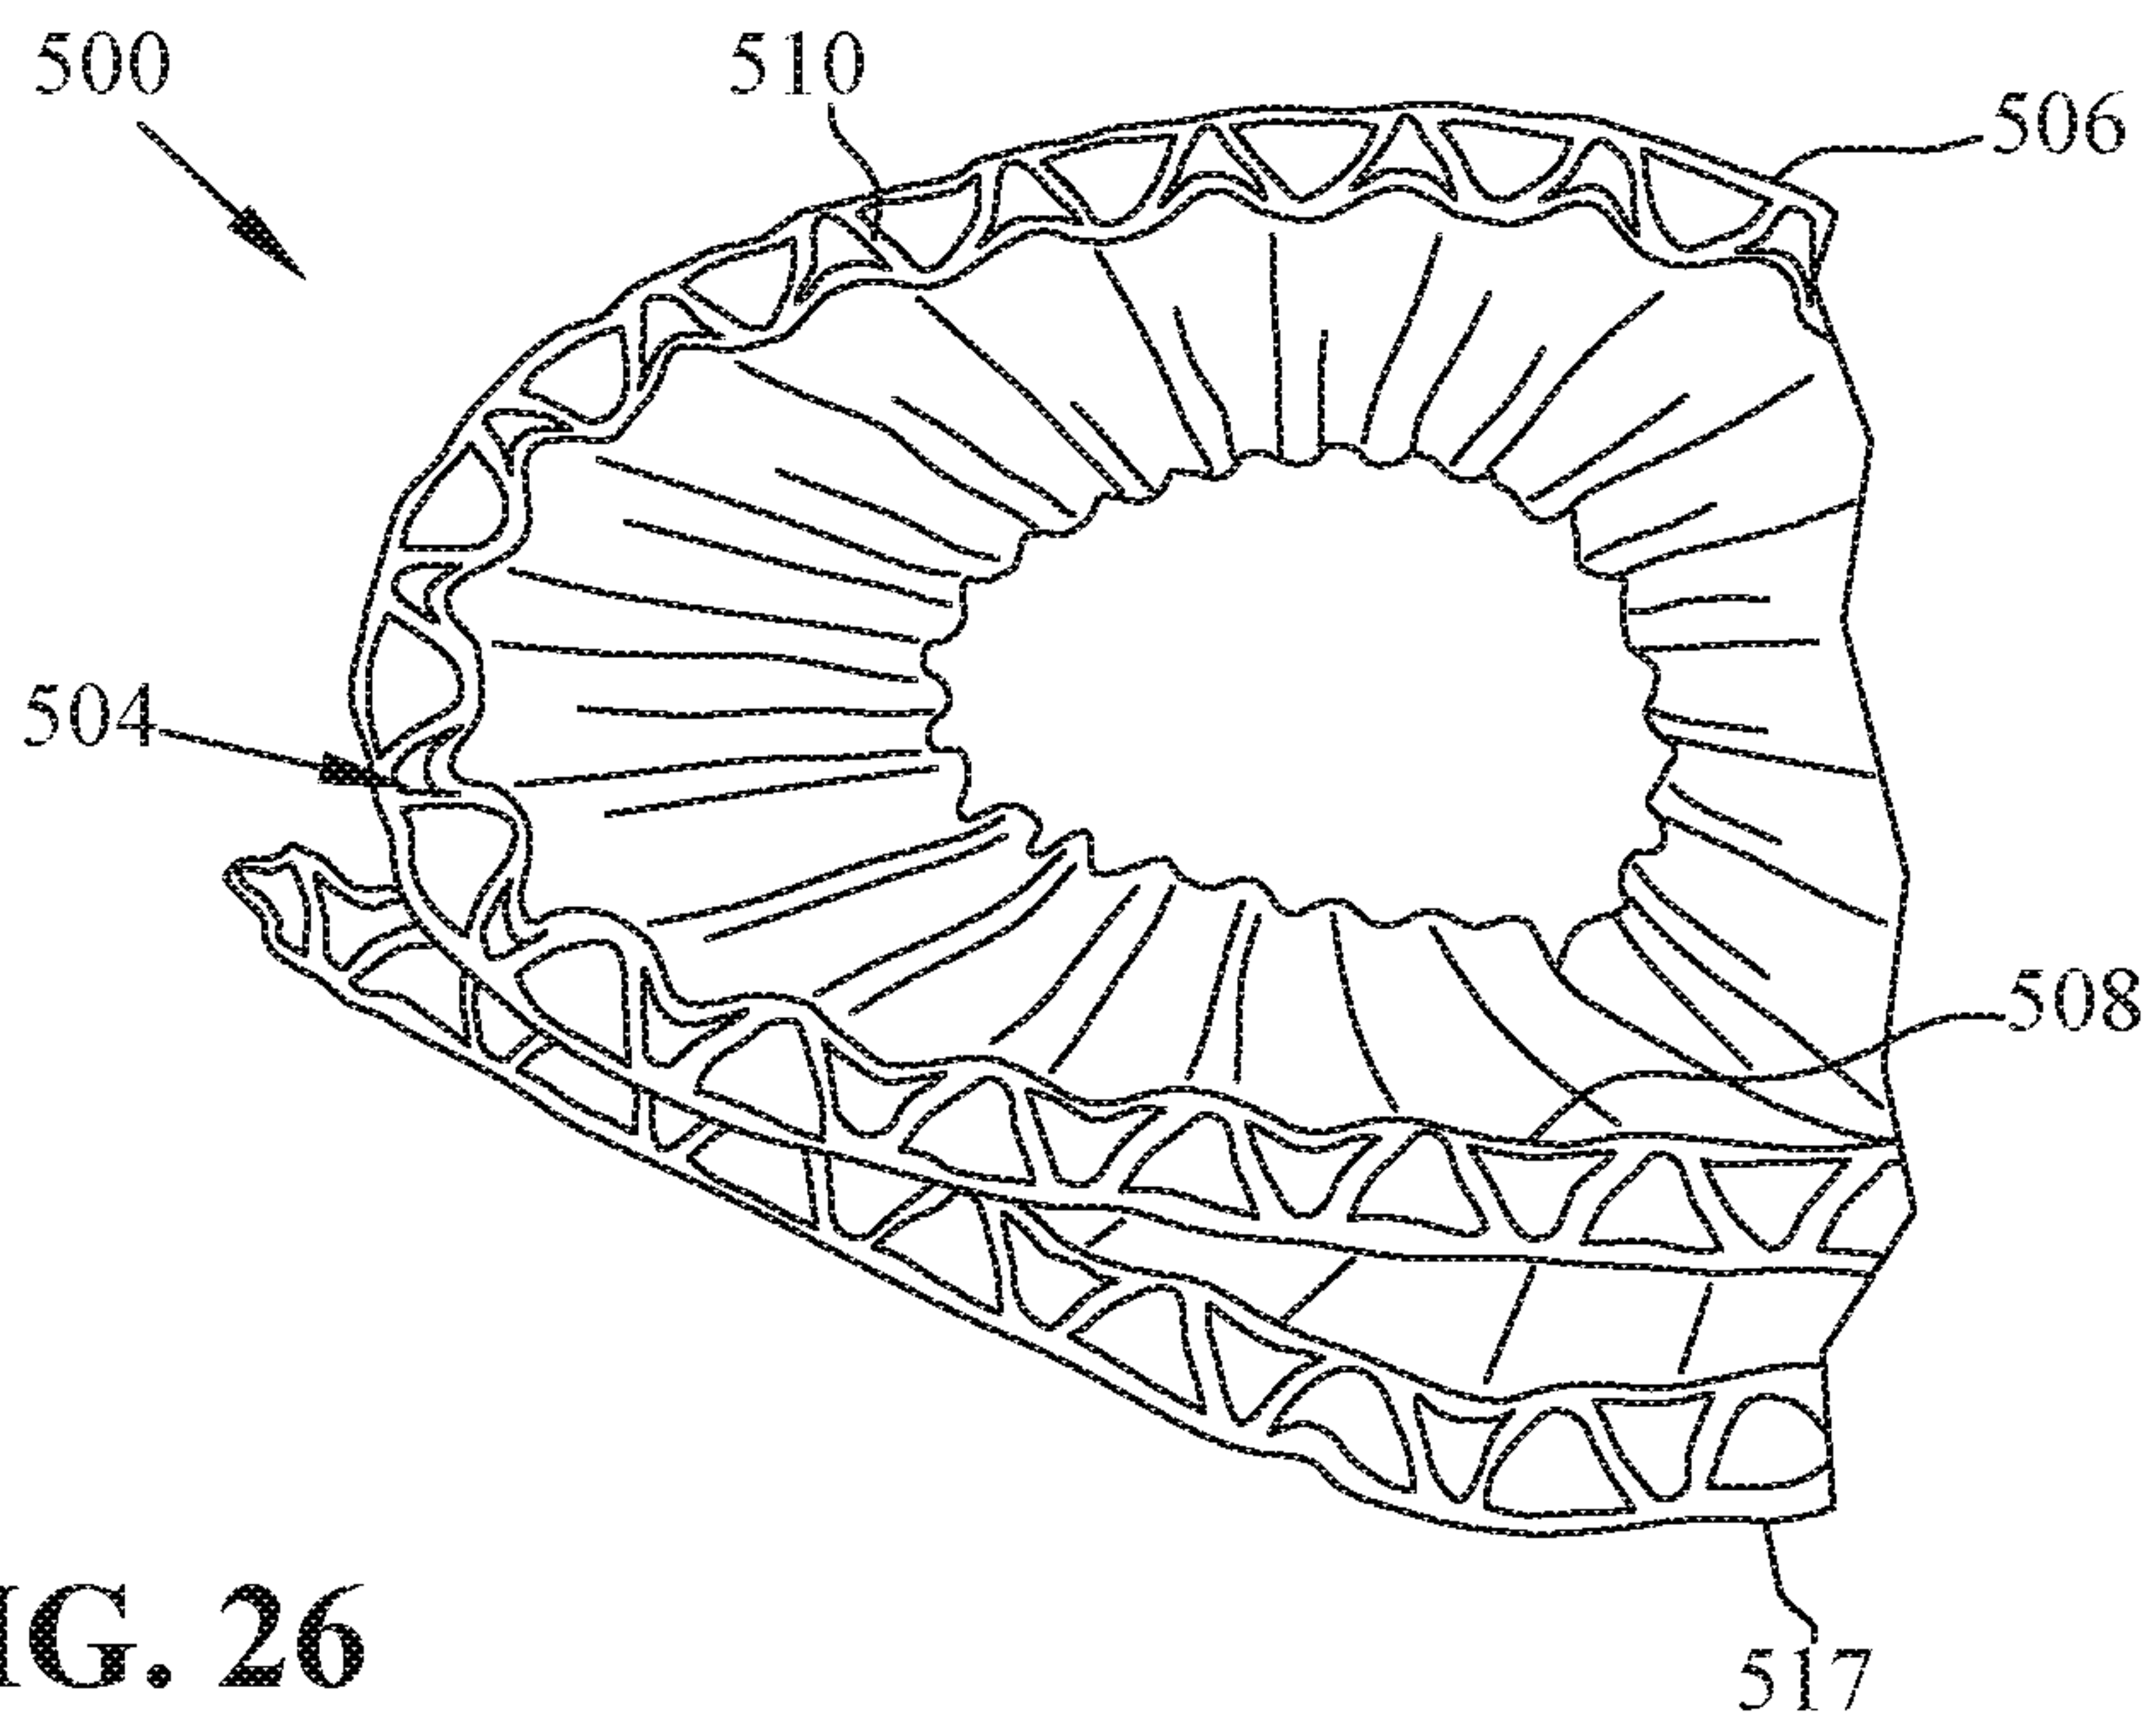
**FIG. 26**

FIG. 26 is an end view of the vehicle frame and cargo bay liner of FIG. 25 shown rolled up wherein corrugations of the liner are readily visible;

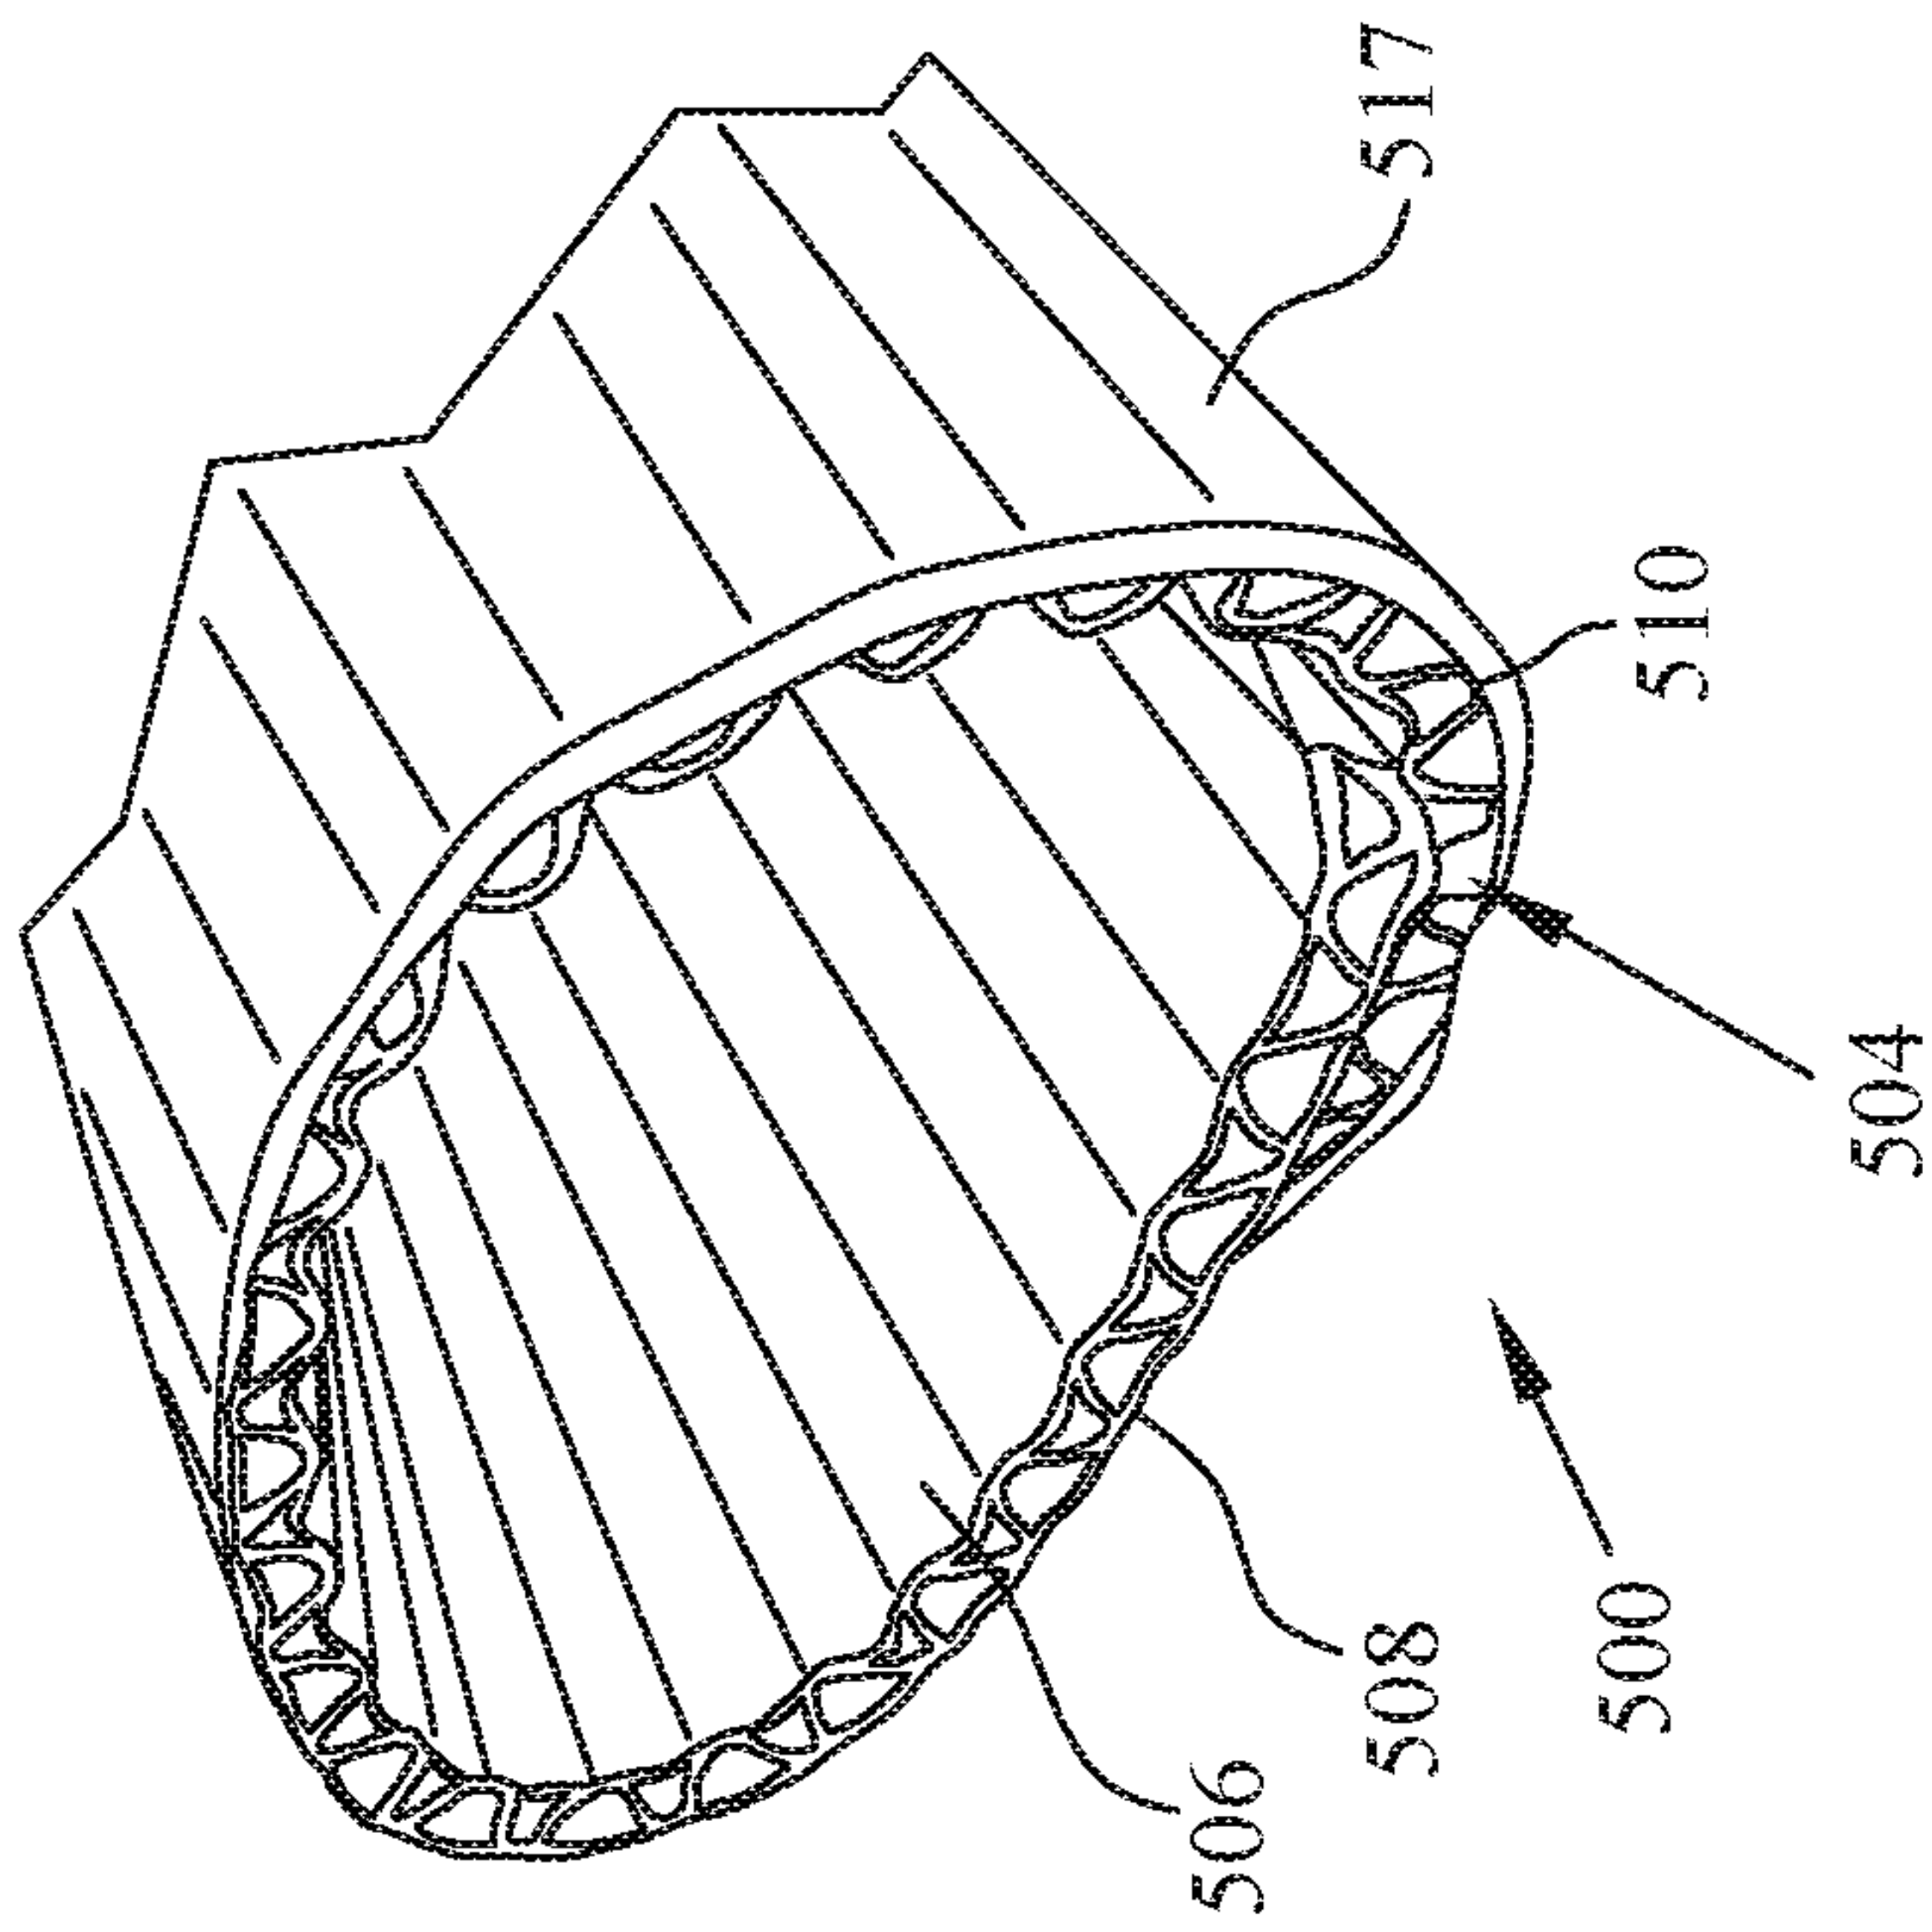
FIG. 27 is a perspective view of the vehicle frame and cargo bay liner of FIG. 25 rolled up with the aluminum foil on the outside thereof;

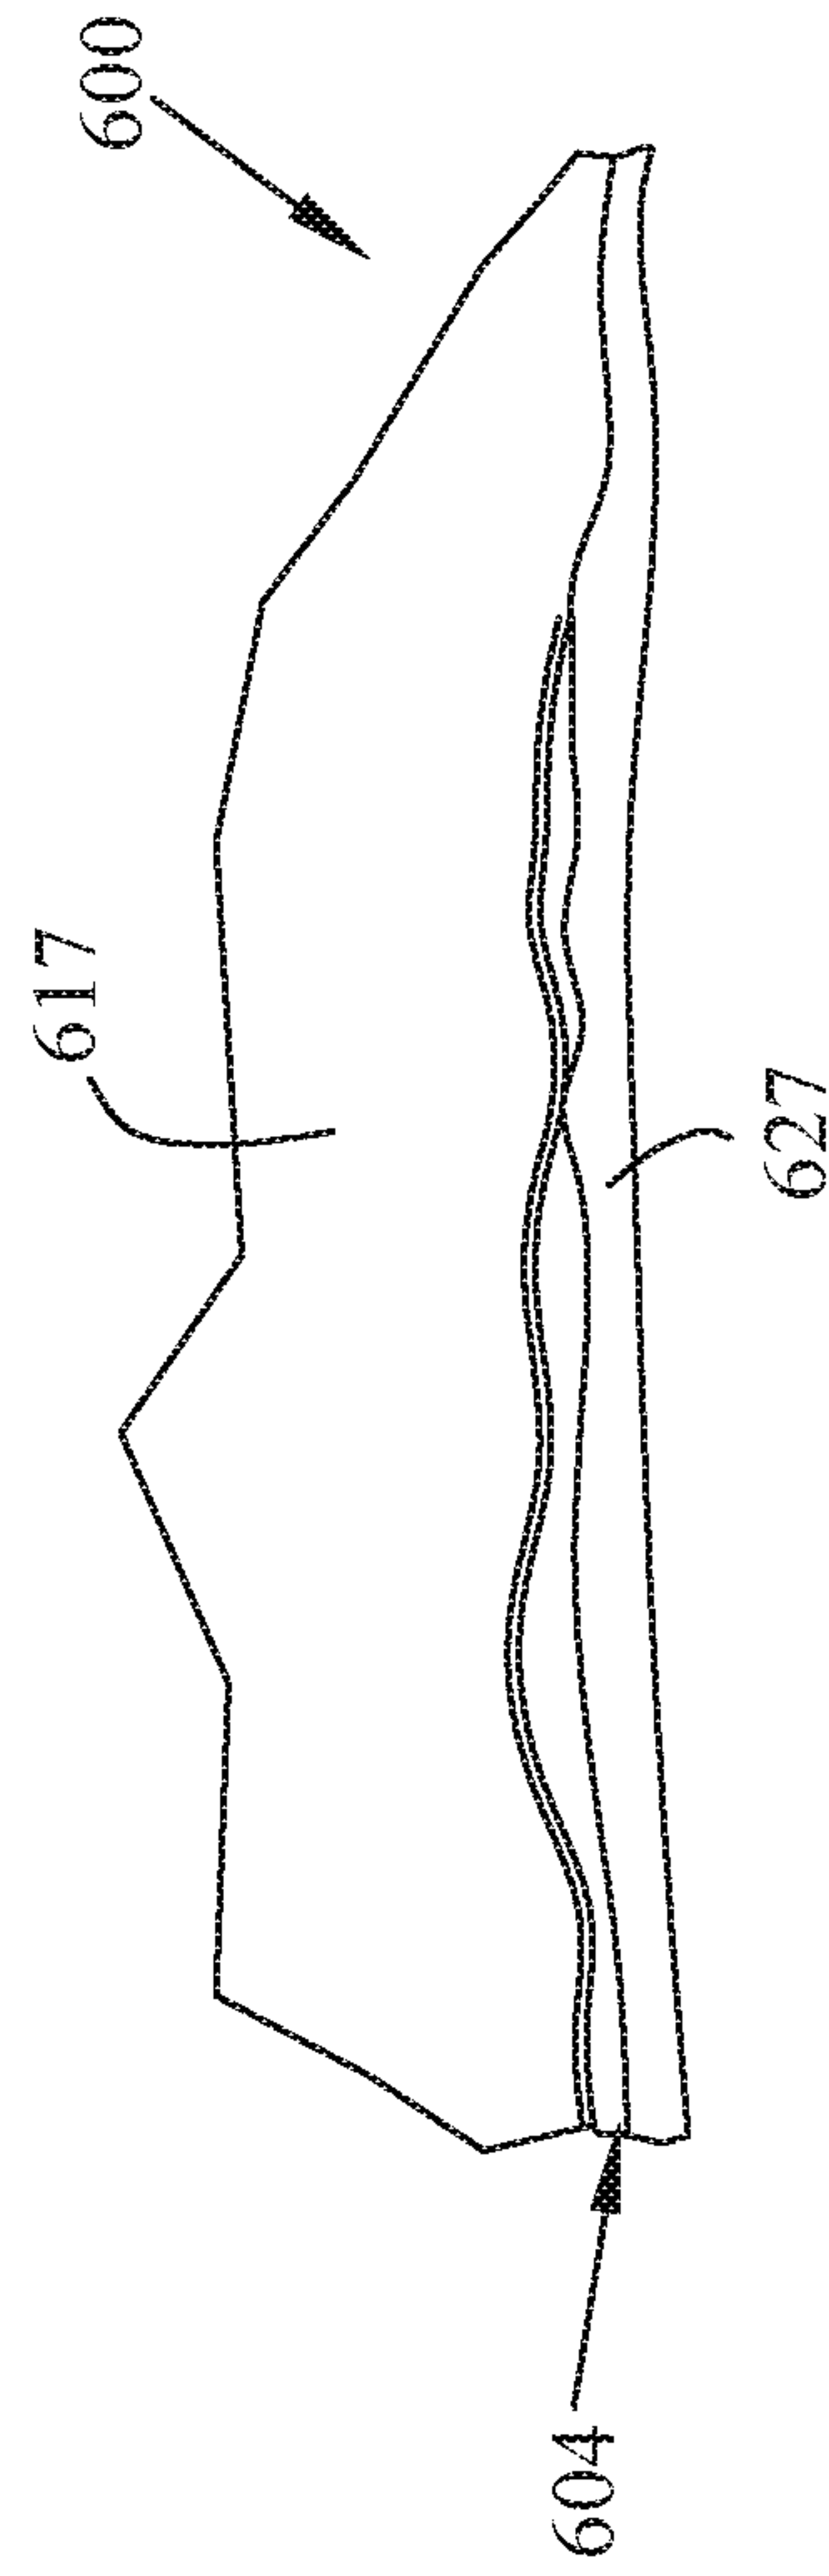
FIG. 28 is an end perspective view of another alternate embodiment vehicle frame and cargo bay liner shown laid out and having aluminum foil on both sides thereof;

Now referring to FIGS. 28-30, an additional embodiment of a 3-ply panel vehicle frame and cargo area liner is

generally indicated as **600**. As with vehicle frame and cargo area liners **500**, vehicle frame and cargo area liner **600** includes a corrugated liner, generally indicated as **604**. Corrugated liner **604** includes a top sheet **606**, a bottom sheet **608**, and a corrugated or sinusoidal ply **610** extending therebetween. Top sheet **606** and bottom sheet **608** are adhered or thermally attached to corrugated ply **610** and may be made from materials similar to corrugated liner **500**, such as but not limited to polyurethane or polyethylene. Alternatively, liner **600** may be an extruded manufactured design, as is well known in the art, including a top ply, a bottom ply and transverse supports, extending between the top and bottom plies, which can include square or rectangular passageways between the plies. Likewise, the extruded liner may be manufactured from materials such as, but not limited to polyurethane or polyethylene.

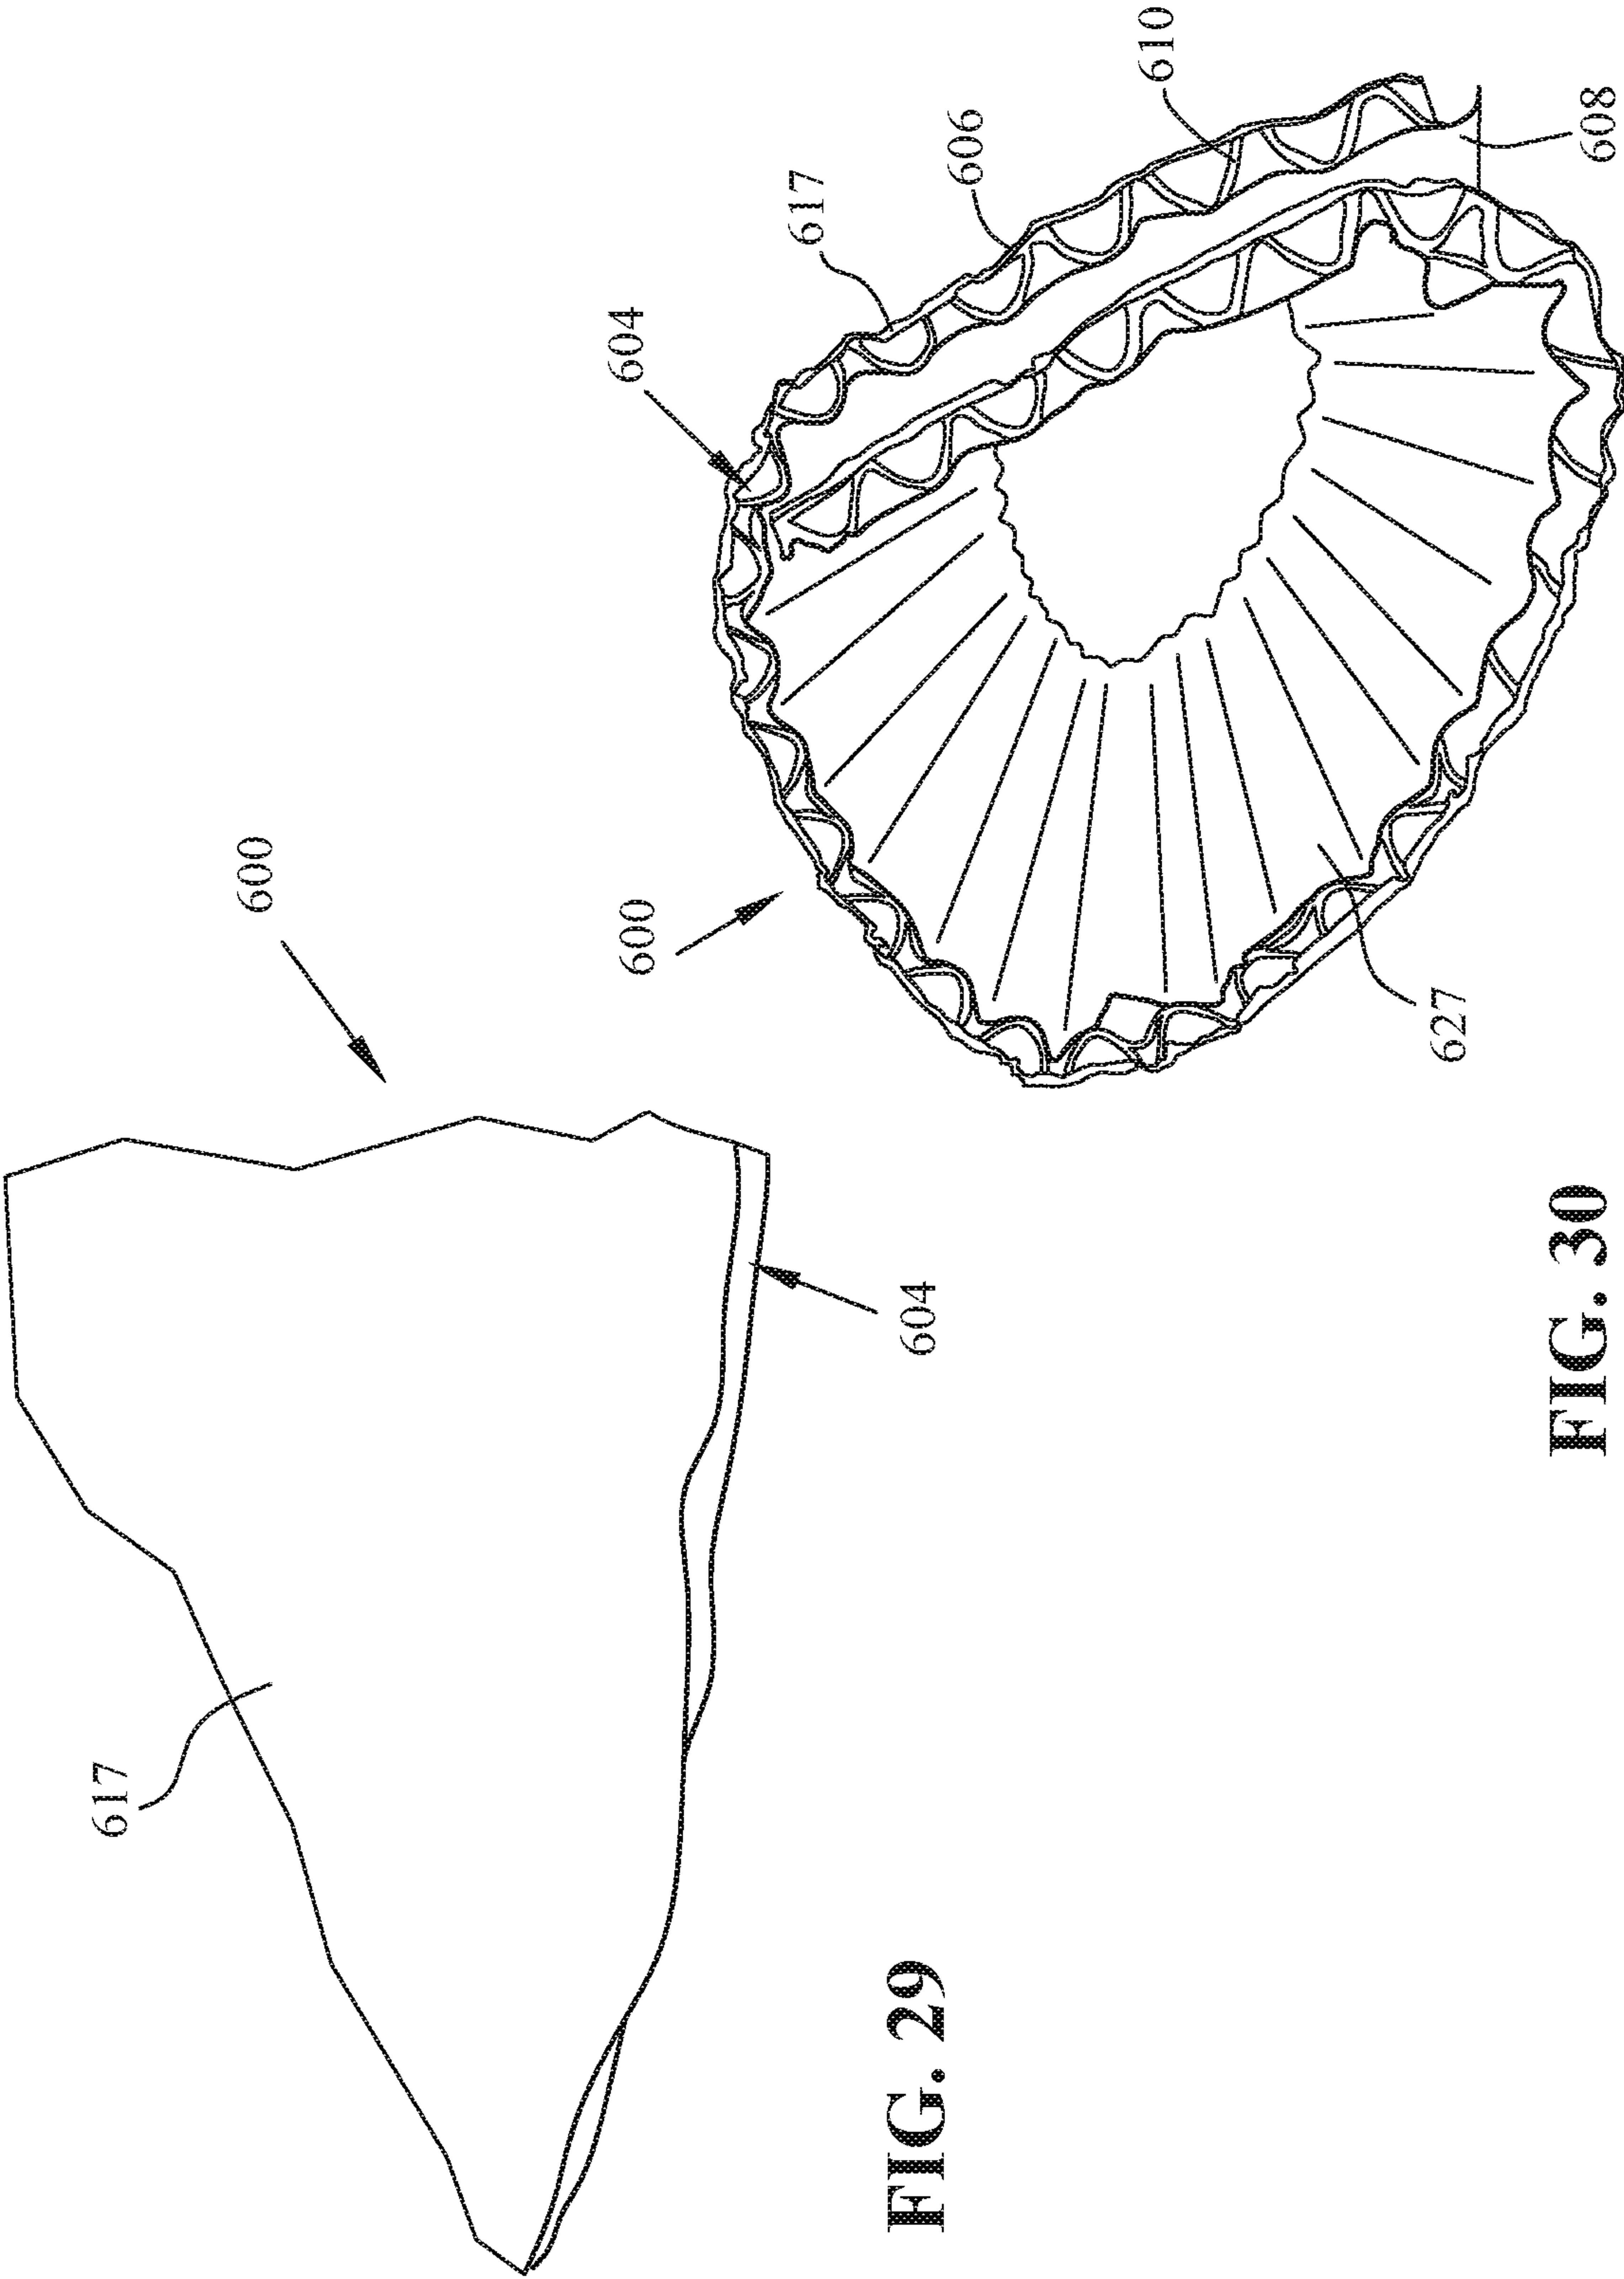
FIG. 29 is a perspective view of the vehicle frame and cargo bay liner of FIG. 28;

FIG. 30 is an end view of the vehicle frame and cargo bay liner of FIG. 28 rolled up and showing the aluminum foil on both sides thereof;

As with vehicle and frame and cargo area liner **500**, liner **600** also includes an aluminum foil or sheet **617** adhered to top ply or sheet **606**. Additionally, however, vehicle frame and cargo area liner **600** also includes a second aluminum foil or sheet **627** adhered to bottom sheet or ply **608** of corrugated liner **604**.

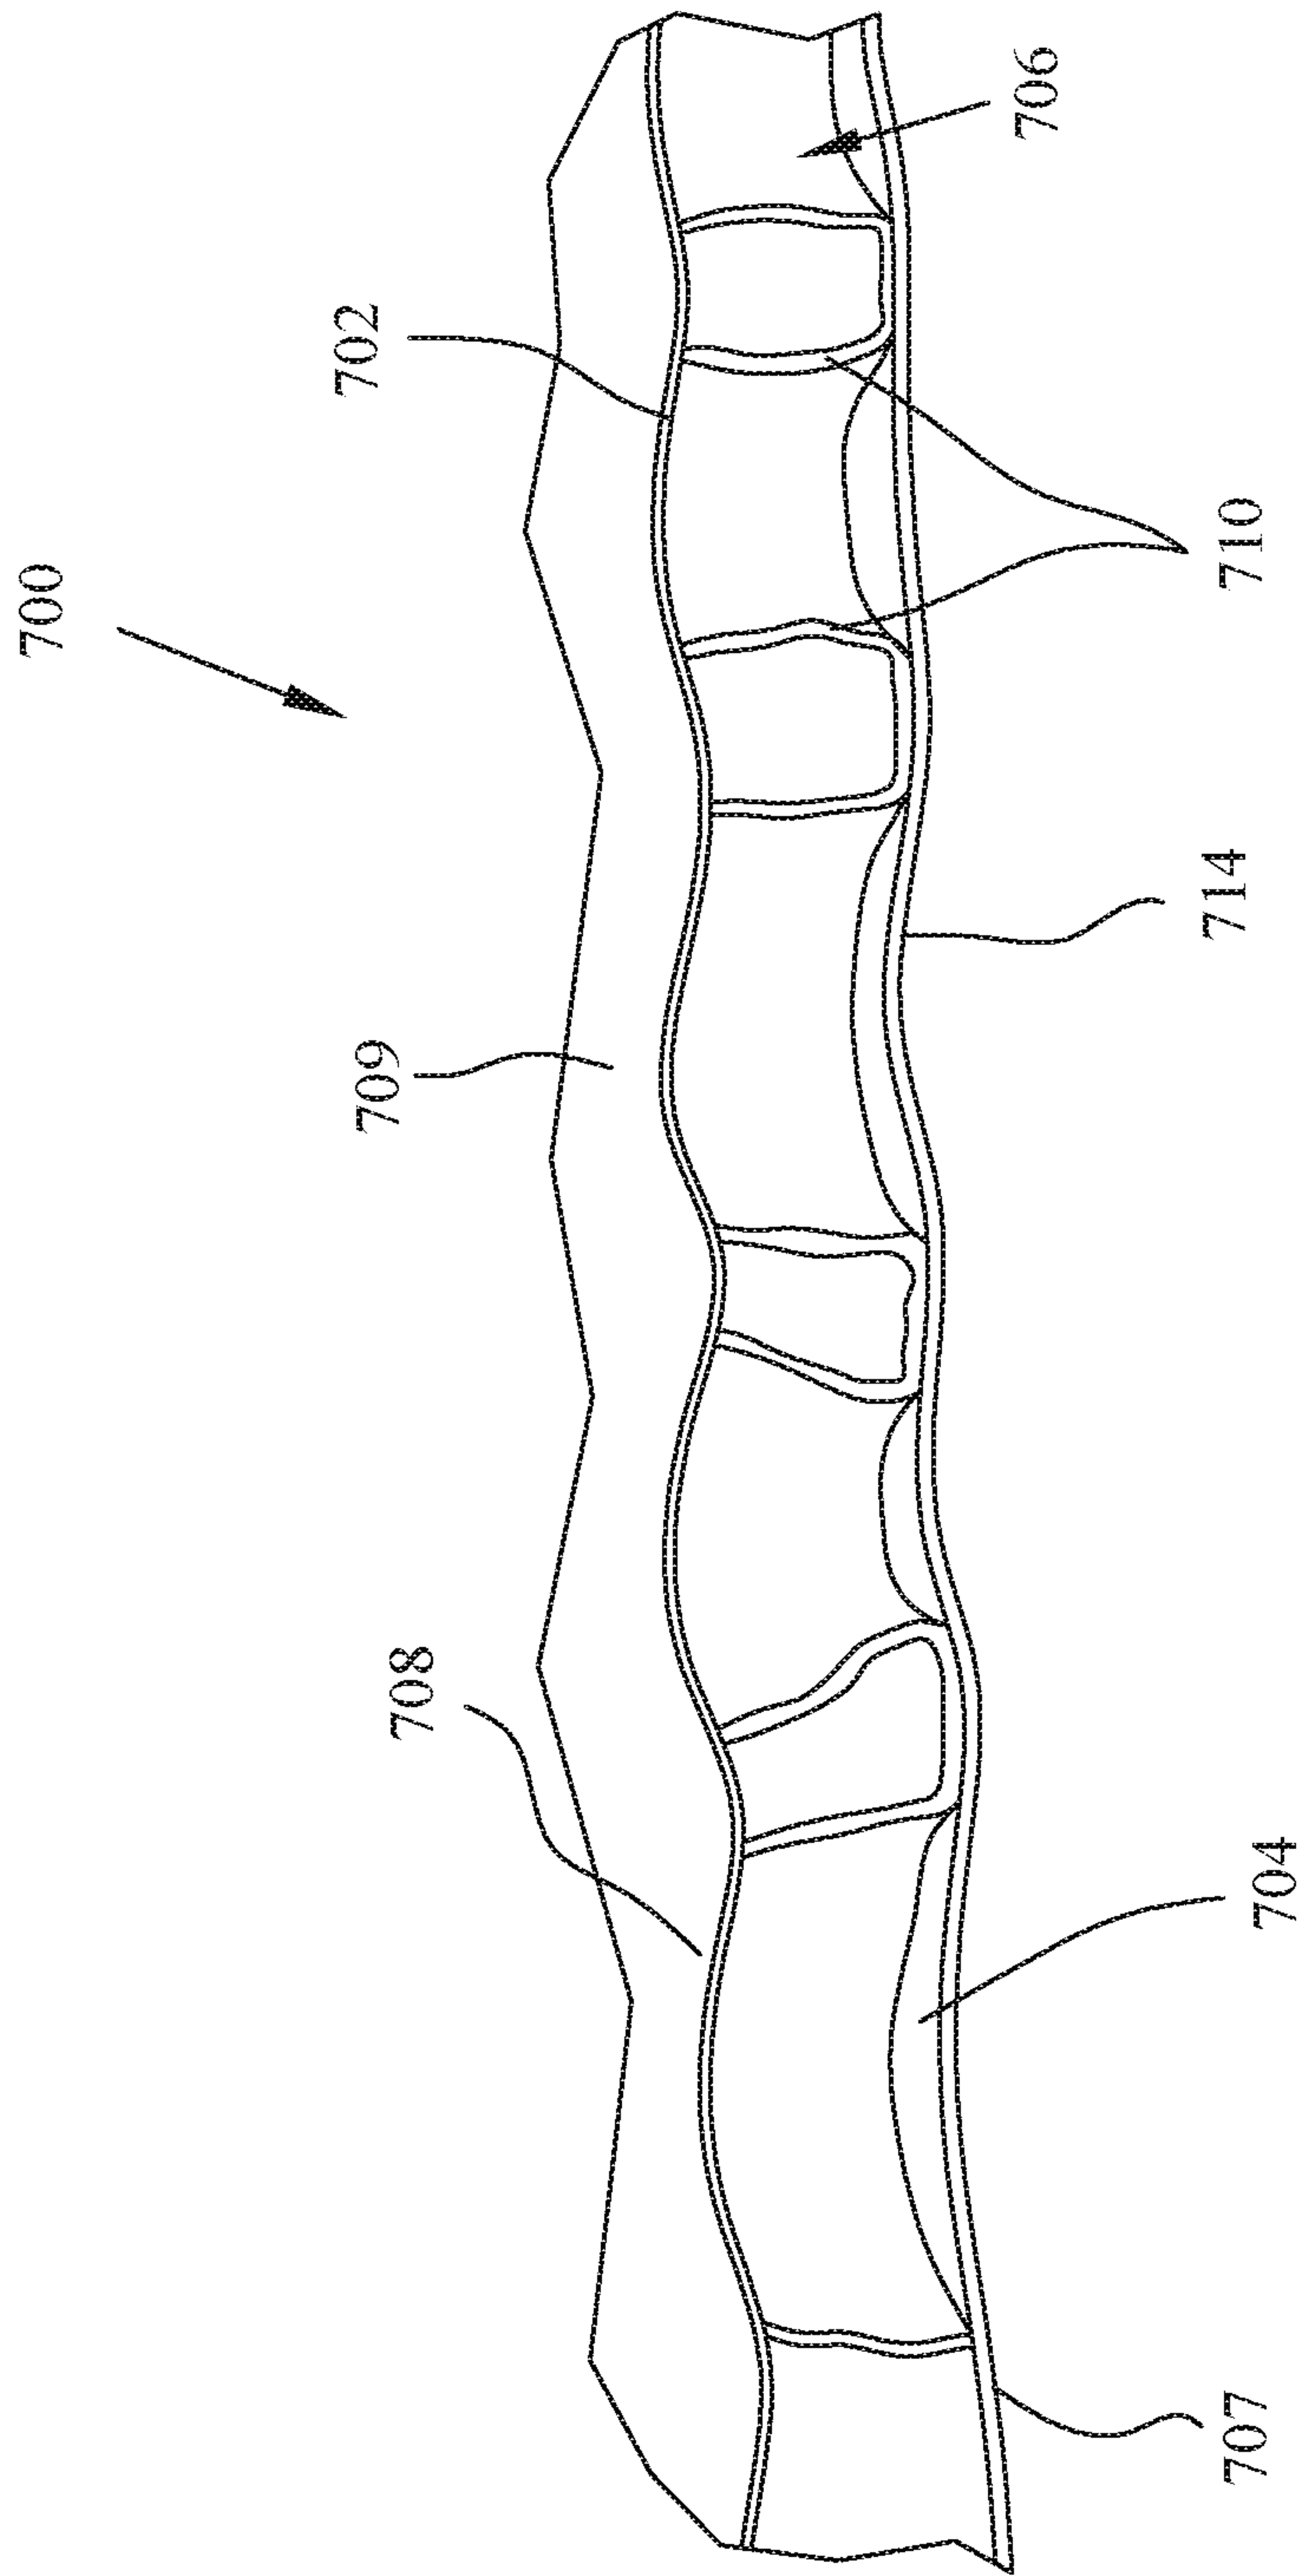
FIG. 31 is a side perspective view of yet another alternate embodiment vehicle frame and cargo bay liner having an aluminum foil on one side and a woven material on the opposite side

Now referring to FIGS. **31-34**, another alternate vehicle frame and cargo area liner is shown generally indicated as **700**. Liner **700** can be provided in a coiled form as liner **400**, making it extremely suitable for use as a liner for vehicle frames and cargo bays. The desired length of liner can be rolled out and cut to size for assembly to the vehicle. Vehicle frame and cargo bay liner **700** is of a 3-ply configuration and includes a top ply, sheet, or layer **702** and a bottom ply, sheet, or layer **704**. A core **706** (see FIG. **31**) separates top sheet **702** from bottom sheet **704**. Additionally, vehicle frame and cargo bay liner **700** also includes a sheet of aluminum foil or metalized film **707** on one side thereof. In the embodiment shown, aluminum foil/metalized film **707** is provided on bottom sheet **404**; however, it should be appreciated that aluminum foil/metalized film could also be provided on the top sheet **702** (see embodiment **700A** discussed below). Aluminum foil/film **707** may be adhered to bottom sheet **704** using an adhesive or other suitable means. Vehicle frame and cargo bay liner **700** also includes a woven or nonwoven layer of material **709** adhered to top layer **702**, opposite the side with aluminum foil **707** or metalized film. In one embodiment, material **709** is a woven sheet of polypropylene fabric.

In the embodiment of the 3 ply vehicle frame and cargo bay liner **700** of FIGS. **31-34**, the aluminum foil **707** is shown adhered to the side of liner **700** with dimples **714** and woven material **709** is shown adhered to the side with convexities **708**; however, in FIGS. **35-37** an alternate embodiment vehicle frame and cargo bay liner, shown generally indicated as **700a**, has the woven or nonwoven sheet of material **709** adhered to the side of the liner having dimples **714** and the aluminum foil **707** adhered to the side of the liner having convexities **708**. Also, the vehicle frame and cargo bay liner may be manufactured with only a layer of woven or nonwoven sheet of fabric material and no aluminum foil or alternately with aluminum foil and no woven or nonwoven fabric. Alternatively, it may be provided with either aluminum foil on both sides or with woven or nonwoven fabric on both sides.
