US011447189B1

(54) **VEHICLE FRAME AND CARGO BAY LINER**

A vehicle and liner assembly is provided that includes a  
recreational vehicle having a housing, a front end, a rear end,  
a top, a bottom, and a pair of sidewalls. A frame assembly  
is provided wherein, the housing is mounted on and sup-  
ported by the frame assembly. The liner is attached to the  
frame assembly and covers at least a substantial portion of the  
bottom of the housing. The liner has a first face having  
projections extending therefrom and a second face having  
openings therein. The openings coincide with and extend  
into corresponding projections on the first face.

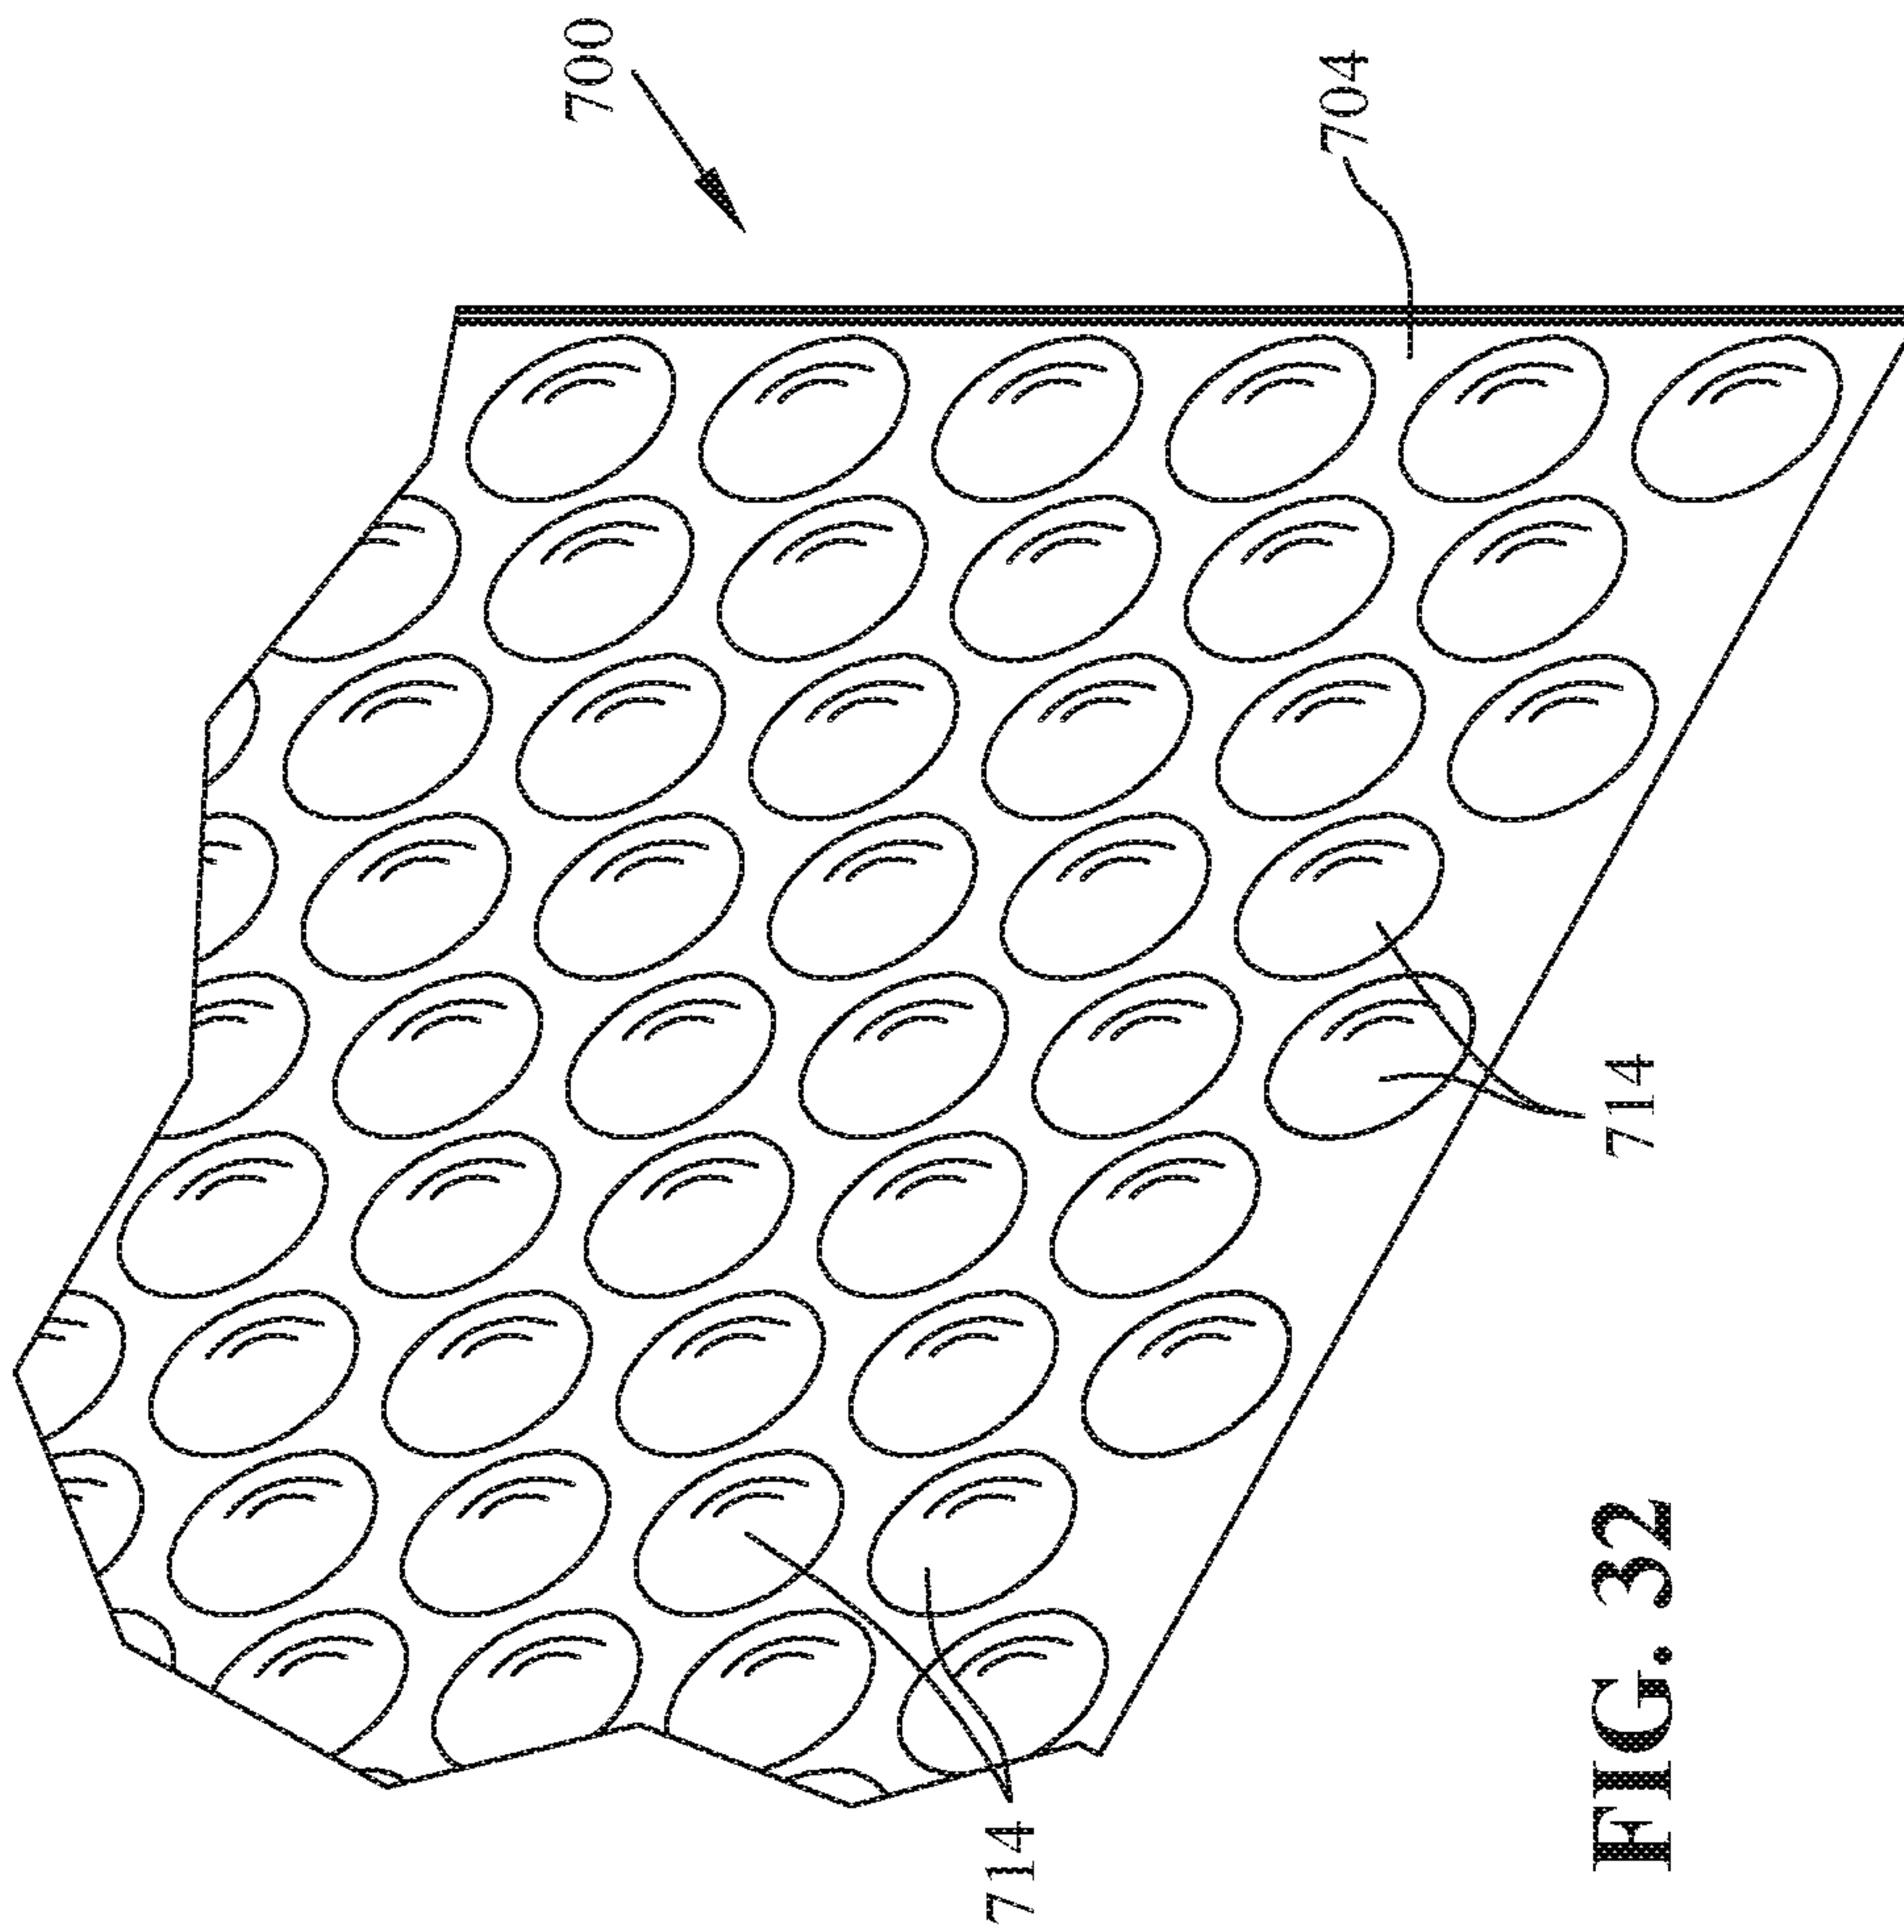
FIG. 32 is a plan view of the vehicle frame and cargo bay liner of FIG. 31 with the aluminum foil and woven material removed show a layer of the liner having dimples thereon.

Now referring to FIGS. **31-34**, another alternate vehicle frame and cargo area liner is shown generally indicated as **700**. Liner **700** can be provided in a coiled form as liner **400**, making it extremely suitable for use as a liner for vehicle frames and cargo bays. The desired length of liner can be rolled out and cut to size for assembly to the vehicle. Vehicle frame and cargo bay liner **700** is of a 3-ply configuration and includes a top ply, sheet, or layer **702** and a bottom ply, sheet, or layer **704**. A core **706** (see FIG. **31**) separates top sheet **702** from bottom sheet **704**. Additionally, vehicle frame and cargo bay liner **700** also includes a sheet of aluminum foil or metalized film **707** on one side thereof. In the embodiment shown, aluminum foil/metalized film **707** is provided on bottom sheet **404**; however, it should be appreciated that aluminum foil/metalized film could also be provided on the top sheet **702** (see embodiment **700A** discussed below). Aluminum foil/film **707** may be adhered to bottom sheet **704** using an adhesive or other suitable means. Vehicle frame and cargo bay liner **700** also includes a woven or nonwoven layer of material **709** adhered to top layer **702**, opposite the side with aluminum foil **707** or metalized film. In one embodiment, material **709** is a woven sheet of polypropylene fabric.

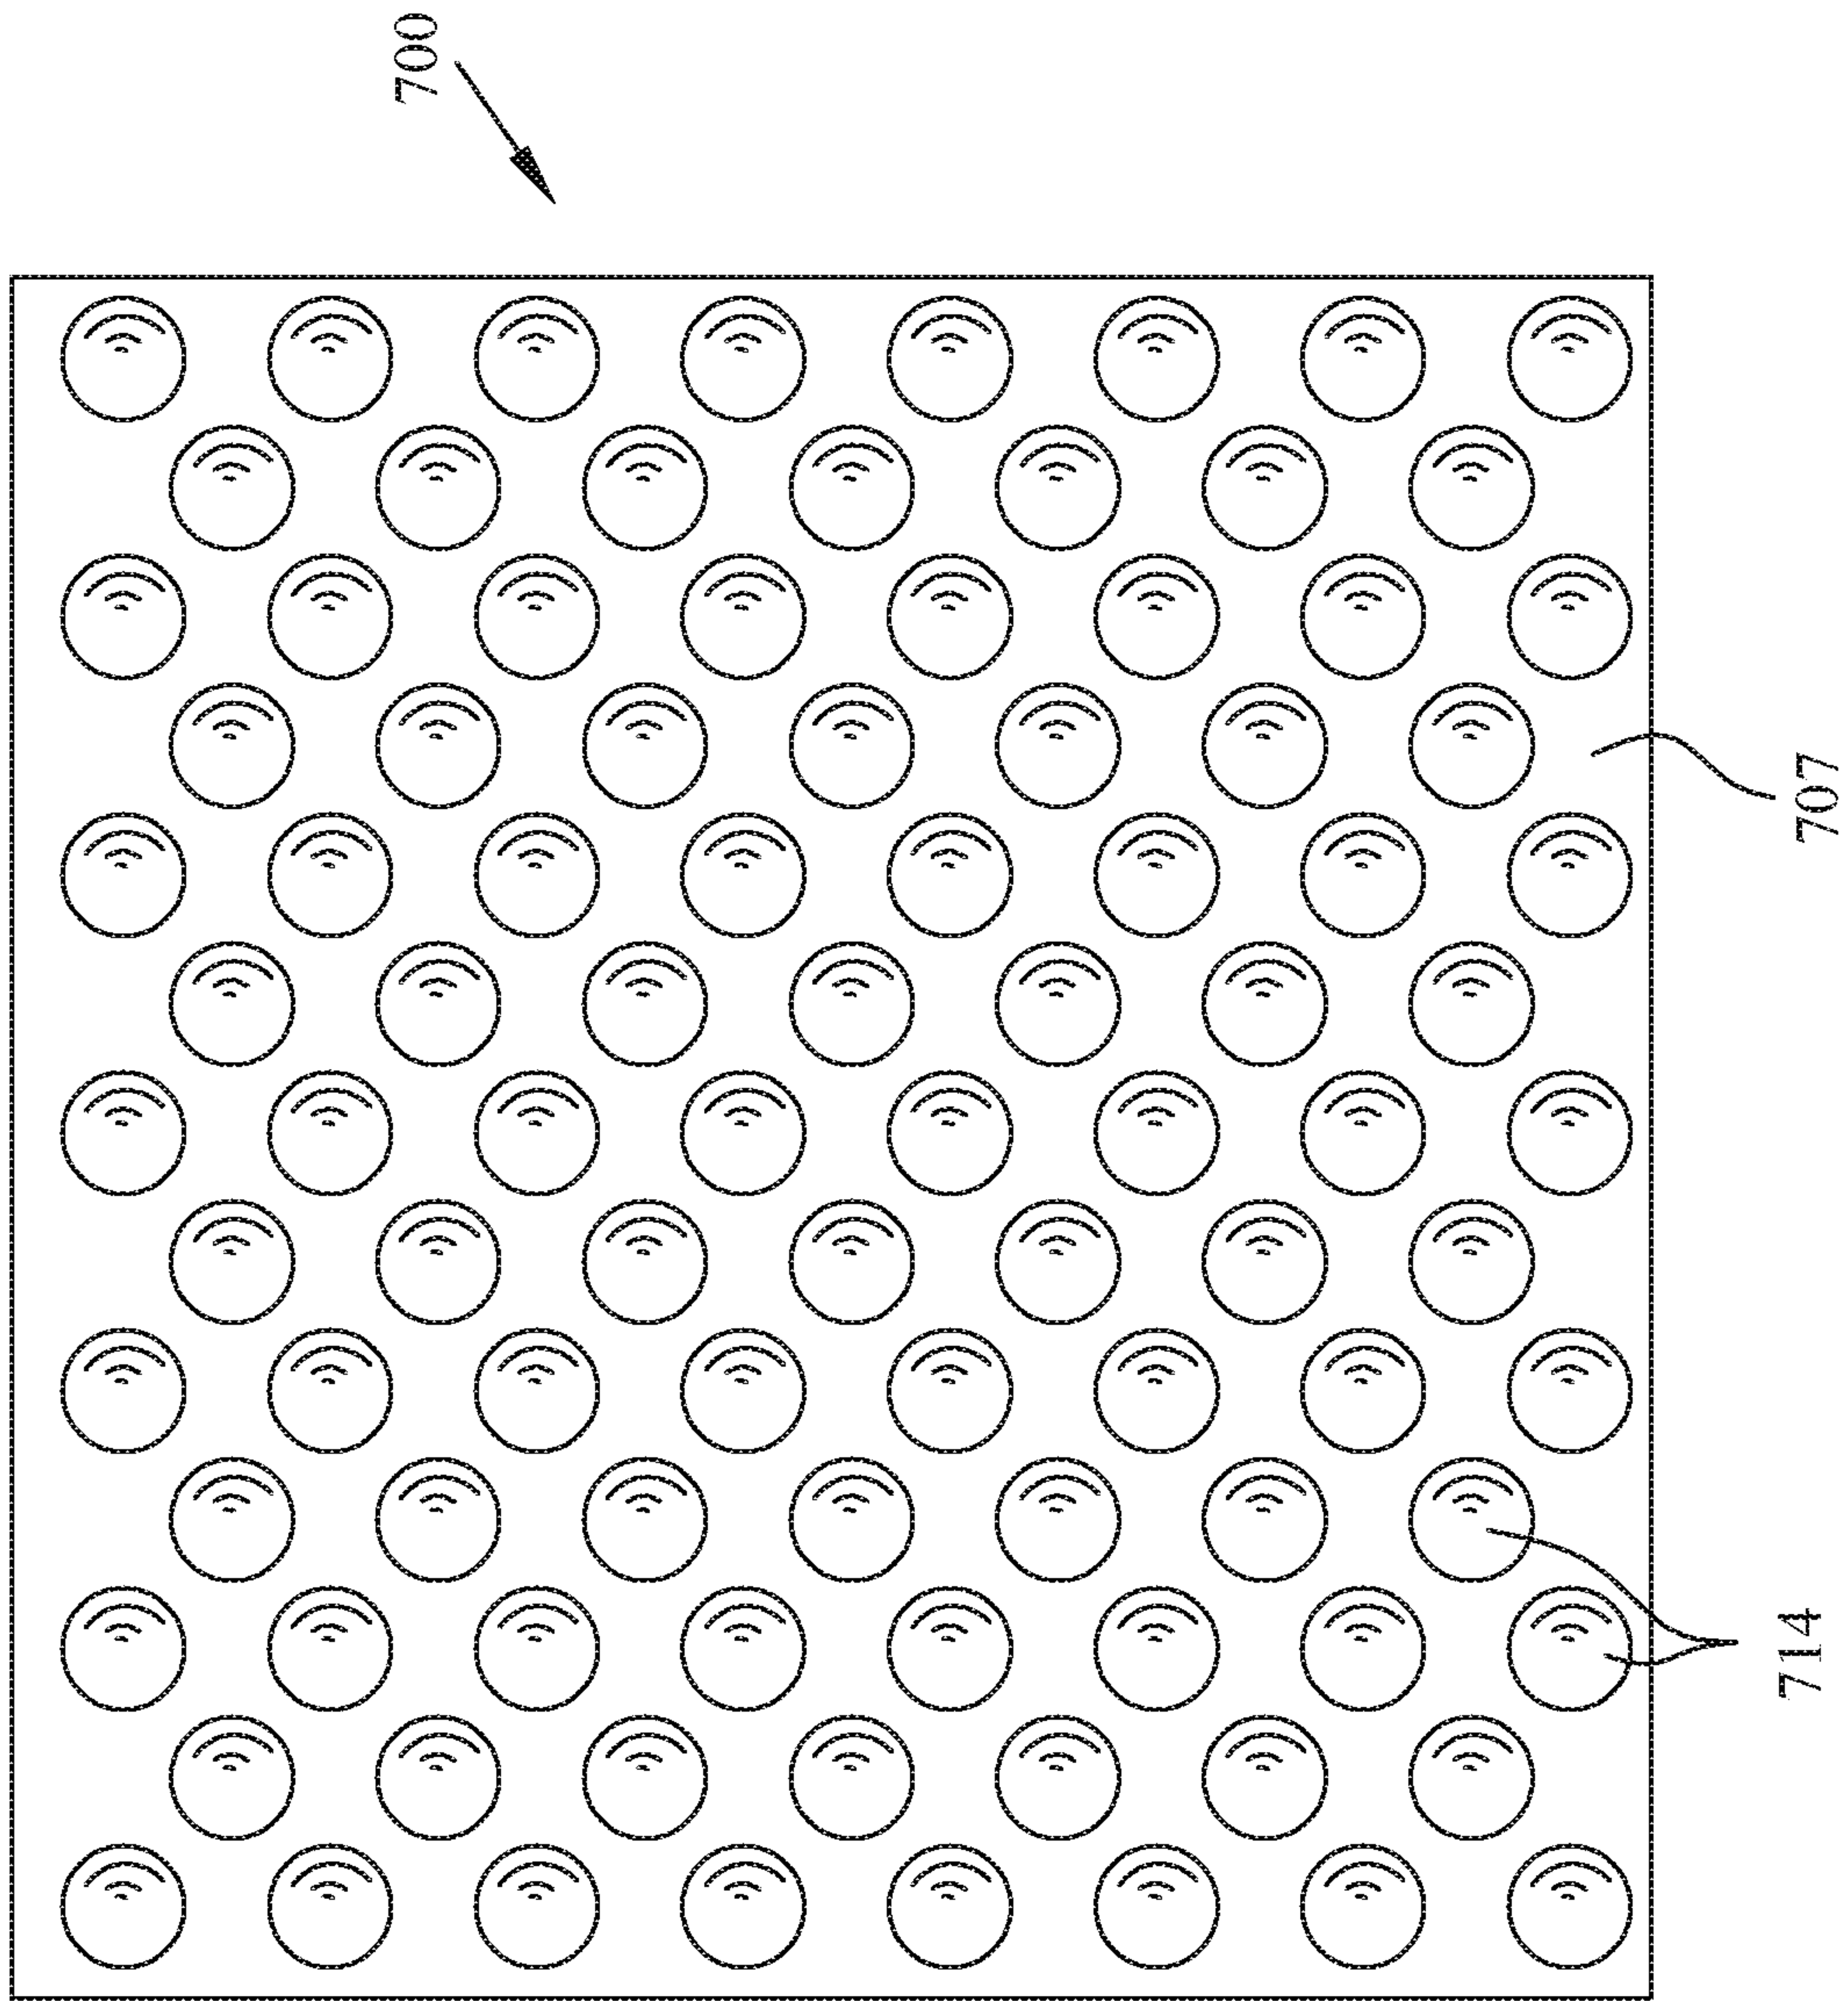
FIG. 33 is a perspective plan view of the vehicle frame and cargo bay liner of FIG. 31 showing the side with dimples and aluminum foil thereon;

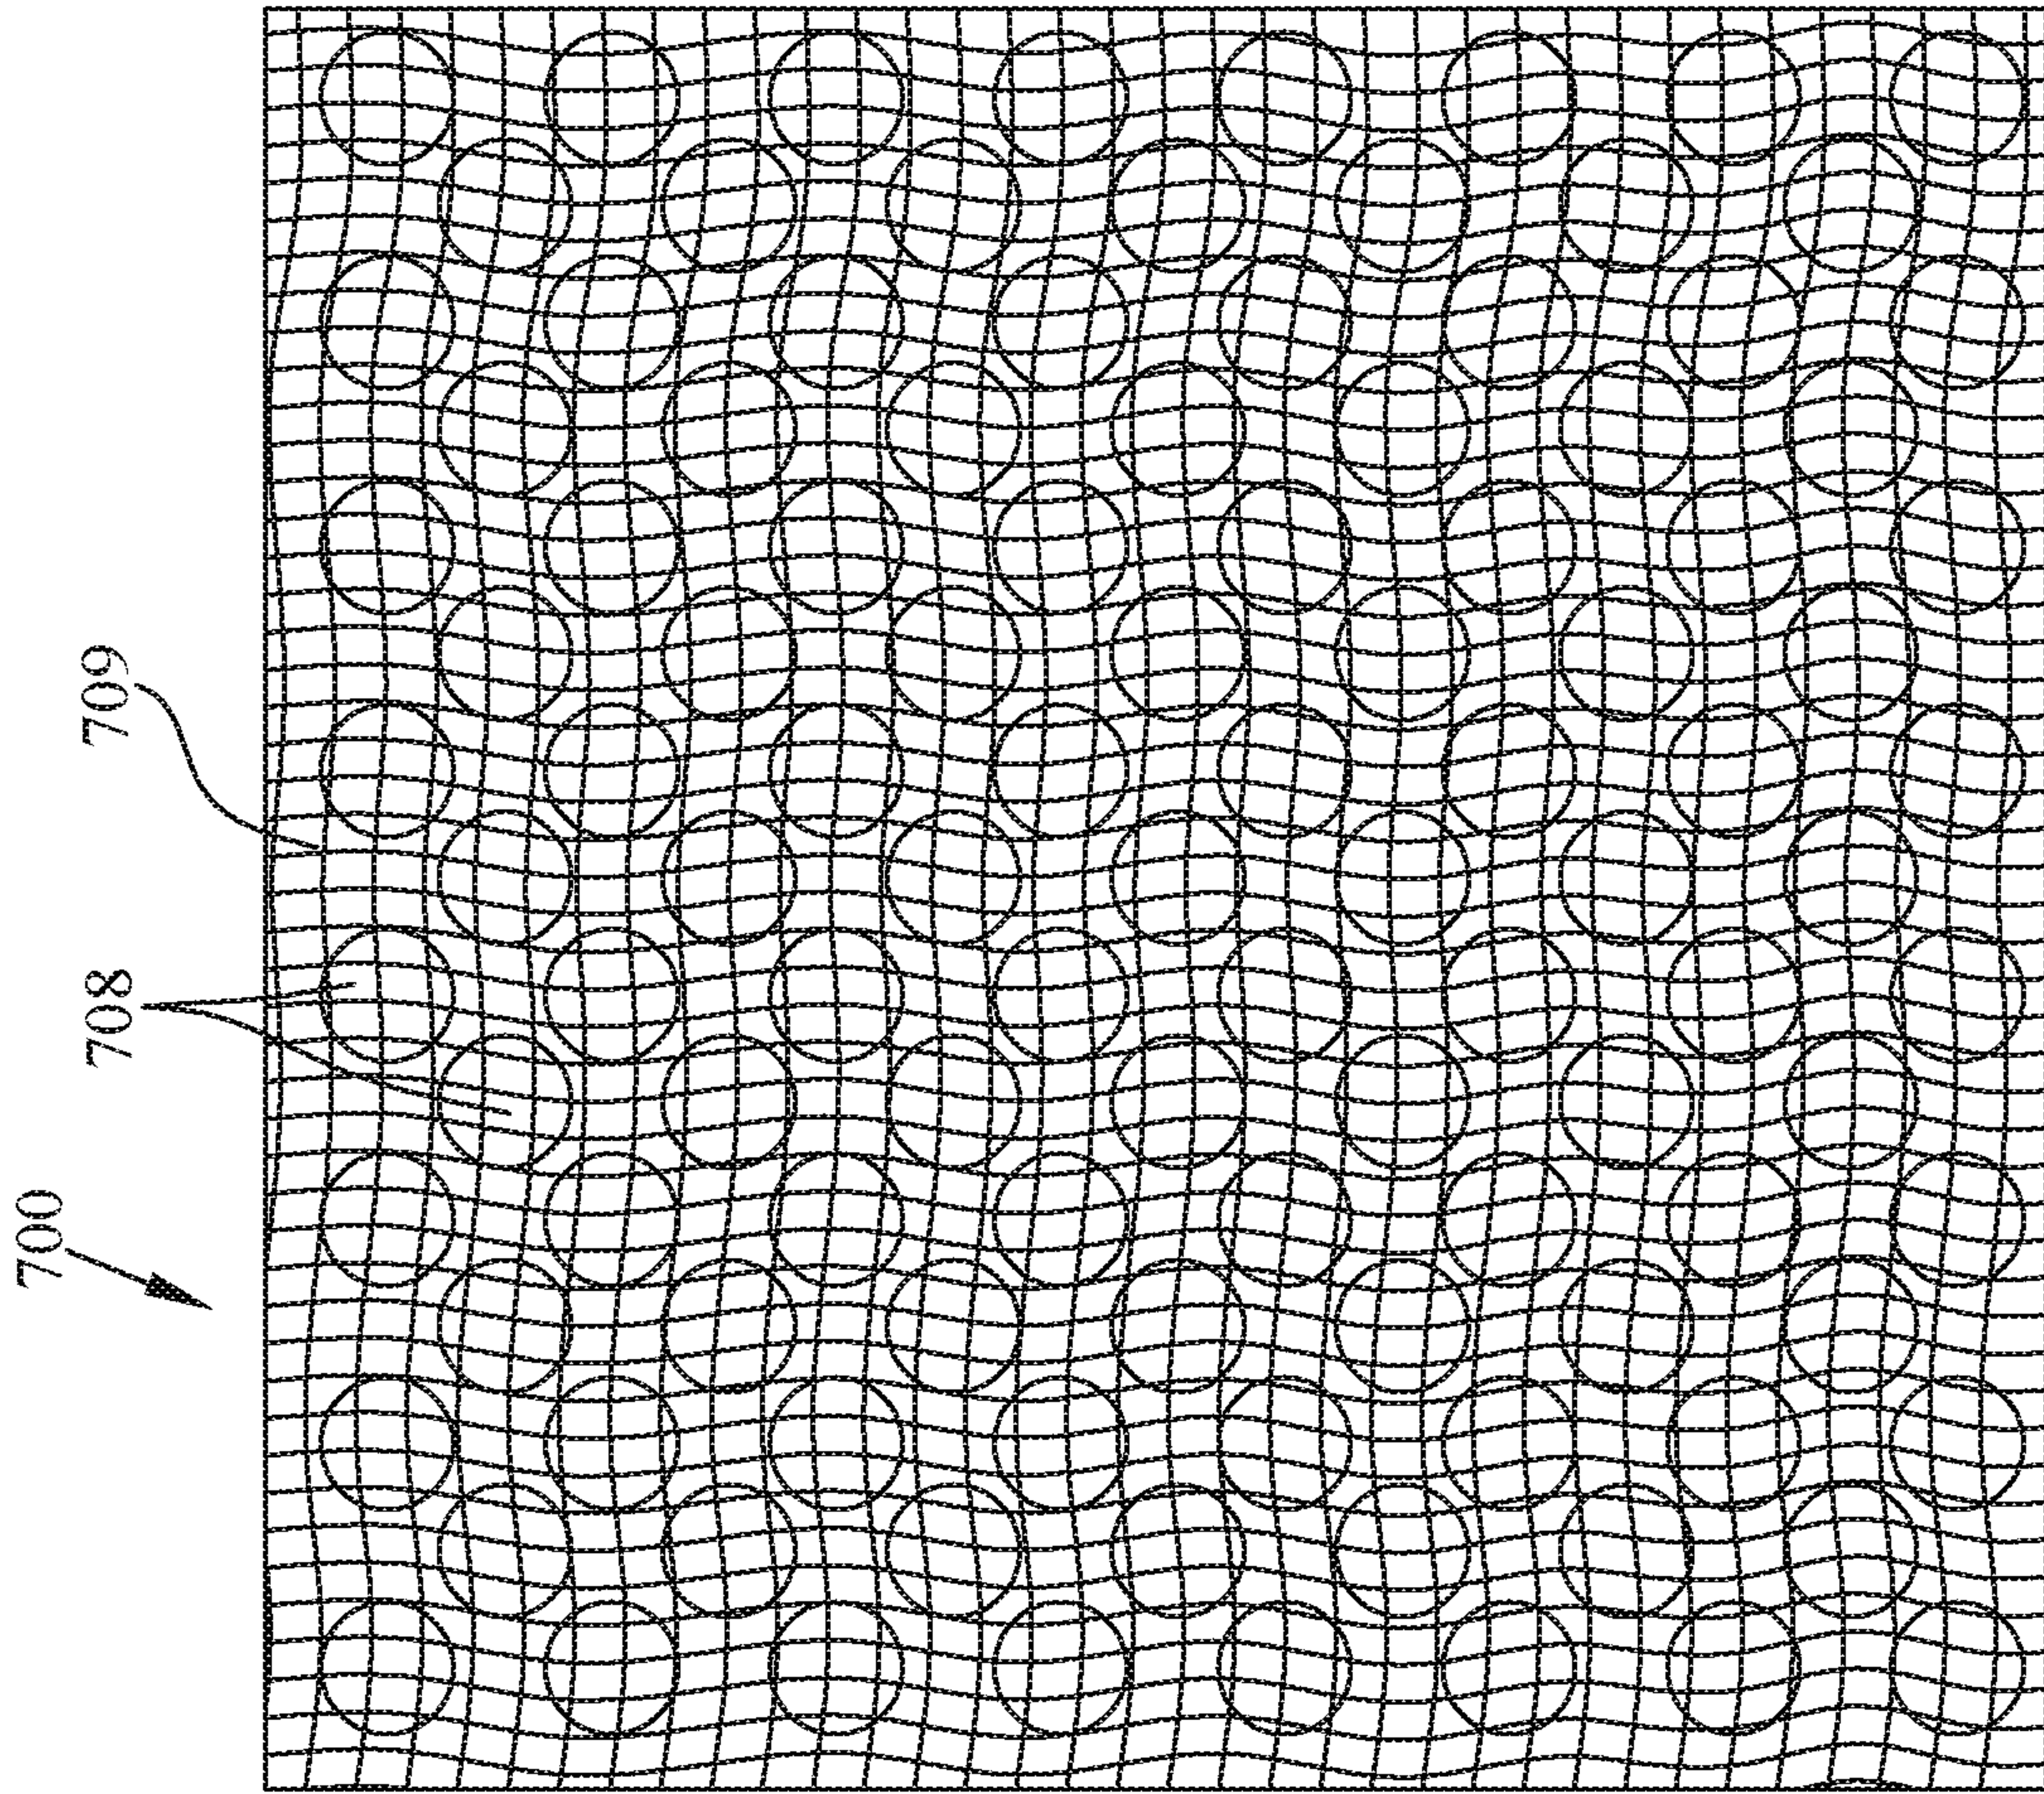
FIG. 34 is a perspective plan view of the vehicle frame and cargo bay liner of FIG. 31 showing a side with convexities and a woven material thereon;

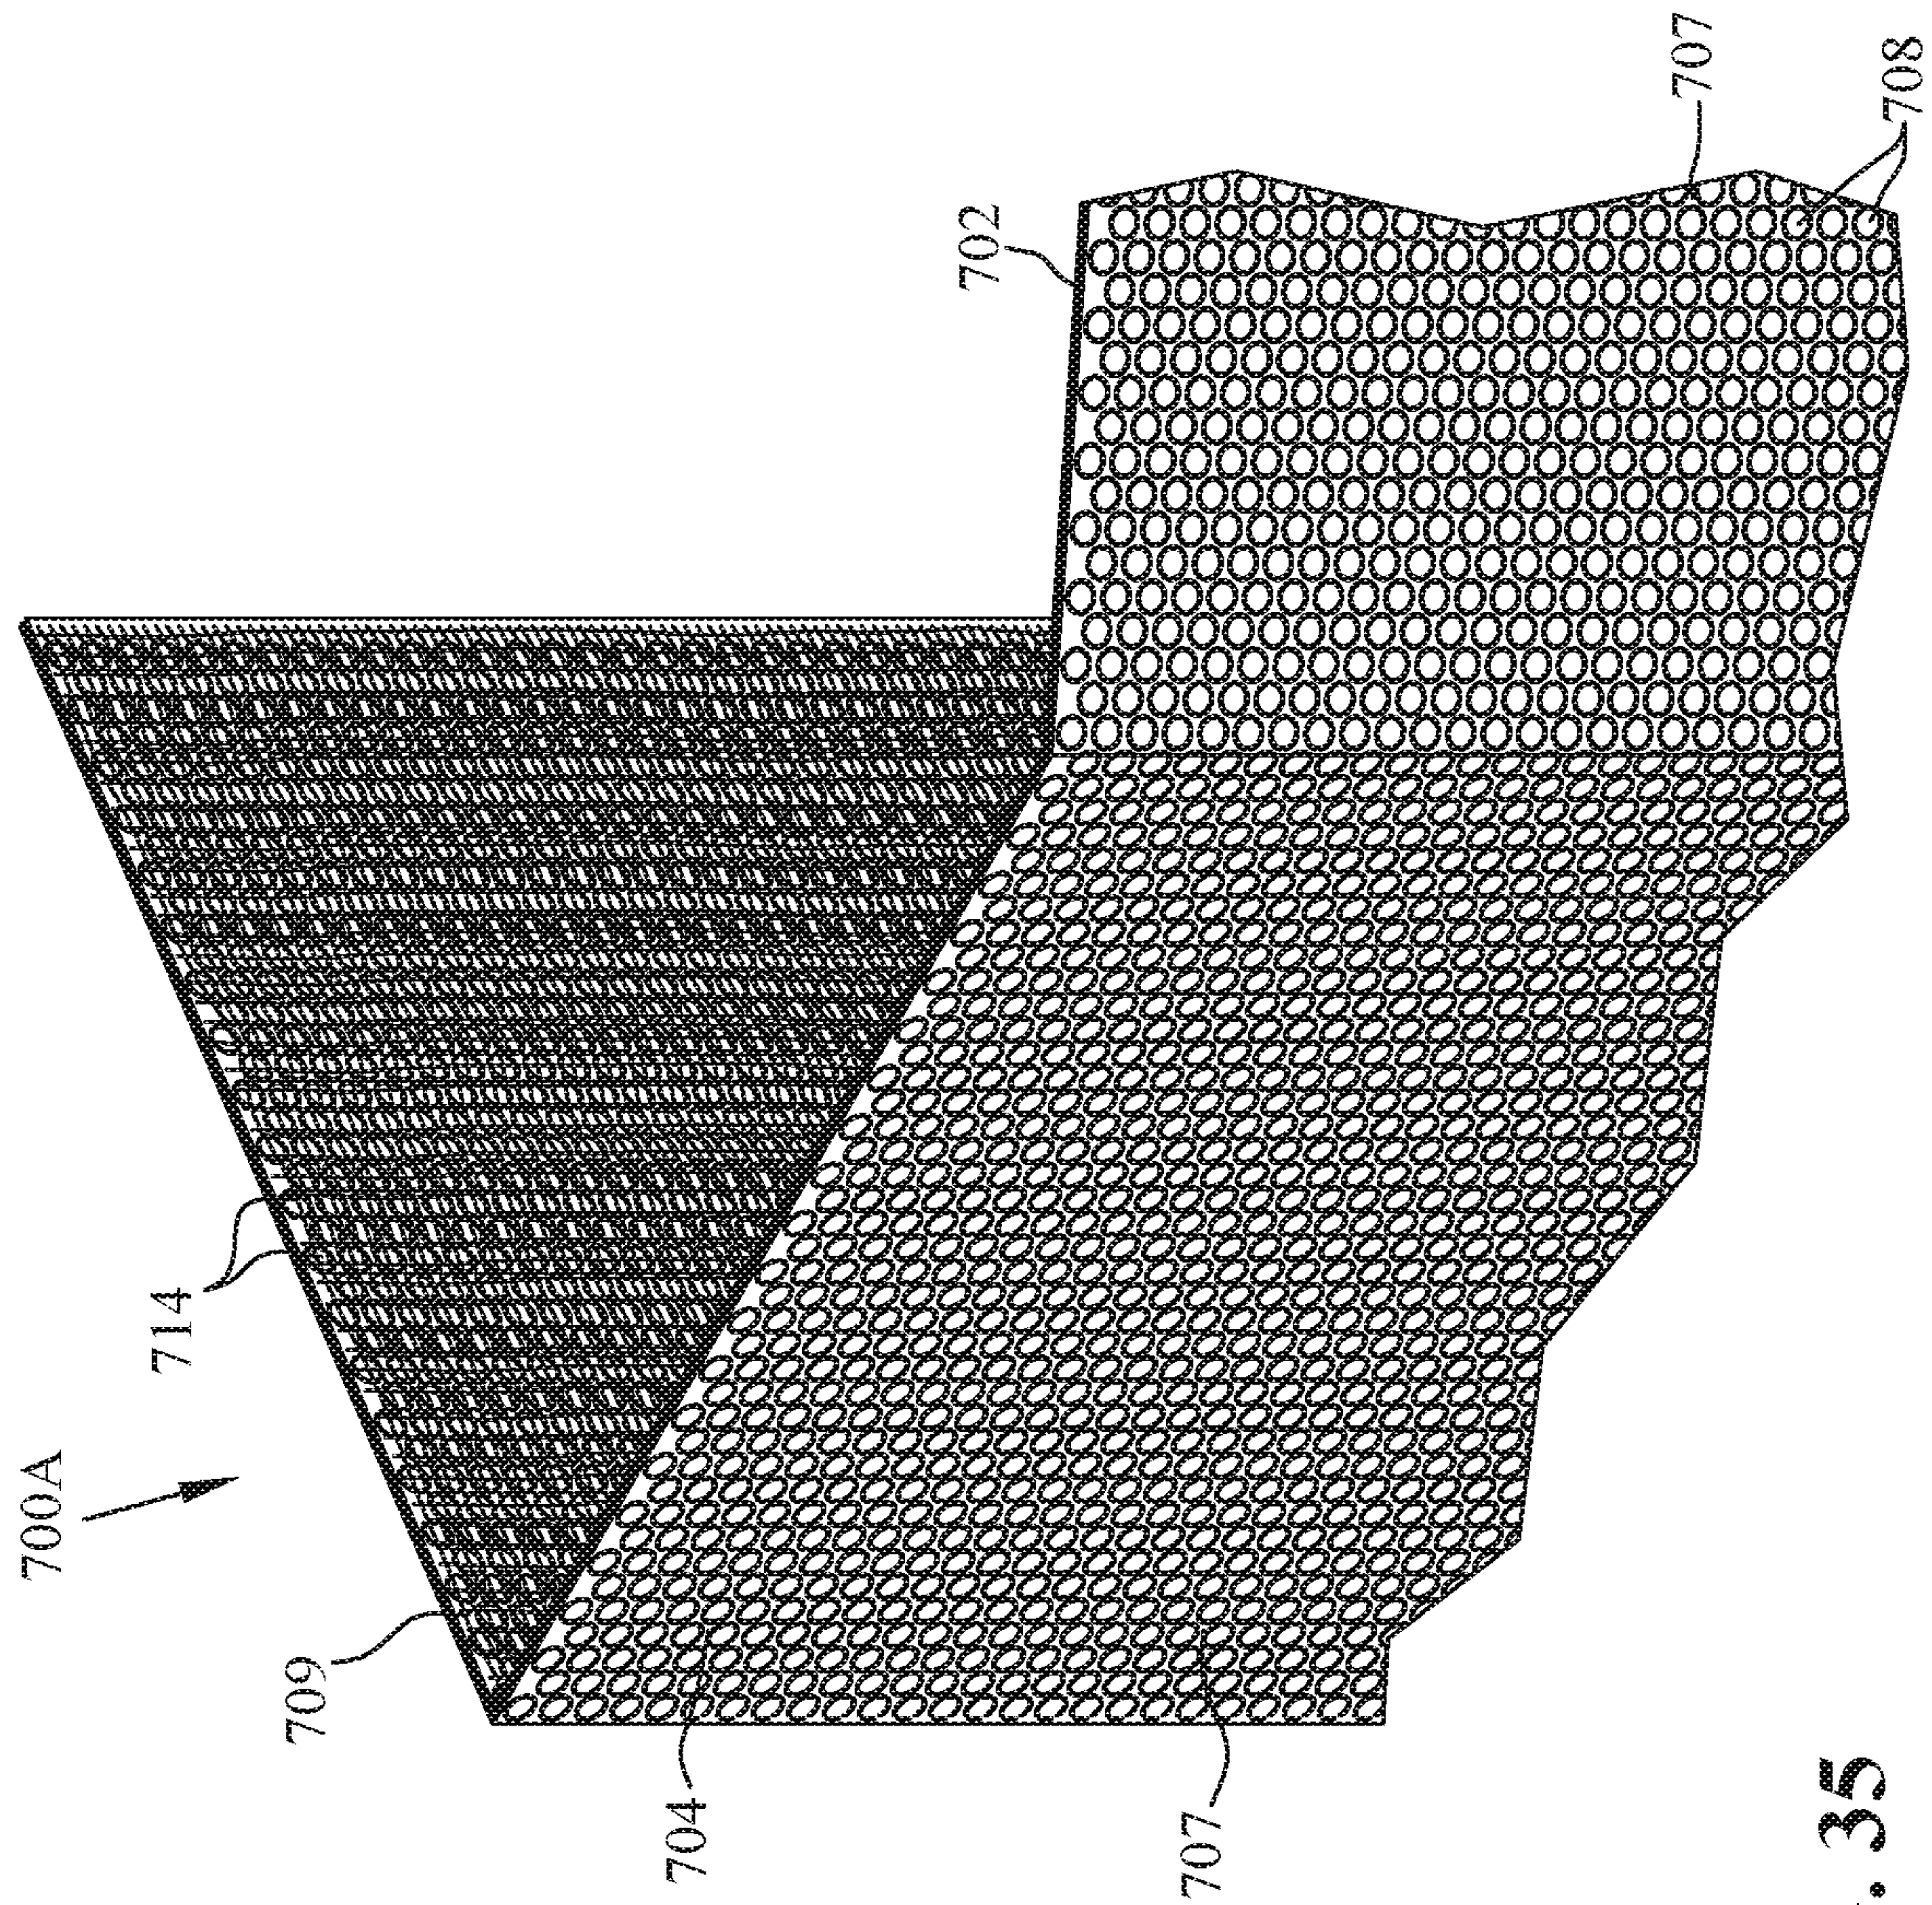
FIG. 35 is a perspective of a similar alternate embodiment view of a vehicle frame and cargo bay liner like FIG. 31, but with the aluminum foil on the side with convexities and a woven material on the opposite side with dimples;

In the embodiment of the 3 ply vehicle frame and cargo bay liner **700** of FIGS. **31-34**, the aluminum foil **707** is shown adhered to the side of liner **700** with dimples **714** and woven material **709** is shown adhered to the side with convexities **708**; however, in FIGS. **35-37** an alternate embodiment vehicle frame and cargo bay liner, shown generally indicated as **700a**, has the woven or nonwoven sheet of material **709** adhered to the side of the liner having dimples **714** and the aluminum foil **707** adhered to the side of the liner having convexities **708**. Also, the vehicle frame and cargo bay liner may be manufactured with only a layer of woven or nonwoven sheet of fabric material and no aluminum foil or alternately with aluminum foil and no woven or nonwoven fabric. Alternatively, it may be provided with either aluminum foil on both sides or with woven or nonwoven fabric on both sides.

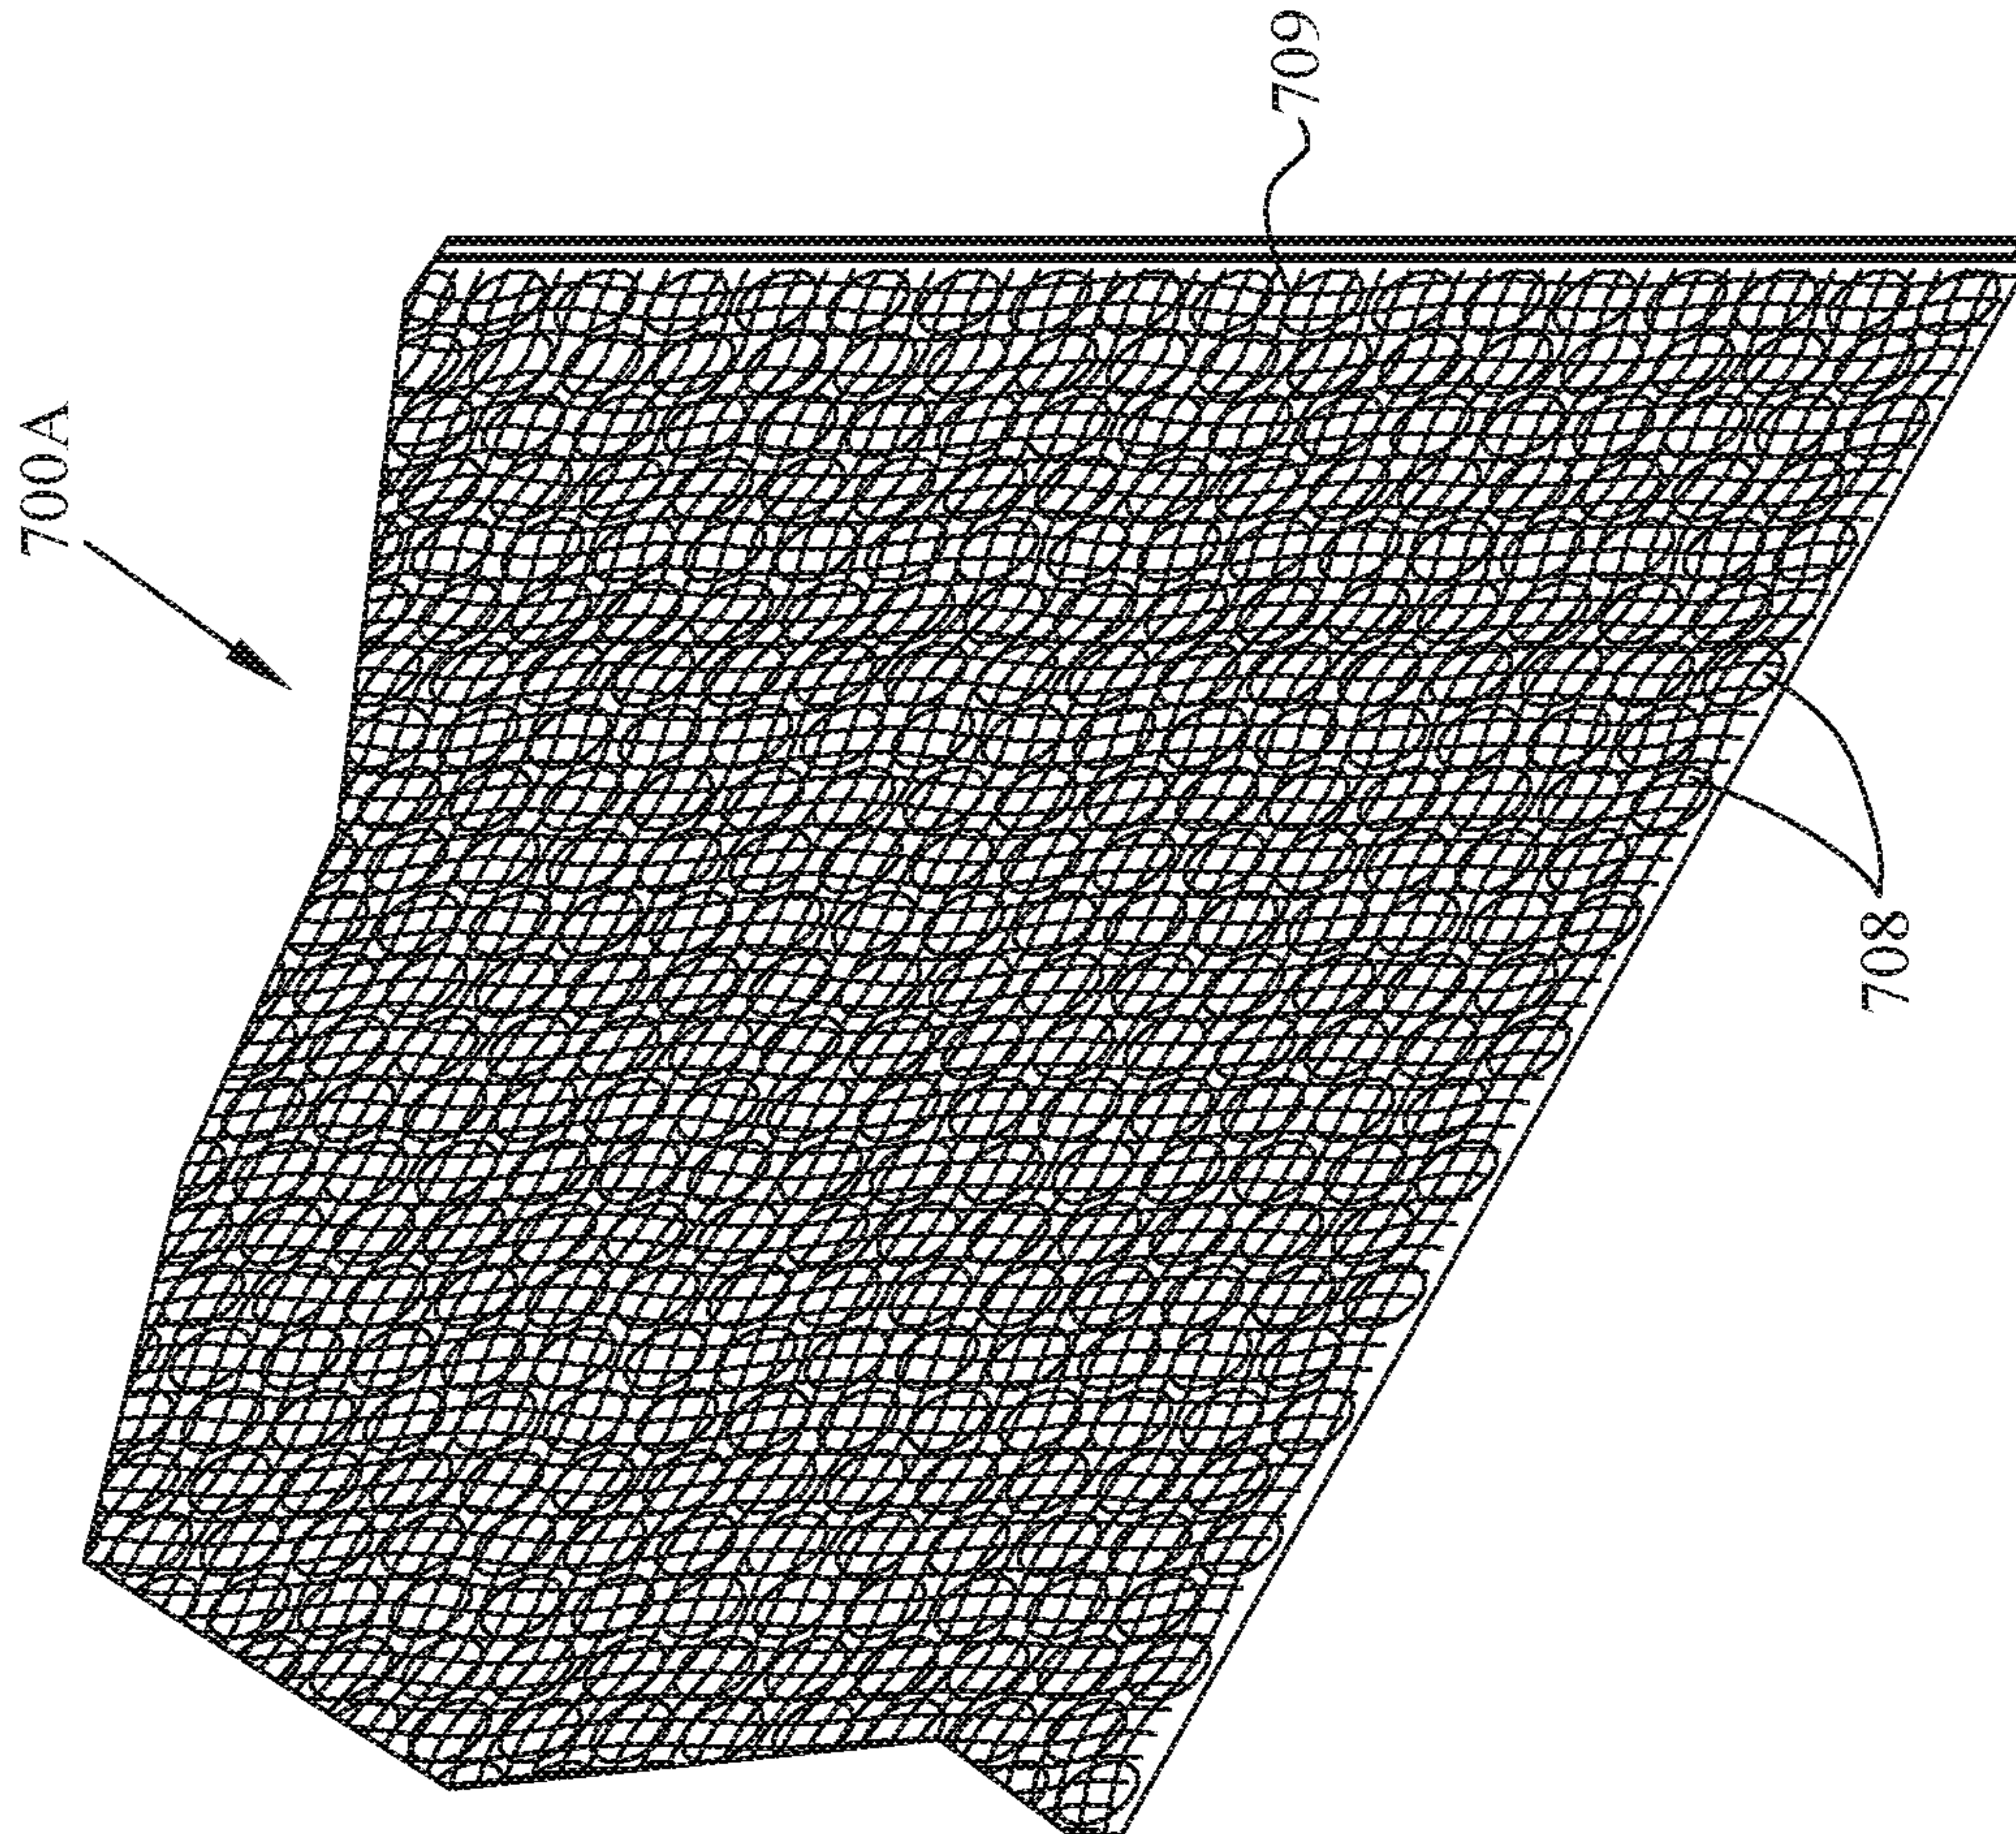
FIG. 36 is a plan perspective plan view of the vehicle frame and cargo bay liner of FIG. 35 showing the dimpled side having the woven material thereon;
