US011447189B1

(54) **VEHICLE FRAME AND CARGO BAY LINER**

A vehicle and liner assembly is provided that includes a  
recreational vehicle having a housing, a front end, a rear end,  
a top, a bottom, and a pair of sidewalls. A frame assembly  
is provided wherein, the housing is mounted on and sup-  
ported by the frame assembly. The liner is attached to the  
frame assembly and covers at least a substantial portion of the  
bottom of the housing. The liner has a first face having  
projections extending therefrom and a second face having  
openings therein. The openings coincide with and extend  
into corresponding projections on the first face.

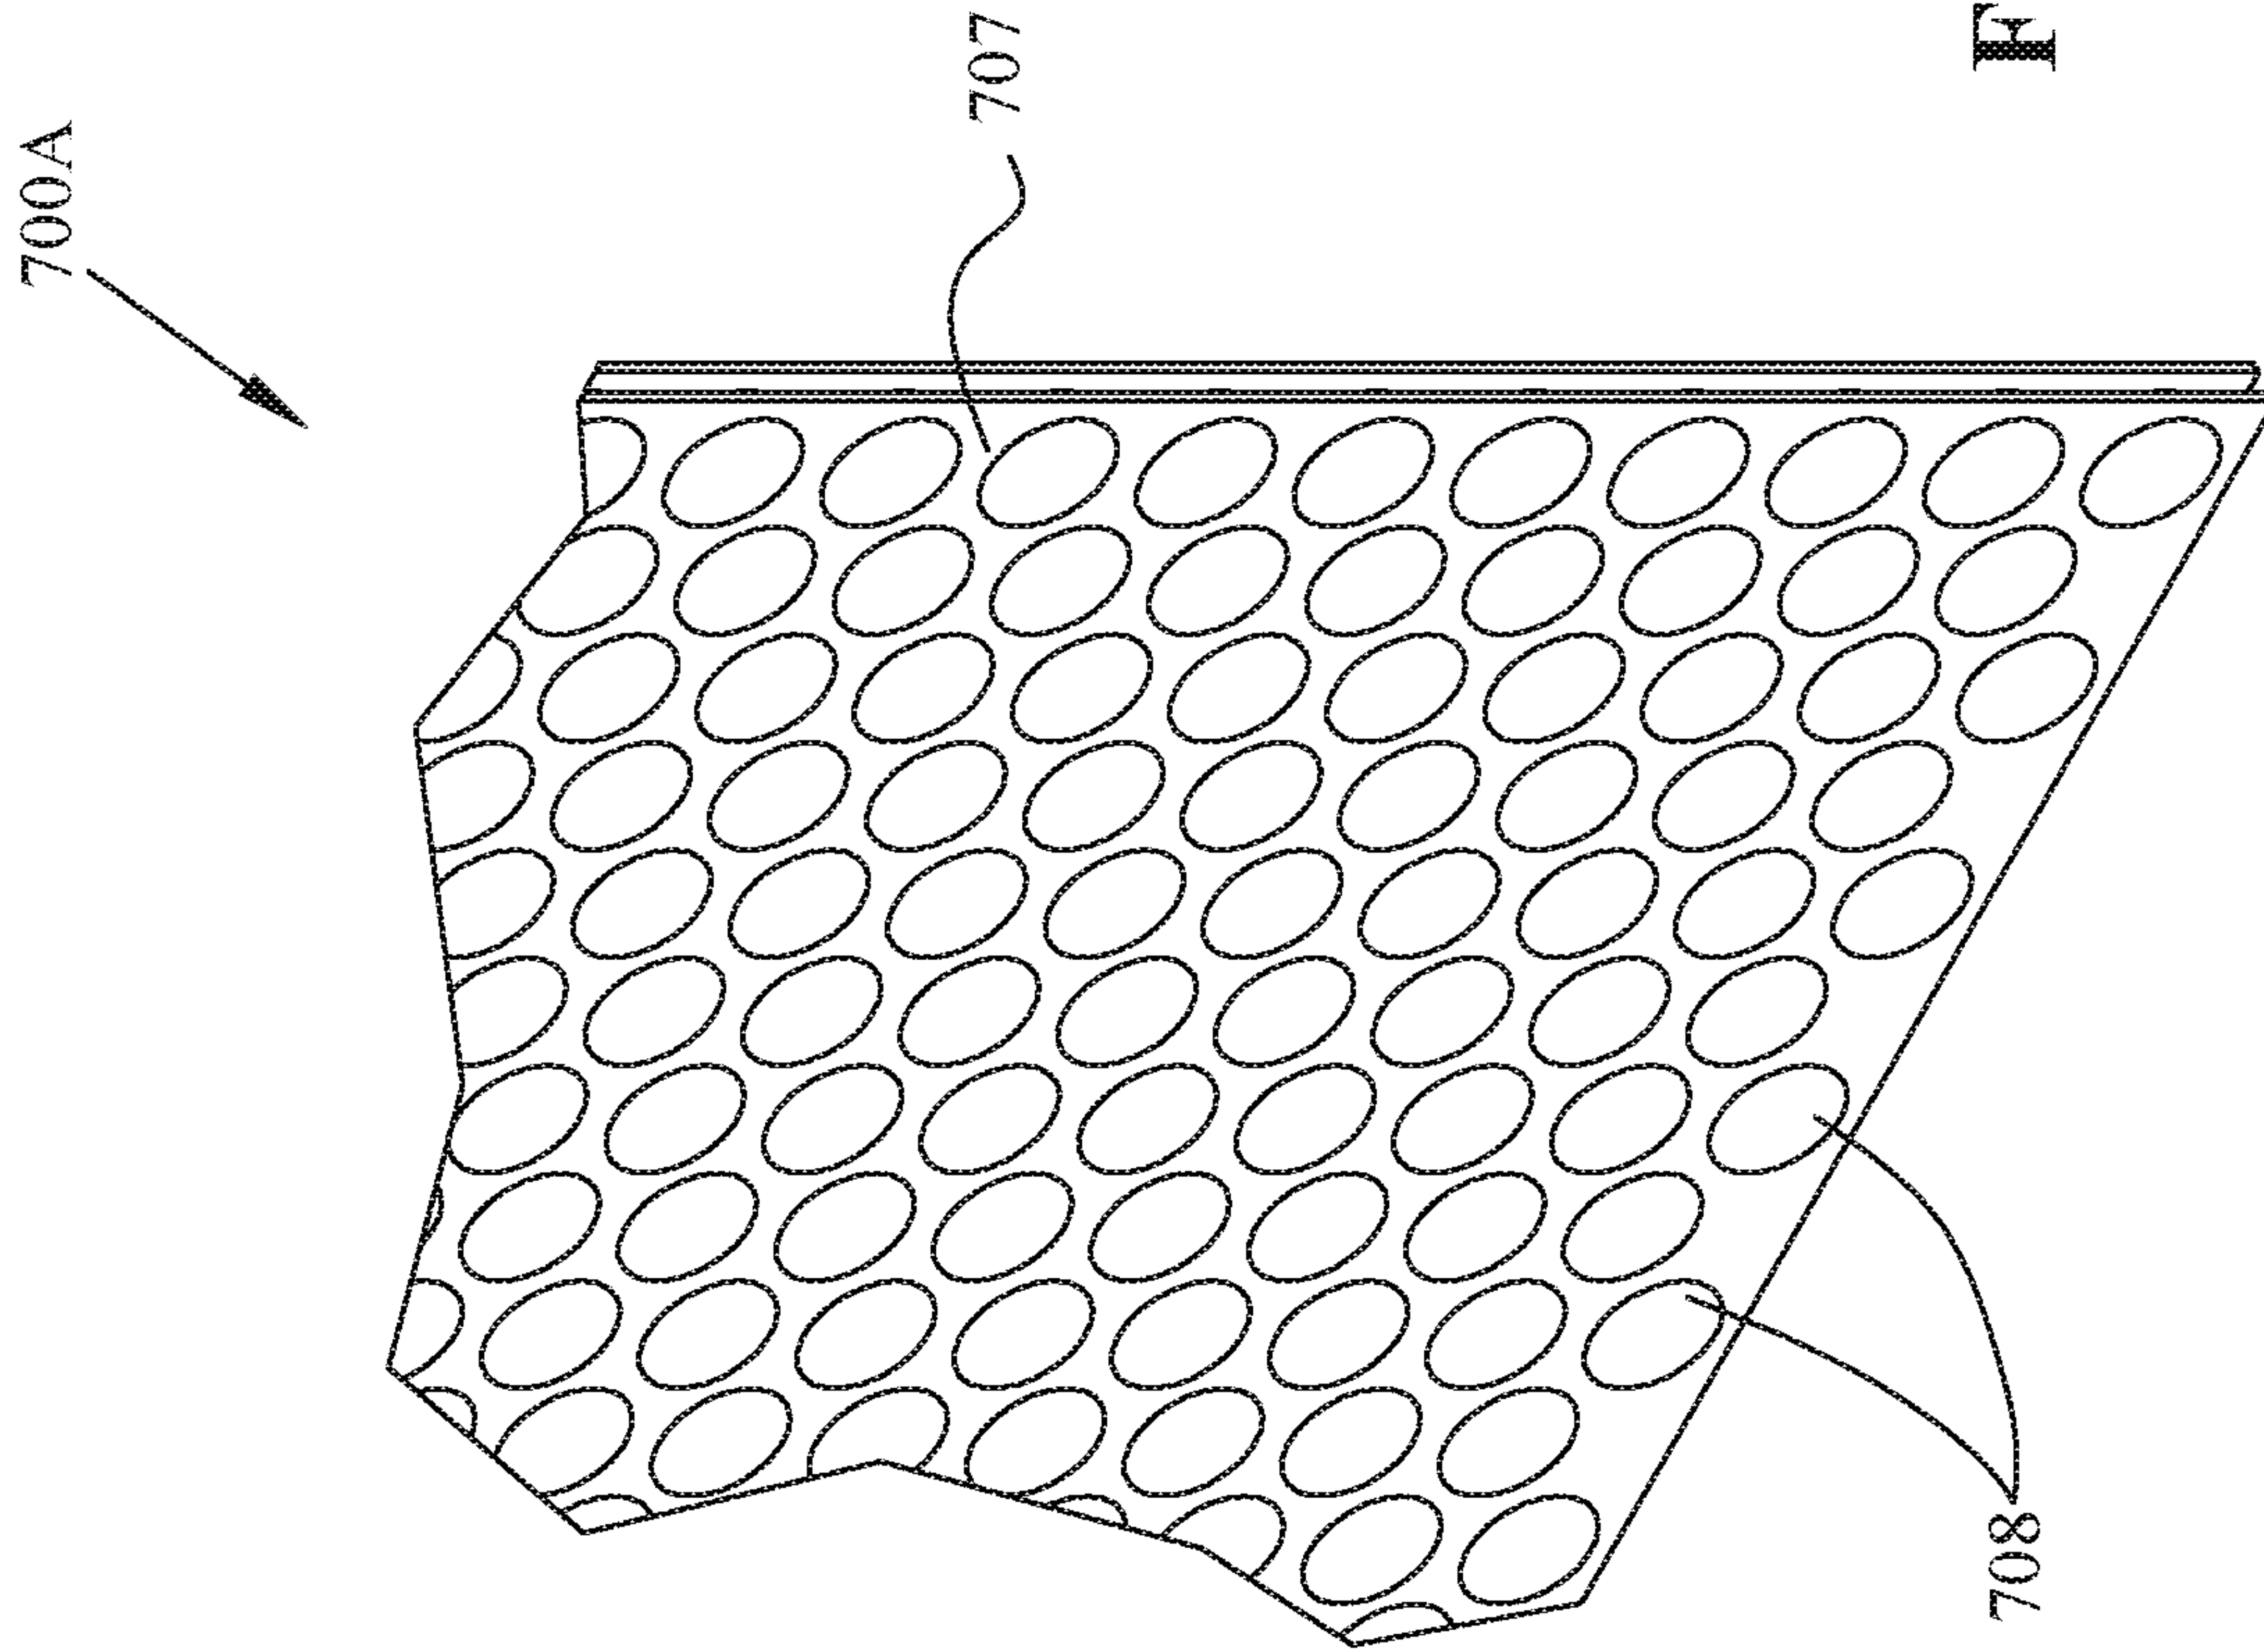
FIG. 37 is a plan perspective plan view of the vehicle frame and cargo bay liner of FIG. 35 showing the convex side having the aluminum foil thereon side;

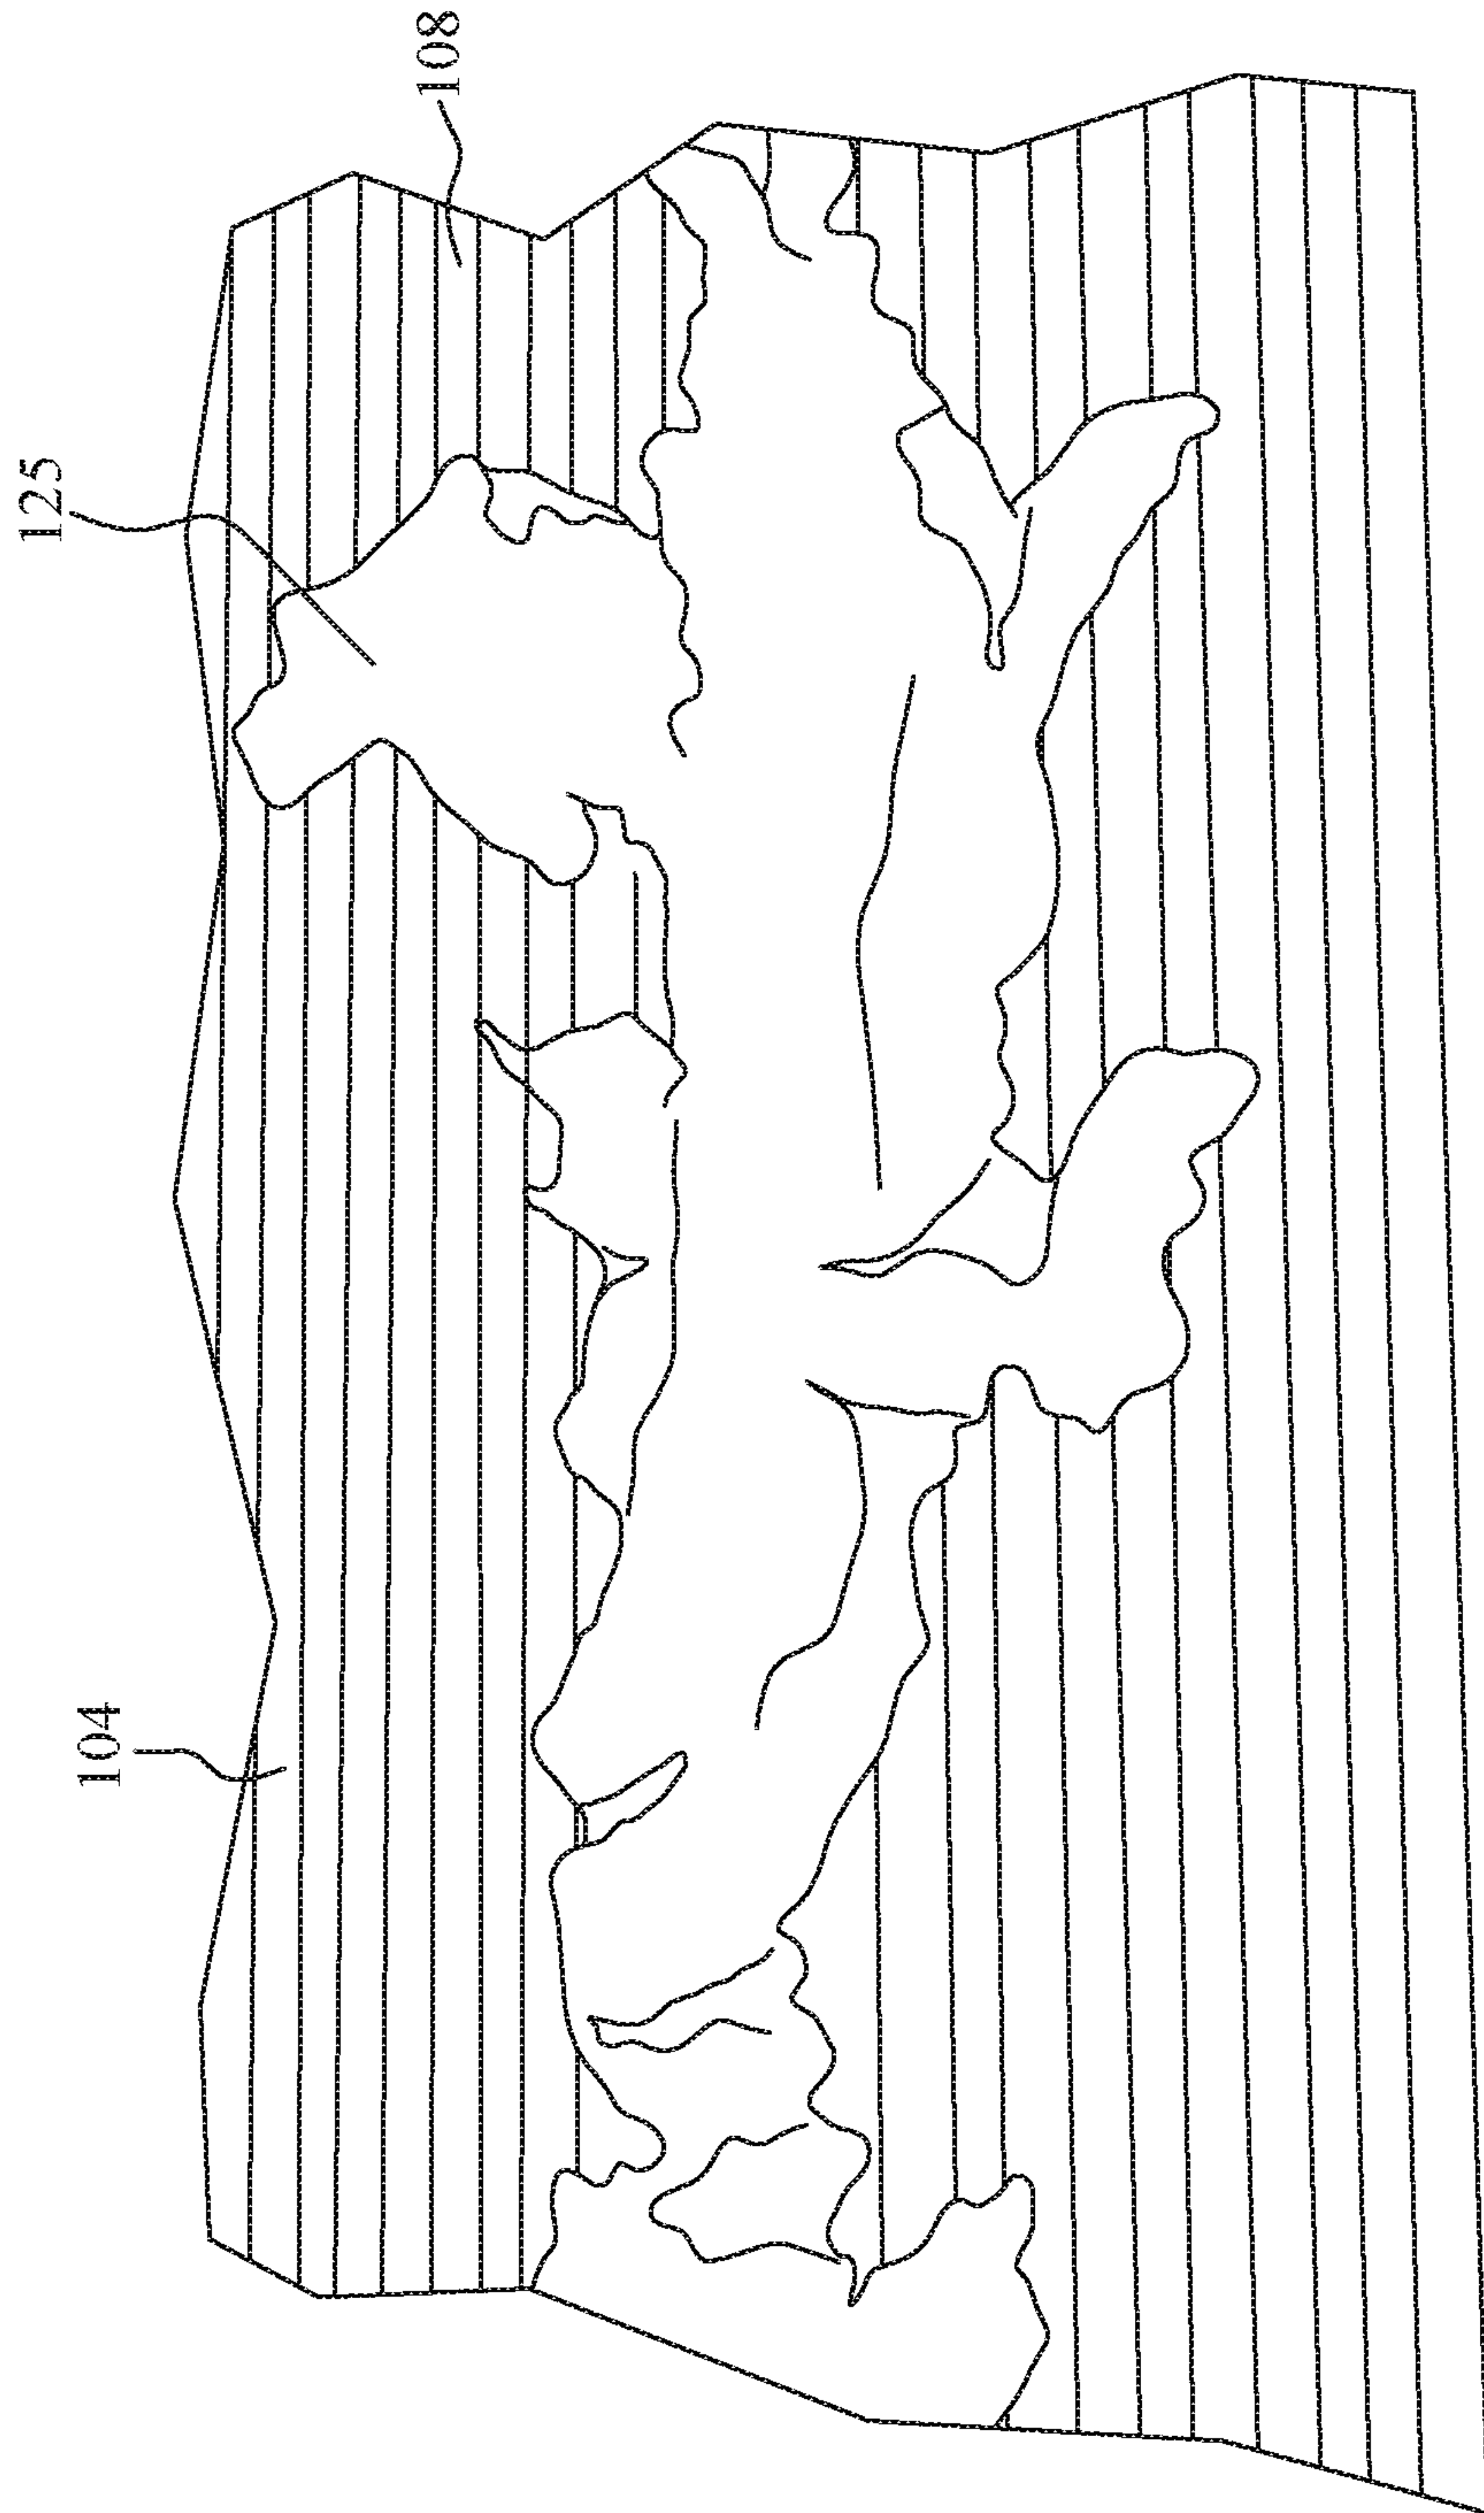
FIG. 38 is a plan perspective view showing a foam sealing material adhered to the bottom of a prior art liner;

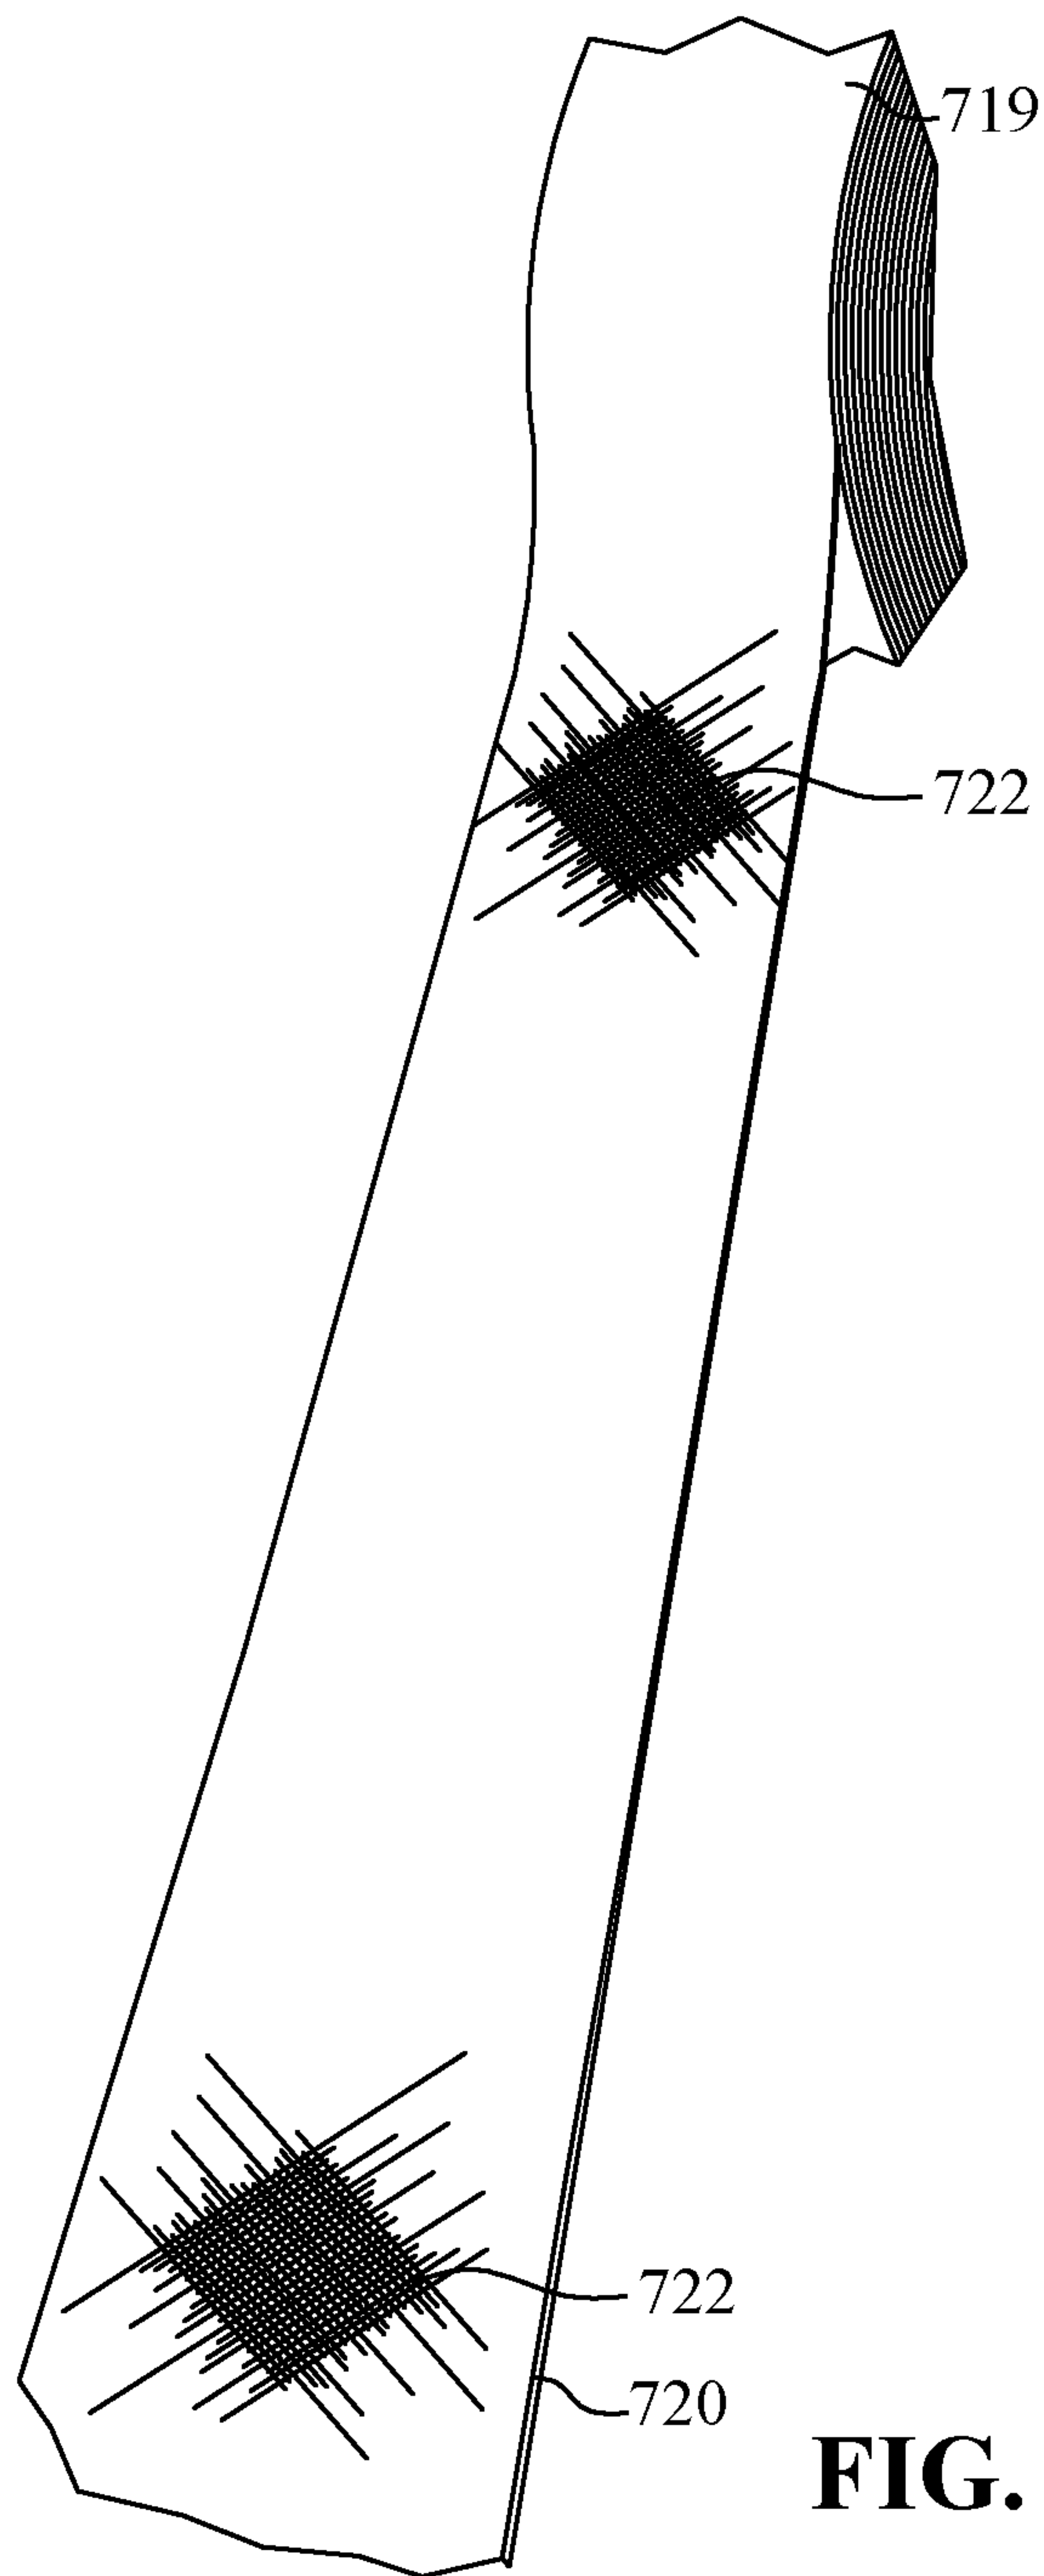
**FIG. 39**

FIG. 39 is a perspective view of a role of repair tape for use in repairing the woven material;

Now referring now to FIGS. **39-42**, a unique repair and reinforcing system is provided for any of the liners provide herein and may be used to repair rips, tears or holes in the

In one embodiment, the repair system includes a role of woven or nonwoven fabric tape shown indicated as 719. In the embodiment shown, the fabric tape includes a woven fabric shown as 722. Also, in the embodiment shown, the tape can be supplied with a contact adhesive attached to one side thereof for attachment to the liner, foil, film or fabric that it is repairing or reinforcing. A protective layer of material 720 (see FIG. 39) to which the adhesive will readily release from may be used to facilitate providing the repair tape in a rolled form or otherwise facilitate removing thereof for easy repair or reinforcement of the recreational vehicle. As shown in FIGS. 42 and 43, repair tape 719 is attached to woven fabric layer 709, on the exterior thereof, creating an additional layer to the liner 700 as is best shown in FIG. 43. It should be appreciated that repair and reinforcing tape 719 could be placed or attached over itself to create additional reinforcing layers, and/or on the other side of the liner over the sheet of aluminum foil or metalized file 707. As many additional layers as is desired can be placed on either or both sides. It should also be appreciated that the repair tape could be an aluminum foil, or metalized film or other polymer or material, but the woven fabric tape has shown to be particularly suitable.

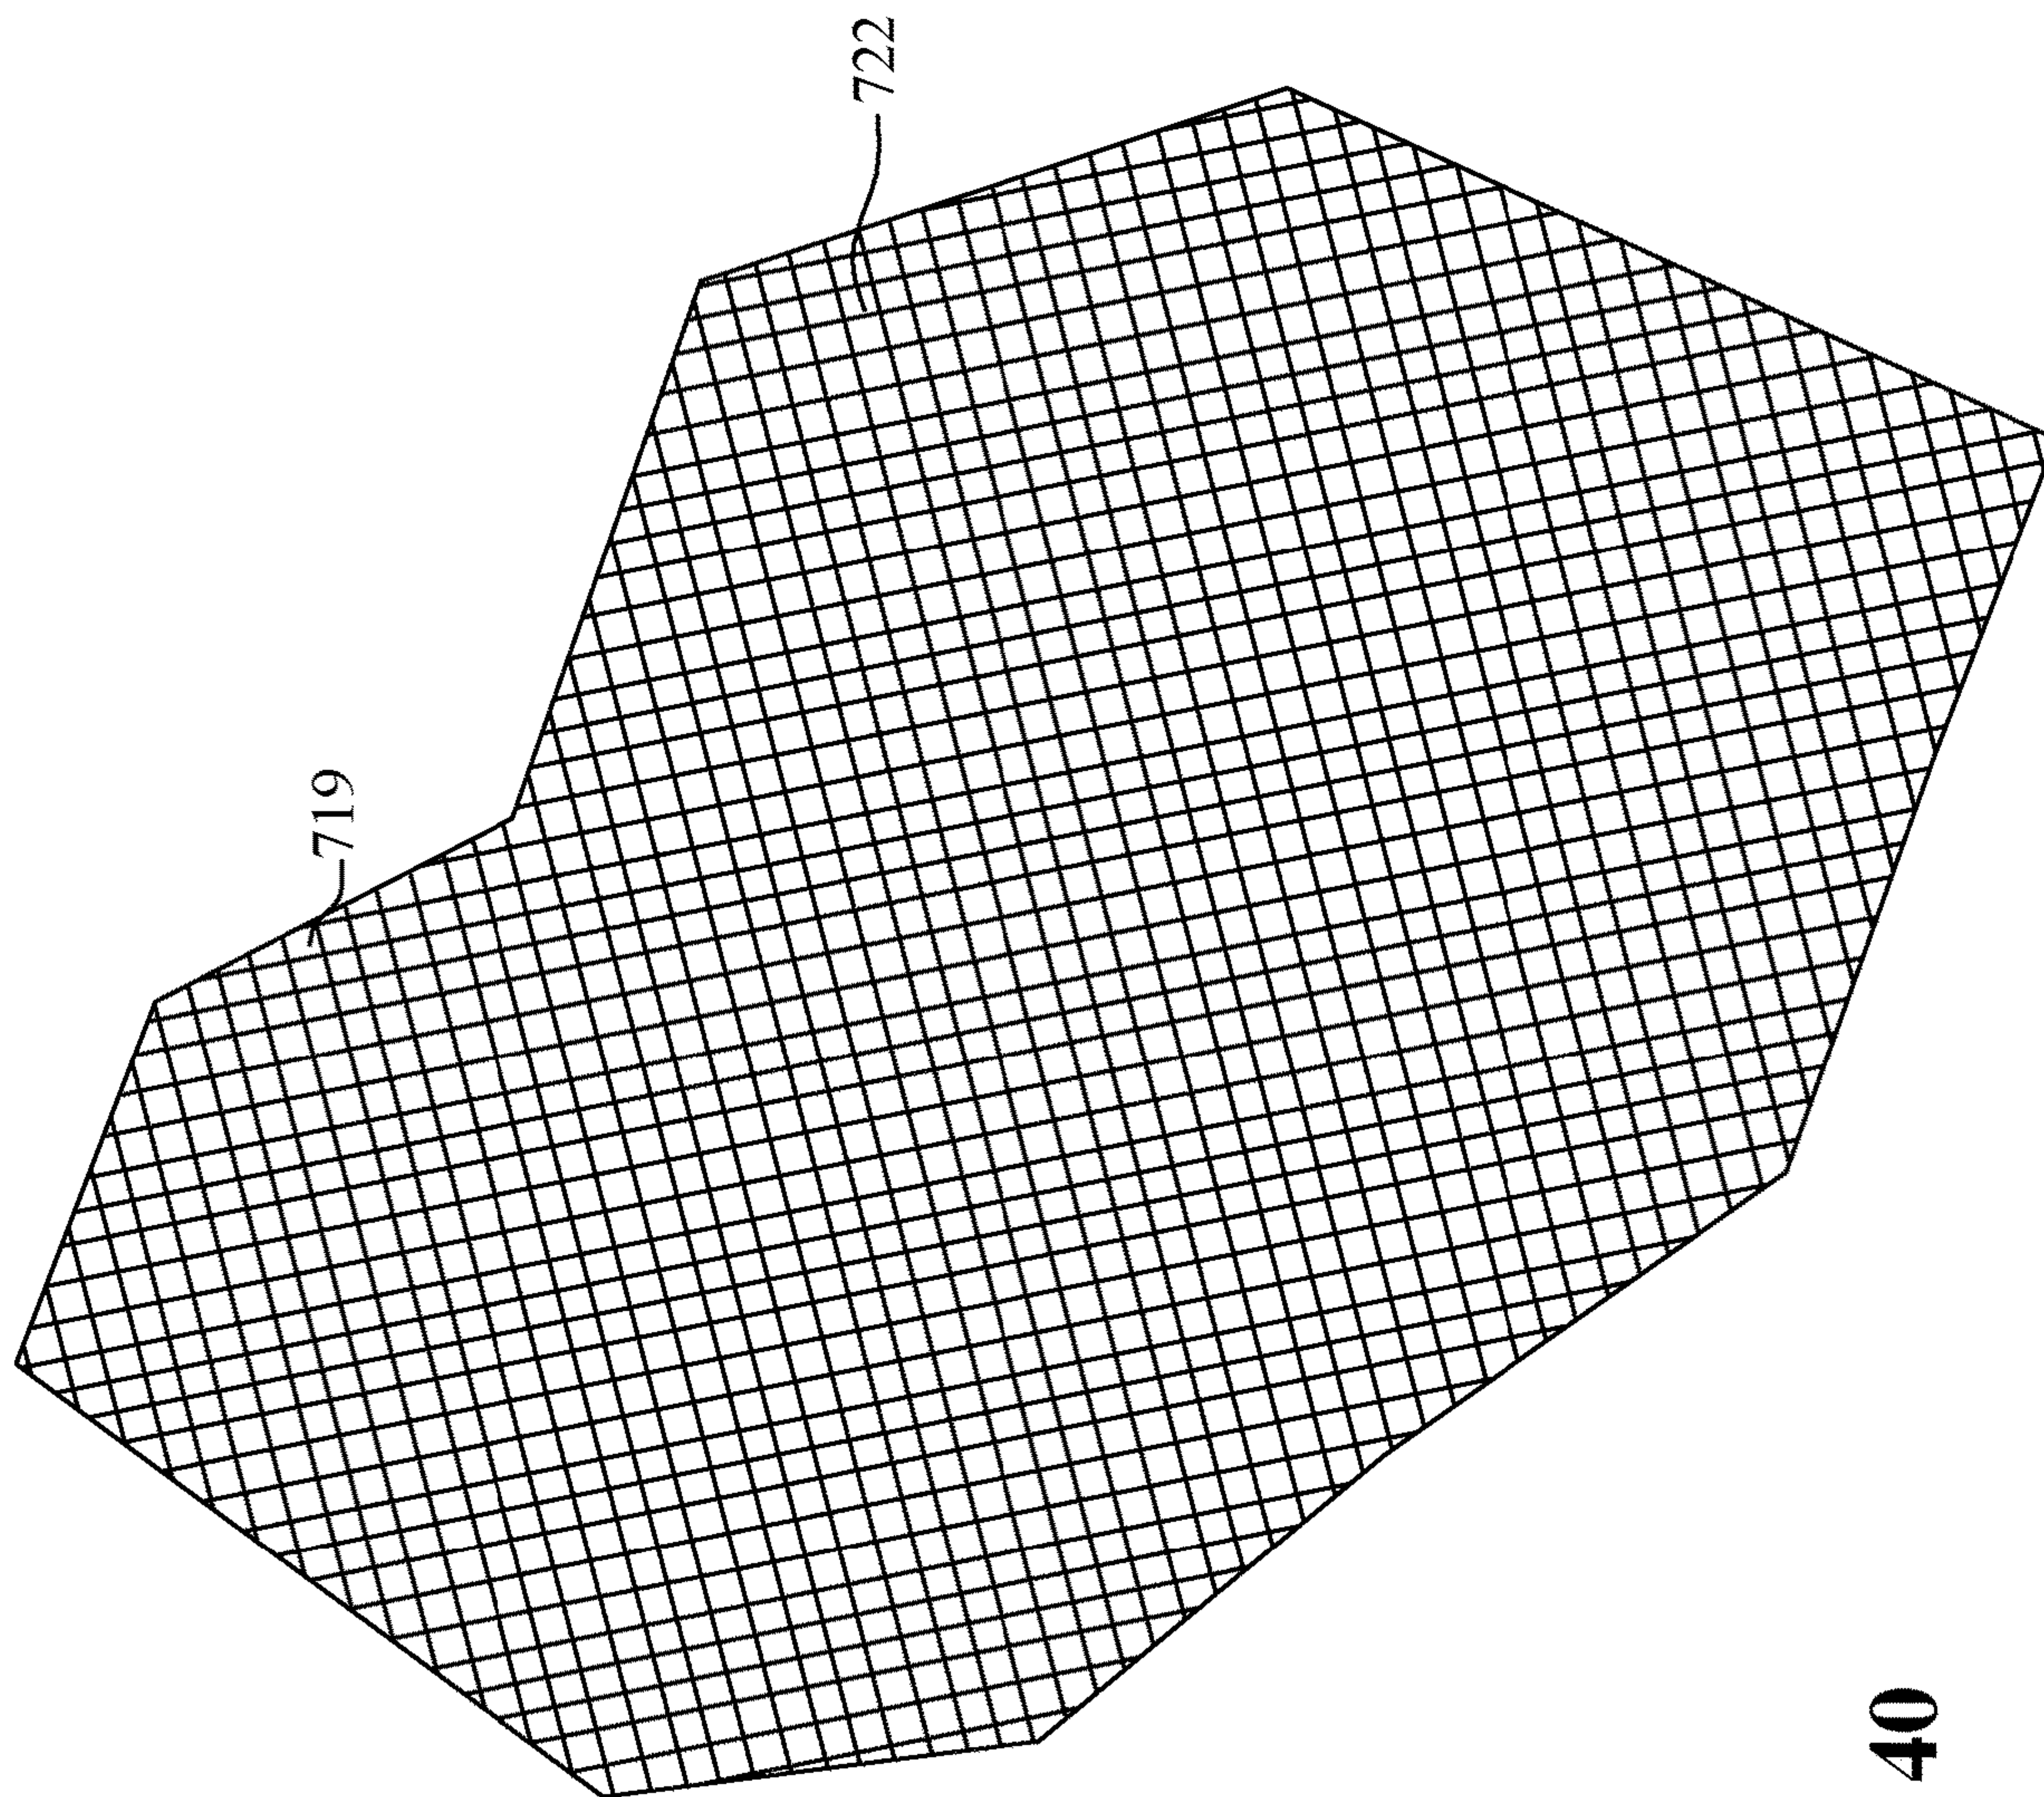
**FIG. 40**

FIG. 40 is an enlarged plan view of the woven material repair tape;

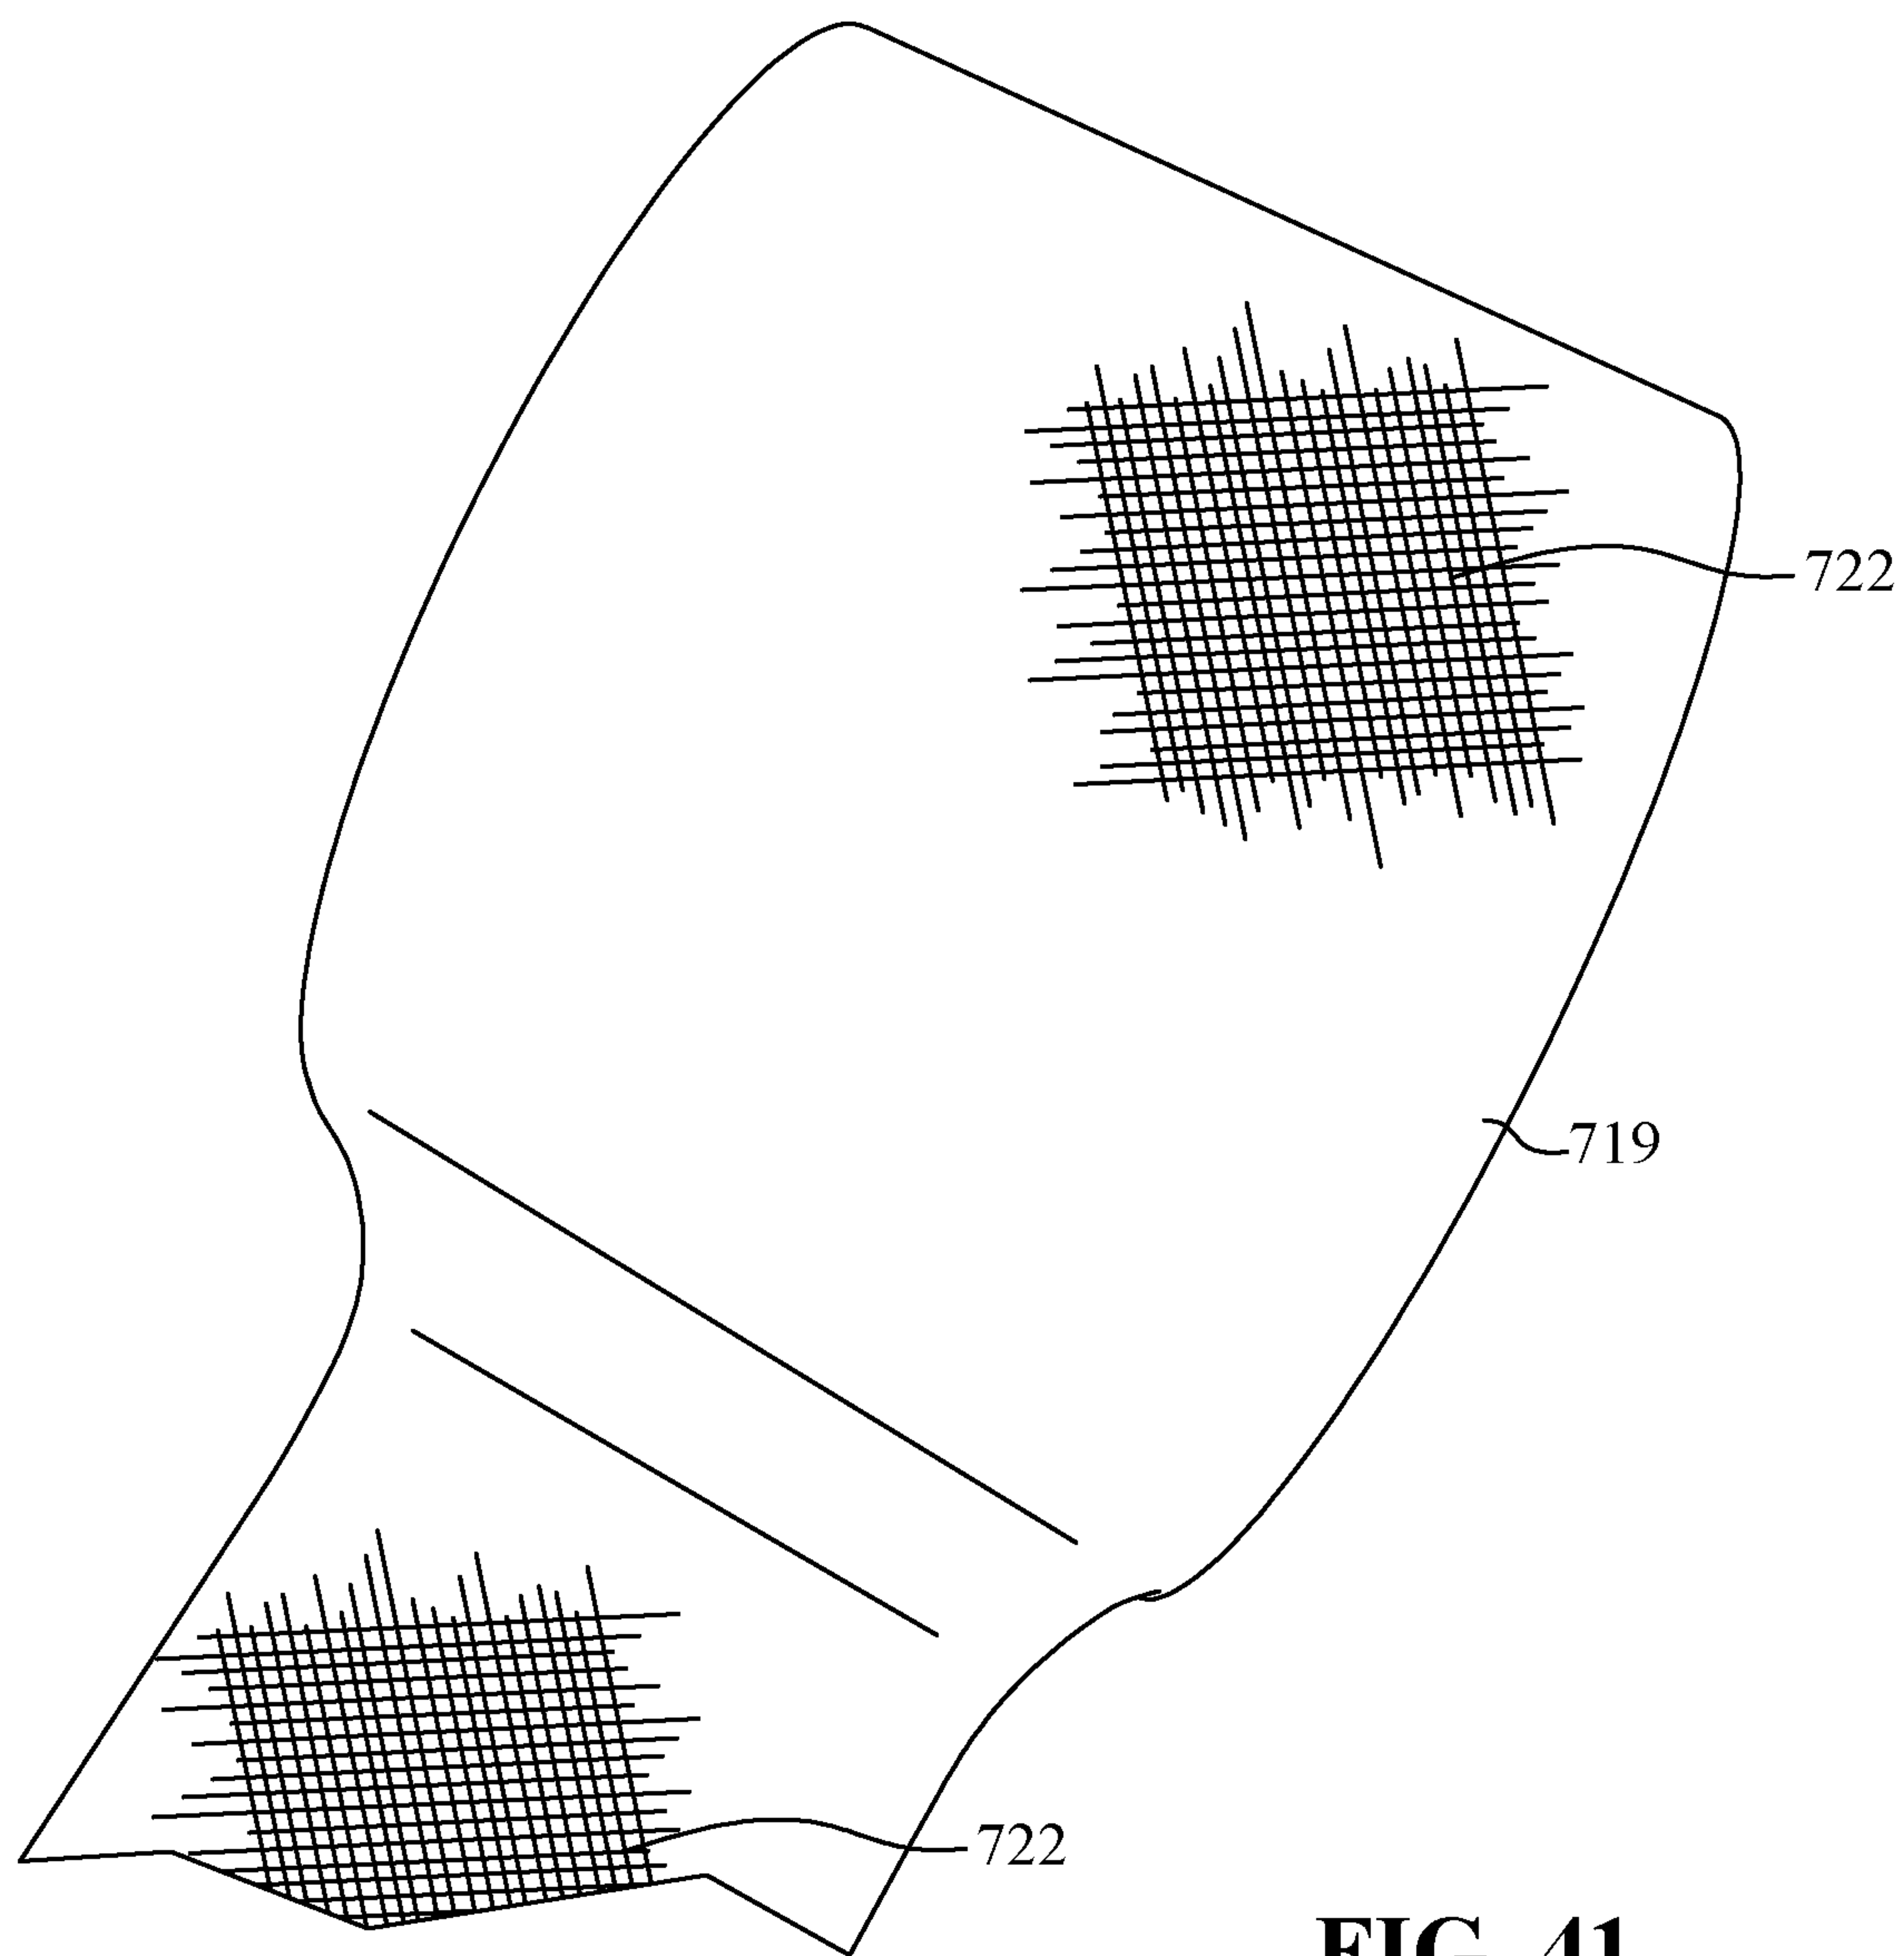
**FIG. 41**

FIG. 41 is another plan view of the role of woven material repair tape;

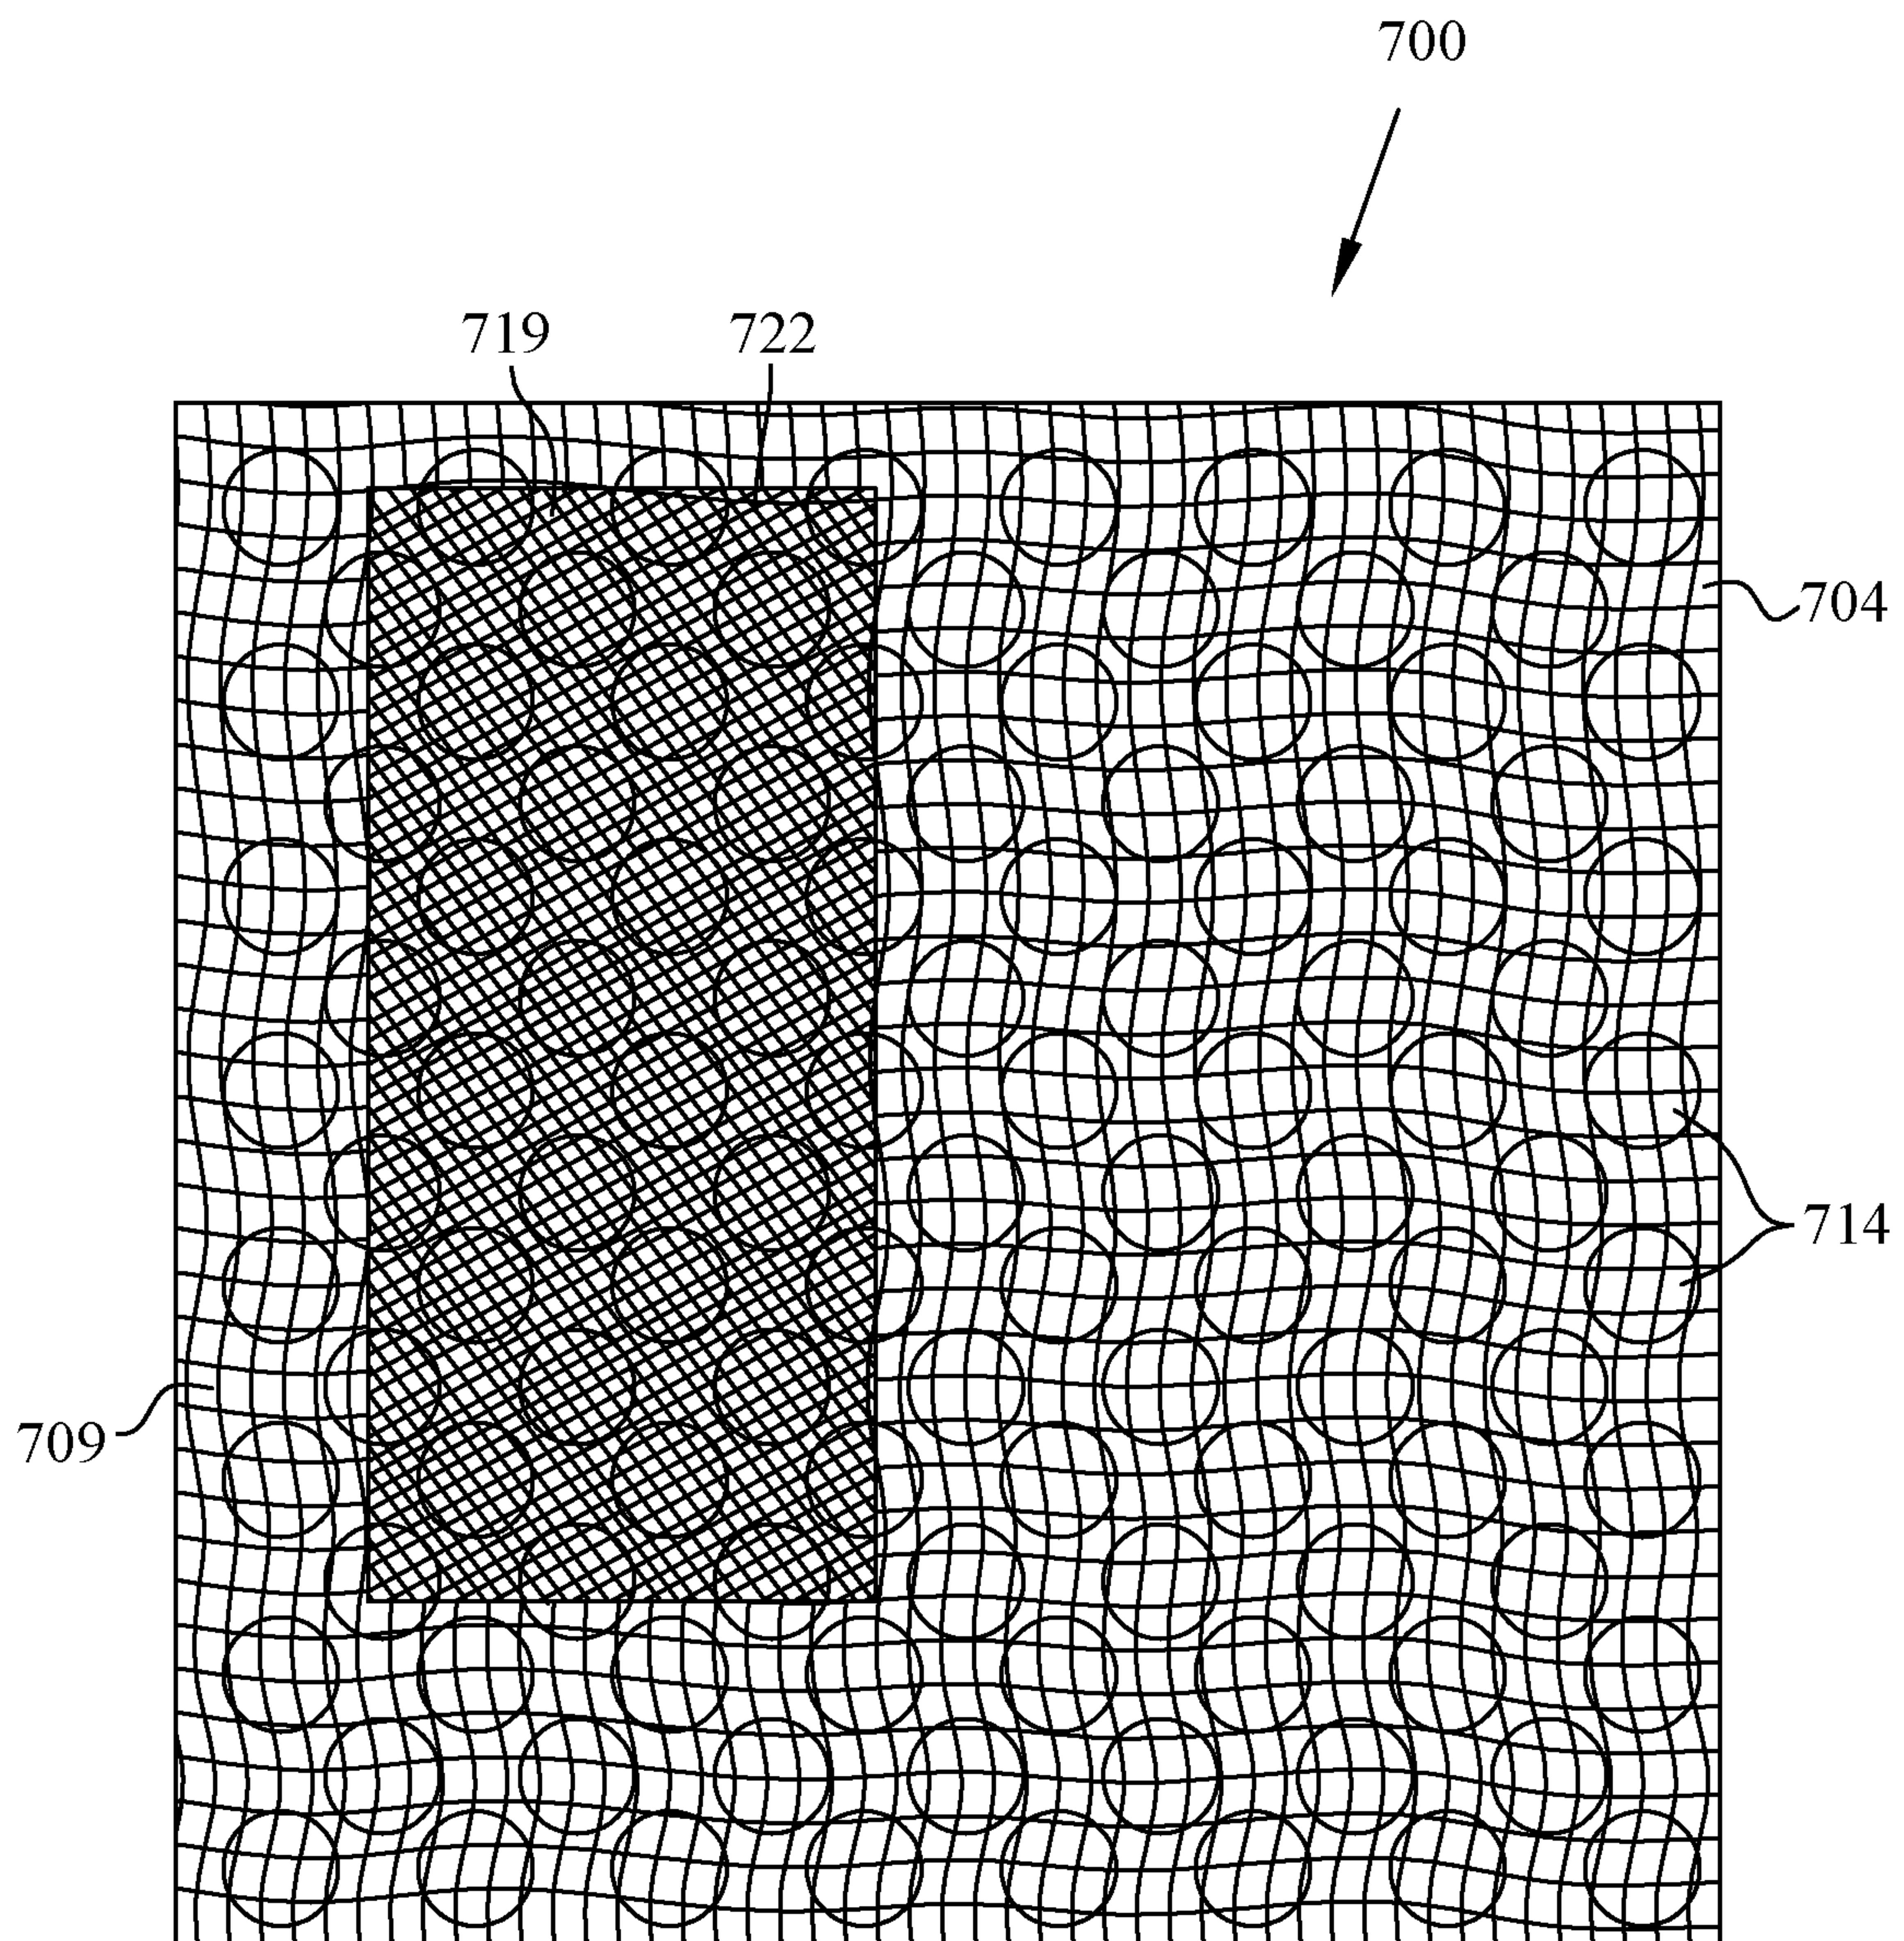
**FIG. 42**

FIG. 42 is a plan view of a liner having a sheet of material with a woven fabric attached thereon and a piece of repair tape attached to the woven material; and
