US011447189B1

(54) **VEHICLE FRAME AND CARGO BAY LINER**

A vehicle and liner assembly is provided that includes a  
recreational vehicle having a housing, a front end, a rear end,  
a top, a bottom, and a pair of sidewalls. A frame assembly  
is provided wherein, the housing is mounted on and sup-  
ported by the frame assembly. The liner is attached to the  
frame assembly and covers at least a substantial portion of the  
bottom of the housing. The liner has a first face having  
projections extending therefrom and a second face having  
openings therein. The openings coincide with and extend  
into corresponding projections on the first face.

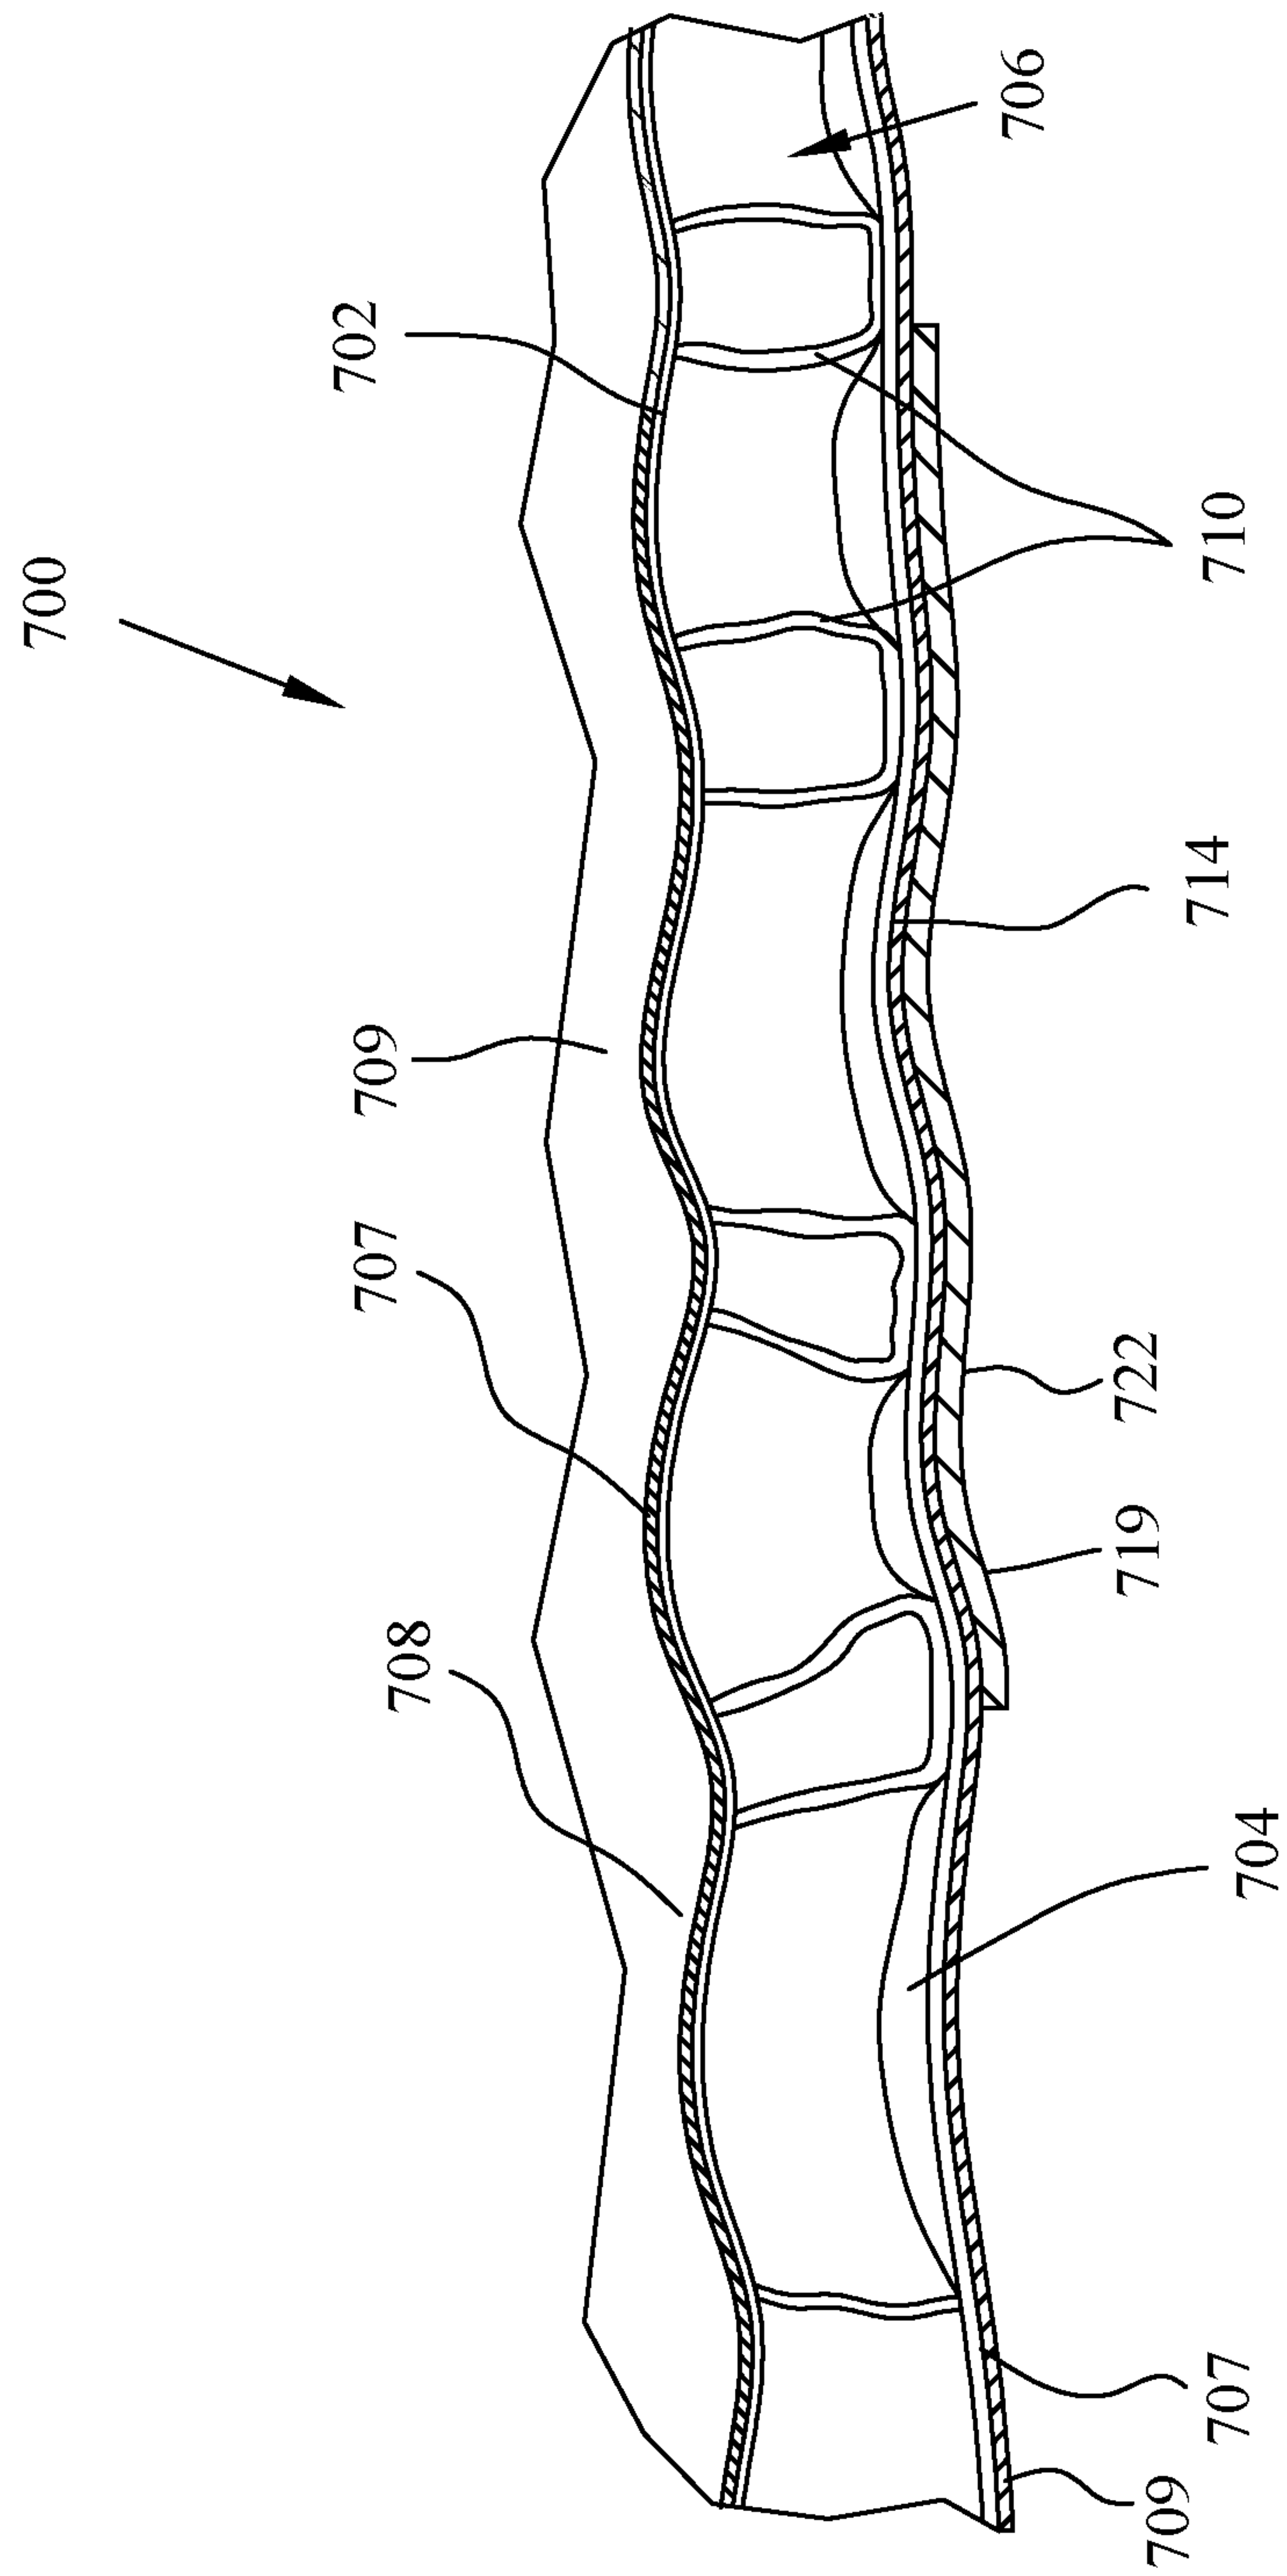
FIG. 43 is a cross sectional view of the liner of FIG. 42 taken through the piece of repair tape.
