(12) **United States Patent**
Pennington

(54) **VEHICLE FRAME AND CARGO BAY LINER**

(71) Applicant: **PennPlastics, LLC**, Mishawaka, IN (US)

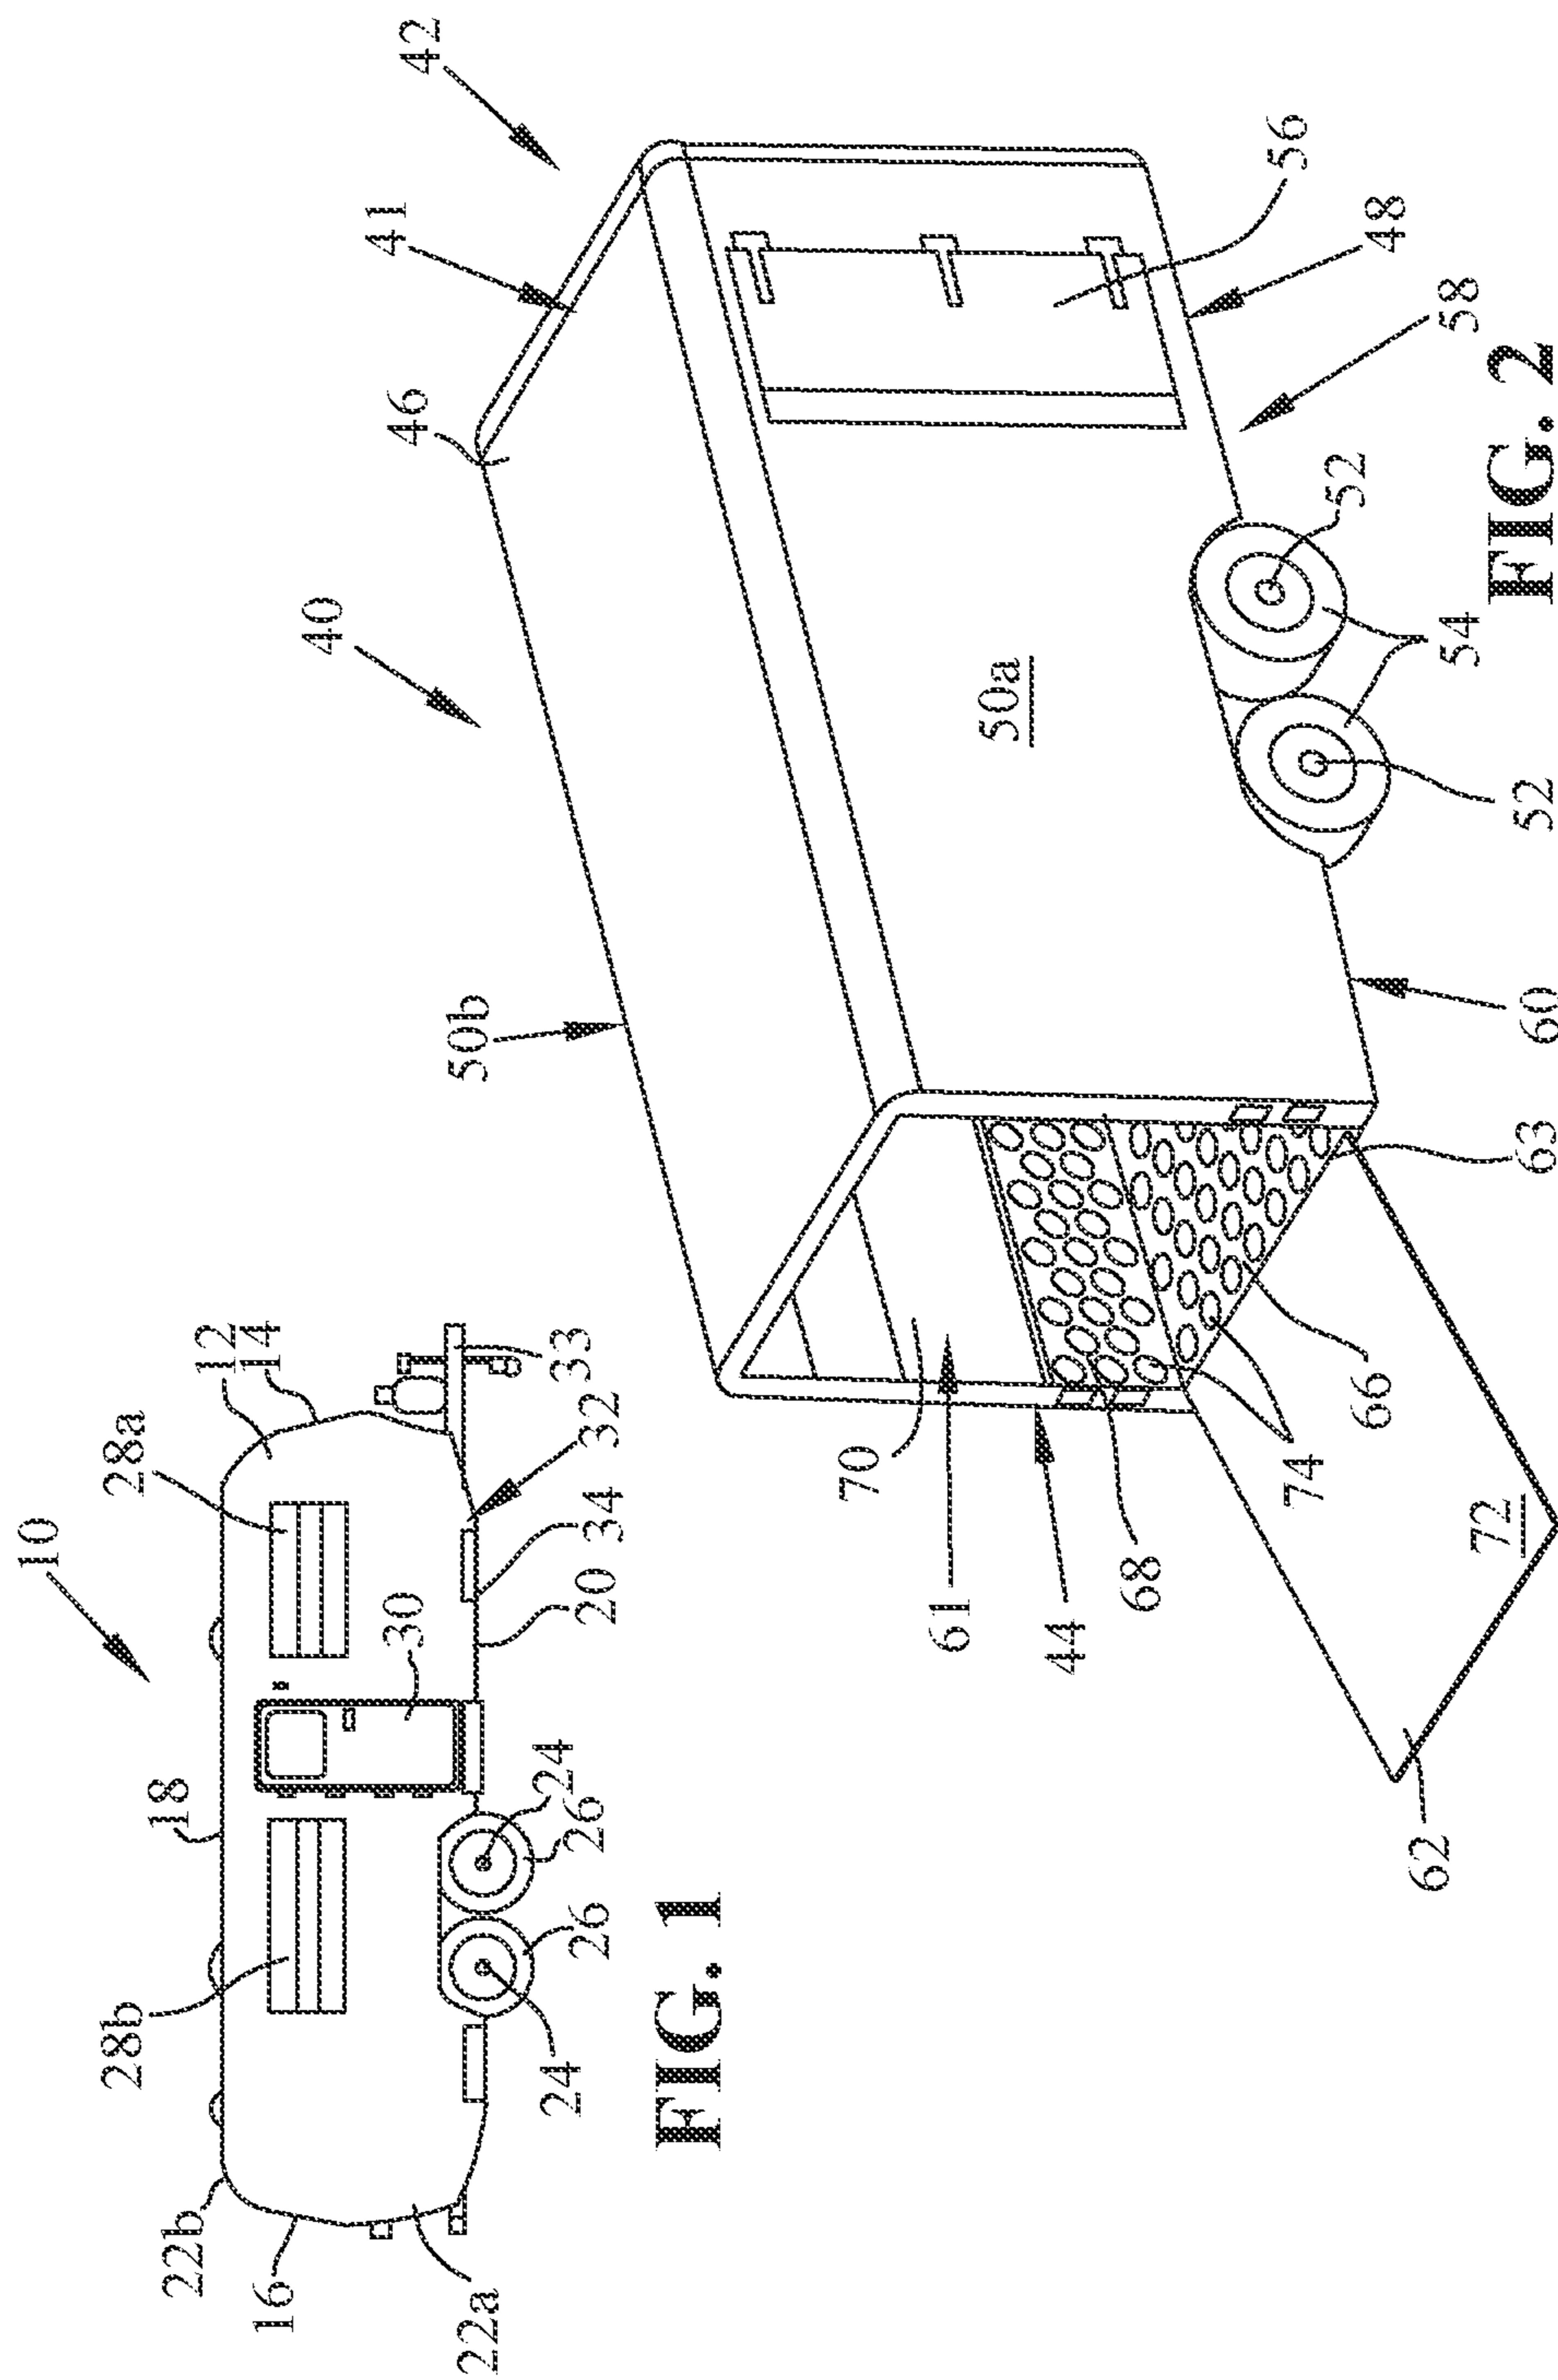
FIG. 1 is a side view of a recreational vehicle and frame liner in accordance with the subject invention;

Referring now to FIG. 1, a recreational vehicle is shown generally indicated as 10. In the embodiment shown, recreational vehicle 10 is a type commonly called a travel trailer. Travel trailer 10 is generally defined by a housing 12 including a front end 14, a rear end 16, a top 18, a bottom 20, and a pair of generally parallel sides 22a, 22b. Recreational 10 further includes a pair of axels 24 having wheels 26 mounted thereon. Recreational vehicle 10 also includes

windows **28a**, **28b** and a door **30**. Housing **14** is mounted upon and supported by a frame assembly, generally indicated as **32**, extending into a hitch **33**. These are all known and common in the recreational vehicle industry. A liner **34** in accordance with the subject invention is mounted and attached at the bottom of frame assembly **32** to protect the undercarriage of recreational vehicle **10** as described above in the background section.

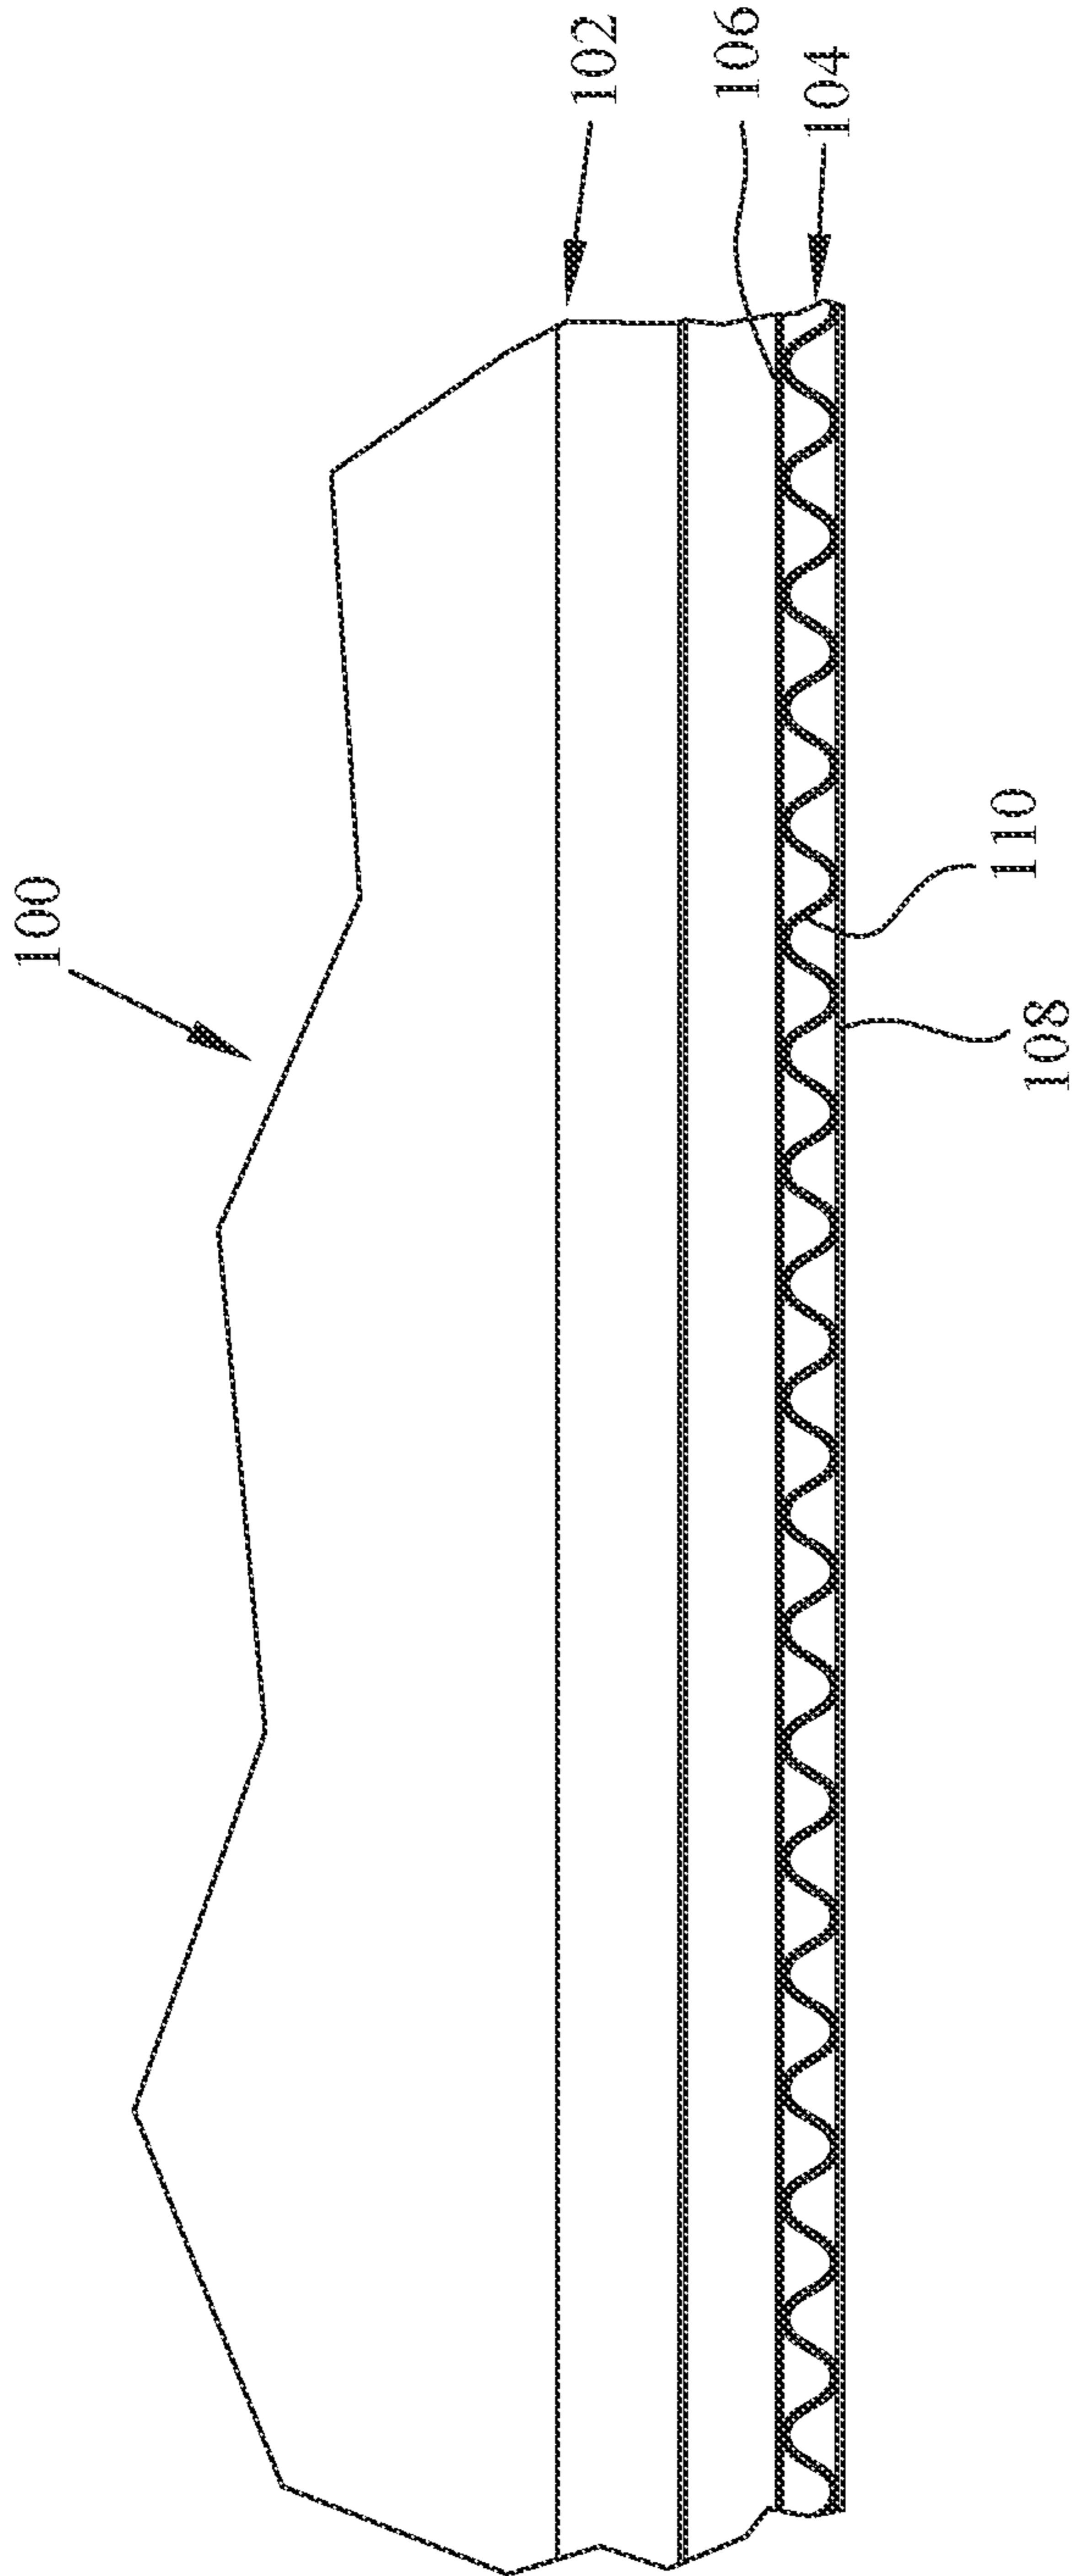
FIG. 3
(PRIOR ART)

FIG. 3 is a side view of a prior art recreational vehicle frame liner;

Referring now to FIGS. 3 and 4, these depict prior art vehicle undercarriage frame liners in common use in the industry. A portion of a recreational vehicle is generally indicated as **100**. Recreational vehicle **100** includes a frame assembly generally indicated as **102** and a corrugated liner generally indicated as **104**. Corrugated liner **104** includes a top sheet **106**, a bottom sheet **108**, and a corrugated or sinusoidal ply **110** extending therebetween. Top sheets **106** and **108** are adhered or attached to corrugated ply **110**. Typically, the corrugated material is polyethylene.

In the recreational vehicle (RV) industry, it is common place to apply a liner beneath the frame to protect the underbody of the vehicle and any parts, plumbing, and/or electrical items that may be beneath the floor of the vehicle. Such a liner can also be referred to as a belly liner. Currently known in-use liners are shown in prior art FIGS. 3 and 4. Typically, the liner material is a corrugated plastic (polyethylene) material. The liner material consists of a top sheet, a bottom sheet, and a spacer extending there between. The spacer has a corrugated or sinusoidal configuration to which the top and bottom sheets are mounted (see Prior Art FIG. 3).

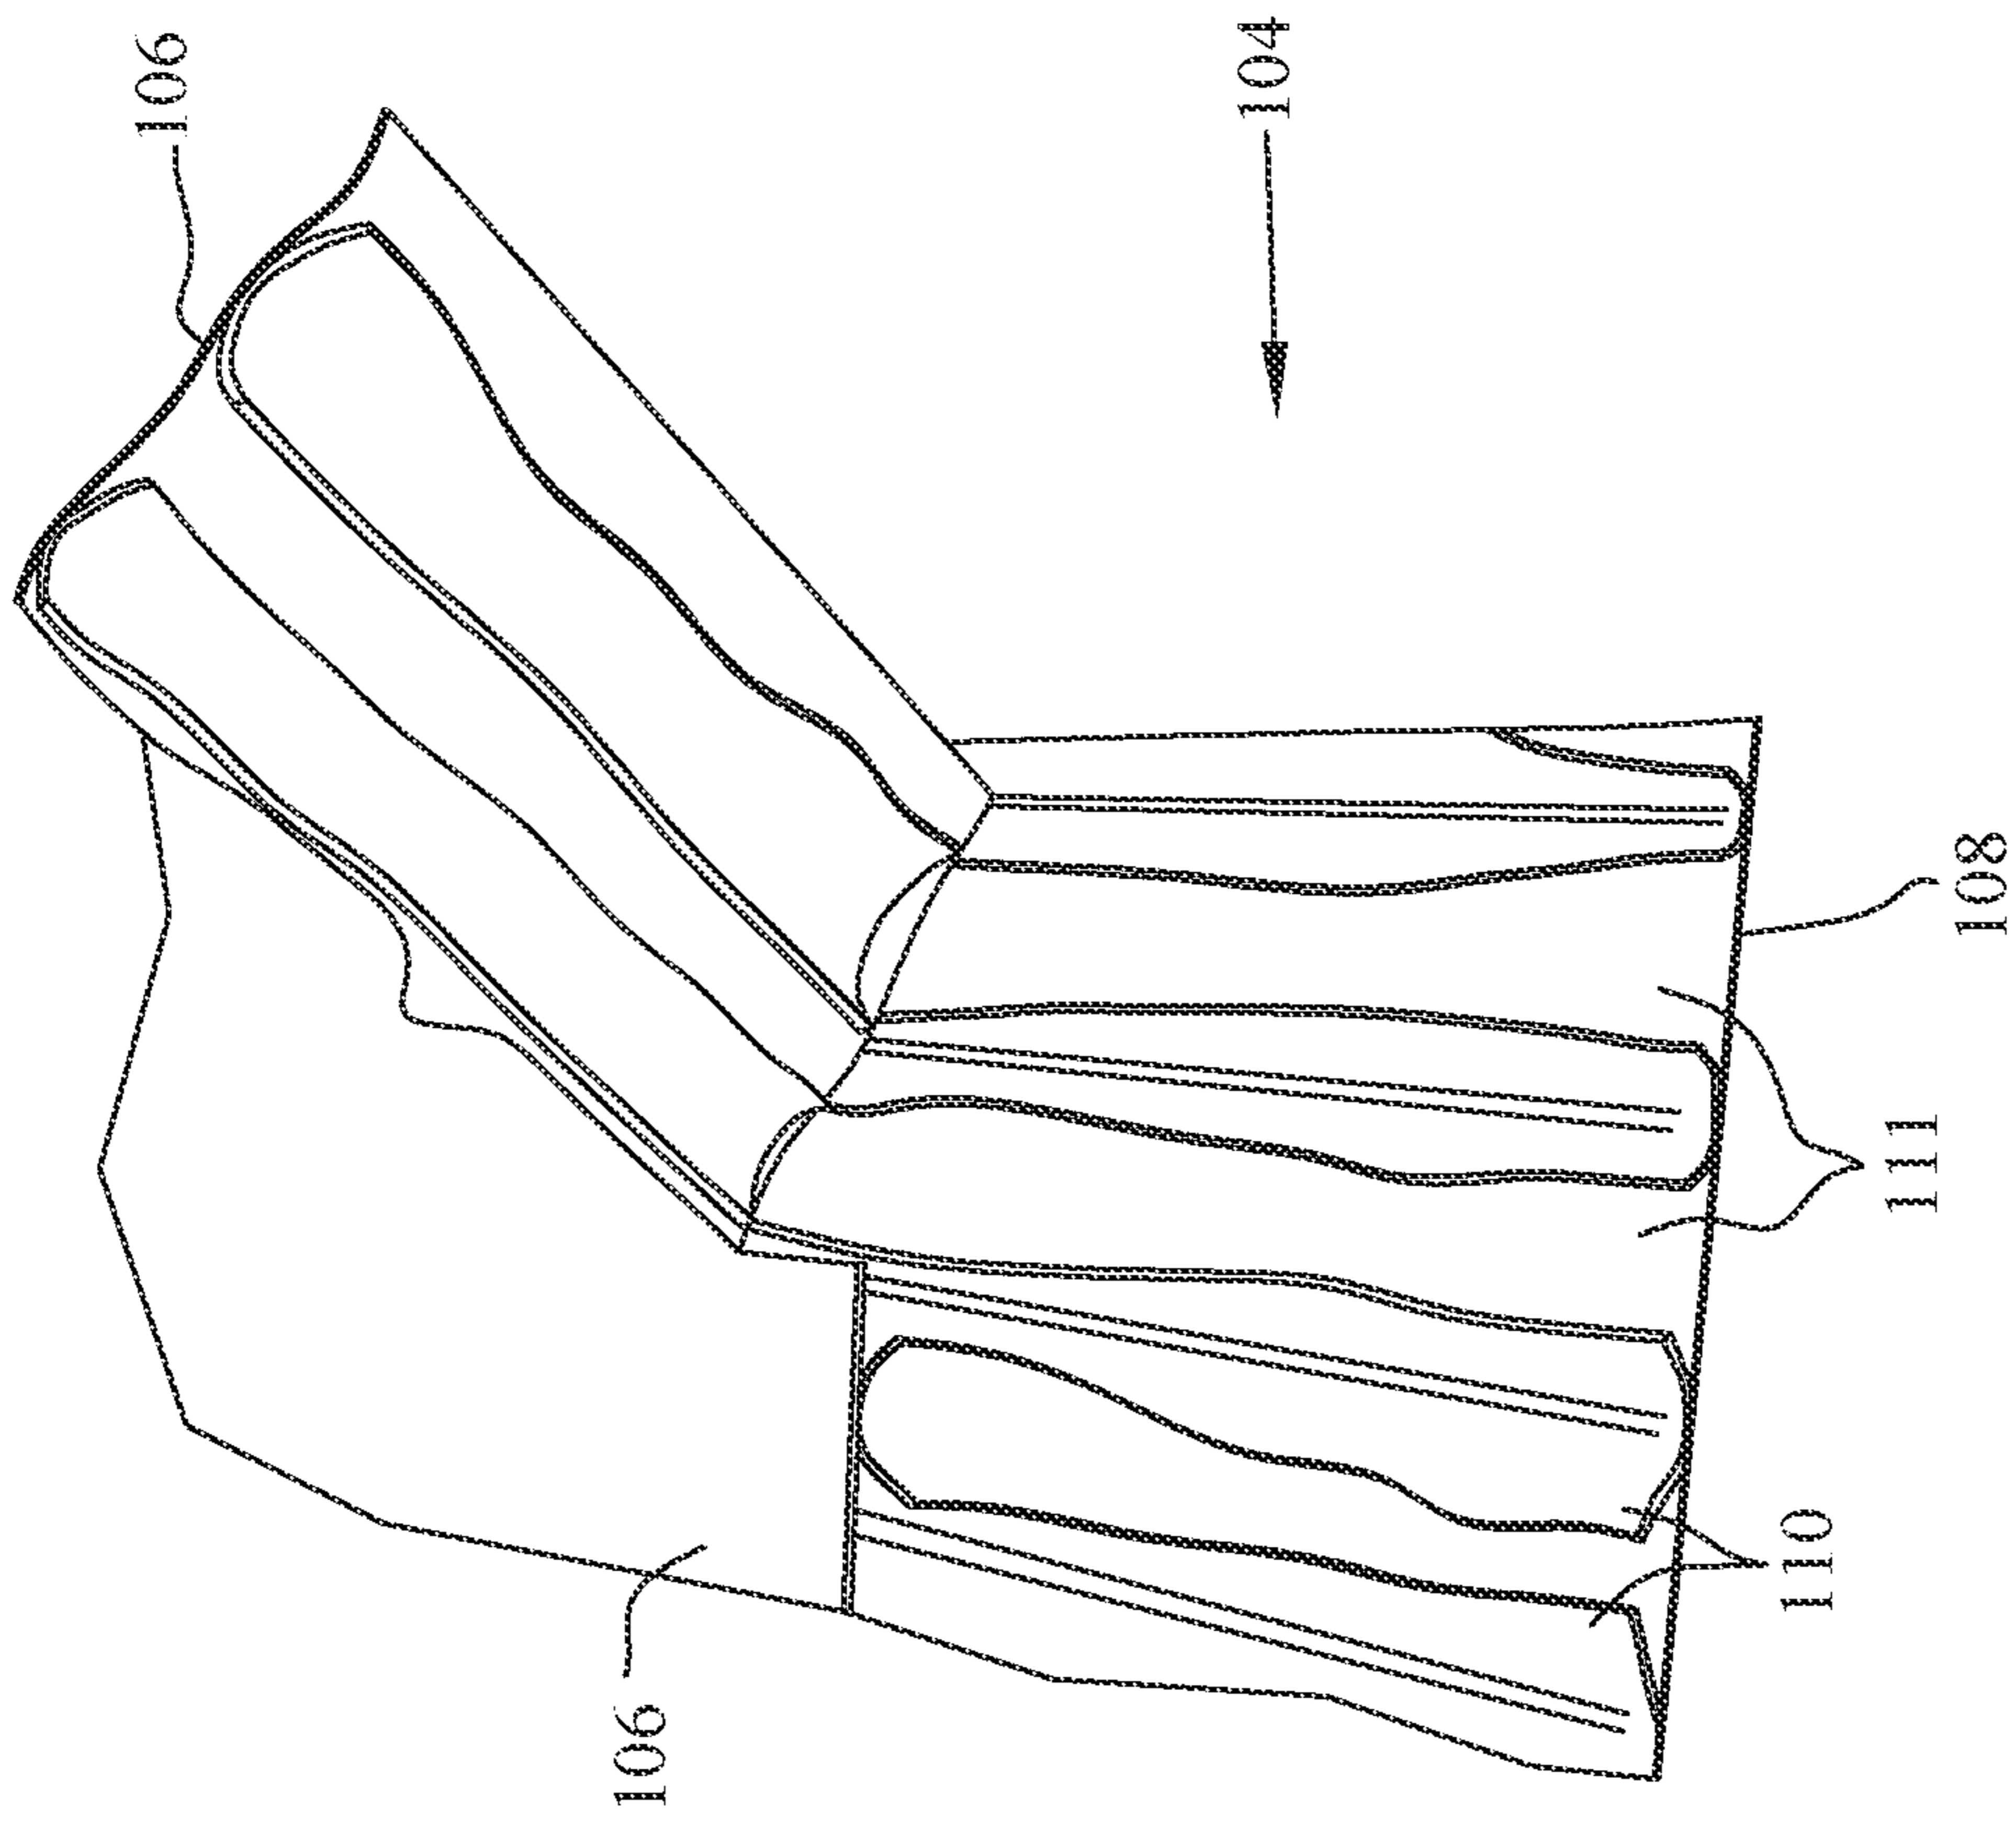
FIG. 3A
(PRIOR ART)

FIG. 3A is an enlarged perspective view of the frame liner in FIG. 3 showing the top layer partially peeled back and channels therein.

Referring to FIG. 3A, a portion of the corrugated liner **104** is shown removed from recreational vehicle **100**. In FIG. 3A, a portion of the top sheet **106** has been pulled back revealing channels **111** that extend between top sheet **106** and bottom sheet **108** and along/within the sinusoidal ply **110**. As should be appreciated, a problem, with the prior art liner is that any water or moisture entering the open ends of the corrugated liner **104** easily crosses through channels **111** so that channels **111** can become filled with water. The water can leak or freezing of the water may cause ripping, tearing or pulling apart of corrugated liner **104**, thereby destroying its structural integrity.

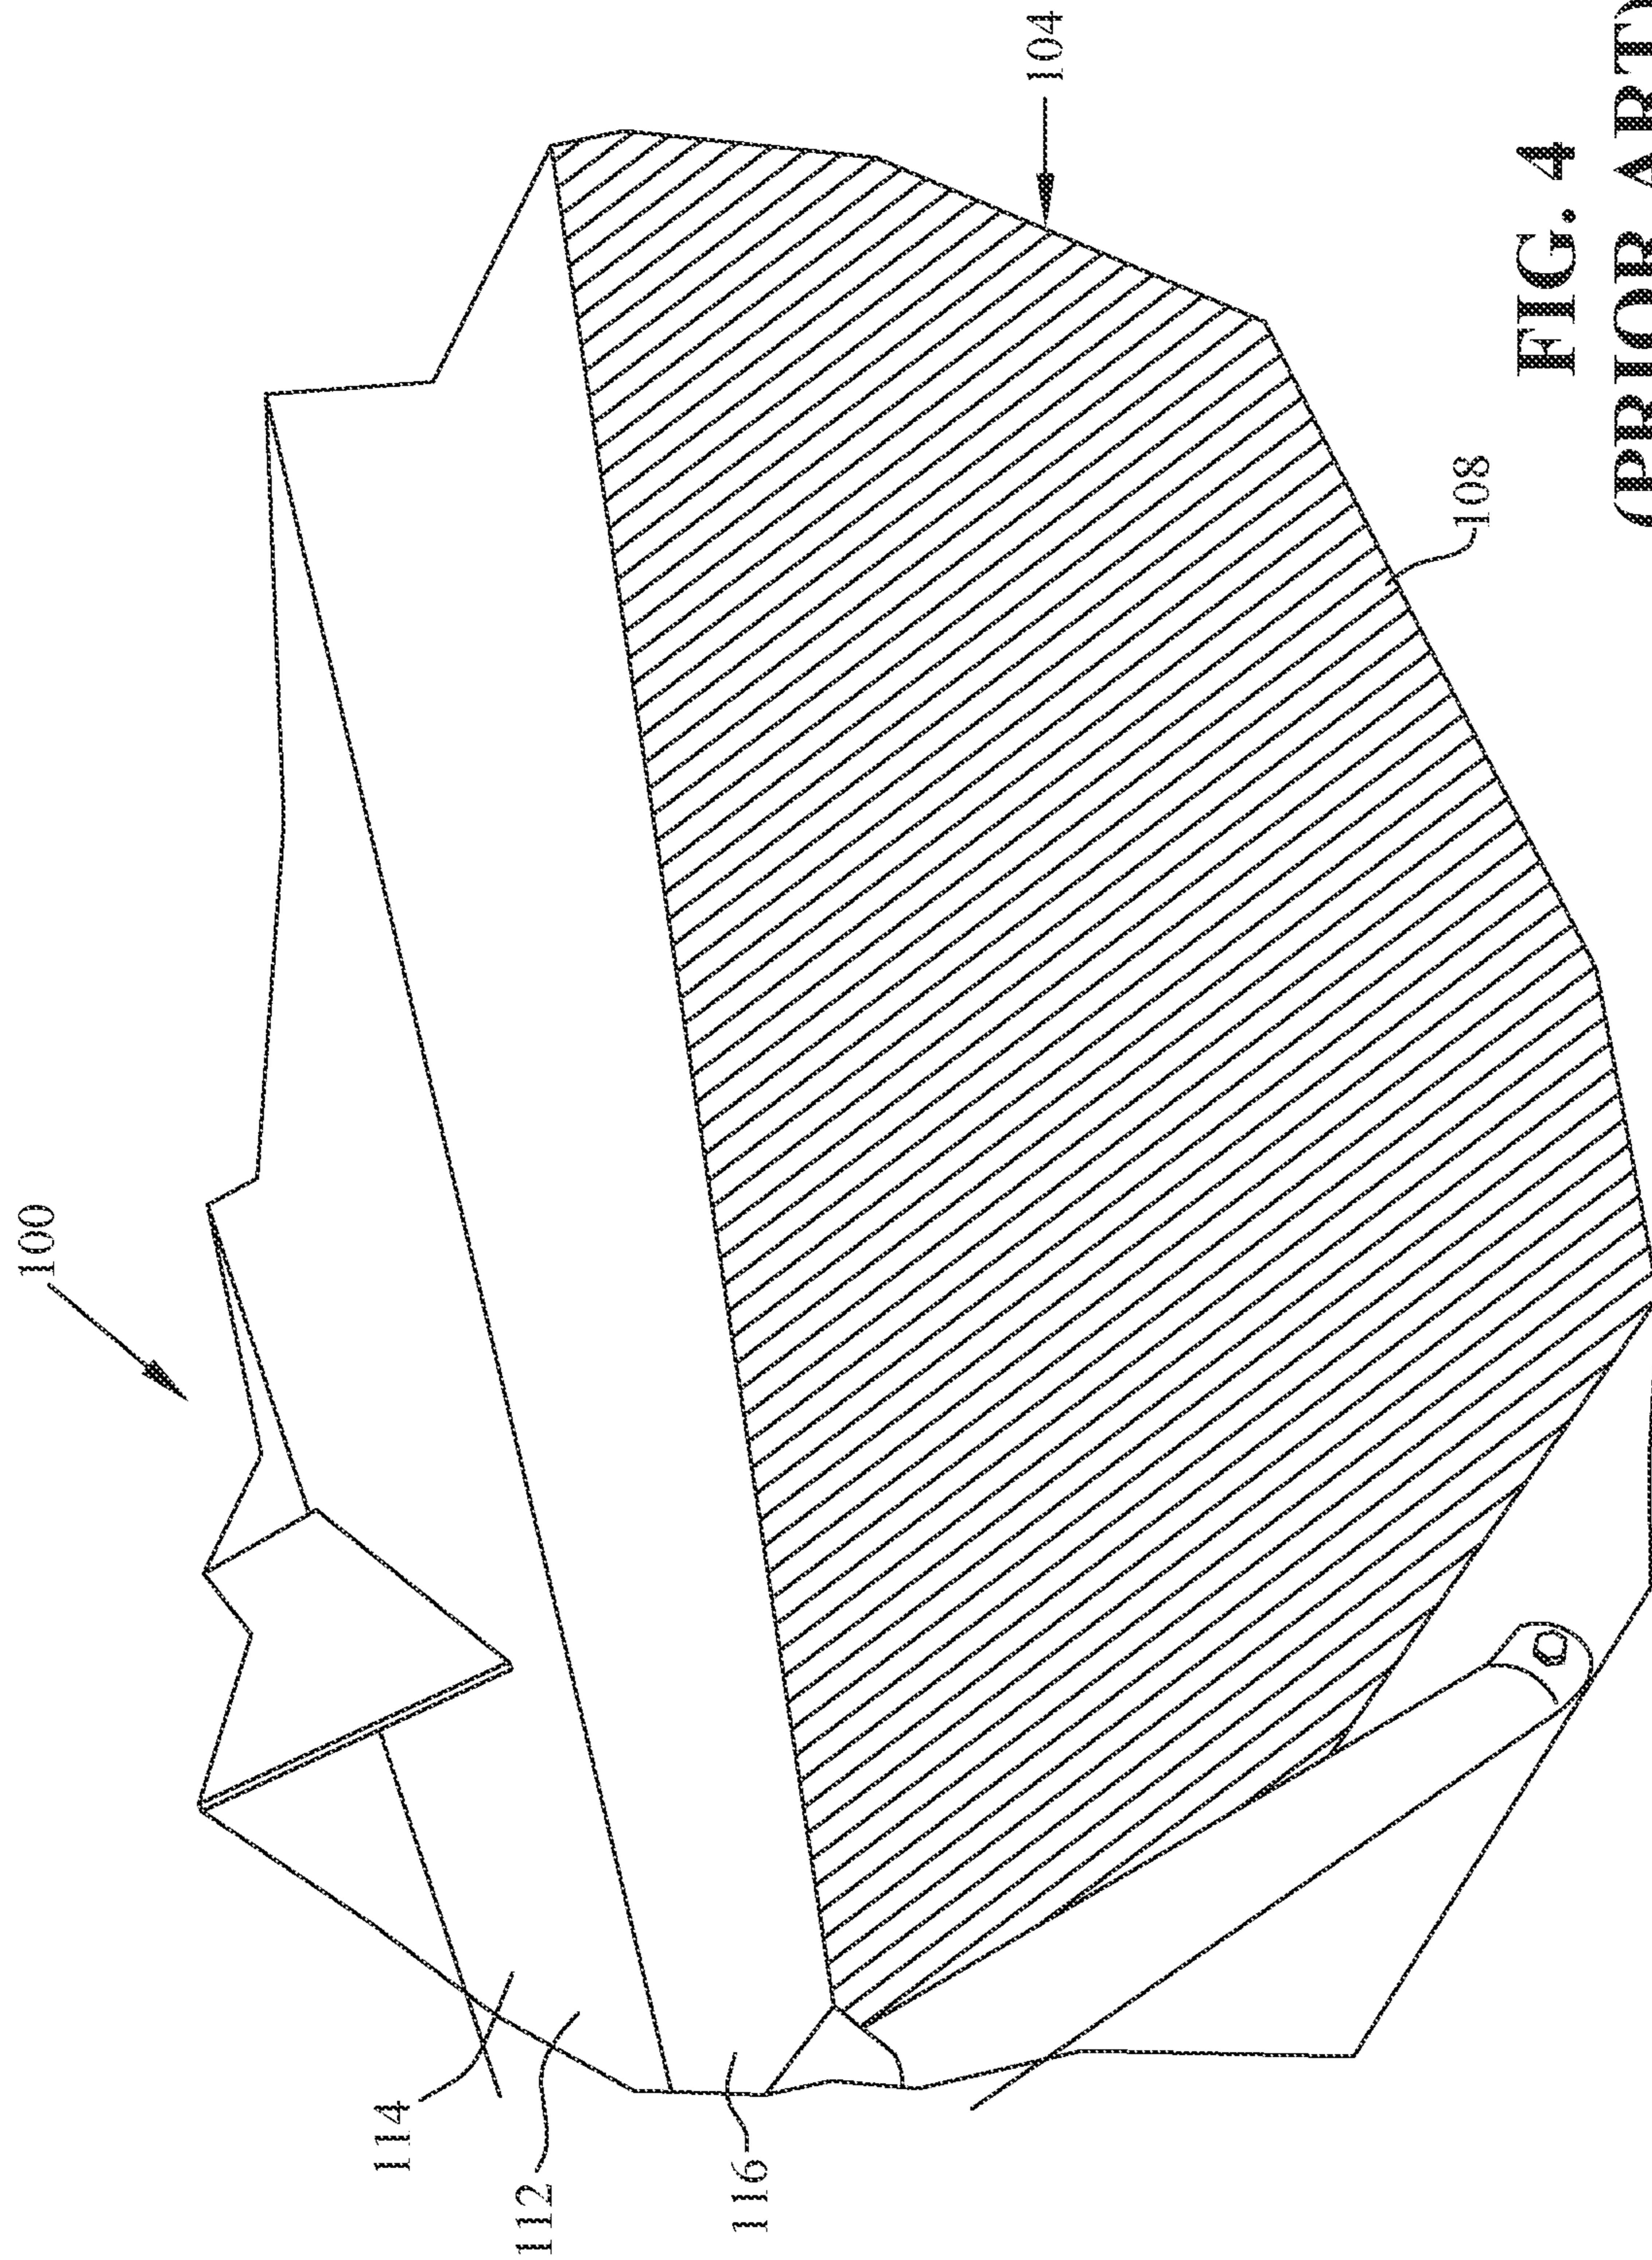
FIG. 4
(PRIOR ART)

FIG. 4 is a bottom prospective view of a prior art recreational vehicle and frame liner;

Referring to FIG. 4, only the bottom sheet **108** of corrugated liner **104** is visible. Furthermore, the corrugations are not visible as recreational vehicle **100** includes a frame

member **112**, such as in I-beam or C-channel including a vertical web **112** and horizontal flange **116**. Side edges of corrugated liner **104** are located on top of flange **112**.

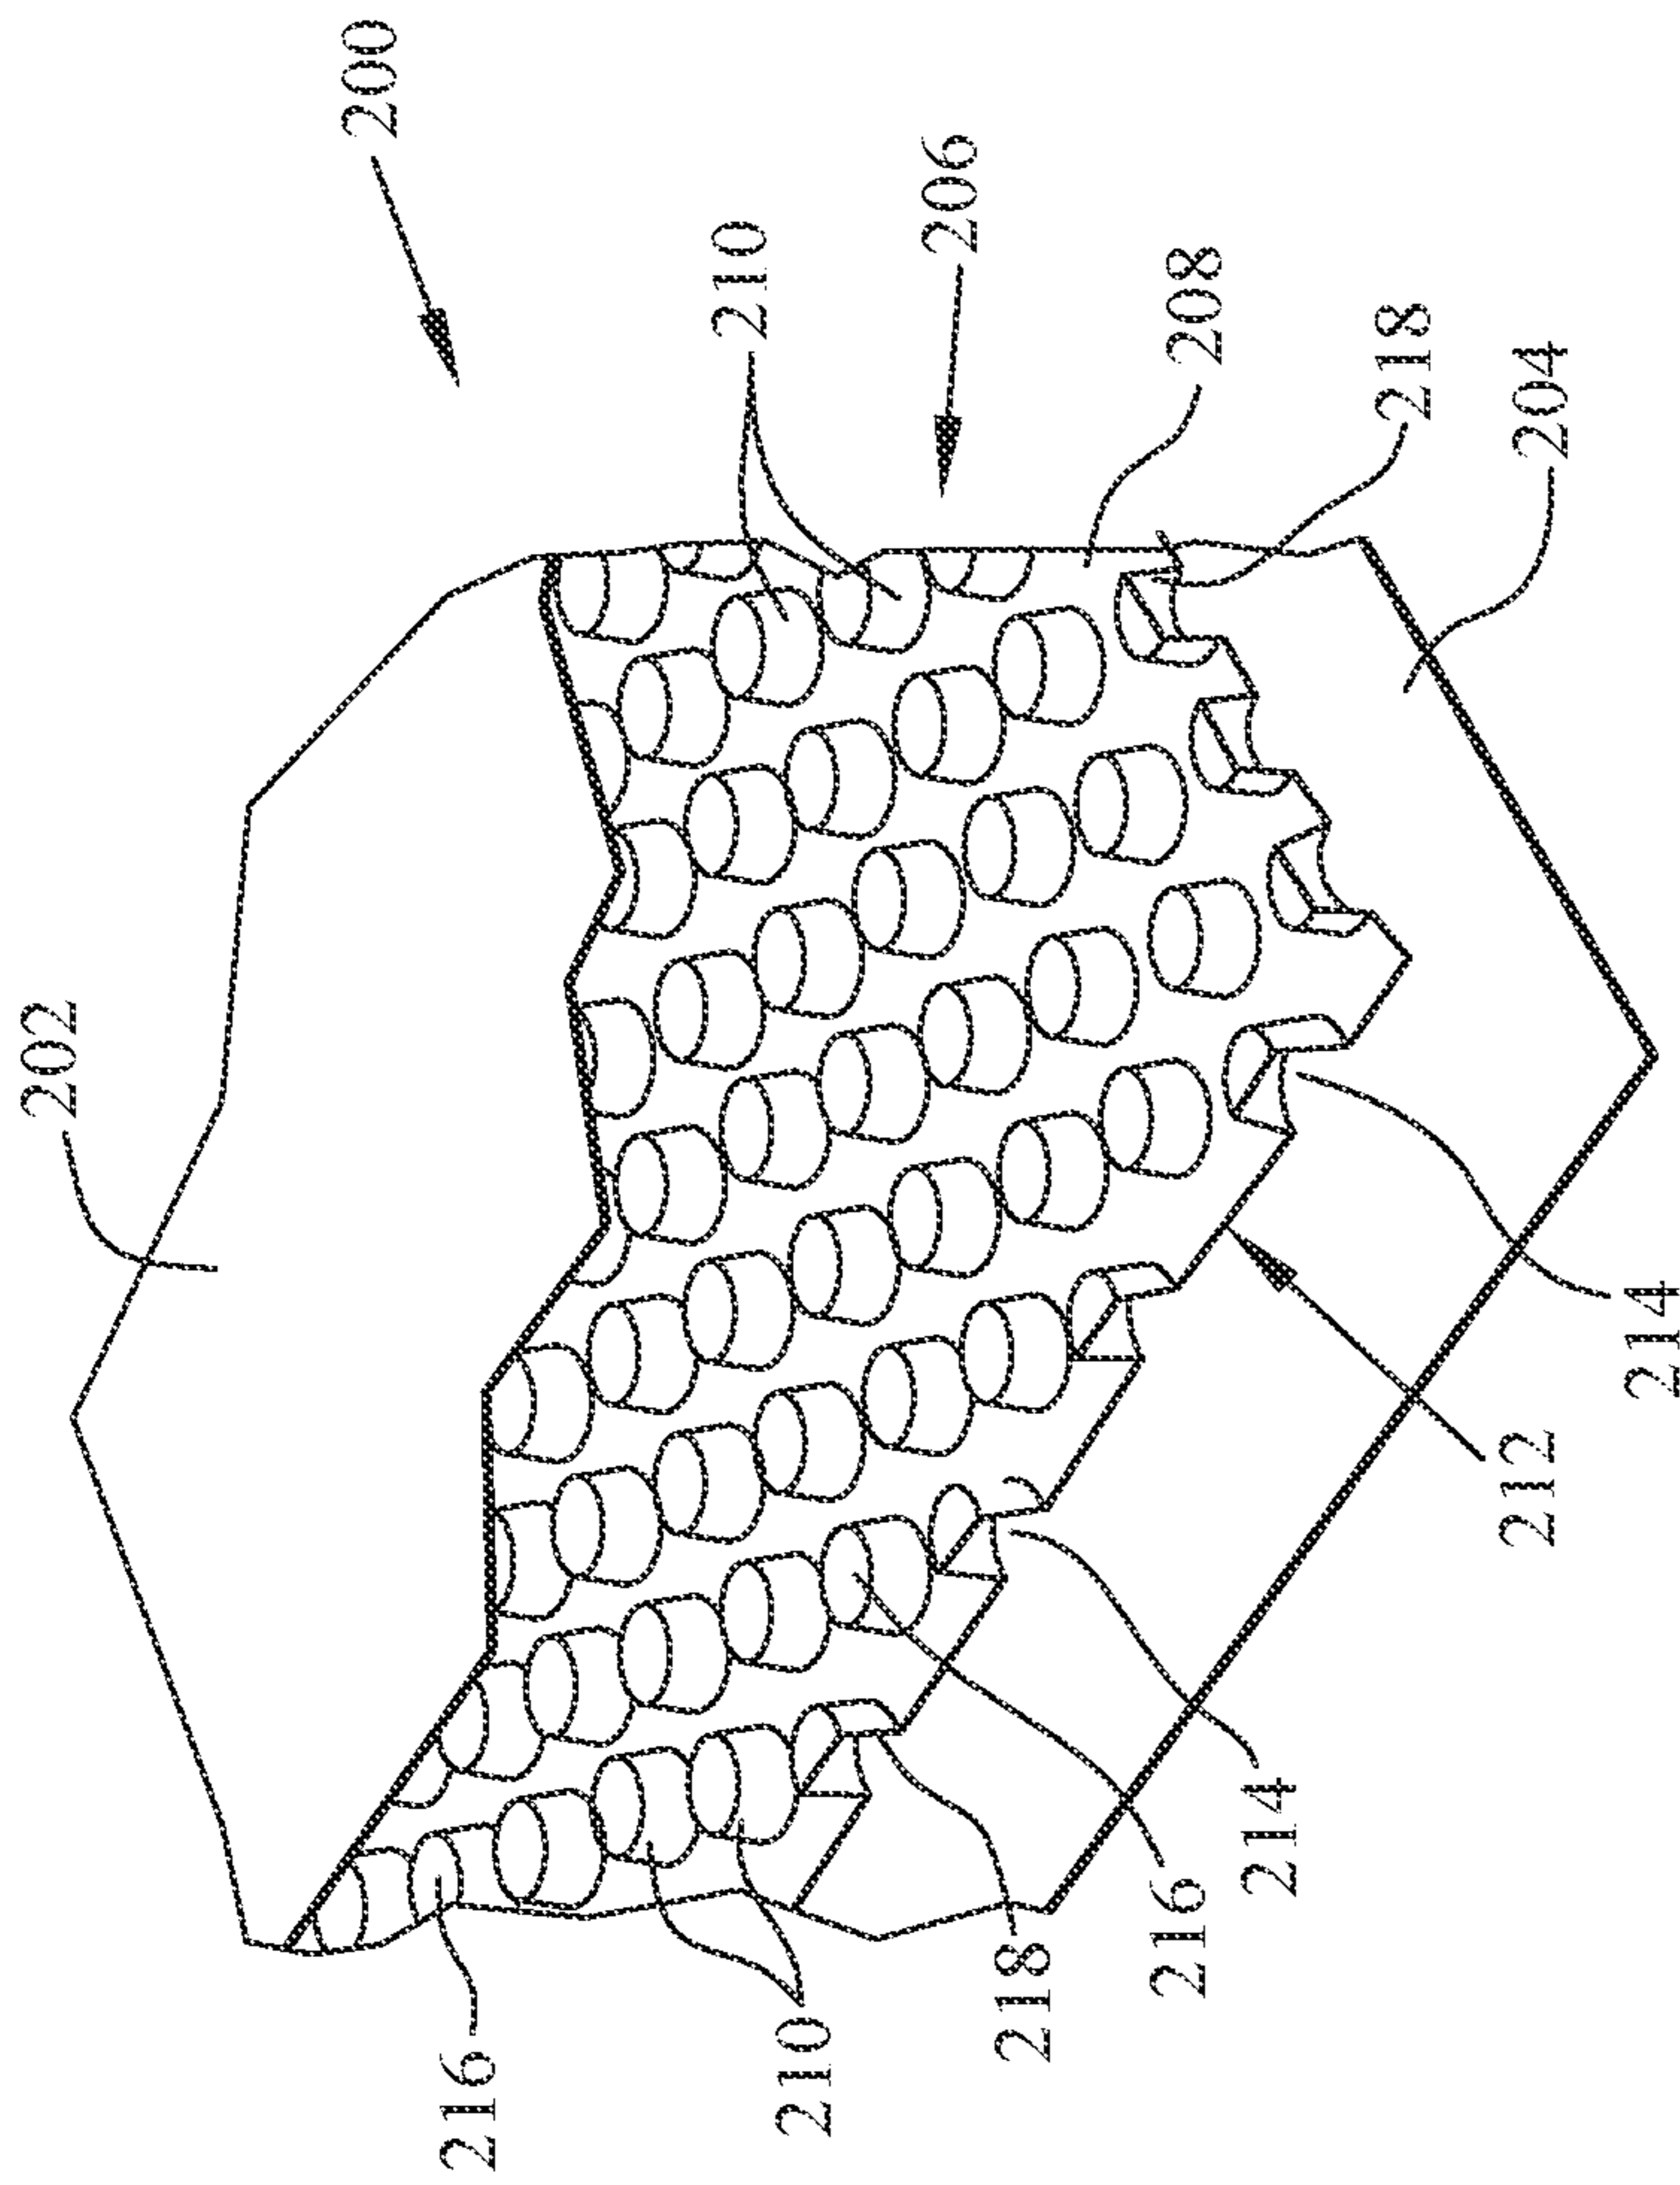
FIG. 5 is an exploded view of a sandwich material from which one embodiment of the liner for the subject invention is taken from;

Referring now to FIG. 5, an embodiment of a 3-ply panel from which the subject liner can be taken is generally indicated as **200**. 3-ply panel **200** includes a top sheet **202**, a bottom sheet **204**, and a core generally indicated as **206**. In a preferred embodiment, 3-ply panel **200** and core **206** is manufactured from polypropylene and is 100% recyclable. Core **206** may also be referred to as plastic honeycomb or plastic bubble board. 3-ply panel **200** may be provided in thicknesses of 10 mm, 5 mm or 3 mm. Applicant has found that the core **206** in a 3 mm thick 3-ply panel **200** is particularly suitable for use as a liner in accordance with the subject invention as will be discussed in further detail below. As can be seen in FIG. 5, core **206** has one face **208** having projections **210** extending upward therefrom. The opposite face **212** includes openings **214** extending downward into projections **212**. Accordingly, projections **210** have a generally cylindrical configuration being hollow in the center thereof and including an end face **216** and side walls **218**. Applicant has determined that one suitable 3-ply panel **200** from which core **206** may be extracted and used is IntePro® 3 mm Titan board from the IntePlast Group.

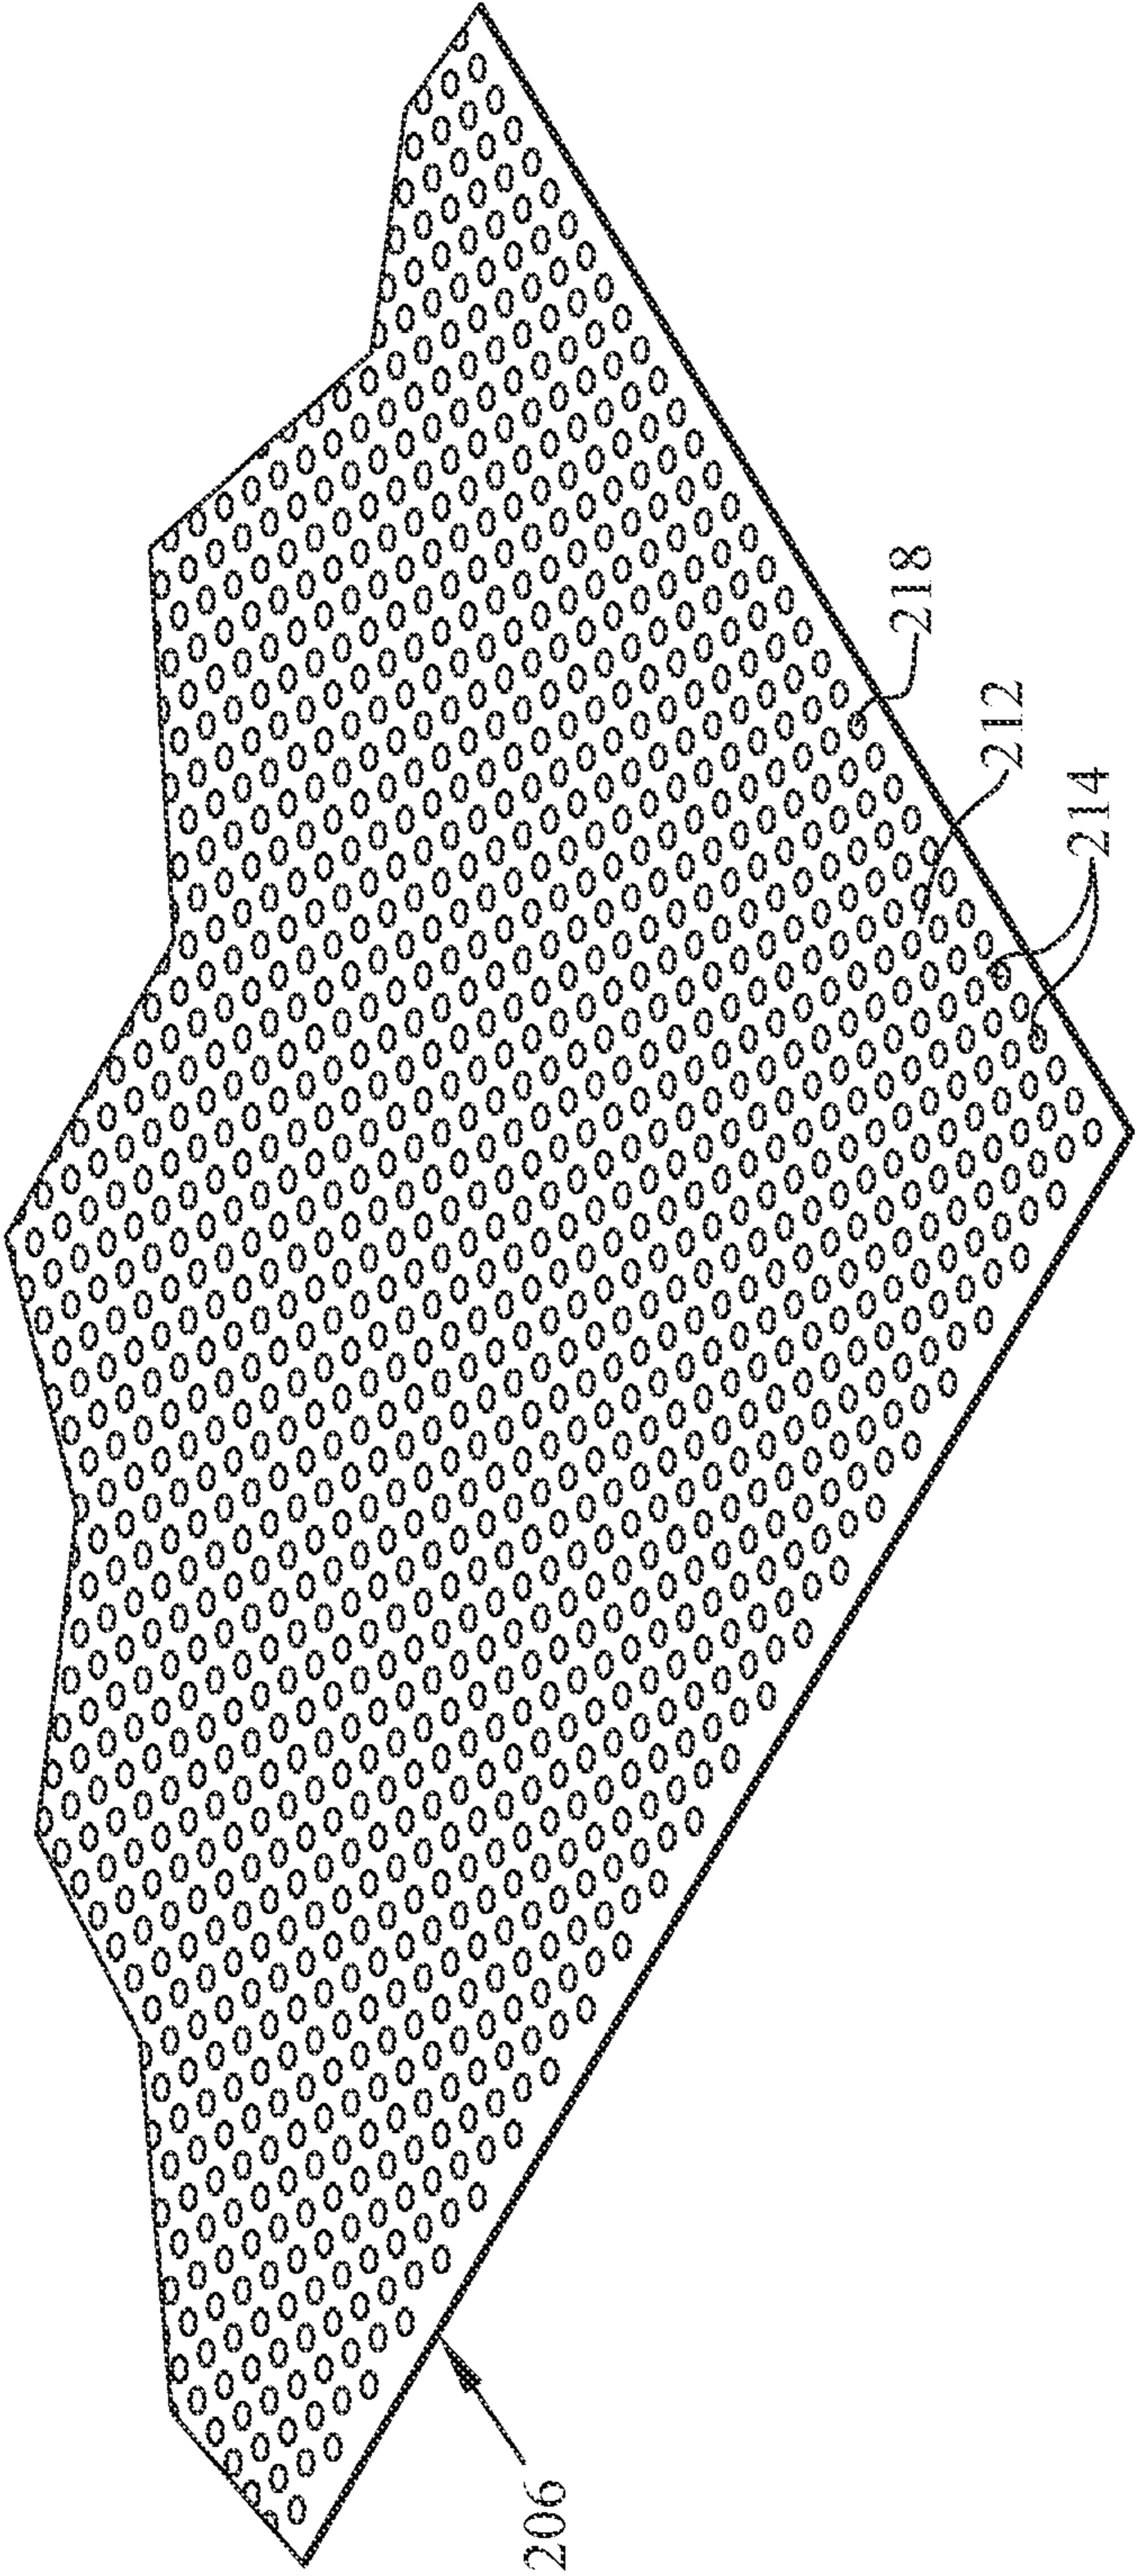
FIG. 6 is a perspective view of one embodiment of a vehicle frame liner and cargo bay liner of the subject invention, with top and bottom sheets removed, showing a face of the liner having openings therein;

Referring now to FIGS. 6-11, further details, of vehicle frame and cargo area liner/core **206** are disclosed. As can be seen, the projections and/or openings **210**, **214**, respectively are aligned in a lengthwise direction of core **206** but going crosswise across core **206**, projections **210** and openings **214** are staggered.

In utilizing core **206** on recreational vehicle **10** and cargo trailer **40**, core **206** is preferably provided in a rolled configuration. It is then unrolled and attached to frame assembly **32** or **58** using threaded fasteners or other attachment means known in the art. Core **206** may be attached with either face **208** having projections **210** or face **212** having opening **214** exposed to the environment on the underside of the recreational vehicle or cargo trailer. Although, heretofore it has been considered that liners and belly liners should have two flat sheets on top and bottom thereof, applicant has conceived that core **206** will provide a suitable liner and provide sufficient rigidity and protect the undercarriage of its vehicle while allowing moisture to better escape.
