(12) **United States Patent**
Pennington

(54) **VEHICLE FRAME AND CARGO BAY LINER**

(71) Applicant: **PennPlastics, LLC**, Mishawaka, IN (US)

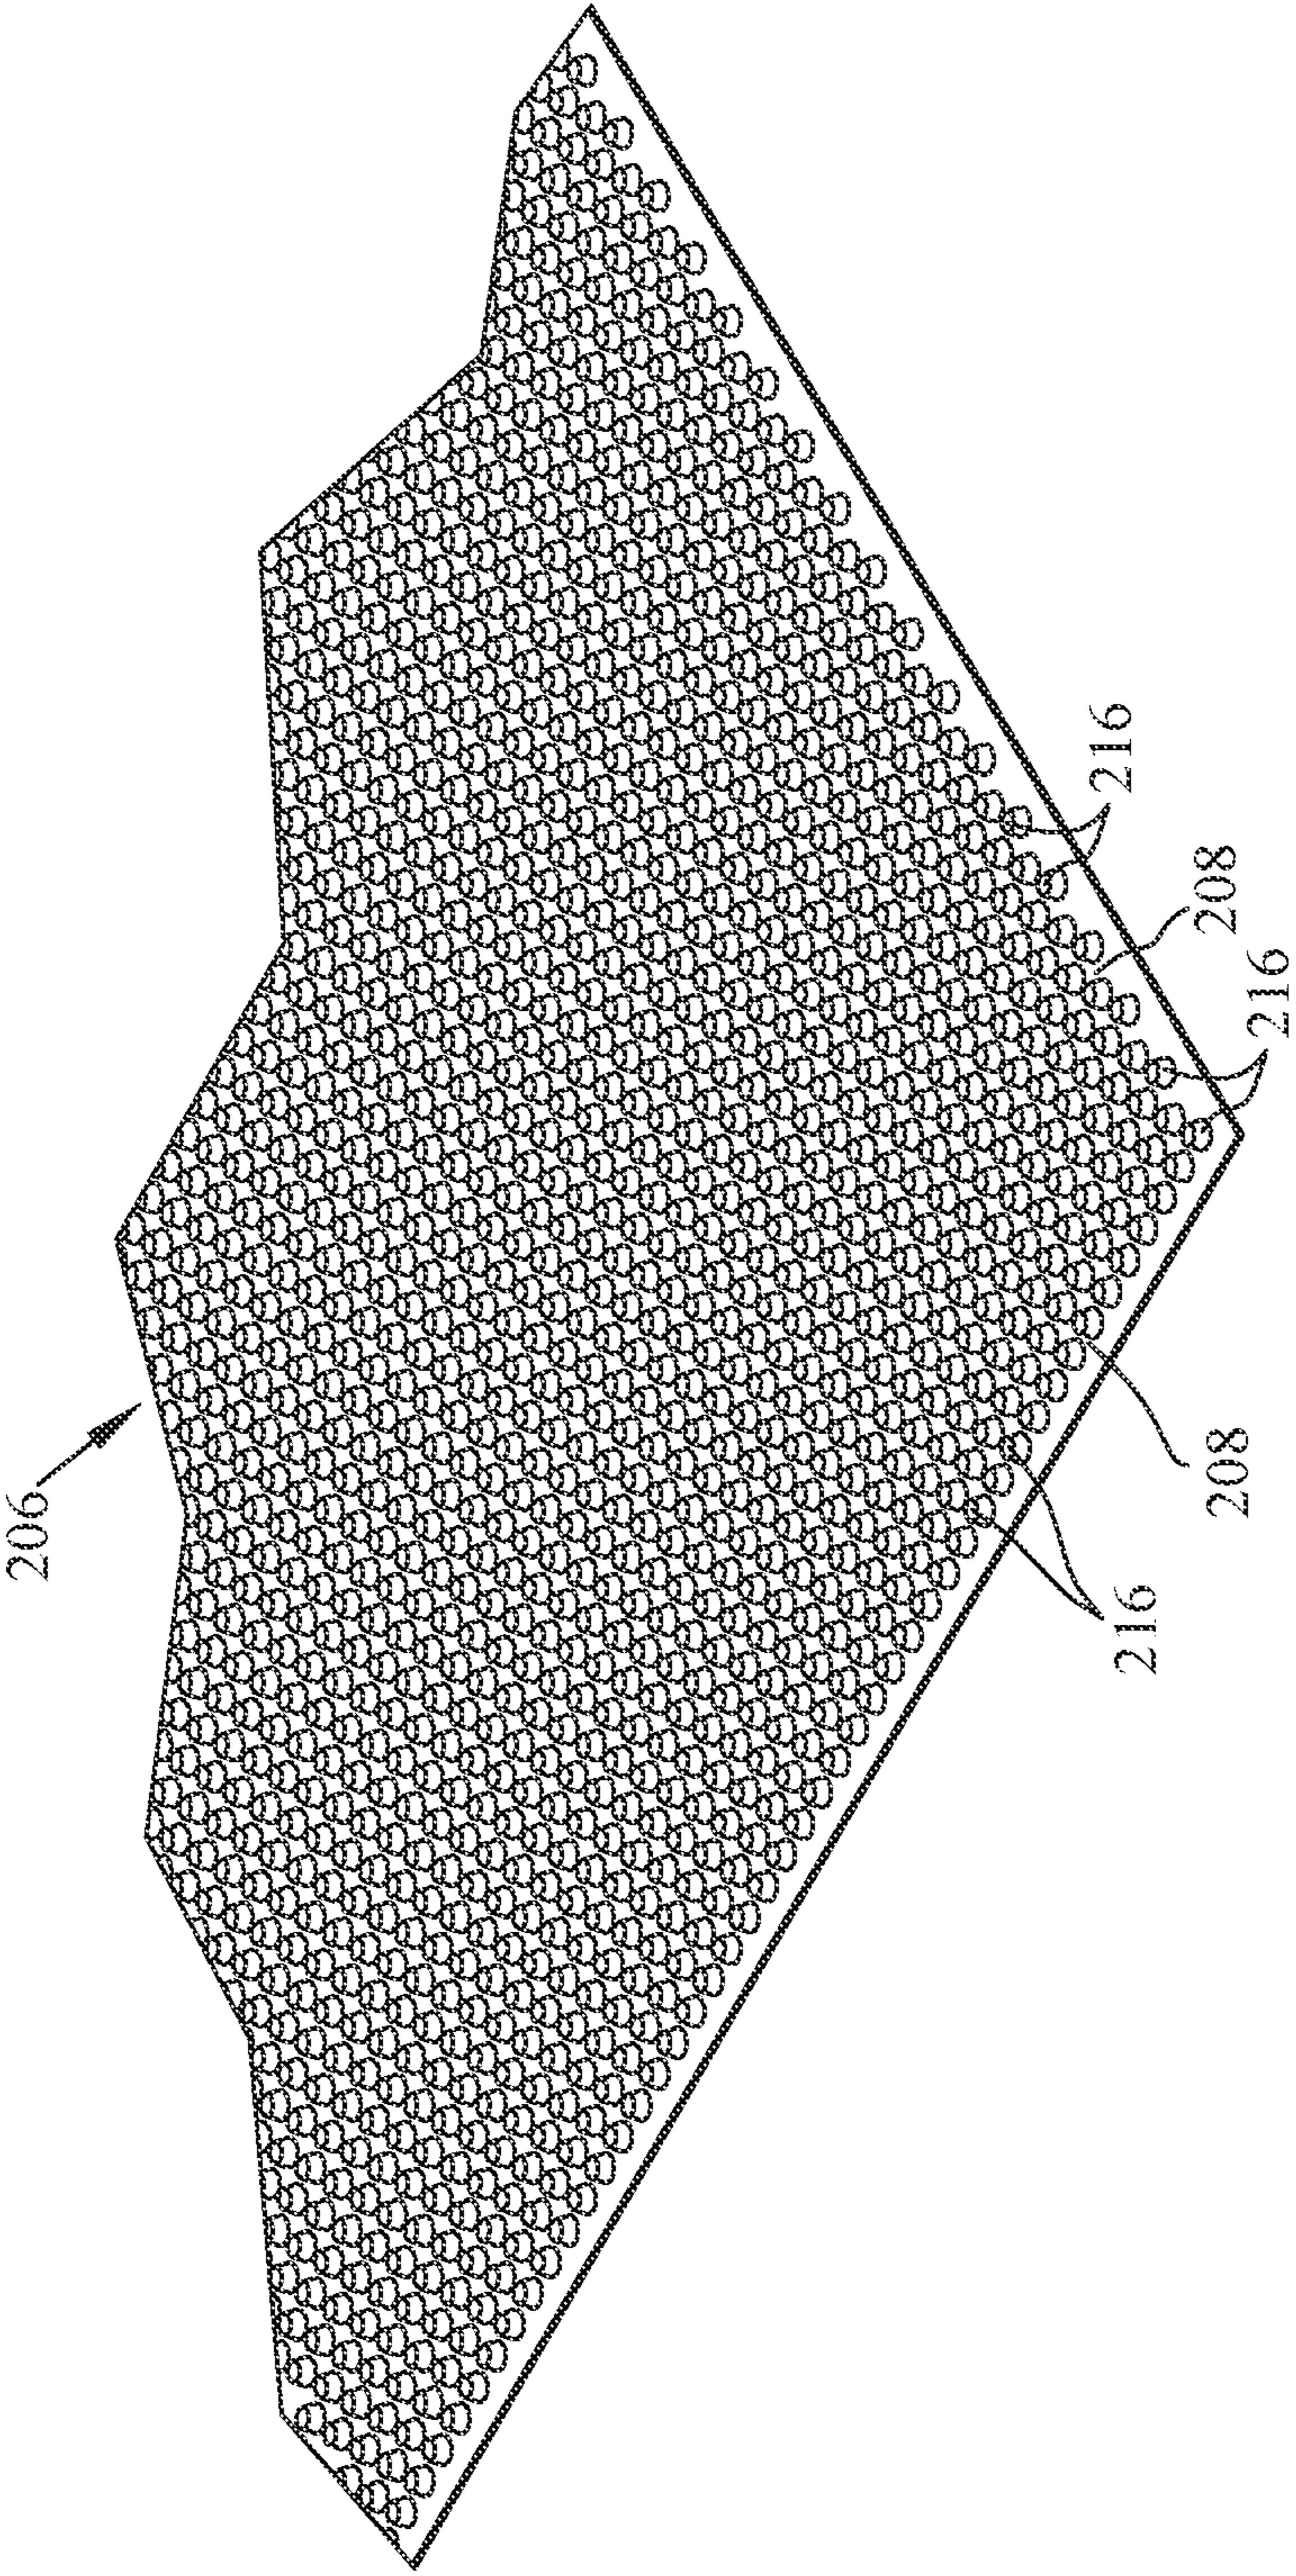
FIG. 7 is the vehicle frame and cargo bay liner of FIG. 6 showing an opposite face of the liner having projections extending therefrom;

Referring to FIG. 7, it can be appreciated that end faces **216** may have a variety of configurations including domed, flat, and/or convex.

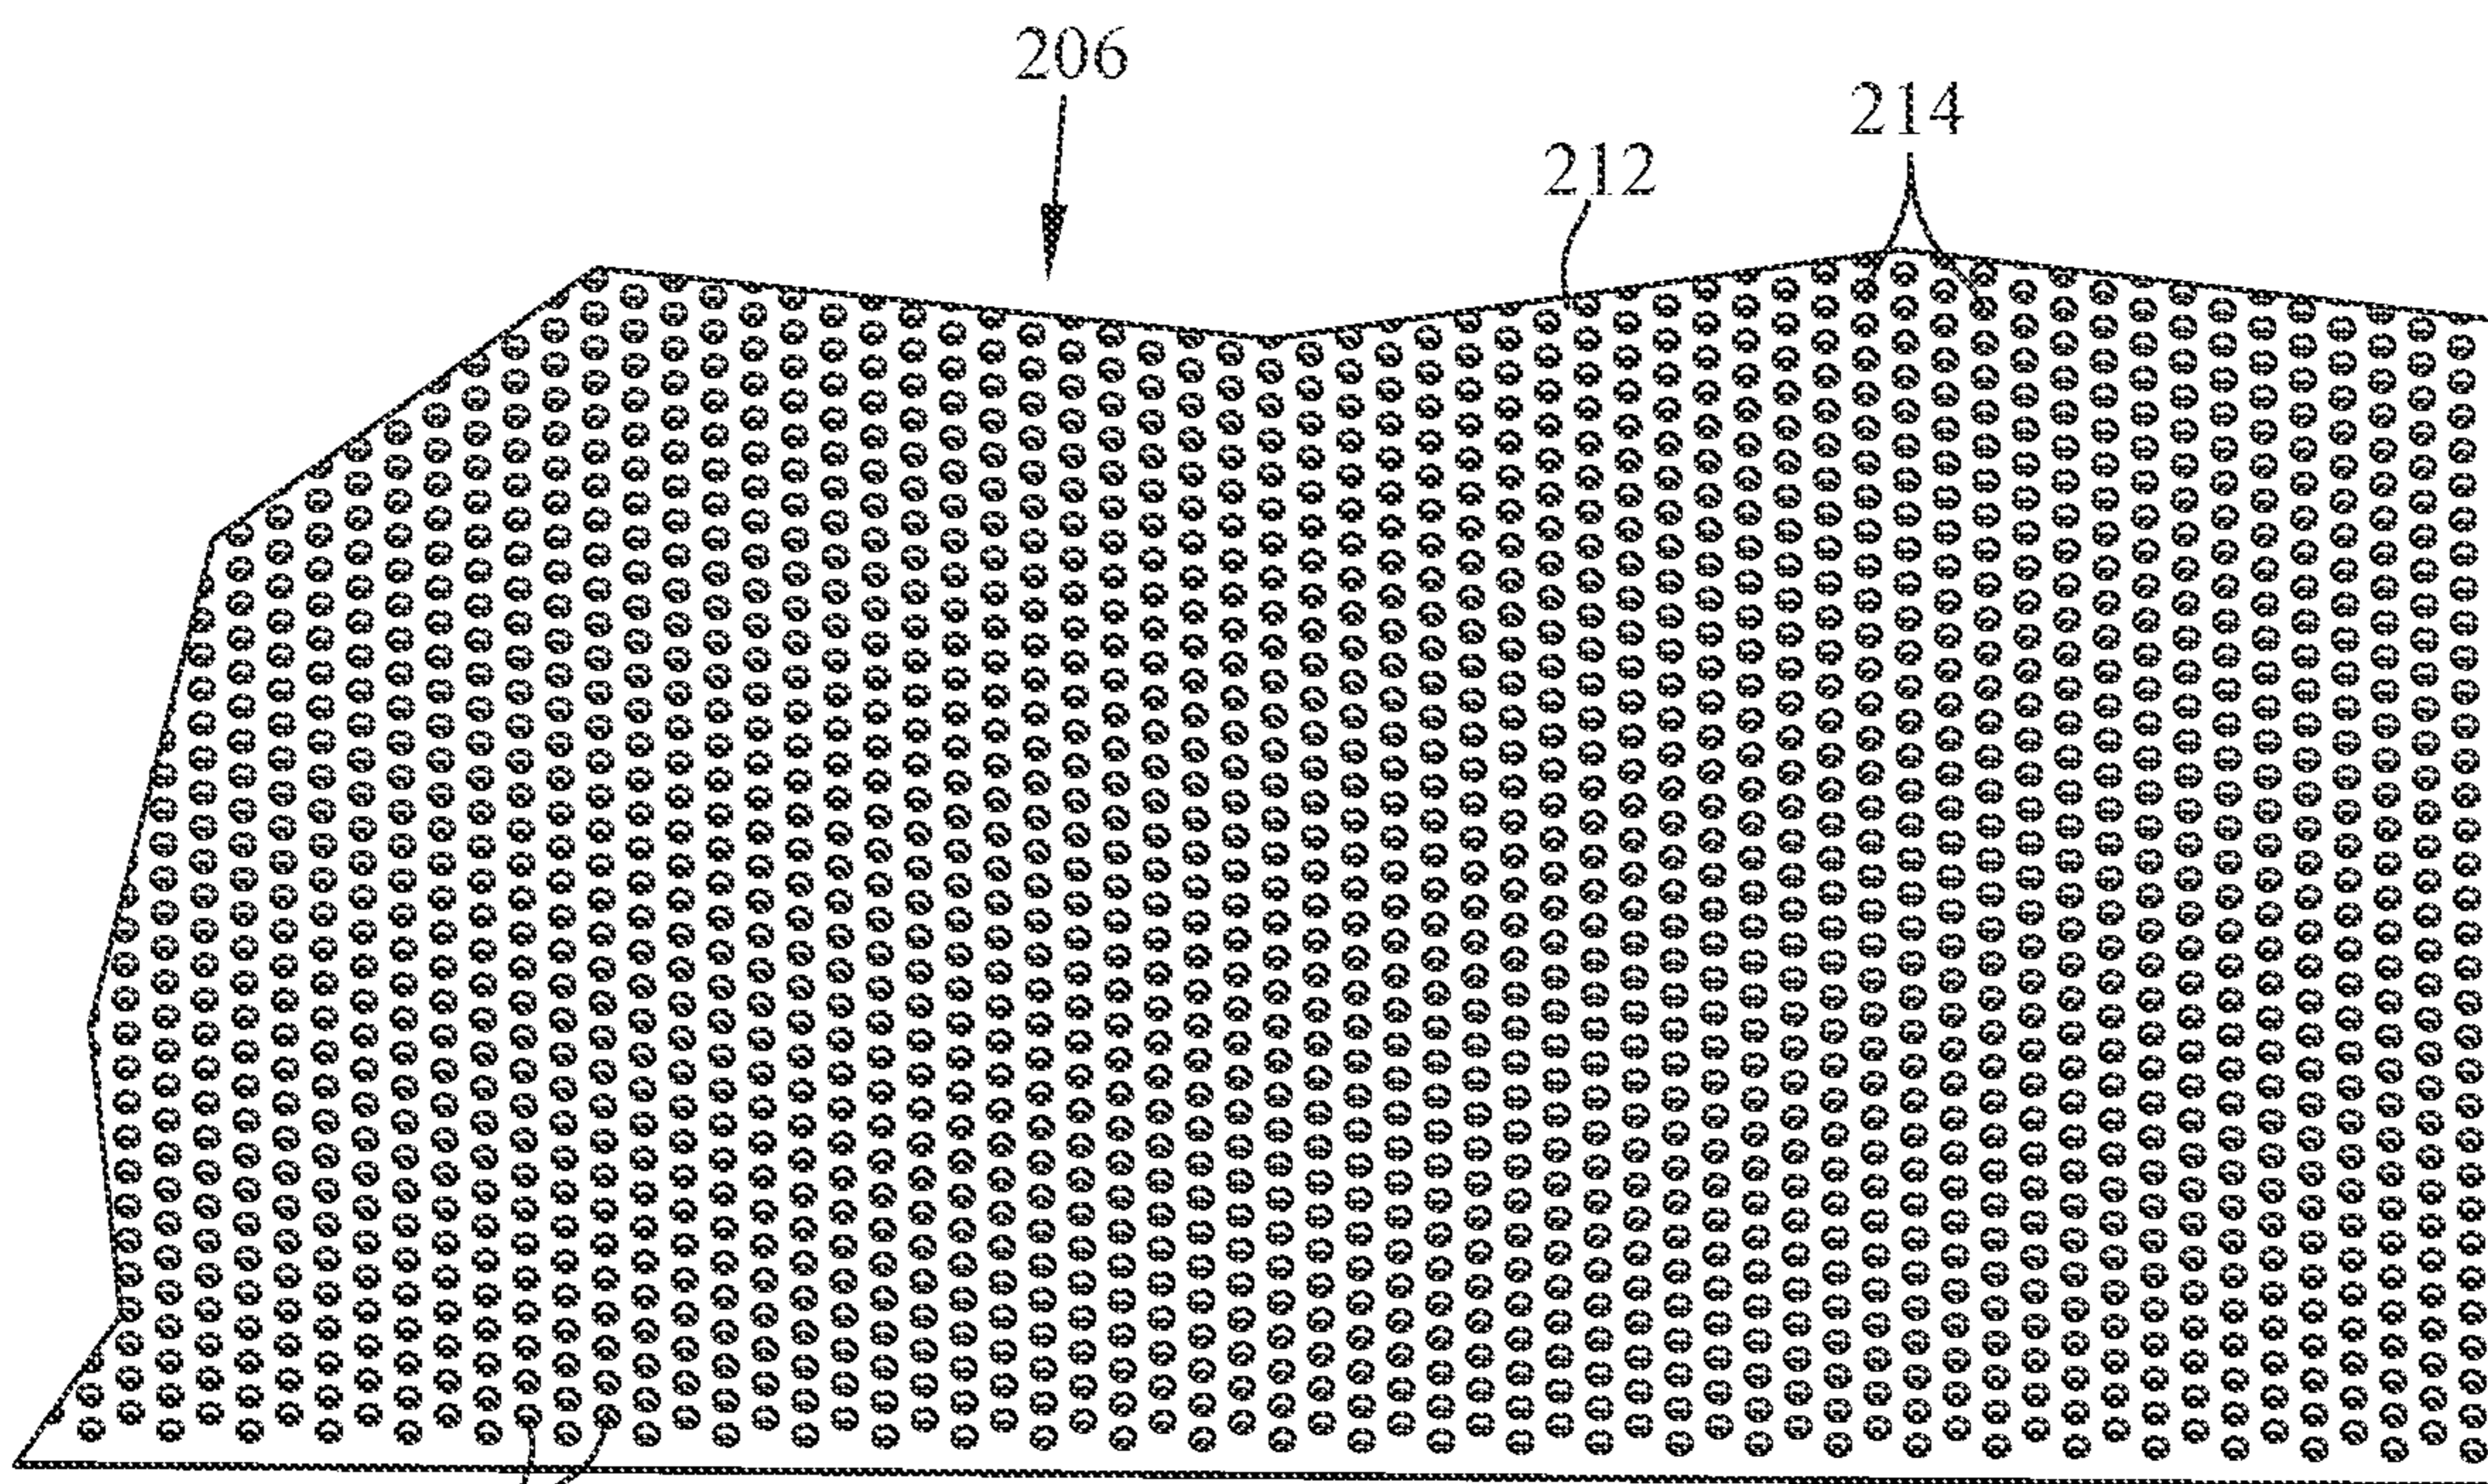
FIG. 8 is a plan view of the liner of FIG. 6 showing the face having openings;

Referring now to FIGS. 6-11, further details, of vehicle frame and cargo area liner/core **206** are disclosed. As can be seen, the projections and/or openings **210**, **214**, respectively are aligned in a lengthwise direction of core **206** but going crosswise across core **206**, projections **210** and openings **214** are staggered.

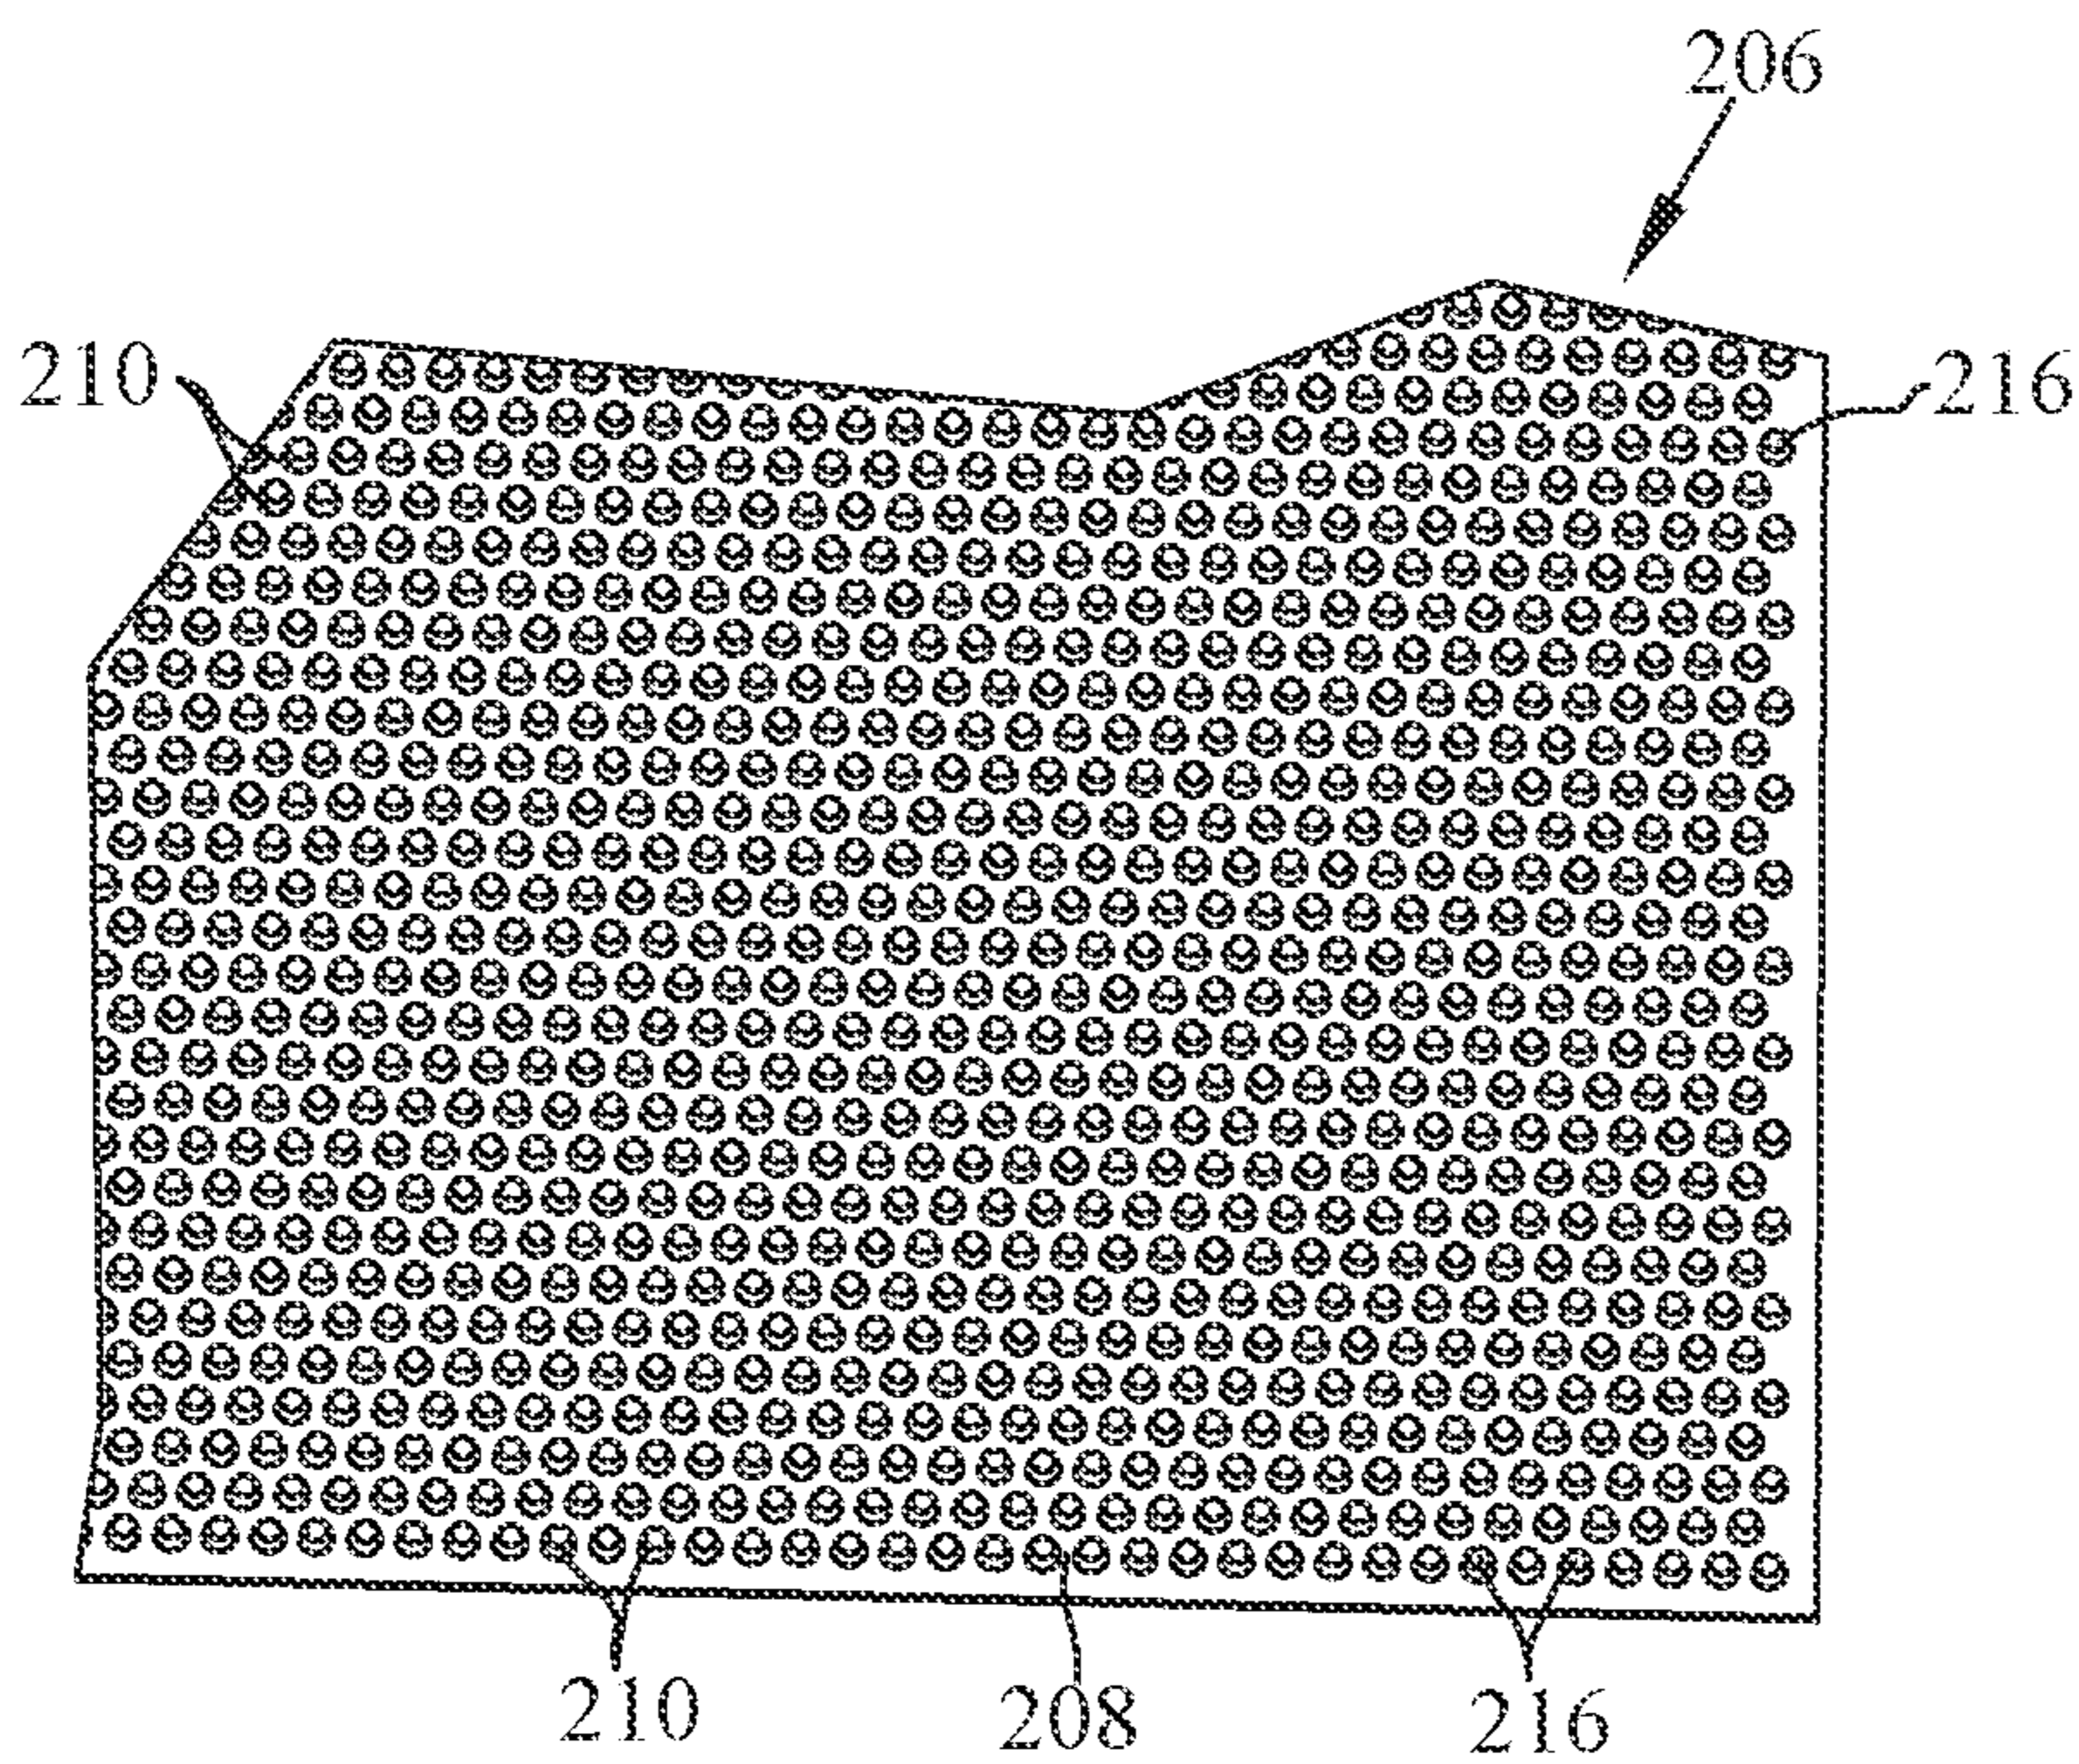
FIG. 9 is a plan view of the liner of FIG. 6 showing the face having projections extending therefrom;

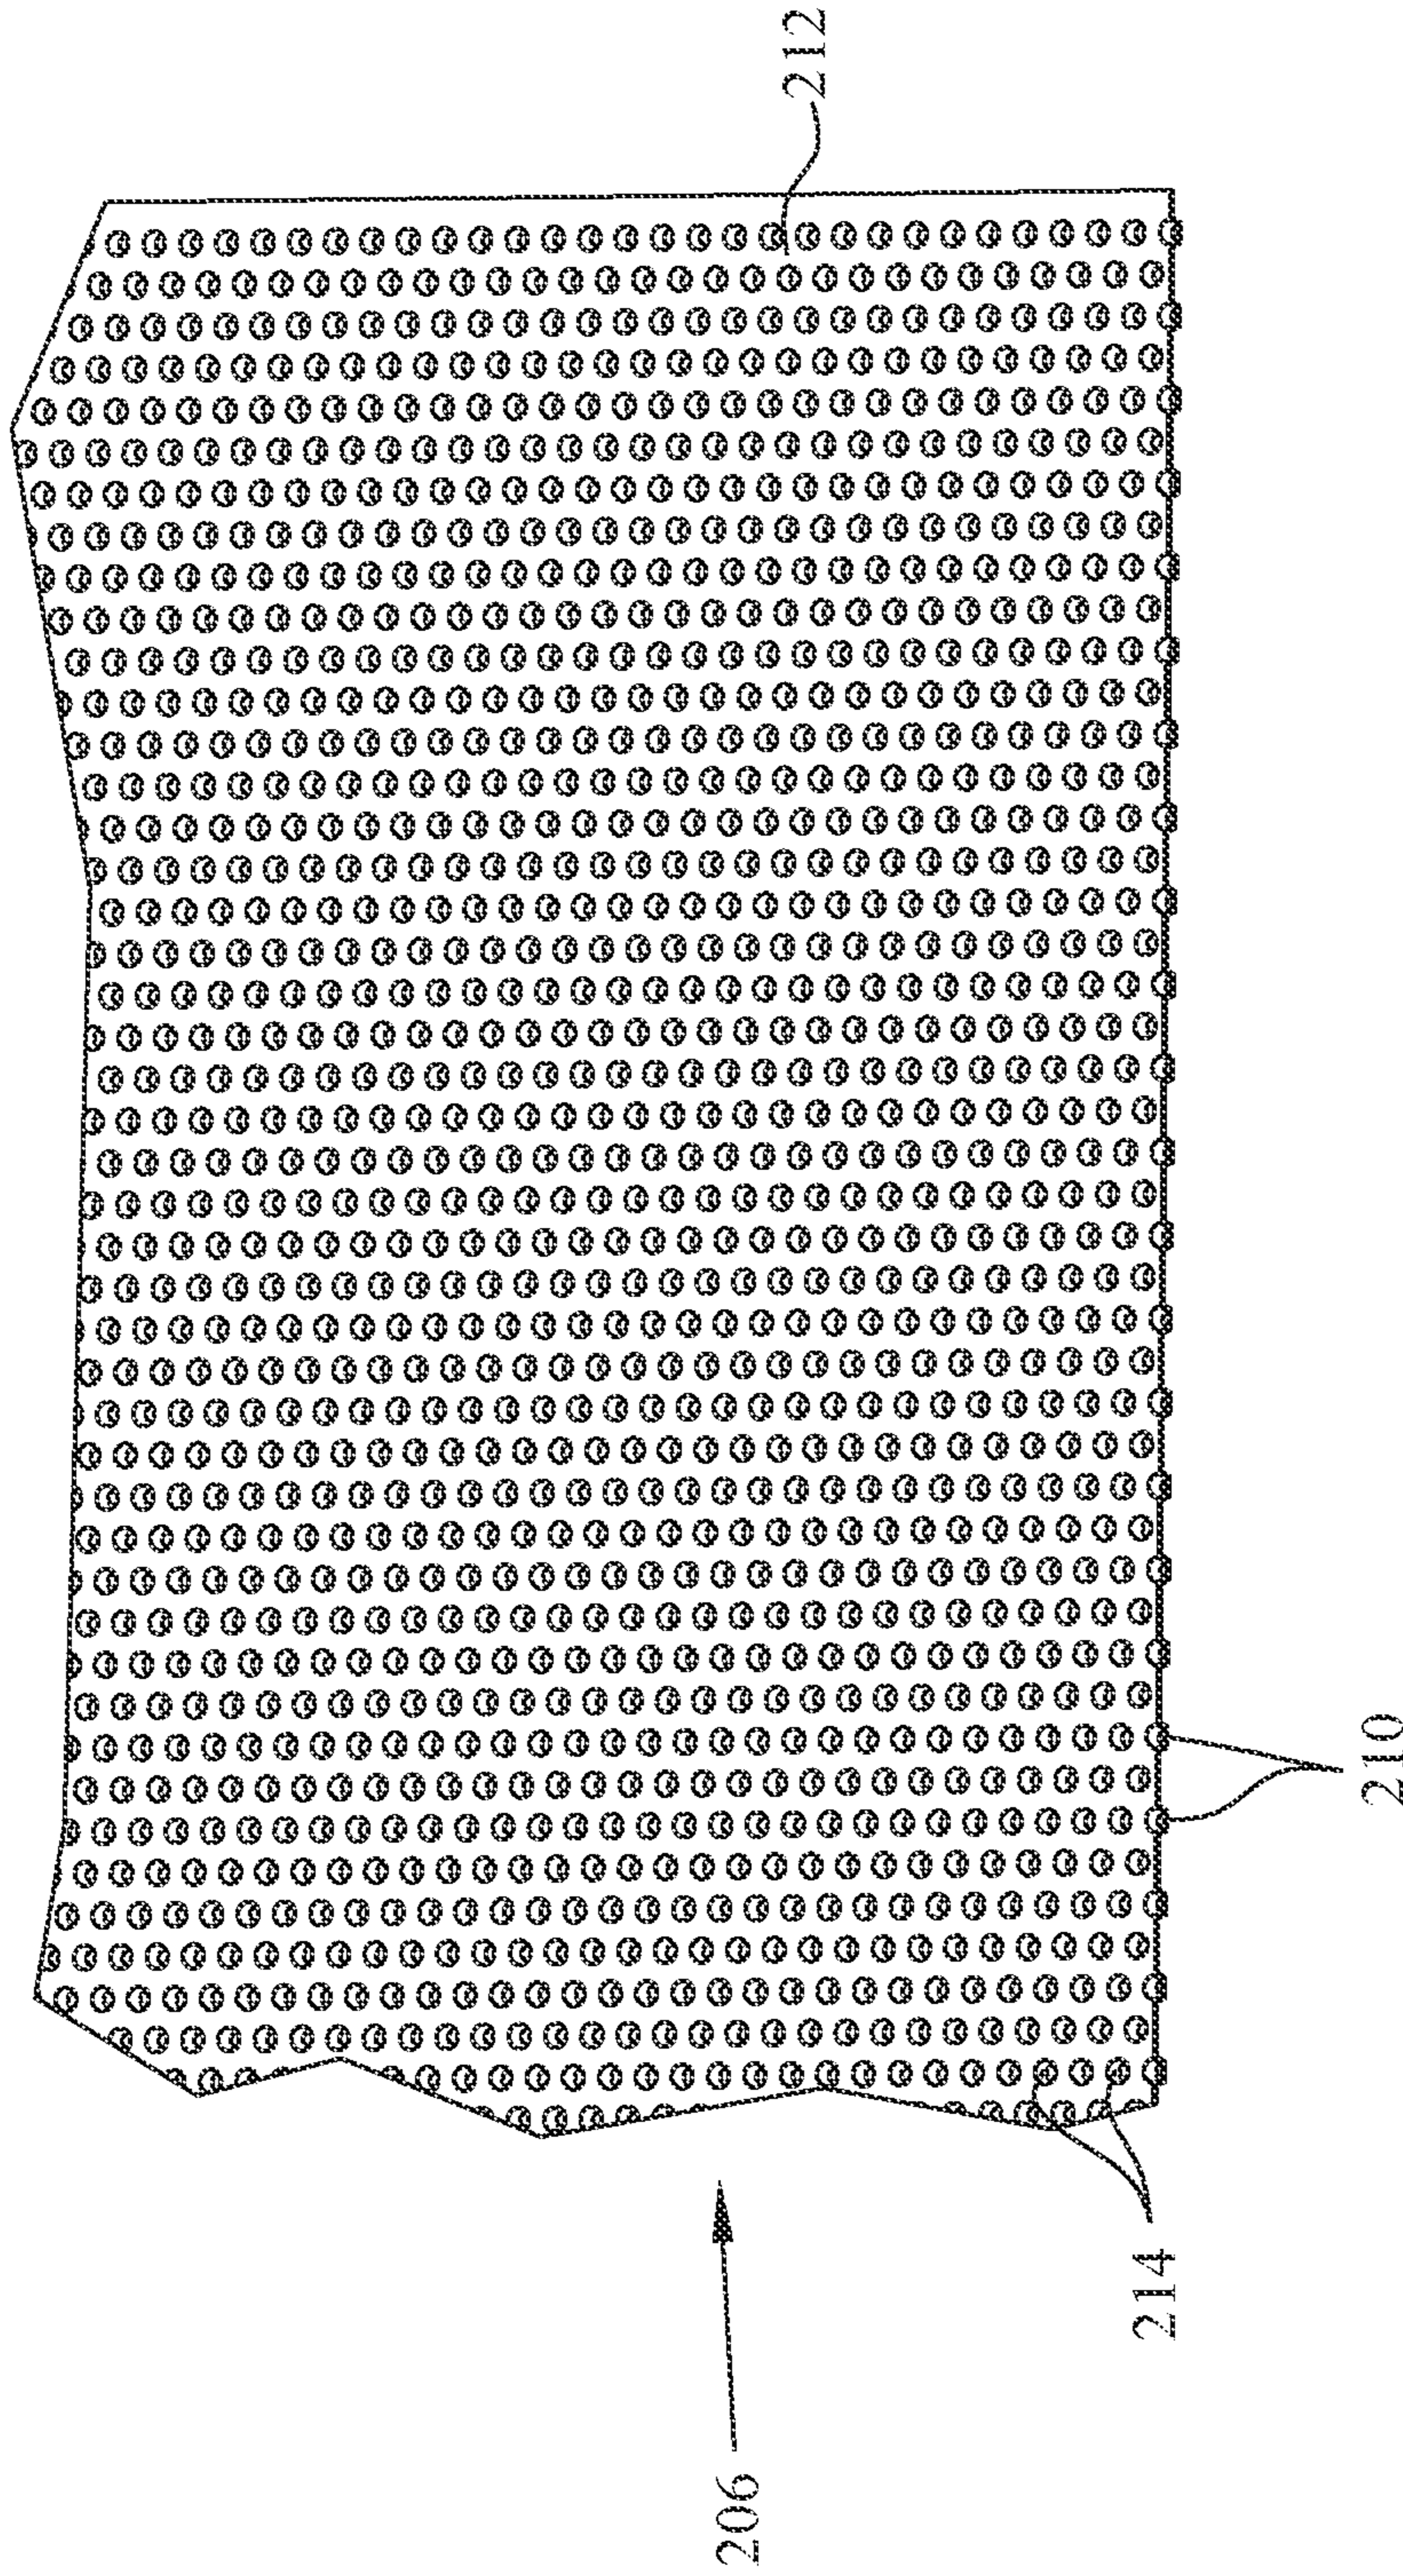
FIG. 10 is another perspective view of the vehicle and cargo bay liner of FIG. 6 with the face having openings facing upward;

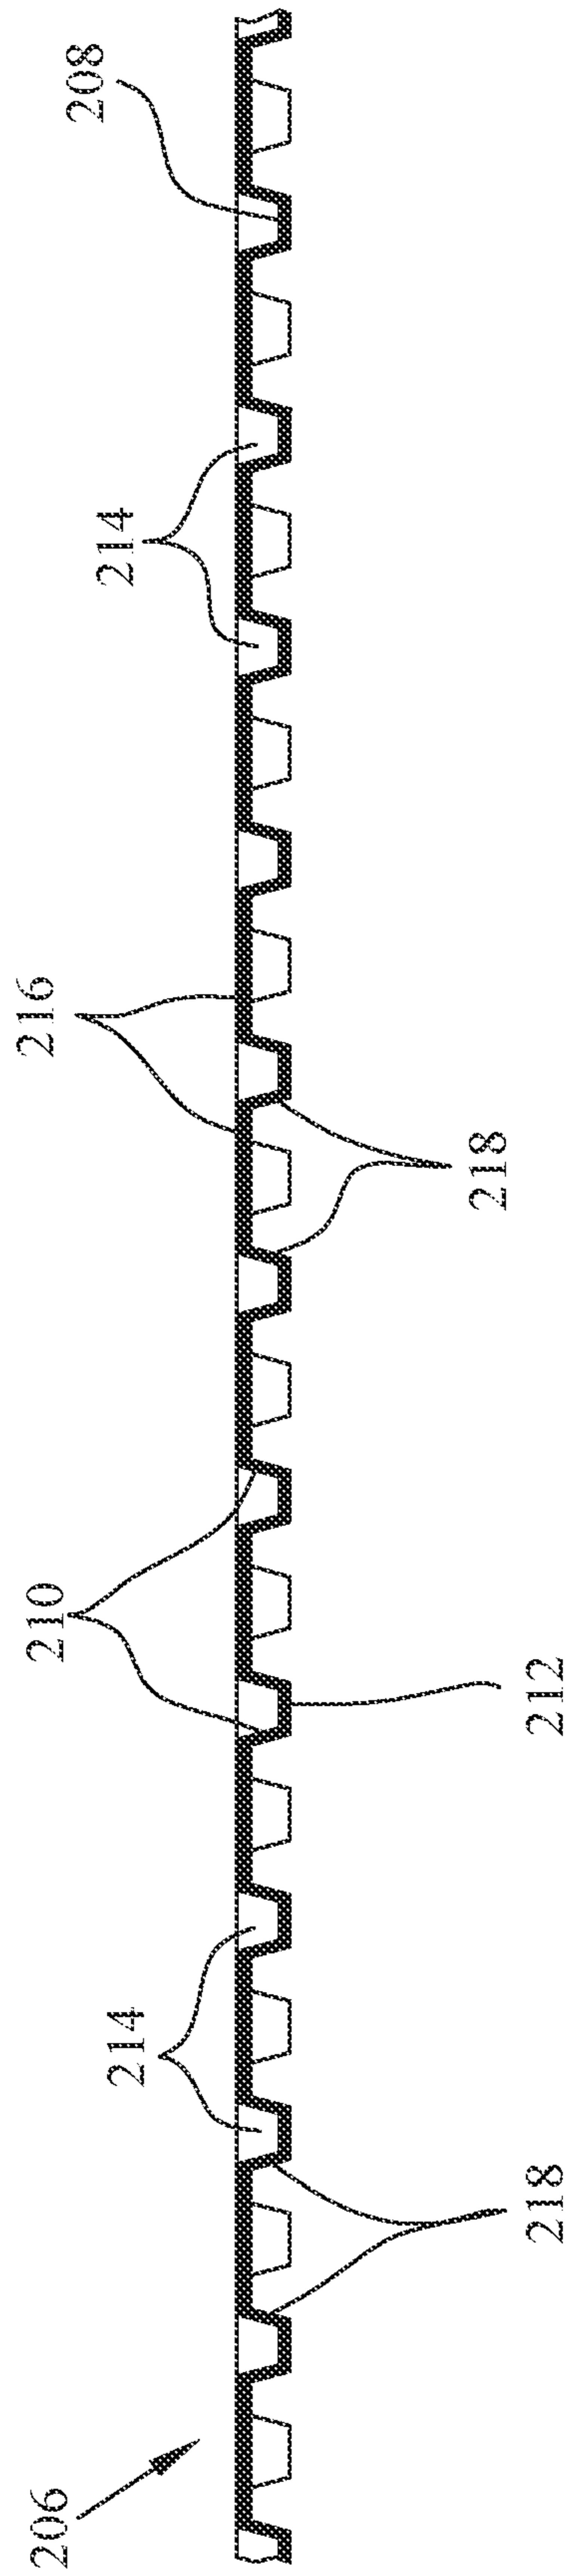
FIG. 11 is a side view of the vehicle and cargo bay liner of FIG. 6 with the projections extending upward;

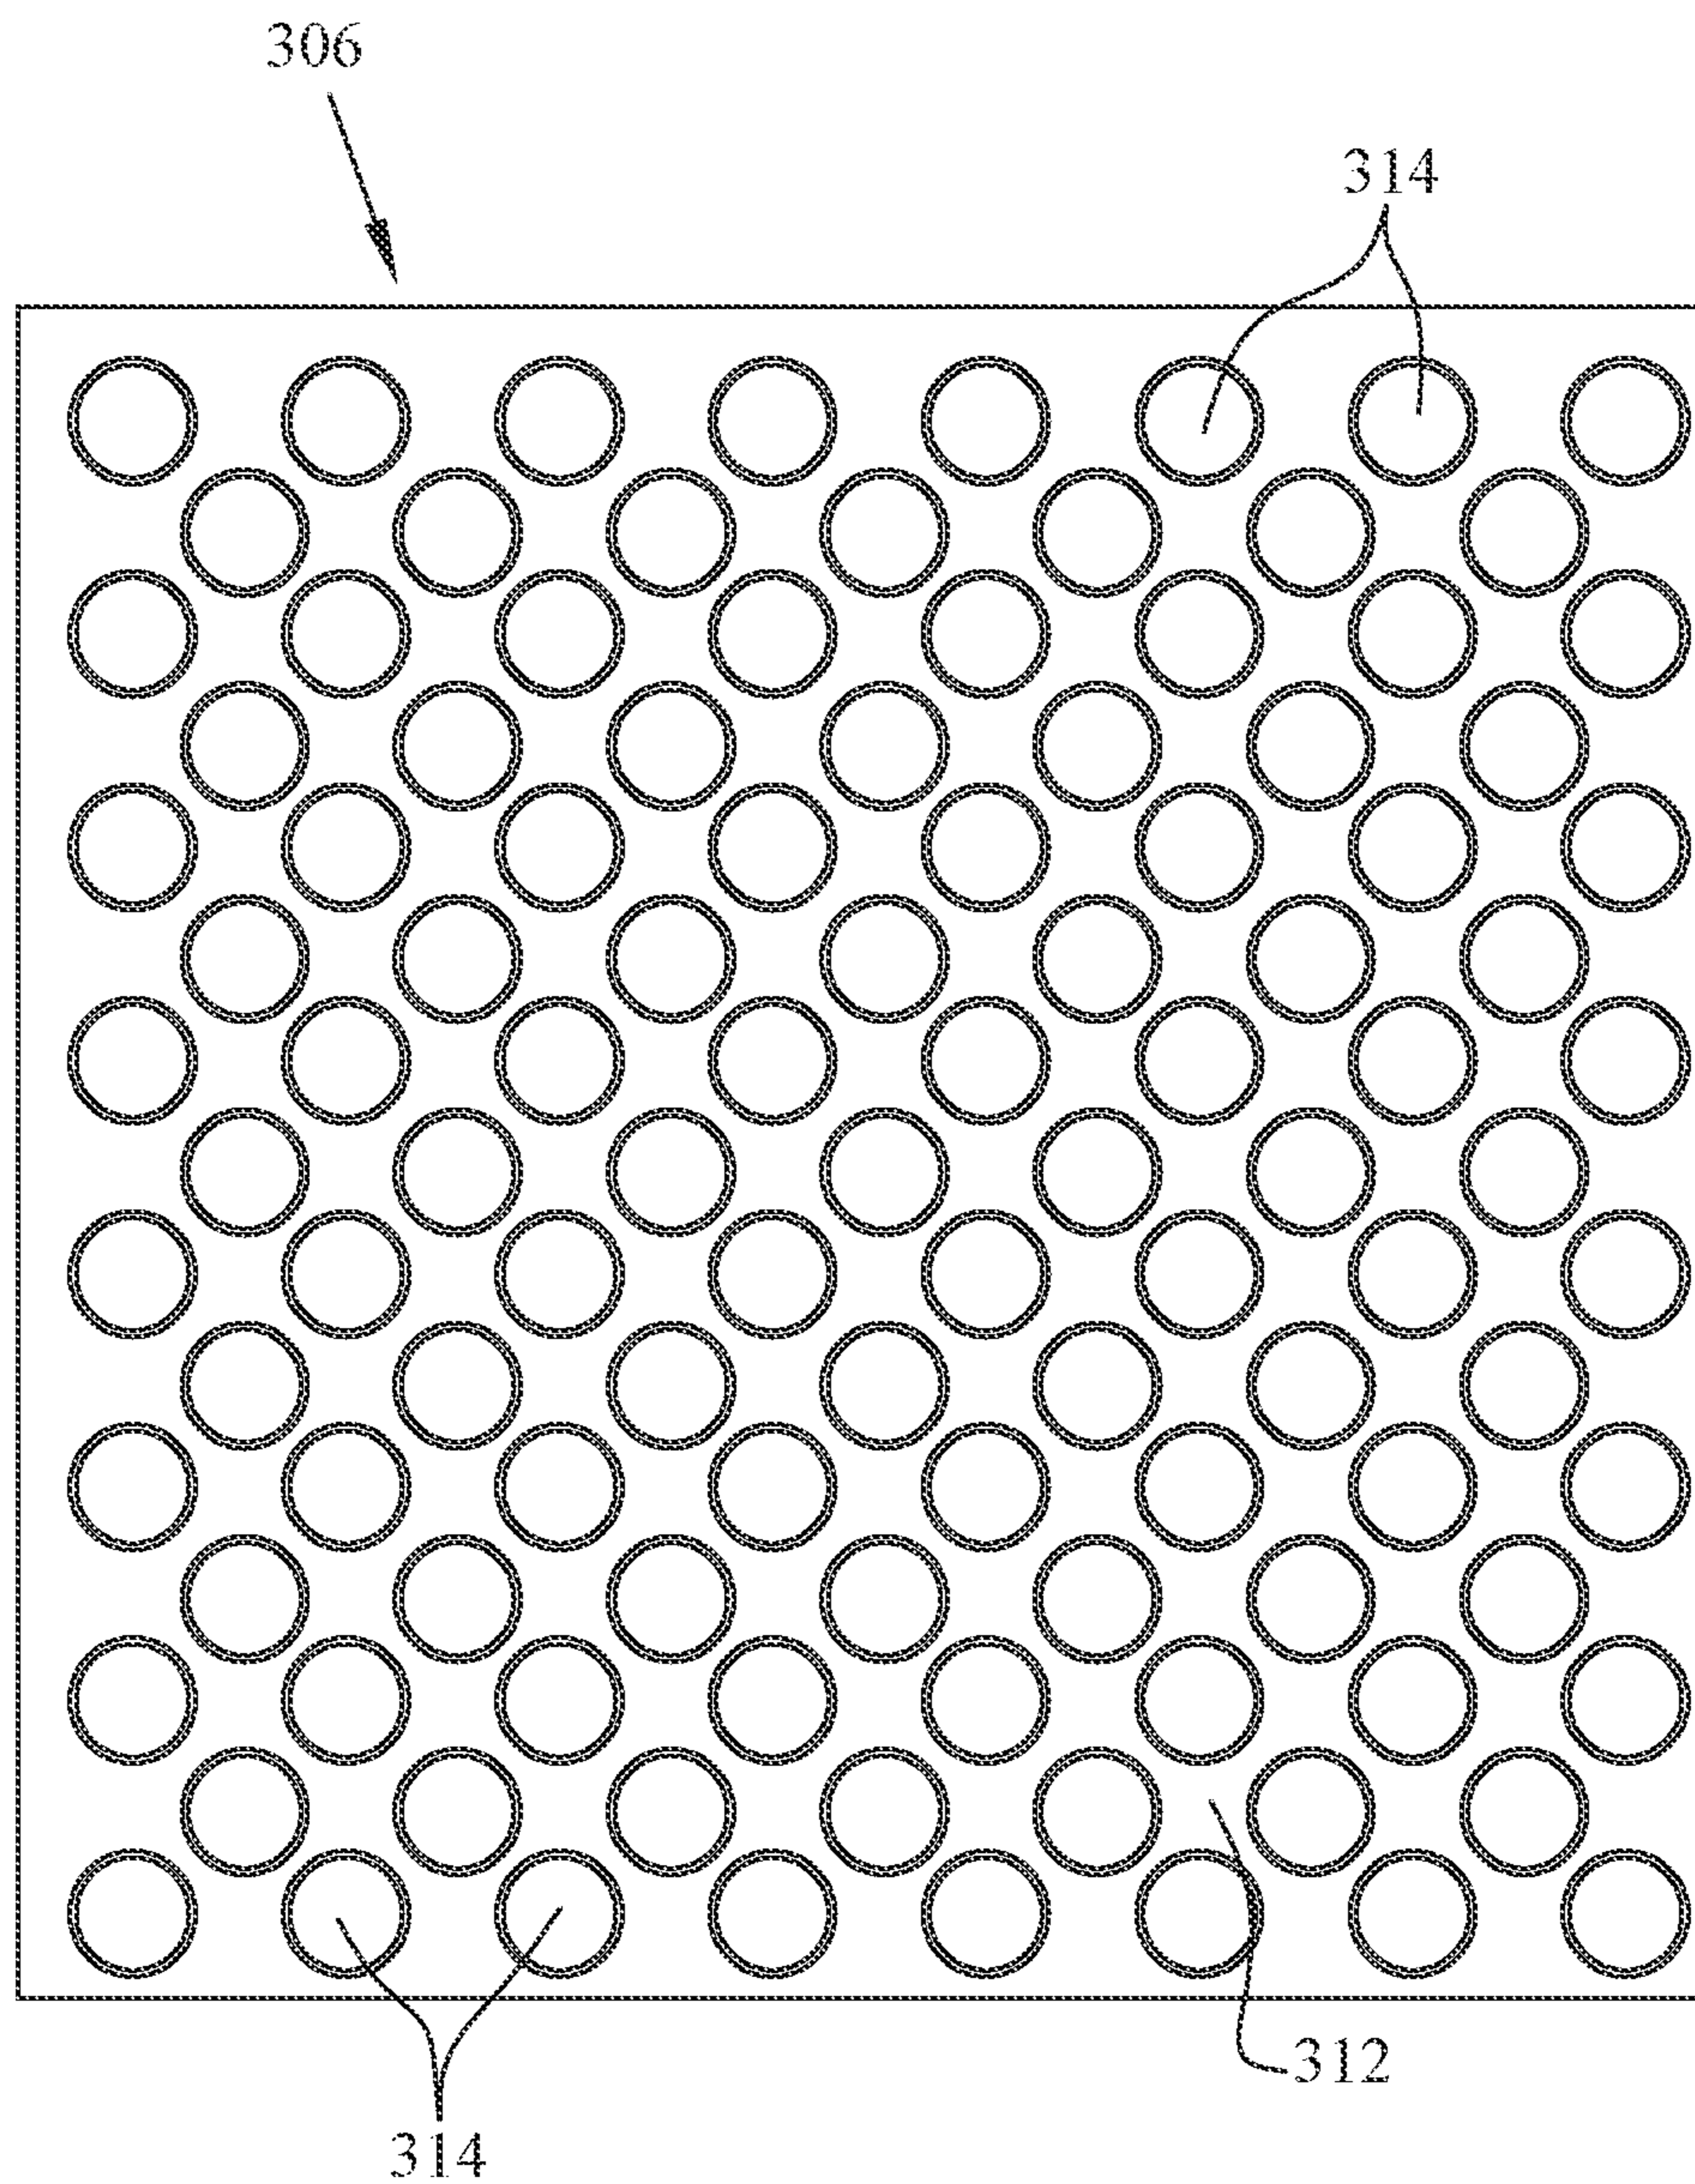
FIG. 12 is a plan view of an alternate embodiment vehicle frame and cargo bay liner showing a face having openings therein;

Now referring to FIGS. 12 and 13, an alternate vehicle frame and cargo area liner is shown generally indicated as **306**. As can be seen in FIG. 13, liner **306** includes a face **308** having projections **210** thereon. As shown in FIG. 12, liner **306** has an opposite face **312** having openings **314** therein. Projections **310** include end faces **316** and sidewalls **318** as best seen in FIG. 13. Line **306** can be manufactured from single or multi-layer materials sandwiched together (twin or triple layer).
