(12) **United States Patent**
Pennington

(54) **VEHICLE FRAME AND CARGO BAY LINER**

(71) Applicant: **PennPlastics, LLC**, Mishawaka, IN (US)

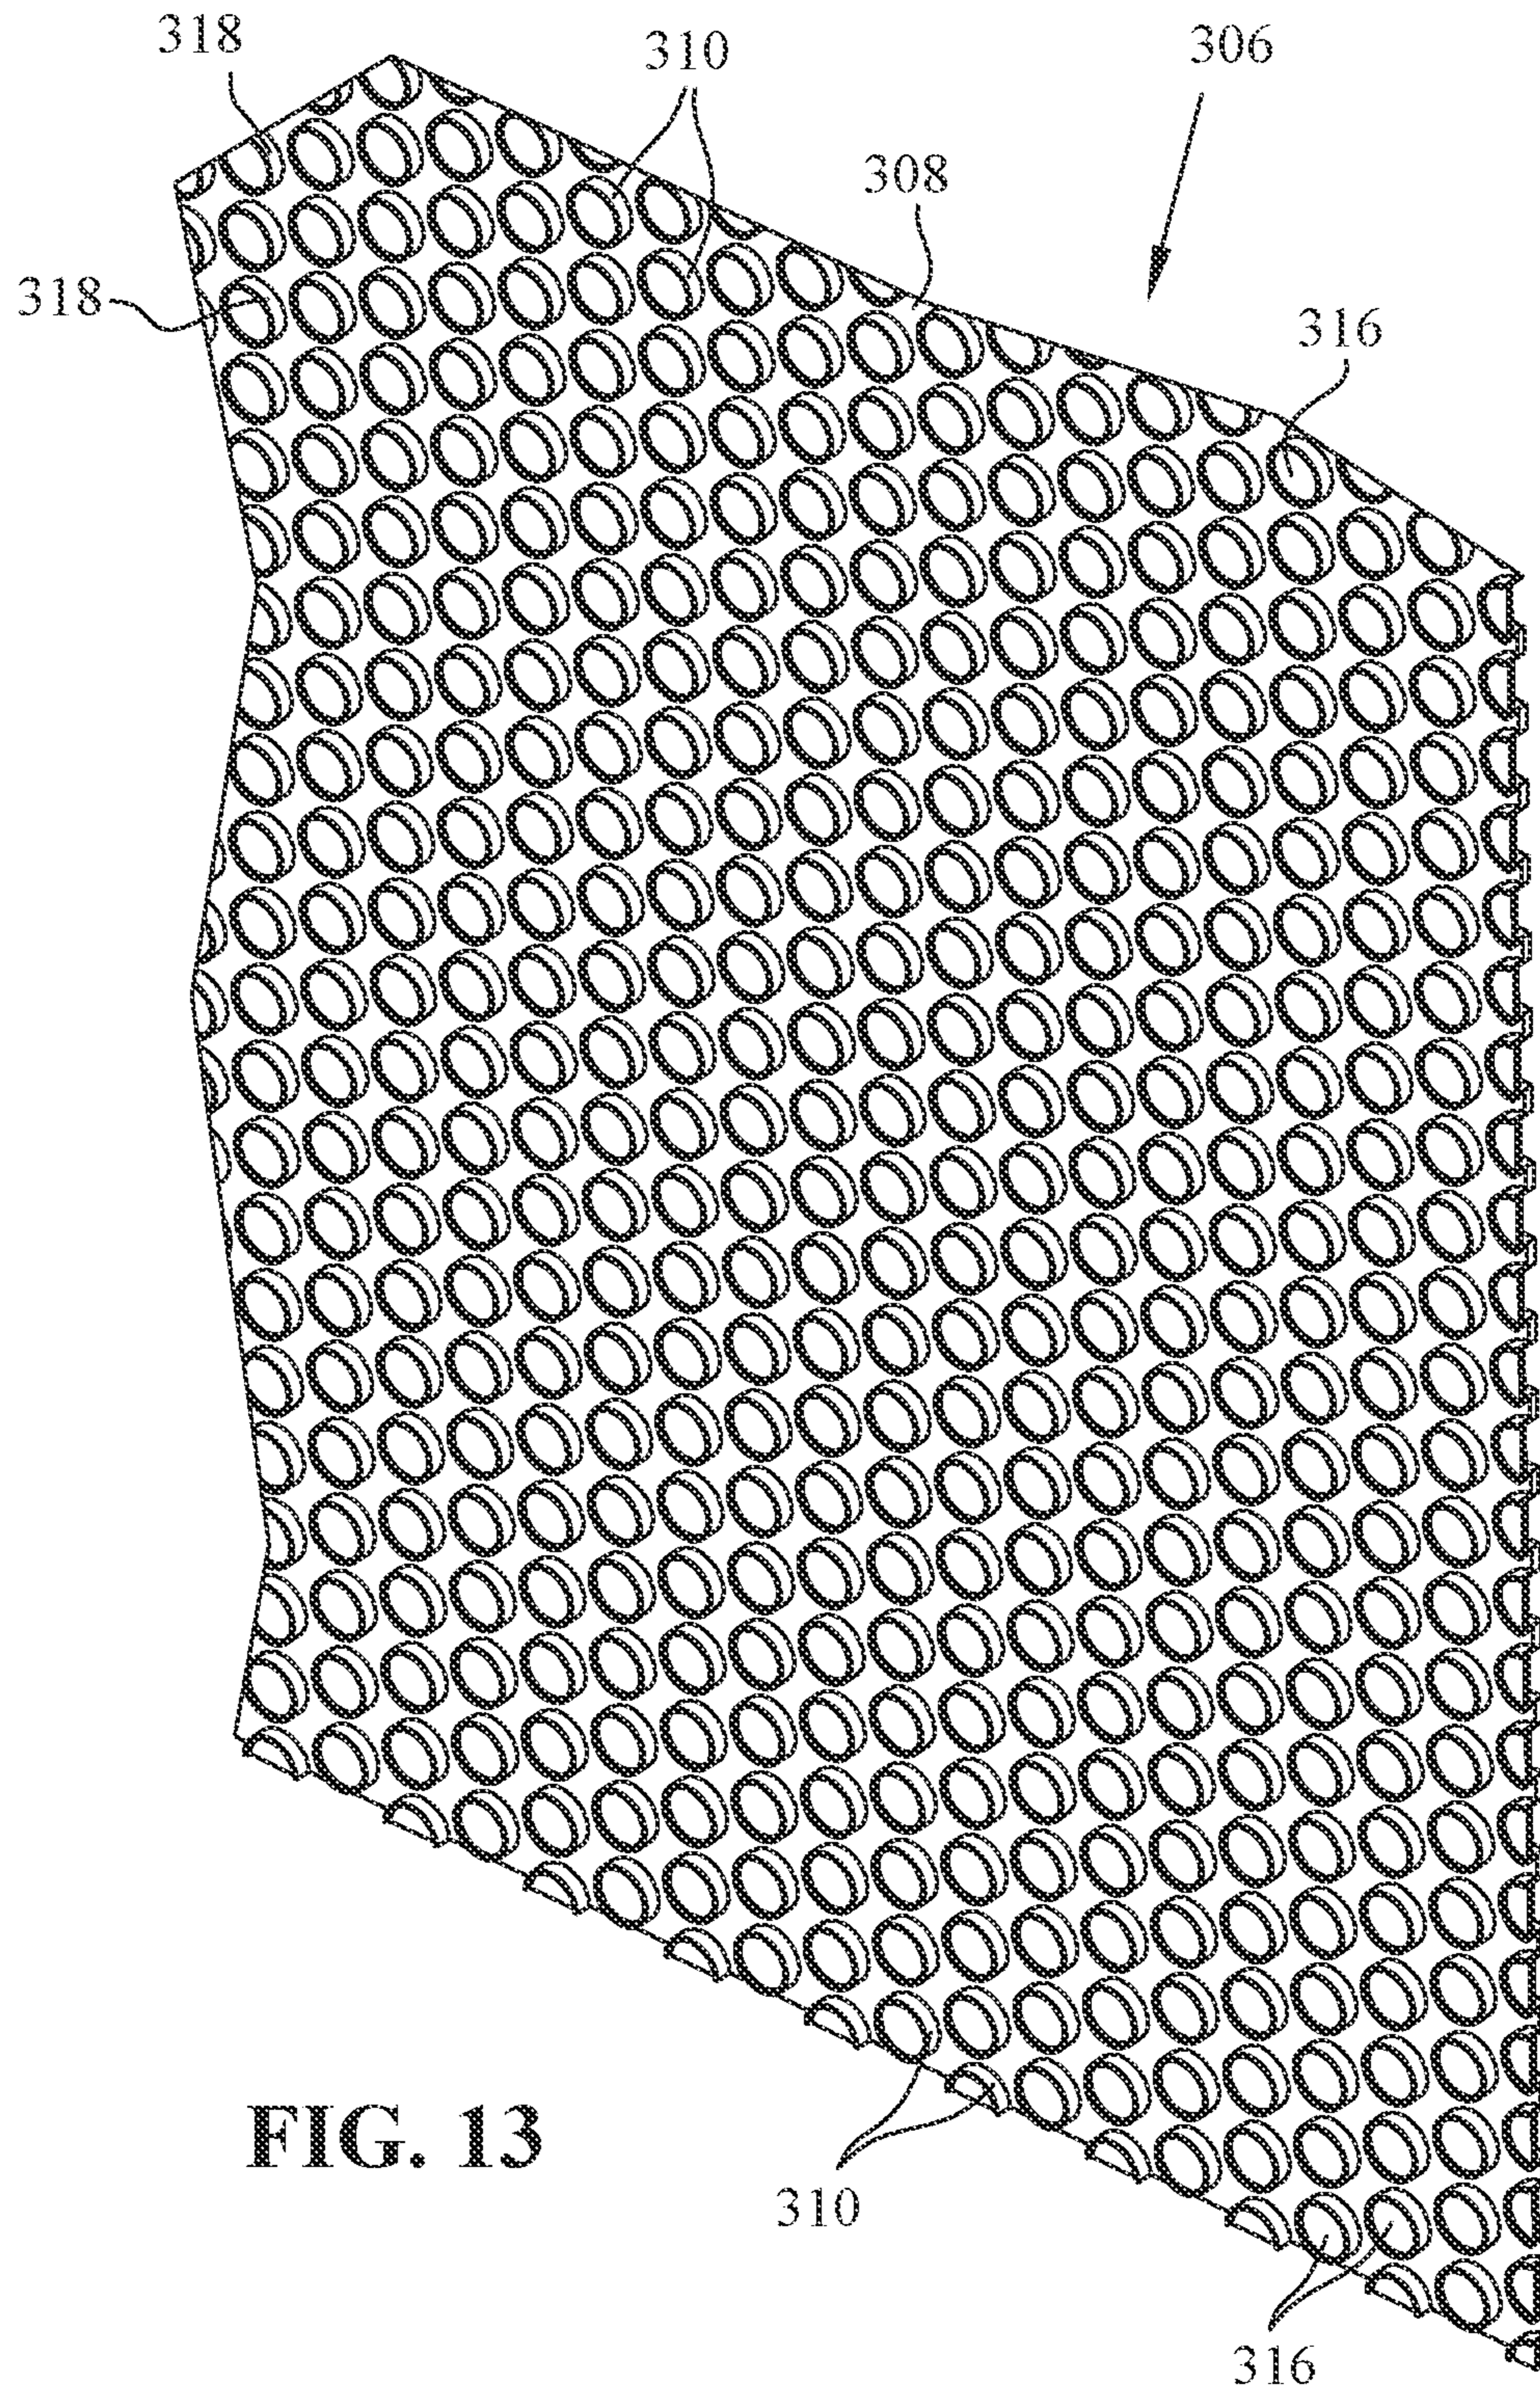
FIG. 13 is a plan perspective view of the alternate embodiment vehicle frame and cargo bay liner of FIG. 12 showing a face having projections extending therefrom;

Now referring to FIGS. 12 and 13, an alternate vehicle frame and cargo area liner is shown generally indicated as **306**. As can be seen in FIG. 13, liner **306** includes a face **308** having projections **210** thereon. As shown in FIG. 12, liner **306** has an opposite face **312** having openings **314** therein. Projections **310** include end faces **316** and sidewalls **318** as best seen in FIG. 13. Line **306** can be manufactured from single or multi-layer materials sandwiched together (twin or triple layer).

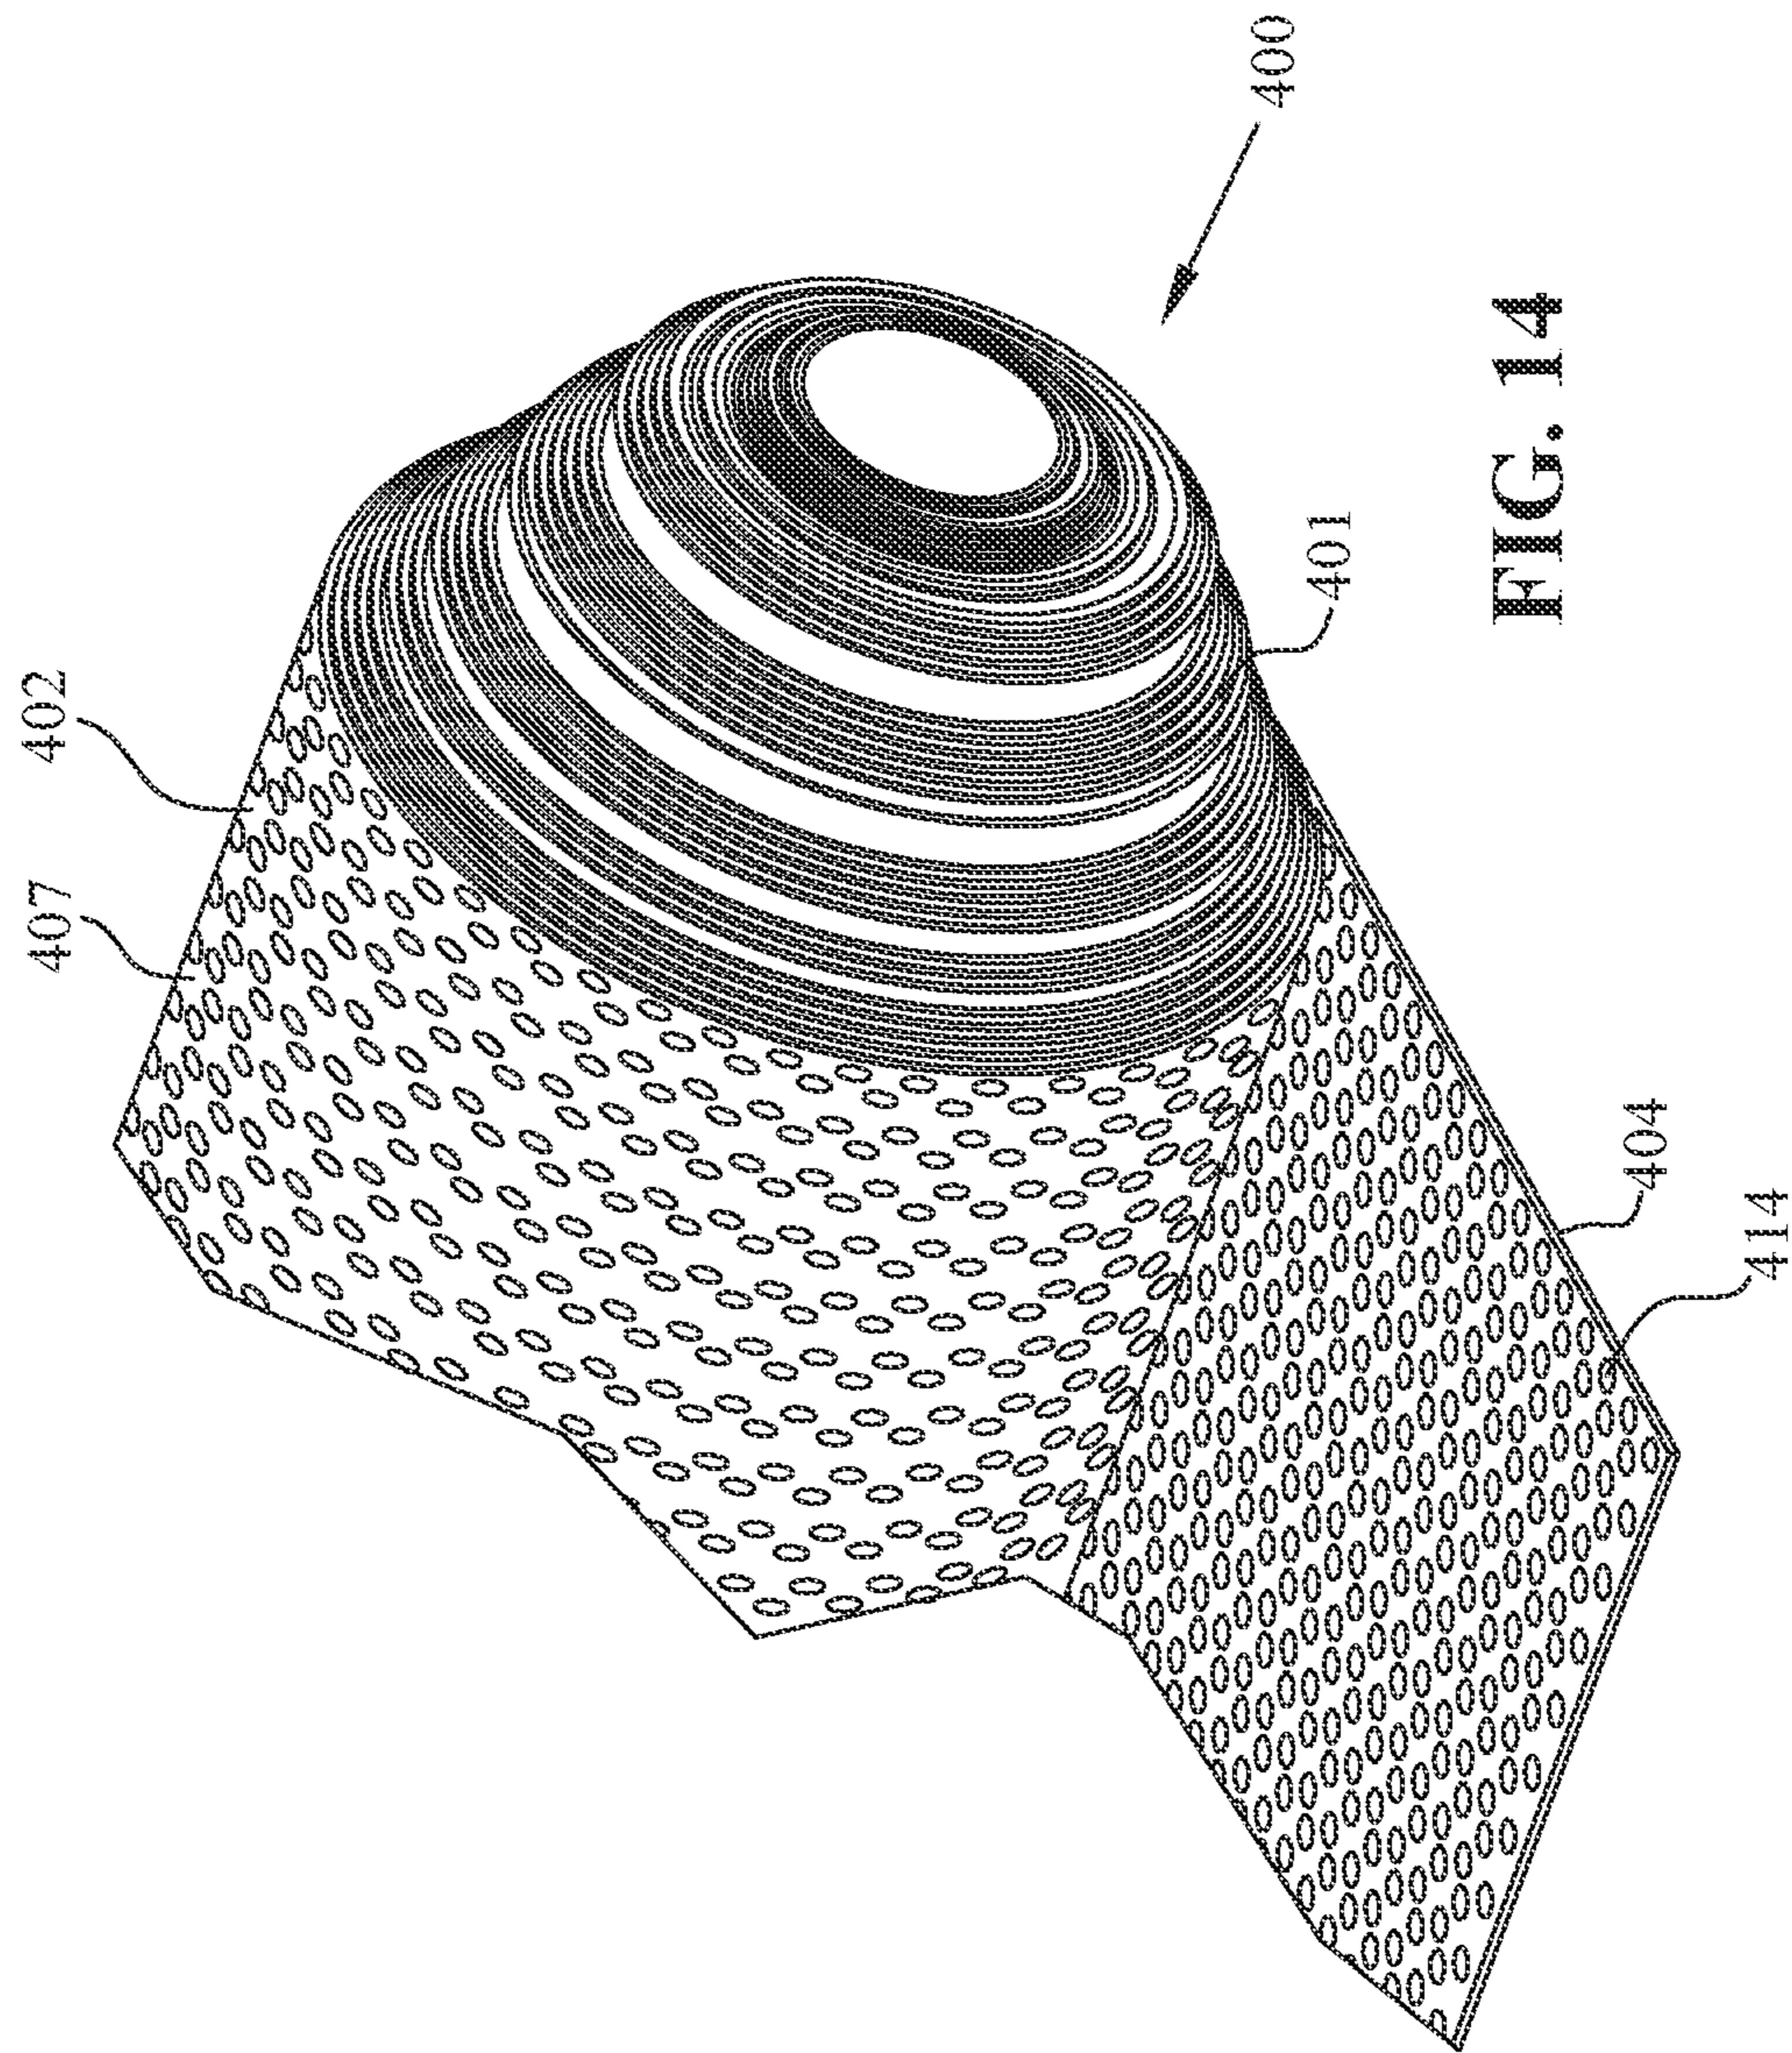
FIG. 14 is a perspective view of another alternate embodiment vehicle frame and cargo bay liner shown rolled in a coil and having aluminum foil on one side thereof;

Now referring to FIGS. 14-24, another alternate vehicle frame and cargo area liner is shown generally indicated as **400**. Liner **400** can be provided in a coiled form **401** as shown in FIGS. 14 and 15, making it extremely suitable for use as a liner for vehicle frames and cargo bays. The desired length of liner can be rolled out and cut to size for assembly to the vehicle. Vehicle frame and cargo bay liner **400** is of a 3-ply configuration and includes a top ply, sheet, or layer **402** and a bottom ply, sheet, or layer **404**. A core **406** (see FIGS. 19 and 22-24) separates top sheet **402** from bottom sheet **404**. Additionally, vehicle frame and cargo bay liner **400** also includes a sheet of aluminum foil or metalized film **407** on one side thereof. In the embodiment shown, aluminum foil/metalized film **407** is provided on top sheet **402**; however, it should be appreciated that aluminum foil or metalized film could also be provided on the bottom sheet **404**. Aluminum foil or metalized film **407** may be adhered to top sheet **402** using an adhesive or other suitable means. The metalized film can be a polymer film coated with a thin layer of metal, which can be aluminum or other suitable metal.

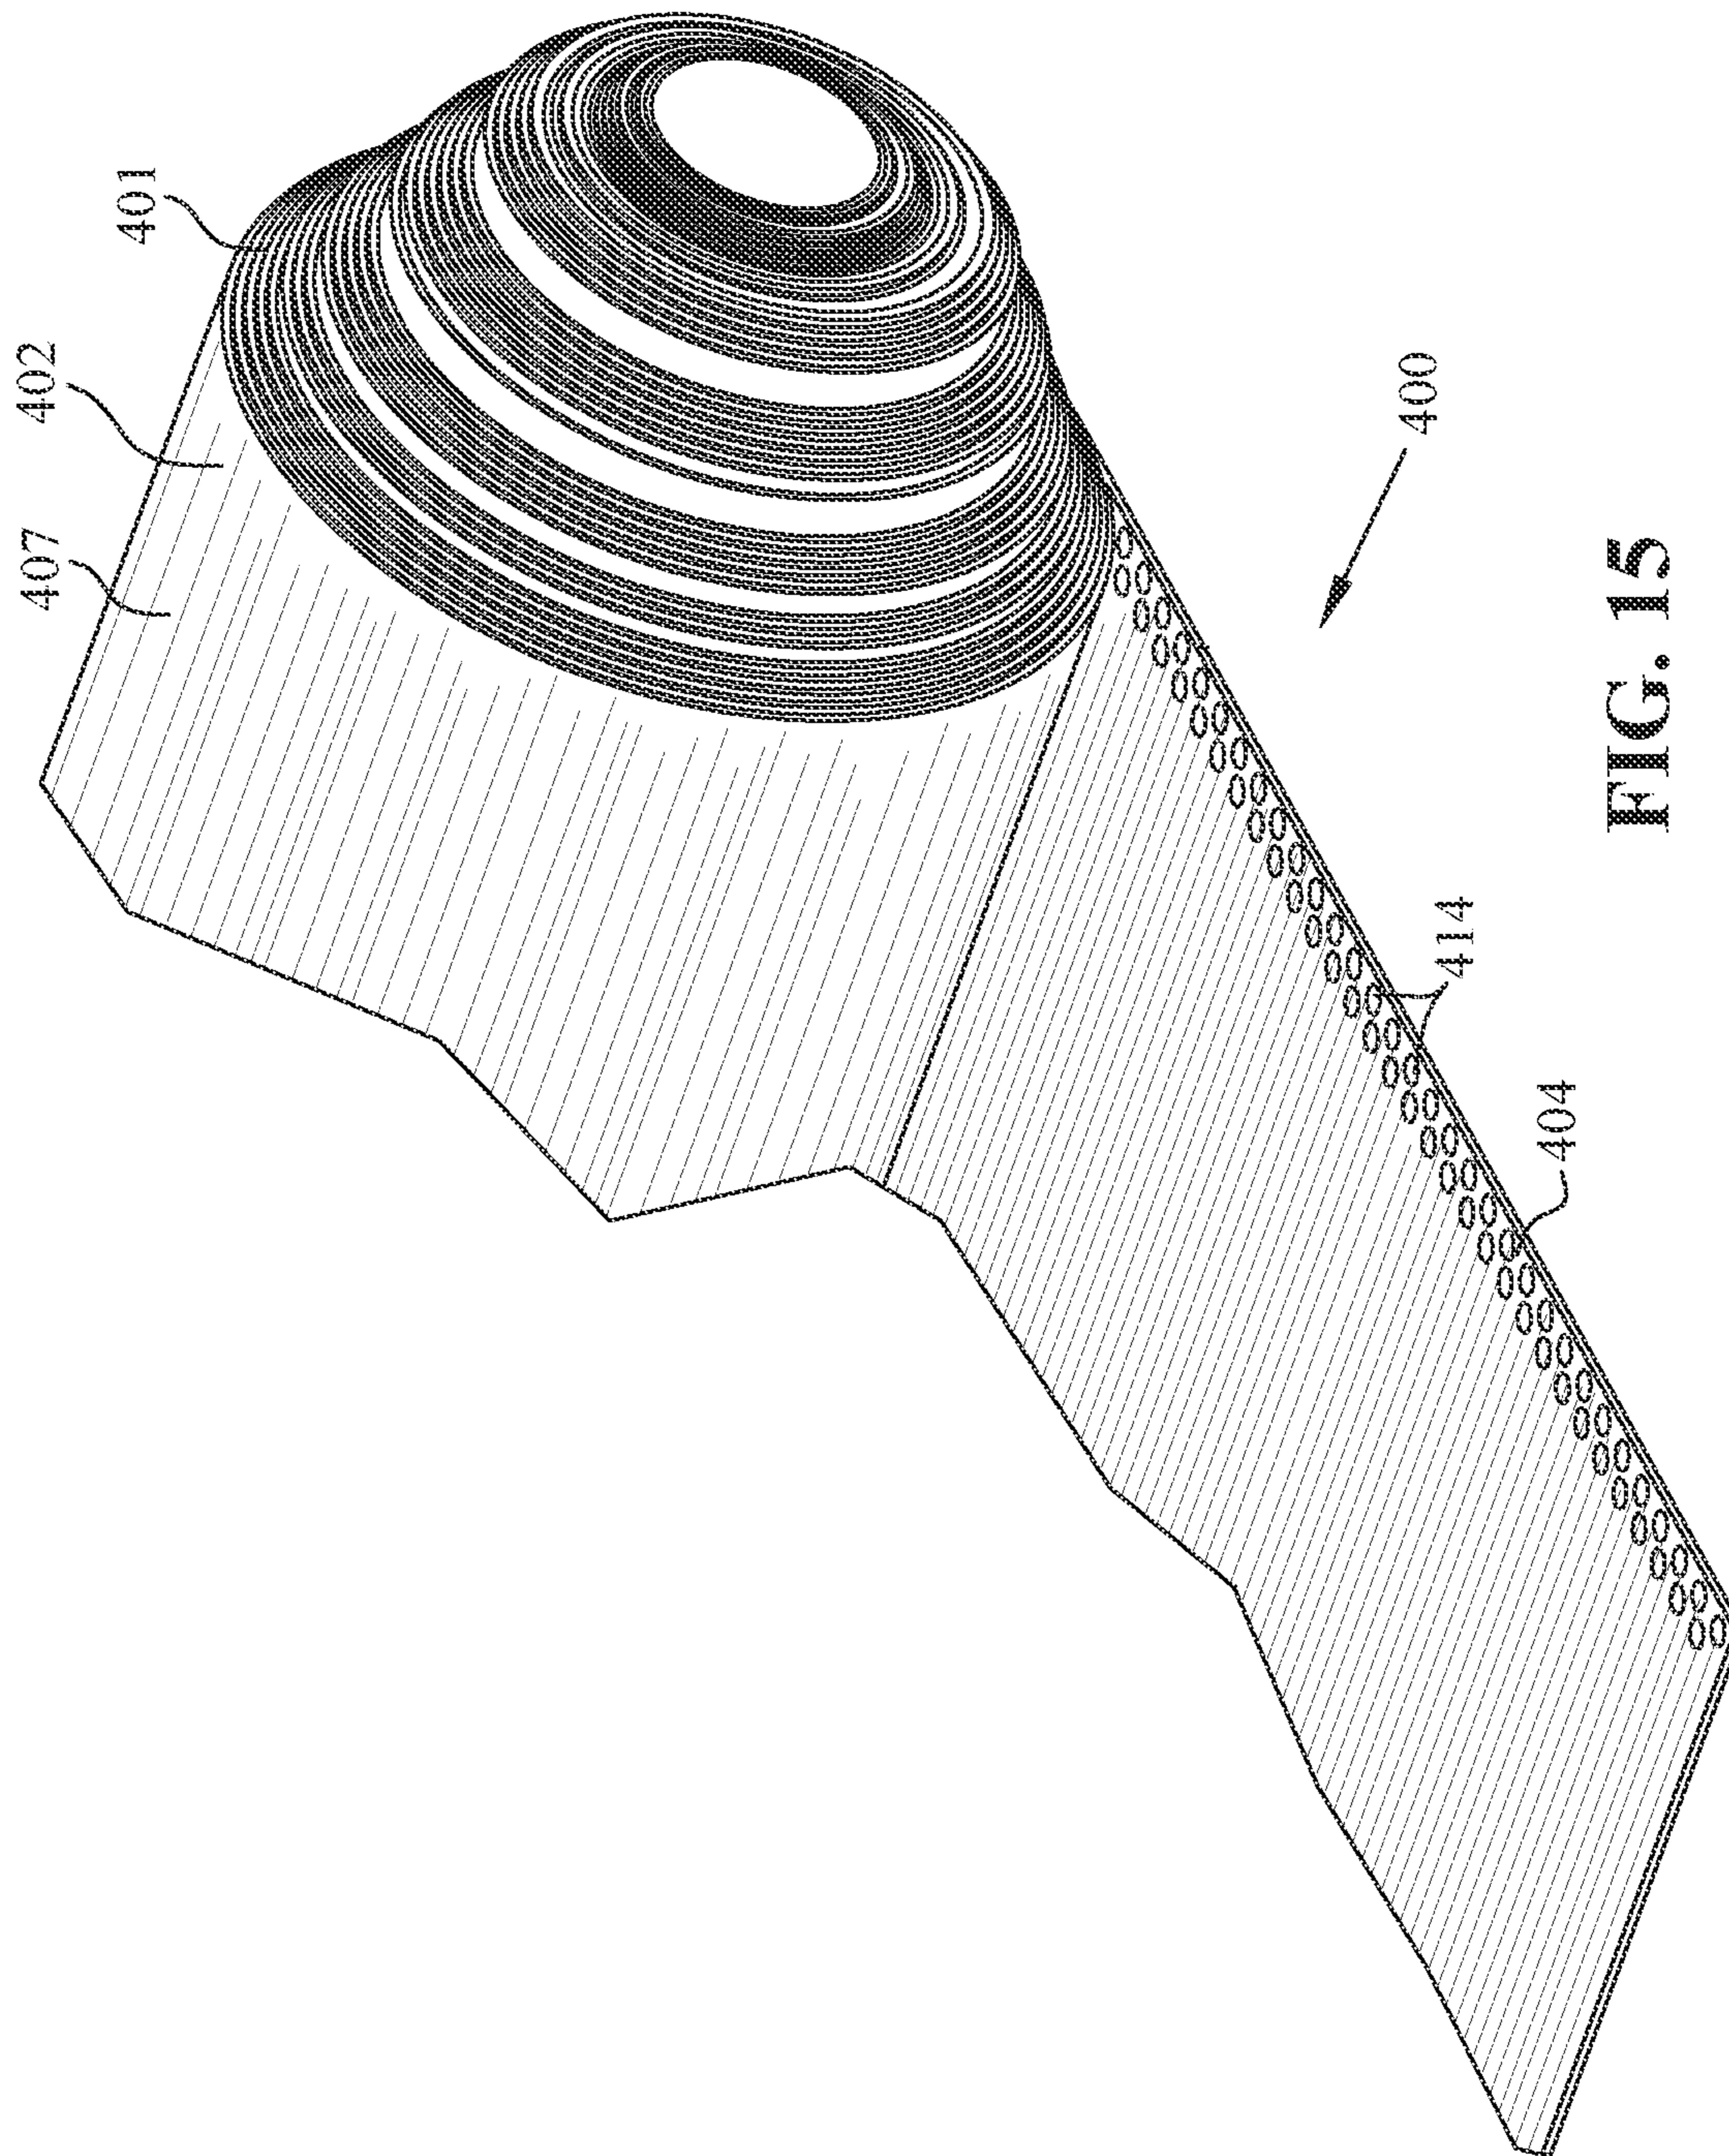
FIG. 15 is a perspective view of the vehicle frame and cargo bay liner of FIG. 14 partially rolled out showing the aluminum foil on a top side thereof;

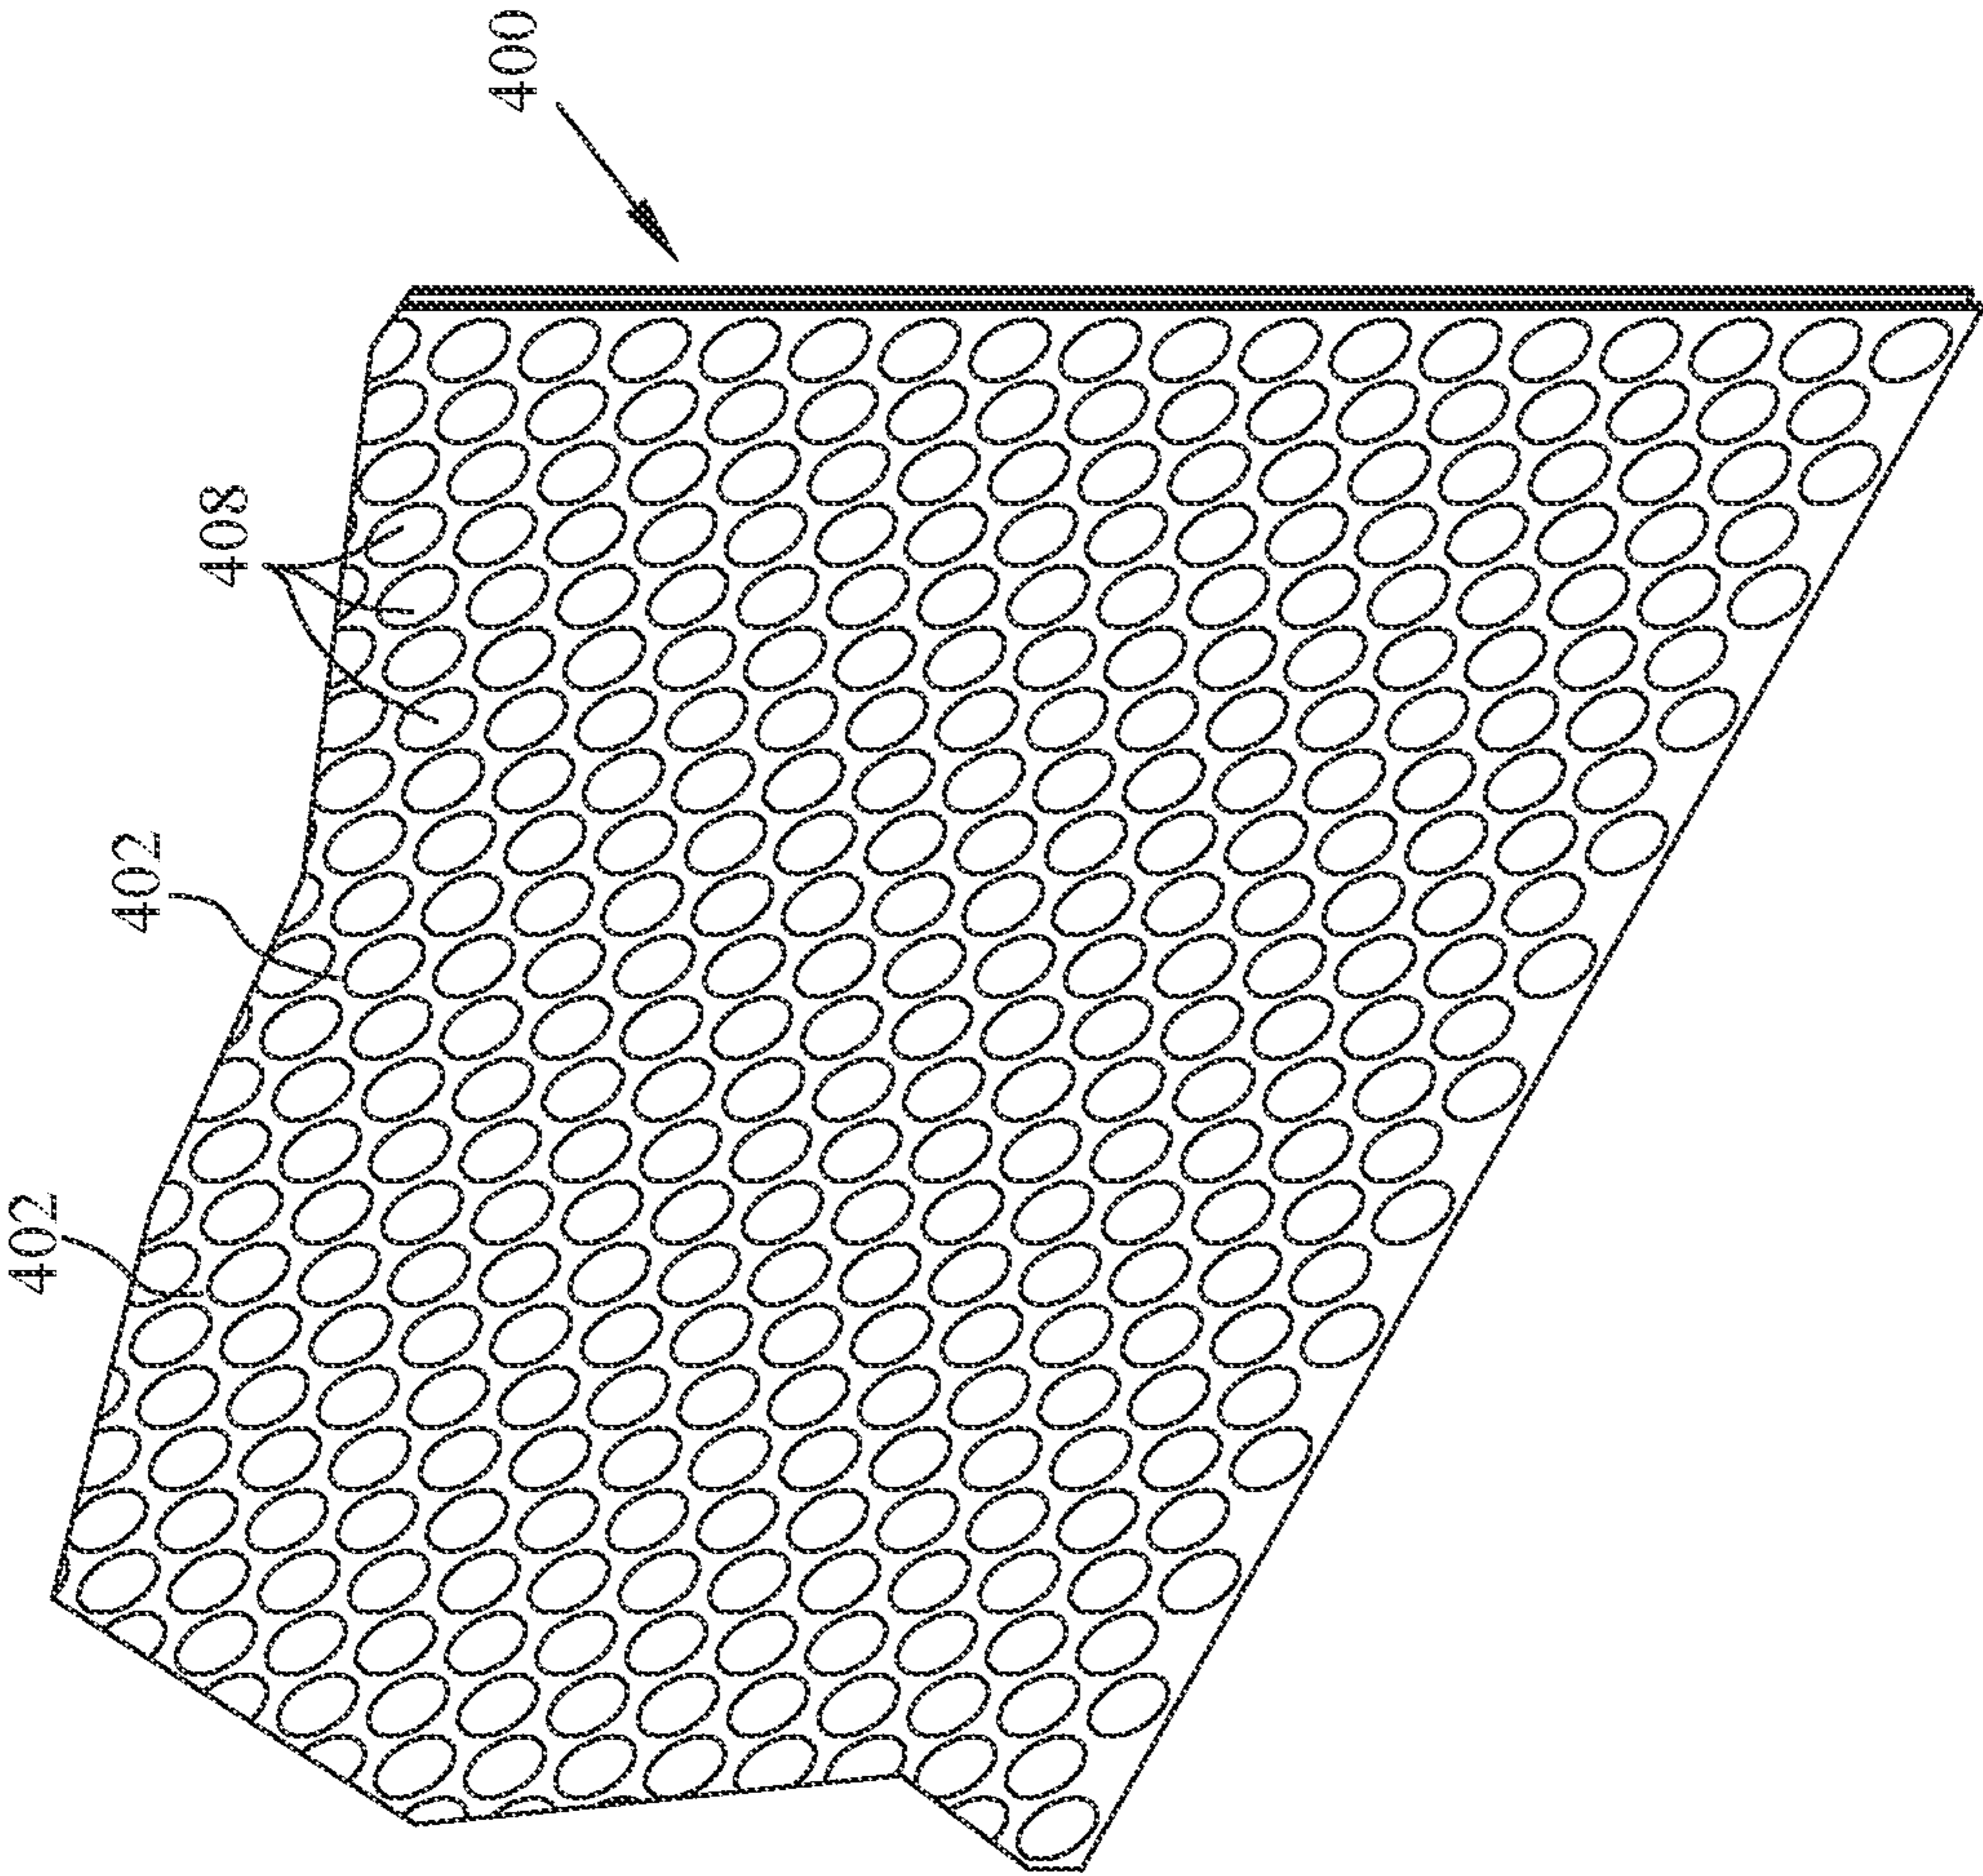
FIG. 16 is a plan view of the vehicle frame and cargo bay liner of FIG. 14 showing the top side with aluminum foil thereon;

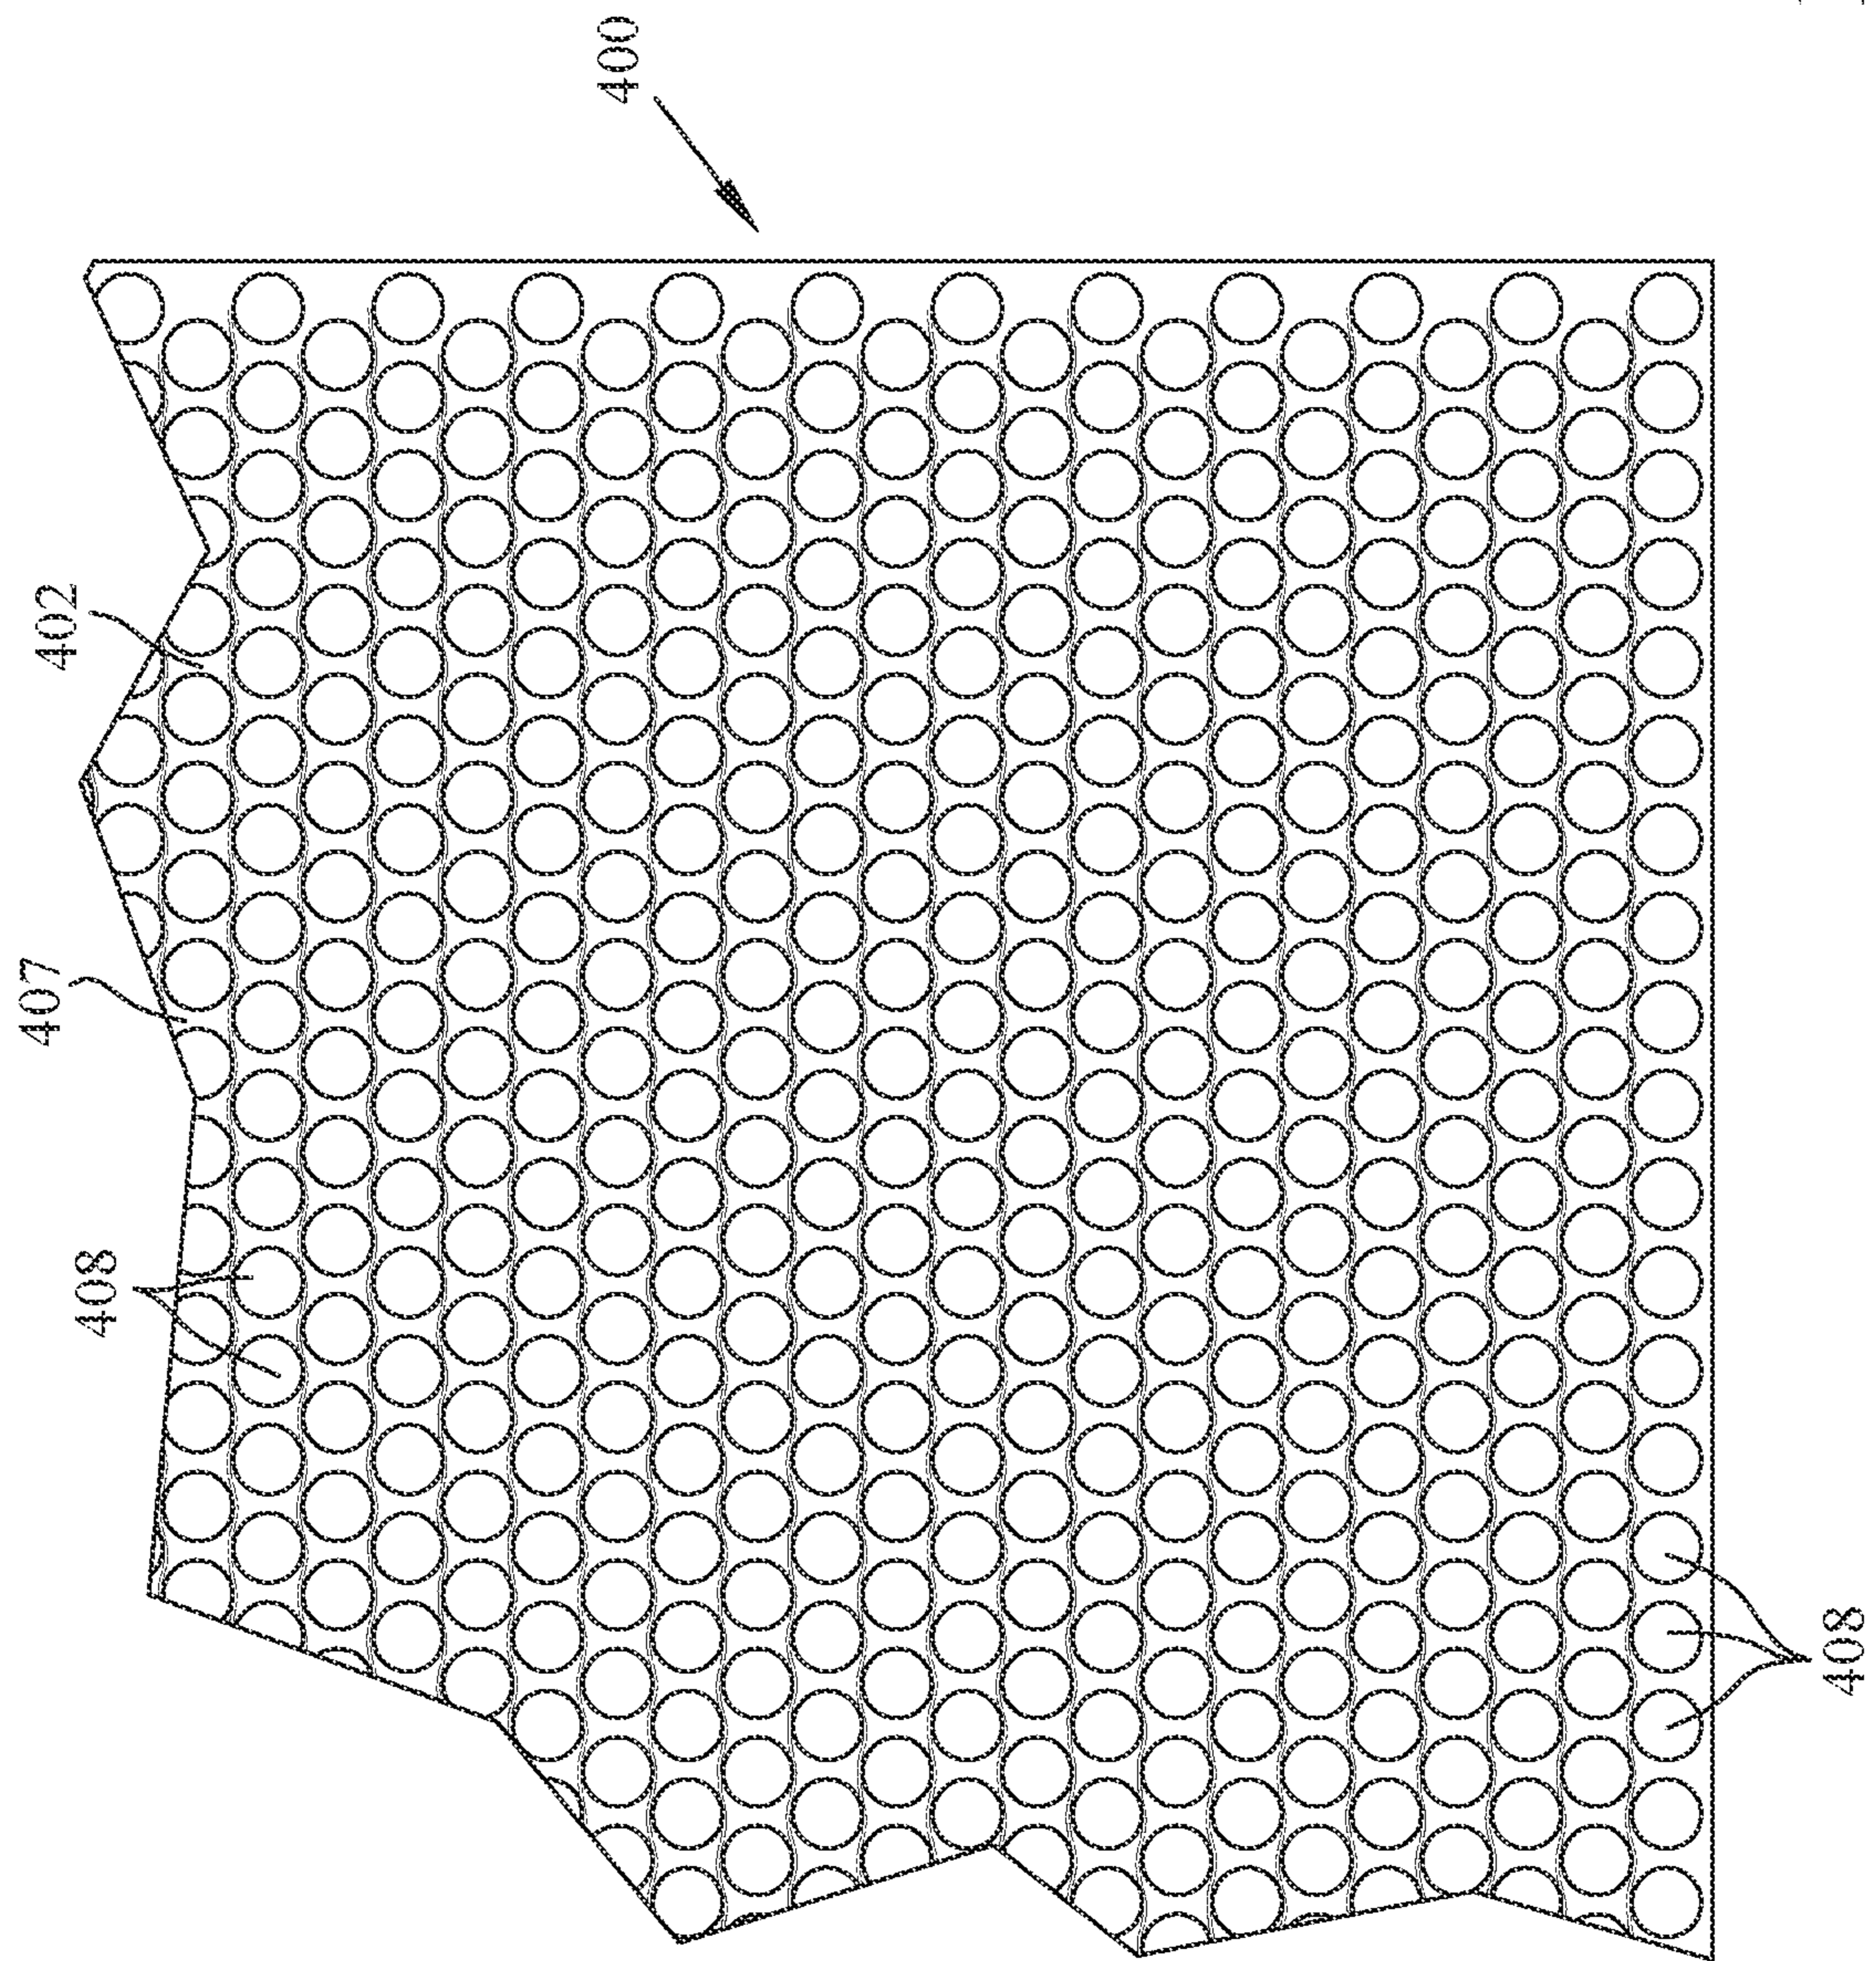
FIG. 17 is an enlarged plan view of the vehicle frame and cargo bay liner of FIG. 14 of the top side having aluminum foil thereon;

In the embodiment shown, vehicle frame and cargo bay liner **400** also includes a plurality of circular convexities **408** on top sheet **402** and a corresponding plurality of circular dimples or depressions **414** in bottom sheet **404**. Vehicle frame and cargo bay liner **400** also includes a plurality of cylindrical projections **410** extending up from bottom sheet **404** and attached to top sheet **402** (see FIGS. 22 and 23). Projections **410** may be thermally bonded to top sheet **402** as well as to bottom sheet **404**. As can be seen in FIGS. 22-24, circular convexities **408** and circular depressions **414** coincide with cylindrical projections **410**. Also, as should be appreciated, cylindrical projections **410** form the core of vehicle frame and cargo bay liner **400**.
