(12) **United States Patent**
Pennington

(54) **VEHICLE FRAME AND CARGO BAY LINER**

(71) Applicant: **PennPlastics, LLC**, Mishawaka, IN (US)

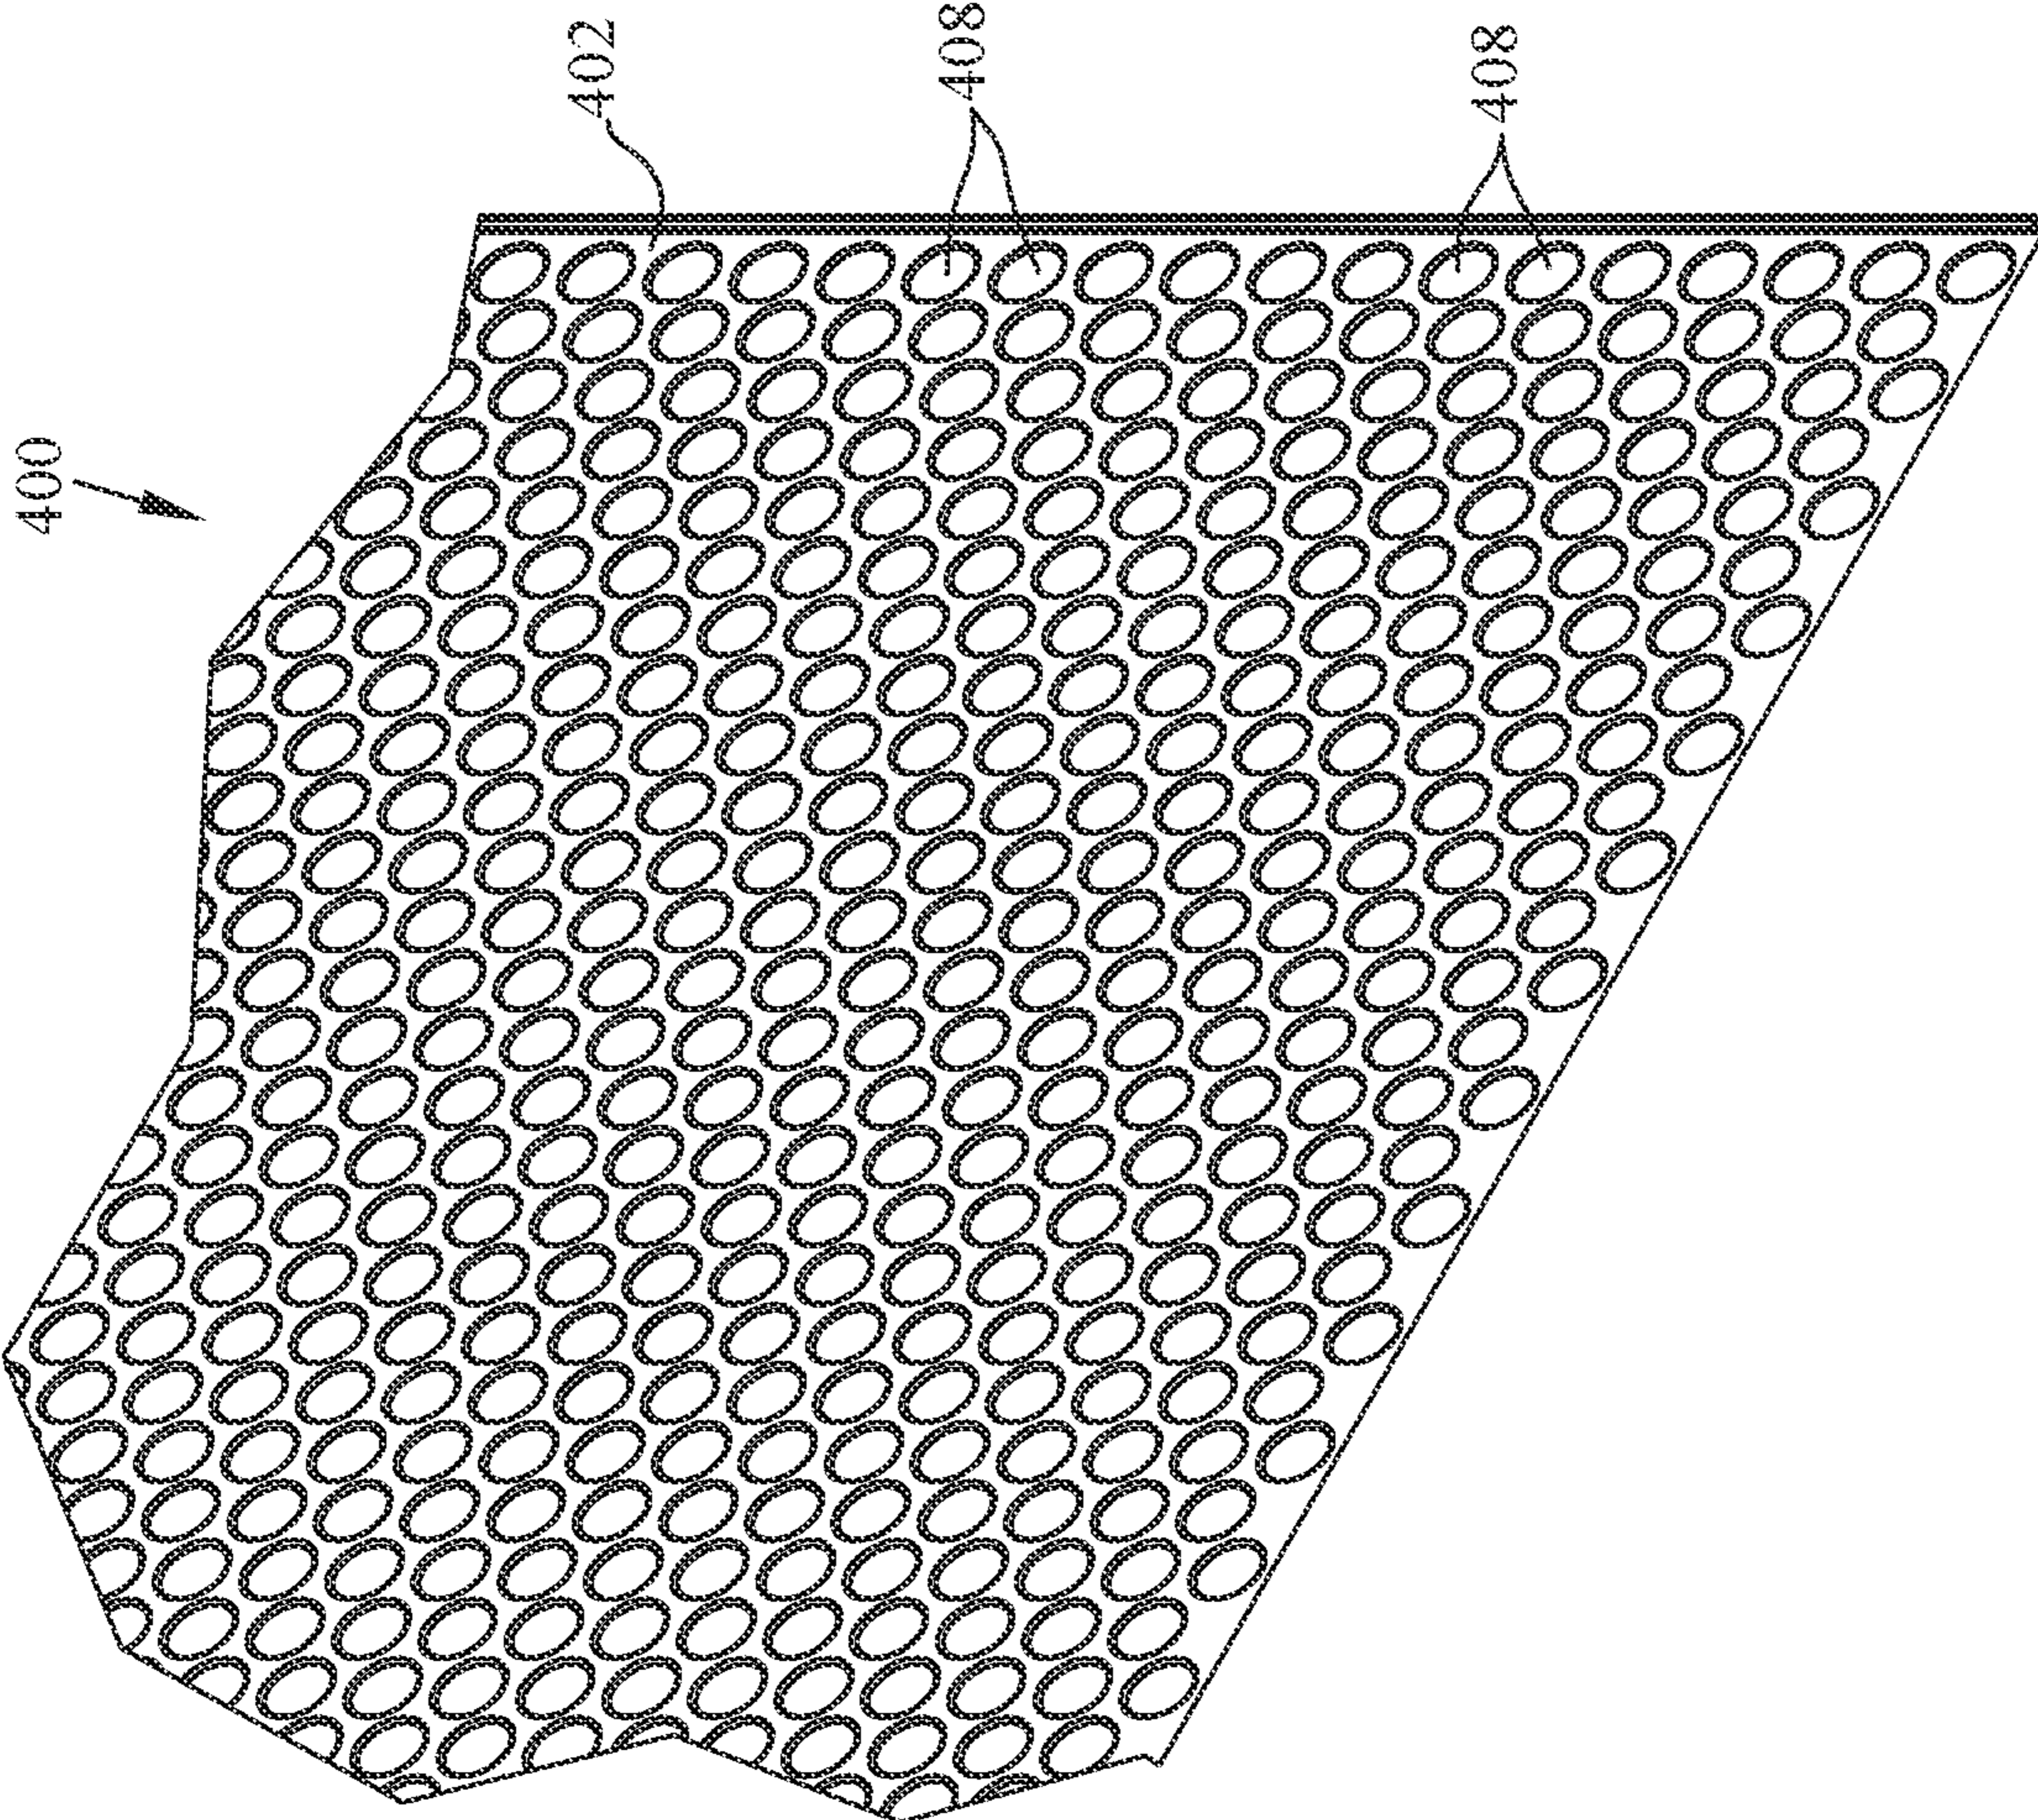
FIG. 18 is a top plan perspective view of the vehicle frame and cargo bay liner of FIG. 14 having the aluminum removed from the top side thereof;

In the embodiment shown, vehicle frame and cargo bay liner **400** also includes a plurality of circular convexities **408** on top sheet **402** and a corresponding plurality of circular dimples or depressions **414** in bottom sheet **404**. Vehicle frame and cargo bay liner **400** also includes a plurality of cylindrical projections **410** extending up from bottom sheet **404** and attached to top sheet **402** (see FIGS. 22 and 23). Projections **410** may be thermally bonded to top sheet **402** as well as to bottom sheet **404**. As can be seen in FIGS. 22-24, circular convexities **408** and circular depressions **414** coincide with cylindrical projections **410**. Also, as should be appreciated, cylindrical projections **410** form the core of vehicle frame and cargo bay liner **400**.

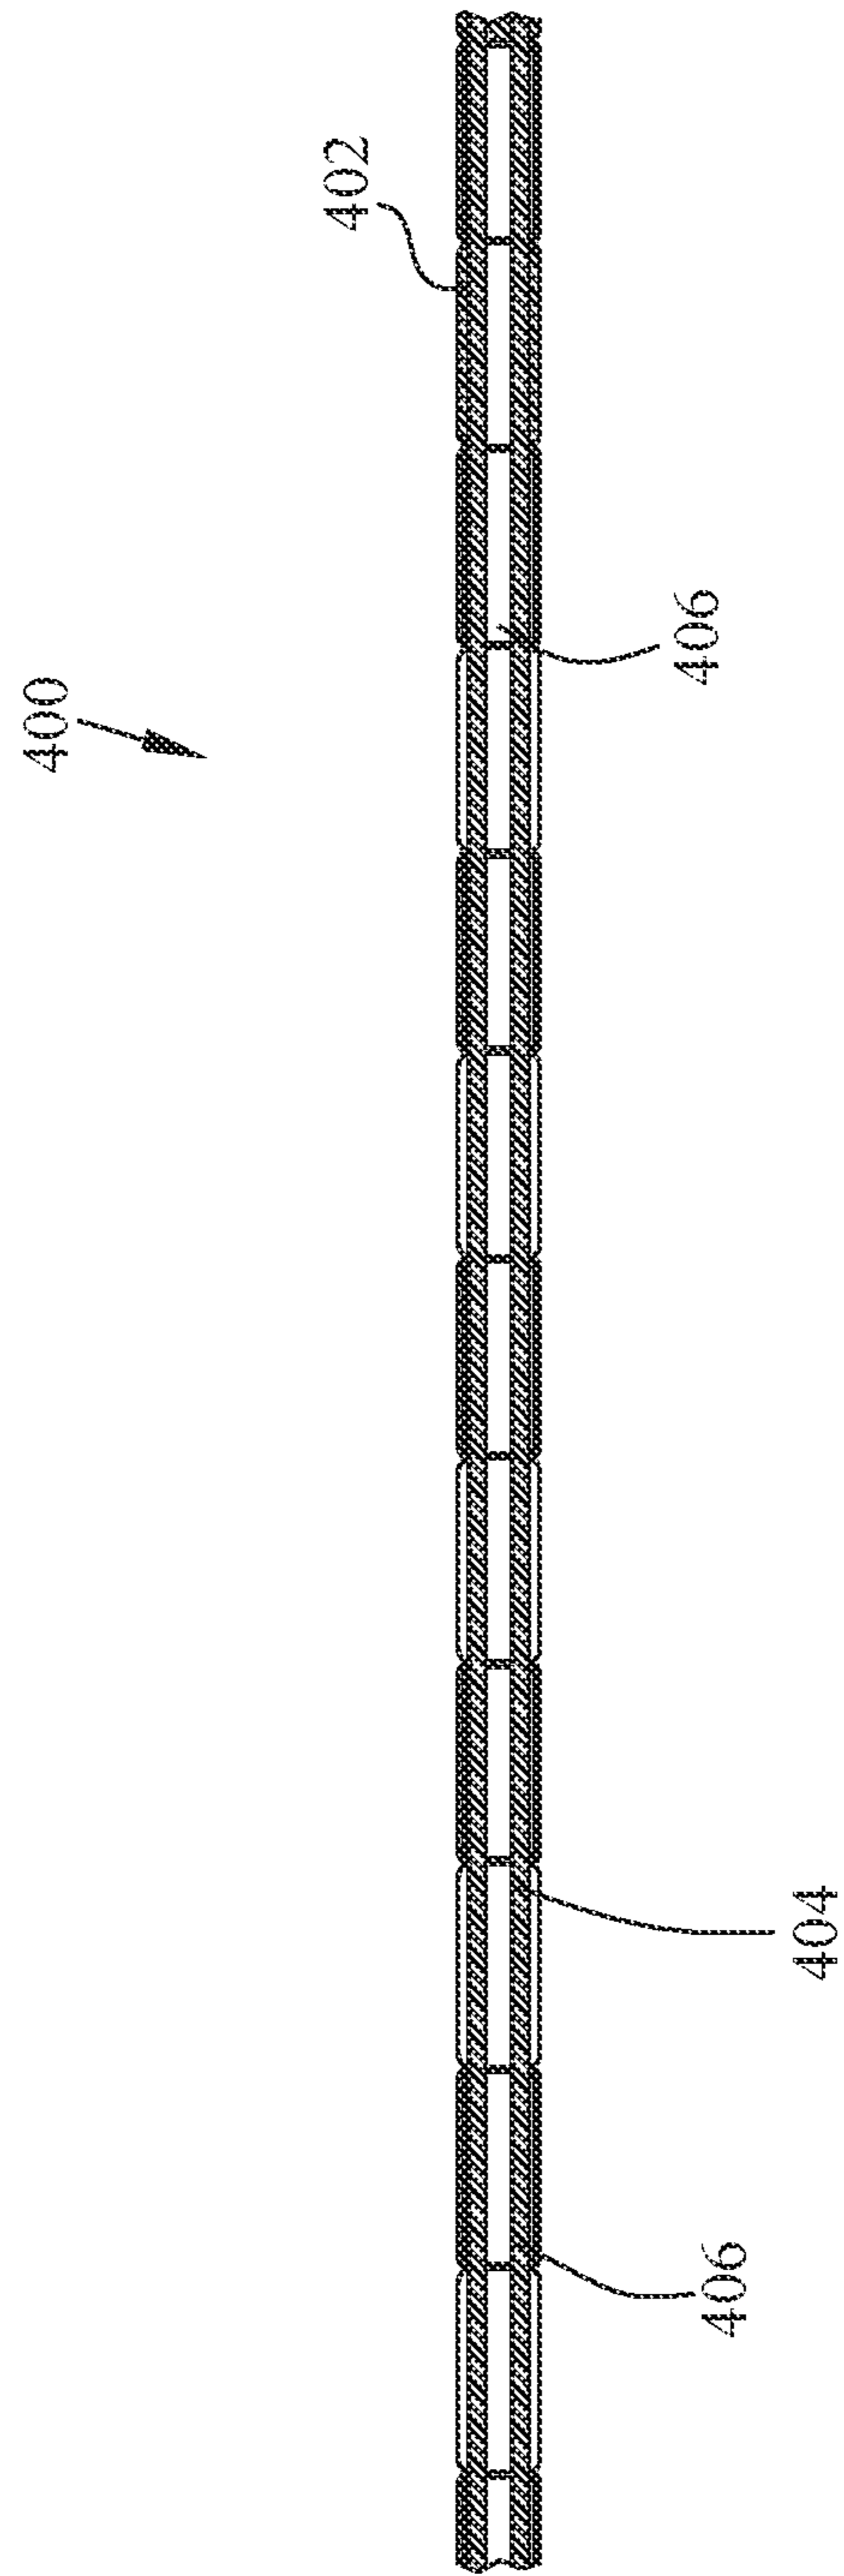
FIG. 19 is a side perspective view of the vehicle frame and cargo bay liner of FIG. 14 with the aluminum foil removed;

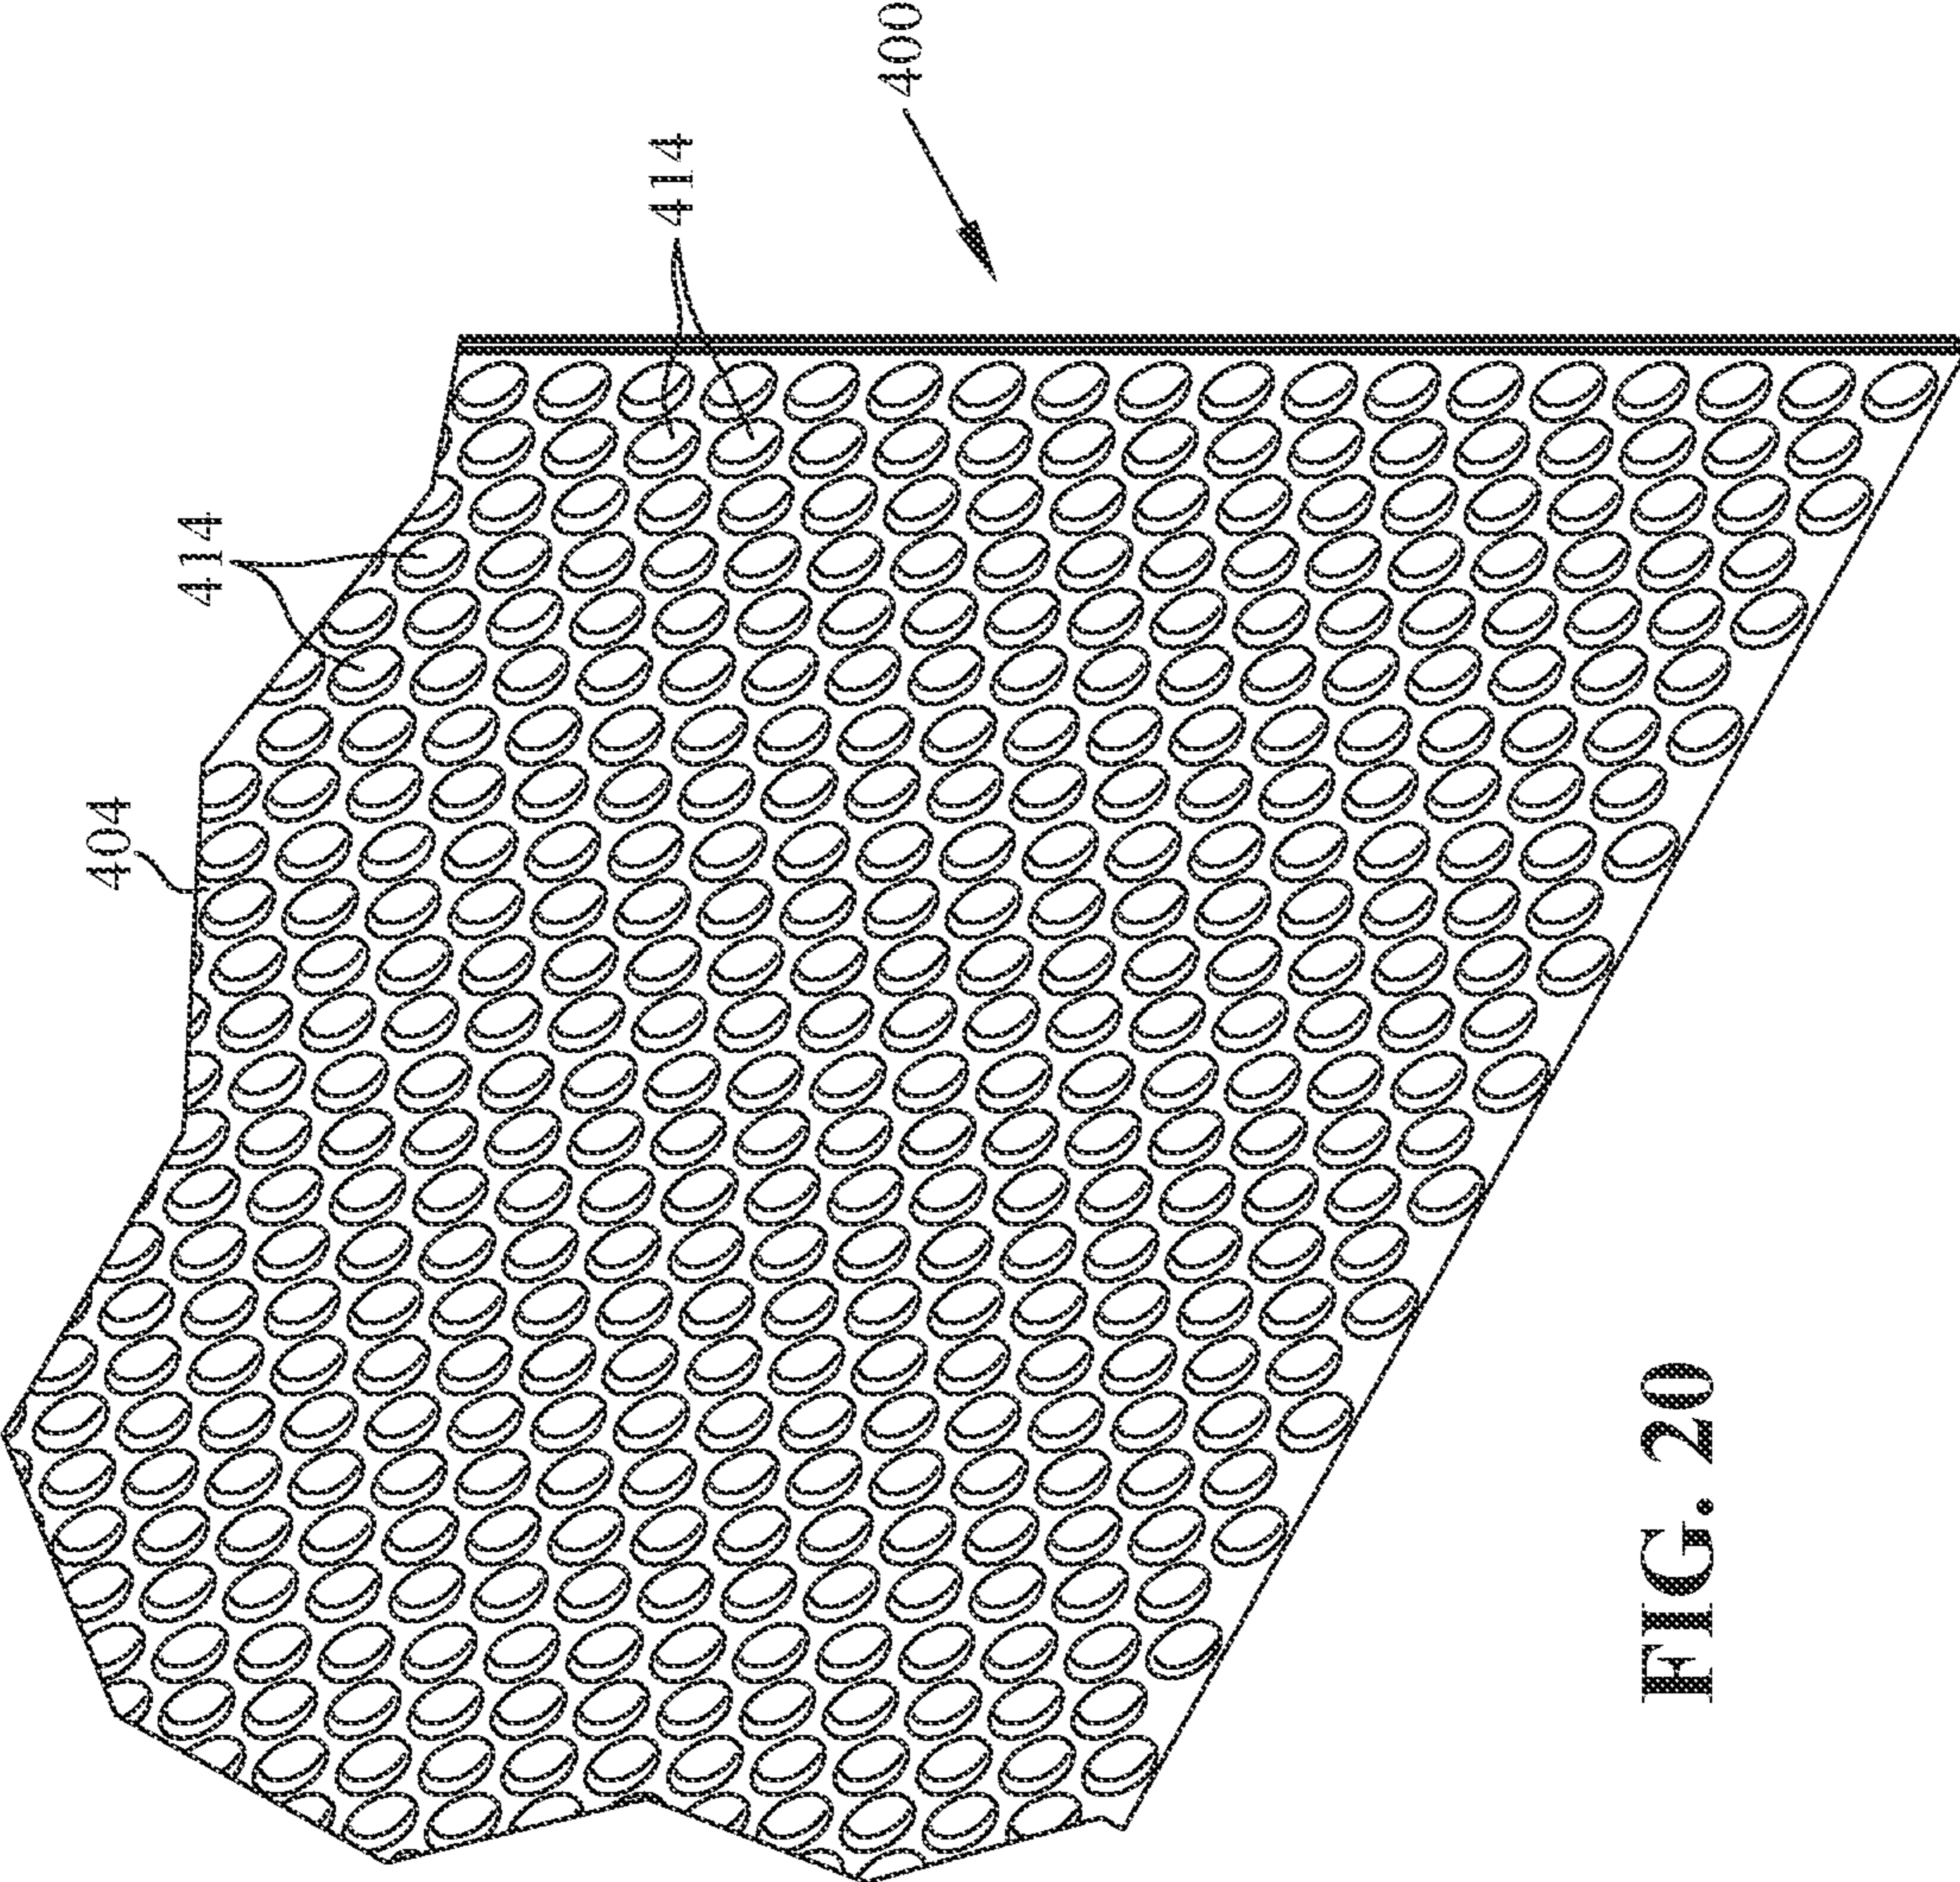
FIG. 20 is a plan perspective view of the bottom side of the vehicle frame and cargo bay liner of FIG. 14;

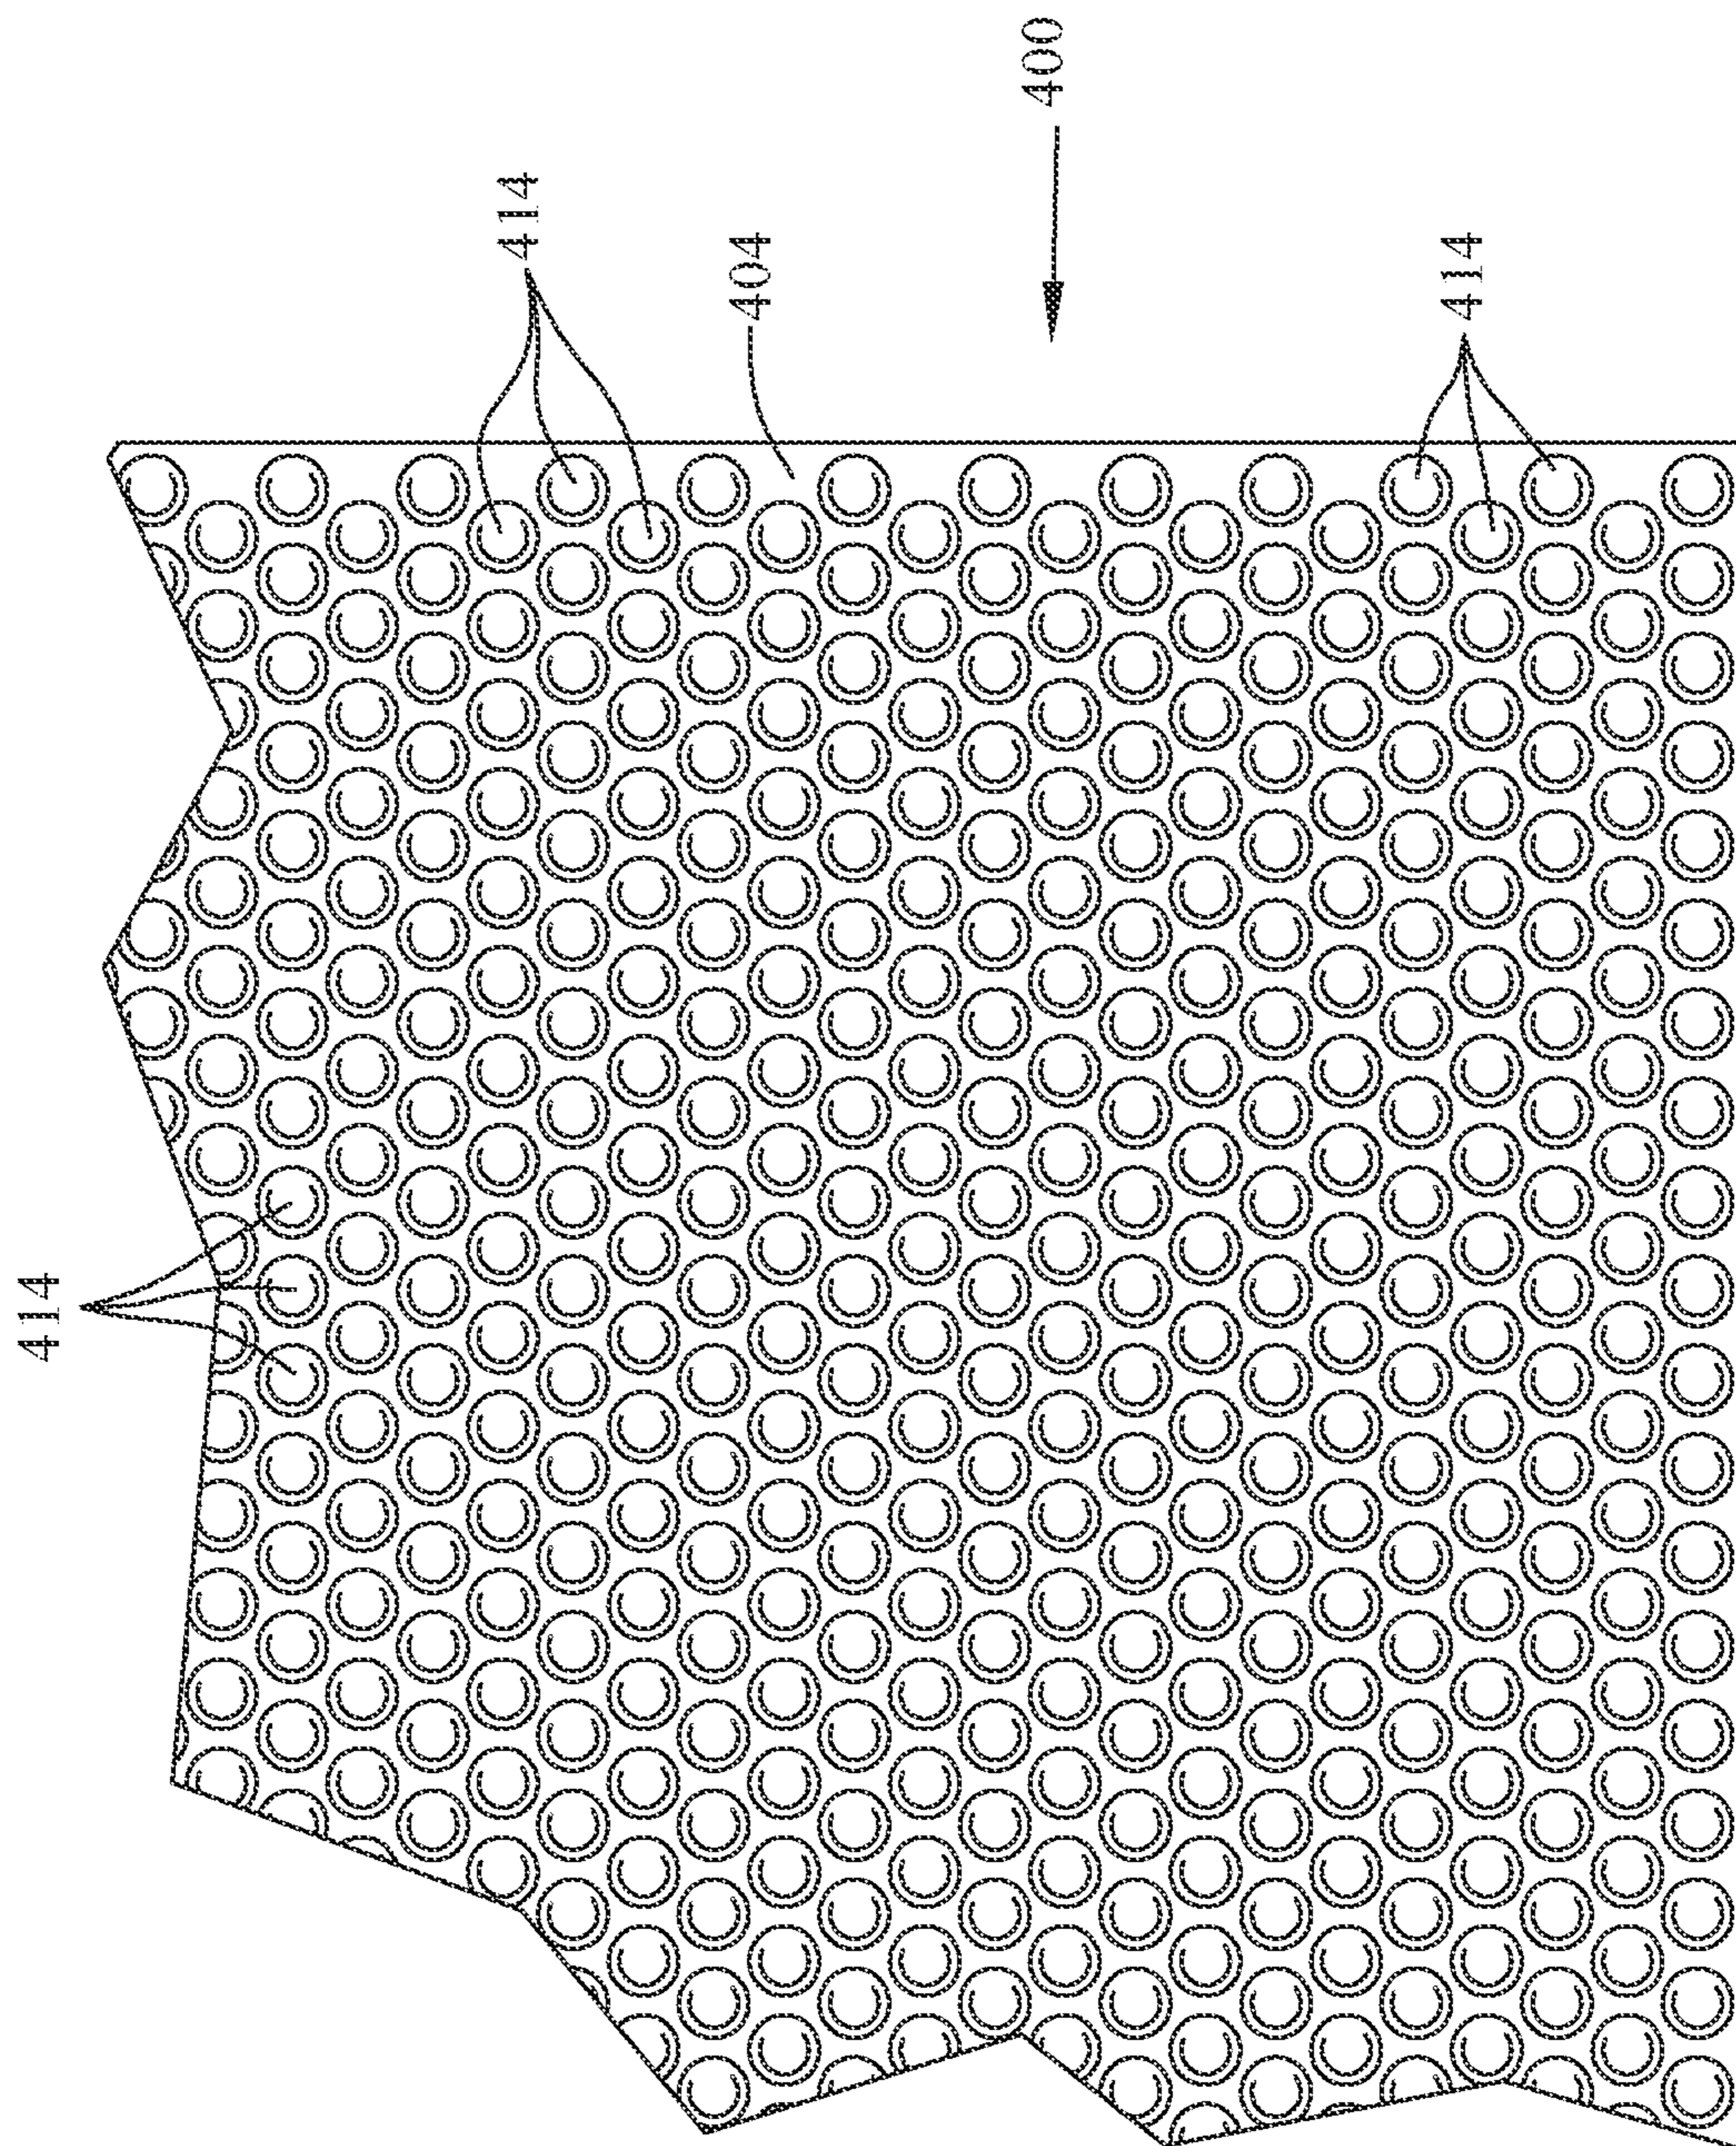
FIG. 21 is an enlarged bottom plan perspective view of the vehicle frame and cargo bay liner of FIG. 14;

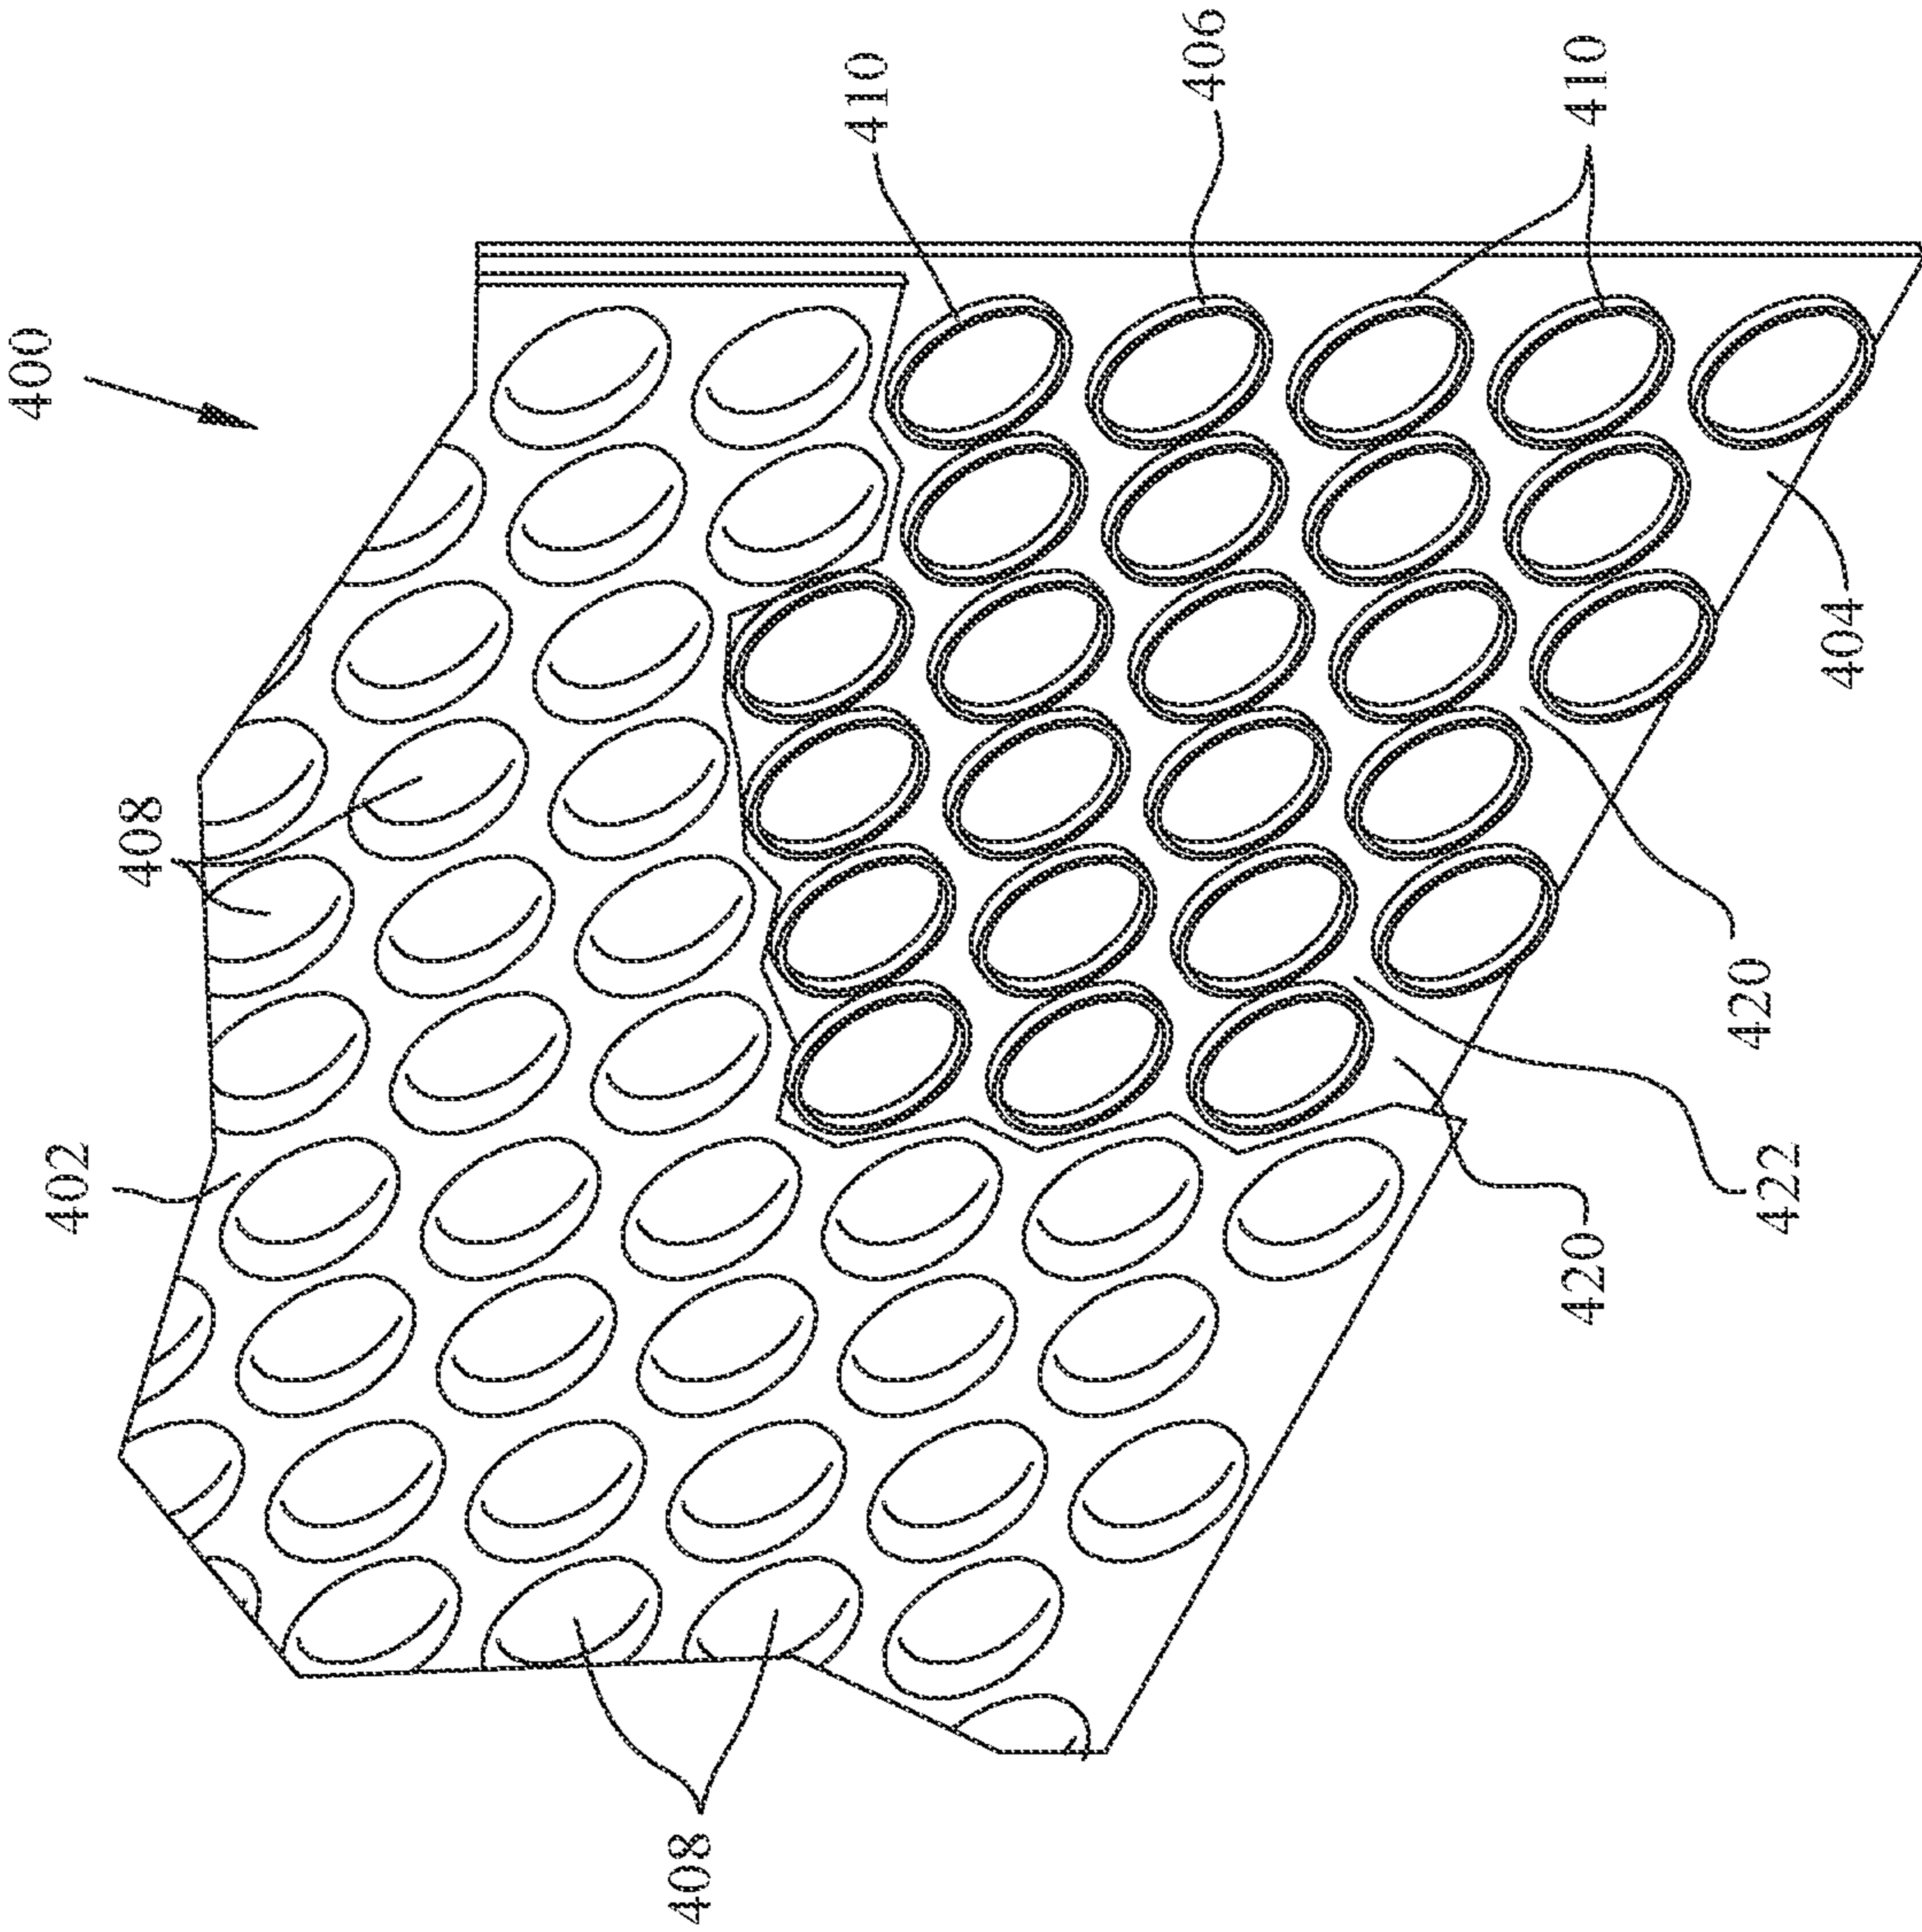
FIG. 22 is a perspective view of a portion of the vehicle frame and cargo bay liner of FIG. 14 showing part of the top layer removed;

As can be seen in FIGS. 22 and 23, cylindrical projections **410** form an obstruction to passage through core **406** such that any water entering the ends thereof is obstructed and impeded or hindered from propagating across liner **400** as compared to channels **111** in corrugated liner **104**, which readily allow transport of liquids. Additionally, as where vehicle frame and cargo bay liner **400** is cut, it will intersect a plurality of cylindrical projections **410** in the liner. As each cylinder is closed off, any water entering into an end of the liner where a projection has been cut will be prevented from further propagating by encountering the wall of the projection. Only a small area or channel **422** between cylindrical projections would allow any water or moisture to enter into core **406** of liner **400**, but that will not readily propagate to the offset projections internal to core **406** that will impede or hinder any advancement of the moisture.

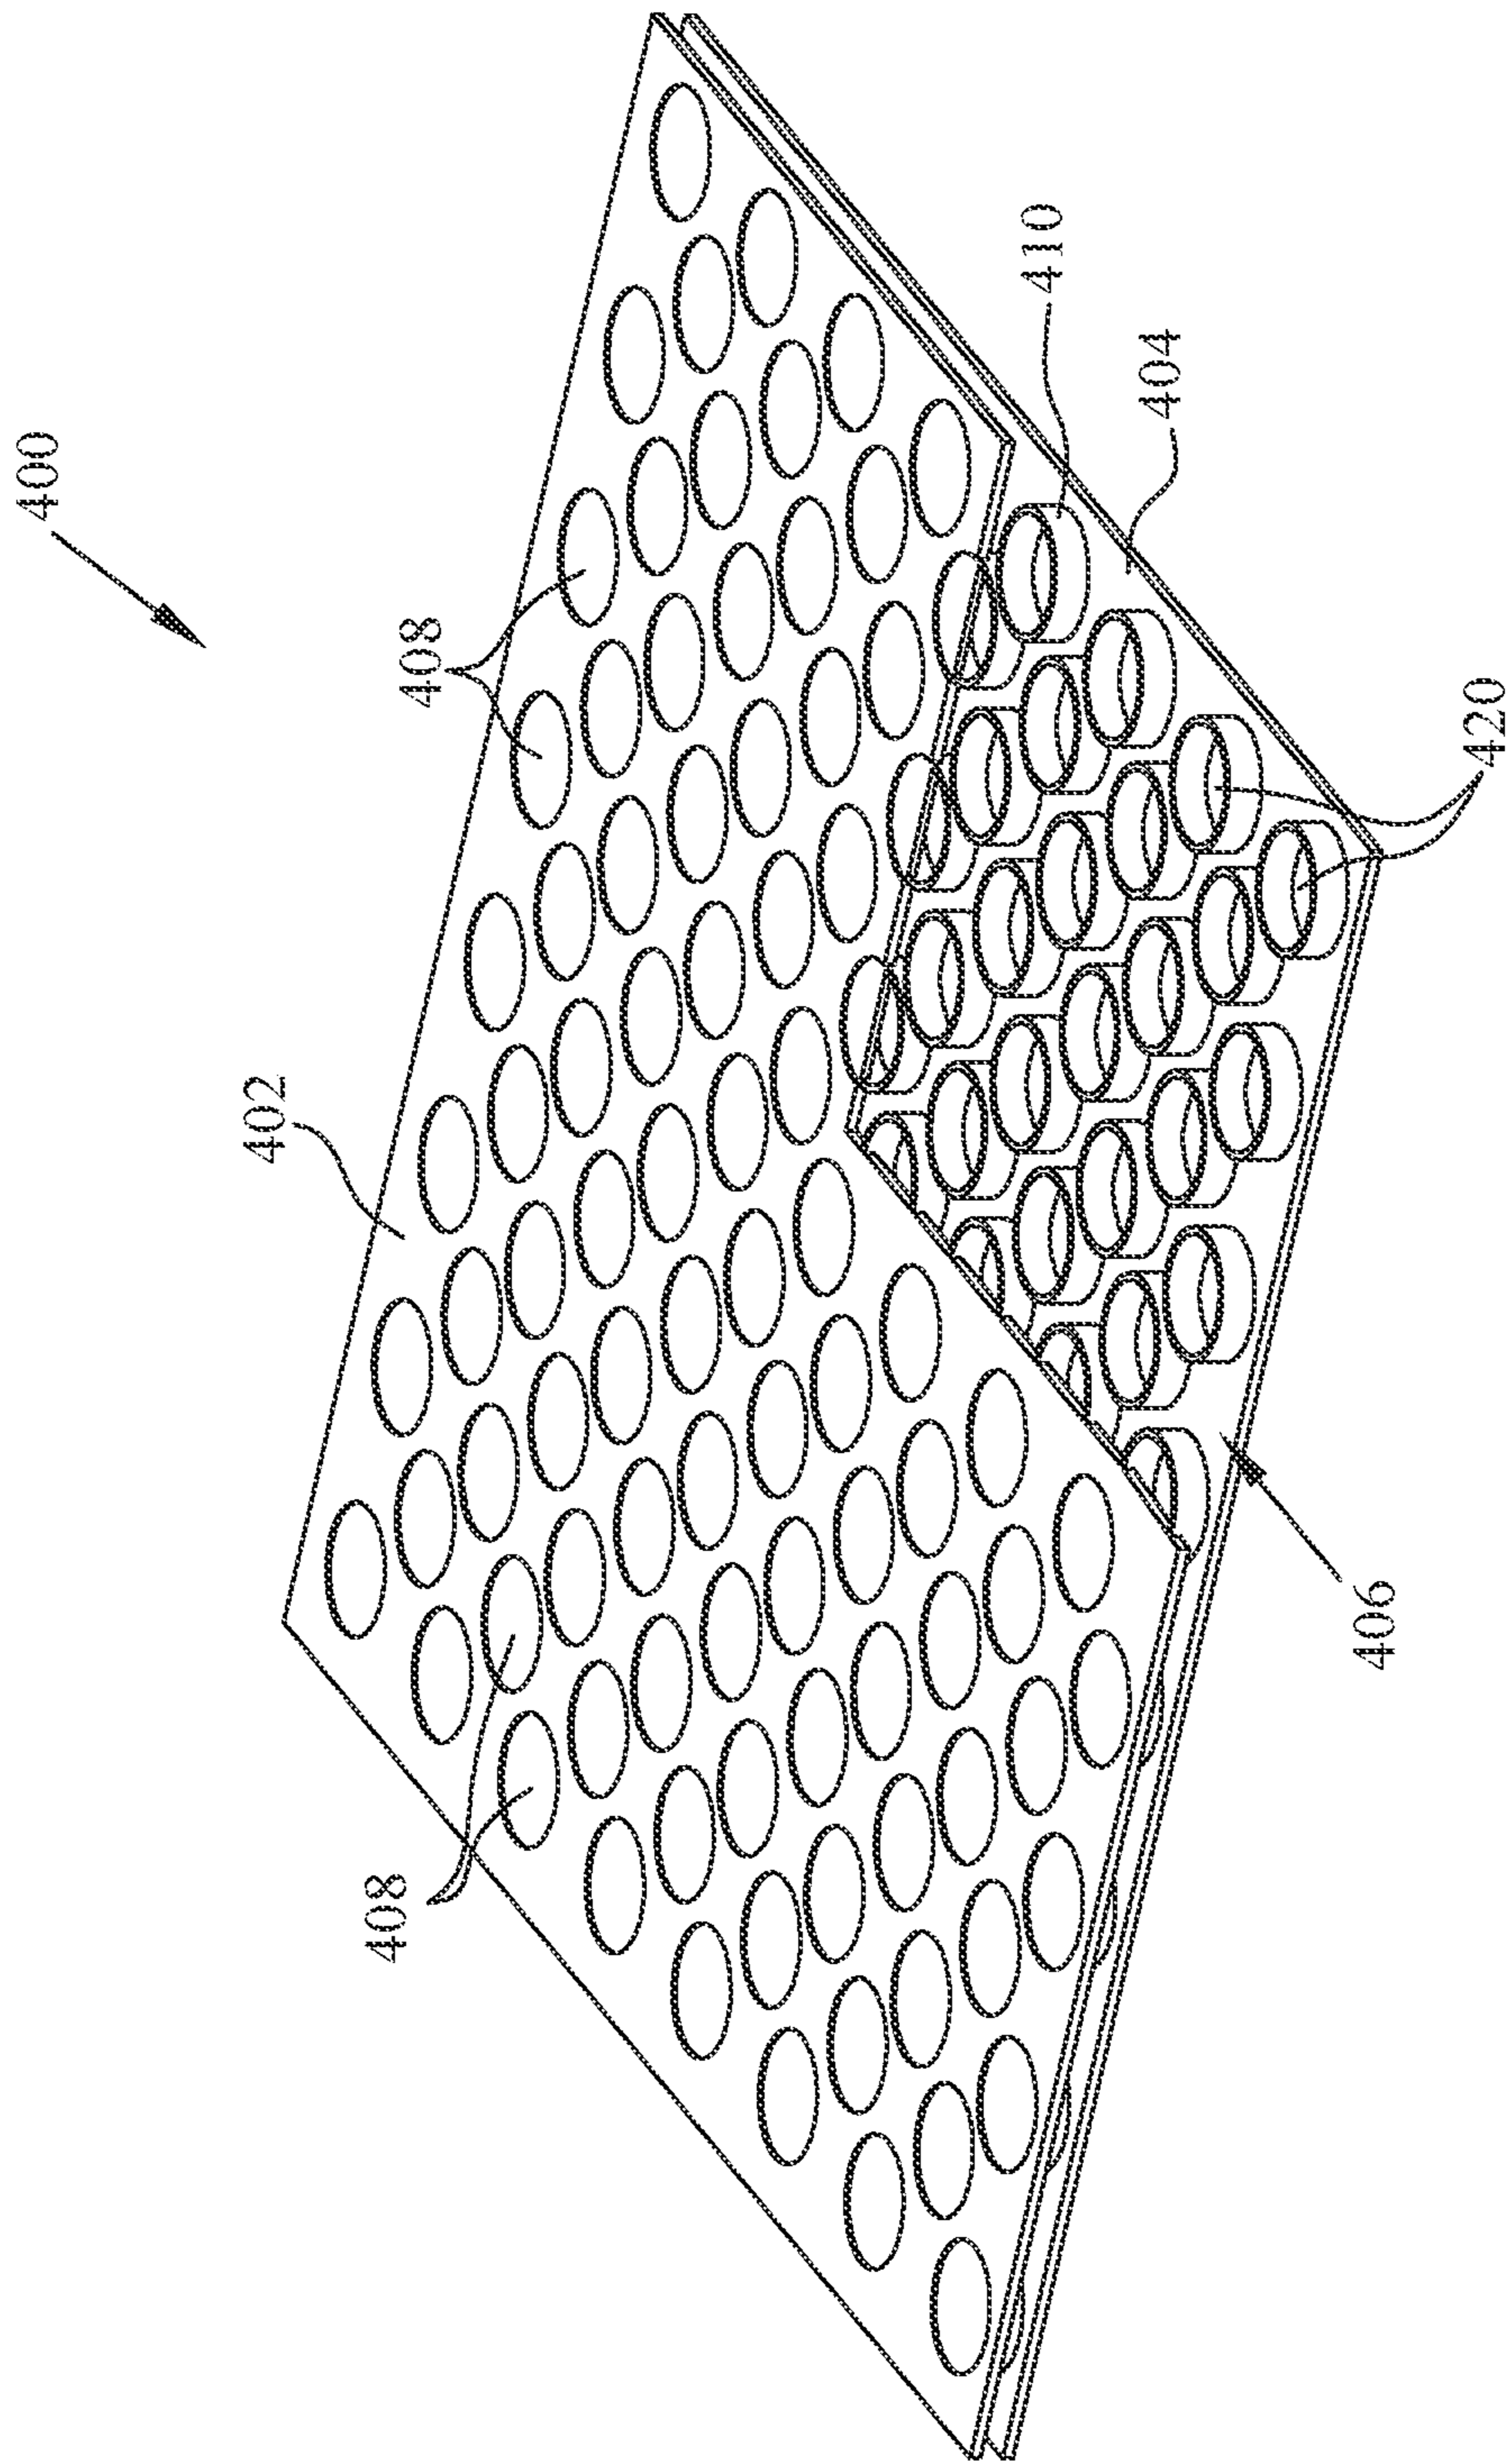
FIG. 23 is another perspective view of a portion of the vehicle frame and cargo bay liner of FIG. 14 with part of the top layer removed;
