(12) **United States Patent**
Pennington

(54) **VEHICLE FRAME AND CARGO BAY LINER**

(71) Applicant: **PennPlastics, LLC**, Mishawaka, IN (US)

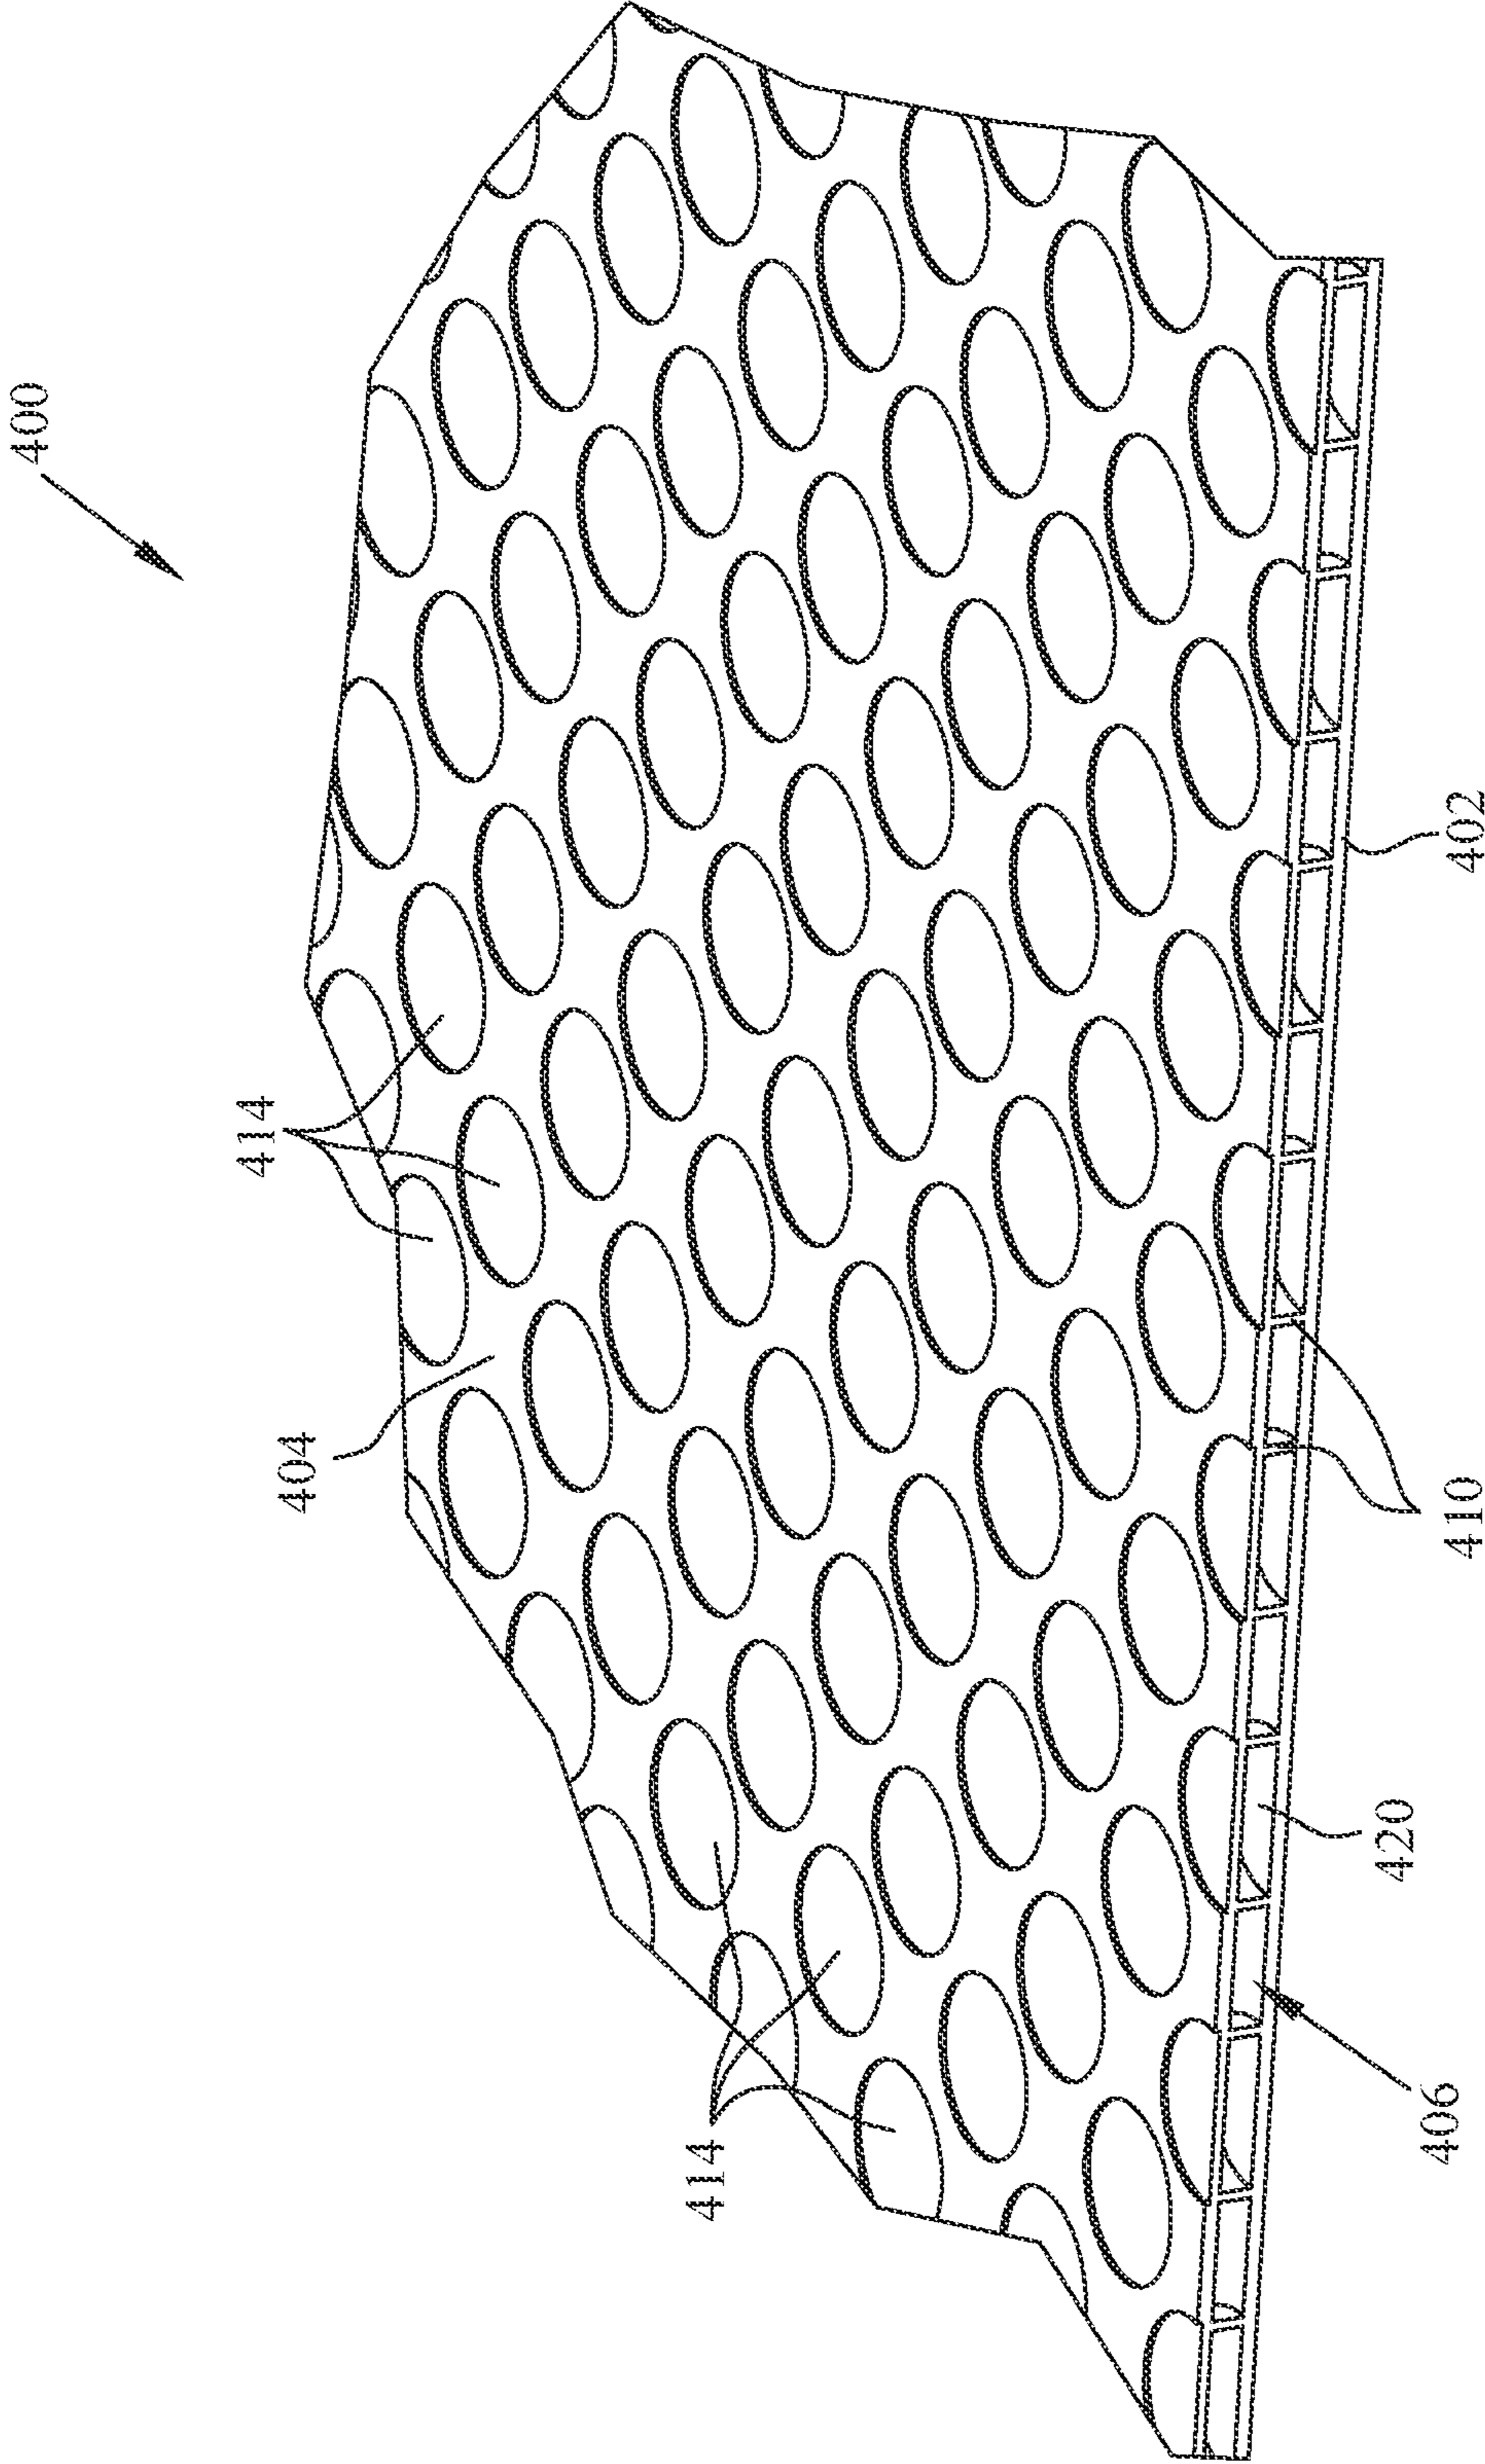
FIG. 24 is a perspective view of the bottom side of a portion of the vehicle frame and cargo bay liner of FIG. 14;

When rolled out and installed on a frame **32** of a recreational vehicle, aluminum sheet or foil or metalized film **407** of liner **400** will preferably be disposed toward the living quarters of the recreational vehicle. Accordingly, the foil/film provides an additional insulation barrier between the ground and living quarters. The aluminum foil/metalized film could be placed towards the ground of a recreational vehicle; however, any stones or debris kicking up may create tearing or holes therein. Additionally, vehicle frame and cargo bay liner **400** may be utilized without the foil/film thereon if desired.

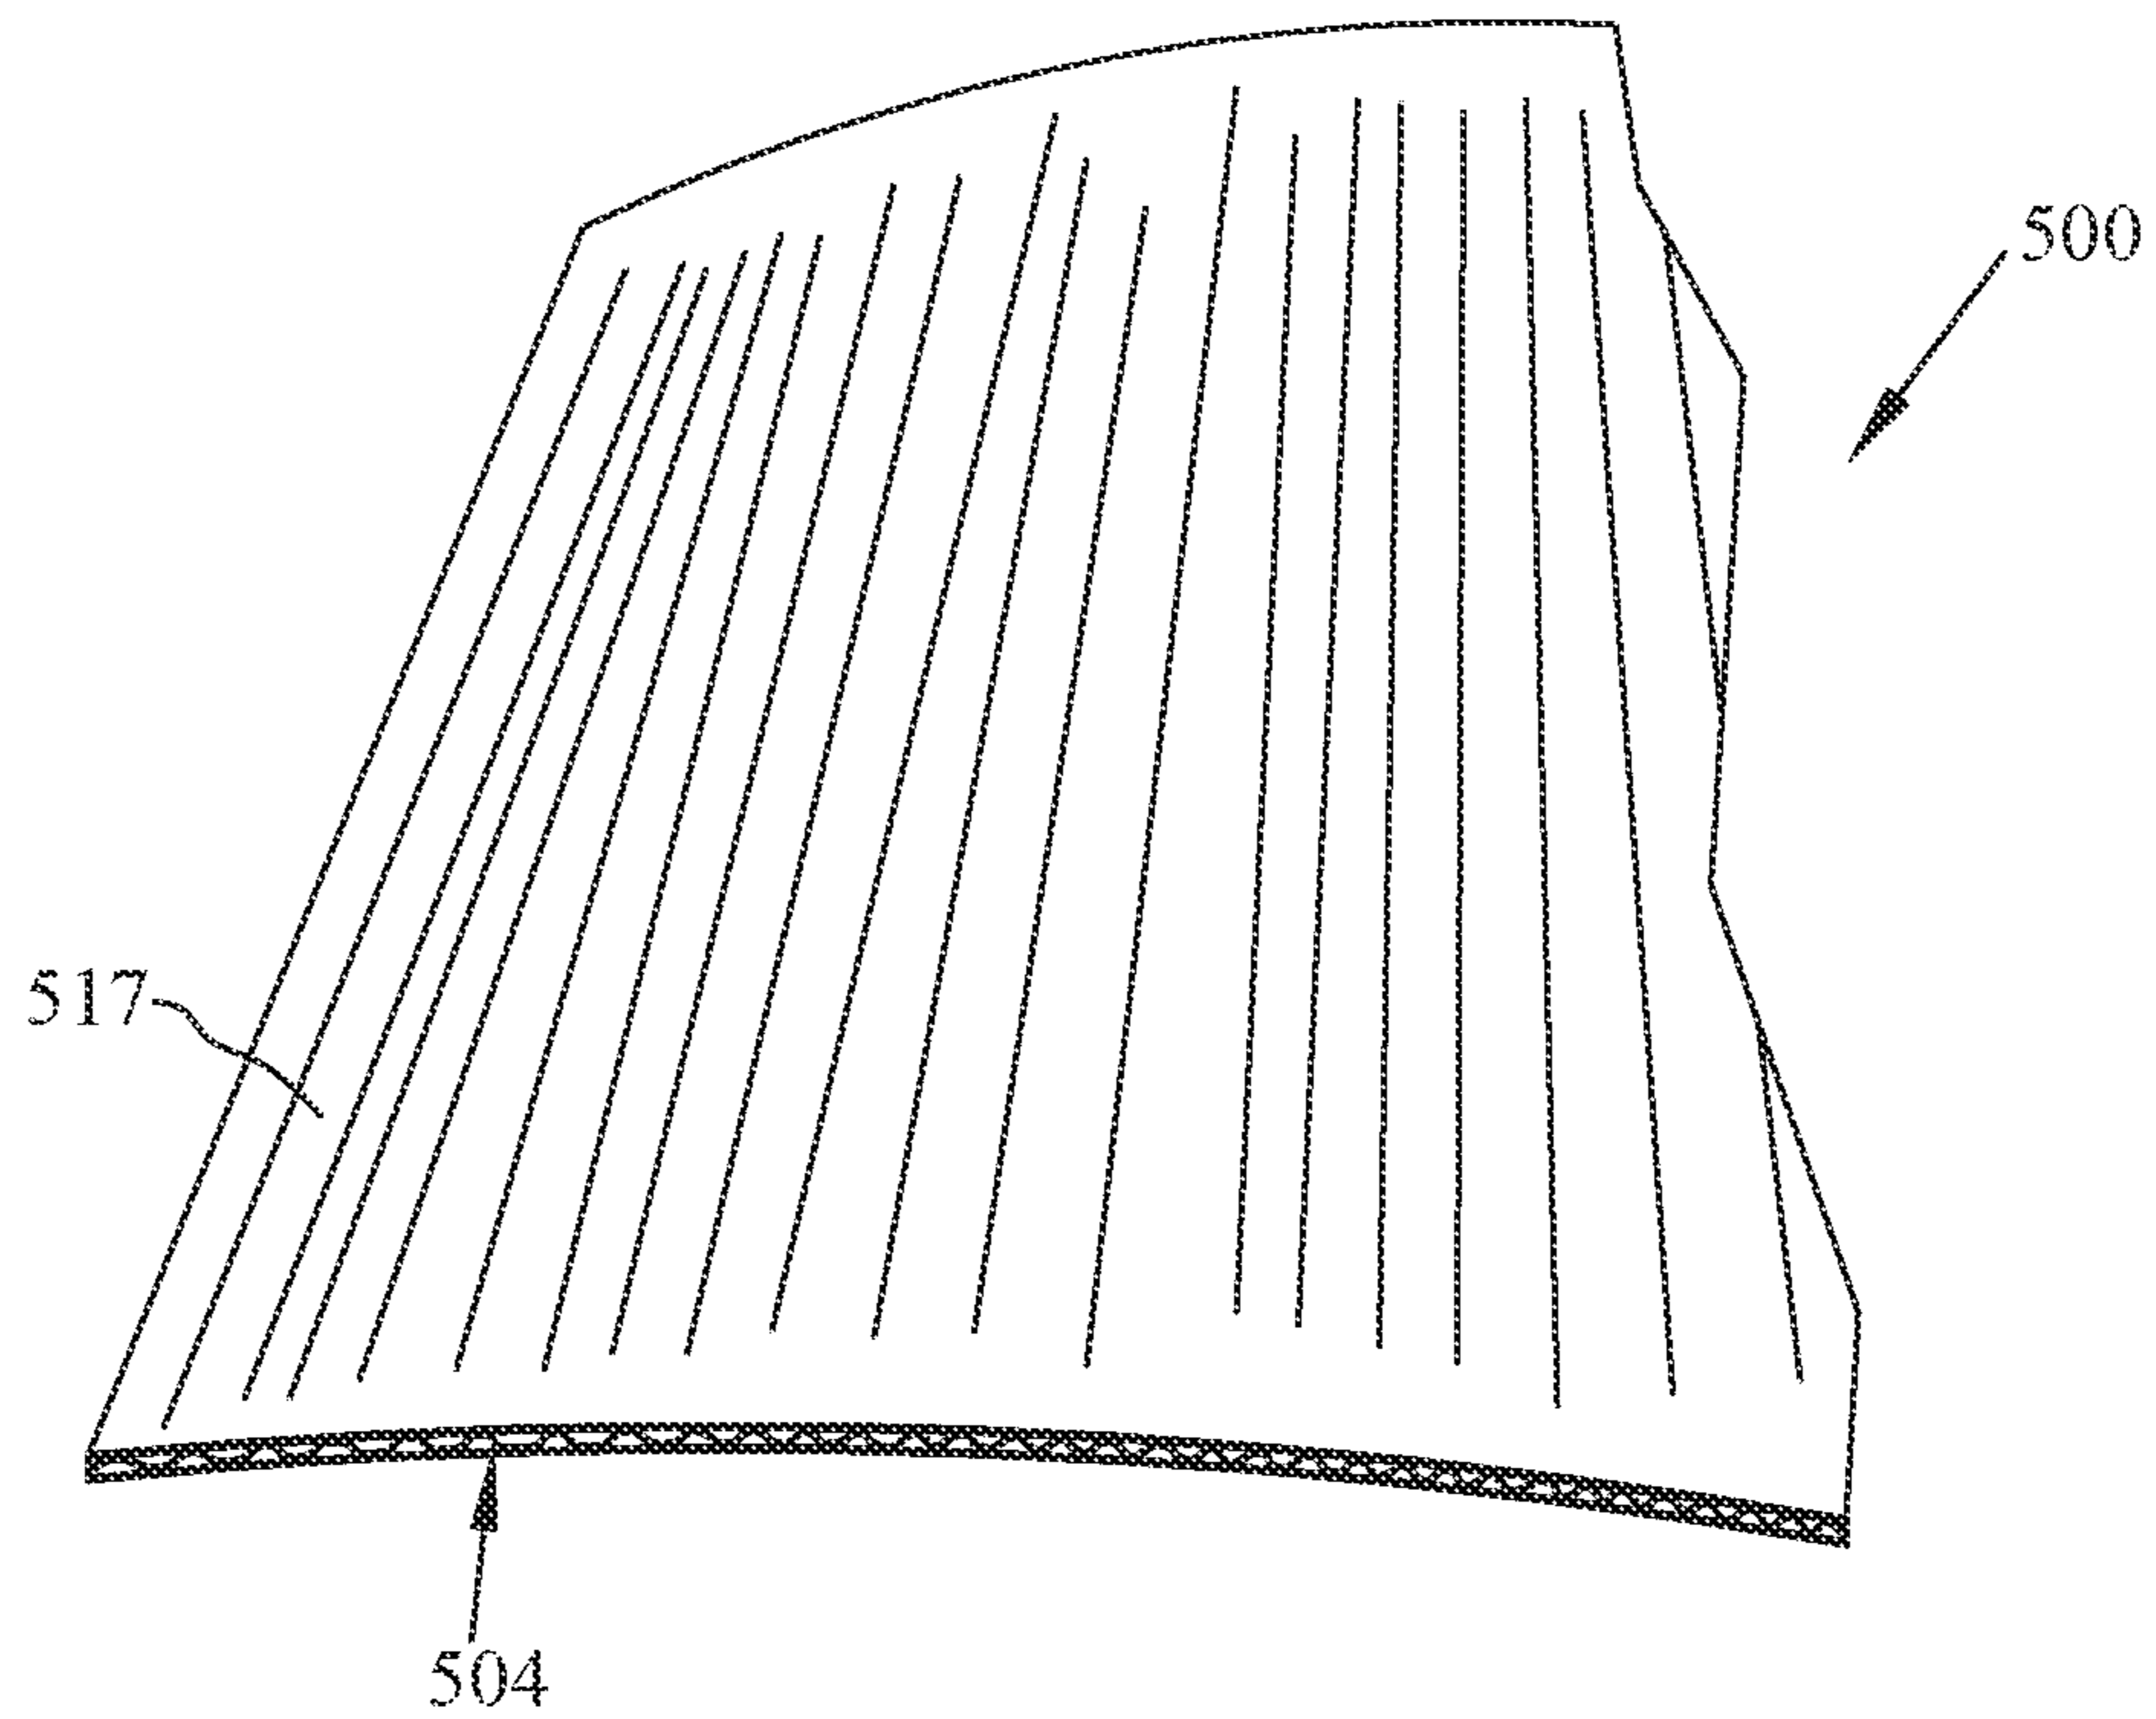
FIG. 25 is a perspective view of an additional alternate embodiment vehicle frame and cargo bay liner shown laid out and having an aluminum foil on one side thereof;

Now referring to FIGS. 25-27, other alternate embodiment vehicle frame and cargo area liner is shown generally indicated as **500**. Liner **500** includes a corrugated liner, generally indicated as **504**. Corrugated liner **504** includes a top sheet **506**, a bottom sheet **508**, and a corrugated or sinusoidal ply **510** extending therebetween, as best shown in FIGS. 26 and 27. Top sheet **506** and bottom sheet **508** each have a generally planar configuration, not including any rolling memory that may be embedded therein and are adhered or thermally attached to corrugated ply **510**. It should be appreciated that the corrugated ply is defined to include either a sinusoidal configuration as shown in FIGS. 26 and 27 or alternately a plurality of member perpendicular to top sheet **506** and bottom sheet **508** such as is shown in the material utilized in FIGS. 7 and 8 of U.S. Pat. No. 10,000,930 B2 to Lowe et al., which is incorporated in its entirety herein by reference. In one embodiment, corrugated liner **504** is polyethylene. Of course, other materials, and in particular, polymers such as polypropylene may be used for corrugated liner **504**. As best shown in FIG. 26, when the corrugated liner **504** is rolled, the outer sheet will become stretched and the inner sheet may fold as shown with top sheet **506**, and bottom sheet **508** in FIG. 26, respectively.

Additionally, vehicle frame and cargo area liner **500** also includes an aluminum foil or sheet or metalized film **517** adhered to top sheet **506** of corrugated liner **504**. Aluminum foil or sheet or metalized film **517** is preferably mounted so that it is between corrugated liner **504** and housing or living quarters **14** of the recreational vehicle **10**, in order to provide additional protection and insulation to the living quarters. However, aluminum foil or sheet or metalized film **517** may also be mounted downwardly on the vehicle frame so that it is facing the road surface. It should be appreciated that aluminum foil or sheet or metalized film **517** may be adhered to bottom sheet **508** rather than top sheet **506**. Vehicle frame and cargo area liner **500** may be mounted to a vehicle frame **32** utilizing means discussed above or other known means.

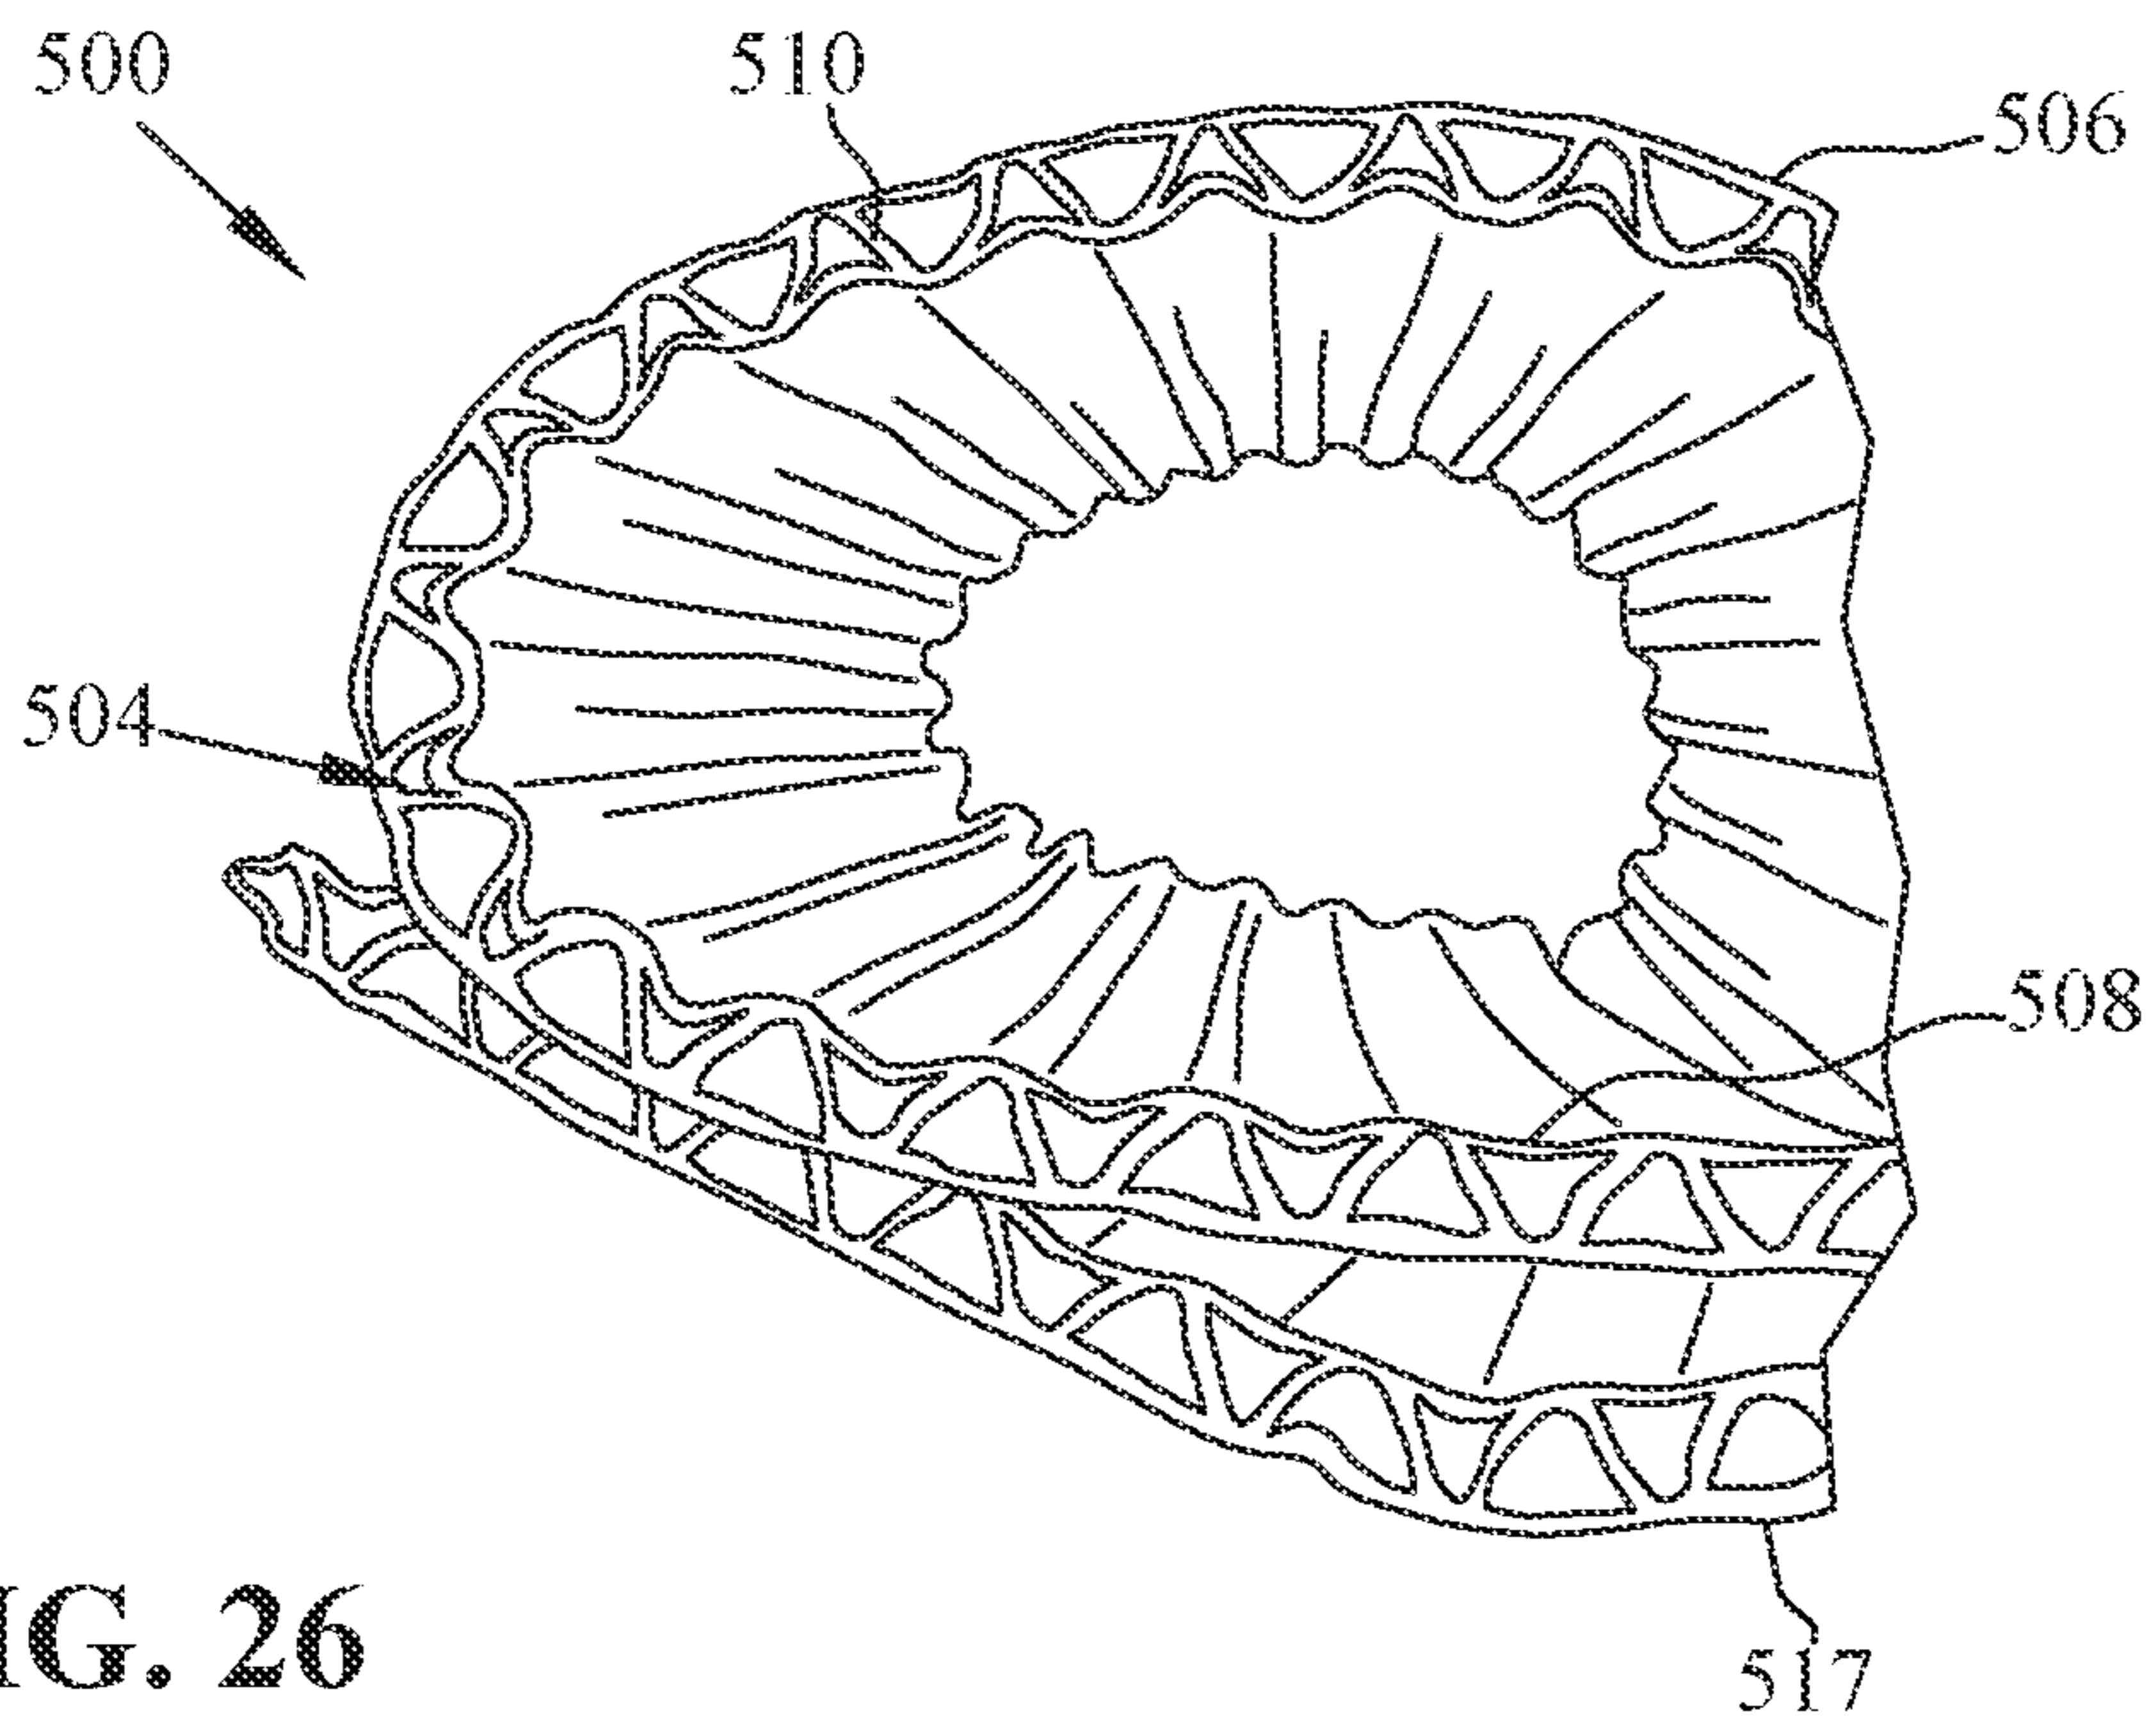
FIG. 26 is an end view of the vehicle frame and cargo bay liner of FIG. 25 shown rolled up wherein corrugations of the liner are readily visible;

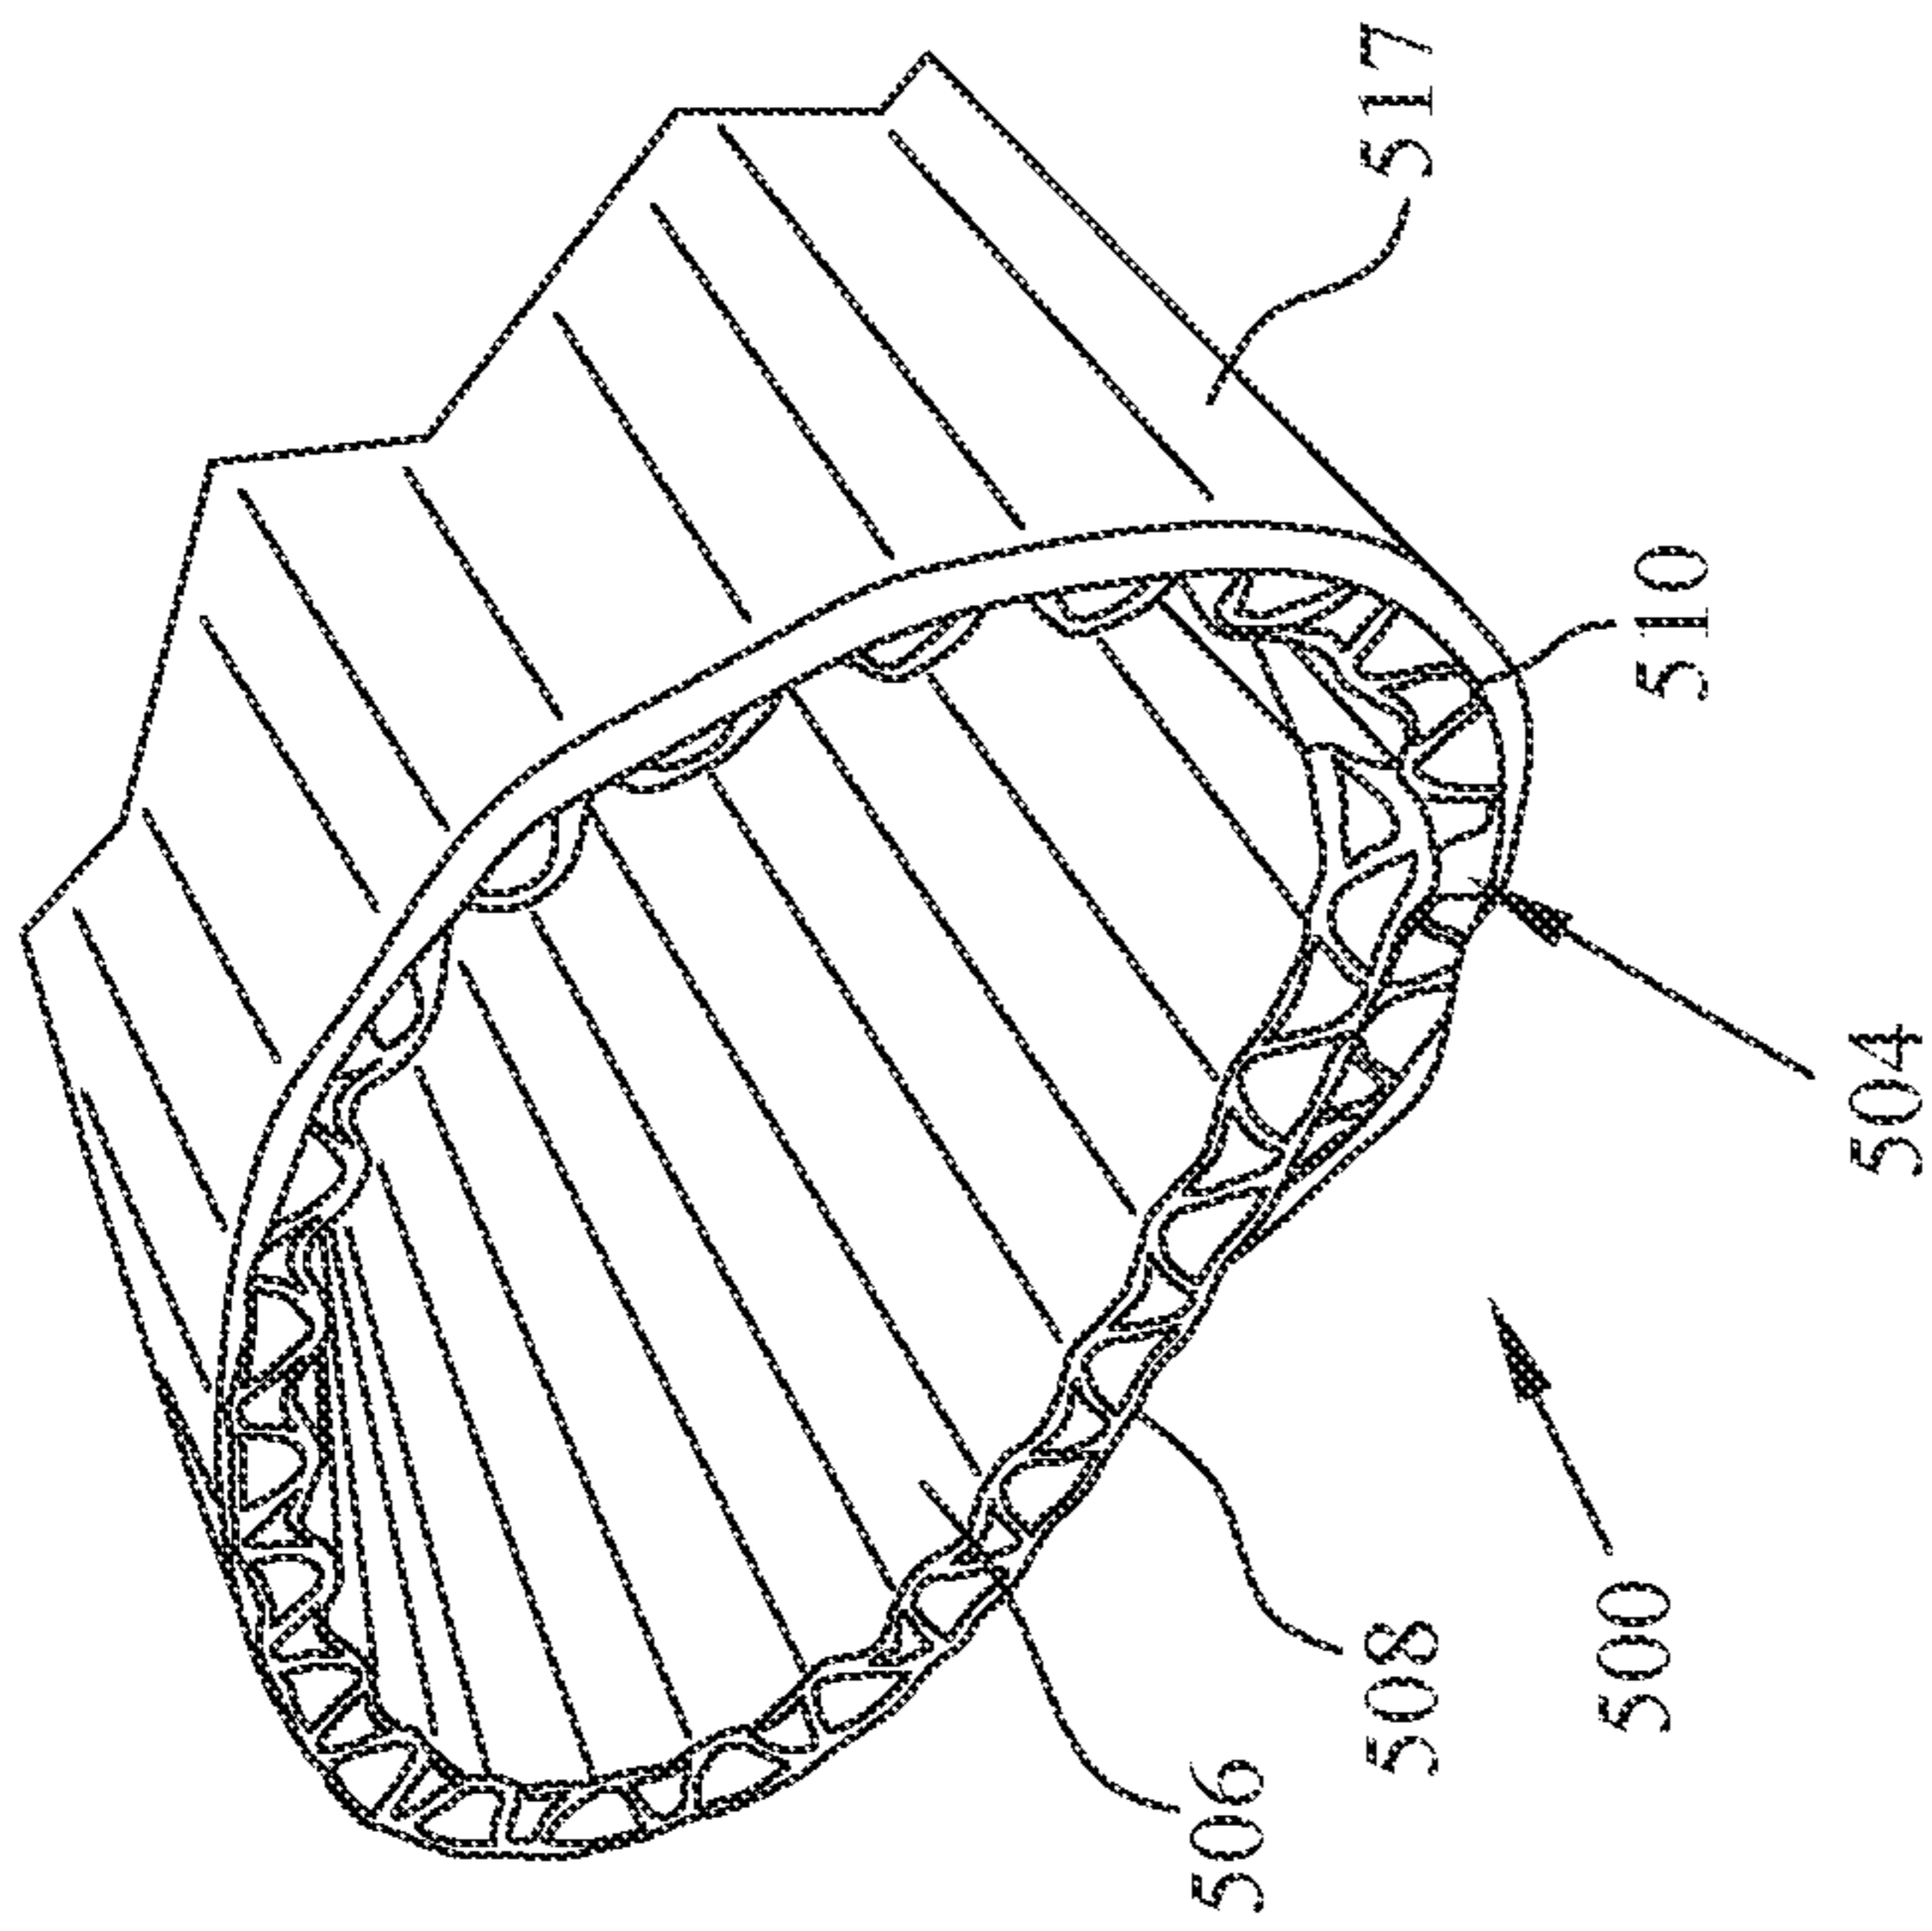
FIG. 27 is a perspective view of the vehicle frame and cargo bay liner of FIG. 25 rolled up with the aluminum foil on the outside thereof;

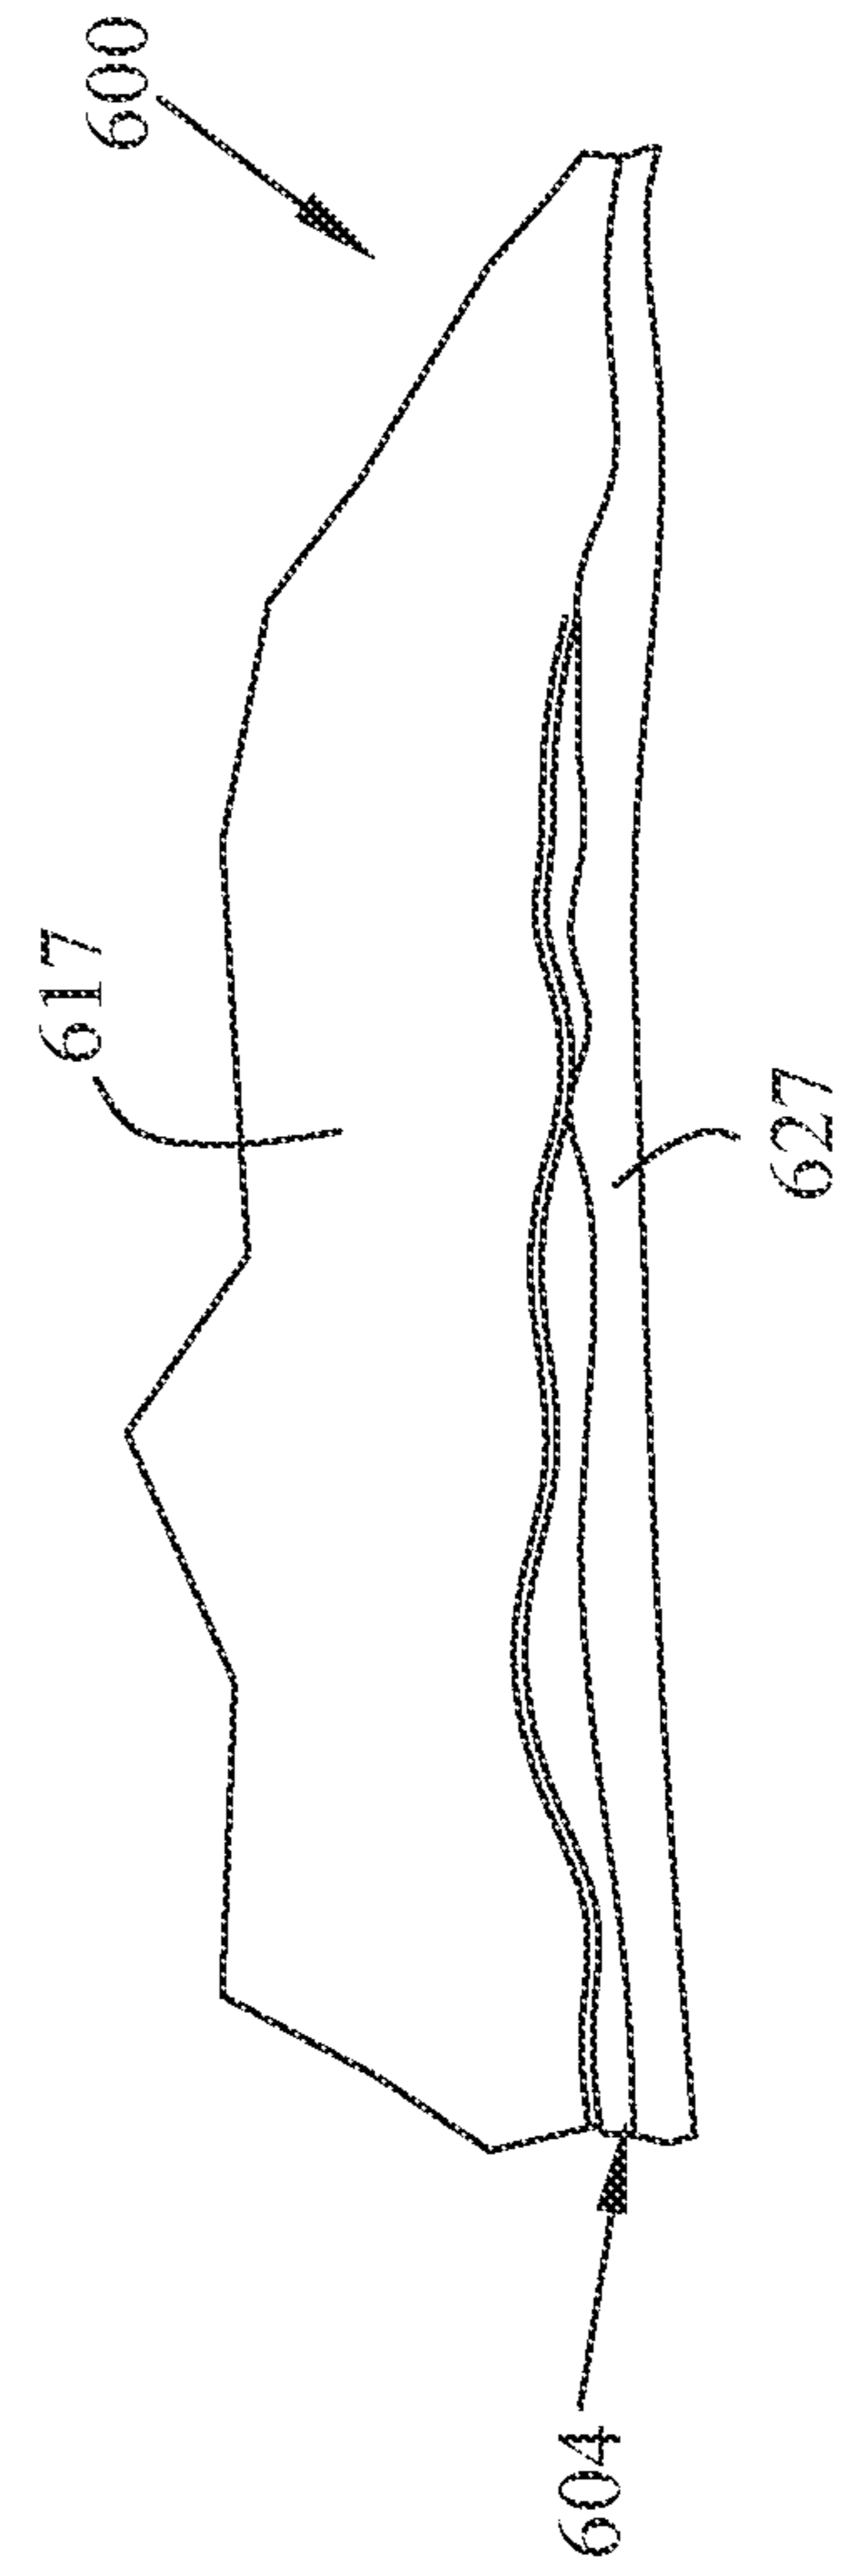
FIG. 28 is an end perspective view of another alternate embodiment vehicle frame and cargo bay liner shown laid out and having aluminum foil on both sides thereof;

Now referring to FIGS. 28-30, an additional embodiment of a 3-ply panel vehicle frame and cargo area liner is generally indicated as **600**. As with vehicle frame and cargo area liners **500**, vehicle frame and cargo area liner **600** includes a corrugated liner, generally indicated as **604**. Corrugated liner **604** includes a top sheet **606**, a bottom sheet **608**, and a corrugated or sinusoidal ply **610** extending therebetween. Top sheet **606** and bottom sheet **608** are adhered or thermally attached to corrugated ply **610** and may be made from materials similar to corrugated liner **500**, such as but not limited to polyurethane or polyethylene. Alternately, liner **600** may be an extruded manufactured design,

As with vehicle and frame and cargo area liner **500**, liner **600** also includes an aluminum foil or sheet **617** adhered to top ply or sheet **606**. Additionally, however, vehicle frame and cargo area liner **600** also includes a second aluminum foil or sheet **627** adhered to bottom sheet or ply **608** of corrugated liner **604**.

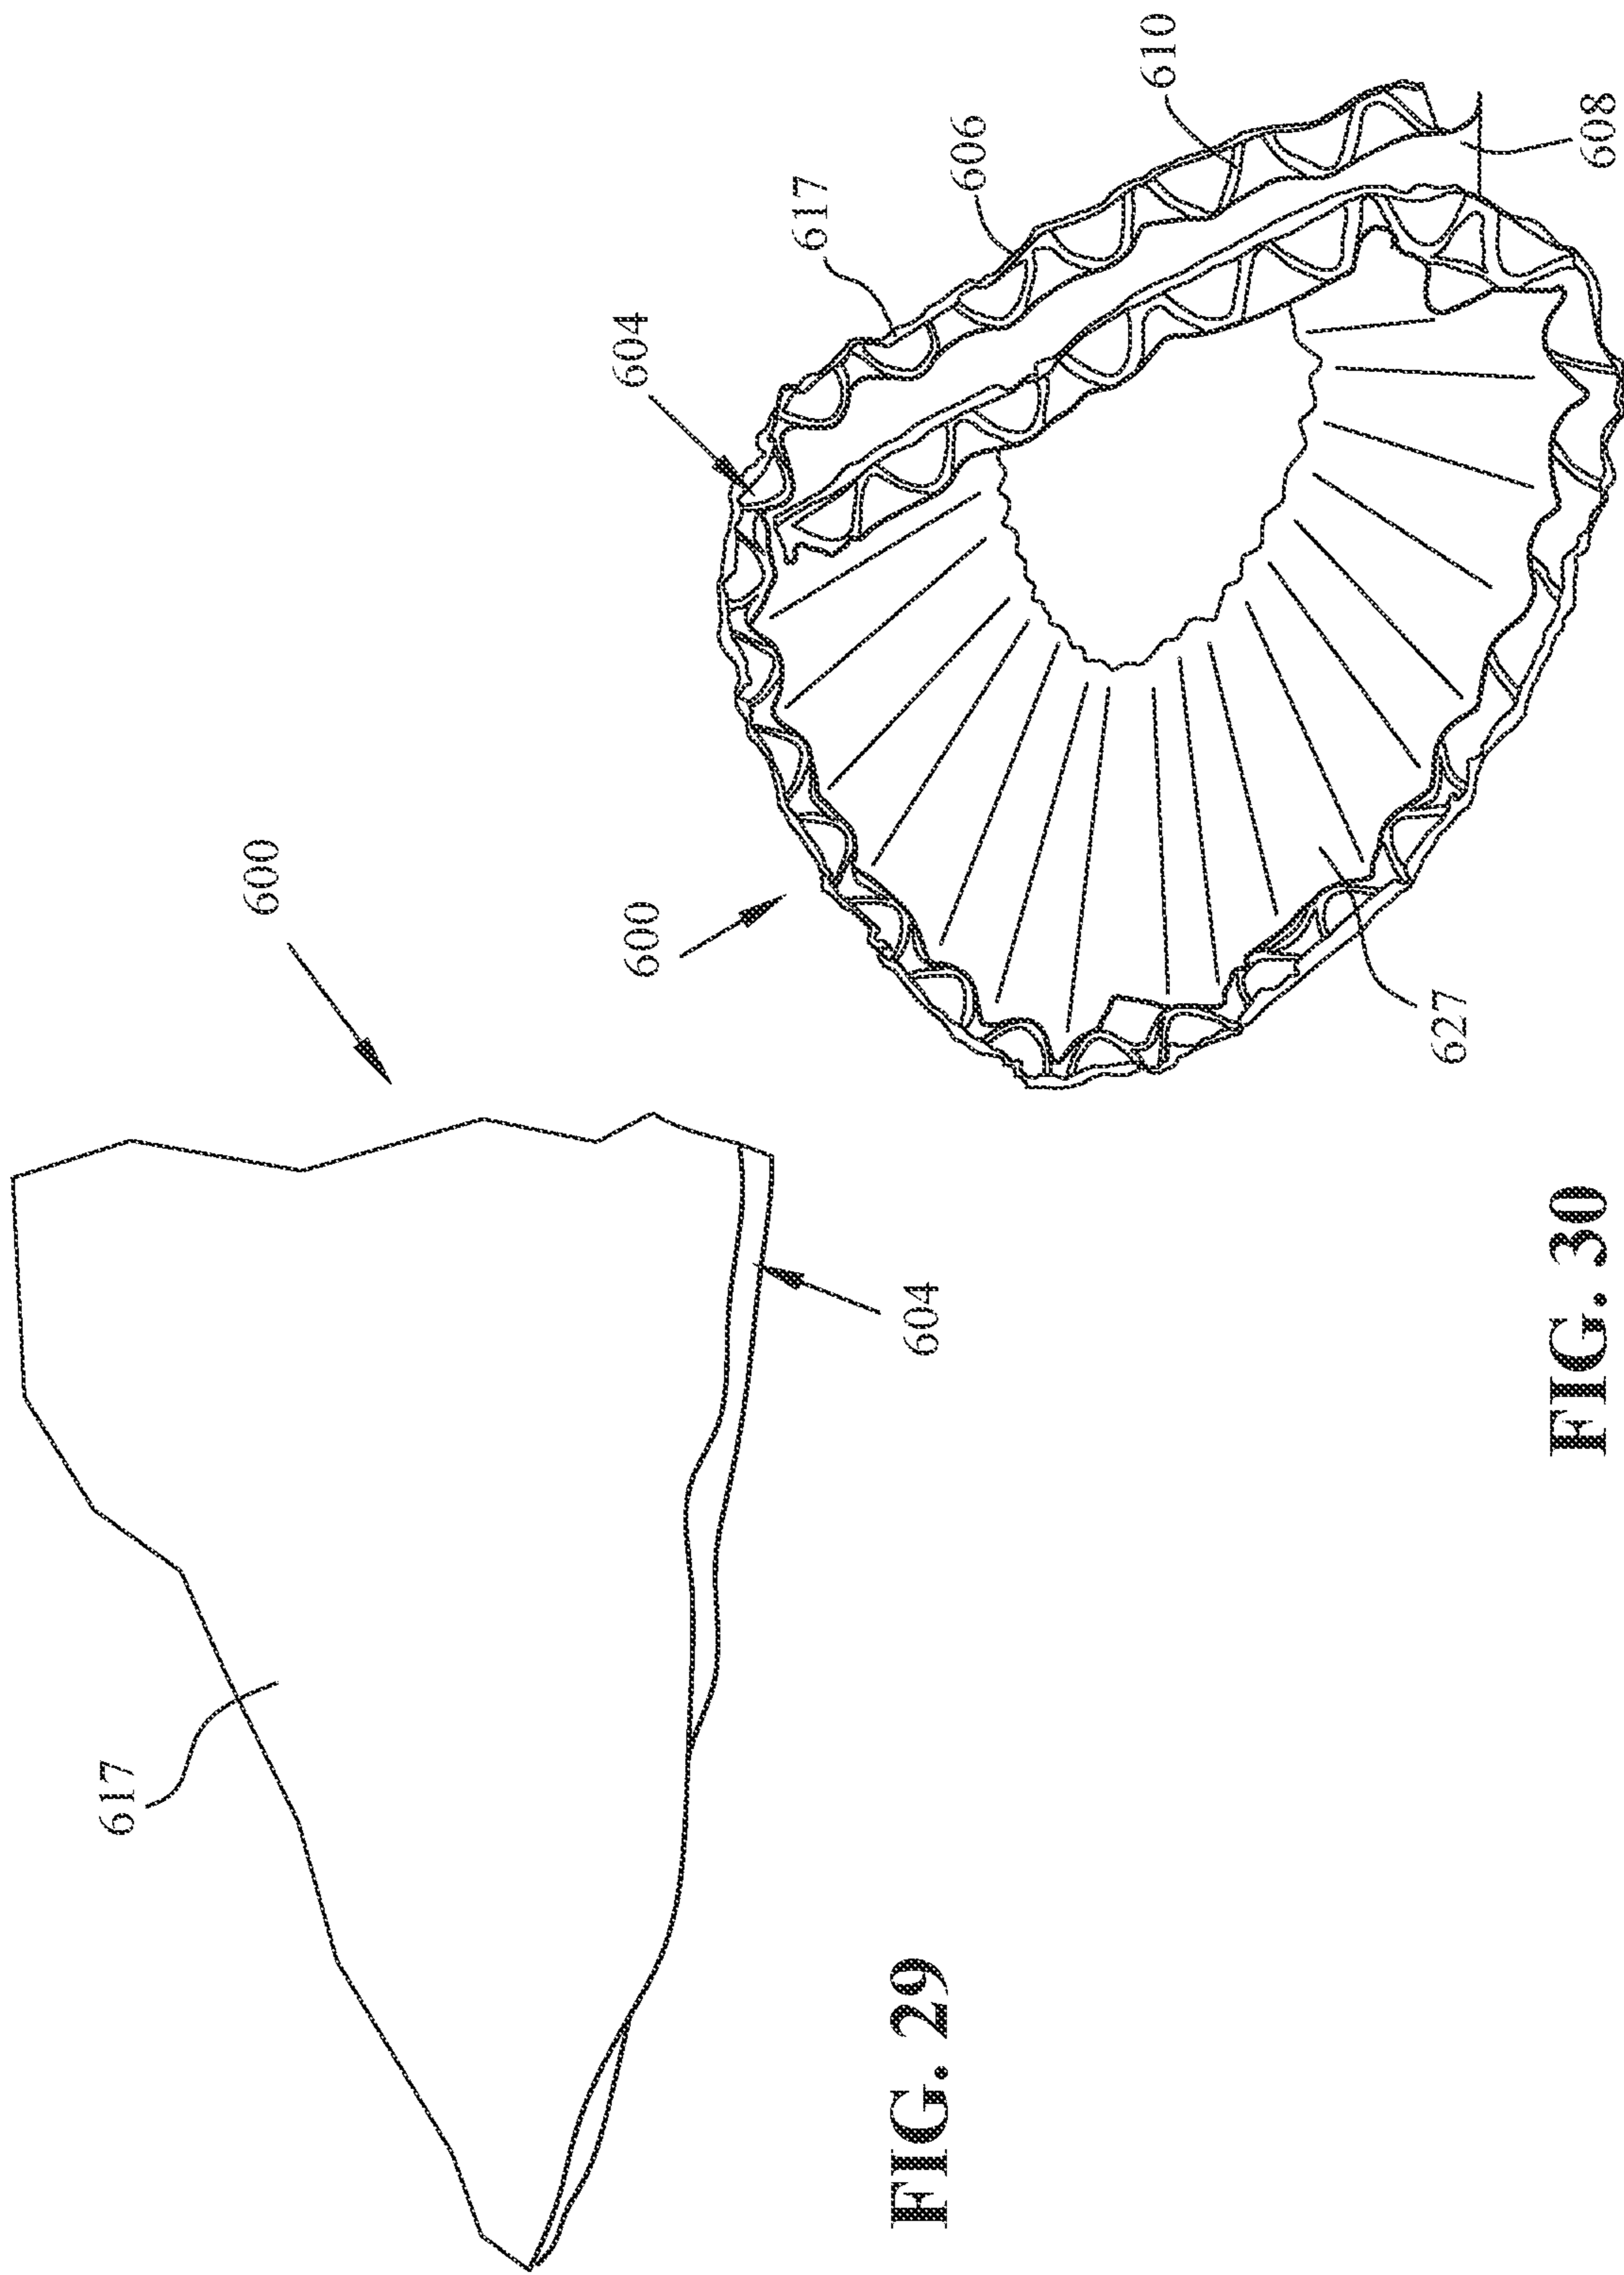
FIG. 29 is a perspective view of the vehicle frame and cargo bay liner of FIG. 28;

FIG. 30 is an end view of the vehicle frame and cargo bay liner of FIG. 28 rolled up and showing the aluminum foil on both sides thereof;
