(12) **United States Patent**
Pennington

(54) **VEHICLE FRAME AND CARGO BAY LINER**

(71) Applicant: **PennPlastics, LLC**, Mishawaka, IN (US)

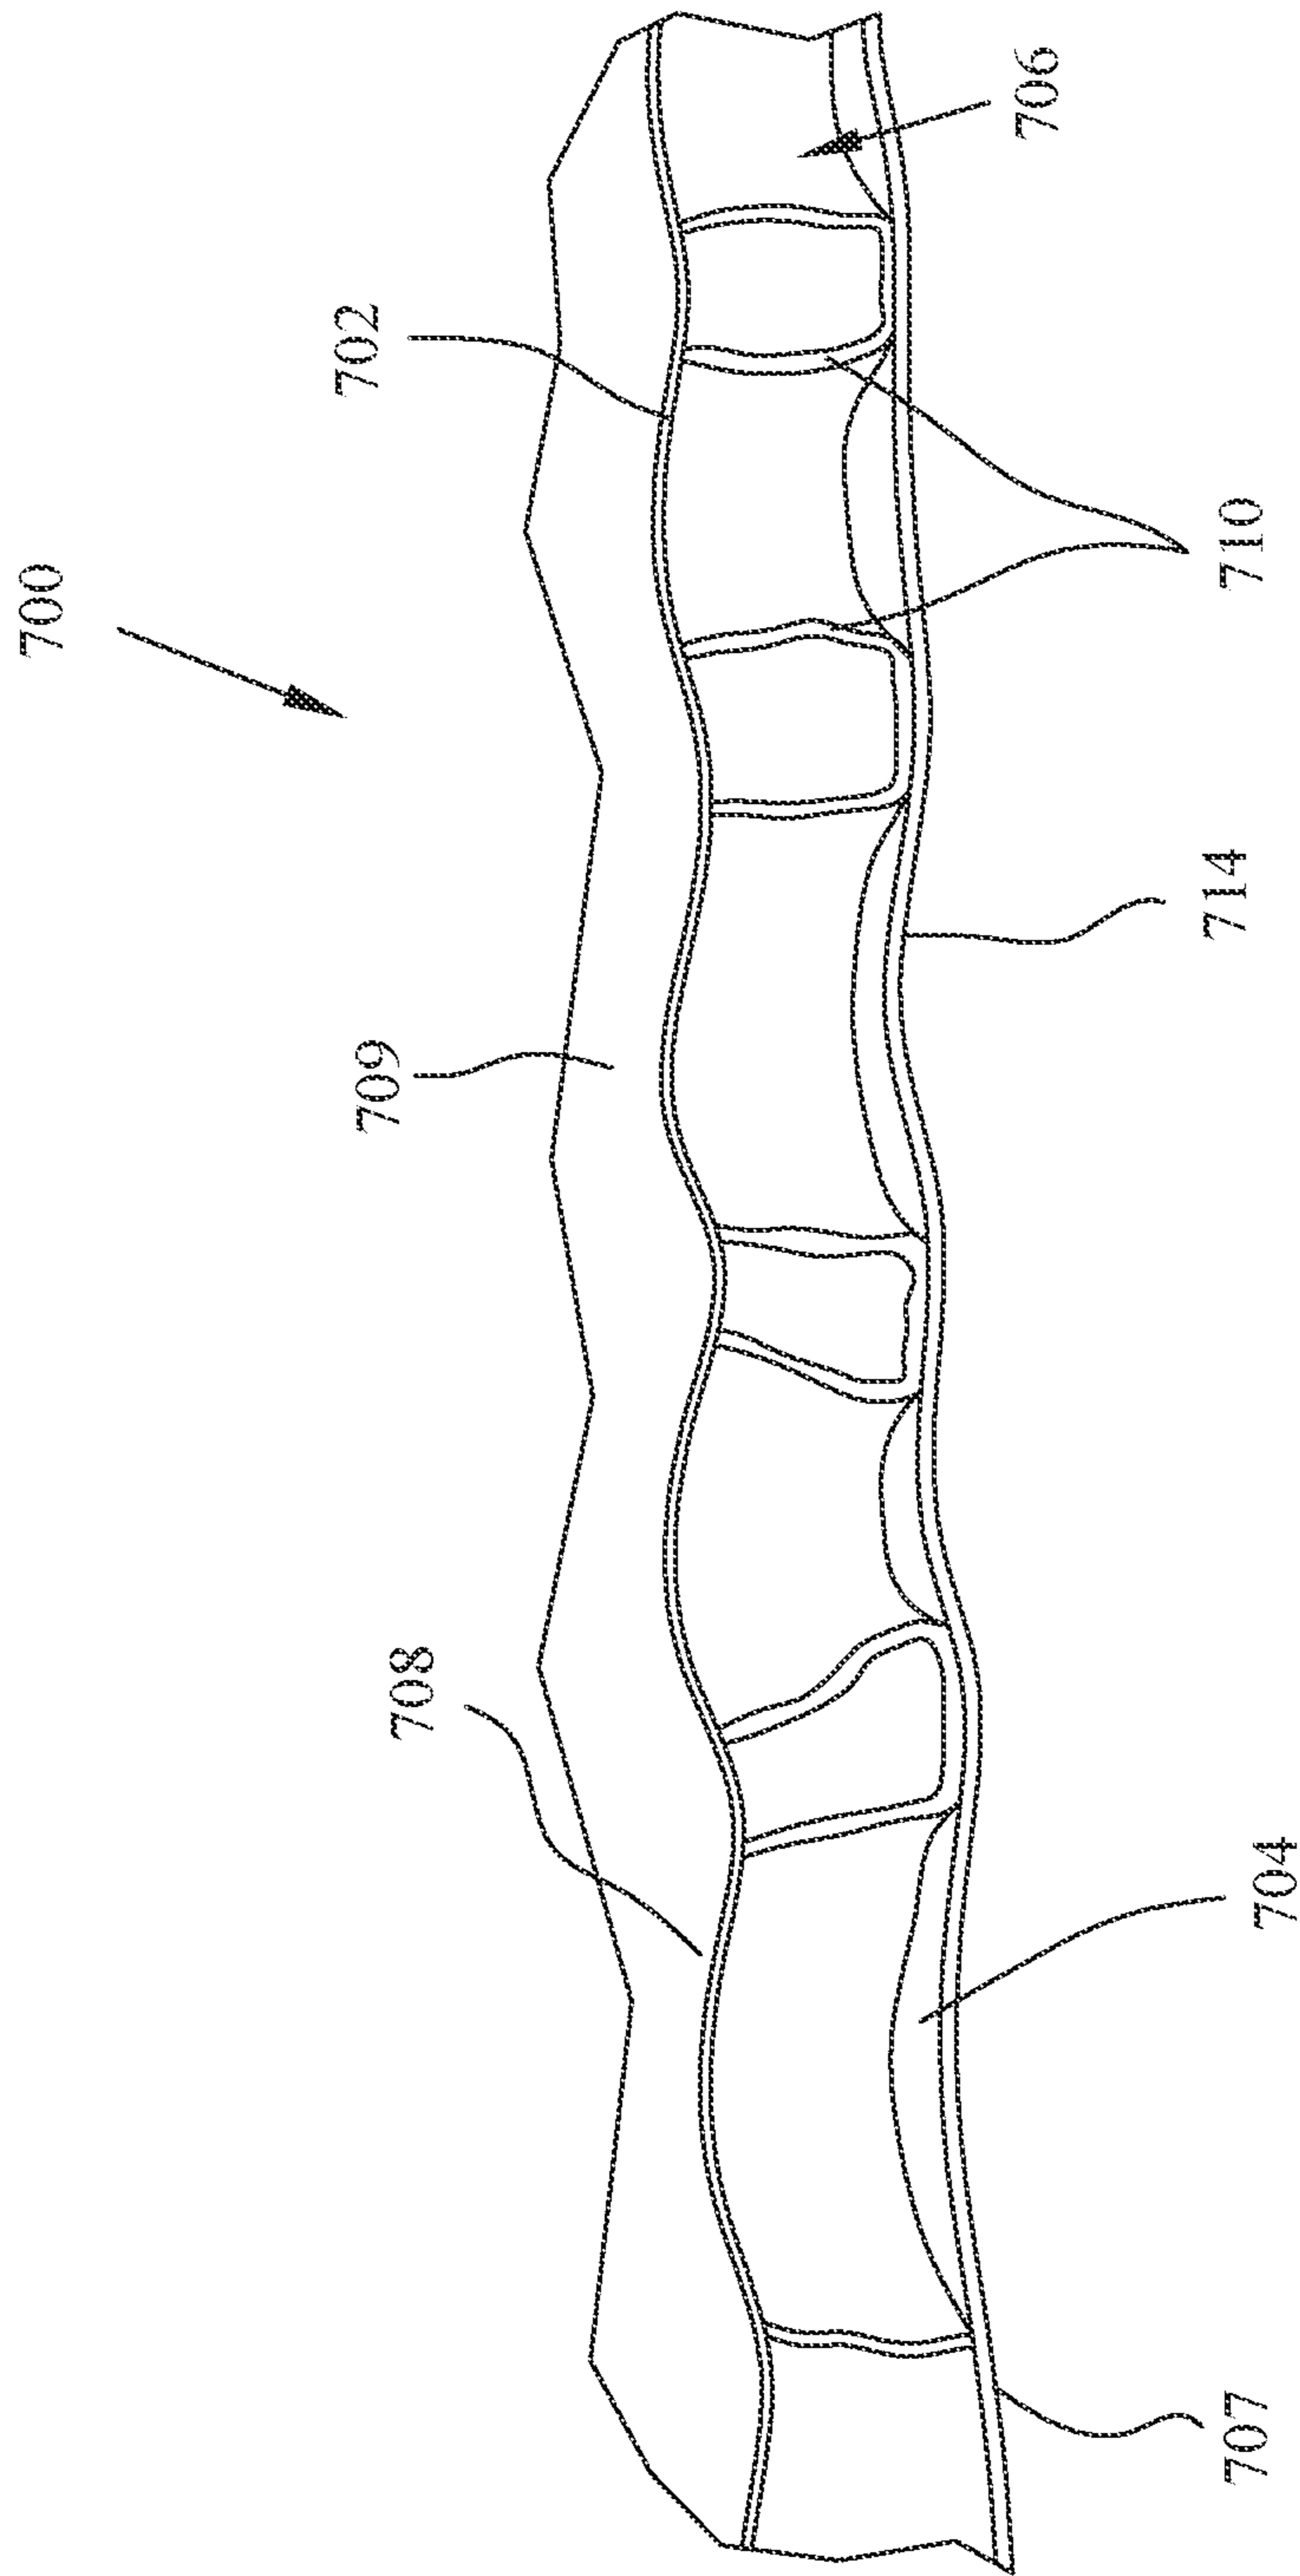
FIG. 31 is a side perspective view of yet another alternate embodiment vehicle frame and cargo bay liner having an aluminum foil on one side and a woven material on the opposite side

Now referring to FIGS. **31-34**, another alternate vehicle frame and cargo area liner is shown generally indicated as **700**. Liner **700** can be provided in a coiled form as liner **400**, making it extremely suitable for use as a liner for vehicle frames and cargo bays. The desired length of liner can be rolled out and cut to size for assembly to the vehicle. Vehicle frame and cargo bay liner **700** is of a 3-ply configuration and includes a top ply, sheet, or layer **702** and a bottom ply, sheet, or layer **704**. A core **706** (see FIG. **31**) separates top sheet **702** from bottom sheet **704**. Additionally, vehicle frame and cargo bay liner **700** also includes a sheet of aluminum foil or metalized film **707** on one side thereof. In the embodiment shown, aluminum foil/metalized film **707** is provided on bottom sheet **704**; however, it should be appreciated that aluminum foil/metalized film could also be provided on the top sheet **702** (see embodiment **700A** discussed below). Aluminum foil/film **707** may be adhered to bottom sheet **704** using an adhesive or other suitable means. Vehicle frame and cargo bay liner **700** also includes a woven or nonwoven layer of material **709** adhered to top layer **702**, opposite the side with aluminum foil **707** or metalized film. In one embodiment, material **709** is a woven sheet of polypropylene fabric.

In the embodiment of the 3 ply vehicle frame and cargo bay liner **700** of FIGS. **31-34**, the aluminum foil or metalized film **707** is shown adhered to the side of liner **700** with dimples **714** and woven material **709** is shown adhered to the side with convexities **708**; however, in FIGS. **35-37** an alternate embodiment vehicle frame and cargo bay liner, shown generally indicated as **700a**, has the woven or nonwoven sheet of material **709** adhered to the side of the liner having dimples **714** and the aluminum foil **707** adhered to the side of the liner having convexities **708**. Any and all of the aluminum foil, metalized film, woven material, and non-woven material can be laminated to the liner **700**. The lamination process can include an adhesive, heat, and/or pressure in the lamination process. Also, the vehicle frame and cargo bay liner may be manufactured with only a layer of woven or nonwoven sheet of fabric material and no aluminum foil or alternately with aluminum foil and no woven or nonwoven fabric. It should be appreciated that the lamination process securely attaches the foil, film and/or fabric firmly to the liner and helps keep the laminated layers in a strong sandwich configuration. This provides significant benefits for numerous things, such as for instance, preventing the foil layer from short circuiting with electric or electronic holes cut through the line as the foil will not slide or move on the liner. Alternately, it may be provided with either aluminum foil on both sides or with woven or nonwoven fabric on both sides.

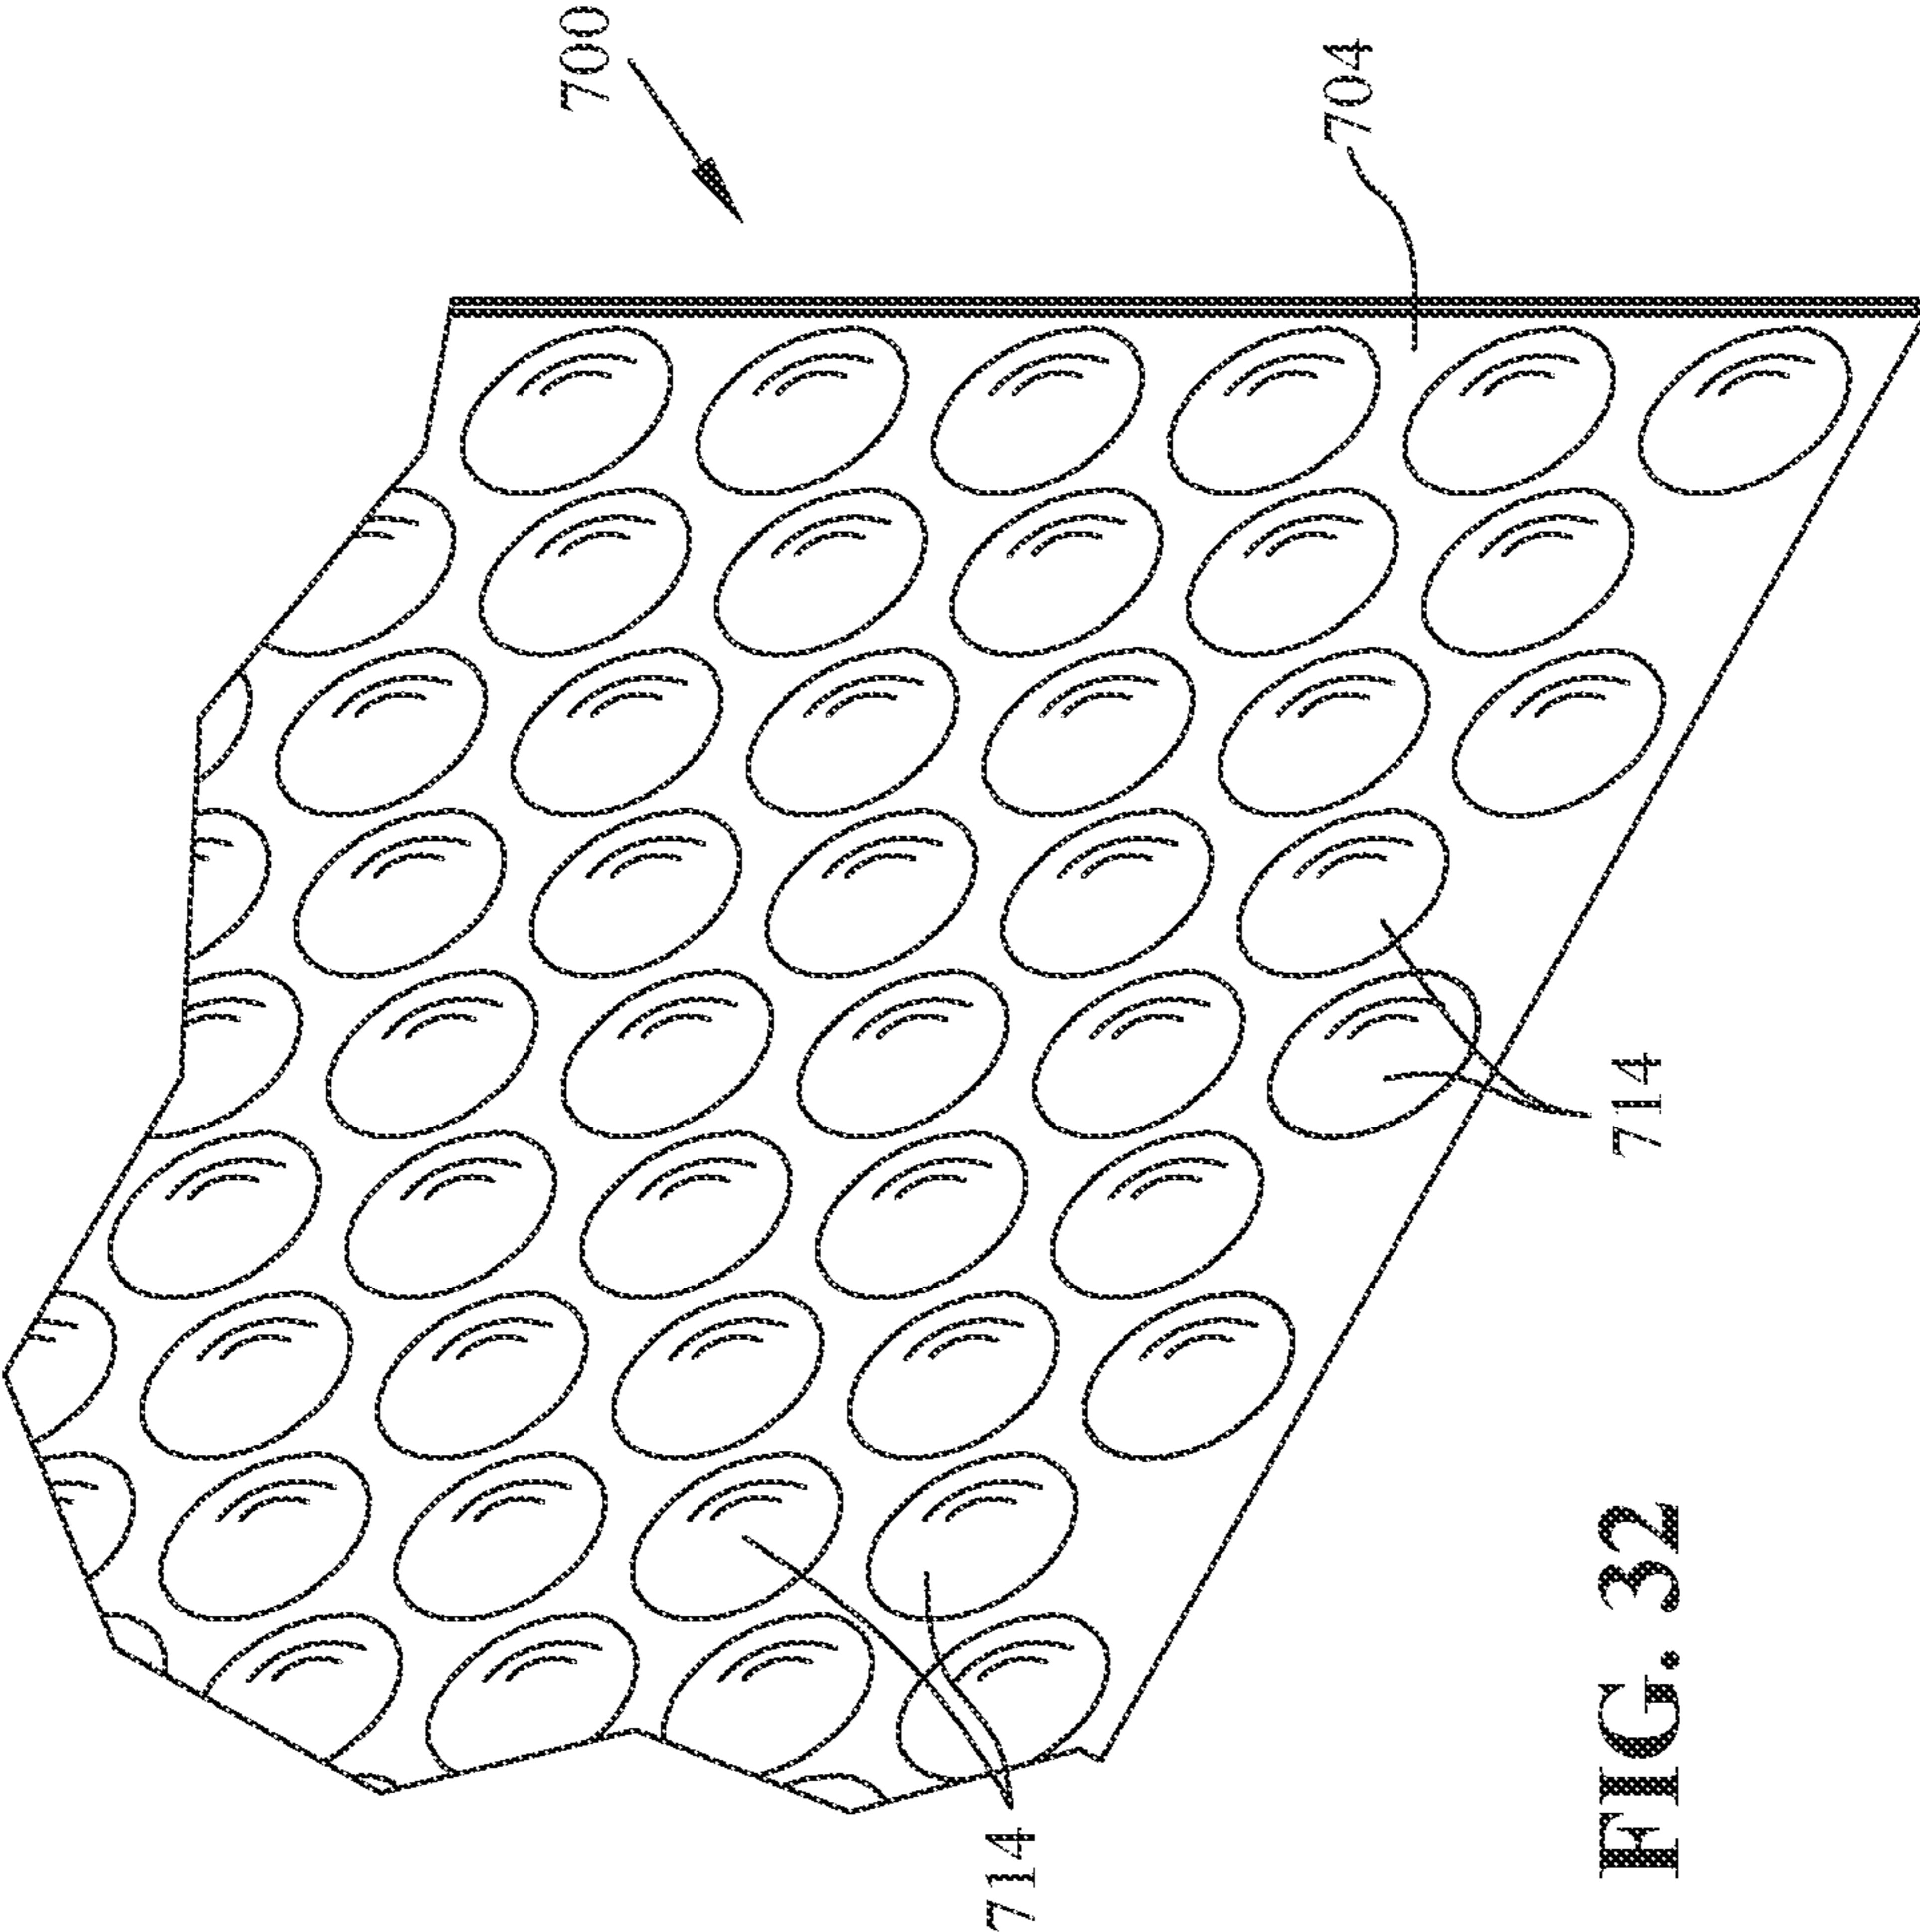
FIG. 32 is a plan view of the vehicle frame and cargo bay liner of FIG. 31 with the aluminum foil and woven material removed show a layer of the liner having dimples thereon.

In the embodiment shown, vehicle frame and cargo bay liner **700** also includes a plurality of circular convexities **708** on top sheet **702** and a corresponding plurality of circular dimples or depressions **714** in bottom sheet **704**. Vehicle frame and cargo bay liner **700** also includes a plurality of cylindrical projections **710** extending up from bottom sheet **704** and attached to top sheet **702** (see FIG. **31**). Projections **710** may be thermally bonded to top sheet **702** as well as to bottom sheet **704**. As can be seen in FIG. **31**, circular convexities **708** and circular depressions **714** coincide with

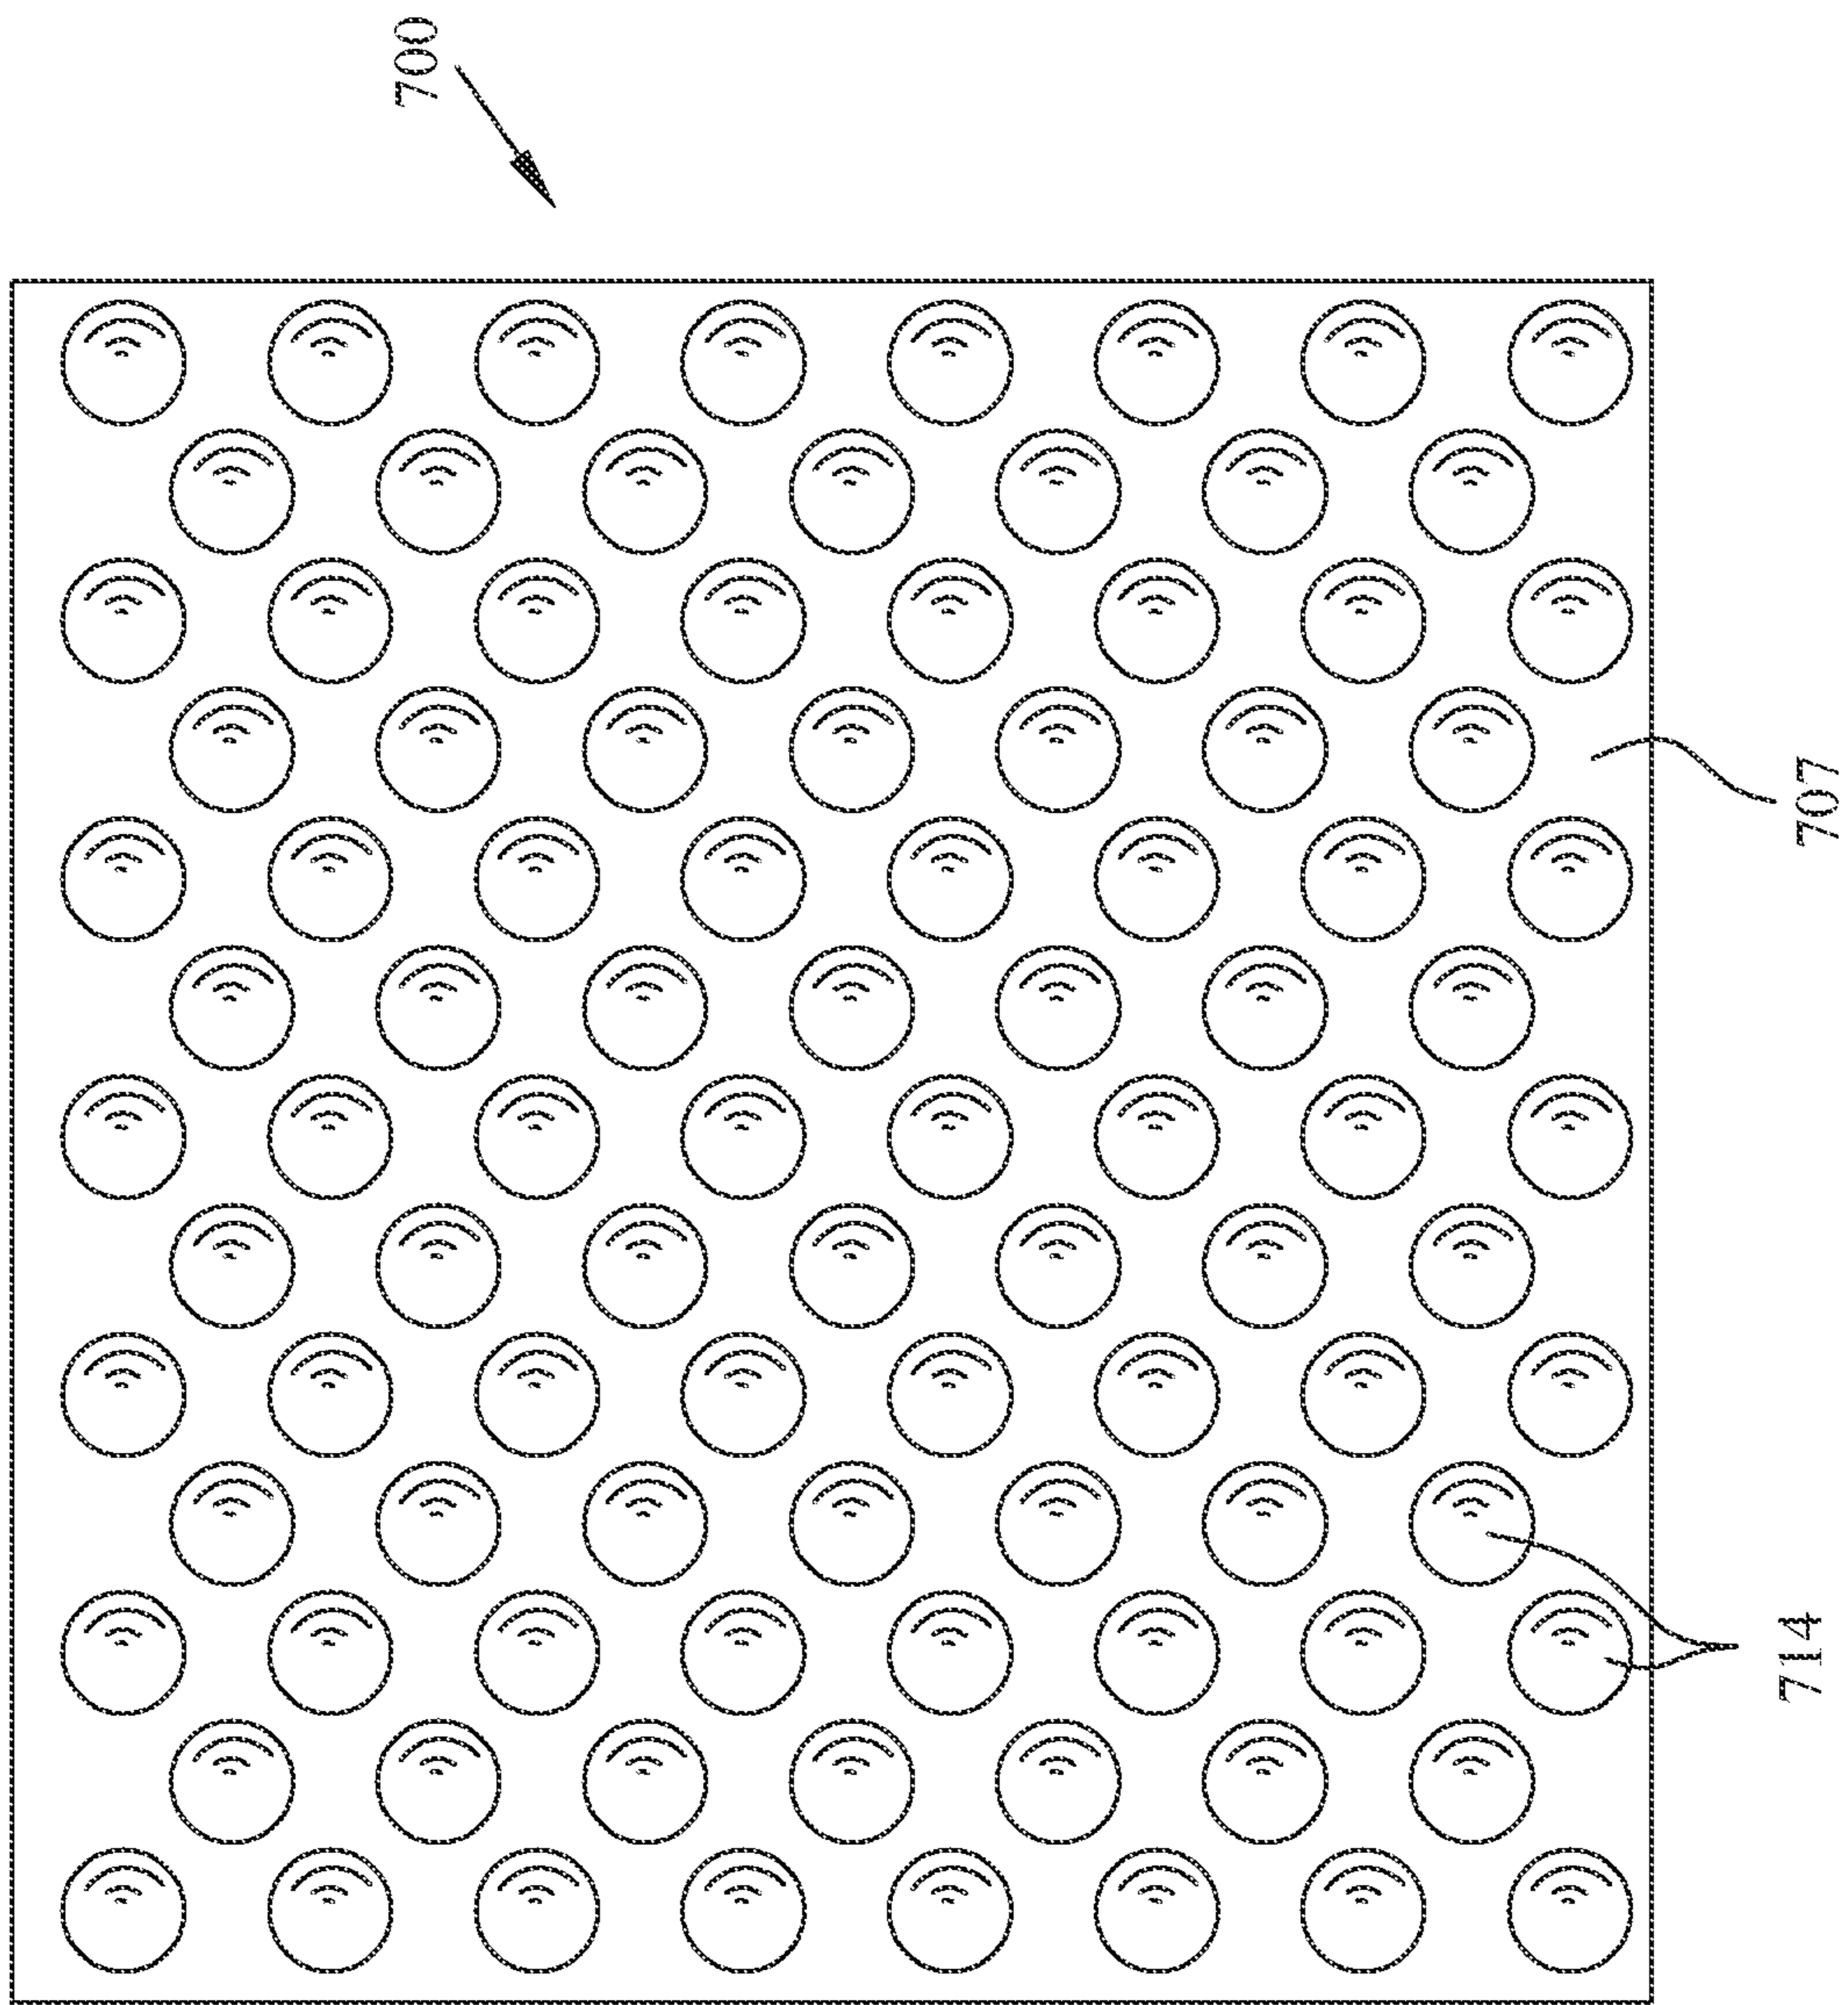
FIG. 33 is a perspective plan view of the vehicle frame and cargo bay liner of FIG. 31 showing the side with dimples and aluminum foil thereon;

When rolled out and installed on a frame **32** of a recreational vehicle, aluminum sheet or foil or metalized film **707** of liner **700** will preferably be disposed toward the living quarters of the recreational vehicle. Accordingly, the foil provides an additional insulation barrier between the ground and living quarters. Sheet of woven or nonwoven material **709** is preferably placed on the side of the liner facing the ground. Sheet of material **709** is particularly suited for receiving a spray foam sealing and insulation material **125** (see FIG. **38**). The spray foam readily adheres to material **709**, and a woven polypropylene material has been found to be very suitable. It should be noted that prior art corrugated liners **104** are typically manufactured from a polyethylene material, which is better at adhering the spray foam material **125** than the polypropylene liners disclosed in embodiments above. However, a woven layer of material **709** is better yet for adhering the spray foam sealing and insulation material. Note, the aluminum foil may be placed towards the ground of a recreational vehicle; however, any stones or debris kicking up may create tearing or holes therein and the foil will not readily adhere a spray foam material thereon.

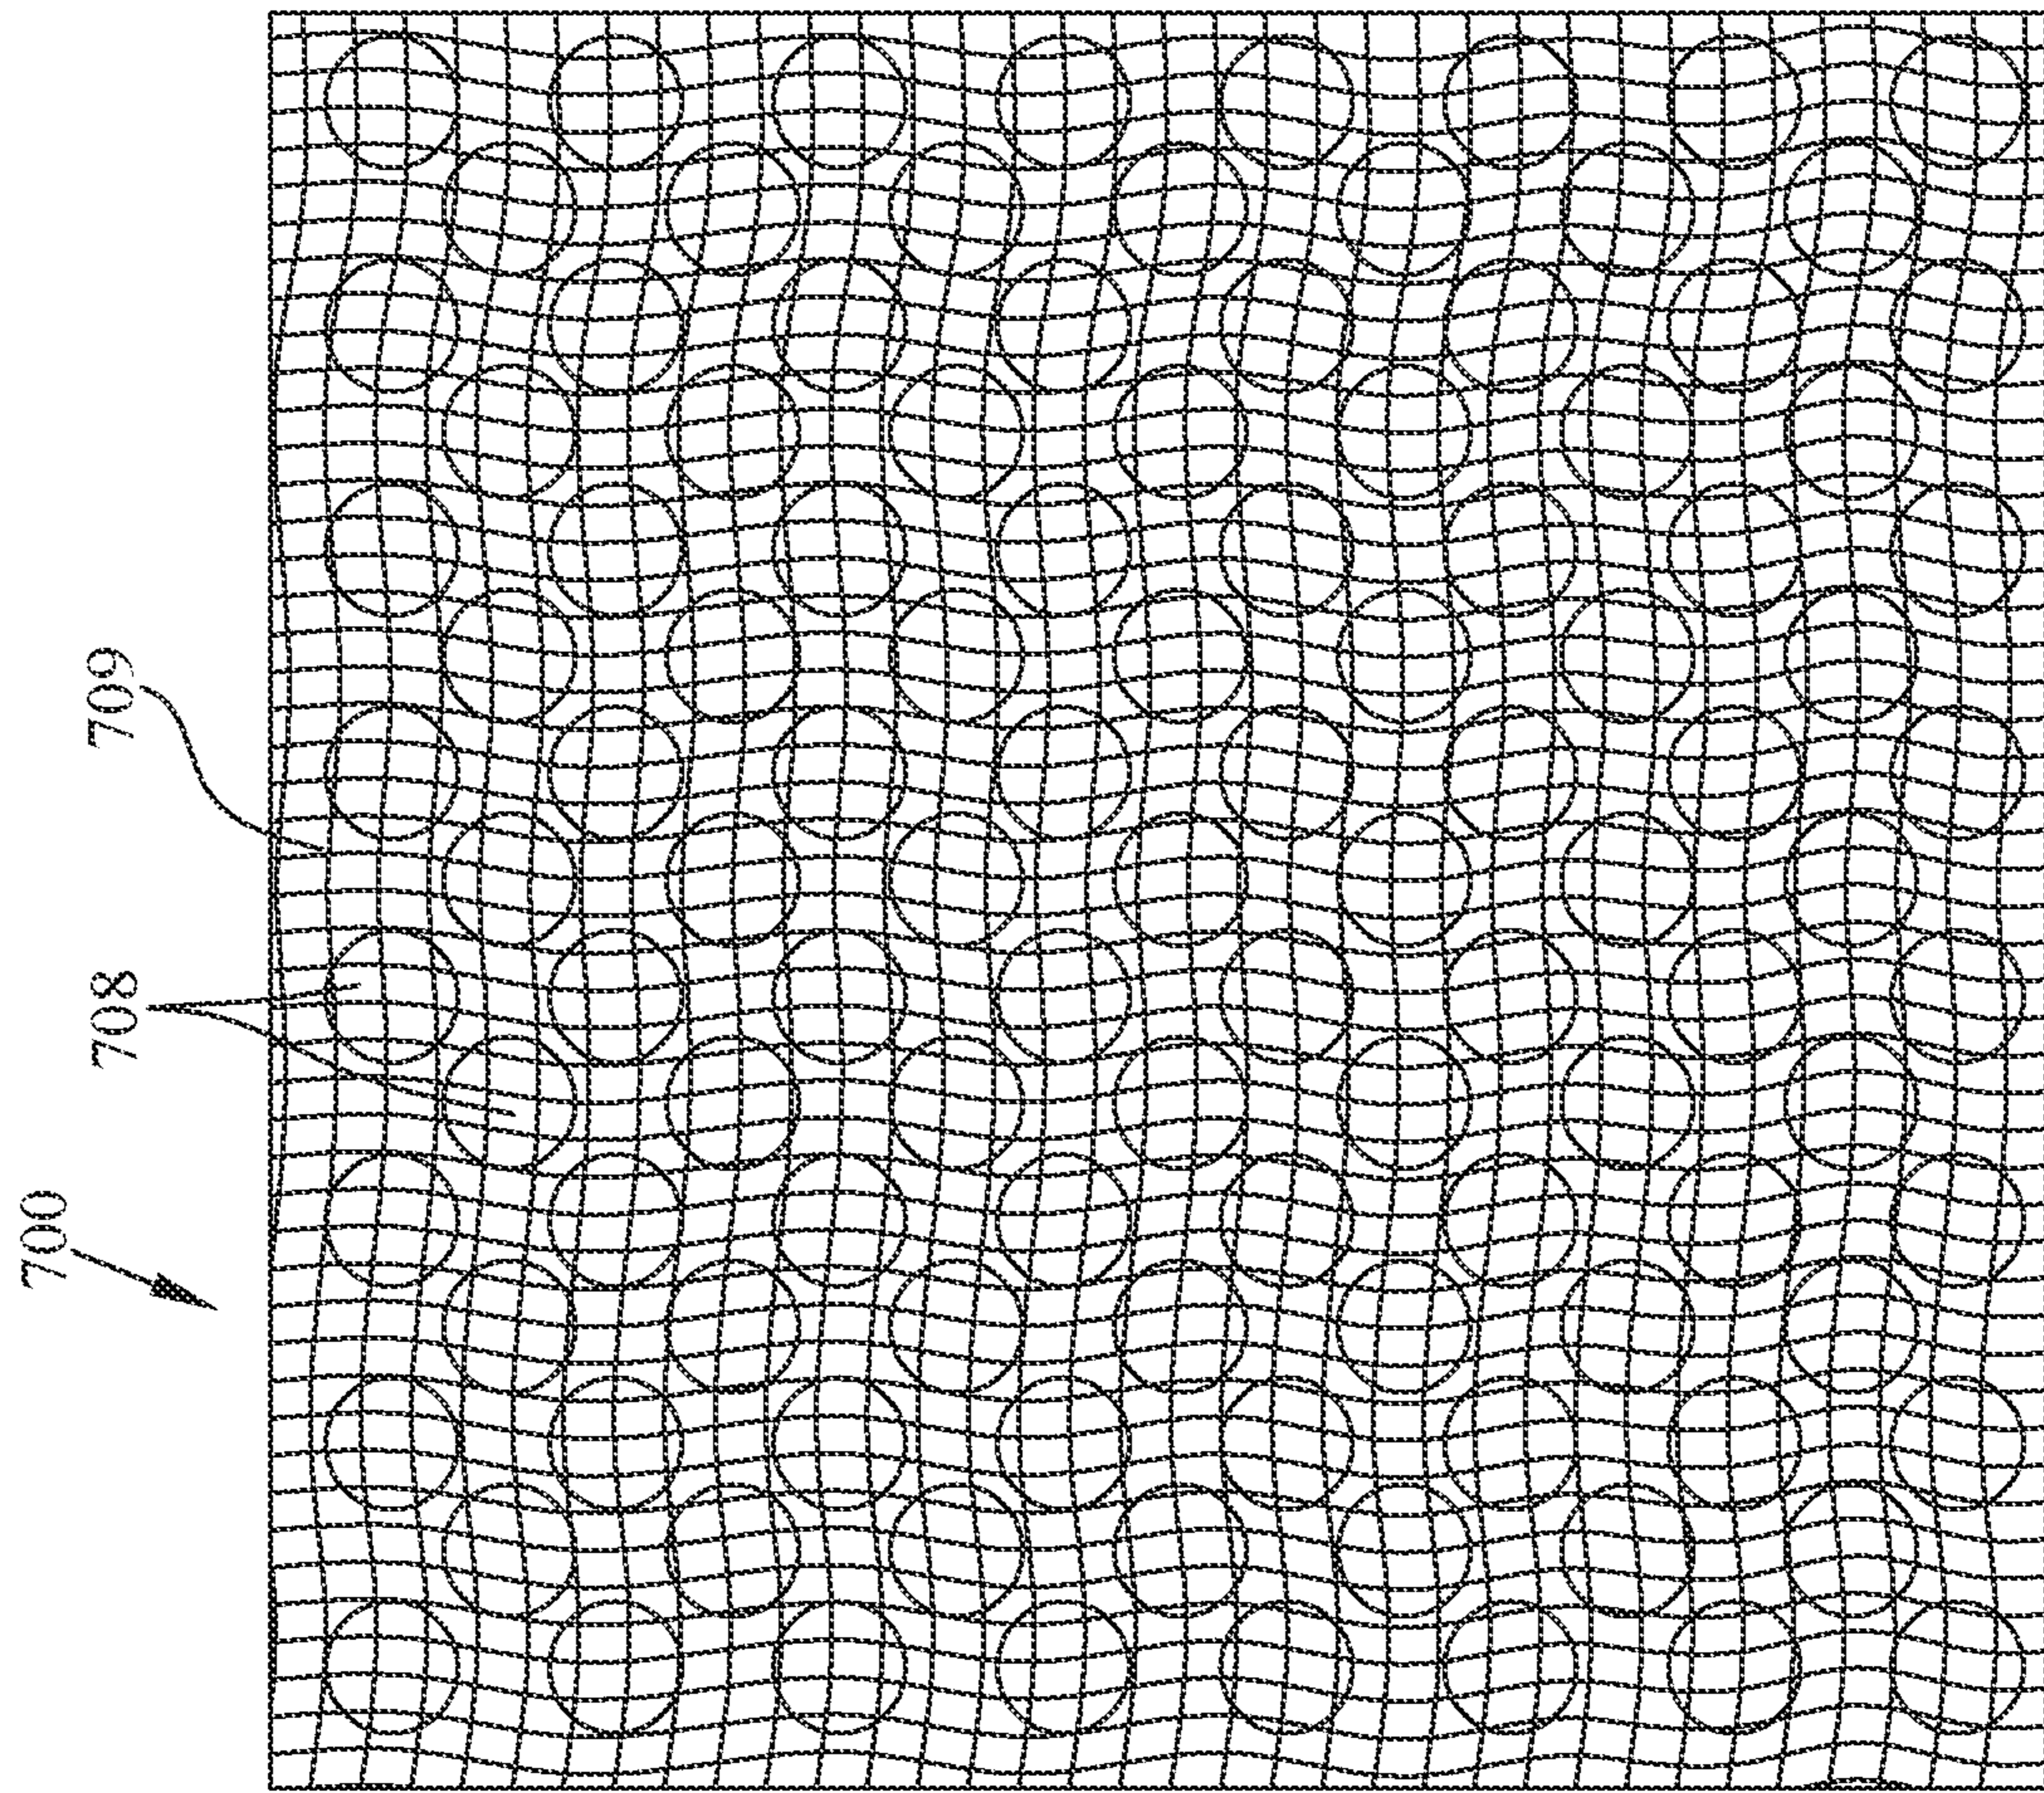
FIG. 34 is a perspective plan view of the vehicle frame and cargo bay liner of FIG. 31 showing a side with convexities and a woven material thereon;

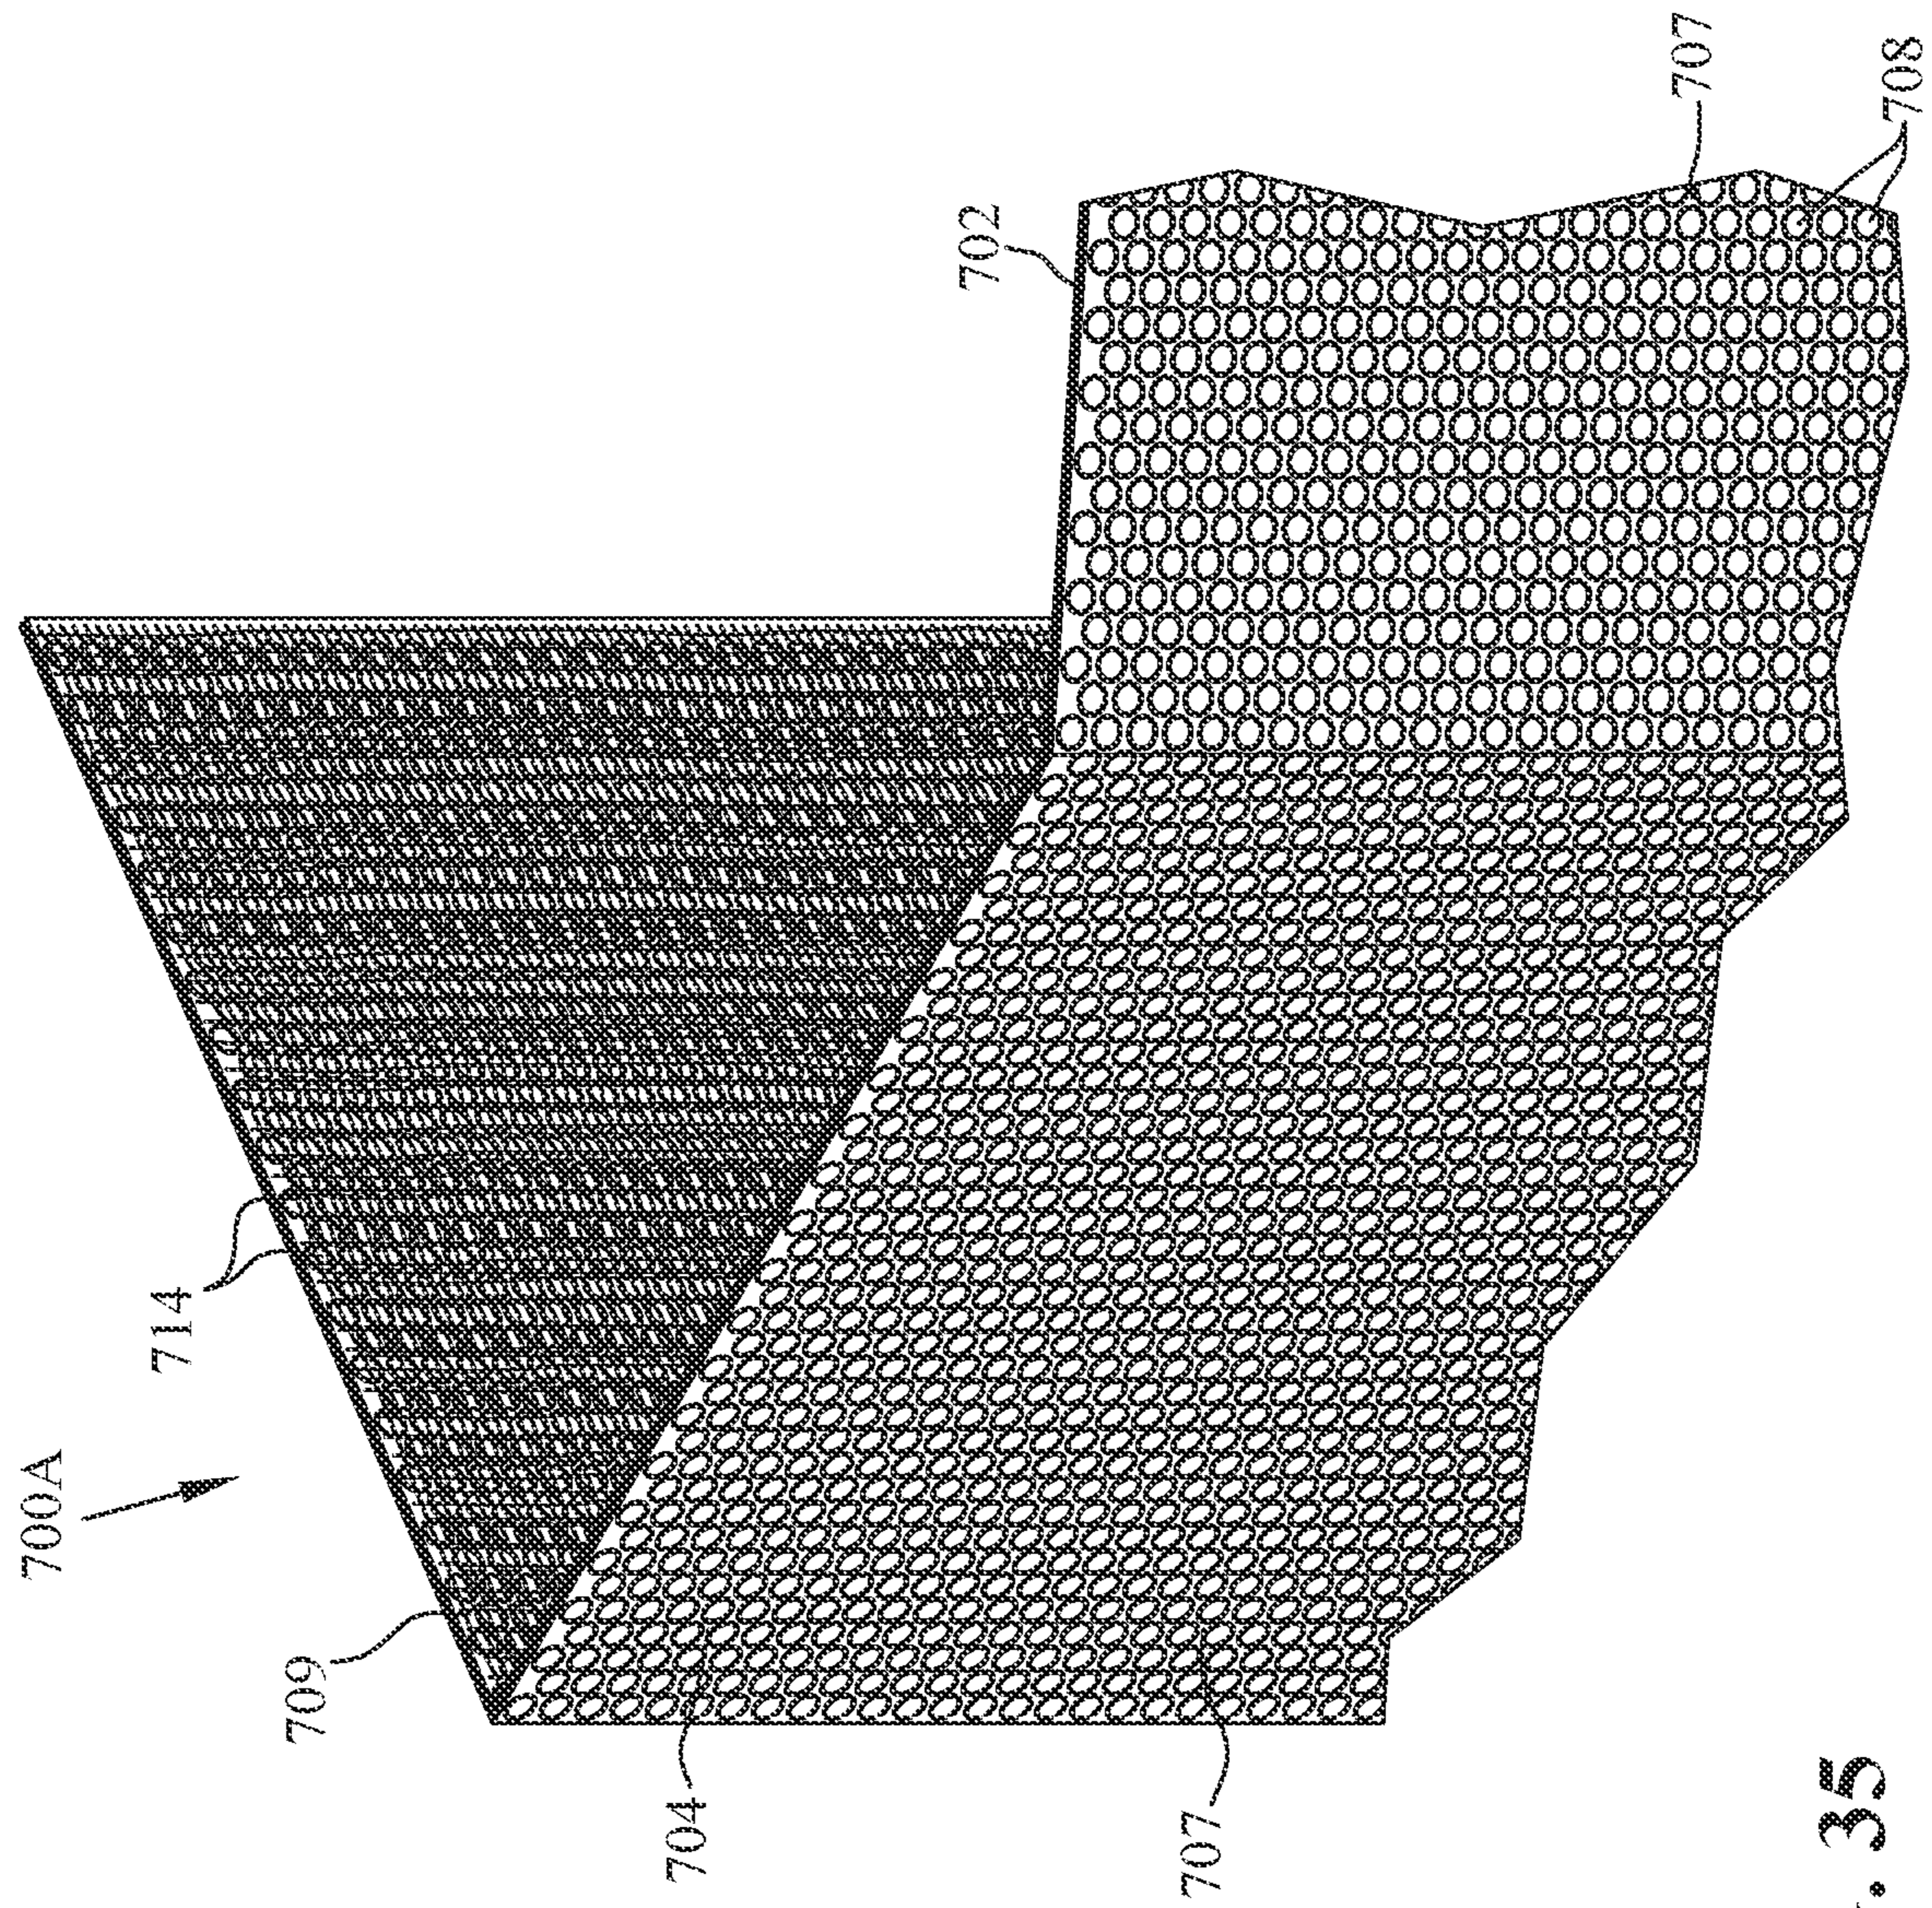
FIG. 35 is a perspective of a similar alternate embodiment view of a vehicle frame and cargo bay liner like FIG. 31, but with the aluminum foil on the side with convexities and a woven material on the opposite side with dimples;
