(12) **United States Patent**
Pennington

(54) **VEHICLE FRAME AND CARGO BAY LINER**

(71) Applicant: **PennPlastics, LLC**, Mishawaka, IN (US)

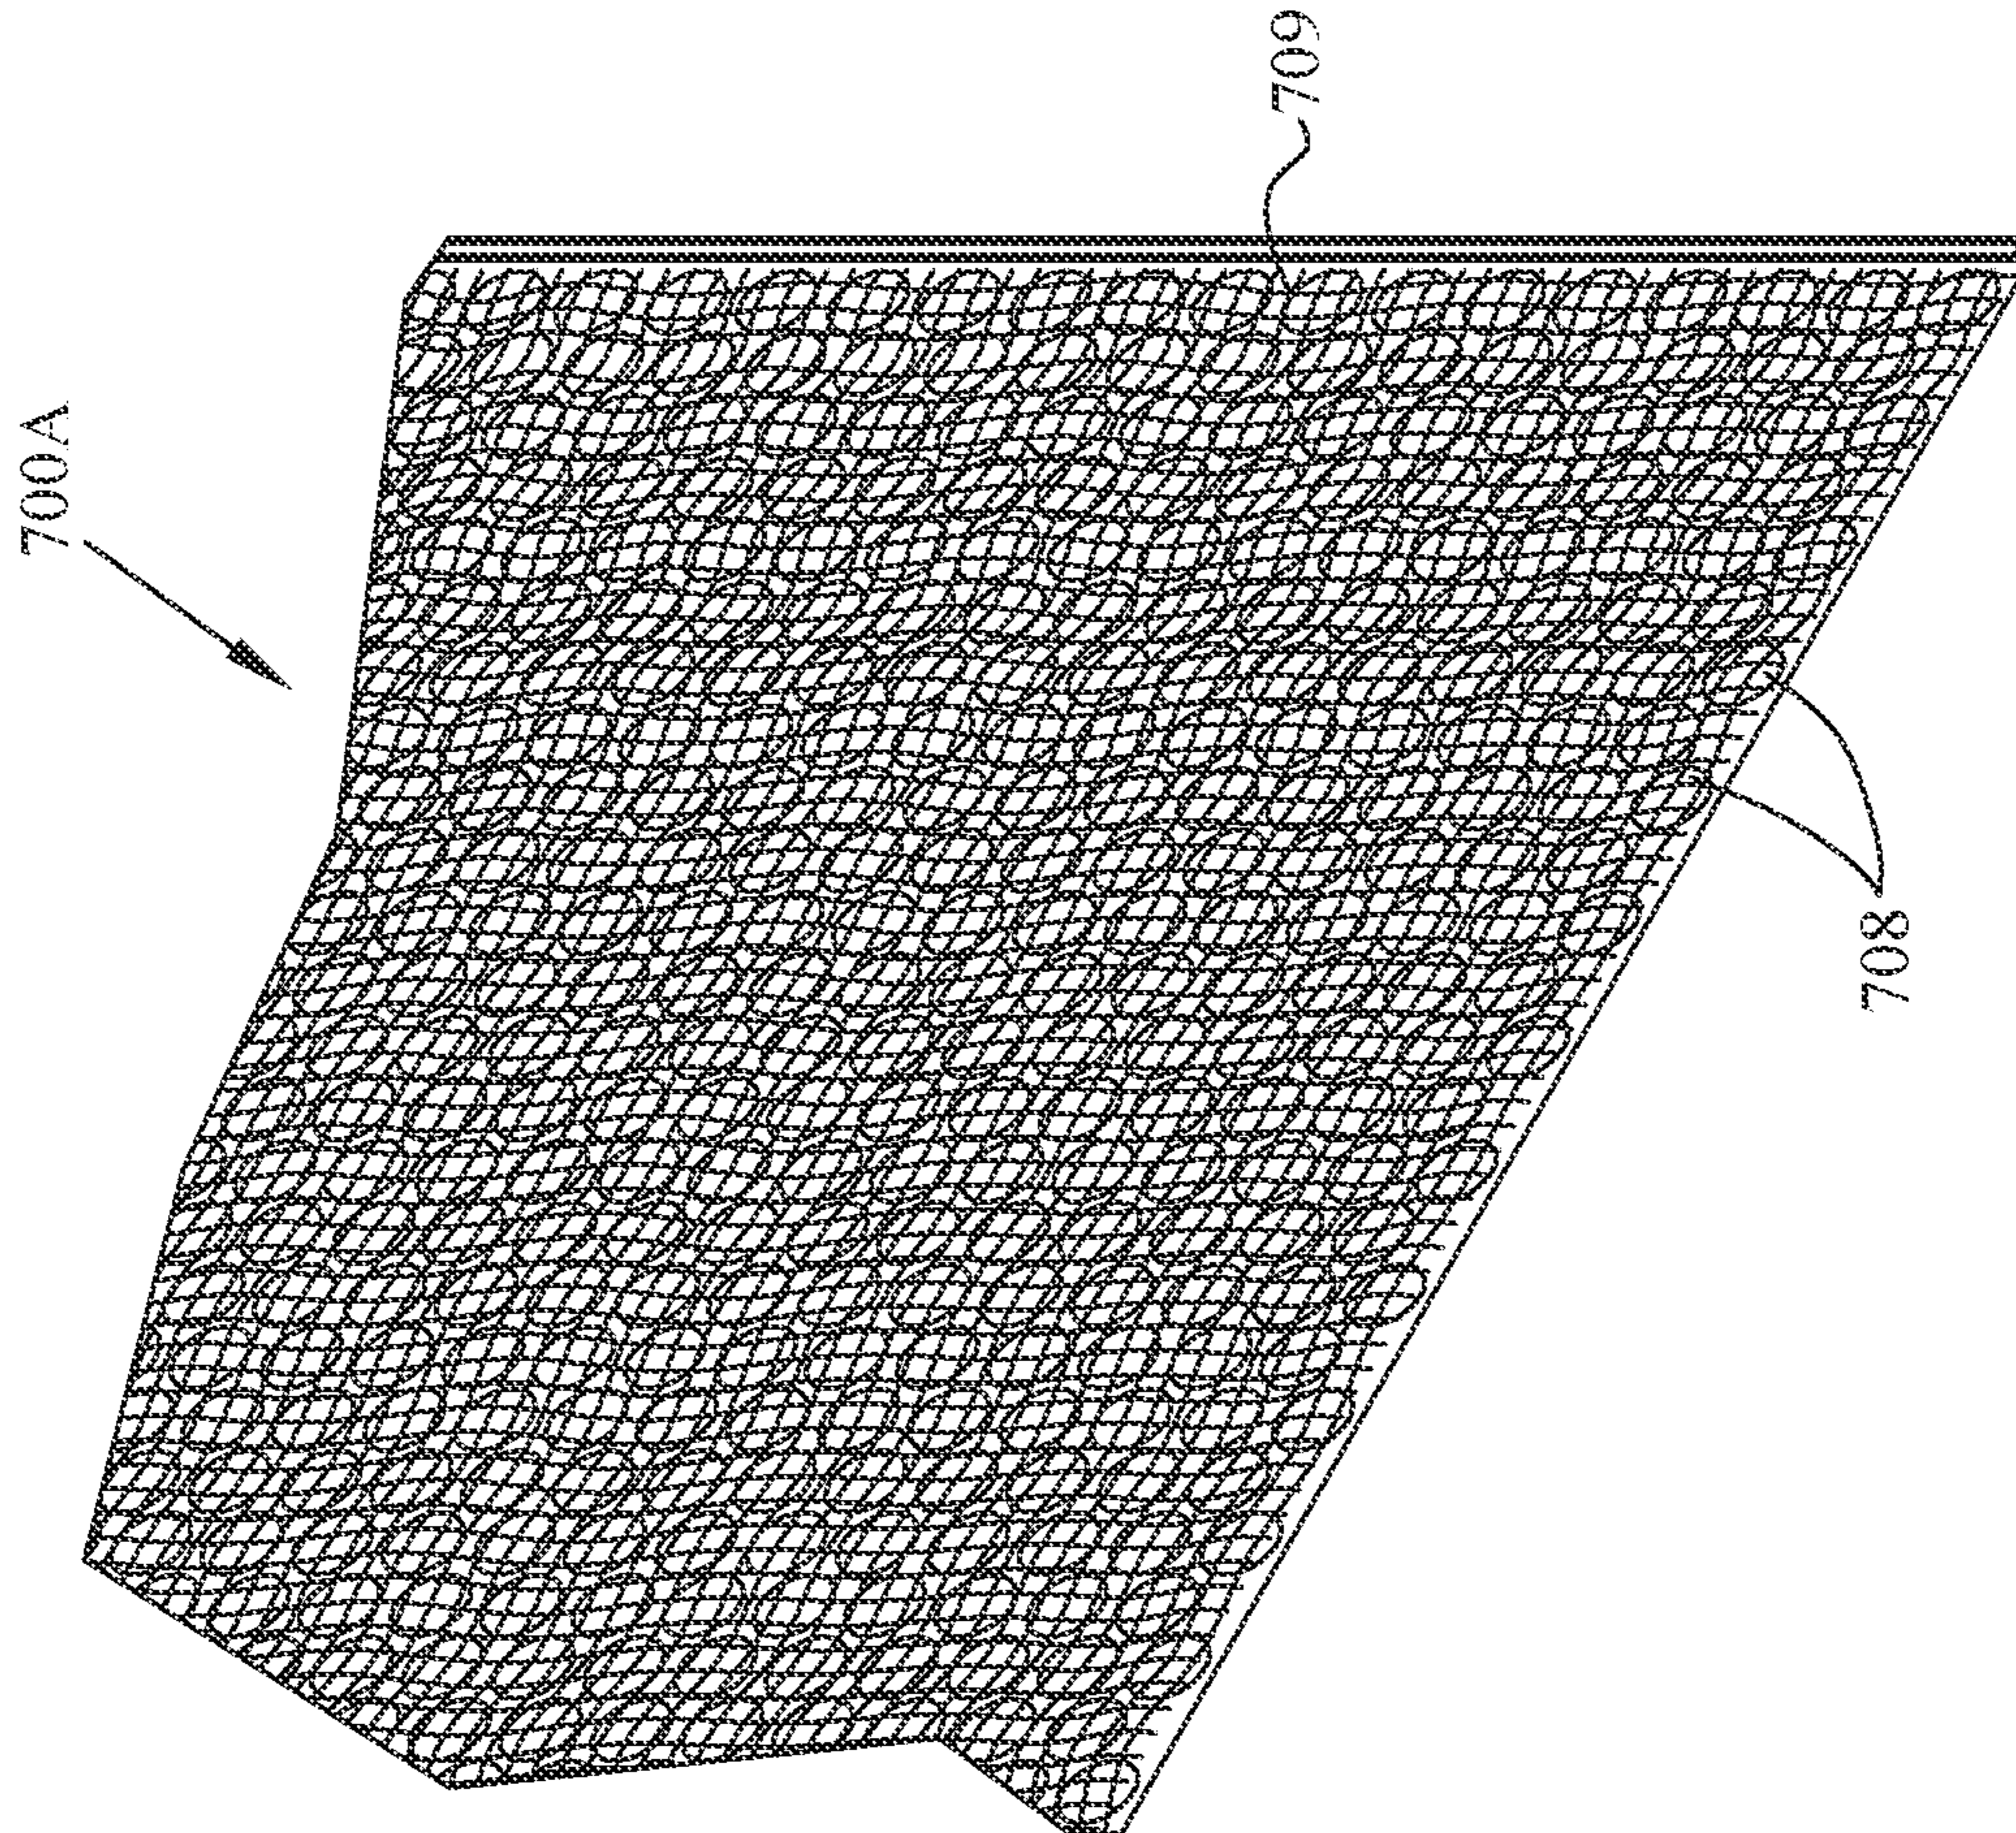
FIG. 36 is a plan perspective plan view of the vehicle frame and cargo bay liner of FIG. 35 showing the dimpled side having the woven material thereon;

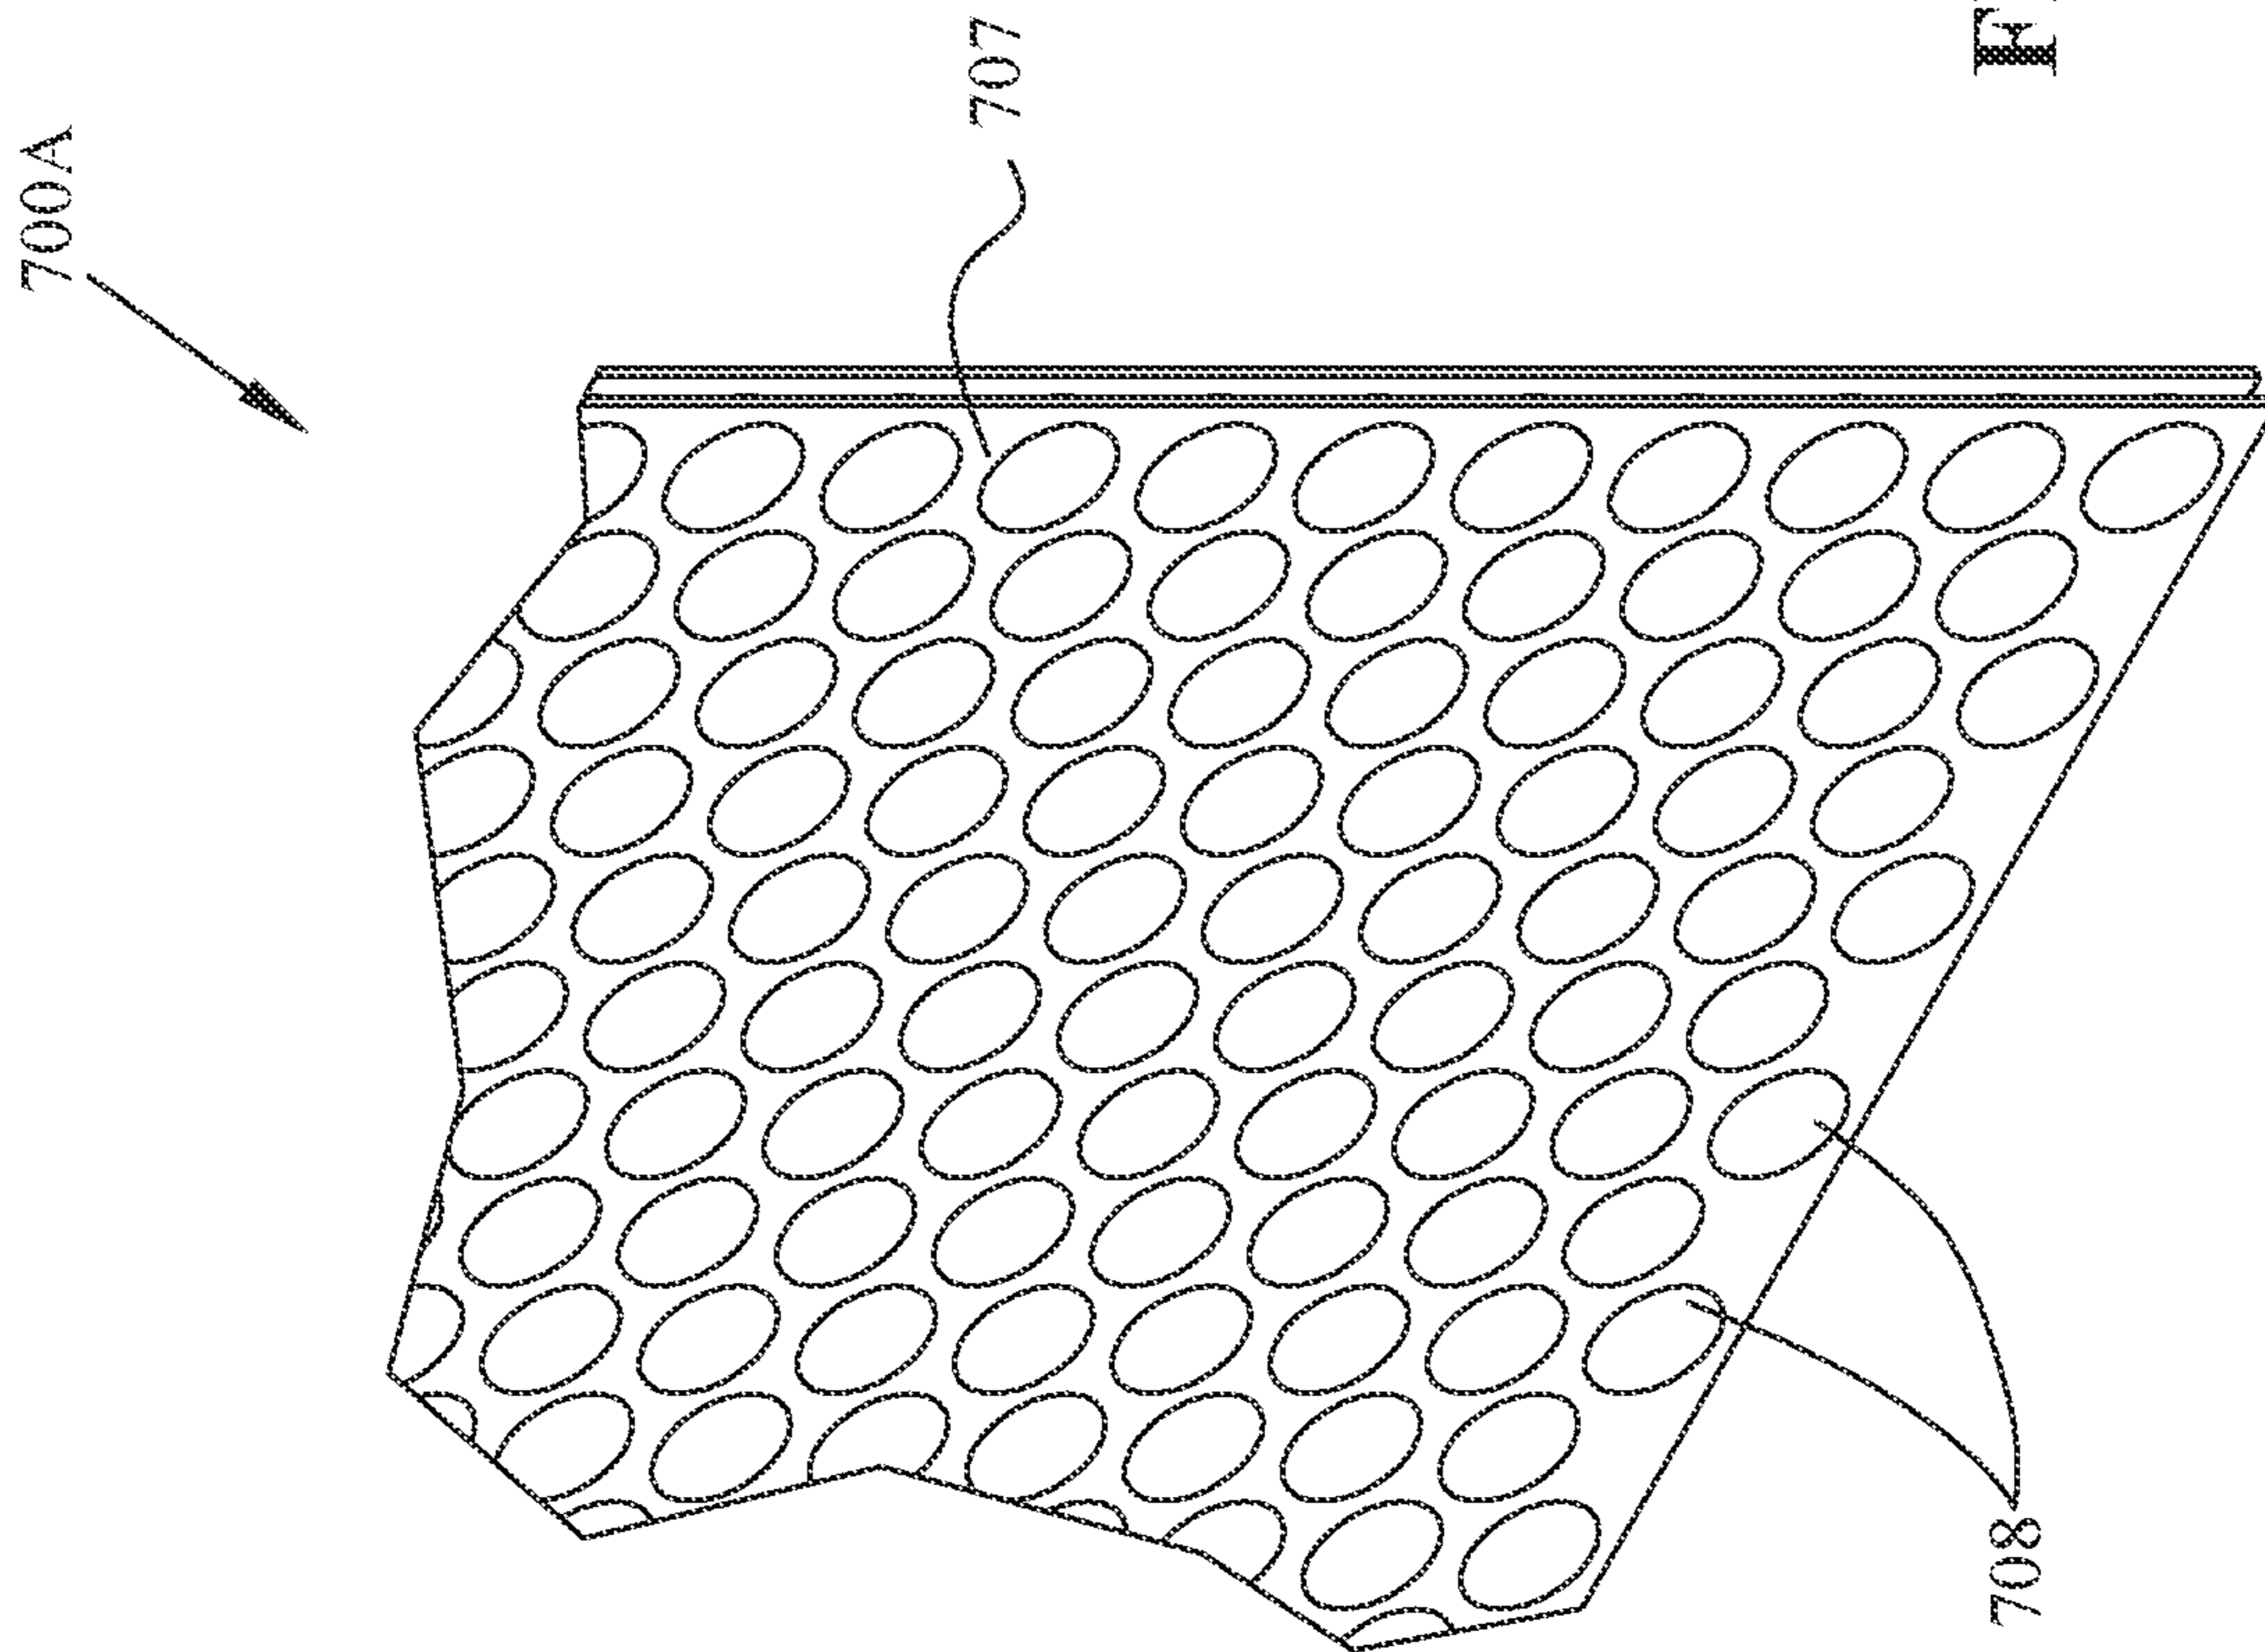
FIG. 37 is a plan perspective plan view of the vehicle frame and cargo bay liner of FIG. 35 showing the convex side having the aluminum foil thereon side;

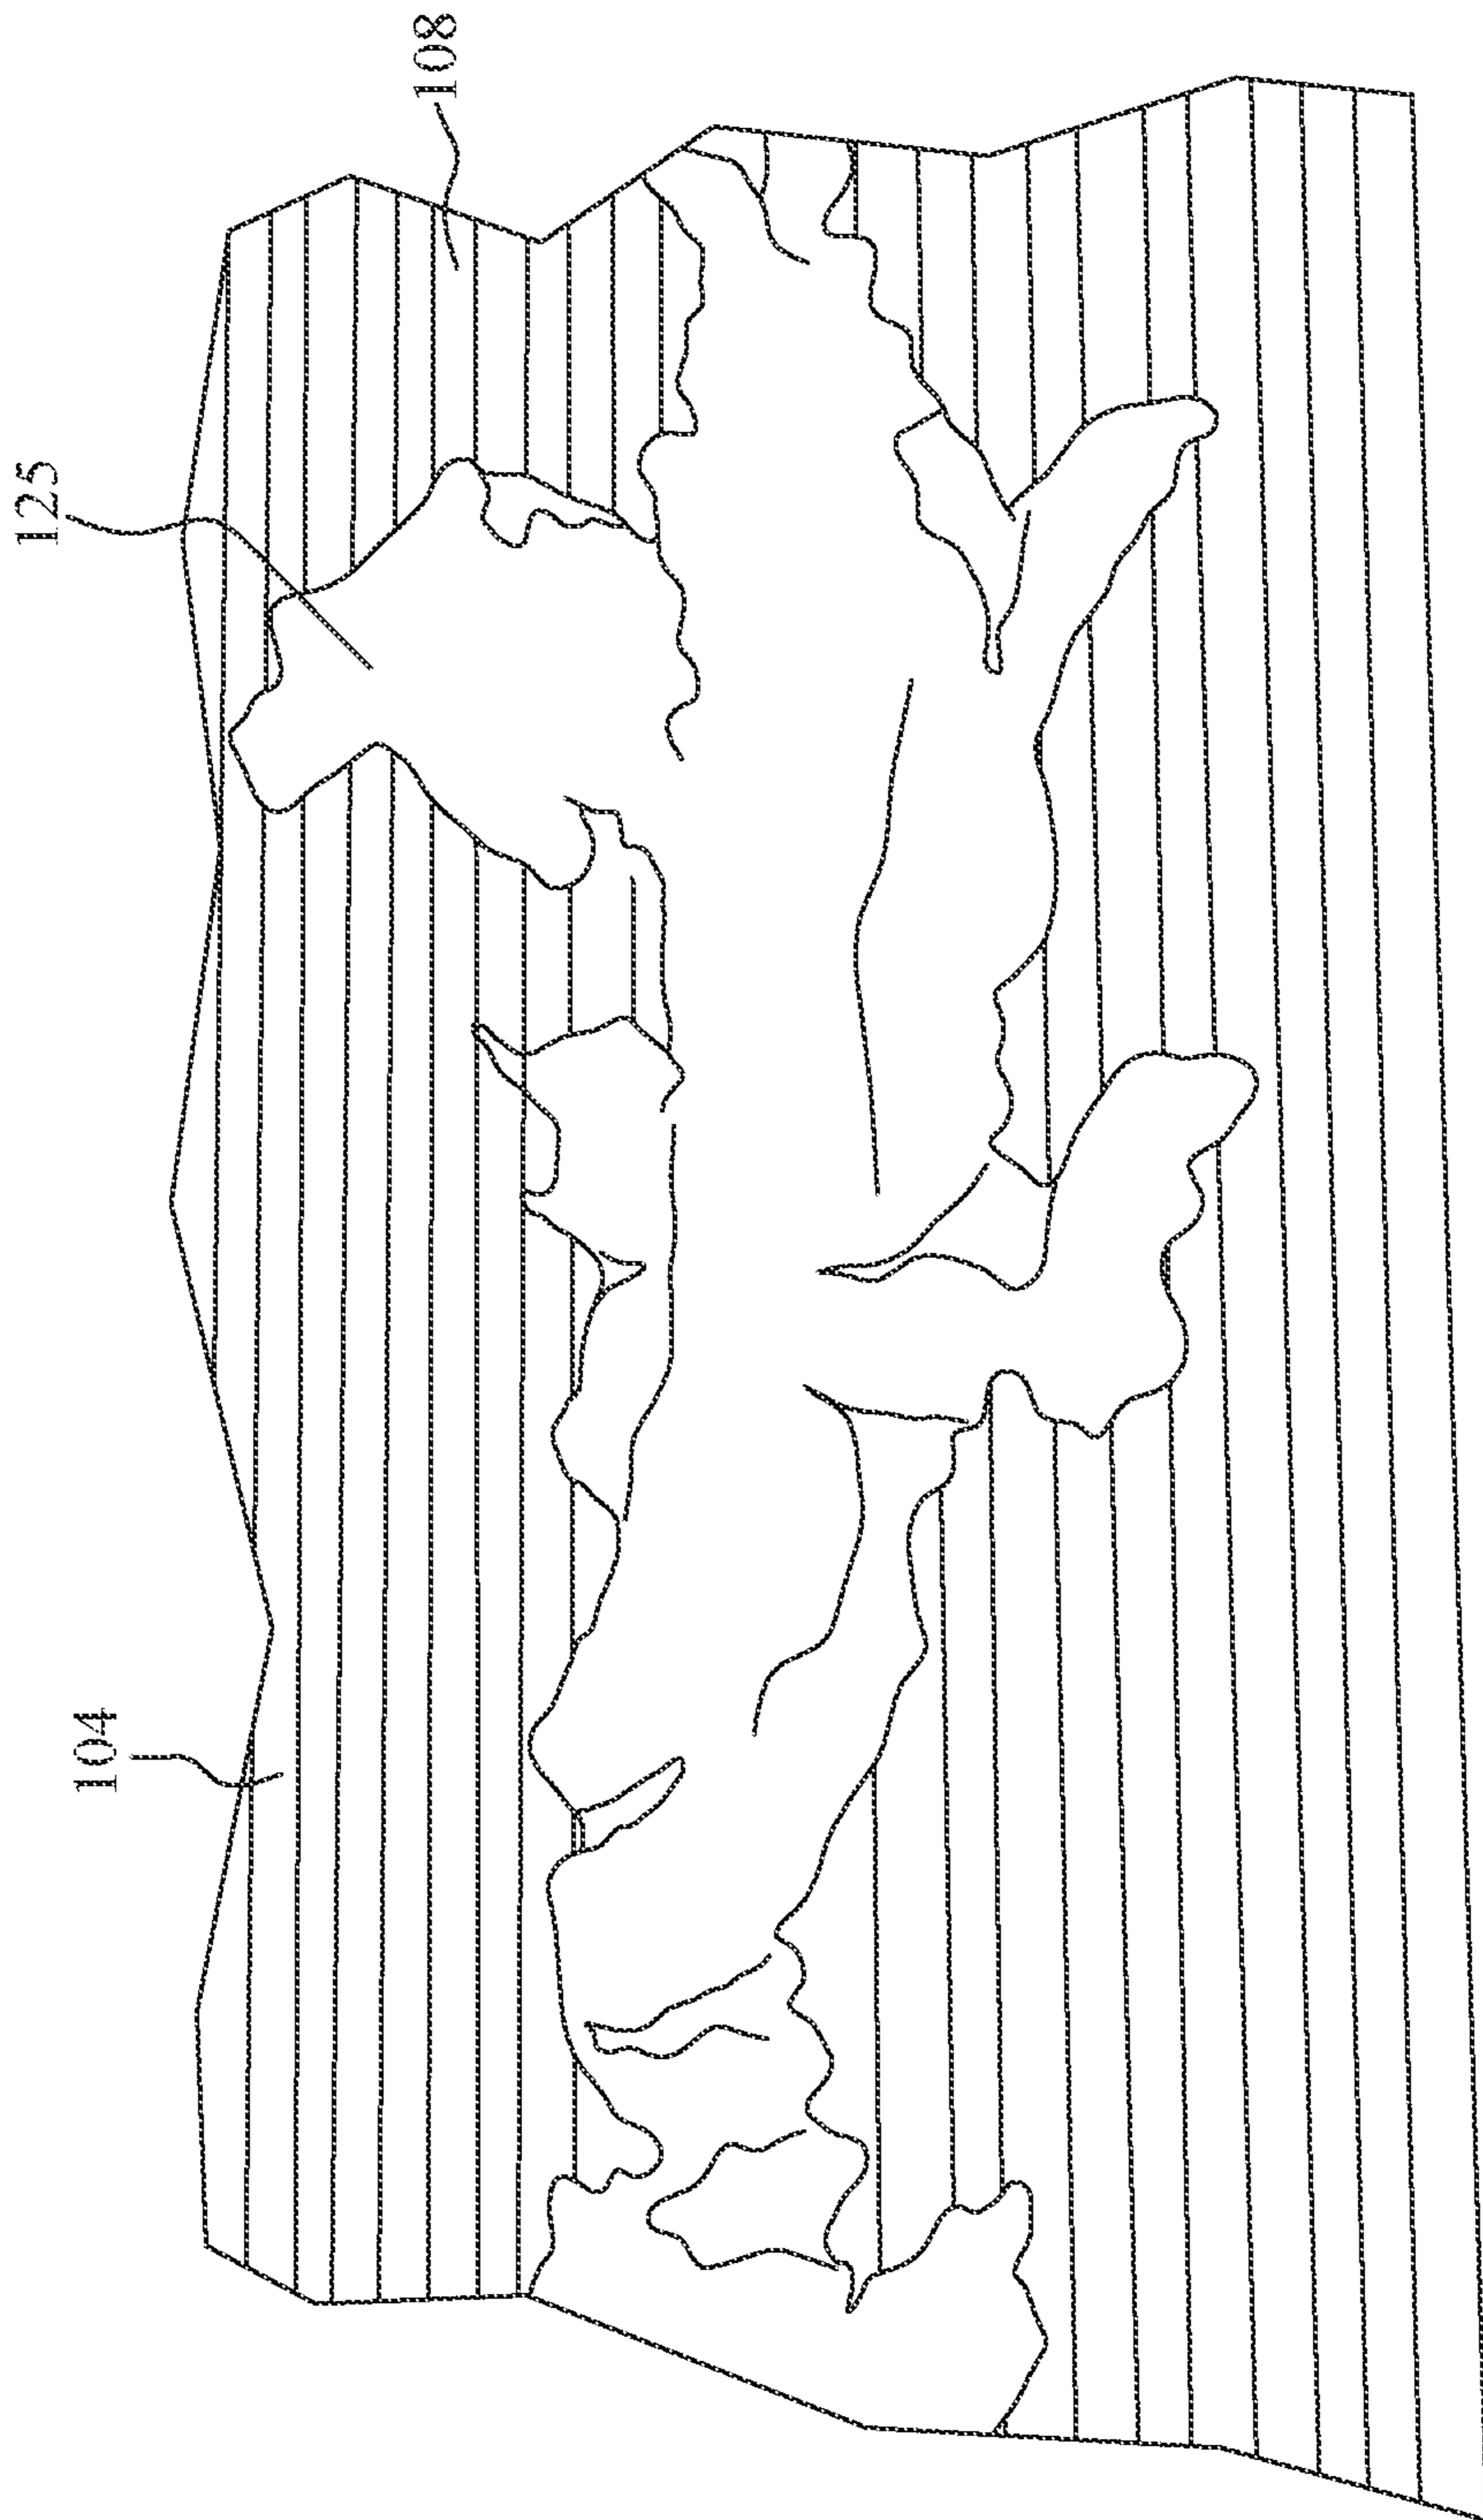
FIG. 38 is a plan perspective view showing a foam sealing material adhered to the bottom of a prior art liner;

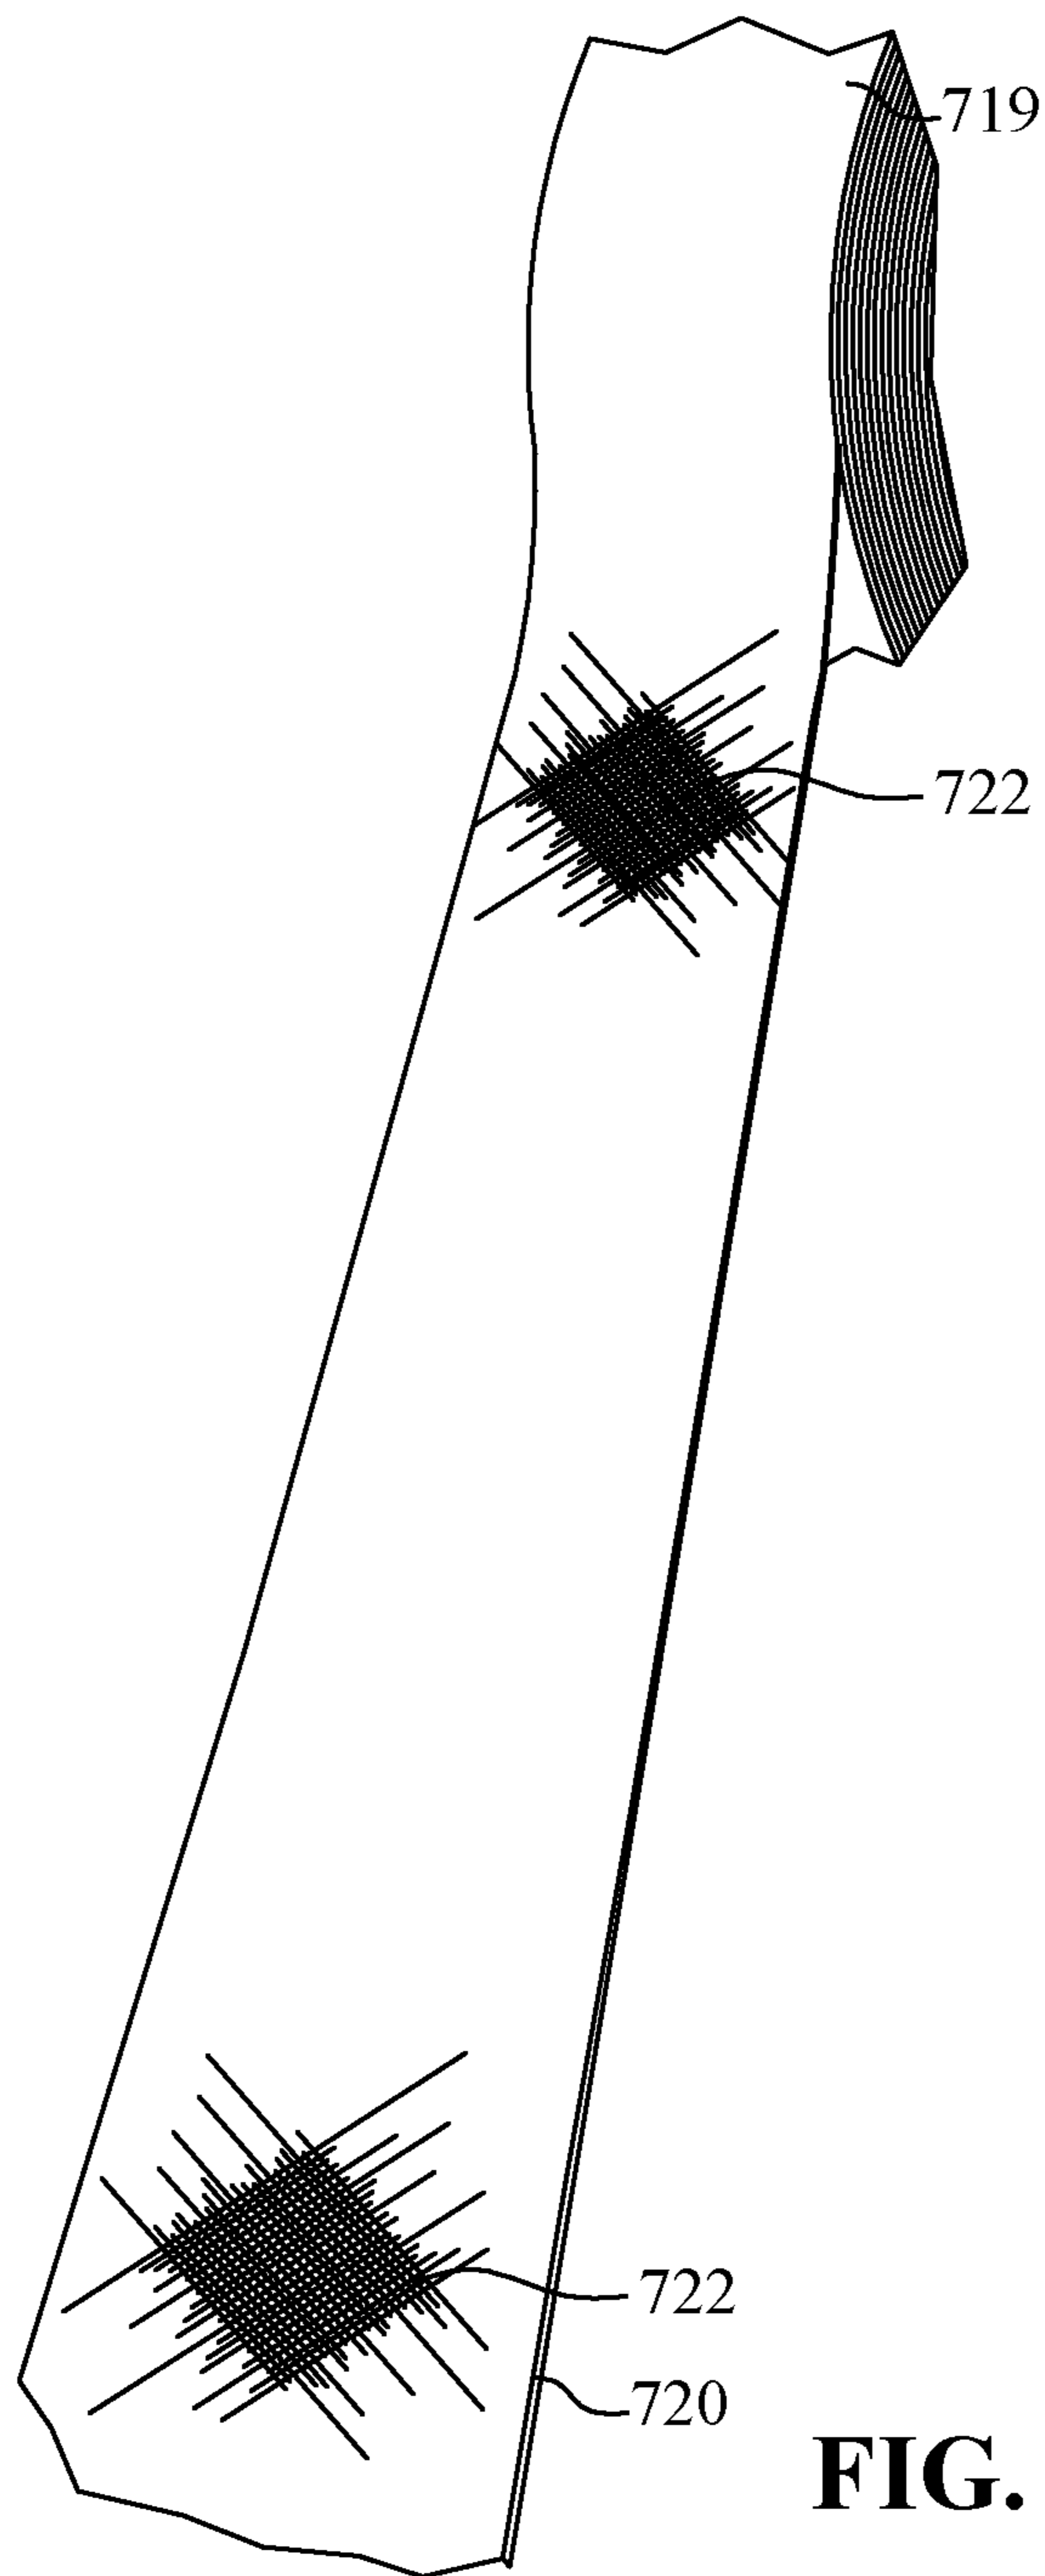
FIG. 39 is a perspective view of a role of repair tape for use in repairing the woven material;

In one embodiment, the repair system includes a role of woven or nonwoven fabric tape shown indicated as 719. In the embodiment shown, the fabric tape includes a woven fabric shown as 722. Also, in the embodiment shown, the tape can be supplied with a contact adhesive attached to one side thereof for attachment to the liner, foil, film or fabric that it is repairing or reinforcing. A protective layer of material 720 (see FIG. 39) to which the adhesive will readily release from may be used to facilitate providing the repair tape in a rolled form or otherwise facilitate removing thereof for easy repair or reinforcement of the recreational vehicle. As shown in FIGS. 42 and 43, repair tape 719 is attached to woven fabric layer 709, on the exterior thereof, creating an additional layer to the liner 700 as is best shown in FIG. 43. It should be appreciated that repair and reinforcing tape 719 could be placed or attached over itself to create additional reinforcing layers, and/or on the other side of the liner over the sheet of aluminum foil or metalized file 707. As many additional layers as is desired can be placed on either or both sides. It should also be appreciated that the repair tape could be an aluminum foil, or metalized film or other polymer or material, but the woven fabric tape has shown to be particularly suitable.

Now referring now to FIGS. 39-42, a unique repair and reinforcing system is provided for any of the liners provide herein and may be used to repair rips, tears or holes in the liner itself, or in the aluminum foil or metalized film or to provided additional support, reinforcement or protection to the liner. However, it is particularly suitable for repairing rips, tears, holes etc. in the woven or nonwoven fabric that may be attached to and covering one or both outer faces of the liner. Such rips, tears etc. may be through only the woven or nonwoven fabric, but also may be through partially or entirely through the body of the liner. Also, it may be necessary to cut through the liner to install plumbing, electrical lines etc. in the recreational vehicle. The repair system can be used to repair around such installations.

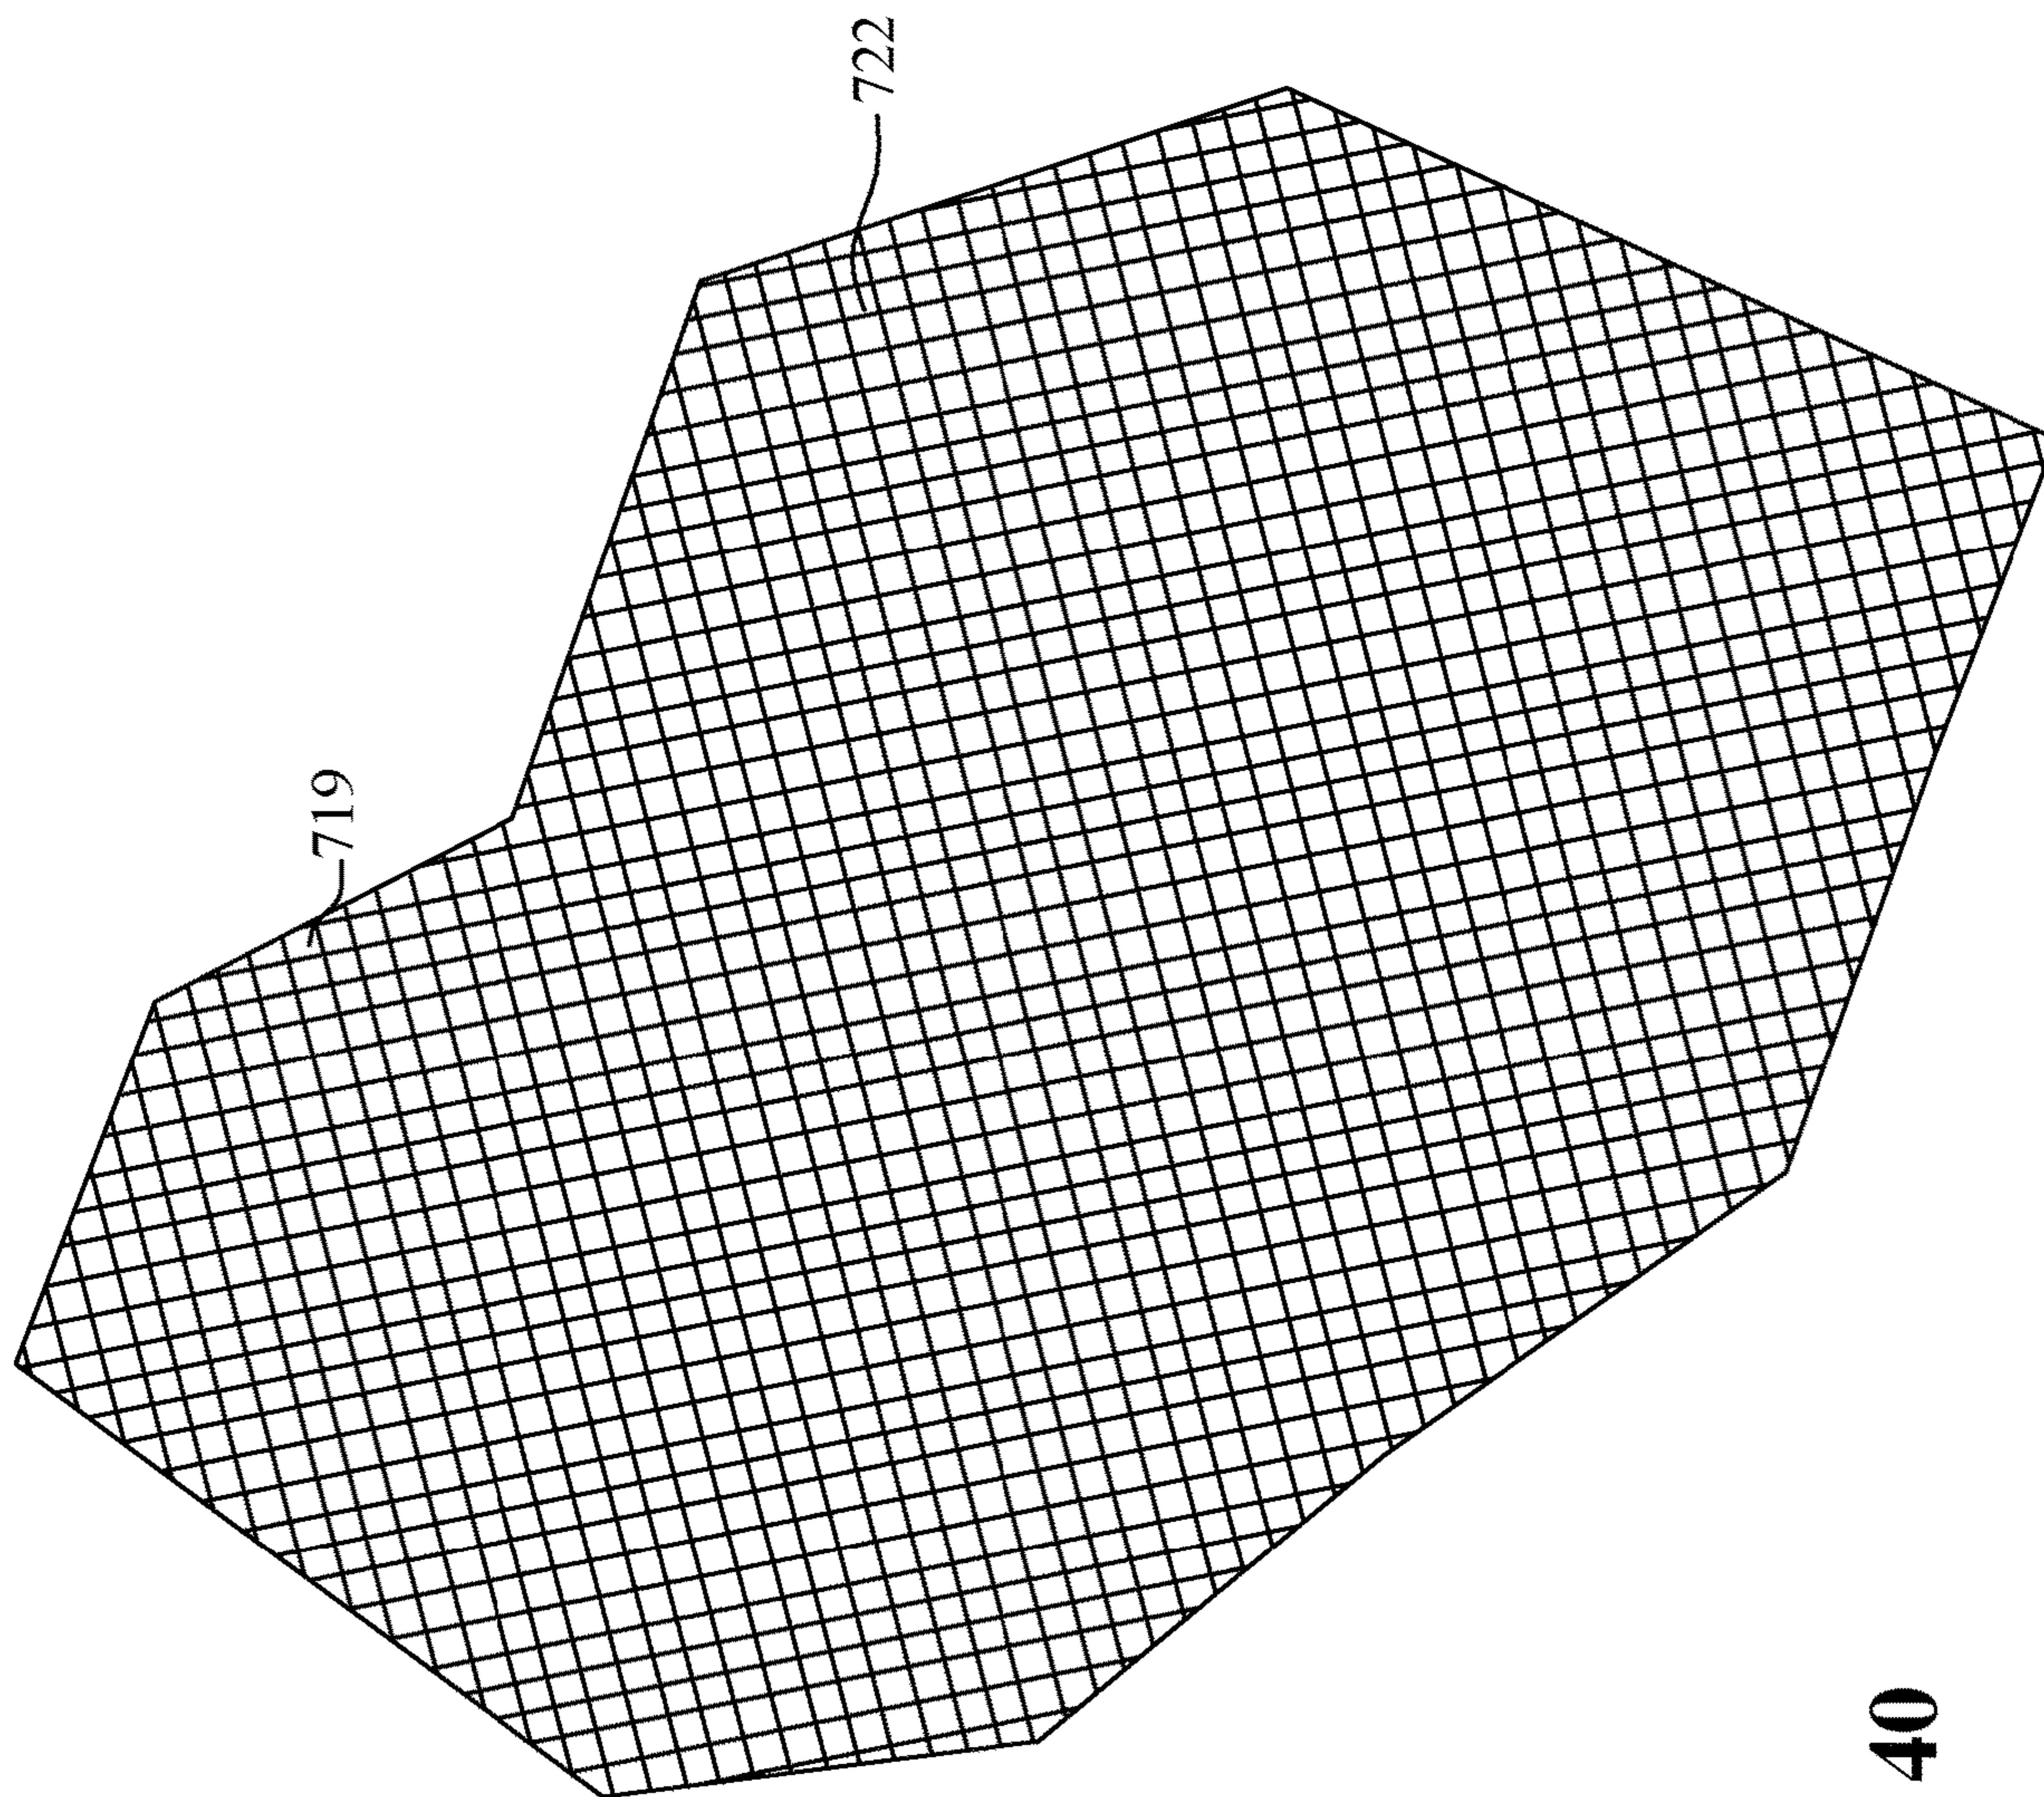
FIG. 40 is an enlarged plan view of the woven material repair tape;

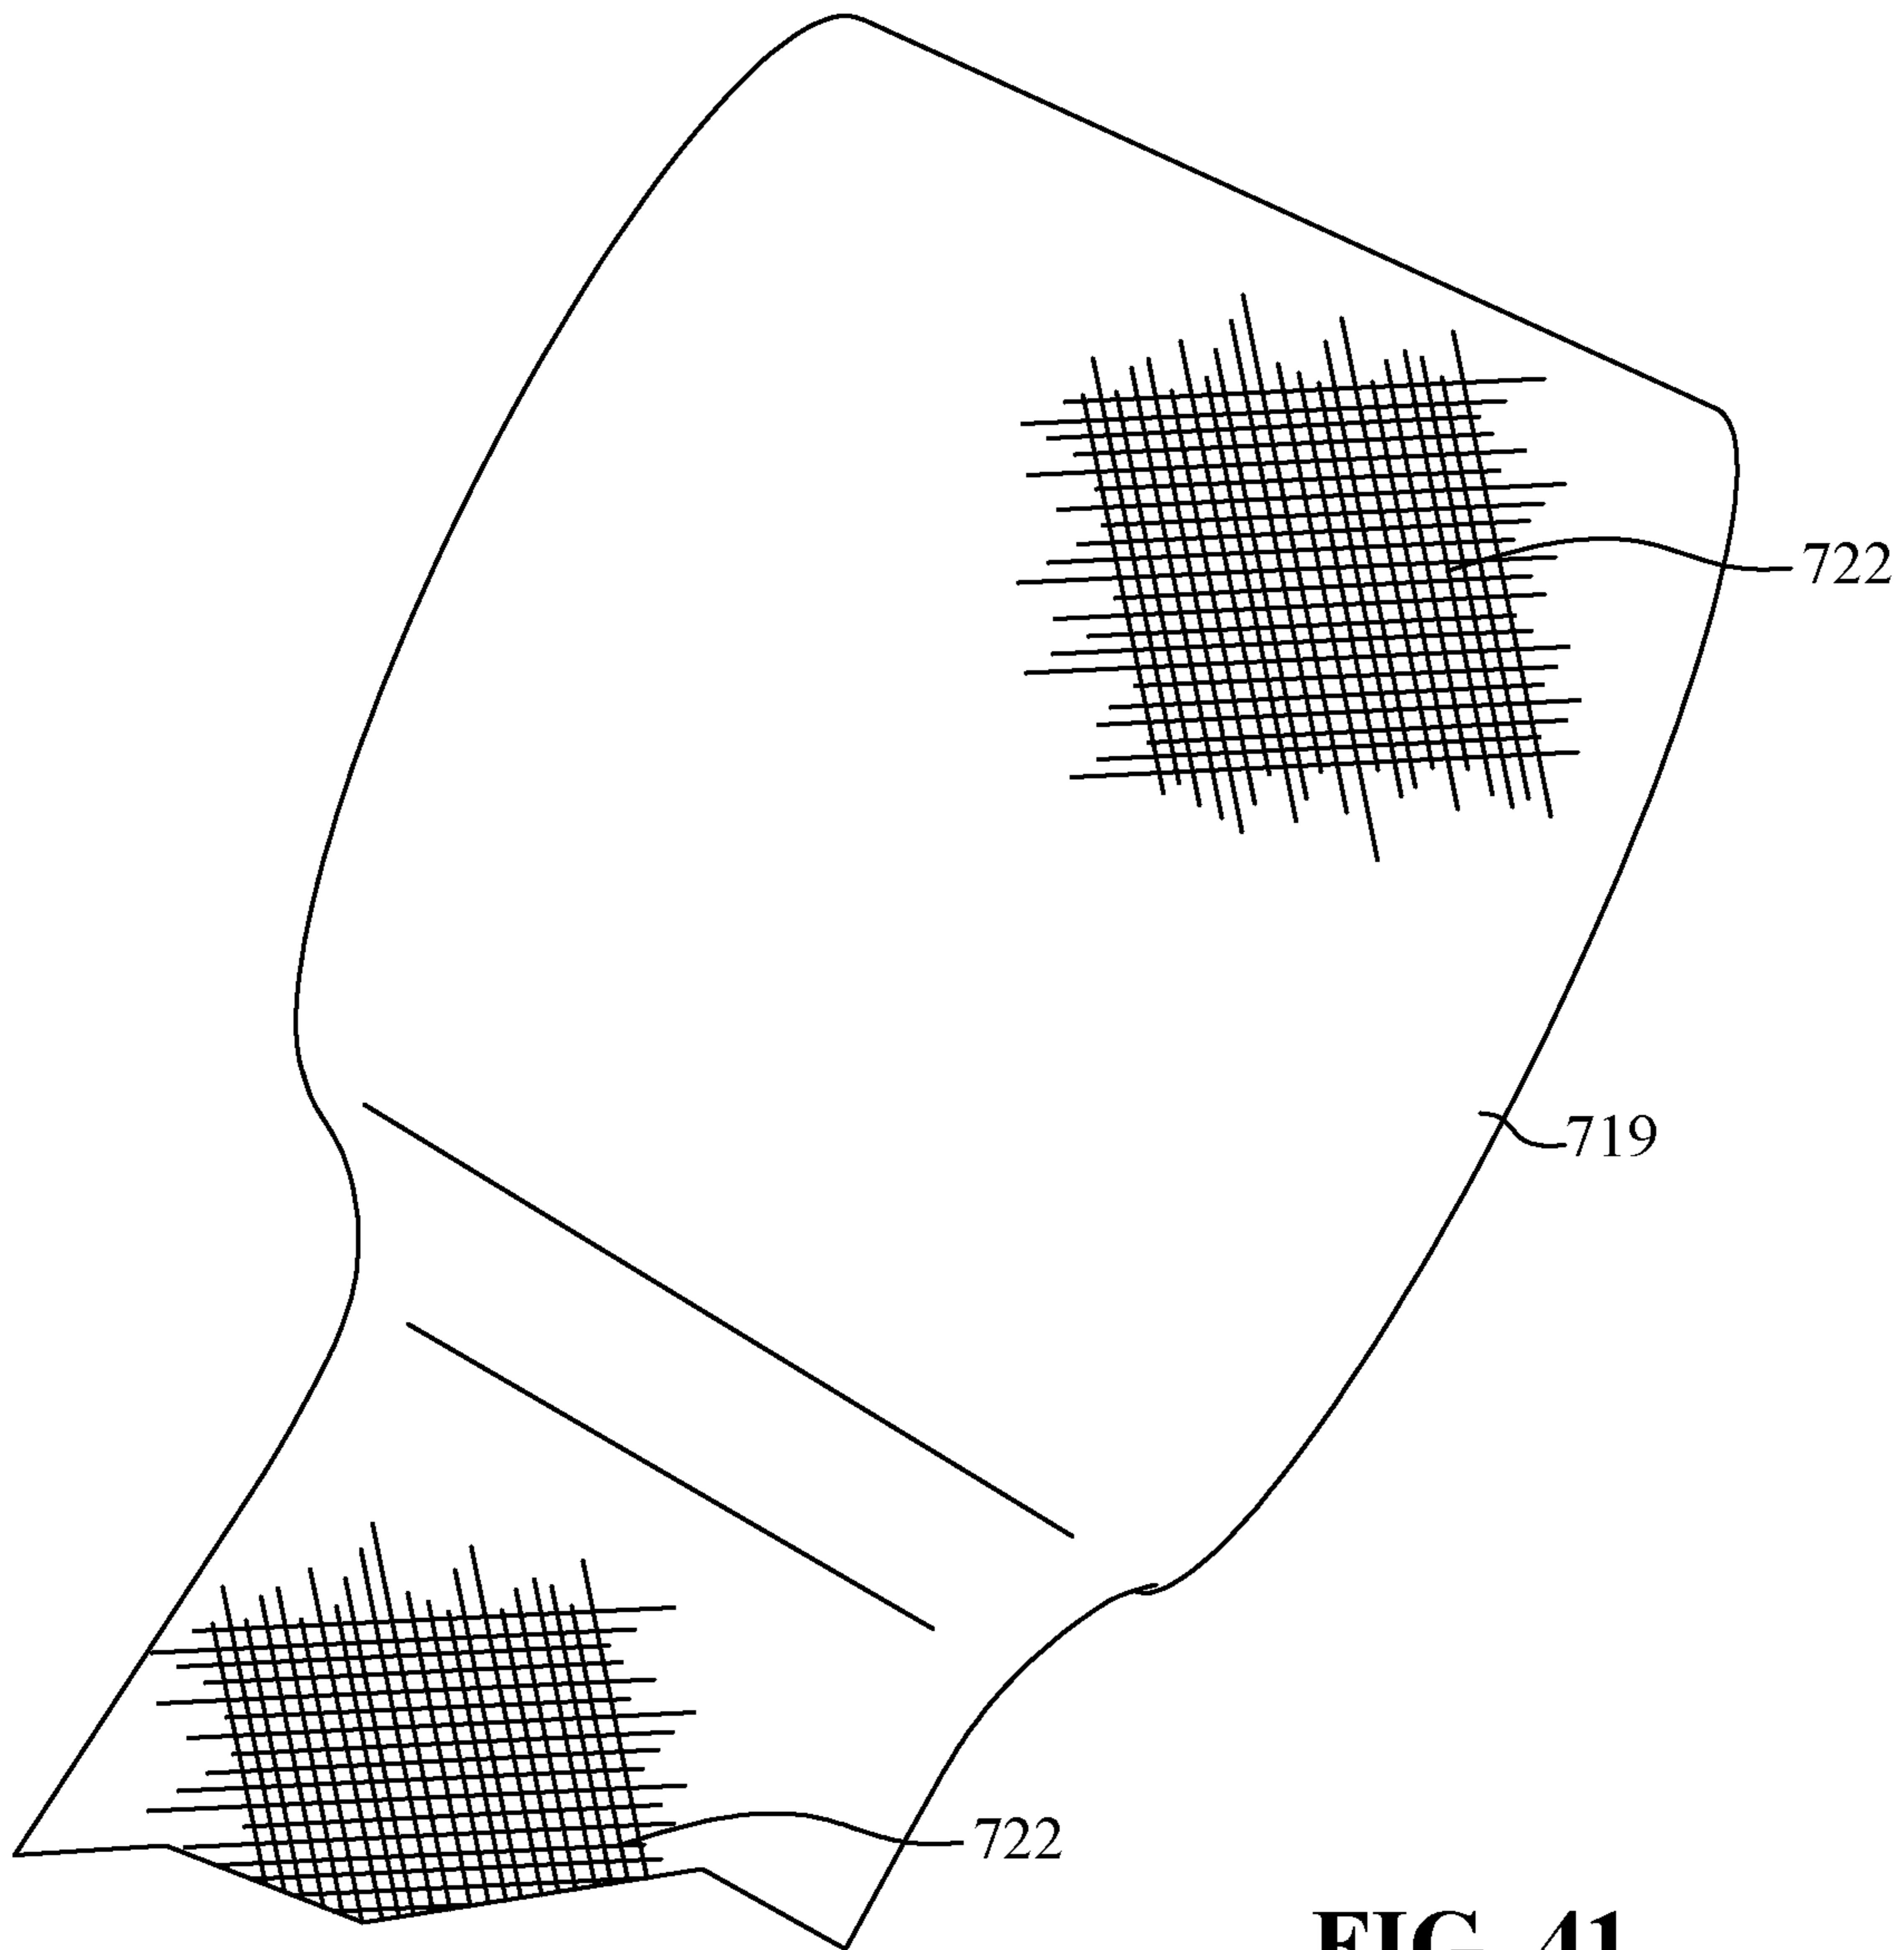
FIG. 41 is another plan view of the role of woven material repair tape;
