(12) **United States Patent**
Pennington

(54) **VEHICLE FRAME AND CARGO BAY LINER**

(71) Applicant: **PennPlastics, LLC**, Mishawaka, IN (US)

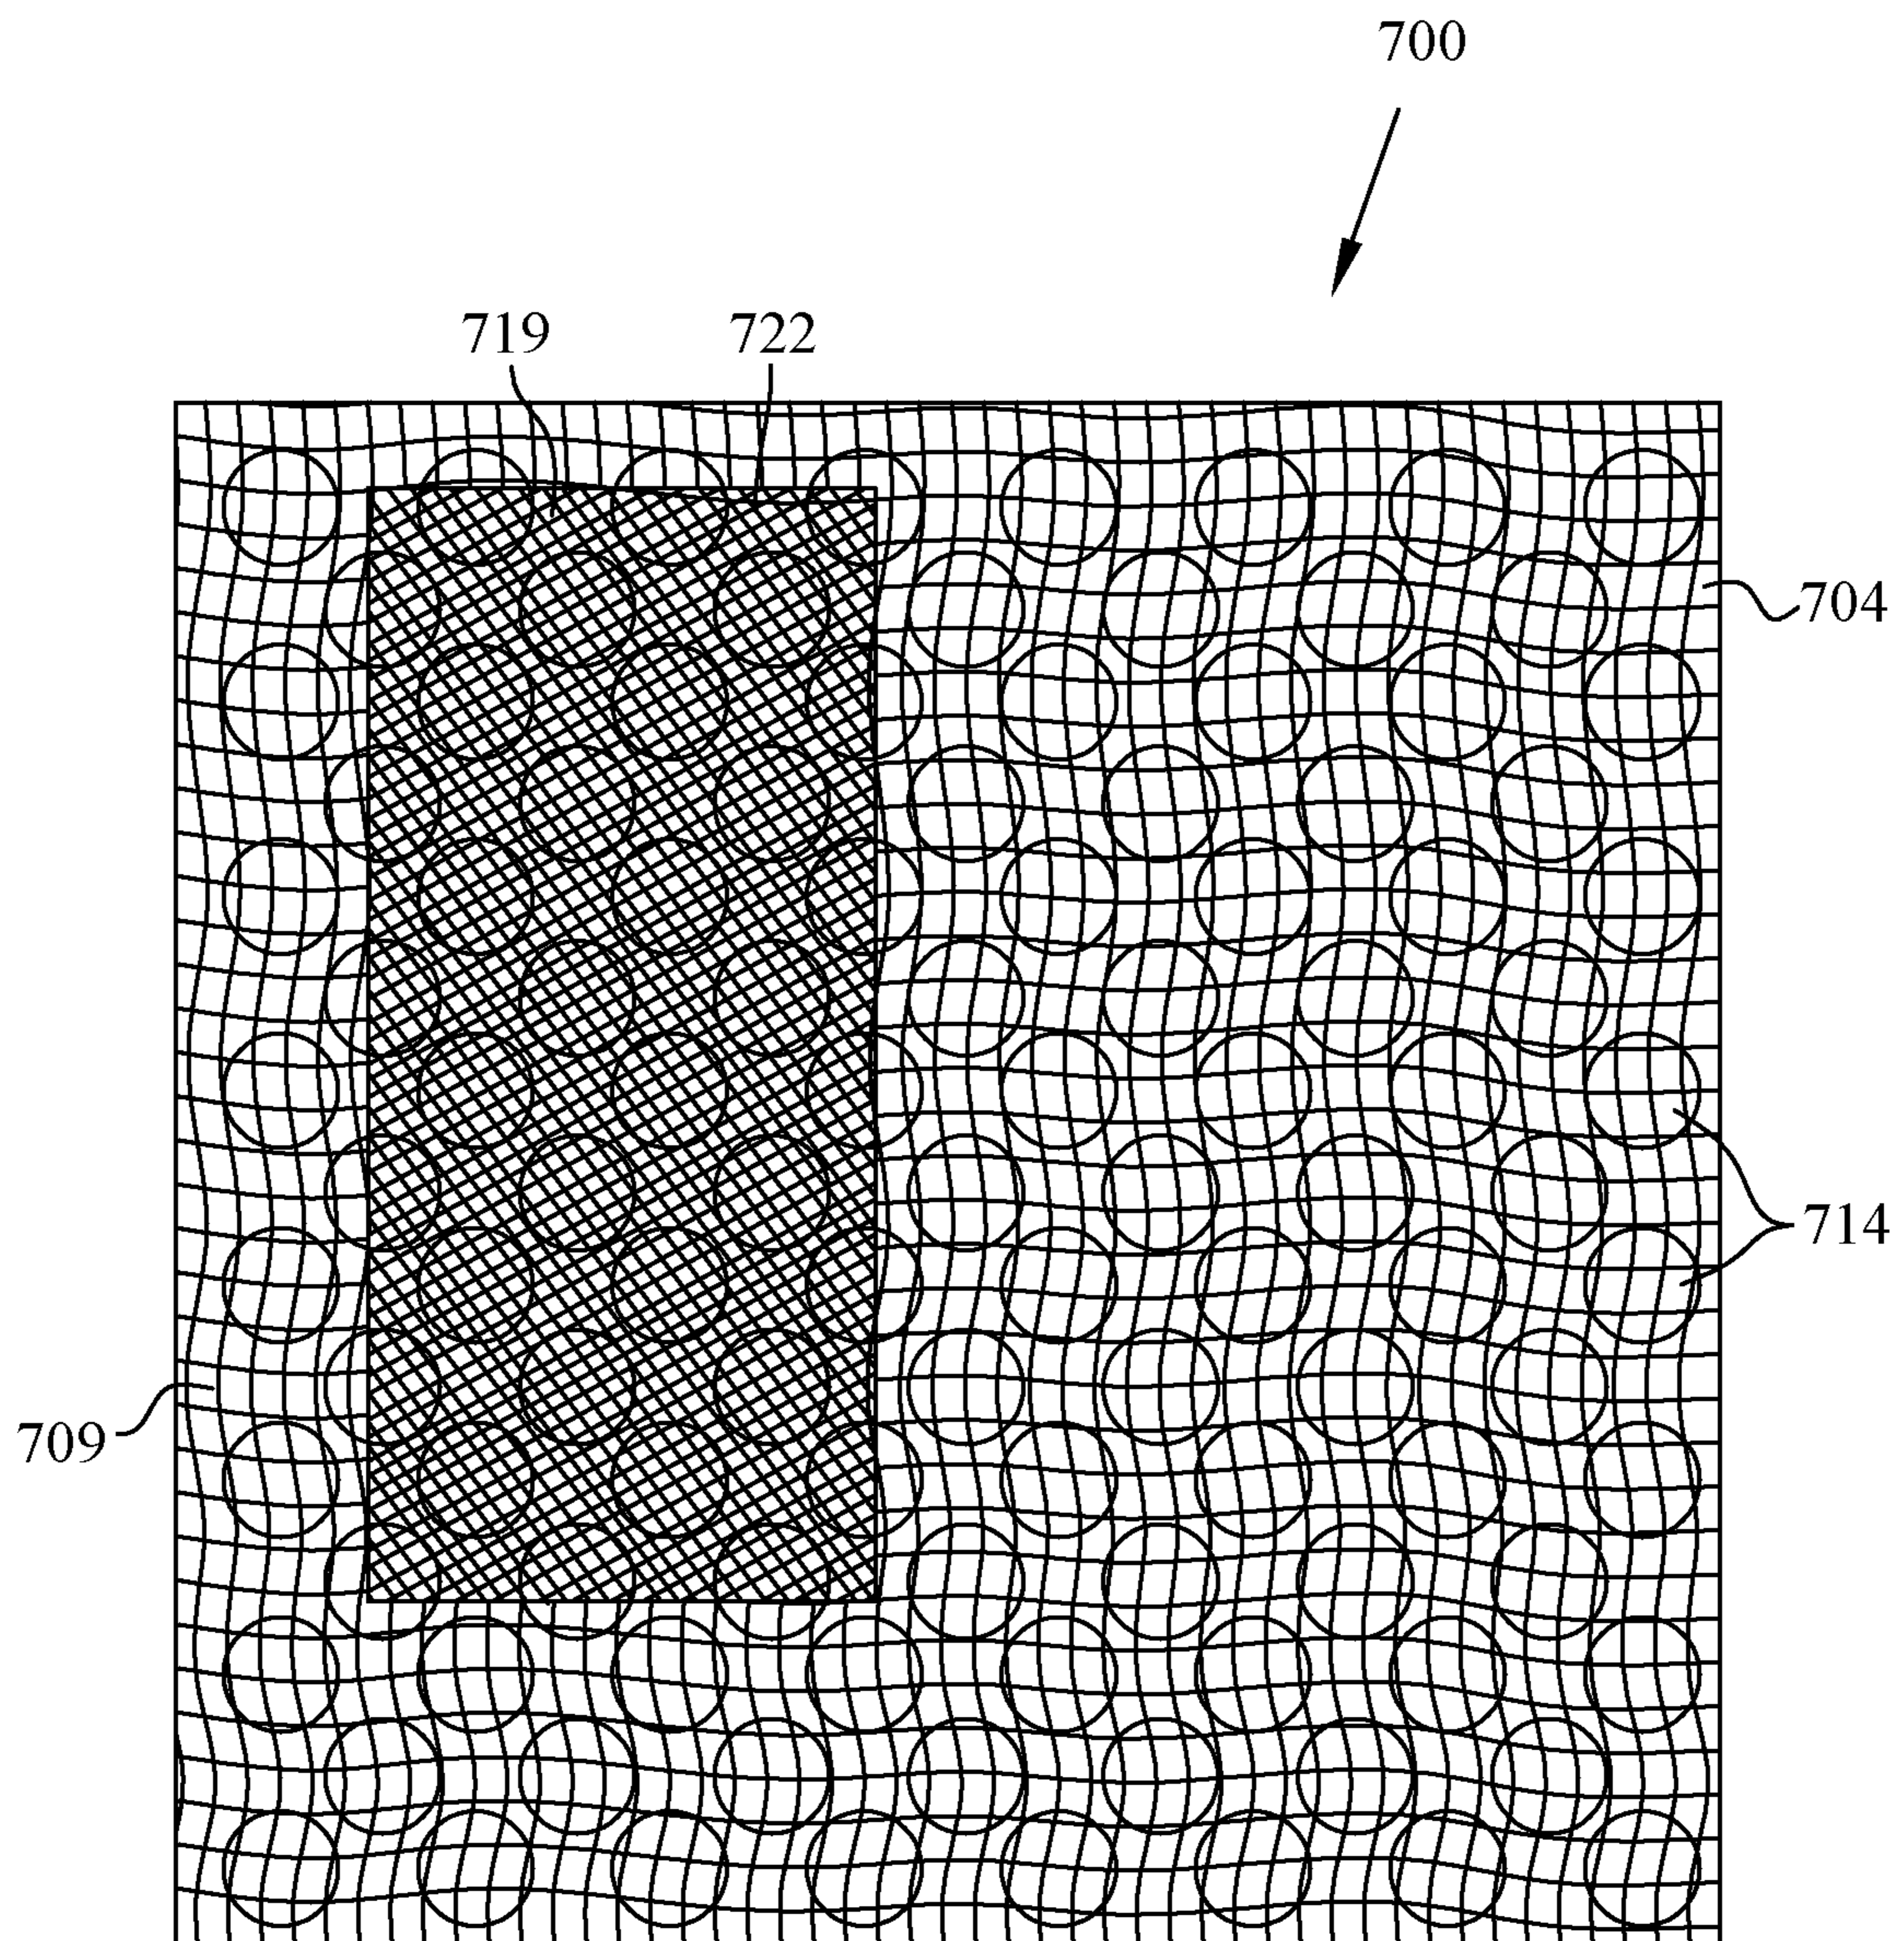
FIG. 42 is a plan view of a liner having a sheet of material with a woven fabric attached thereon and a piece of repair tape attached to the woven material; and

Now referring now to FIGS. 39-42, a unique repair and reinforcing system is provided for any of the liners provide herein and may be used to repair rips, tears or holes in the liner itself, or in the aluminum foil or metalized film or to provided additional support, reinforcement or protection to the liner. However, it is particularly suitable for repairing rips, tears, holes etc. in the woven or nonwoven fabric that may be attached to and covering one or both outer faces of the liner. Such rips, tears etc. may be through only the woven or nonwoven fabric, but also may be through partially or entirely through the body of the liner. Also, it may be necessary to cut through the liner to install plumbing, electrical lines etc. in the recreational vehicle. The repair system can be used to repair around such installations.

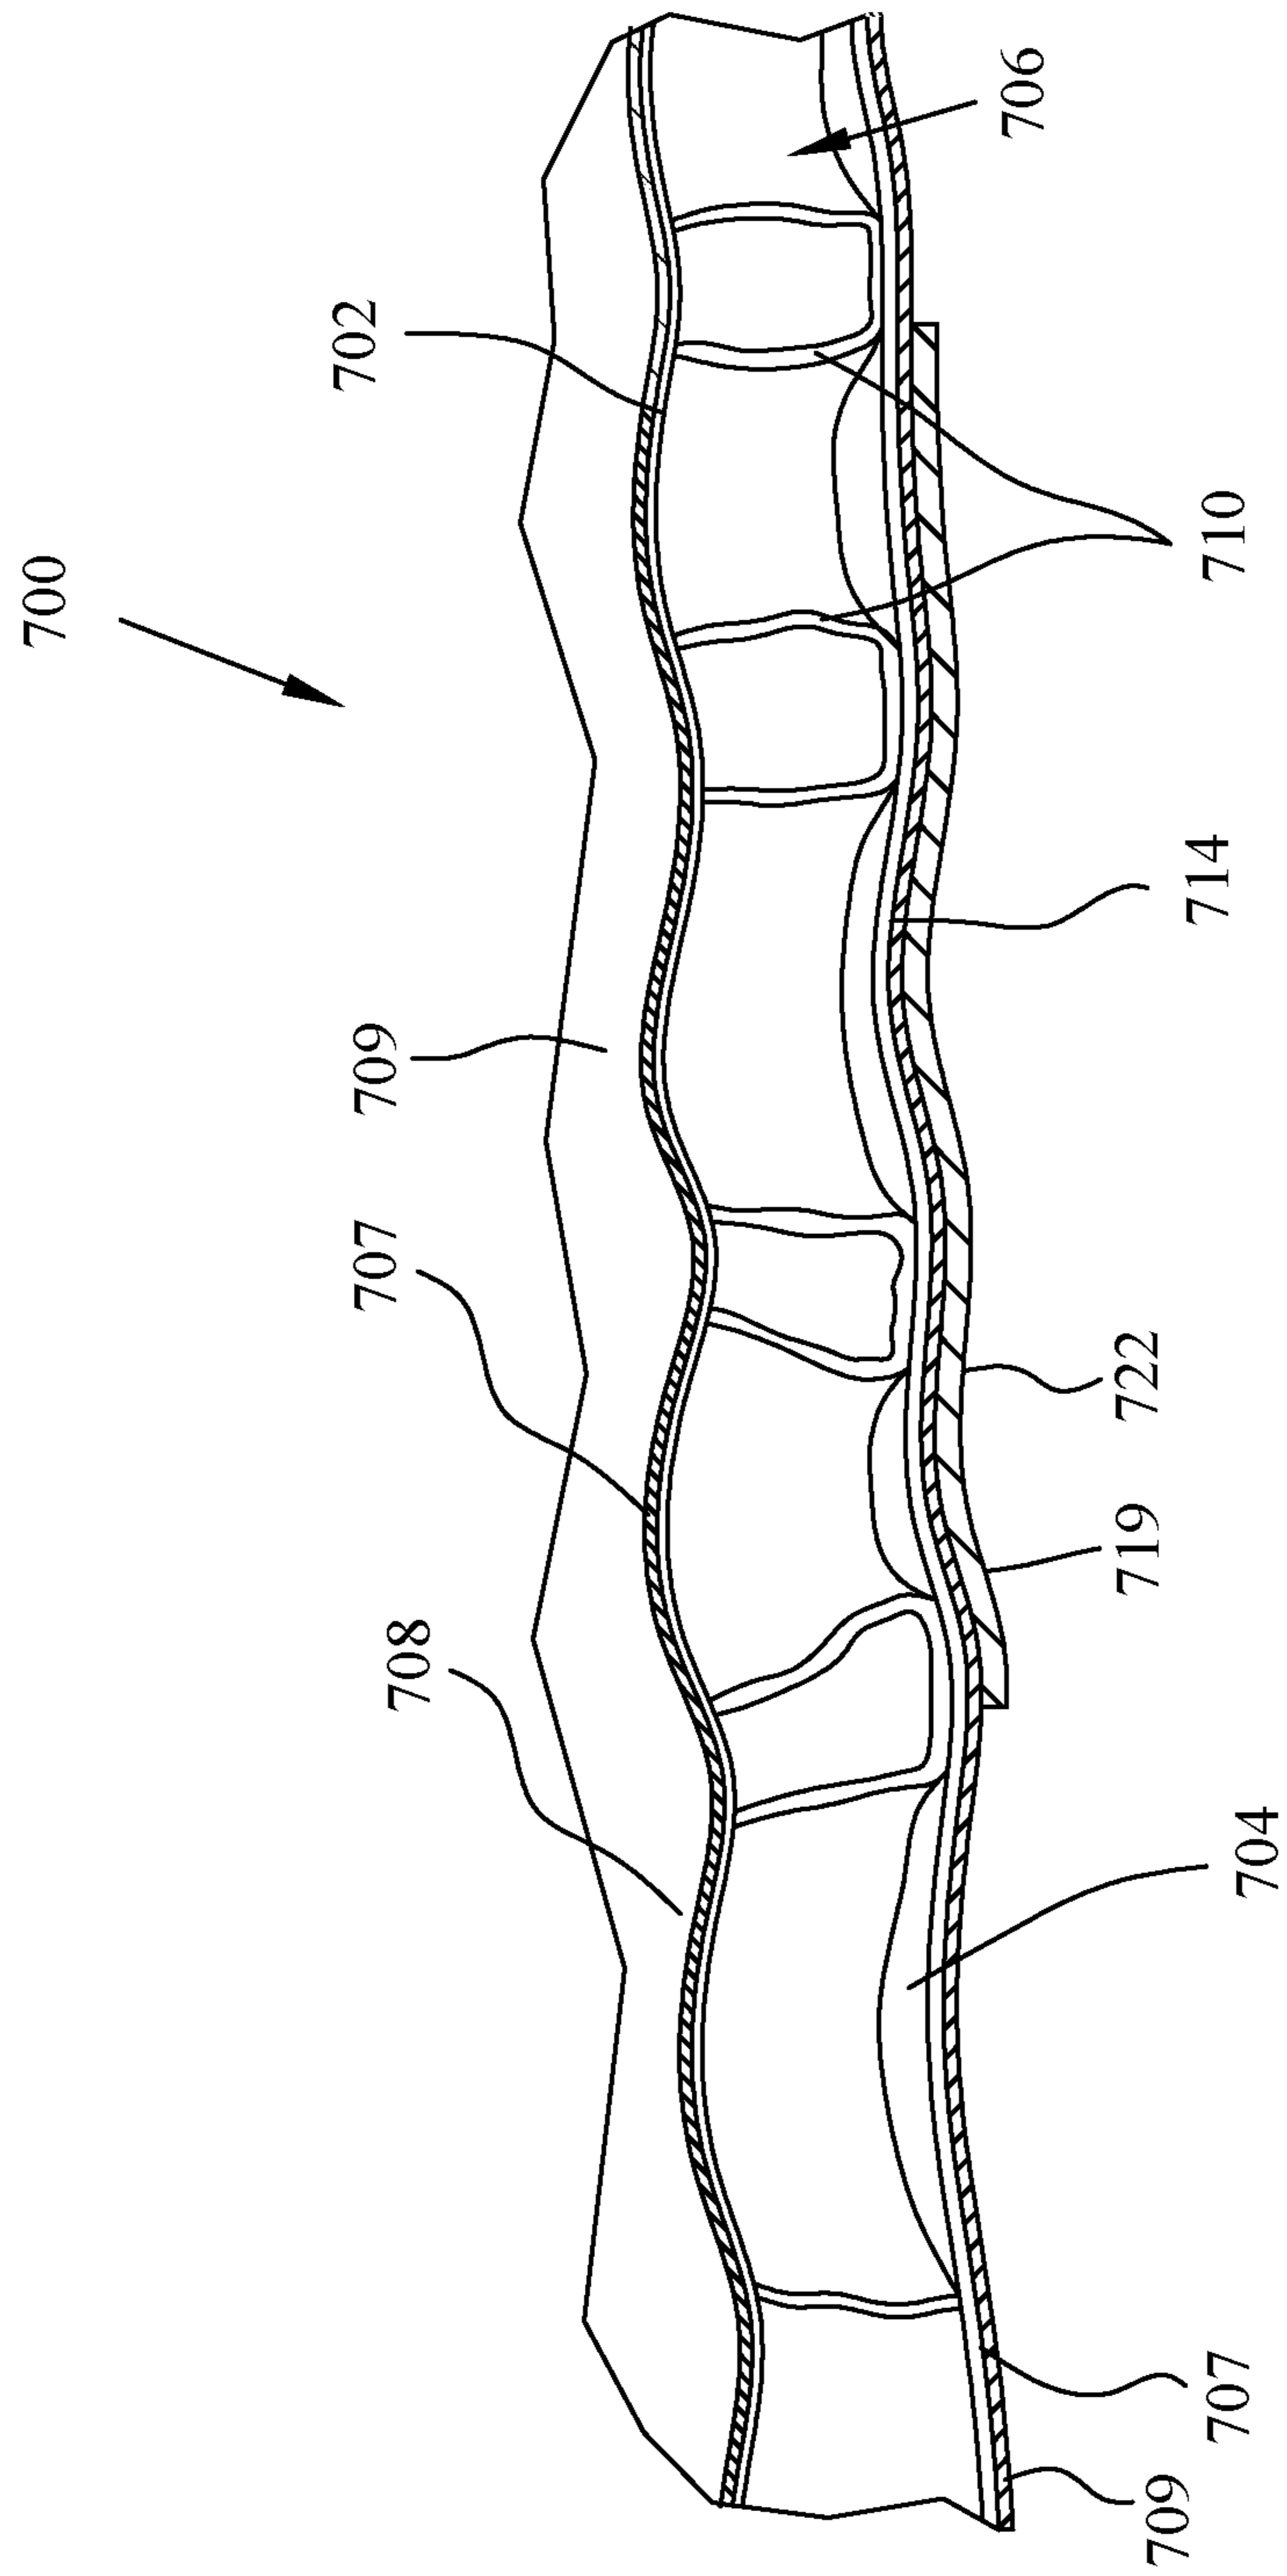
FIG. 43 is a cross sectional view of the liner of FIG. 42 taken through the piece of repair tape.
