(12) **United States Patent**  
**Pennington**

(54) **VEHICLE FRAME AND CARGO BAY LINER**

(57) **ABSTRACT**

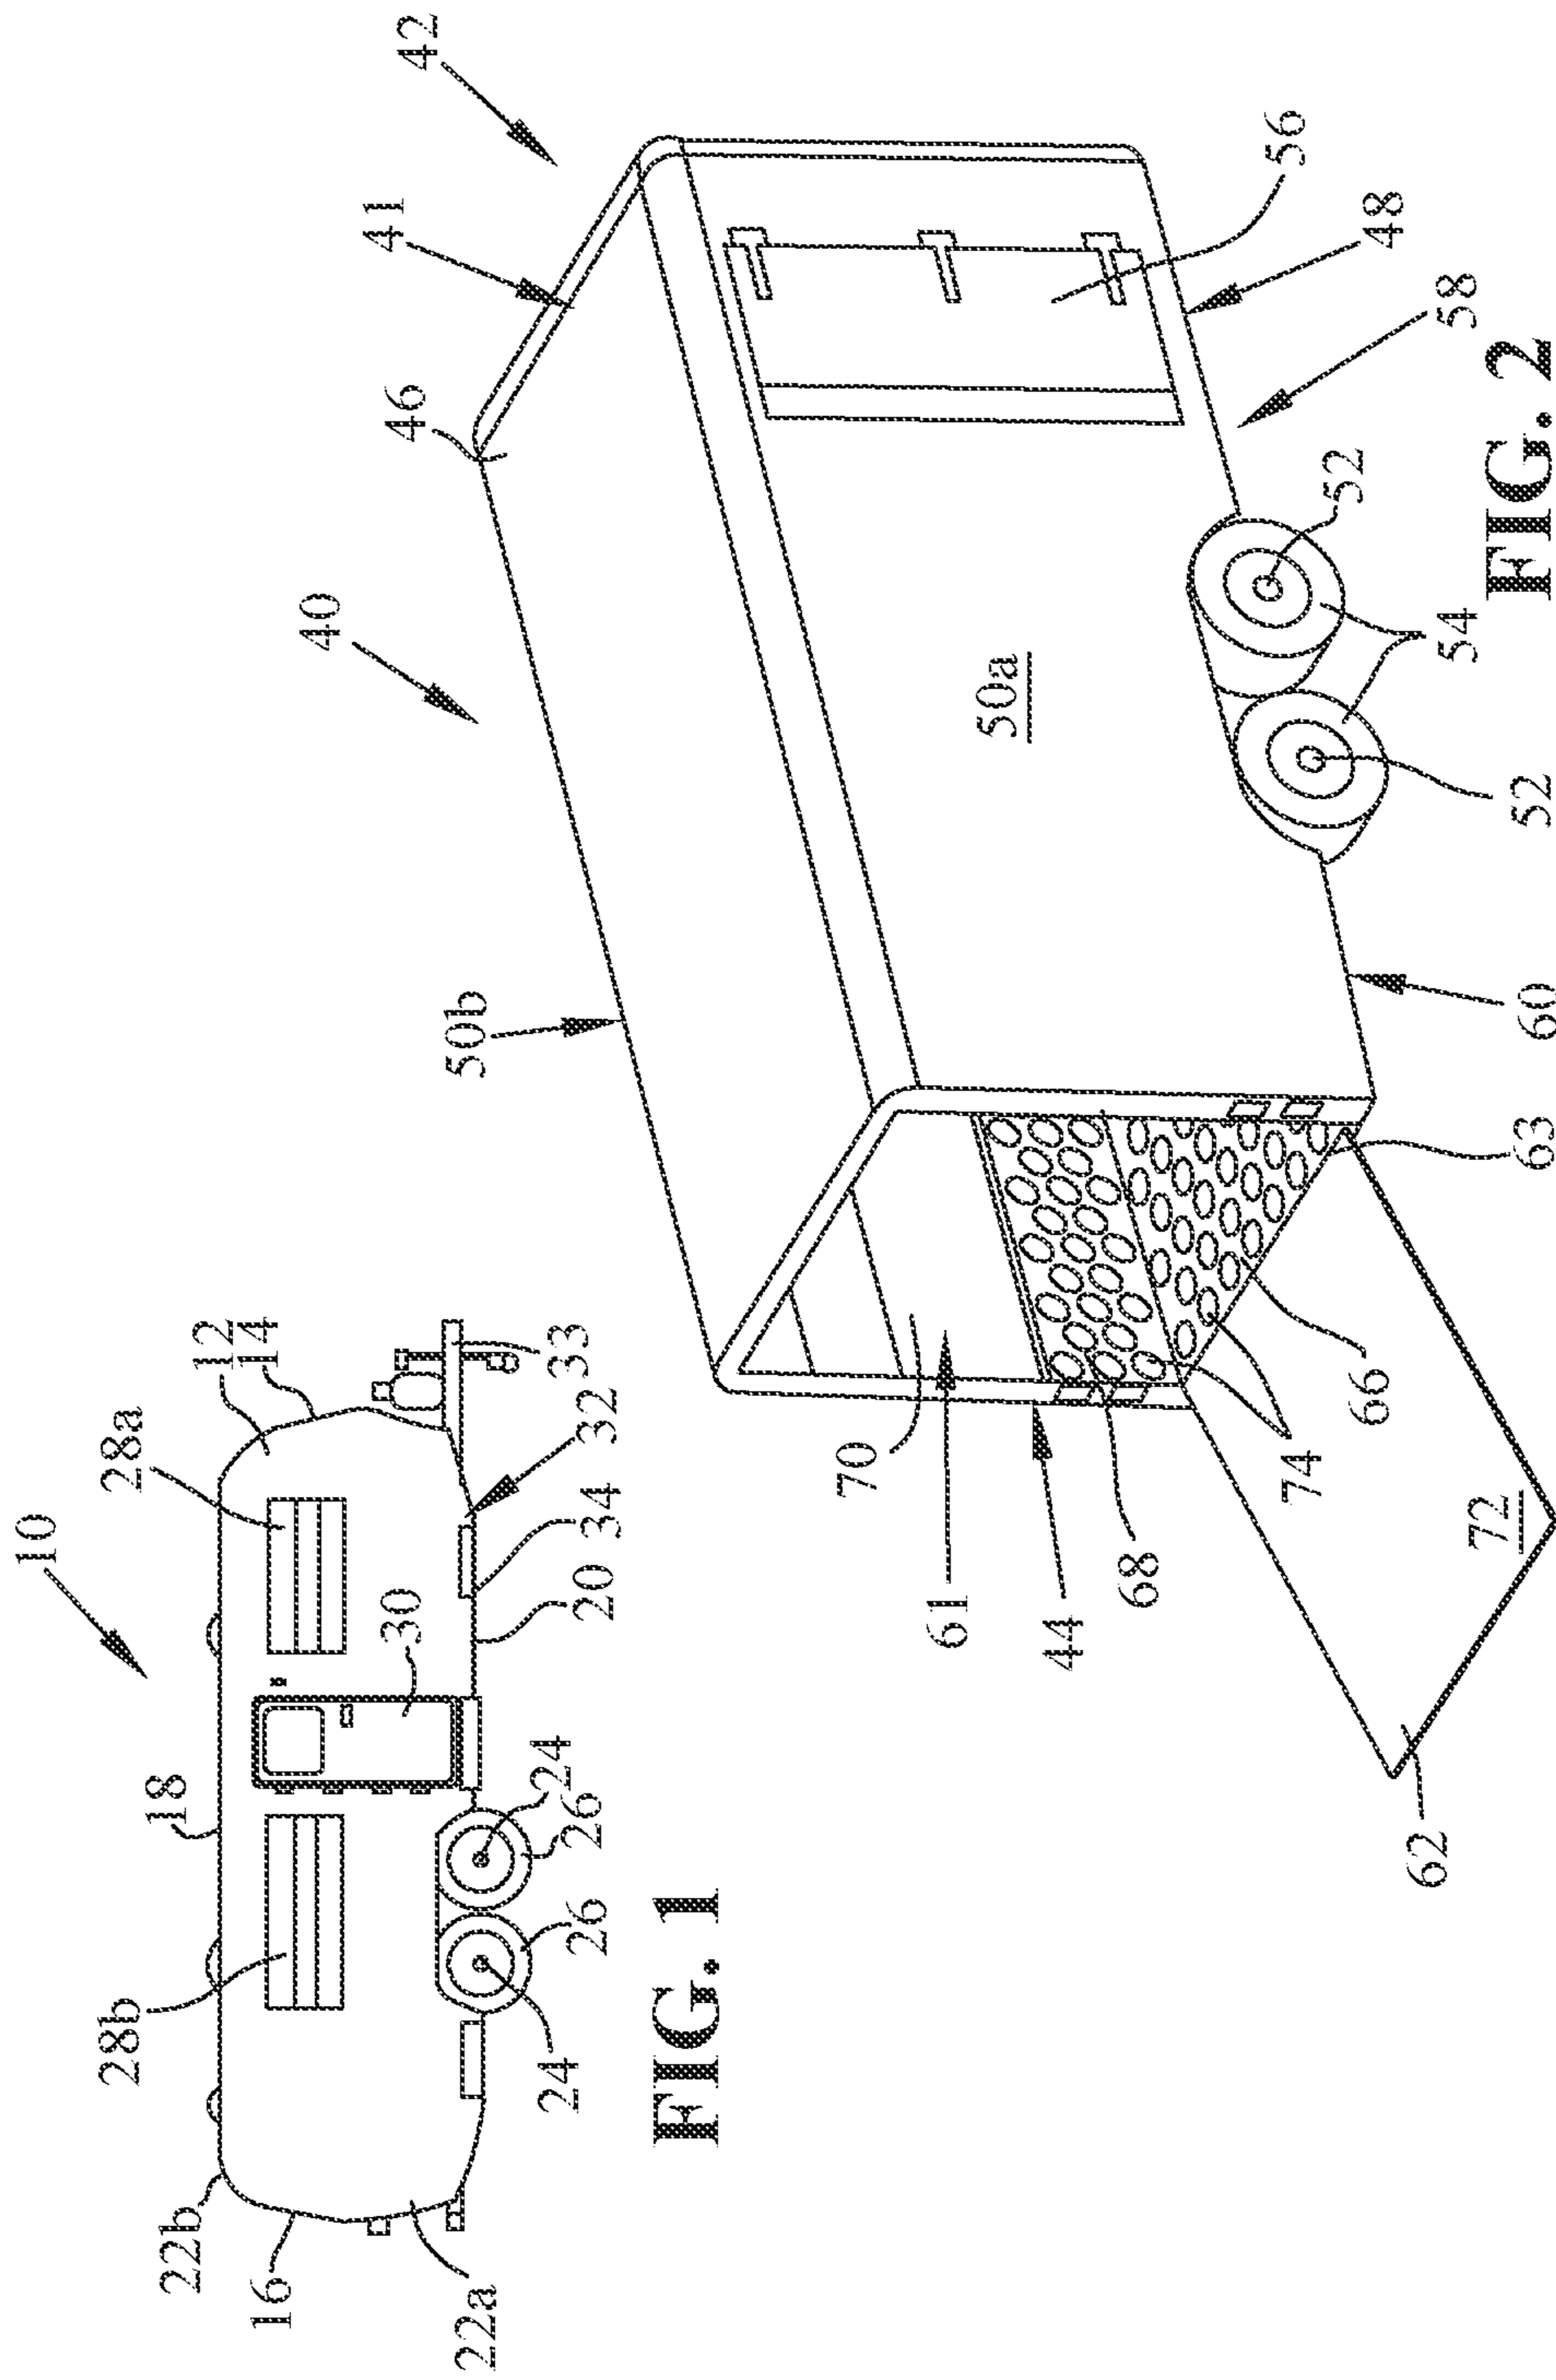
FIG. 1 is a side view of a recreational vehicle and frame liner in accordance with the subject invention;

Referring now to FIG. 1, a recreational vehicle is shown generally indicated as 10. In the embodiment shown, recreational vehicle 10 is a type commonly called a travel trailer. Travel trailer 10 is generally defined by a housing 12 including a front end 14, a rear end 16, a top 18, a bottom 20, and a pair of generally parallel sides 22a, 22b. Recreational 10 further includes a pair of axels 24 having wheels 26 mounted thereon. Recreational vehicle 10 also includes

windows **28a**, **28b** and a door **30**. Housing **14** is mounted upon and supported by a frame assembly, generally indicated as **32**, extending into a hitch **33**. These are all known and common in the recreational vehicle industry. A liner **34** in accordance with the subject invention is mounted and attached at the bottom of frame assembly **32** to protect the undercarriage of recreational vehicle **10** as described above in the background section.

FIG. 2 is a perspective view of a cargo trailer and cargo bay liner in accordance with the subject invention;

Now referring to FIG. 2, a trailer of a type normally considered a cargo trailer or toy hauler is shown generally indicated as **40**. A toy hauler is generally considered to be a vehicle that has at least a portion or all of the trailer designed as a cargo area or bay to contain and transport another type of vehicle, such as but not limited to motorcycles, ATV's, snowmobiles, or specialty vehicles. Similar to recreational vehicle **10**, carbon trailer **40** is defined by a housing, generally indicated as **41**. Housing **41** includes a front end **42**, a rear end **44**, a top **46**, a bottom **48**, and a pair of generally parallel sides **50a**, **50b**. Cargo trailer **40** further includes a pair of axels **52** having wheels **54** mounted thereon. Cargo trailer **40** also includes a door **56**. Housing **41** is mounted upon and supported by a frame assembly, generally indicated as **58** that extends into a hitch **59**. These are all known and common in the cargo trailer and toy hauler industry. Cargo trailer **40** includes a liner **60** in accordance with the subject invention that is mounted and attached at the bottom of frame assembly **58** to protect the undercarriage of cargo trailer **40** similar to recreational vehicle **10**.

Cargo trailer **40** also includes a cargo or bay area, generally indicated as **61** which is accessed through a door **62** which swings downward at rear end **44** on a bottom hinge **64**. A floor liner **66** in accordance with the subject invention is mounted on top of the floor of cargo area **61** and a similar liner **68** is mounted on walls **70** of cargo area **61**. In the embodiment shown, wall liner **68** is mounted partially up wall **70**; however, it should be appreciated that the liner could be mounted to extend completely up wall **70**. The liner may also be mounted partially or completely on a front wall of cargo area **61** as well on an inside surface **72** of rear door **62**. Although not shown to scale, in embodiments shown in FIG. 2, liners **66** and **68** include projections **74** extending from the liner into the cargo area.

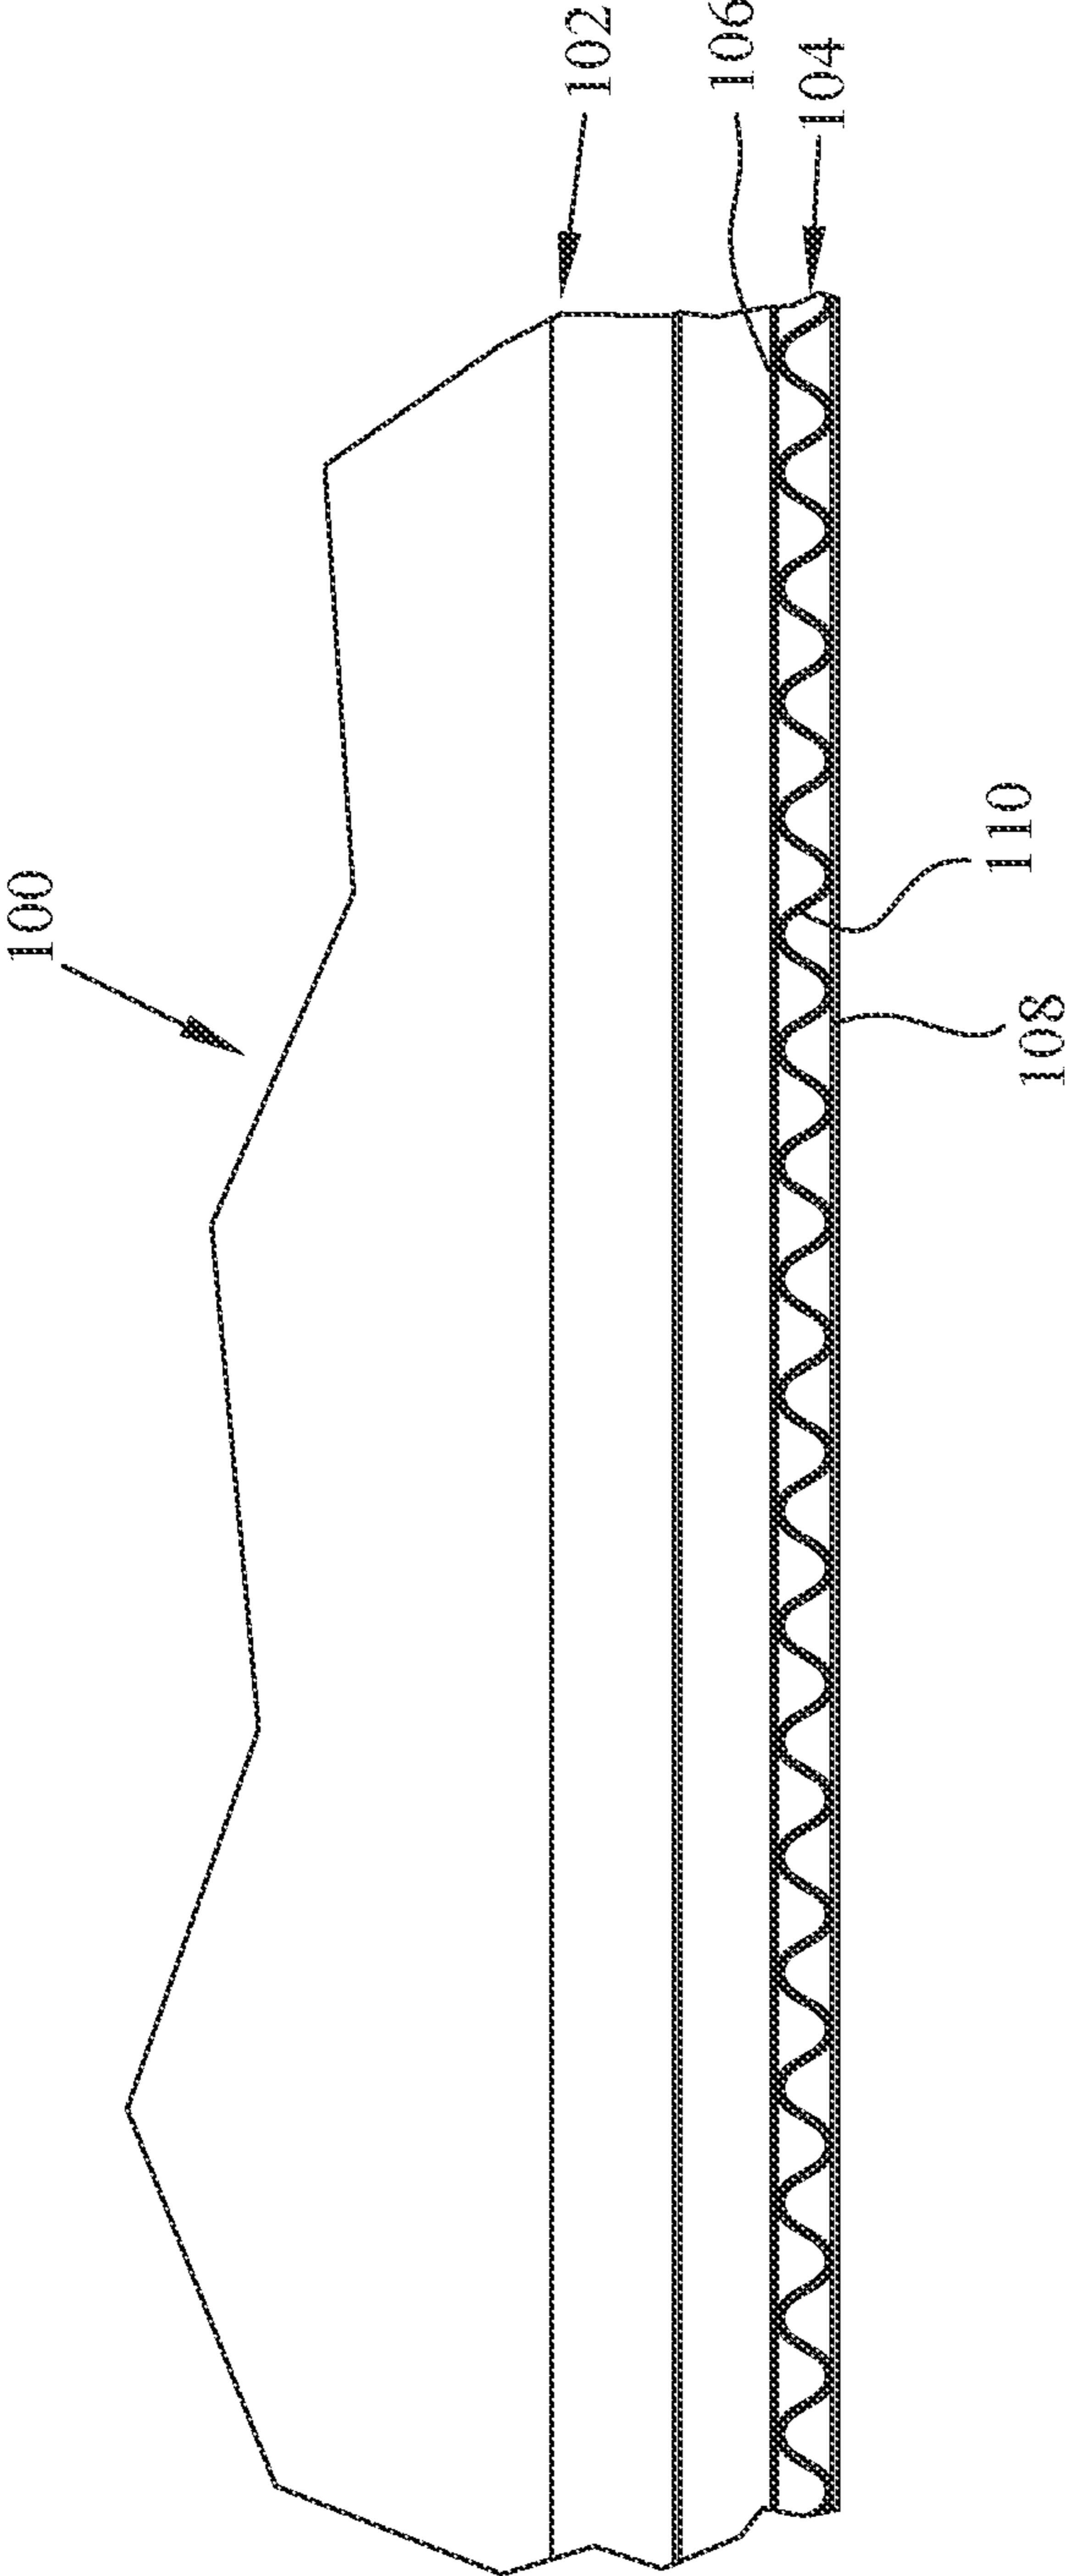
FIG. 3  
(PRIOR ART)

FIG. 3 is a side view of a prior art recreational vehicle frame liner;

Referring now to FIGS. 3 and 4, these depict prior art vehicle undercarriage frame liners in common use in the industry. A portion of a recreational vehicle is generally indicated as **100**. Recreational vehicle **100** includes a frame assembly generally indicated as **102** and a corrugated liner generally indicated as **104**. Corrugated liner **104** includes a top sheet **106**, a bottom sheet **108**, and a corrugated or sinusoidal ply **110** extending therebetween. Top sheets **106** and **108** are adhered or attached to corrugated ply **110**. Typically, the corrugated material is polyethylene.

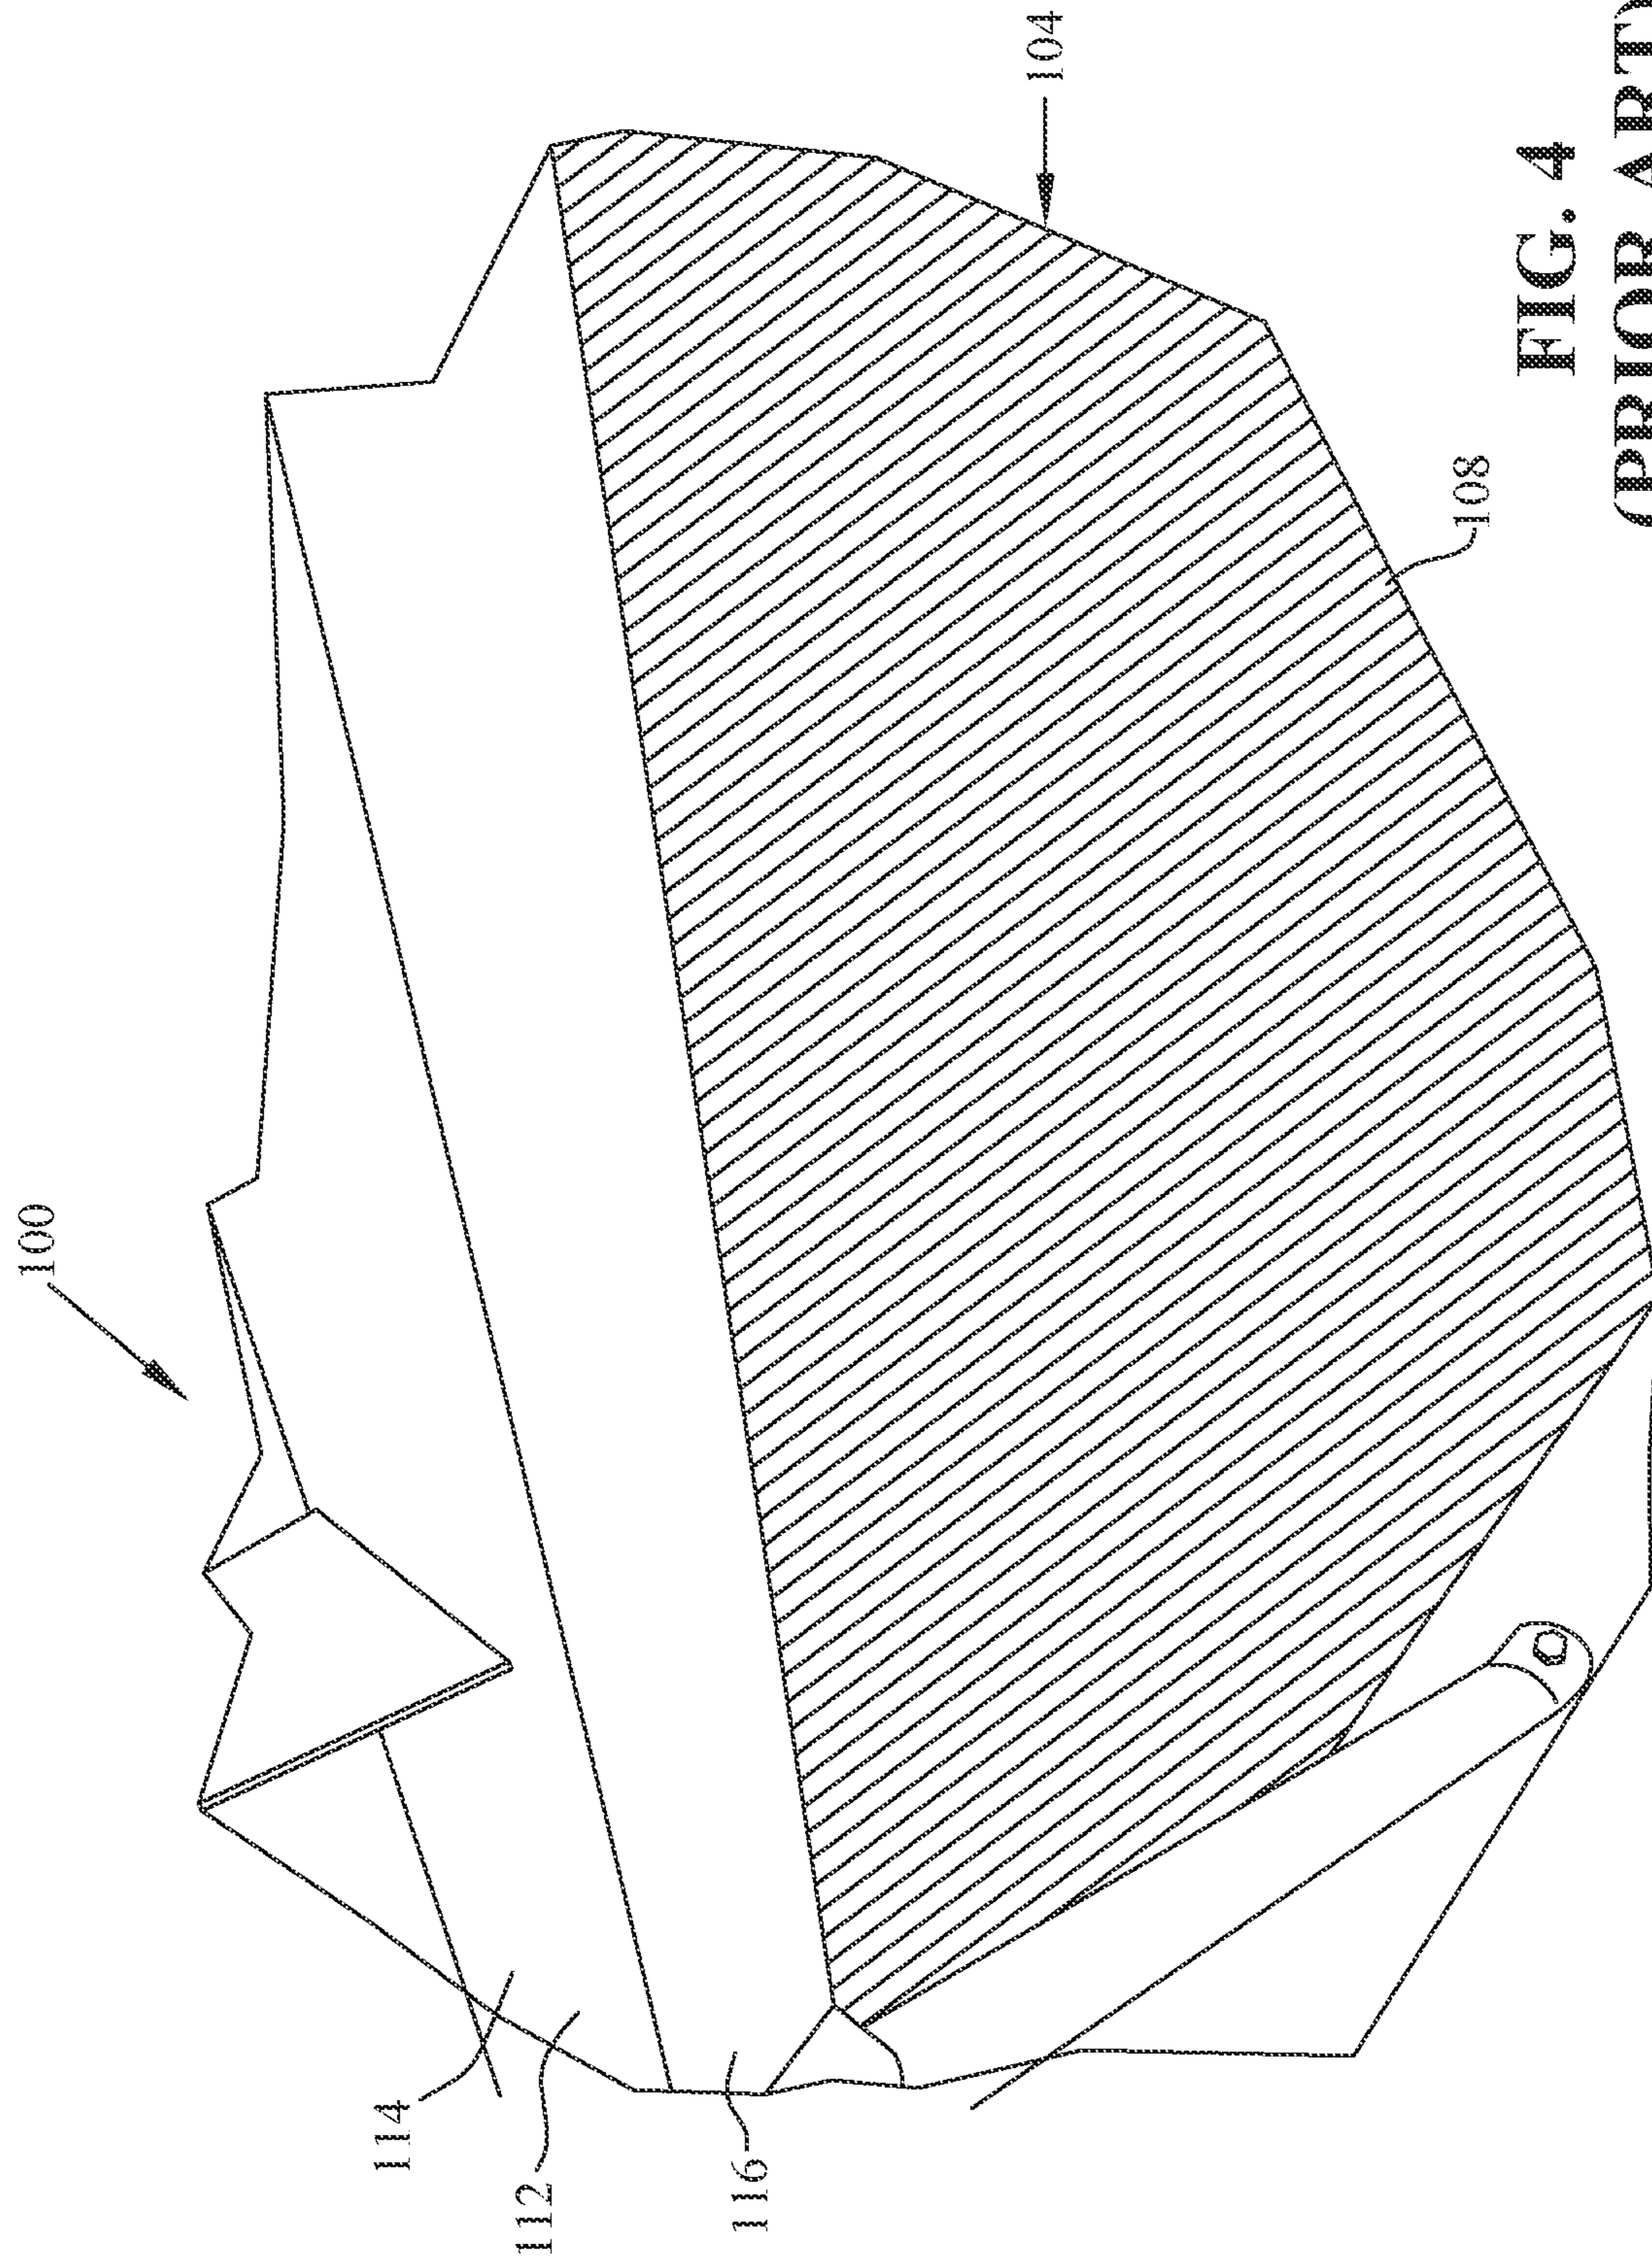
**FIG. 4**  
**(PRIOR ART)**

FIG. 4 is a bottom prospective view of a prior art recreational vehicle and frame liner;

Referring to FIG. 4, only the bottom sheet **108** of corrugated liner **104** is visible. Furthermore, the corrugations are not visible as recreational vehicle **100** includes a frame

member **112**, such as in I-beam or C-channel including a vertical web **112** and horizontal flange **116**. Side edges of corrugated liner **104** are located on top of flange **112**.

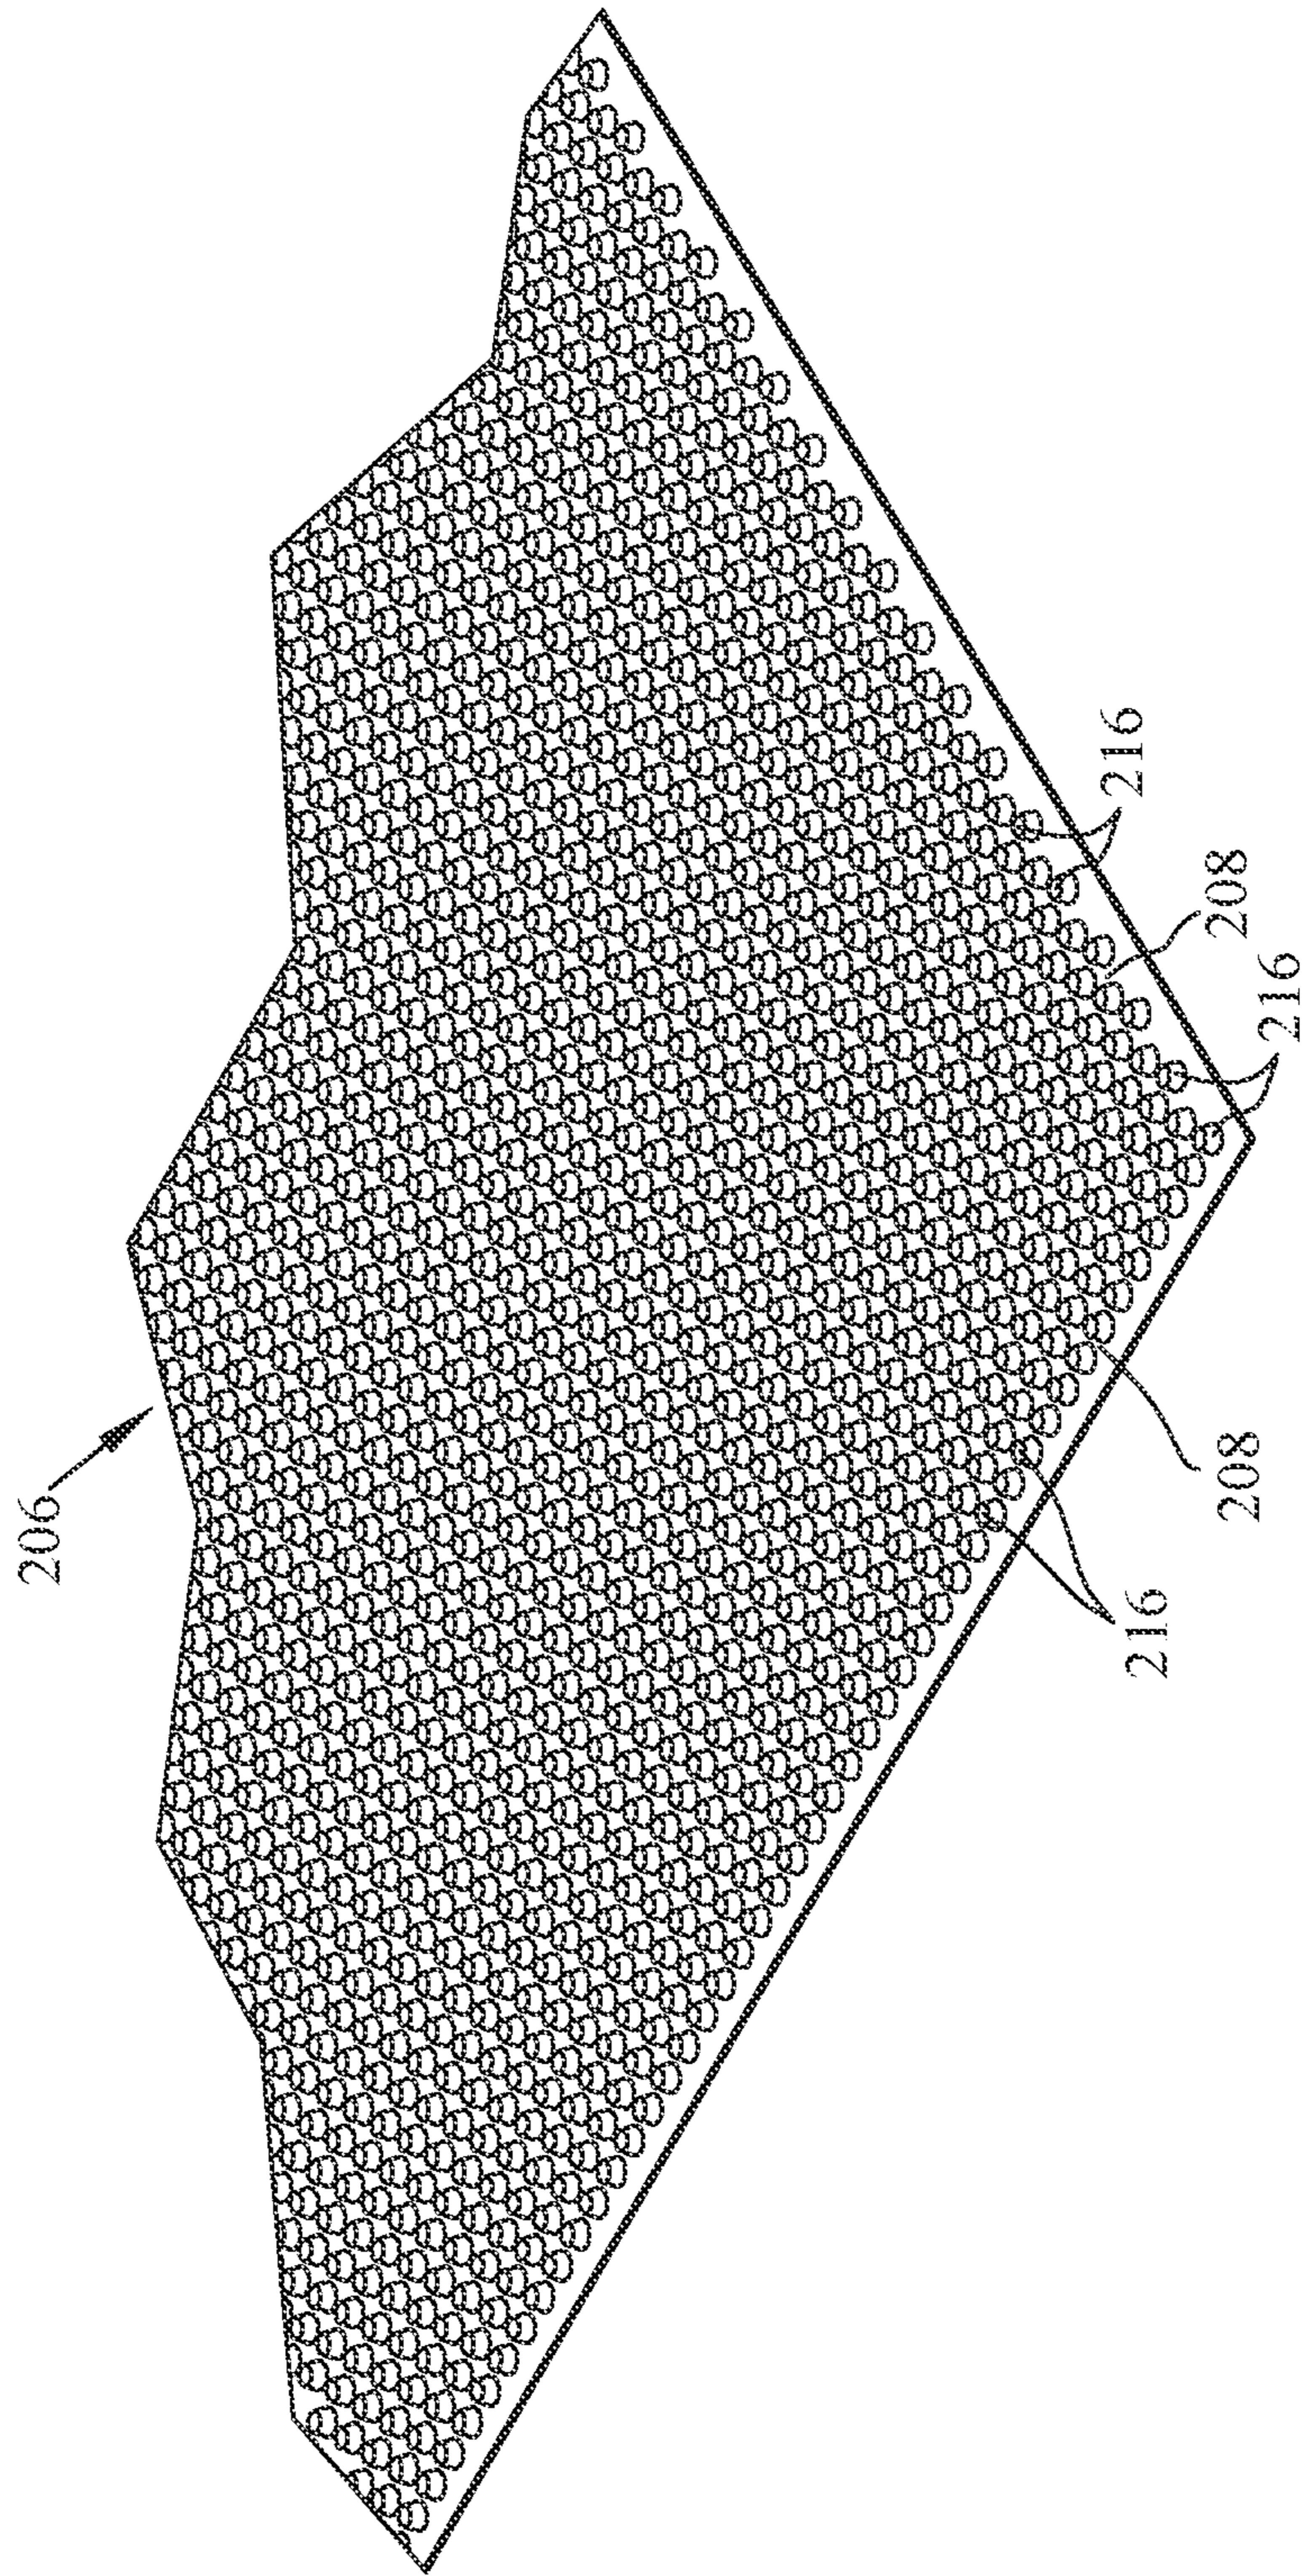
FIG. 7 is the vehicle frame and cargo bay liner of FIG. 6 showing an opposite face of the liner having projections extending therefrom;

Referring to FIG. 7, it can be appreciated that end faces **216** may have a variety of configurations including domed, flat, and/or convex.

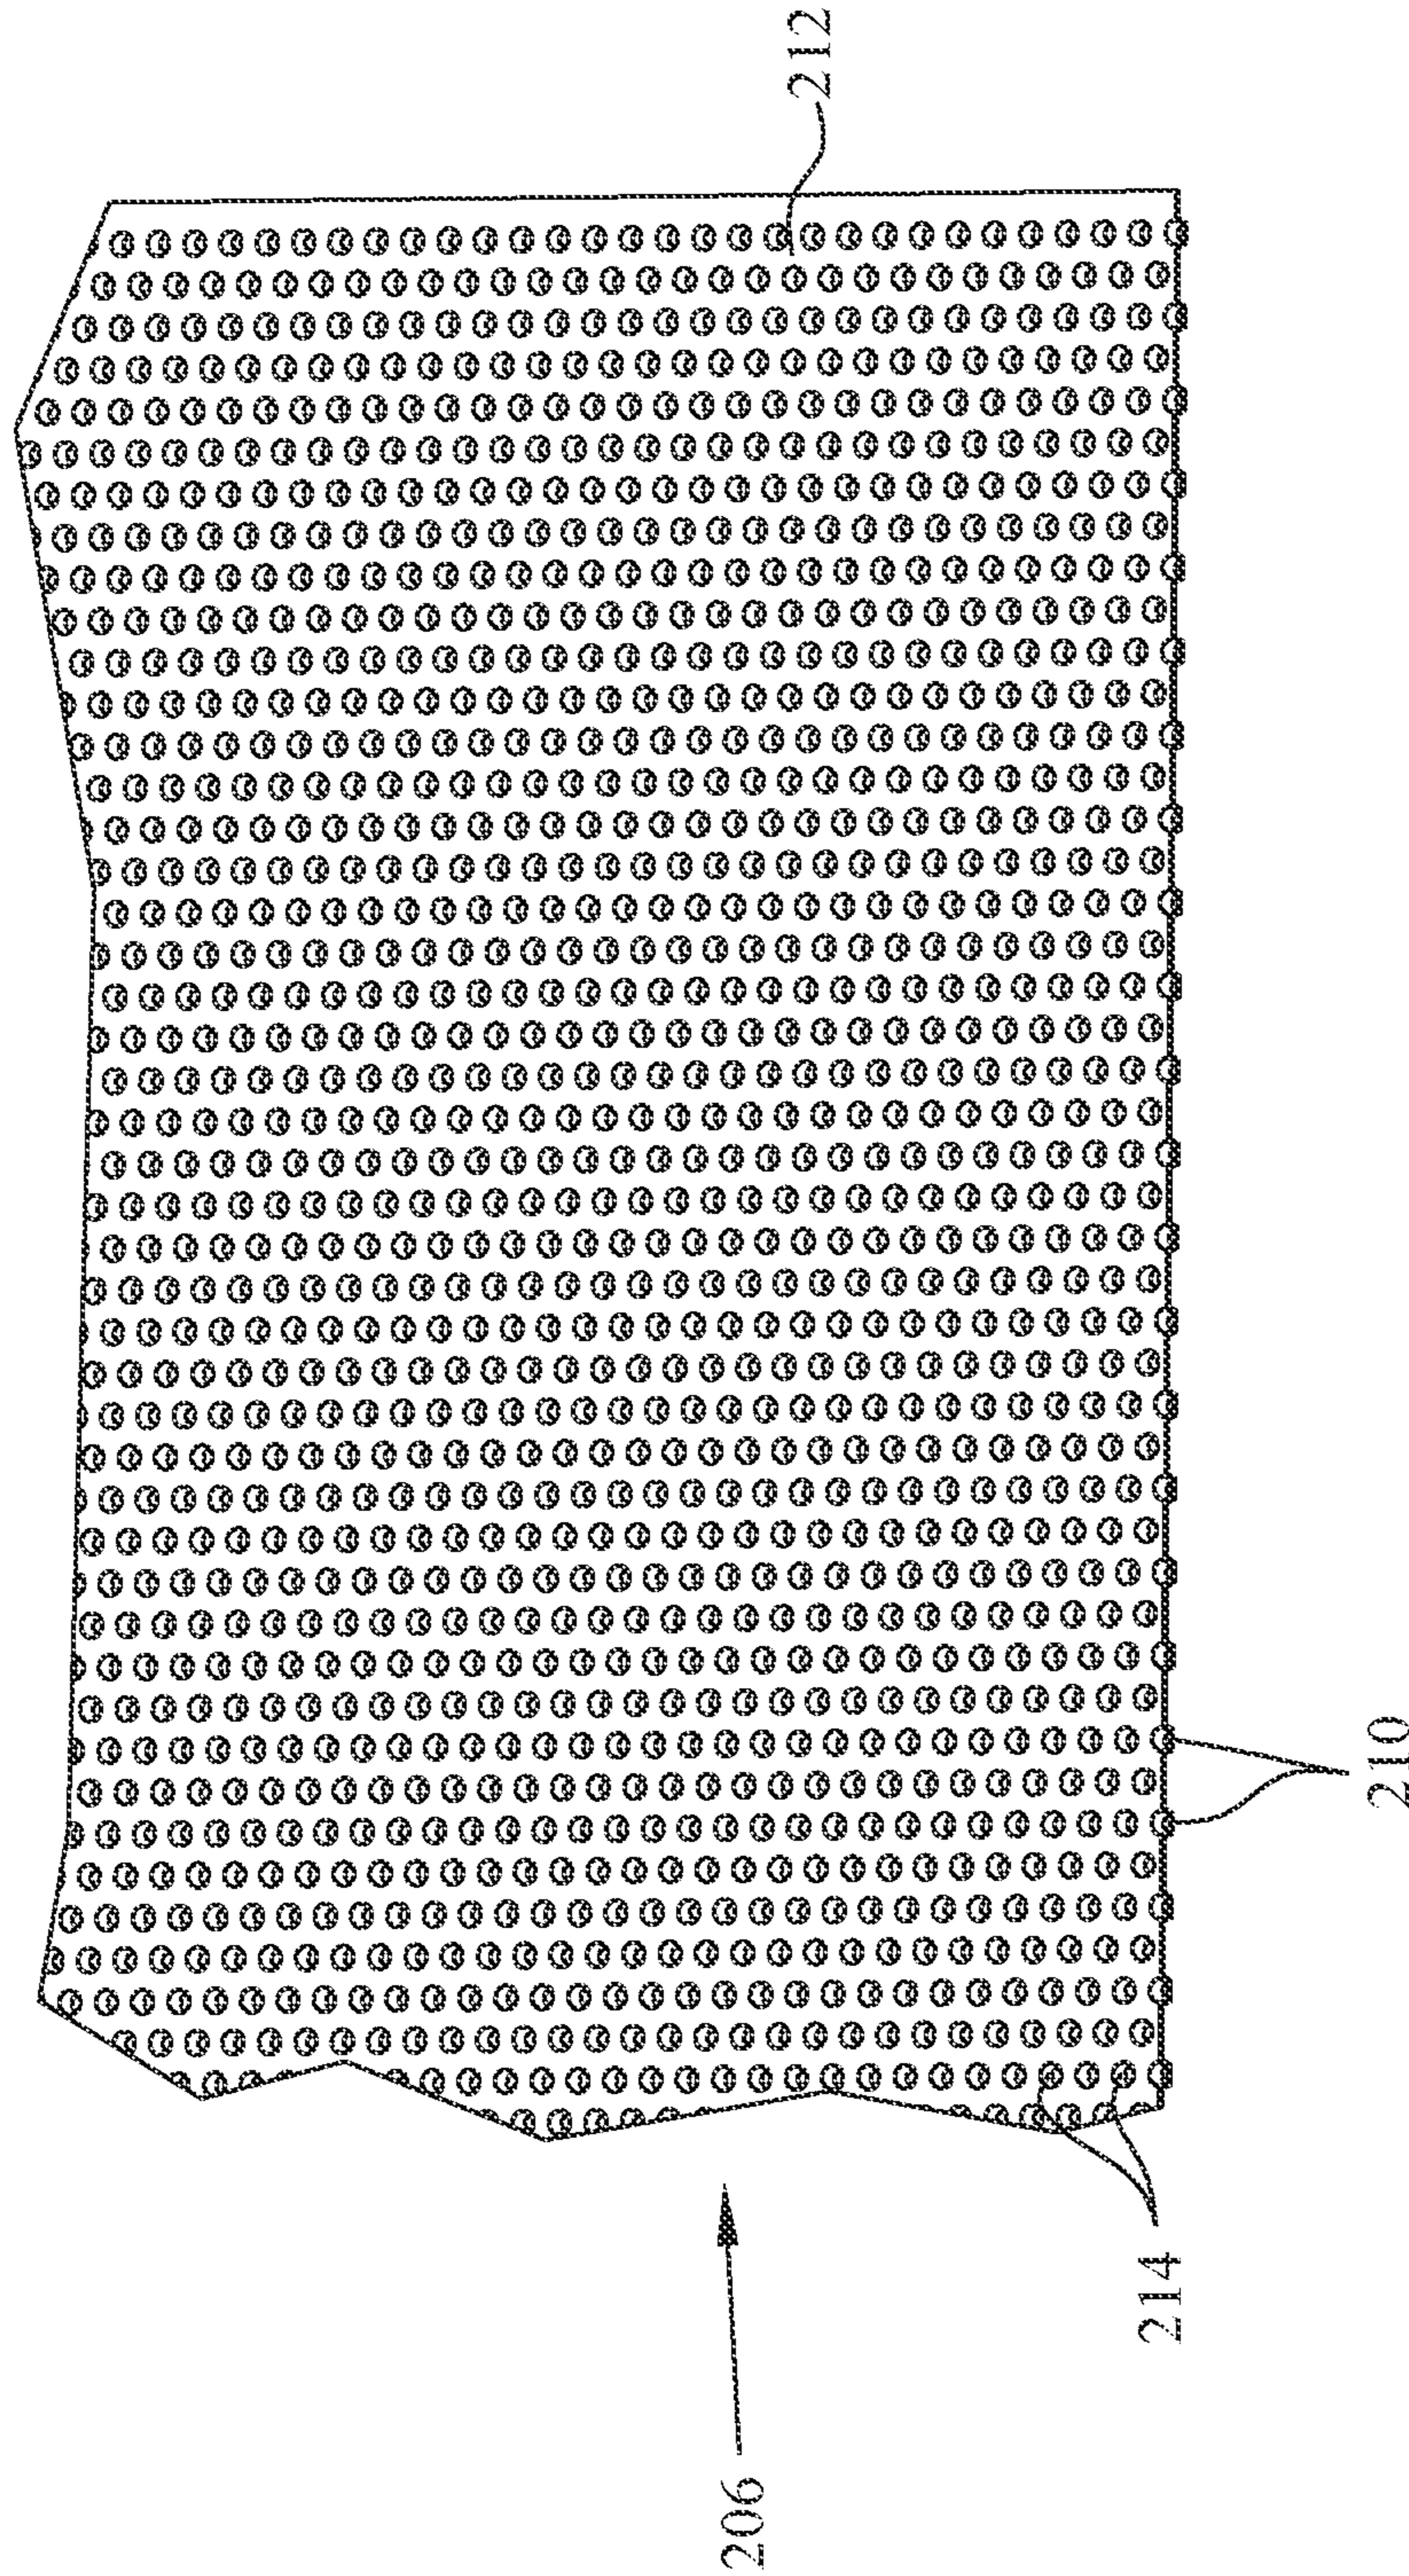
FIG. 10 is another perspective view of the vehicle and cargo bay liner of FIG. 6 with the face having openings facing upward;

Referring now to FIGS. 6-11, further details, of vehicle frame and cargo area liner/core **206** are disclosed. As can be seen, the projections and/or openings **210**, **214**, respectively are aligned in a lengthwise direction of core **206** but going crosswise across core **206**, projections **210** and openings **214** are staggered.

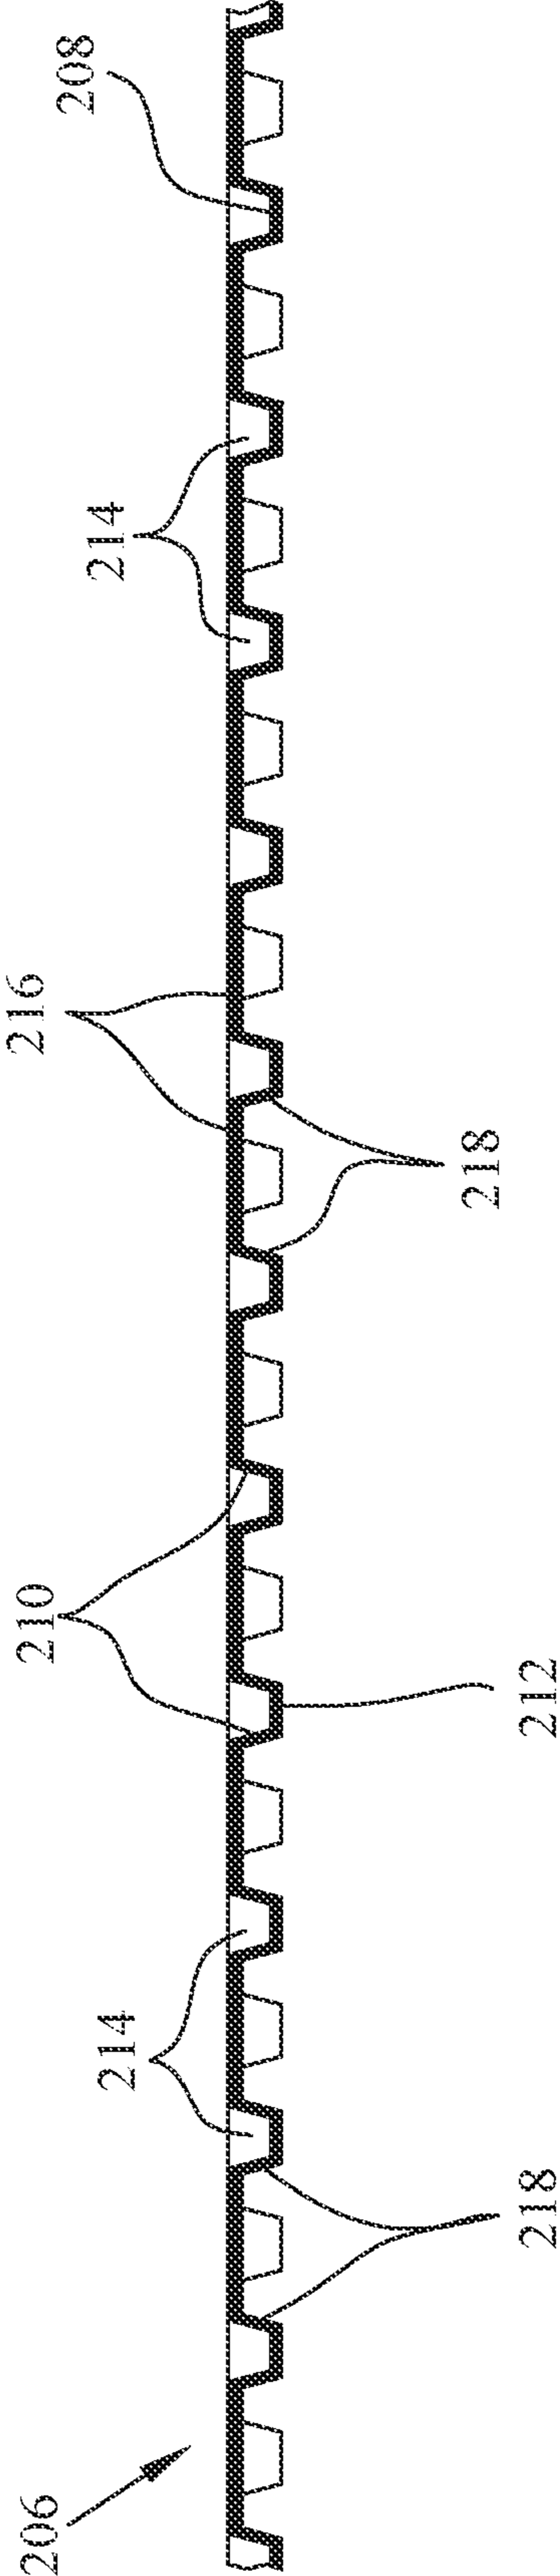
FIG. 11 is a side view of the vehicle and cargo bay liner of FIG. 6 with the projections extending upward;
