(12) **United States Patent**  
**Pennington**

(54) **VEHICLE FRAME AND CARGO BAY LINER**

(57) **ABSTRACT**

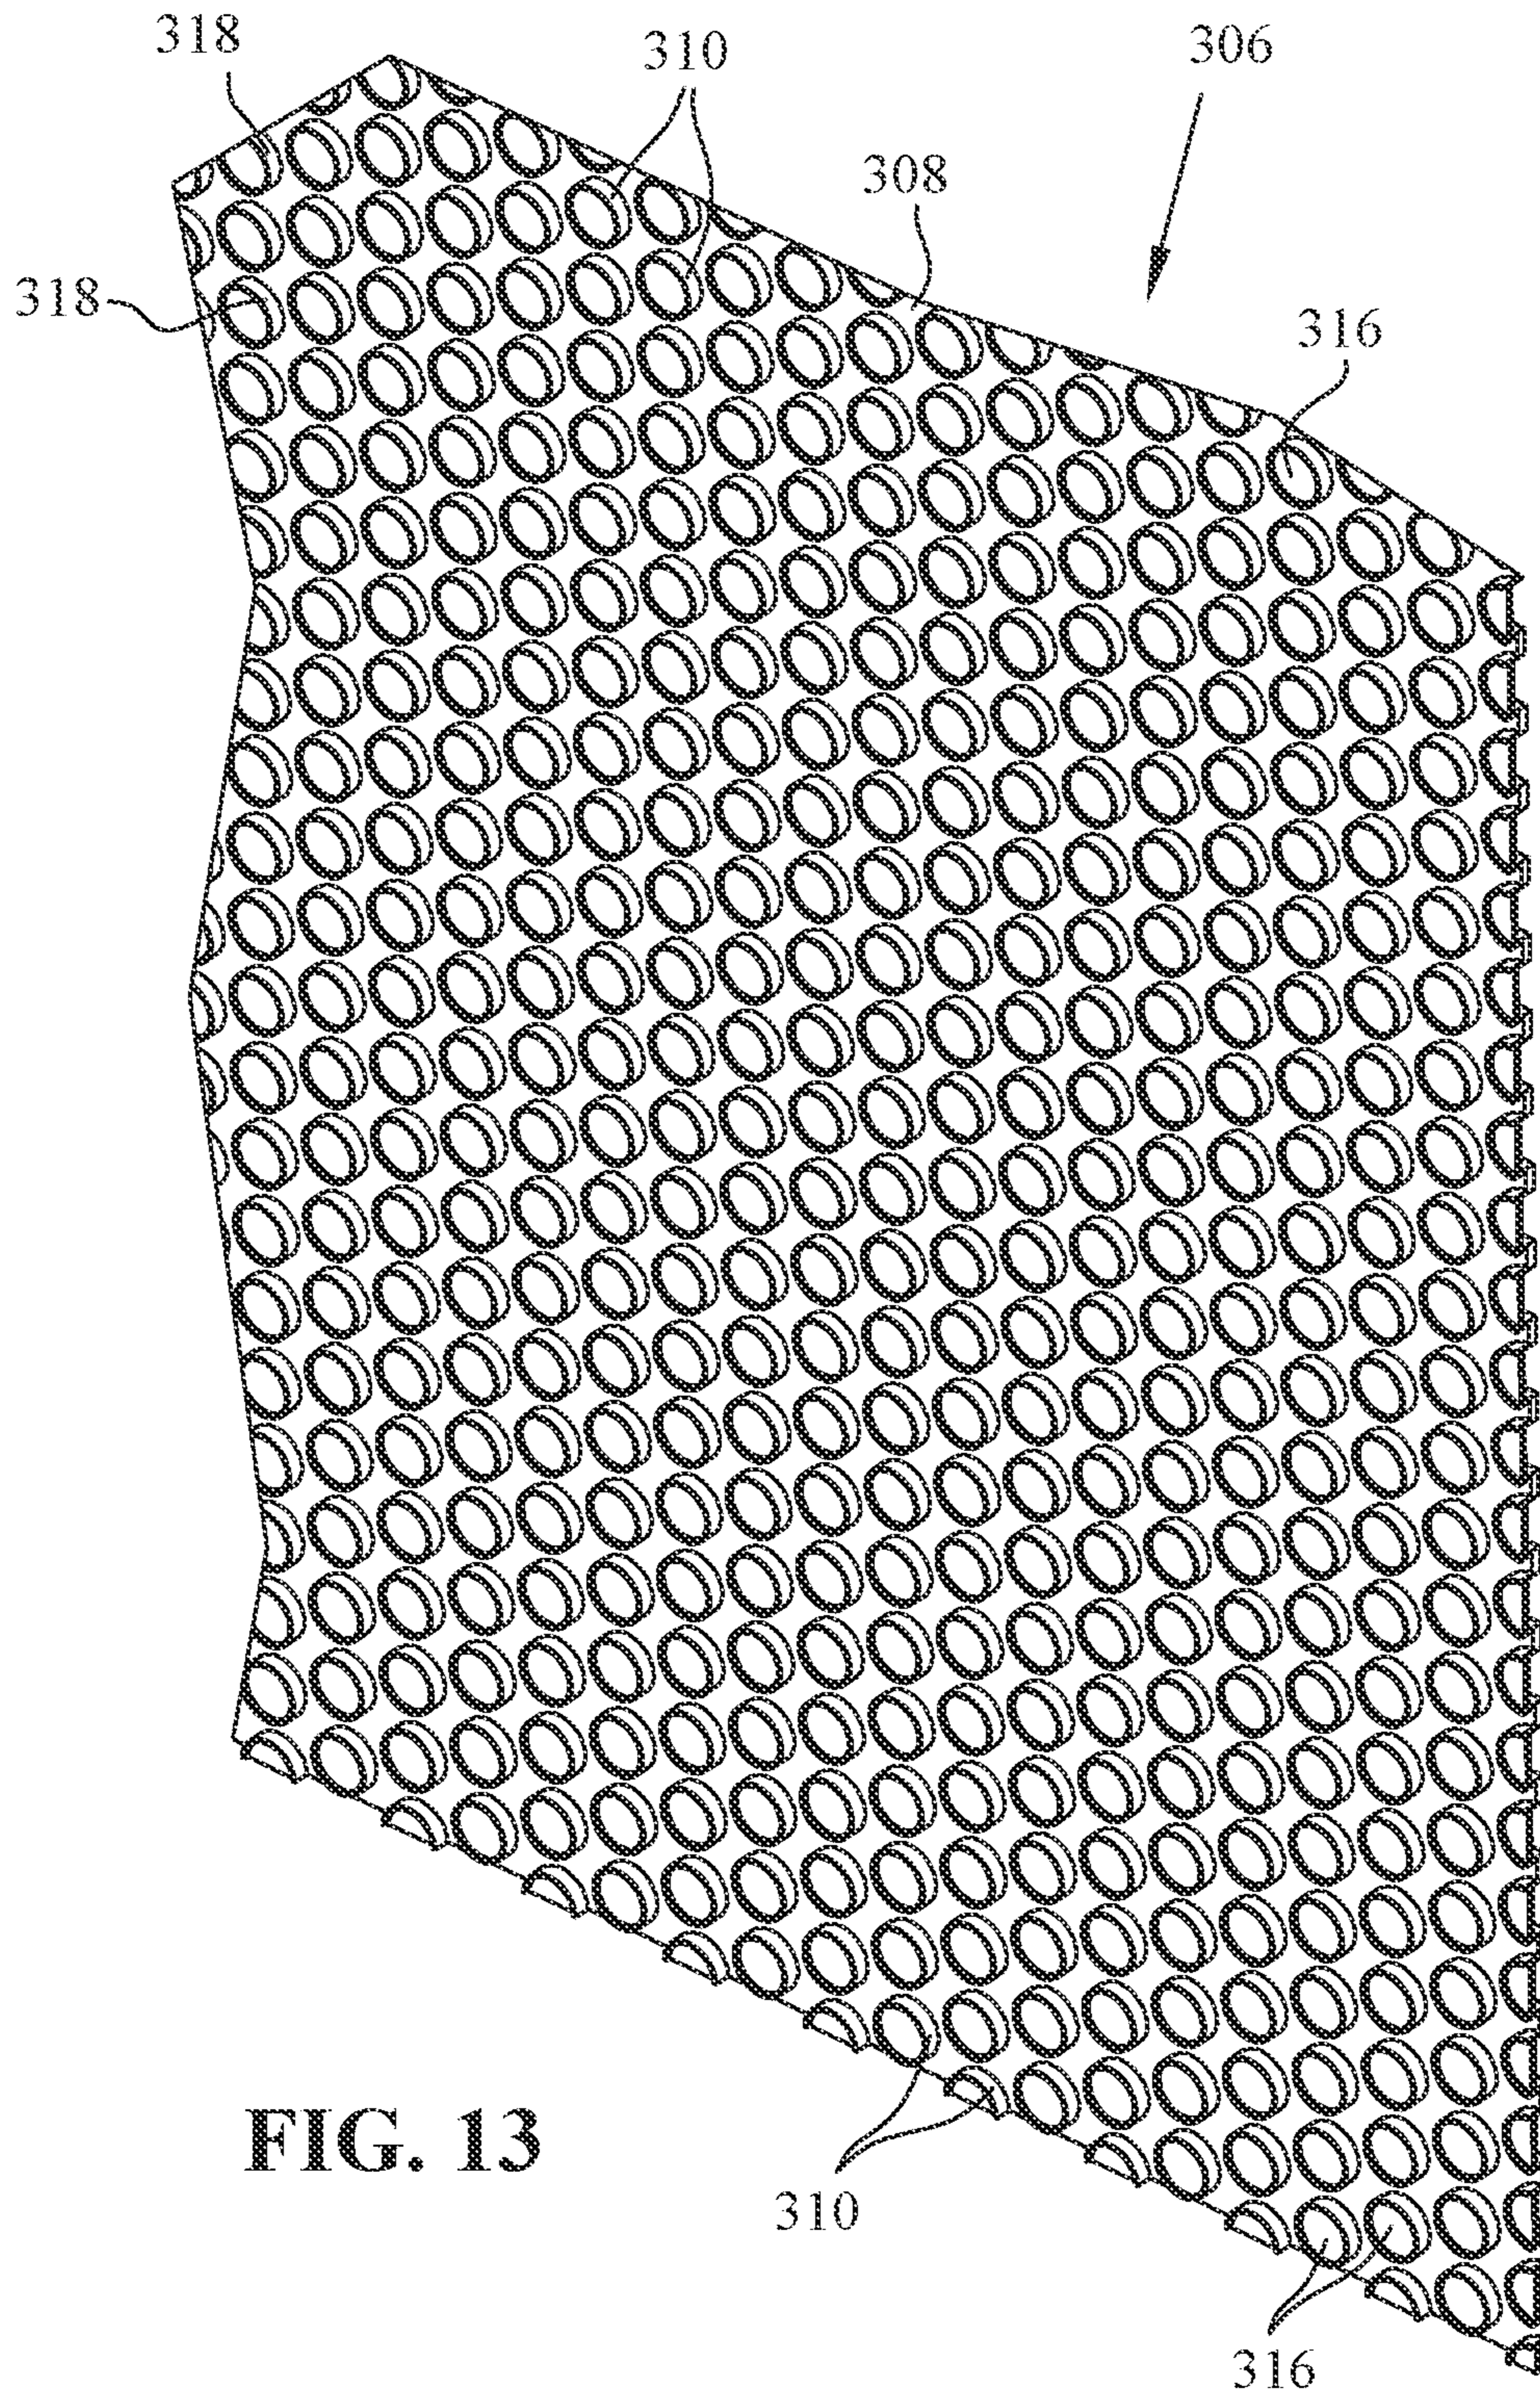
FIG. 13 is a plan perspective view of the alternate embodiment vehicle frame and cargo bay liner of FIG. 12 showing a face having projections extending therefrom;

Now referring to FIGS. 12 and 13, an alternate vehicle frame and cargo area liner is shown generally indicated as **306**. As can be seen in FIG. 13, liner **306** includes a face **308** having projections **210** thereon. As shown in FIG. 12, liner **306** has an opposite face **312** having openings **314** therein. Projections **310** include end faces **316** and sidewalls **318** as best seen in FIG. 13. Line **306** can be manufactured from single or multi-layer materials sandwiched together (twin or triple layer).

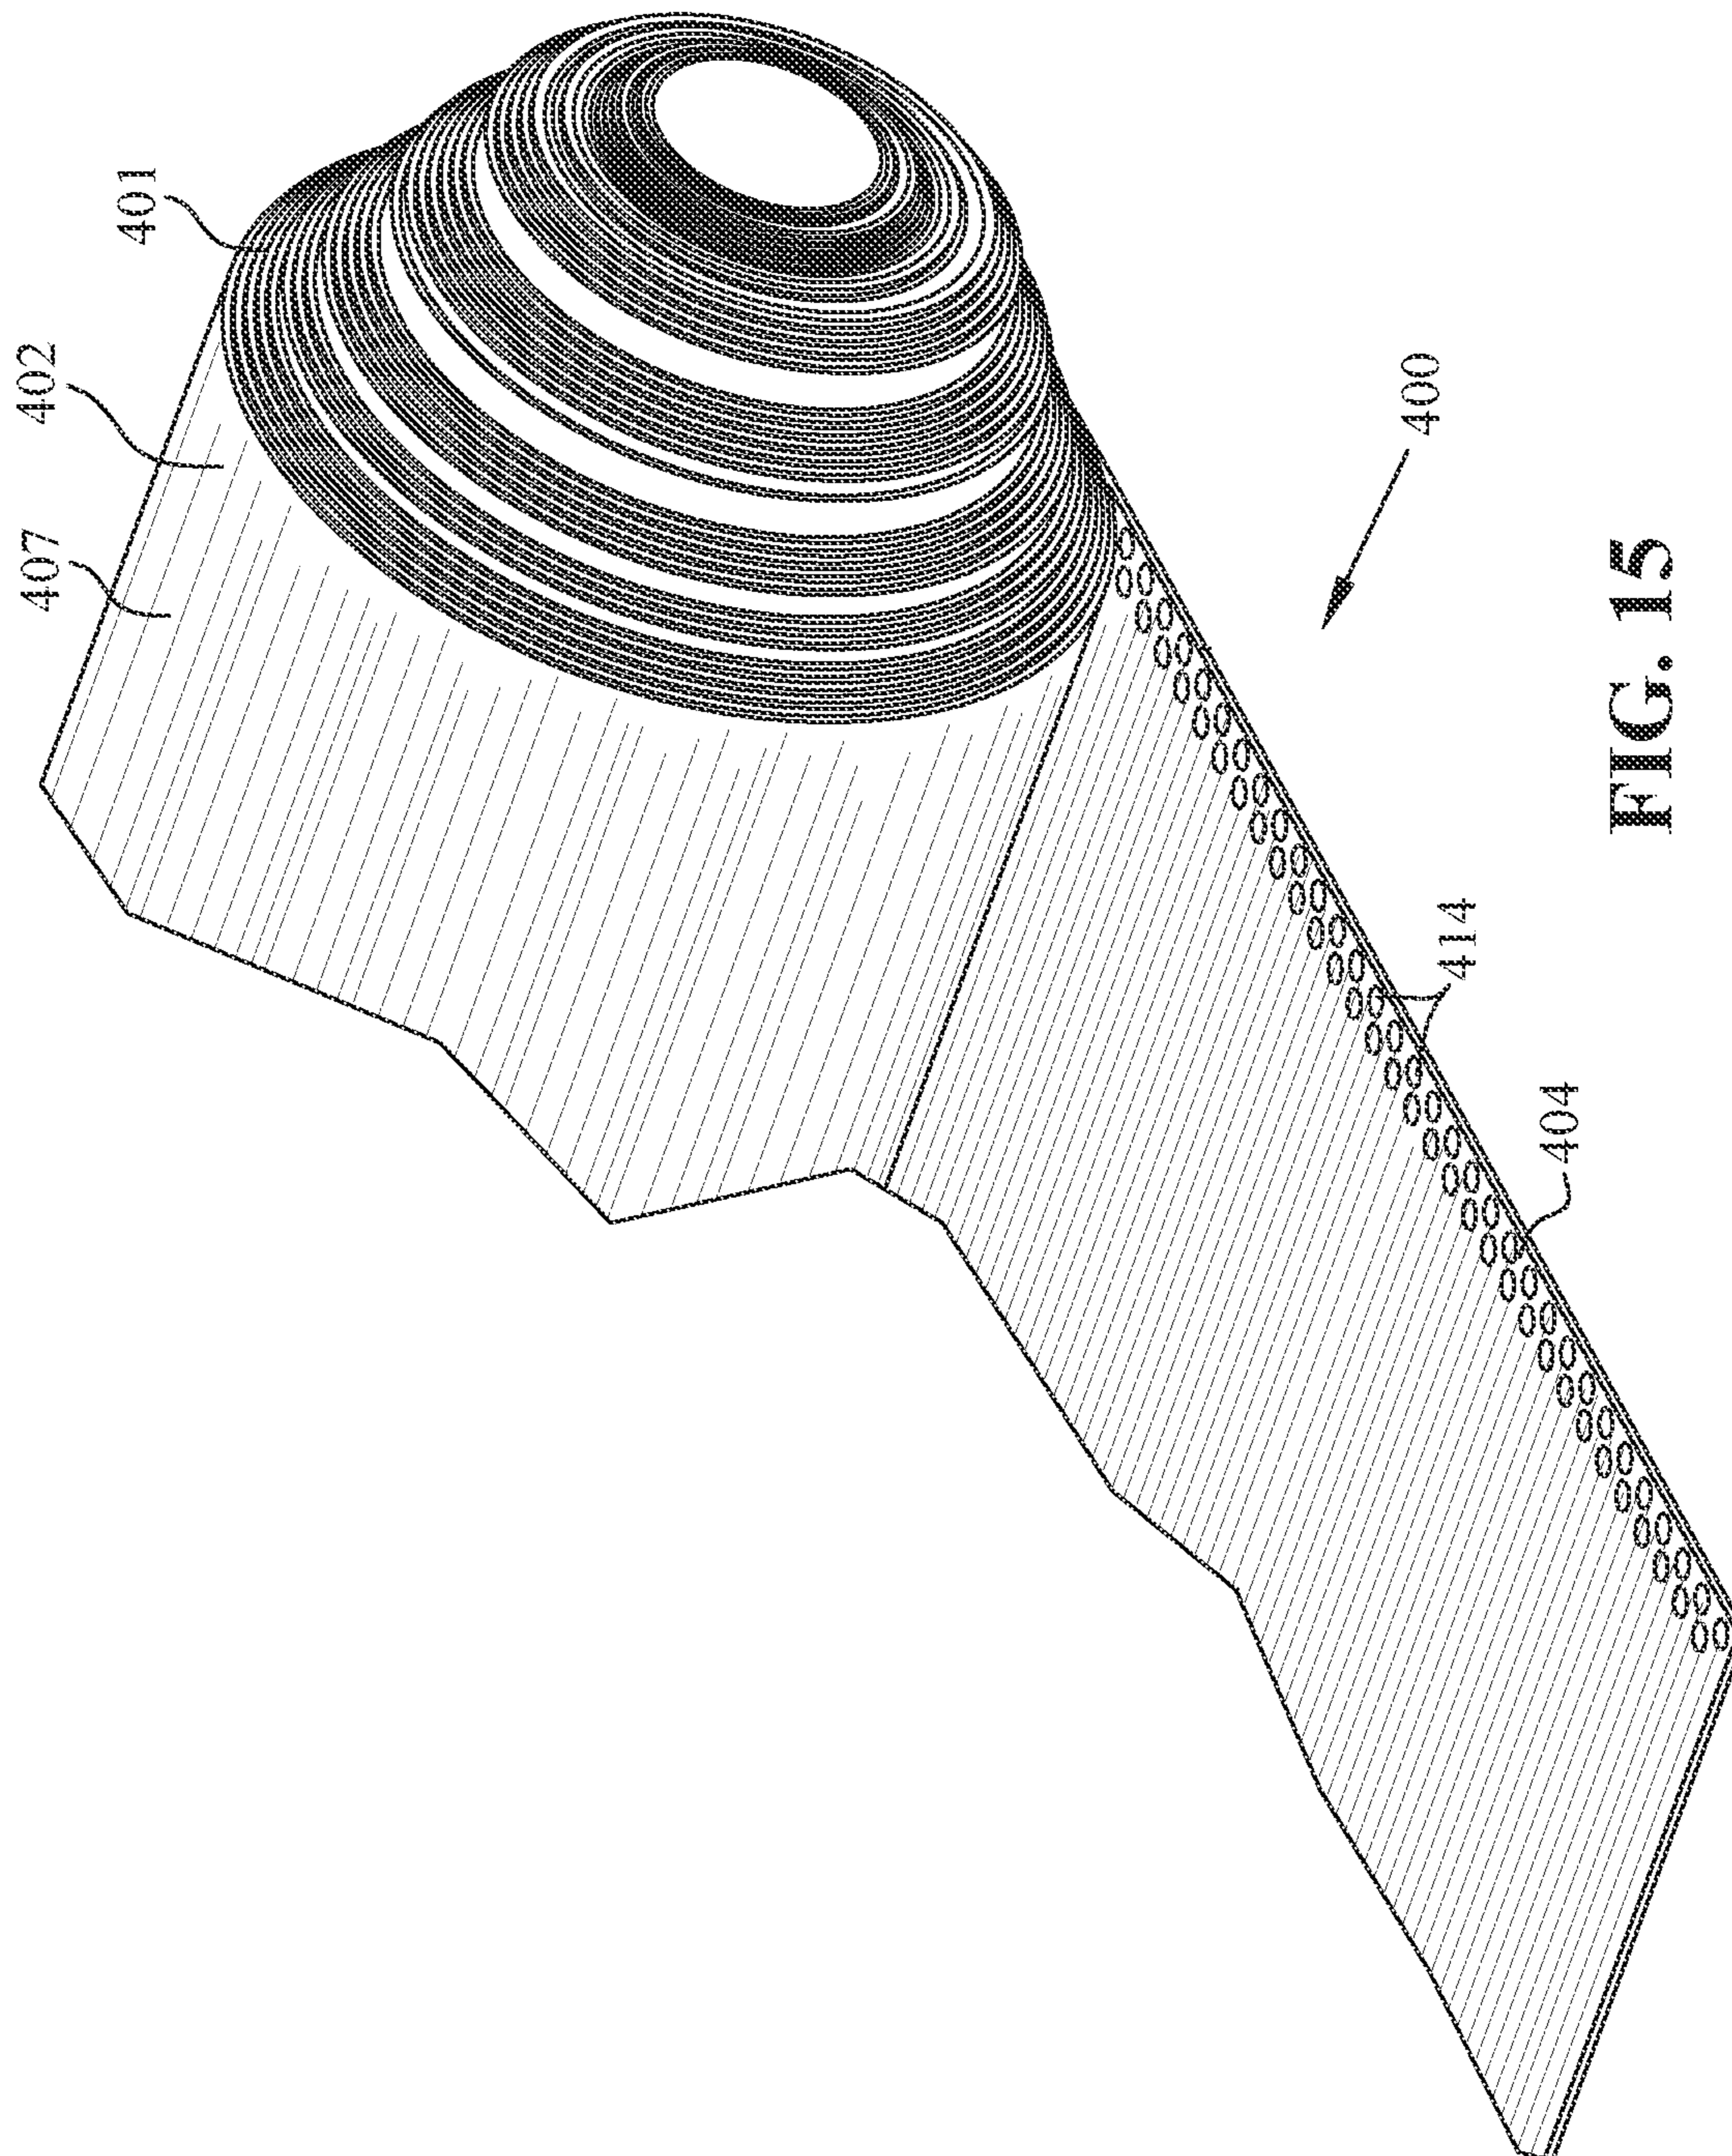
FIG. 15 is a perspective view of the vehicle frame and cargo bay liner of FIG. 14 partially rolled out showing the aluminum foil on a top side thereof;

Now referring to FIGS. 14-24, another alternate vehicle frame and cargo area liner is shown generally indicated as **400**. Liner **400** can be provided in a coiled form **401** as shown in FIGS. 14 and 15, making it extremely suitable for use as a liner for vehicle frames and cargo bays. The desired length of liner can be rolled out and cut to size for assembly to the vehicle. Vehicle frame and cargo bay liner **400** is of a 3-ply configuration and includes a top ply, sheet, or layer **402** and a bottom ply, sheet, or layer **404**. A core **406** (see FIGS. 19 and 22-24) separates top sheet **402** from bottom sheet **404**. Additionally, vehicle frame and cargo bay liner **400** also includes a sheet of aluminum foil or metalized film **407** on one side thereof. In the embodiment shown, aluminum foil/metalized film **407** is provided on top sheet **402**; however, it should be appreciated that aluminum foil or metalized film could also be provided on the bottom sheet **404**. Aluminum foil or metalized film **407** may be adhered to top sheet **402** using an adhesive or other suitable means. The metalized film can be a polymer film coated with a thin layer of metal, which can be aluminum or other suitable metal.

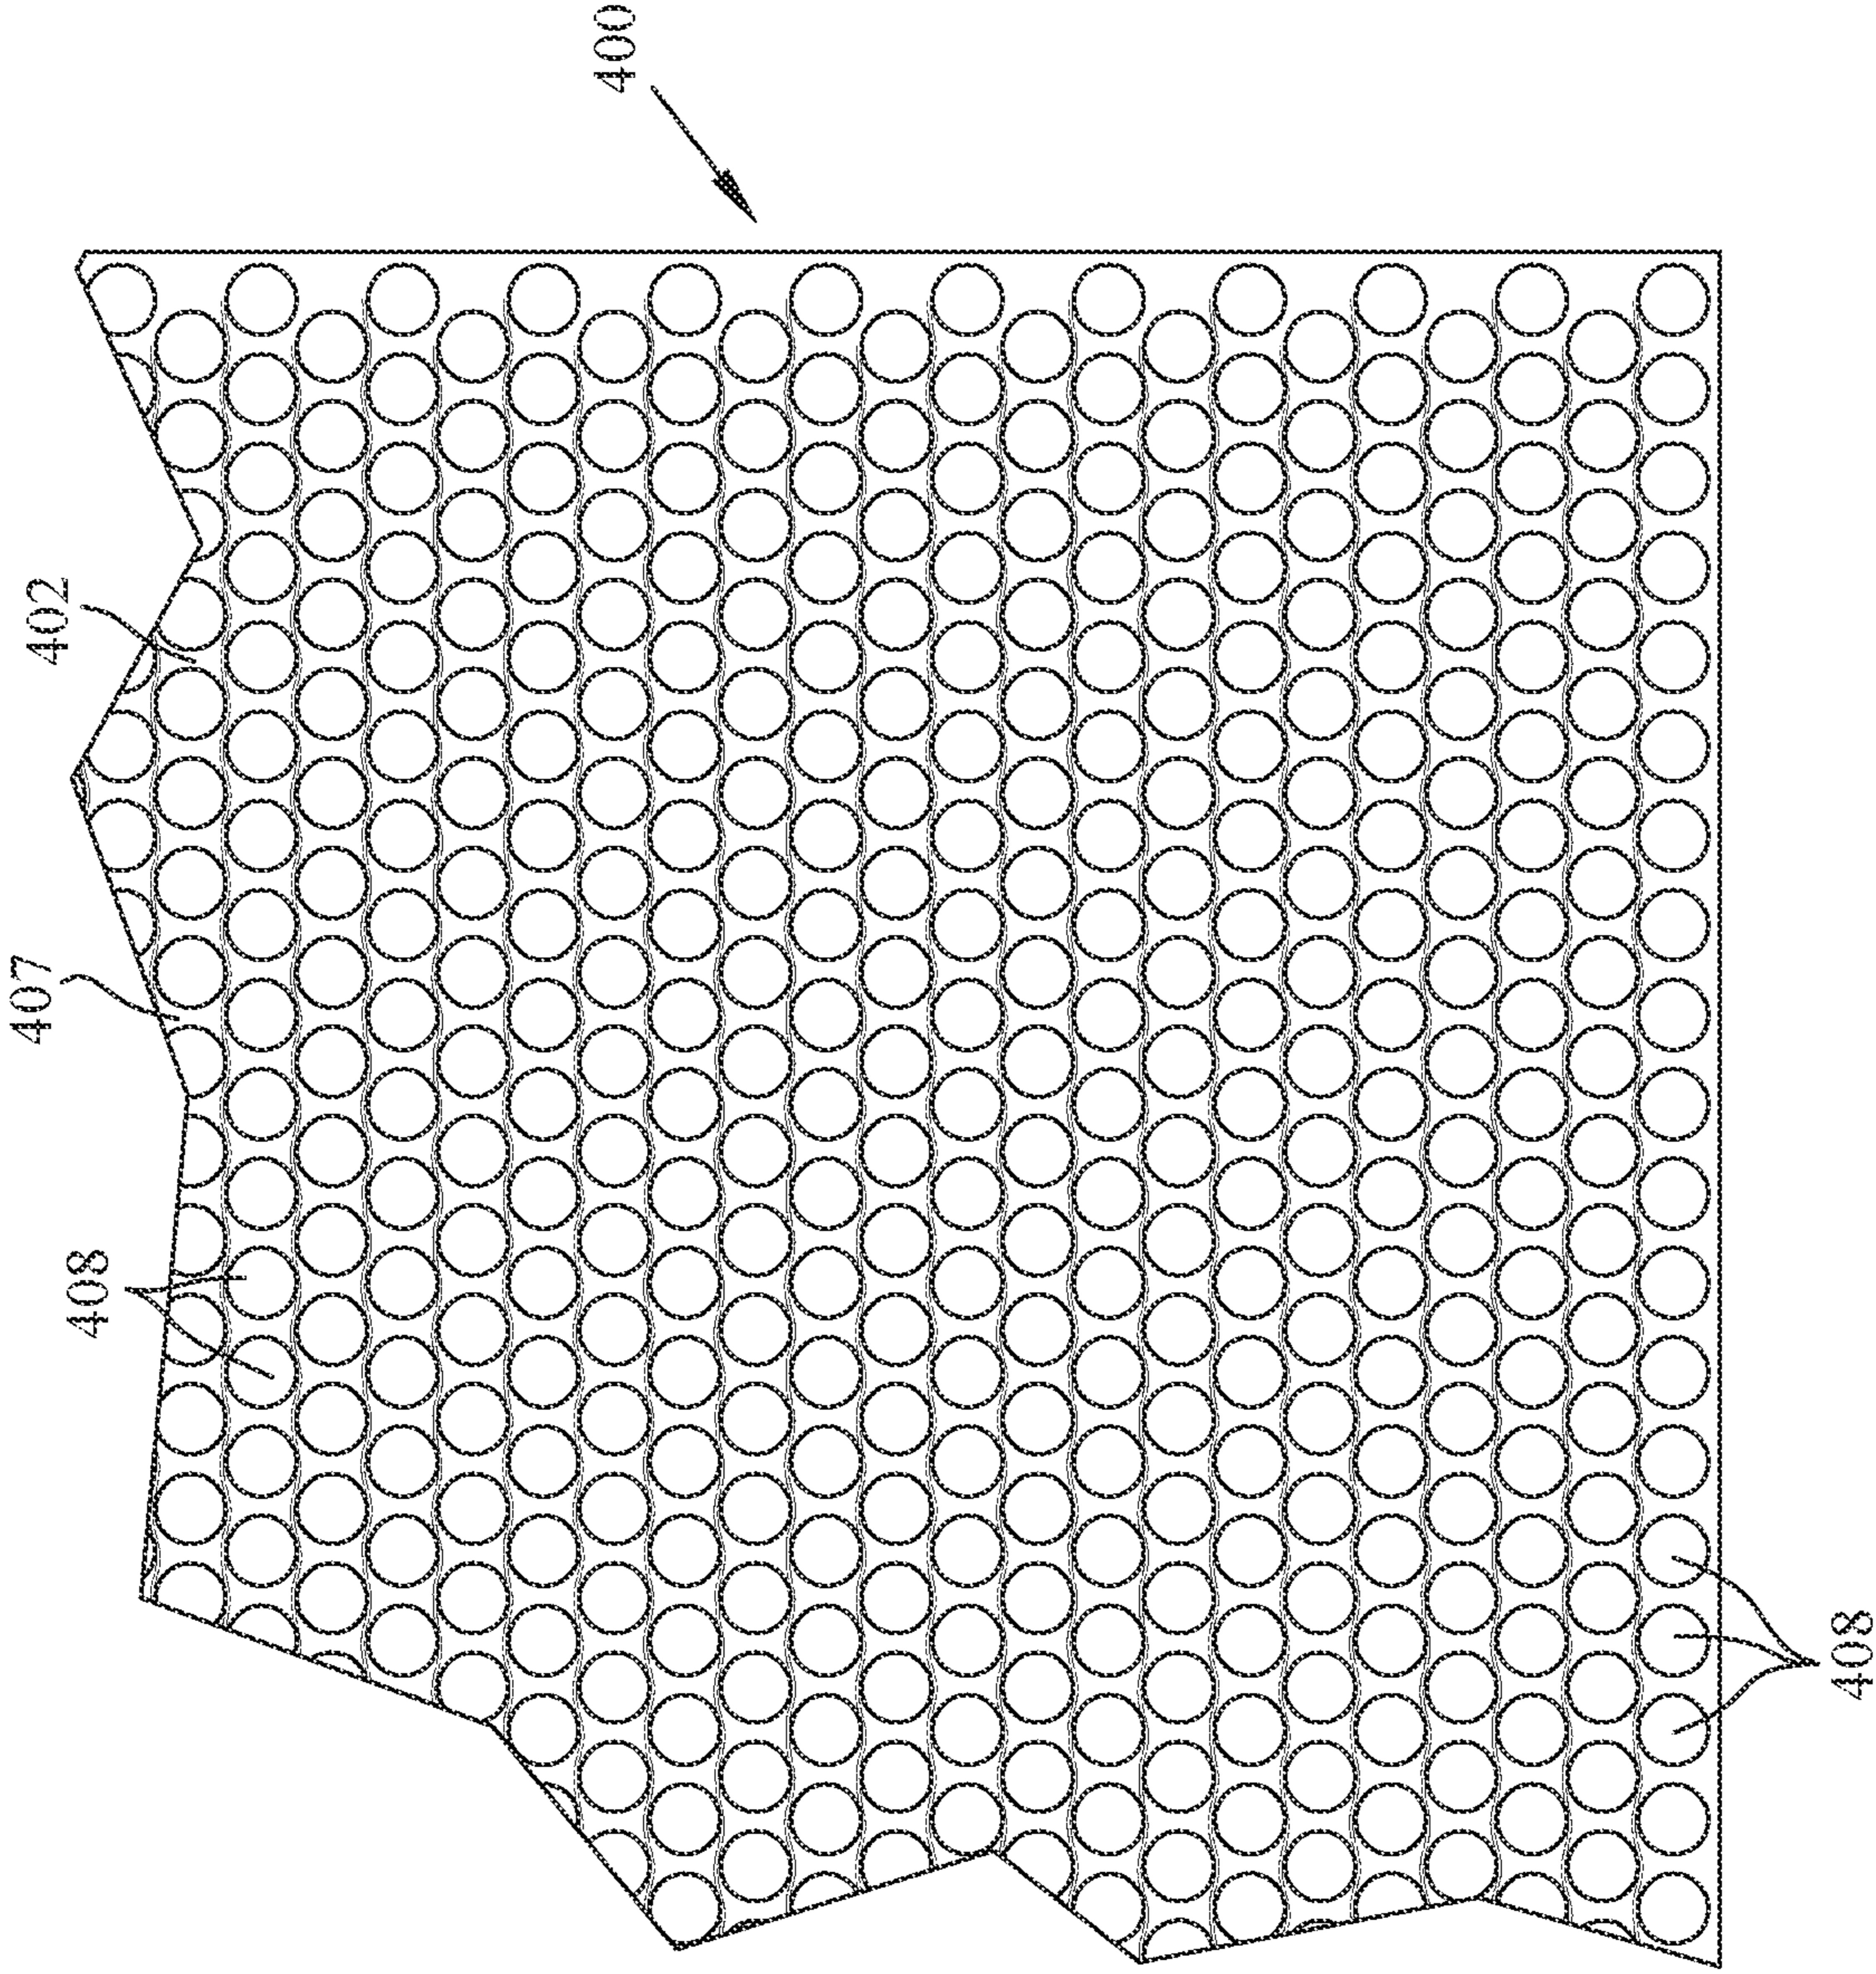
FIG. 17 is an enlarged plan view of the vehicle frame and cargo bay liner of FIG. 14 of the top side having aluminum foil thereon;

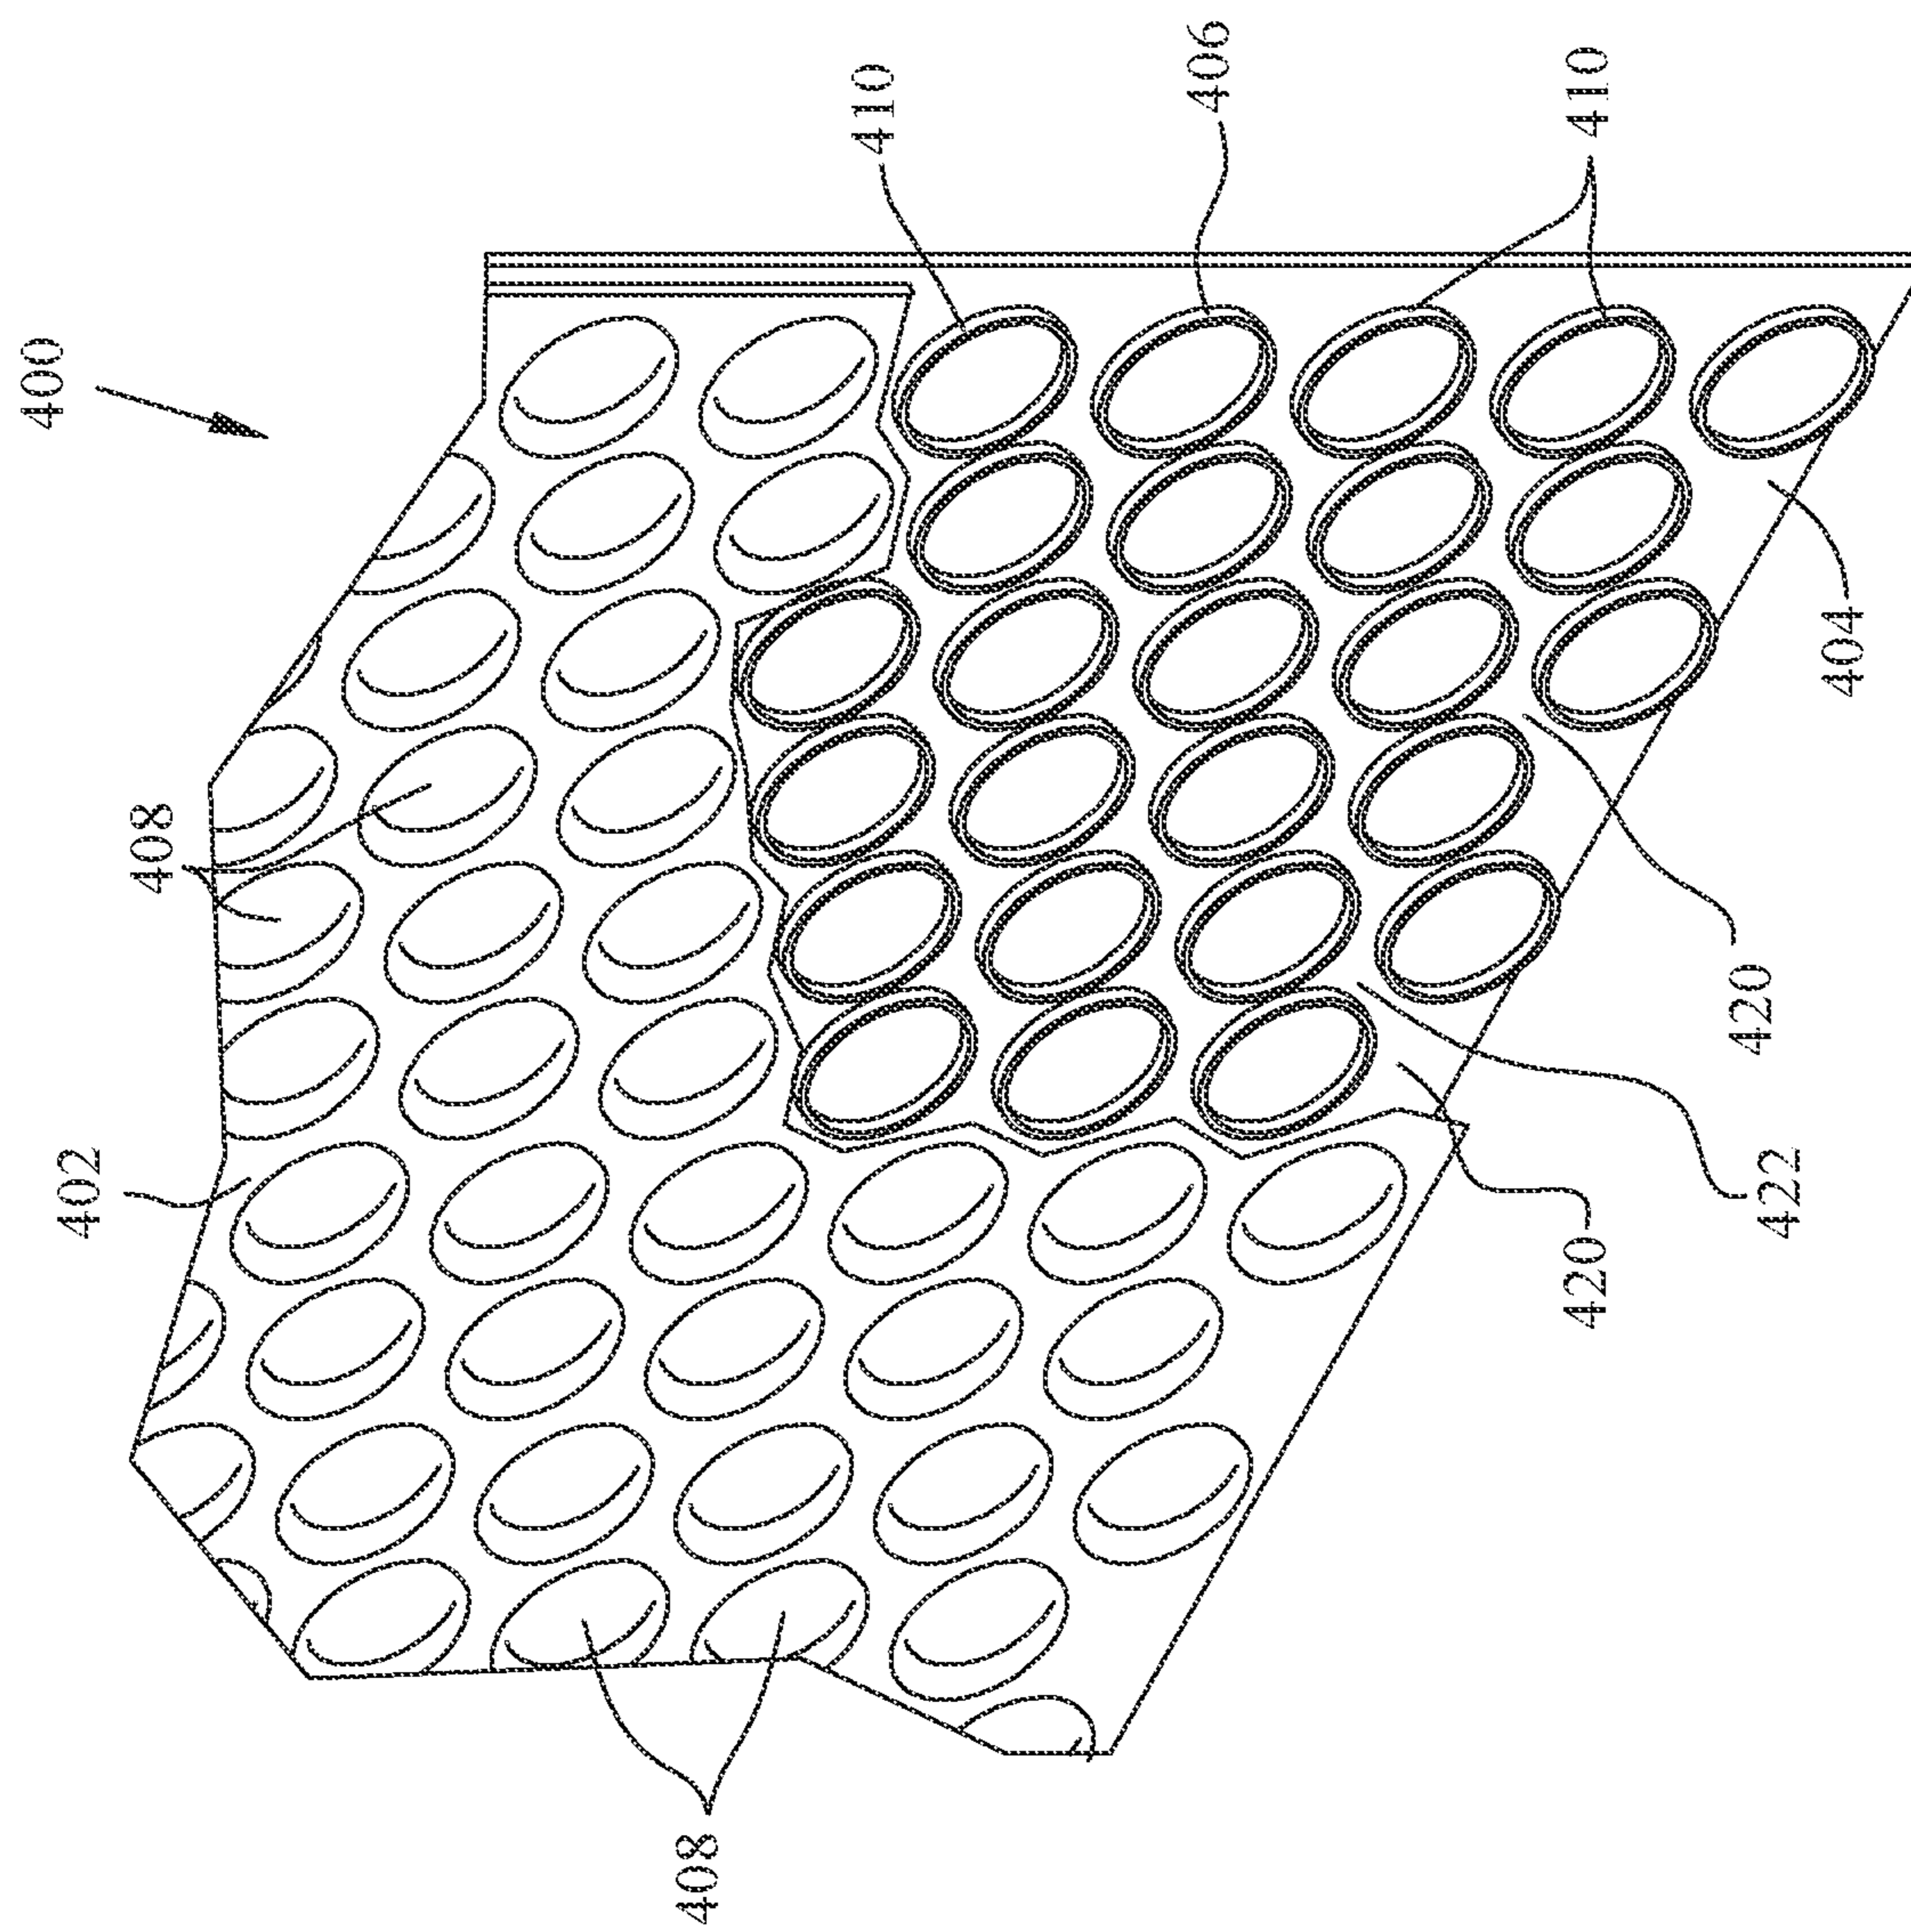
FIG. 22 is a perspective view of a portion of the vehicle frame and cargo bay liner of FIG. 14 showing part of the top layer removed;

As can be seen in FIGS. 22 and 23, cylindrical projections **410** form an obstruction to passage through core **406** such that any water entering the ends thereof is obstructed and impeded or hindered from propagating across liner **400** as compared to channels **111** in corrugated liner **104**, which readily allow transport of liquids. Additionally, as where vehicle frame and cargo bay liner **400** is cut, it will intersect a plurality of cylindrical projections **410** in the liner. As each cylinder is closed off, any water entering into an end of the liner where a projection has been cut will be prevented from further propagating by encountering the wall of the projection. Only a small area or channel **422** between cylindrical projections would allow any water or moisture to enter into core **406** of liner **400**, but that will not readily propagate to the offset projections internal to core **406** that will impede or hinder any advancement of the moisture.

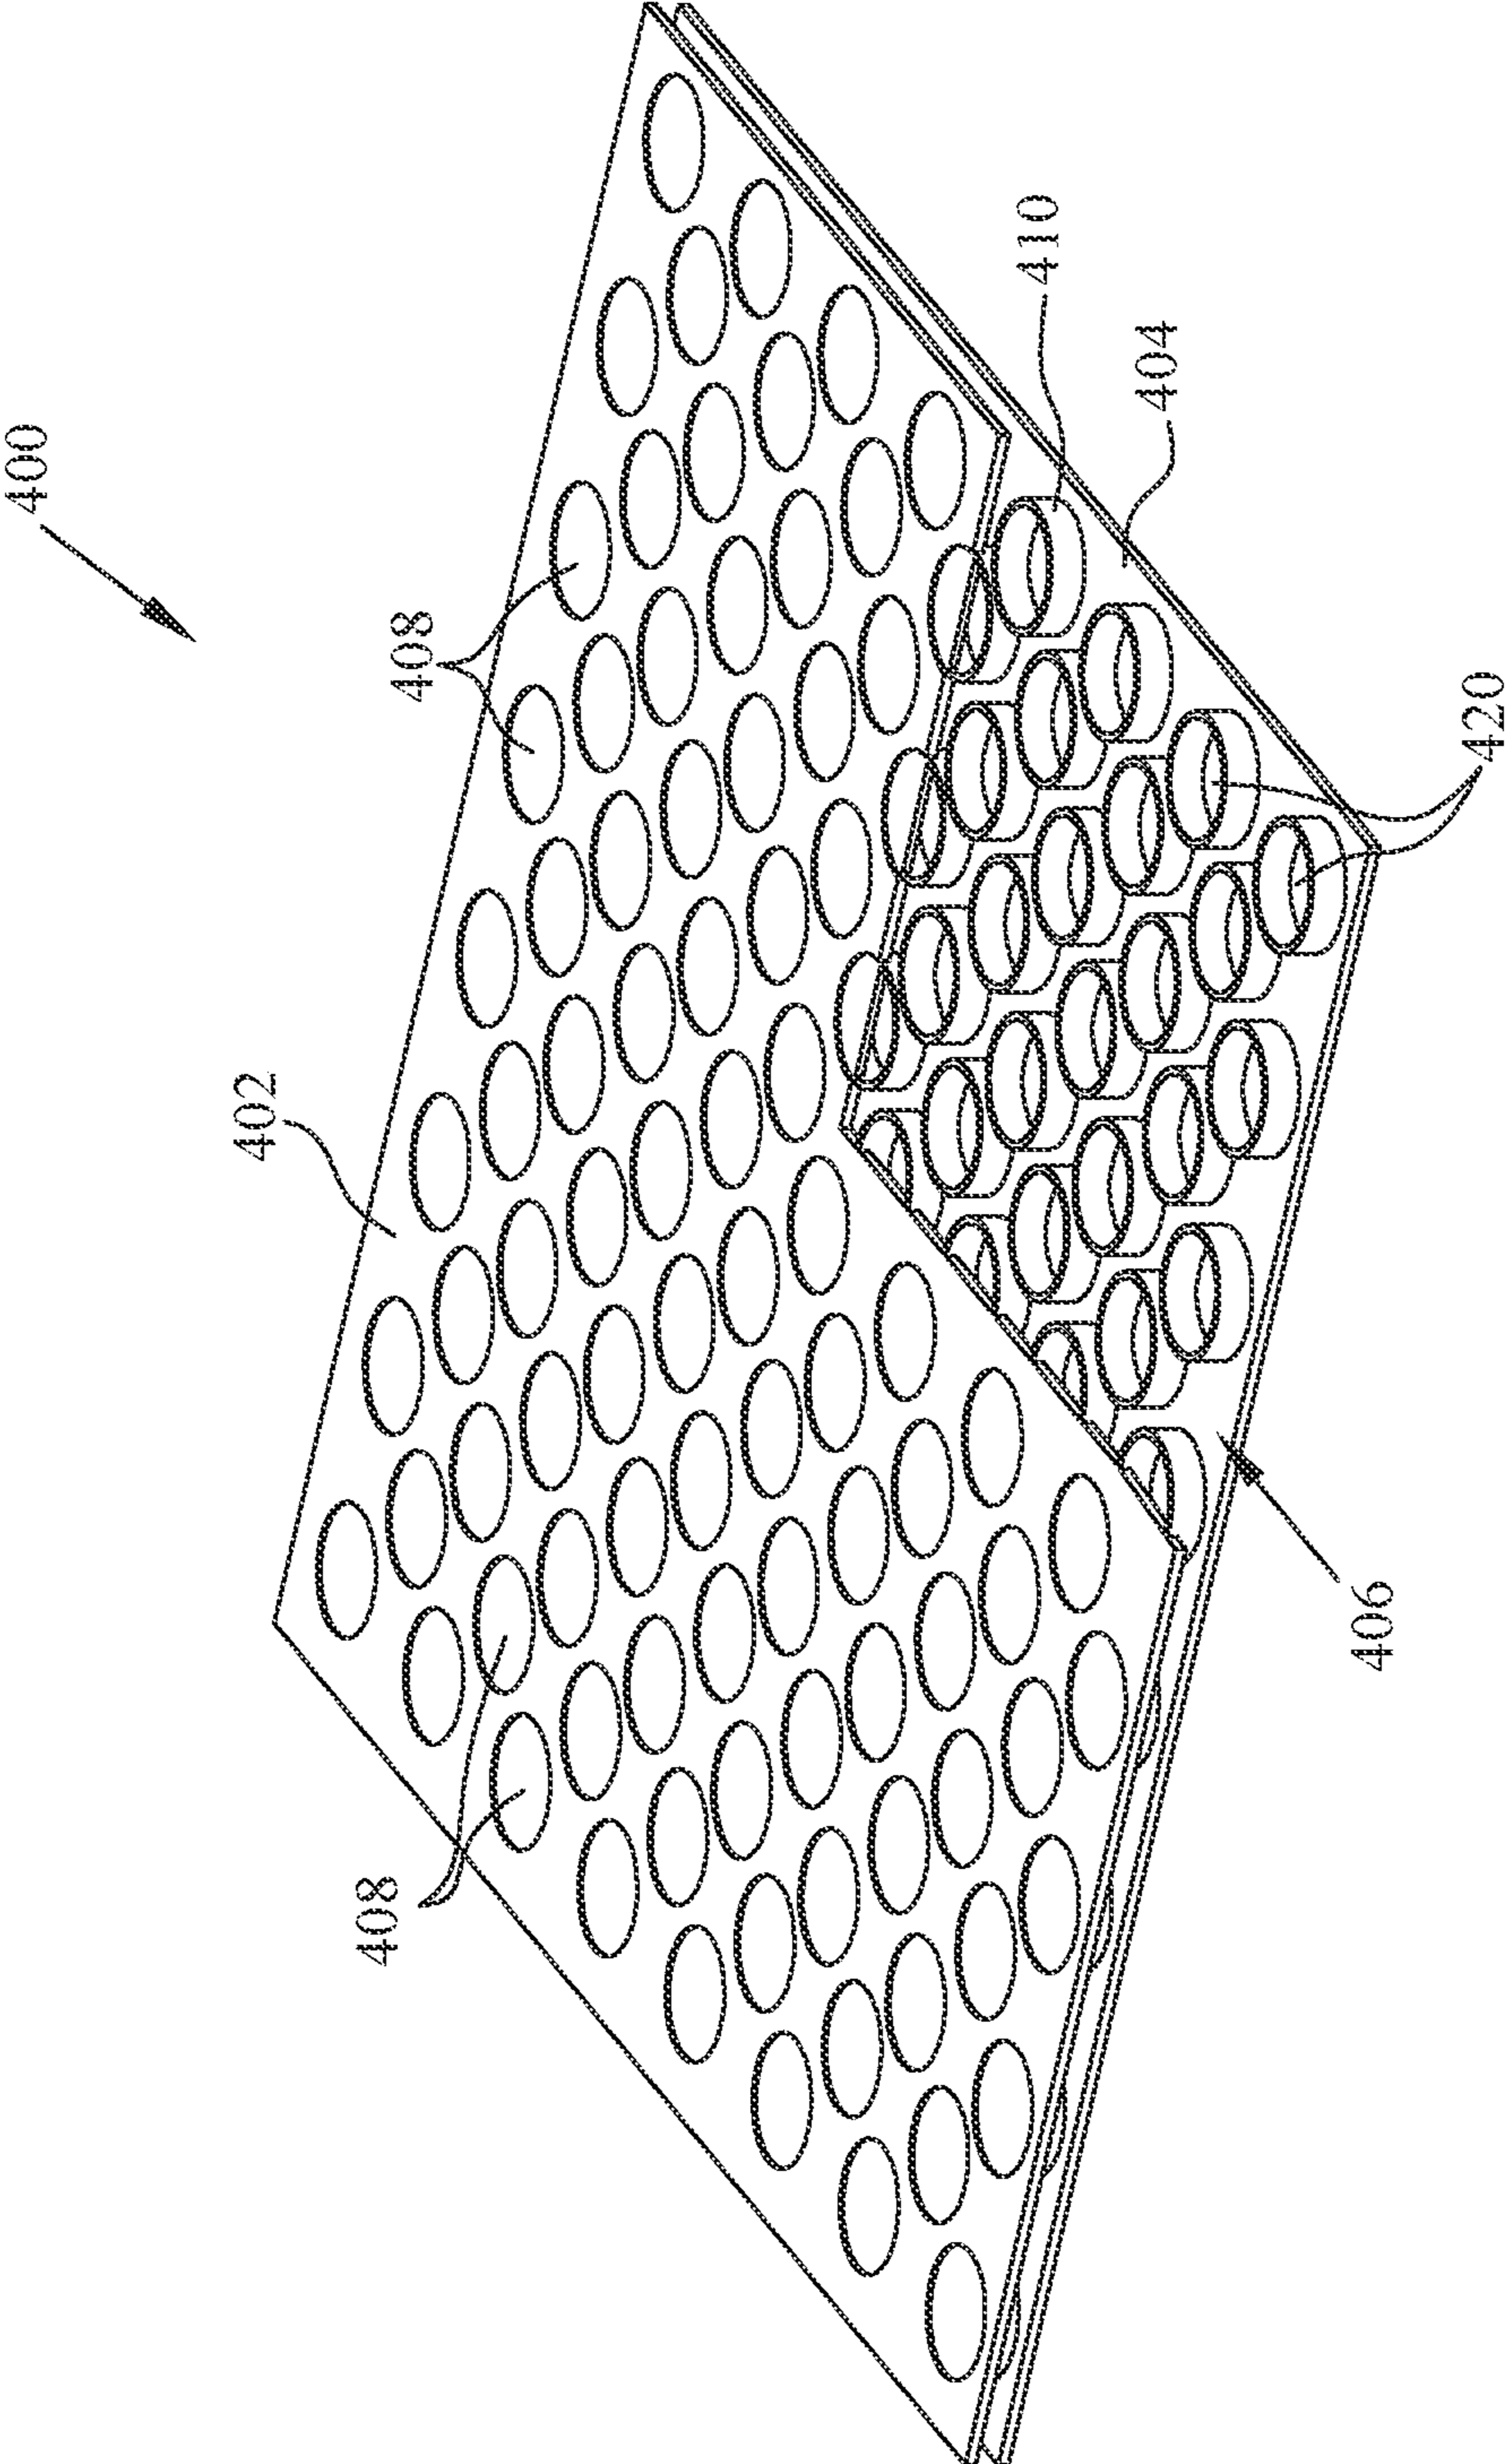
FIG. 23 is another perspective view of a portion of the vehicle frame and cargo bay liner of FIG. 14 with part of the top layer removed;
