(12) **United States Patent**  
**Pennington**

(54) **VEHICLE FRAME AND CARGO BAY LINER**

(57) **ABSTRACT**

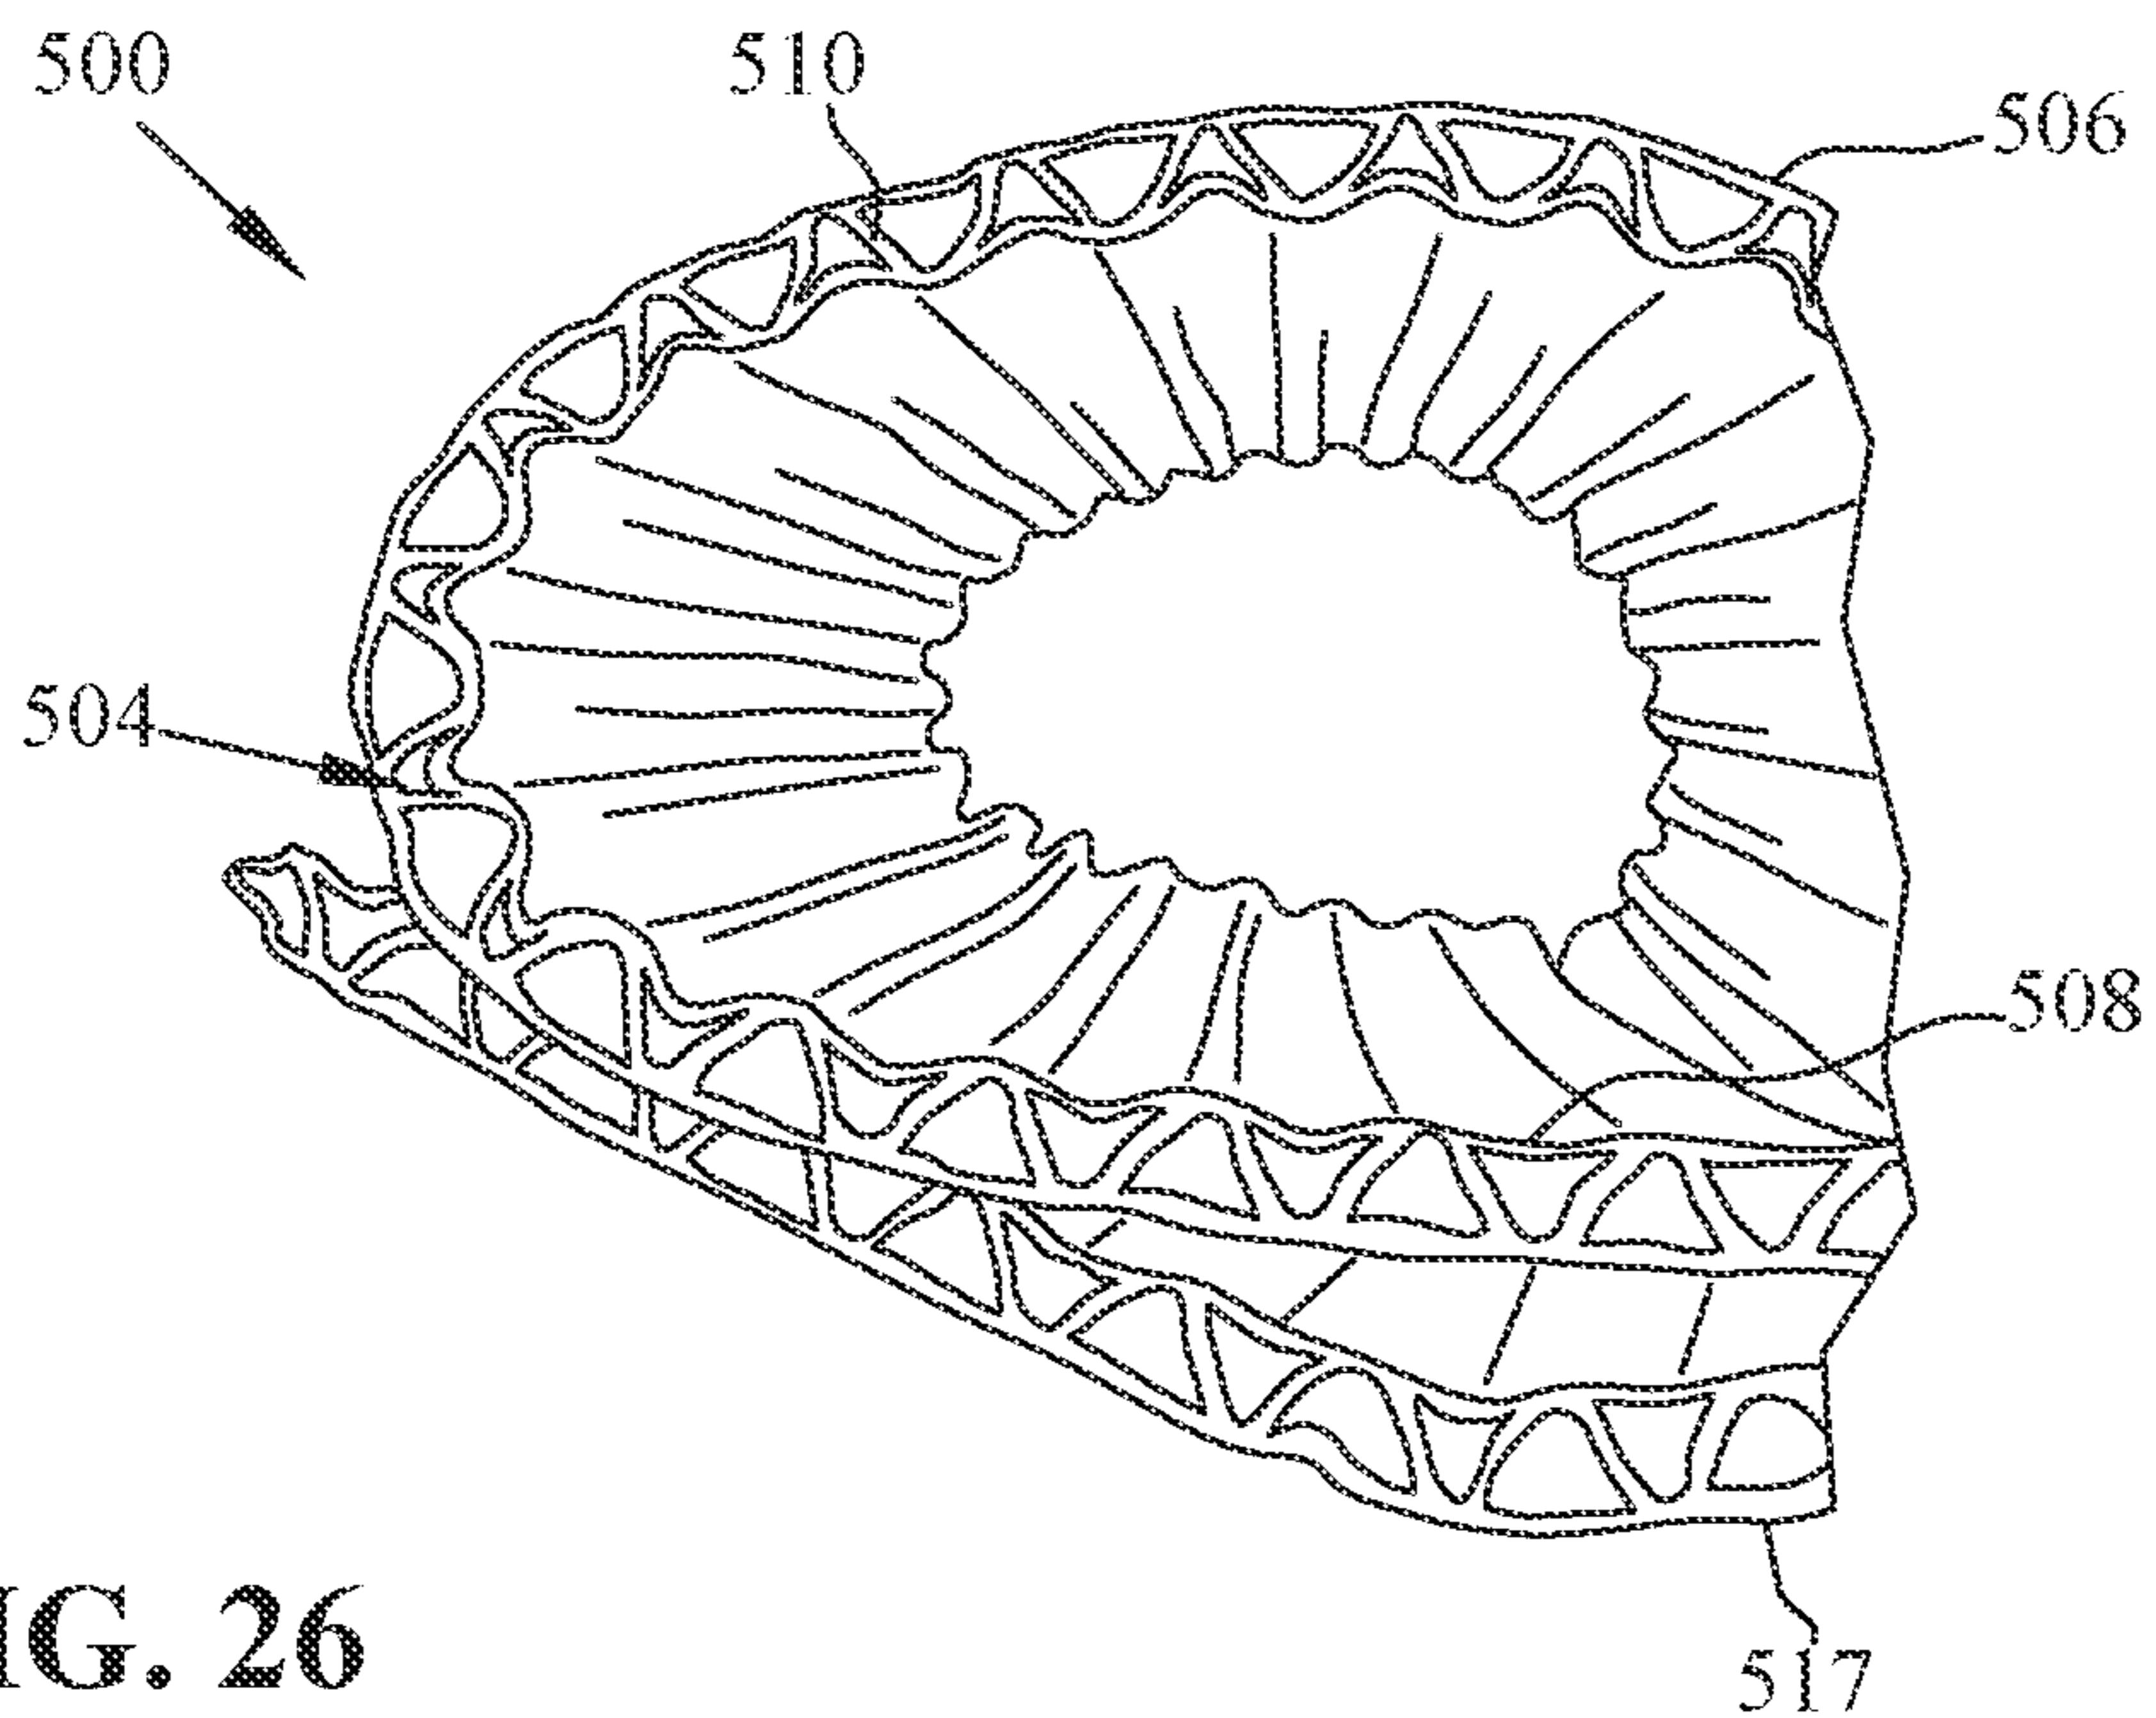
**FIG. 26**

FIG. 26 is an end view of the vehicle frame and cargo bay liner of FIG. 25 shown rolled up wherein corrugations of the liner are readily visible;

Now referring to FIGS. 25-27, other alternate embodiment vehicle frame and cargo area liner is shown generally indicated as **500**. Liner **500** includes a corrugated liner, generally indicated as **504**. Corrugated liner **504** includes a top sheet **506**, a bottom sheet **508**, and a corrugated or sinusoidal ply **510** extending therebetween, as best shown in FIGS. 26 and 27. Top sheet **506** and bottom sheet **508** each have a generally planar configuration, not including any rolling memory that may be embedded therein and are adhered or thermally attached to corrugated ply **510**. It should be appreciated that the corrugated ply is defined to include either a sinusoidal configuration as shown in FIGS. 26 and 27 or alternately a plurality of member perpendicular to top sheet **506** and bottom sheet **508** such as is shown in the material utilized in FIGS. 7 and 8 of U.S. Pat. No. 10,000,930 B2 to Lowe et al., which is incorporated in its entirety herein by reference. In one embodiment, corrugated liner **504** is polyethylene. Of course, other materials, and in particular, polymers such as polypropylene may be used for corrugated liner **504**. As best shown in FIG. 26, when the corrugated liner **504** is rolled, the outer sheet will become stretched and the inner sheet may fold as shown with top sheet **506**, and bottom sheet **508** in FIG. 26, respectively.

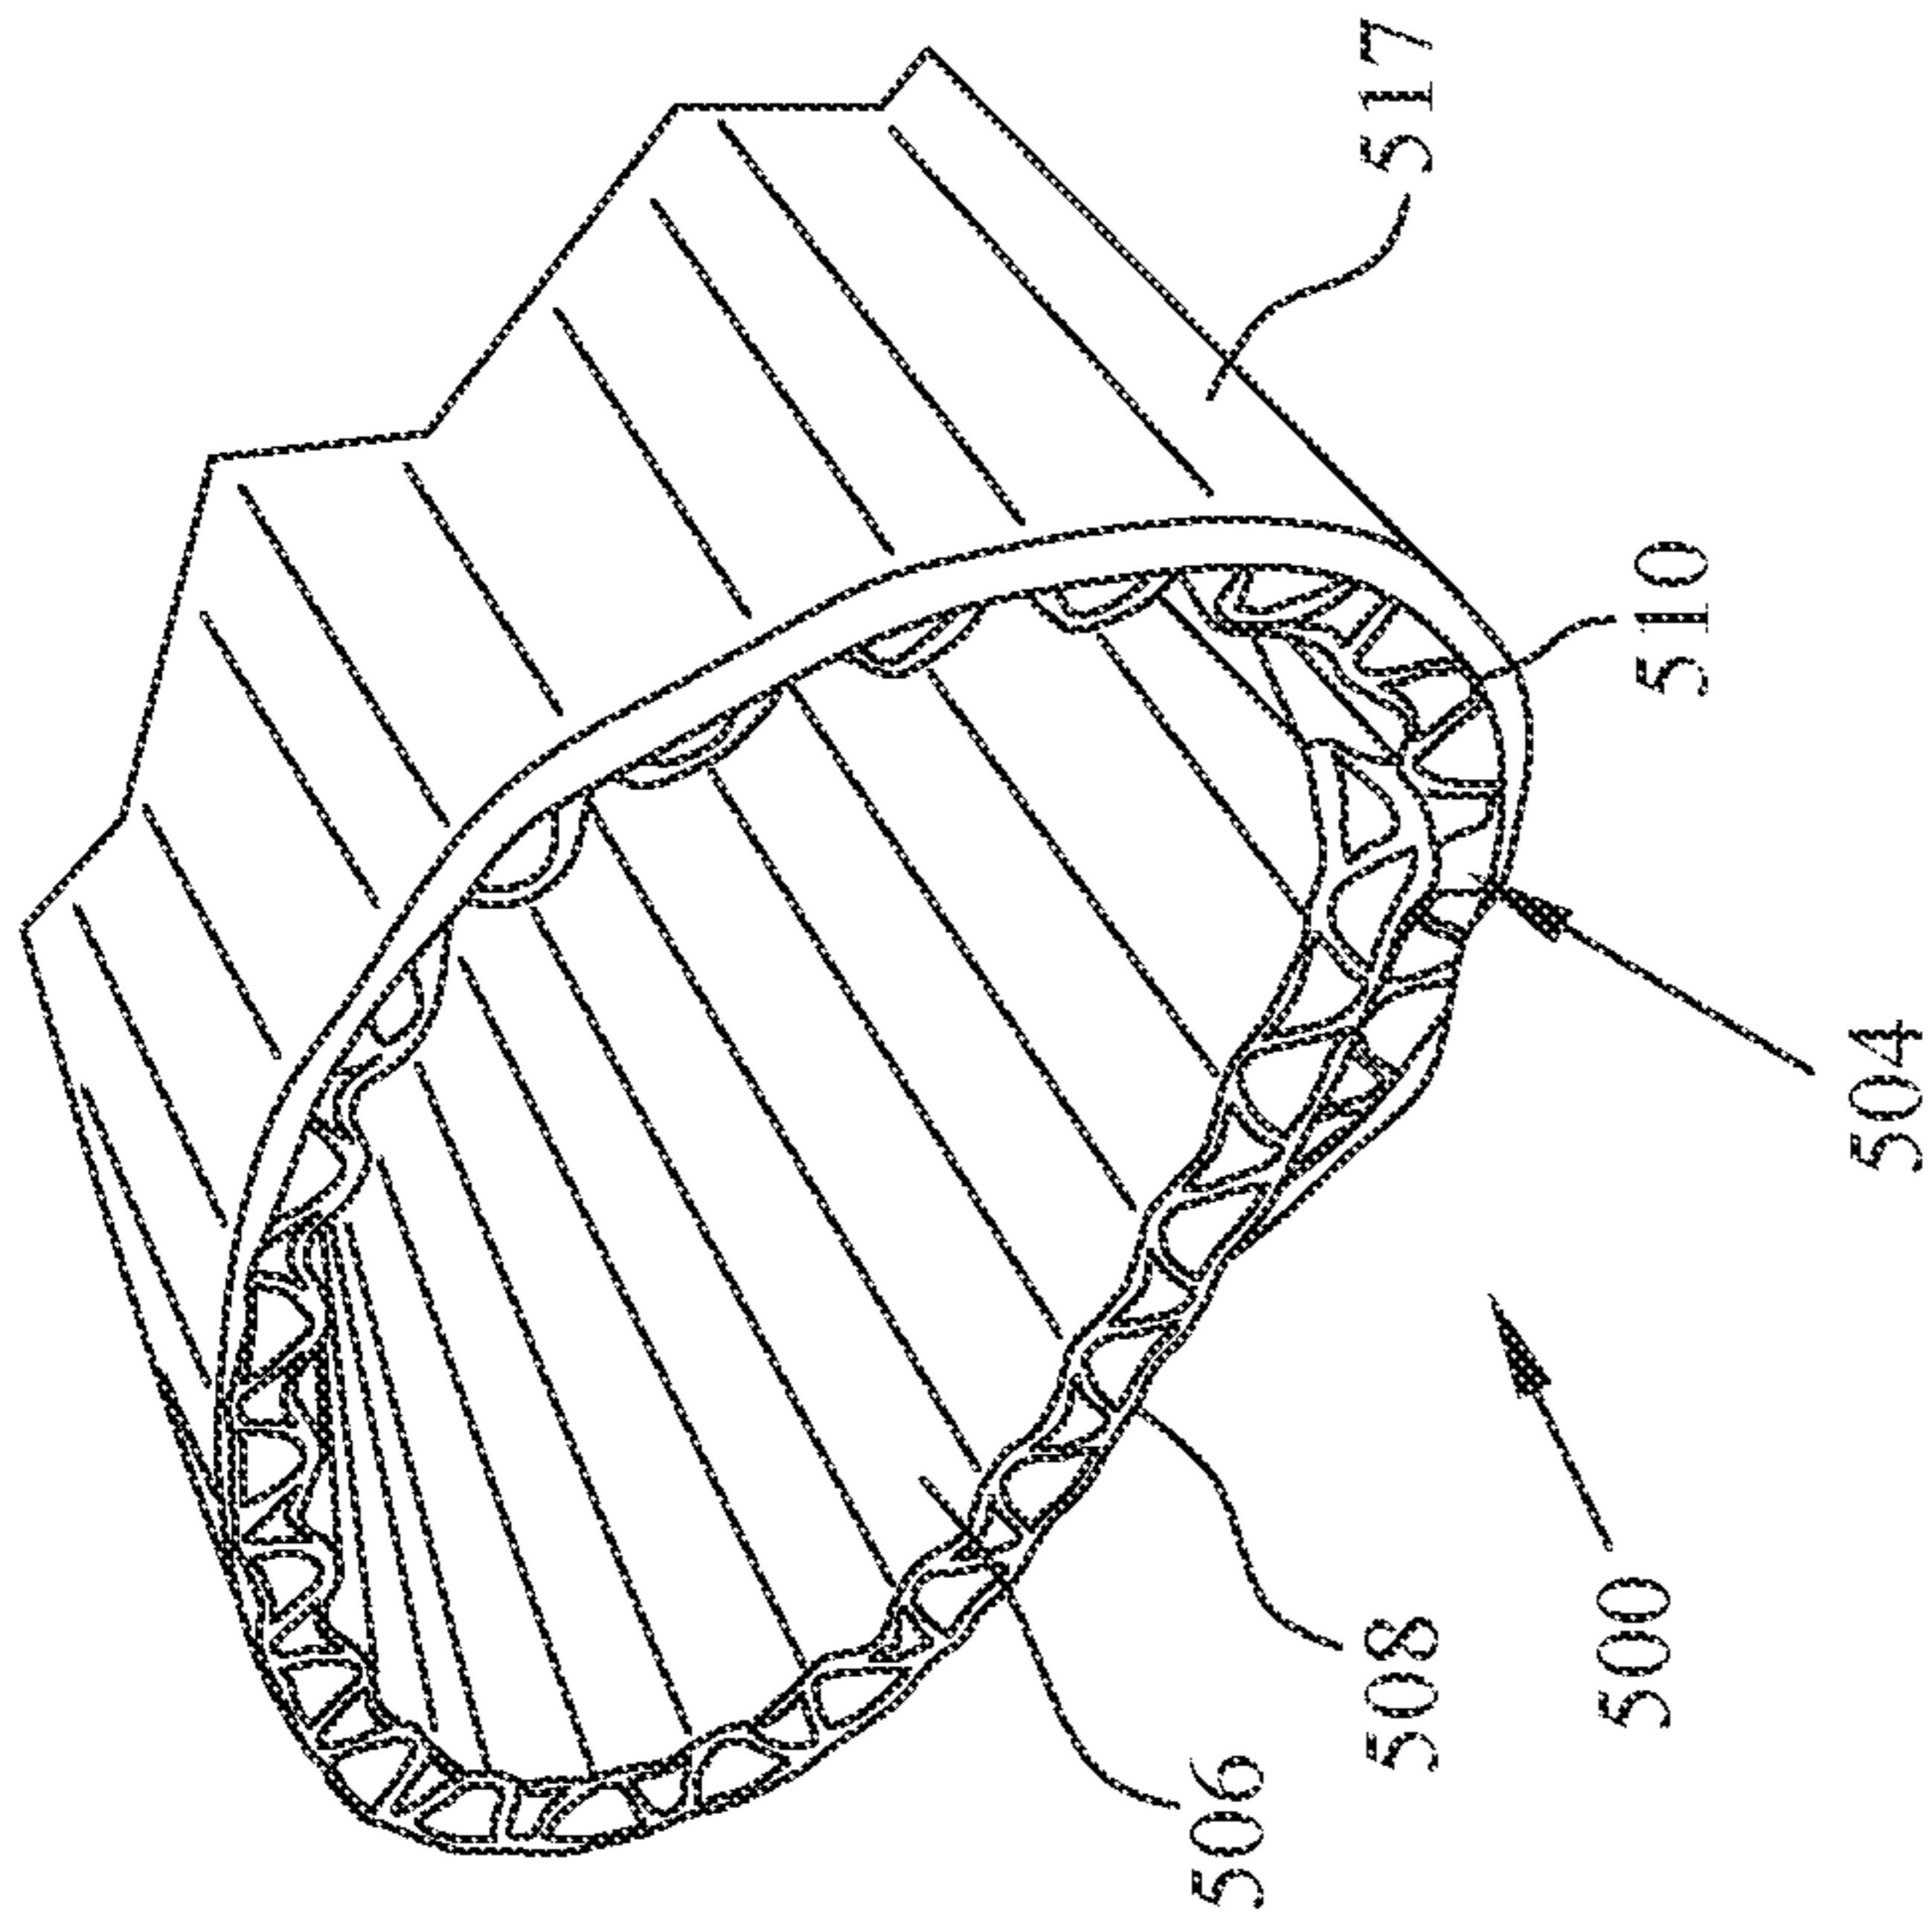
FIG. 27 is a perspective view of the vehicle frame and cargo bay liner of FIG. 25 rolled up with the aluminum foil on the outside thereof;

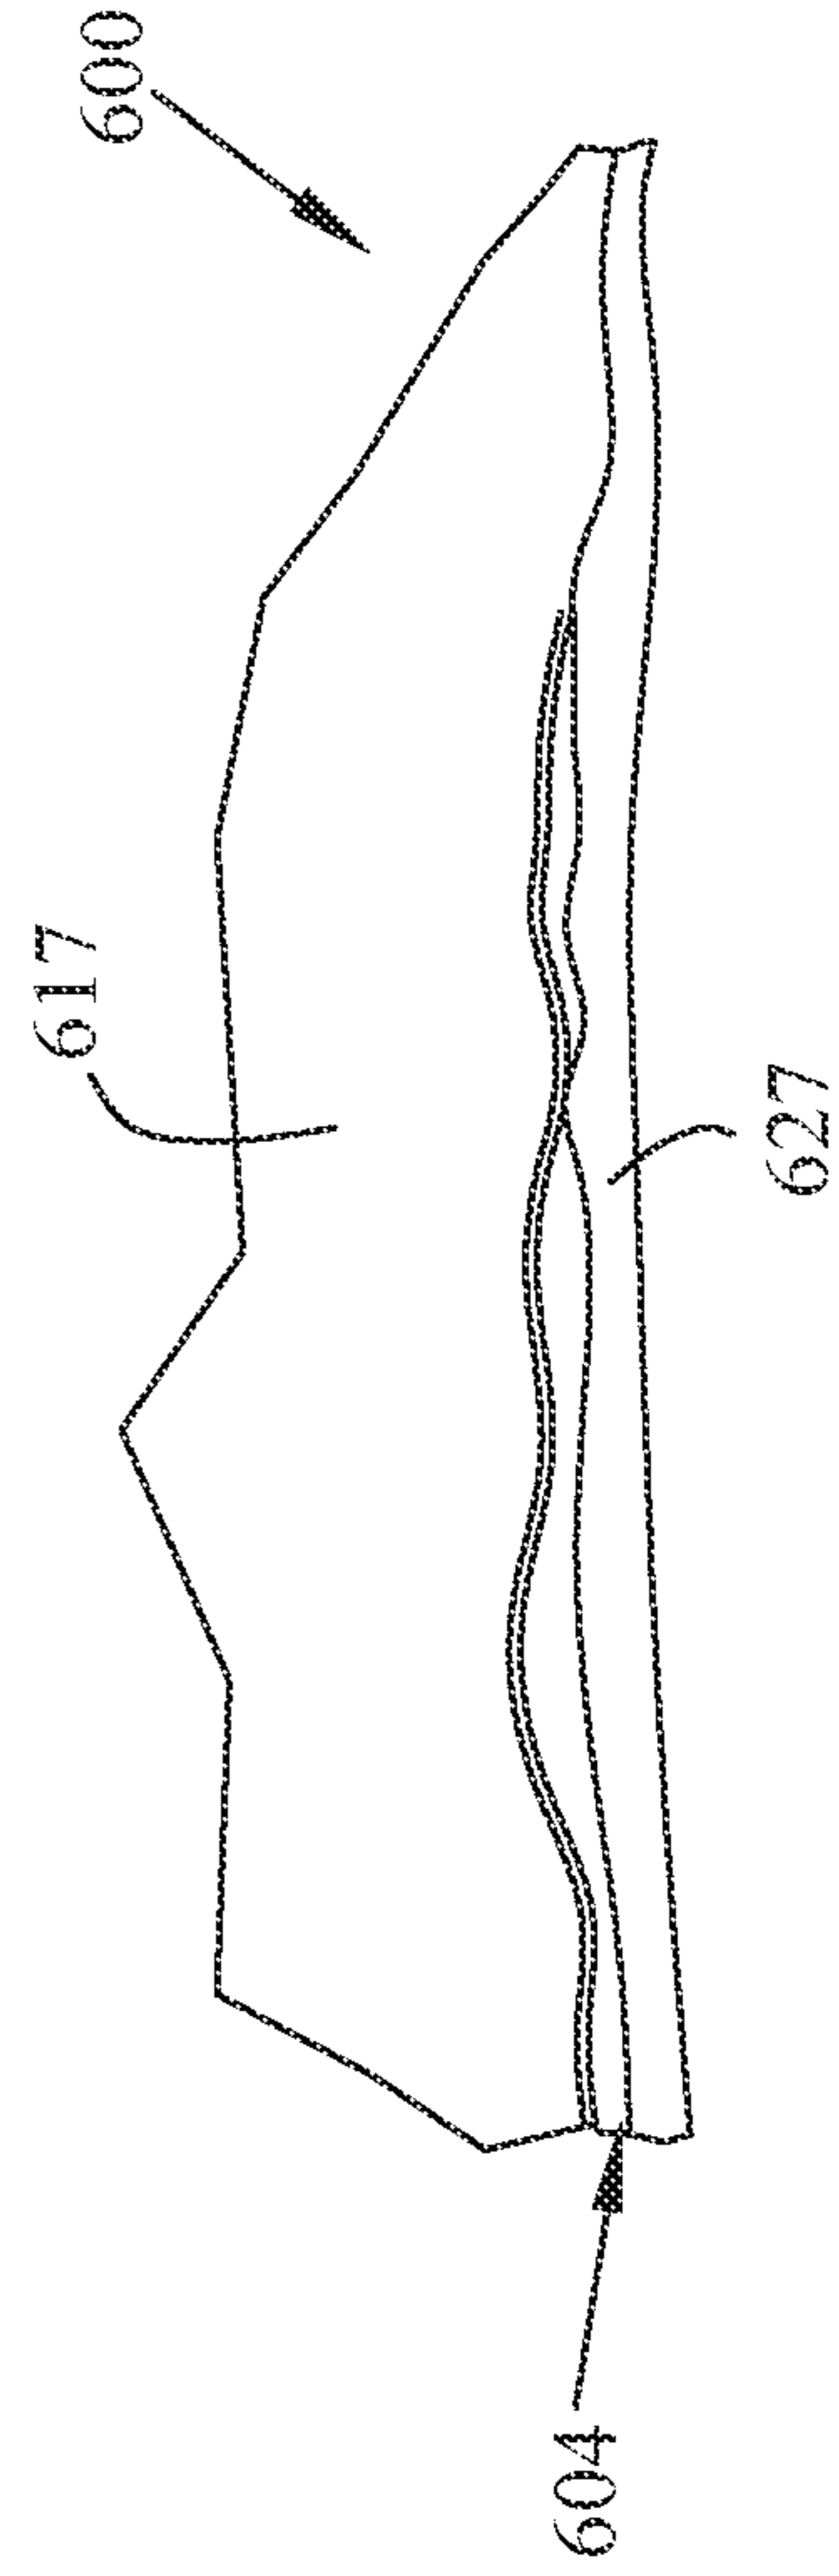
FIG. 28 is an end perspective view of another alternate embodiment vehicle frame and cargo bay liner shown laid out and having aluminum foil on both sides thereof;

Now referring to FIGS. 28-30, an additional embodiment of a 3-ply panel vehicle frame and cargo area liner is generally indicated as **600**. As with vehicle frame and cargo area liners **500**, vehicle frame and cargo area liner **600** includes a corrugated liner, generally indicated as **604**. Corrugated liner **604** includes a top sheet **606**, a bottom sheet **608**, and a corrugated or sinusoidal ply **610** extending therebetween. Top sheet **606** and bottom sheet **608** are adhered or thermally attached to corrugated ply **610** and may be made from materials similar to corrugated liner **500**, such as but not limited to polyurethane or polyethylene. Alternately, liner **600** may be an extruded manufactured design,

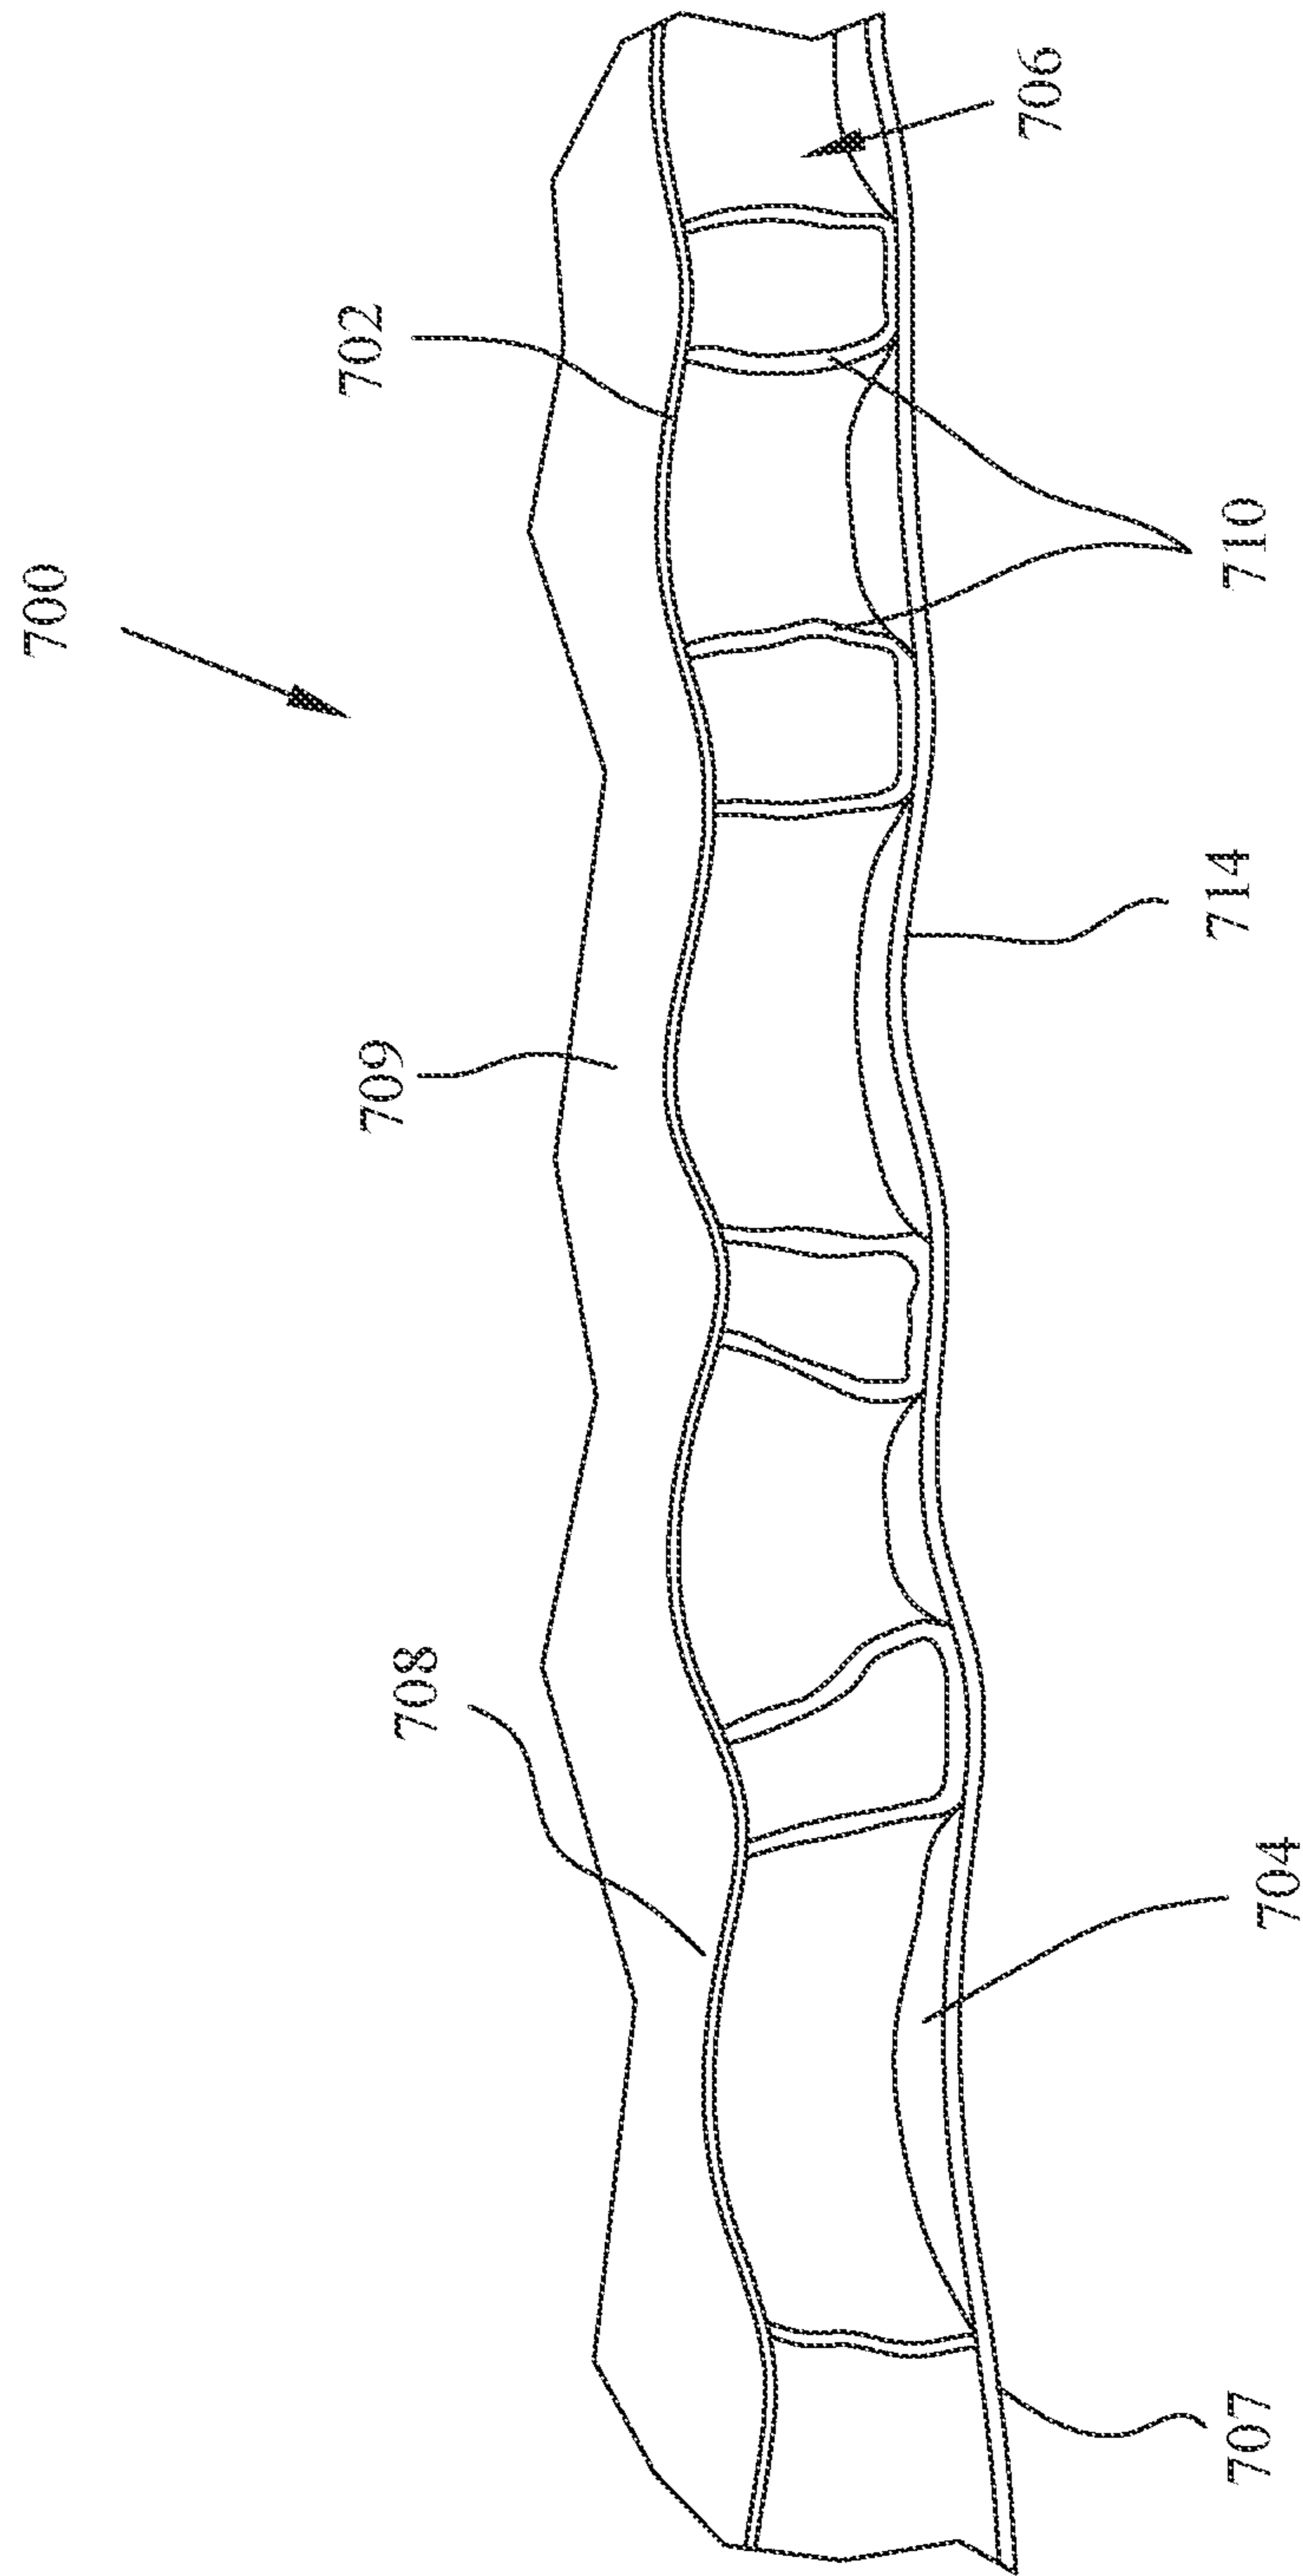
FIG. 31 is a side perspective view of yet another alternate embodiment vehicle frame and cargo bay liner having an aluminum foil on one side and a woven material on the opposite side

Now referring to FIGS. **31-34**, another alternate vehicle frame and cargo area liner is shown generally indicated as **700**. Liner **700** can be provided in a coiled form as liner **400**, making it extremely suitable for use as a liner for vehicle frames and cargo bays. The desired length of liner can be rolled out and cut to size for assembly to the vehicle. Vehicle frame and cargo bay liner **700** is of a 3-ply configuration and includes a top ply, sheet, or layer **702** and a bottom ply, sheet, or layer **704**. A core **706** (see FIG. **31**) separates top sheet **702** from bottom sheet **704**. Additionally, vehicle frame and cargo bay liner **700** also includes a sheet of aluminum foil or metalized film **707** on one side thereof. In the embodiment shown, aluminum foil/metalized film **707** is provided on bottom sheet **704**; however, it should be appreciated that aluminum foil/metalized film could also be provided on the top sheet **702** (see embodiment **700A** discussed below). Aluminum foil/film **707** may be adhered to bottom sheet **704** using an adhesive or other suitable means. Vehicle frame and cargo bay liner **700** also includes a woven or nonwoven layer of material **709** adhered to top layer **702**, opposite the side with aluminum foil **707** or metalized film. In one embodiment, material **709** is a woven sheet of polypropylene fabric.

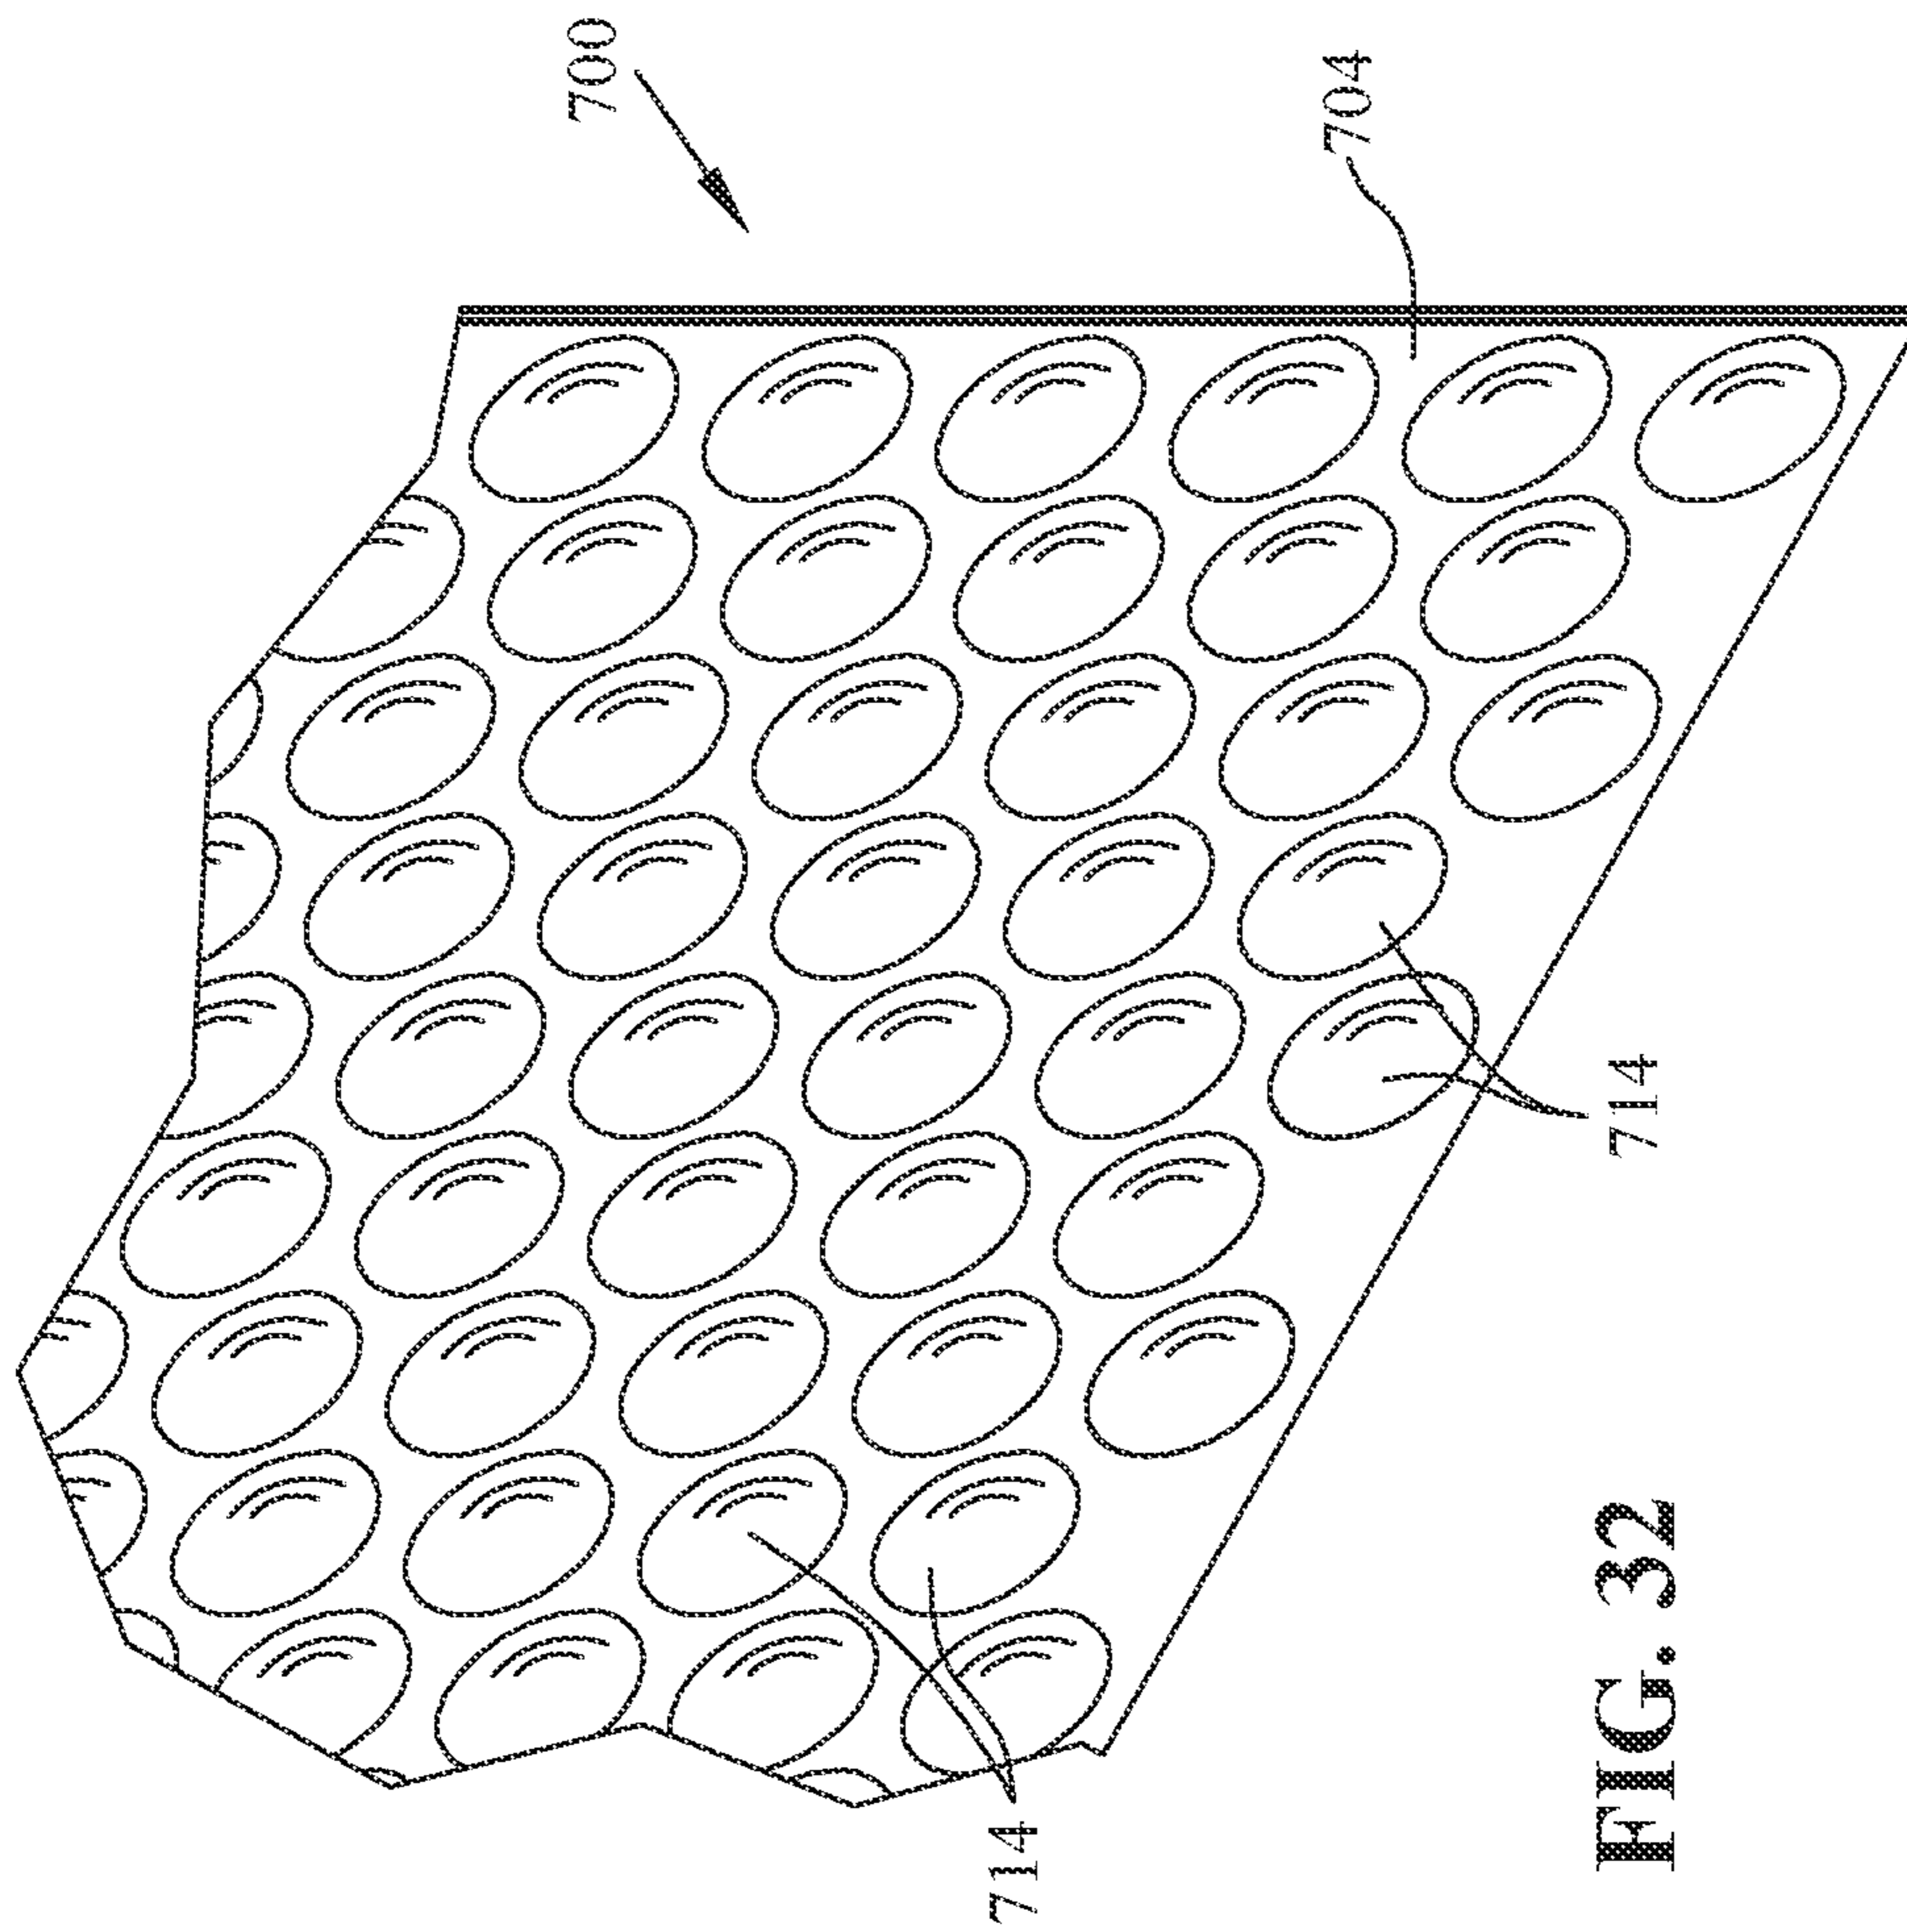
FIG. 32 is a plan view of the vehicle frame and cargo bay liner of FIG. 31 with the aluminum foil and woven material removed show a layer of the liner having dimples thereon.

In the embodiment shown, vehicle frame and cargo bay liner **700** also includes a plurality of circular convexities **708** on top sheet **702** and a corresponding plurality of circular dimples or depressions **714** in bottom sheet **704**. Vehicle frame and cargo bay liner **700** also includes a plurality of cylindrical projections **710** extending up from bottom sheet **704** and attached to top sheet **702** (see FIG. **31**). Projections **710** may be thermally bonded to top sheet **702** as well as to bottom sheet **704**. As can be seen in FIG. **31**, circular convexities **708** and circular depressions **714** coincide with

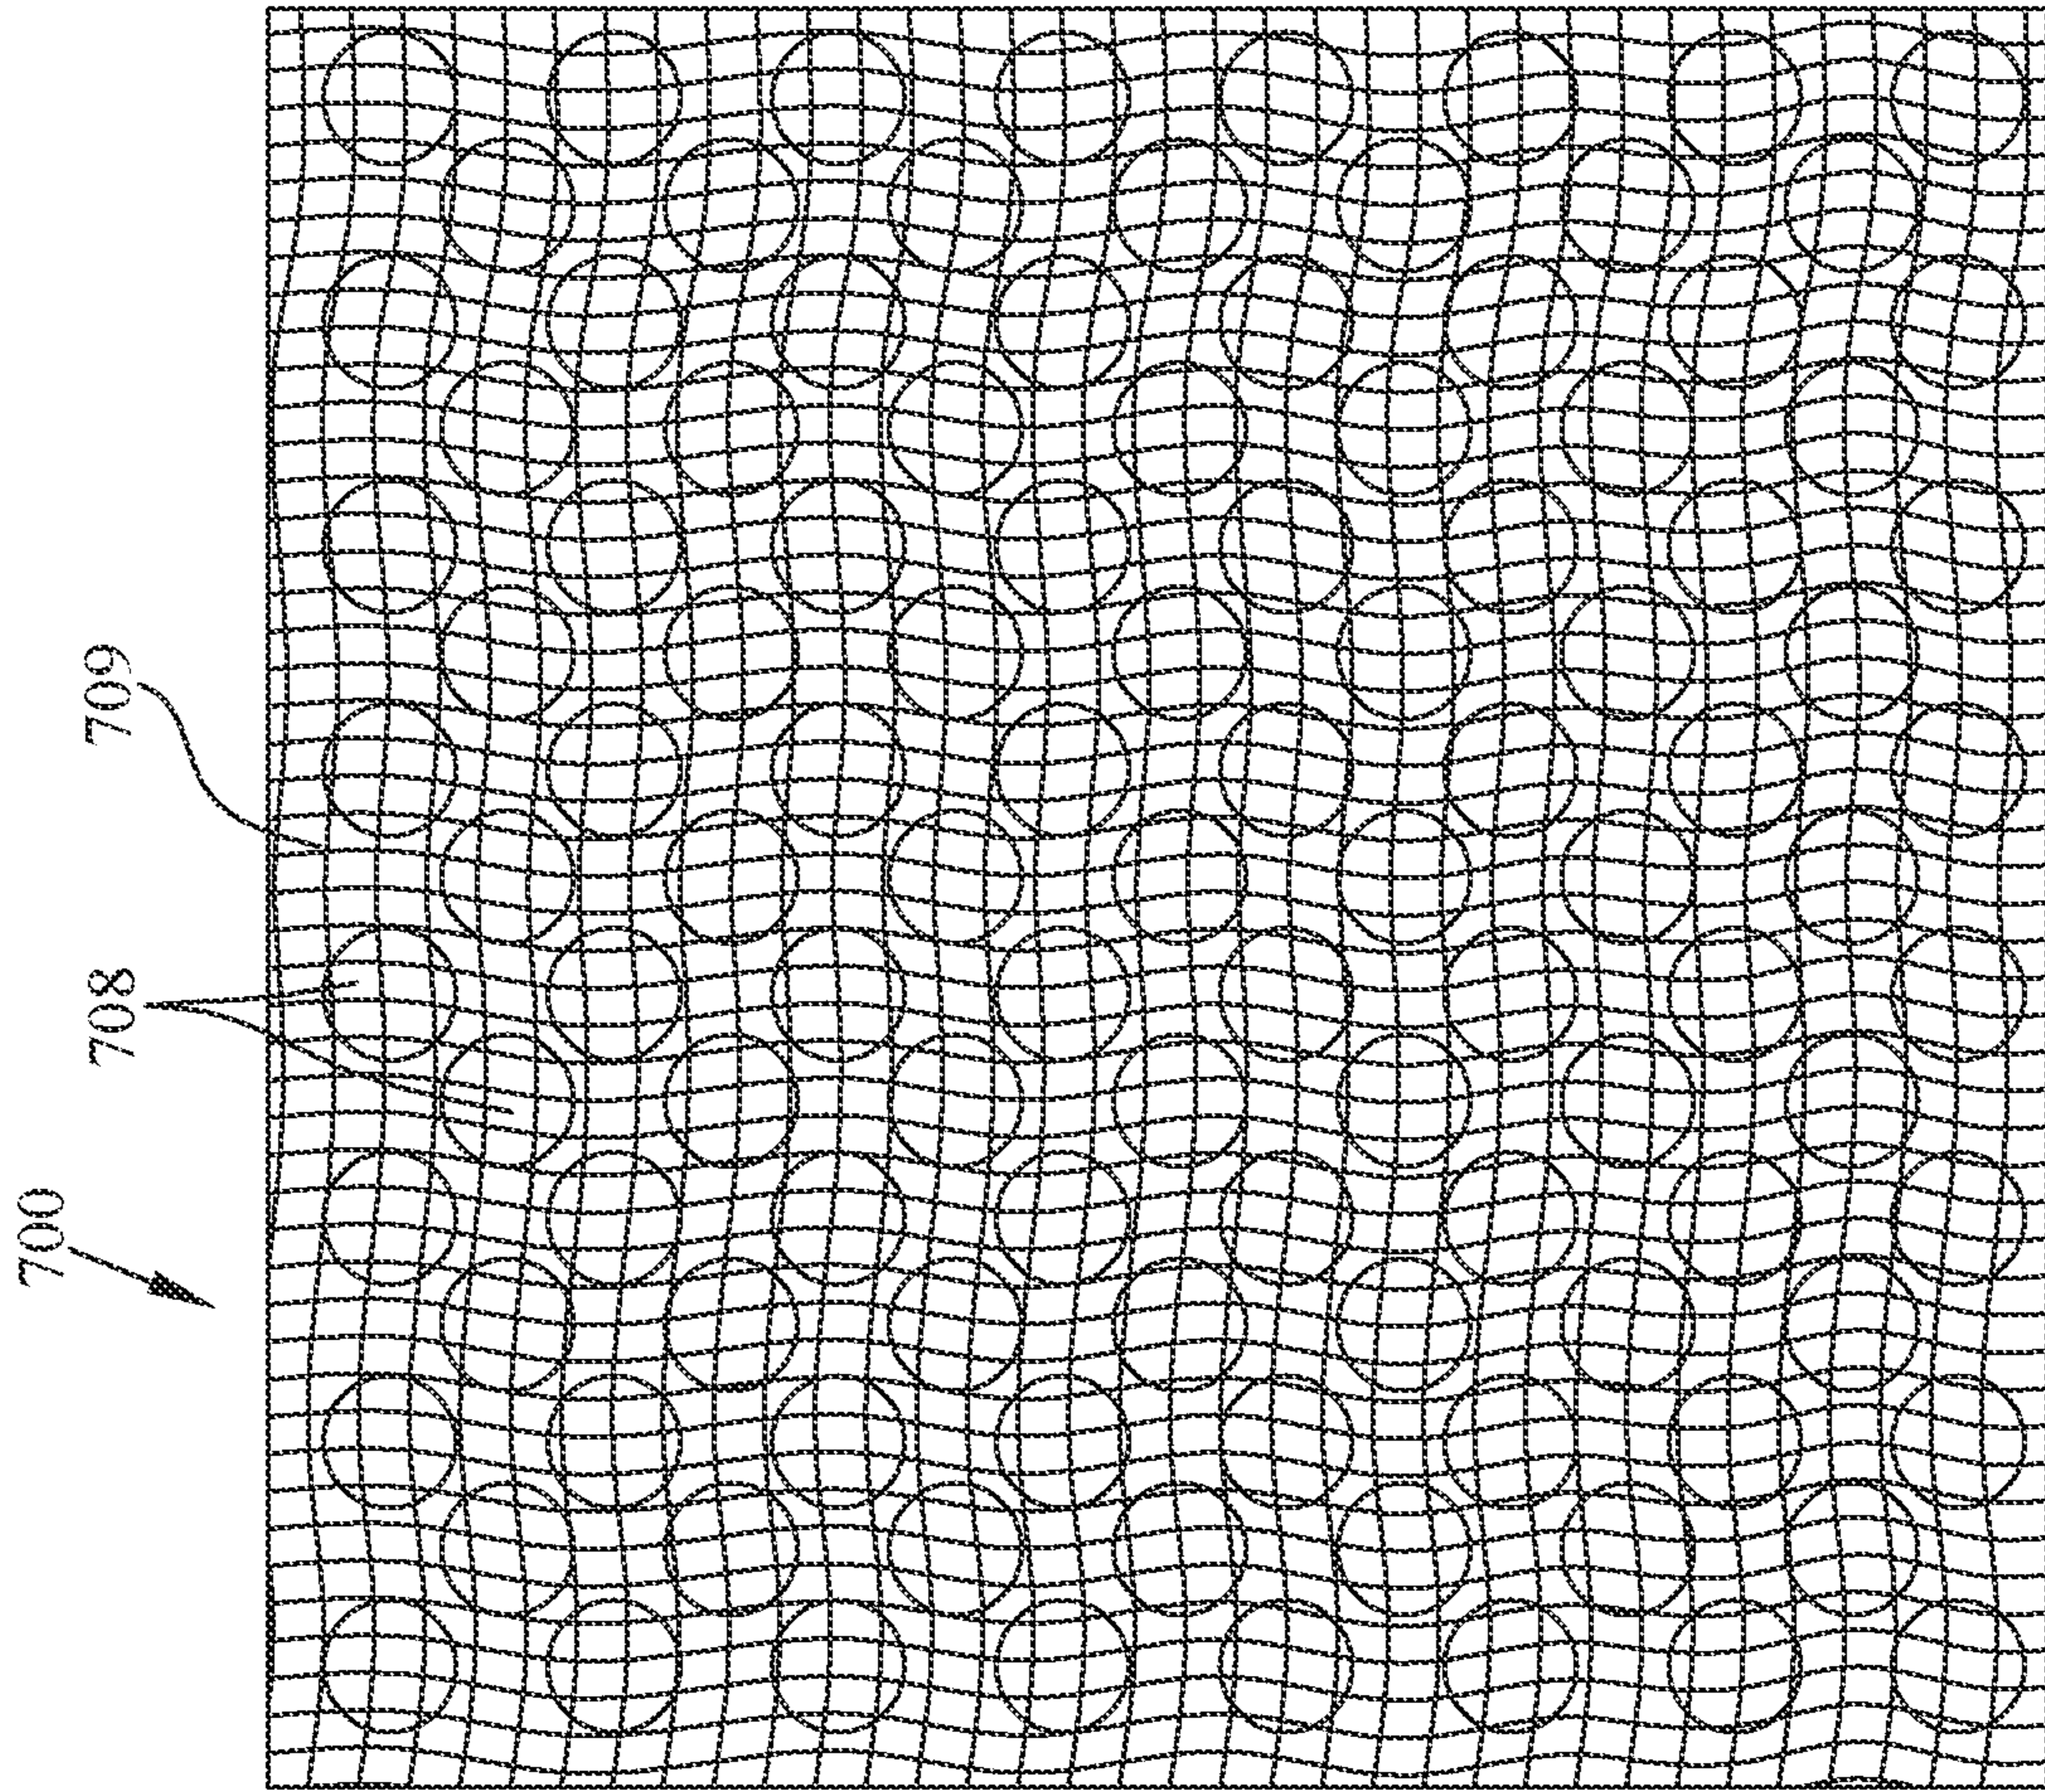
FIG. 34 is a perspective plan view of the vehicle frame and cargo bay liner of FIG. 31 showing a side with convexities and a woven material thereon;
