(12) **United States Patent**  
**Pennington**

(54) **VEHICLE FRAME AND CARGO BAY LINER**

(57) **ABSTRACT**

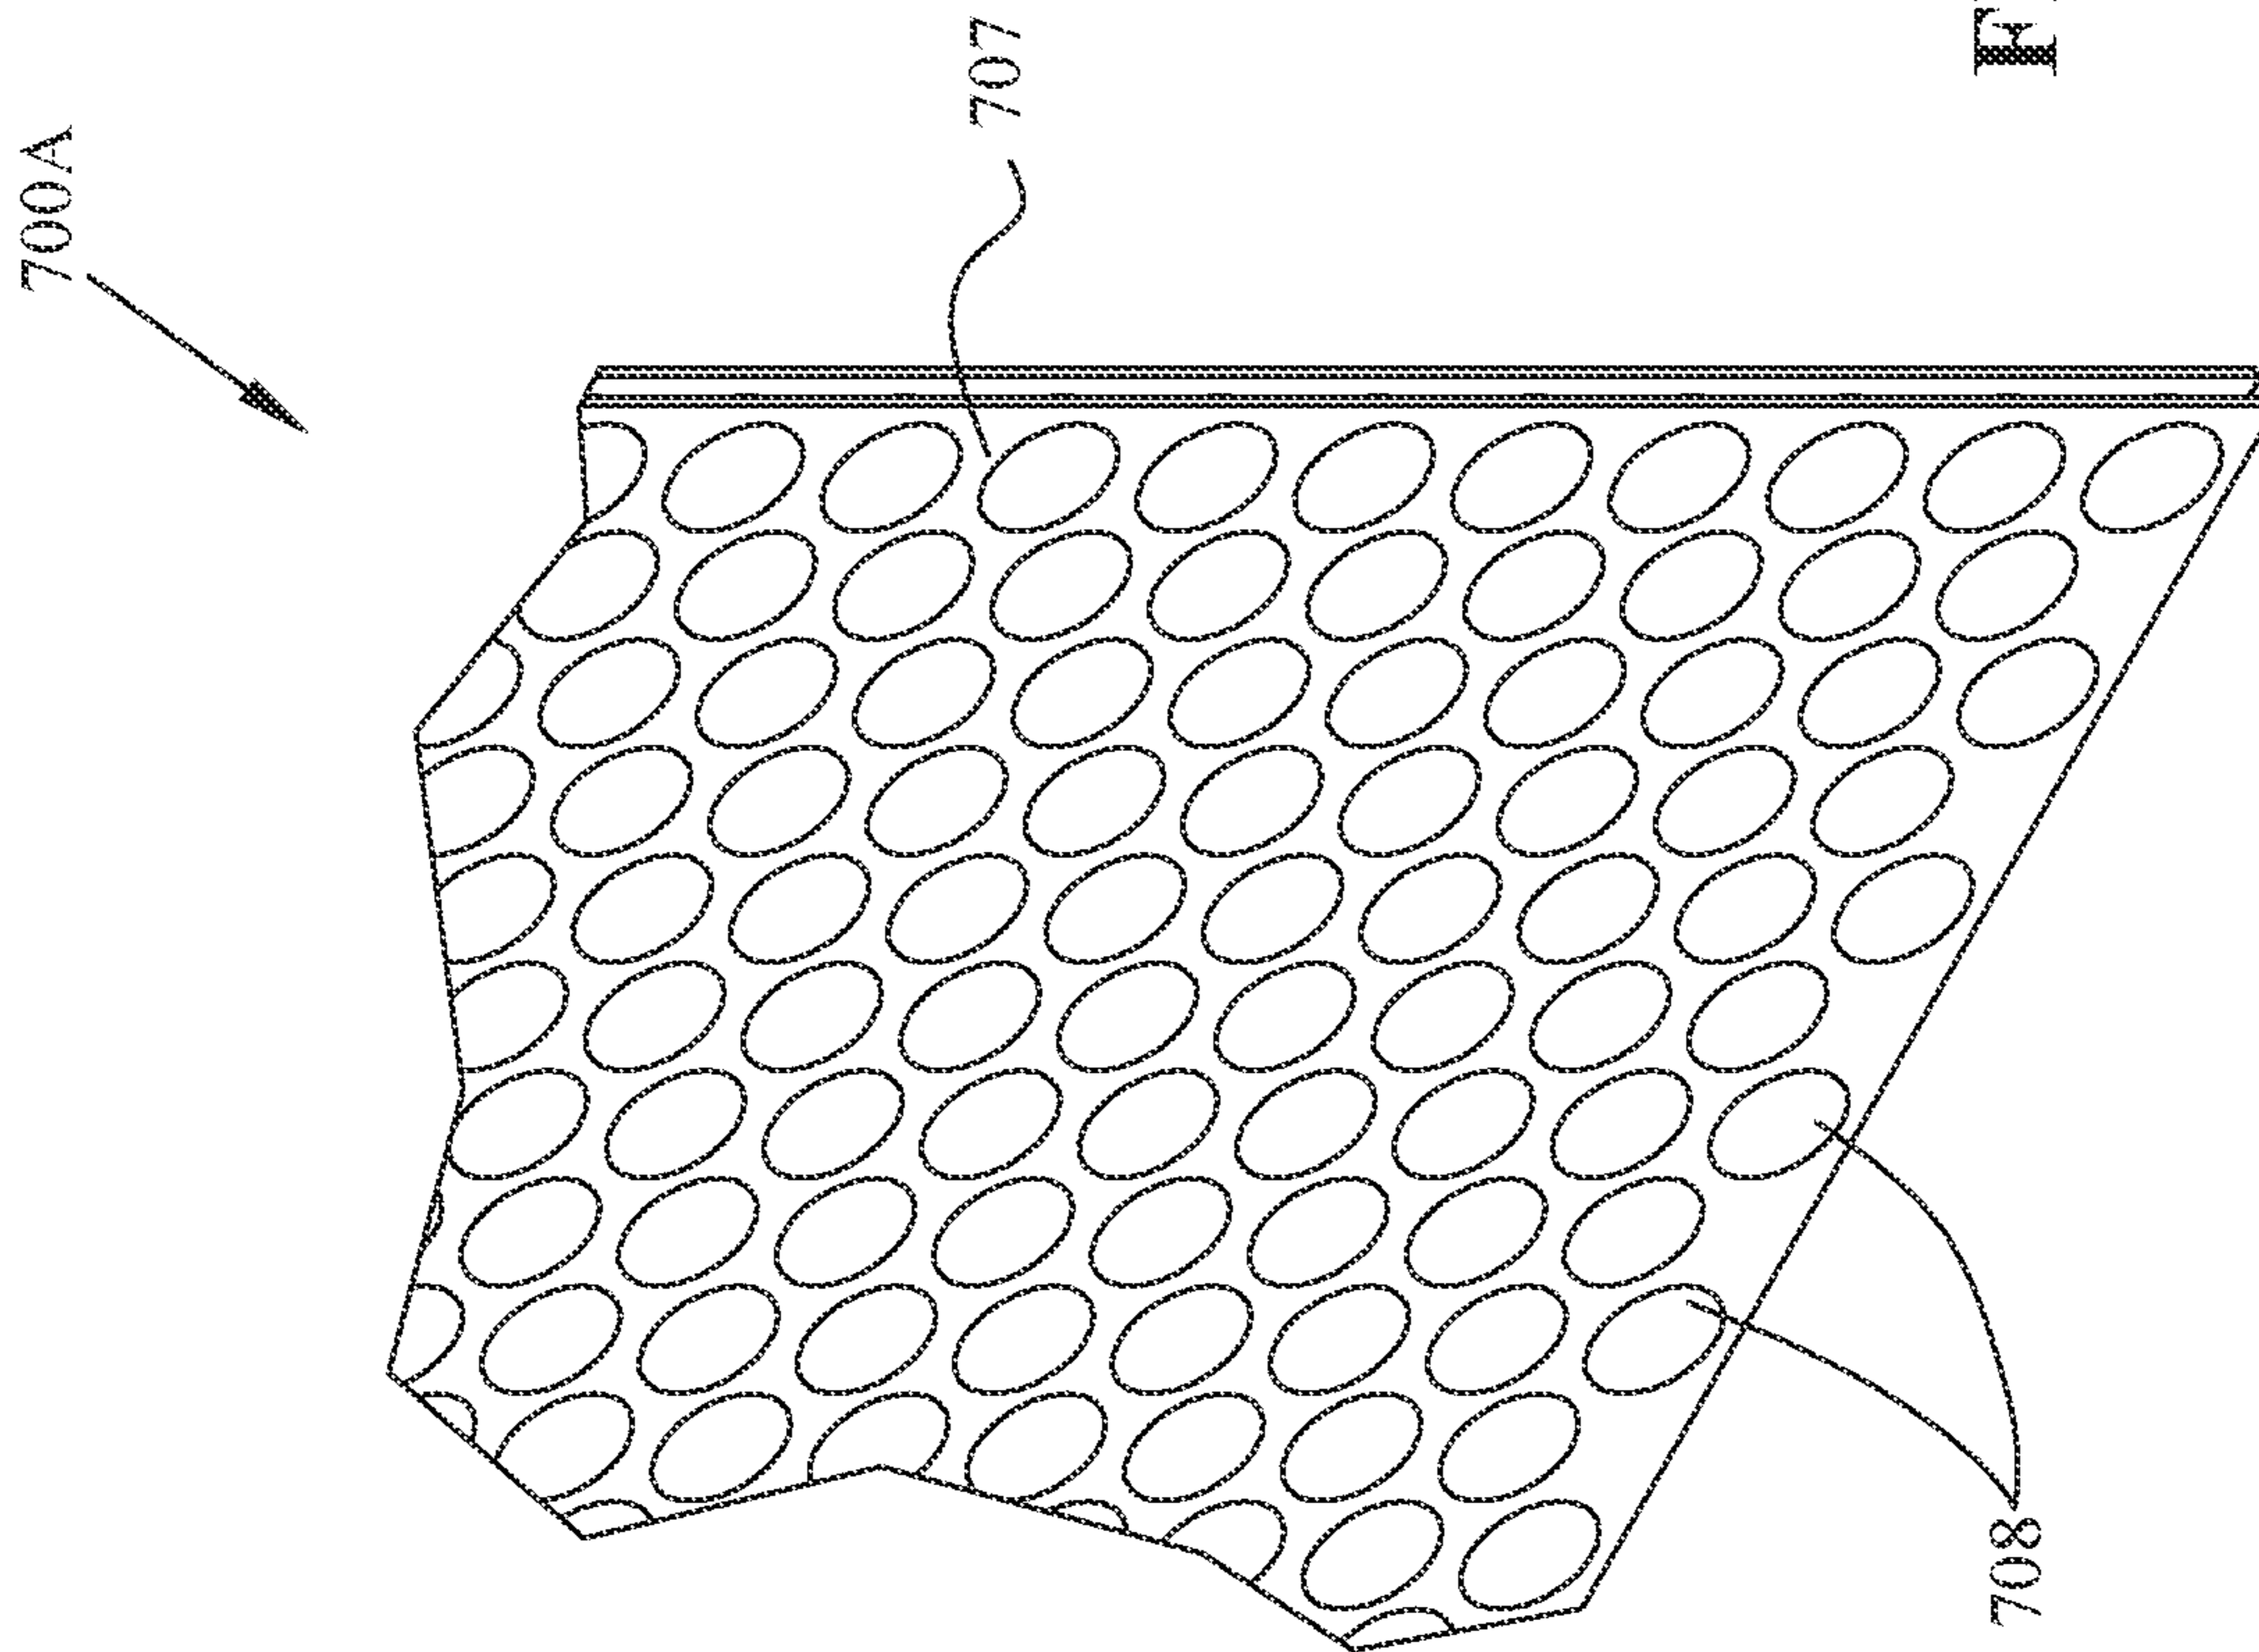
FIG. 37 is a plan perspective plan view of the vehicle frame and cargo bay liner of FIG. 35 showing the convex side having the aluminum foil thereon side;

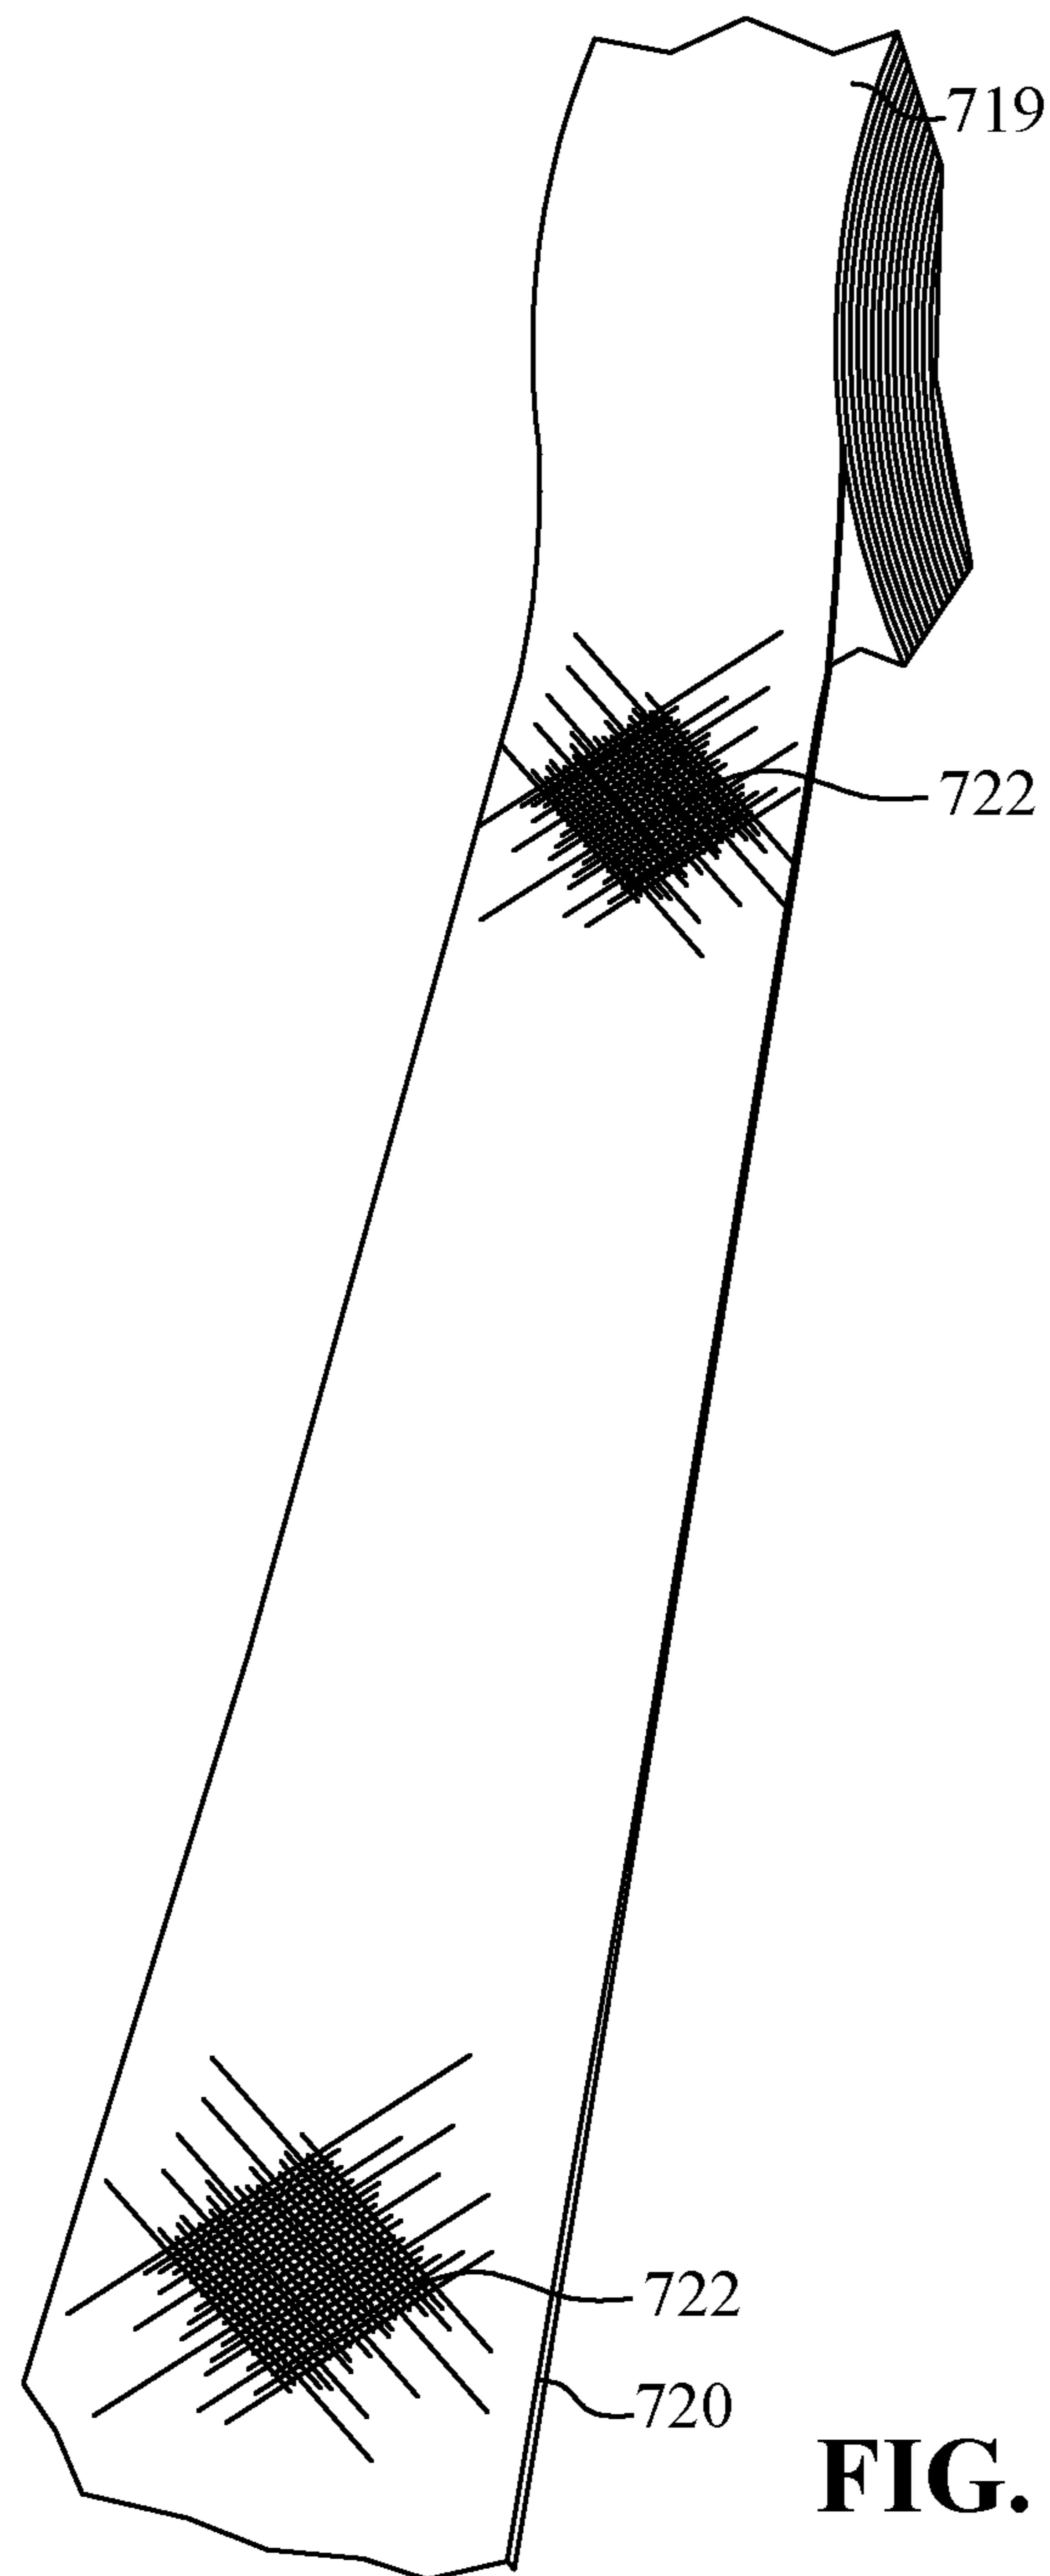
**FIG. 39**

FIG. 39 is a perspective view of a role of repair tape for use in repairing the woven material;

Now referring now to FIGS. 39-42, a unique repair and reinforcing system is provided for any of the liners provide herein and may be used to repair rips, tears or holes in the liner itself, or in the aluminum foil or metalized film or to provided additional support, reinforcement or protection to the liner. However, it is particularly suitable for repairing rips, tears, holes etc. in the woven or nonwoven fabric that may be attached to and covering one or both outer faces of the liner. Such rips, tears etc. may be through only the woven or nonwoven fabric, but also may be through partially or entirely through the body of the liner. Also, it may be necessary to cut through the liner to install plumbing, electrical lines etc. in the recreational vehicle. The repair system can be used to repair around such installations.

In one embodiment, the repair system includes a role of woven or nonwoven fabric tape shown indicated as 719. In the embodiment shown, the fabric tape includes a woven fabric shown as 722. Also, in the embodiment shown, the tape can be supplied with a contact adhesive attached to one side thereof for attachment to the liner, foil, film or fabric that it is repairing or reinforcing. A protective layer of material 720 (see FIG. 39) to which the adhesive will readily release from may be used to facilitate providing the repair tape in a rolled form or otherwise facilitate removing thereof for easy repair or reinforcement of the recreational vehicle. As shown in FIGS. 42 and 43, repair tape 719 is attached to woven fabric layer 709, on the exterior thereof, creating an additional layer to the liner 700 as is best shown in FIG. 43. It should be appreciated that repair and reinforcing tape 719 could be placed or attached over itself to create additional reinforcing layers, and/or on the other side of the liner over the sheet of aluminum foil or metalized file 707. As many additional layers as is desired can be placed on either or both sides. It should also be appreciated that the repair tape could be an aluminum foil, or metalized film or other polymer or material, but the woven fabric tape has shown to be particularly suitable.

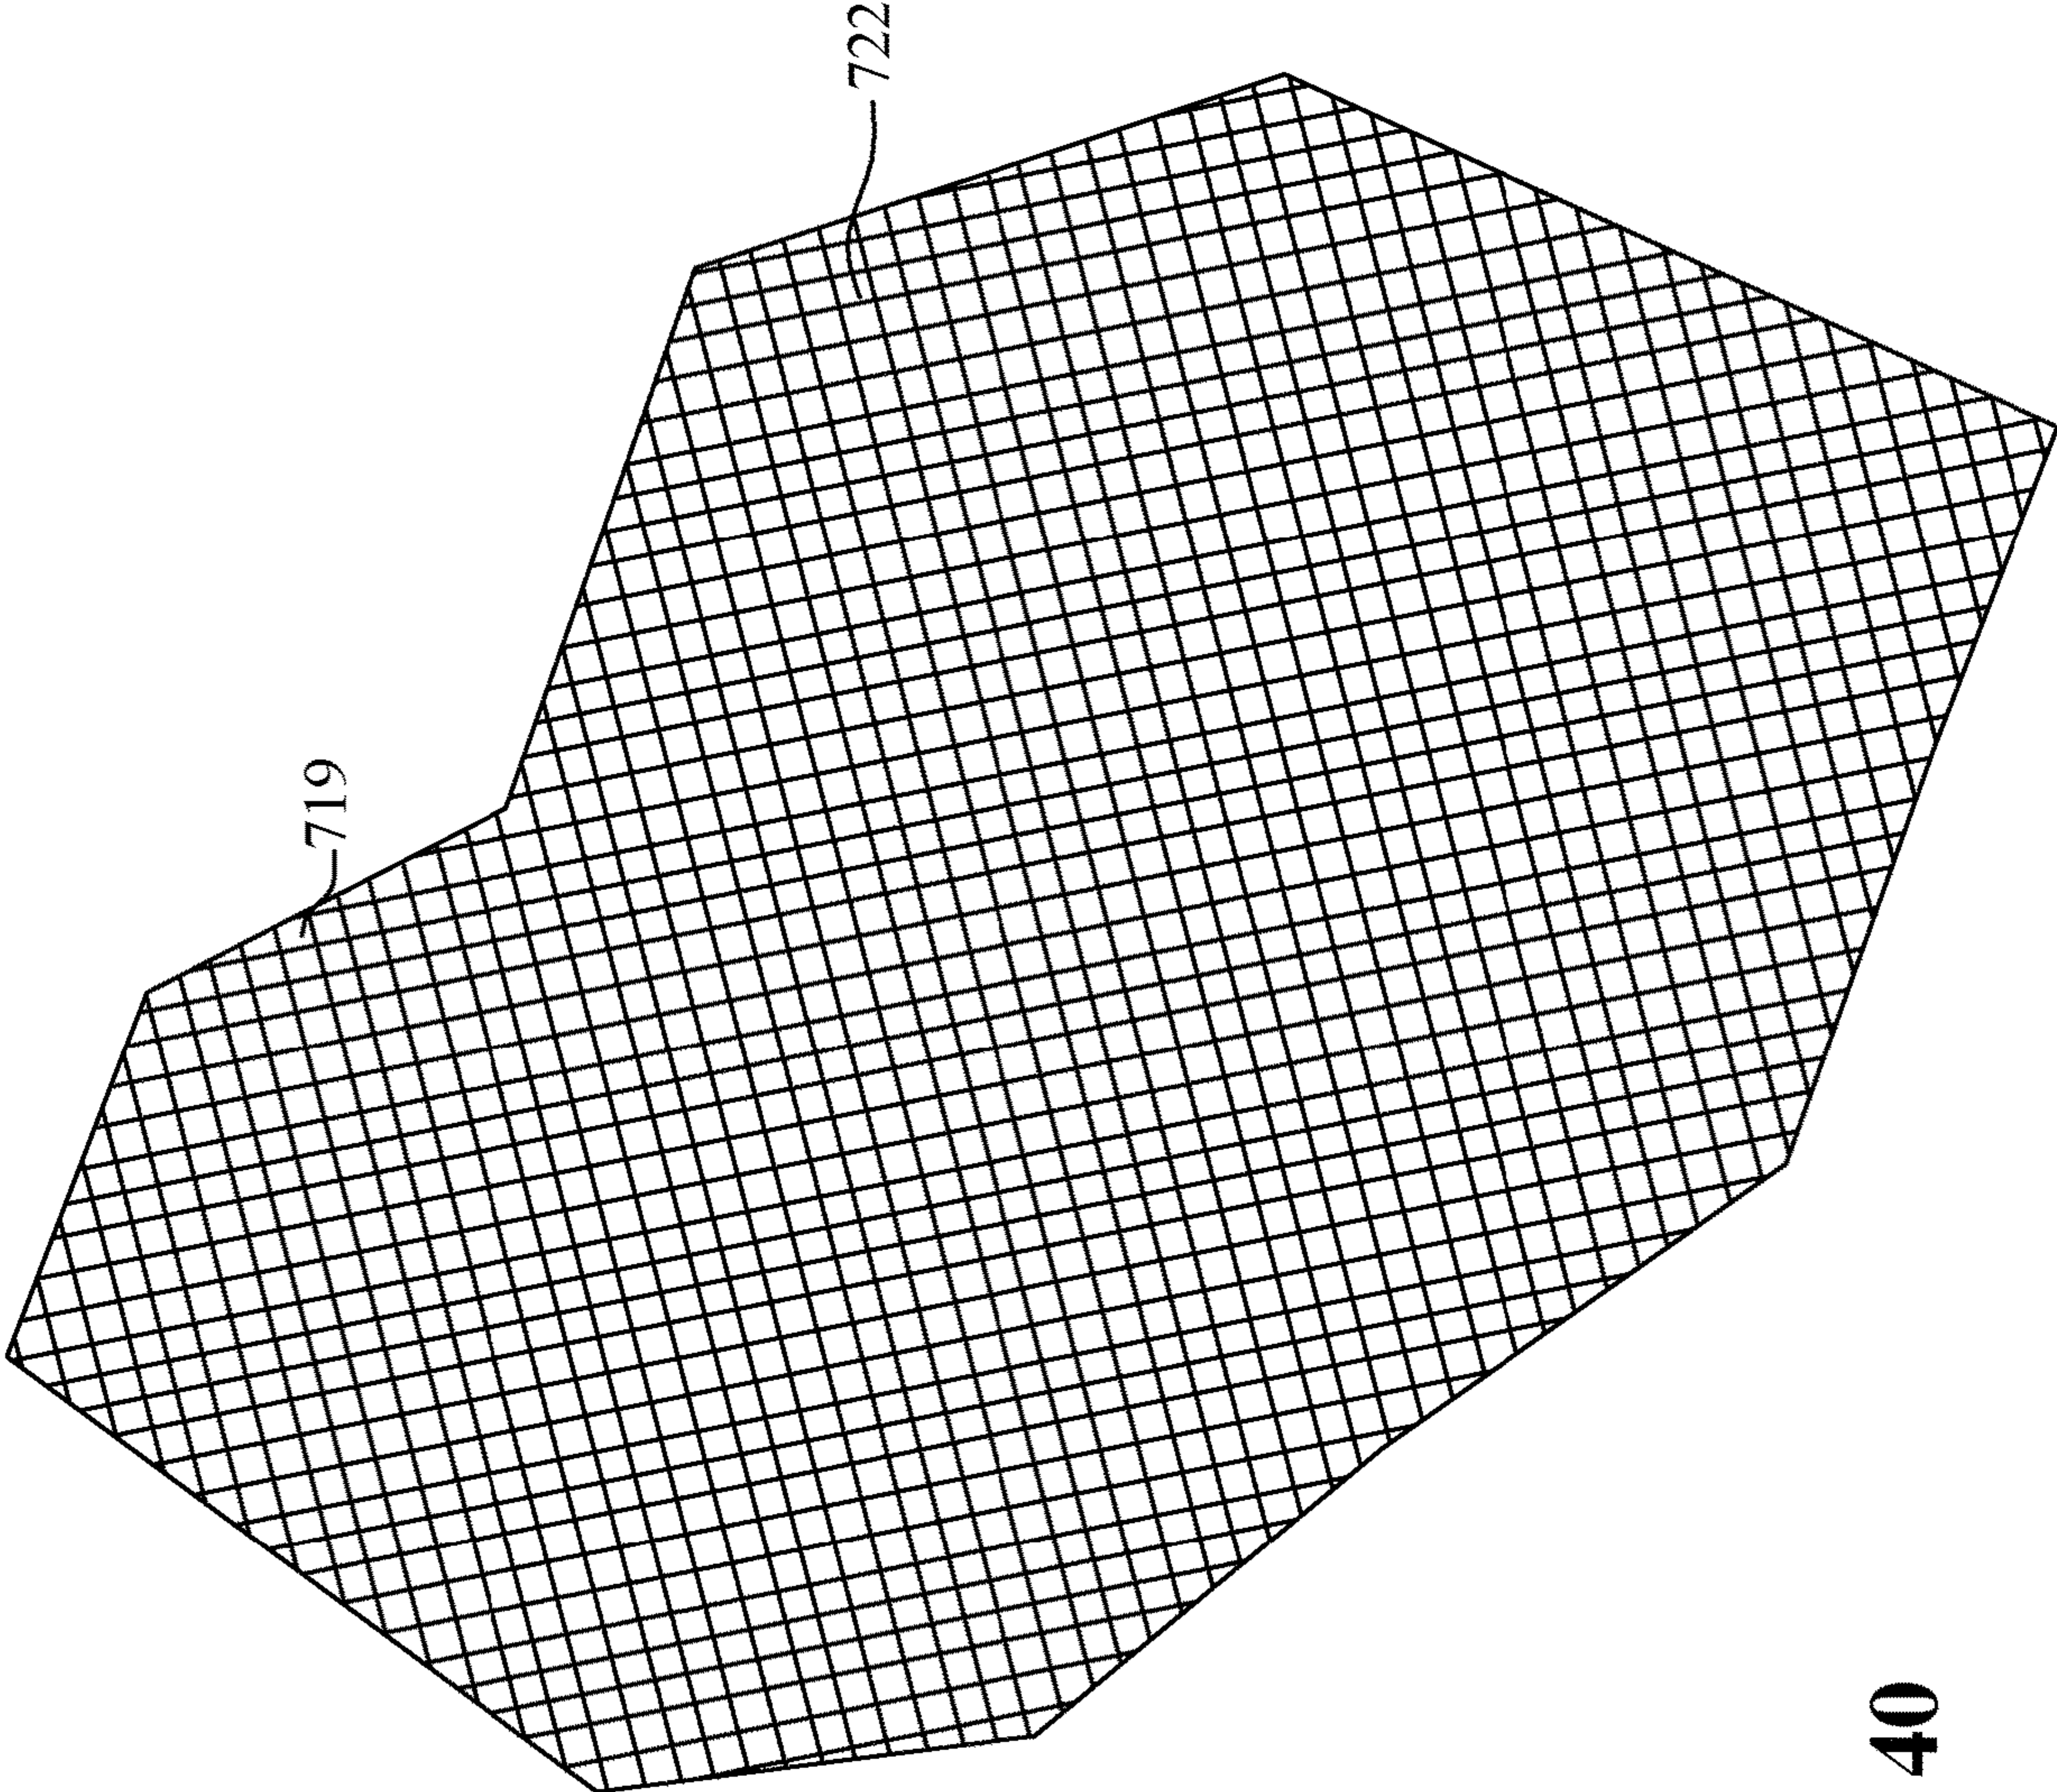
FIG. 40 is an enlarged plan view of the woven material repair tape;
