(10) **Patent No.:** **US 11,492,230 B2**
(45) **Date of Patent:** **Nov. 8, 2022**

(54) **SHEAVE LINER INCLUDING WEAR INDICATORS**

(71) Applicant: **OTIS ELEVATOR COMPANY**,
Farmington, CT (US)

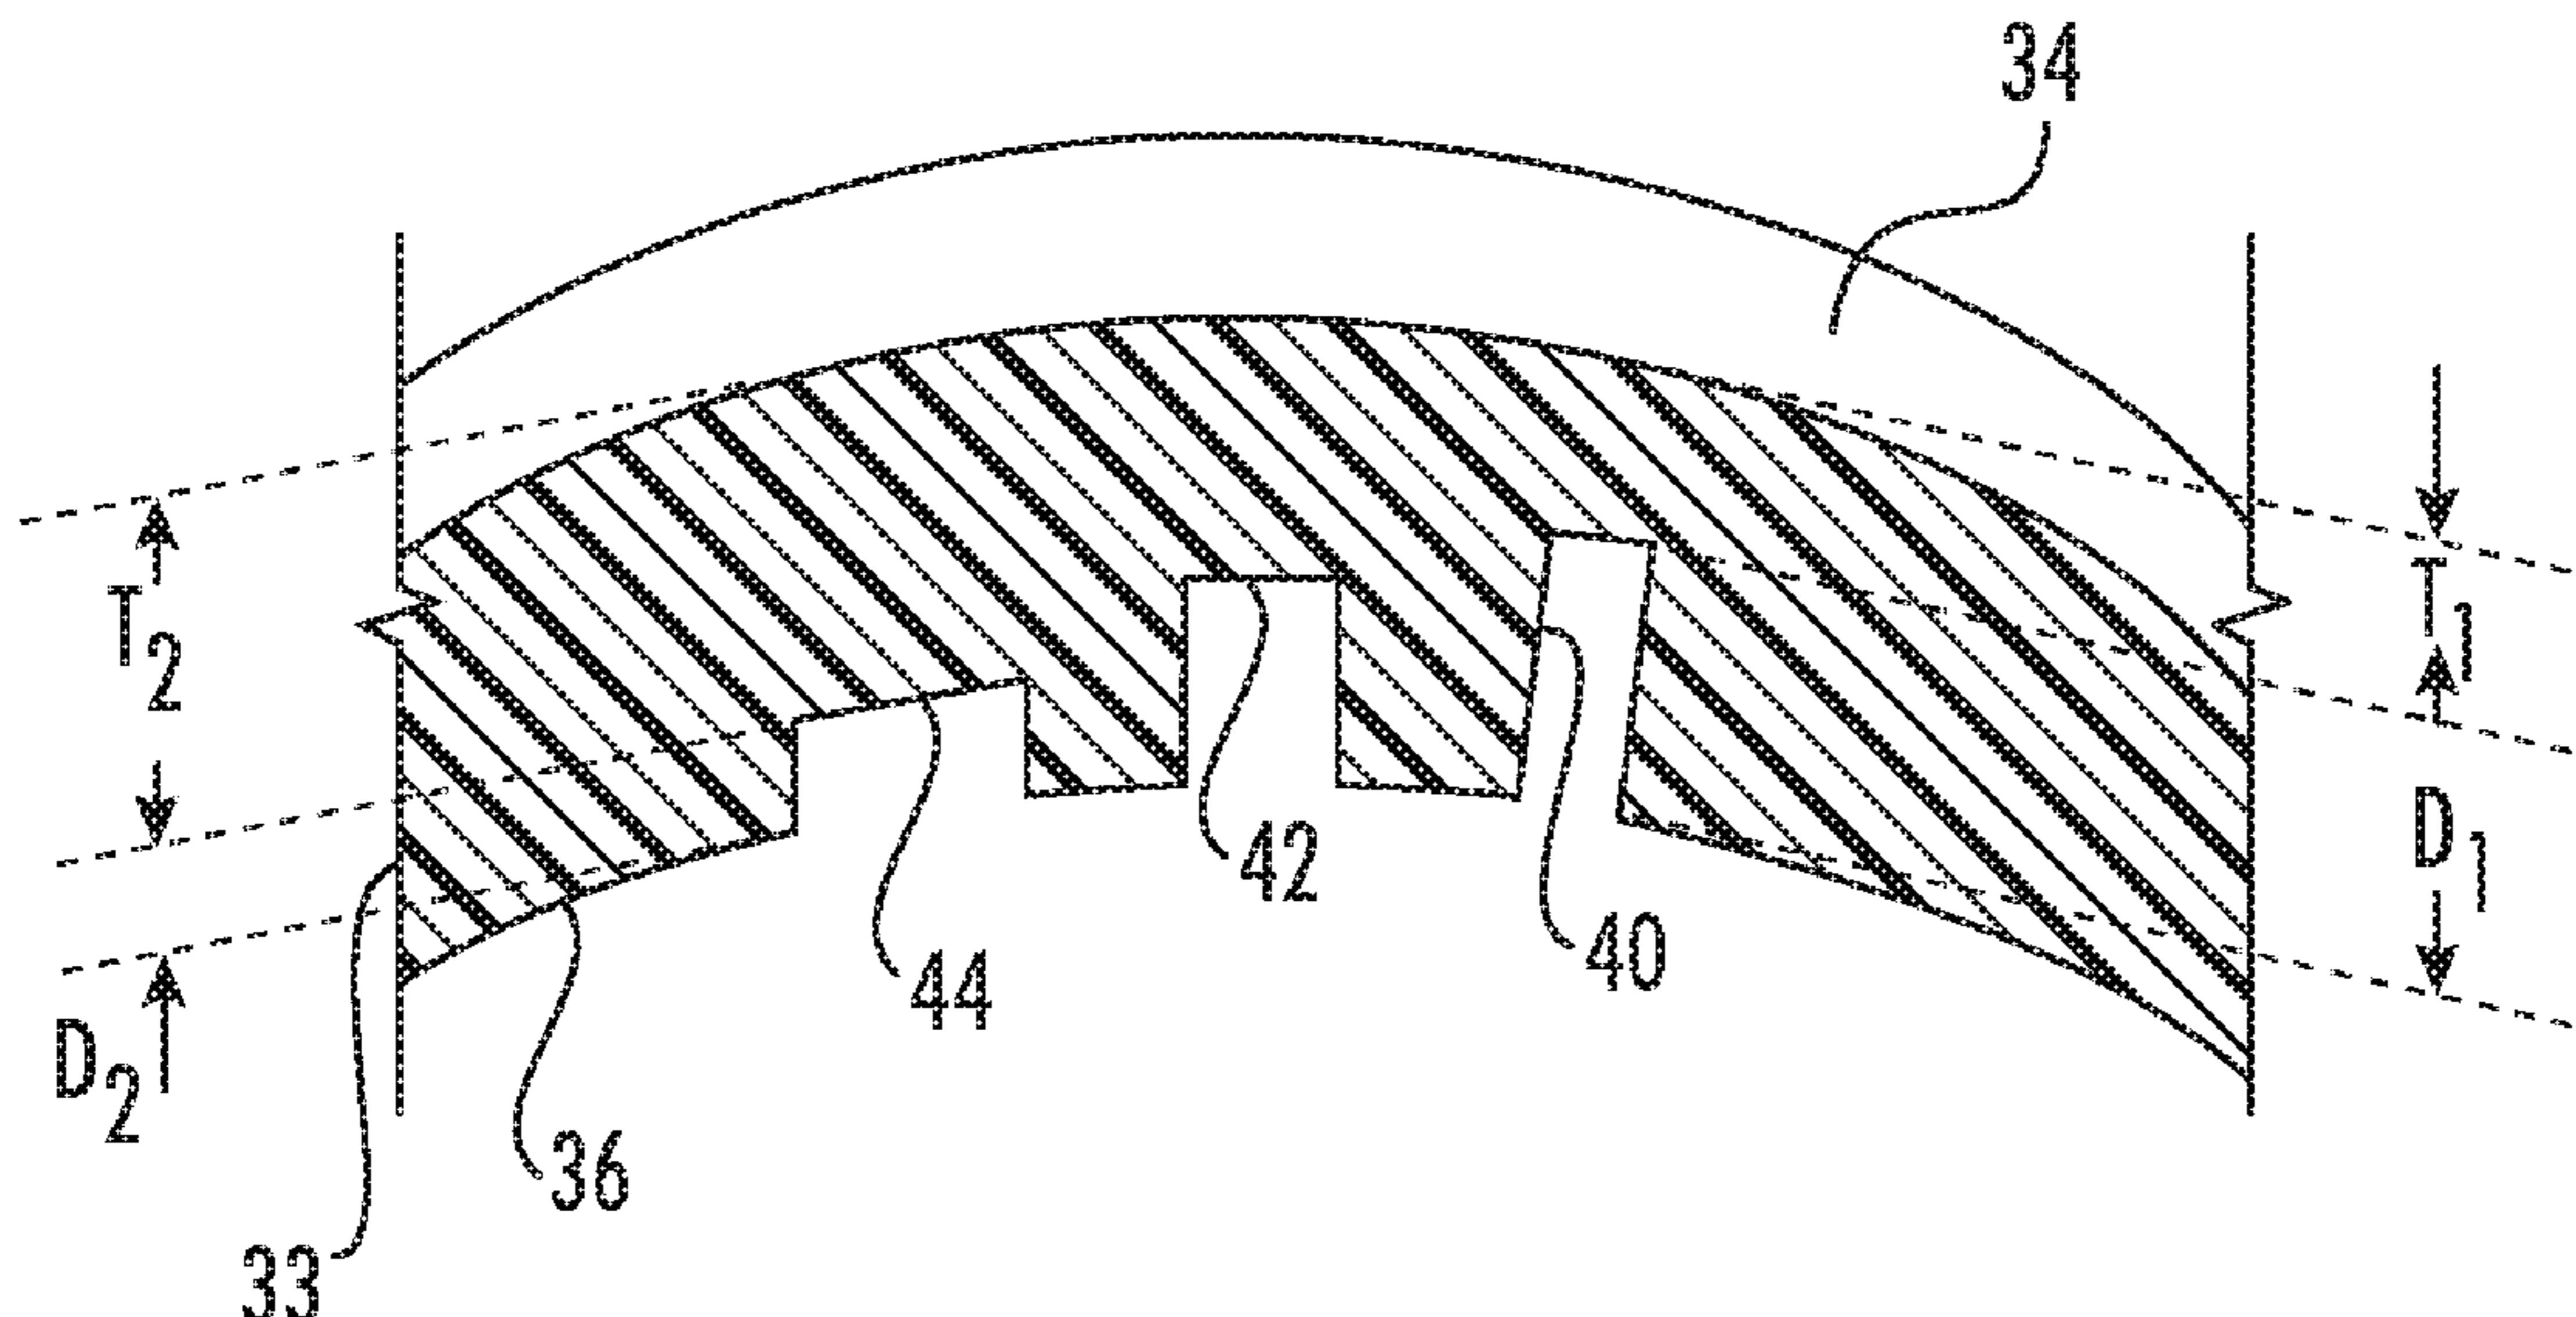
An illustrative example embodiment of an elevator sheave liner includes a liner body having a first surface configured to engage an elevator load bearing member and an oppositely facing second surface. The liner body includes a plurality of blind holes in the second surface including at least a first blind hole and a second blind hole. The first blind hole has a first depth and the second blind hole has a second, different depth. A material of the liner body has a first thickness between the first blind hole and the first surface and a second, different thickness between the second blind hole and the first surface.

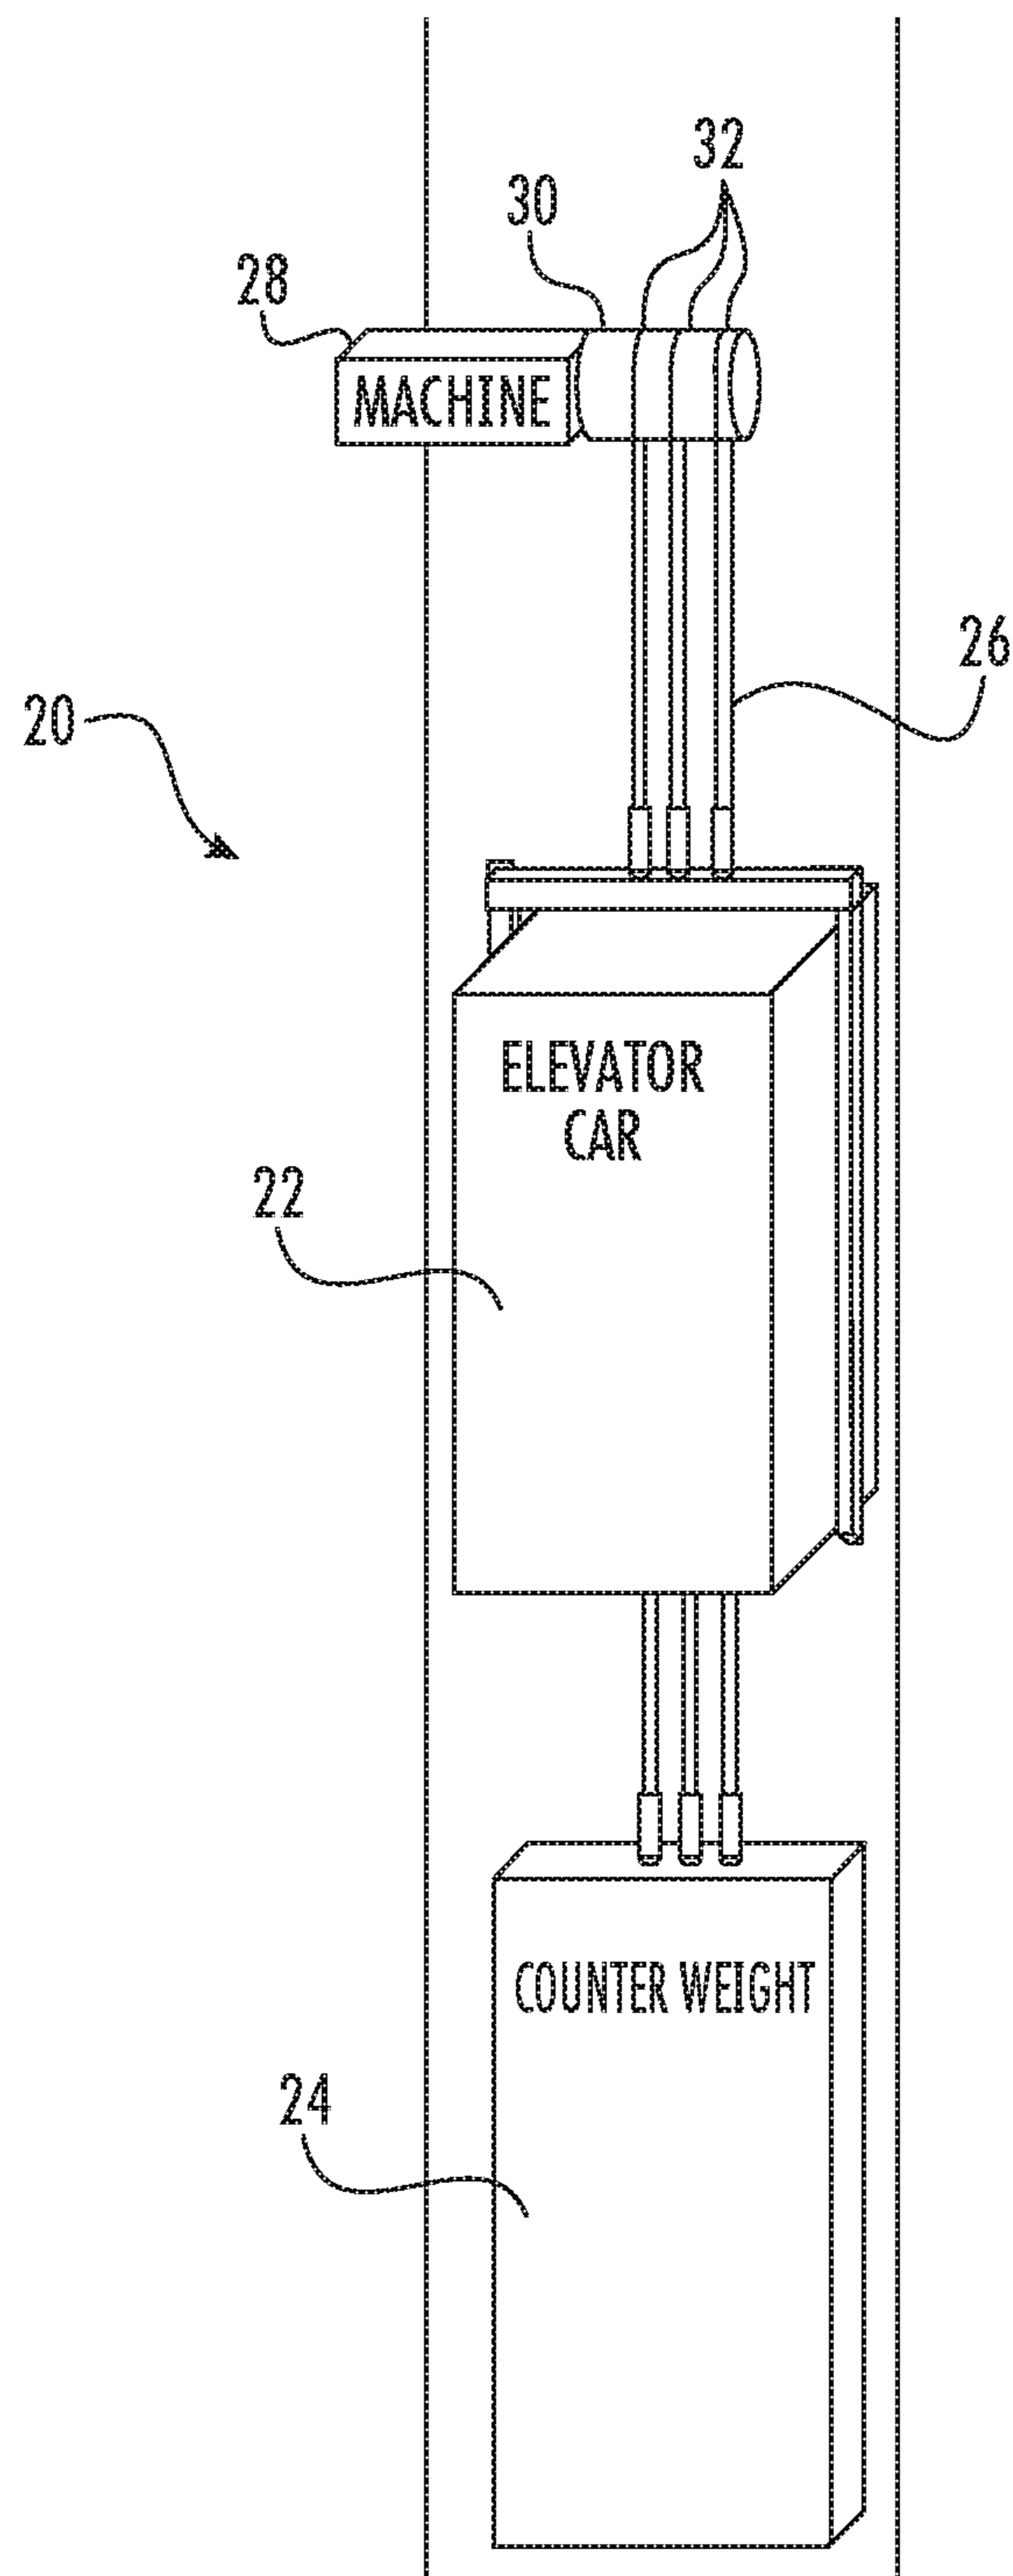
FIG. 1 schematically illustrates selected portions of an elevator system including sheave liners designed according to an embodiment of this invention.

FIG. 1 schematically illustrates selected portions of an elevator system 20. An elevator car 22 and counterweight 24 are supported by load bearing members 26. For discussion purposes, the load bearing members 26 in this example embodiment are a plurality of round steel ropes. A machine 28 operates in a known manner to selectively cause move-

ment of a traction sheave 30 and the load bearing members 26 to control the movement and position of the elevator car 22.

The traction sheave 30 includes a plurality of sheave liners 32 that provide a surface against which the load bearing members 26 are received. The sheave liners 32 in this example comprise a plastic material that is selected to provide a desired traction characteristic. Other embodiments include a polymer or polyurethane material. Some embodiments of sheave liners 32 comprise friction materials including a metal or a ceramic, such as the those used in brake pads or liners. Given this description, those skilled in the art will be able to select an appropriate material to meet the needs of their particular situation.

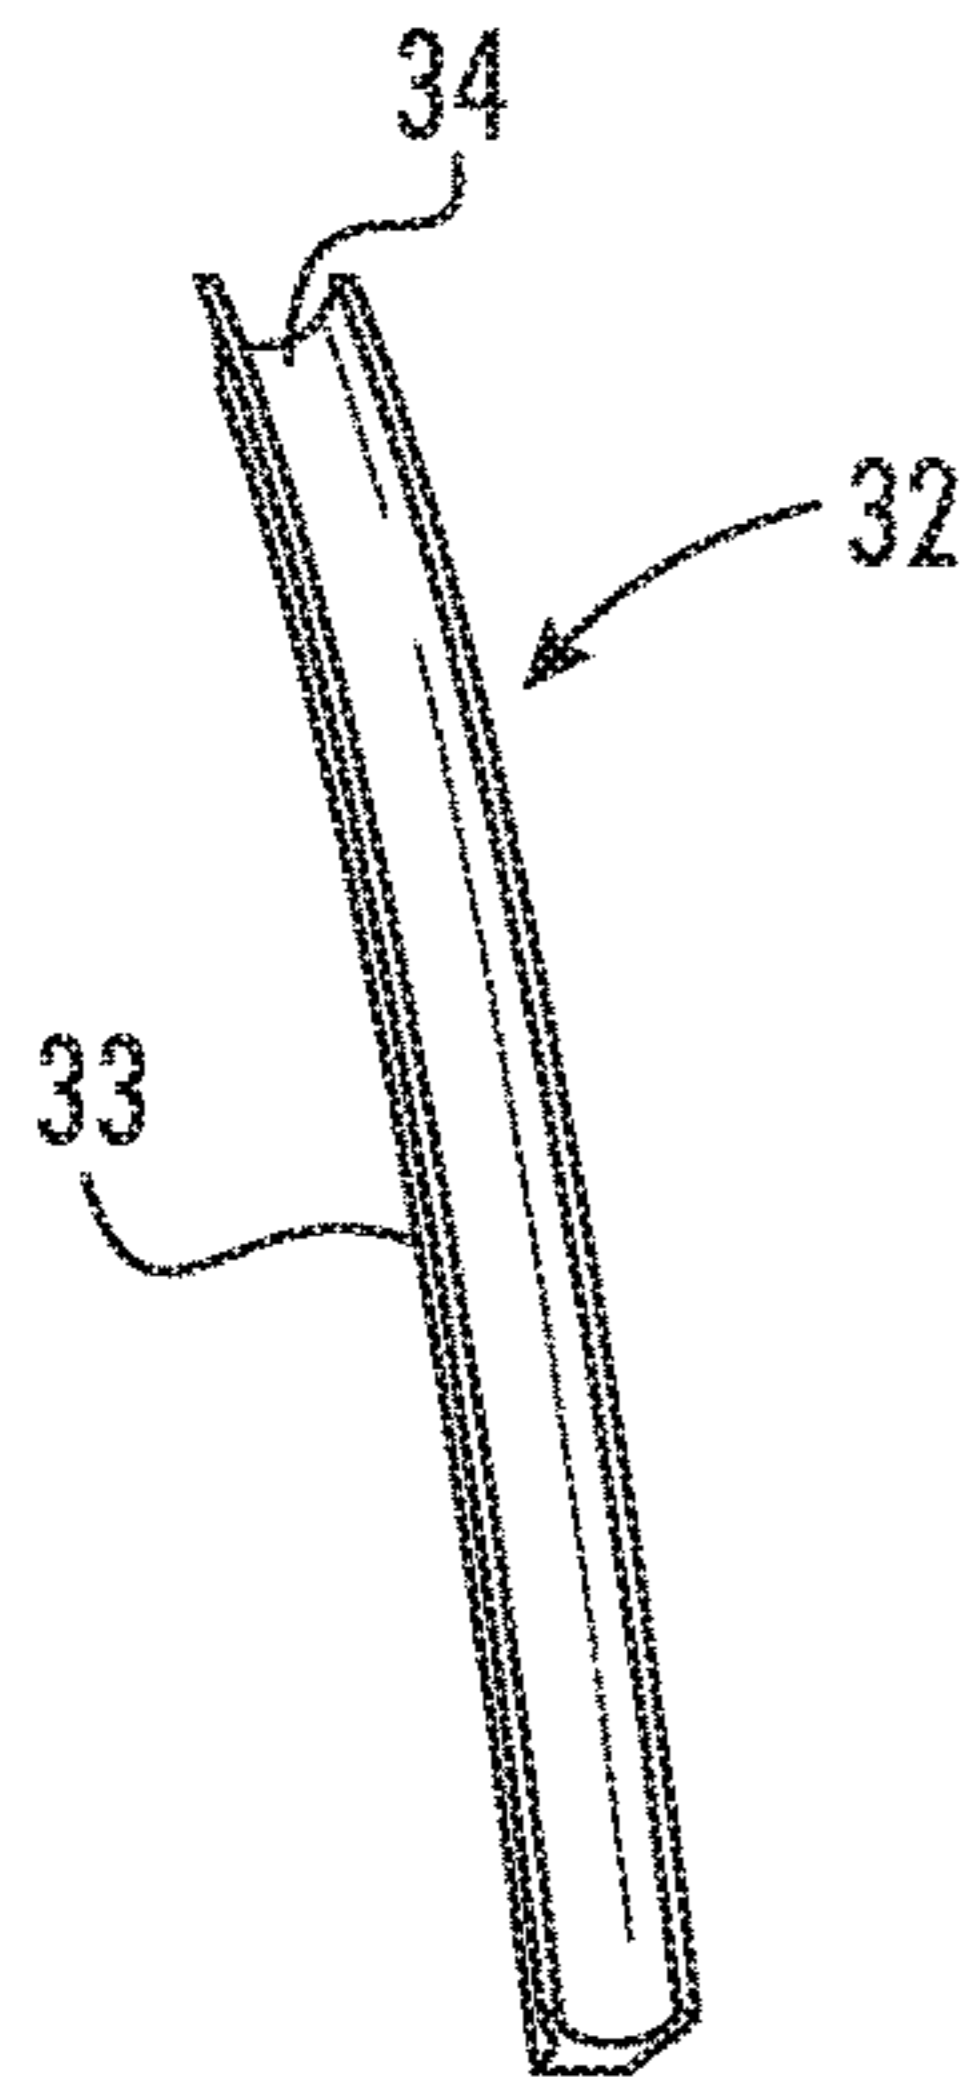
FIG. 2 is a perspective illustration of a portion of an example sheave liner designed according to an embodiment of this invention.

FIGS. 2-4 show a portion of a sheave liner 32 in an initial or baseline condition. A liner body 33 includes a first surface 34 that is configured to engage one of the load bearing members 26. In this example, the first surface 34 is concave and has a radius of curvature corresponding to the outside surface of a round steel rope load bearing member 26. The liner body 33 includes a second surface 36 that faces in a different direction from the first surface 34. In this example, the second surface 36 is received against the traction sheave 30 and defines the inside diameter surface of the sheave liner 32.

A plurality of blind holes 40, 42 and 44 through the second surface 36 extend into the liner body 33. The blind holes 40-44 provide a visible indication of an amount of wear of the sheave liner 32 over time.

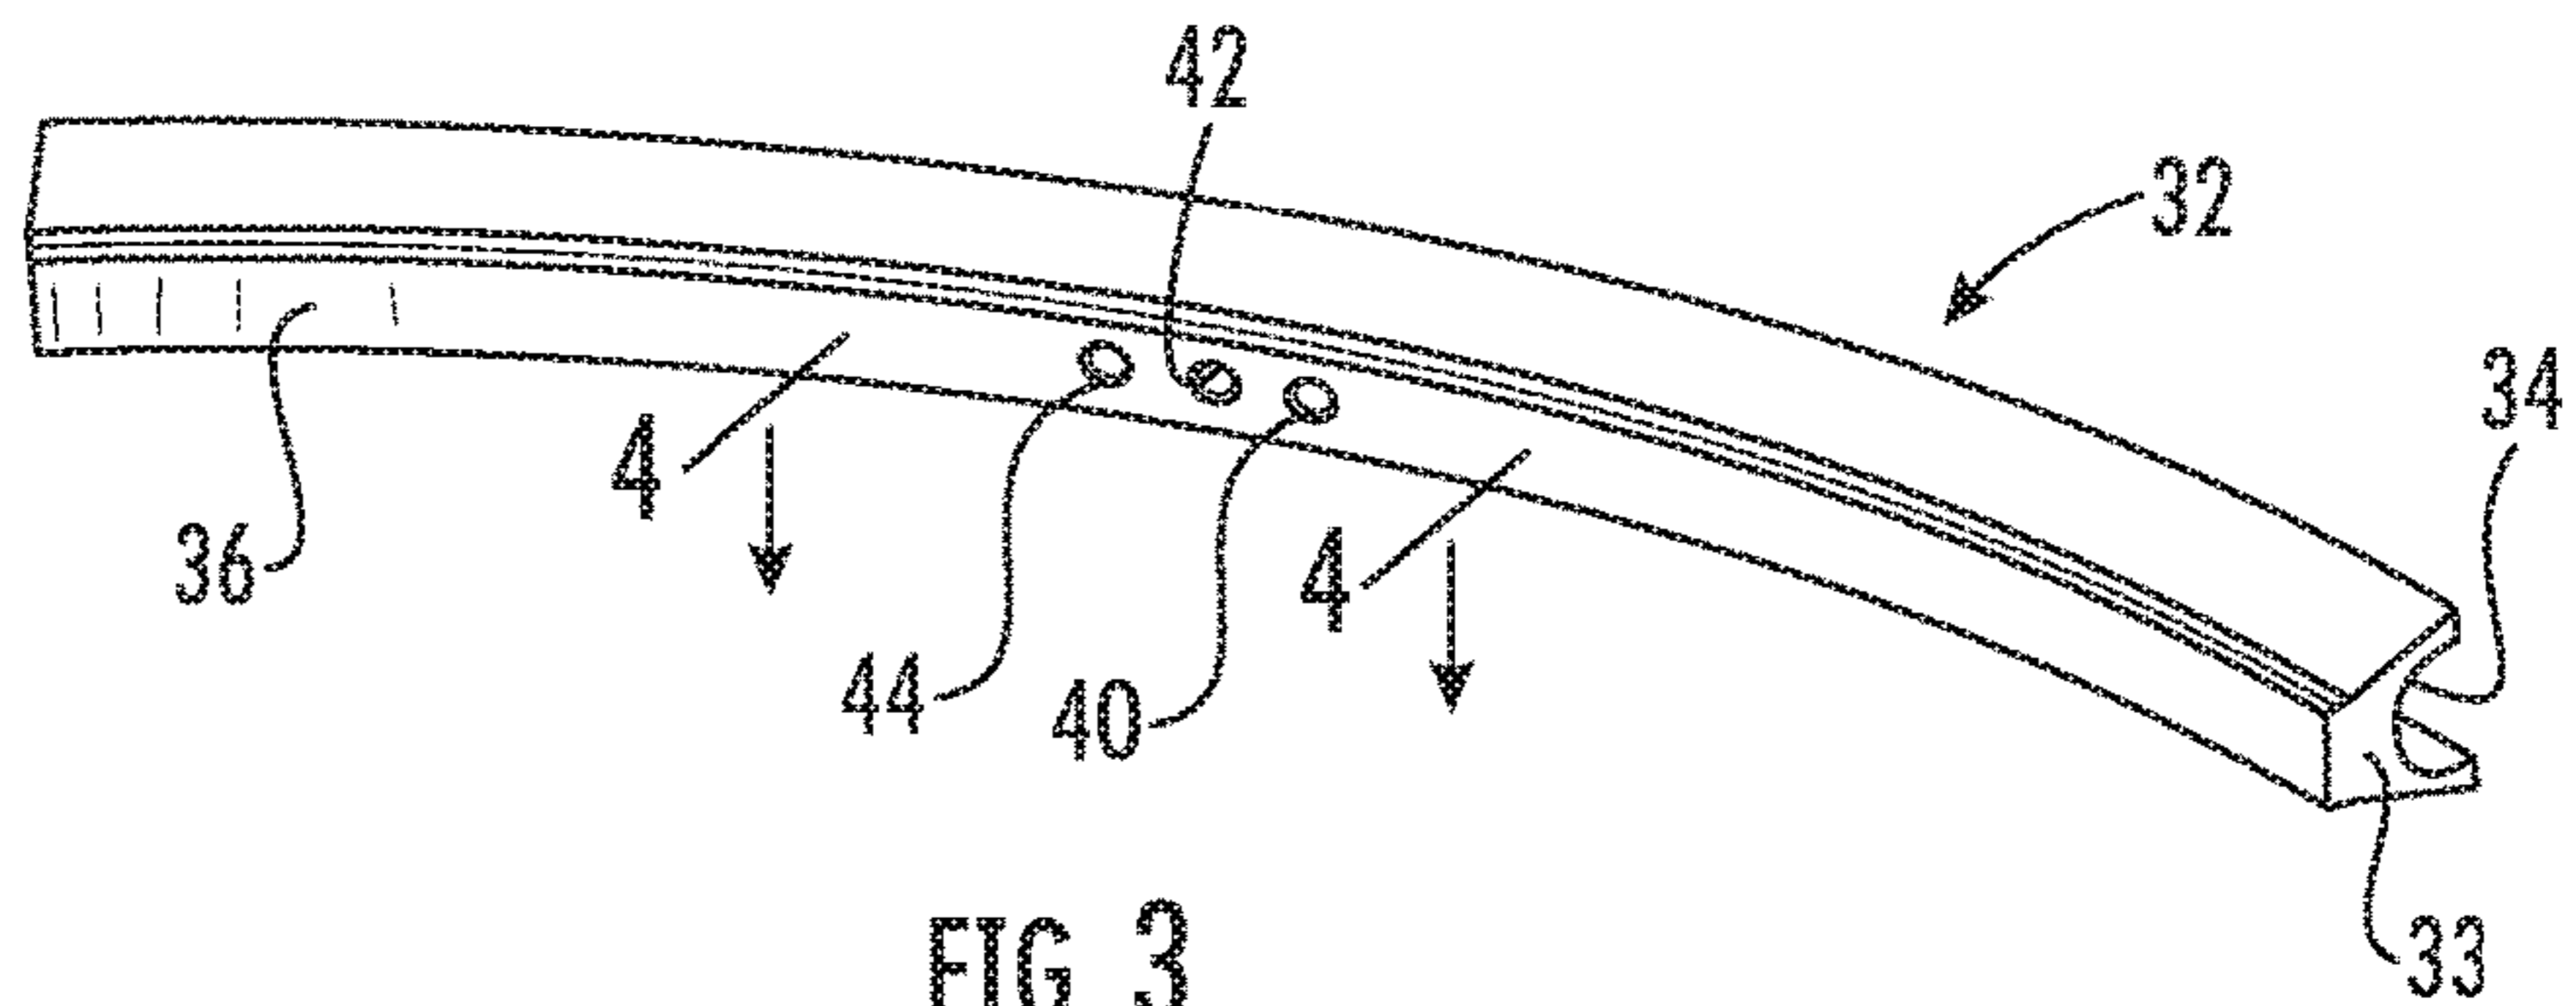
FIG. 3 shows the portion of a sheave liner from FIG. 2 from another perspective.

Another feature of the illustrated embodiment is that each of the blind holes has a width that is different than the width of the other blind holes. In this example, the first blind hole 40 has a first width that is not as wide as the width of the blind hole 42. The blind hole 44 has the largest width and shortest depth in this example.

In the illustrated example embodiment, the blind holes 40-44 are arranged in a line and the deepest and thinnest blind hole 40 is situated at one end of the line while the most shallow and most wide blind hole 44 is at an opposite end of the line. This arrangement further enhances the visual indication of progressive wear of the sheave liner material.

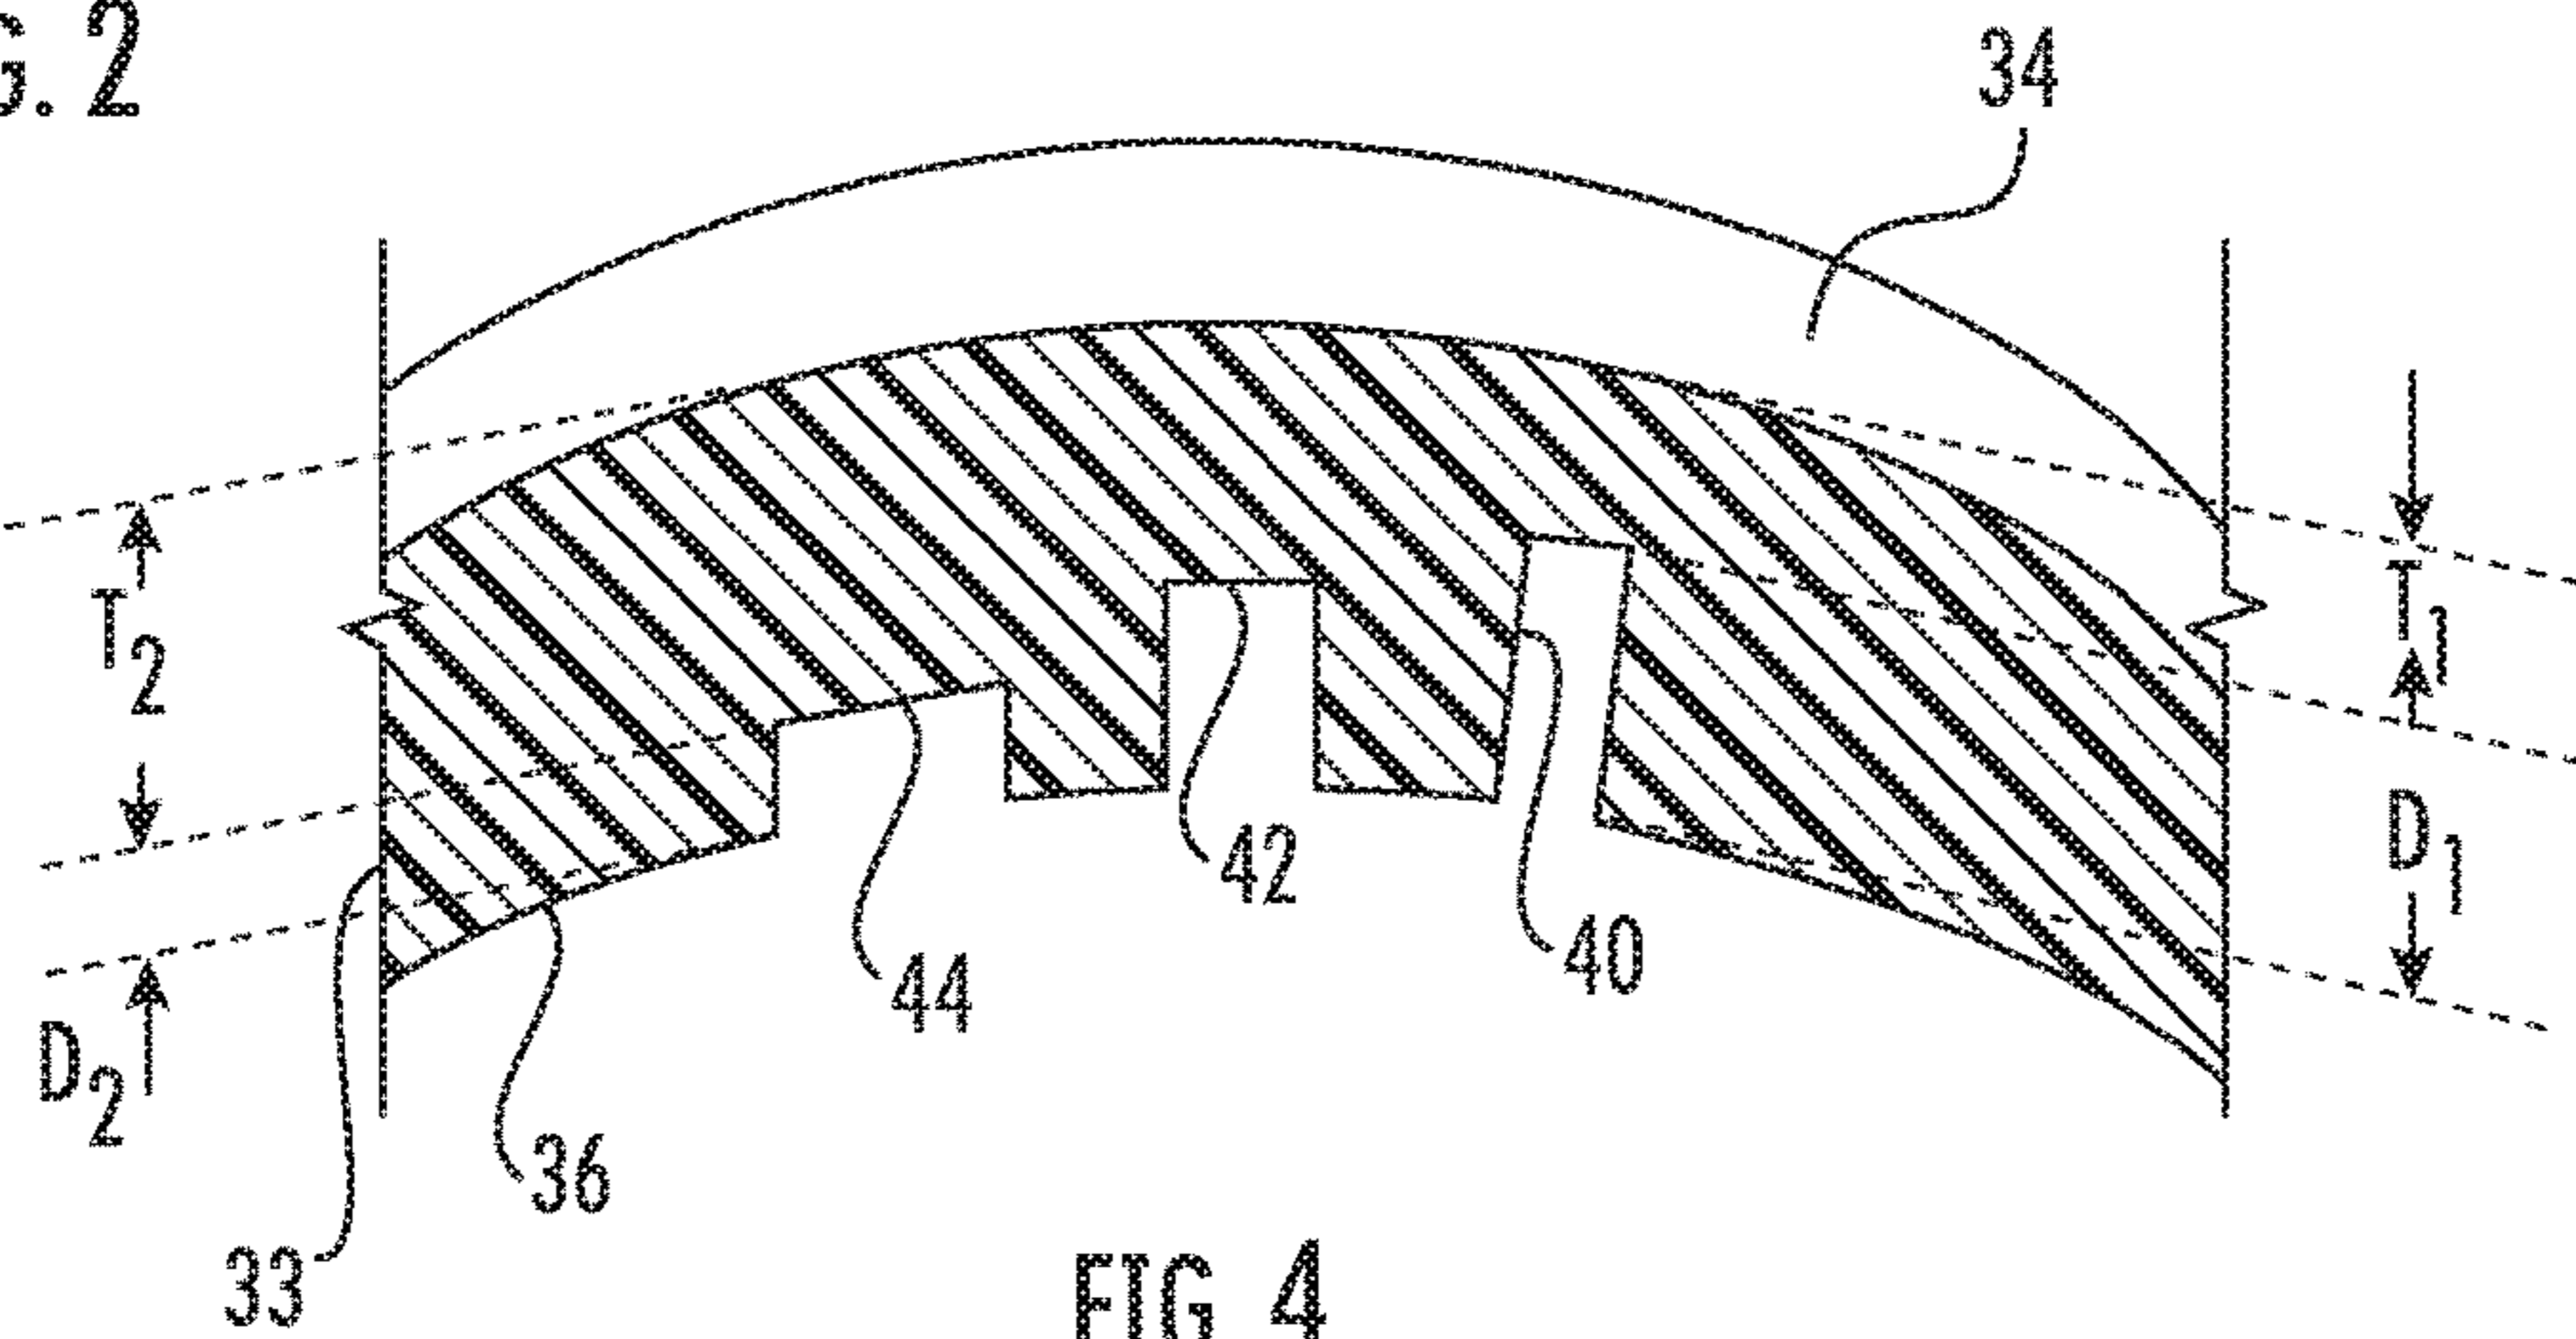
FIG. 4 is a cross-sectional illustration taken along the lines 4-4 in FIG. 3.

Considering the blind hole 40 as a first blind hole, it has a first depth D_1 shown in FIG. 4. In the initial or manufactured condition, the material of the liner body 33 has a first thickness T_1 between the deepest end of the first blind hole 40 and the first surface 34. In this embodiment the deepest end of the first blind hole 40 is the portion of the blind hole 40 that is closest to the first surface 34.

Considering the blind hole 44 as a second blind hole, it has a second depth D_2 . As can be appreciated from FIG. 4, the second depth D_2 is less than the first depth D_1 of the first blind hole. The material of the liner body 33 has a second thickness T_2 between the deepest portion of the second blind hole 44 and the first surface 34 of the sheave liner 32.

The illustrated example embodiment includes three different depths for the three different example blind holes 40, 42 and 44.

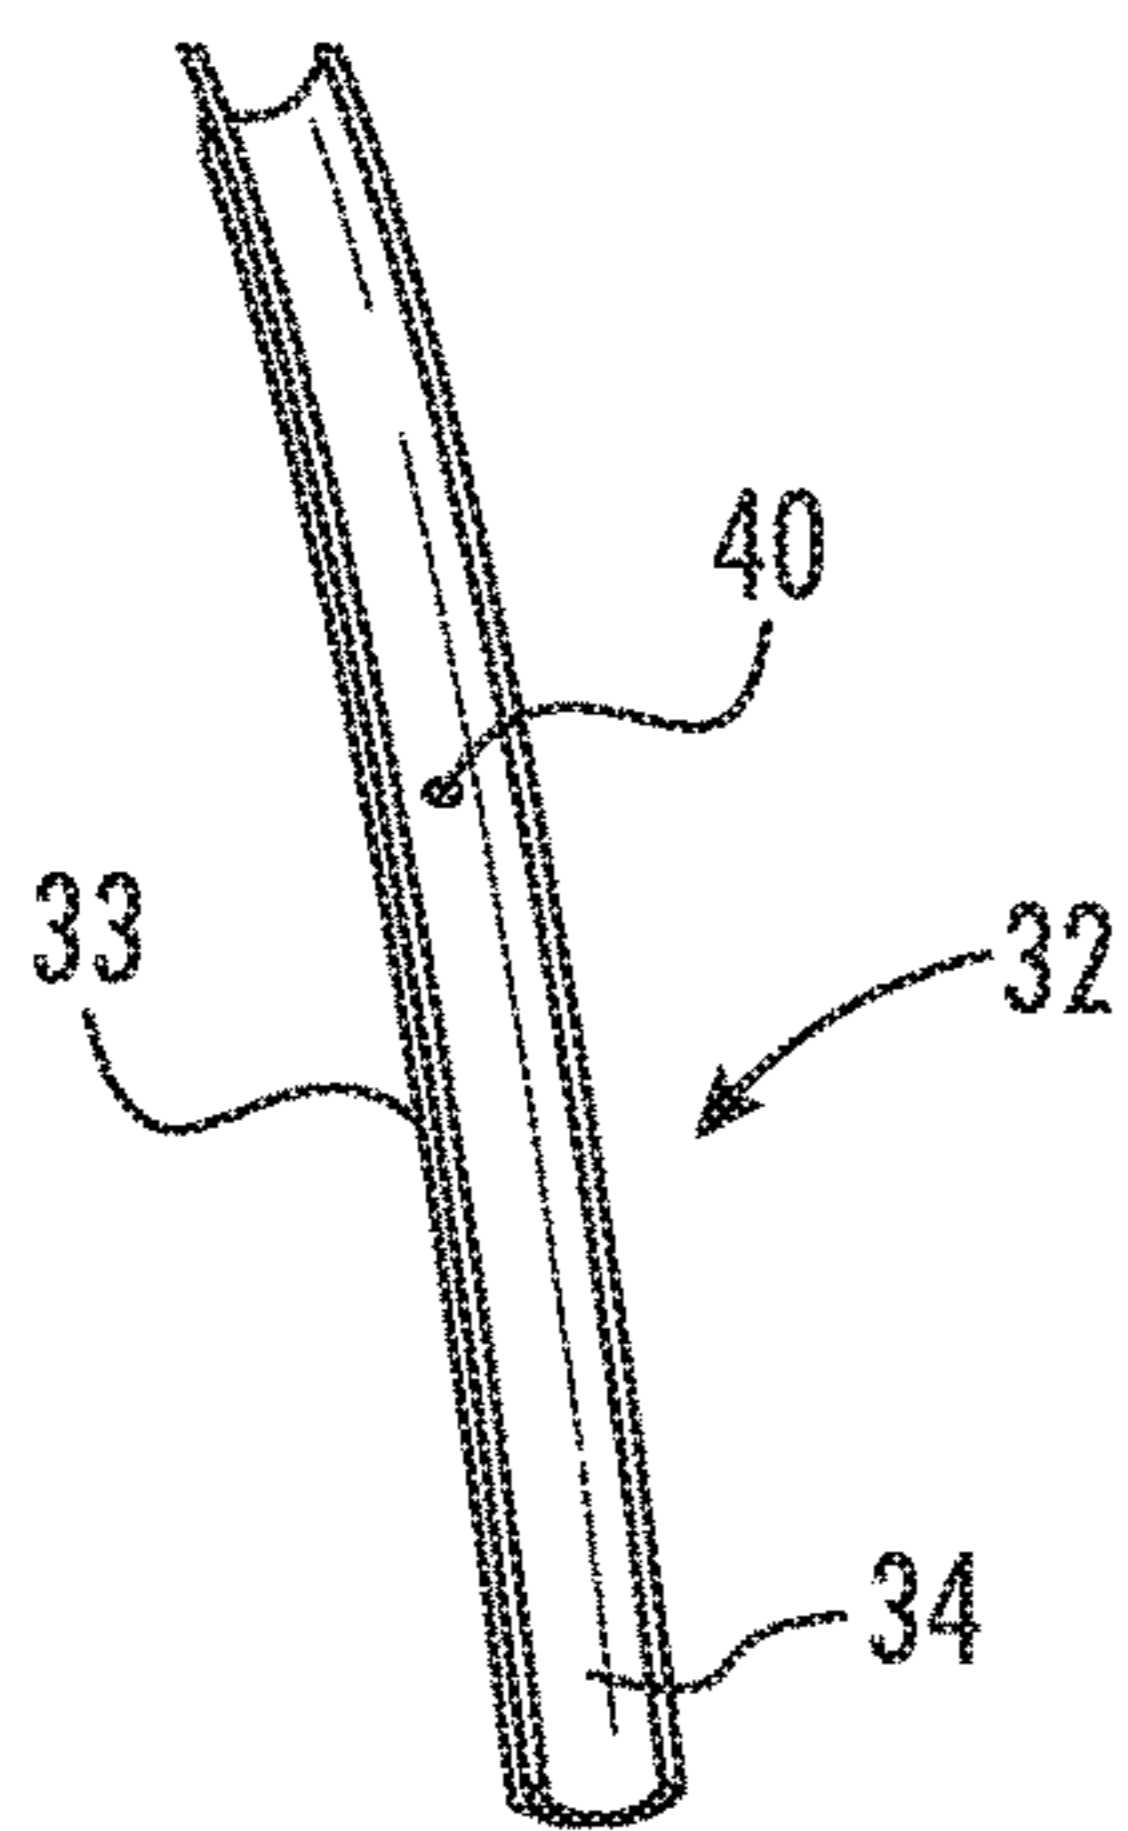
FIG. 5 illustrates an example embodiment of a sheave liner in a first wear condition.

The blind holes 40-44 provide a visual indication of an amount of wear of the material of the liner body 33 over time because as the sheave liner 32 wears, the thickness of the material between the first surface 34 and the second surface 36 decreases. Eventually, a sufficient amount of the material will be worn away so that the first blind hole 40 becomes a visible through hole between the second surface 36 and the first surface 34. This condition is shown in FIG. 5. The single hole 40 visible in FIG. 5 provides a visual indication of the amount of wear that a sheave liner 32 has experienced since being installed in the elevator system 20. The amount of liner material remaining when the first hole 40 initially becomes visible in the first surface 34 corresponds to the first depth D_1 . In some installations, the presence of a single visible hole indicates some acceptable amount of wear of the sheave liner 32 that does not require liner replacement. Maintenance personnel may recognize the presence of a single hole 40 in a sheave liner 32 as an indication that the sheave liner 32 has become worn but does not yet need to be replaced.

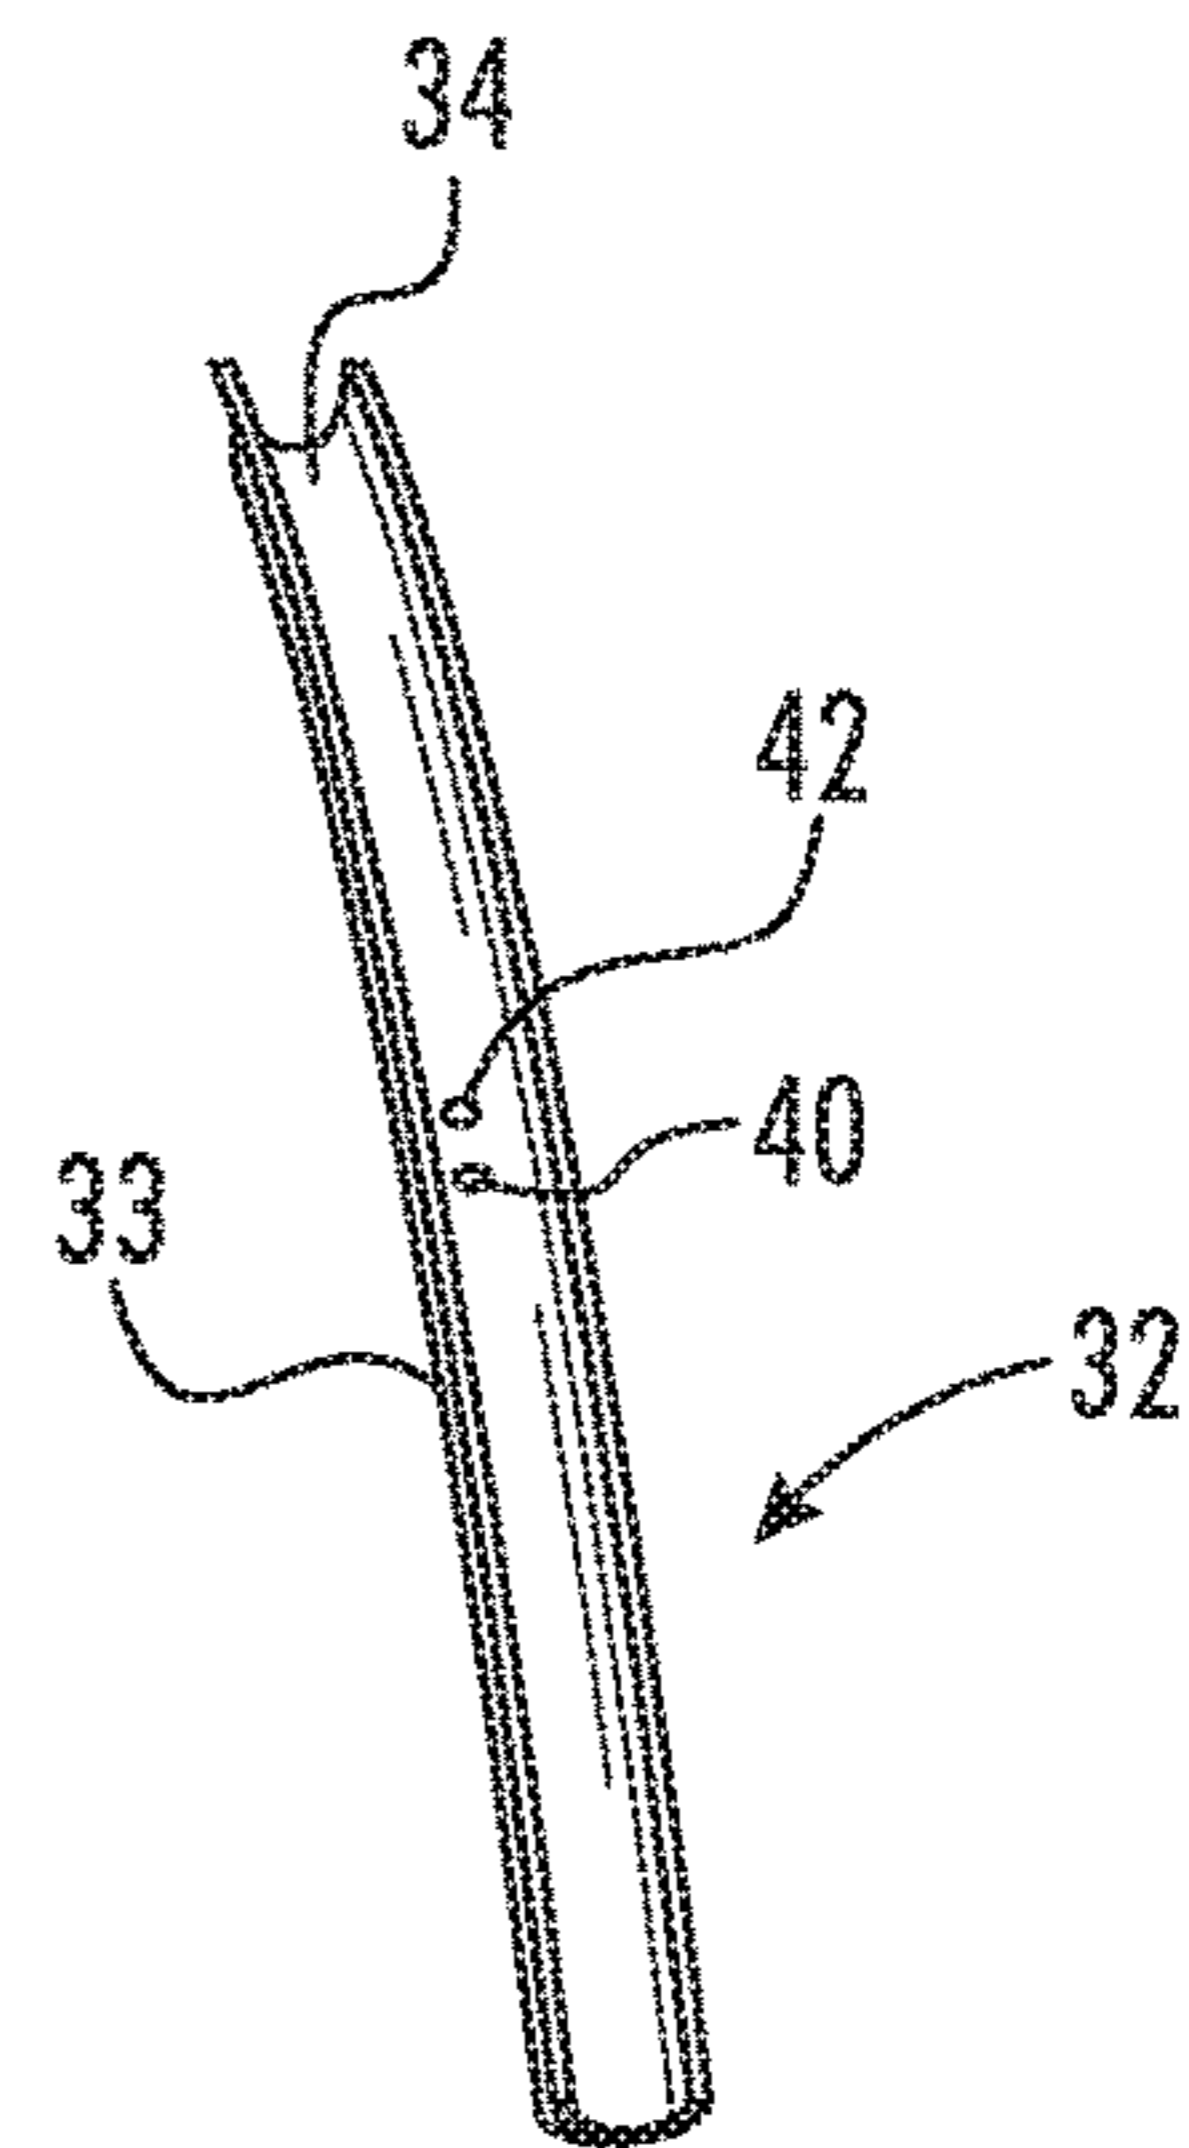
FIG. 6 illustrates the embodiment of FIG. 5 in a second wear condition.

second surface 36. At some point, the blind hole 42 becomes a visible through hole between the first surface 34 and the second surface 36. This condition is shown in FIG. 6. Depending on the particular liner configuration, the presence of a second visible hole may indicate a need to replace the sheave liner immediately. In other installations, the presence of a second hole 42 as shown in FIG. 6 provides an indication to maintenance personnel that the sheave liner 32 is in a condition that is acceptable but will require replacement in the near future.

In the example embodiment, the blind hole 44 is set to a depth D_2 so that when a third visible hole is apparent at the first surface 34, that indicates a condition in which the sheave liner 32 should be replaced immediately. The remaining material thickness corresponding to the depth D_2 is considered small enough to warrant immediate replacement of the liner.

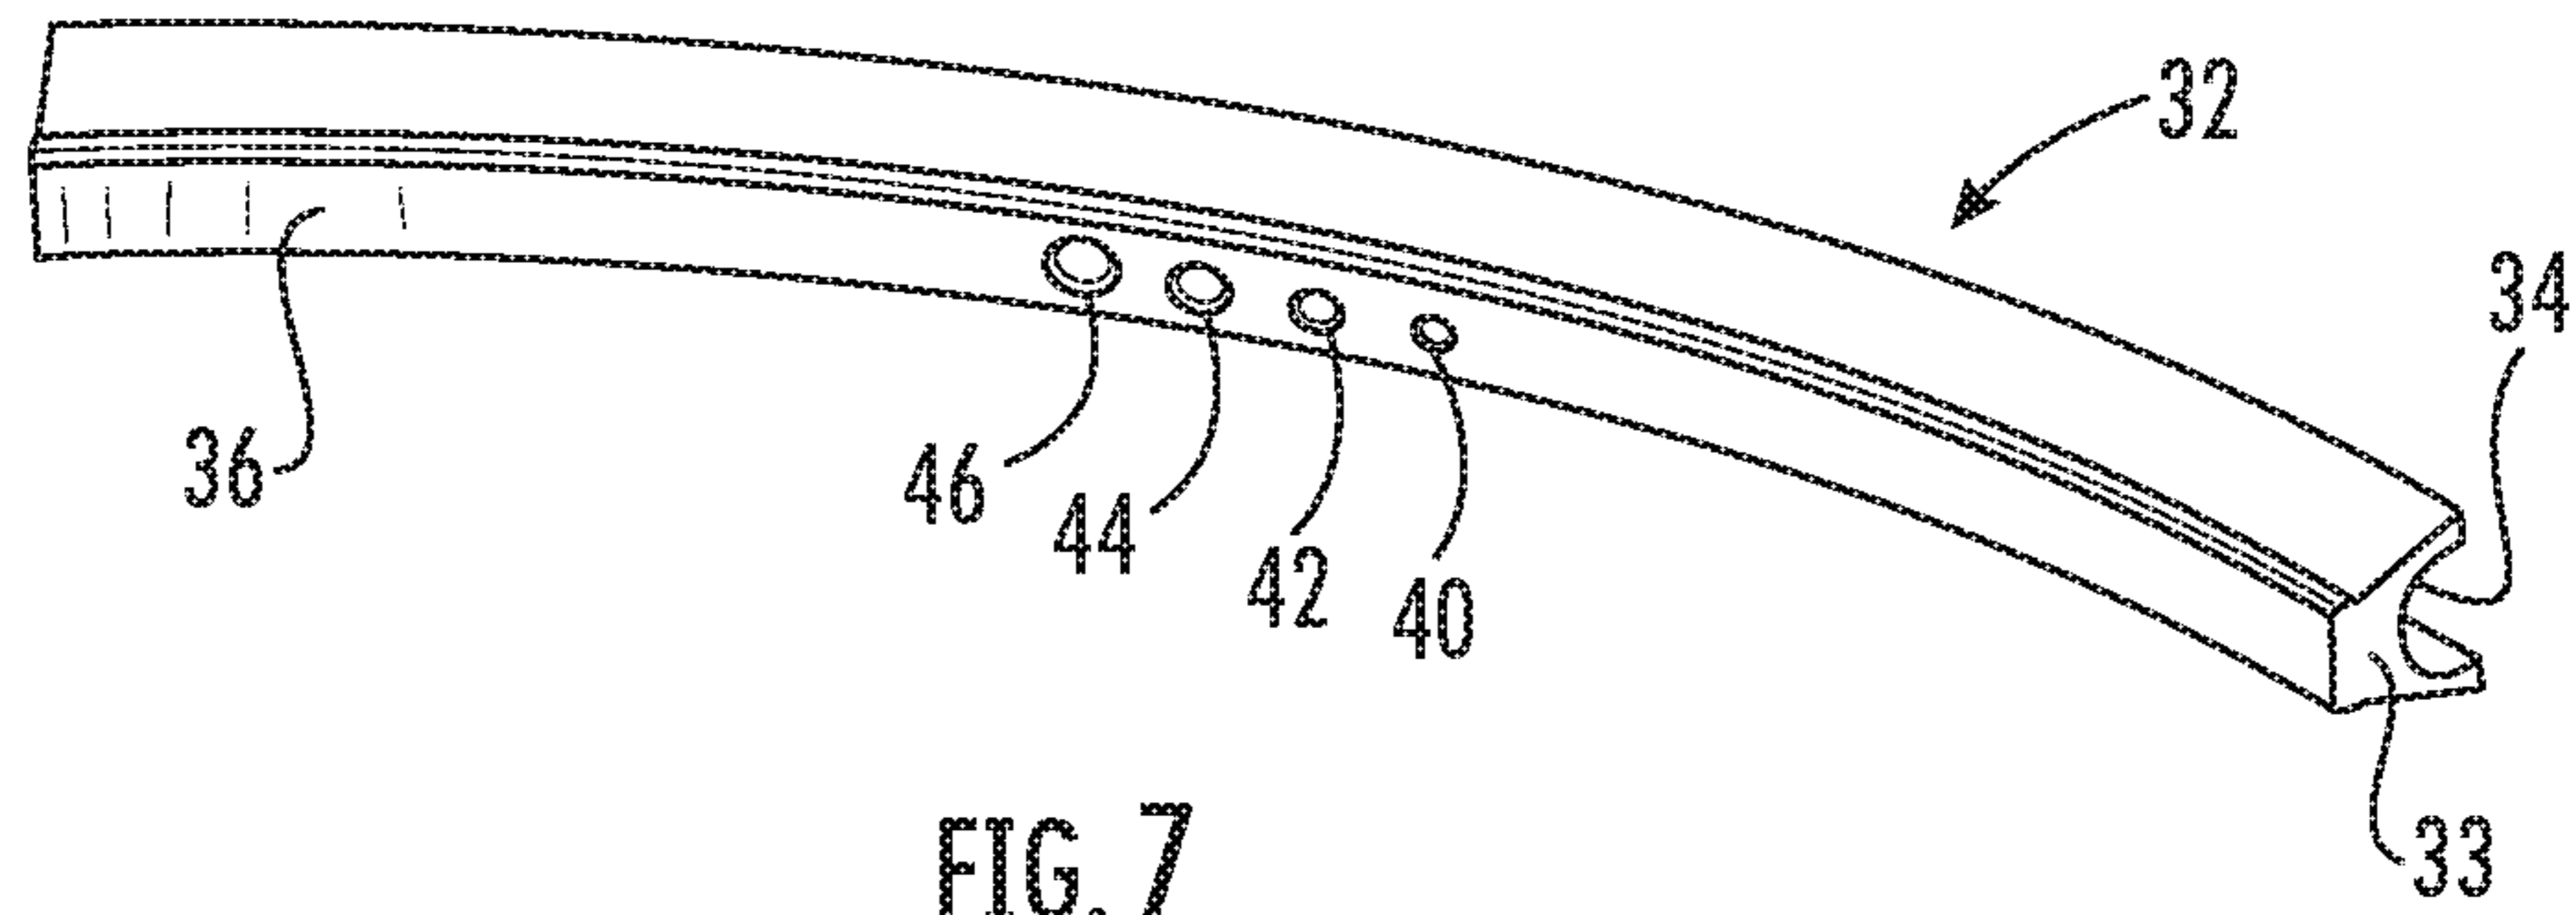
FIG. 7 illustrates another example embodiment of a sheave liner.

While three blind holes are illustrated for discussion purposes, some embodiments include more or less than three holes. FIG. 7 shows an embodiment that includes four holes 40-46. FIG. 8 shows an embodiment including two holes 40 and 42. Further, some embodiments include a series of blind holes spaced about the circumference of the sheave liner 32 to increase the likelihood that maintenance personnel will be
