(10) **Patent No.:** **US 11,492,230 B2**
(45) **Date of Patent:** **Nov. 8, 2022**

(54) **SHEAVE LINER INCLUDING WEAR INDICATORS**

(71) Applicant: **OTIS ELEVATOR COMPANY**,
Farmington, CT (US)

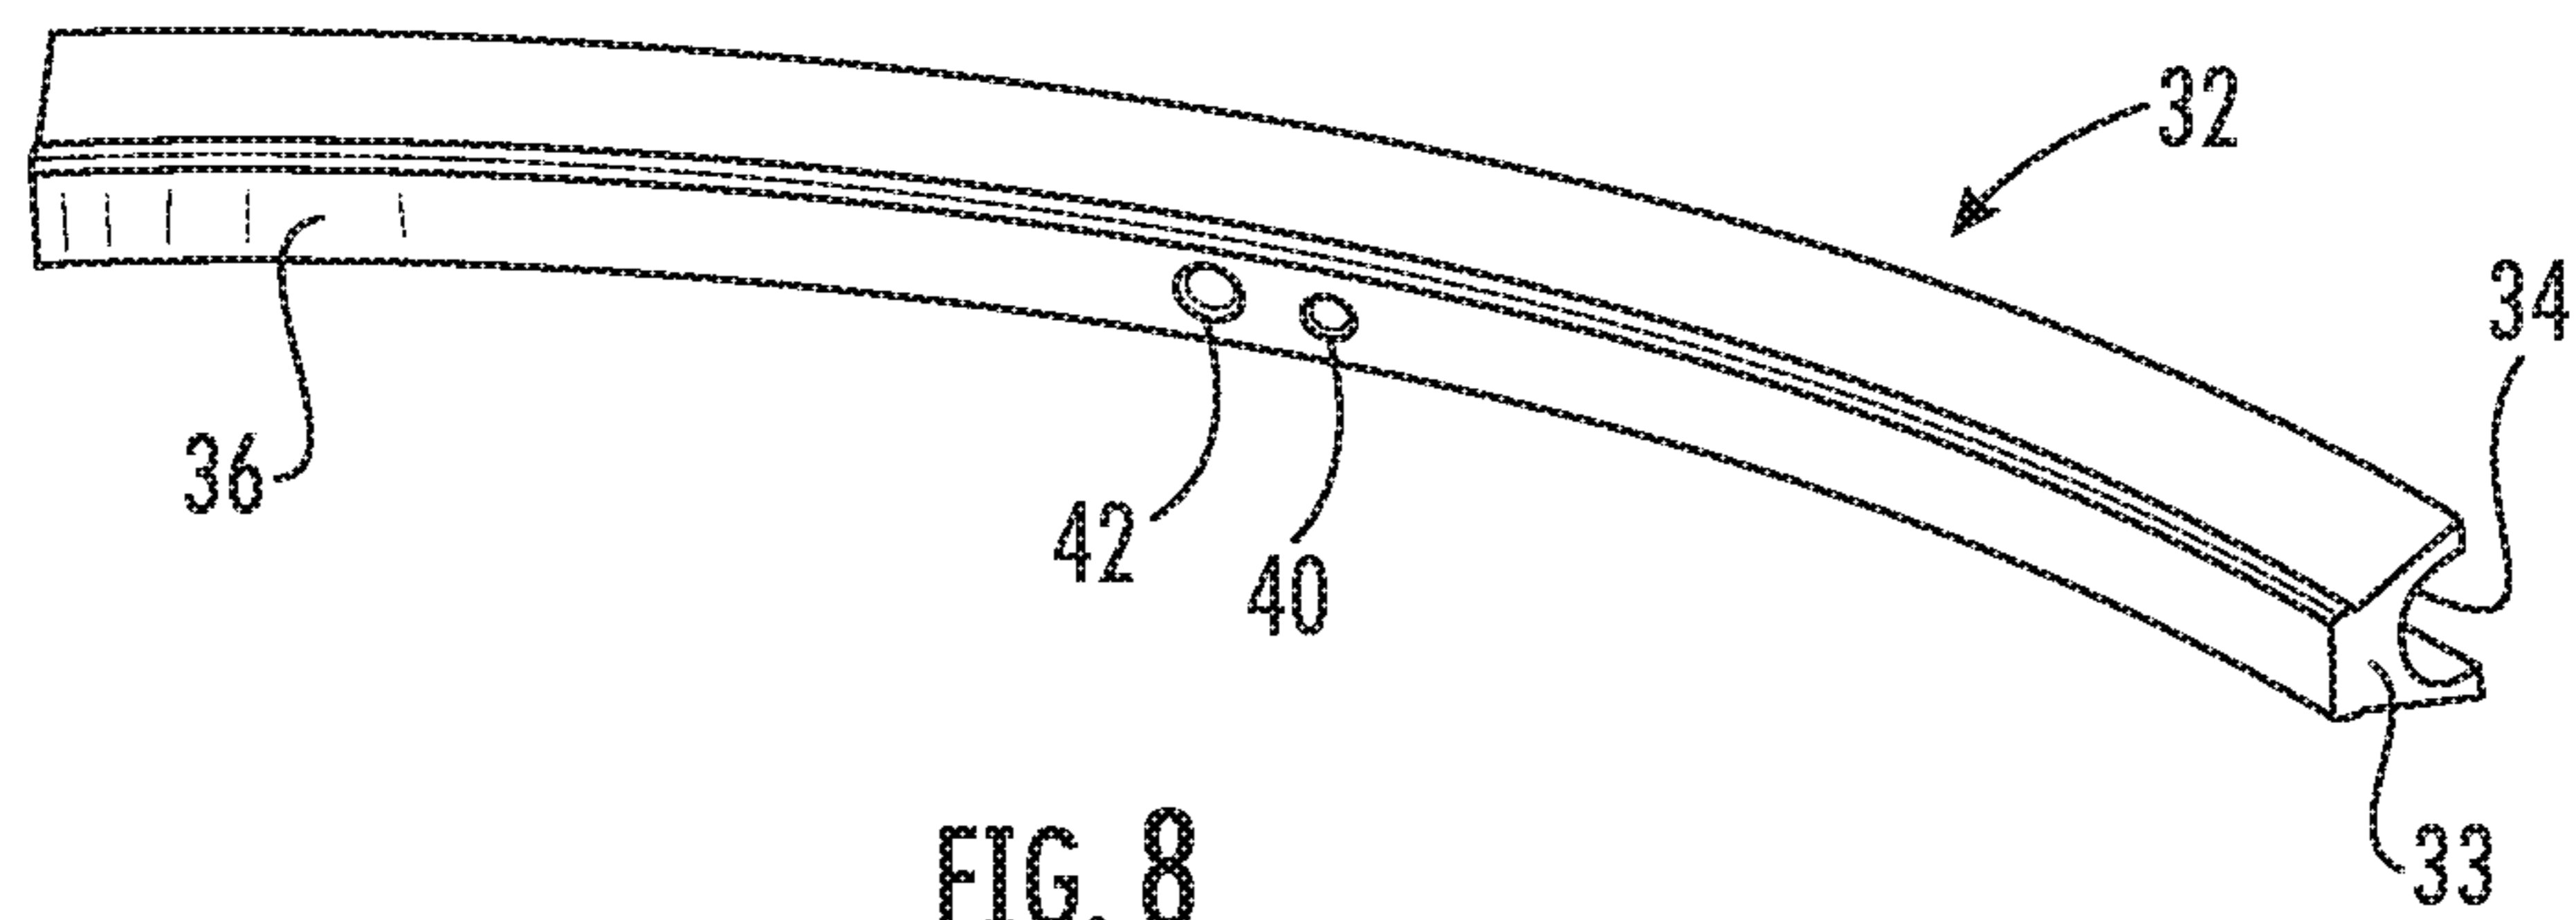
FIG. 8 illustrates another example embodiment of a sheave liner.

able to observe whether visible holes are present regardless of the particular orientation of the sheave 30 or sheave liner 32 during an inspection procedure. For example, three through holes may be situated together at each of four different locations spaced approximately 90° apart from each other around the inner circumference of the sheave liner 32. Given that the sheave liner 32 will wear consistently around its periphery, the number of holes visible at any one of those locations will be the same. Spacing blind holes about the second surface 36 in this manner further enhances the economies associated with determining a condition of the elevator sheave liner 32.

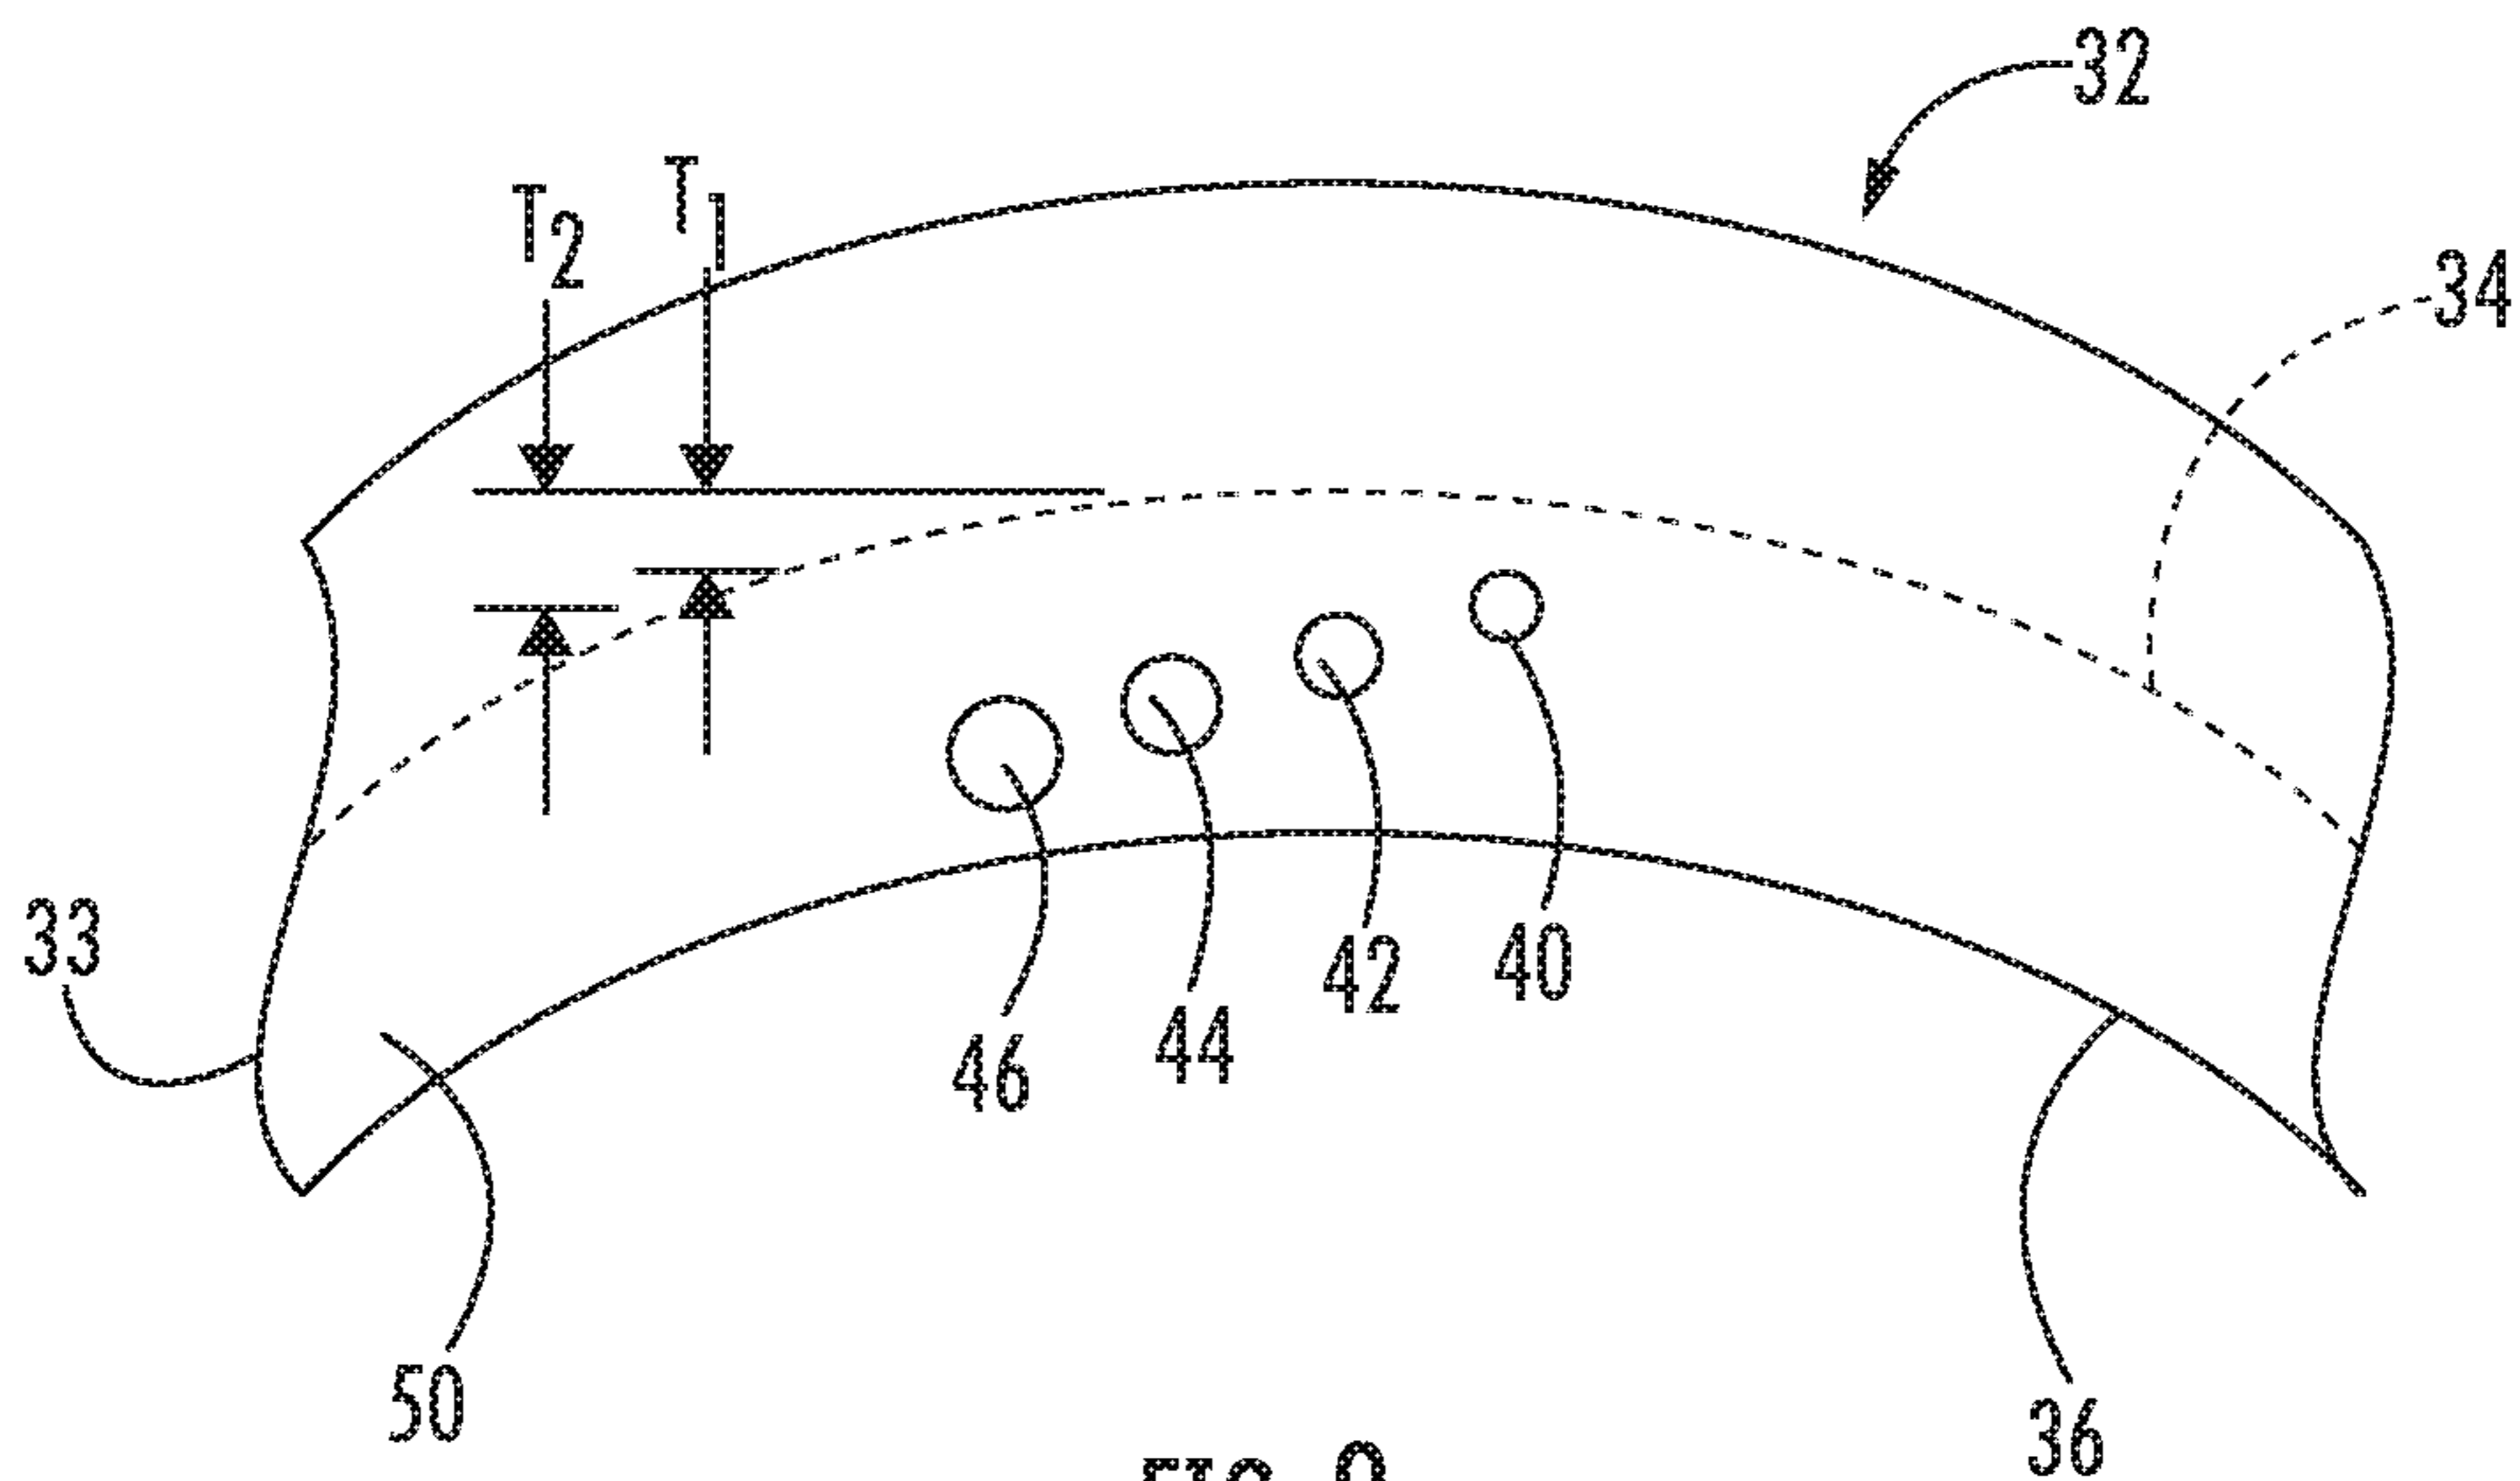
FIG. 9 illustrates another example embodiment of a sheave liner.

Another embodiment is shown in FIG. 9 where holes 40-46 are provided in a second surface 50 on a side of the sheave liner 32. In this example the blind hole 40 is situated closer to the first surface 34 compared to the other holes 42-46. The position of the first hole 40 leaves a first thickness T_1 of the material of the sheave liner body 33 between the first hole 40 and the surface 34 that engages the load bearing member. The second hole 42 leaves a second thickness T_2 of the material of the liner body 33 between the second hole 42 and the surface 34. The holes 44 and 46 are progressively further from the surface 34. As the sheave liner 32 wears over time the holes 40-46 will sequentially become visible indicating progressive wear in a similar manner that the holes in the embodiments described above provide a visual indication of wear.

In some embodiments like that shown in FIG. 9, the holes are blind holes and in other embodiments the holes extend through the liner body 33 from one side surface 50 to an oppositely facing side surface.
