(10) **Patent No.:** **US 11,492,230 B2**
(45) **Date of Patent:** **Nov. 8, 2022**

(54) **SHEAVE LINER INCLUDING WEAR INDICATORS**

(71) Applicant: **OTIS ELEVATOR COMPANY**,
Farmington, CT (US)

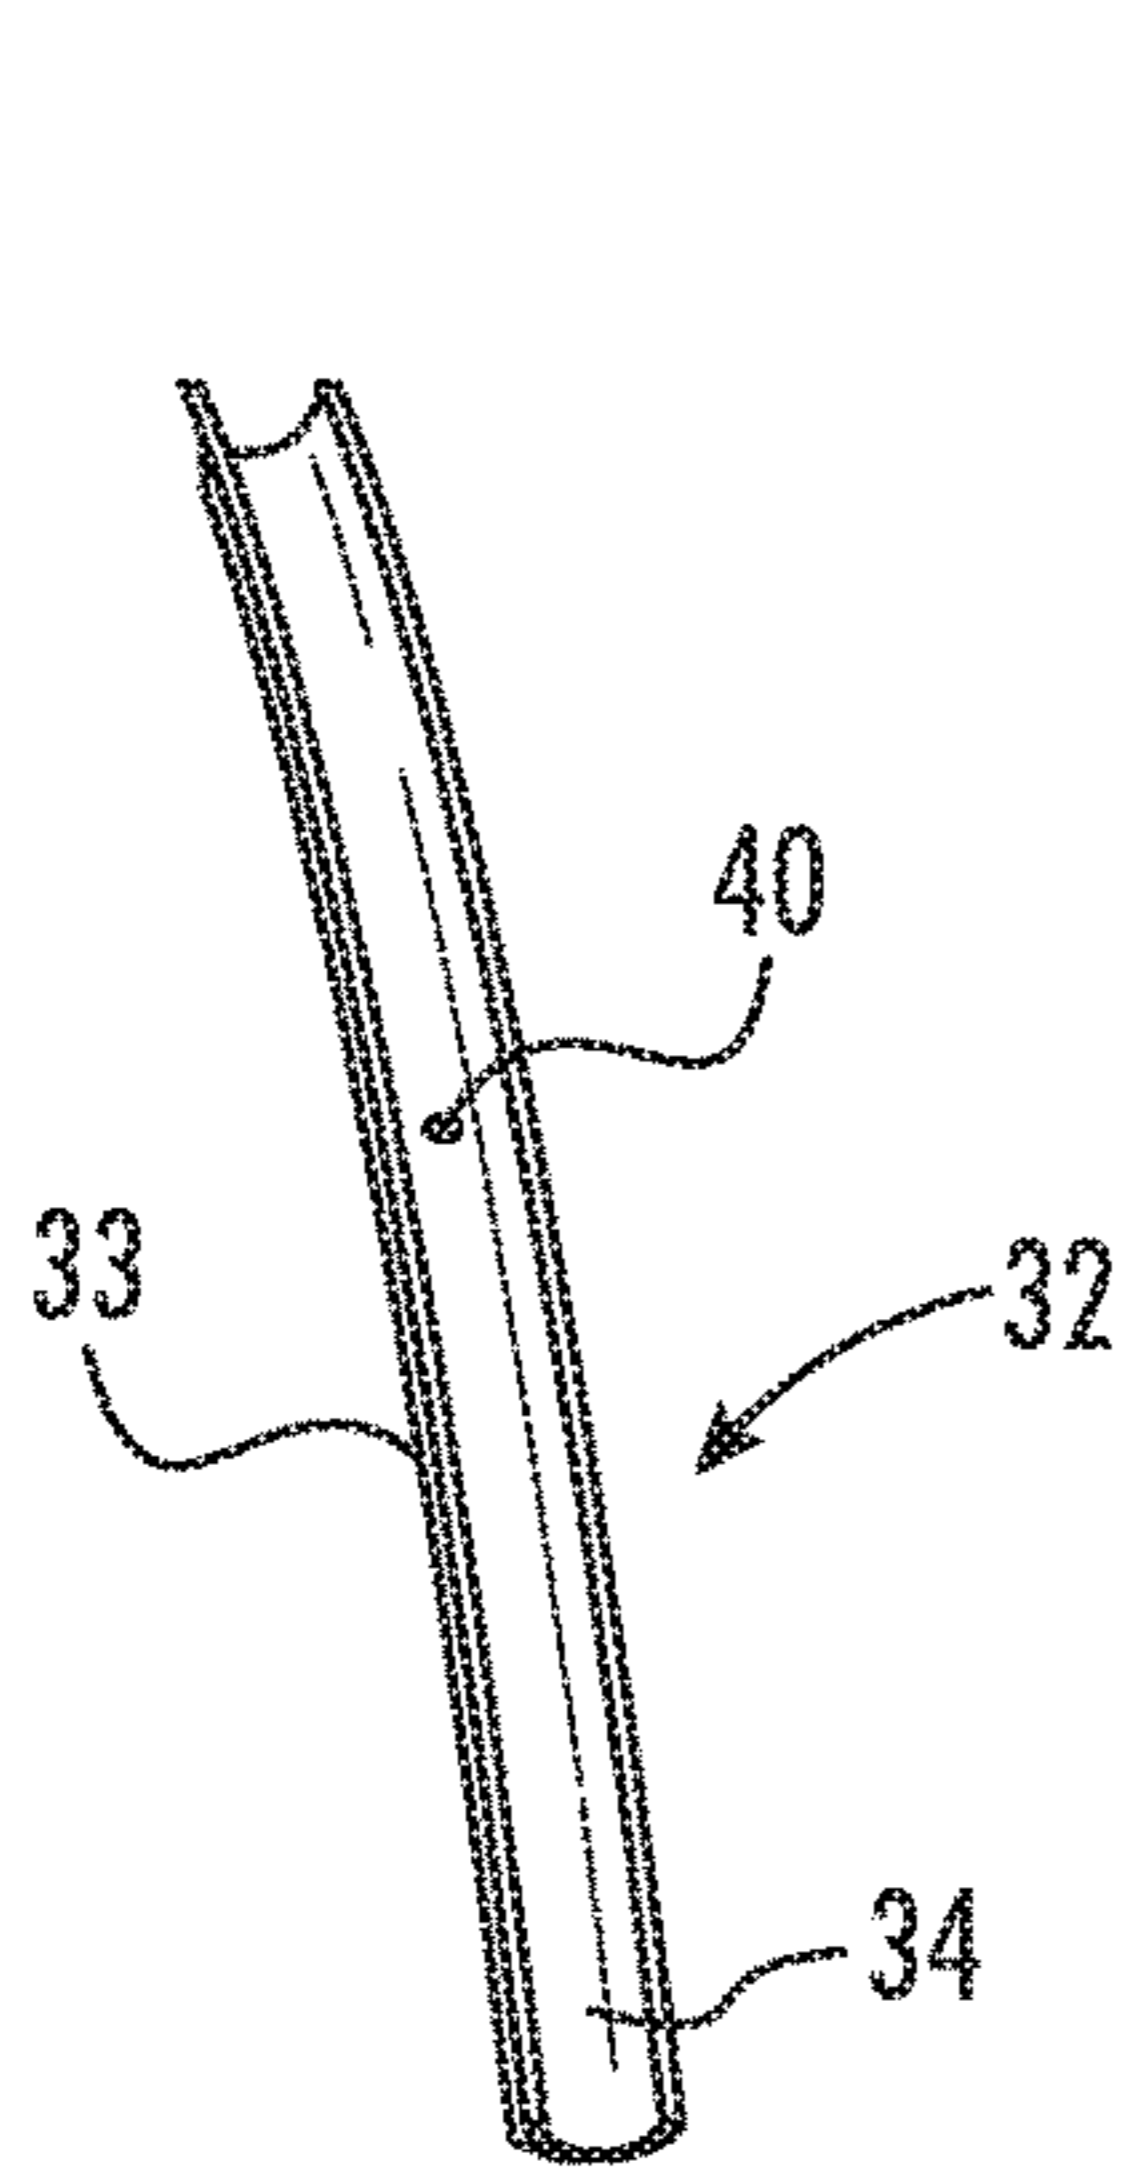
FIG. 5 illustrates an example embodiment of a sheave liner in a first wear condition.

The blind holes 40-44 provide a visual indication of an amount of wear of the material of the liner body 33 over time because as the sheave liner 32 wears, the thickness of the material between the first surface 34 and the second surface 36 decreases. Eventually, a sufficient amount of the material will be worn away so that the first blind hole 40 becomes a visible through hole between the second surface 36 and the first surface 34. This condition is shown in FIG. 5. The single hole 40 visible in FIG. 5 provides a visual indication of the amount of wear that a sheave liner 32 has experienced since being installed in the elevator system 20. The amount of liner material remaining when the first hole 40 initially becomes visible in the first surface 34 corresponds to the first depth D_1 . In some installations, the presence of a single visible hole indicates some acceptable amount of wear of the sheave liner 32 that does not require liner replacement. Maintenance personnel may recognize the presence of a single hole 40 in a sheave liner 32 as an indication that the sheave liner 32 has become worn but does not yet need to be replaced.

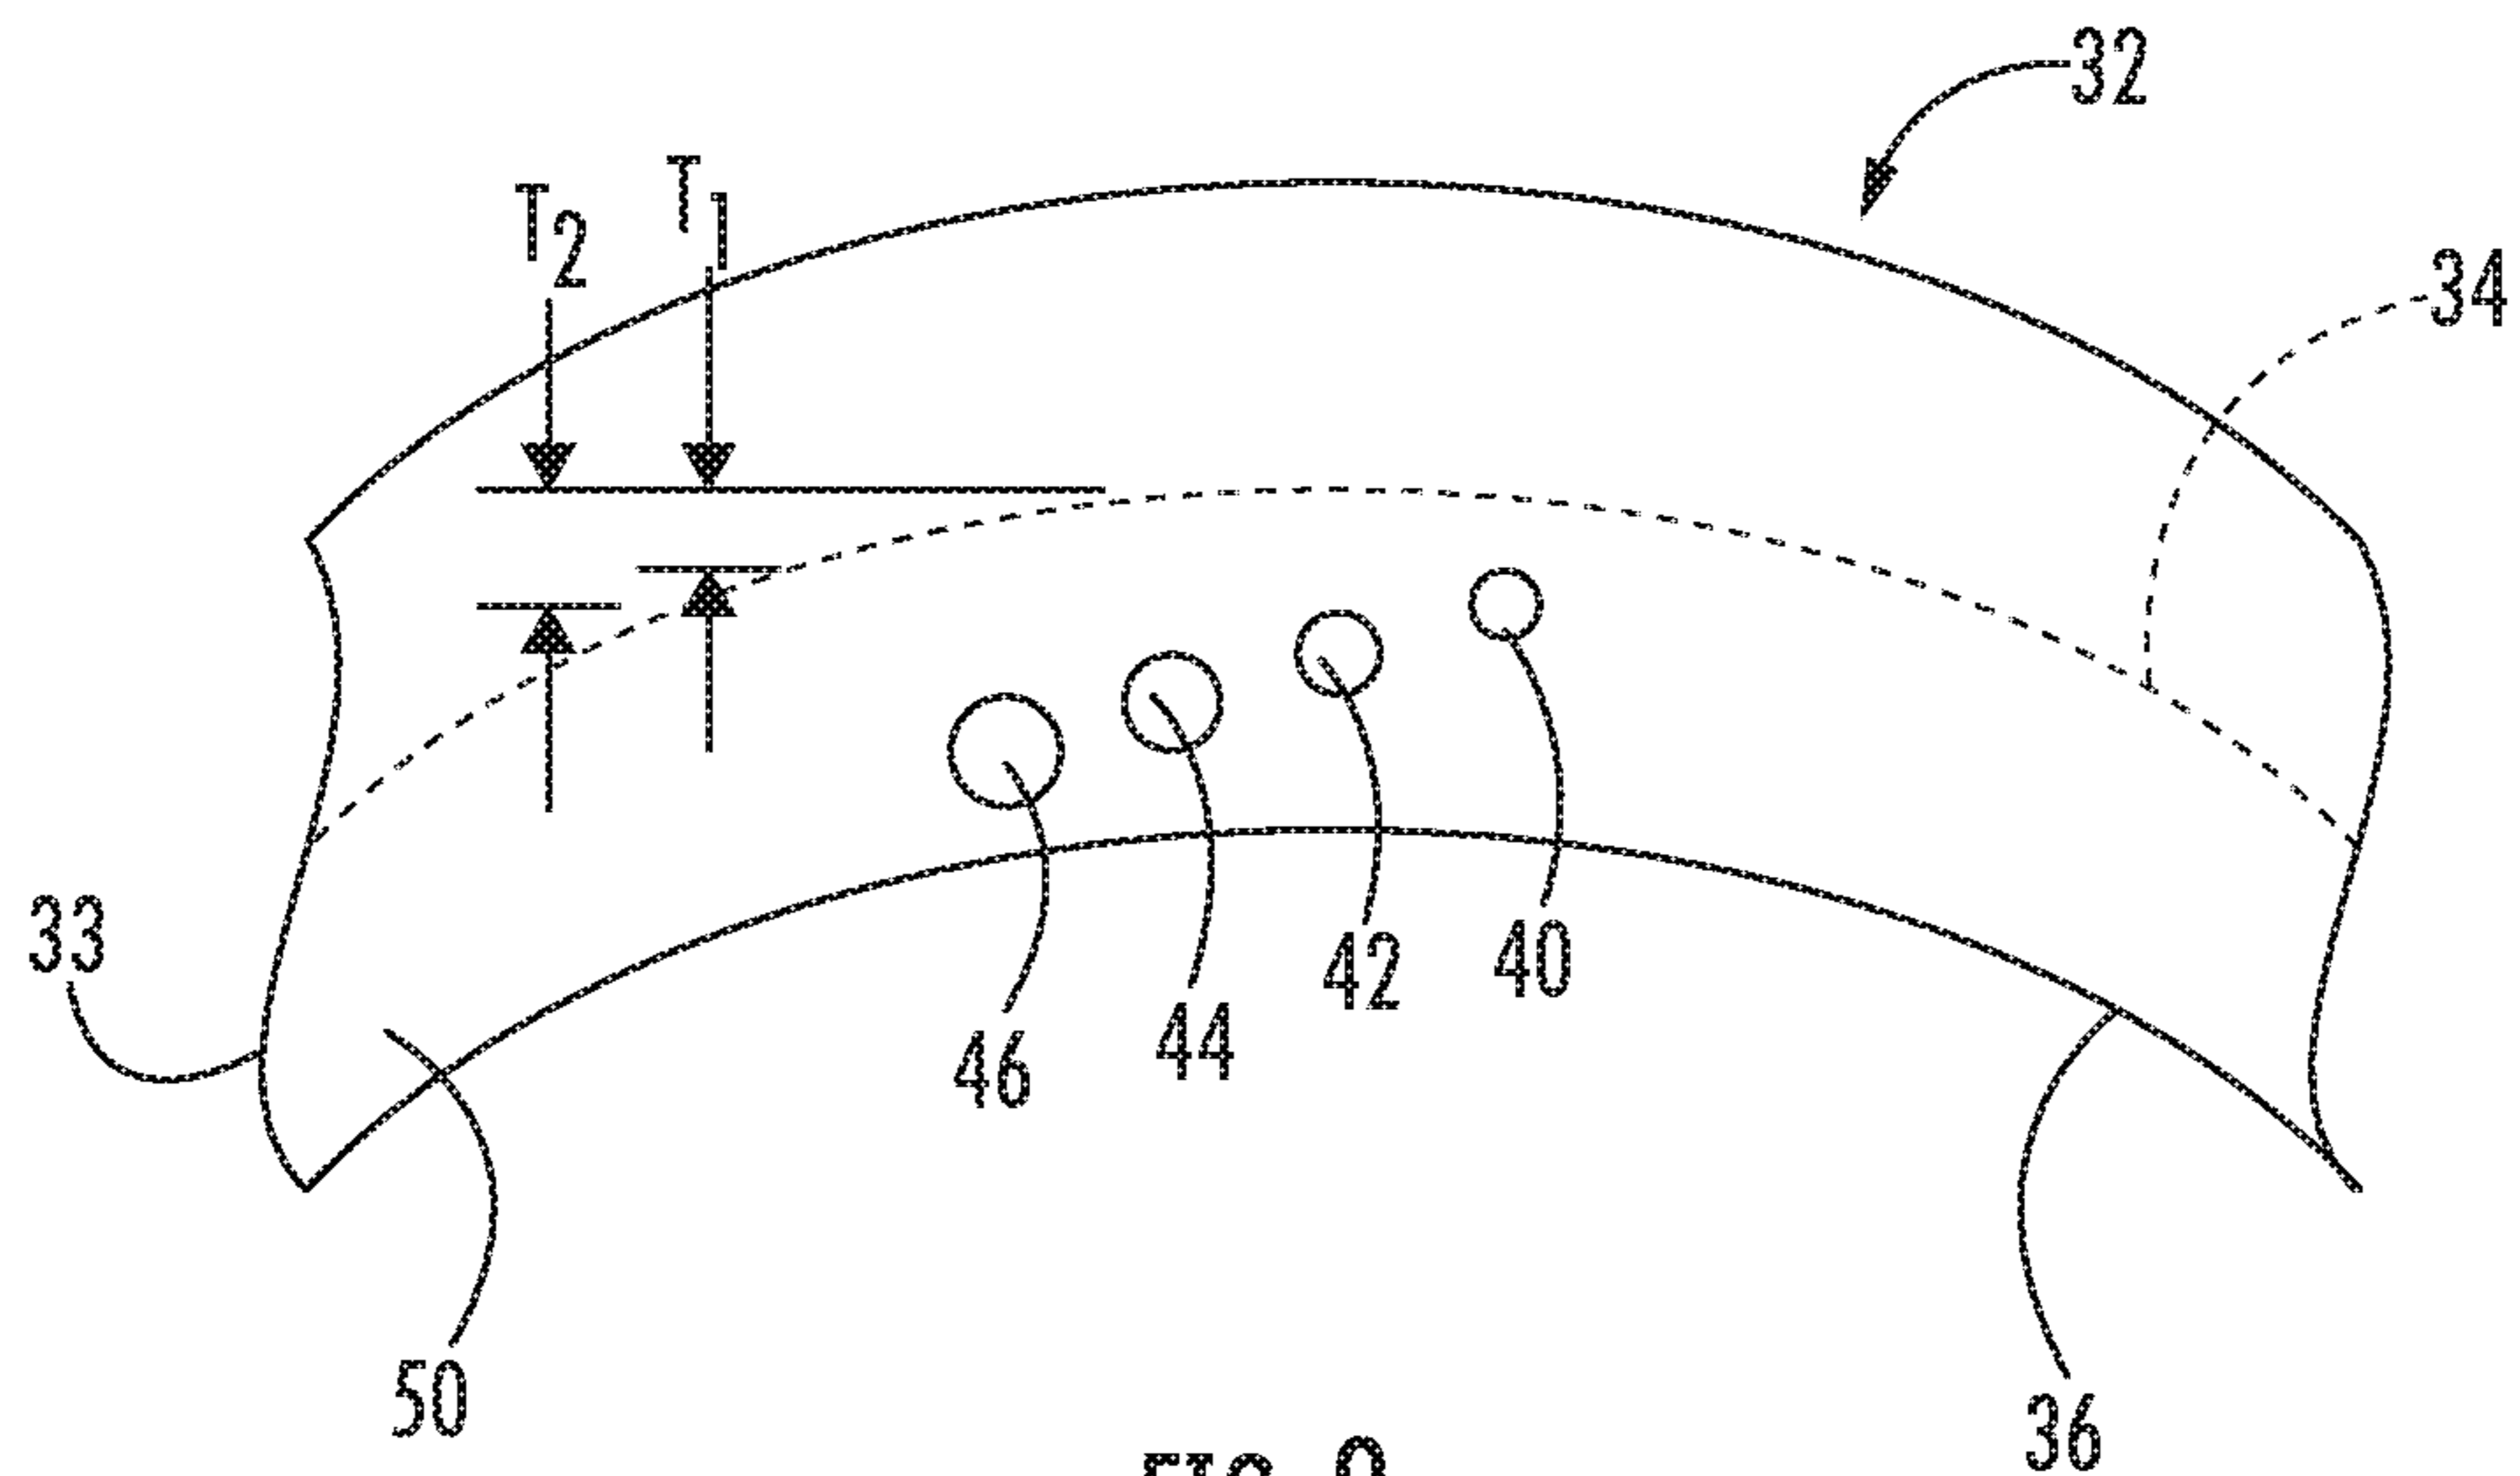
FIG. 9 illustrates another example embodiment of a sheave liner.

Another embodiment is shown in FIG. 9 where holes 40-46 are provided in a second surface 50 on a side of the sheave liner 32. In this example the blind hole 40 is situated closer to the first surface 34 compared to the other holes 42-46. The position of the first hole 40 leaves a first thickness T_1 of the material of the sheave liner body 33 between the first hole 40 and the surface 34 that engages the load bearing member. The second hole 42 leaves a second thickness T_2 of the material of the liner body 33 between the second hole 42 and the surface 34. The holes 44 and 46 are progressively further from the surface 34. As the sheave liner 32 wears over time the holes 40-46 will sequentially become visible indicating progressive wear in a similar manner that the holes in the embodiments described above provide a visual indication of wear.

In some embodiments like that shown in FIG. 9, the holes are blind holes and in other embodiments the holes extend through the liner body 33 from one side surface 50 to an oppositely facing side surface.
