US011504813B2

(12) **United States Patent**
Whittle et al.

(54) **METHODS FOR HEALTH MONITORING OF CERAMIC MATRIX COMPOSITE COMPONENTS IN GAS TURBINE ENGINES**

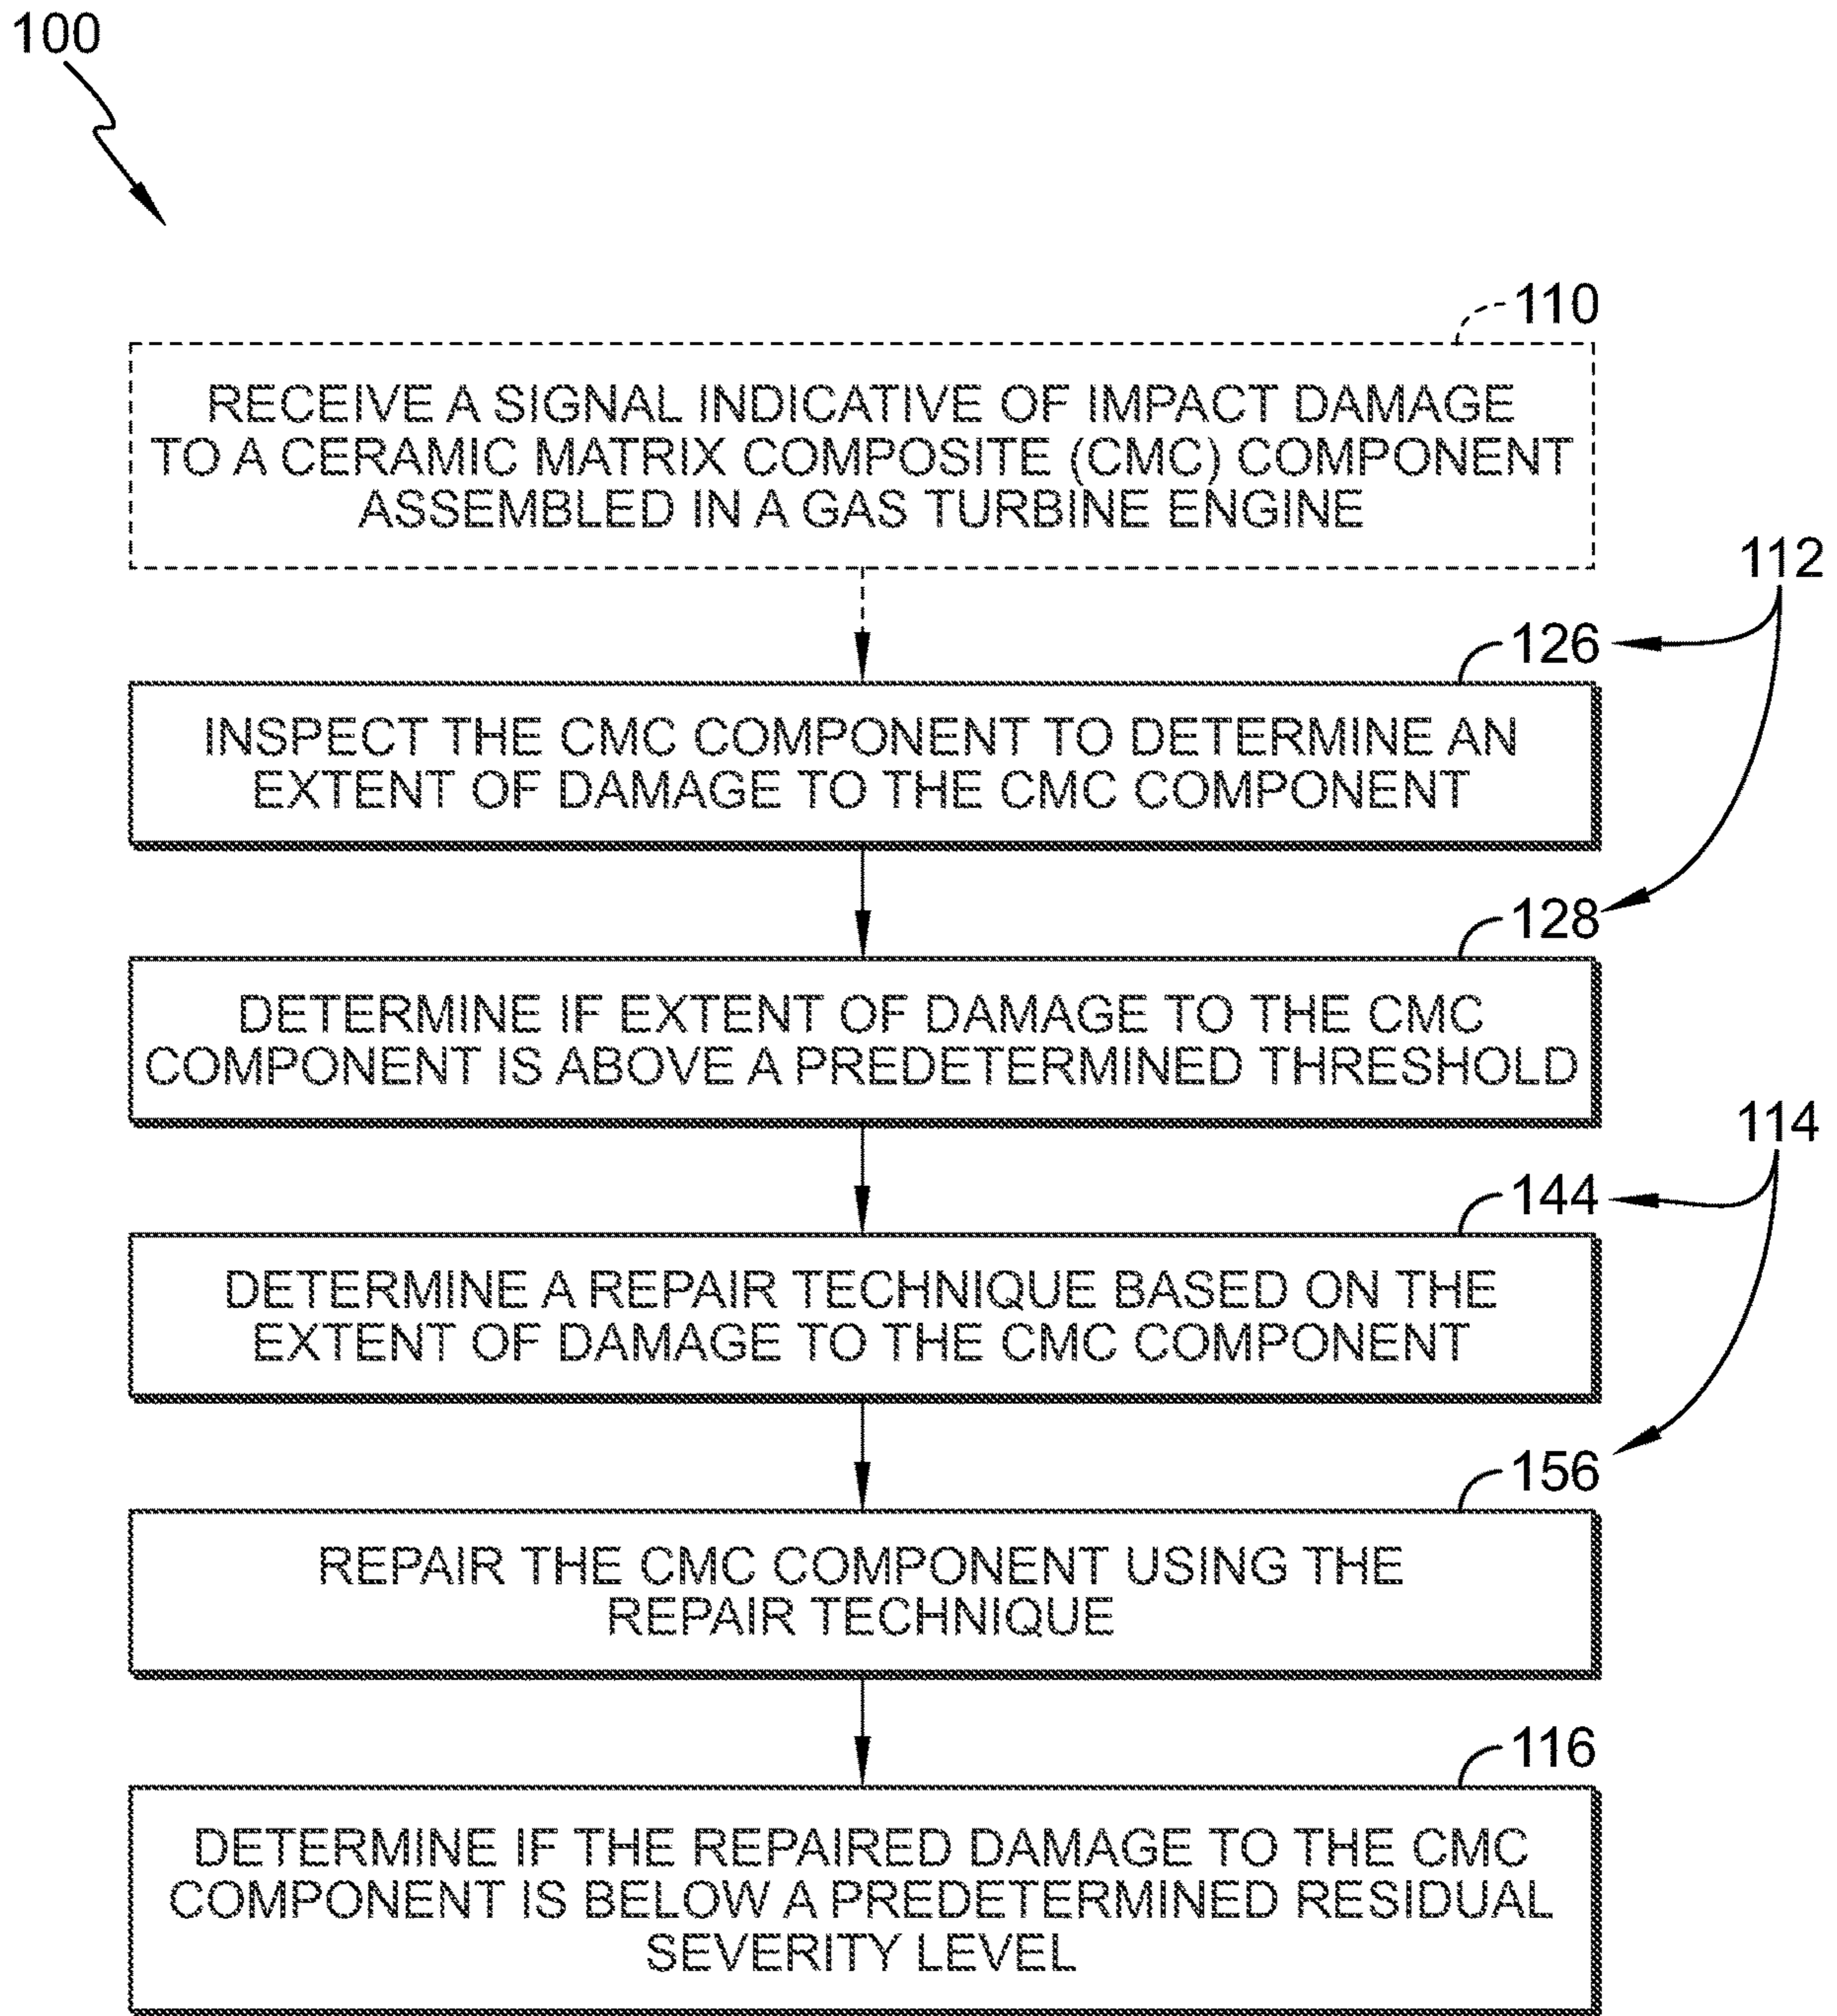
FIG. 3 is a diagrammatic view of a method of monitoring damage to a component made of ceramic matrix composite material included in one of the rotating wheel assemblies and the static turbine vane assembly of FIG. 2 showing the method includes (i) inspecting the ceramic matrix composite component to determine an extent of damage to the component, (ii) determining if the extent of damage to the ceramic matrix composite component is above a predetermined threshold, (iii) determining a repair technique to repair the damage to the ceramic matrix composite component based on the extent of damage to the component, and (iv) repairing the ceramic matrix composite component using the repair technique;

A method 100 for detecting, inspecting, and repairing impact damage to a ceramic matrix composite component 24, 26, 28 assembled in a gas turbine engine 10 is shown in FIG. 3. The gas turbine engine 10 includes a fan 12, a compressor 14, a combustor 16, and a turbine 18 as shown in FIG. 1. The fan 12 is driven by the turbine 18 and provides thrust for propelling an aircraft. The compressor 14 compresses and delivers air to the combustor 16. The combustor 16 mixes fuel with the compressed air received from the compressor 14 and ignites the fuel. The hot, high-pressure products of the combustion reaction in the combustor 16 are directed into the turbine 18 to cause the turbine 18 to rotate about an axis 11 of the gas turbine engine 10 and drive the compressor 14 and the fan 12.

The method 100 includes an inspection step 112, a repair step 114, and an assessment step 116 as shown in FIGS. 3 and 6-9. The inspection step 112 includes inspecting the ceramic matrix composite component 24, 26, 28 to determine an extent of damage 30 to the ceramic matrix composite component 24, 26, 28 and determining if the extent of damage 30 to the ceramic matrix composite component 24, 26, 28 is above a predetermined threshold. The repair step 114 includes determining a repair technique to repair the damage to the ceramic matrix composite component 24, 26, 28 based on the extent of damage 30 to the ceramic matrix composite component 24, 26, 28 and repairing the ceramic matrix composite component 24, 26, 28 using the repair technique. The assessment step 116 includes determining the repaired damage is below a predetermined residual severity limit so that the engine 10 may be cleared or permitted for flight.

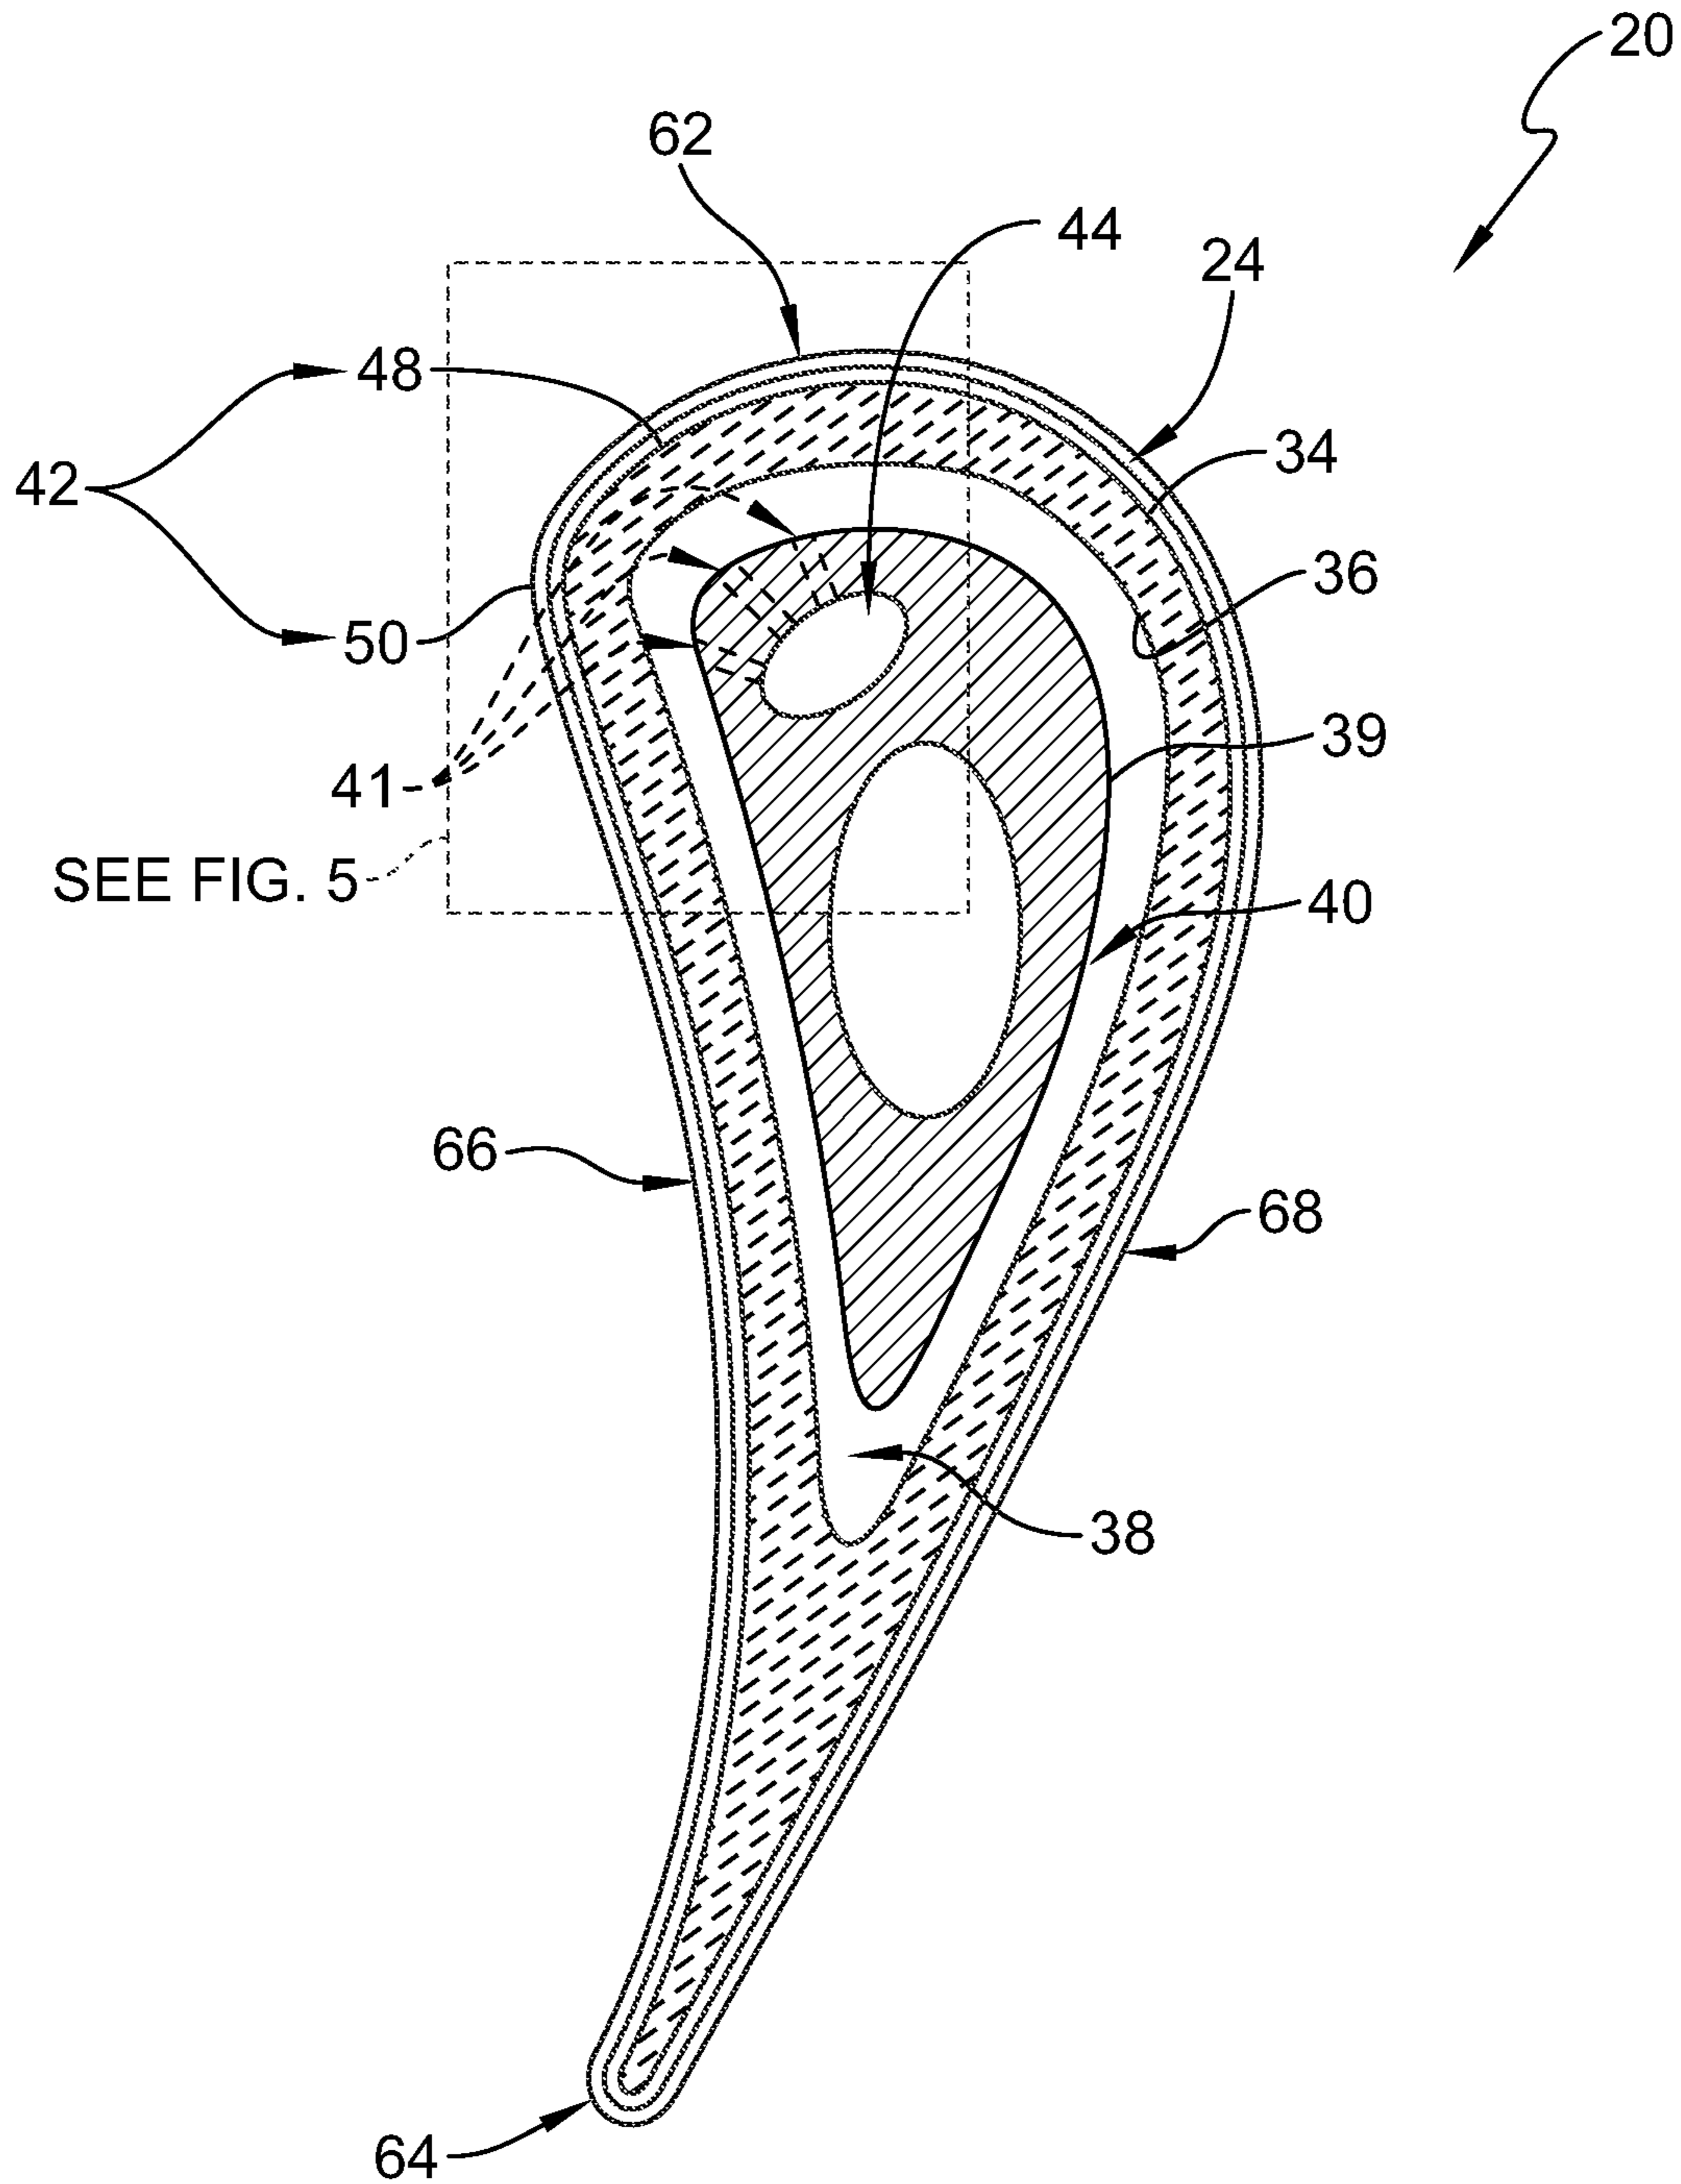
FIG. 4 is a section view of the static turbine vane ring of FIG. 2 taking along line 4-4 showing the ceramic matrix composite vane has a protective coating that surrounds an outer surface of the ceramic matrix composite vane;

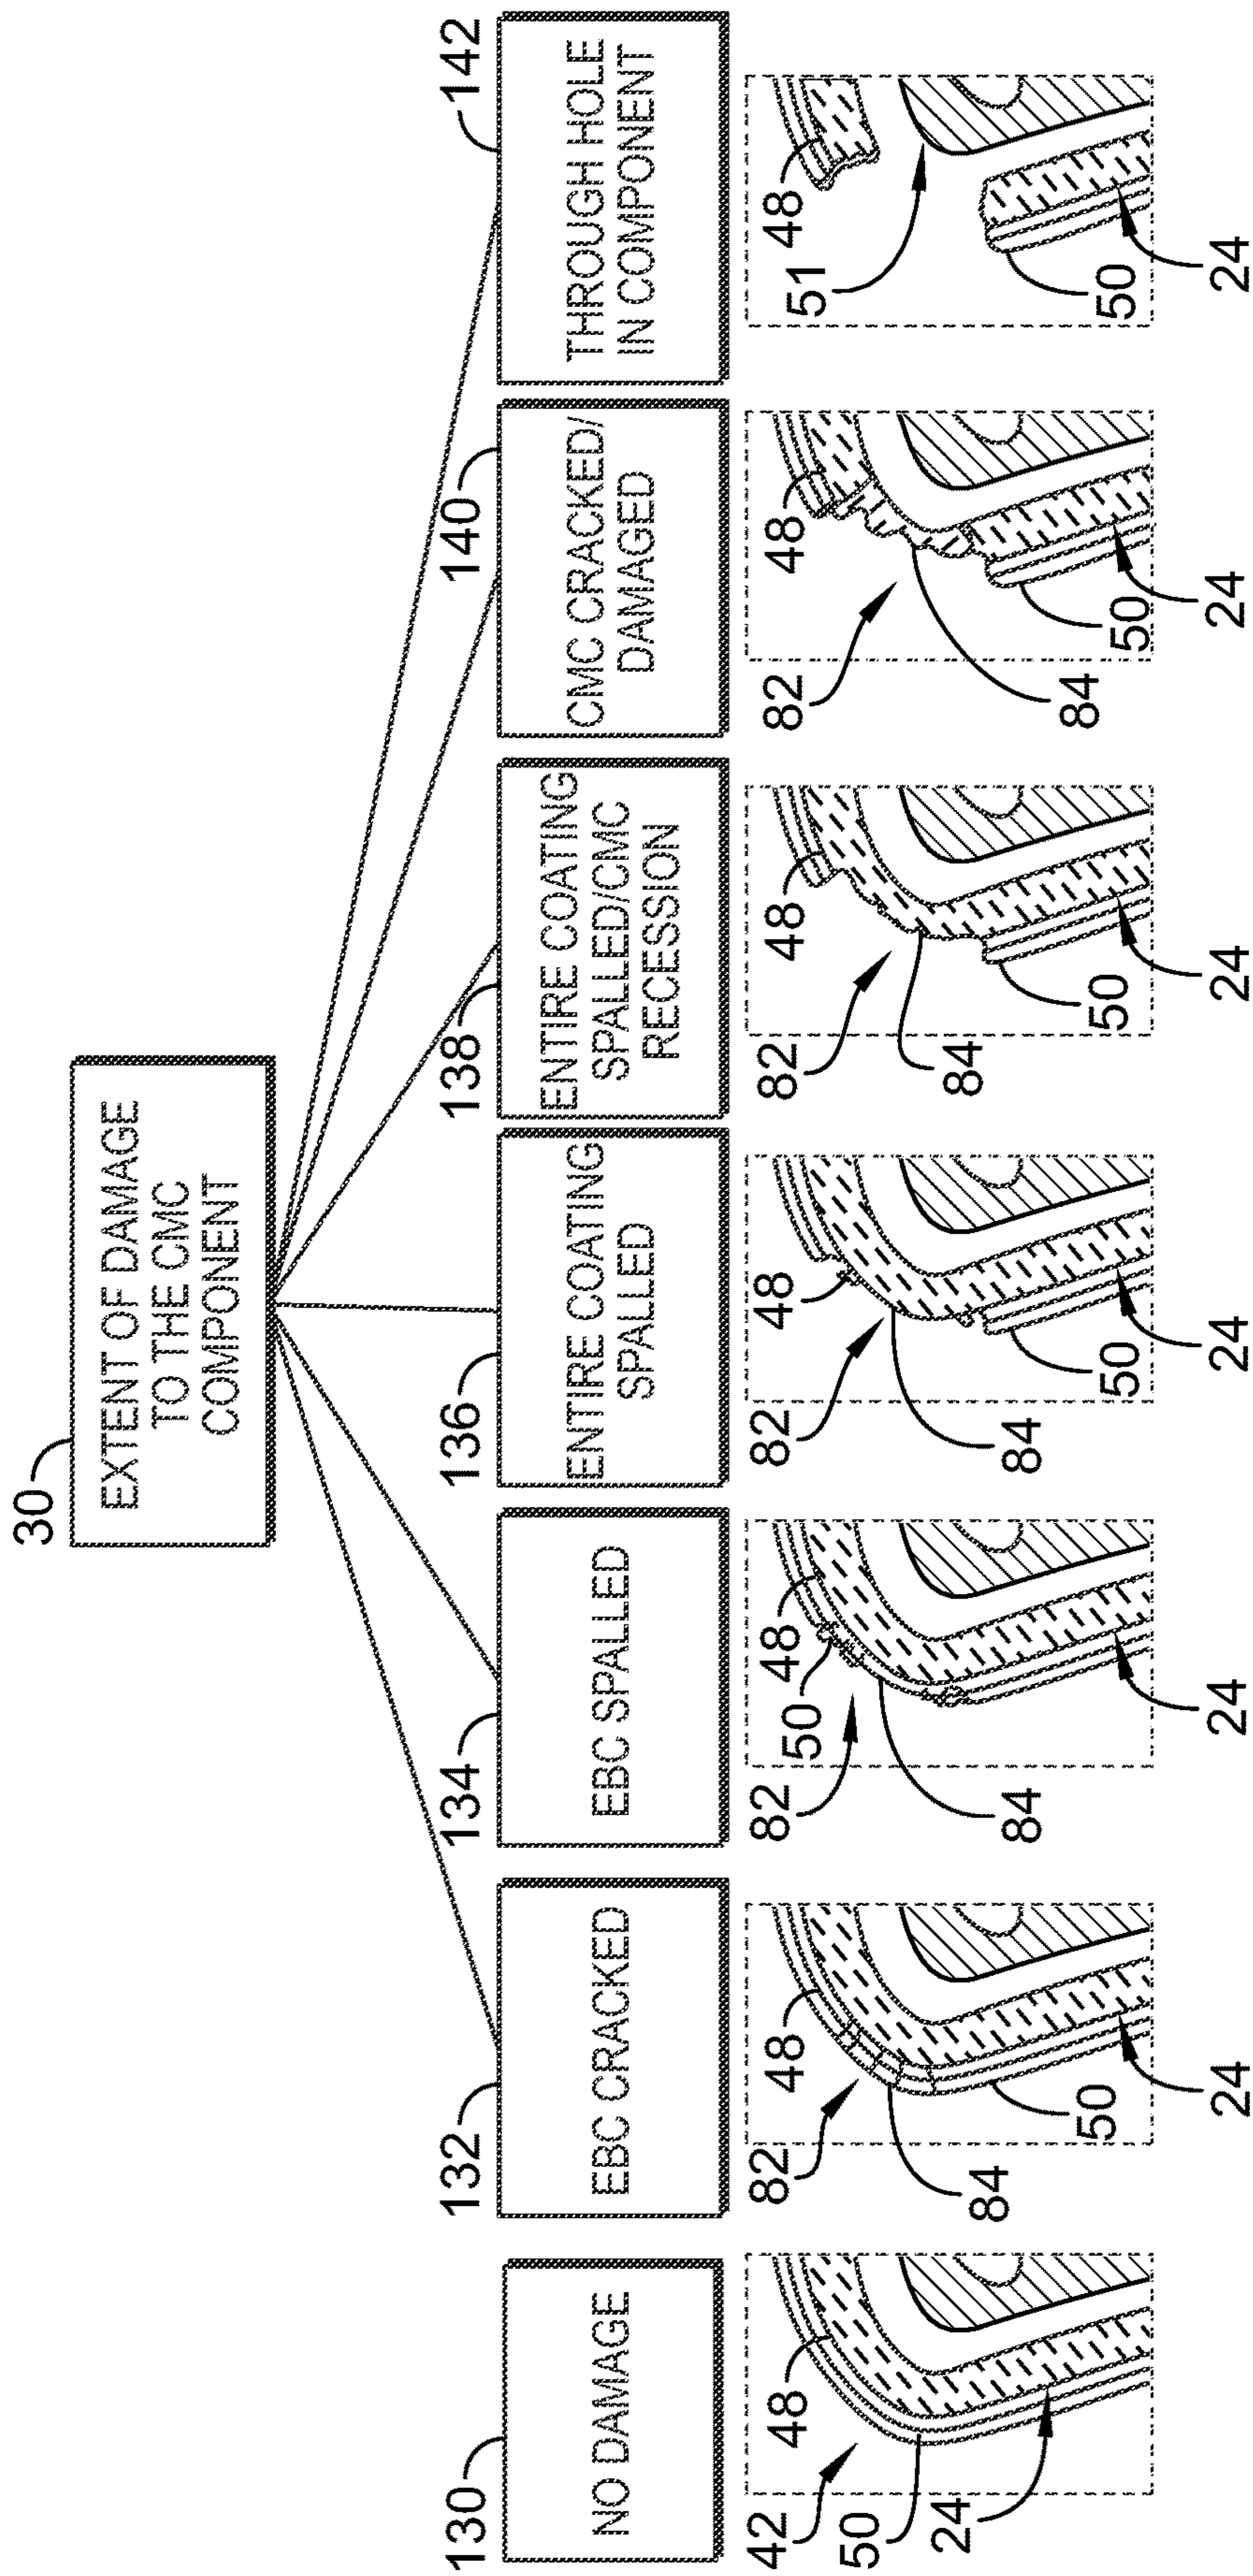
FIG. 5 is a diagrammatic view of different stages of damage to the protective coating and the ceramic matrix composite material of the ceramic matrix composite vane;

The extent of damage **30** is determined based on the damage to the layers **48**, **50** of the protective coating **42** and the ceramic matrix composite material of the component **24** as shown in FIG. 5. As the extent of damage **30** progresses, the more adversely affected the vane assembly **20**. For example, as opposed to cracking in the environmental barrier coating layer **50**, holes **51** through the component **24** may expose the spar **40** of the metallic support structure **32**, which may weaken the underlying support structure **32** of the vane assembly **20**.

As shown in FIG. 5, the baseline is no damage to the ceramic matrix composite component **24**. No damage to the ceramic matrix composite component **24** includes an intact protective coating **42** as indicated by block **130**.

Initial signs of impact damage **30** may include cracking in the environmental barrier coating layer **50** of the protective coating **42** of the ceramic matrix composite component **24** as shown in FIG. 5. Cracking in the environmental barrier coating layer **50** without spalling in the environmental barrier coating layer **50** of the protective coating **42** is indicated by block **132**.

As the damage progresses, the extent of damage **30** may include spalling in the environmental barrier coating layer **50** of the protective coating **42** as shown in FIG. 5. Spalling in the environmental barrier coating layer **50** without spalling in bond layer **48** of the protective coating **42** is indicated by block **134**. In some embodiments, the block **134** may indicate spalling in the environmental barrier coating layer **50** without recession of the ceramic matrix composite material if the protective coating **42** does not include the bond layer **48**.

of the protective coating **42** as shown in FIG. 5. Spalling in both layers **48**, **50** without recession of the ceramic matrix composite material of the ceramic matrix composite component **24** is indicated by block **136**.

As the ceramic matrix composite material is exposed to the hot gases in the gas path **17**, the extent of damage **30** includes recession of the ceramic matrix composite material of the ceramic matrix composite component **24** as shown in FIG. 5. The extent of damage may also include oxidation of the ceramic matrix composite material in such instances. Recession of the ceramic matrix composite material of the component **24** without spalling in the ceramic matrix composite material of the ceramic matrix composite component **24** is indicated by block **138**.

The extent of damage **30** to the component **24** may include spalling in the ceramic matrix composite material of the ceramic matrix composite component **24** as shown in FIG. 5. Spalling in the ceramic matrix composite material of the component **24** without a hole **51** extending through the ceramic matrix composite material into the interior cavity **38** of the ceramic matrix composite component **24** is indicated by block **140**.

As the damage progresses, the extent of damage **30** may include the hole **51** that extends through the protective coating **42** and ceramic matrix composite material of the ceramic matrix composite component **24**. The hole **51** opens into the interior cavity **38** formed in the ceramic matrix composite component **24**, exposing the spar **40** to the hot gases. Such an extent of damage is indicated by block **142**.

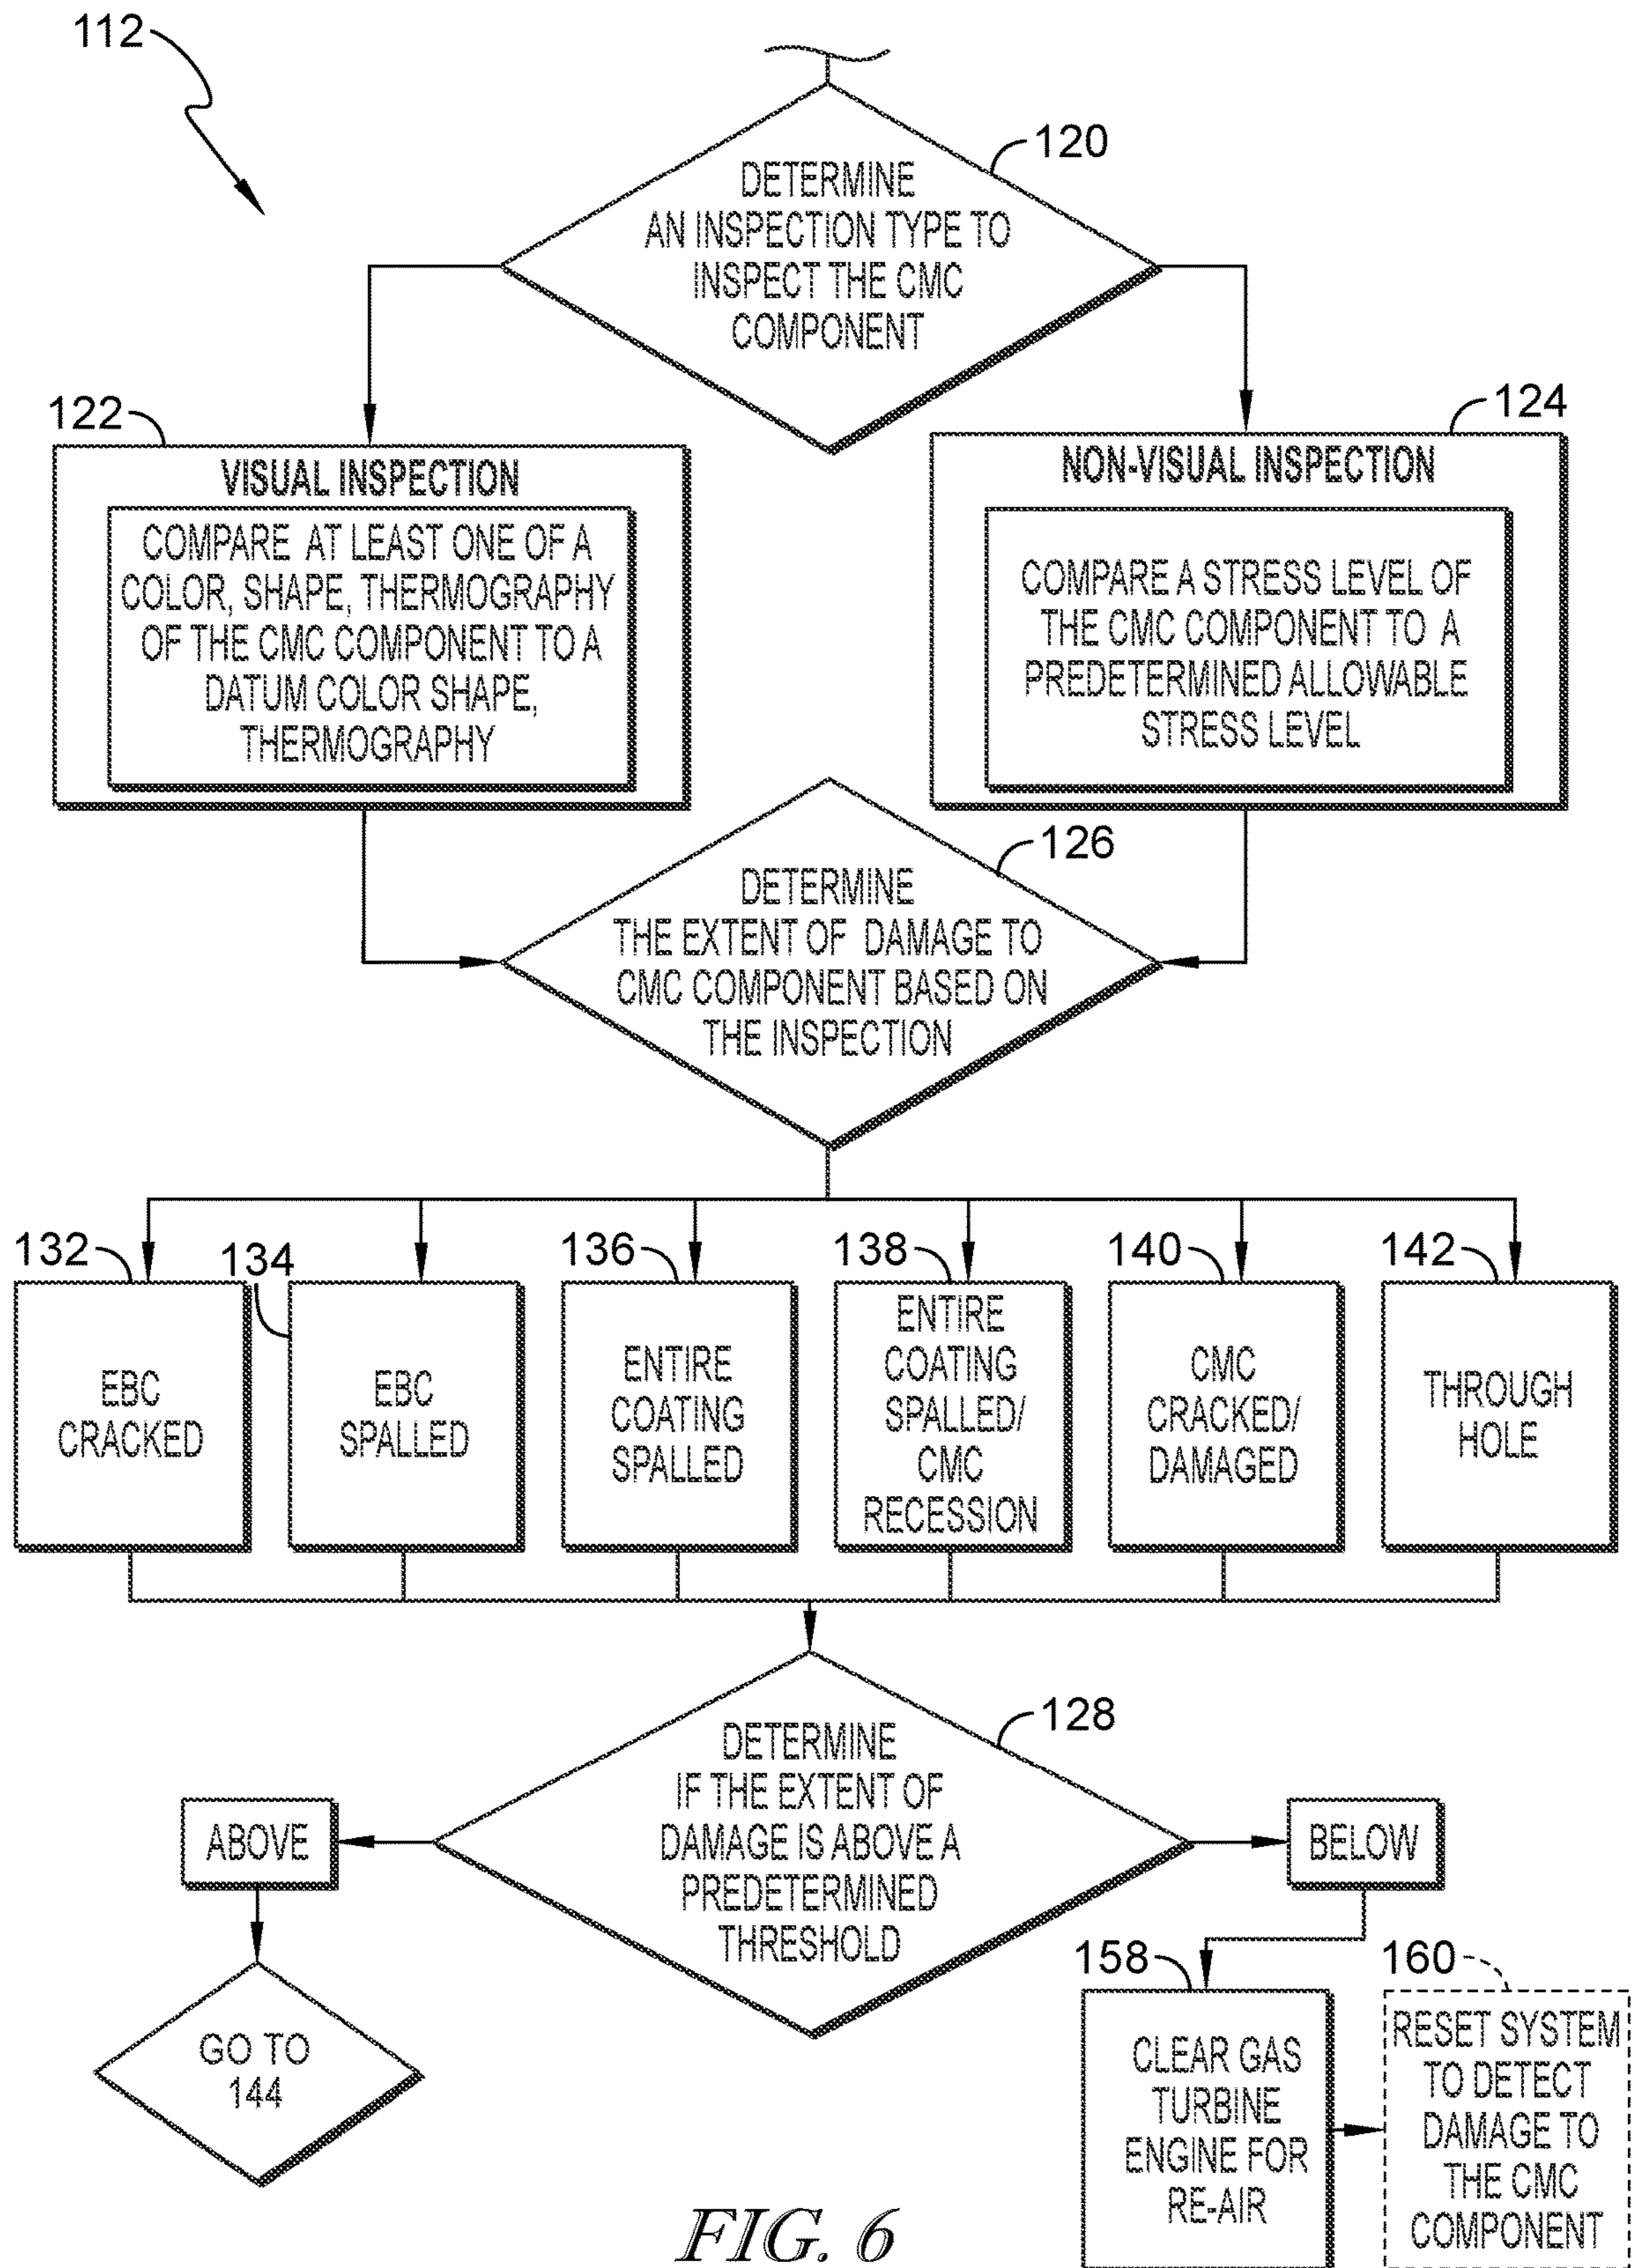
FIG. 6 is a diagrammatic view of the inspecting step of FIG. 3 showing the inspecting step includes one of a visual inspection and a non-visual inspection of the extent of damage to the ceramic matrix composite component;

Before the extent of damage 30 is inspected, the inspection step 112 begins by determining which type of inspection is to be used as indicated by block 120 as shown in FIG. 6. The extent of damage 30 is inspected by one of a visual inspection 122 and a non-visual inspection 124. The visual inspection 122 includes visibly observing a physical characteristic of the ceramic matrix composite component 24, 26, 28, such as color, shape, or thermography. The non-visual inspection 124 includes measuring other non-visual characteristics of the component 24, 26, 28, such as stress levels in the component 24, 26, 28.

Once the inspection type **122**, **124** is selected, the inspection step **112** continues to determining the extent of damage **30** to the ceramic matrix composite component **24**, **26**, **28** as indicated by block **126** as shown in FIG. 6. Using the selected inspection type, i.e. visual **122** or non-visual **124**, the extent of damage **30** to the ceramic matrix composite component **24**, **26**, **28** is inspected to determine the extent of damage **30** to the ceramic matrix composite component **24**, **26**, **28**.

If the extent of damage **30** is below the predetermined threshold, the component **24**, **26**, **28** is acceptable for use and the method continues by clearing the engine **10** for re-air as indicated by block **158** in FIG. 6. In some embodiments, once the engine **10** is cleared or permitted for flight, the engine health monitoring system **86** may be reset to detect the signal indicative of impact damage **30** to the ceramic matrix composite component **24**, **26**, **28** as suggested by block **160**.

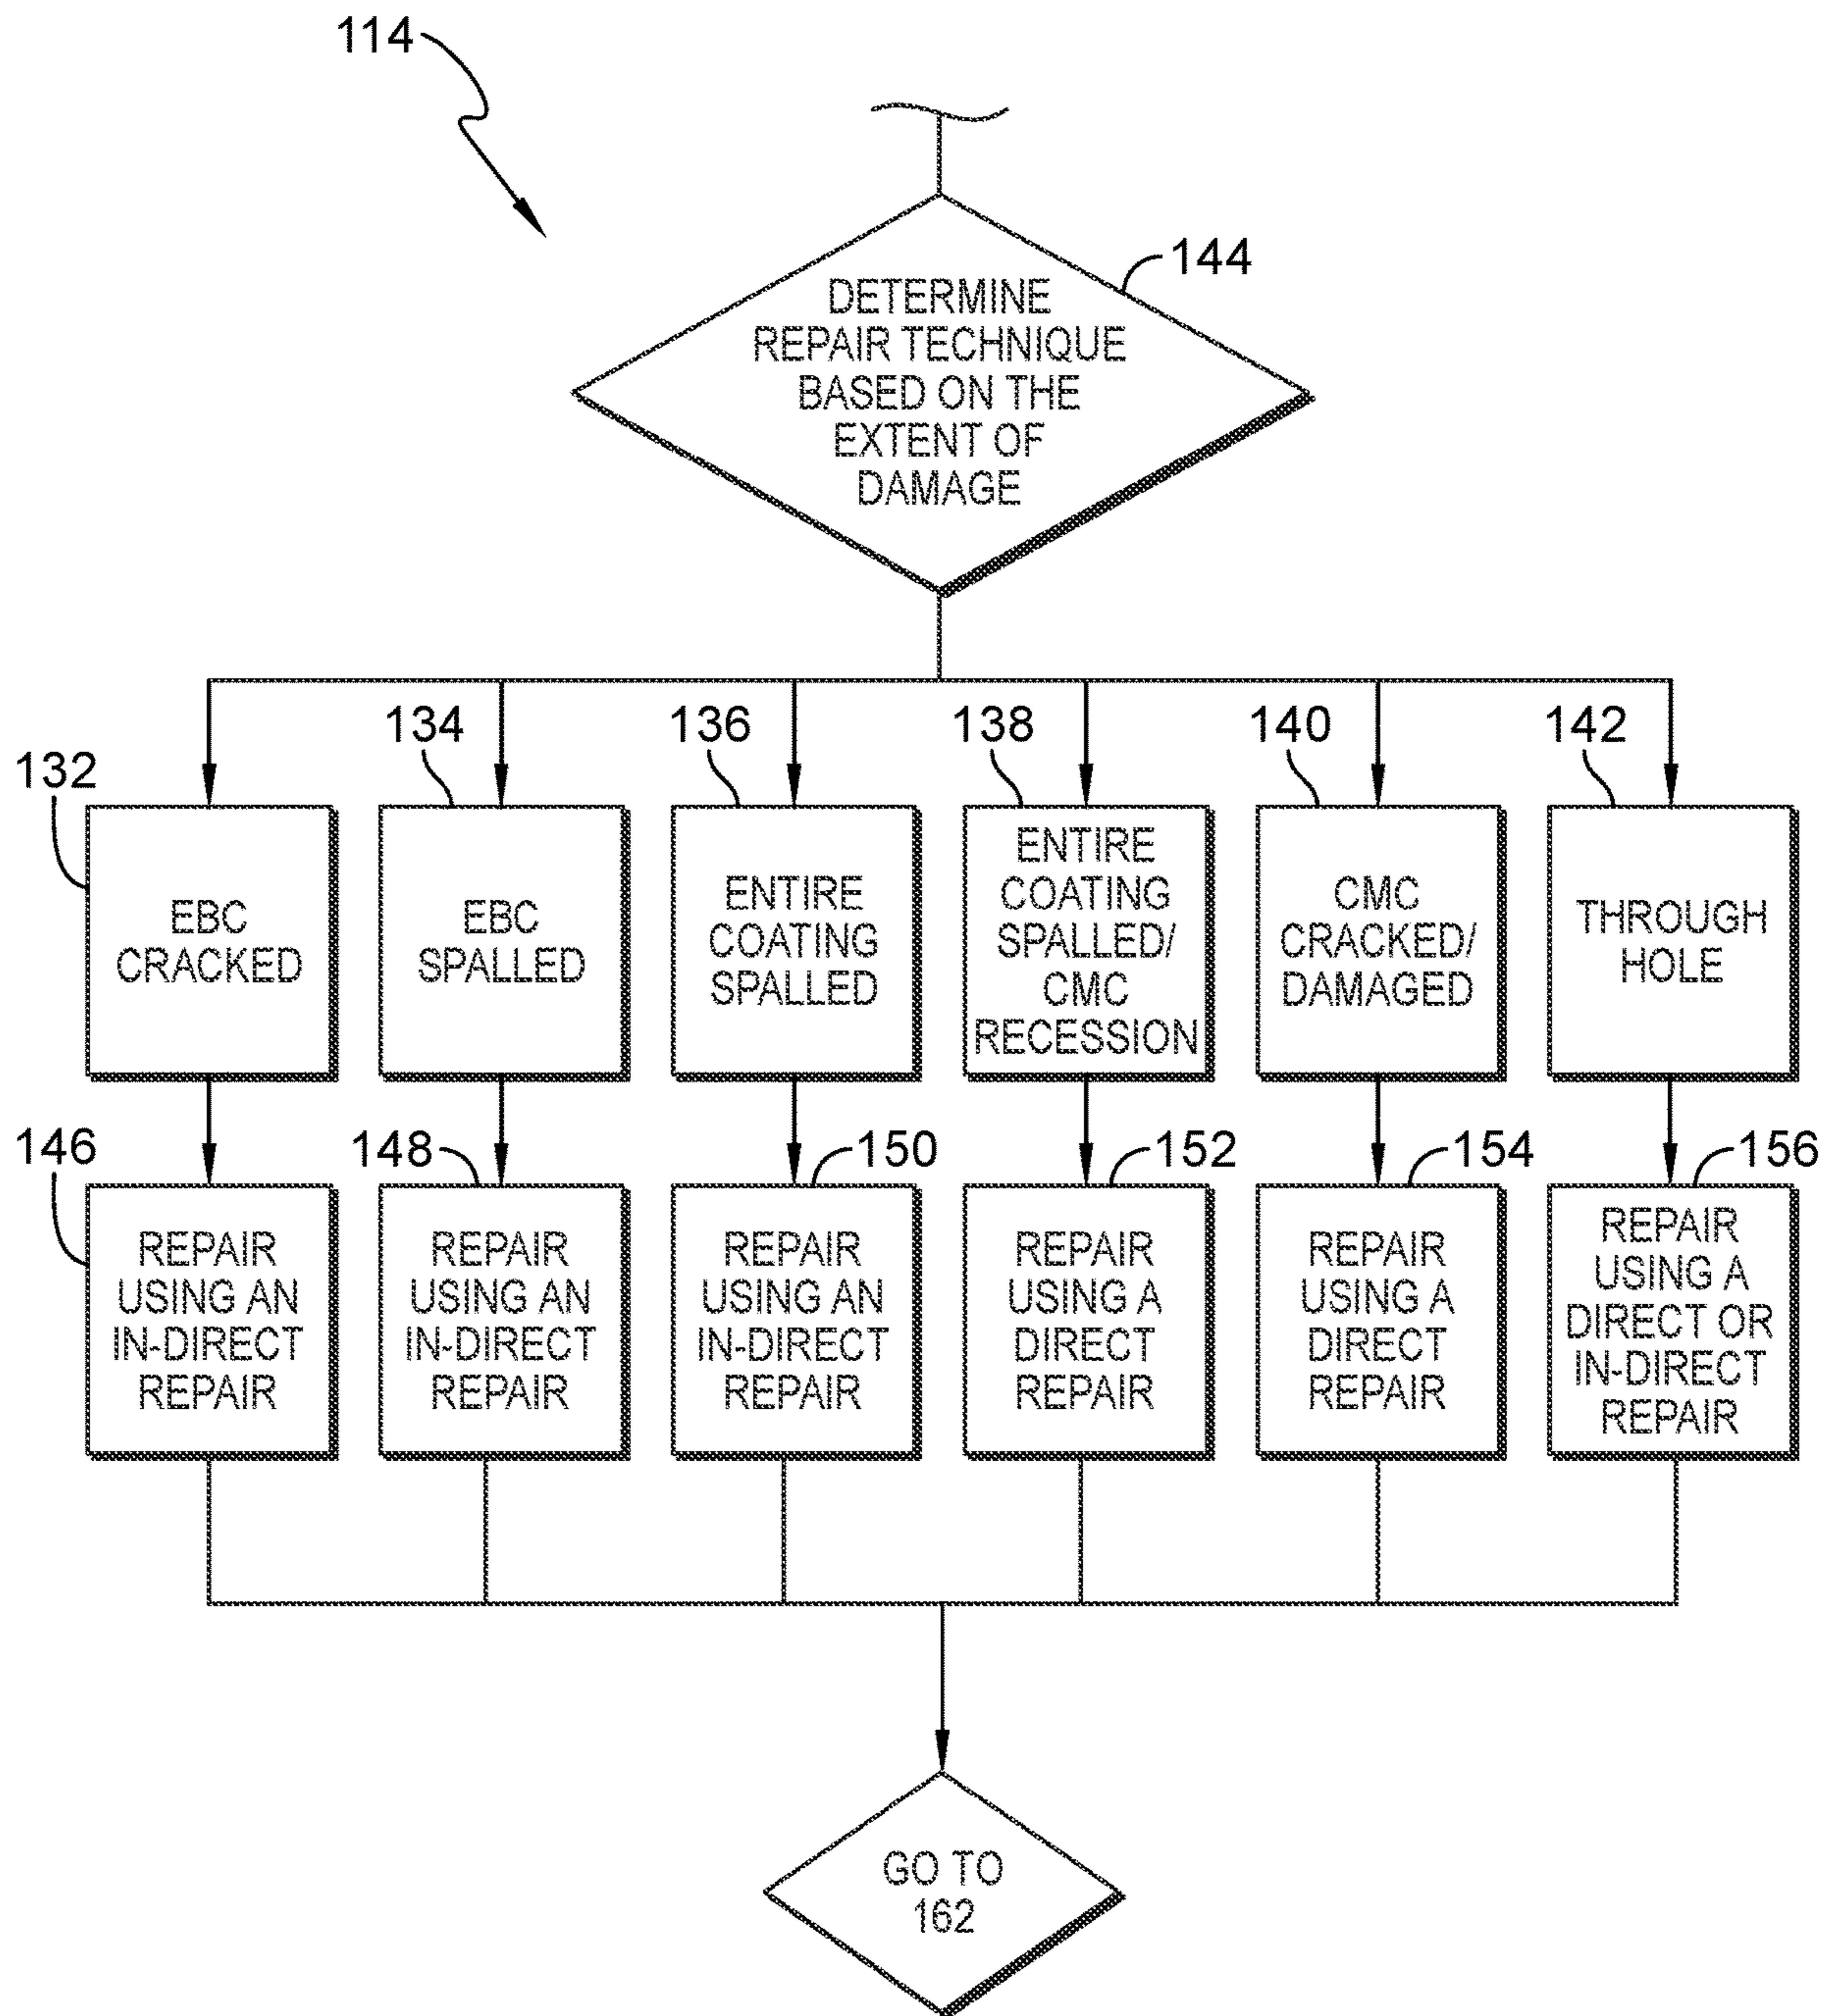
FIG. 7 is a diagrammatic view of the repair step of FIG. 3 showing the repair technique includes one of a direct repair of the ceramic matrix composite material of the ceramic matrix composite component and an in-direct repair of the ceramic matrix composite material of the ceramic matrix composite component based on the extent of damage to the component;

If the extent of damage **30** is above the predetermined threshold, the method continues to the repair step **114**. The repair step **114** begins by determining the repair technique **146**, **148**, **150**, **152**, **154**, **156** to be used to repair the ceramic matrix composite component **24**, **26**, **28** based on the extent of damage **30** as indicated by block **144**. In the illustrative embodiments, the repair technique **146**, **148**, **150**, **152**, **154**, **156** may be one of a direct repair **146**, **148**, **150**, **156** of the ceramic matrix composite material of the component **24**, **26**,
