US011504813B2

(12) **United States Patent**
Whittle et al.

(54) **METHODS FOR HEALTH MONITORING OF CERAMIC MATRIX COMPOSITE COMPONENTS IN GAS TURBINE ENGINES**

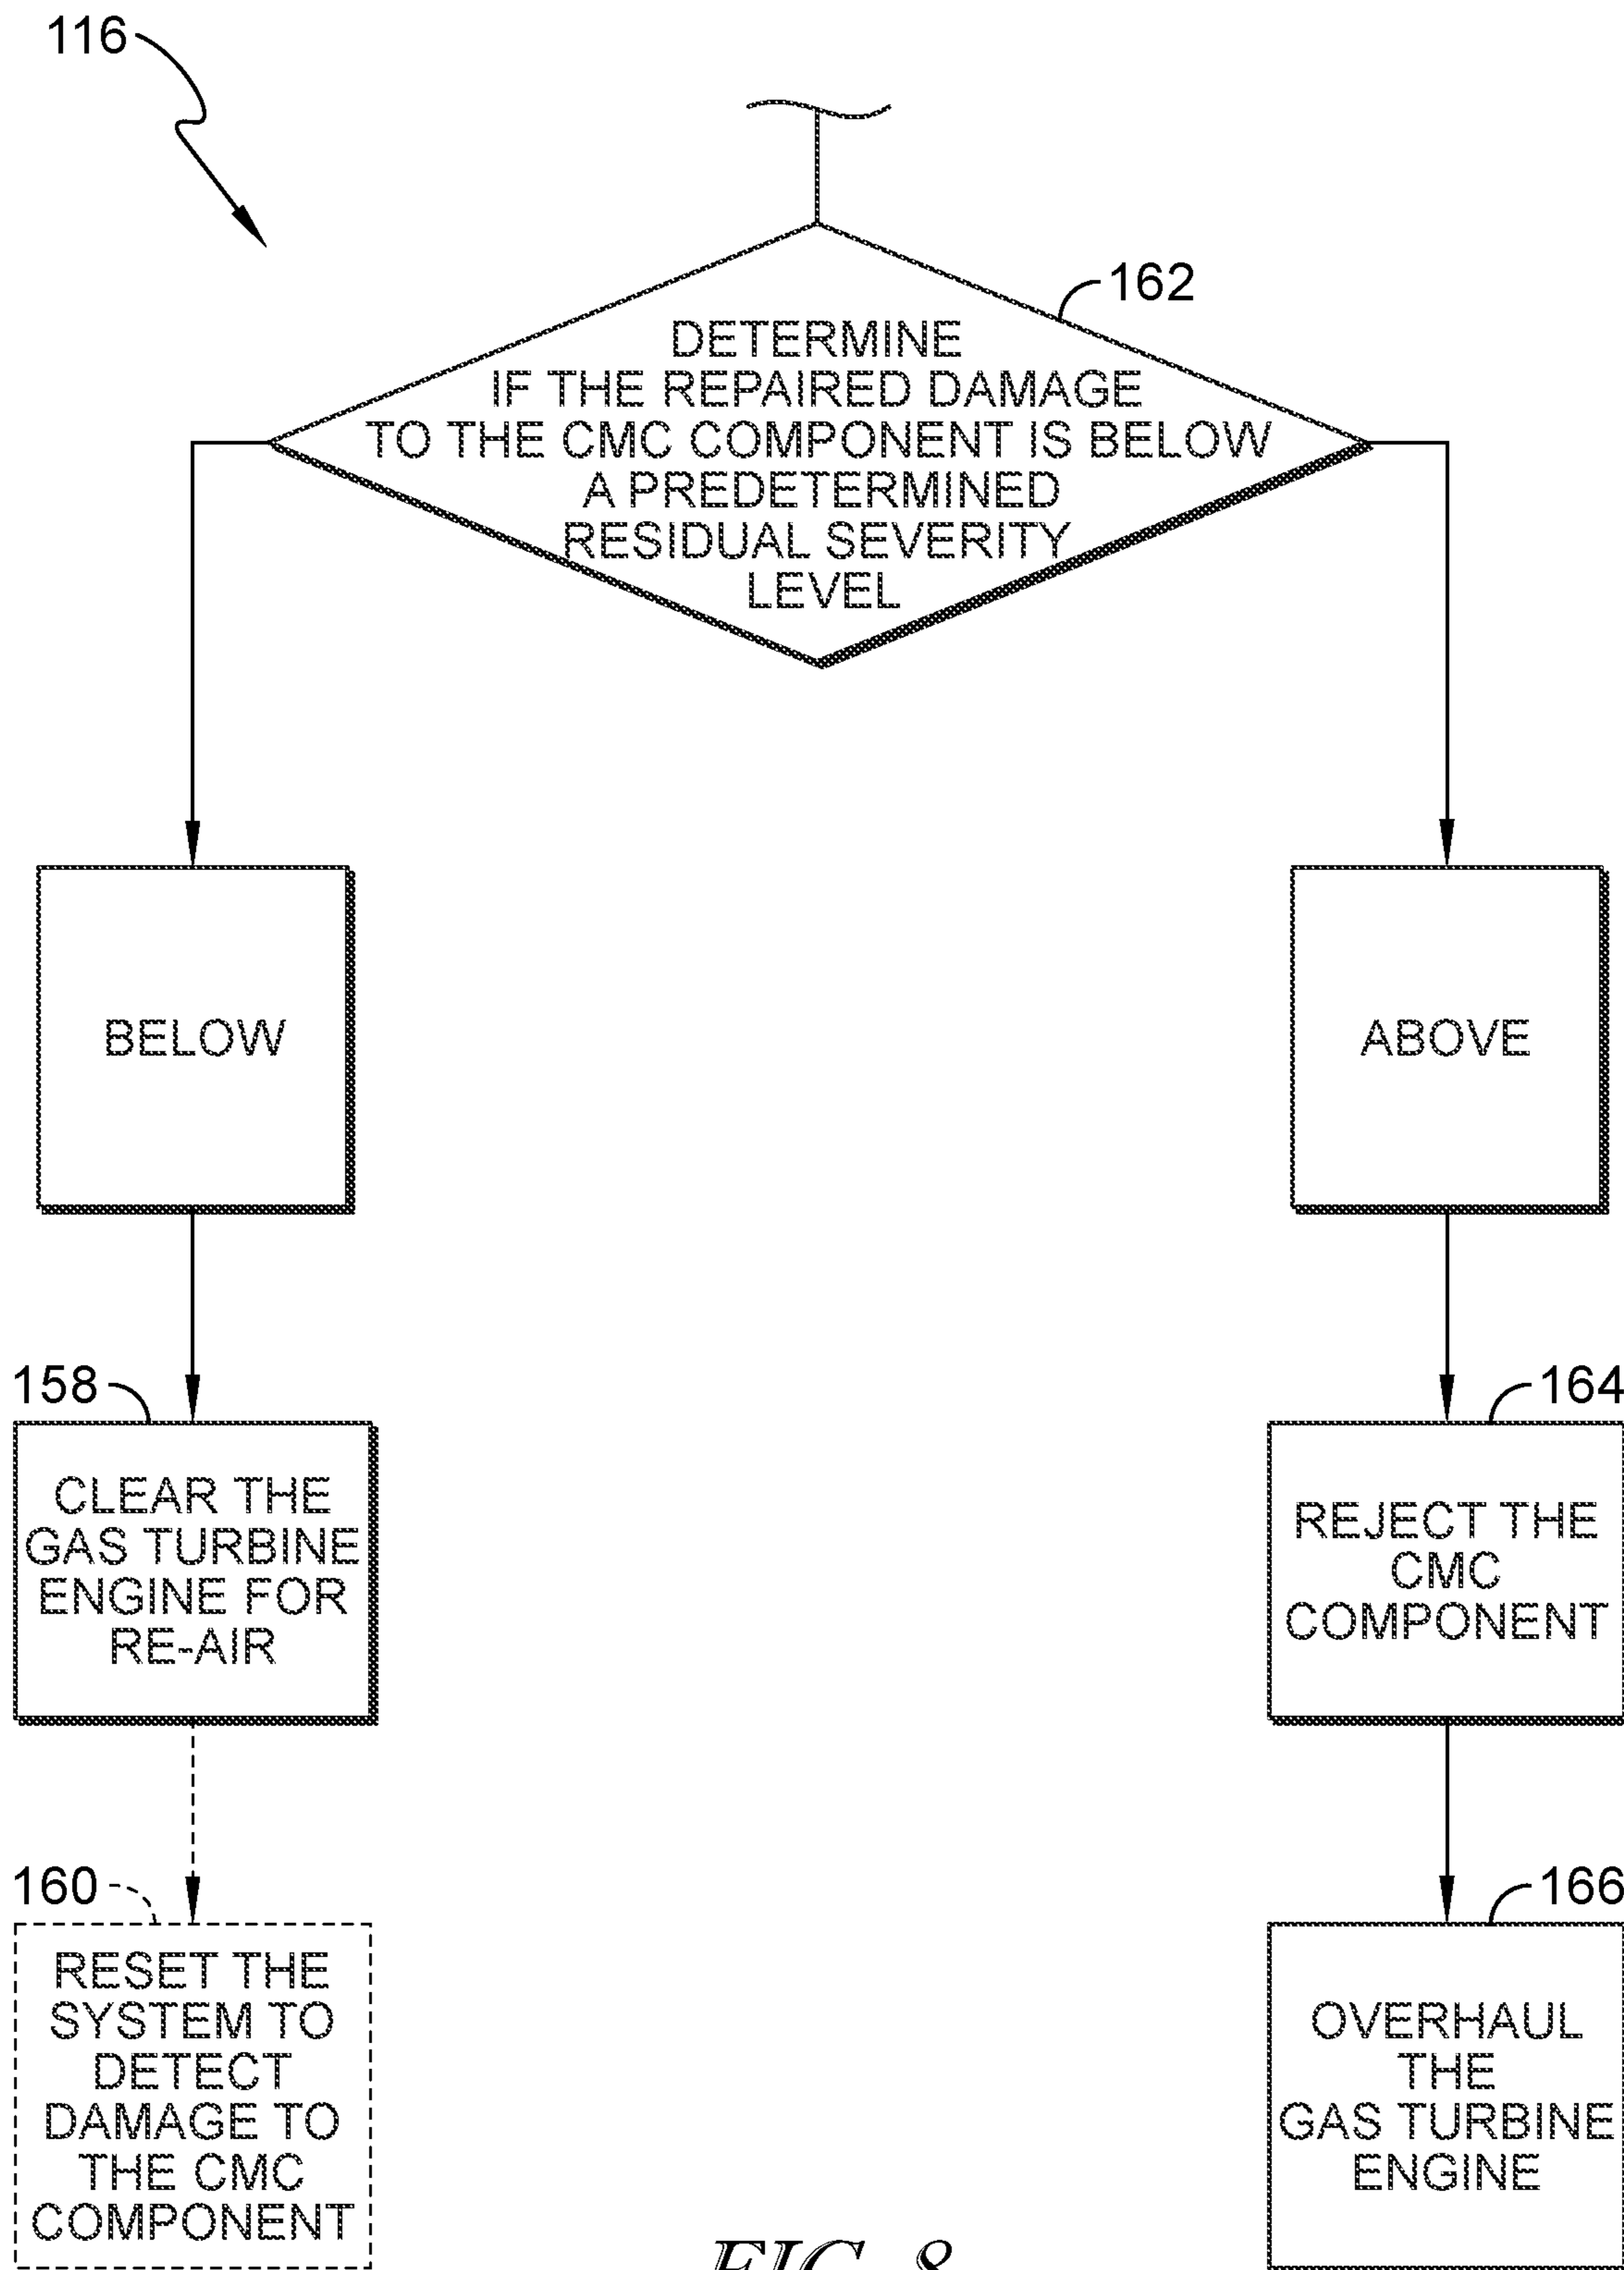
FIG. 8 is a diagrammatic view of the assessment step of FIG. 3 showing the assessment step includes determining if the repaired damaged to the ceramic matrix composite component is below a predetermined residual severity limit; and

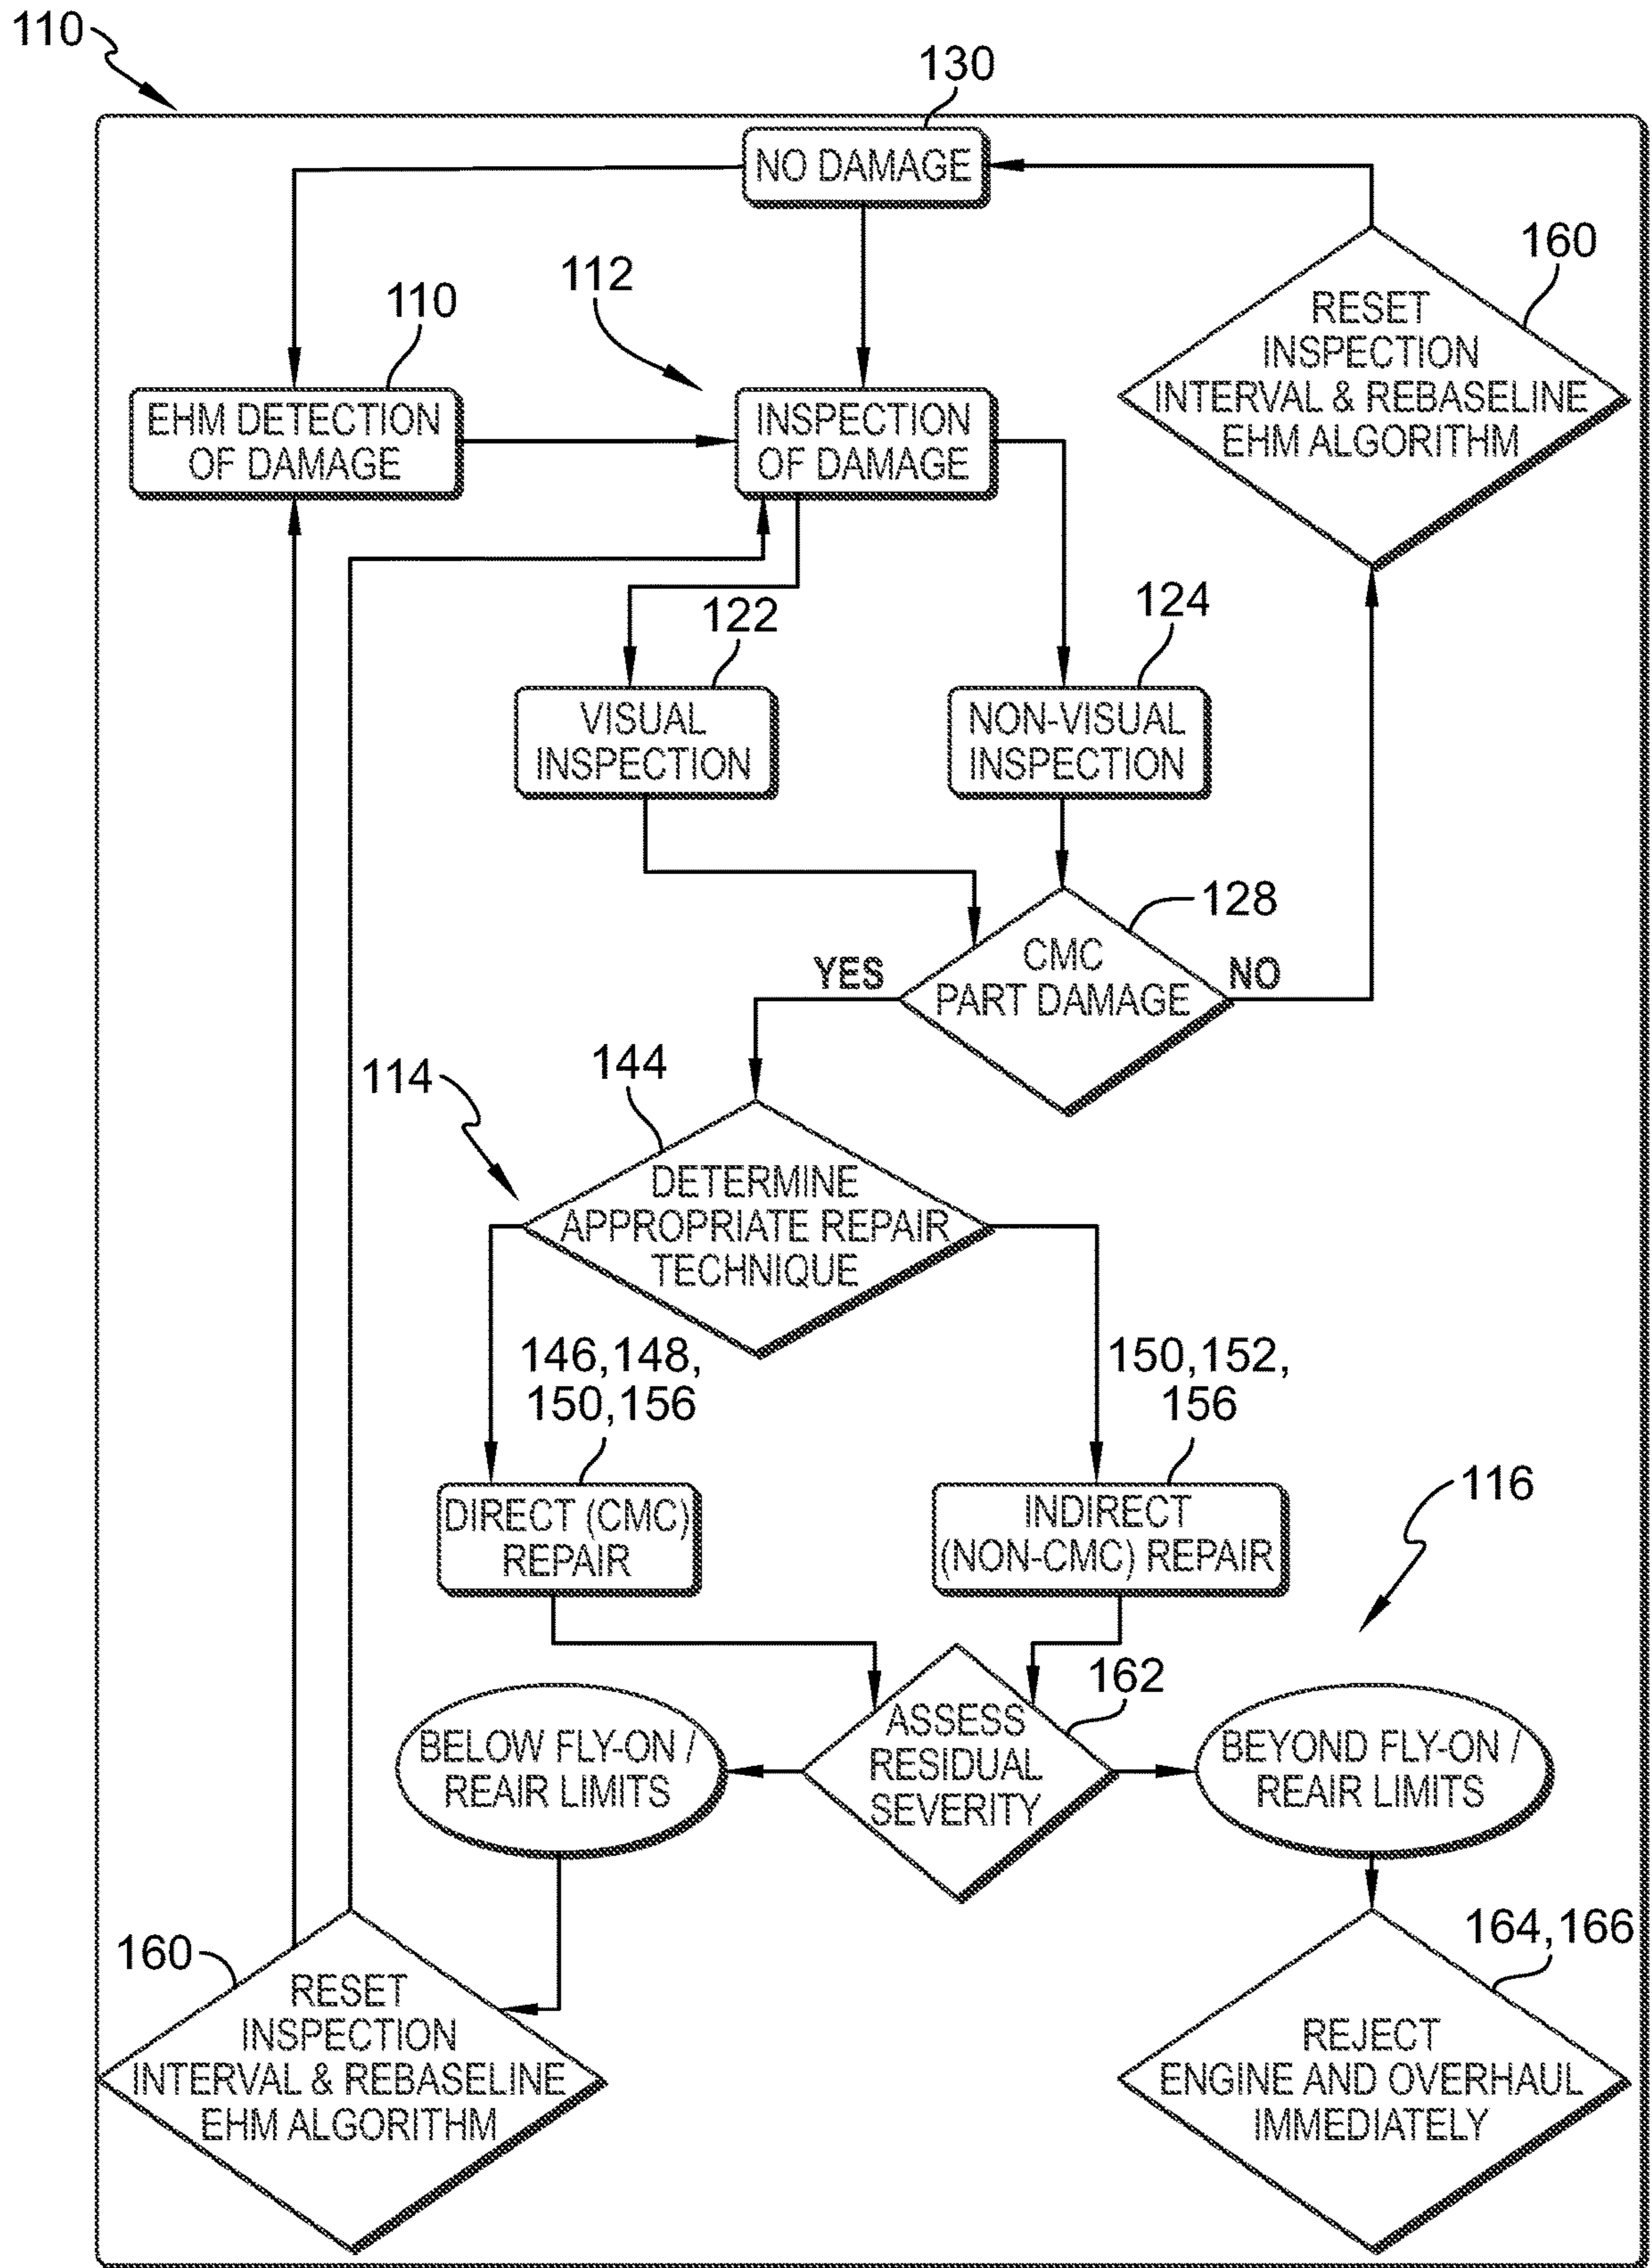
FIG. 9 is a diagrammatic view of the method of FIG. 3 showing the method includes a detection step along with the inspection, repair, and assessment steps.
