(10) **Patent No.:** **US 11,592,051 B1**
(45) **Date of Patent:** **Feb. 28, 2023**

(54) **BOLT EXTENDER ARRANGEMENT**

A bolt extender includes a bottom portion defining internal threads and a multi-sided outer surface, an upper shoulder, and a threaded rod projecting upwardly from said upper shoulder.

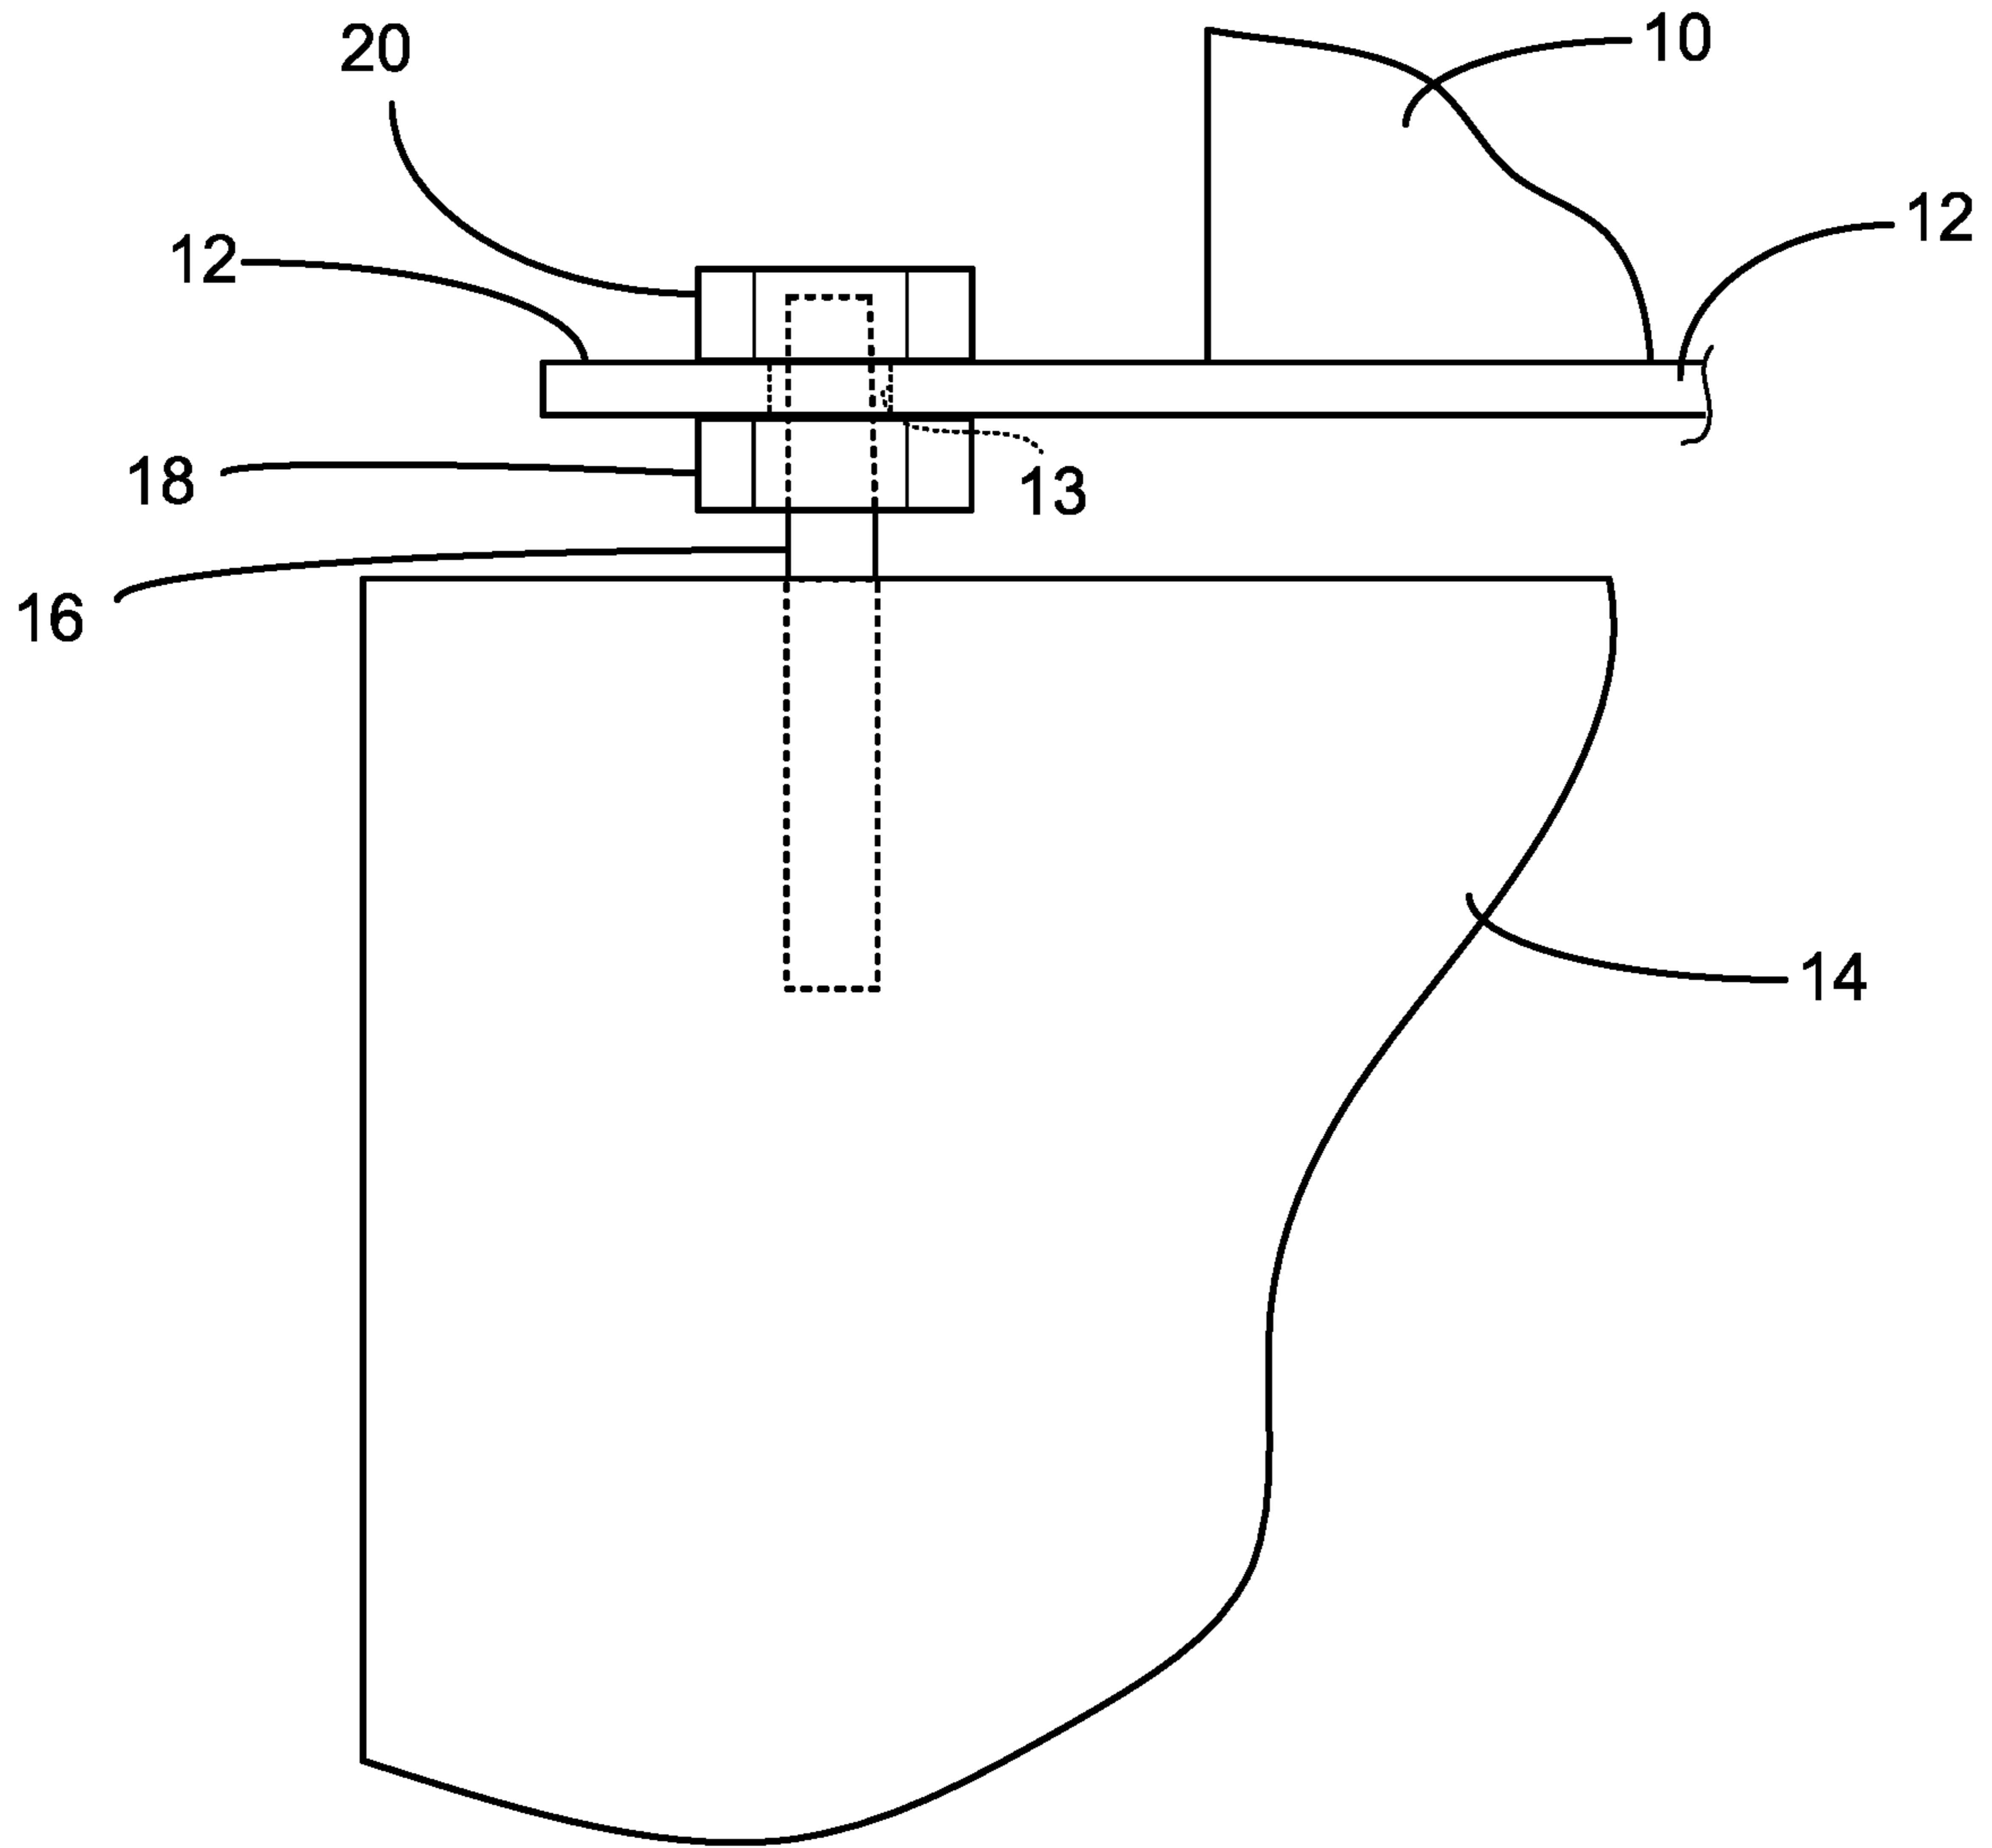
Fig 2 Prior Art

FIG. 2 is an enlarged, close-up view of one of the bolt arrangements of FIG. 1, showing that the threaded rod is too short for full engagement of the threads of the tightening nut;

Sometimes, the projecting portion of the threaded foundation rod 16 is too short to permit full engagement of the tightening nut 20. FIGS. 1 and 2 show a case in which one of the threaded foundation rods 16 is too short. This may occur, for instance, if the installer is overzealous in burying the threaded rods 16 in the foundation 14, or if the foundation is at a slight decline, which necessitates a longer threaded projection of some of the rods 16 to accommodate a longer adjustment to ensure a plumb installation of the pole 10.

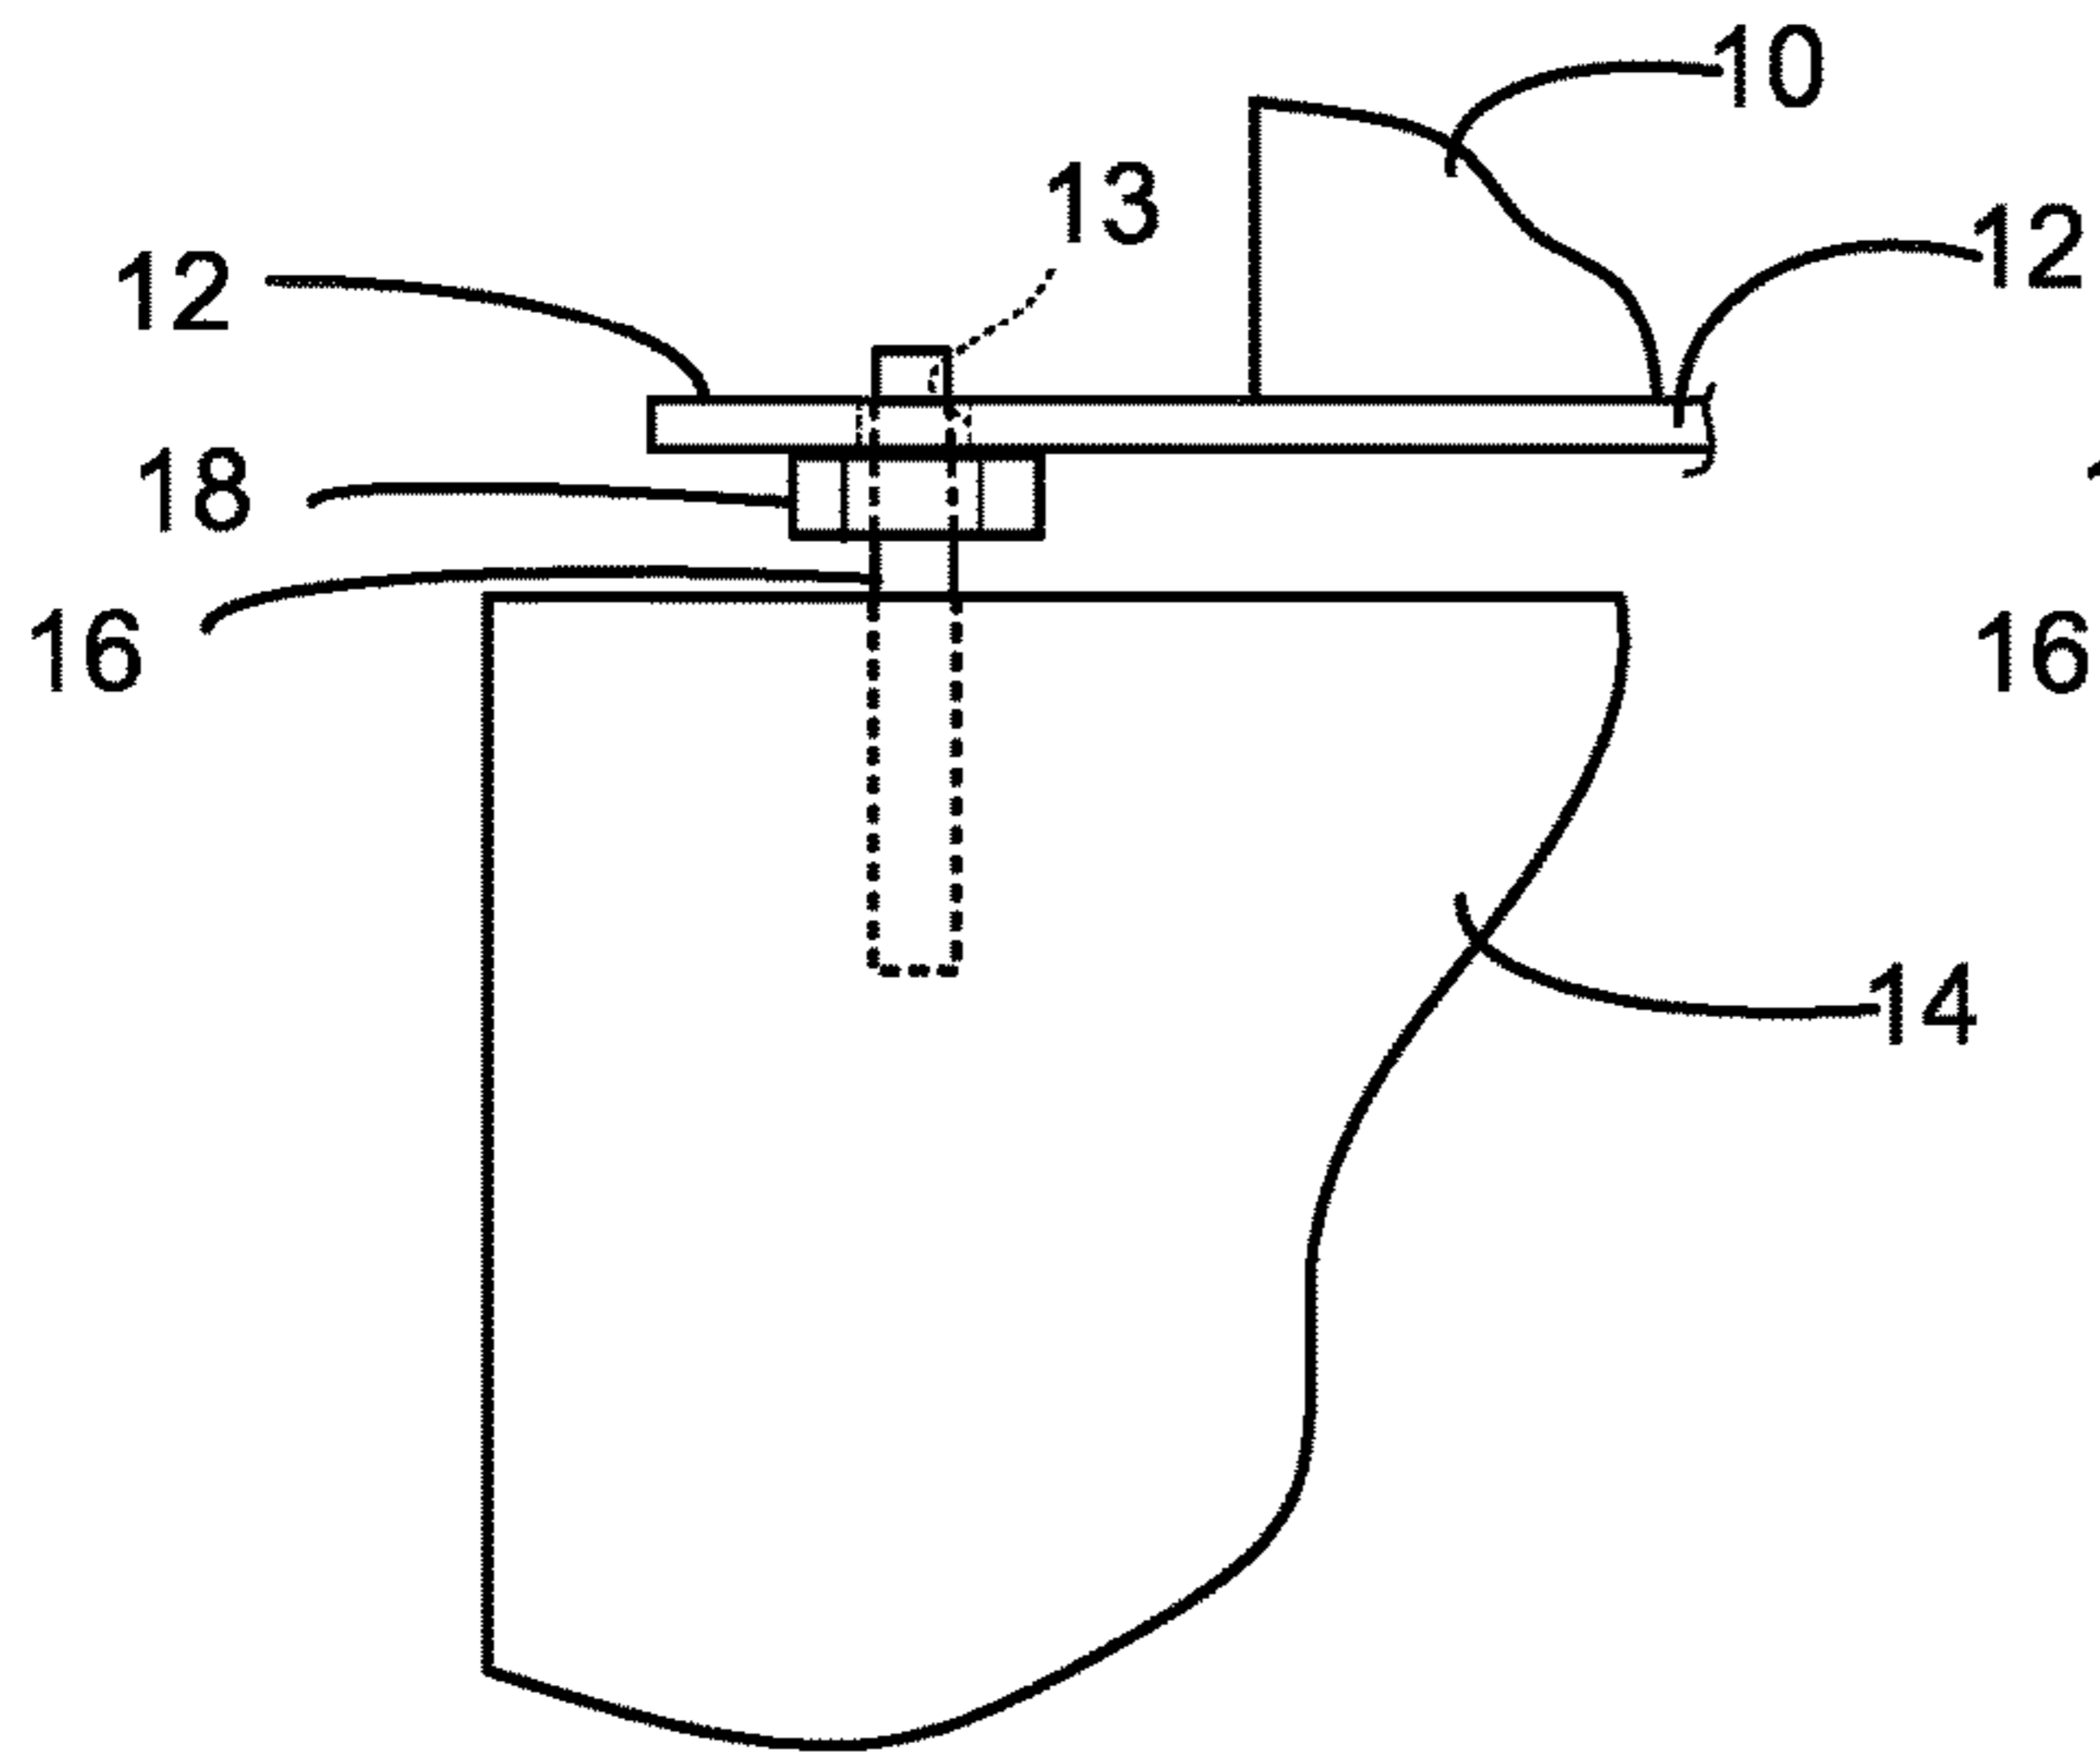
Fig 3

FIG. 3 is a view similar to FIG. 2, but with the tightening nut removed, in preparation for correcting the issue of the short, threaded rod;

FIGS. 3-6 show the steps in preparing for correcting the issue of the threaded rod 16 which is too short for full engagement of the threads of the tightening nut 20. The first step, shown in FIG. 3, is to remove the tightening nut 20. (Although the other foundation rods 16 are not shown, it is understood that all the tightening nuts 20 are removed from all the foundation rods.) Next, as shown in FIG. 4, the pole 10 with its flanged base 12 is removed. Then, as shown in FIG. 5, the leveling nut 18 is removed from the too-short foundation rod 16. The other leveling nuts 18 are left on the other foundation rods 16. Finally, as shown in FIG. 6, the projecting portion of the too-short threaded foundation rod 16 is cut to a predetermined level, if necessary. In this particular embodiment, the exposed portion of the too-short threaded foundation rod 16 is cut to a length of 2 inches from the top of the foundation 14.

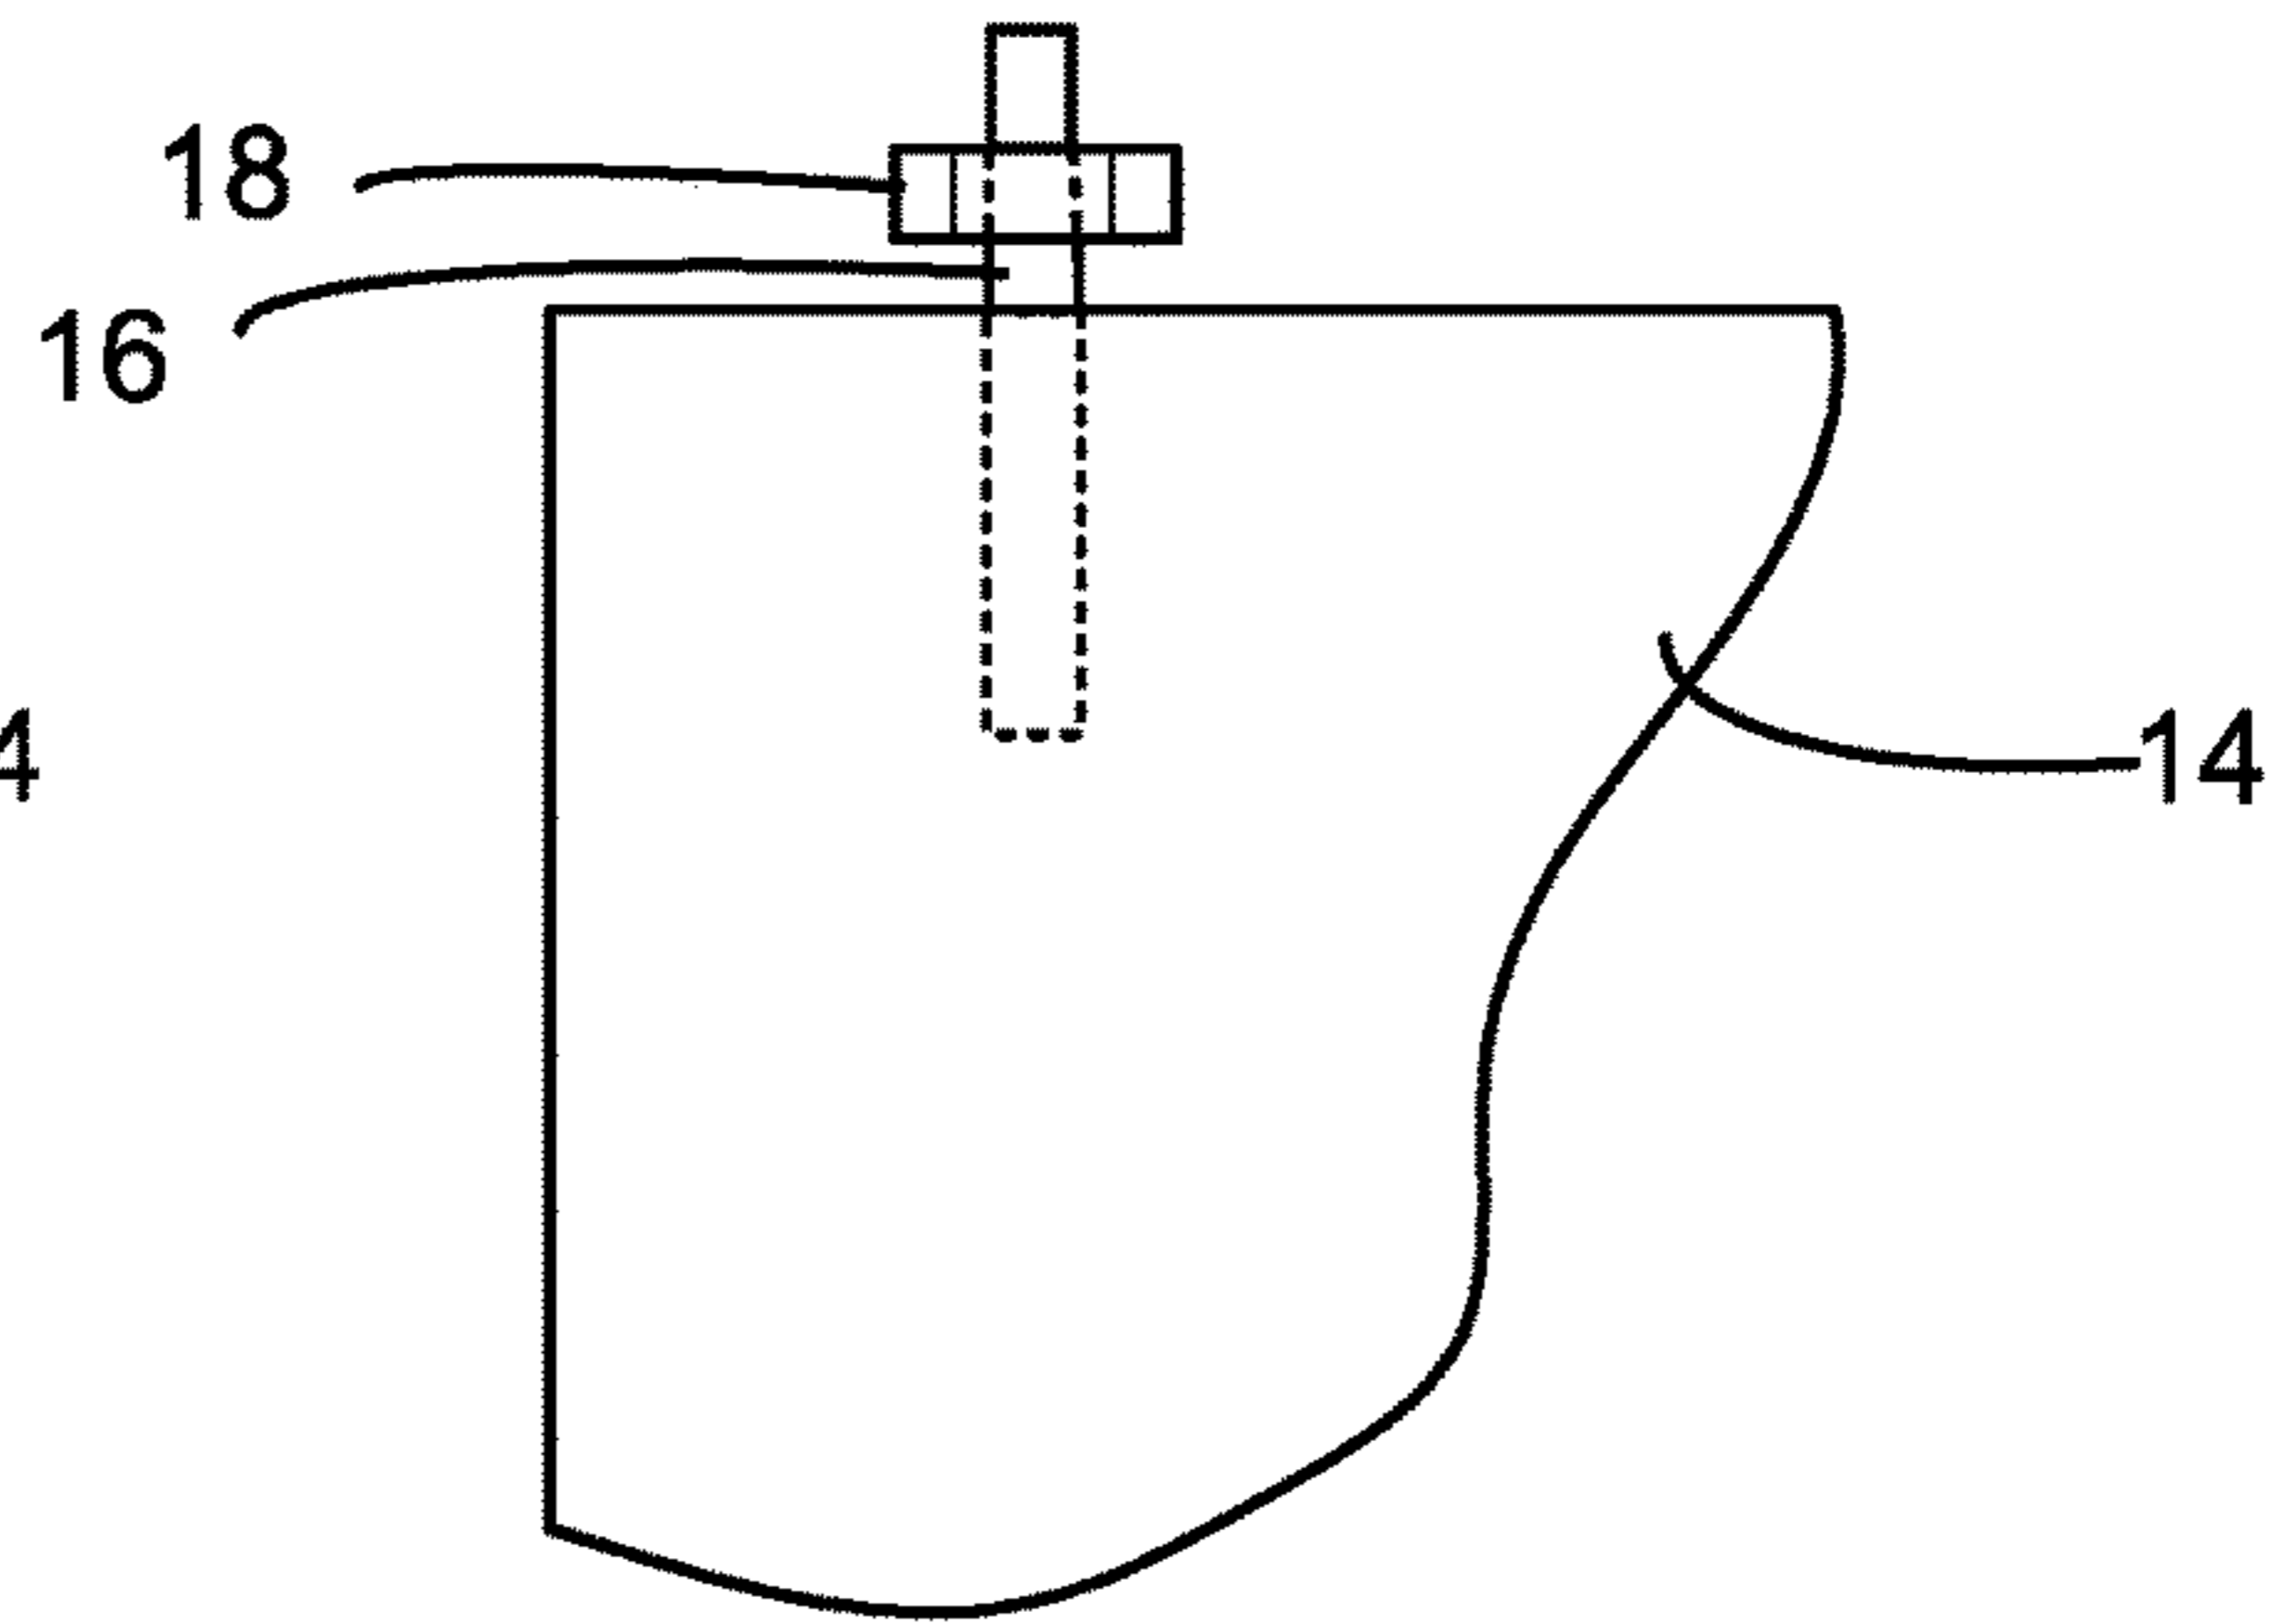
Fig 4

FIG. 4 is a view similar to FIG. 3, with the flanged pole removed, in the next step for correcting the issue with the short, threaded rod;

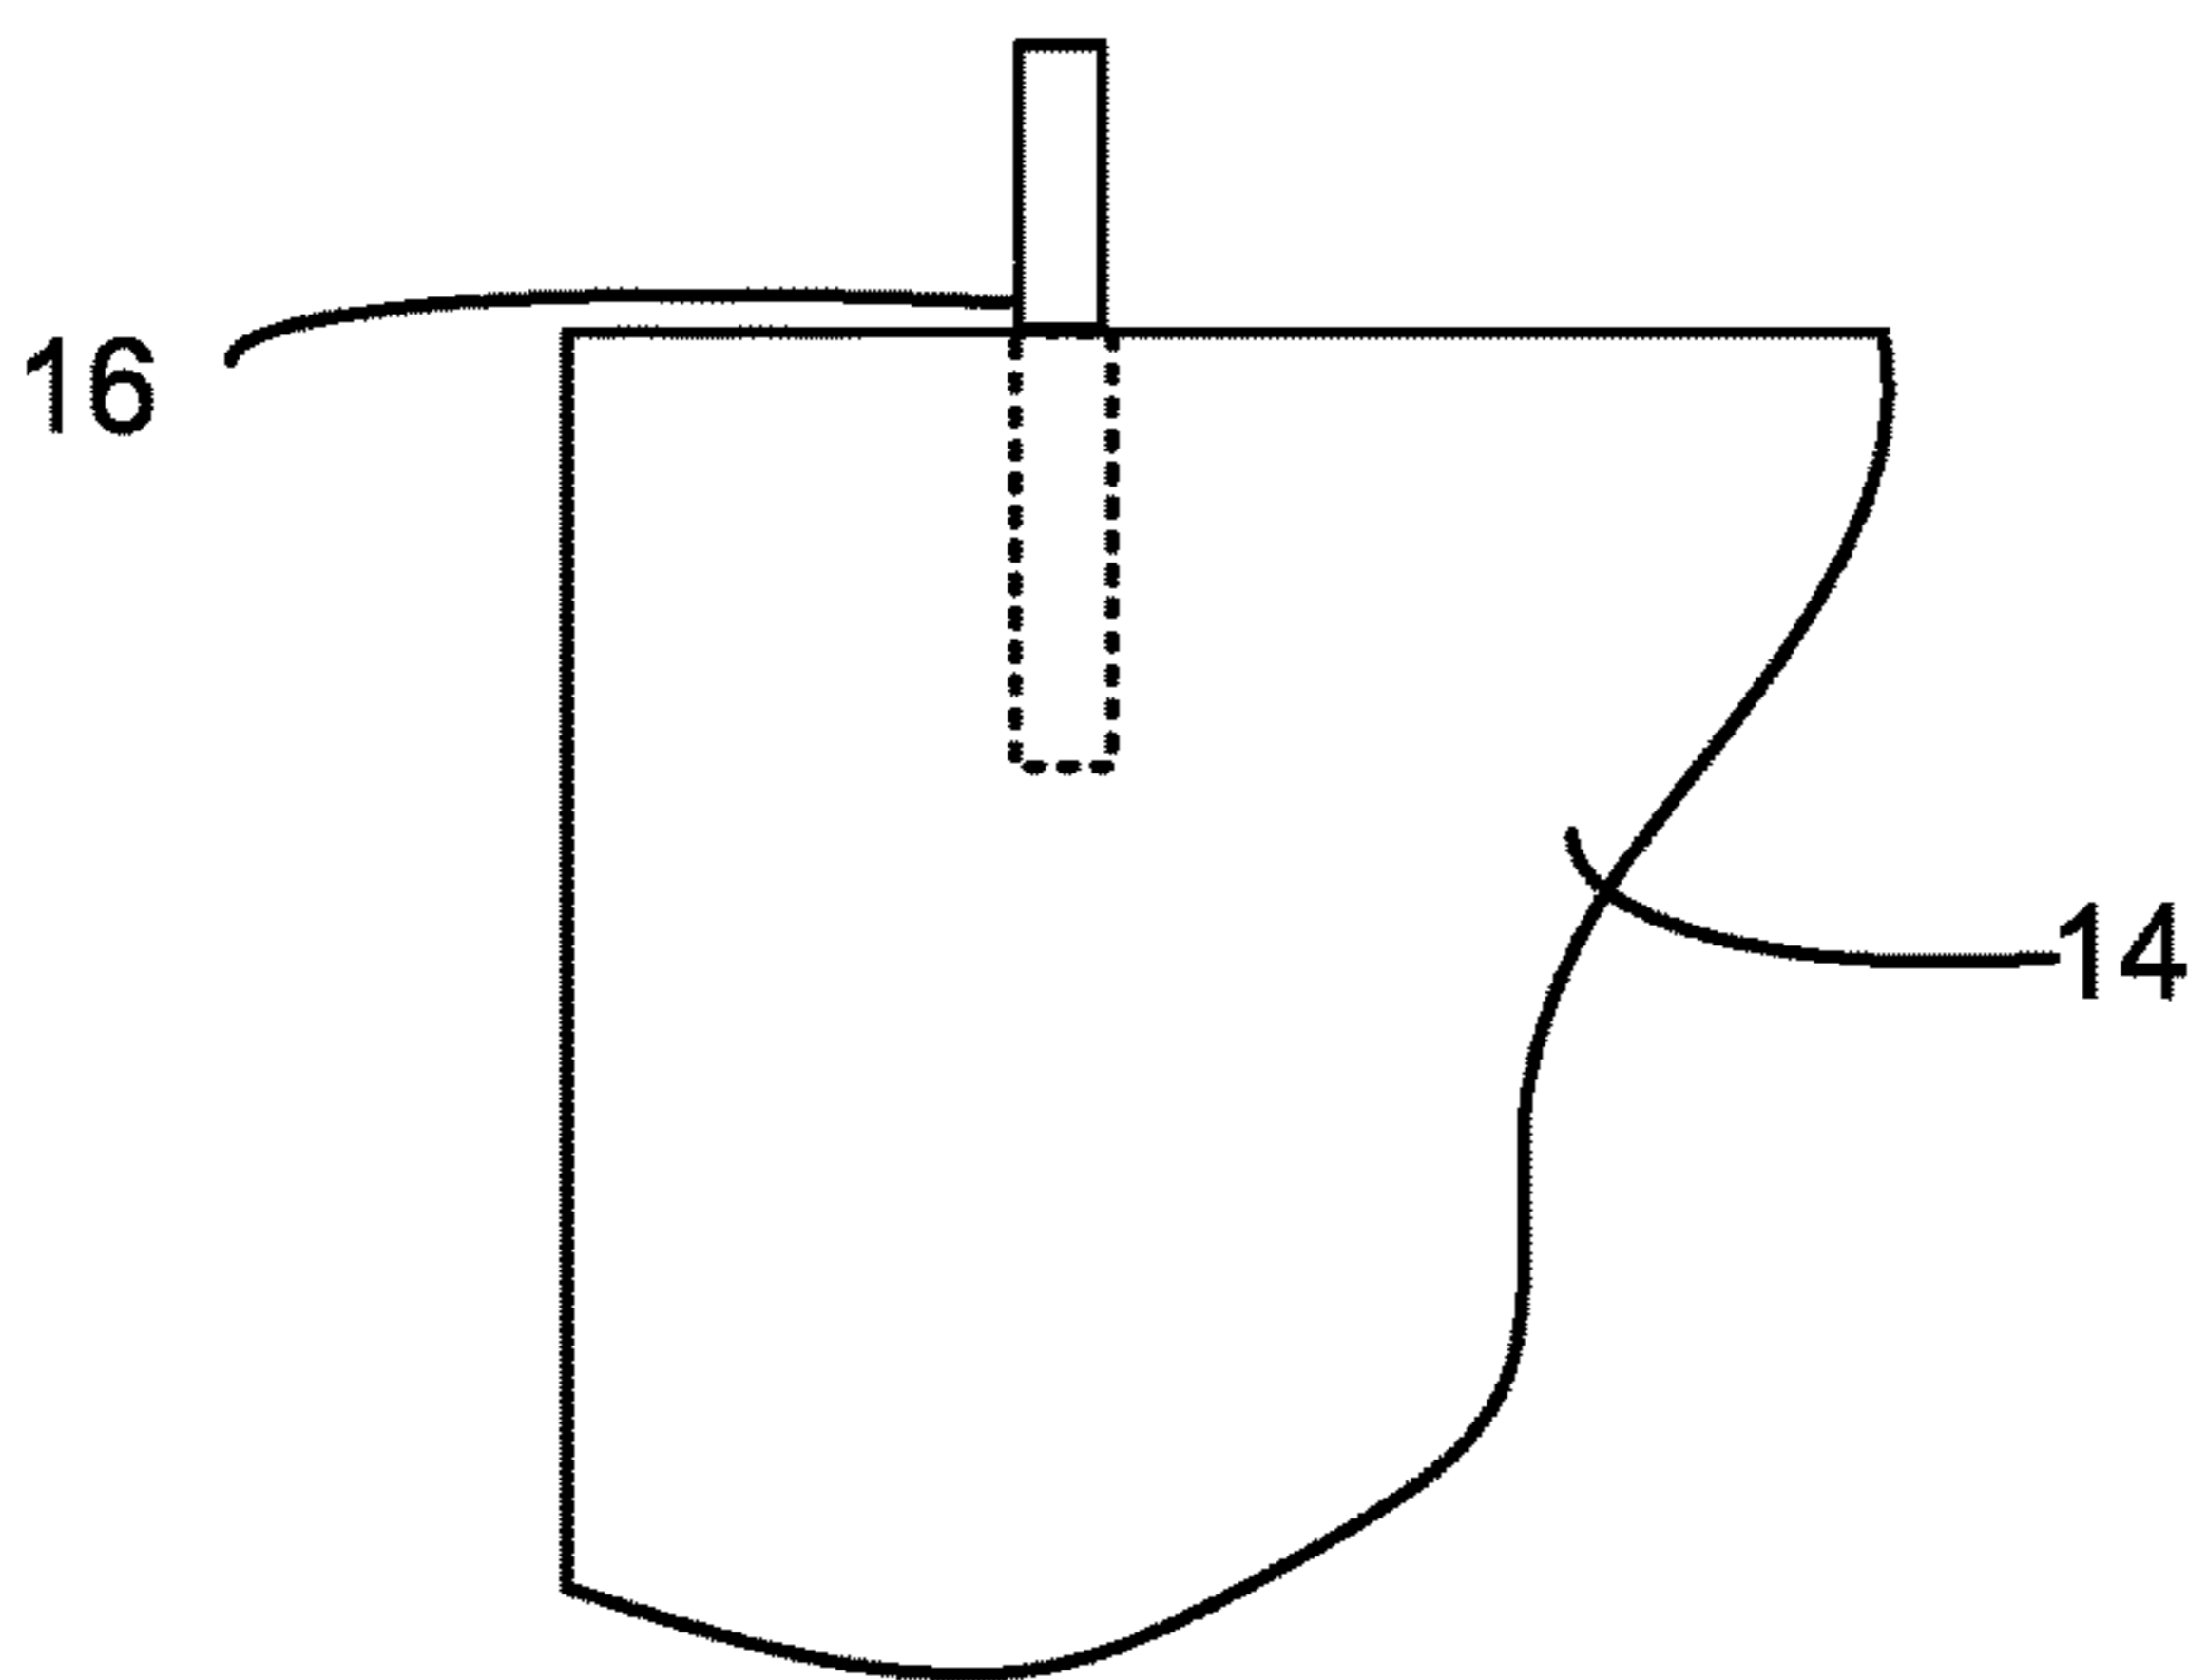
Fig 5

FIG. 5 is a view similar to FIG. 4, with leveling nut removed, in the next step for correcting the issue of the short, threaded rod;

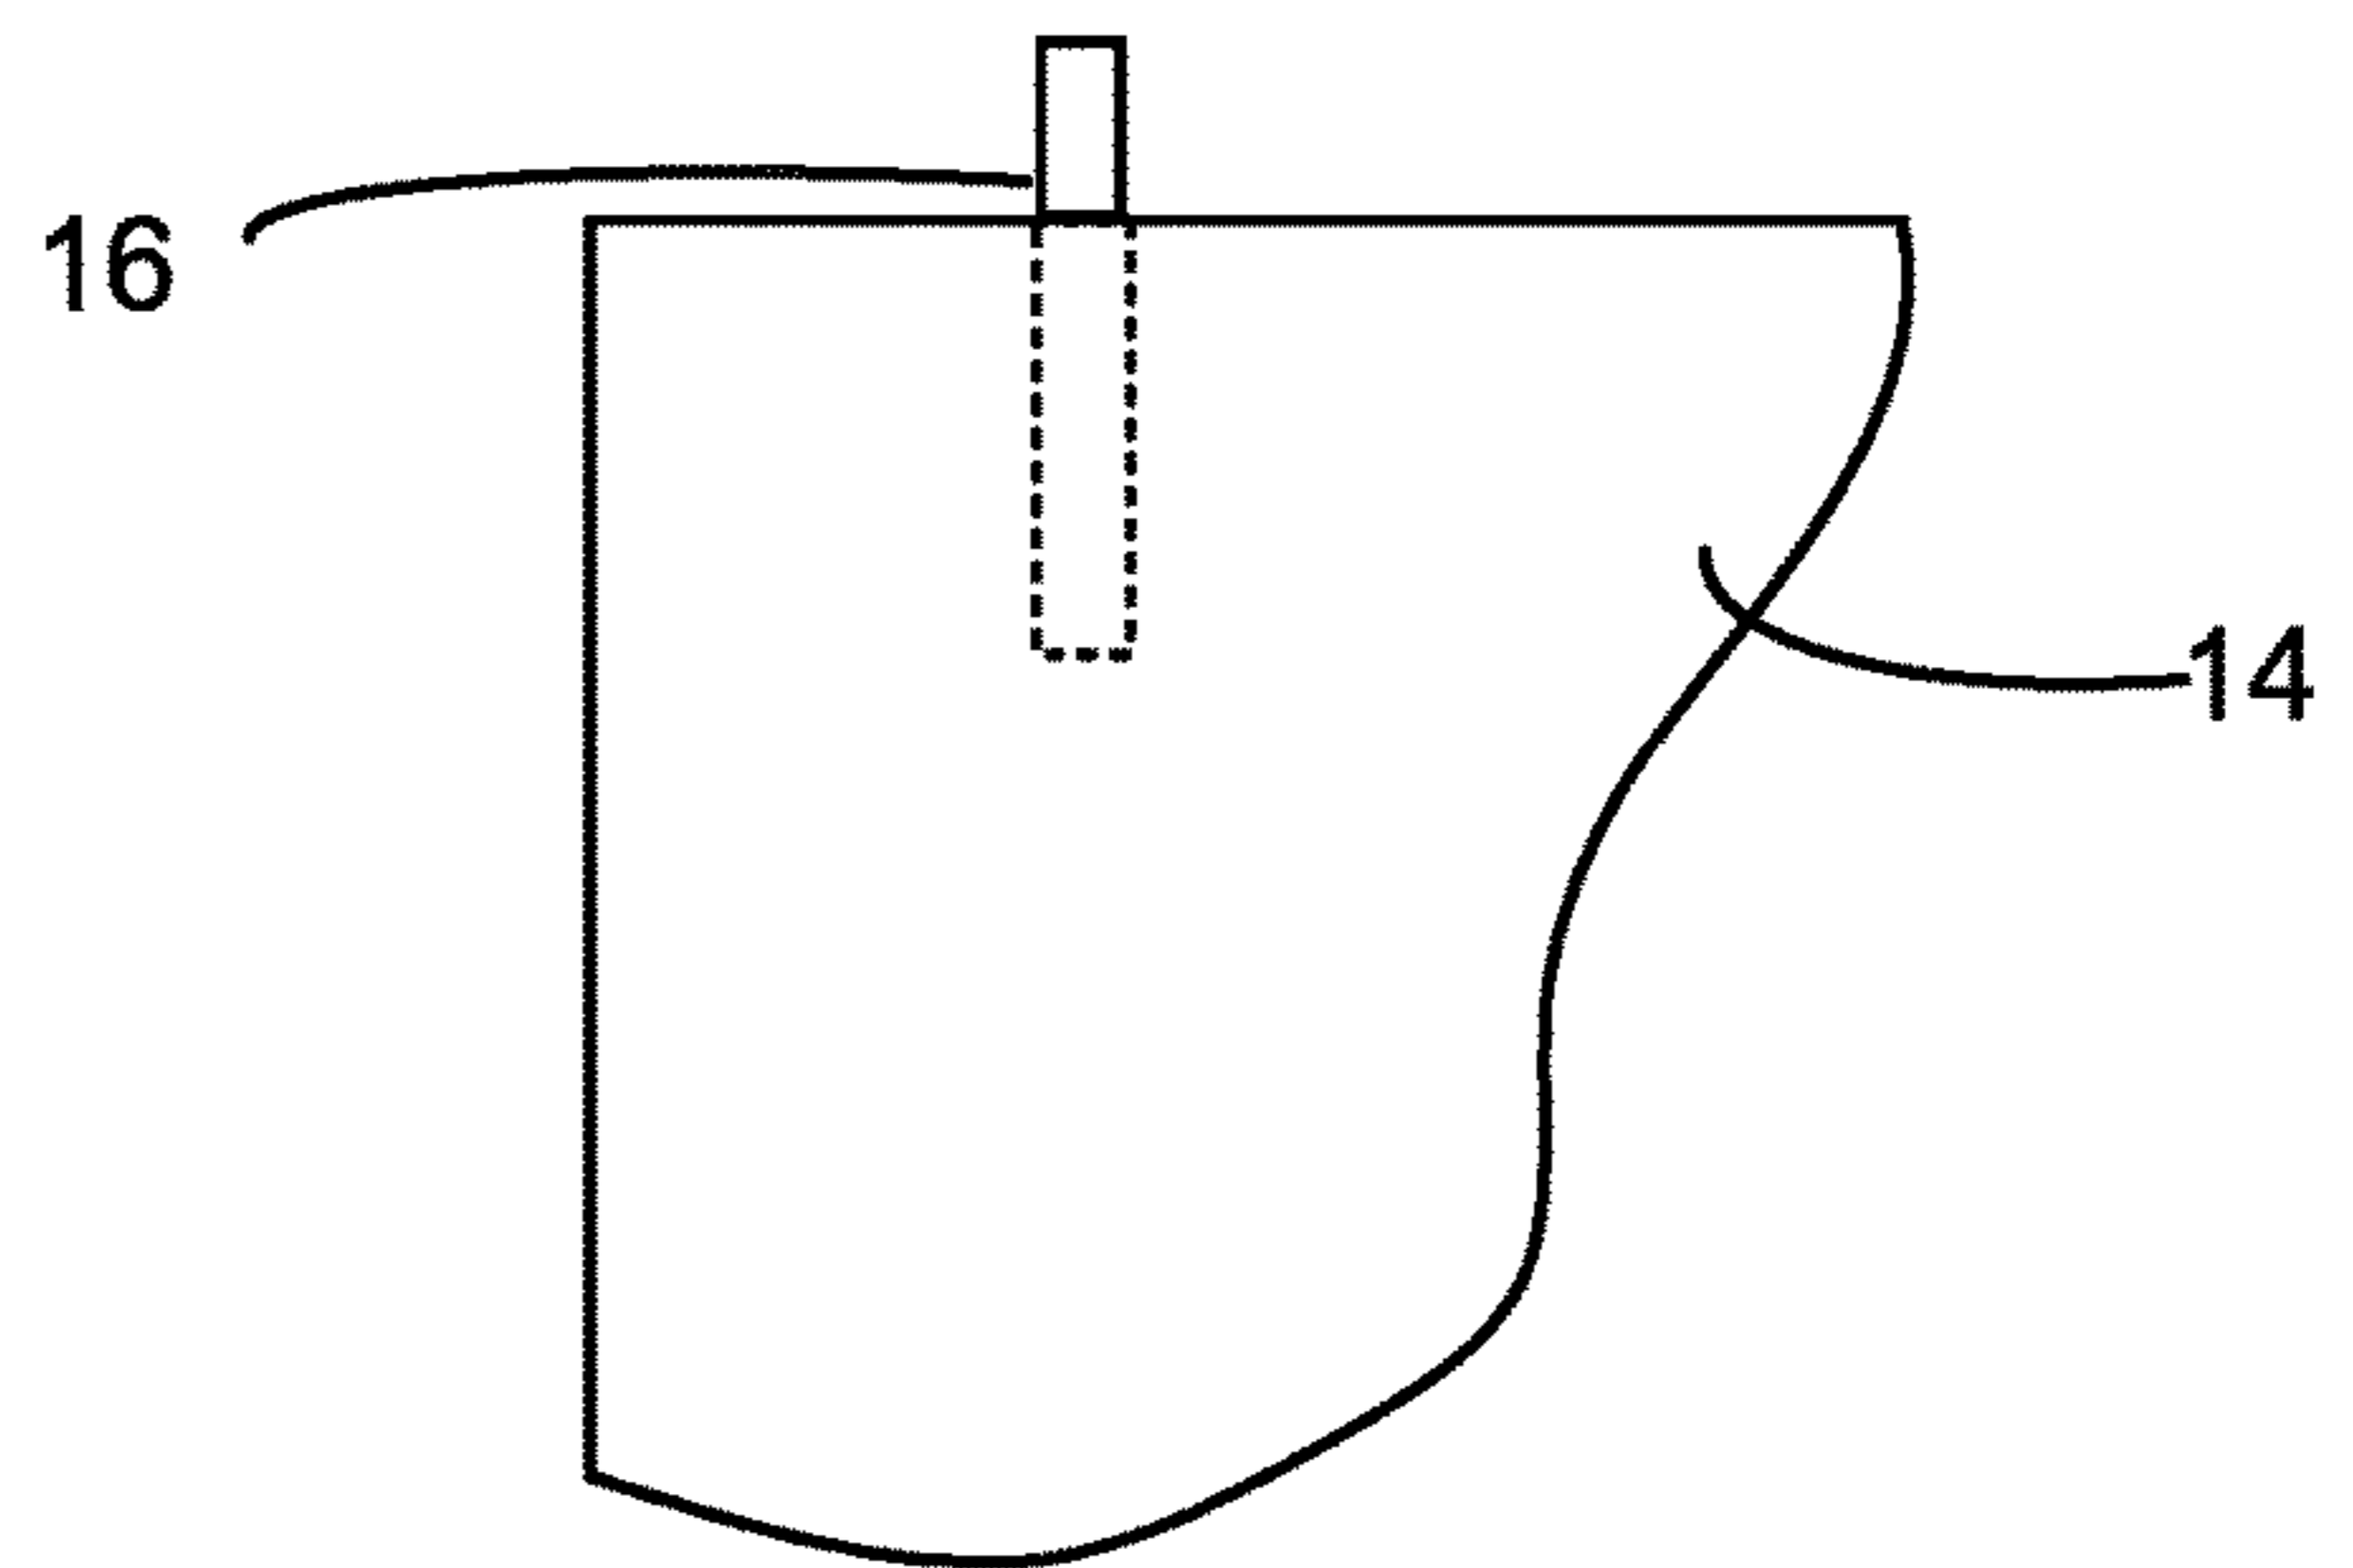
Fig 6

FIG. 6 is a view similar to FIG. 5, with the protruding portion of the short, threaded rod cut to a predetermined length, in the next step for correcting the issue of the short, threaded, rod;
