(10) **Patent No.:** **US 11,592,051 B1**
(45) **Date of Patent:** **Feb. 28, 2023**

(54) **BOLT EXTENDER ARRANGEMENT**

A bolt extender includes a bottom portion defining internal threads and a multi-sided outer surface, an upper shoulder, and a threaded rod projecting upwardly from said upper shoulder.

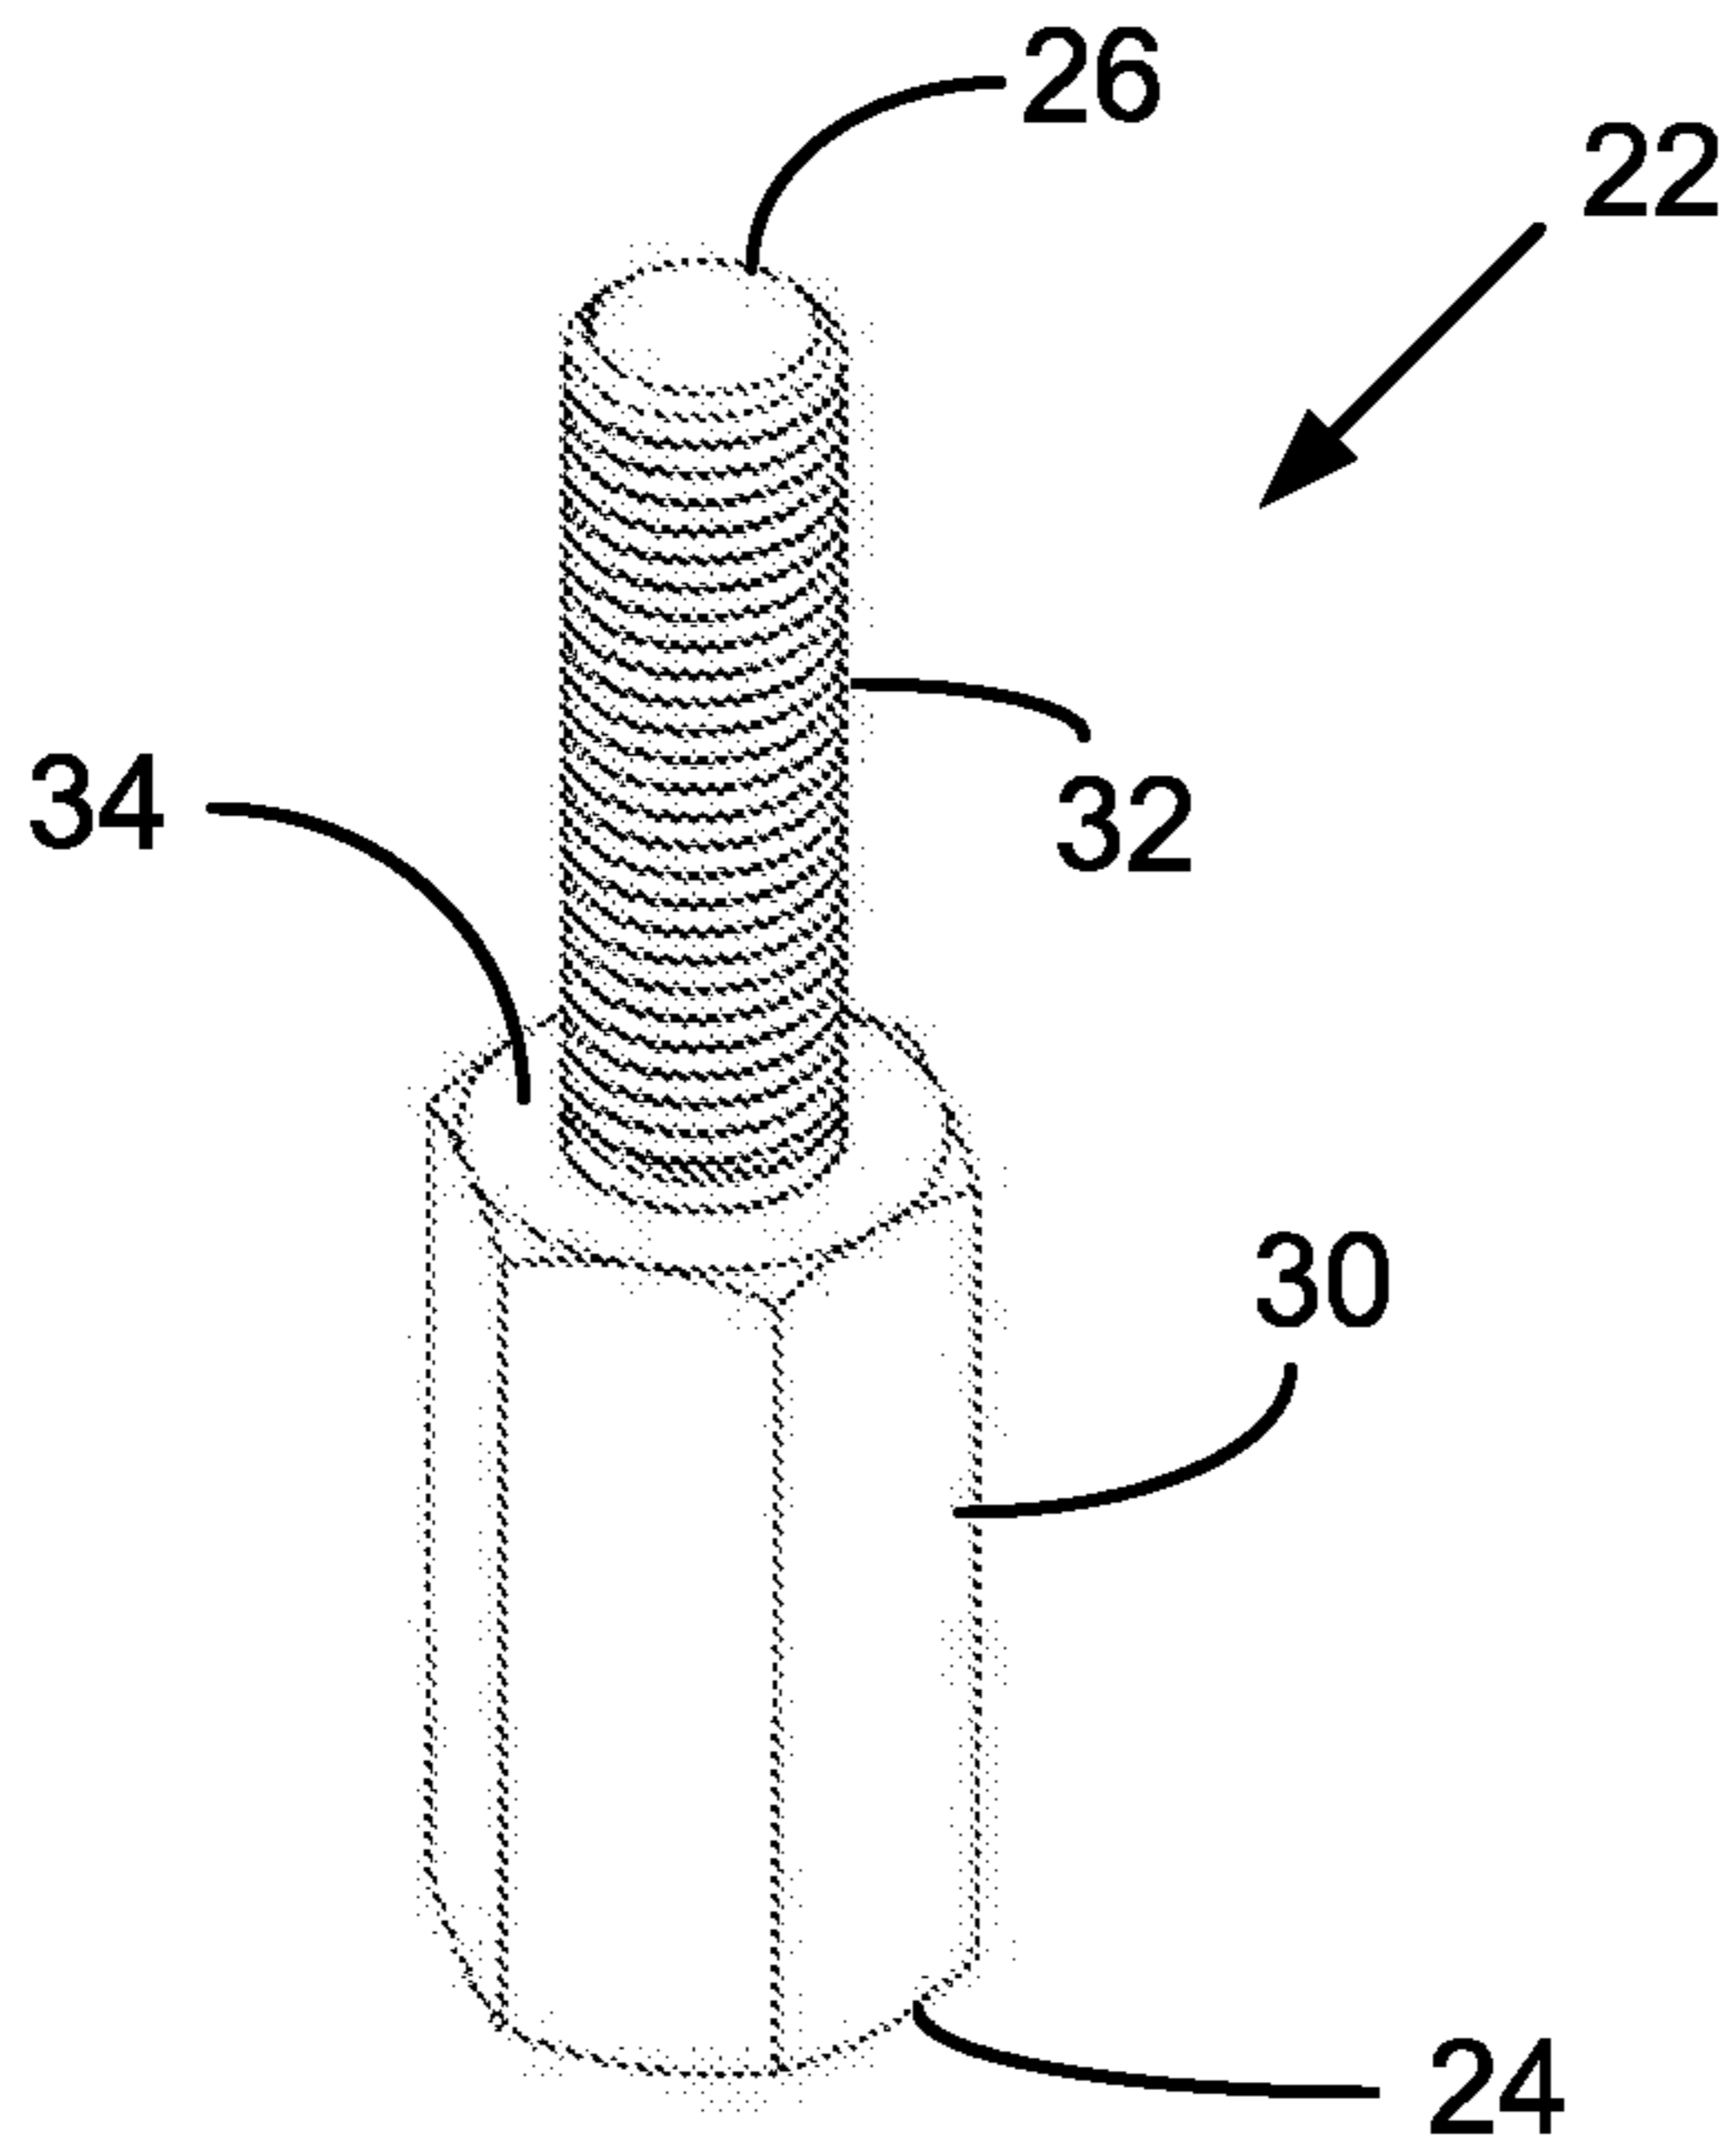
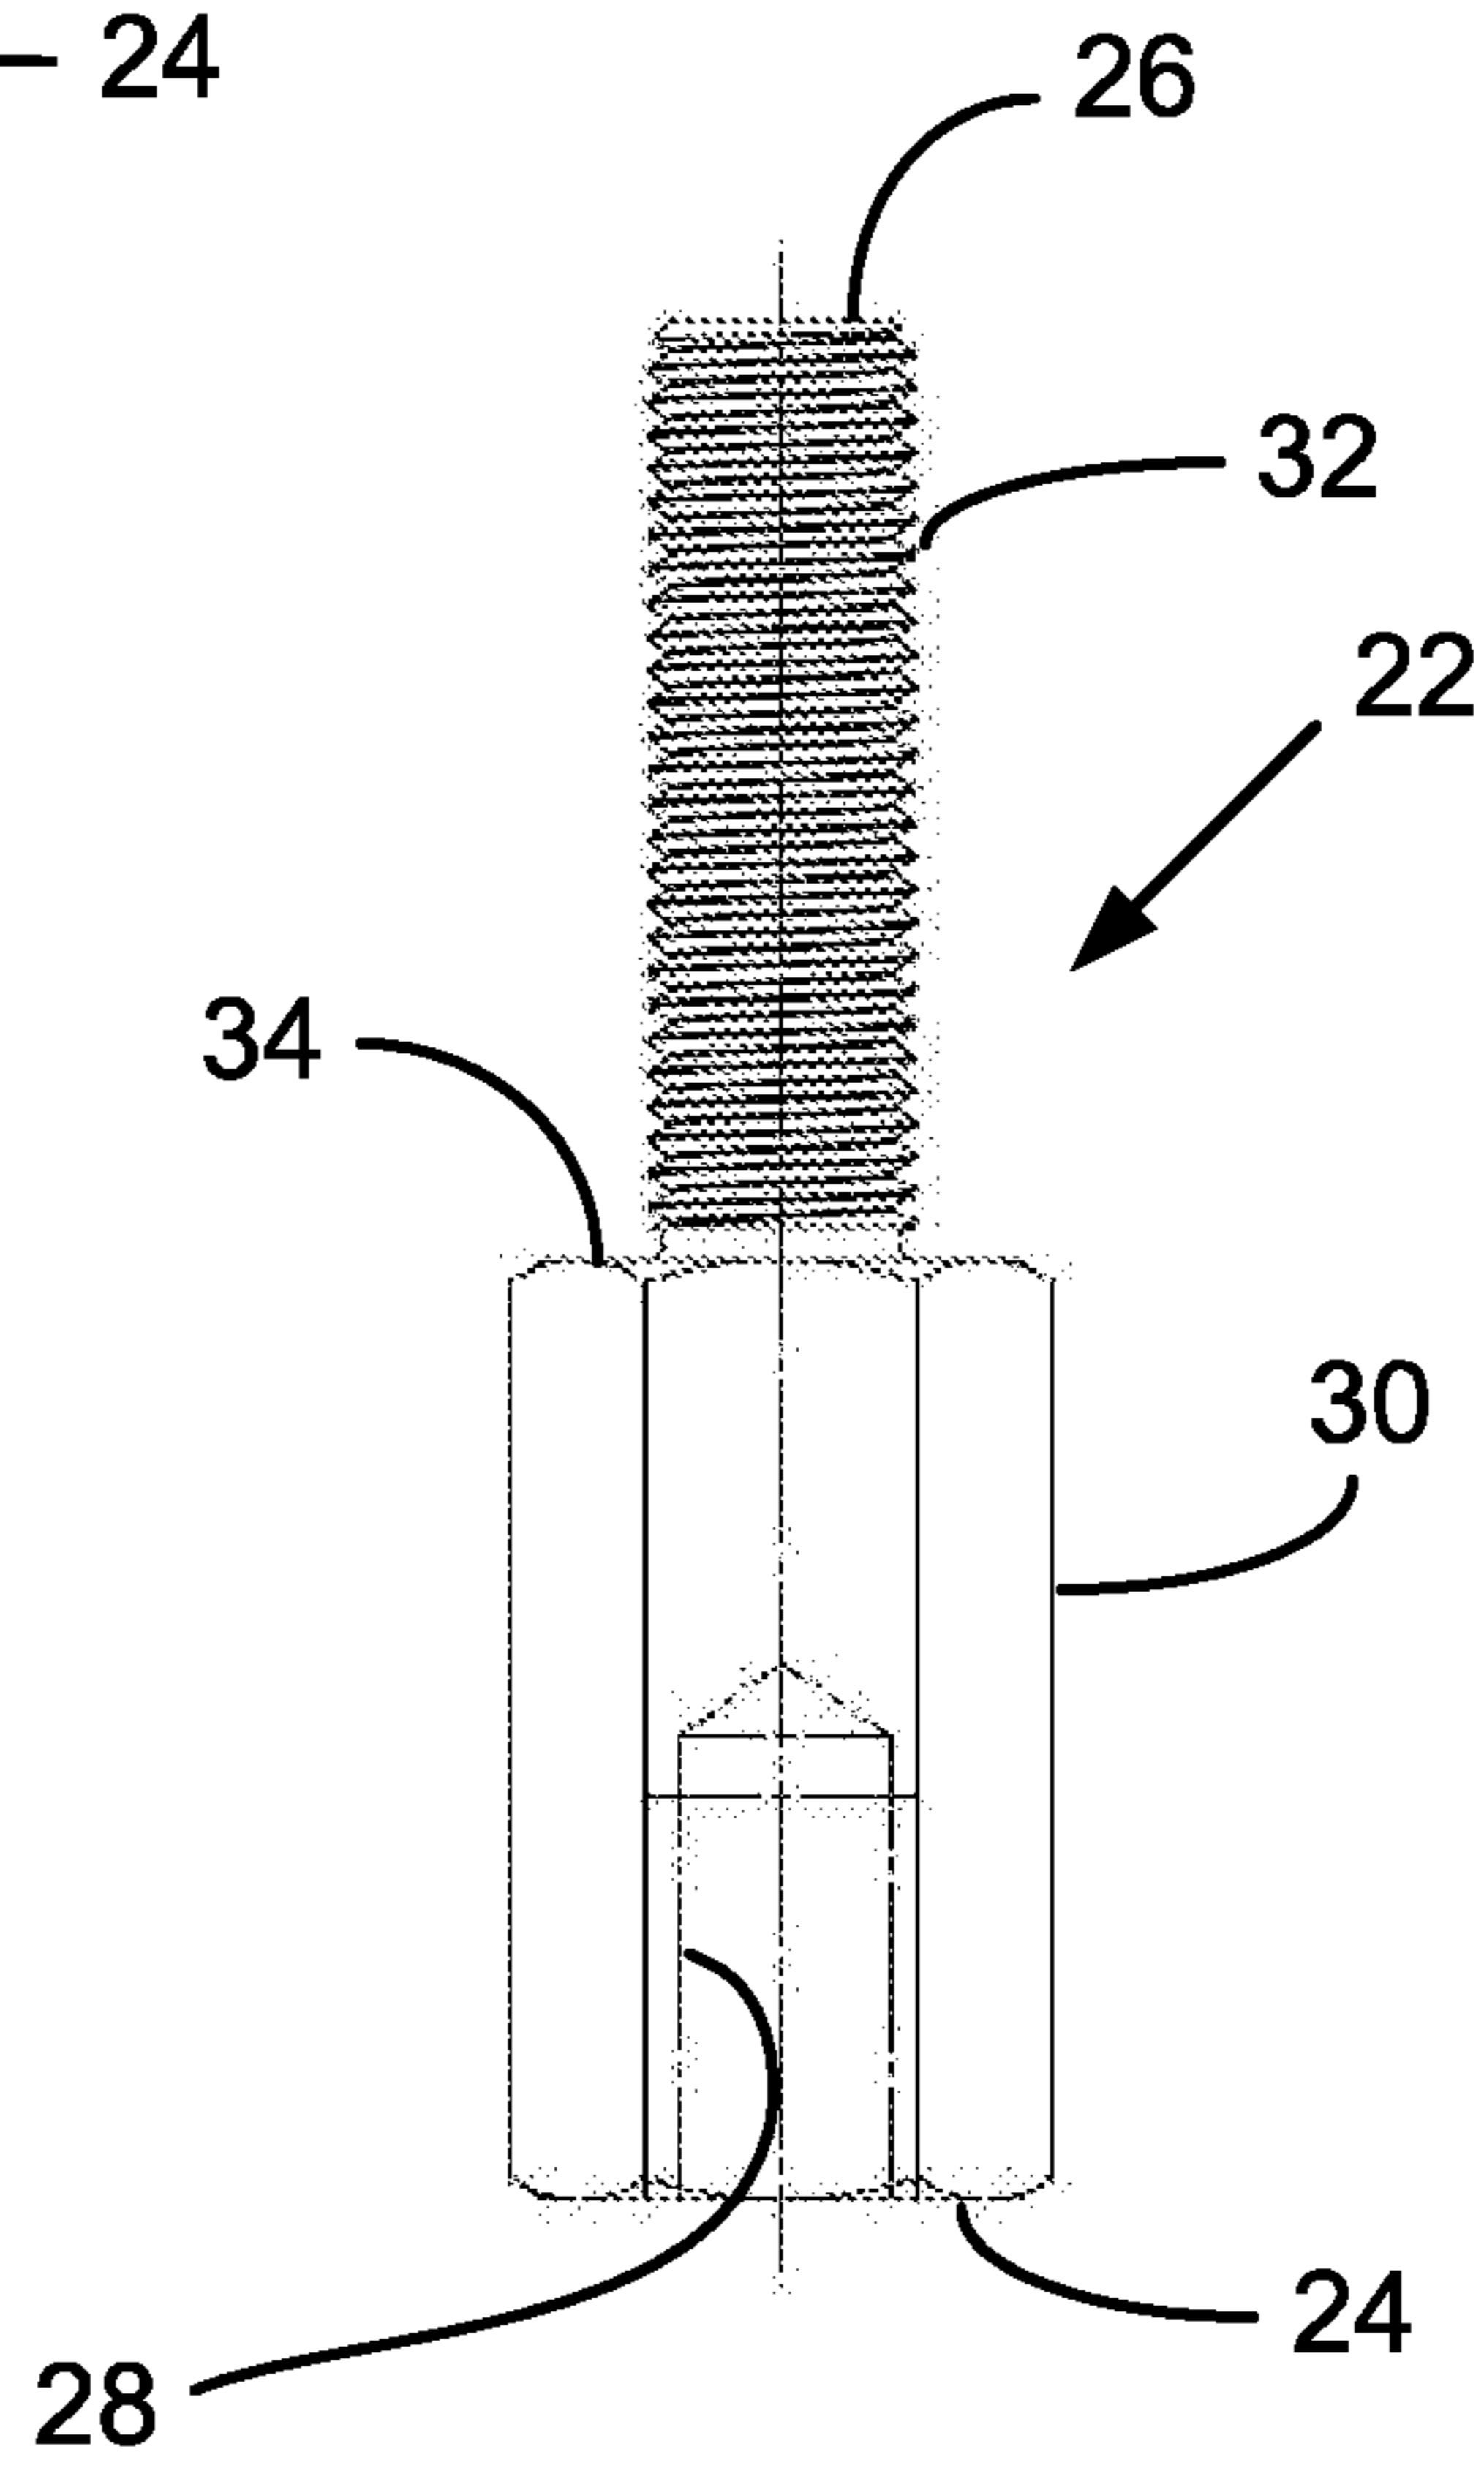
FIG. 7 is a perspective view of a bolt extender which is used to correct the issue of the short, threaded rod;

FIG. 8 is a side view of the bolt extender of FIG. 7;

FIGS. 7 and 8 show a bolt extender 22, which is used to correct the problem of the too-short threaded foundation rod 16. The bolt extender 22 is an elongated member having a bottom end 24 and a top end 26. The bottom portion of the bolt extender 22, extending from the bottom end 24, defines a hollow cylindrical internal surface 28 with internal threads. The bottom portion also has a multisided external surface 30, which, in this case, is hexagonal. The multisided external surface 30 continues to an upper shoulder 34. Extending from the top of the upper shoulder 34 is an elongated, solid rod 32 having external threads. The threaded internal surface 28 and the threaded outer surface of the rod 32 are coaxial. In a preferred embodiment, the thread size and pitch of the threaded outer surface portion 32 matches that of the internally threaded surface 28 (which also matches that of the threaded foundation rod 16).

The shoulder 34 acts as the leveling nut for the corrected installation, as described in more detail below.

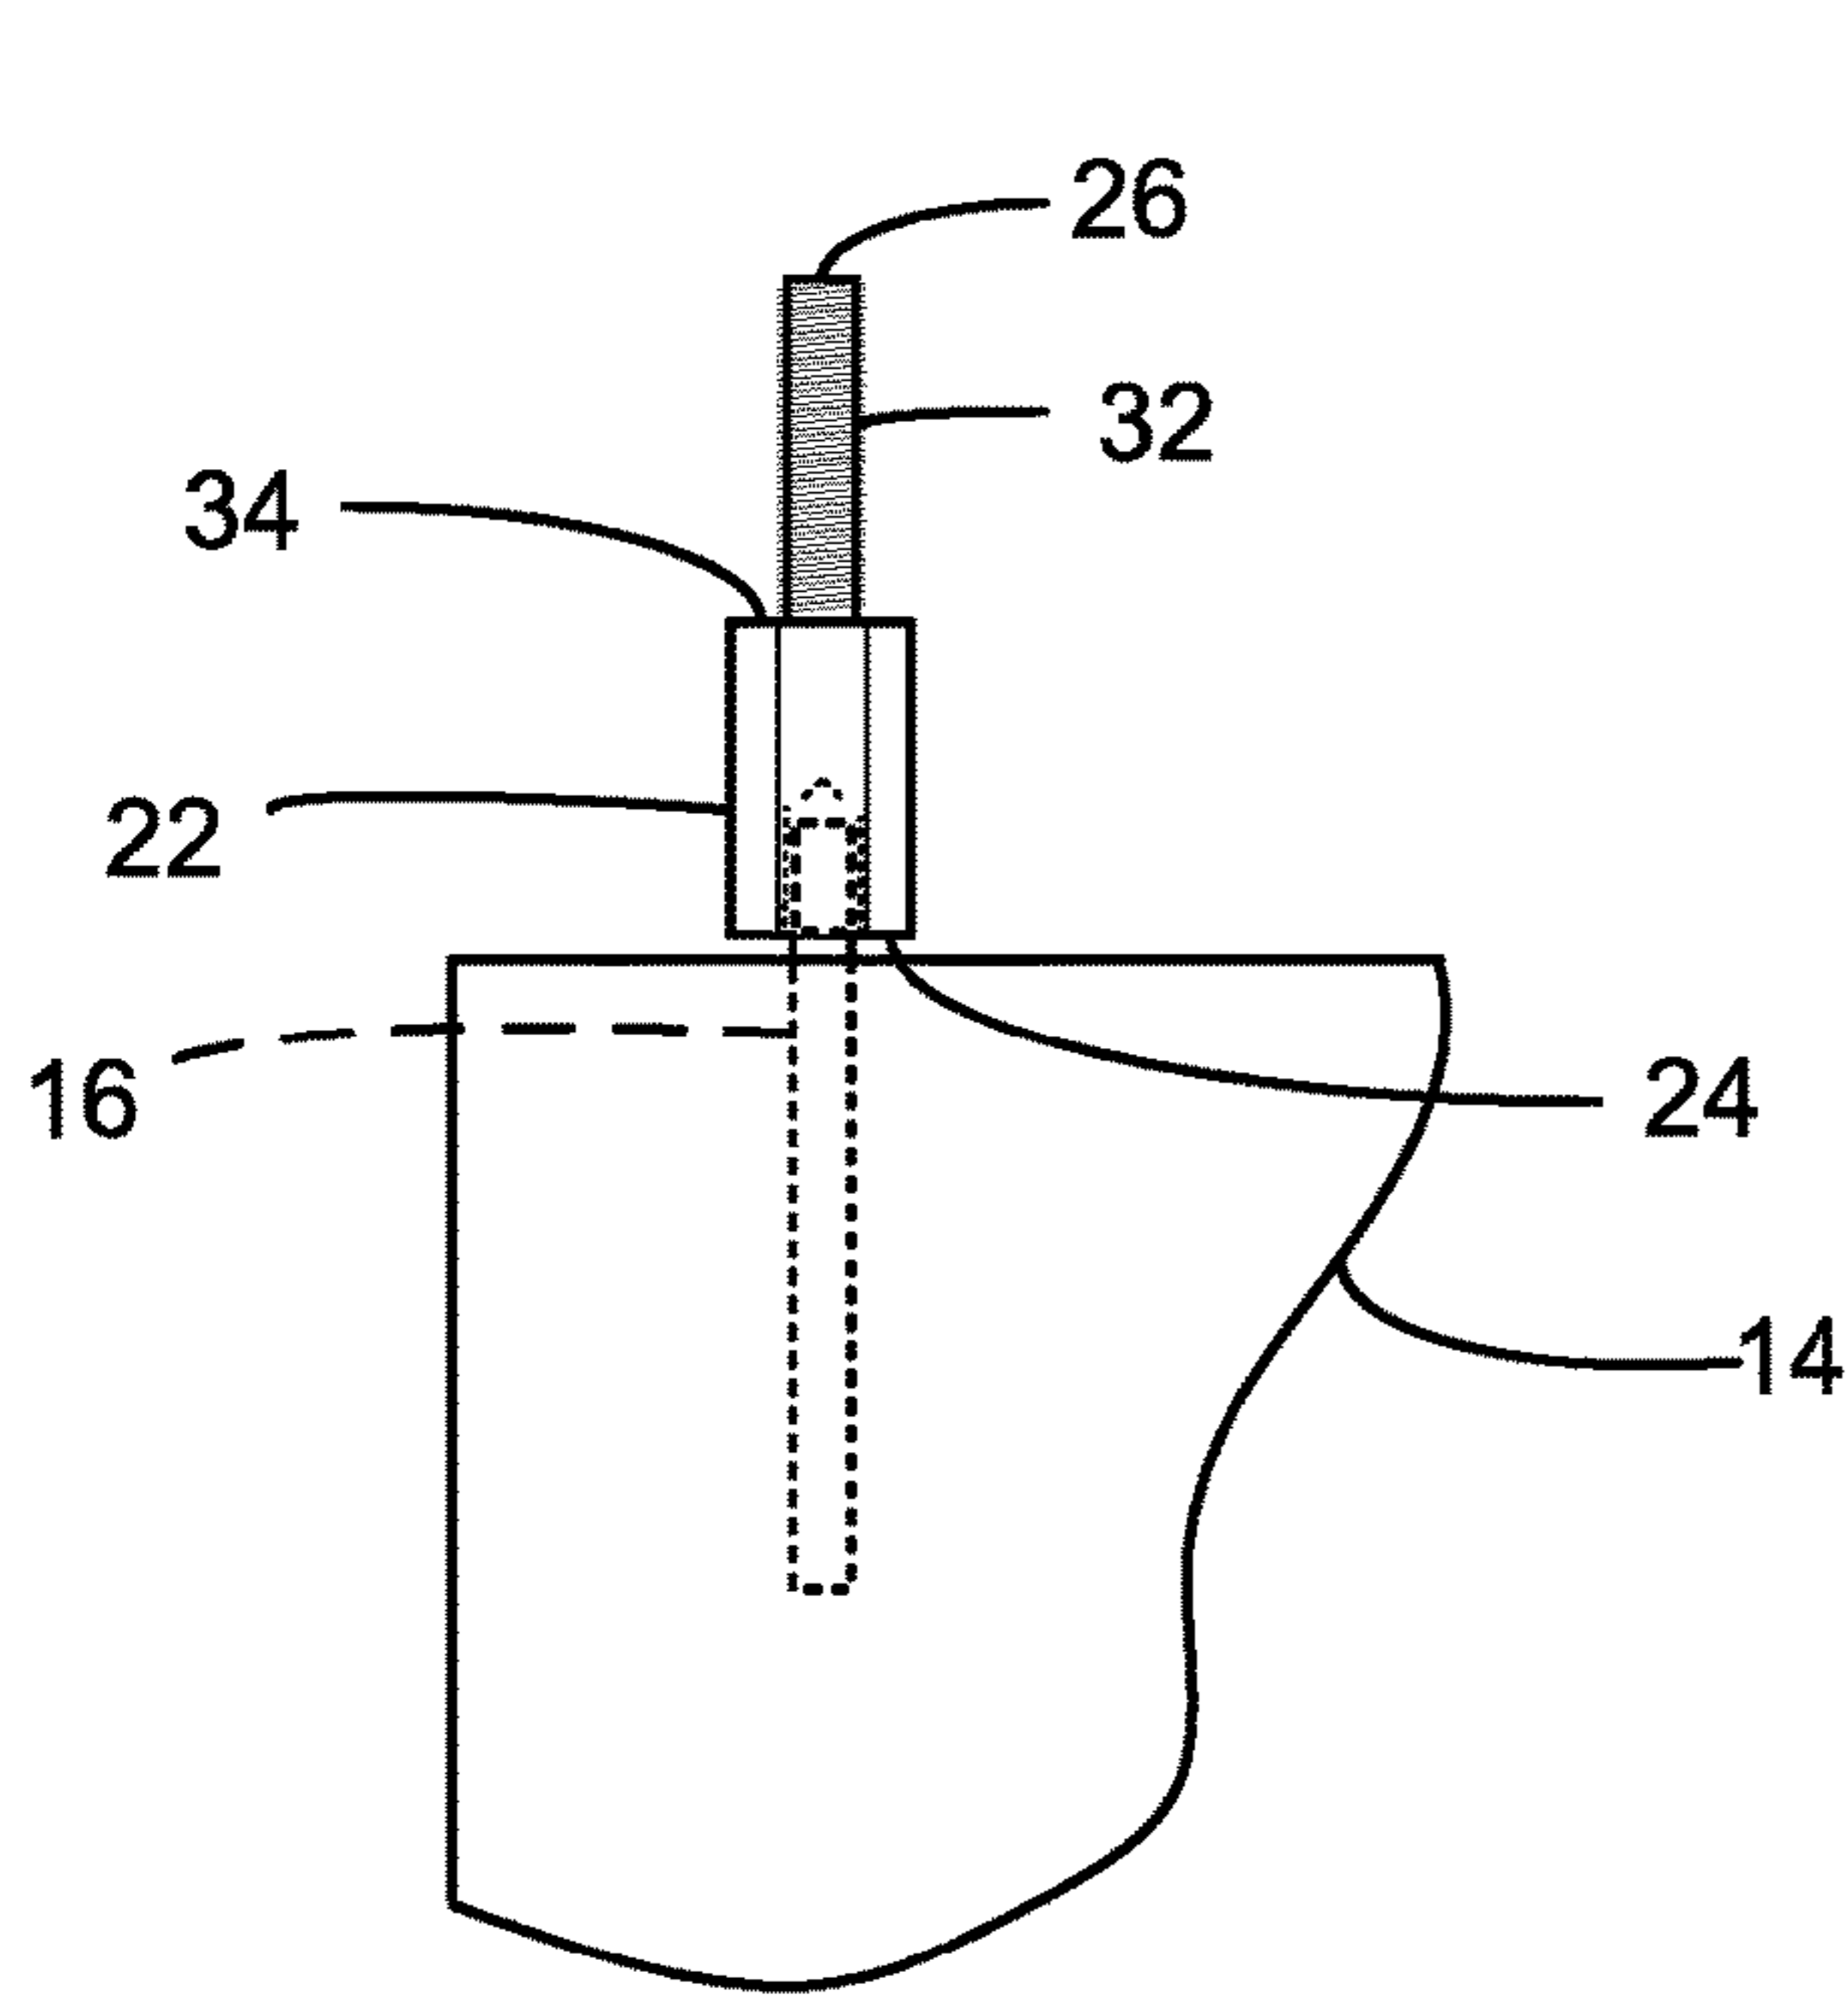
Fig 9

FIG. 9 is a view similar to FIG. 6, but with the bolt extender of FIGS. 7 and 8 installed, in the next step for correcting the issue of the short, threaded rod;

In FIG. 9, the bolt extender 22 of FIGS. 7 and 8 has been partially threaded onto the threaded foundation rod 16 so that the shoulder 34 of the bolt extender 22 is at the correct elevation to ensure that the flange 12 will be horizontal and the pole 10 will be vertical upon final installation. The leveling nuts 18 that were on the other threaded foundation rods 16 remain on those rods 16 to ensure the proper vertical alignment of the pole 10. It may be advantageous to provide a flat plate (not shown) during installation, to temporarily replace the pole 10 and flange 12 for the purpose of checking that the leveling nuts 18 are properly threaded into their respective rods 16 to ensure that the flat plate is horizontally oriented (thus ensuring that the pole will be vertically oriented once installed) and that the bolt extender 22 and the leveling nuts 18 are sufficiently threaded over their respective rods 16 to provide ample remaining threads for full engagement of the threads of the tightening nuts 20.

Should any of the rods 16 prove to be too short for full engagement of the threads of its respective tightening nut 20, the bolt extender 22 may be threaded farther down onto its rod 16 to lower the elevation of its shoulder 34, and all the other leveling nuts 18 would then also be threaded farther down their respective rods 16 until all rods 16 provide full engagement of the threads of the tightening nuts 20.

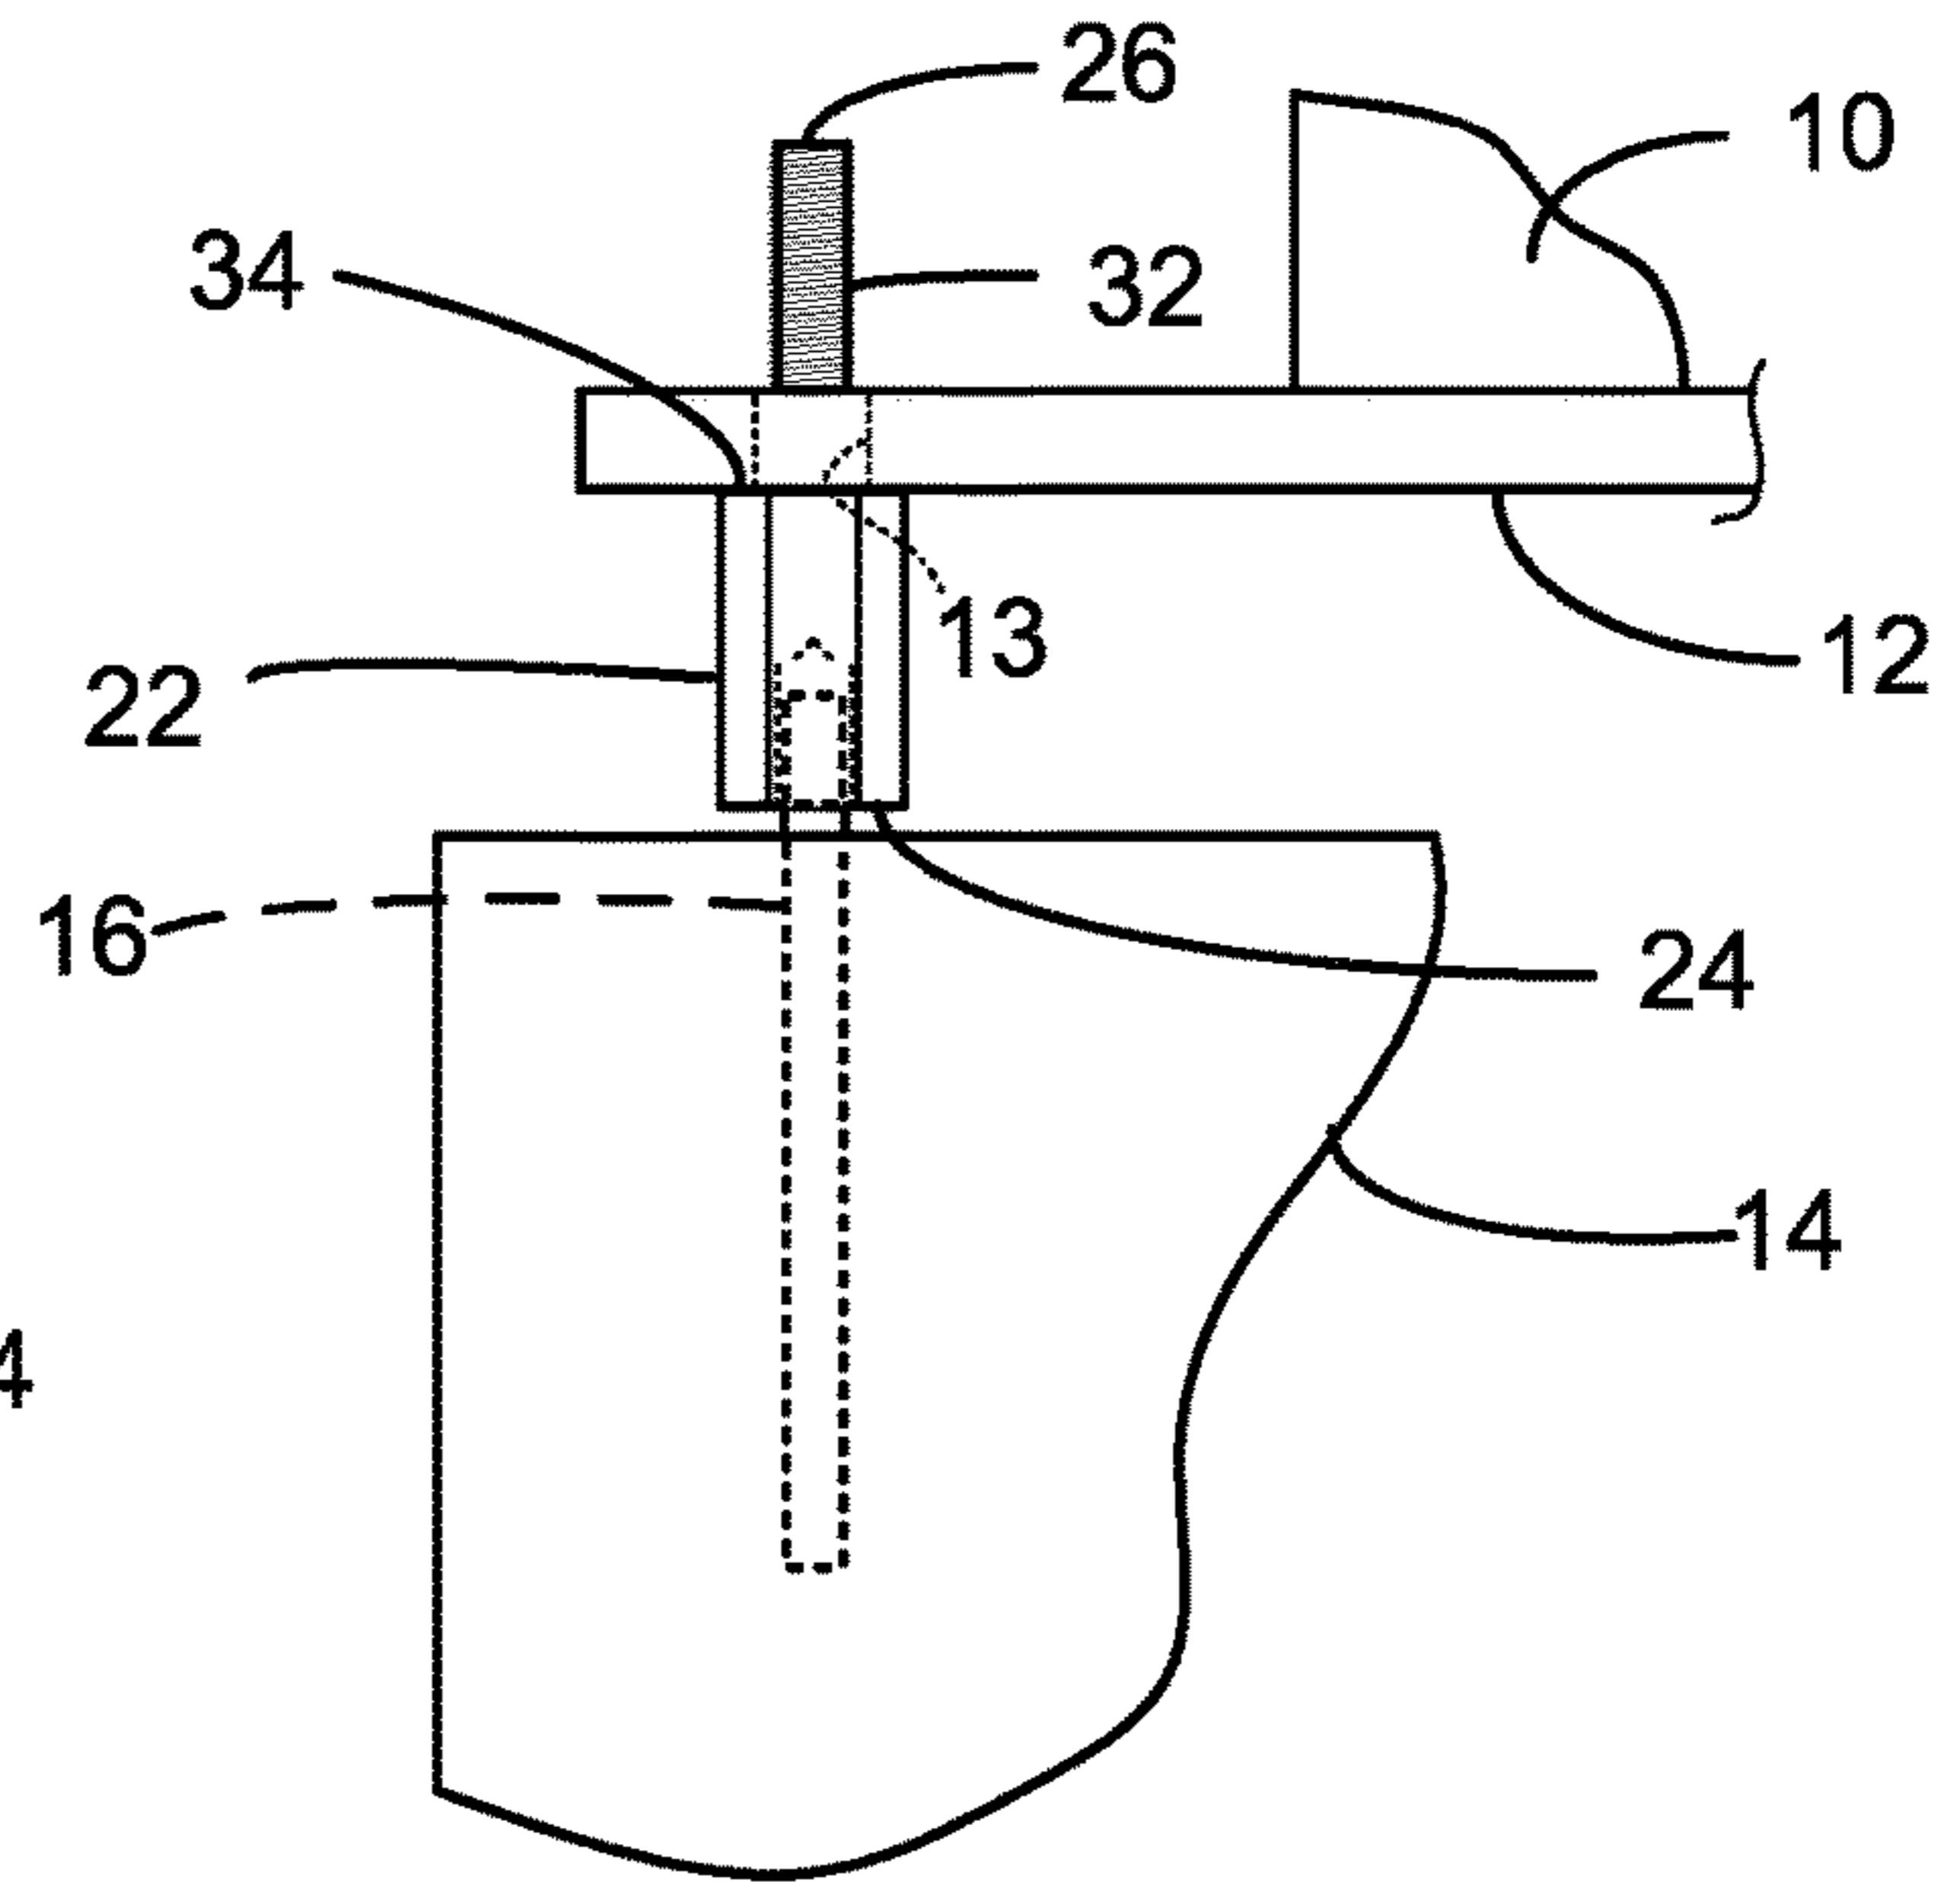
Fig 10

FIG. 10 is a view similar to FIG. 9, with the flanged pole reinstalled, in the next step for correcting the issue of the short, threaded rod;

Once the leveling nuts 18 are properly threaded onto their respective rods 16 so that the tops of these leveling nuts 18 are at the same elevation as the shoulder 34 on the bolt extender 22, the pole 10 with its flanged base 12 is mounted so that the flanged base 12 rests atop the shoulder 34 and atop the leveling nuts 18, as shown in FIG. 10. After confirming that the pole 10 is vertically aligned, the tightening nuts 20 are threaded onto their corresponding rods 16 or bolt extender 22, as shown in FIGS. 11 and 12. Once more, the installation is checked to make sure the pole 10 is vertically aligned and that there is full engagement of the threads on all the tightening nuts 20.

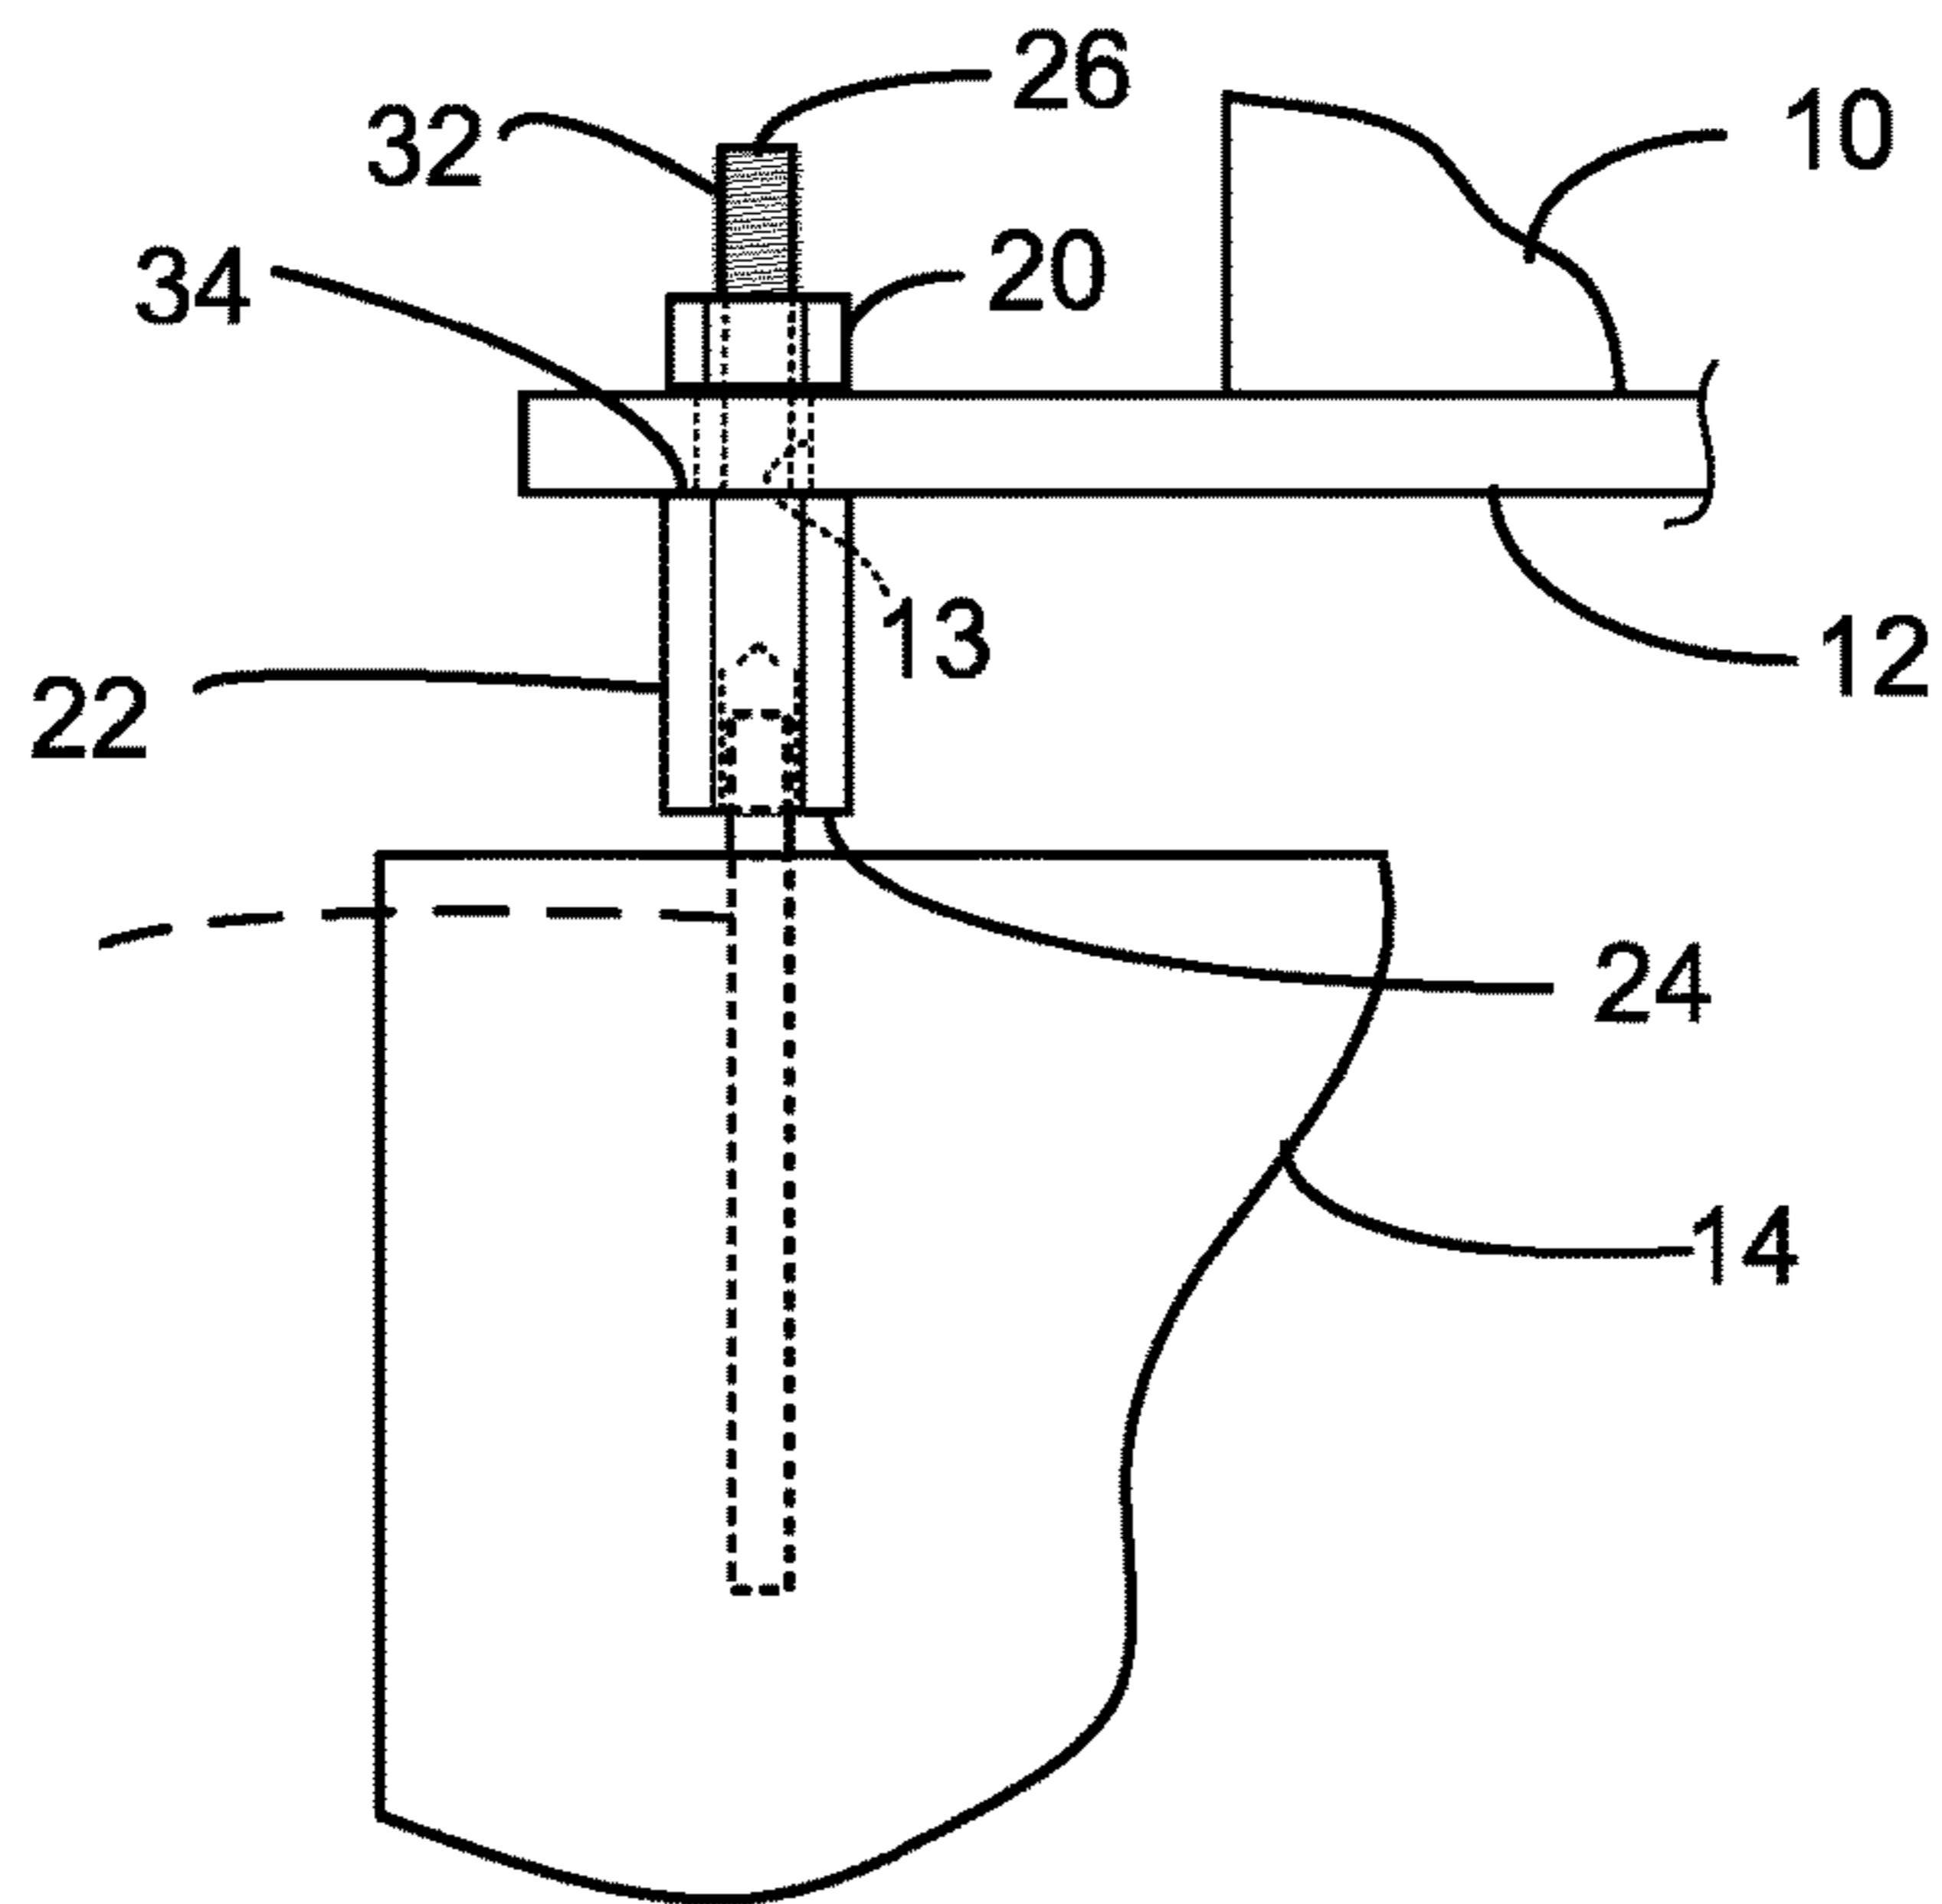
Fig 11

FIG. 11 is a view similar to FIG. 10, with the tightening nut reinstalled, in the last step for correcting the issue of the short, threaded rod, and
